**Photographic Log,  
CES Environmental Services Facility Site Visit,  
Houston, Texas**

The following photographs were taken and described by Terry Andrews, Remediation Division, Texas Commission on Environmental Quality (TCEQ), while visiting the CES Environmental Services (CES) facility in Houston, Texas on September 2, 2014, from approximately 12:40 to 2:25 PM. The goal of this site visit was to evaluate the stormwater that is ponded on the site. Mr. Andrews was accompanied during the visit by Gary Moore, OSC, EPA Region 6 ER.

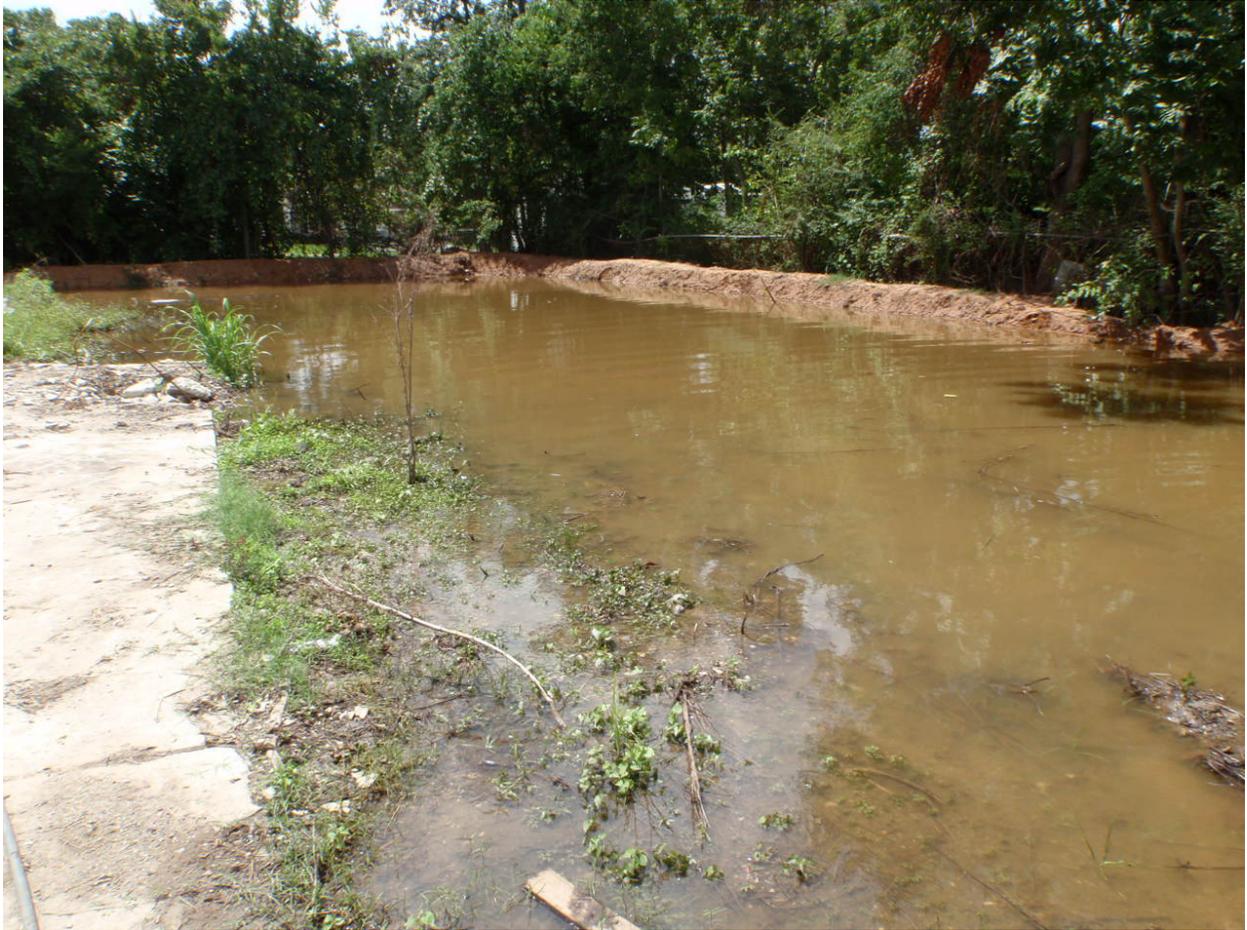
**Photograph #1, September 2, 2014 – View looking southwest at stormwater ponded along earthen berm in the southwest corner of the CES site.**

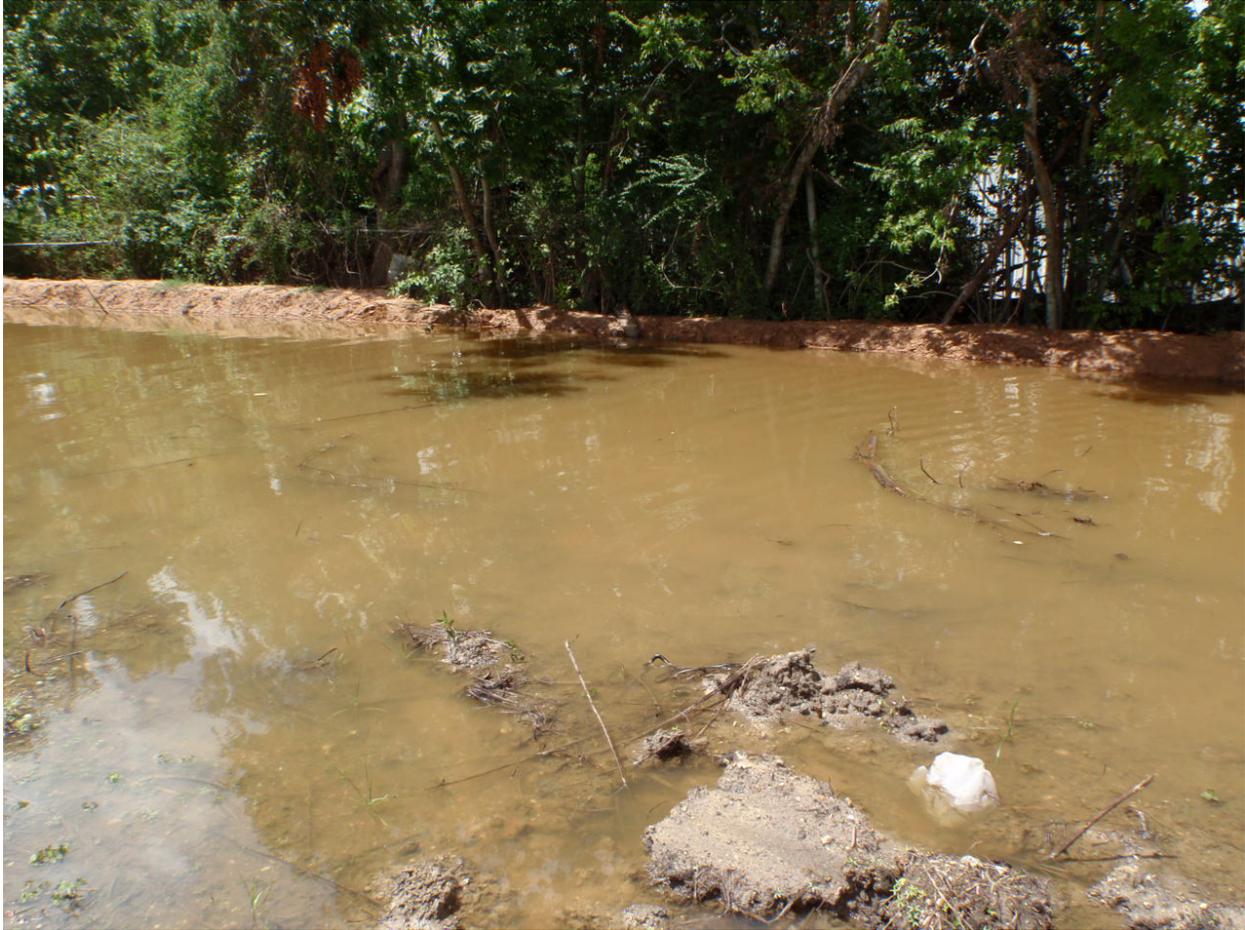
**Photograph #2, September 2, 2014 – View looking west at stormwater ponded along earthen berm in the southwest corner of the CES site. Note that in the shadowed area near the center of the photograph, there is only 9-10 inches of freeboard available.**

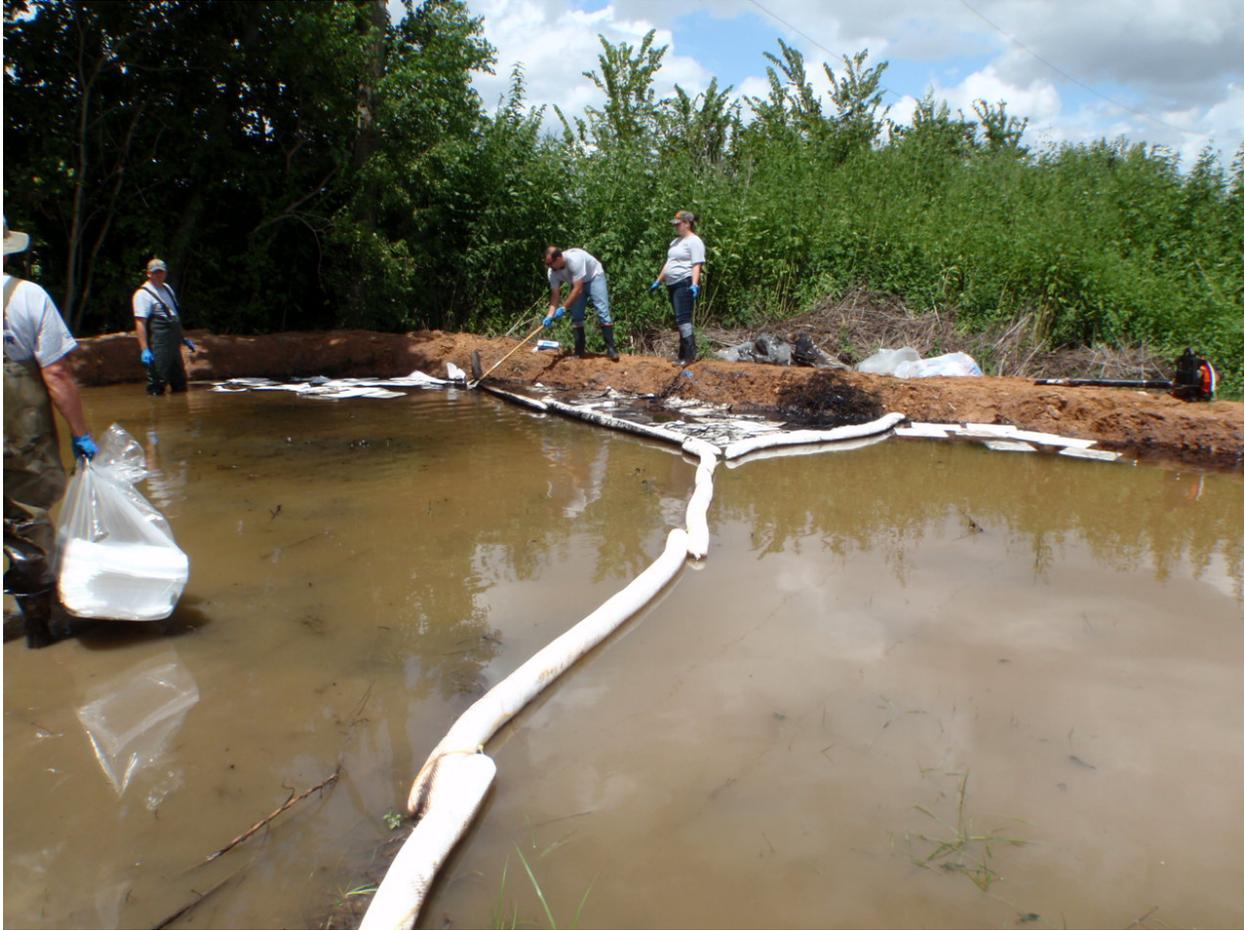
**Photograph #3, August 2, 2014 - View looking northwest at team removing oil from the surface of the stormwater that is ponded against the berm. The team thought that the oil was coming from either the berm or soils under the berm.**

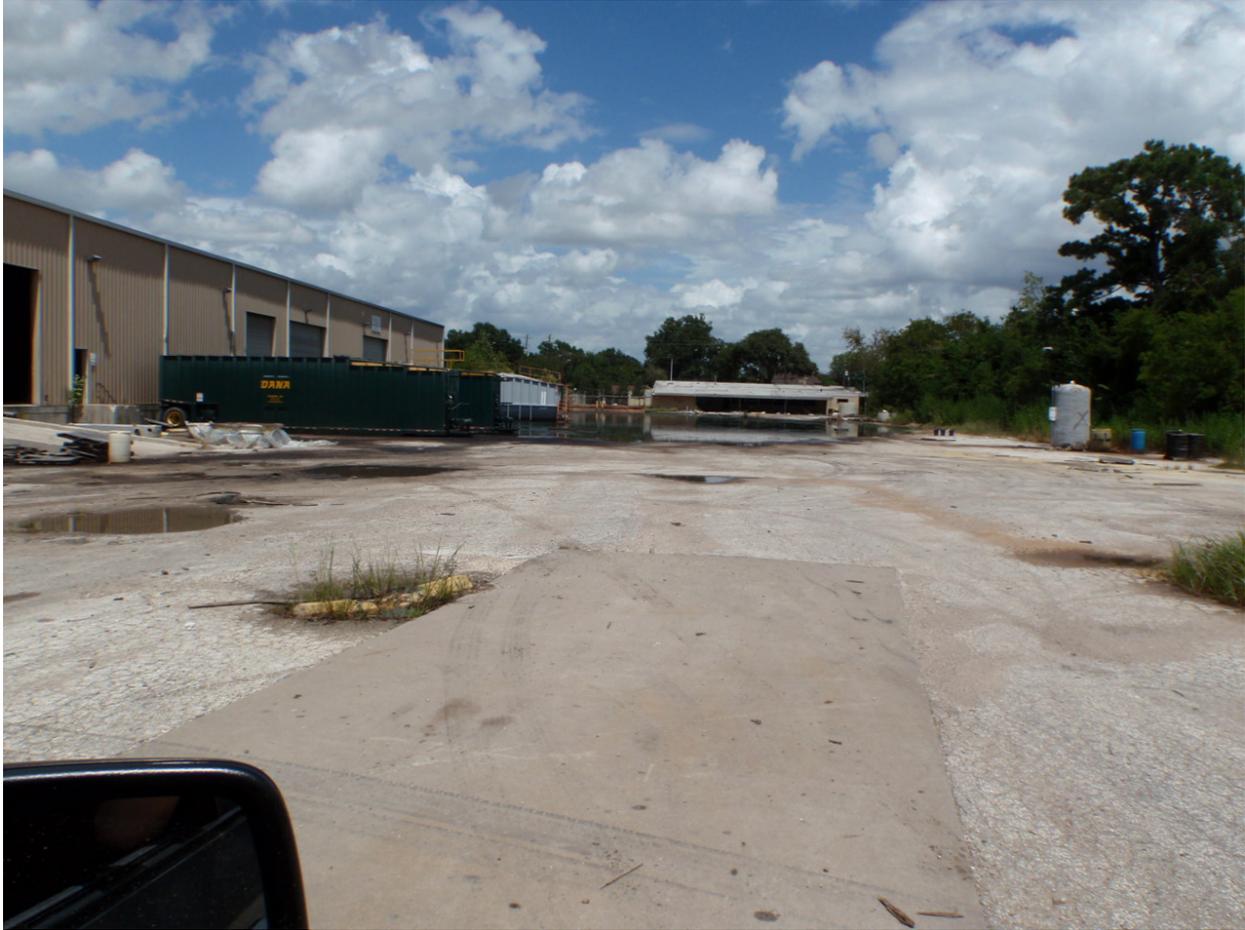
Photograph #4, September 2, 2014 – View looking north at stormwater ponded in the north part of the site.

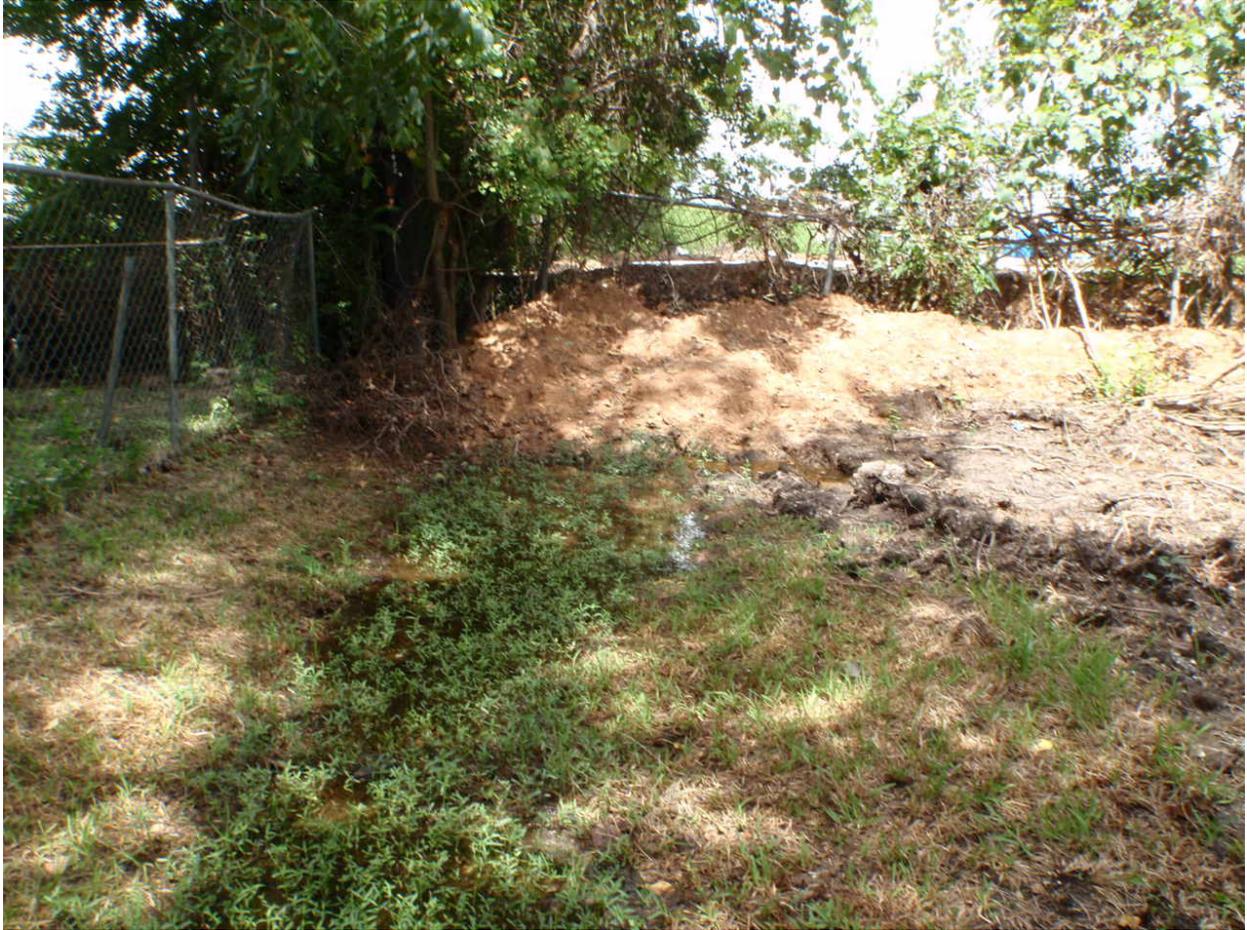
Photograph #5, September 2, 2014 – View looking north from residential property located south of the earthen berm. The fenceline (with trees and in the middle of the berm) separates the CES property from the residential property. There was no visible staining, sheen or oil on the water in the drainage ditch.
