CES Environmental
Services, Inc.
HOUSTON, TX

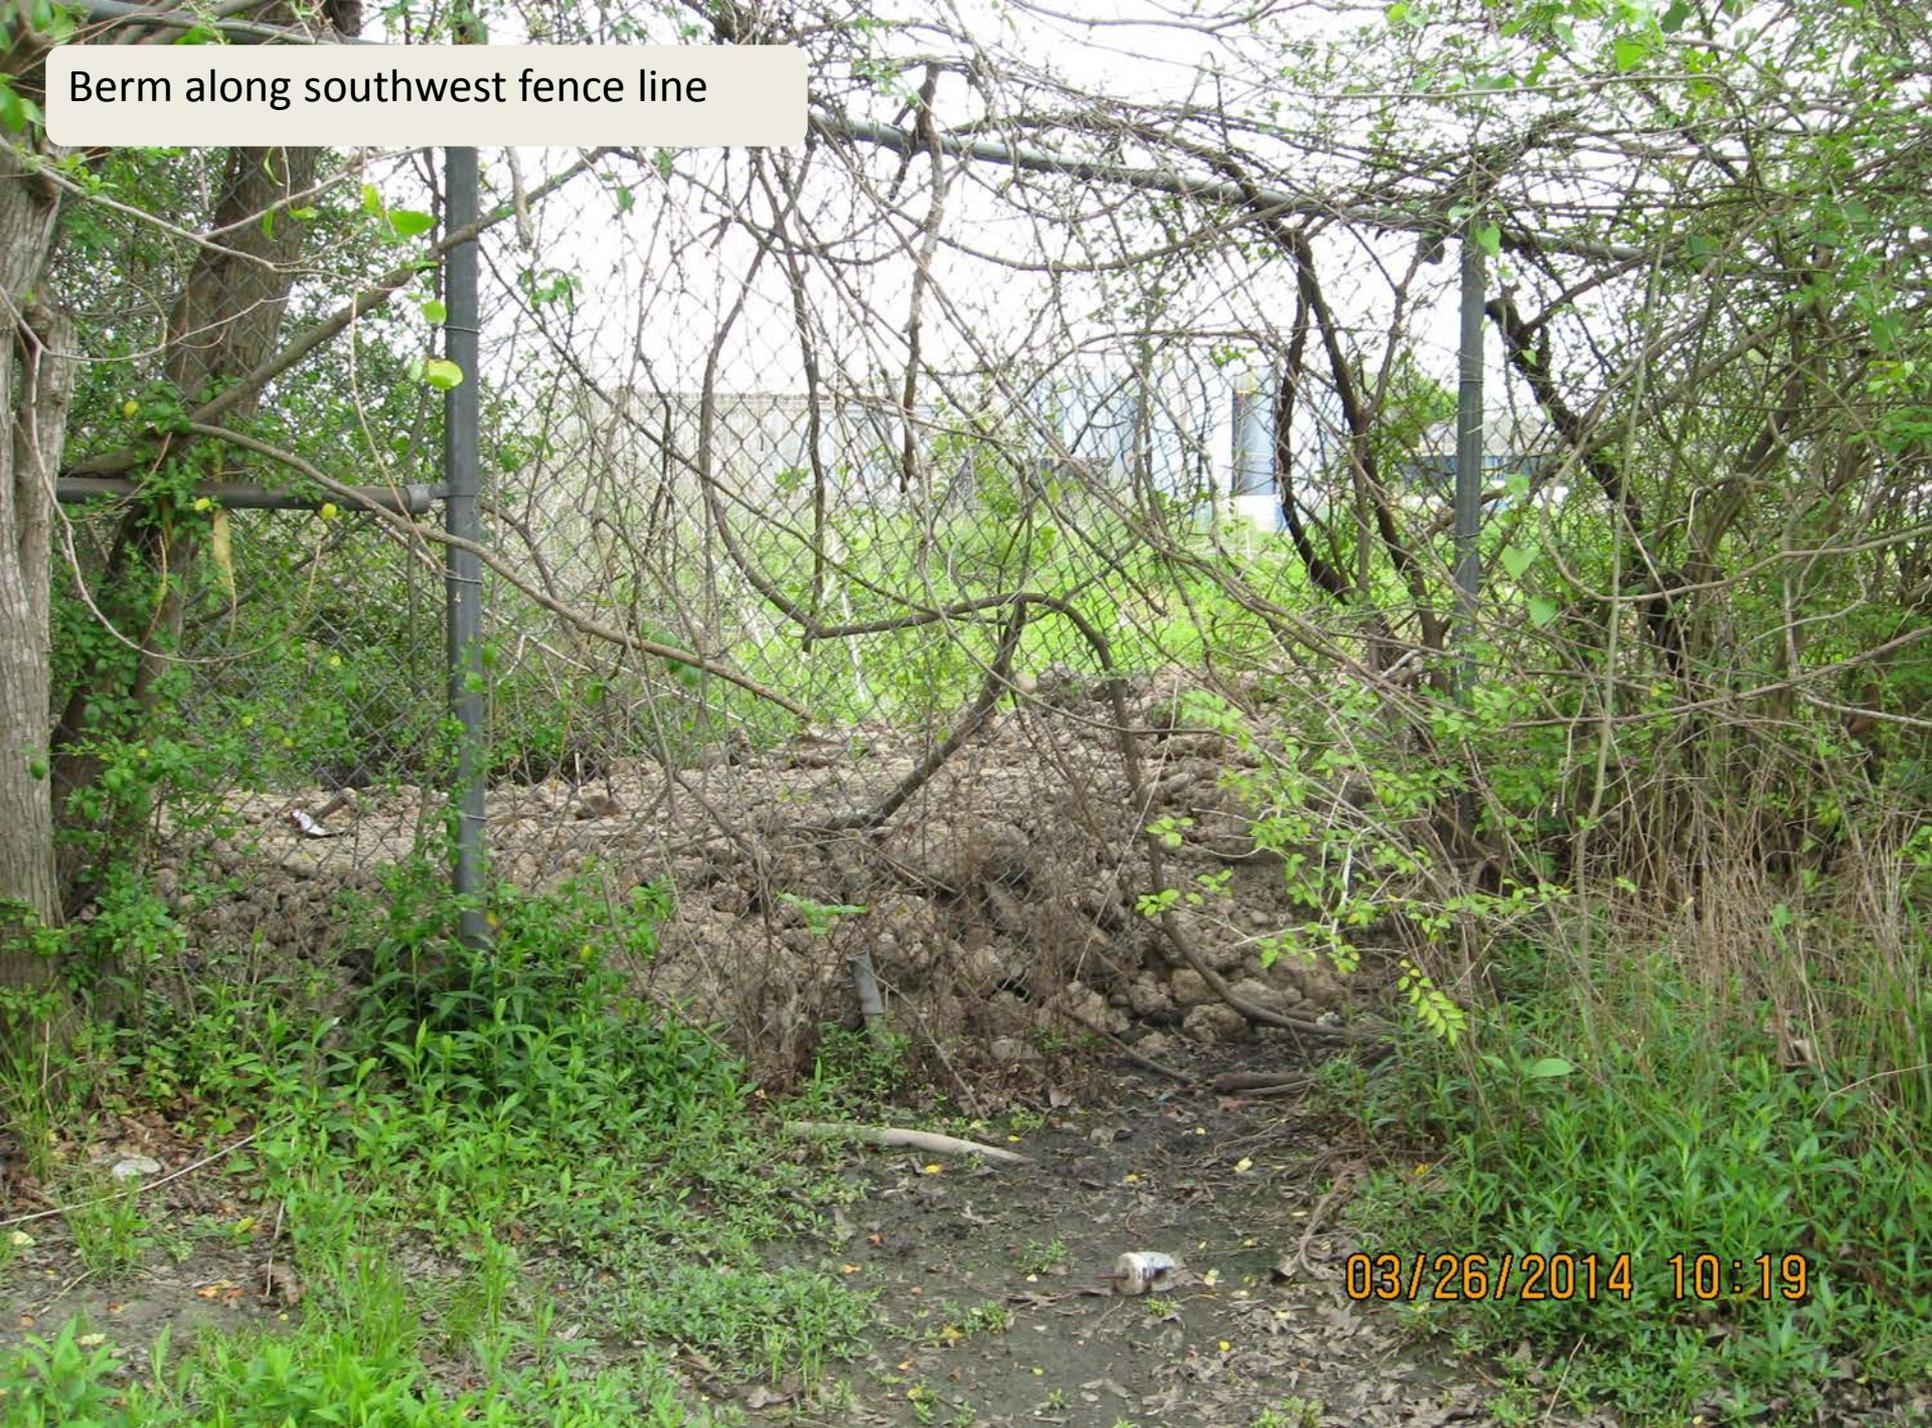
Berm along southwest fence line

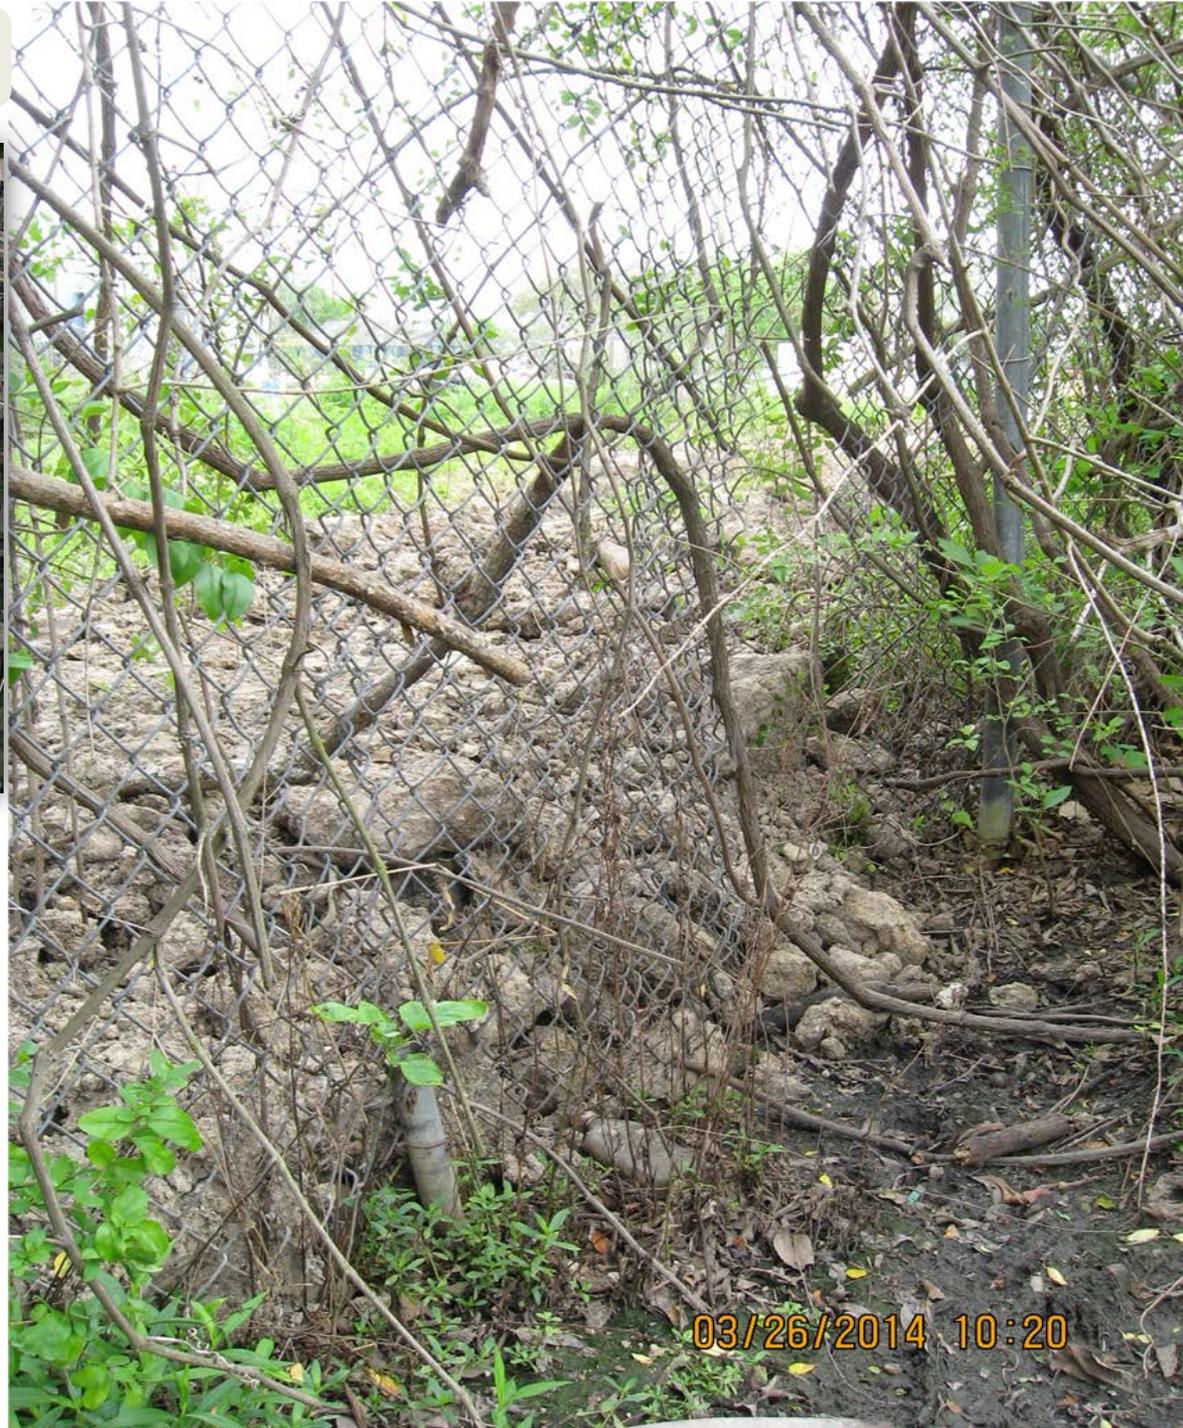
Berm along portion of west fence line
