Re: Addendum to the Demolition Work Plan
Former ASARCO-Encycle Demolition Project

**Re: Structural Integrity Assessment of Smoke Stack
Former Encycle/Texas, Inc. /ASARCO Facility (Encycle)
5500 Up River Road
Corpus Christi, Nueces County, Texas**

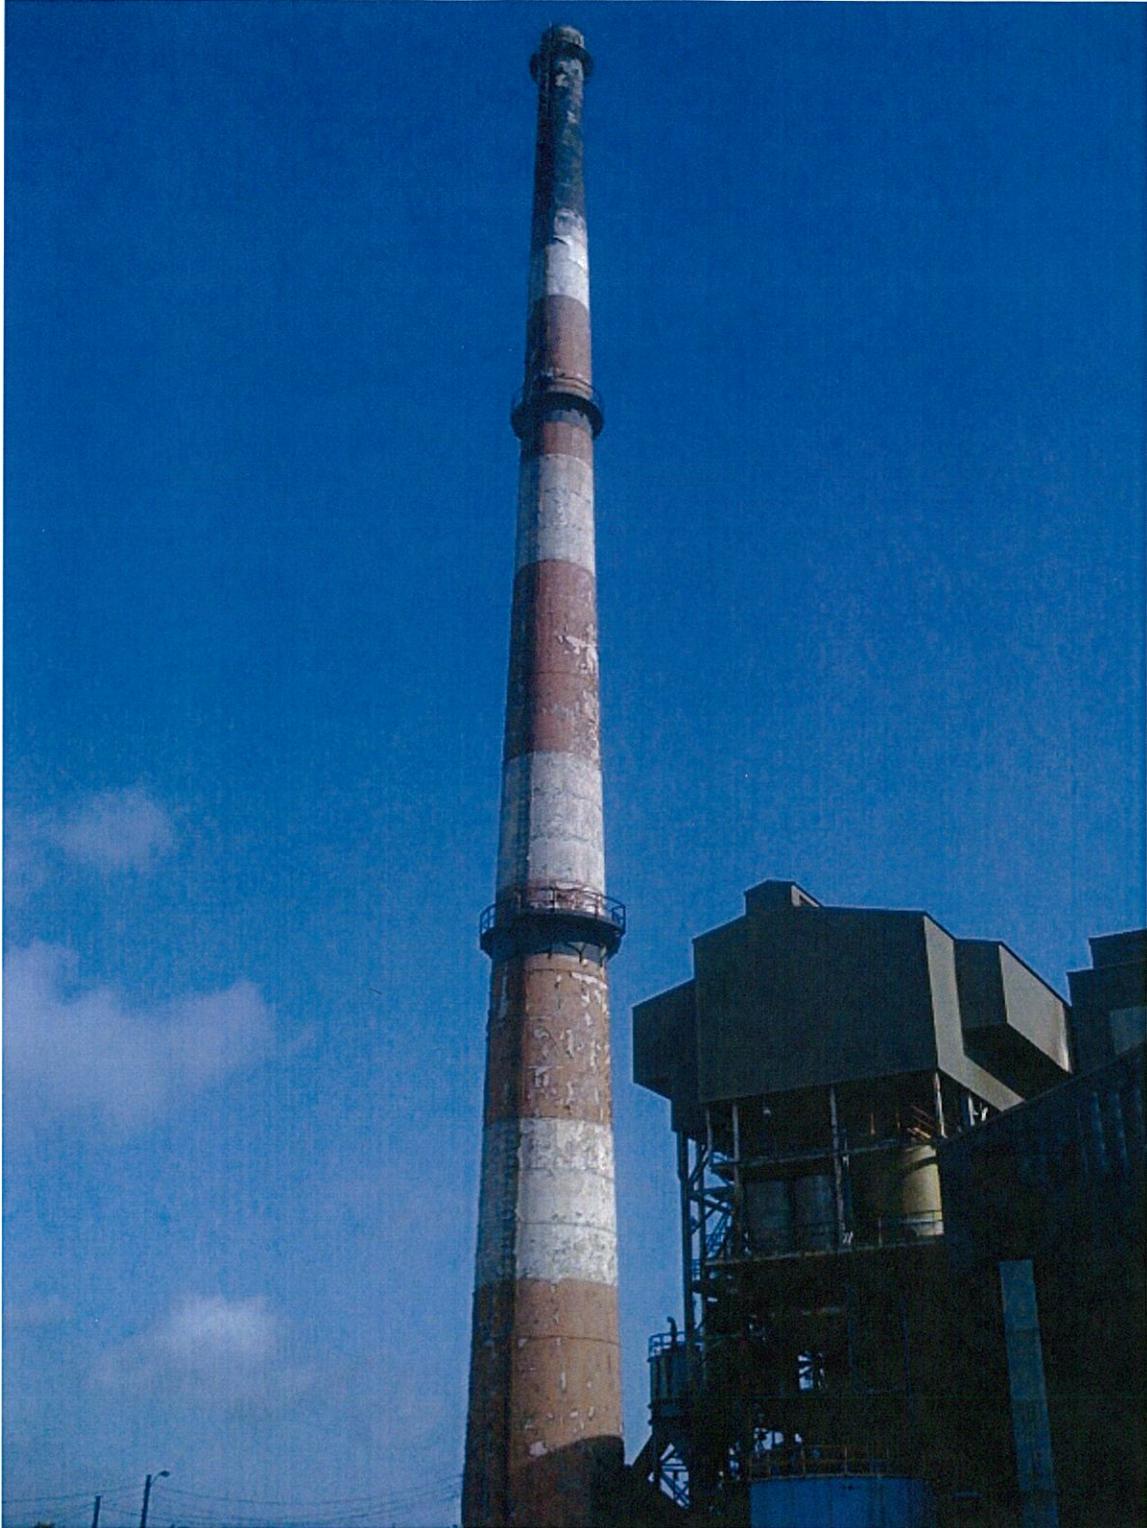
The smoke stack is reportedly 315 feet tall and is located near the western most part of the referenced site. It varies in diameter from approximately 21'-4" to reportedly 8 to 10 feet at the tip (Photo 1). The exterior face of the stack is exposed concrete with alternating layers of paint coating which is in various stages of peeling. The interior face of the stack is lined with masonry with no visible concrete. There is a steel framed access hatch at the north elevation which is approximately 24" wide and 36" tall (Photo 2). The thickness of the wall of the smoke stack is approximately 32" at the access hatch (Photo 3). The steel framed access hatch is framed within a masonry opening that is approximately 55" wide and 96" tall (Photo 4). While at the site we attempted to determine the thickness of the concrete portion of the wall by removing a small portion of the brick masonry at the interior face of the smoke stack (Photo 5). We chipped approximately 4-6" but were unable to locate the concrete. Looking vertically while standing within the stack, there appears to be 7 or 8 "rings" that protrude slightly toward the inside of the stack as one looks toward the tip. There was insufficient light to determine if these rings were concrete or masonry.

Photo 1 – View of Smoke Stack Looking North

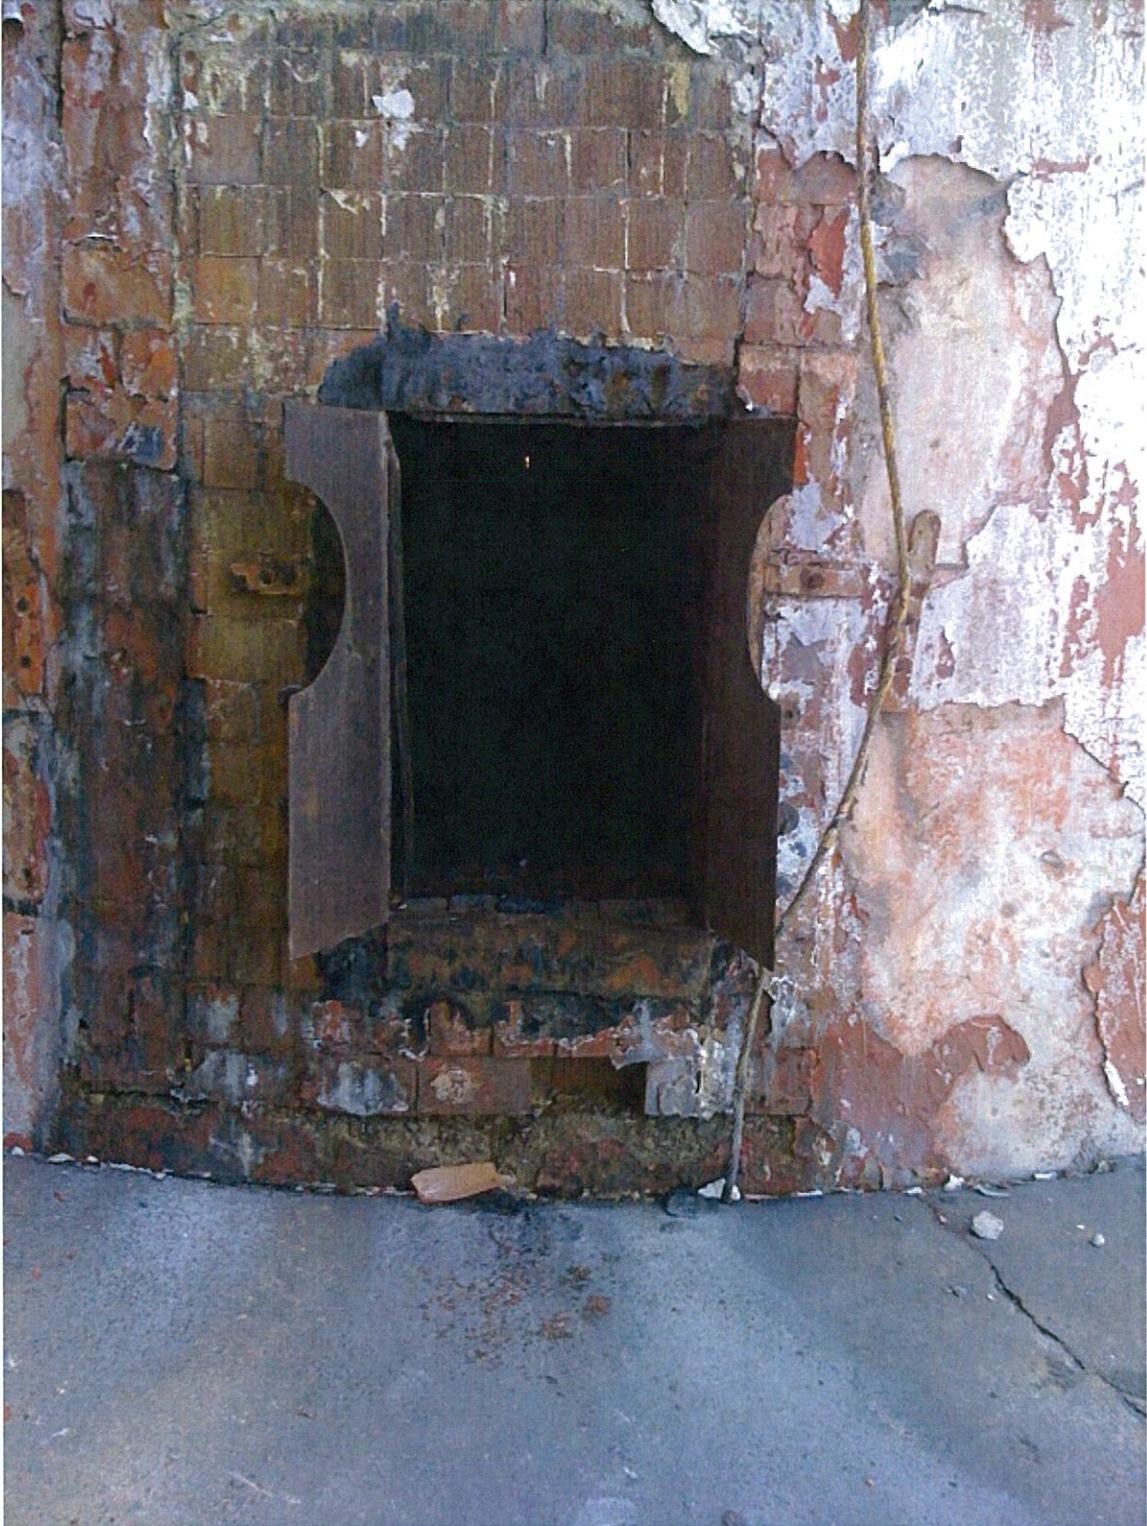
Photo 2 – View of Access Hatch at North Elevation of Smoke Stack

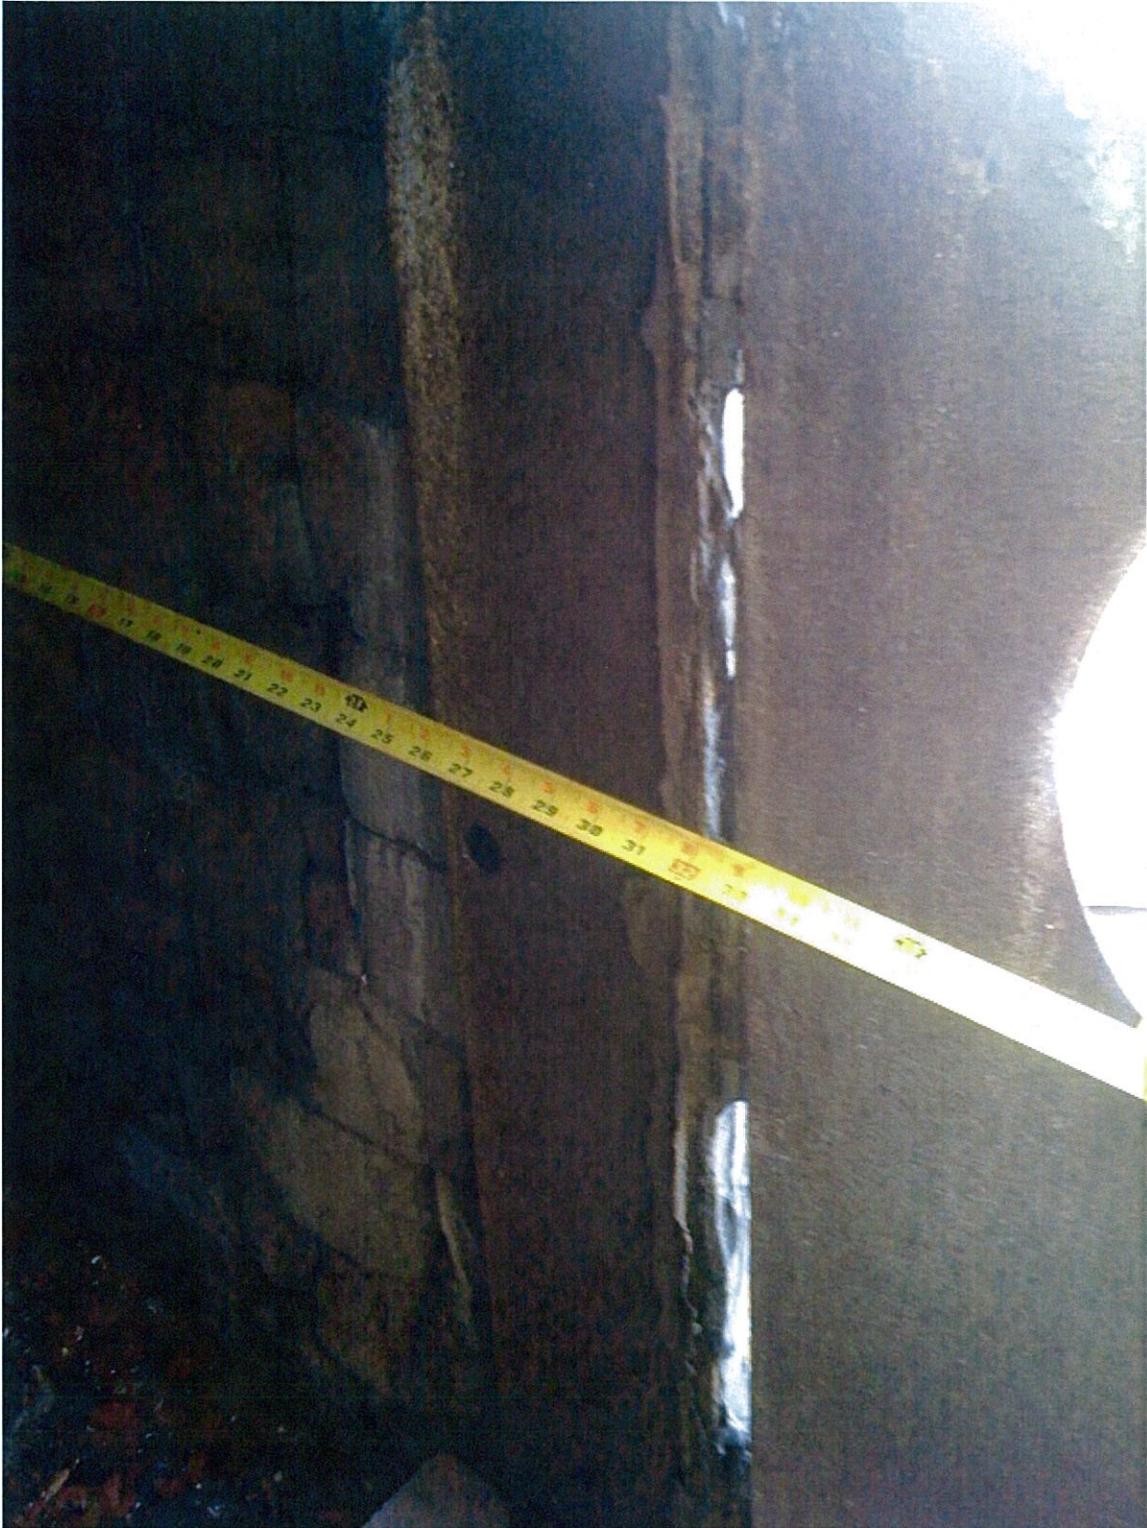
Photo 3 – View of Overall Wall Thickness of Smoke Stack Taken at Access Hatch at North Elevation

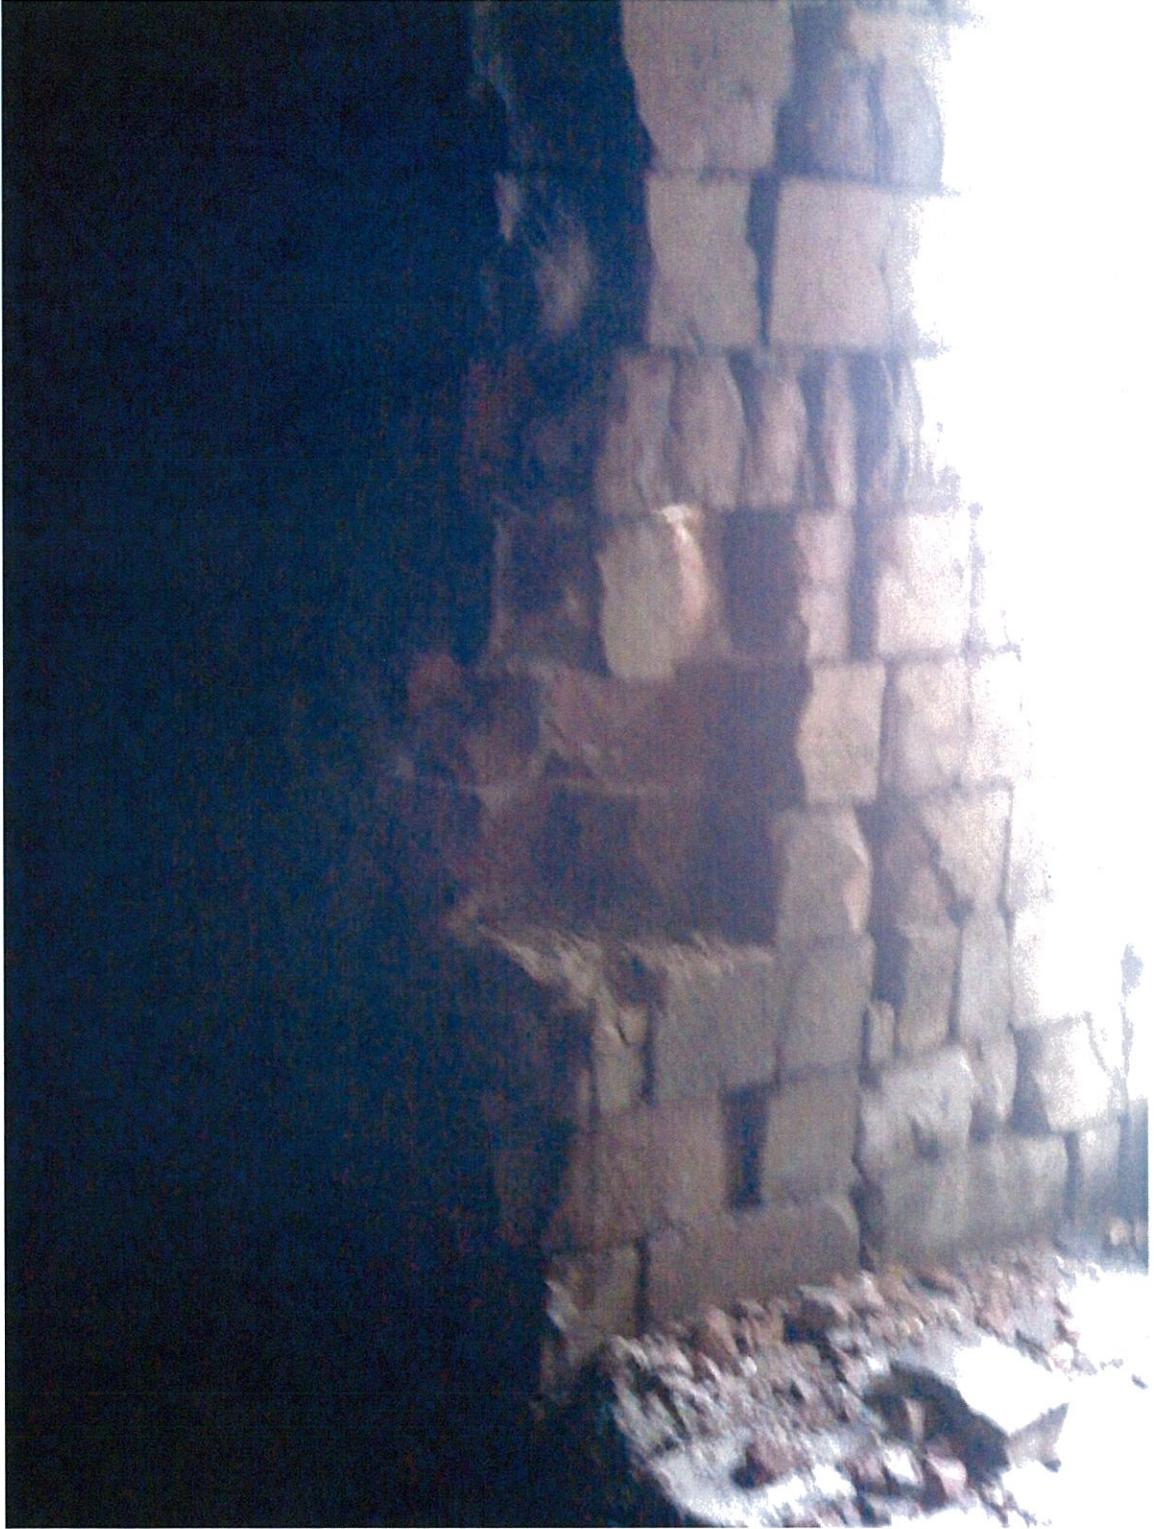
Photo 5 – View of Northwest Corner of Access Hatch Taken From Interior

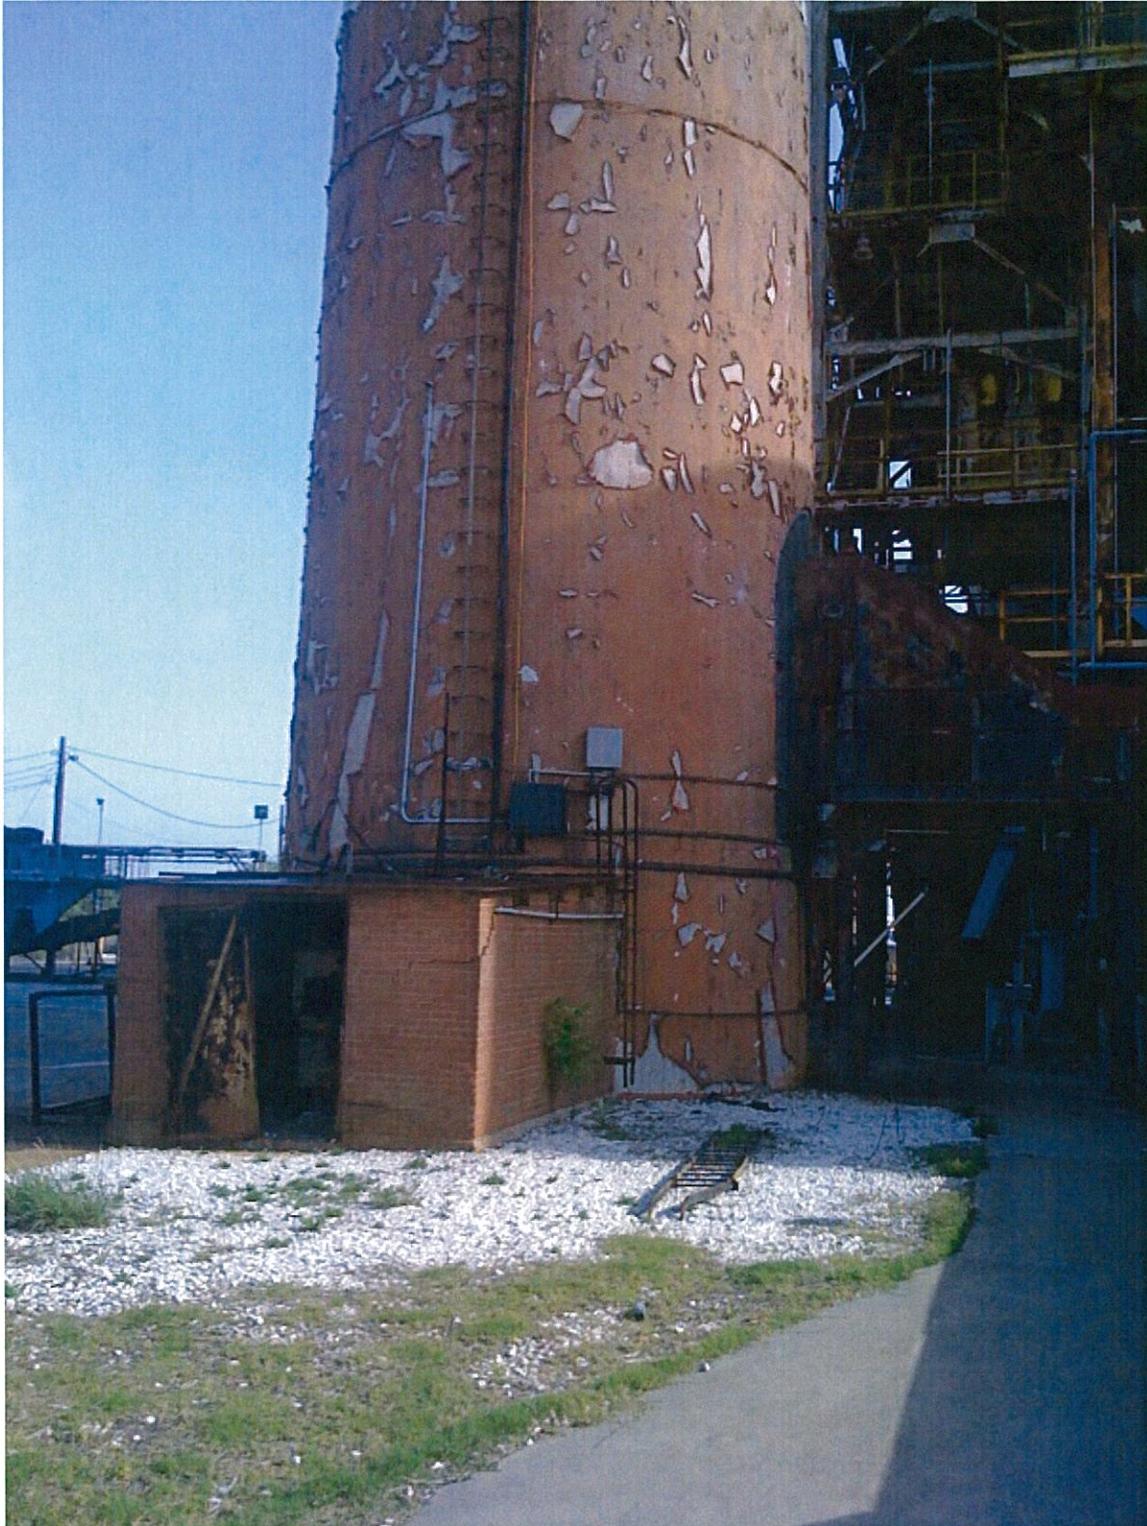
At the base of the smoke stack at the south elevation is a small exterior brick masonry enclosure with a small opening through the wall of the stack (Photo 6). Slightly above the base of the stack at the east elevation is an elevated structure which penetrates through the wall of the stack (Photo 7). The opening through the stack wall is approximately 9' wide and 11' tall, and is located approximately 9' above ground elevation.

Photo 6 – View of Base of Smoke Stack Taken at South Elevation Looking North

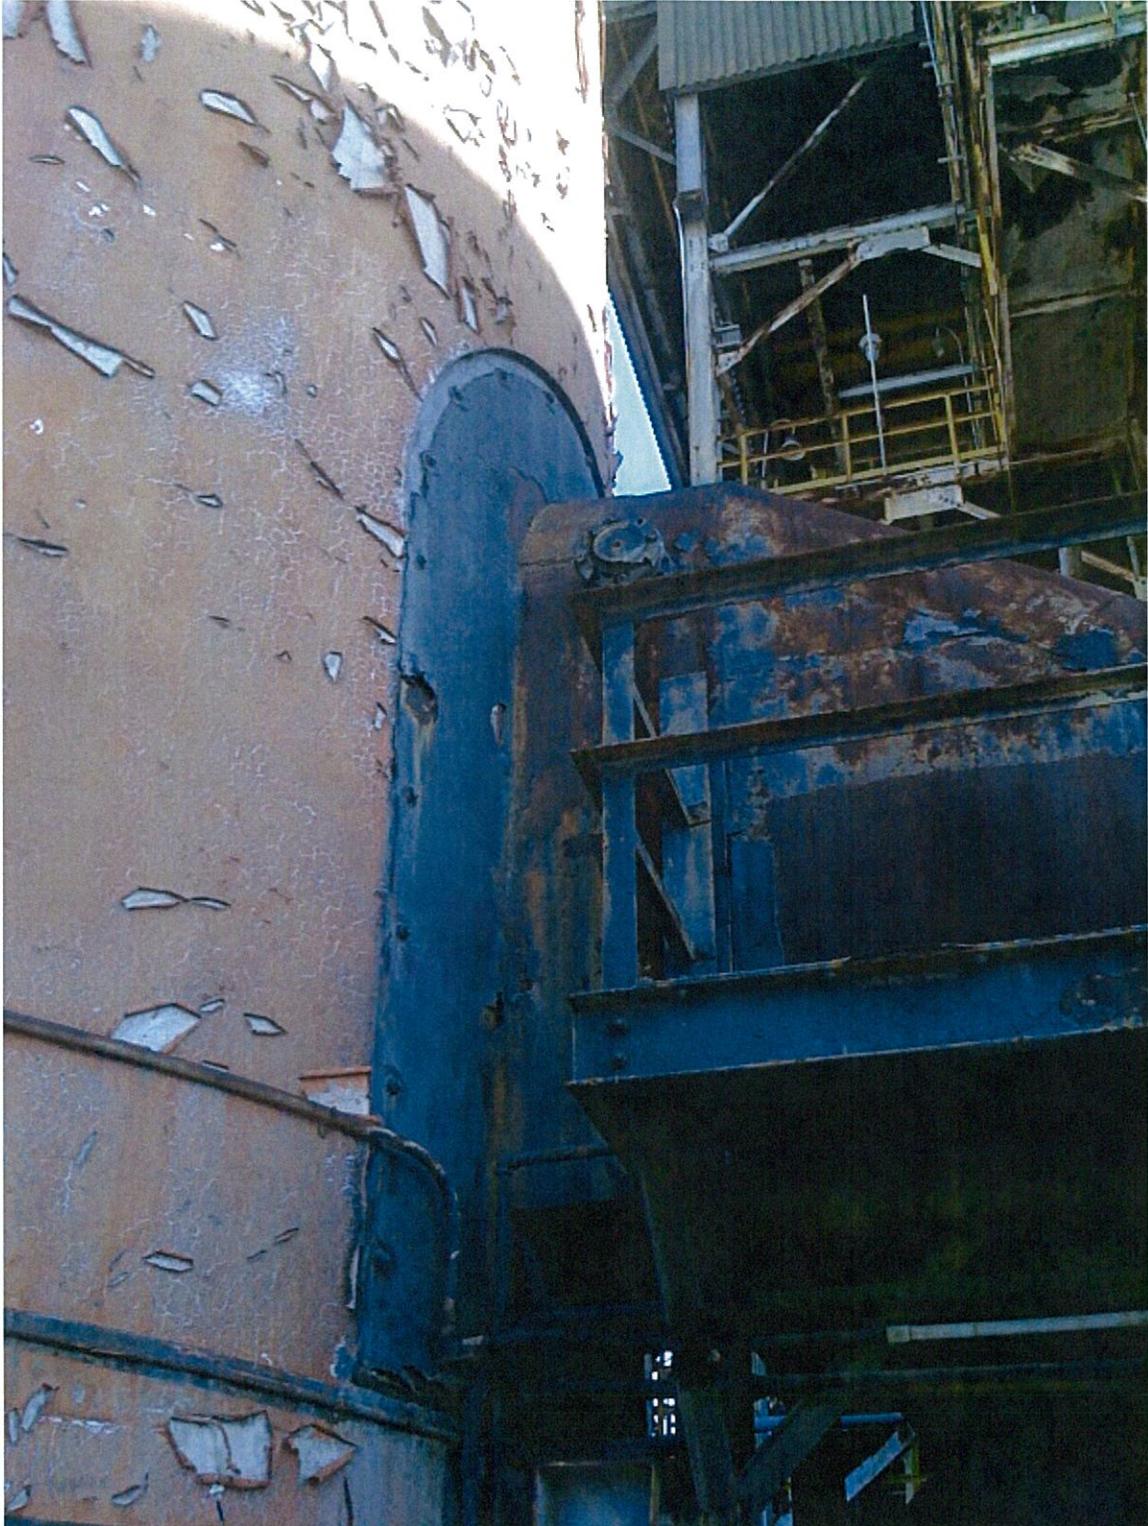
Photo 7 – View of Elevated Structured Opening at East Wall of Smoke Stack

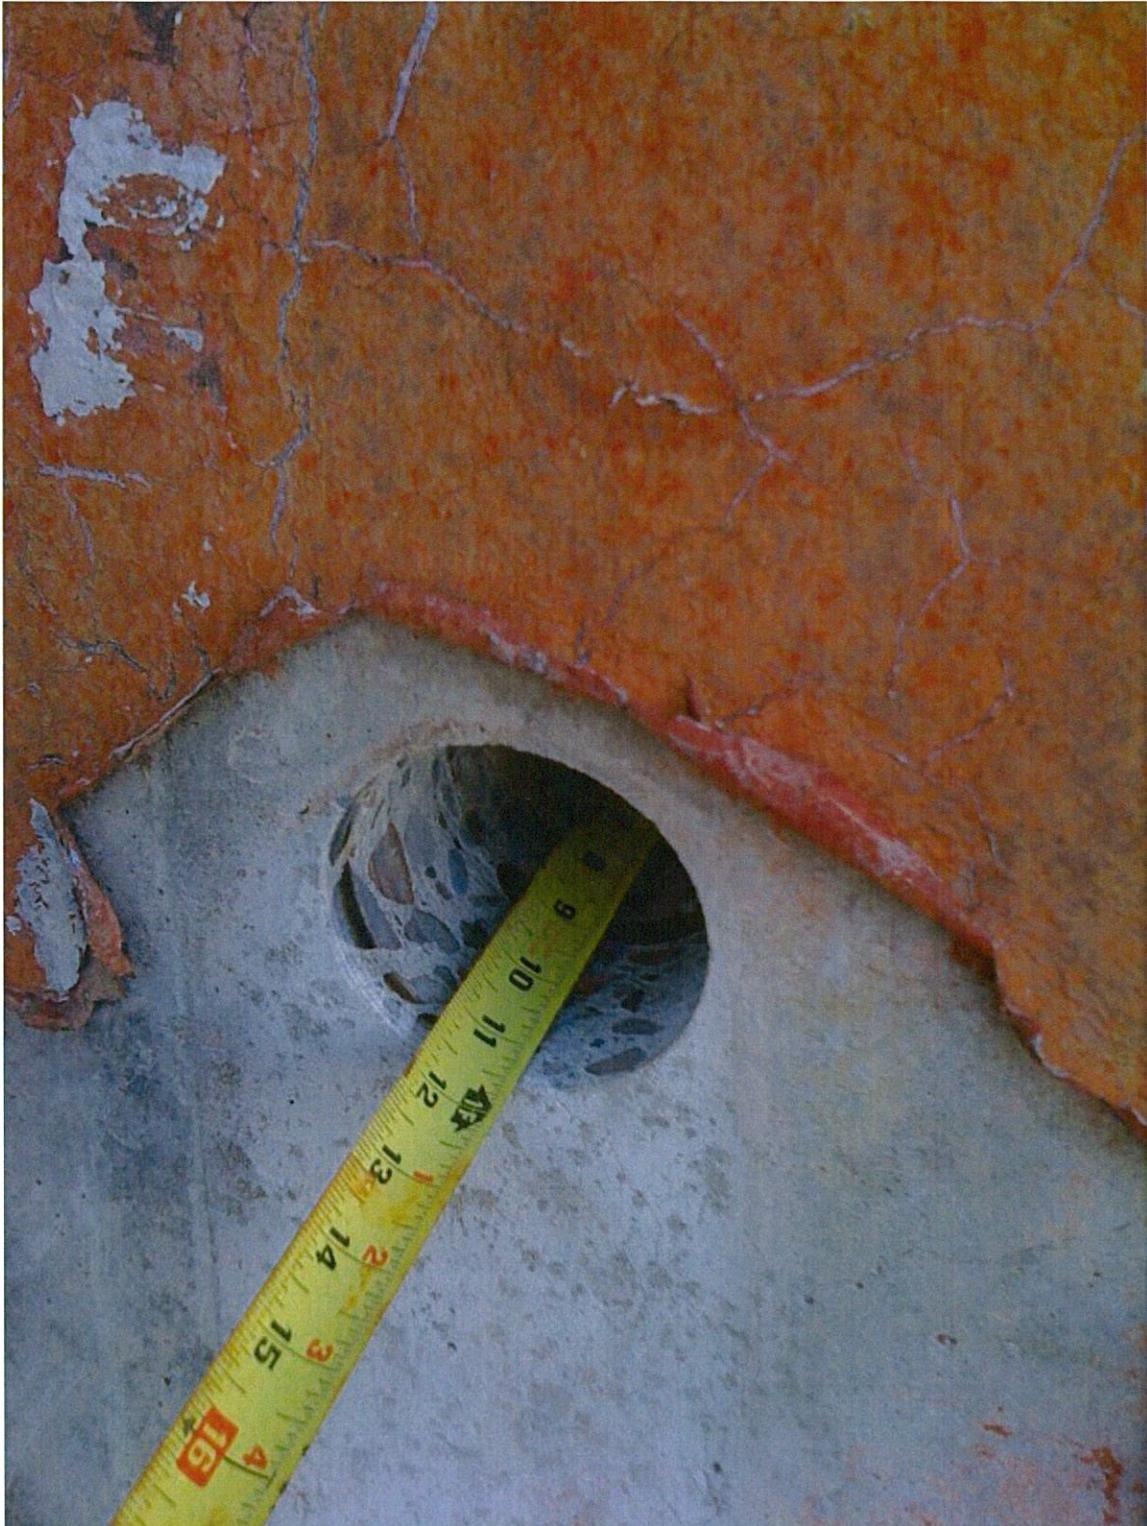
At the west elevation of the smoke stack there is evidence that a concrete core of a portion of the stack wall was taken (Photo 8). The core measures about 11½" deep. I understand the purpose of the core was for

environmental testing purposes. Visual appearance of the matrix of the concrete suggest concrete of good quality and strength. The core was taken through reinforcing which indicated 1" vertical reinforcing and 3/8" horizontal ties.

Photo 8 – View of Previously Taken Core of Wall at West Elevation of Smoke Stack

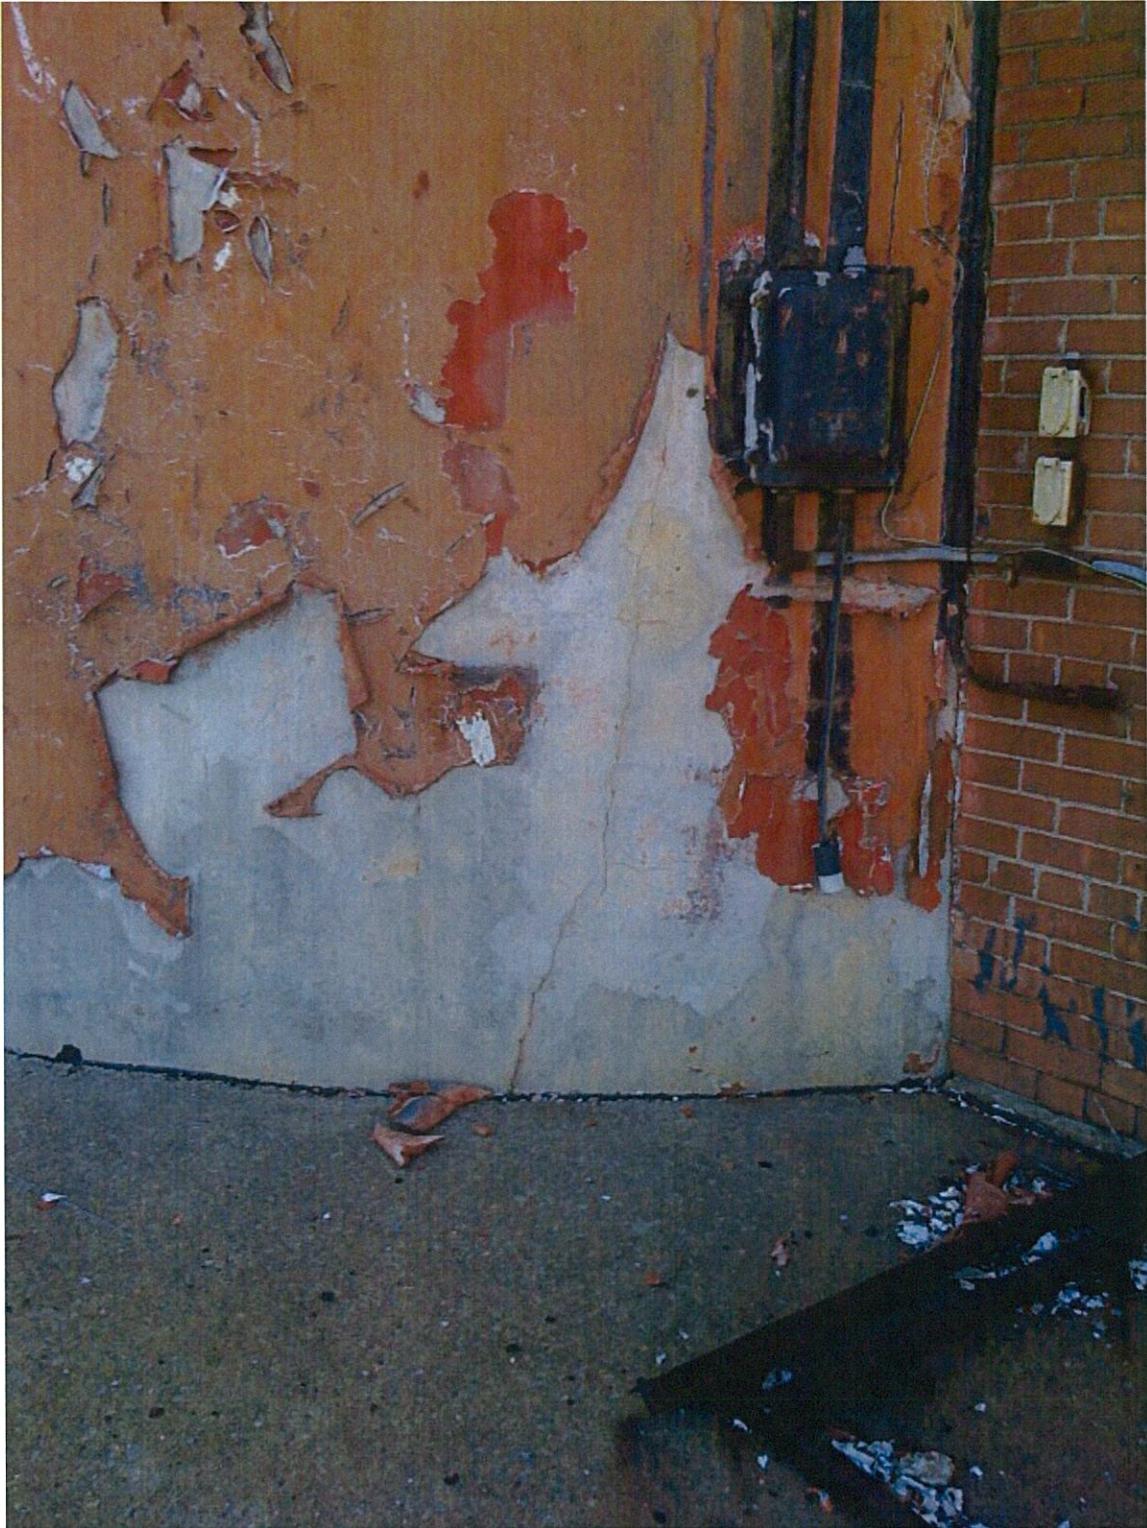
Near the southwest elevation of the smoke stack there is evidence of some thermal or temperature cracking near the base of the concrete wall (Photo 9). I do not believe this is a structural concern as it is likely related to normal shrinkage of concrete during the curing process.

Photo 9 – View of Hairline Cracking Near Base of Smoke Stack at Southwest Elevation

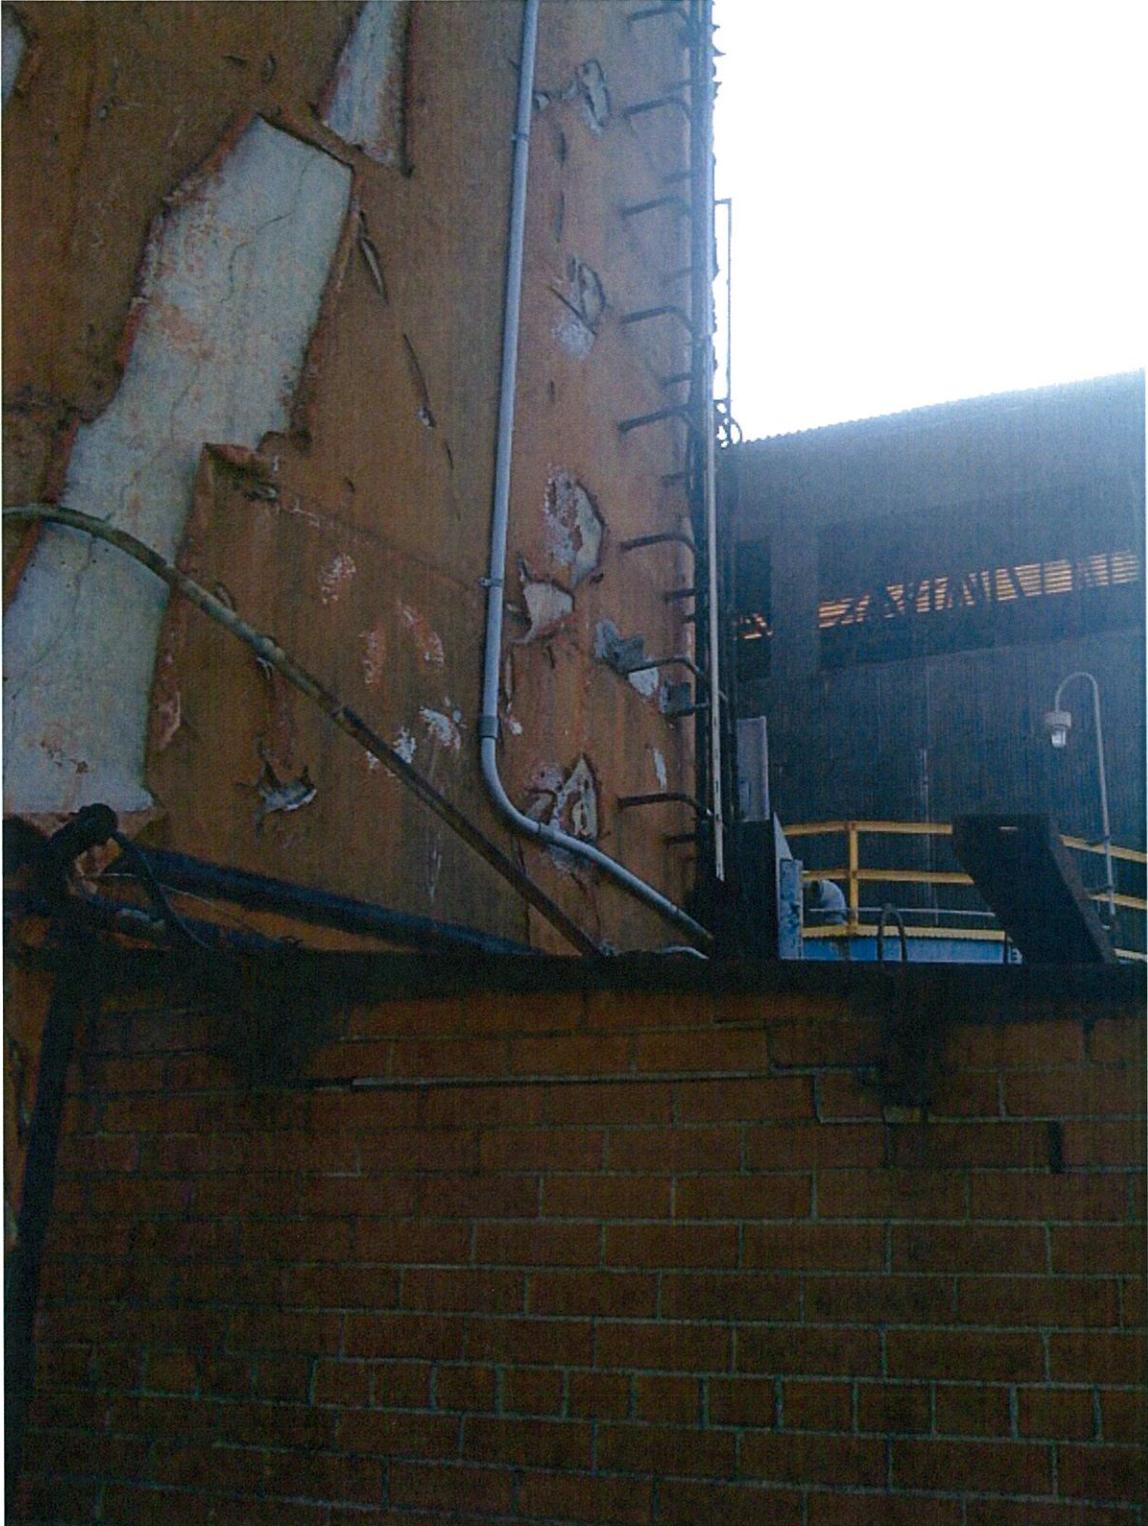
At the south elevation, there is a vertical ladder consisting of bent reinforcing extending outward from the stack wall (Photo 10). Because of the highly corrosive salt air environment, I recommend that the ladder not be used during the course of the work as corrosion or weakening of the reinforcing is highly likely.

Photo 10 – View of Vertical Ladder at South Elevation of Smoke Stack
