**Texas Commission on Environmental Quality
New Technology Research & Development (NTRD) Program
Monthly Project Status Report**

Contract Number: 582-11-13472-2019

Grantee: Transportation Power, Inc.

Report for the Monthly period: 04/06/13 – 05/03/13 **Date Submitted:** 05/10/13

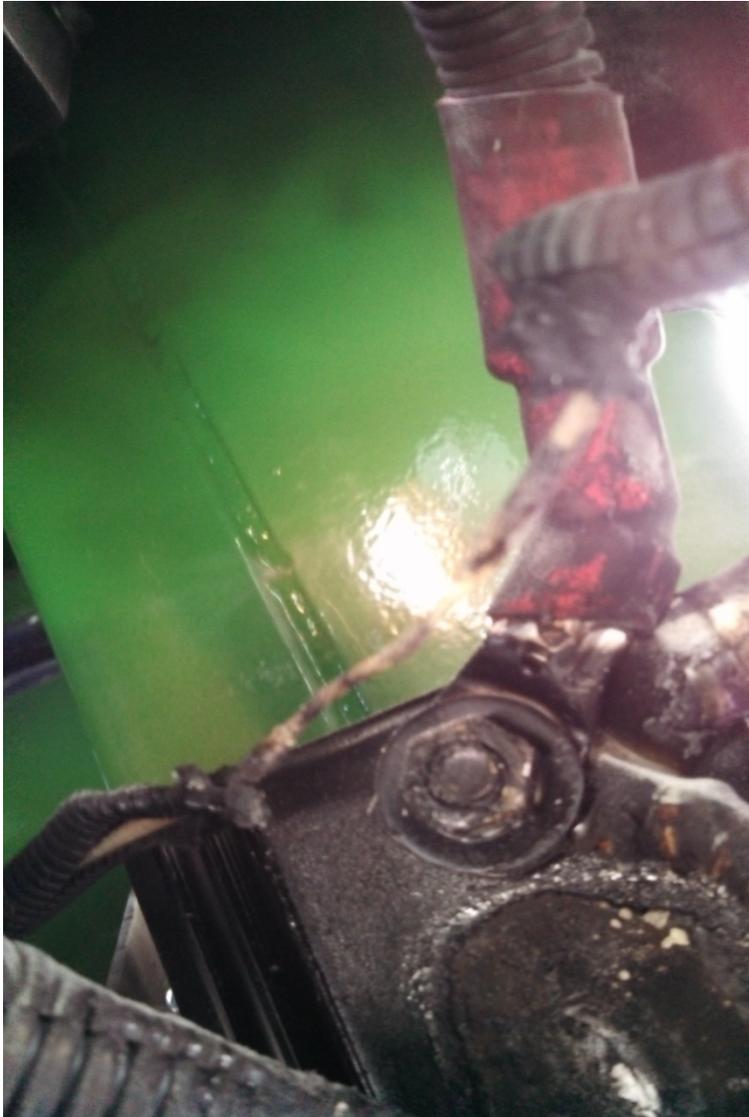
- f) HEB personnel expressed their view that the large charging plugs were difficult to maneuver.
- g) On April 22, 2013, at the beginning of the second week of testing, a switching device used to protect the 12-volt battery from accidental discharging overheated and caused a small wiring fire. Figure 2 is a close-up photo of part of the battery protector switch that overheated and the adjacent wiring that was damaged.

Figure 2. Battery protector switch and adjacent wiring following damage caused by overheating.

- f) Improving the maneuverability of the charging plugs could be achieved by redesigning the charging mechanism or adding handles to the plugs.
- g) The overheating and subsequent fire clearly originated within the protector switch and potential solutions included replacing this with a different switch, inserting a fuse into the circuit to cut off power before a similar event could occur, or removing the switch entirely.

- g) A thorough investigation of the wiring fire concluded that the battery protector switch overheated under load and that the quickest, safest way to avoid future incidents was to simply remove these devices from both tractors. This was done and both tractors subsequently performed without any similar incidents. Removal of the switches leaves the 12-volt battery in each tractor susceptible to inadvertent discharging when tractors are left idle for extended periods, but this risk is seen as minimal due to the fact that the tractors are expected to be operated more or less continuously. The manufacturer of the battery protector switch will be contacted and an effort will be made to determine if there were any measures TransPower could have taken to prevent it from overheating. TransPower conducted a formal safety review and evaluated the safety of its drive system wiring in general to determine if there are other areas where such overheating could pose difficulties and to assess whether wiring changes or addition of fuses or other protective devices are warranted. It was determined that there weren't any urgent requirements of this nature on the two yard tractors, but that to the extent practical, additional fusing and protection may be included in future drive system installations..
