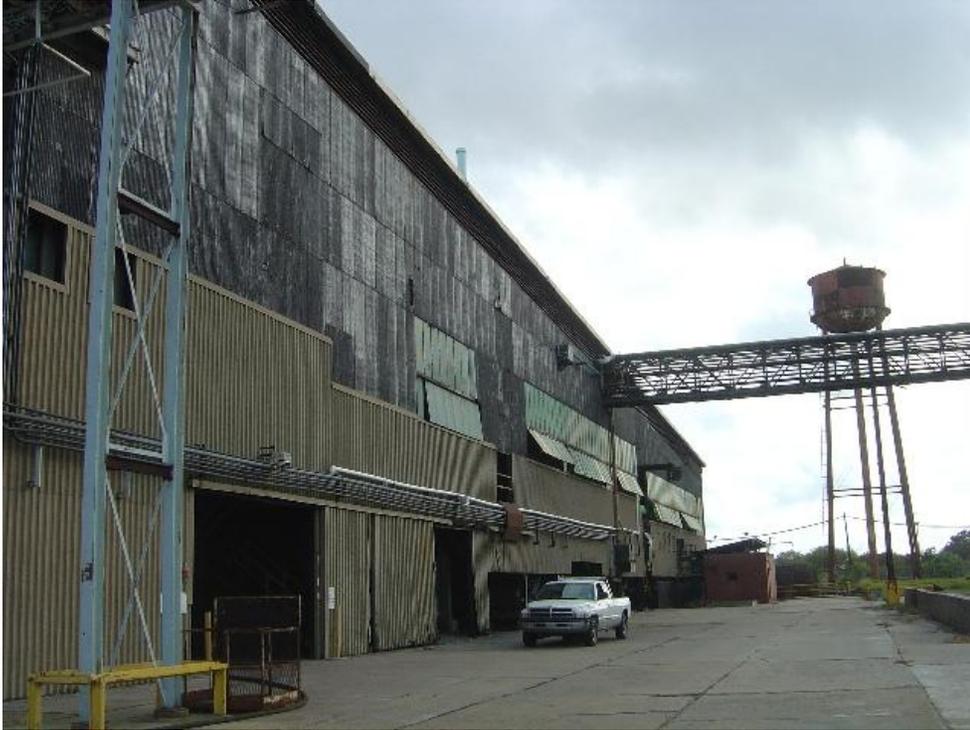
Photograph No. 1. Black galvestos coating on the west exterior wall of Facility No. 1, approximately 15 to 30 feet above ground level, view facing south. Photograph taken by K. Brandner, November 27, 2006.

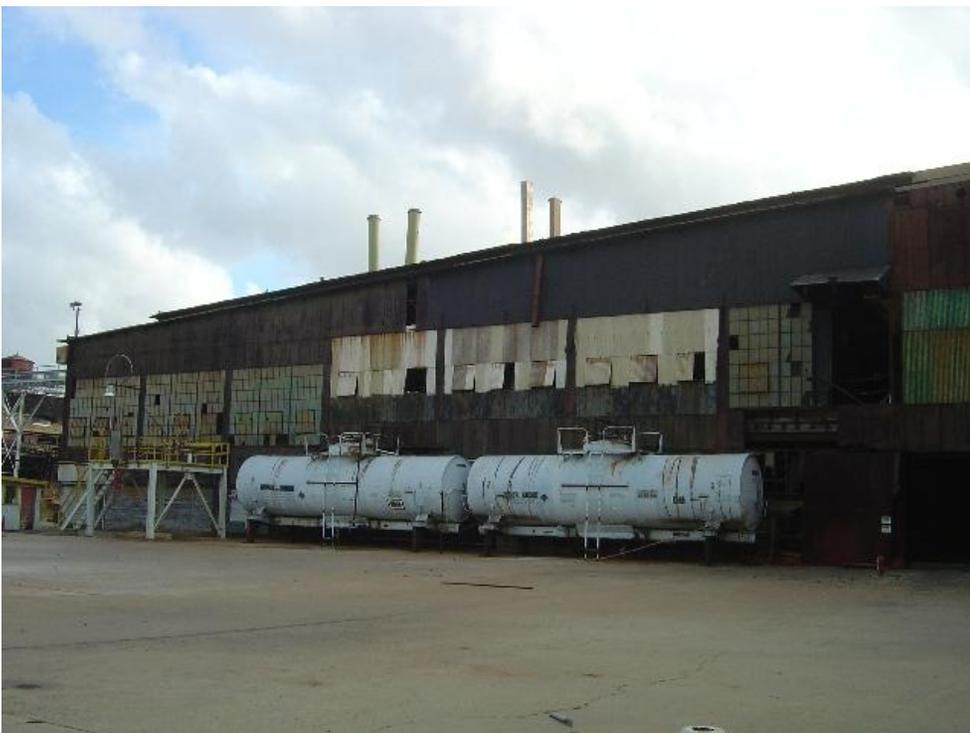
Photograph No. 2. Black galvestos coating on the north exterior wall of Facility No. 2, view facing southeast. Photograph taken by K. Brandner, November 27, 2006.

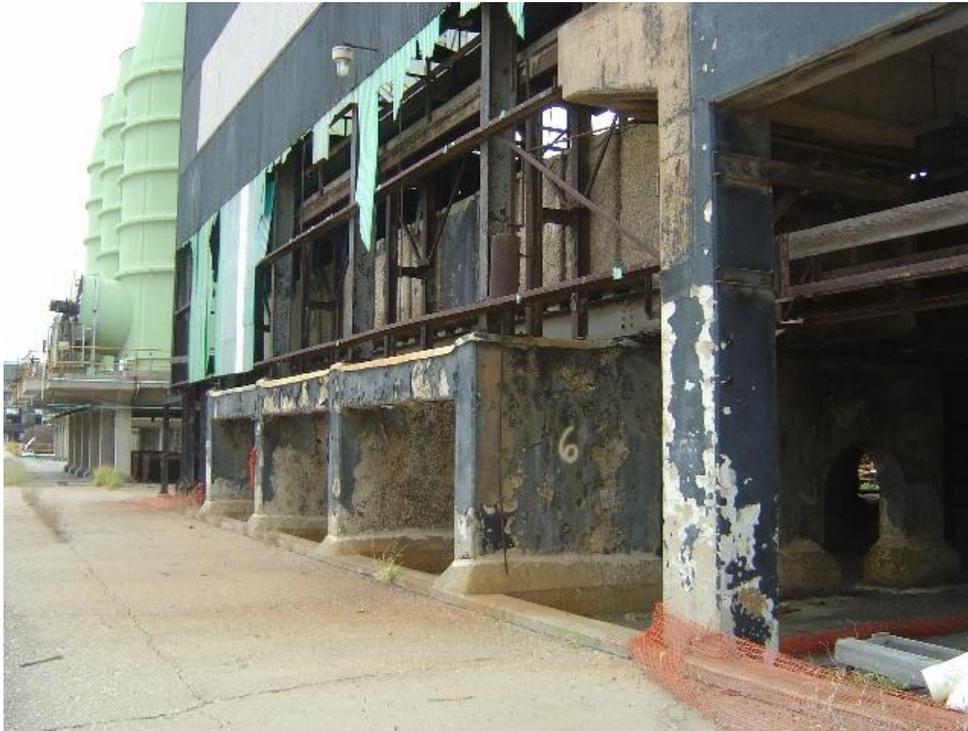
Photograph No. 3. Black galvestos coating on concrete pillars and south exterior wall of East Cell House, view facing west. Photograph taken by K. Brandner, November 29, 2006.

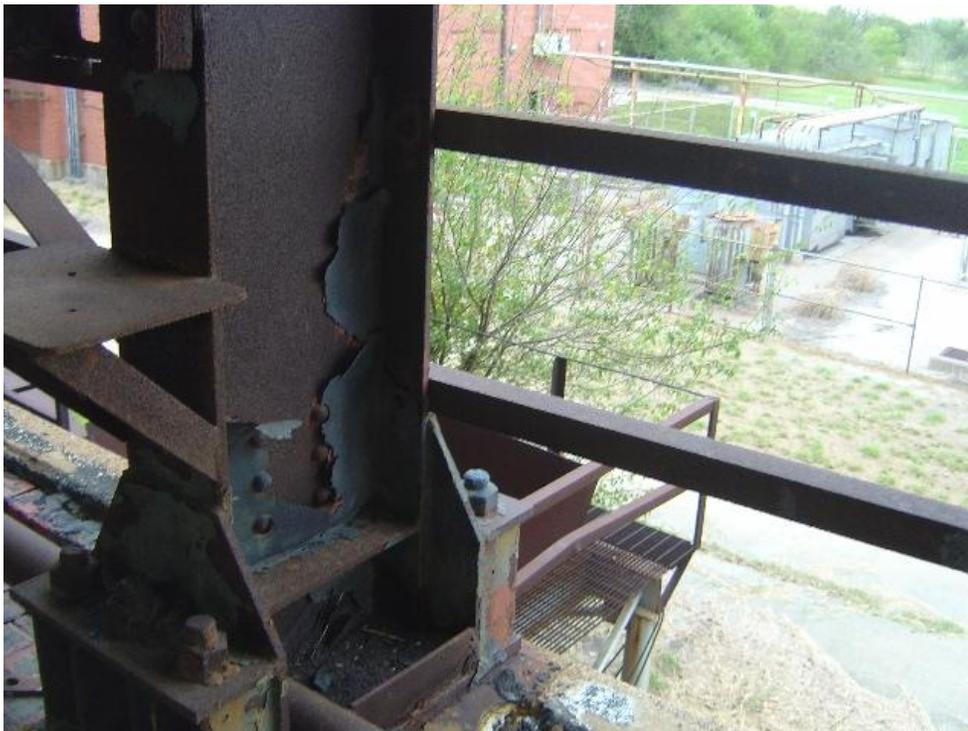
Photograph No. 4. Black galvestos coating on steel I-beam at east end, 2nd floor of East Cell House, view facing east. Photograph taken by K. Brandner, November 29, 2006.

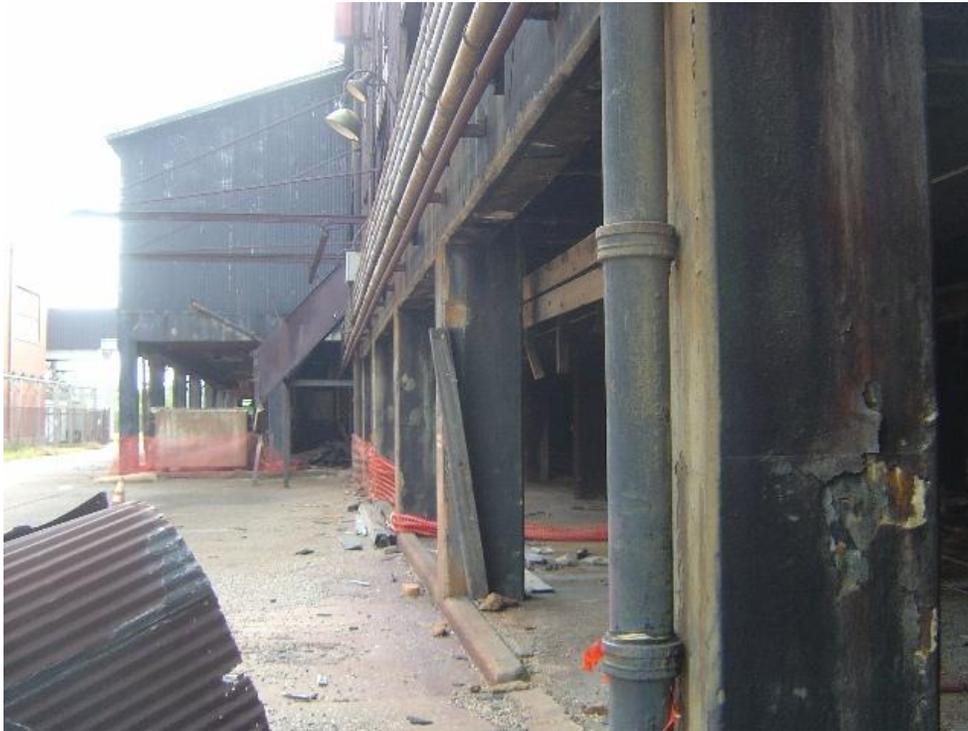
Photograph No. 5. Black galvestos coating on concrete pillars, exterior wall, and steel pipe at east end of West Cell House, view facing south. Photograph taken by K. Brandner, November 29, 2006.

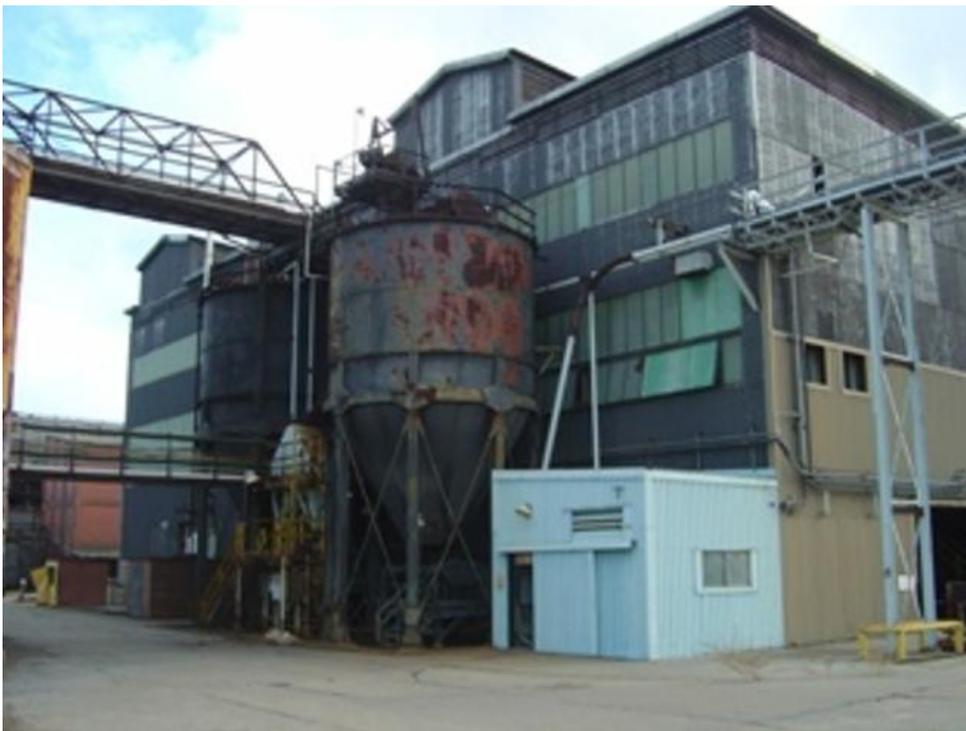
Photograph No. 6. Black galvestos coating on two large steel cone-shaped tanks north of Facility No. 1, view facing southeast. Photograph taken by K. Brandner, November 27, 2006.

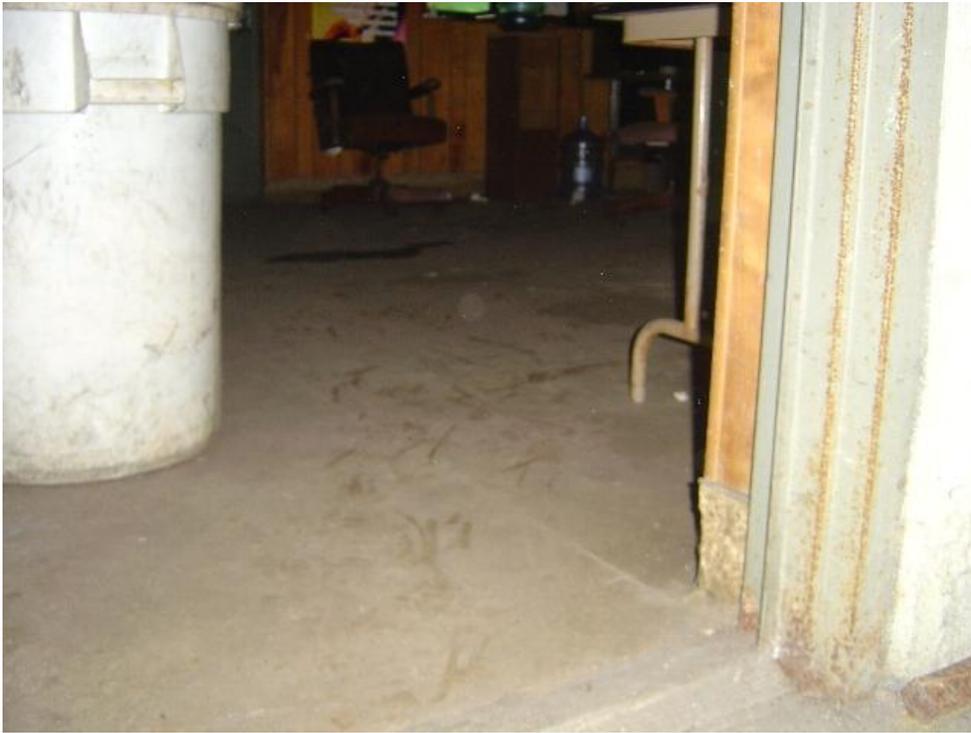
Photograph No. 7. Brown linoleum floor covering in office on 2nd floor of Facility No. 1, view facing southwest. Photograph taken by K. Brandner, November 27, 2006.

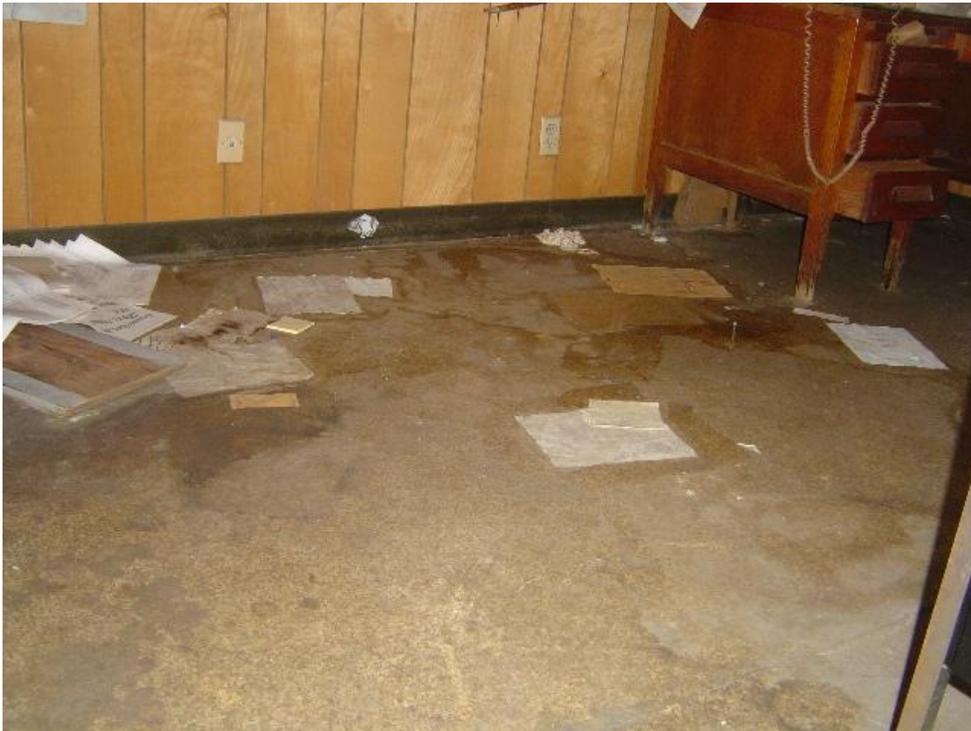
Photograph No. 8. Brown linoleum floor covering in office on 2nd floor of Facility No. 2, view facing west. Photograph taken by K. Brandner, November 27, 2006.

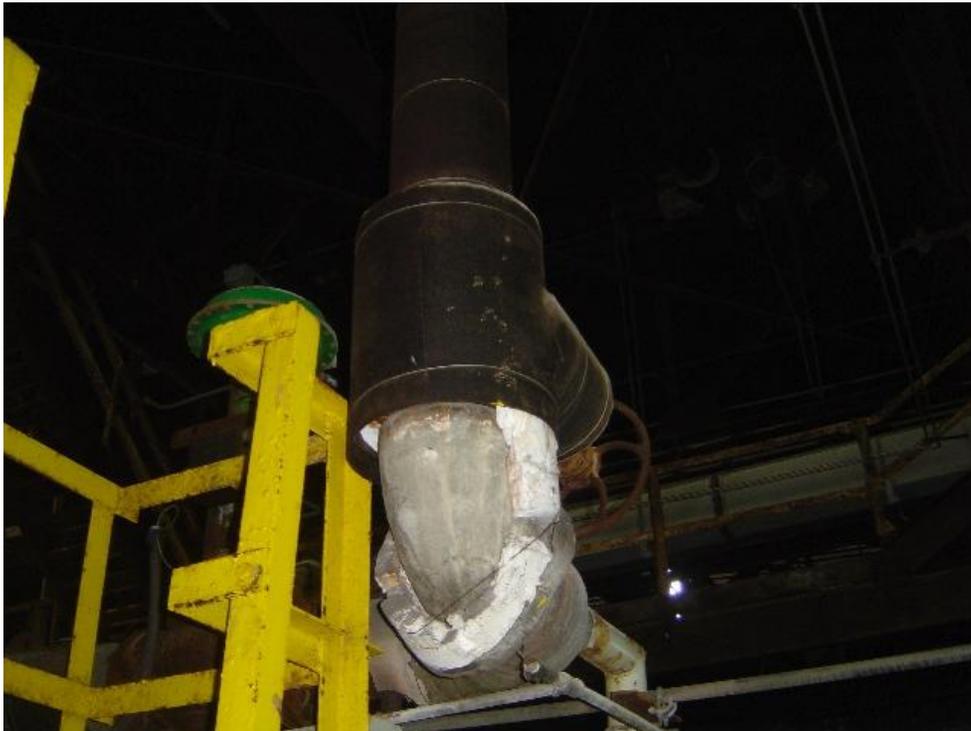
Photograph No. 9. White pipe wrap on 2nd floor of Facility No. 1, view facing southwest. Photograph taken by K. Brandner, November 27, 2006.

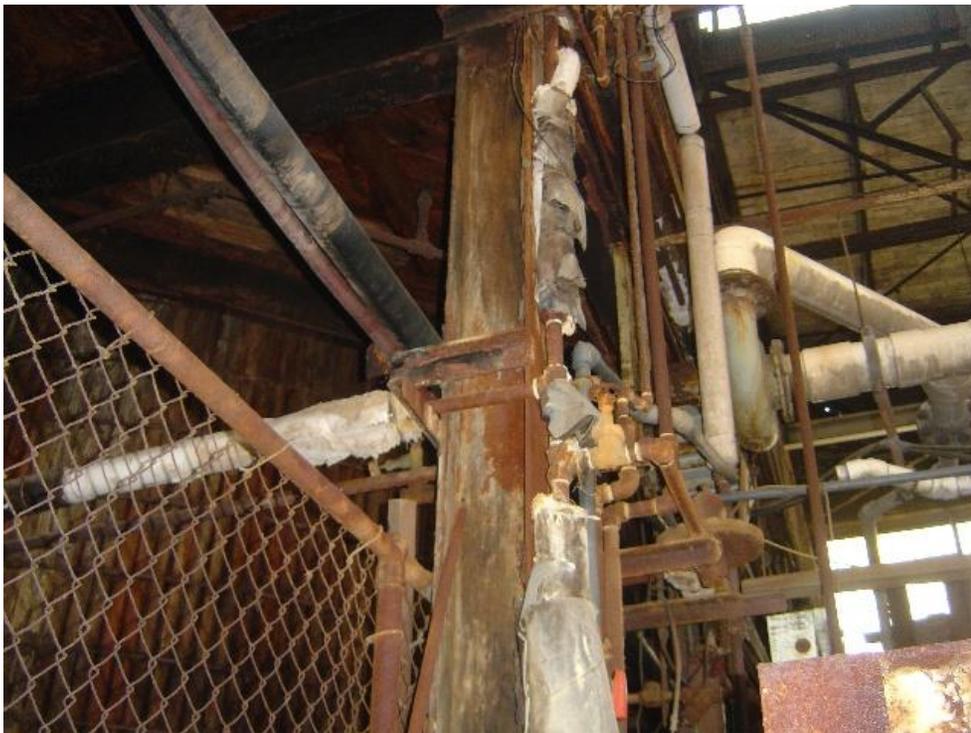
Photograph No. 10. White pipe wrap on 2nd floor of Facility No. 2, view facing west. Photograph taken by K. Brandner, November 27, 2006.

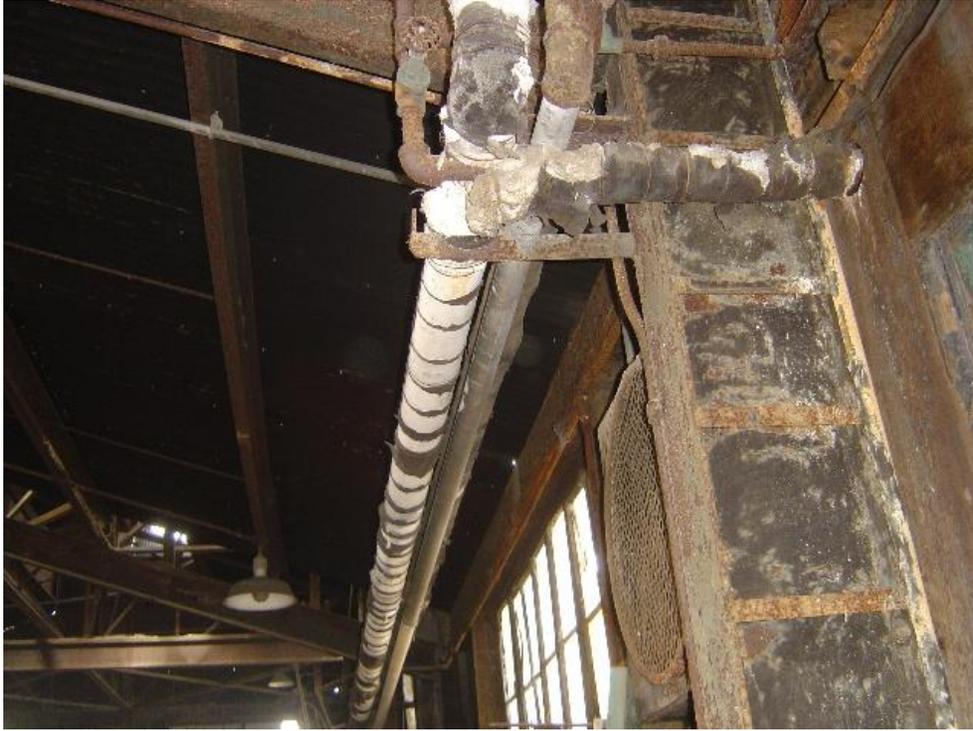
Photograph No. 11. White pipe wrap on 2nd floor of West Cell House, view facing north. Photograph taken by K. Brandner, November 29, 2006.

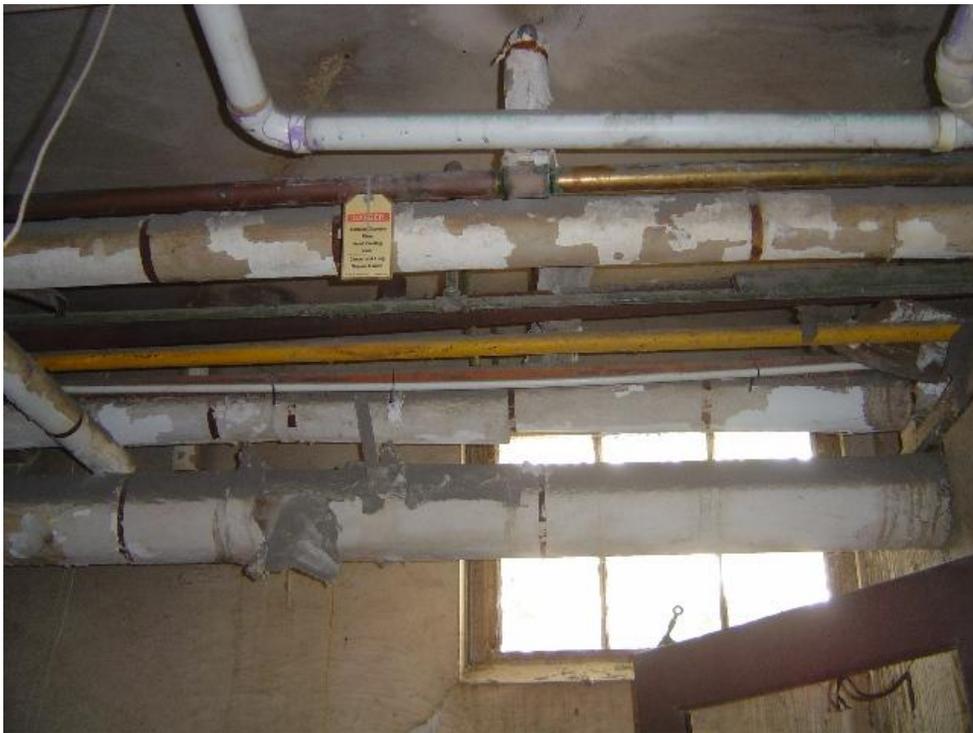
Photograph No. 12. White pipe wrap in basement of Admin Building and Lab (Building 46), view facing north. Photograph taken by K. Brandner, December 1, 2006.

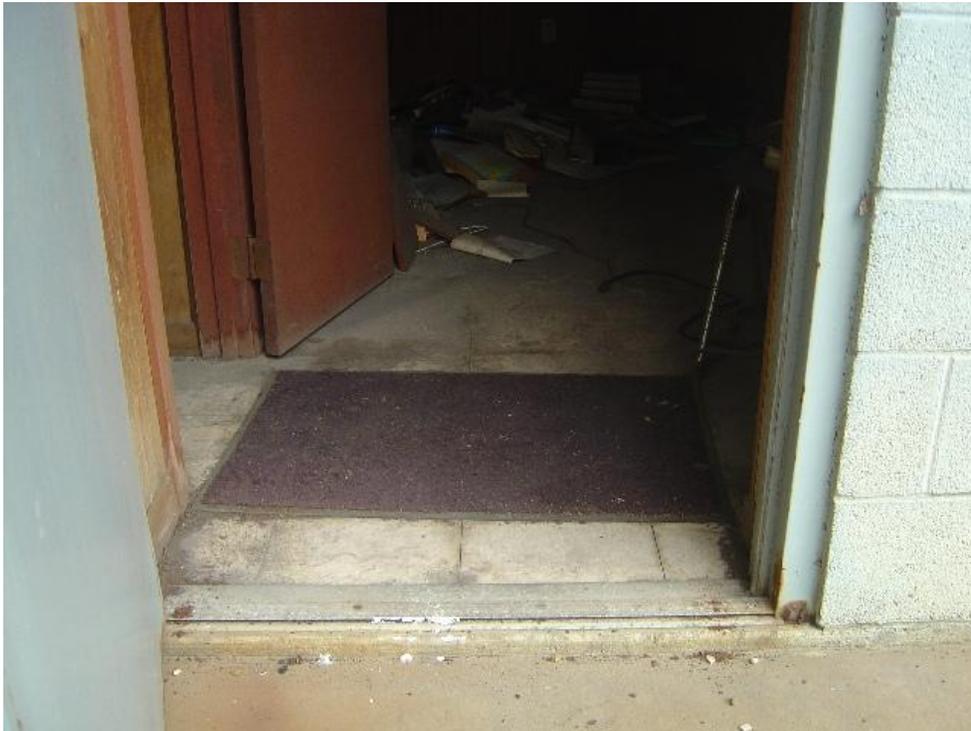
Photograph No. 13. 12" x 12" light brown floor tile in office at northeast end of Facility No. 2, view facing north. Photograph taken by K. Brandner, November 28, 2006.

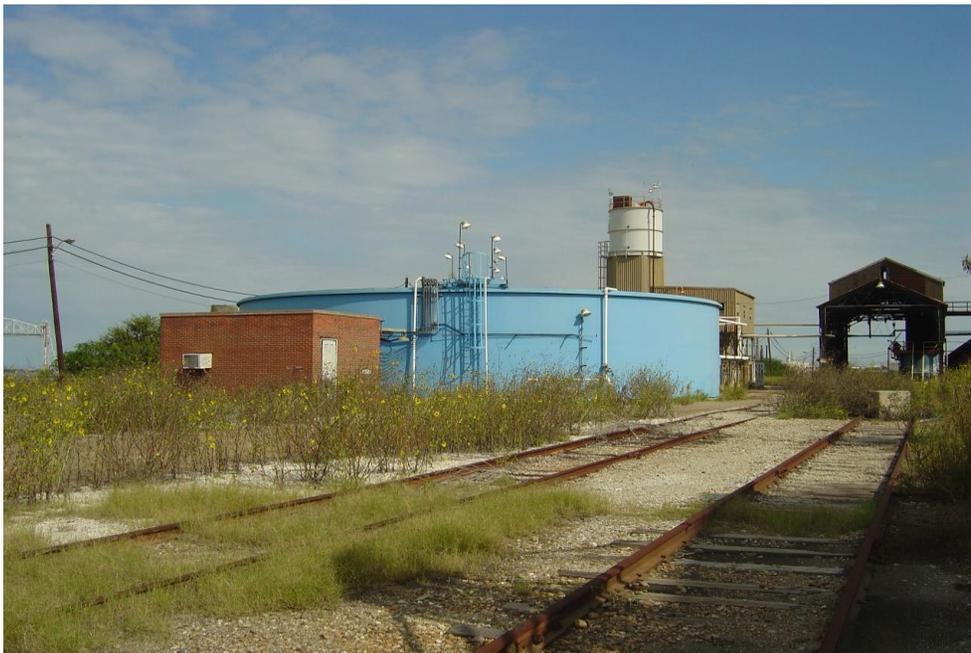
Photograph No. 14. Red brick building in foreground (Building 12) has a tar and gravel roof, view facing east. Blue reactor/clarifier tank in background. Photograph taken by K. Brandner, November 28, 2006.

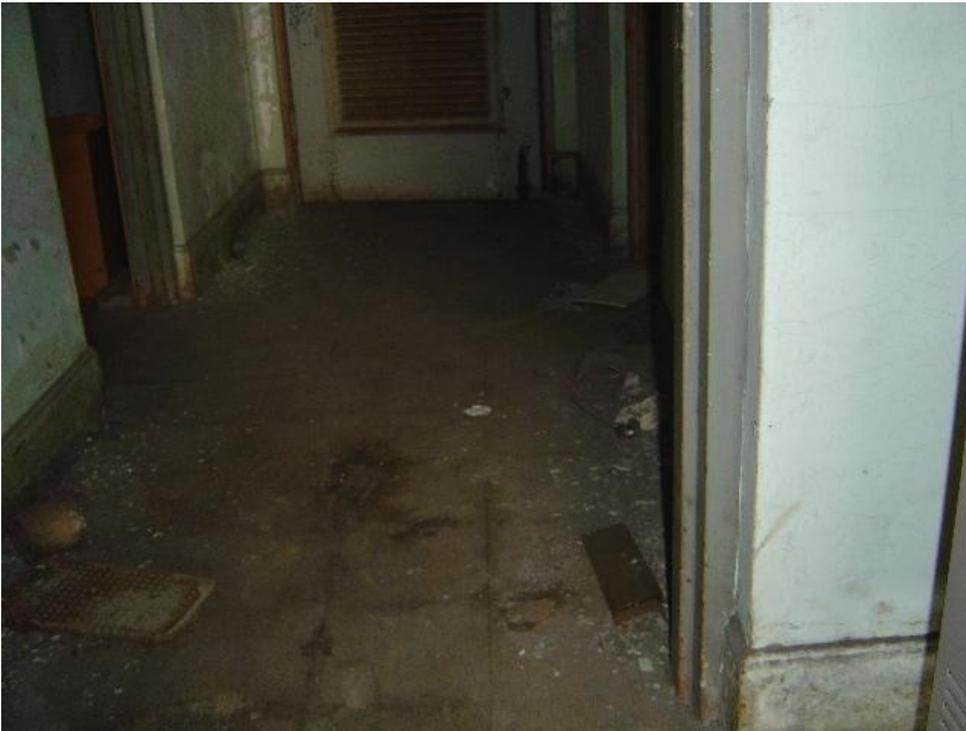
Photograph No. 15. 9" x 9" light brown floor tile on 2nd floor office at south end of Power House, view facing south. Photograph taken by K. Brandner, November 29, 2006.

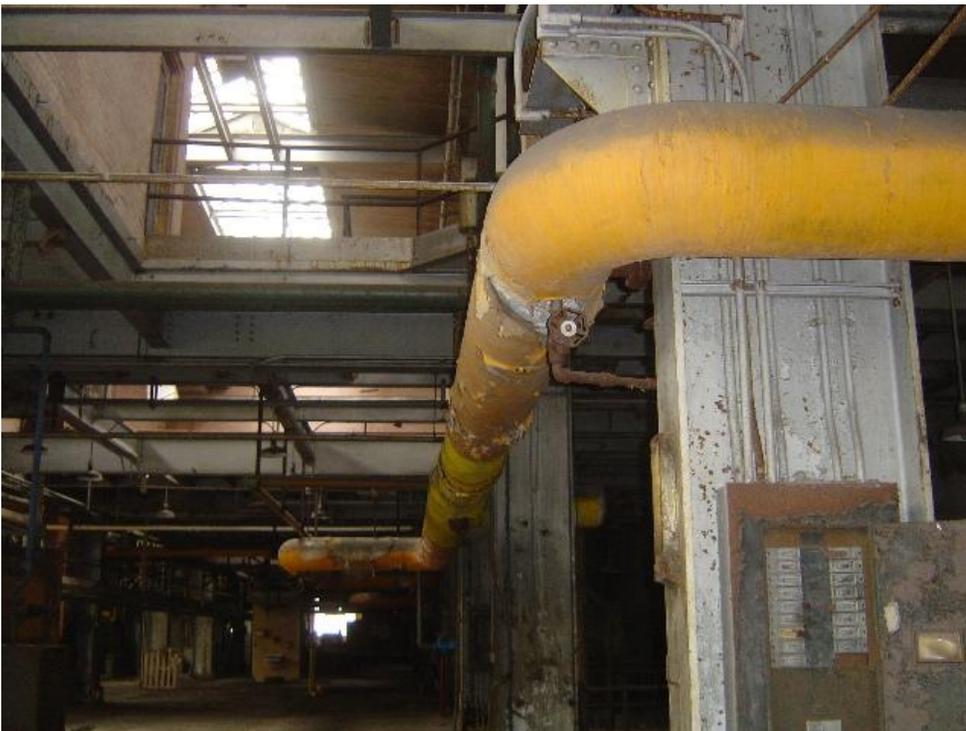
Photograph No. 16. 18"-diameter white pipe wrap with orange exterior jacket on steel pipe running north-south approximately 12 feet above ground level above the 1st floor of the Power House, view facing south. Photograph taken by K. Brandner, November 29, 2006.

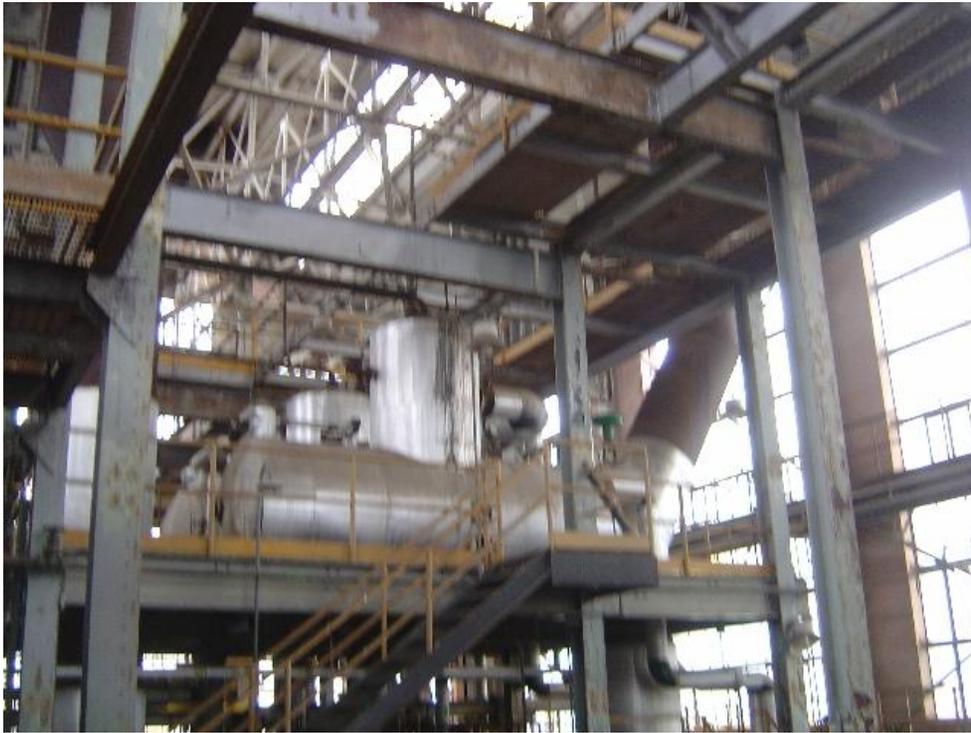
Photograph No. 17. Boilers on the 2nd floor of the Power House, view facing north. Photograph taken by K. Brandner, November 29, 2006.

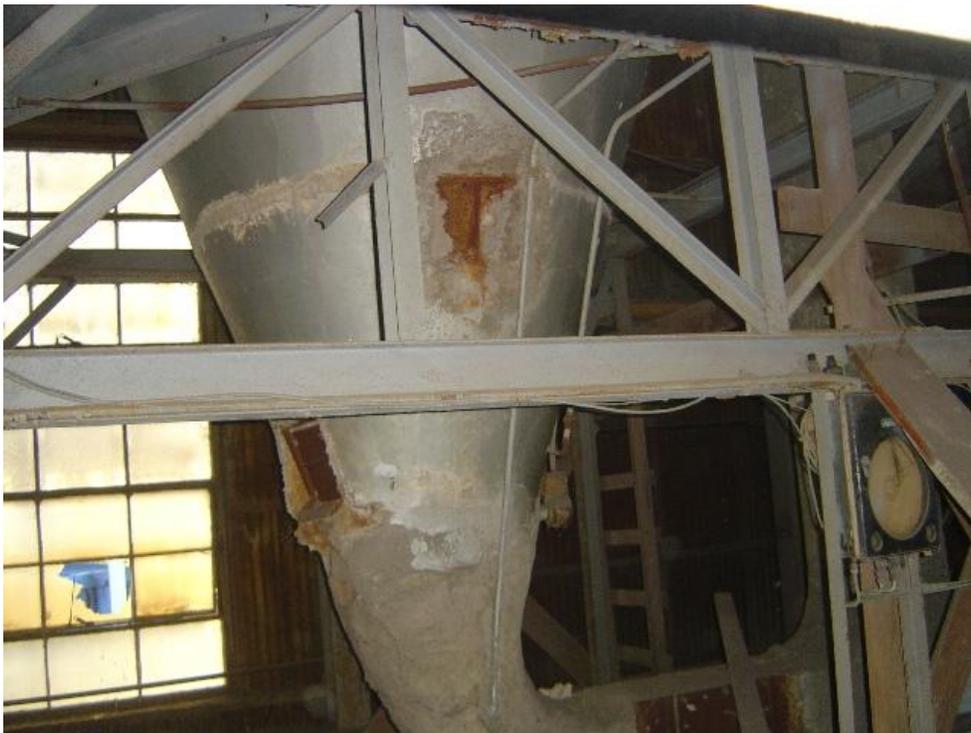
Photograph No. 18. Boiler in the Zinc Building, view facing south. Photograph taken by K. Brandner, November 29, 2006.

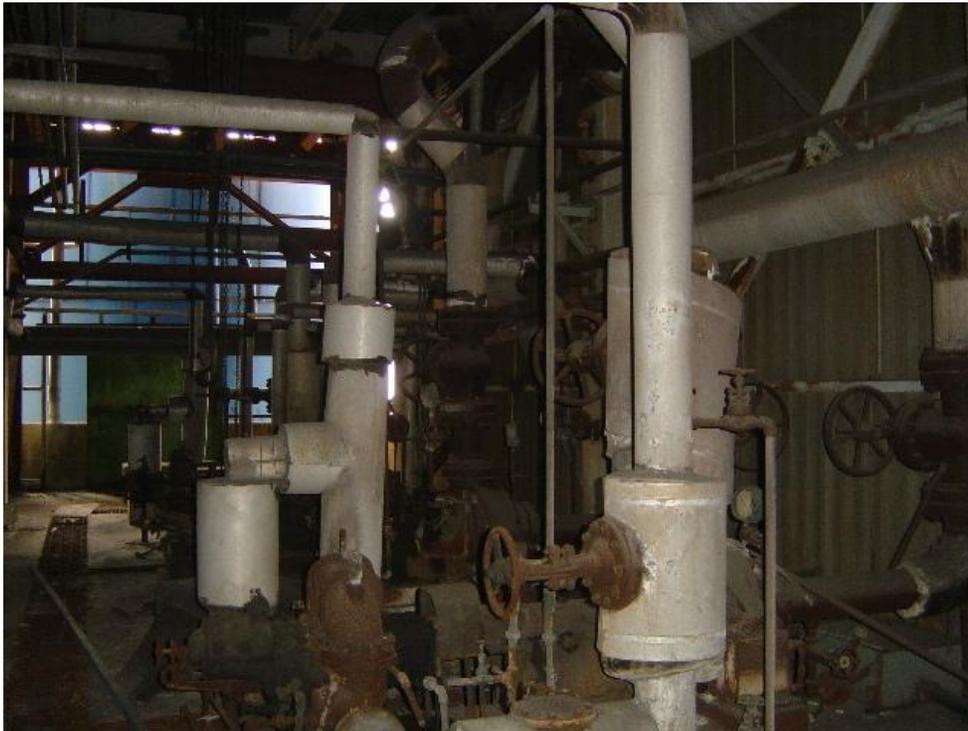
Photograph No. 19. White pipe wrap with outer sheet metal jacket on pipes on the 1st floor at the east end of Facility No. 4, view facing south. Photograph taken by K. Brandner, November 28, 2006.

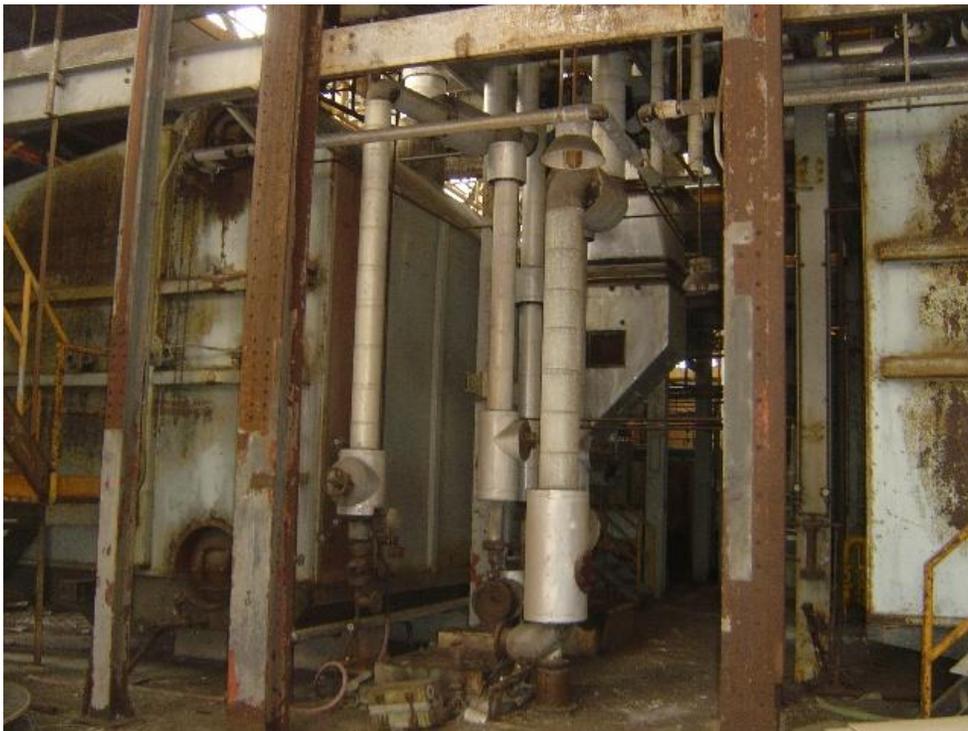
Photograph No. 20. White pipe wrap with outer sheet metal jacket on pipes on the 1st floor at the southeast end of the Power House, view facing south. Photograph taken by K. Brandner, November 29, 2006.

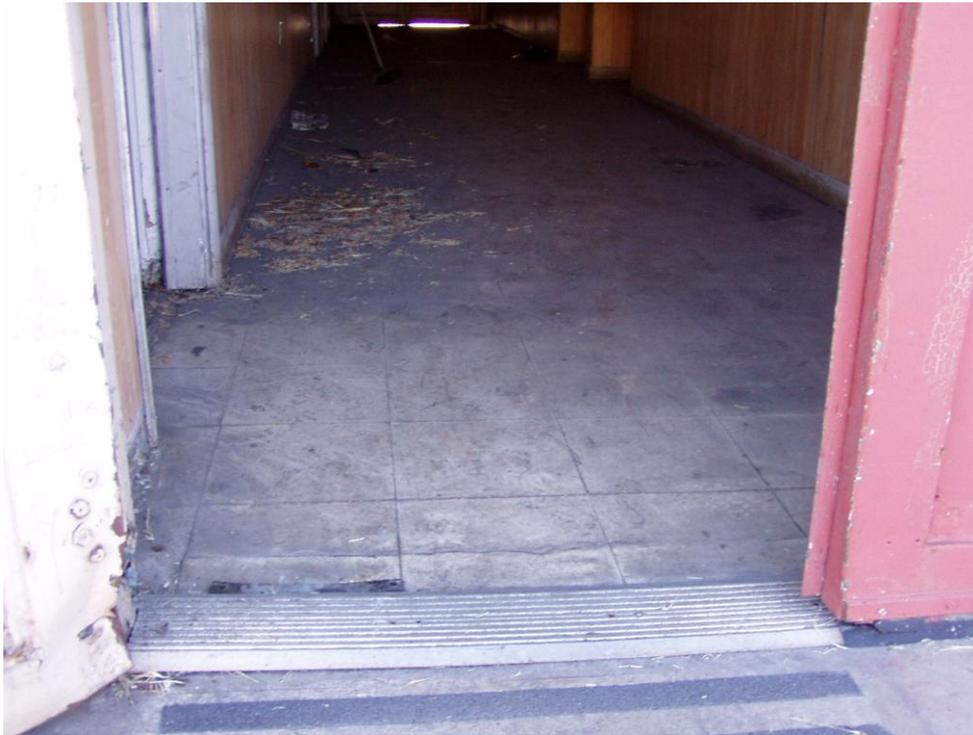
Photograph No. 21. 12" x 12" white floor tile with light gray streaks in Change House/Guard House, view facing south. Photograph taken by K. Brandner, December 1, 2006.

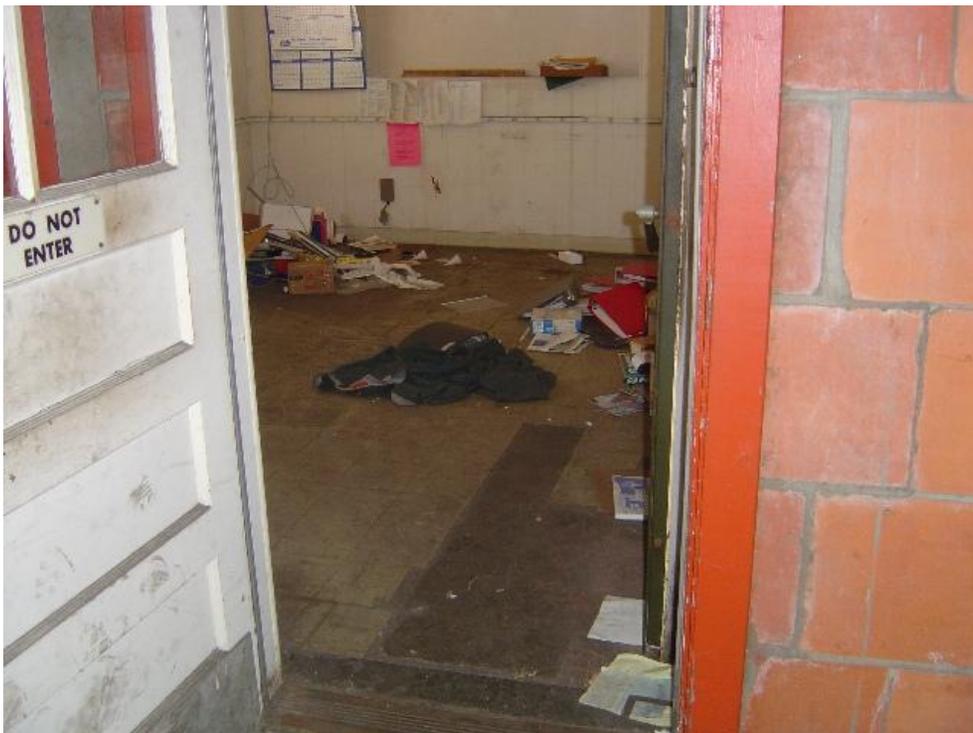
Photograph No. 22. 9" x 9" cream-white floor tile in office at northeast end of Warehouse Storage Building 51, view facing east. Photograph taken by K. Brandner, December 1, 2006.

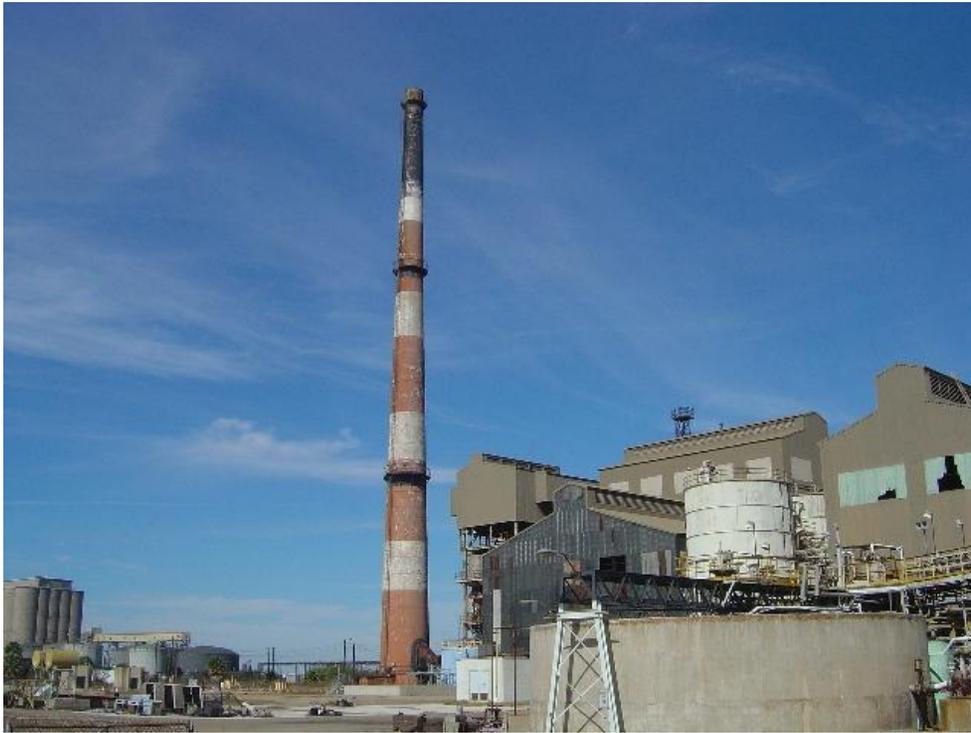
Photograph No. 23. Large red and white smokestack directly southwest of Facility No. 4, view facing northwest. Photograph taken by K. Brandner, December 1, 2006.
