JASTER-QUINTANILLA & ASSOCIATES, INC.

March 15, 2011

**Re: Structural Integrity Assessment
Former Encycle/Texas, Inc. /ASARCO Facility (Encycle)
5500 Up River Road
Corpus Christi, Nueces County, Texas**

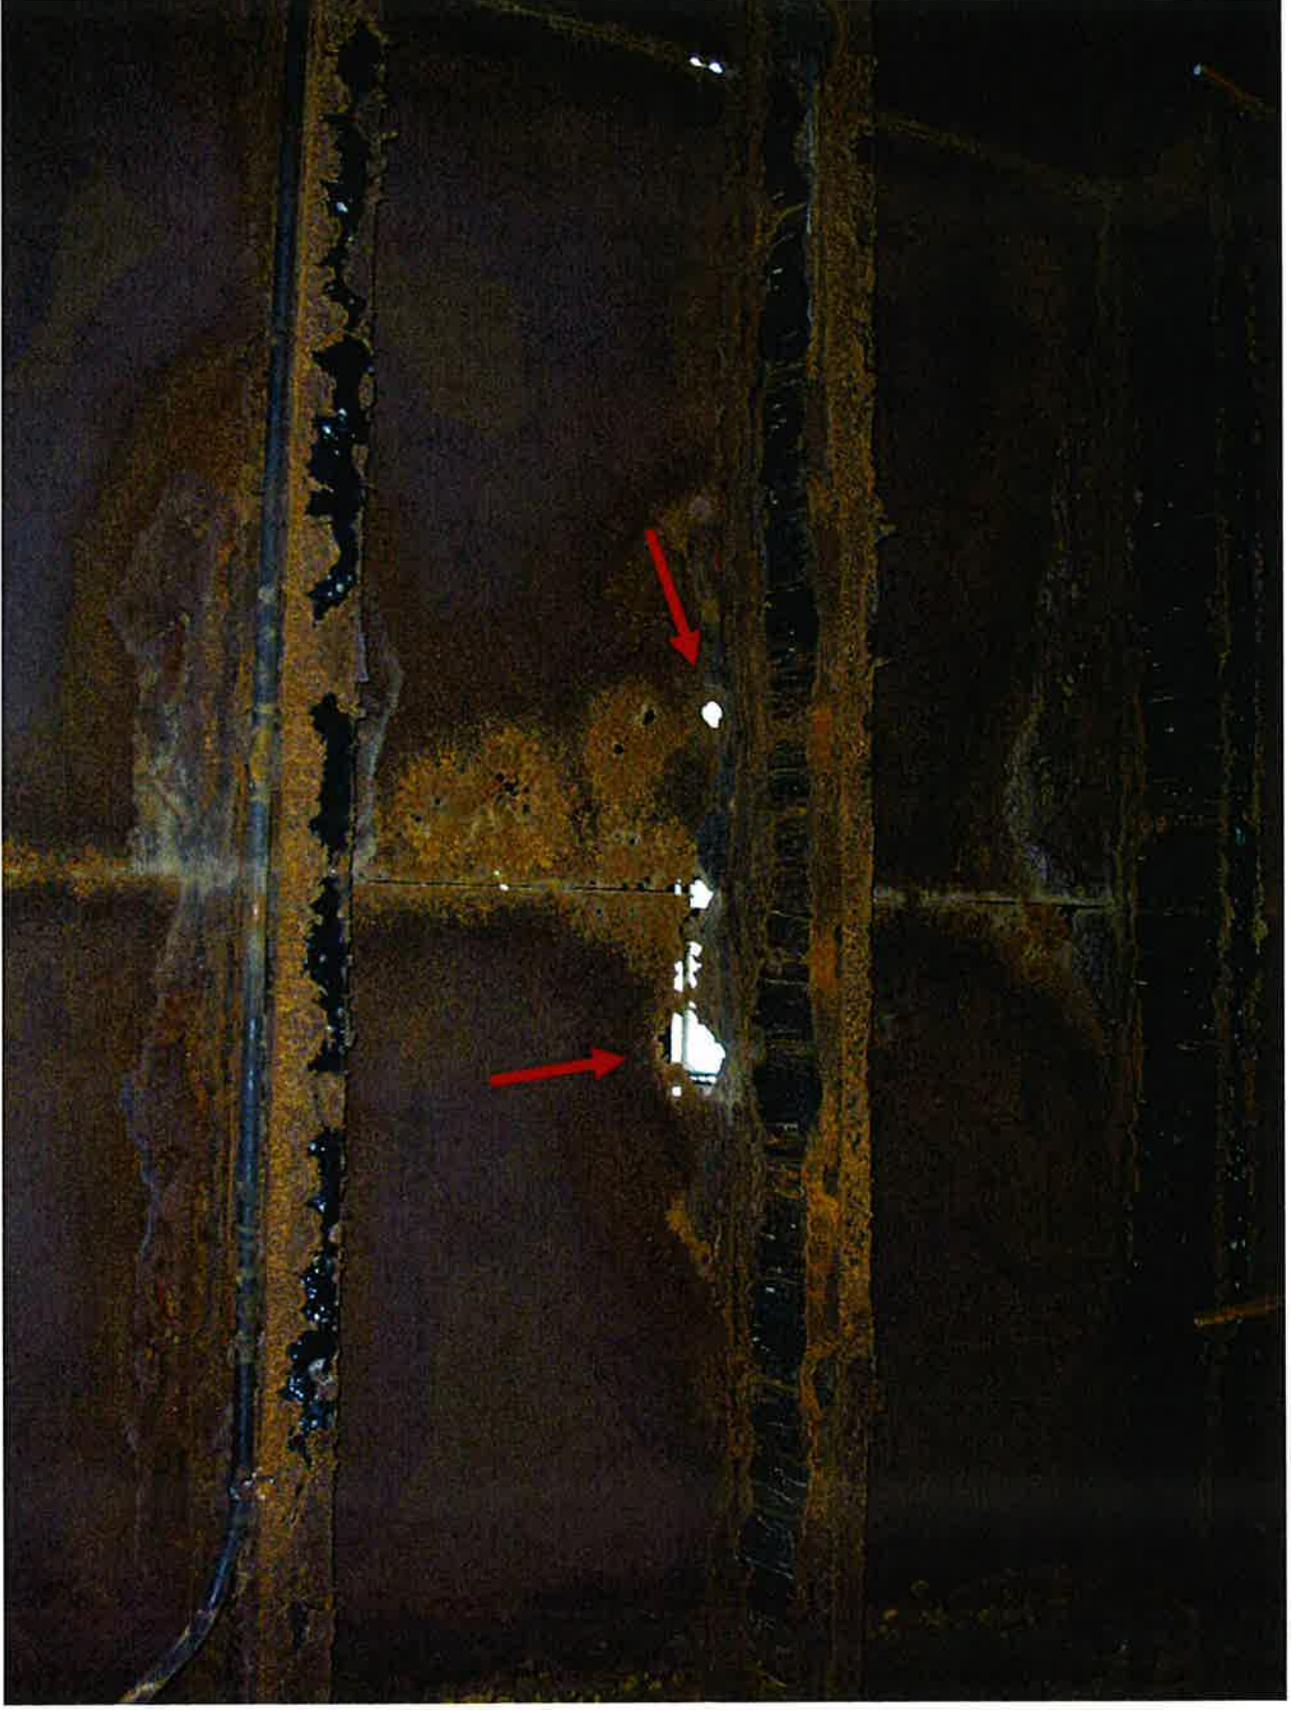
1. There are portions of the elevated catwalk at the north portion where checkered plate decking is deteriorated and structurally unsound (Photo 1). There are obvious holes and other areas where the plate has corroded and is de-laminating. The beams supporting the plate have been structurally compromised and are structurally unsound (Photo 2). The steel columns supporting the steel beams are severely deteriorated and structurally unsound (Photo 3).

PHOTO 1 – DETERIORATED CHECKERED PLATE AT ELEVATED CATWALK AT NORTH PORTION OF BUILDING 1

I believe that the second level catwalk at the north portion of Facility No. 1 is structurally unsound and shall not be used for support during the asbestos abatement process.

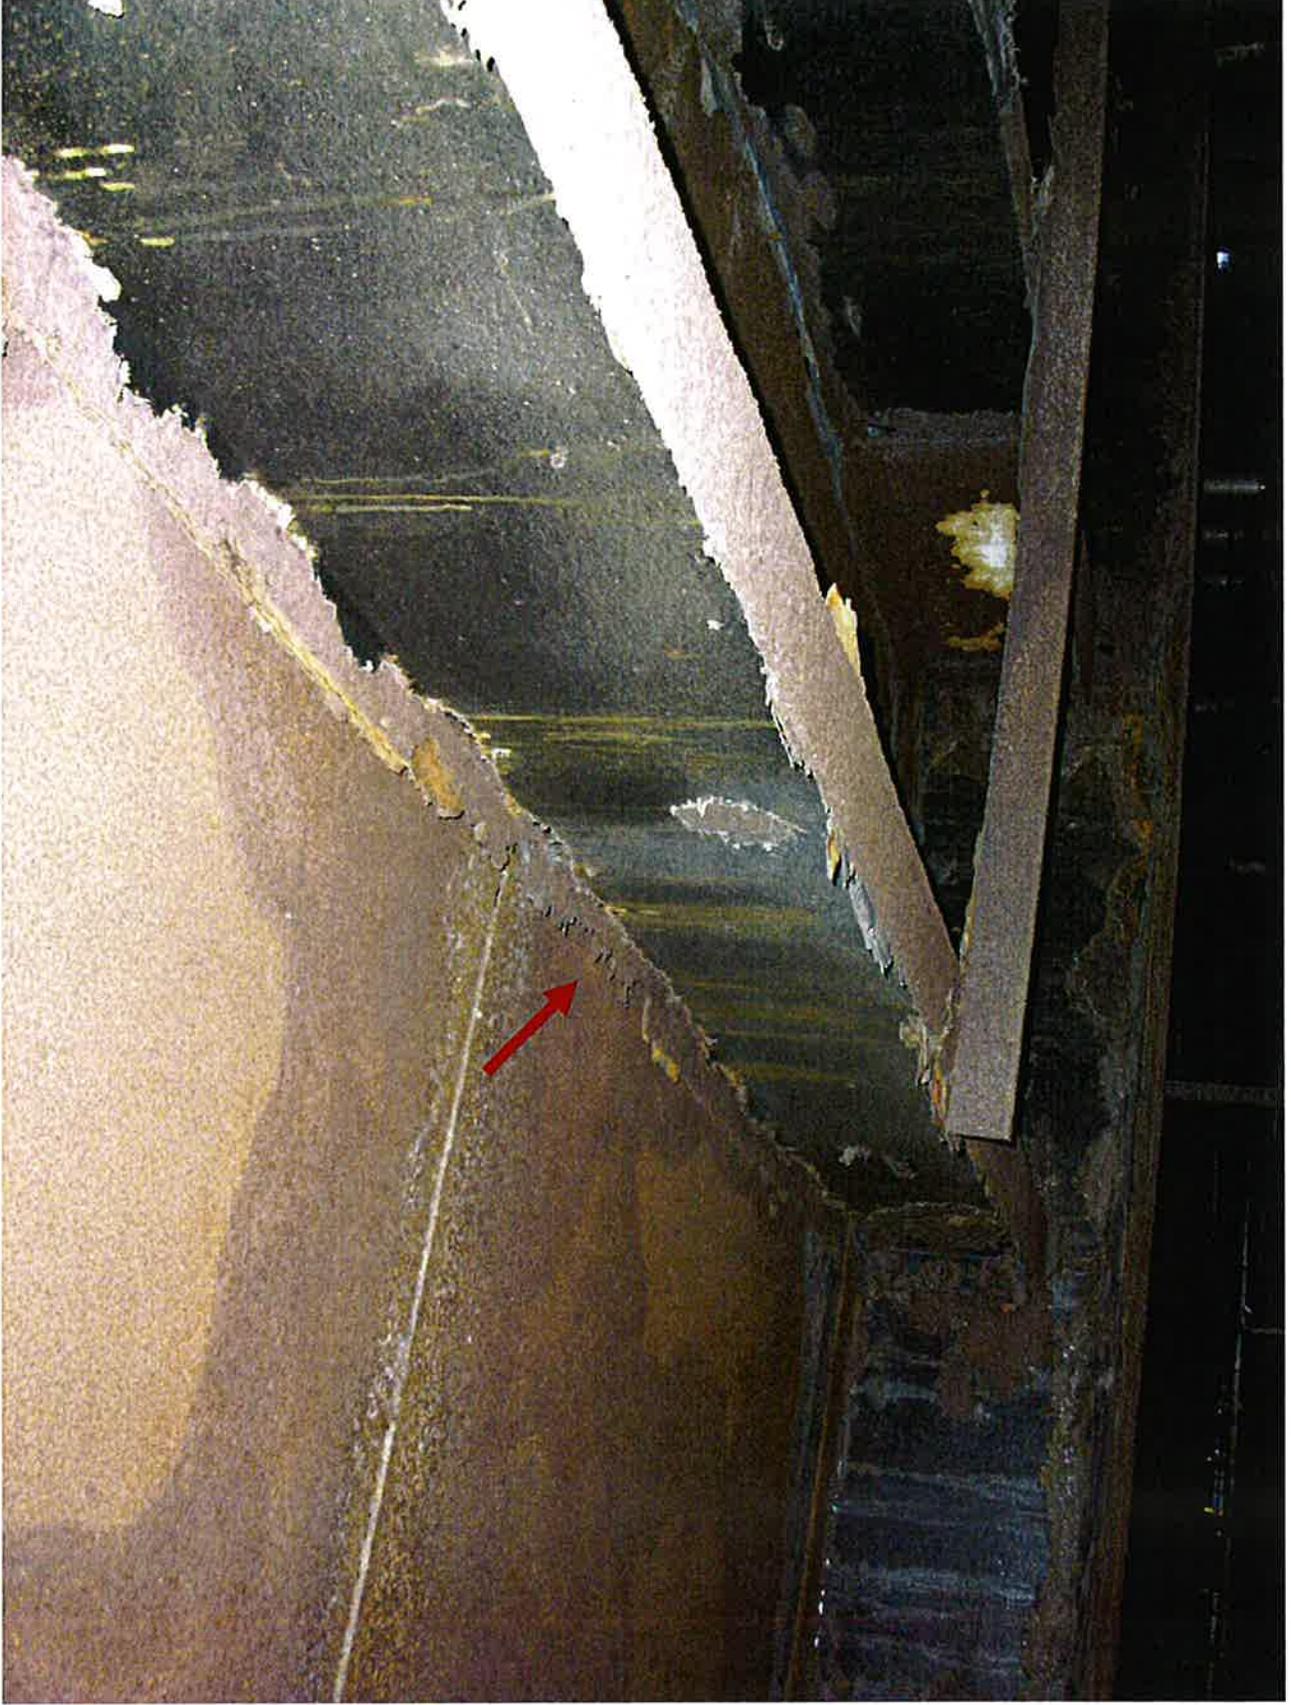
PHOTO 2 – DETERIORATED TOP FLANGE OF BEAM AT CATWALK OF BUILDING 1

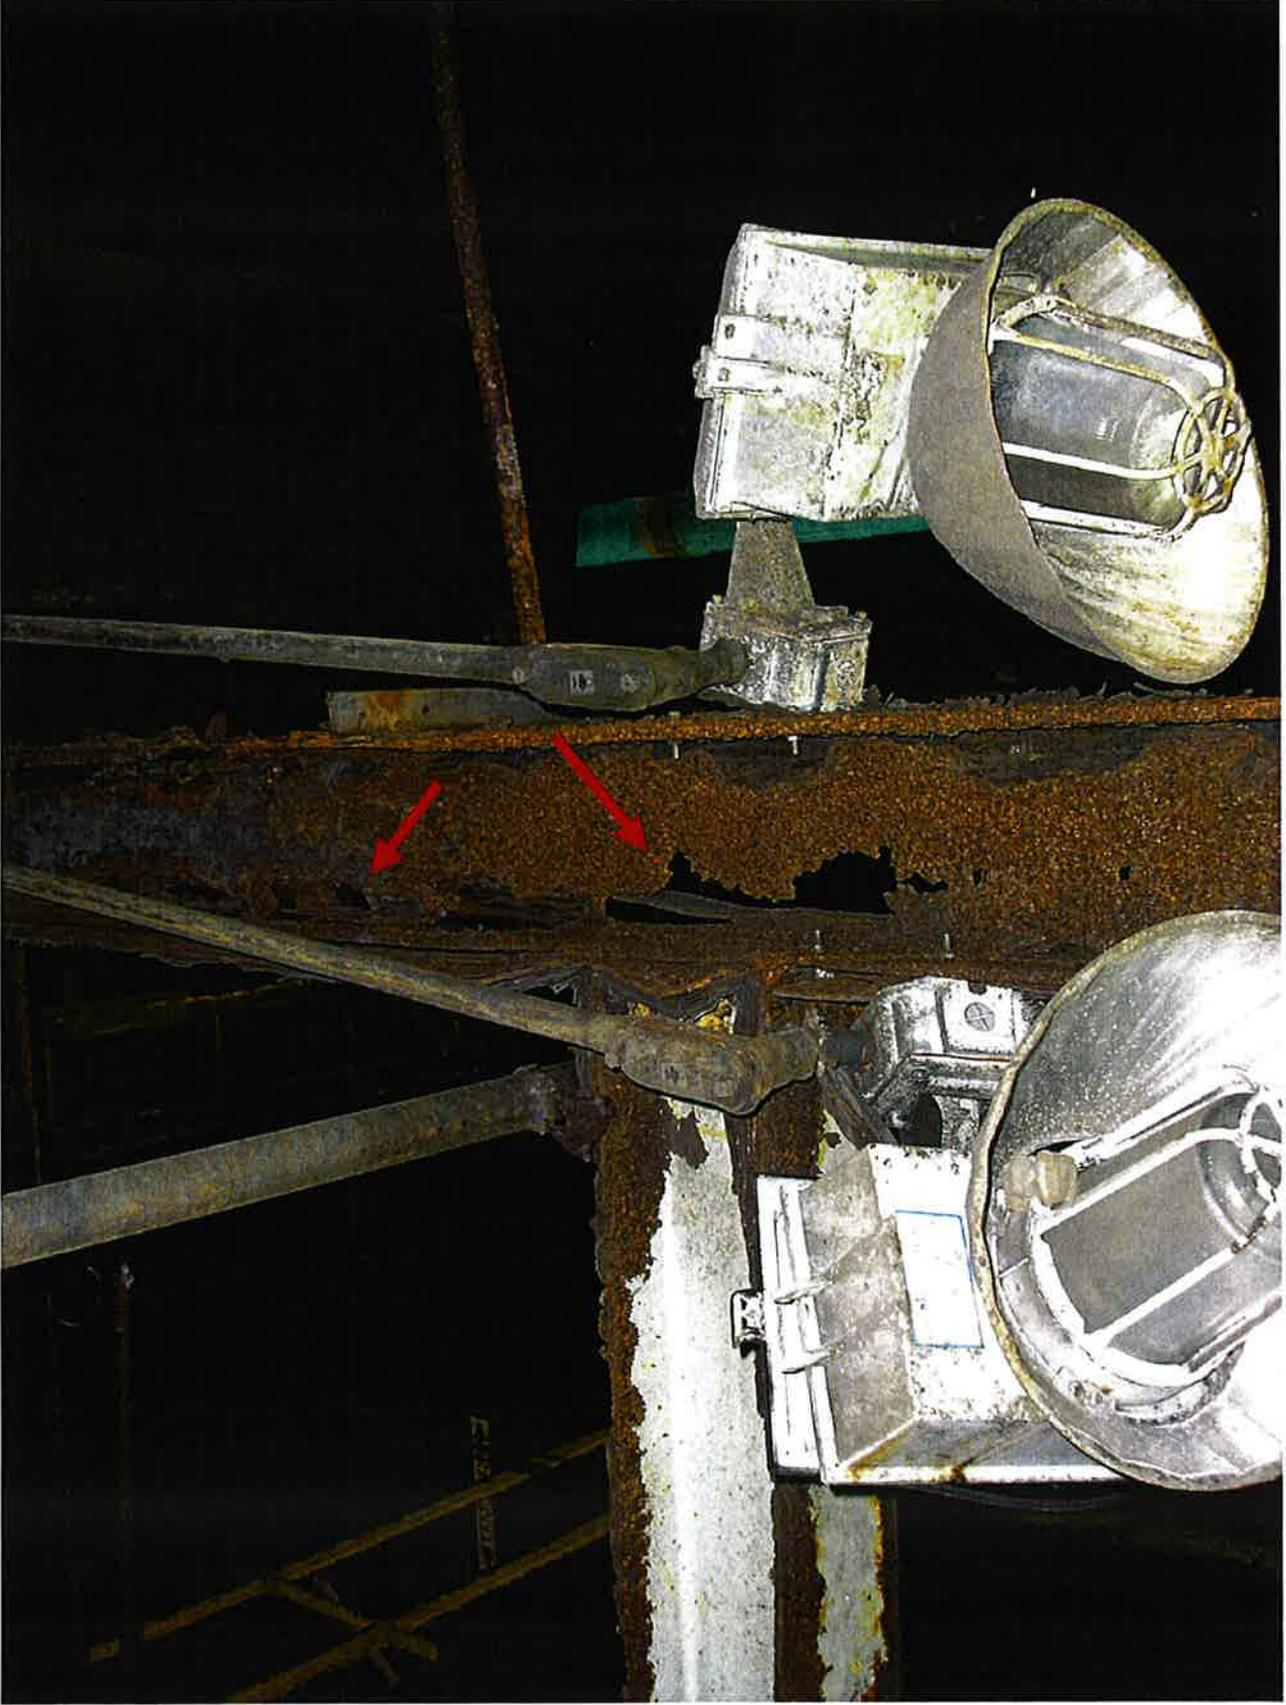
PHOTO 3 – DETERIORATED COLUMN AT ELEVATED CATWALK OF BUILDING 1

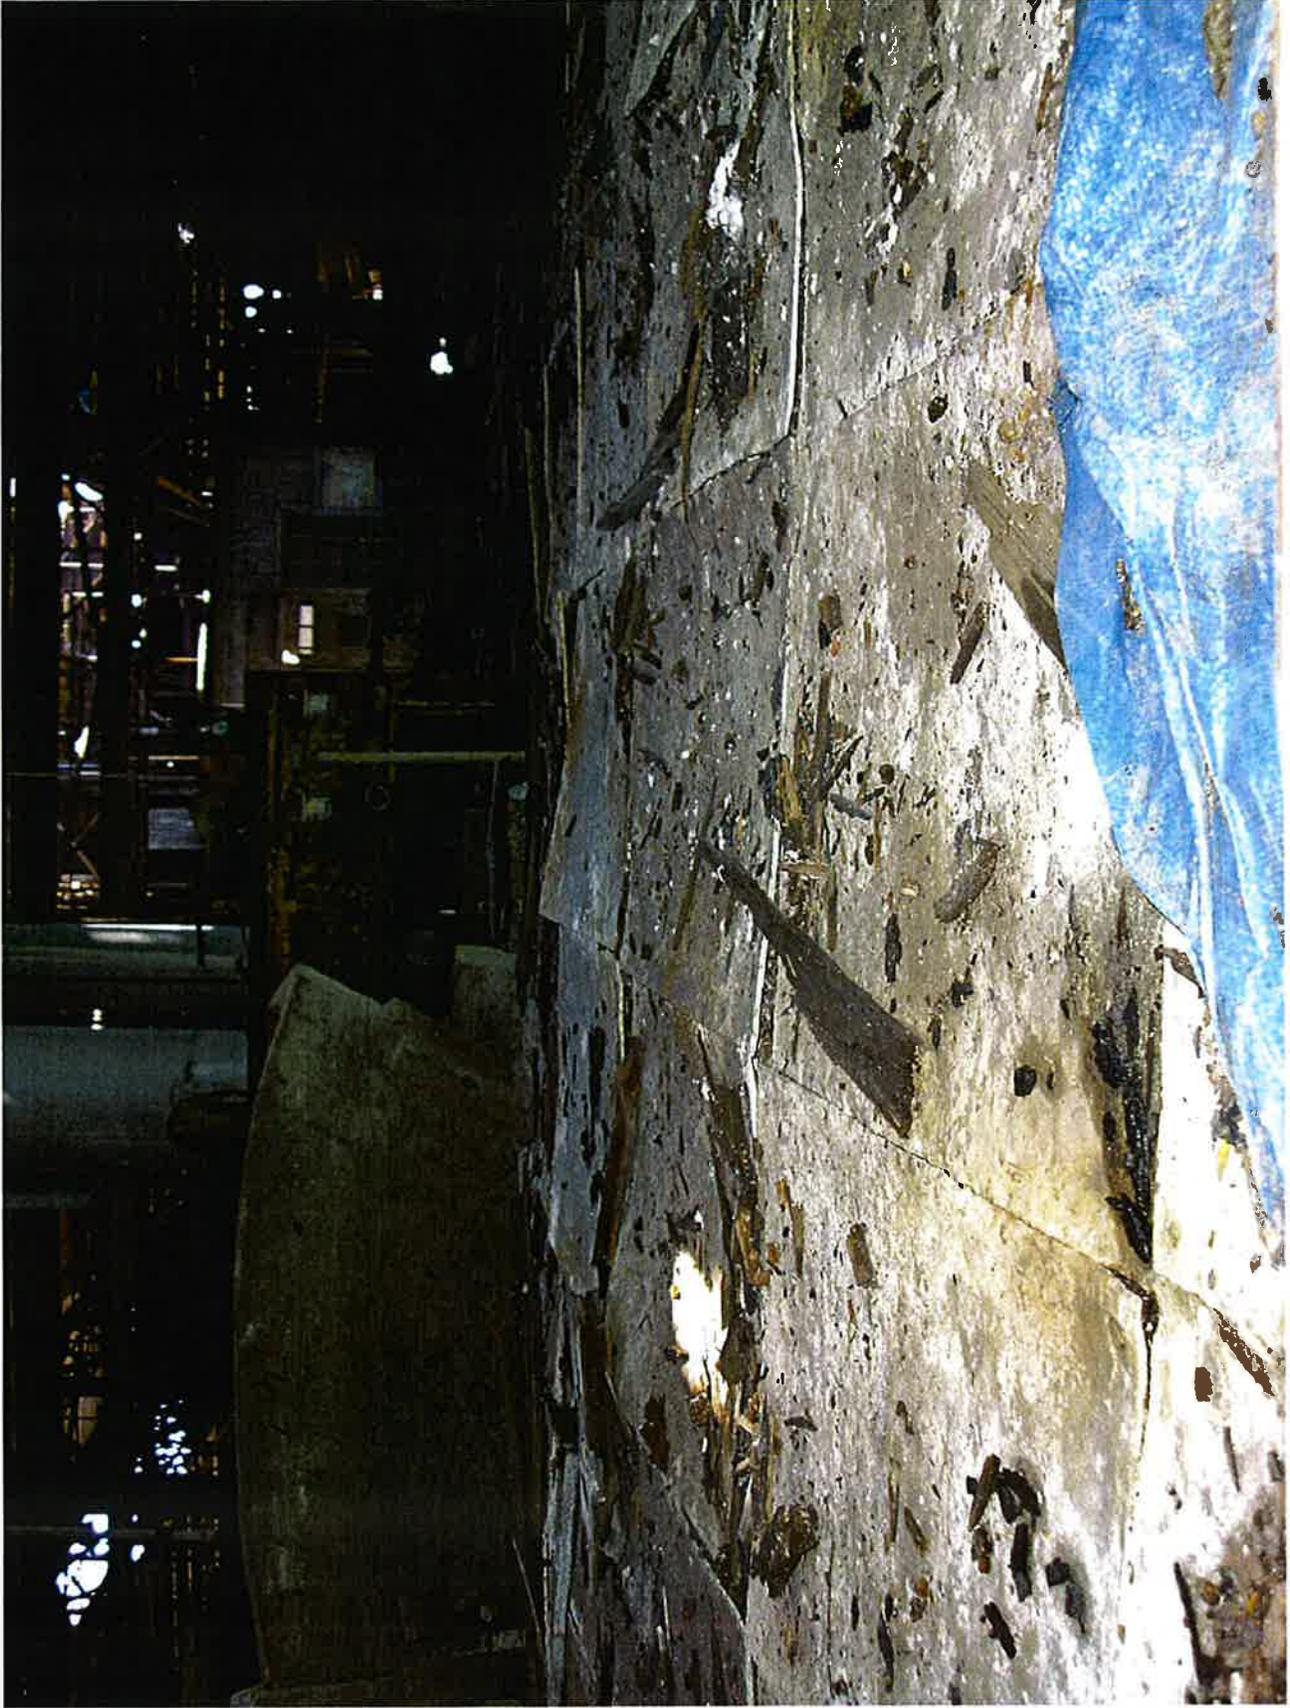
This building is a large predominantly conventional steel framed building with three elevated levels within the building. A portion of the second floor of the east half of the building (east of the blue curtain) consist of diagonal wood decking spanning between 2x12 wood beams supported by steel beams. The entire wood framed portion appears to be deteriorated, likely due to "dry rot" of the wood framing. There are remnants of a "blue curtain" which separates the western half of the building from the eastern half. The elevated second level wood framed portion exhibits considerable wood rotting and is not structurally sound (Photo 4, photo is taken standing on the west half looking east). There are columns supporting the east half of the wood framed second level which are severely deteriorated and structurally unsound (Photo 5). There are also exterior wall girts (horizontal wall beams to which exterior wall panel attaches) at the east half of the north wall that are severely deteriorated and structurally unsound (Photo 6).

PHOTO 4 – VIEW OF SECOND LEVEL FLOOR AT EAST HALF OF BUILDING 2

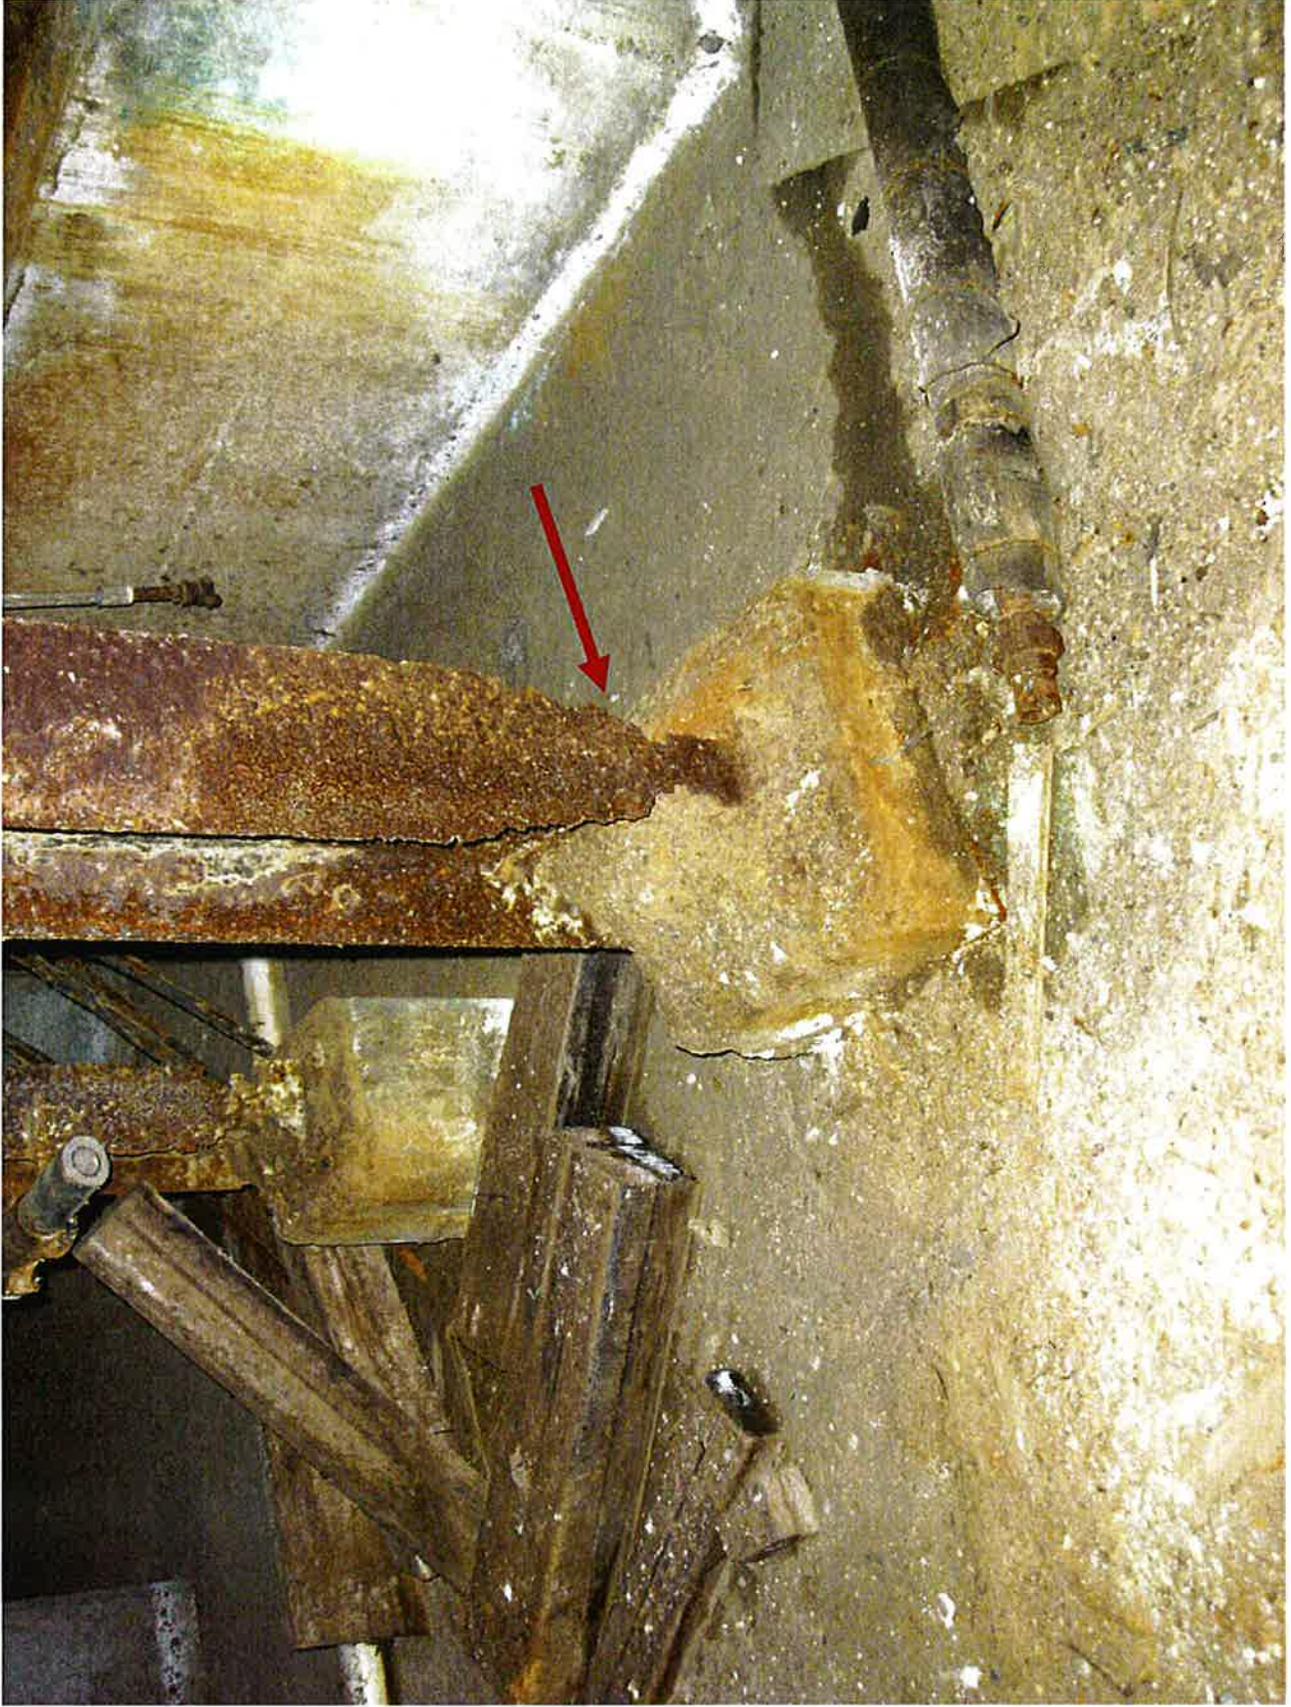
PHOTO 5 - DETERIORATED COLUMN AT BUILDING 2

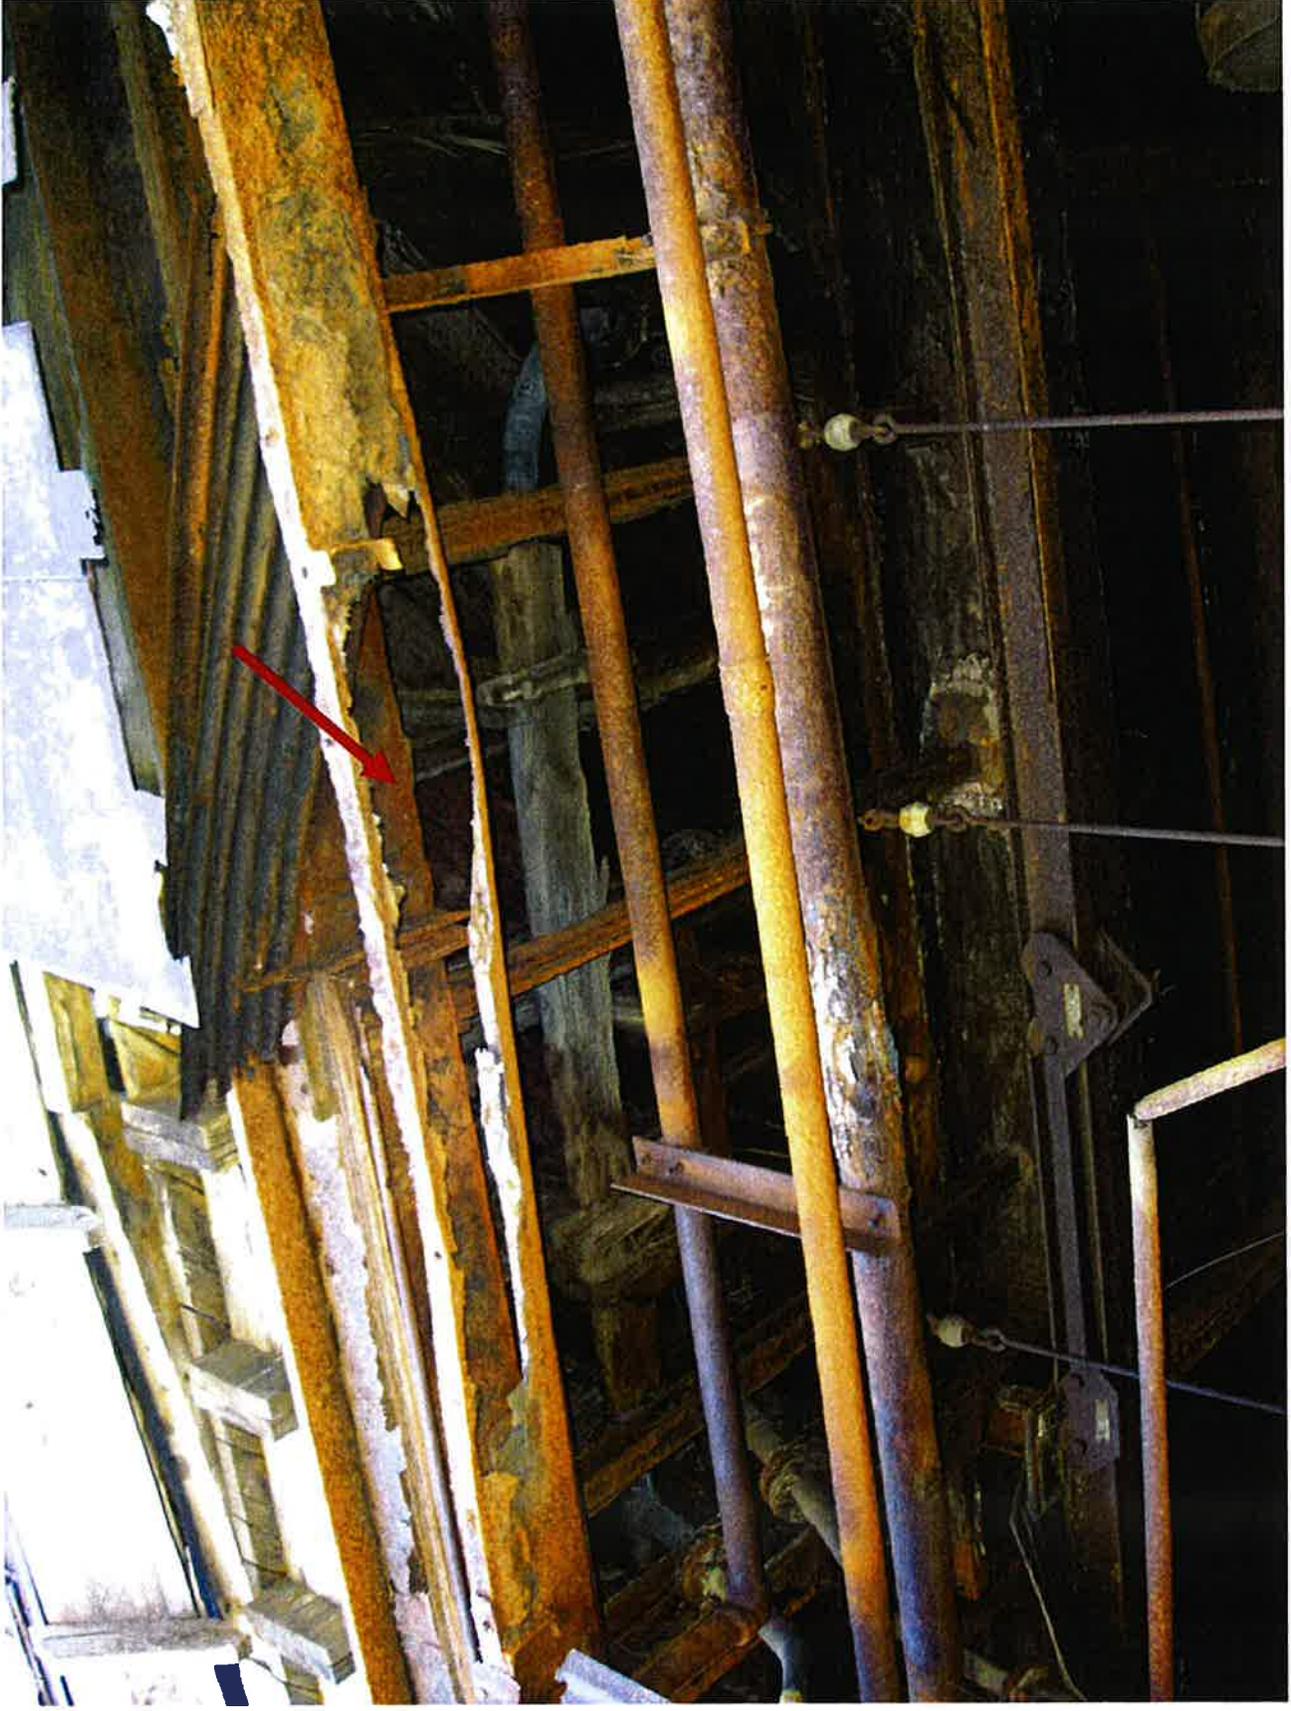
PHOTO 6 – DETERIORATED WALL GIRTS AT NORTH FACE OF BUILDING 2

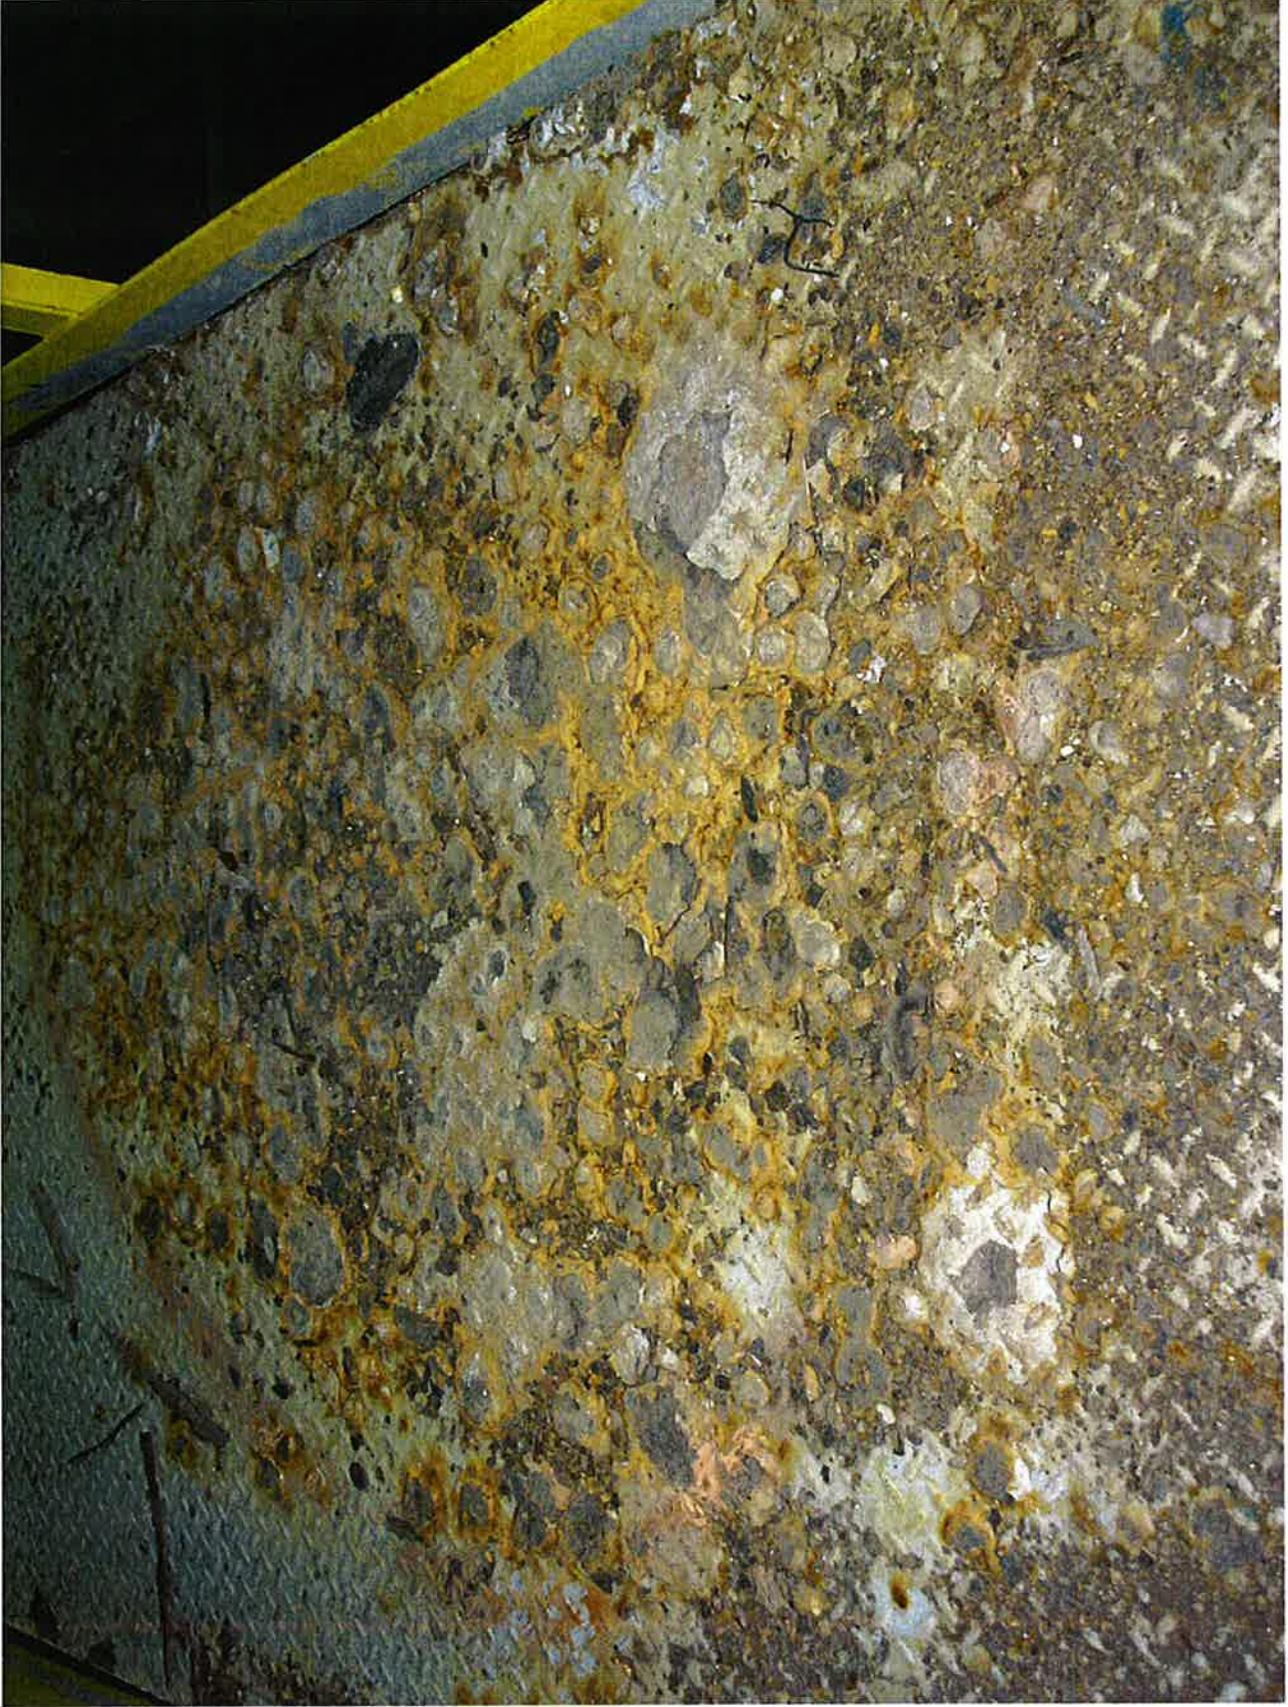
The west half of this building also exhibits significant structural distress. There are areas at the second level catwalk where the checkered plate decking is compromised (Photo 7). There are many areas where the plate has de-laminated and become very soft, with some noticeable openings thru the

PHOTO 7 – COMPROMISED CHECKERED PLATE AT SECOND LEVEL OF WEST HALF OF BUILDING 2

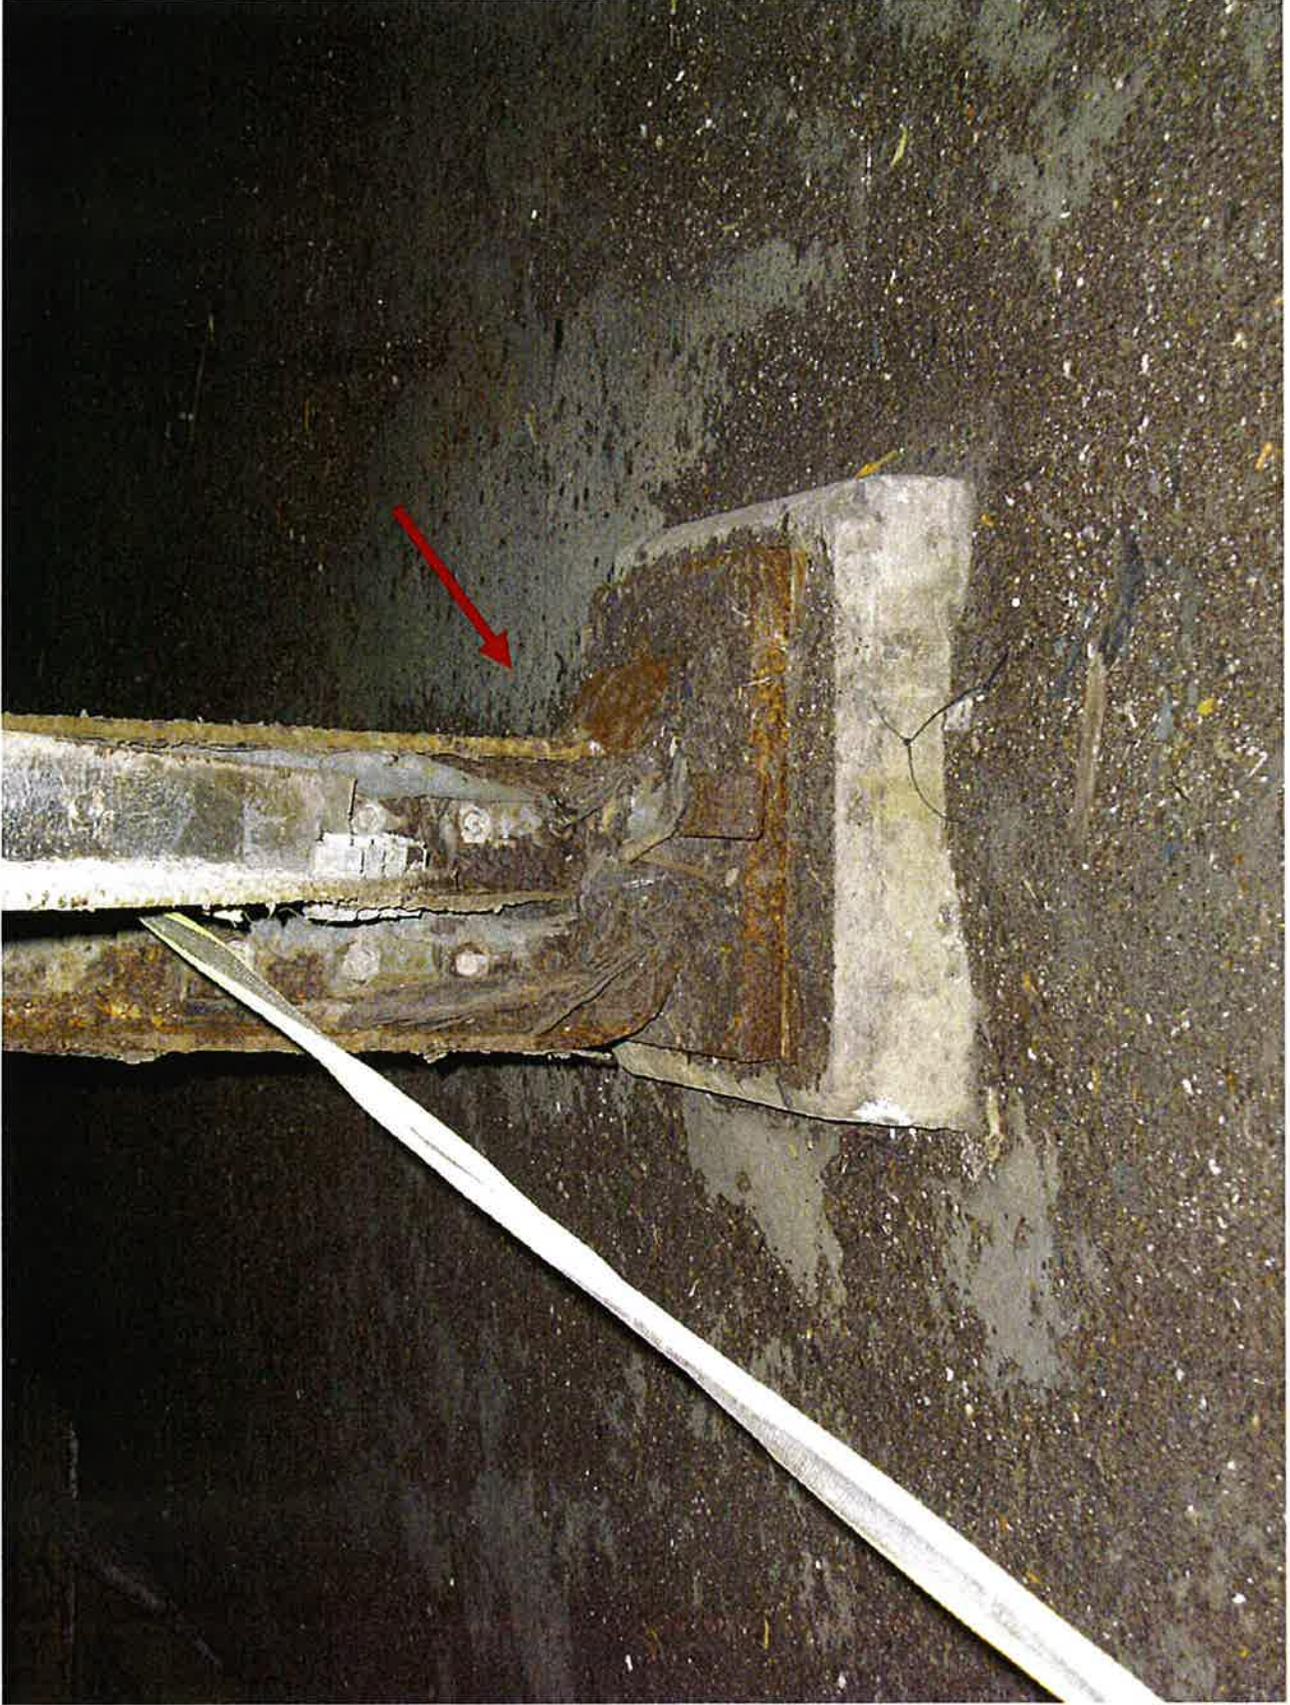
There is evidence of structural failure at the second interior column line from the west elevation. At the first interior bay from the south elevation a full height column supporting 3 elevated levels and a large steel roof truss has settled approximately 3 inches and shifted approximately 3 inches to the west (Photo 8). The column immediately north has also failed and shifted (Photo 9). Another column on this same grid at the north end of the building has failed and shifted approximately 2 inches (Photo 10). All framing above this row of columns is affected by these column failures. The steel roof trusses that are supported by these columns all appear to slope downward due to the deterioration and settling of the bottom of the columns. There is some asbestos containing piping near the catwalk at the west half of this building (Photo 11). This catwalk is supported on one side by the noted failed columns and should not be used during the asbestos abatement process.

PHOTO 8 - FAILED COLUMN AT FIRST INTERIOR BAY, LOOKING NORTH, WEST HALF OF BUILDING 2

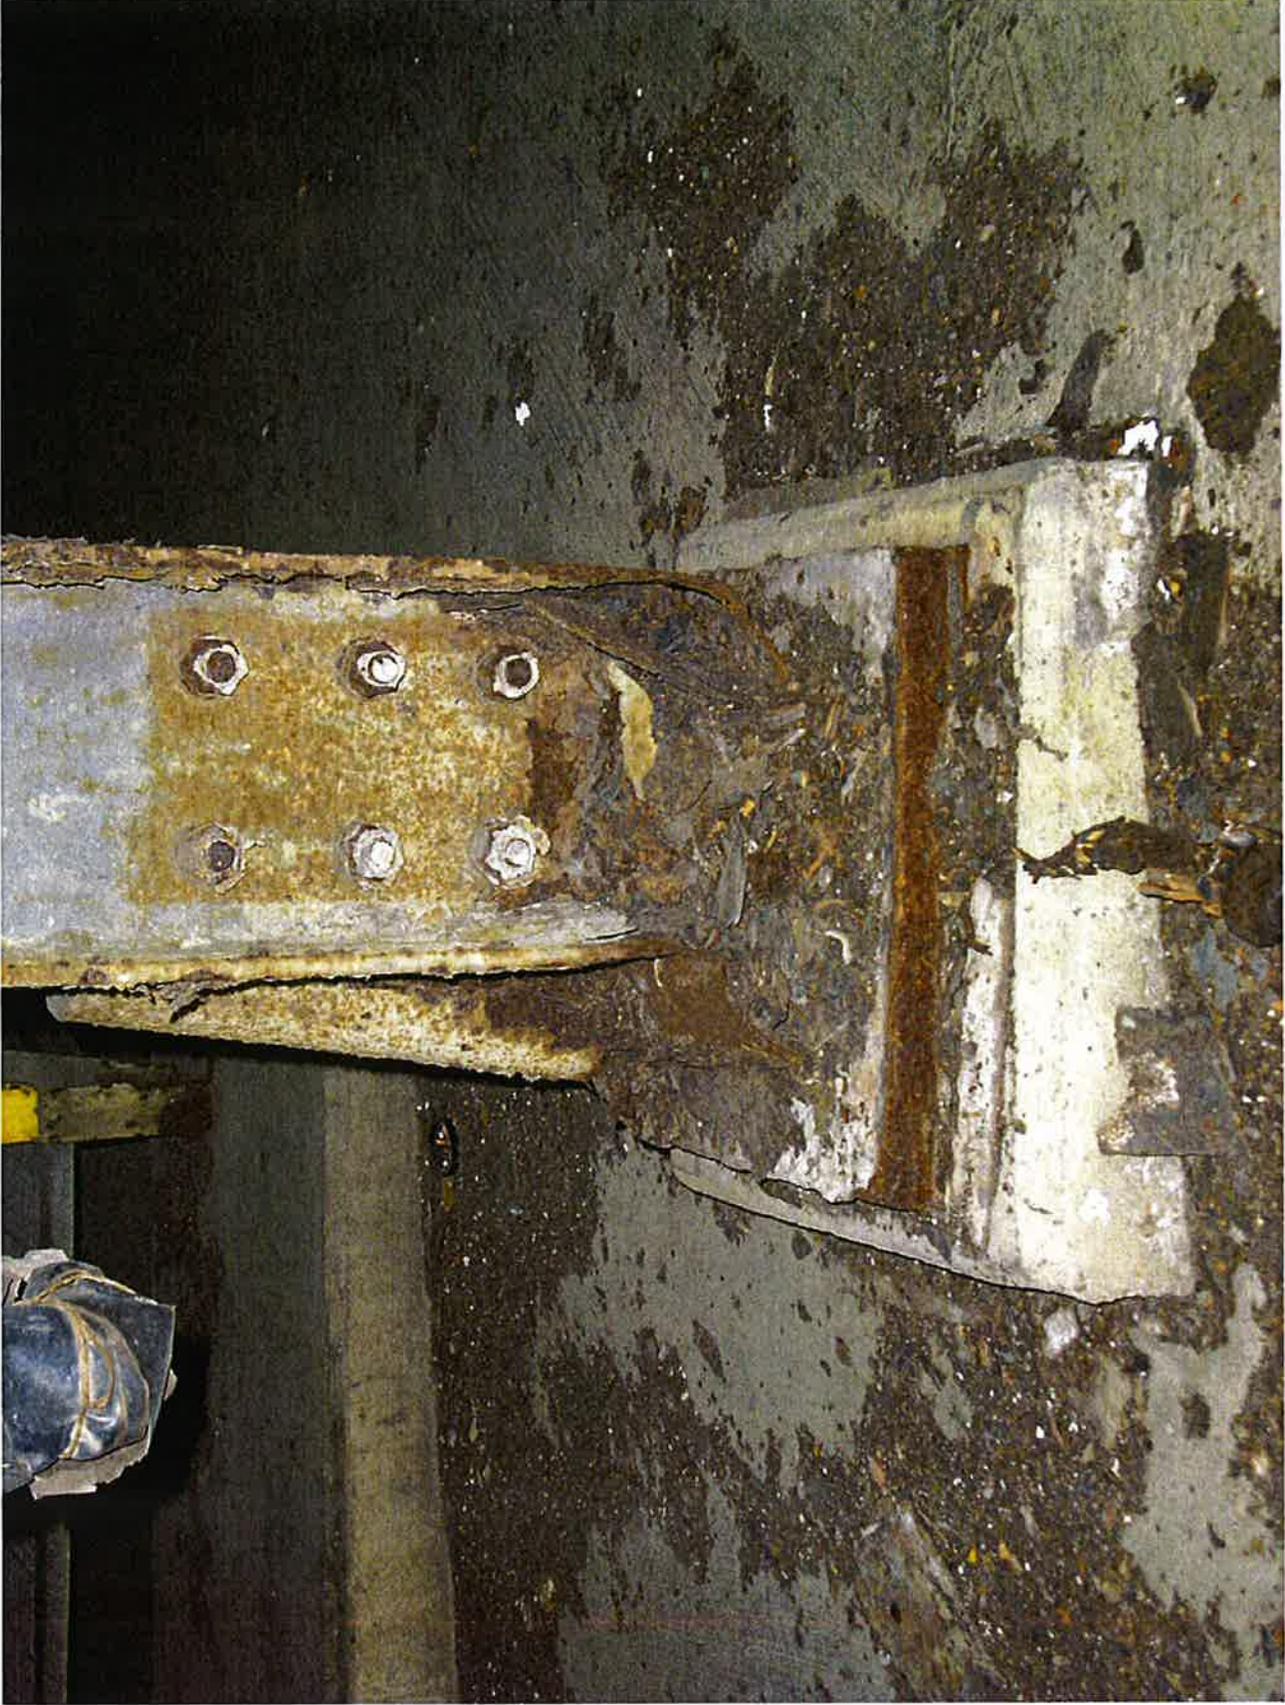
PHOTO 9 – FAILED COLUMN AT SECOND INTERIOR BAY, LOOKING SOUTH, WEST HALF OF BUILDING 2
