JASTER-QUINTANILLA & ASSOCIATES, INC.

March 15, 2011

**Re: Structural Integrity Assessment
Former Encycle/Texas, Inc. /ASARCO Facility (Encycle)
5500 Up River Road
Corpus Christi, Nueces County, Texas**

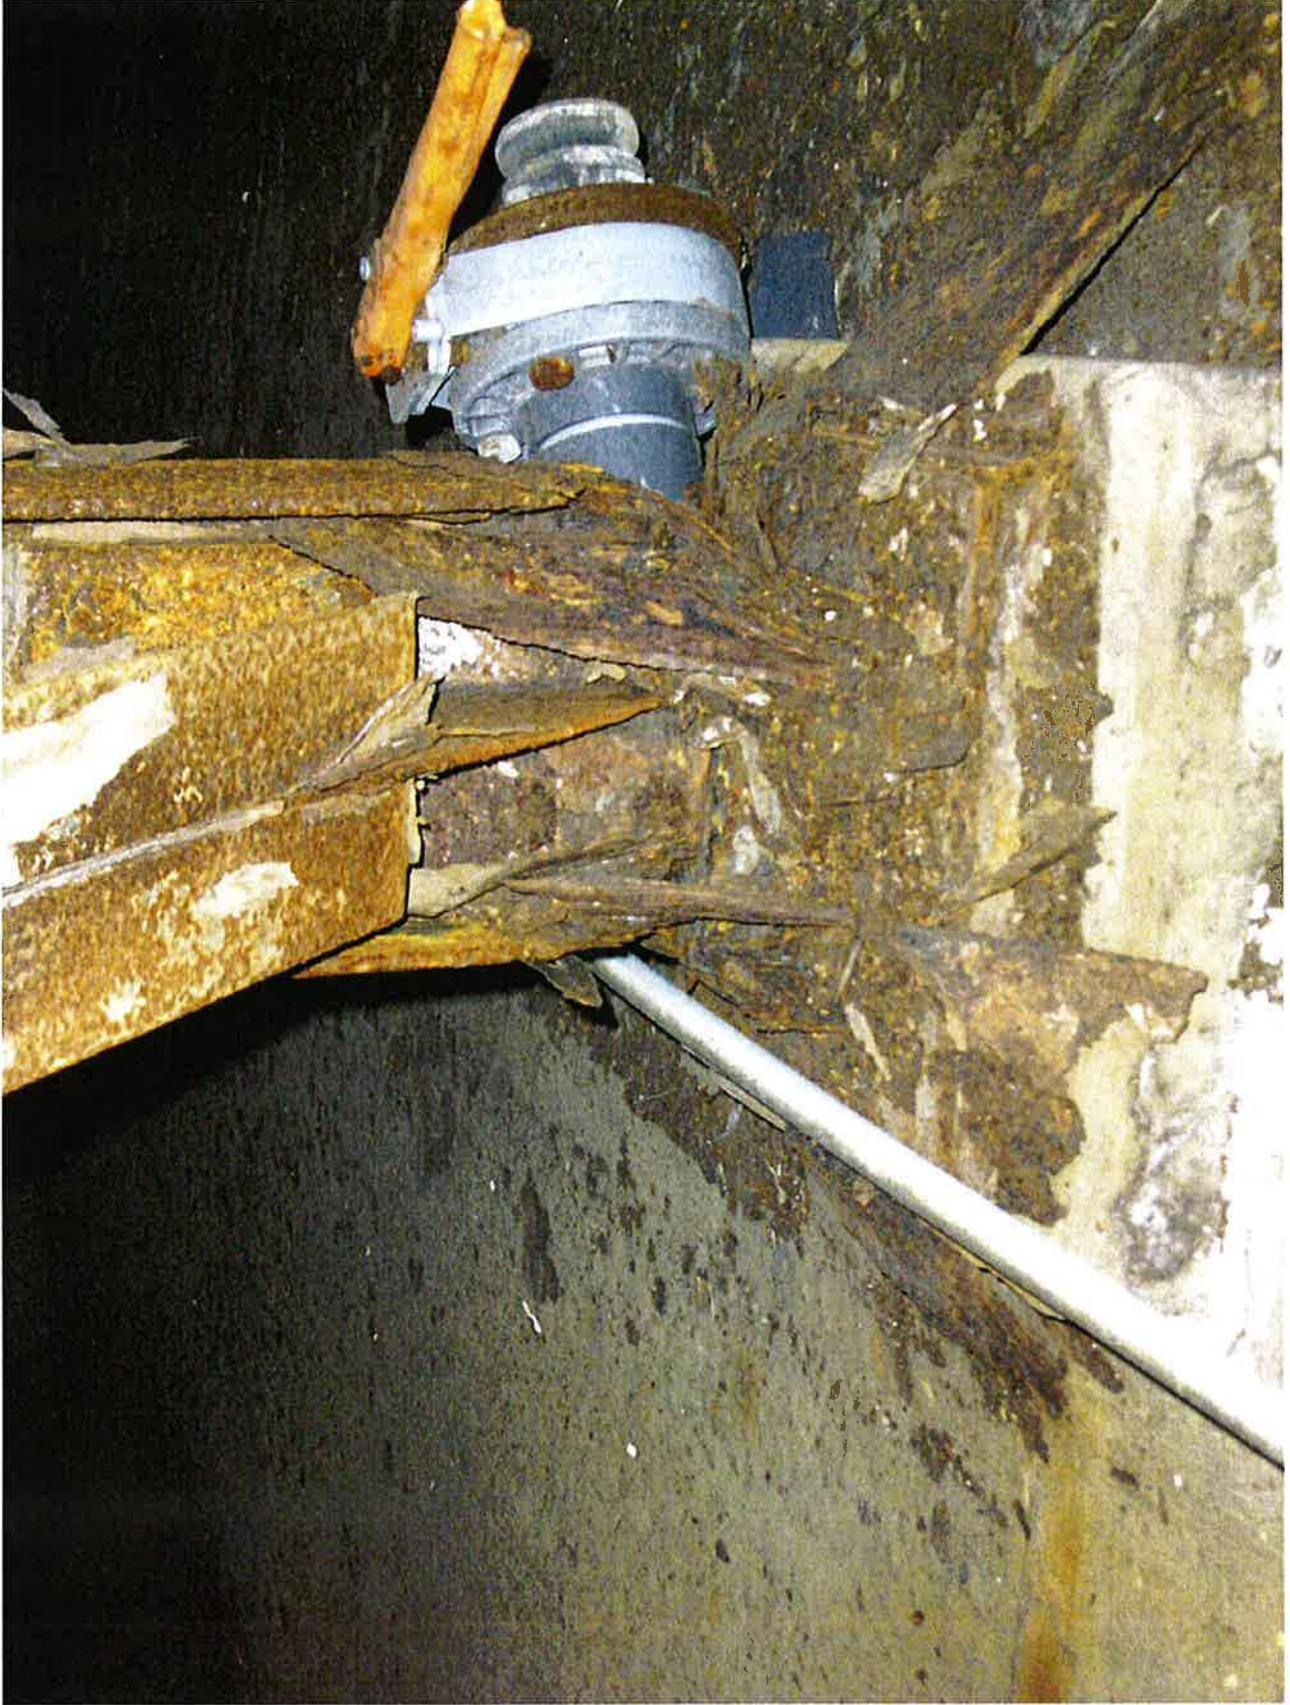
There is evidence of structural failure at the second interior column line from the west elevation. At the first interior bay from the south elevation a full height column supporting 3 elevated levels and a large steel roof truss has settled approximately 3 inches and shifted approximately 3 inches to the west (Photo 8). The column immediately north has also failed and shifted (Photo 9). Another column on this same grid at the north end of the building has failed and shifted approximately 2 inches (Photo 10). All framing above this row of columns is affected by these column failures. The steel roof trusses that are supported by these columns all appear to slope downward due to the deterioration and settling of the bottom of the columns. There is some asbestos containing piping near the catwalk at the west half of this building (Photo 11). This catwalk is supported on one side by the noted failed columns and should not be used during the asbestos abatement process.

PHOTO 10 - FAILED COLUMN AT NORTH END, LOOKING NORTH, WEST HALF OF BUILDING 2

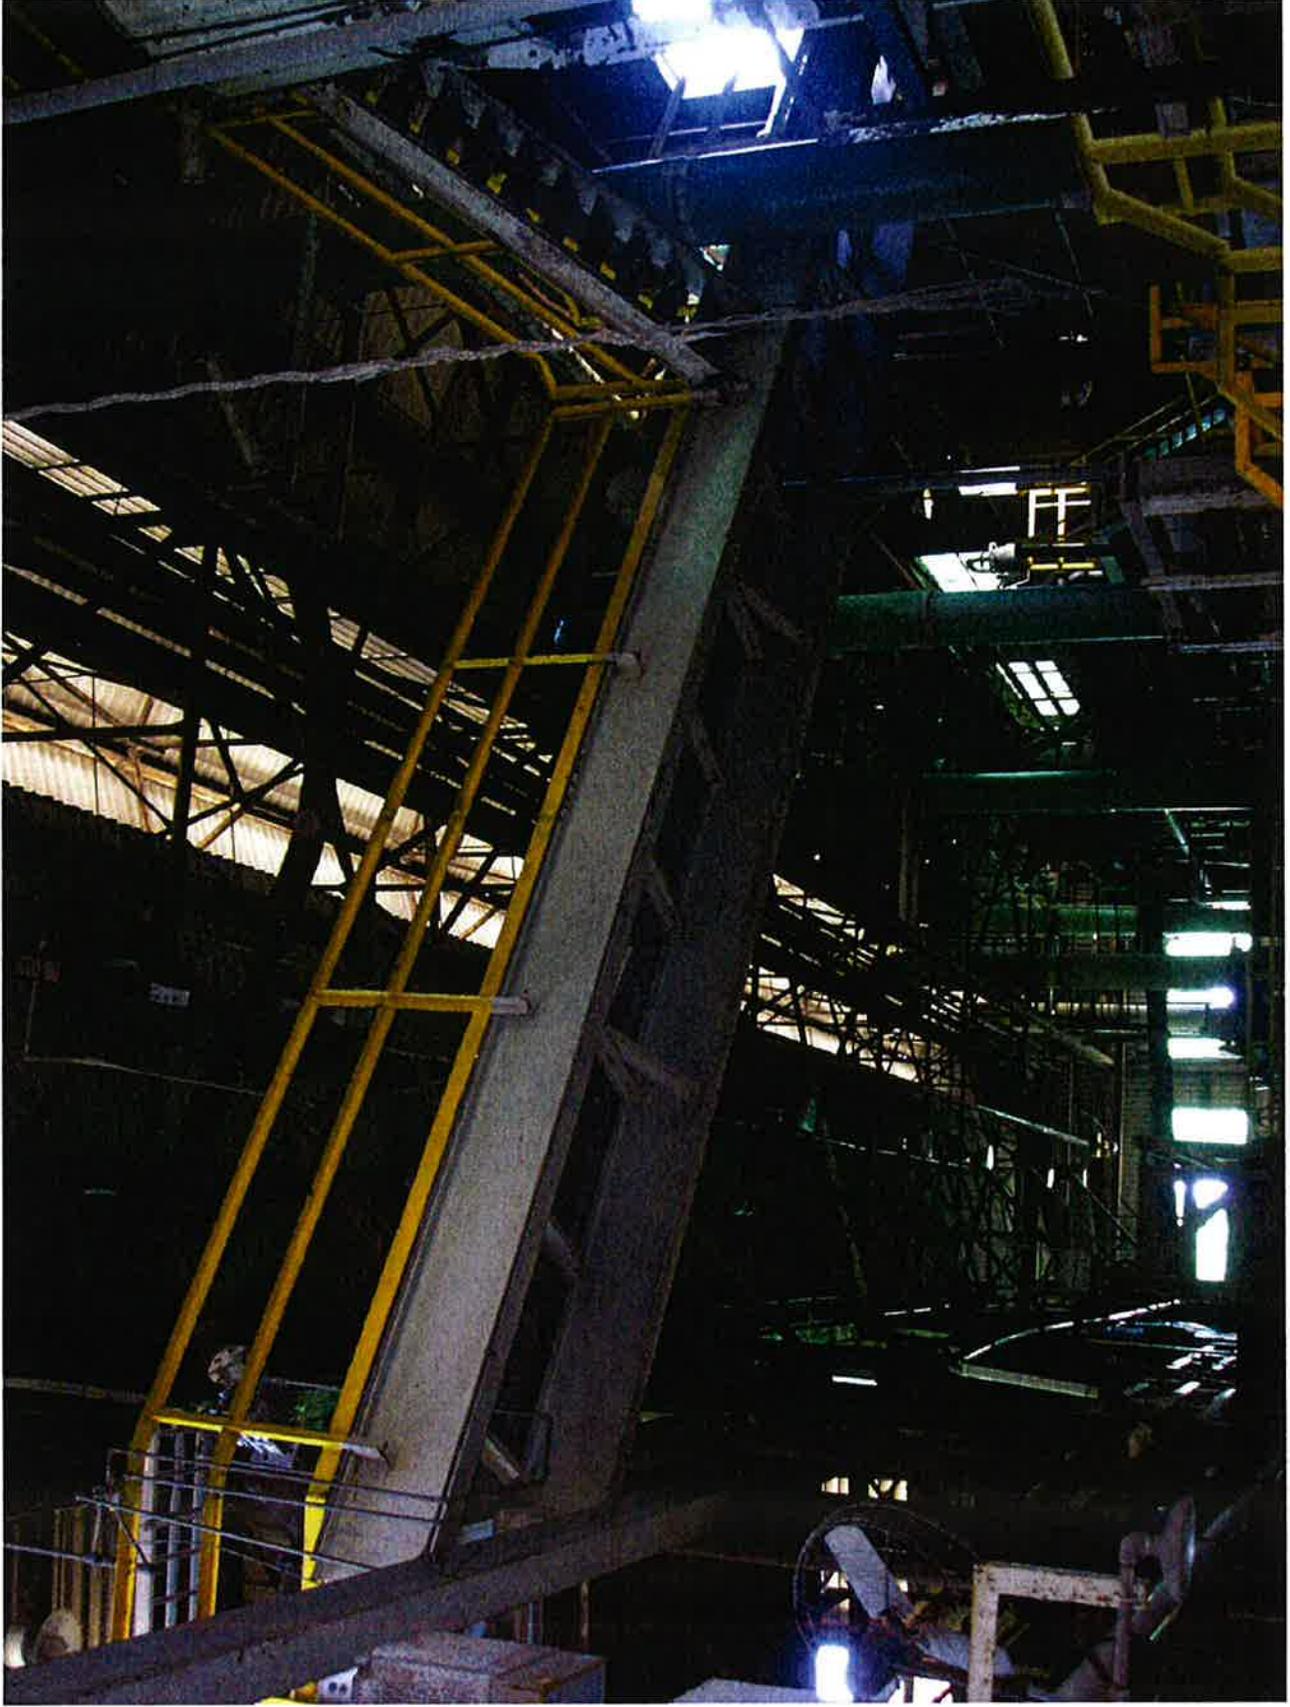
PHOTO 11 – ELEVATED CATWALK AT WEST HALF OF BUILDING 2

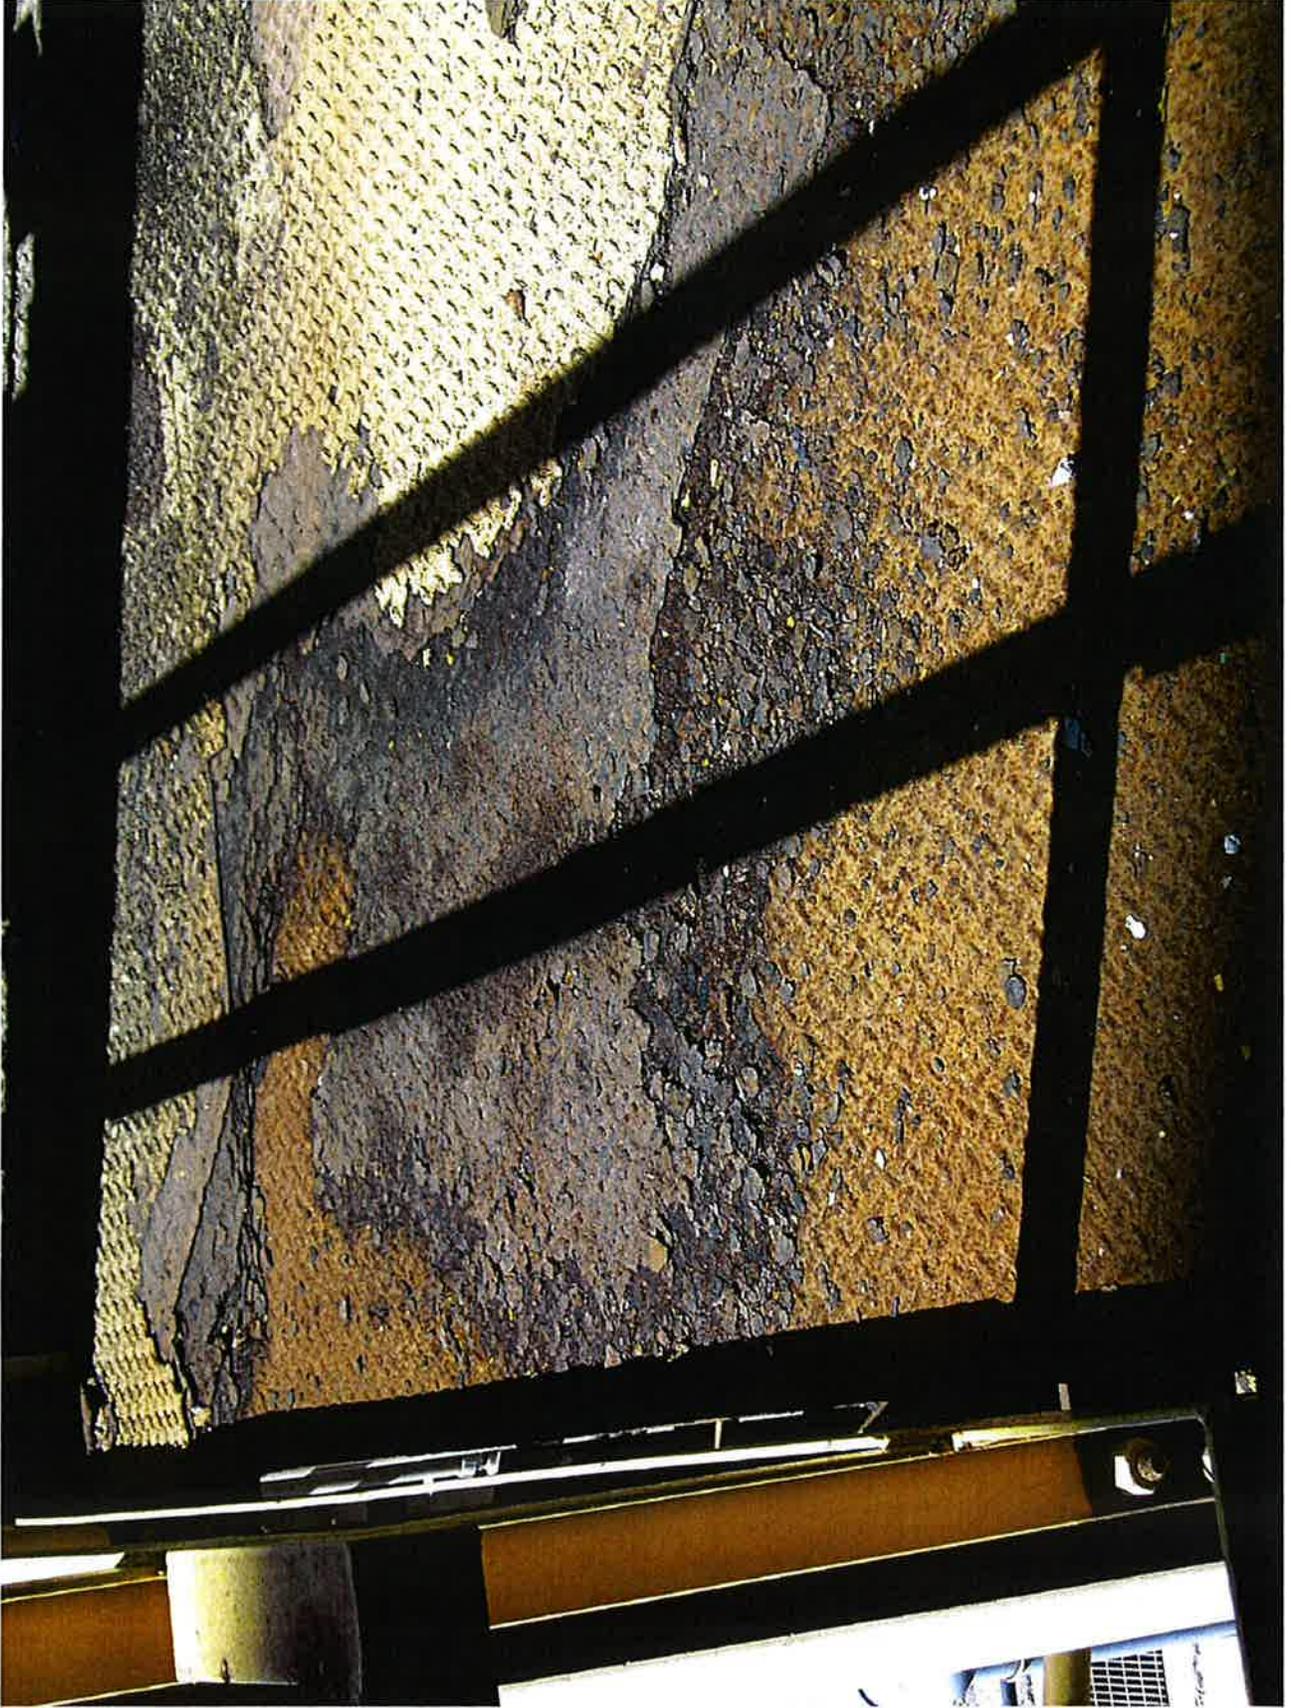
This building is a tall predominantly conventional steel framed building with five elevated levels within the building. The elevated levels are a combination of concrete and checkered plate supported by steel beams. There are areas where the checkered plate exhibits some de-lamination and deterioration (Photo 12). In general, this building appears to possess sufficient structural integrity to allow for planned asbestos abatement with the following exception:

PHOTO 12 - DETERIORATED CHECKERED PLATE AT WEST HALF OF BUILDING 4

1. No concentrated point loads shall be applied over the checkered plate. Temporary wood decking shall be installed over checkered plate to support asbestos abatement personnel.

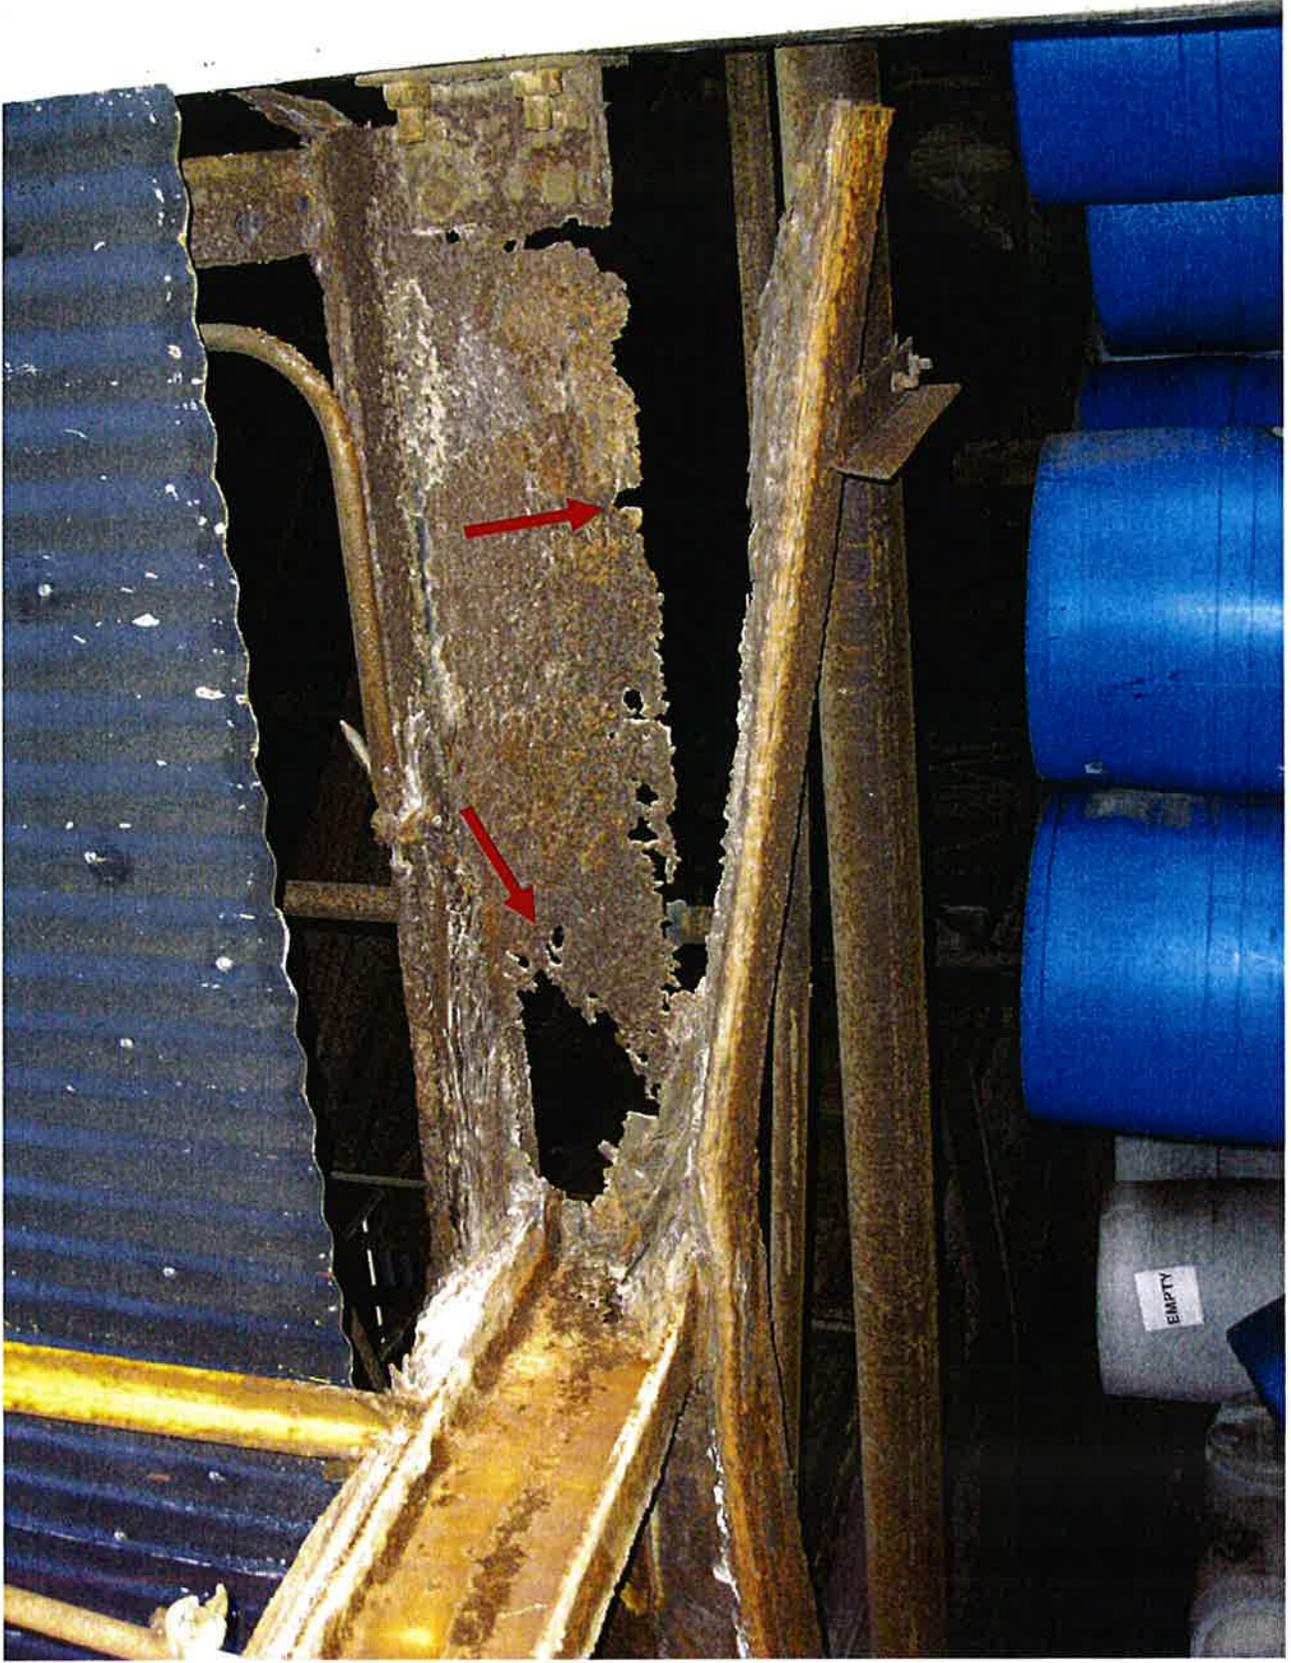
1. At the interface between buildings 7 (Old Casting Building) and 16 (East Cell House), there are some severely deteriorated steel beams (Photo 13). During abatement, no one shall be allowed to work beneath or near these deteriorated beams.

PHOTO 13 – DETERIORATED BEAM AT INTERFACE BETWEEN BUILDINGS 7 AND 16

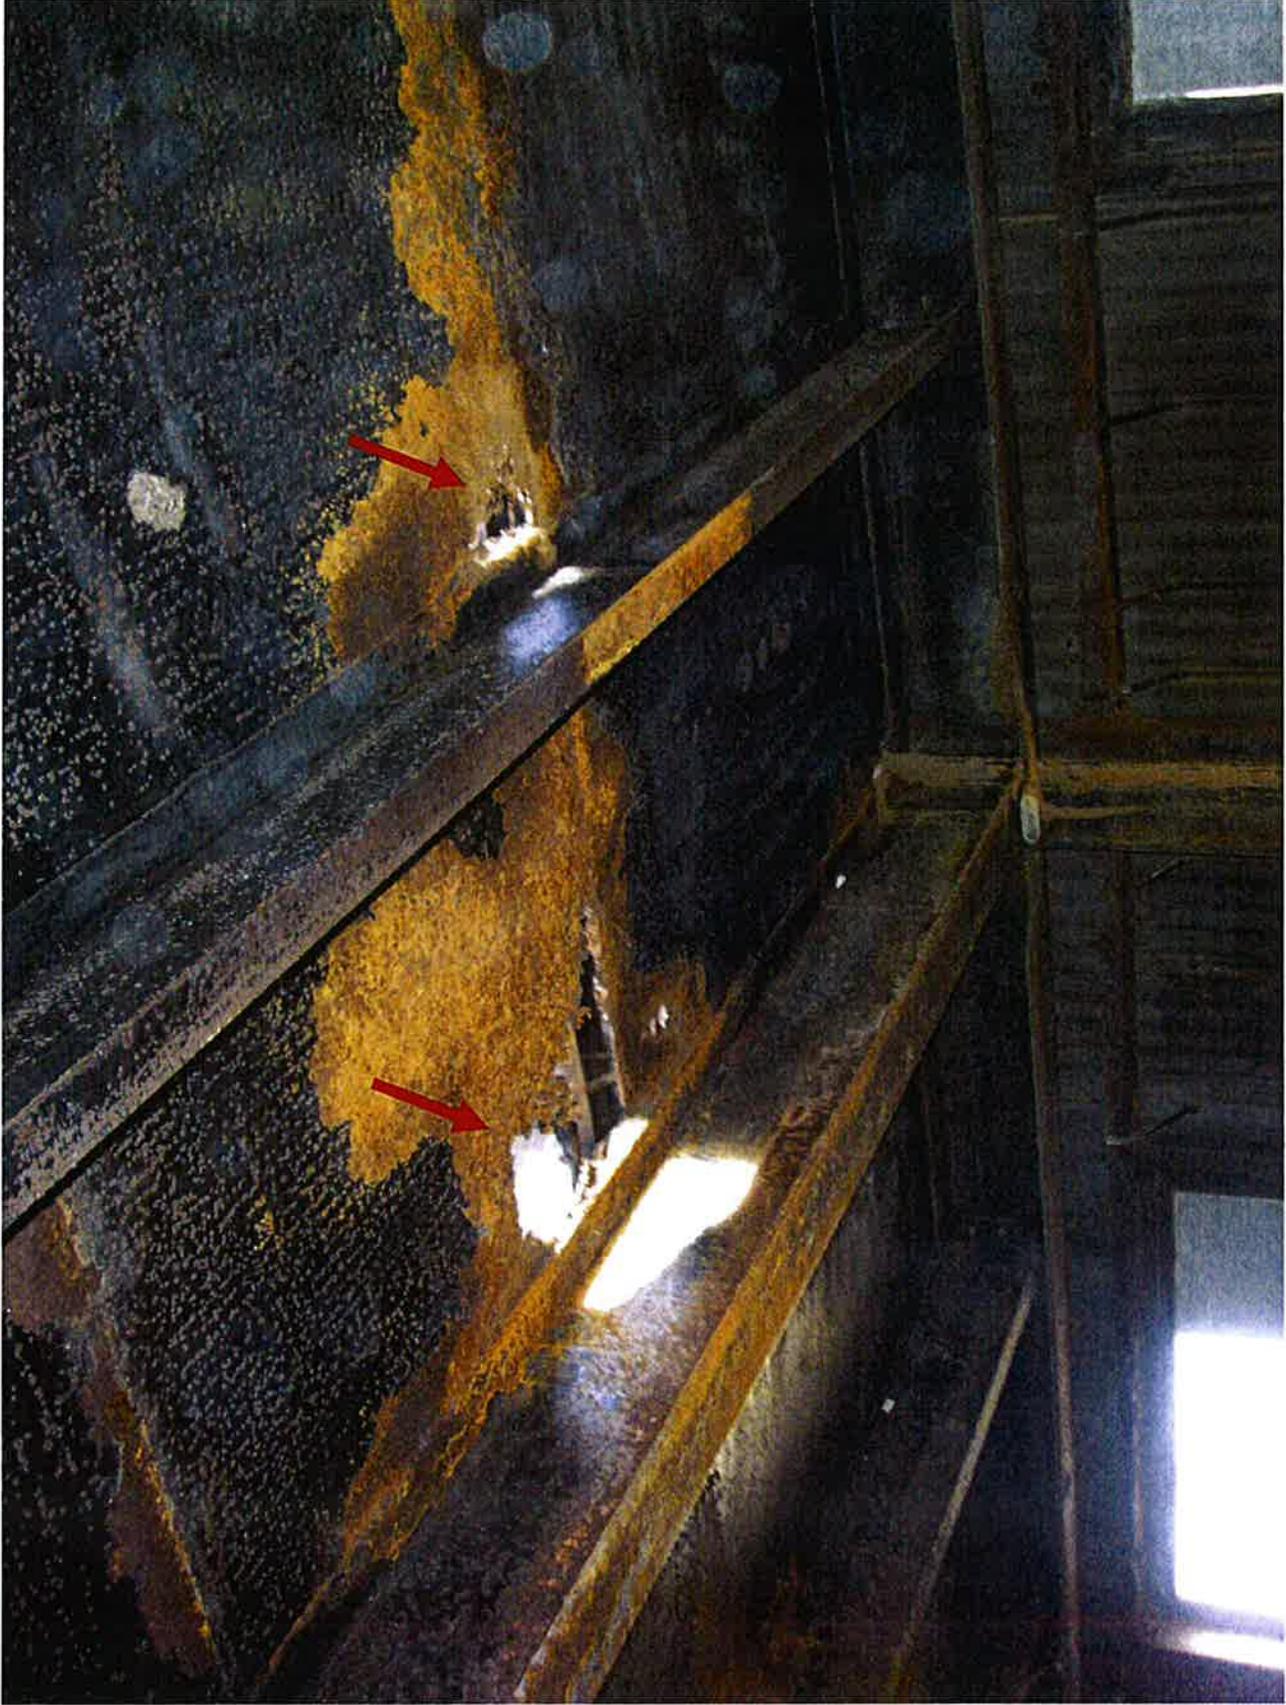
1. There are portions of the very small elevated third level where the checkered plate decking is deteriorated and structurally unsound (Photo 14). There are obvious holes and other areas where plate has corroded and is de-laminating. The beams supporting the plate are beginning to show some signs of deterioration, but appear to have adequate strength at the present time. No concentrated point loads shall be applied over the checkered plate. Temporary wood decking shall be installed over checkered plate to support asbestos abatement personnel.

PHOTO 14 – DETERIORATED CHECKERED PLATE AT THIRD LEVEL OF BUILDING 9

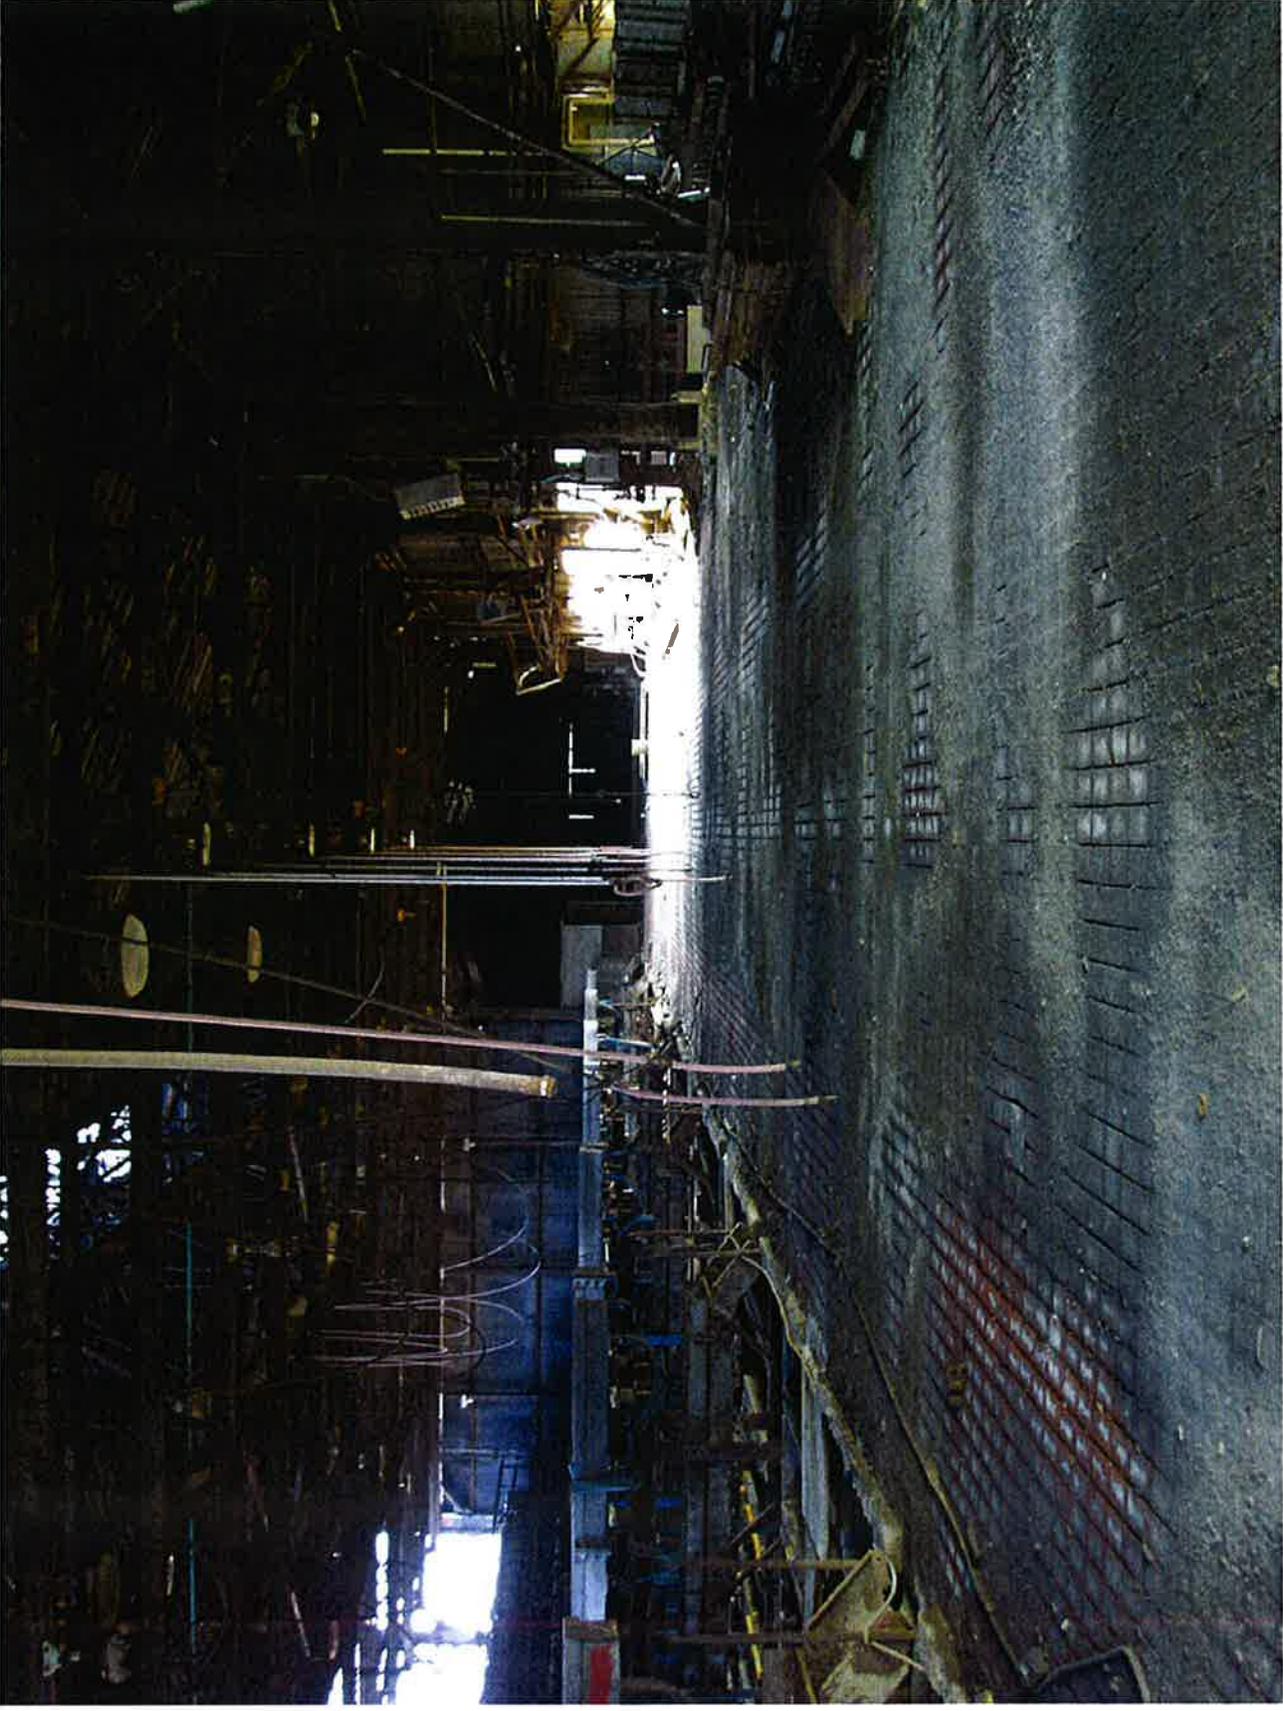
This building is a large predominantly conventional steel framed building with an elevated level within the building. The east half of the elevated level consist of a concrete frame with "acid brick" as the floor surface (Photo 15). The east half of the elevated floor appears structurally sound. The west half of this building previously housed corrosive containers which likely contributed to deterioration of cross-catwalks (Photos 16, 17, and 18). These steel framed catwalks and any other second level structural supports in the west half of this building are severely deteriorated and shall not be used for support during the asbestos abatement process.

PHOTO 15 – VIEW OF EAST HALF OF SECOND LEVEL OF BUILDING 16

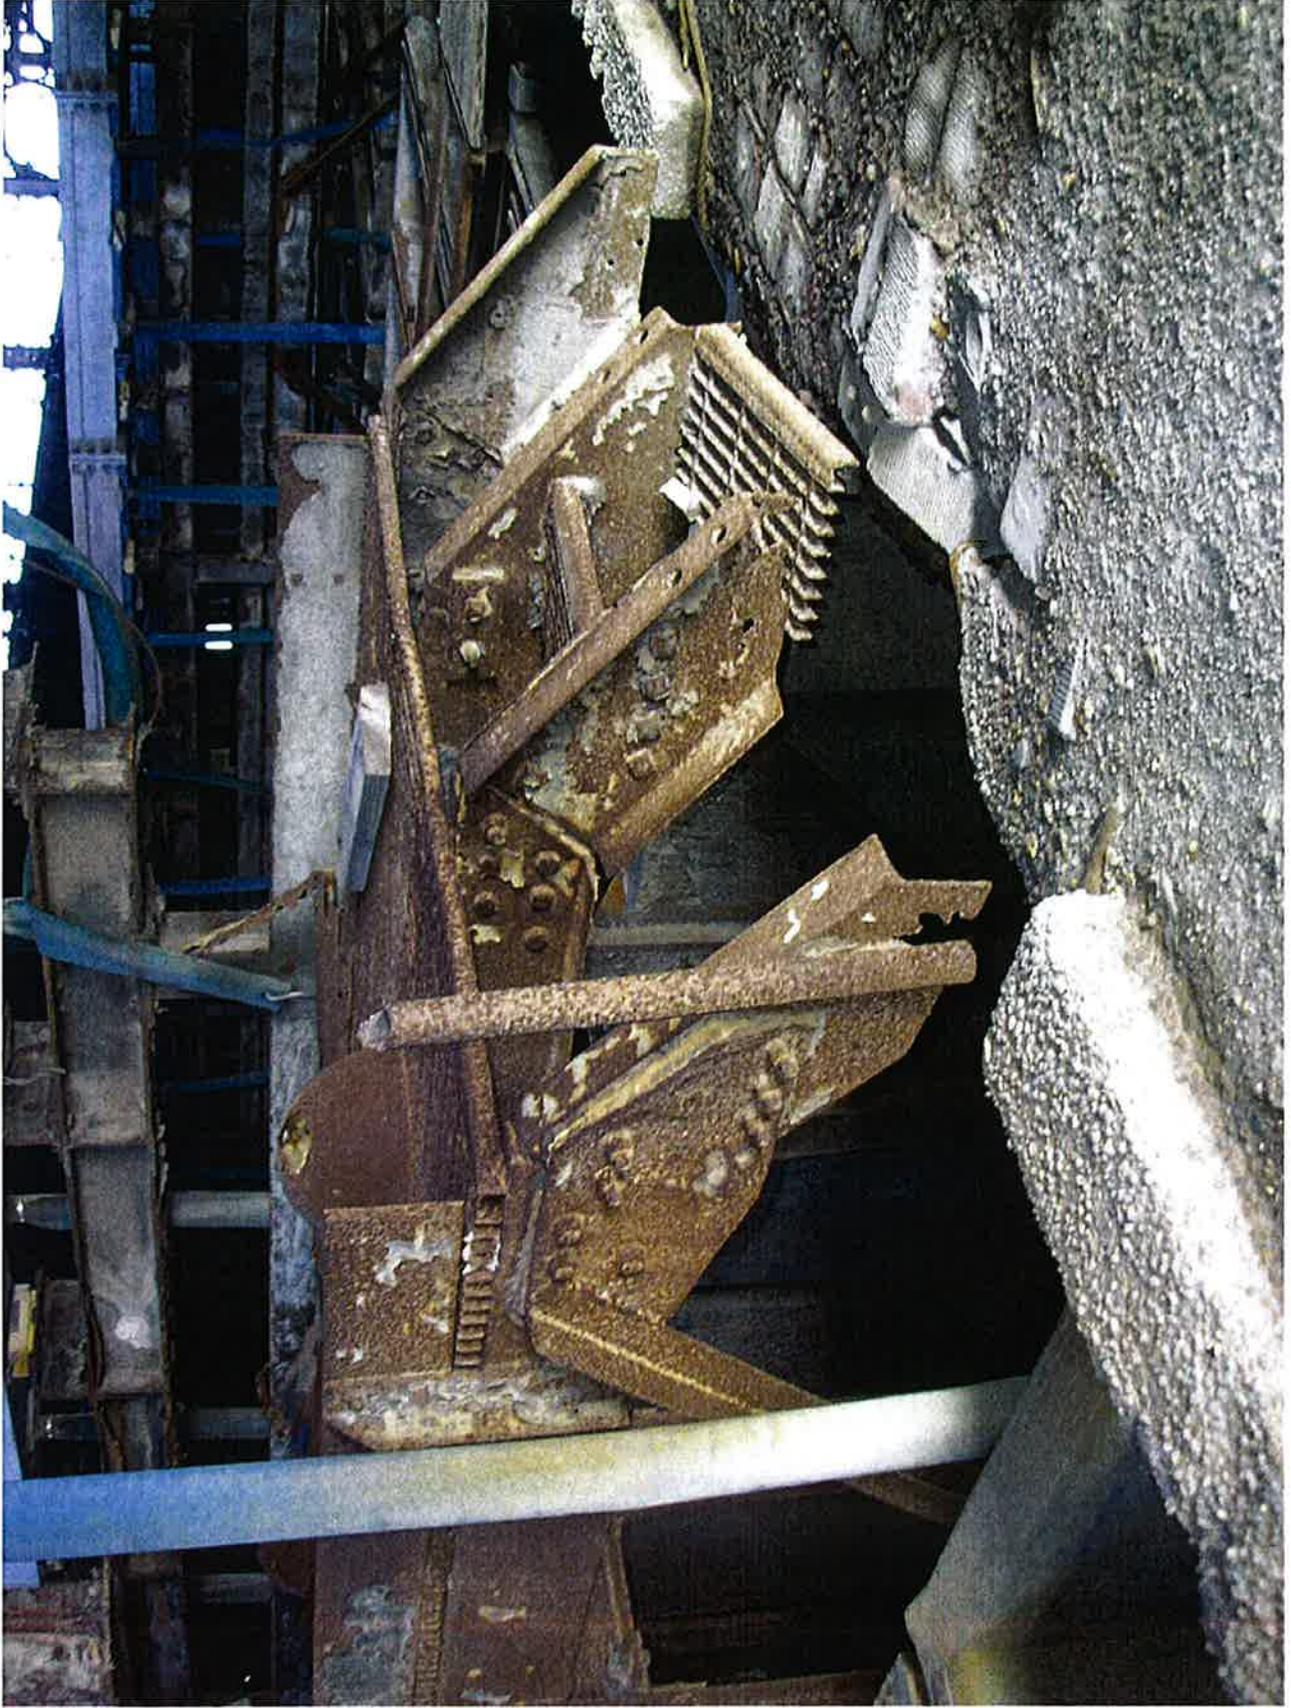
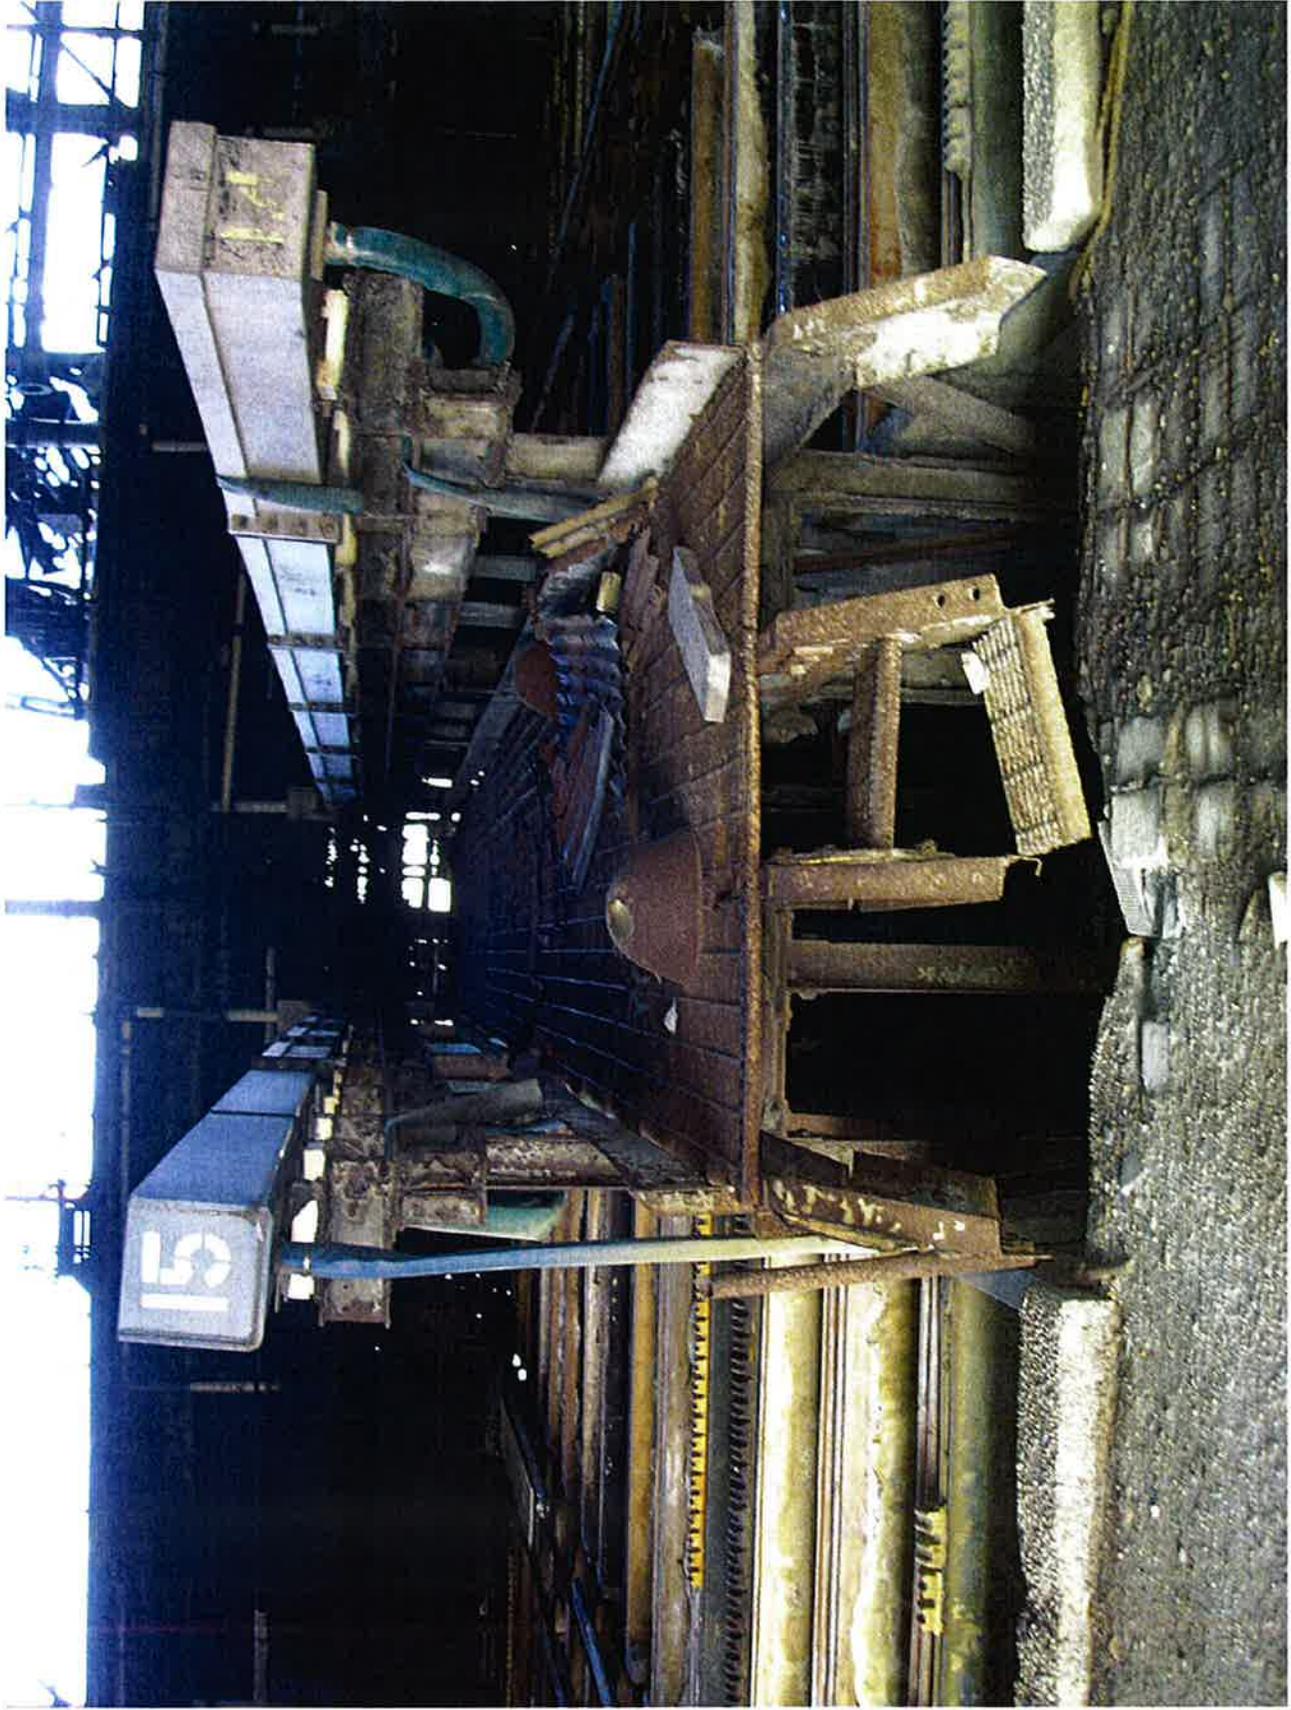
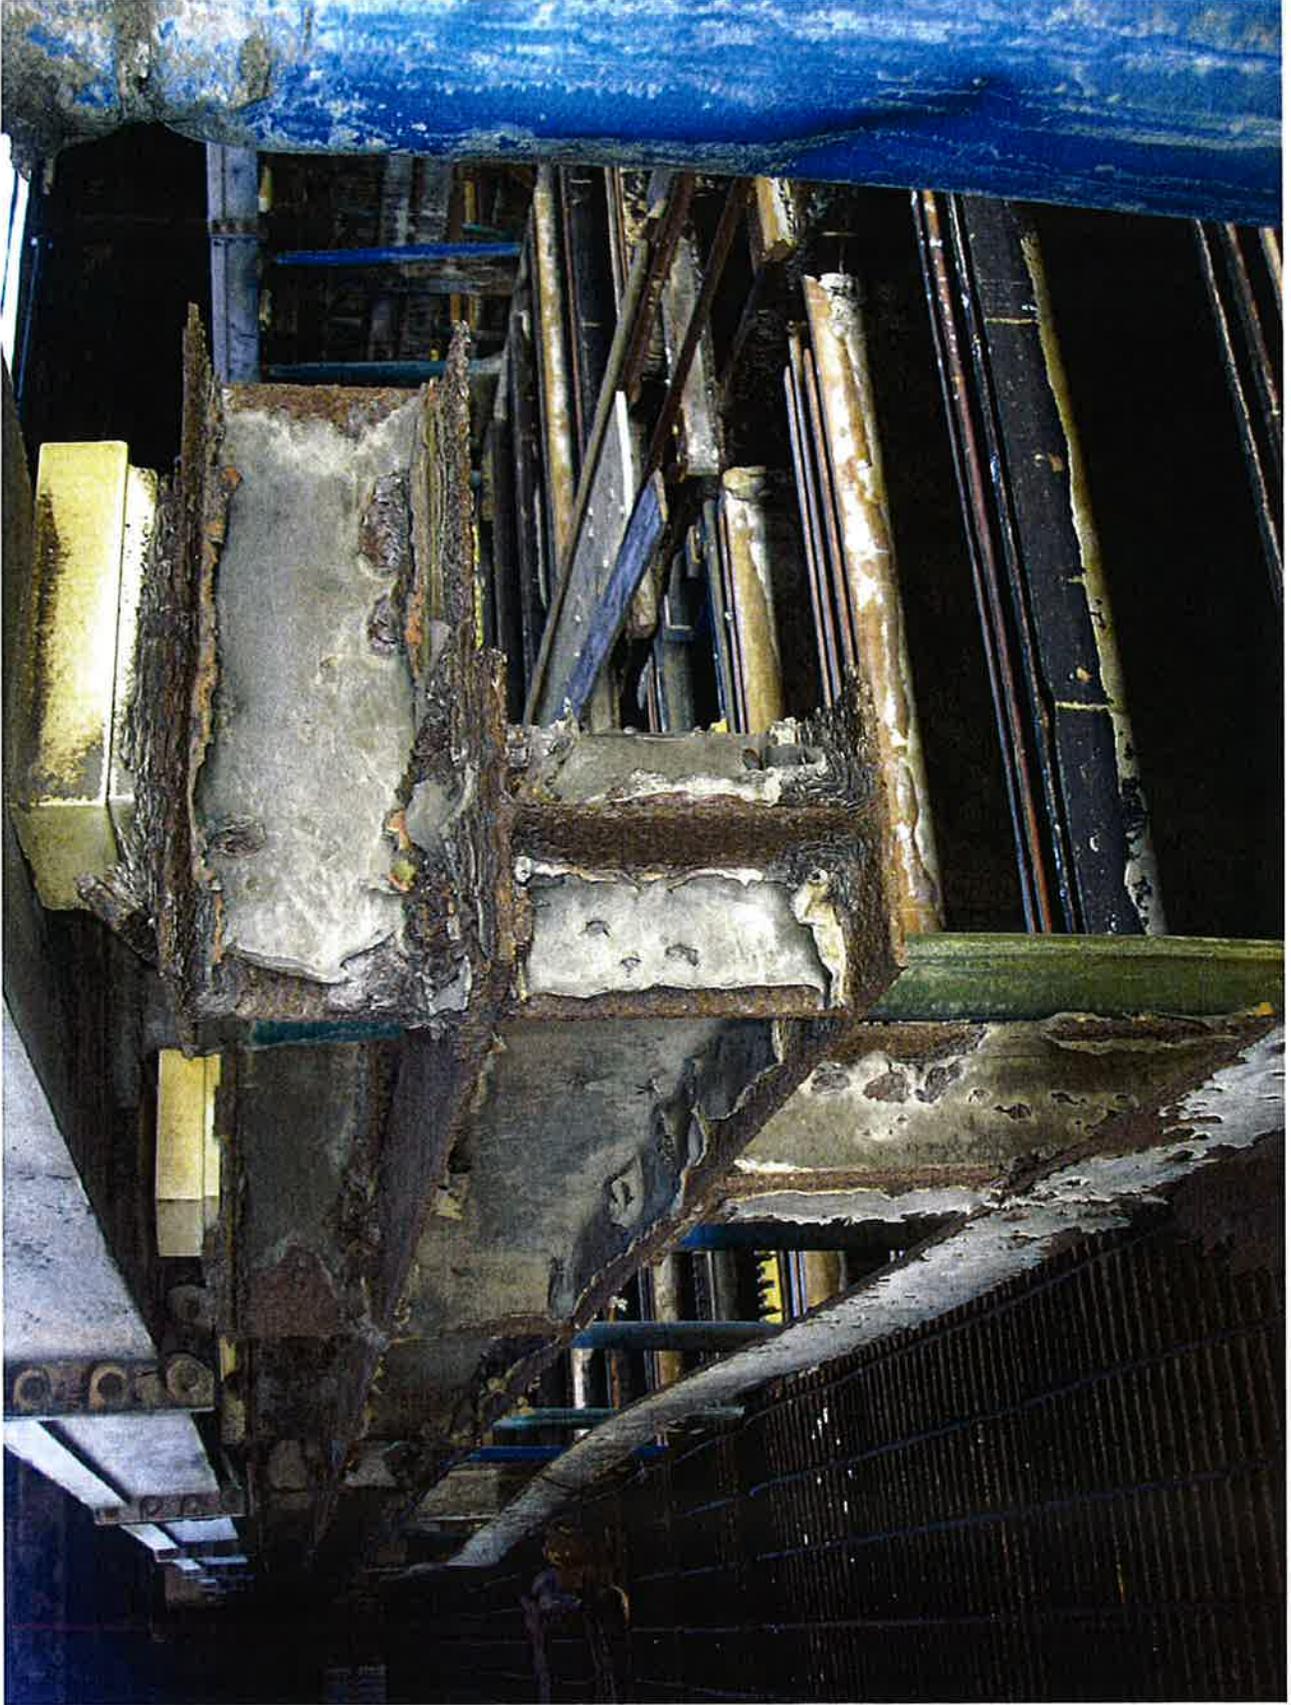
PHOTO 16 – DETERIORATED CATWALK AT WEST HALF OF BUILDING 16

PHOTO 17 – DETERIORATED CATWALK AT WEST HALF OF BUILDING 16

PHOTO 18 – DETERIORATED CATWALK AT WEST HALF OF BUILDING 16

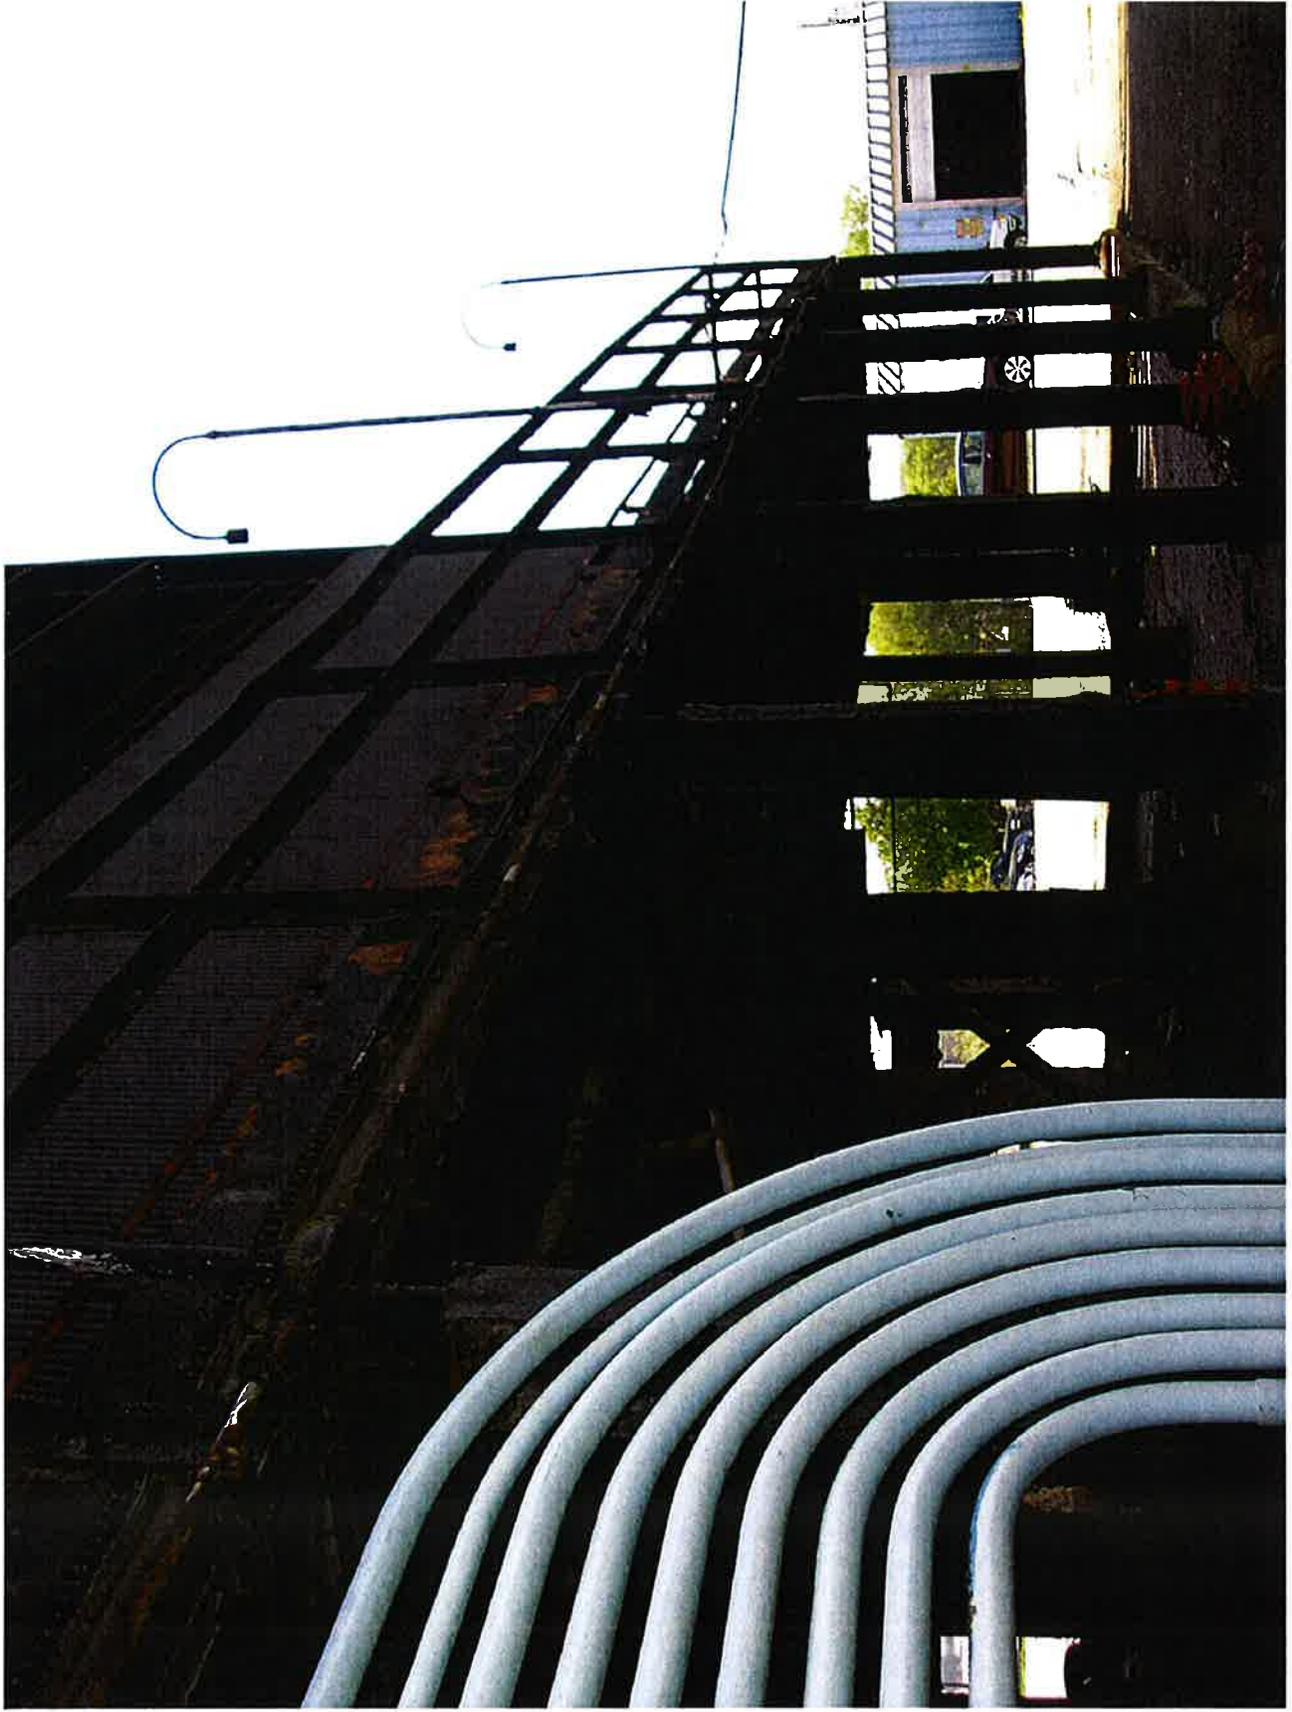
At the exterior of the west side of this building is an exterior elevated steel framed catwalk (Photo 19). There is significant deterioration of much of the framing of this catwalk. Many of the steel support beams are structurally unsound (Photos 20, 21, 22 and 23). There is also a portion along part of the interior catwalk at the west side where the steel framing is totally deteriorated (Photo 24). In general, I believe the elevated concrete second level at the east half of this building has sufficient

PHOTO 19 - VIEW OF CATWALK AT WEST ELEVATION OF BUILDING 16

structural integrity to allow for safe support during planned abatement. I do not believe the second level at the west half, and the exterior and interior steel framed catwalk along the west side have sufficient structural integrity during the abatement process and shall not be used for support during the abatement process. During abatement, no one shall be allowed to work beneath or near the elevated west half of the building and the steel framed catwalks along the west side.
