JASTER-QUINTANILLA & ASSOCIATES, INC.

March 15, 2011

**Re: Structural Integrity Assessment
Former Encycle/Texas, Inc. /ASARCO Facility (Encycle)
5500 Up River Road
Corpus Christi, Nueces County, Texas**

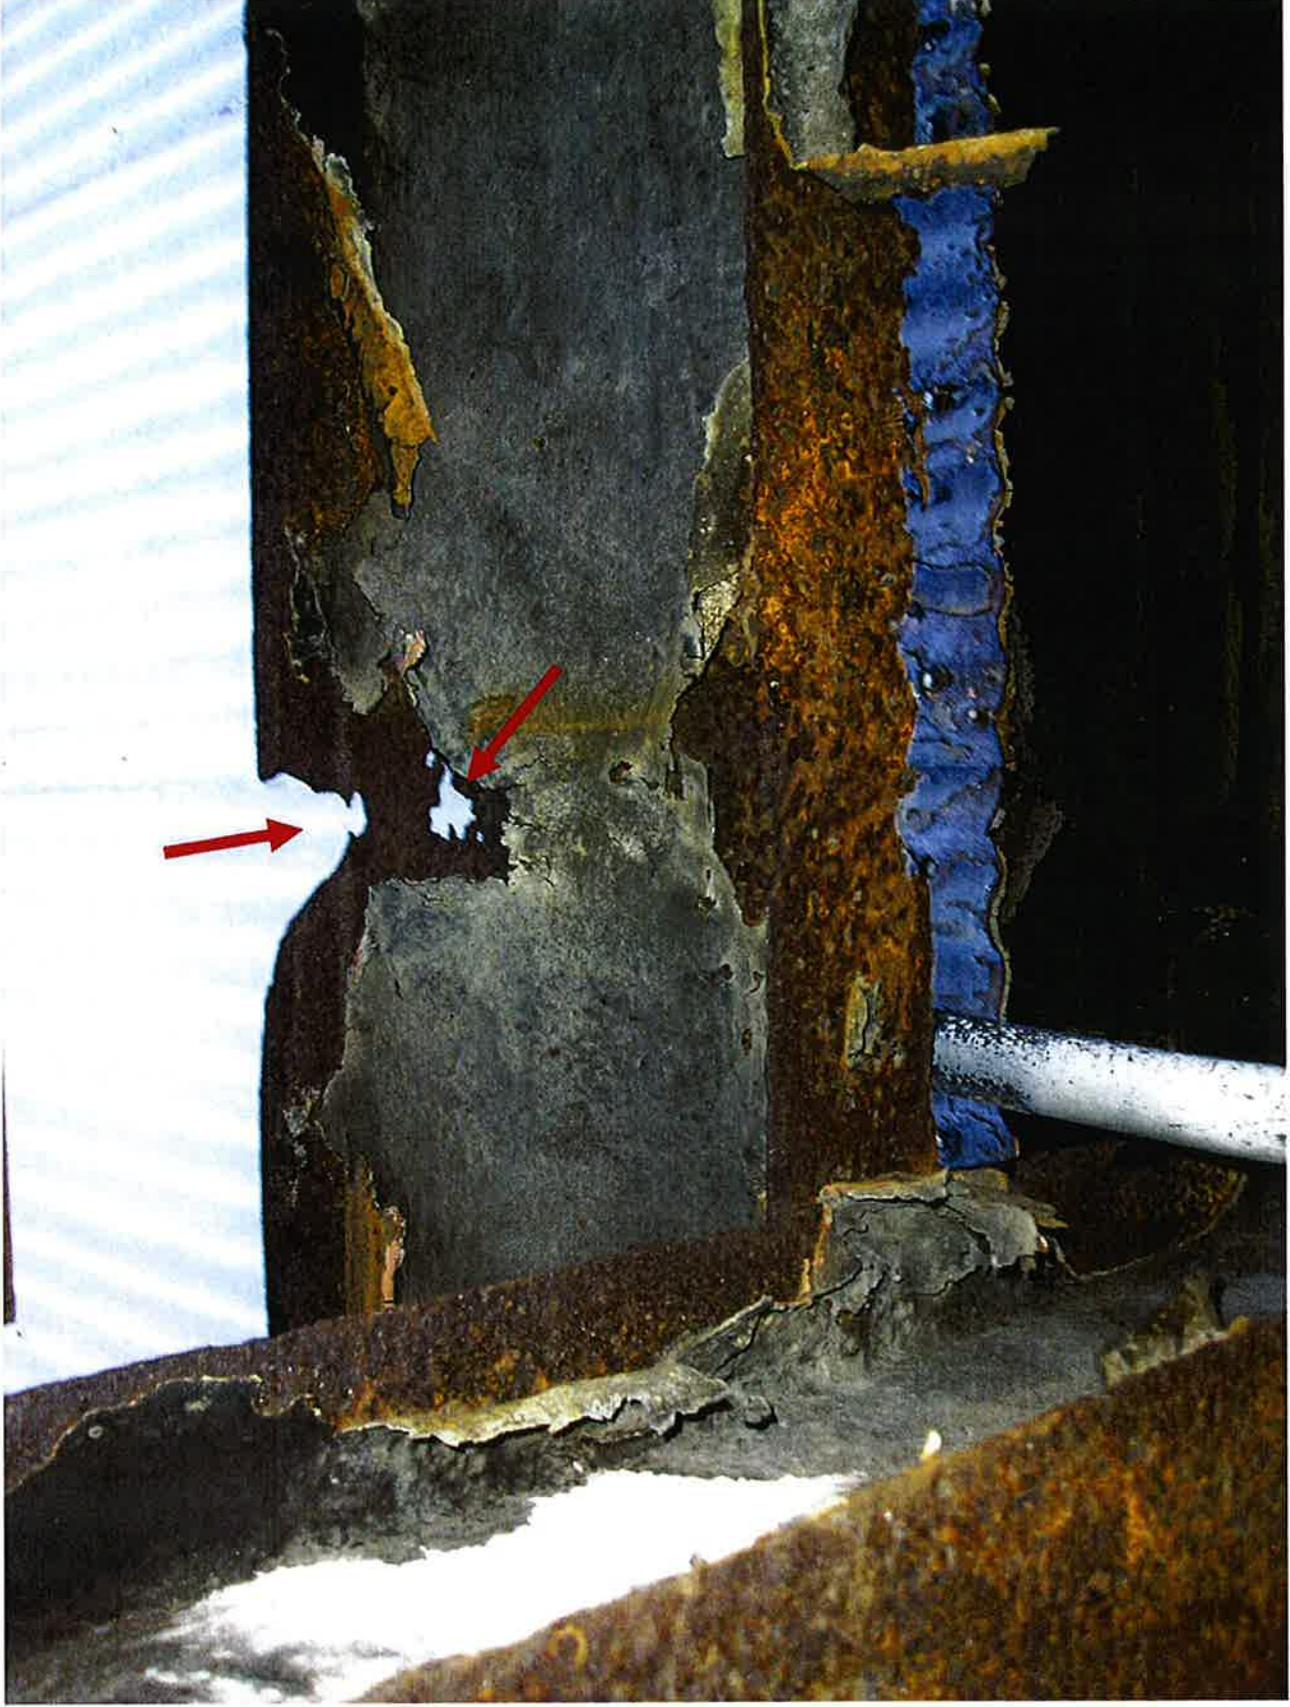
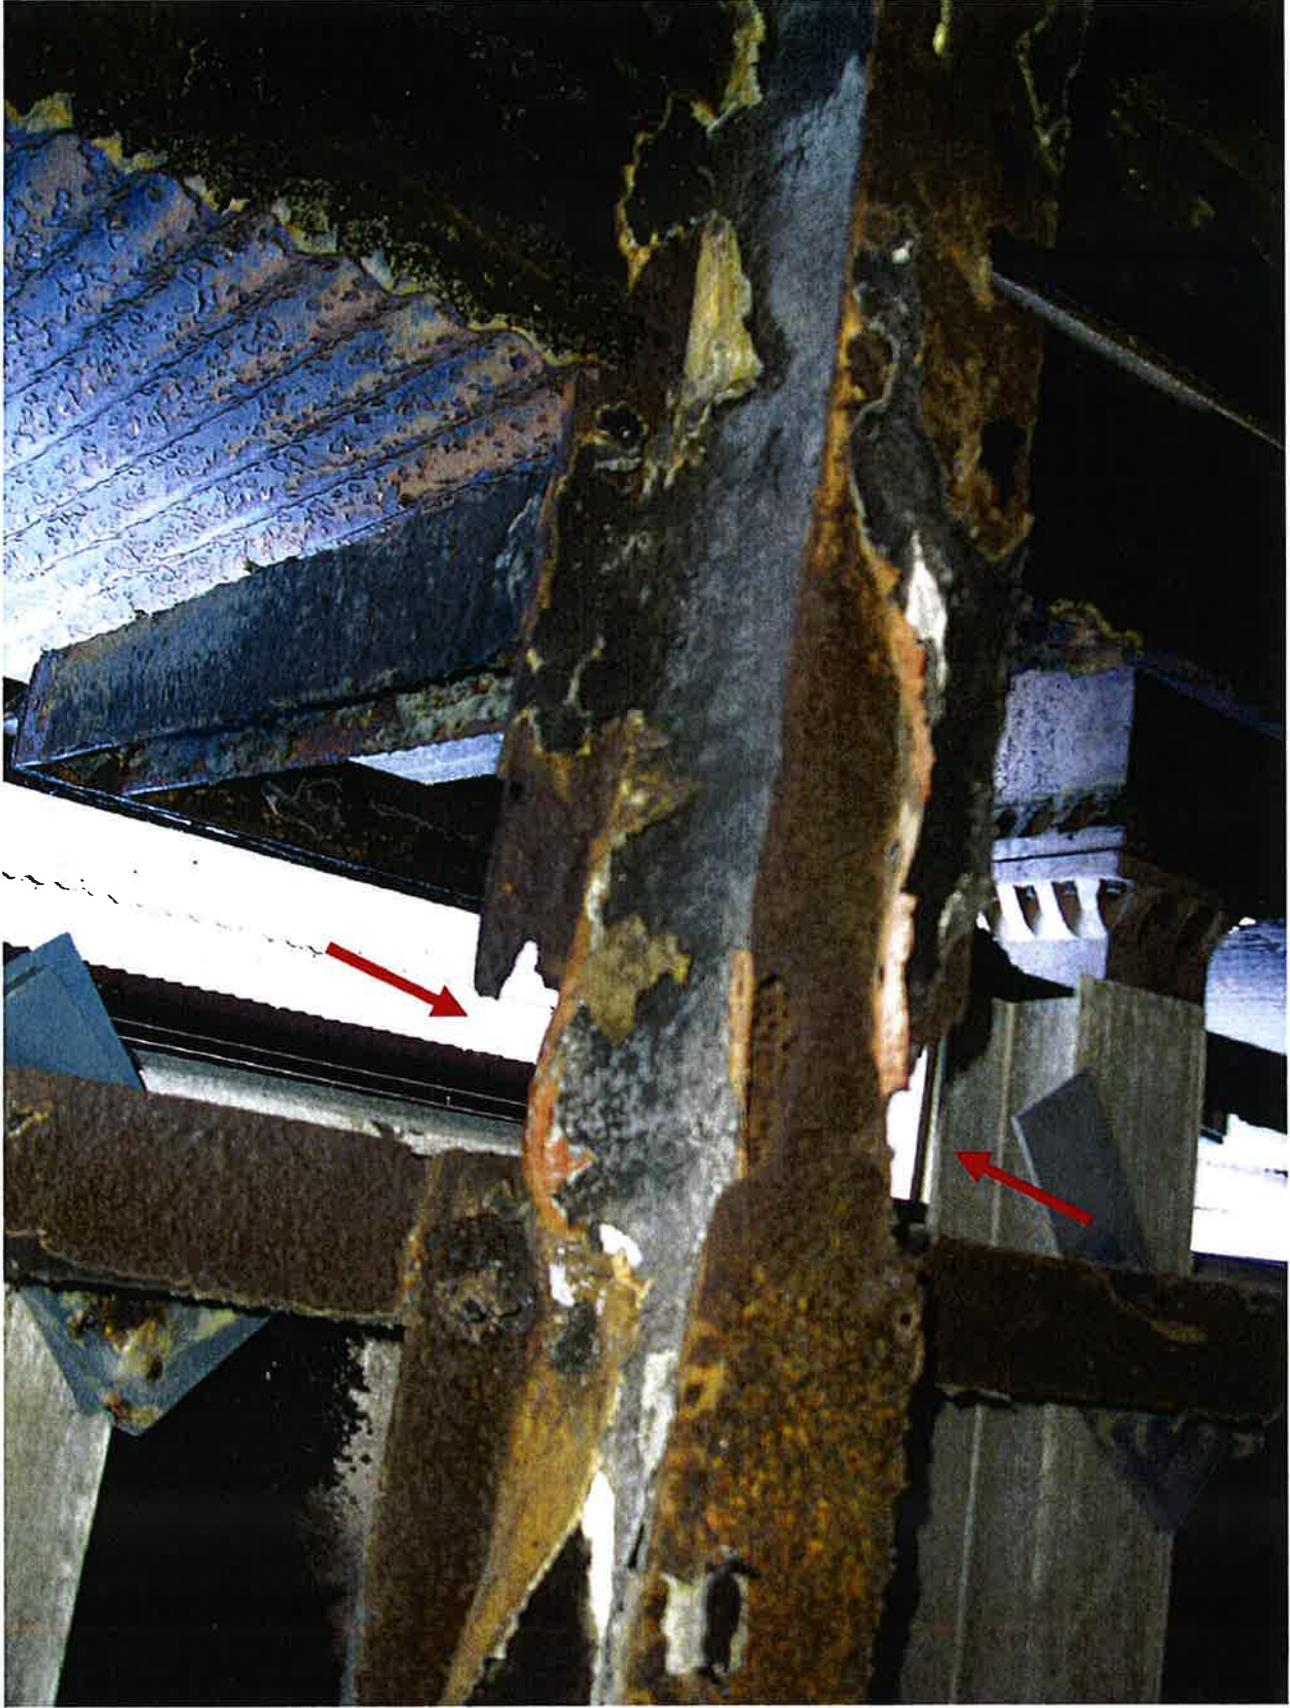
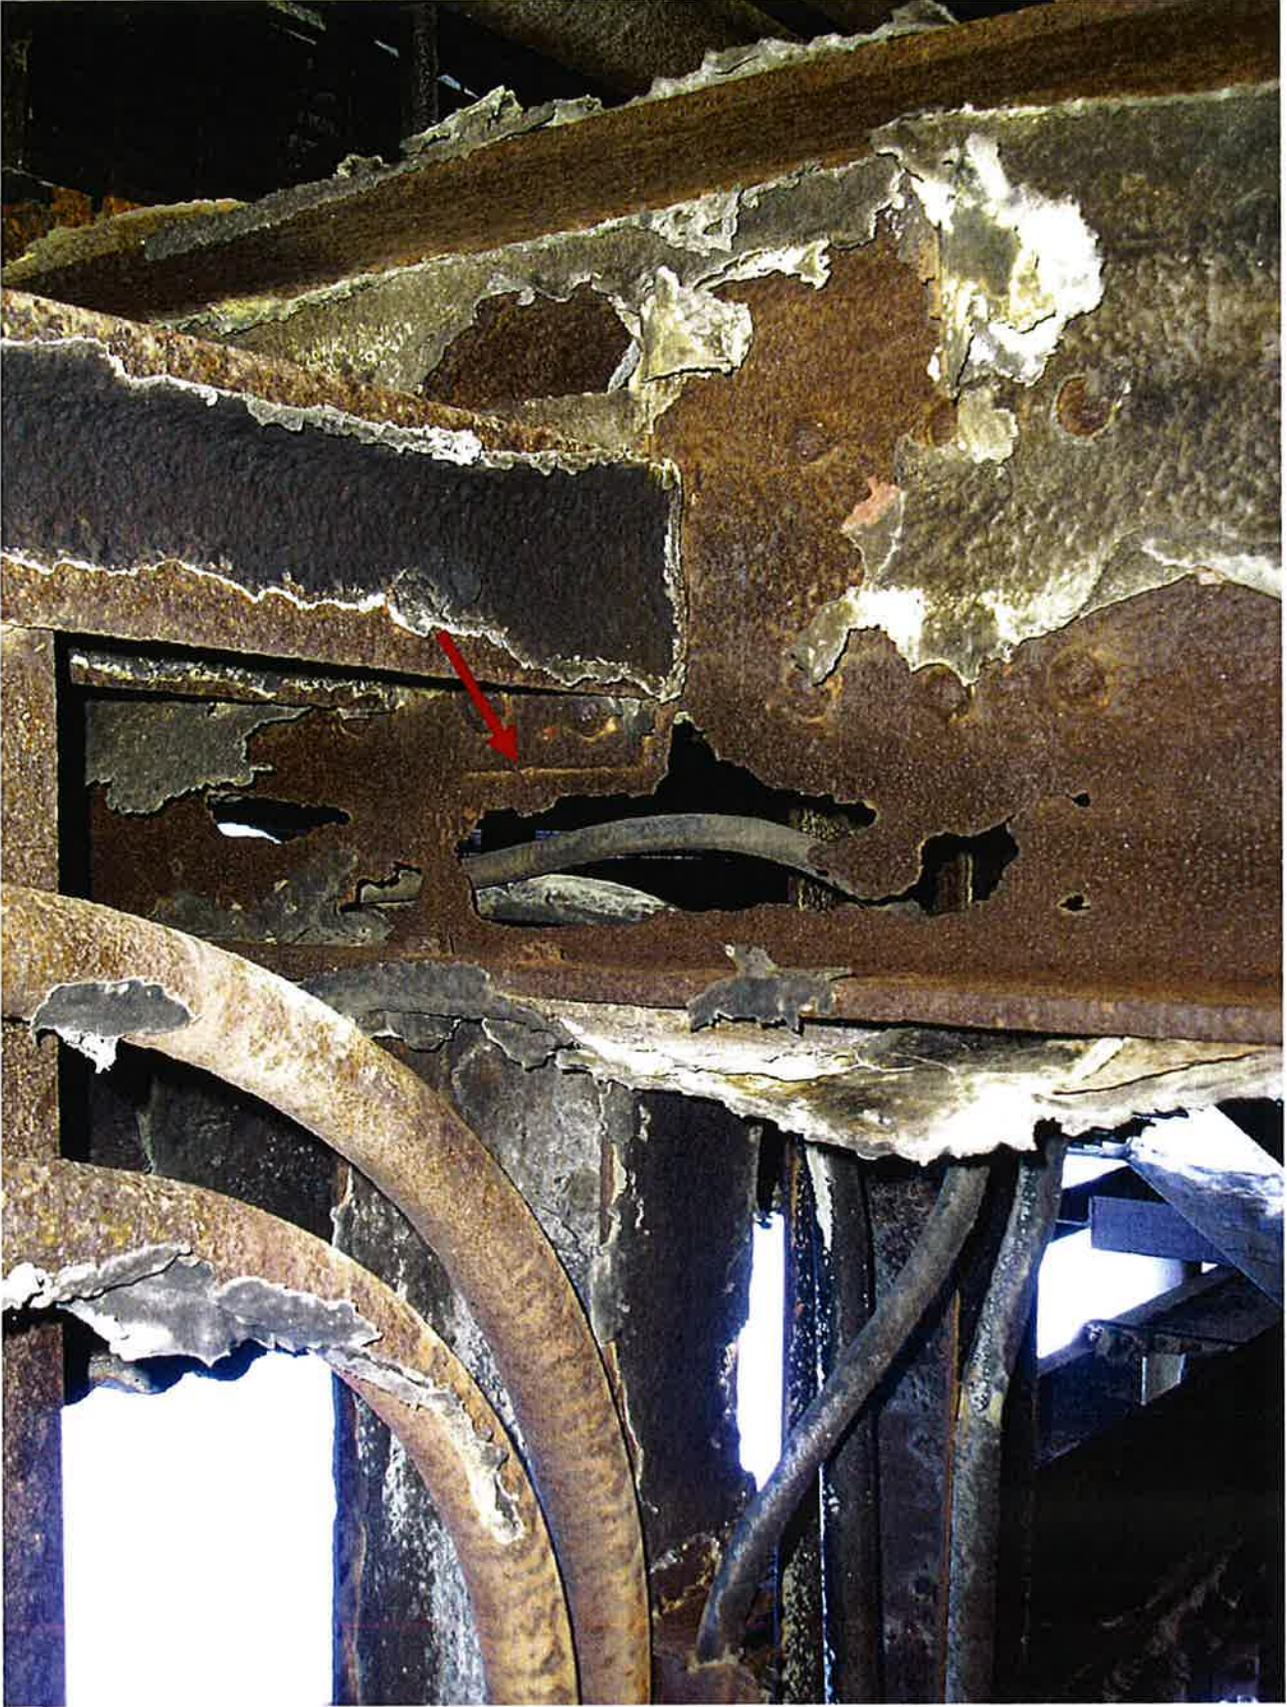
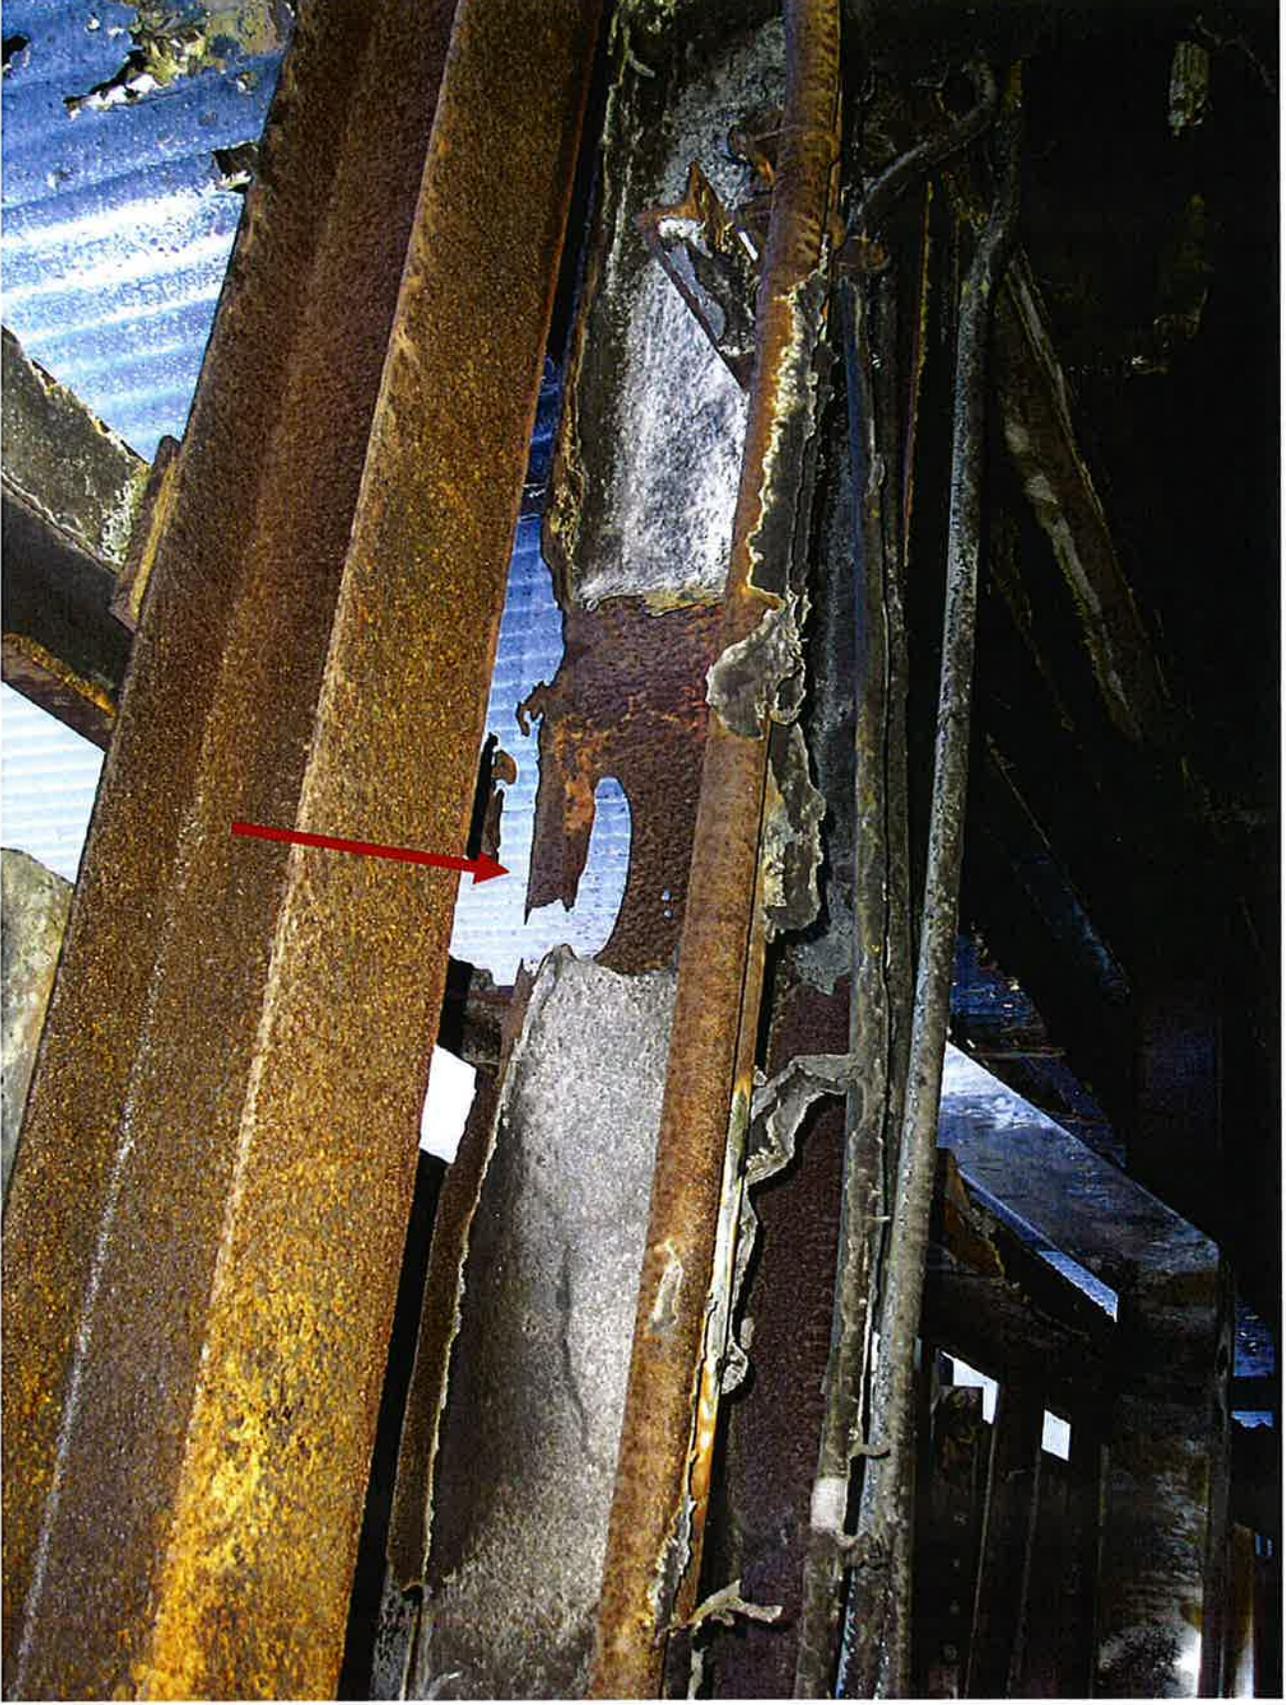
At the exterior of the west side of this building is an exterior elevated steel framed catwalk (Photo 19). There is significant deterioration of much of the framing of this catwalk. Many of the steel support beams are structurally unsound (Photos 20, 21, 22 and 23). There is also a portion along part of the interior catwalk at the west side where the steel framing is totally deteriorated (Photo 24). In general, I believe the elevated concrete second level at the east half of this building has sufficient

PHOTO 20 – DETERIORATED FRAMING AT EXTERIOR CATWALK AT WEST SIDE OF BUILDING 16

PHOTO 21 – DETERIORATED FRAMING AT EXTERIOR CATWALK AT WEST SIDE OF BUILDING 16

PHOTO 22 – DETERIORATED FRAMING AT EXTERIOR CATWALK AT WEST SIDE OF BUILDING 16

PHOTO 23 – DETERIORATED FRAMING AT EXTERIOR CATWALK AT WEST SIDE OF BUILDING 16

structural integrity to allow for safe support during planned abatement. I do not believe the second level at the west half, and the exterior and interior steel framed catwalk along the west side have sufficient structural integrity during the abatement process and shall not be used for support during the abatement process. During abatement, no one shall be allowed to work beneath or near the elevated west half of the building and the steel framed catwalks along the west side.

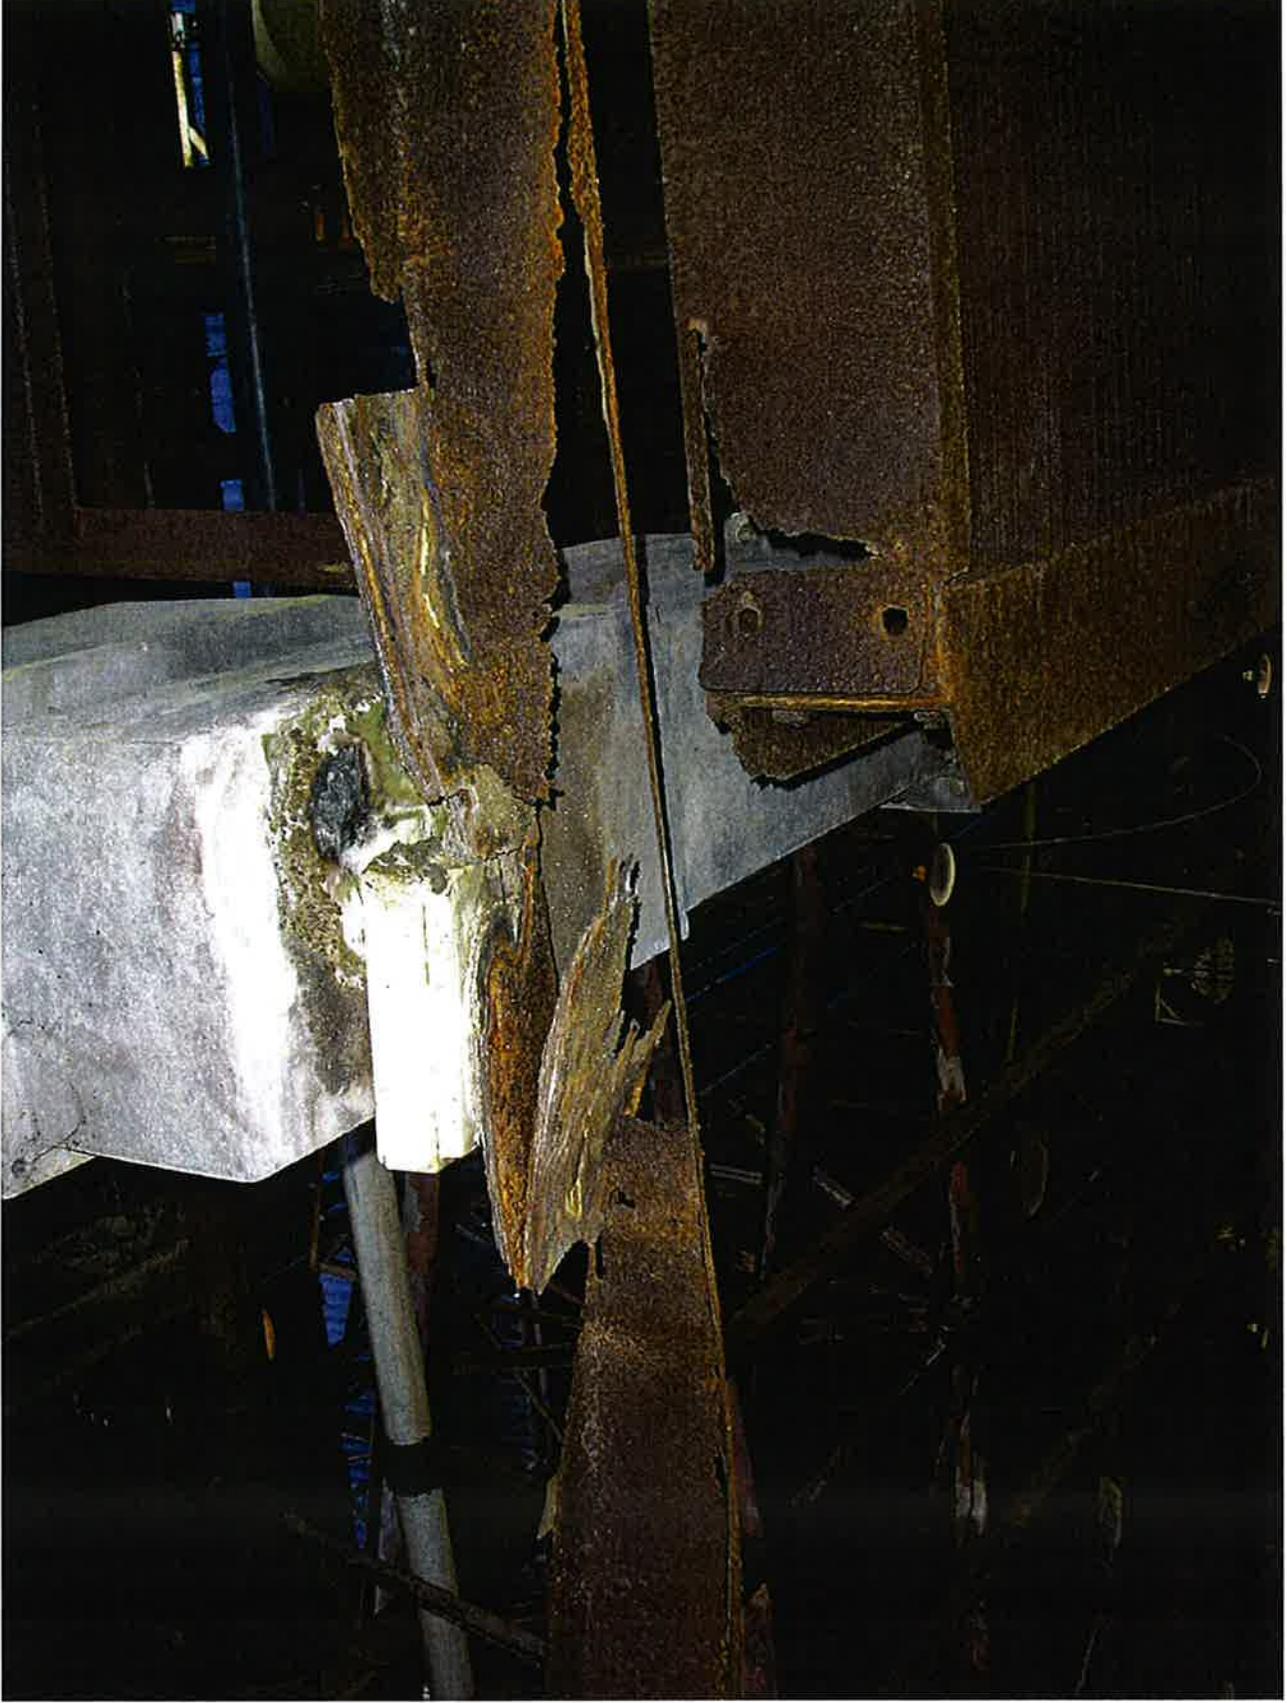
PHOTO 24 – DETERIORATED FRAMING AT INTERIOR CATWALK AT WEST SIDE OF BUILDING 16

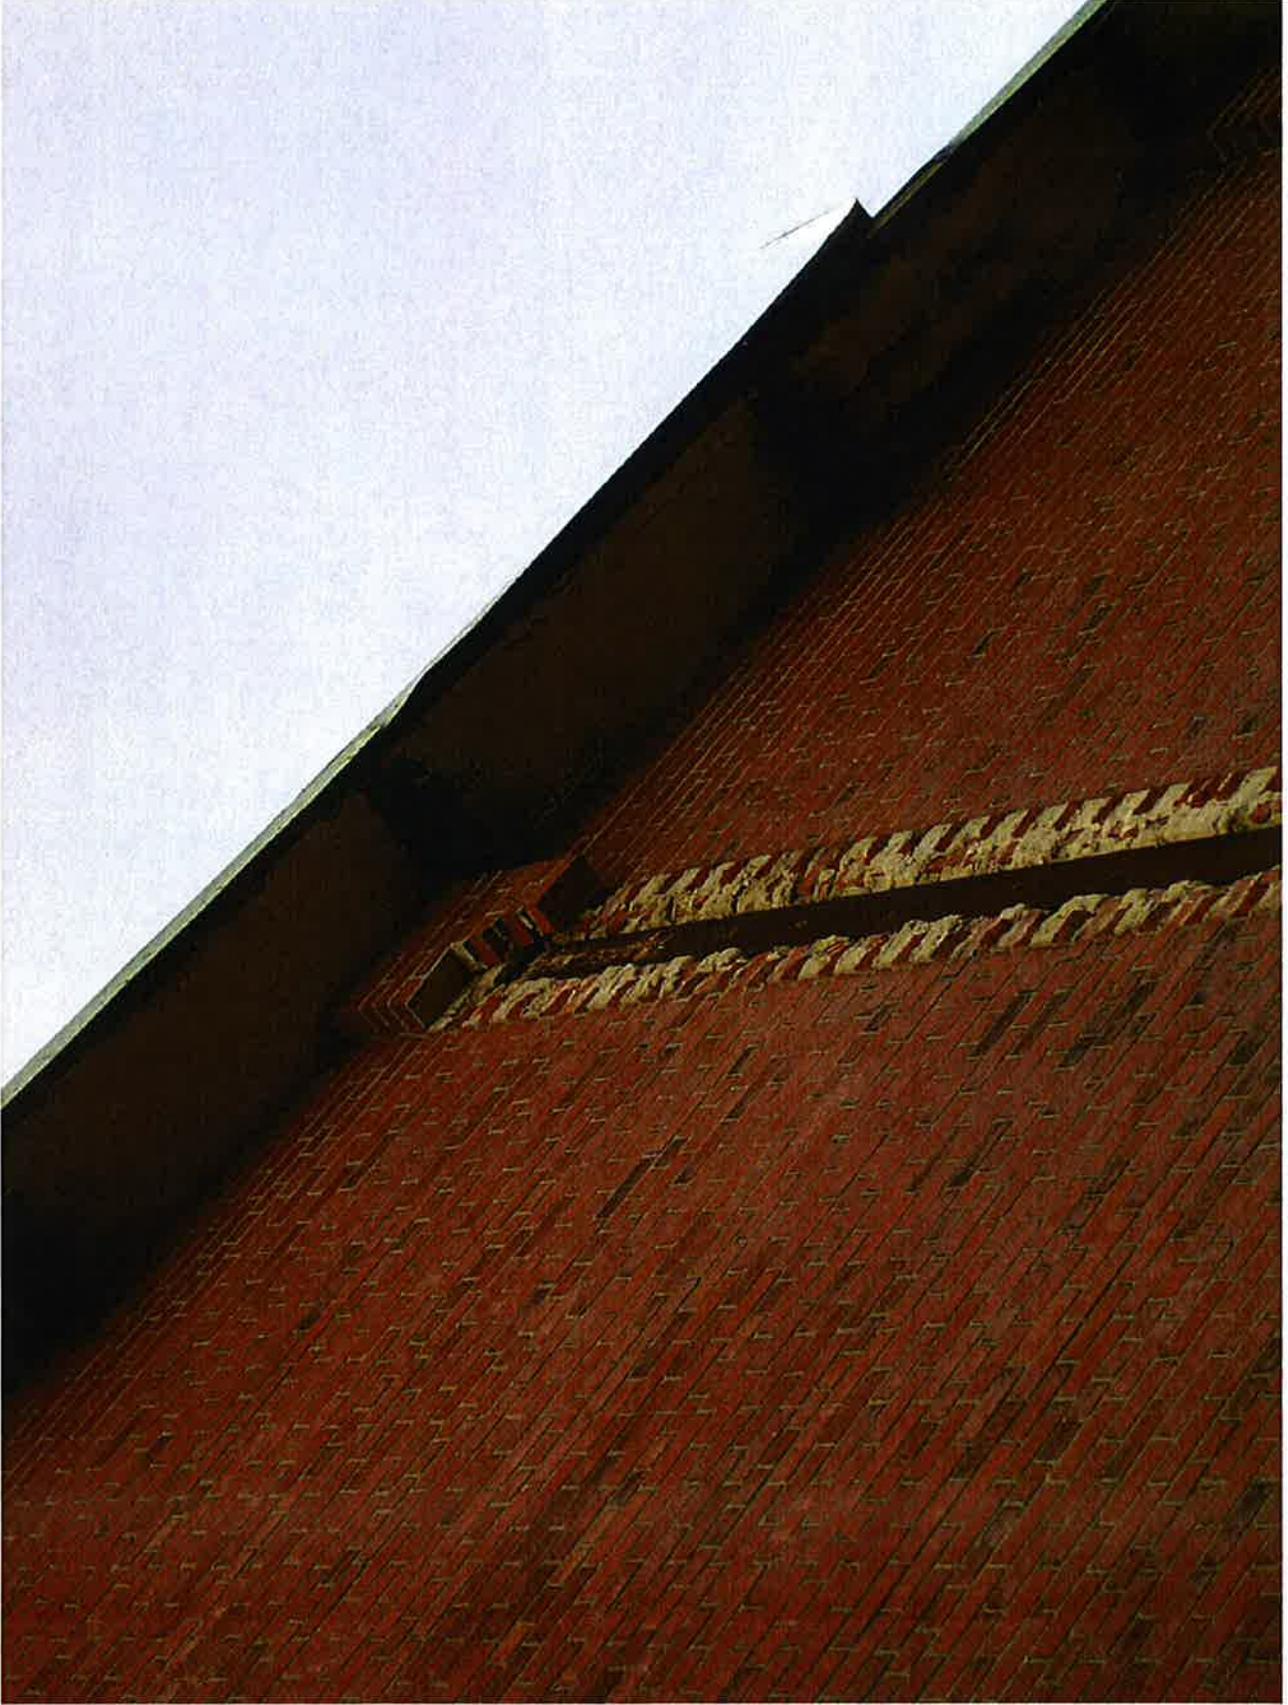
1. There is obvious masonry veneer distress at exterior pilasters at the north wall (Photo 25) and northwest corner (Photo 26). Abatement personnel shall not be allowed in areas immediately adjacent to distressed masonry.

PHOTO 25 – VIEW OF MASONRY DISTRESS AT NORTH WALL OF BUILDING 17

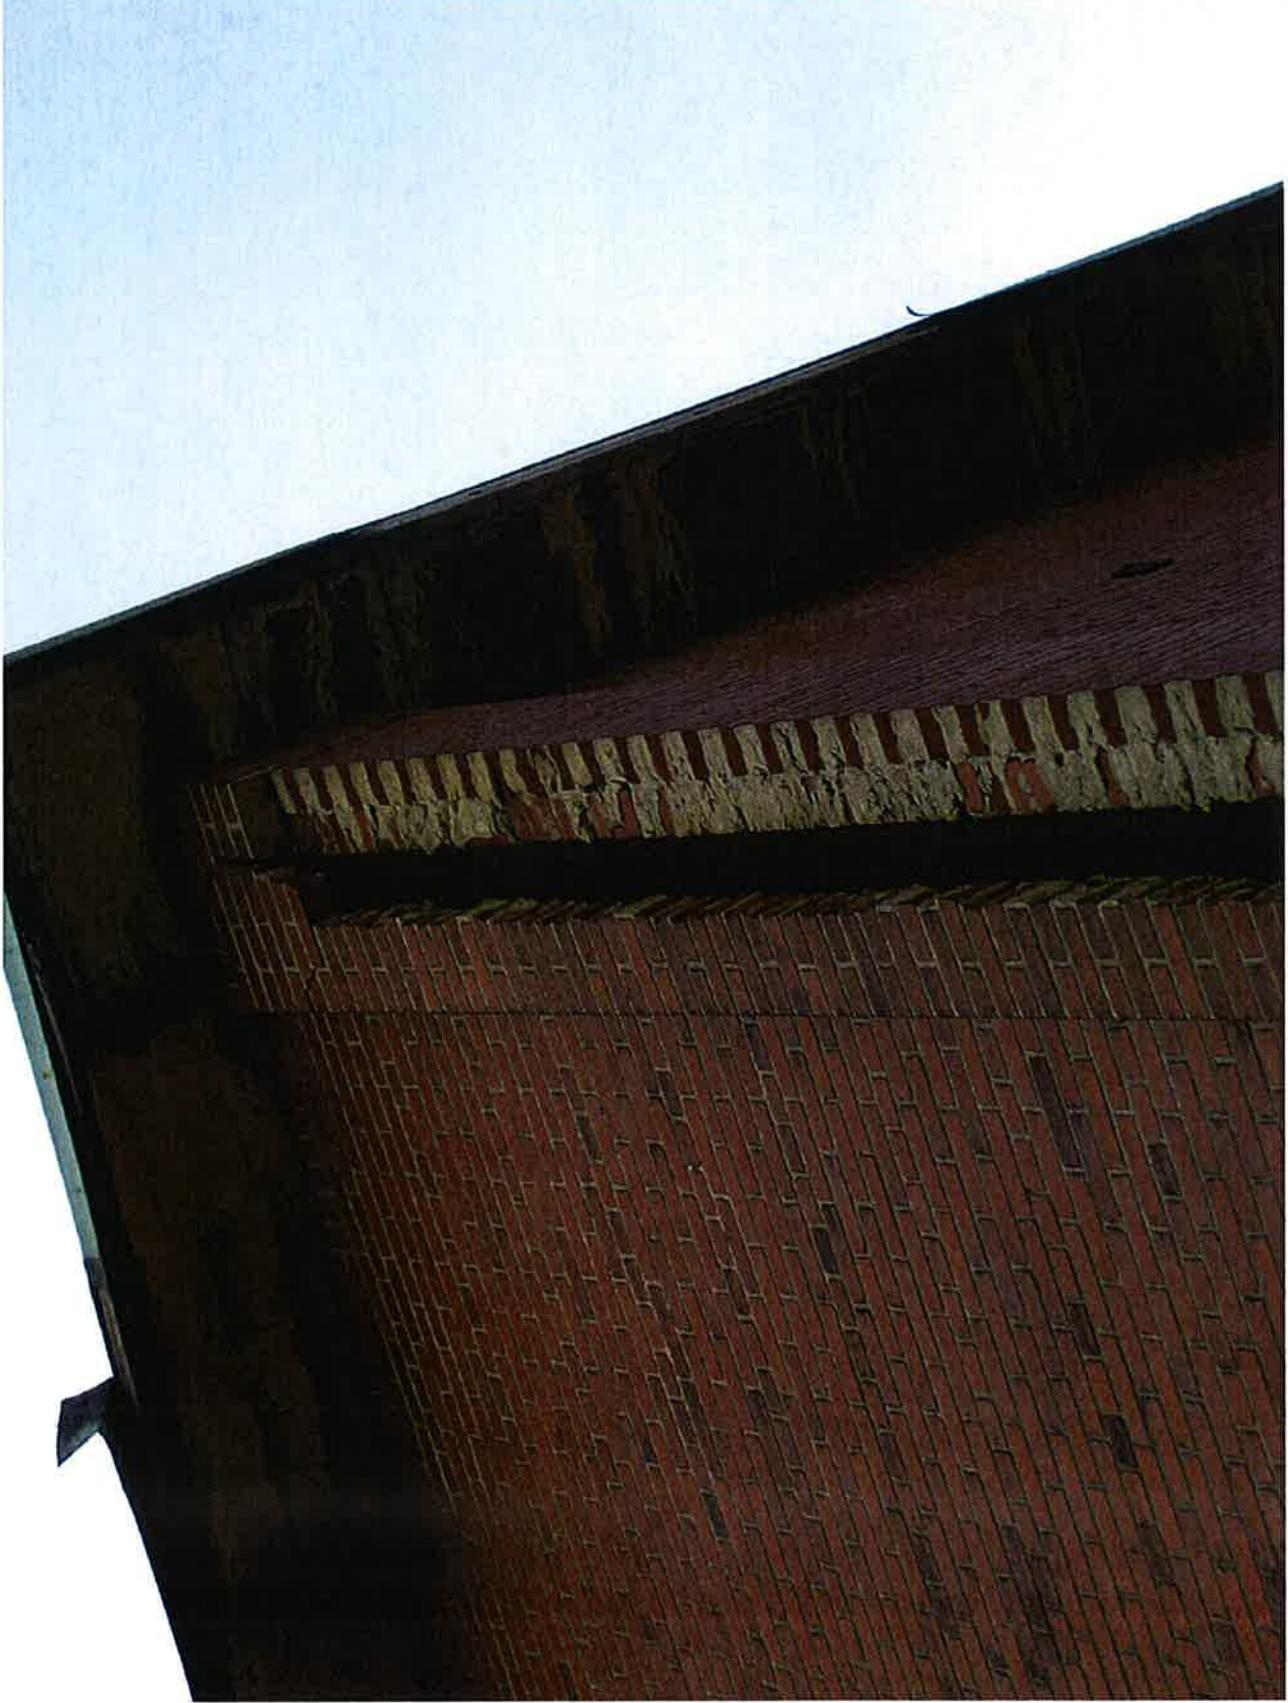
PHOTO 26 – VIEW OF MASONRY DISTRESS AT NORTHWEST CORNER OF BUILDING 17

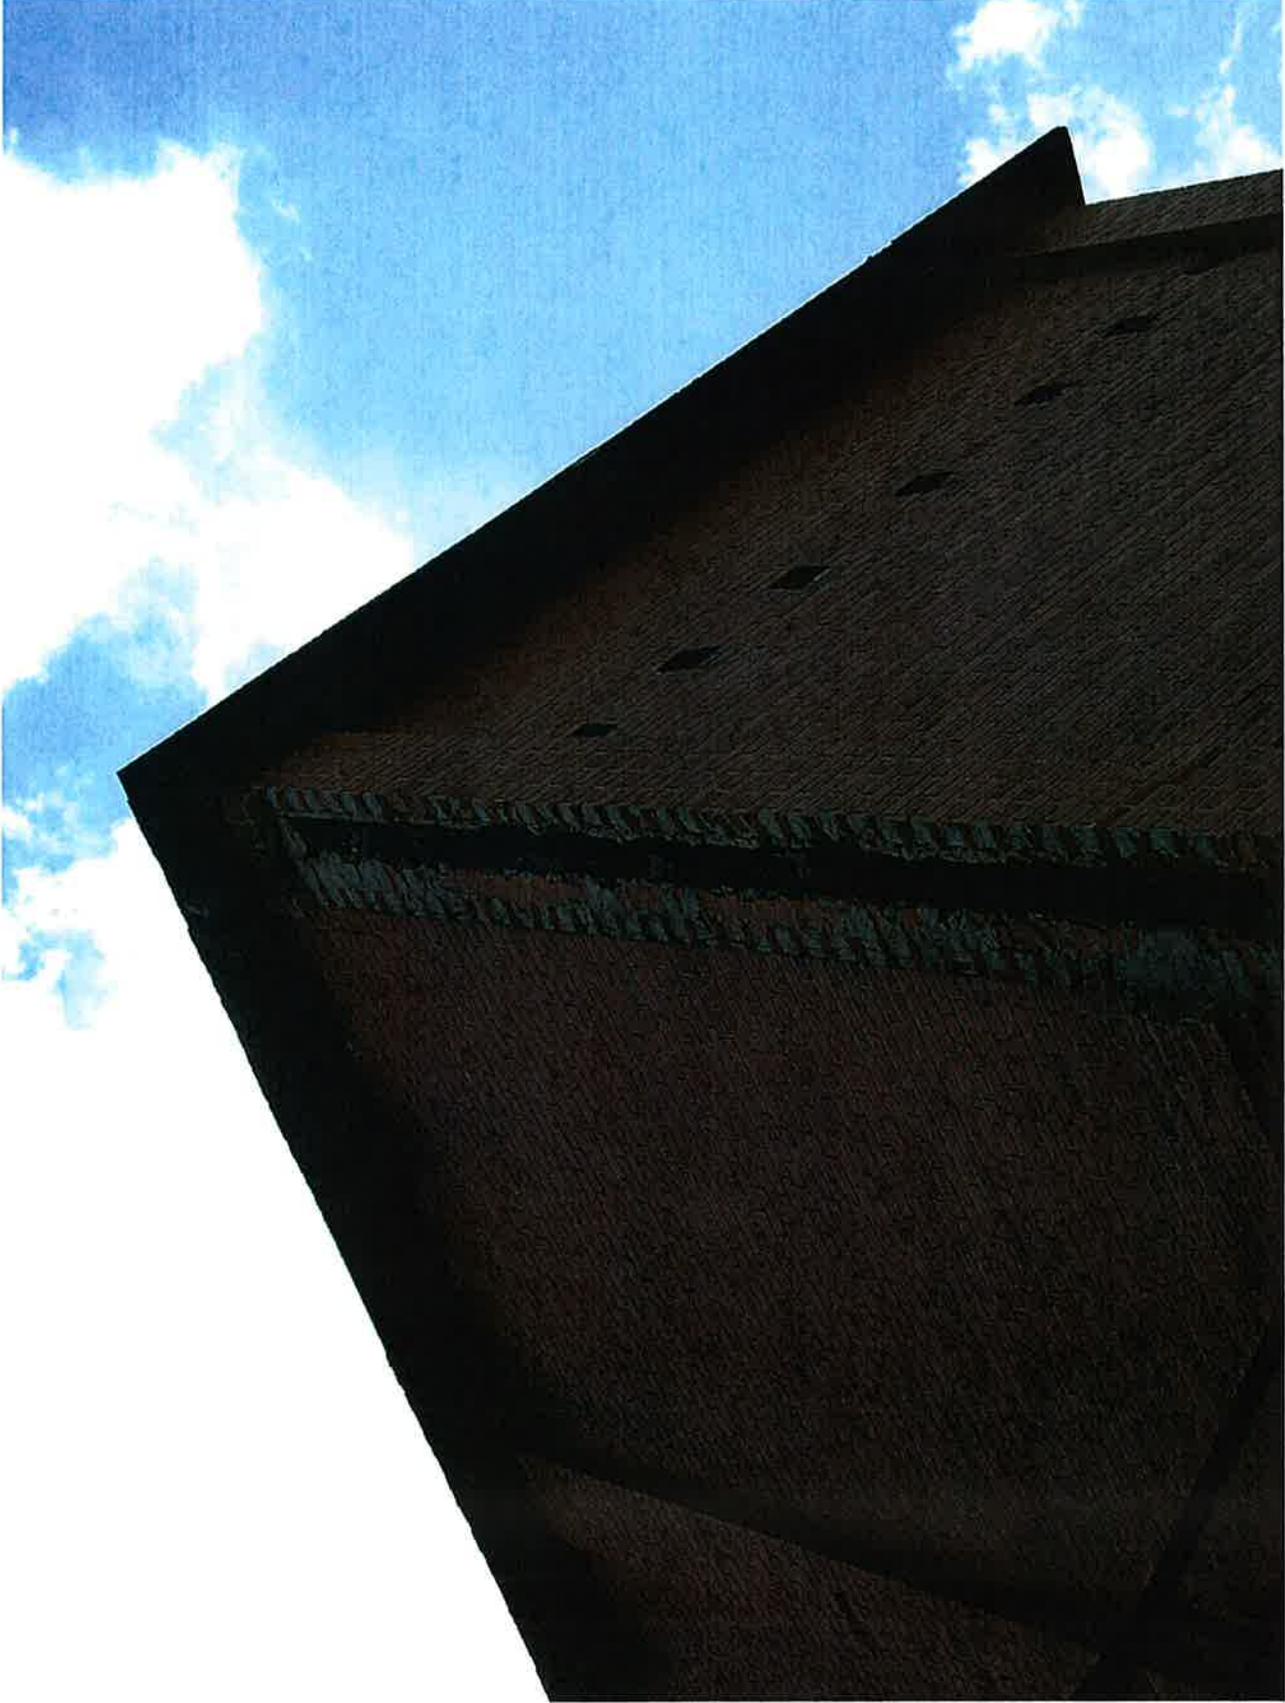
1. There is obvious masonry veneer distress at the northeast corner pilaster (Photo 27). Abatement personnel shall not be allowed in area immediately adjacent to distressed masonry.

PHOTO 27 – VIEW OF MASONRY DISTRESS AT NORTHWEST CORNER OF BUILDING 24

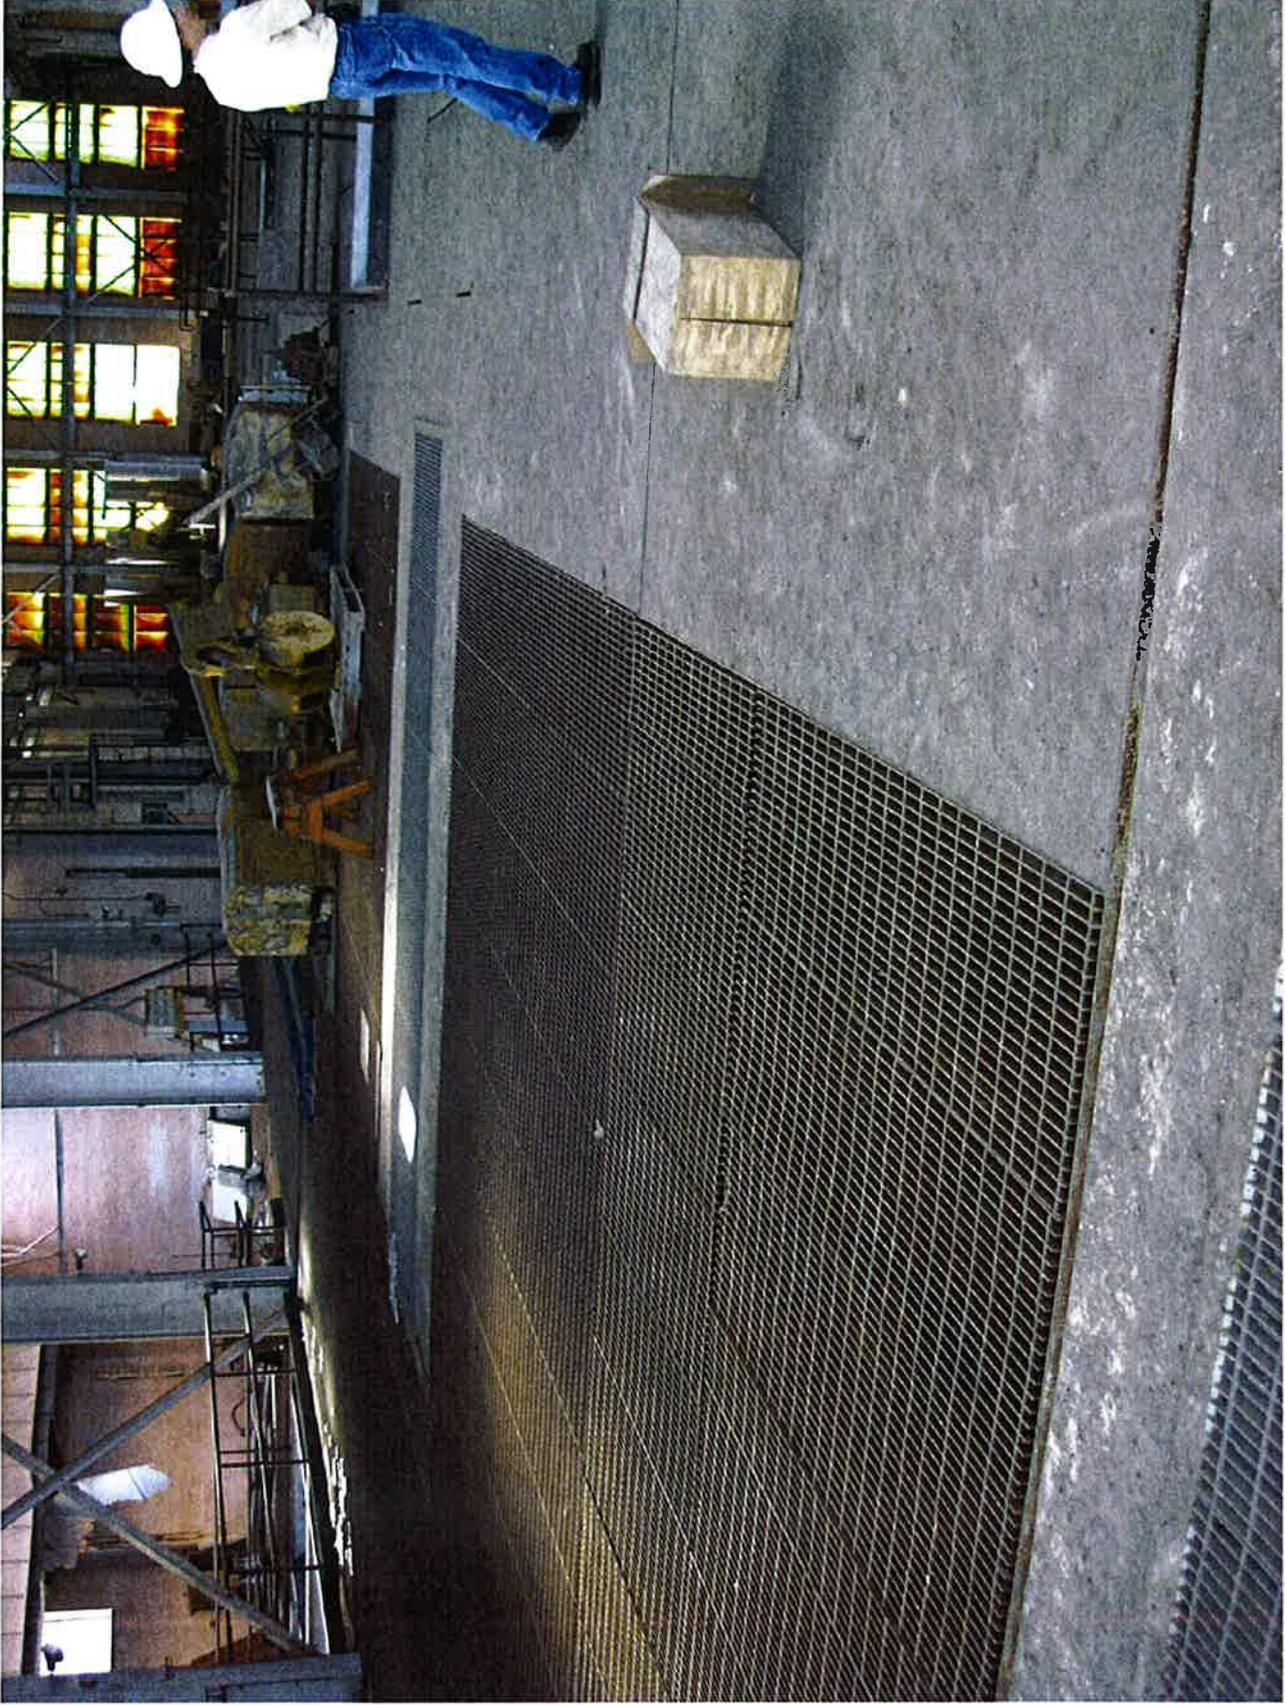
This building is a large predominantly conventional steel framed building with two elevated levels within the building. The elevated second level consist of areas with checkered plate supported by steel beams as well as steel grating supported by steel beams at the east half of the building, and steel grating at the west half (turbine deck) of the building. There is also some elevated concrete framing at the second level (Photo 28).

PHOTO 28 – VIEW OF GRATED TURBINE LEVEL AT SECOND FLOOR OF EAST HALF OF BUILDING 25

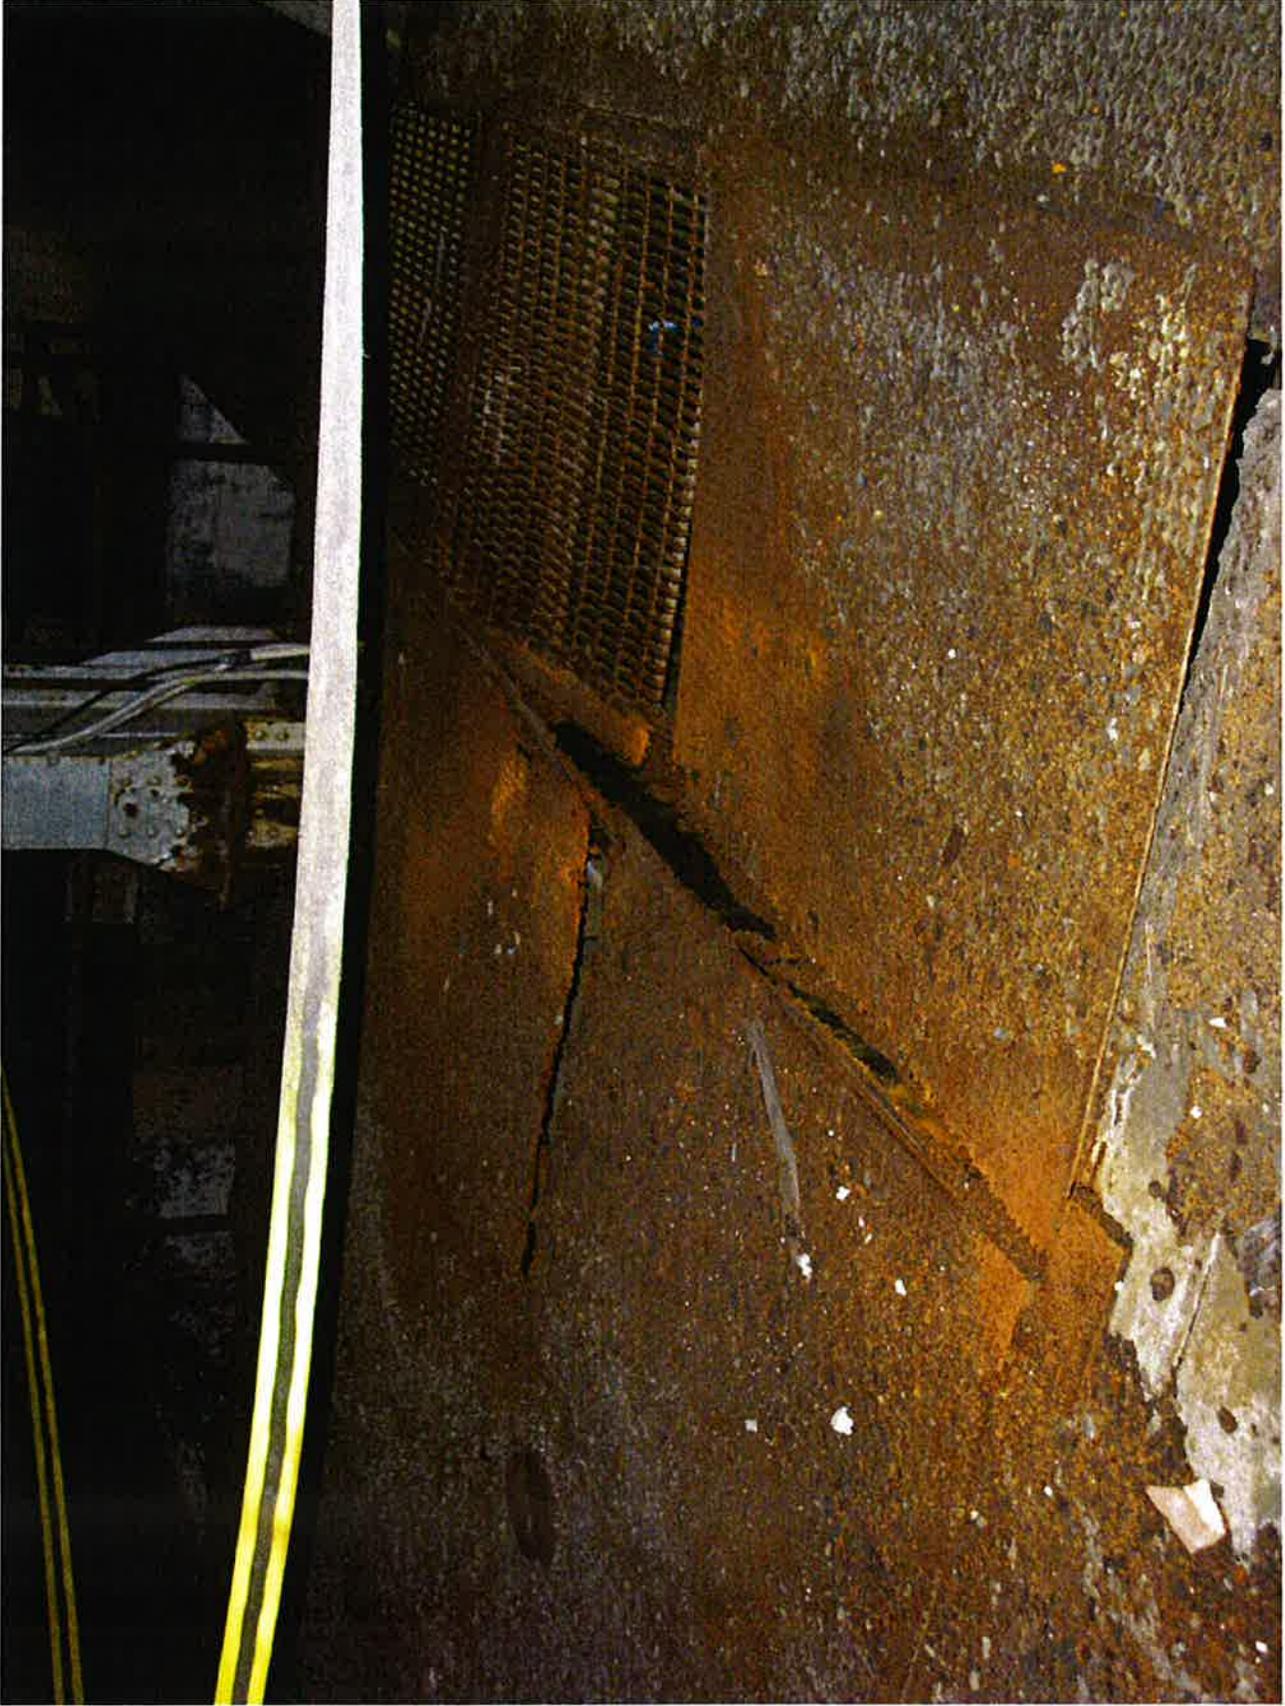
1. There is a portion of checkered plate and grated area at the center portion of the first floor which is structurally unsound (Photo 29). Do not use this area for support during abatement process.
2. There is a portion of the first floor near the northeast corner which has checkered plate and grating over shallow (+/- four feet deep) concrete pit construction (Photo 30). Remove the checkered plate and grating and utilize the concrete pit for support during abatement process.

PHOTO 29 – VIEW OF UNSOUND CHECKERED PLATE AREA AT CENTER PORTION OF FIRST FLOOR BUILDING 25
