JASTER-QUINTANILLA & ASSOCIATES, INC.

March 15, 2011

**Re: Structural Integrity Assessment
Former Encycle/Texas, Inc. /ASARCO Facility (Encycle)
5500 Up River Road
Corpus Christi, Nueces County, Texas**

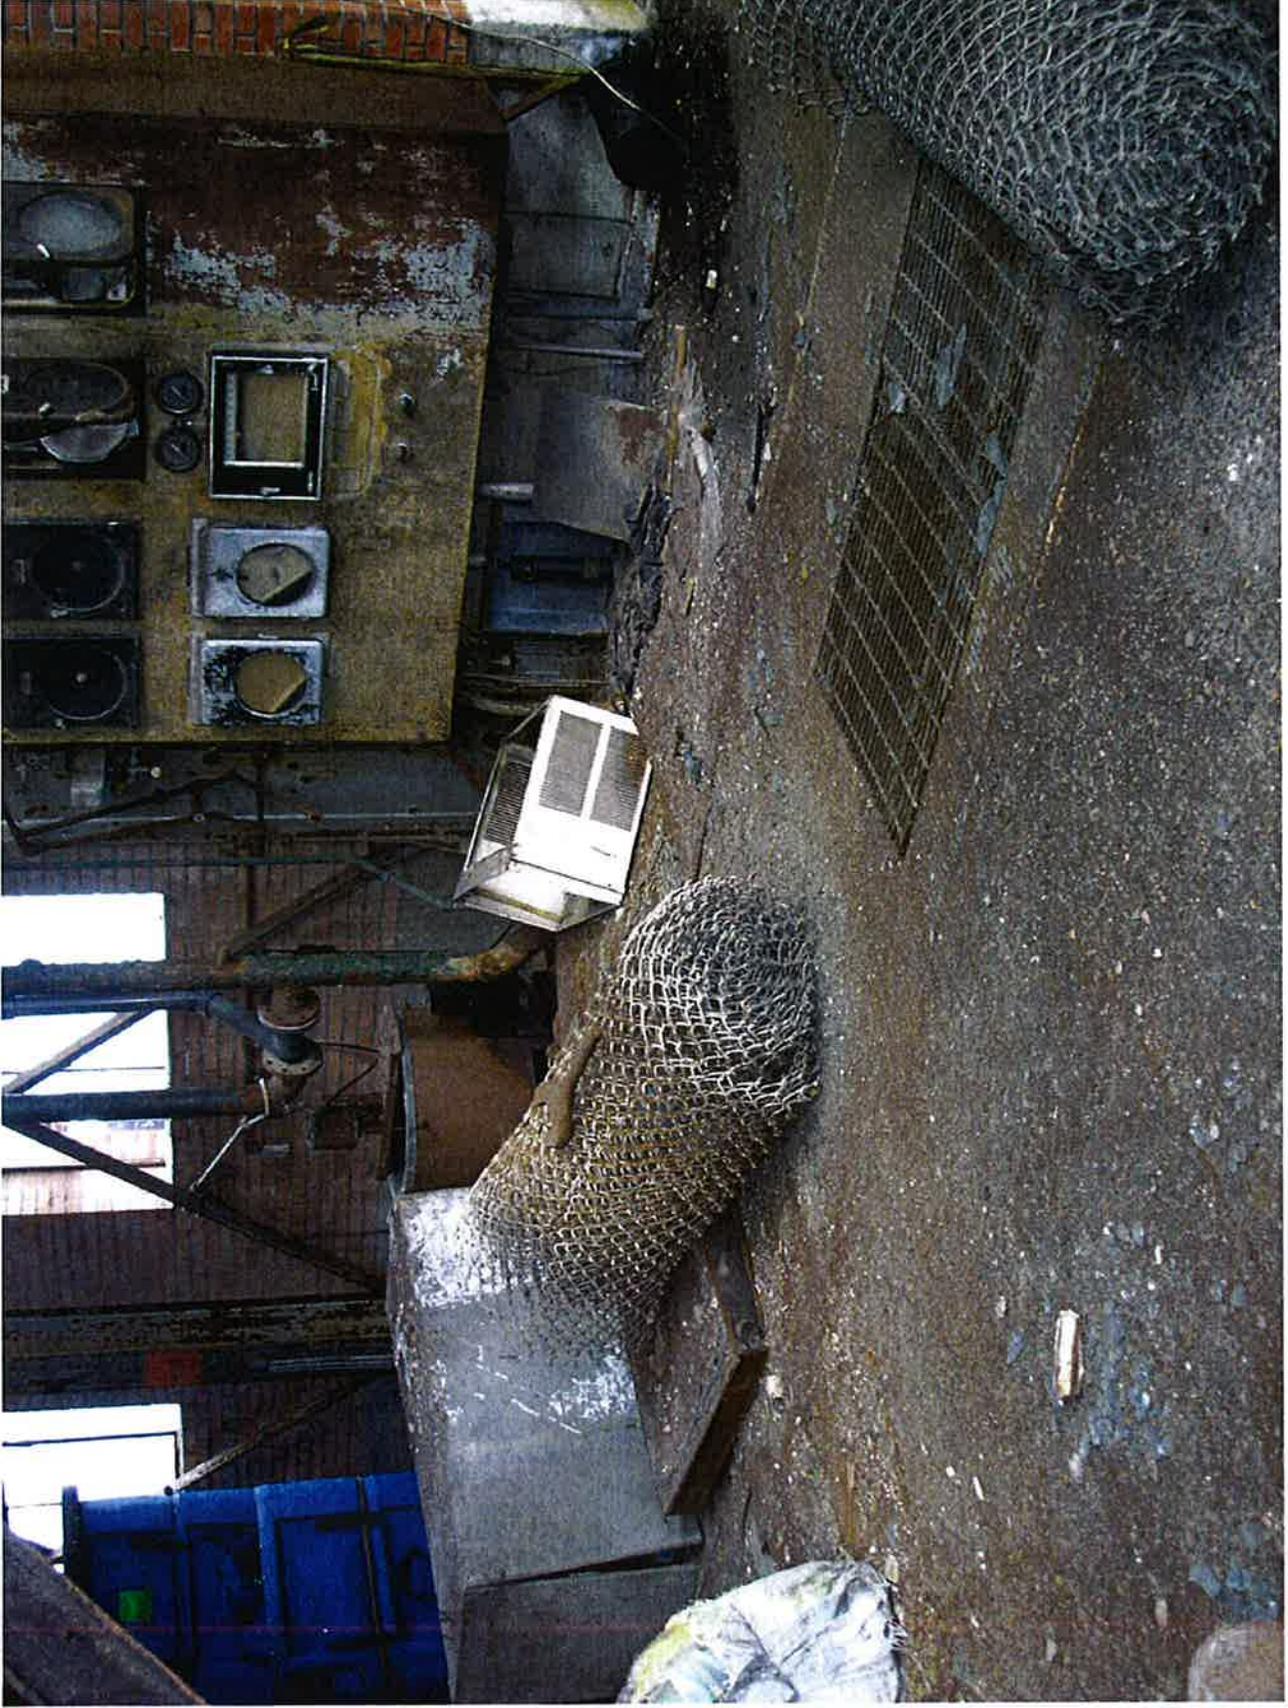
1. There is a portion of checkered plate and grated area at the center portion of the first floor which is structurally unsound (Photo 29). Do not use this area for support during abatement process.
2. There is a portion of the first floor near the northeast corner which has checkered plate and grating over shallow (+/- four feet deep) concrete pit construction (Photo 30). Remove the checkered plate and grating and utilize the concrete pit for support during abatement process.

PHOTO 30 – VIEW OF NORTH PORTION OF FIRST FLOOR, NORTHEAST CORNER OF BUILDING 25

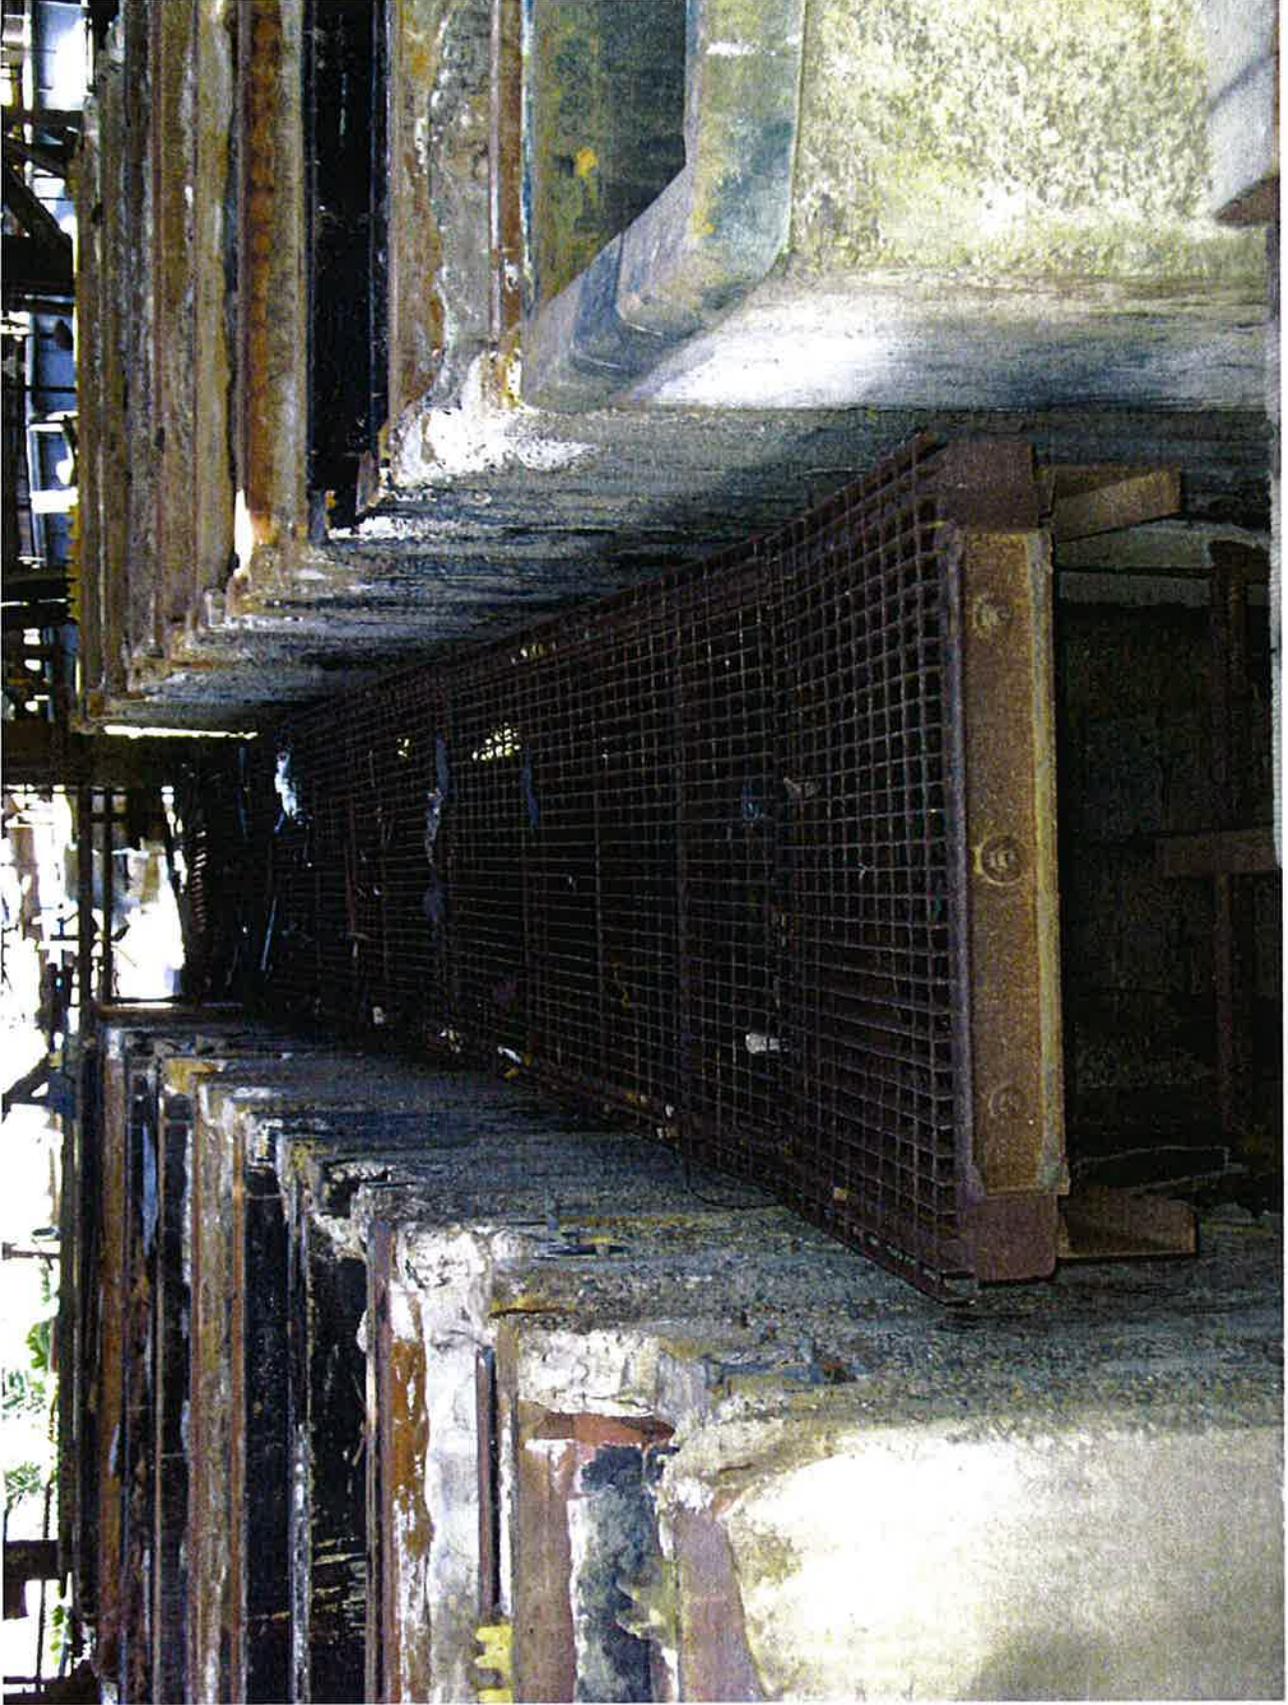
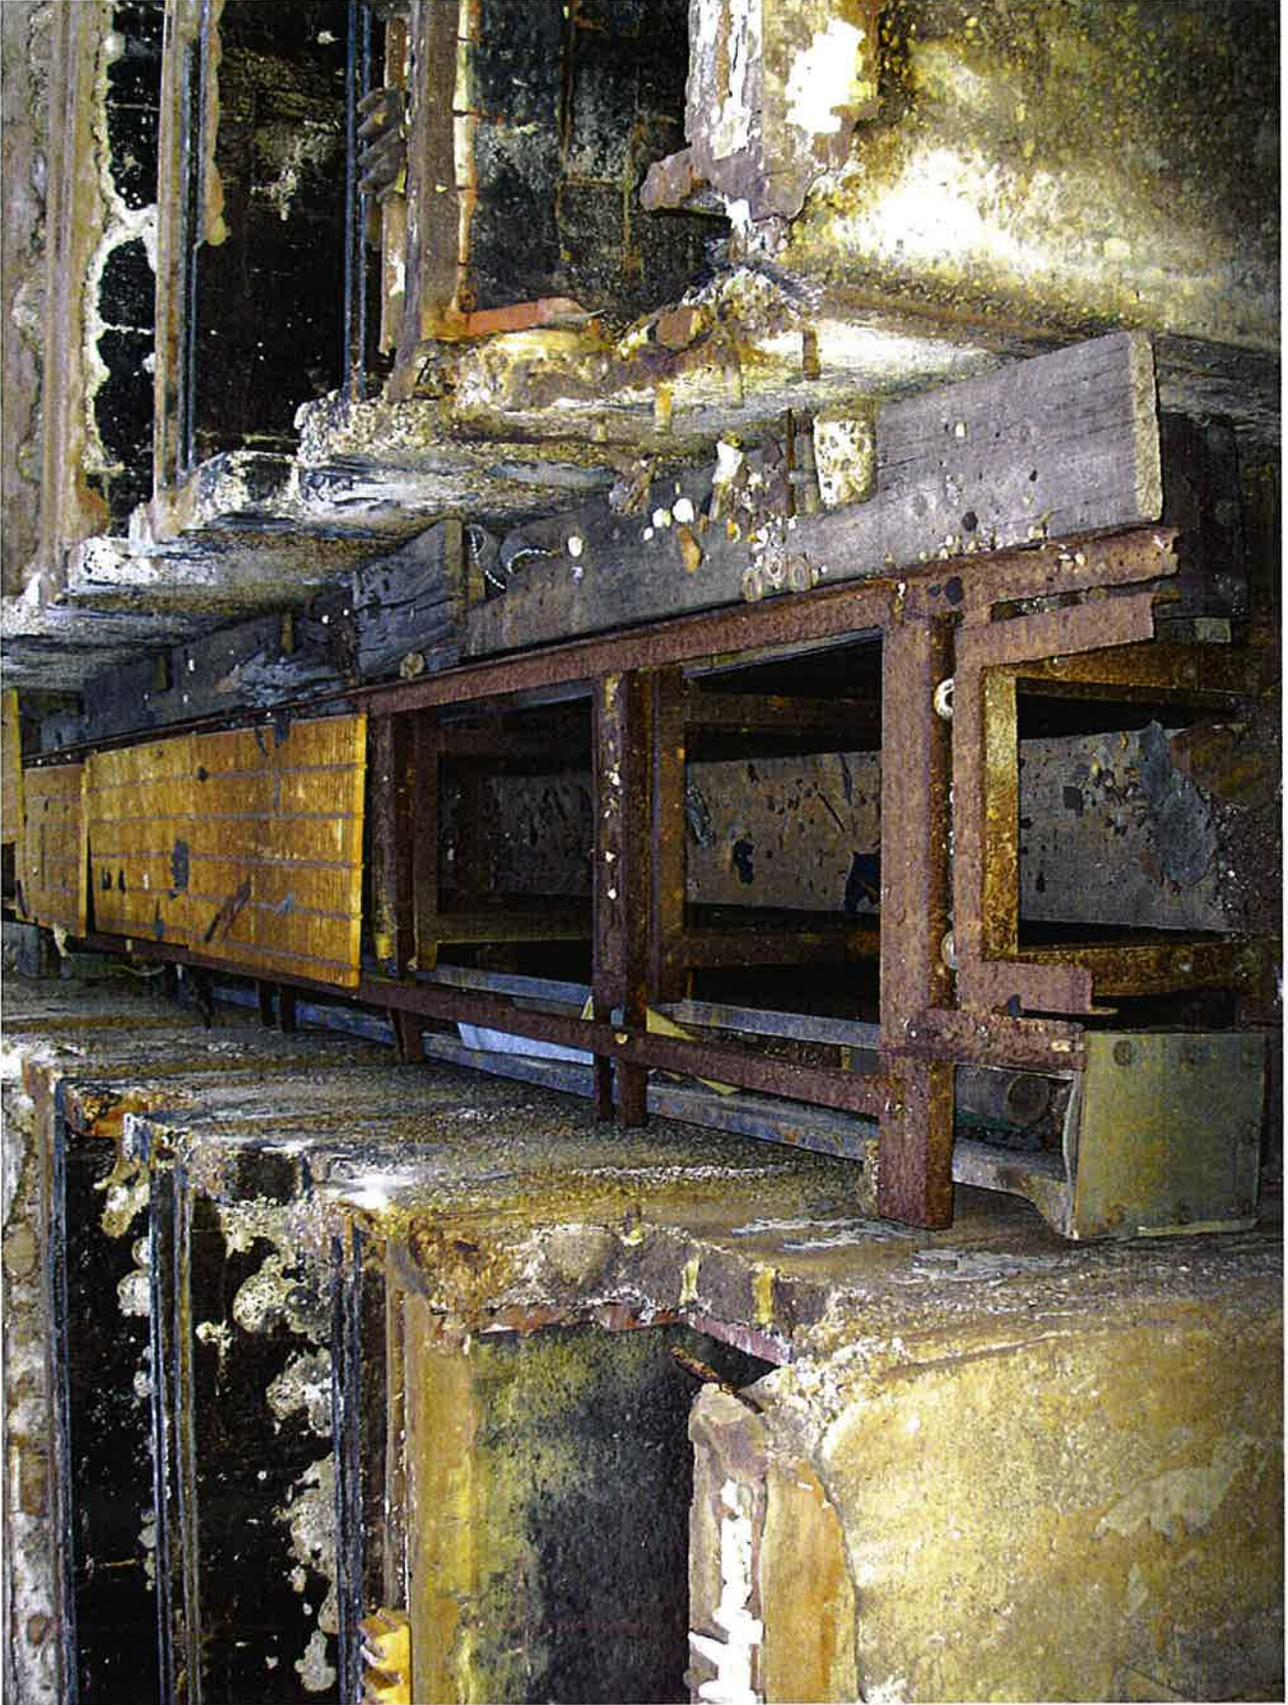
This building is a large predominantly conventional steel framed building with two elevated levels within the building. The east half of the second level consist of pre-cast concrete channels supported by concrete beams and columns, and appears structurally sound. The west half of this building previously housed corrosive containers which contributed to deterioration of cross-catwalks (Photos 31 and 32). These framed catwalks, and any other second level structural supports in the west half of this building are severely deteriorated and shall not be used for support during the abatement process.

PHOTO 31 - DETERIORATED CATWALK AT WEST HALF OF BUILDING 26

PHOTO 32 – DETERIORATED CATWALK AT WEST HALF OF BUILDING 26

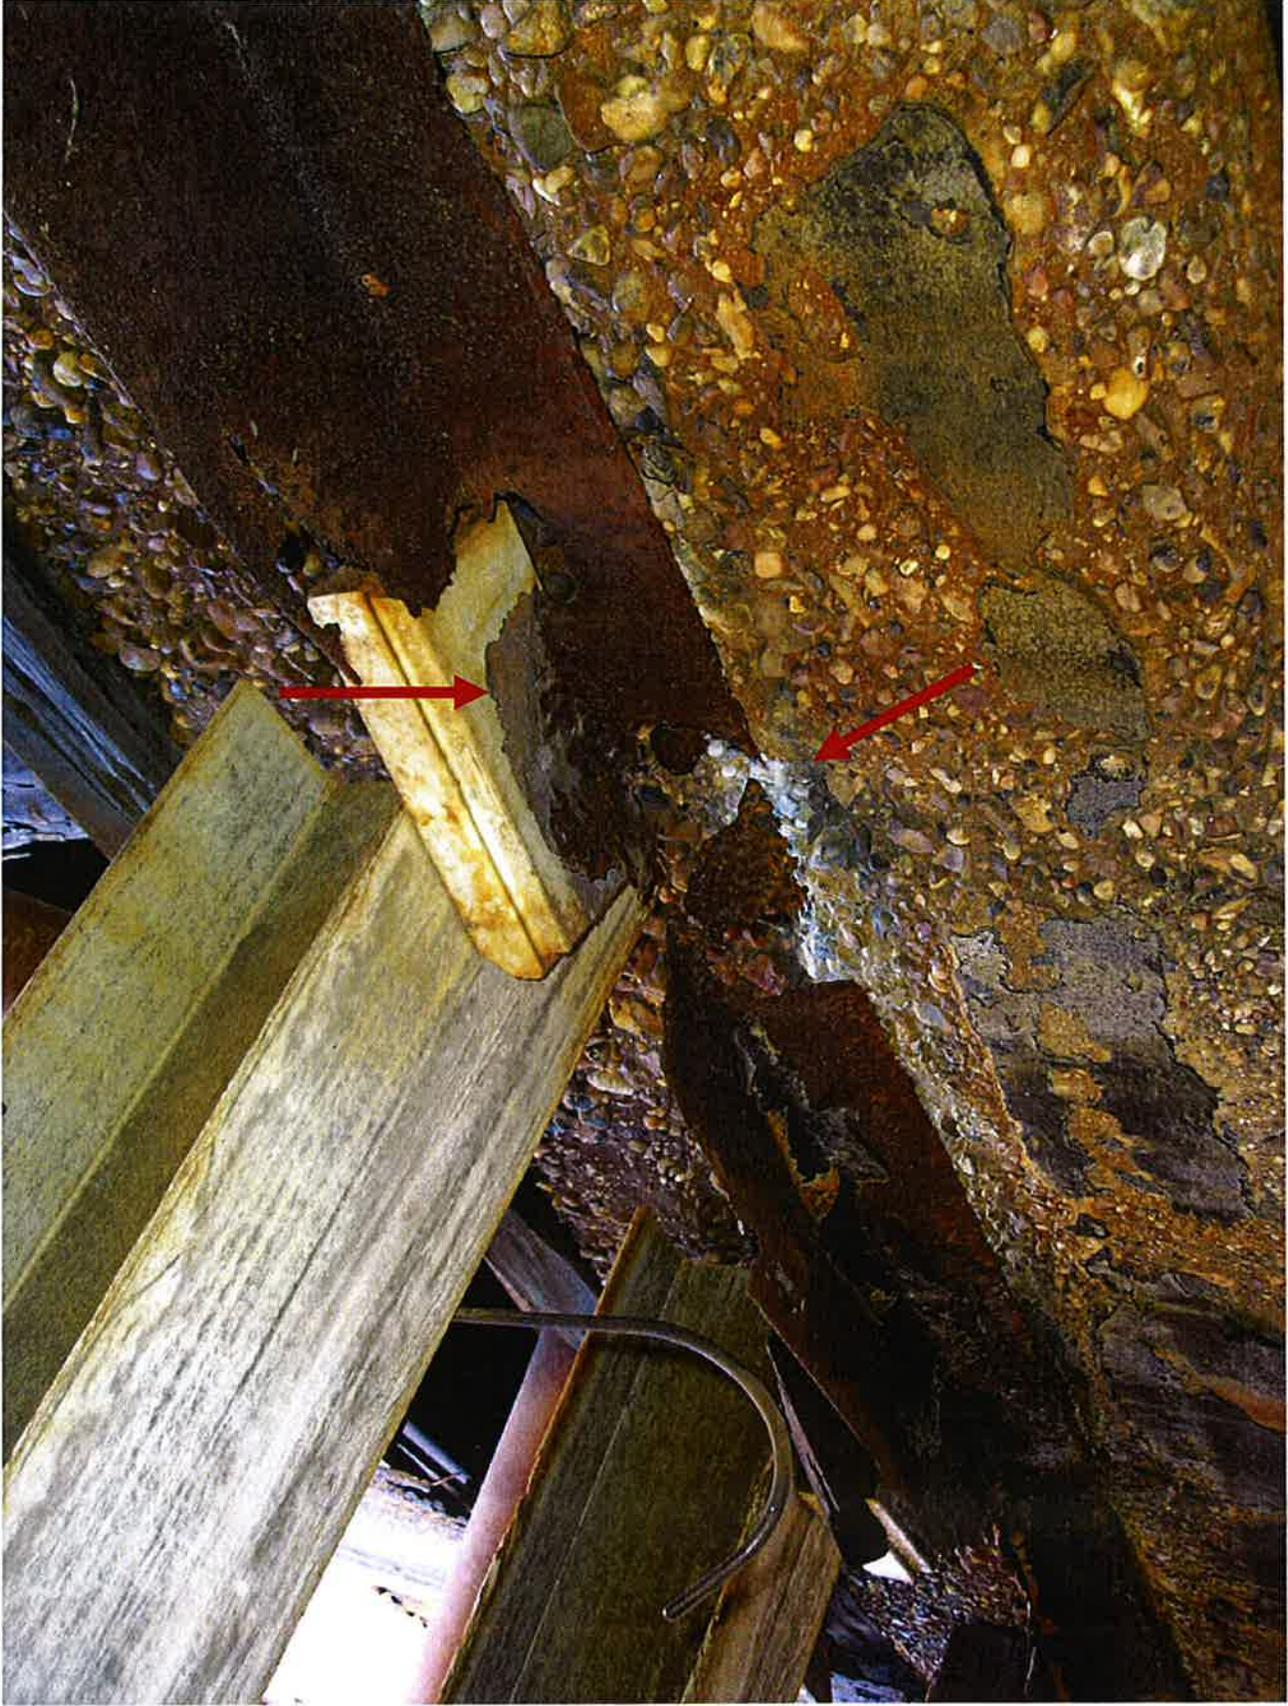
At the exterior of the west side of this building is an exterior elevated steel framed catwalk. There is significant deterioration of much of the framing of this catwalk, and in some locations fiberglass beams were installed to replace deteriorated steel beams (Photo 33). While the fiberglass beams appear to be structurally sound, the support angles were not replaced and are structurally unsound.

PHOTO 33 – DETERIORATED SUPPORT OF FIBERGLASS BEAM AT CATWALK AT WEST SIDE OF BUILDING 26

In general I believe the elevated concrete second level at the east half of this building has sufficient structural integrity to allow for safe support during planned abatement. I do not believe the second level at the west half, and the exterior and interior steel framed catwalk along the west side have sufficient structural integrity and shall not be used for support during the abatement process. During abatement, no one shall be allowed to work beneath or near the elevated west half of the building and the steel framed catwalks along the west side.

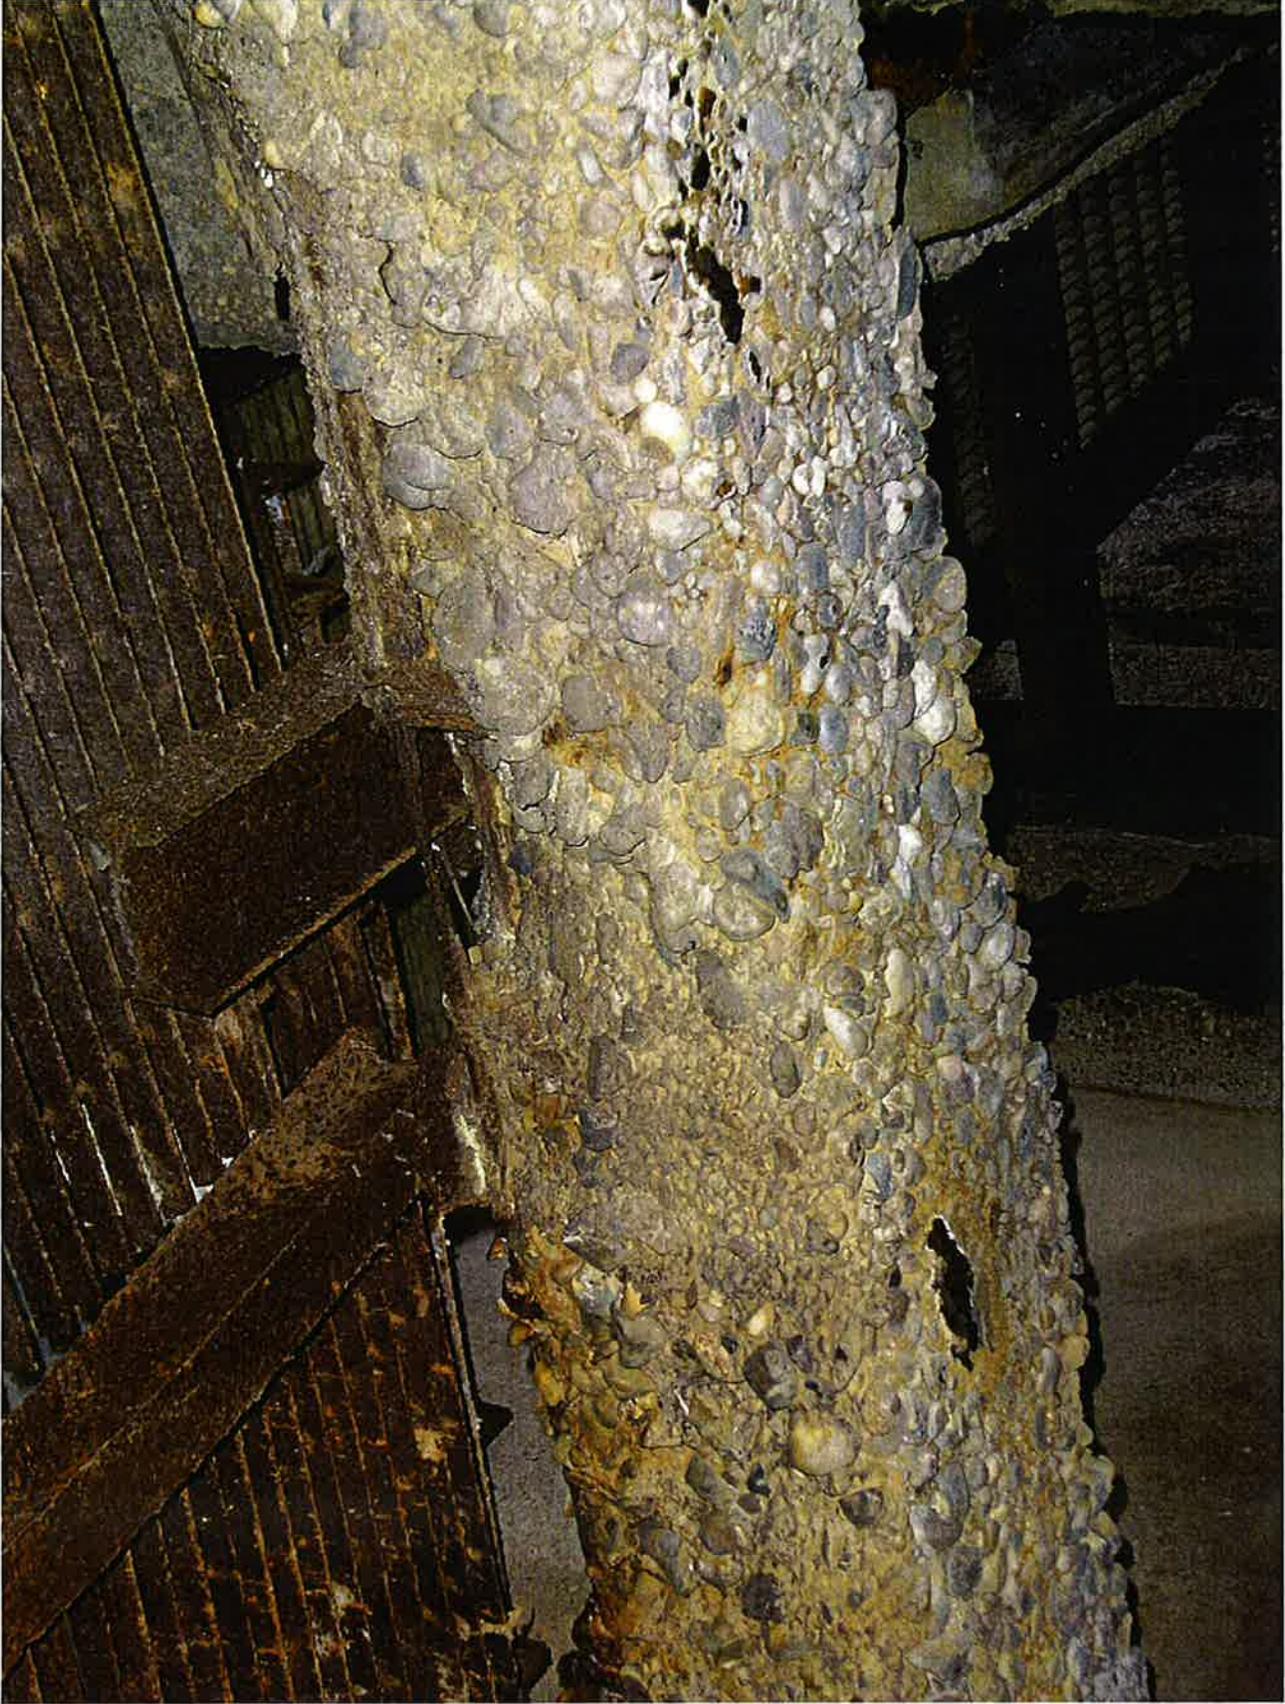
There are also areas where steel members and grating are supported by concrete beams which are structurally unsound (Photo 34). Many of the concrete beams have lost considerable amounts of concrete and there is little cement binder to hold the aggregate together.

PHOTO 34 – DETERIORATED CONCRETE BEAM AT WEST SIDE OF BUILDING 26

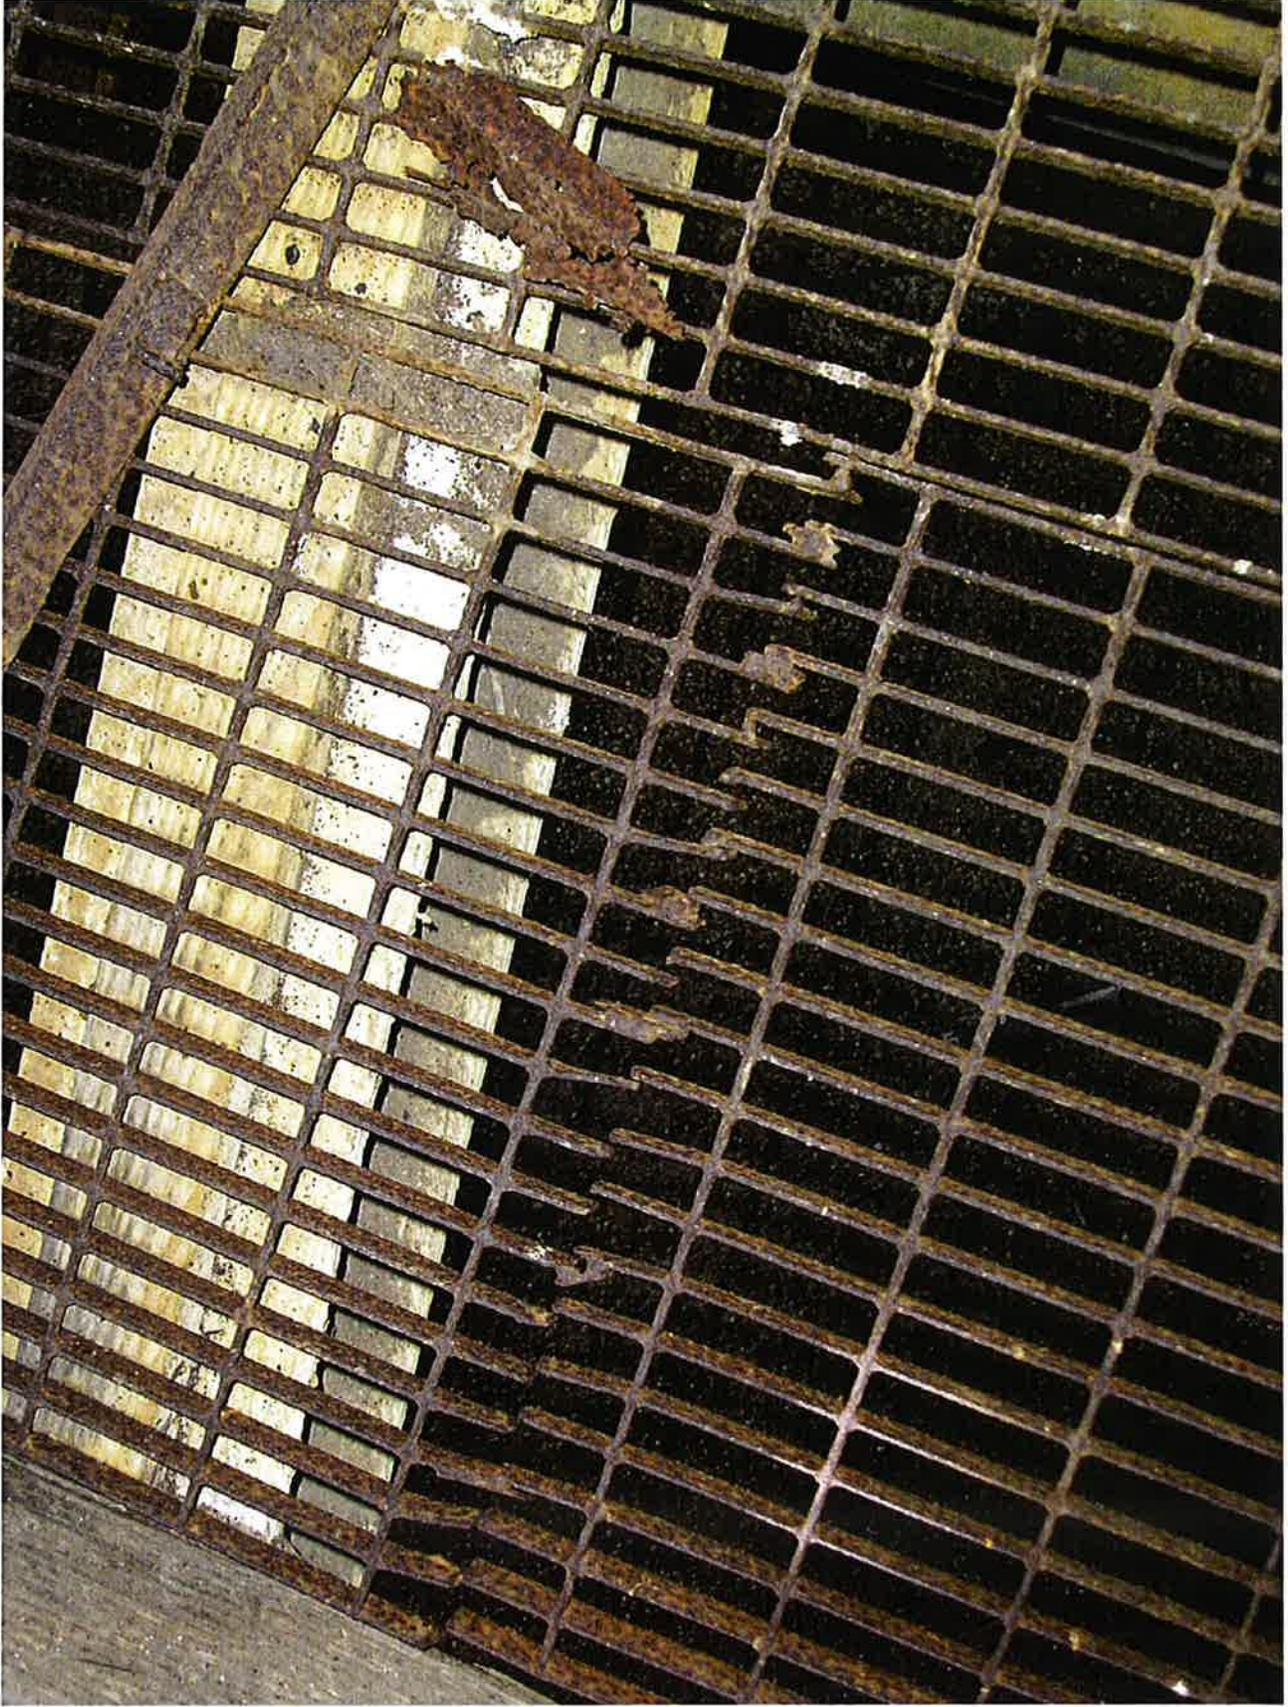
There are also areas where grating at the catwalk is not properly supported. In many cases, the ends of grating are not lapped at beam supports and there is insufficient weld between the ends of grating to properly transfer and support weight (Photo 35).

PHOTO 35 – VIEW OF GRATING AT SECOND LEVEL OF CATWALK AT WEST SIDE OF BUILDING 26
