Storage Tank Fire at Intercontinental Terminals Company, LLC (ITC) Terminal

Deer Park, Texas | Incident Date: March 17, 2019 | No. 2019-01-I-TX

Investigation Report

Published: July 6, 2023

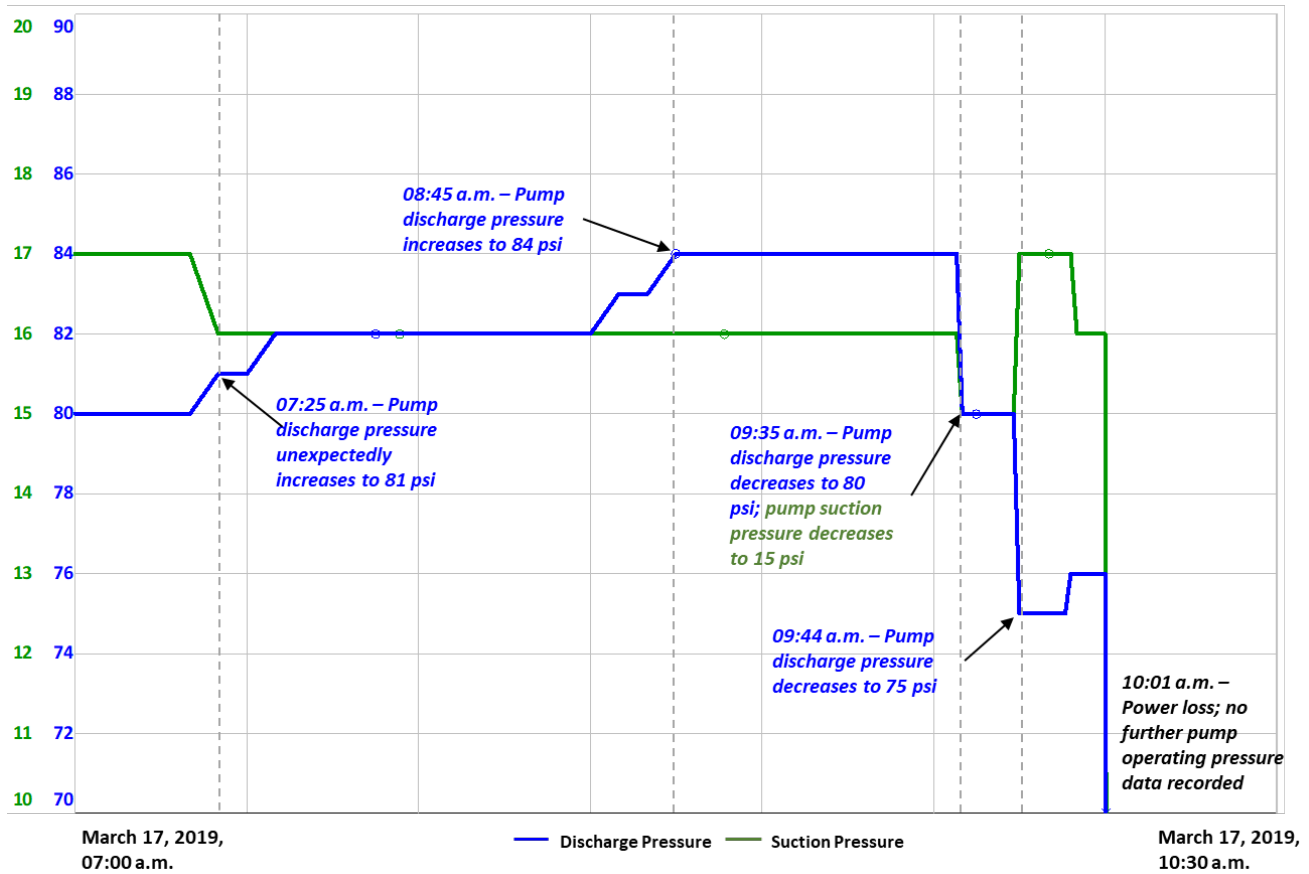
Tank 80-8 Pump Discharge Pressure & Suction Pressure

On the morning of March 17, 2019, as the Tank 80-8 circulation pump continued to operate, distributed control system (DCS) data for the tank indicated a series of unanticipated changes in the monitored operating pressures, flow rate, and tank volume. Beginning at approximately 7:25 a.m., the pump discharge pressure began to increase with no change in operation having occurred (**Figure 7**). By 8:45 a.m., the pump discharge pressure had gradually increased from 80 psi to 84 psi. At approximately 9:30 a.m., when the mechanical seal on the pump failed and butane-enriched naphtha product began to release to the atmosphere, the recorded tank level began to decrease, and recorded average flow rate^a for the tank, automatically calculated from changes in tank level measurements, began to increase (**Figure 8**). At approximately 9:35 a.m., the pump discharge pressure abruptly dropped to 80 psi, and within the next 10 minutes dropped further to 75 psi. At the same time, the recorded average flow rate of material from the tank had increased to about 158 barrels per hour (bph), and by 9:44 a.m. had increased to over 388 bph.

Figure 7. Recorded data historian trends showing recorded pump operating pressure data for Tank 80-8.
(Credit: CSB)

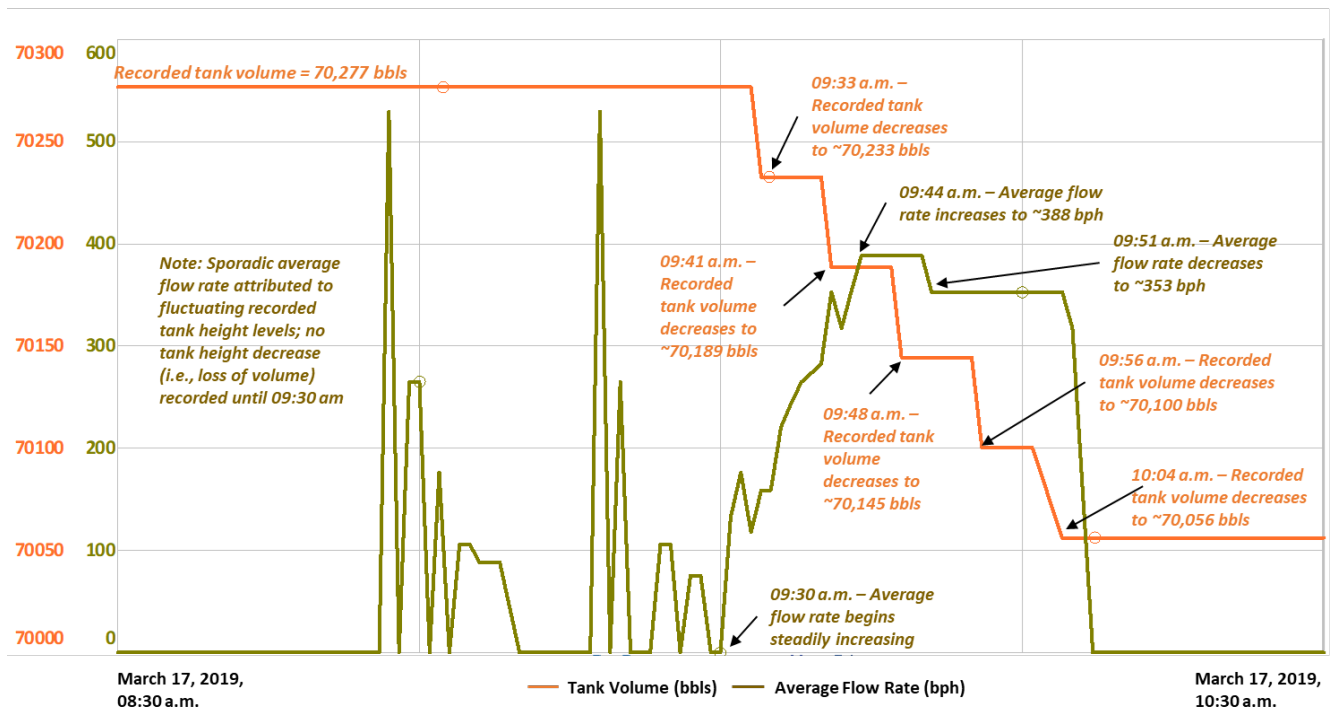
Tank 80-8 Recorded Tank Volume & Average Flow Rate

Figure 8. Recorded data historian trends showing recorded average flow rate and tank volume data for Tank 80-8. (Credit: CSB)

Between 9:30 and 10:00 a.m., the recorded tank volume^a in Tank 80-8 decreased by more than 177 barrels as the naphtha product continued to release from the failed pump.^b At 10:00:46 a.m., approximately 30 minutes after the release began, the butane-enriched naphtha product releasing from the Tank 80-8 piping manifold ignited (**Figure 9**). No operators were working outside in the First & Second 80's tank farm during this time frame. The acting shift manager was working in the adjacent Third 80's tank farm that morning and an operator was working in the nearby 100's tank farm. However, neither of them heard, saw, or smelled anything out of the ordinary during the time of the release. The First & Second 80's tank farm was not equipped with a gas detection system.

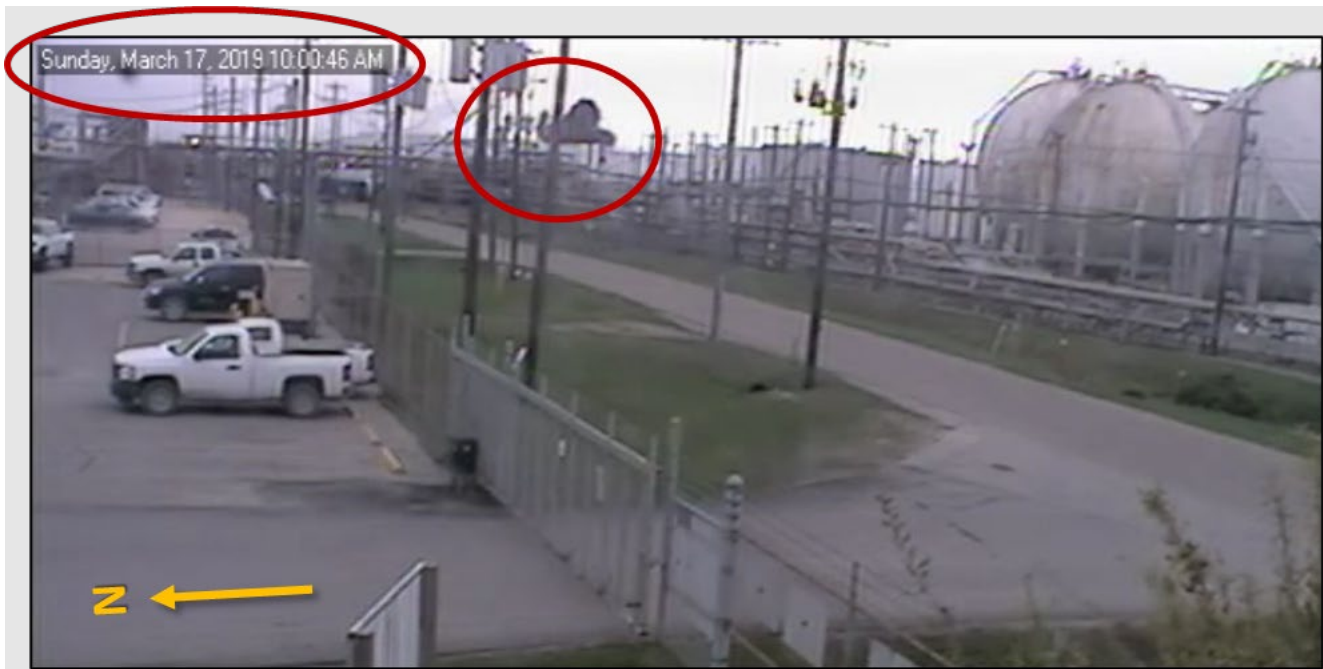
Figure 9. ITC Deer Park terminal security camera footage showing fireball over First & Second 80's Tank Farm at 10:00:46 a.m. on March 17, 2019. (Credit: ITC, annotations by CSB)

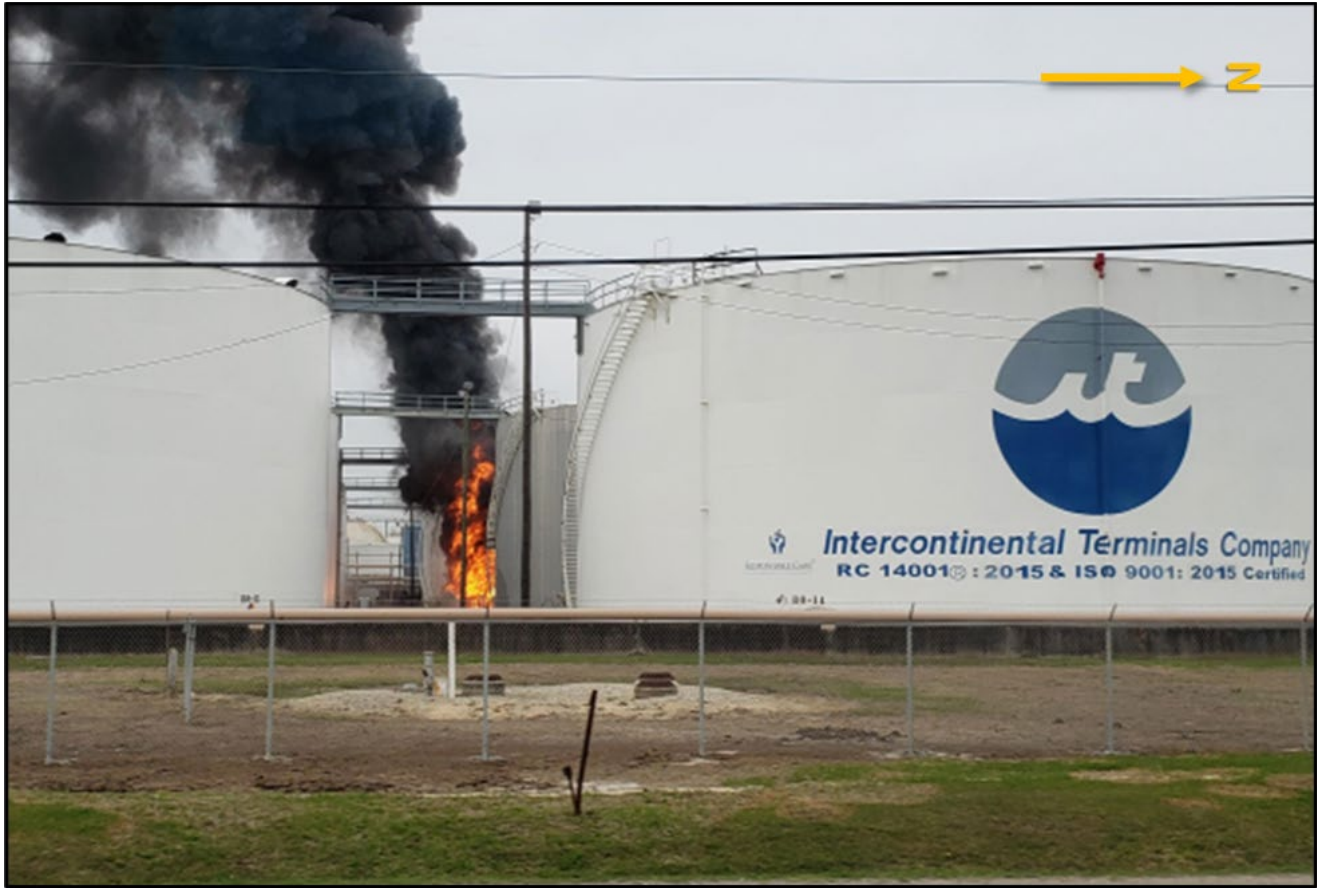
Figure 11. Initial ITC tank fire that ignited at Tank 80-8 on March 17, 2019. (Credit: HCFMO, annotations by CSB)

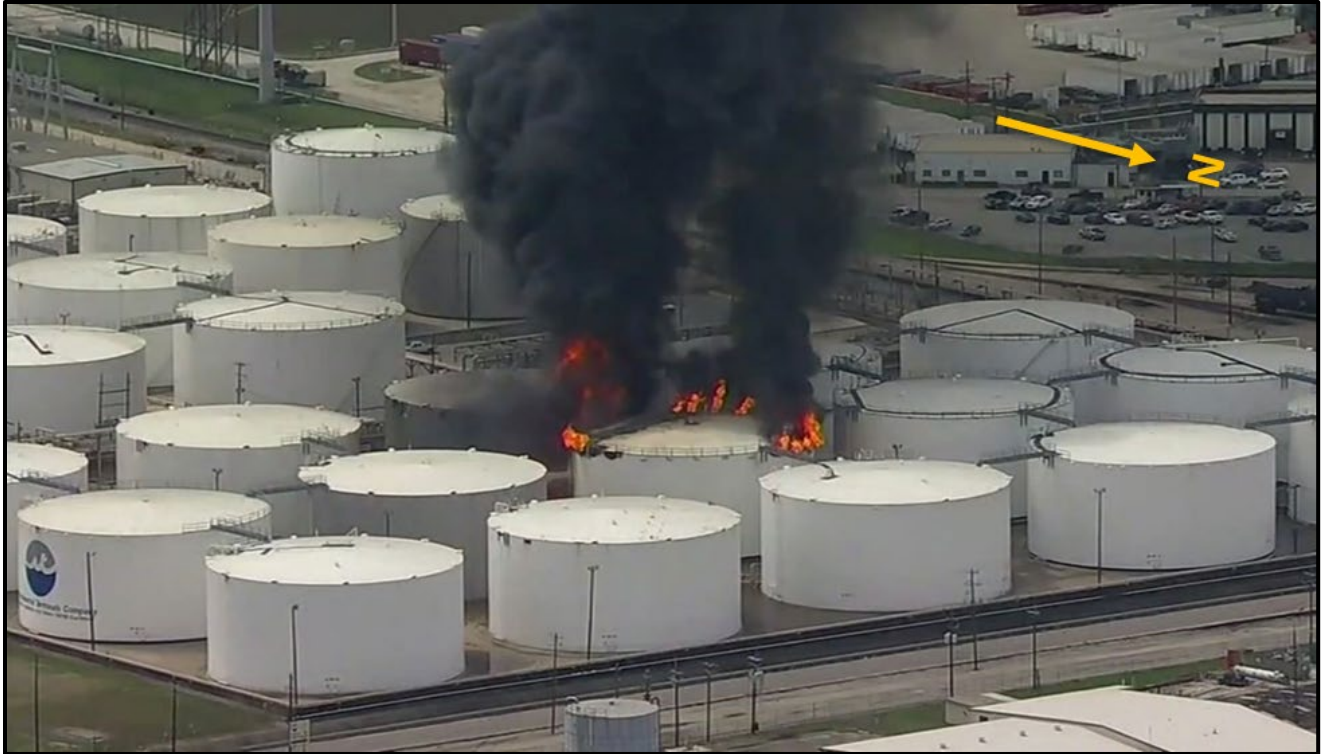
Given that Tank 80-8 was situated in the center of the First & Second 80's tank farm, the initial response efforts focused on using water to cool the tanks, control the fire, and prevent it from spreading. Since Tanks 80-9 and 80-12 were both empty, resources were not focused on cooling these tanks; however, a wind shift caused the fire to inundate the Second 80's tank farm manifold located in this area, which connected to process piping from other locations in the facility.^a As a result, the ERT positioned a portable fire monitor between Tanks 80-11 and 80-12 to assist with cooling efforts and prevent the combustible insulation surrounding Tank 80-11 from reigniting. At this time, fire was visible near the rim of Tank 80-8, with flames being expelled through the roof vents (**Figure 12**).

Figure 12. ITC fire involving Tank 80-8 on the morning of March 17, 2019. (Credit: ABC13 Houston, annotations by CSB)

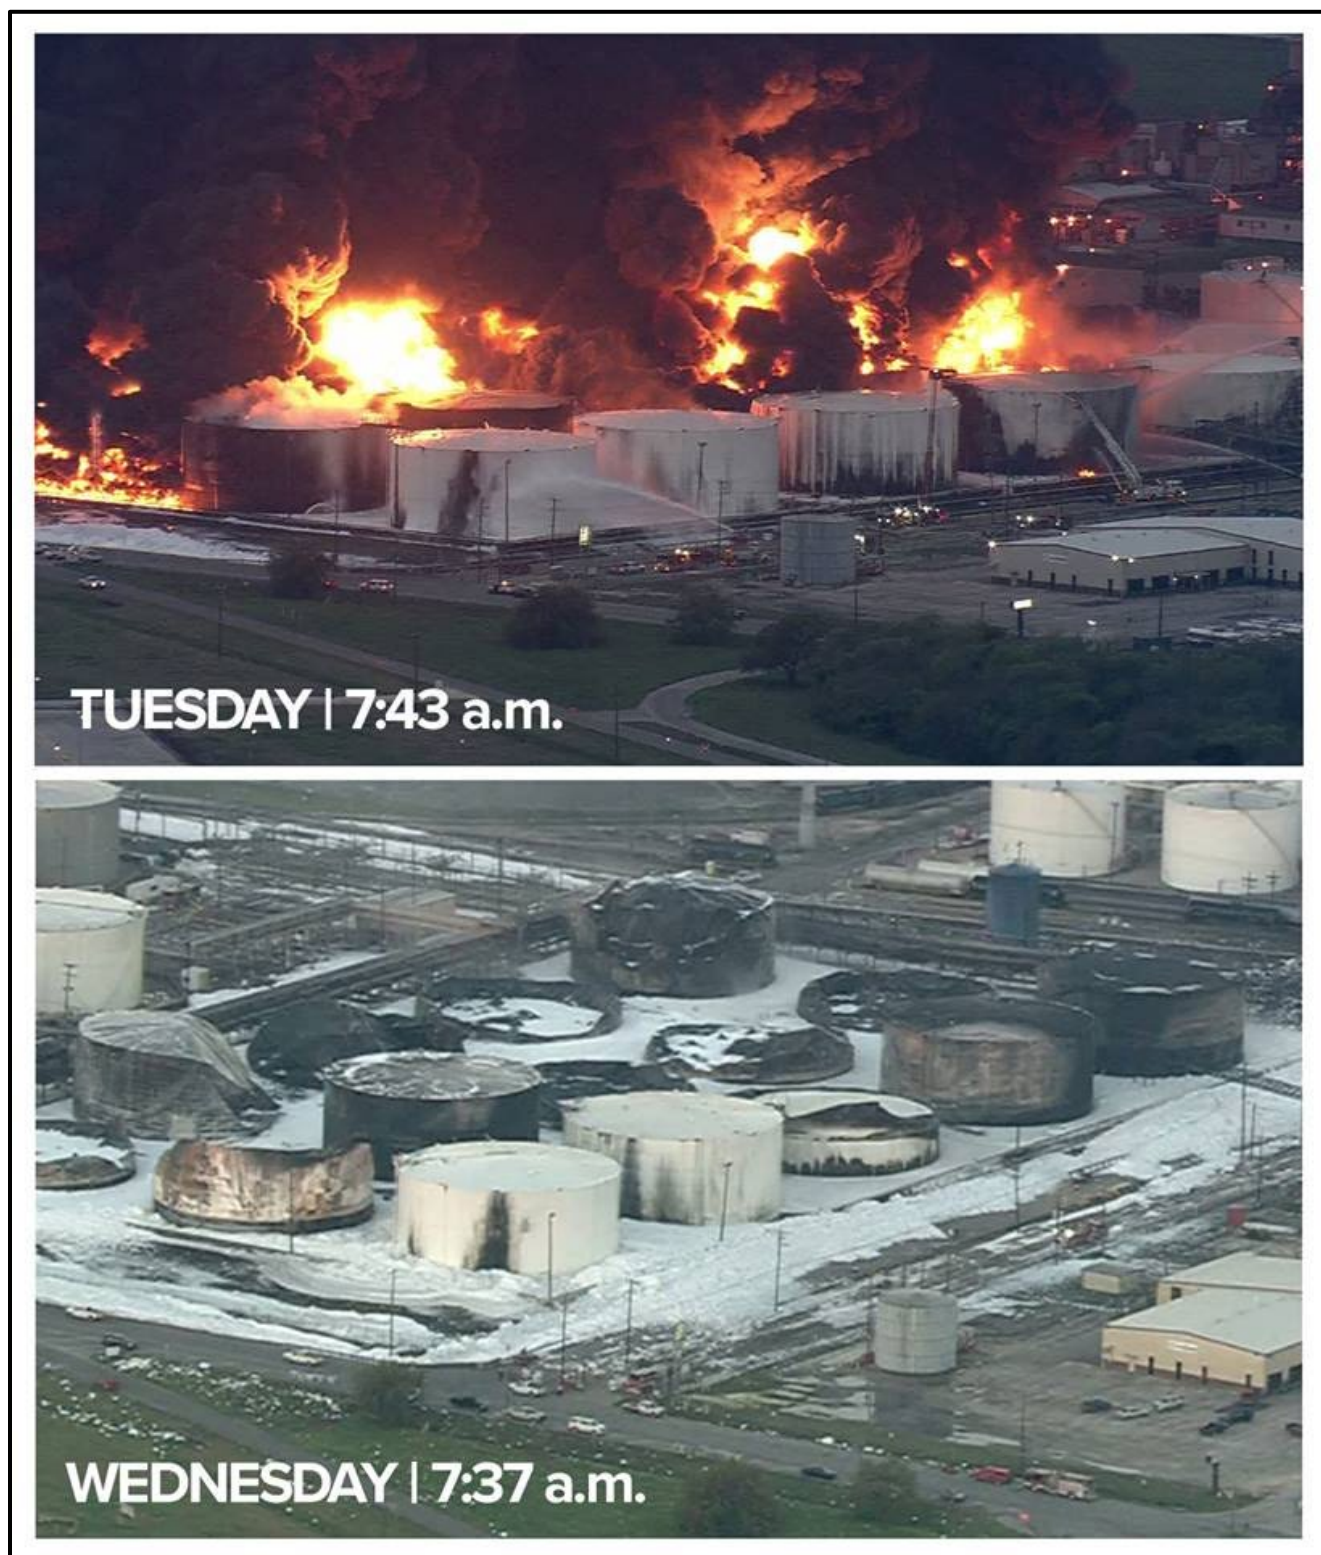
Figure 14. First & Second 80's tank farm on fire on Tuesday, March 19, 2019, and fully extinguished on Wednesday, March 20, 2019. (Credit: KHOU 11 News)

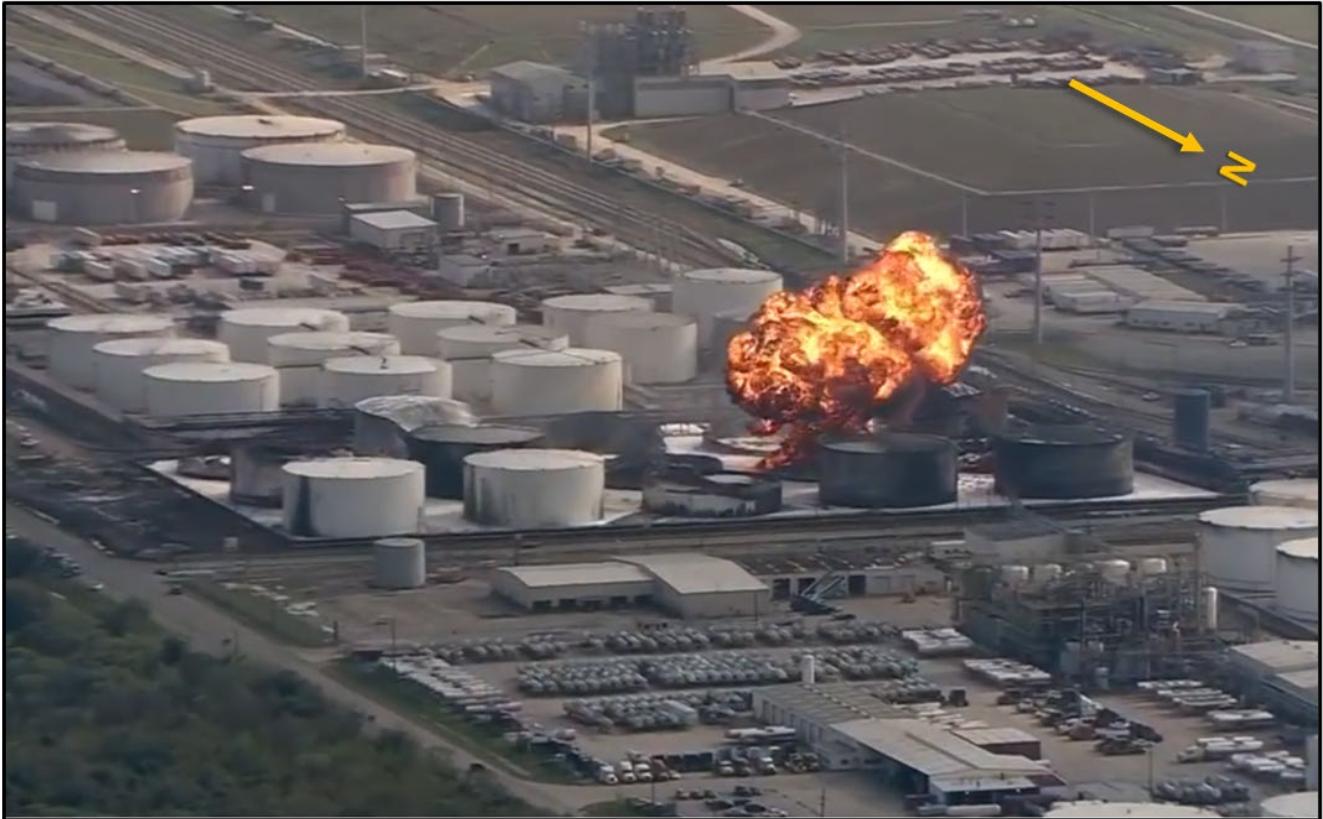
Figure 15. Tank 80-5 flare-up that occurred on March 20, 2019. (Credit: “Raw video ITC fire reignites in Deer Park”, annotations by CSB)

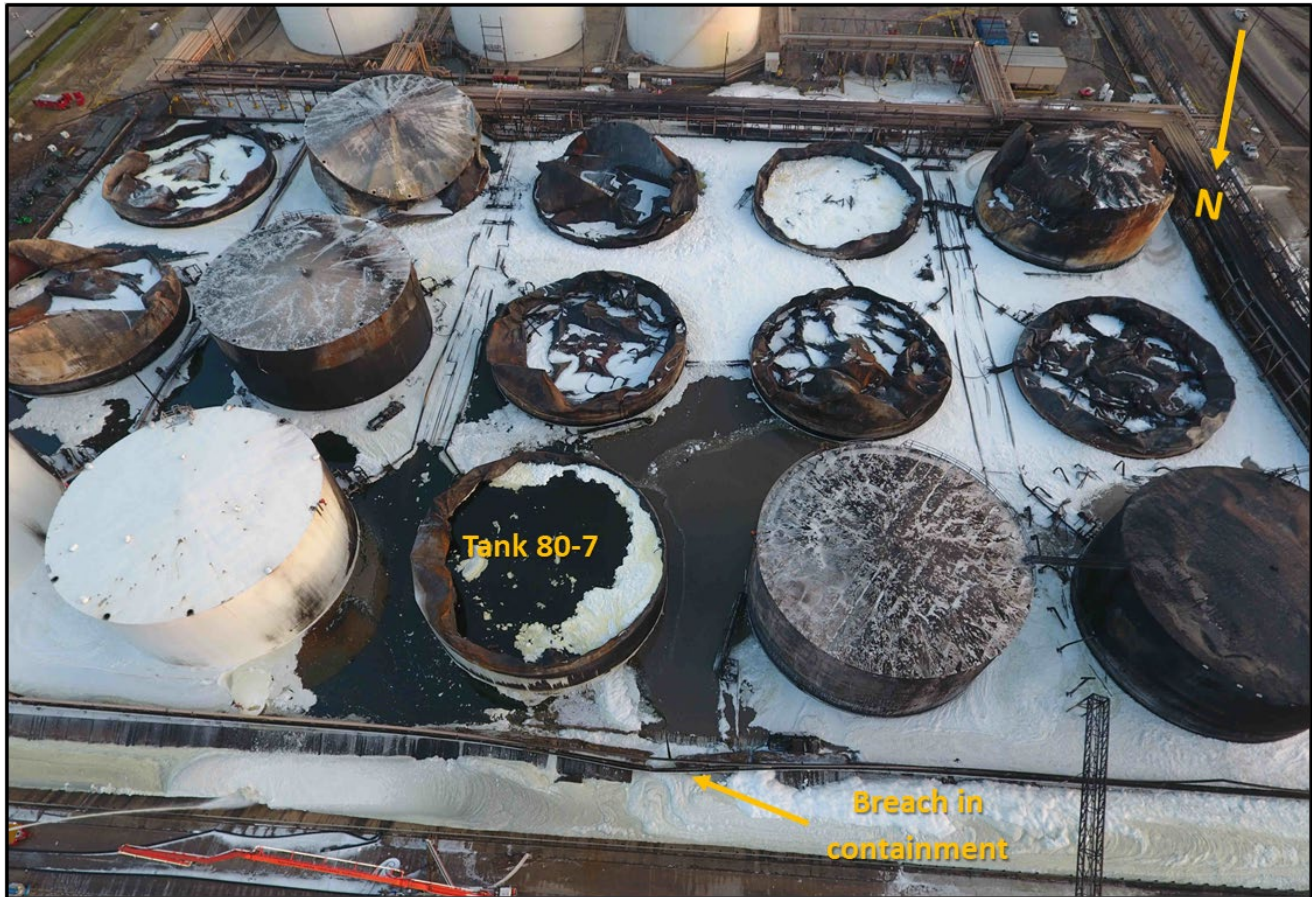
On Friday, March 22, 2019, at around 12:15 p.m., the secondary containment wall surrounding the First & Second 80's tank farm partially collapsed near Tank 80-7. The containment wall displaced laterally due to excessive lateral soil and hydrostatic pressures.^b The containment wall failure allowed the mixture of released hydrocarbon products, firefighting foam, and contaminated water previously confined to the tank farm to exit the containment area and enter the ditch running adjacent to Tidal Road on the north side of the tank farm

Figure 16. Overhead view of the First & Second 80's tank farm containment wall failure that allowed materials to enter the surrounding waterways on Friday, March 22, 2019. (Credit: ITC, annotations by CSB)

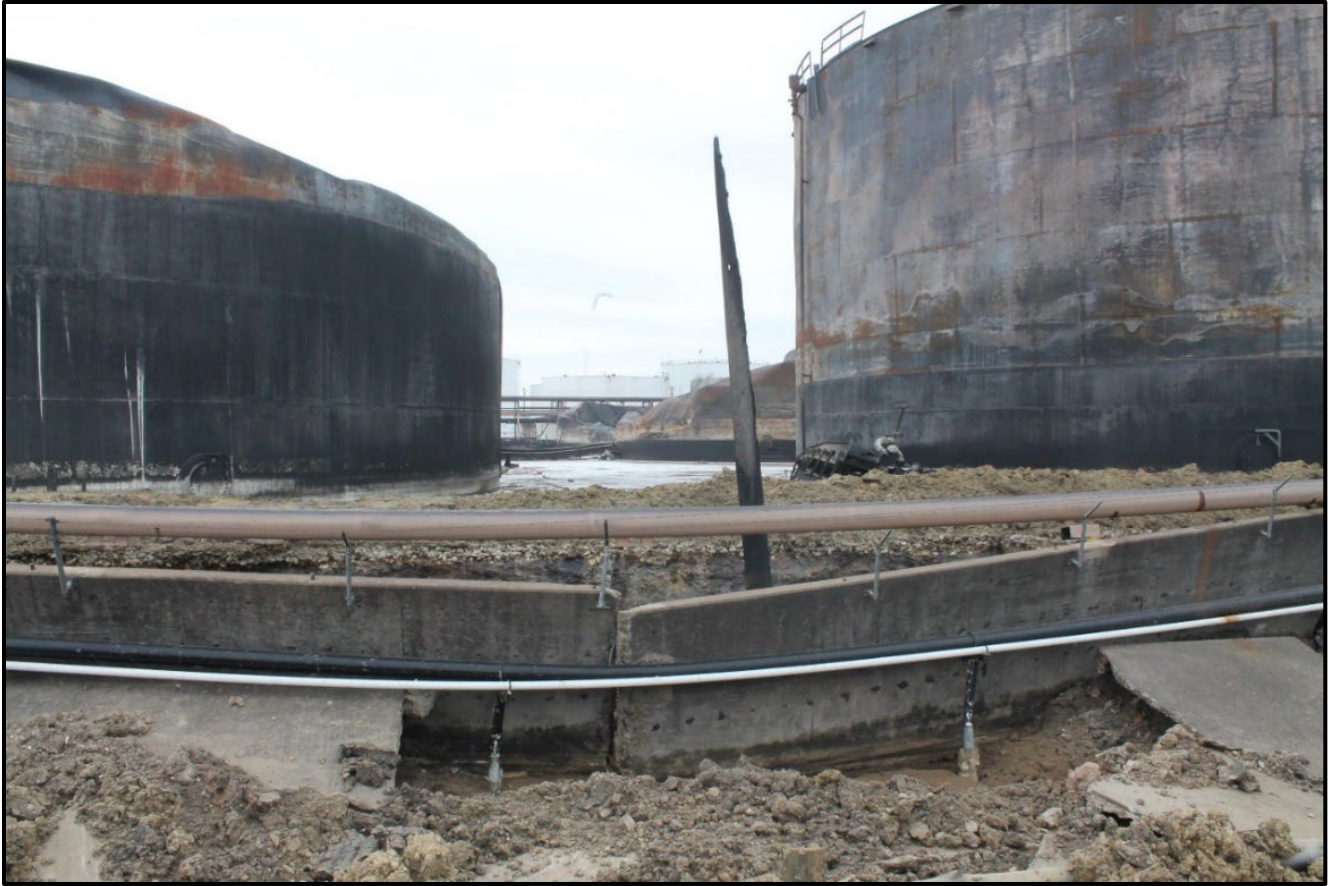
(Figure 16). The release also resulted in the potential for elevated levels of volatile organic compounds (VOCs)^a in the immediate industrial area. As a result, ITC notified its industrial neighbors and local state parks of the potential exposure and recommended that they shelter in place. The breach in the containment wall measured roughly 10 feet in width (Figure 17).

Figure 17. Close-up view of the First & Second 80's tank farm containment wall breach that occurred on Friday, March 22, 2019. (Credit: HCFMO).

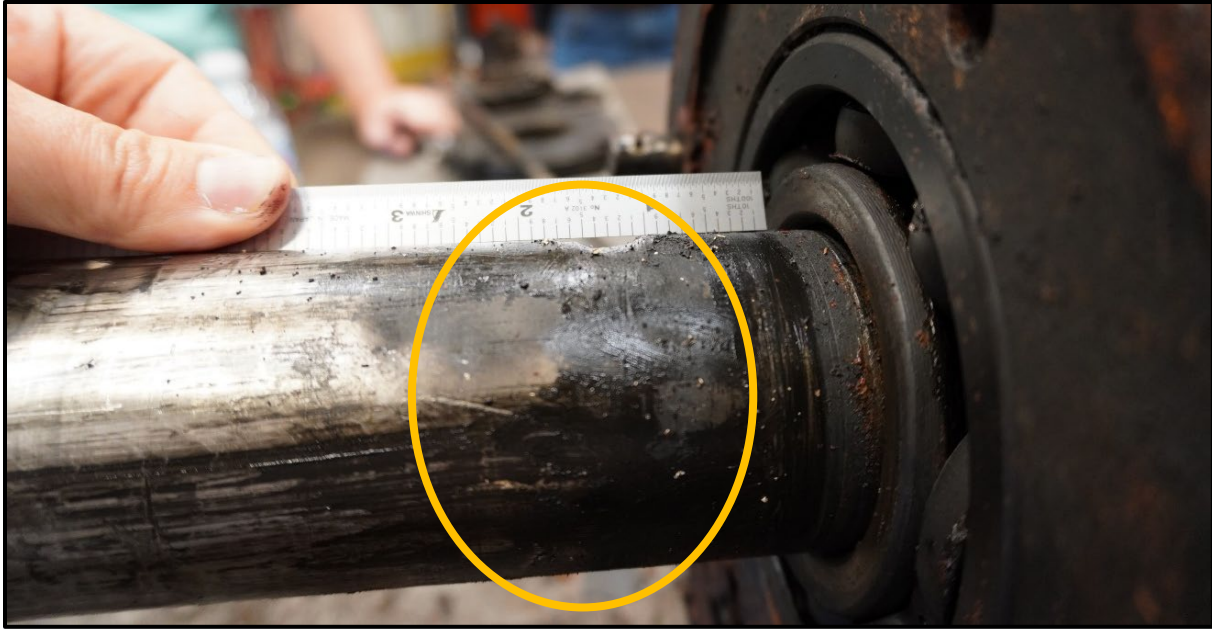
Following the incident, the Tank 80-8 circulation pump skid was transported to a third-party facility for inspection and teardown (**Figure 22**). The pump was fully disassembled to allow for visual examination of its individual components and documentation of their condition. Severe degradation and wear damage were observed on the pump shaft, seal, and outboard bearing. Substantial abrasive wear was visible on the pump shaft adjacent to the seal on the inboard side of the bearing housing (**Figure 23**). Extensive contact wear was also visible on the seal gland (**Figure 24**).

Figure 23. The severe abrasive wear damage observed on the Tank 80-8 pump shaft adjacent to inboard side of bearing housing, on August 30, 2019. (Credit: CSB)

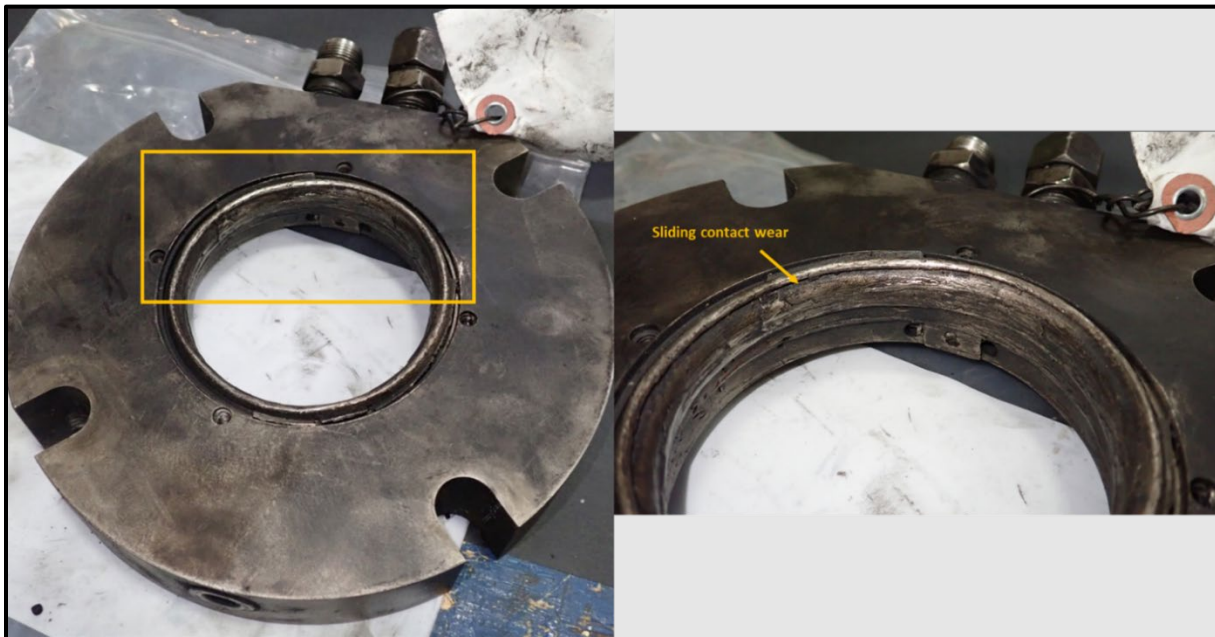
Figure 24. Smeared metal on inside surface of seal gland that indicates sliding contact with the pump shaft. (Credit: Stress Engineering)

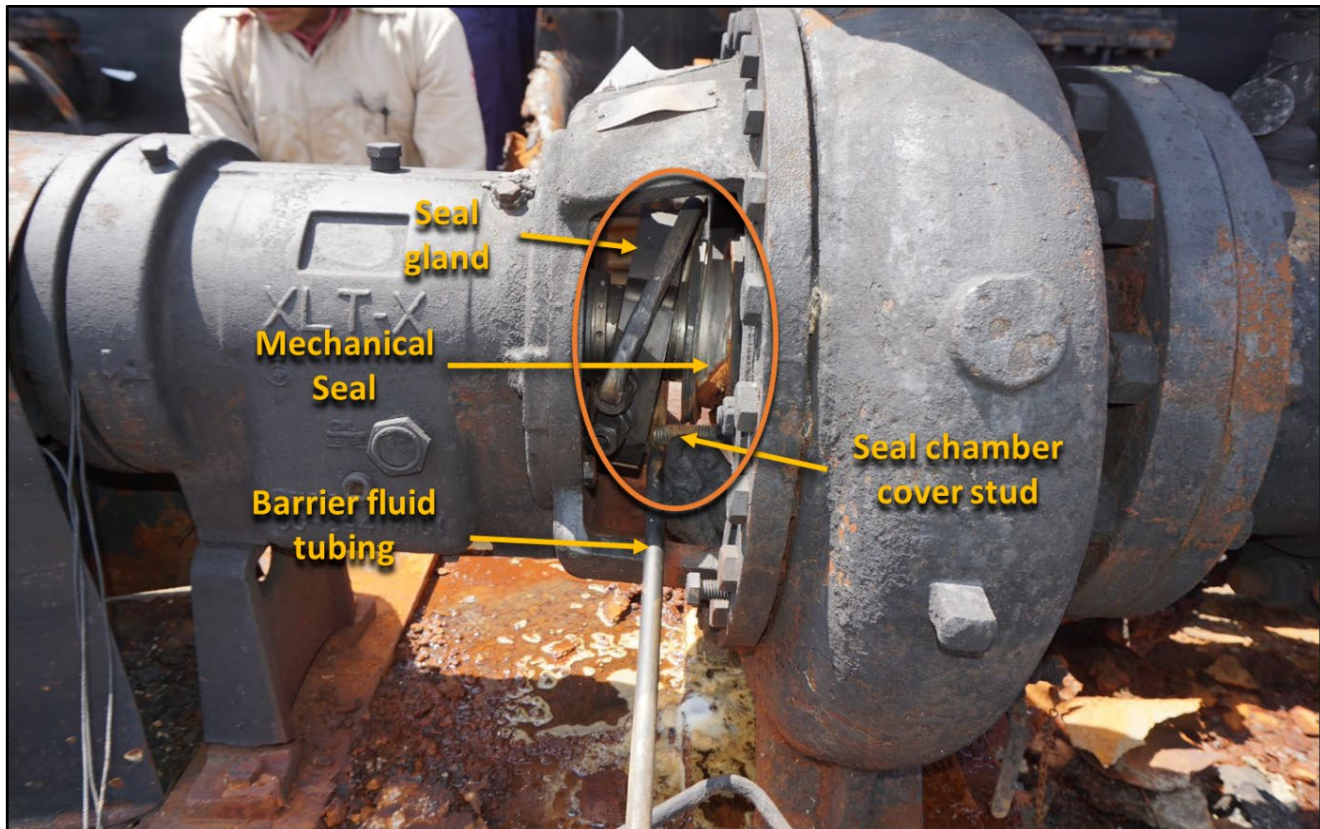
Figure 26. Tank 80-8 circulation pump. This photo shows the point of separation observed between the mechanical seal gland and seal chamber cover where the butane-enriched naphtha product released. (Credit: CSB).

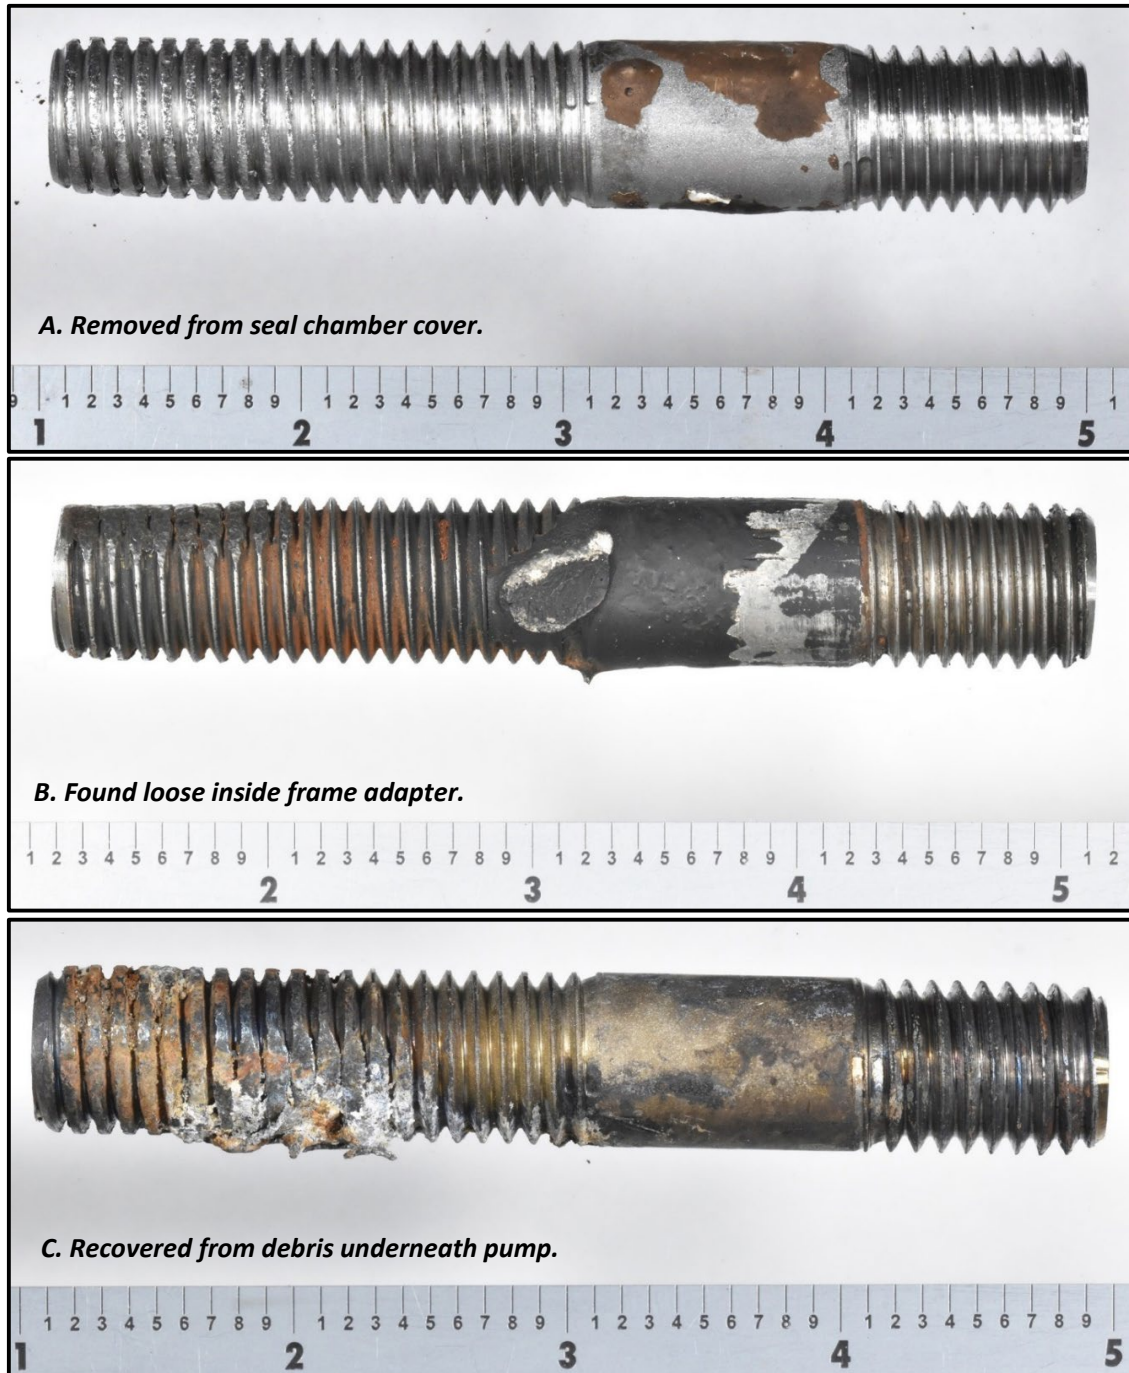
^a The internal threads of the blind holes in which the studs were located, as well as the threads on the studs where they engaged the blind holes, were in good condition.

Figure 27. Three seal chamber cover studs recovered from Tank 80-8 circulation pump, post-cleaning. The longer threaded ends passed through the slots in the seal gland, while the shorter threaded ends were engaged in the seal chamber cover. (Credit: Stress Engineering)

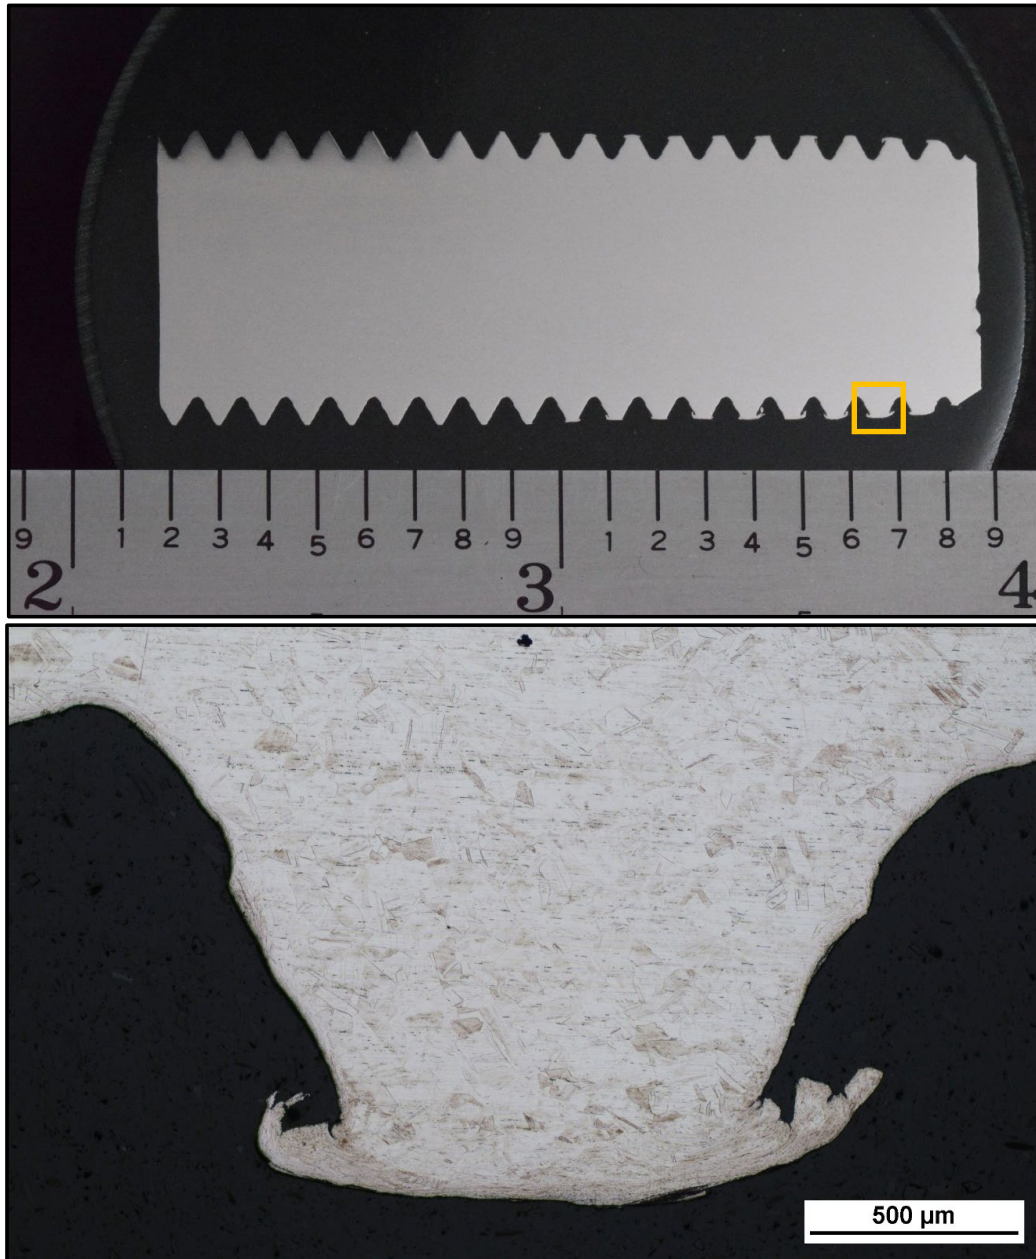
Figure 28. Section of threads from seal chamber stud that projected through slots in seal gland, where flattening of the thread crowns was observed (Credit: Stress Engineering)
