# CHAPTER 11

## FISH CREEK (SEGMENT 0841J)

## North Fork Fish Creek (Segment 0841Q)

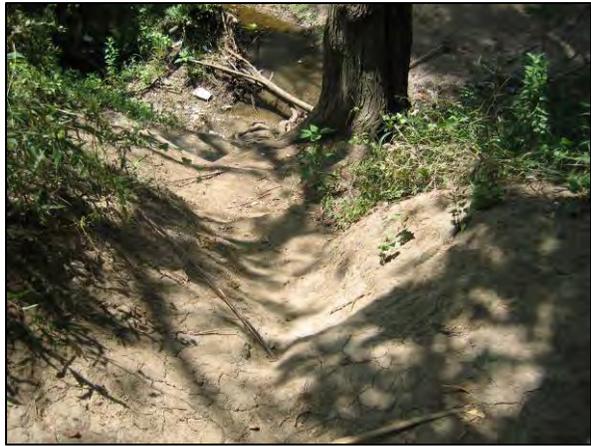
Available parking is limited to the sides of neighborhood streets and the parking lot of the elementary school. While access to the stream was moderately difficult, there were two footpaths identified through the vegetation along the sides of the stream. One footpath was located at the 0-m transect and another was located at the 300-m transect. Both of the footpaths were observed on both sides of the stream indicating some crossing of the streambed occurred at these locations ([Photogroup 11-7](#)).

**Photogroup 11-7** Fish Creek Site FS103 showing footpaths at 0-m and 300-m transects providing access to creek from both banks. (Individual pictured is TIAER staff.) [\[Return to Text\]](#)

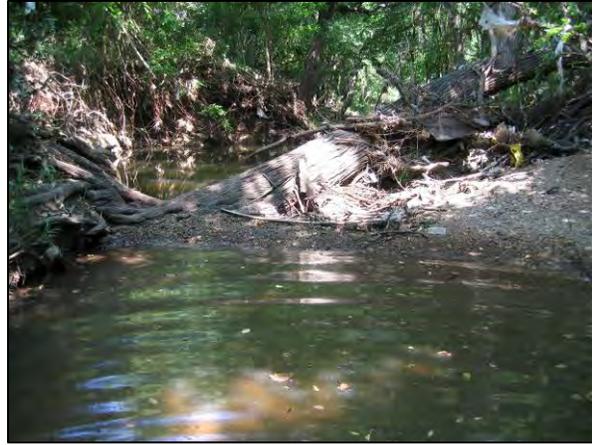
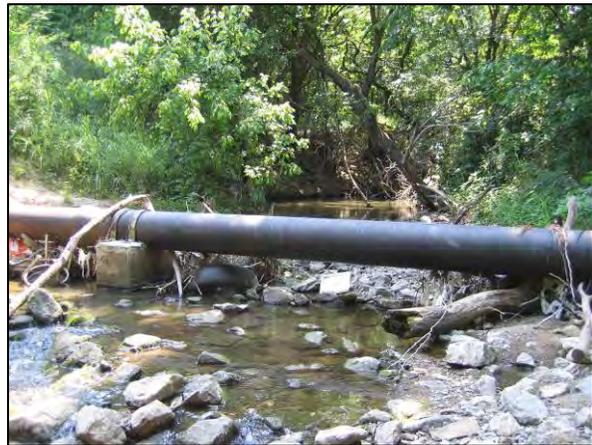
Obstructions were identified at several locations of the stream. Three log jams were observed at the 120-m, 180-m, and 270-m, transects and one pipe at the 60-m transect ([Photogroup 11-8](#)).

**Photogroup 11-8** Fish Creek Site FS103 showing obstructions of trees at 120-m, 180-m, and 270-m transects and pipe crossing at 60-m transect. (Individuals pictured are TIAER staff.) [\[Return to Text\]](#)

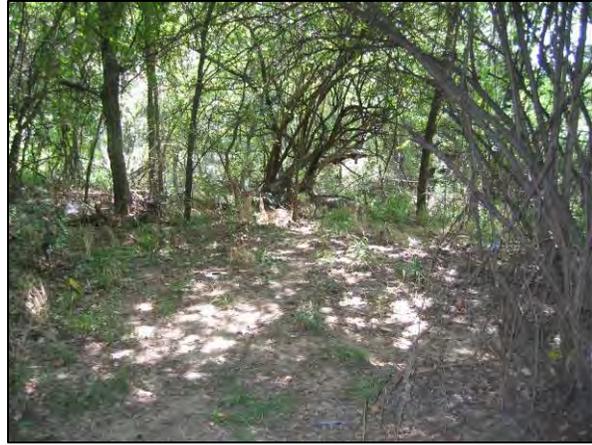
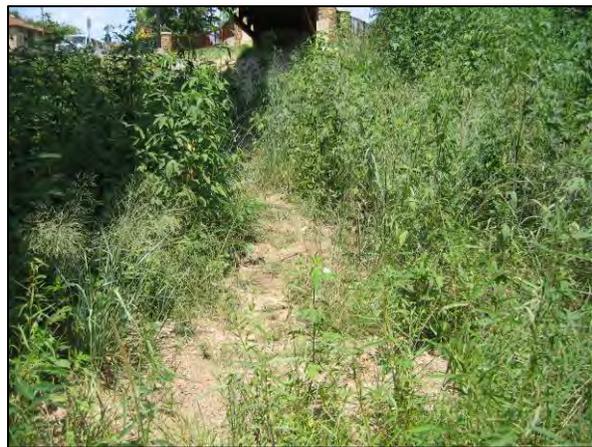
Access to the stream was moderately difficult, though footpaths to the stream were observed at the 0-m transect and the 300-m transect ([Photogroup 11-11](#)). The dominant substrate of the stream was cobble to boulder in size, which made walking in the stream very difficult and dangerous. Due to the risk of personal injury, only the 0-m, 150-m and 180-m transect depths were collected during the second survey. During the third survey, conditions had changed somewhat and field personnel were able to collect nine of the eleven depths. During one of the surveys, neighborhood children sitting on the bridge crossing the stream volunteered the comment that field personnel were going into the “scary” part, which led field staff to assume they rarely ventured into that portion of the stream. This segment of FS104 was a cobble-bottom stream that was wadeable in depth but dangerous to attempt.

**Photogroup 11-11** Fish Creek Site FS104 showing footpaths to stream. (Individual pictured is TIAER staff.) [\[Return to Text\]](#)

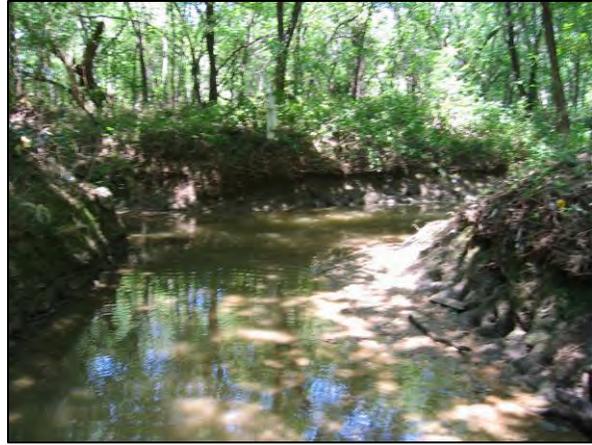
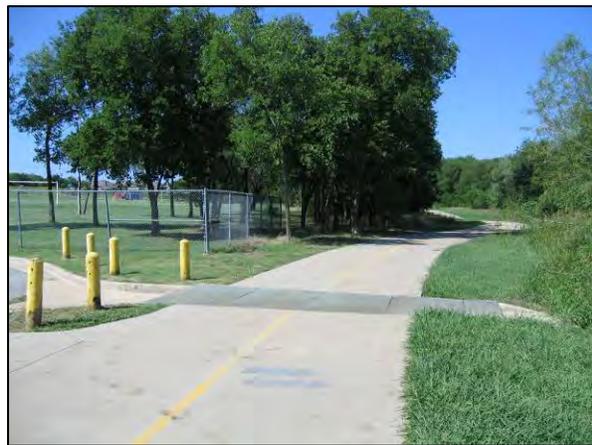
The surveyed reach at Site FS105 was wadeable with a gravel bottom. The substrate changed to a very unusual concrete block bottom between the 240-m and 270-m transects ([Photogroup 11-14](#); upper left photograph). During the first two surveys, no stream channel obstructions were observed. However, during the third survey, five log jams were encountered near the 60-m, 120-m and 180-m transects ([Photogroup 11-15](#)).

**Photogroup 11-14** Fish Creek Site FS105 showing stream and streambank characteristics (upper left photograph the concrete block streambed), stream tributary (upper right), access point (middle left), and surround area, including footpath leading to creek. [\[Return to Text\]](#)

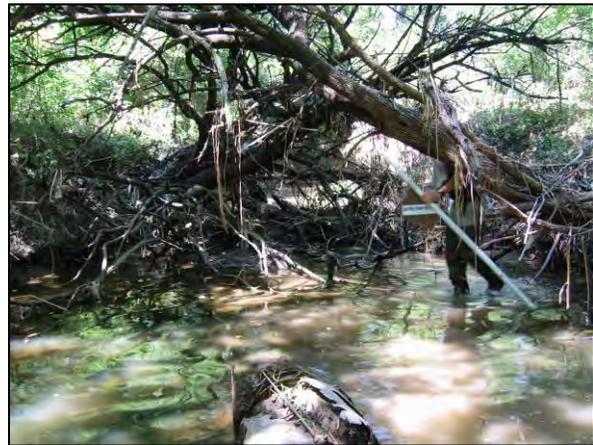
Two log jams were observed at the 180-m transect and the 240-m transect ([Photogroup 11-19](#)). A total of five pools were identified during the three surveys. One pool was identified during each of the first two trips and three pools were identified during the third survey. Dimensions of the pools are listed in Table 11-10.

**Photogroup 11-19** Fish Creek Site FS106 showing obstacles from fallen trees and associated debris at the 180-m and 240-m transects. [Note field crew in both photographs] [\[Return to Text\]](#)

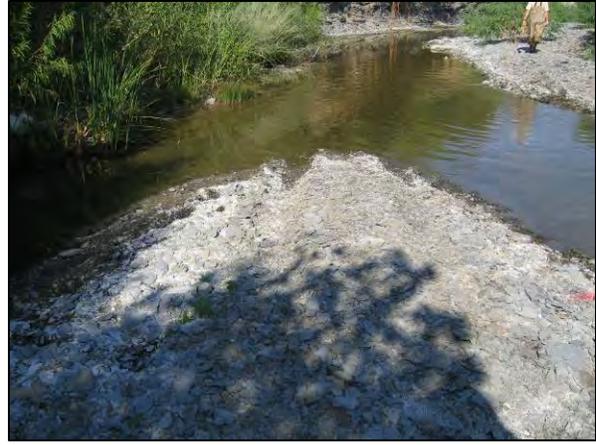
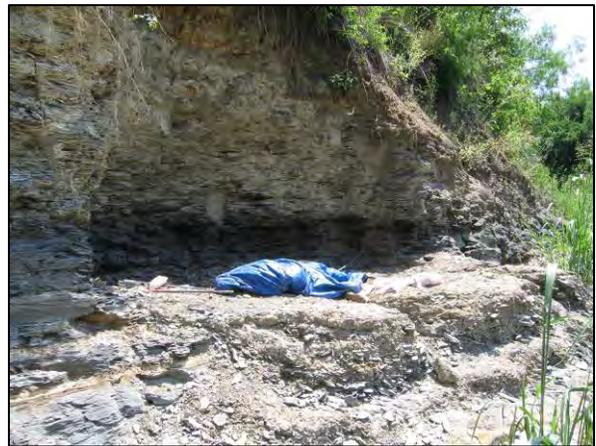
**Photogroup 11-24** North Fork Fish Creek showing ATV tracks and trail at Site FN101 (upper row and lower row left) and tent stakes and tarp for tent at Site FN101. (Individuals photographed are TIAER staff.) [\[Return to Text\]](#)

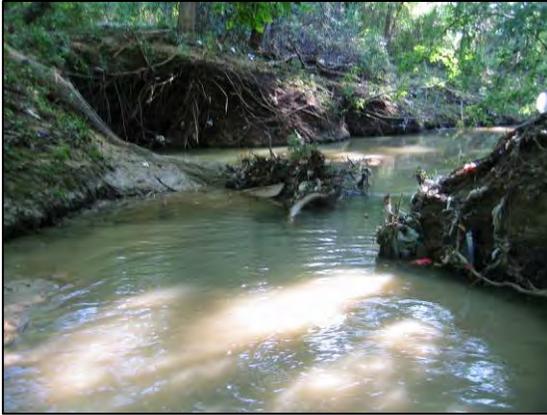
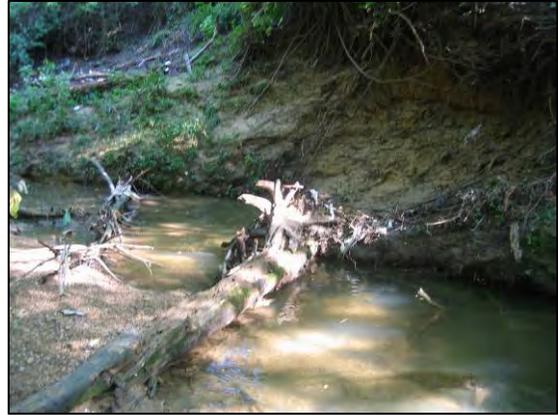
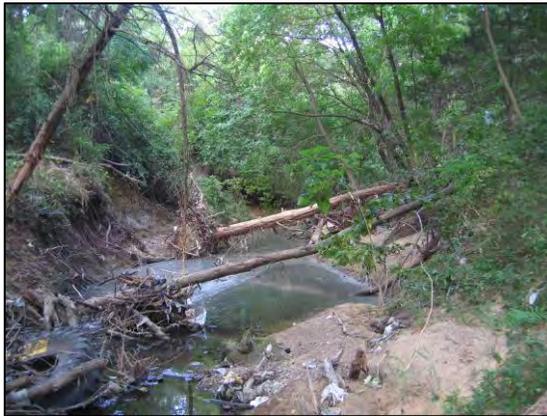
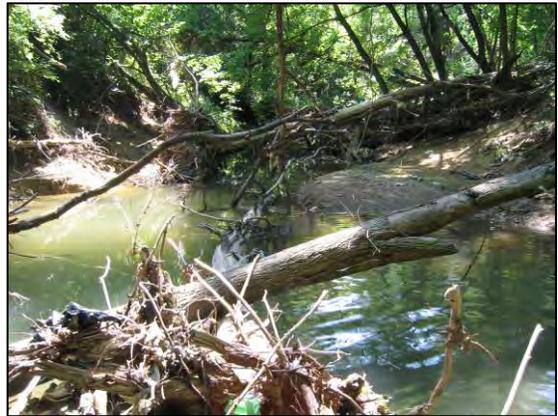
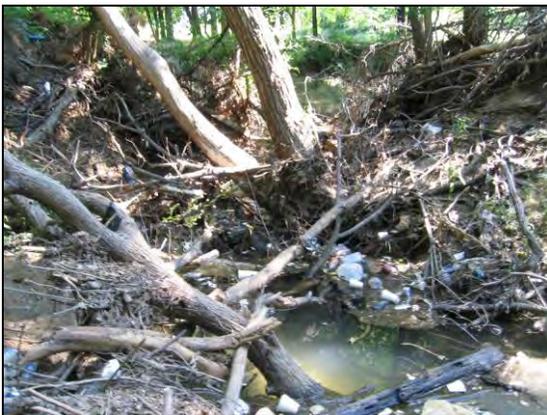
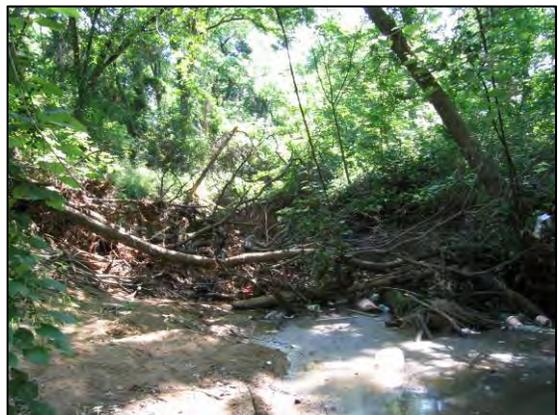
**Photogroup 12-3** Kirby Creek Site KC101 showing obstructions observed at several transects during the surveys. [Return to Text](#)

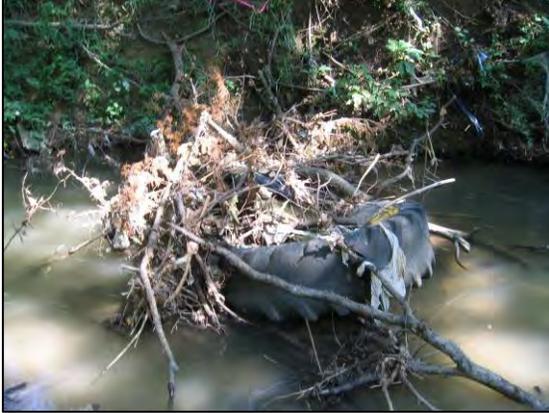
**Photogroup 12-4** Kirby Creek Site KC101 showing obstruction containing large tire  
[\[Return to Text\]](#)
