Dallas-Fort Worth Metroplex Urban Creeks
Trinity River Bacteria TMDL Project
Recreational Use-Attainability Analysis Report

Report to TMDL Team
Texas Commission on Environmental Quality
Project and Work Order Number
582-5-70859-26

Jeff Stroebel
Tim Jones
Larry Hauck
Texas Institute for Applied Environmental Research
Tarleton State University
Stephenville, Texas

November 2010

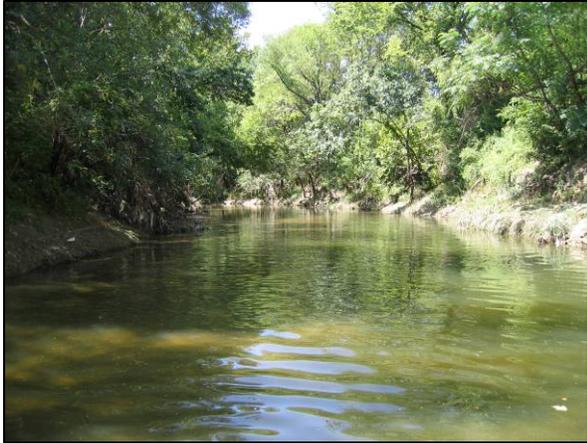
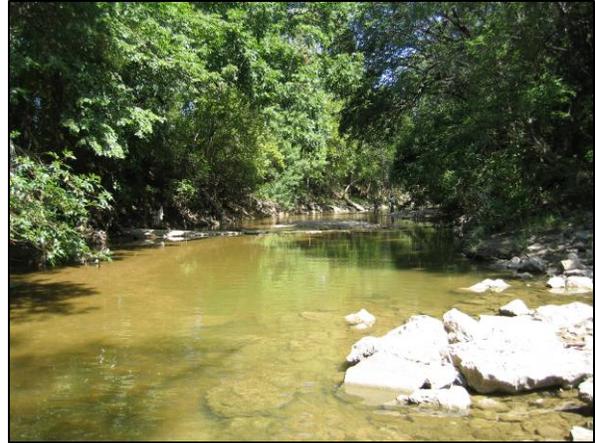
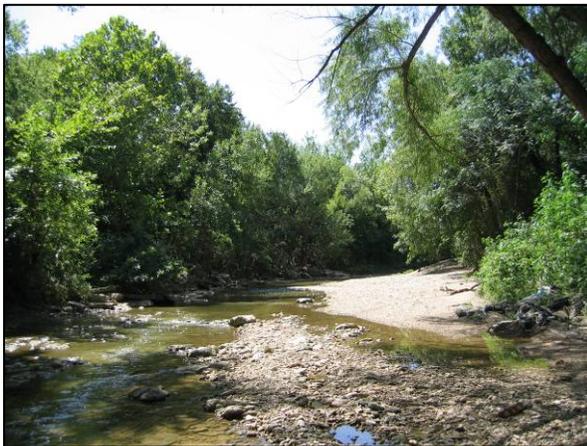
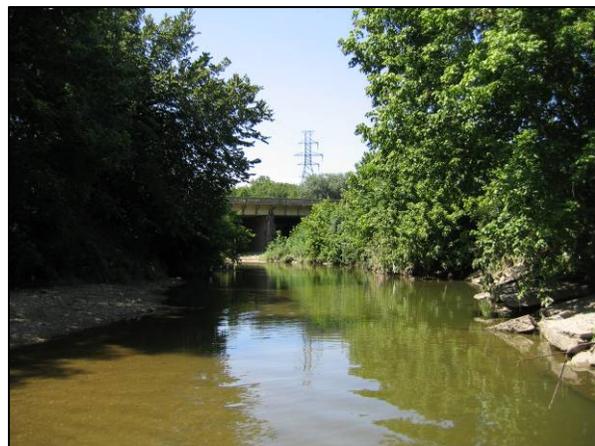
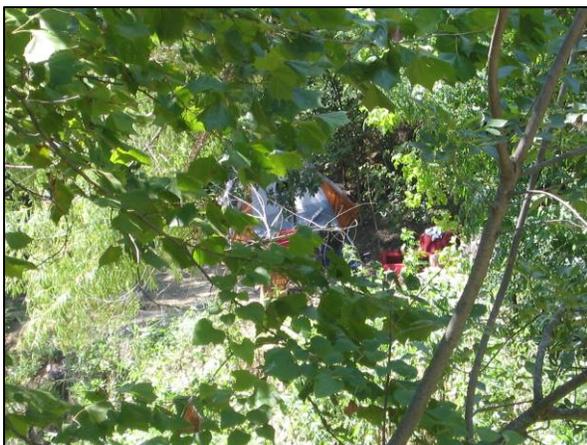
Photogroup 3-1 Sycamore Creek Site SC101 depicting stream and tree/shrub dominated riparian zone and on the lower row a distant photograph through the trees of a tent at the homeless camp near the creek. [\[Return to Text\]](#)

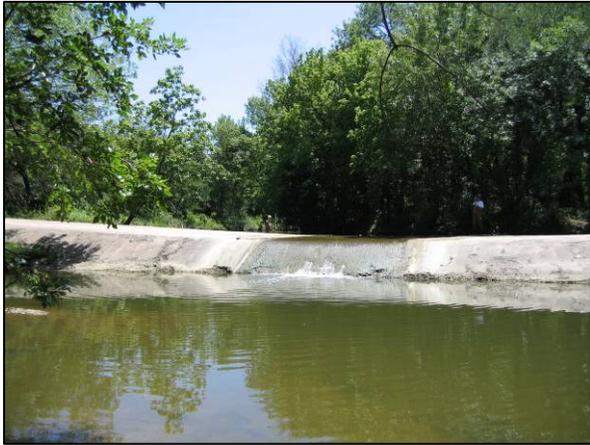
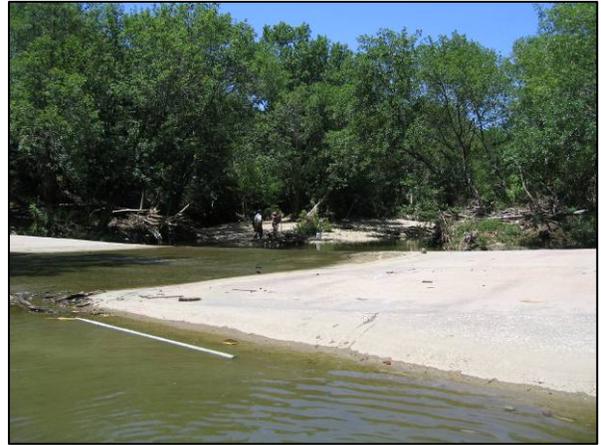
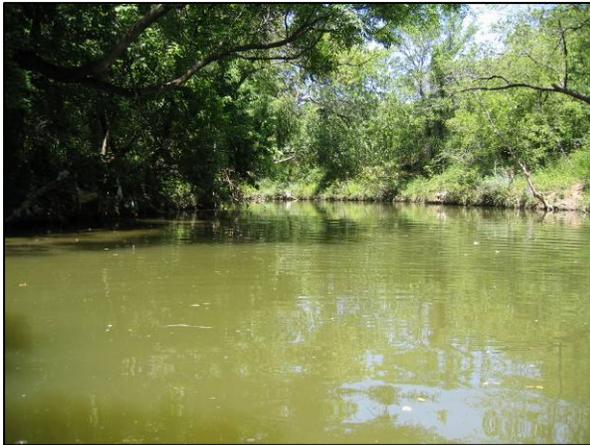
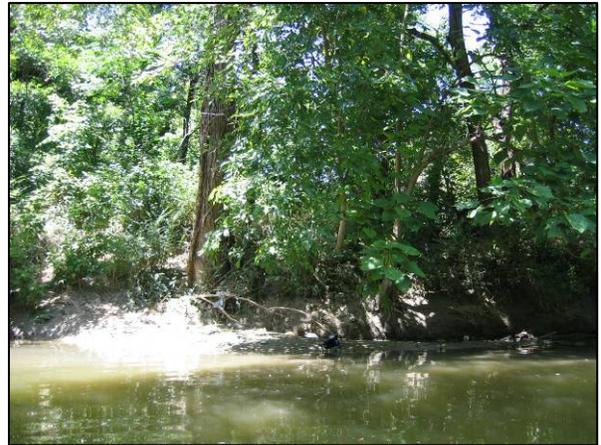
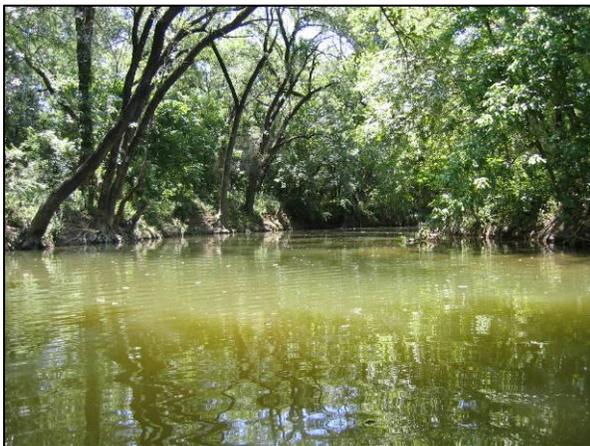
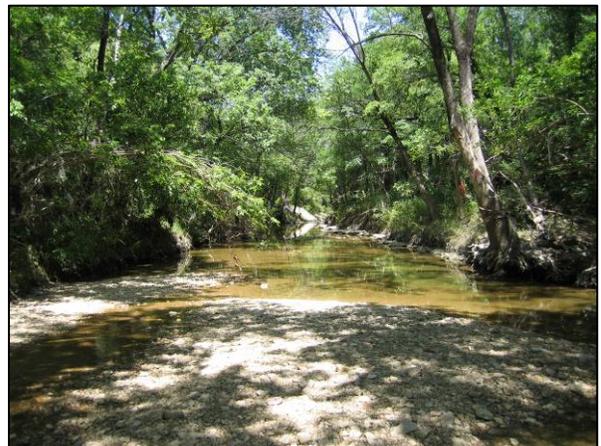
Photogroup 3-7 Sycamore Creek Site SC103 showing stream channel, pooled conditions, and riparian vegetation. [Return to Text](#)

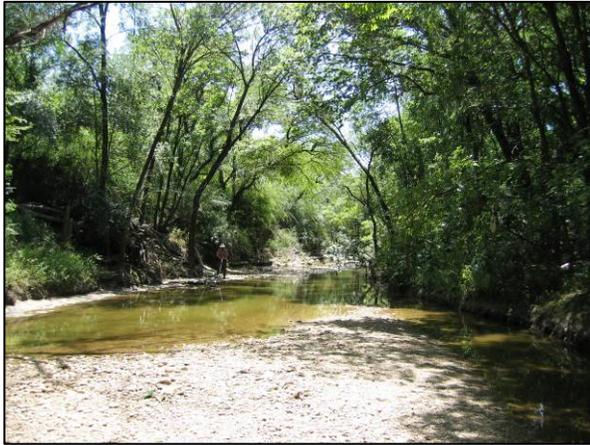
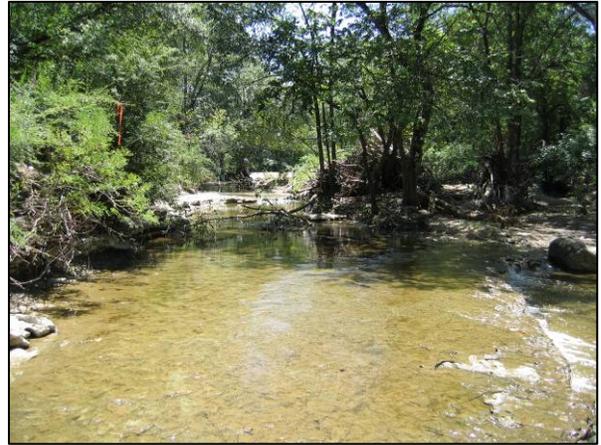
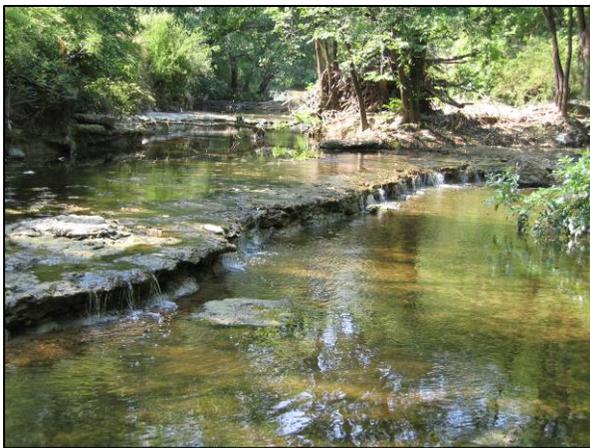
Photogroup 3-8 Sycamore Creek Site SC103 showing additional areas of stream channel and riparian vegetation. [\[Return to Text\]](#)

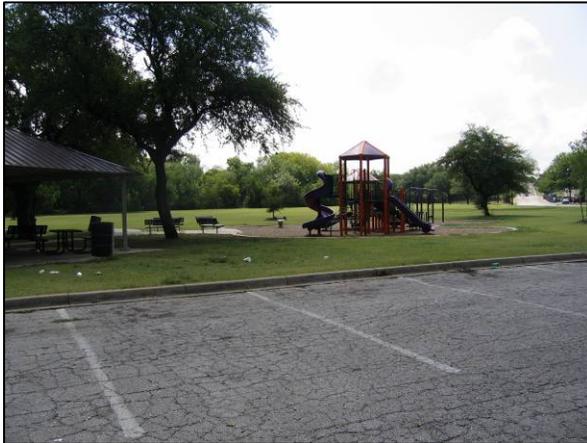
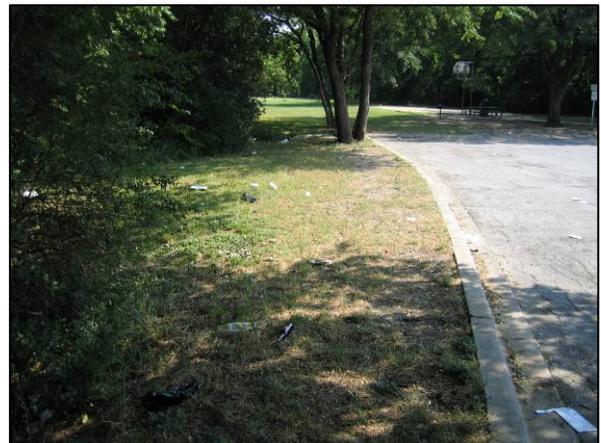
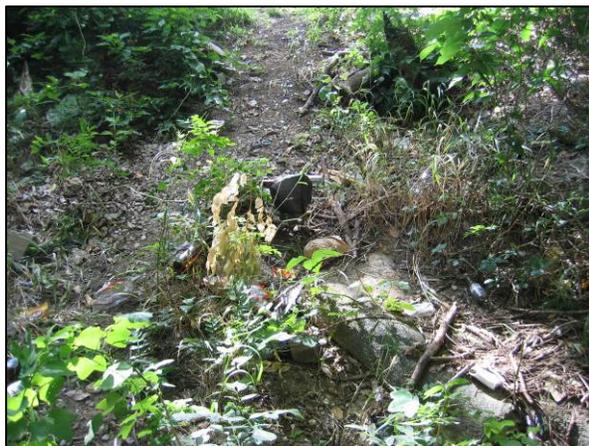
A children play structure and pavilion structure are located east of the parking lot. Several visits to the site for interviews revealed bottles and cups strewn about, as the trash barrels located by the pavilion appeared to be ignored. Access to the stream appears to be moderately easy but dangerous based on the broken glass and bottles along the footpath. [Photogroup 3-11](#) depicts the structures at the small park and the areas of trash and broken glass. During TIAER's visits to the site, not one person was observed utilizing the play structure. One interview from a city employee stated that he had never observed the play structure being utilized either. Overall, not much activity was observed at this location.

Photogroup 3-11 Sycamore Creek Site SC104 showing conditions in Glen Garden Park. [\[Return to Text\]](#)

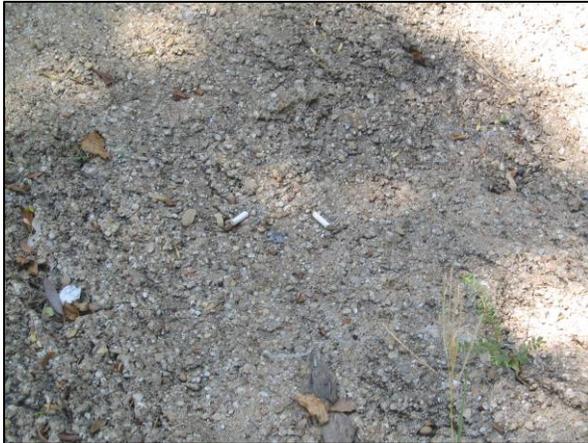
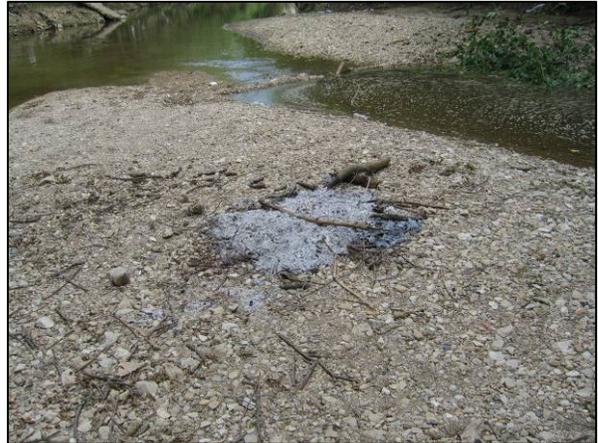
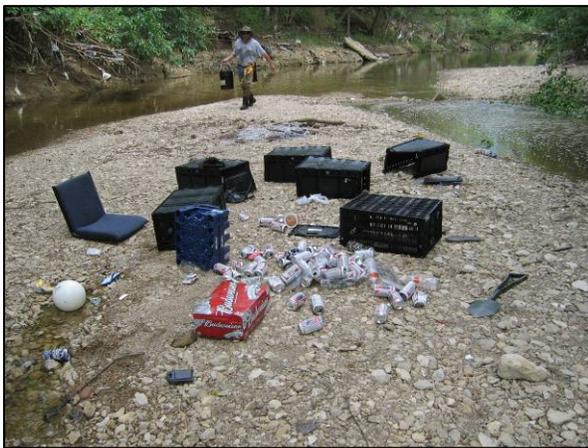
Photogroup 3-12 Sycamore Creek showing evidence of human activity in the stream channel, including cigarette butts, remnants of camp fire, and signs of party on gravel bar. (Note that some photographs are repeats of previous photographs; Individual pictured is TIAER staff.) [\[Return to Text\]](#)

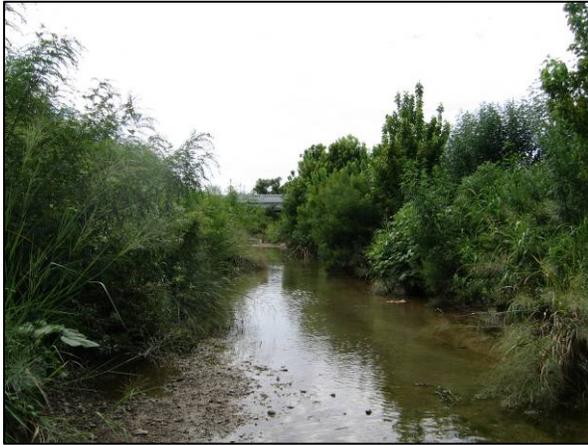
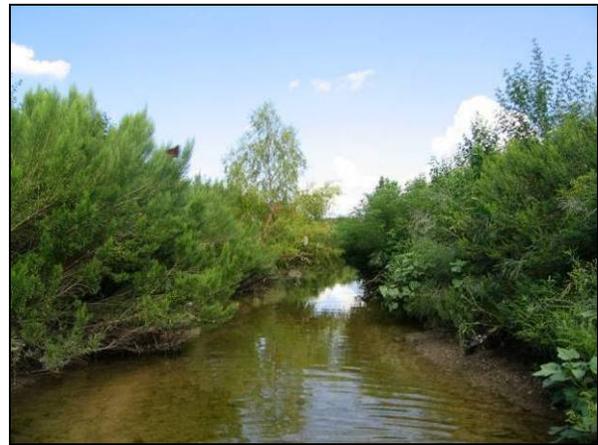
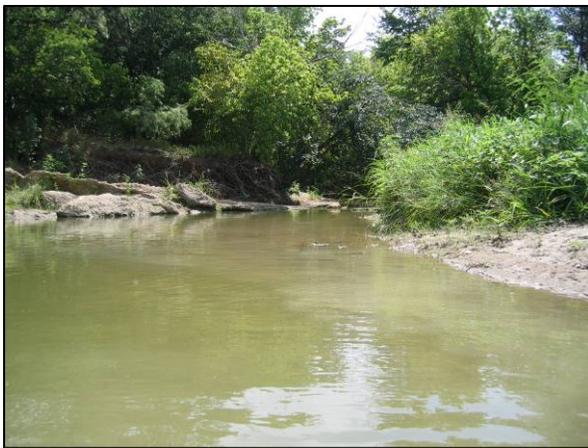
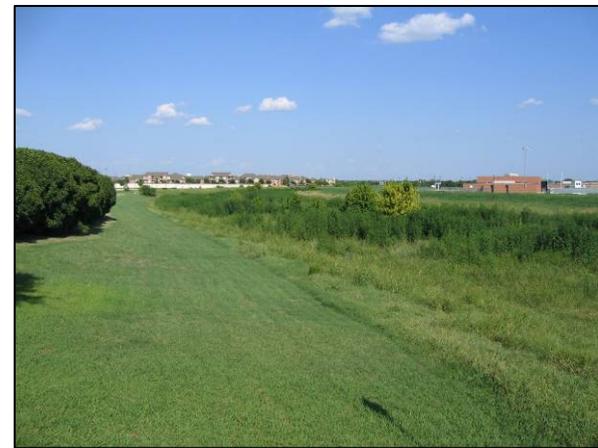
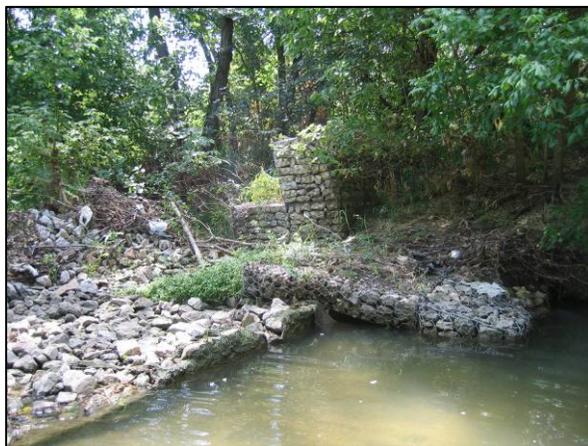
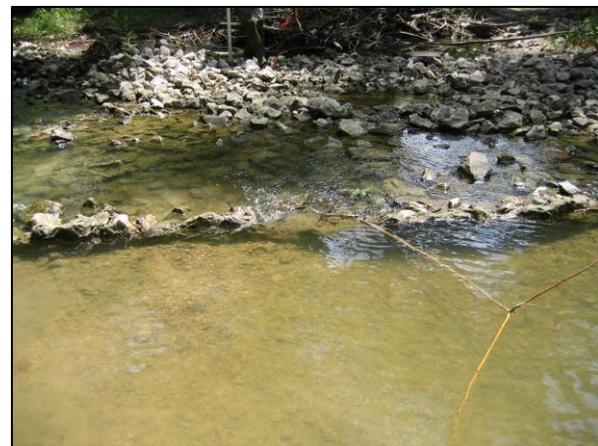
**Photogroup 5-1**

Grapevine Creek Site GC101 showing creek upstream and downstream at 0-m transect (upper row), downstream at 300-m transect (middle row left), and riparian zone on lower half of reach (middle row right) and at 210-m transect (lower row). [\[Return to Text\]](#)

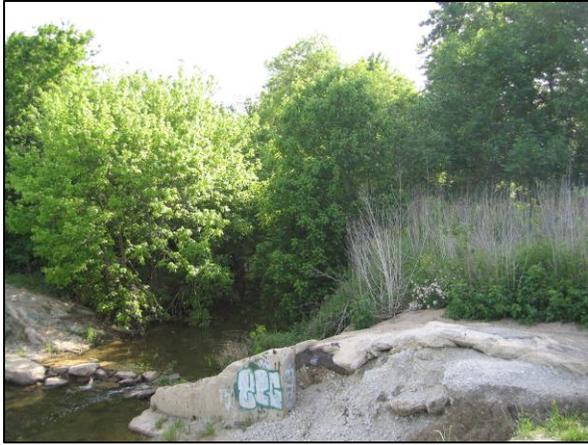
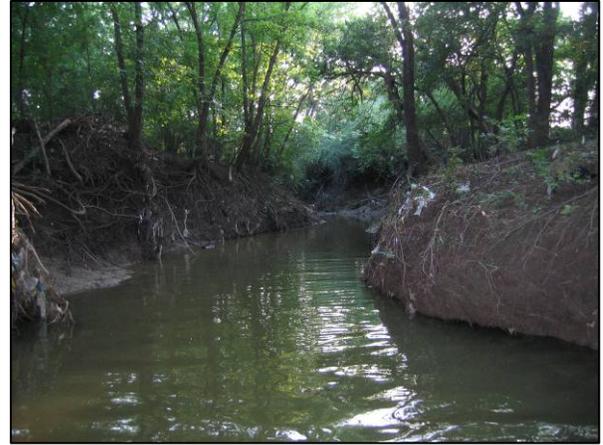
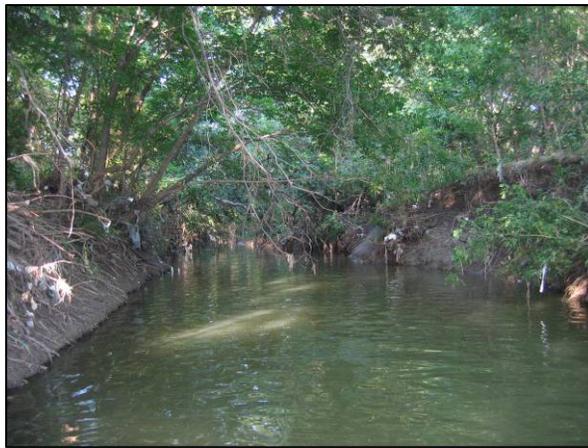
Site CC101 is located at Colgate Park off SE 4th Street in Grand Prairie. A local resident indicated that the park was abandoned some time ago but local children still use the park for bike riding. He also indicated that he observed youngsters in the stream frequently, and TIAER staff observed three children walking their bikes through the stream on the day of initial scouting.

Photogroup 7-1 Cottonwood Creek Site CC101 showing access at remnant bridge crossing, and the stream at 0-m and 300-m transects. [\[Return to Text\]](#)

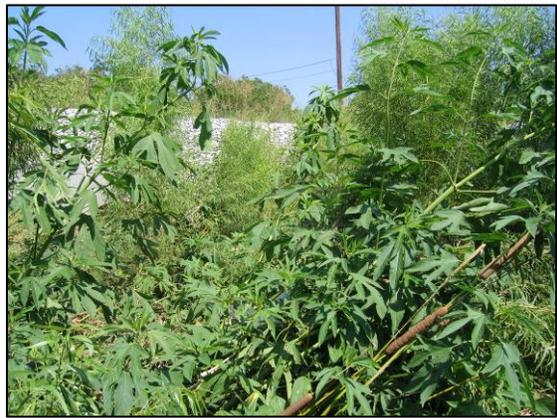
Photogroup 8-1 Dalworth Creek Site DW101 depicting steepness of bank and gabions. (Individual pictured is TIAER staff.) [\[Return to Text\]](#)

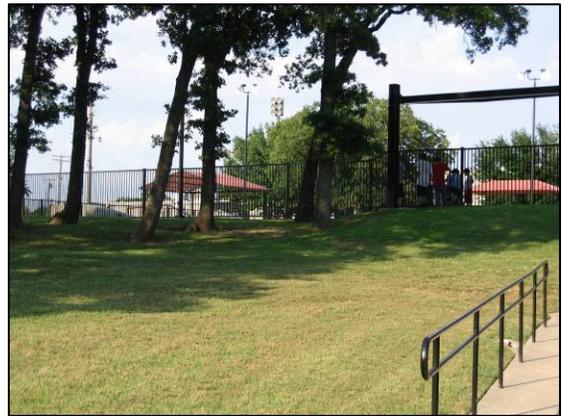
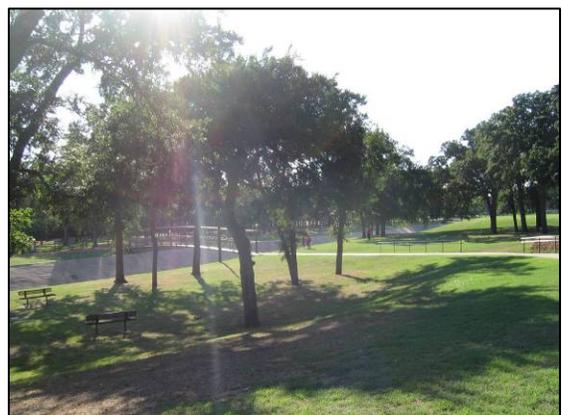
Photogroup 9-16 Delaware Creek Site DC104 showing amenities and conditions in Lively Park. [Return to Text](#)

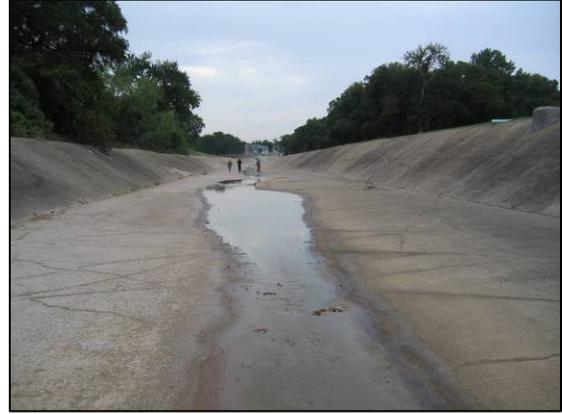
Photogroup 9-17 Delaware Creek Site DC104 at 0-m 300-m transects, and tributary entry at 180-m transect. Note: People in creek are TIAER survey crew. [\[Return to Text\]](#)

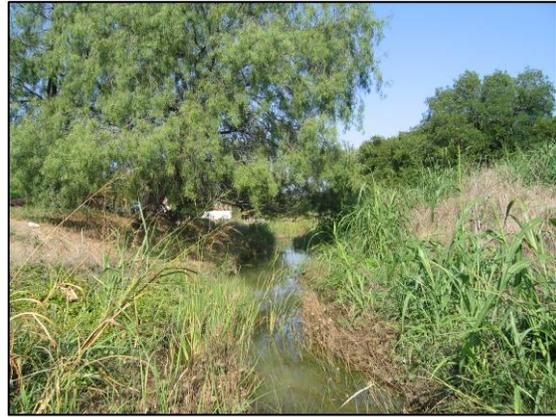
Photogroup 10-3 Estelle Creek Site EC102 showing stream conditions and proximity to apartment complex. [Return to text](#)

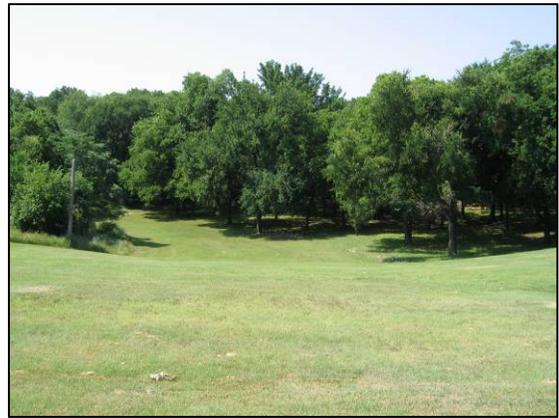
Photogroup 12-1 Kirby Creek Site KC101 showing Natural Science Education Center Grounds of the upper portion of the study reach [Return to Text](#)
