# Attoyac Bayou Recreational Use Attainability Analysis

**Attoyac Bayou  
Recreational Use Attainability Analysis**

**Texas State Soil and Water Conservation Board  
Project # 09-10**

**October 2012**

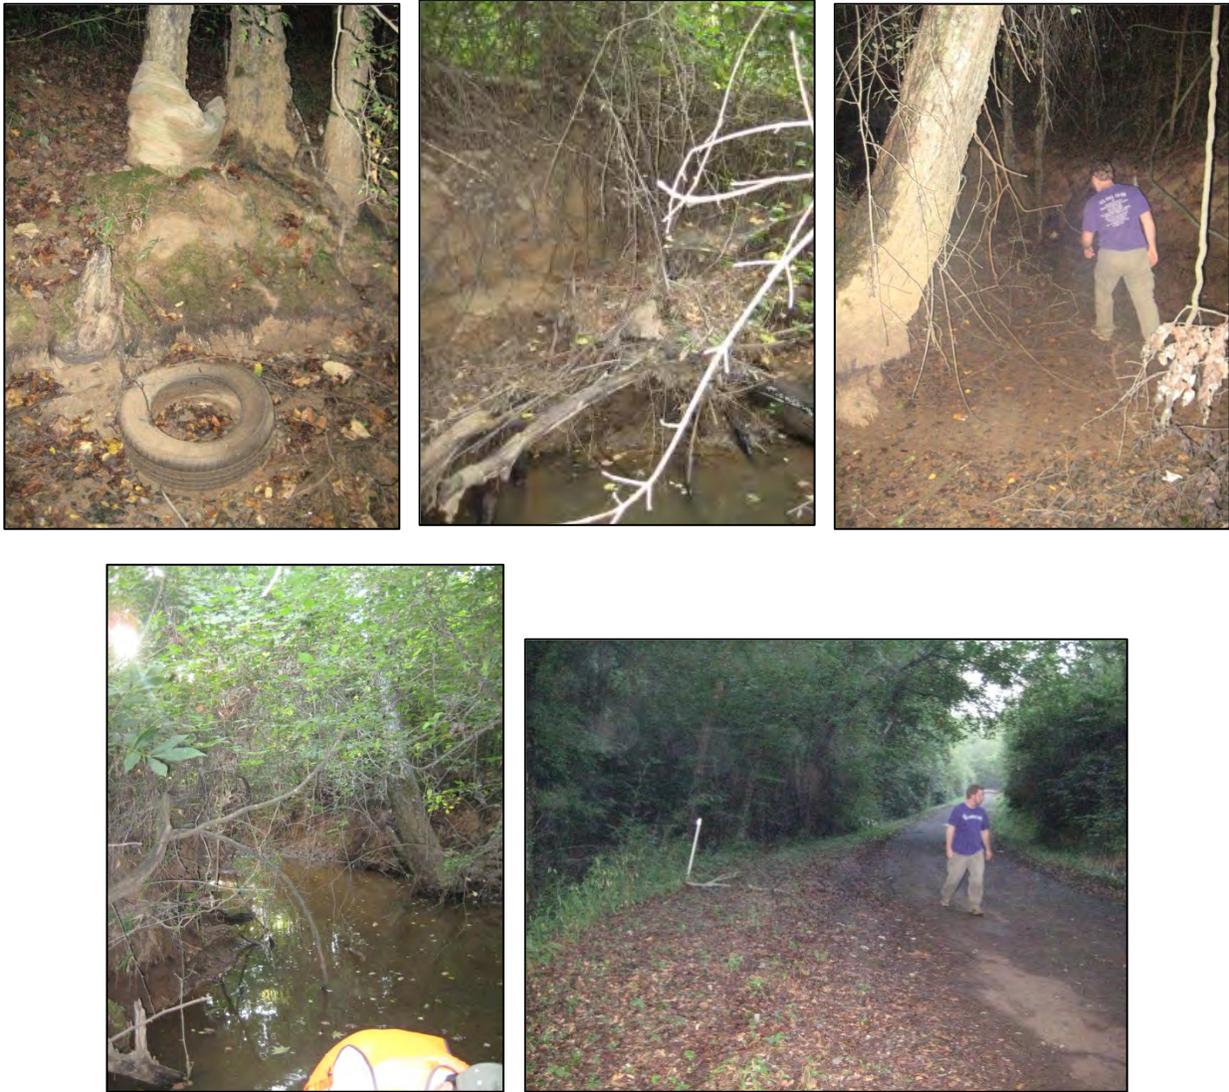
**Photogroup 4-3** Attoyac 3 depicting bank access and general bank appearance. All individuals featured are SFASU and CES staff. Top left: Large channel litter against left bank, August 2012; Top center: 150-m transect, left bank, July 2012; Top right: 30-m transect, downstream, August 2012; Bottom left: 150-m transect, upstream, July 2012; Bottom right: Stream access point from CR 3181.

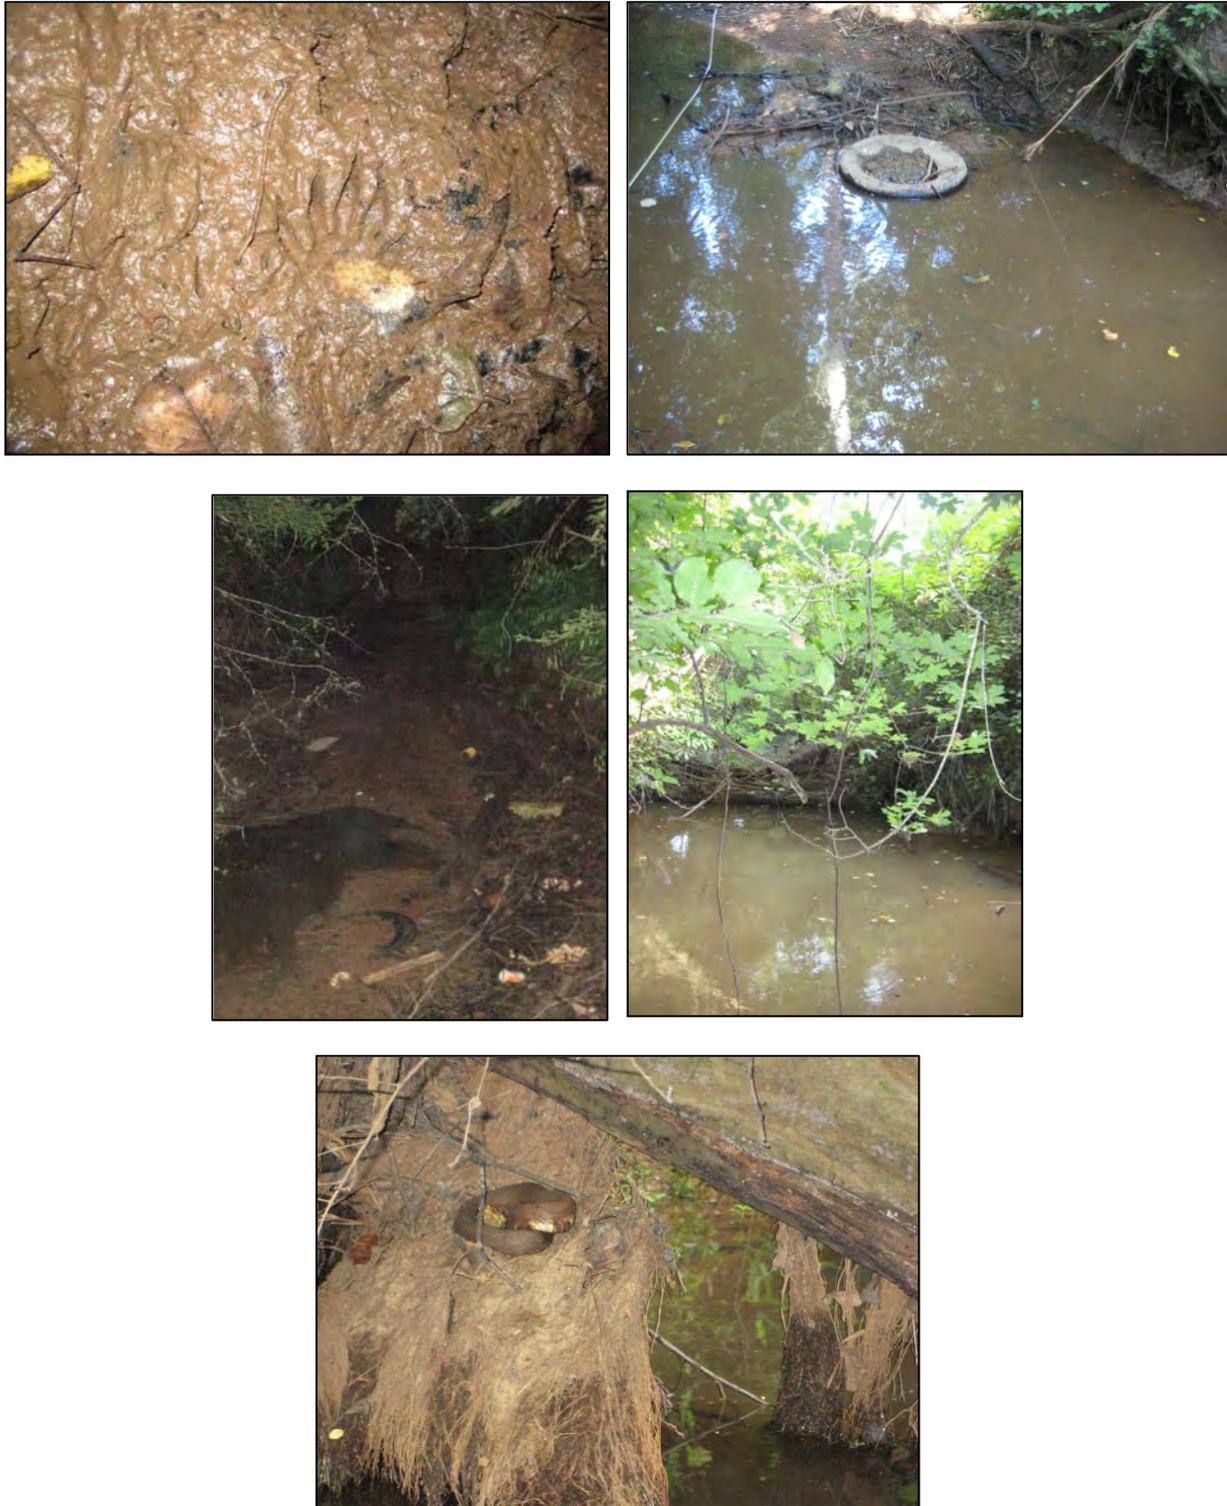
**Photogroup 4-3** Attoyac 3 Depicting water surface characteristics further stream features. Top left Raccoon tracks, August 2012; Top right: Large litter in channel (tire), July 2012; Middle left: 300-m transect, upstream, August 2012; Middle right: 300-m transect, downstream, July 2012; Bottom: Water Moccasin in channel, July 2012.

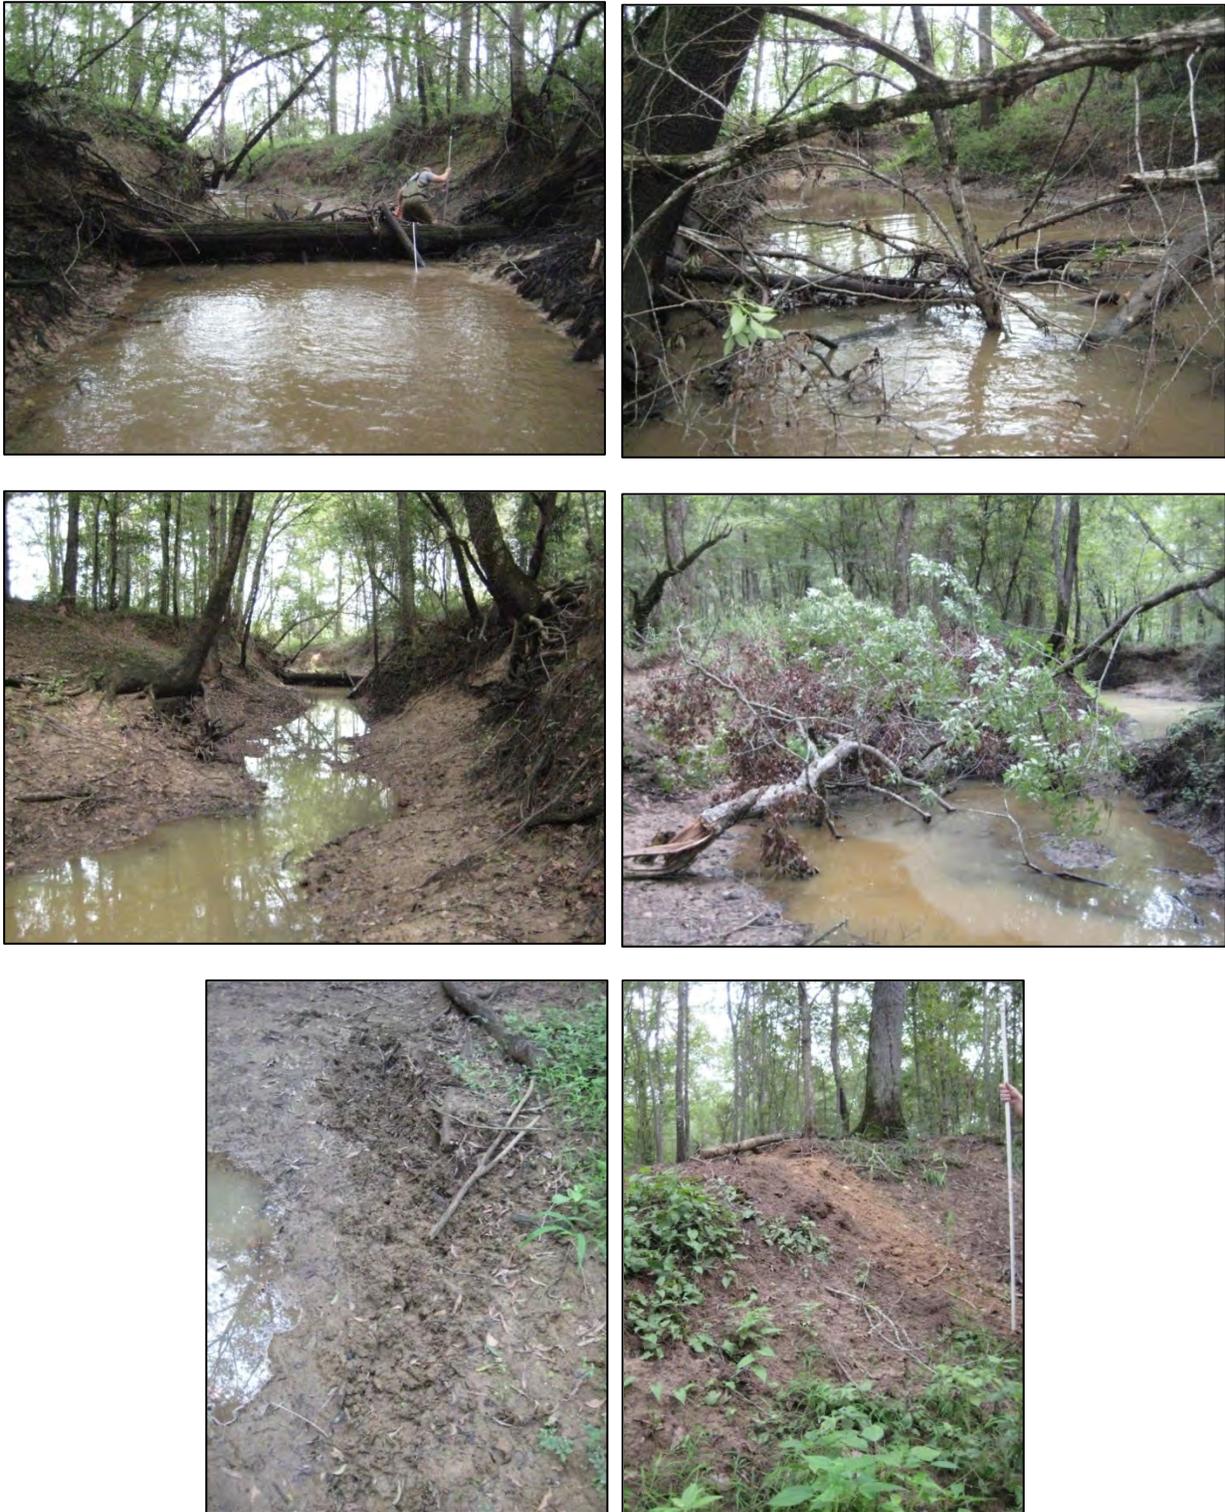
**Photogroup 4-12** Attoyac 13 depicting water surface appearance and potential sources of contamination. Top left: Large woody debris, July 2012; Top right: 300-m, upstream, July 2012; Middle left: 300-m, upstream, August 2012; Middle right: Woody debris, August 2012; Bottom left: Feral hog use, August 2012; Bottom right: Feral hog use, August 2012.

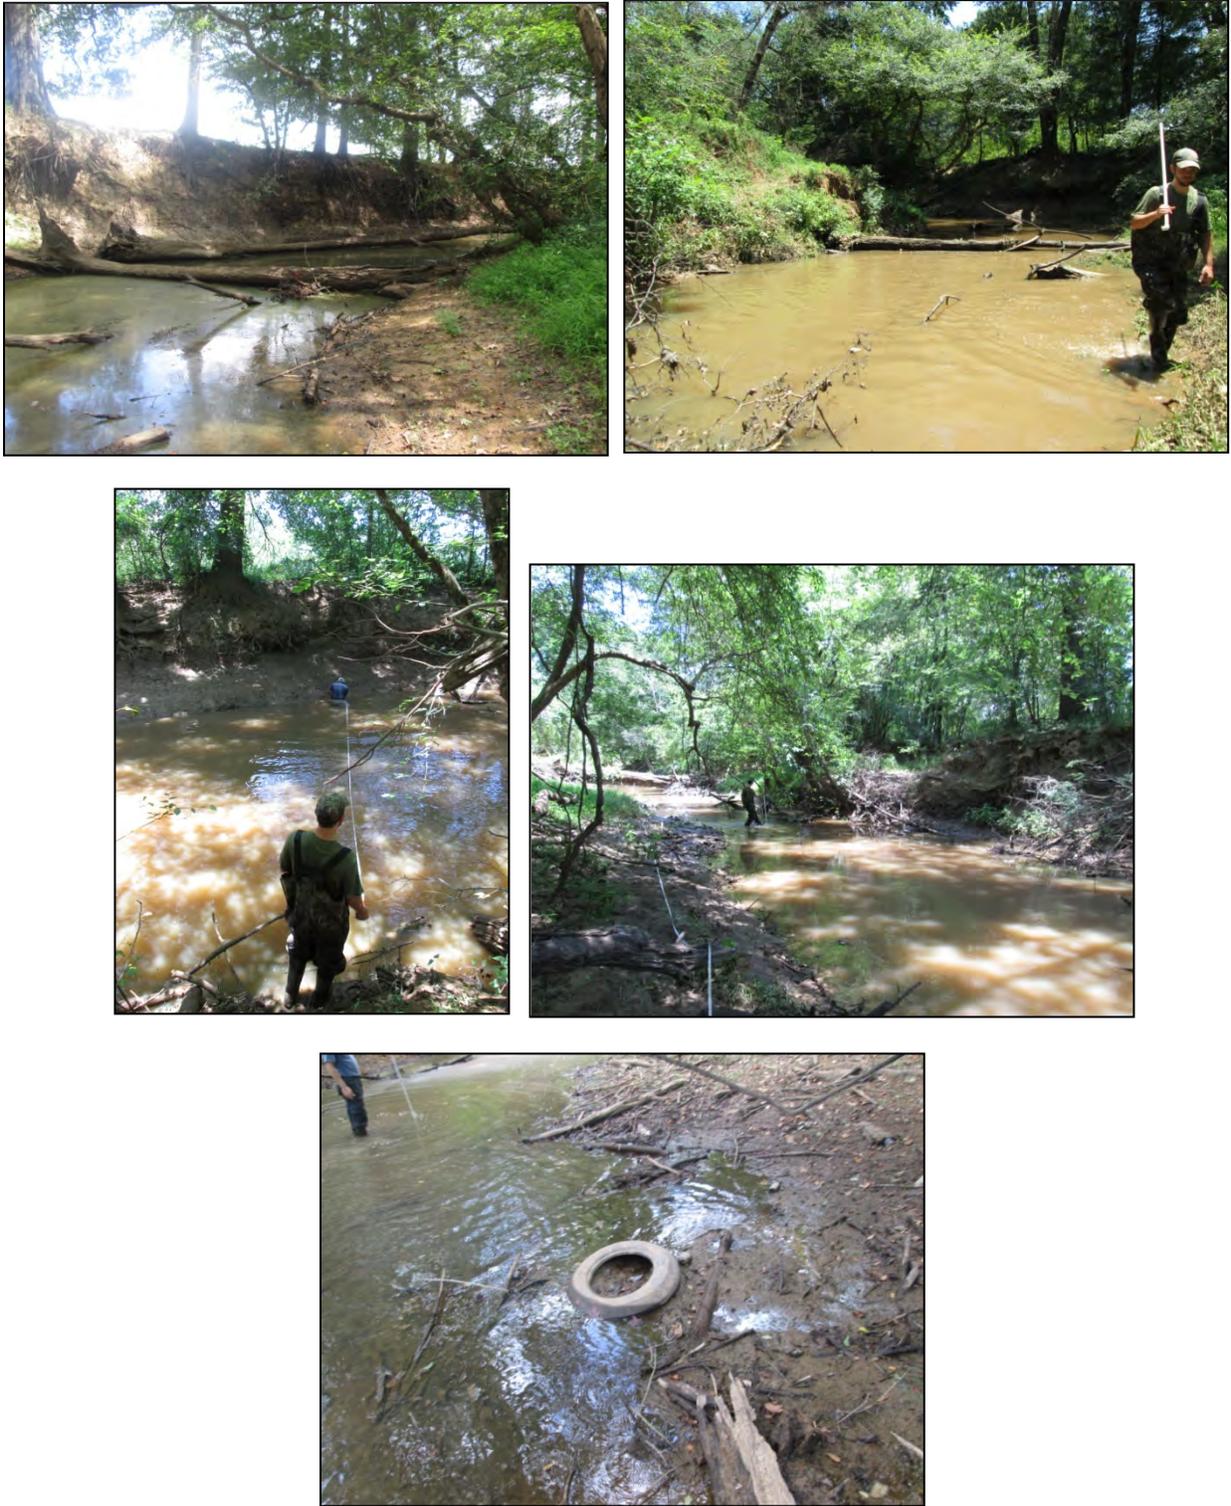
**Photogroup 4-14** Attoyac 15 depicting water surface characteristics. All individuals featured are SFASU and CES staff. Top left: 300-m transect, upstream, August 2012; Top right: 300-m, downstream, July 2012; Middle left: Stream width measurement, July 2012; Middle right: 150-m transect, upstream, July 2012; Bottom: Channel litter (tire), August 2012.

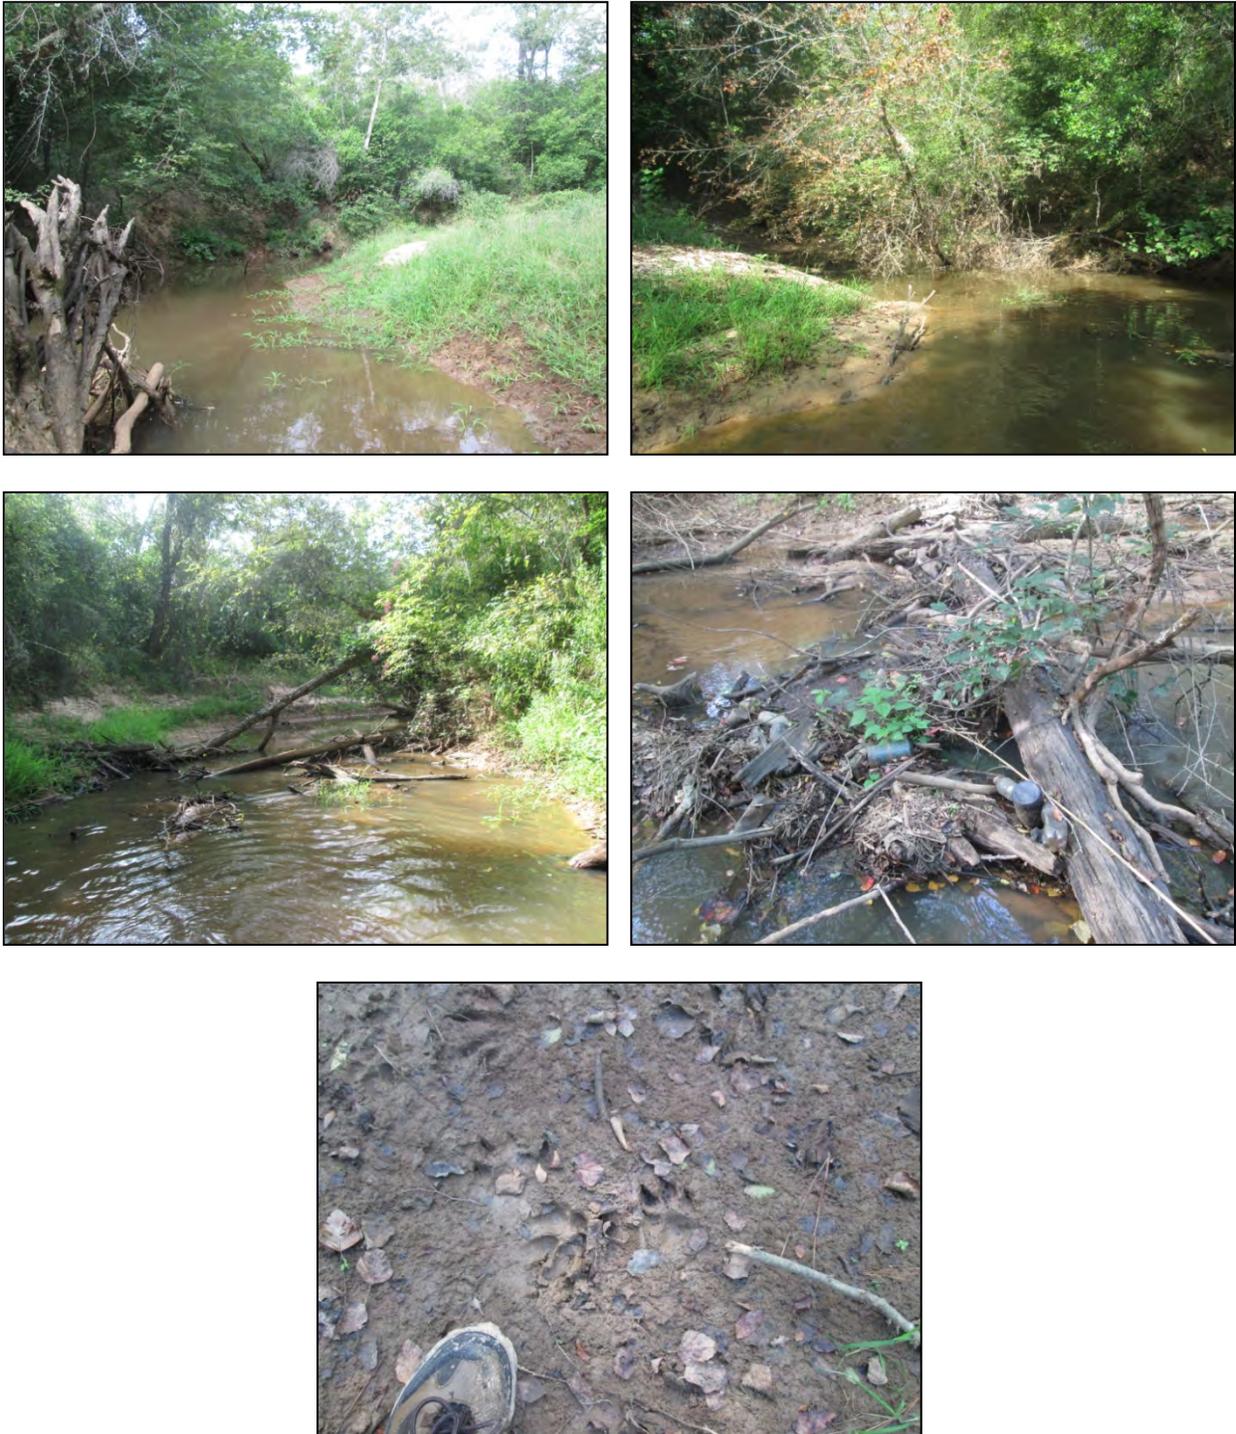
**Photogroup 4-21** Big Iron Ore 4 depicting water surface characteristics. Top left: 150-m transect, upstream, August 2012; Top right: 300-m transect, downstream, August 2012; Middle left: 300-m transect, upstream, August 2012; Middle right: Log jam with small channel litter; Bottom: Coyote tracks along stream bank.

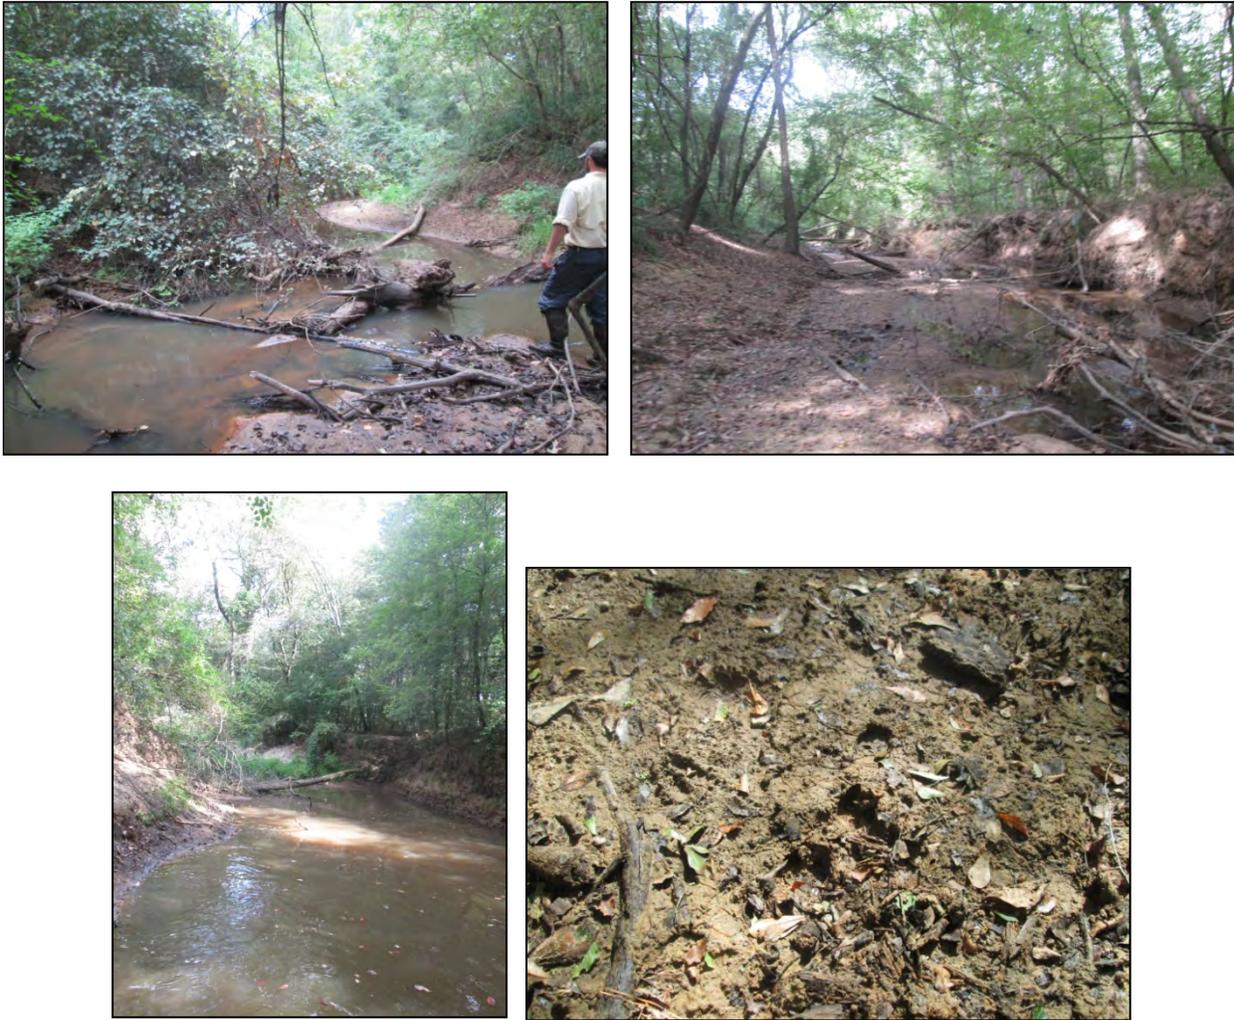
**Photogroup 4-22** Big Iron Ore 5 depicting water surface characteristics and potential source of contamination. All individuals featured are SFASU and CES staff. Top left: 30-m transect, upstream, August 2012, Top right: 150-m transect, downstream, August 2012; Bottom left: 300-m transect, upstream, August 2012; Bottom right: Feral hog tracks.

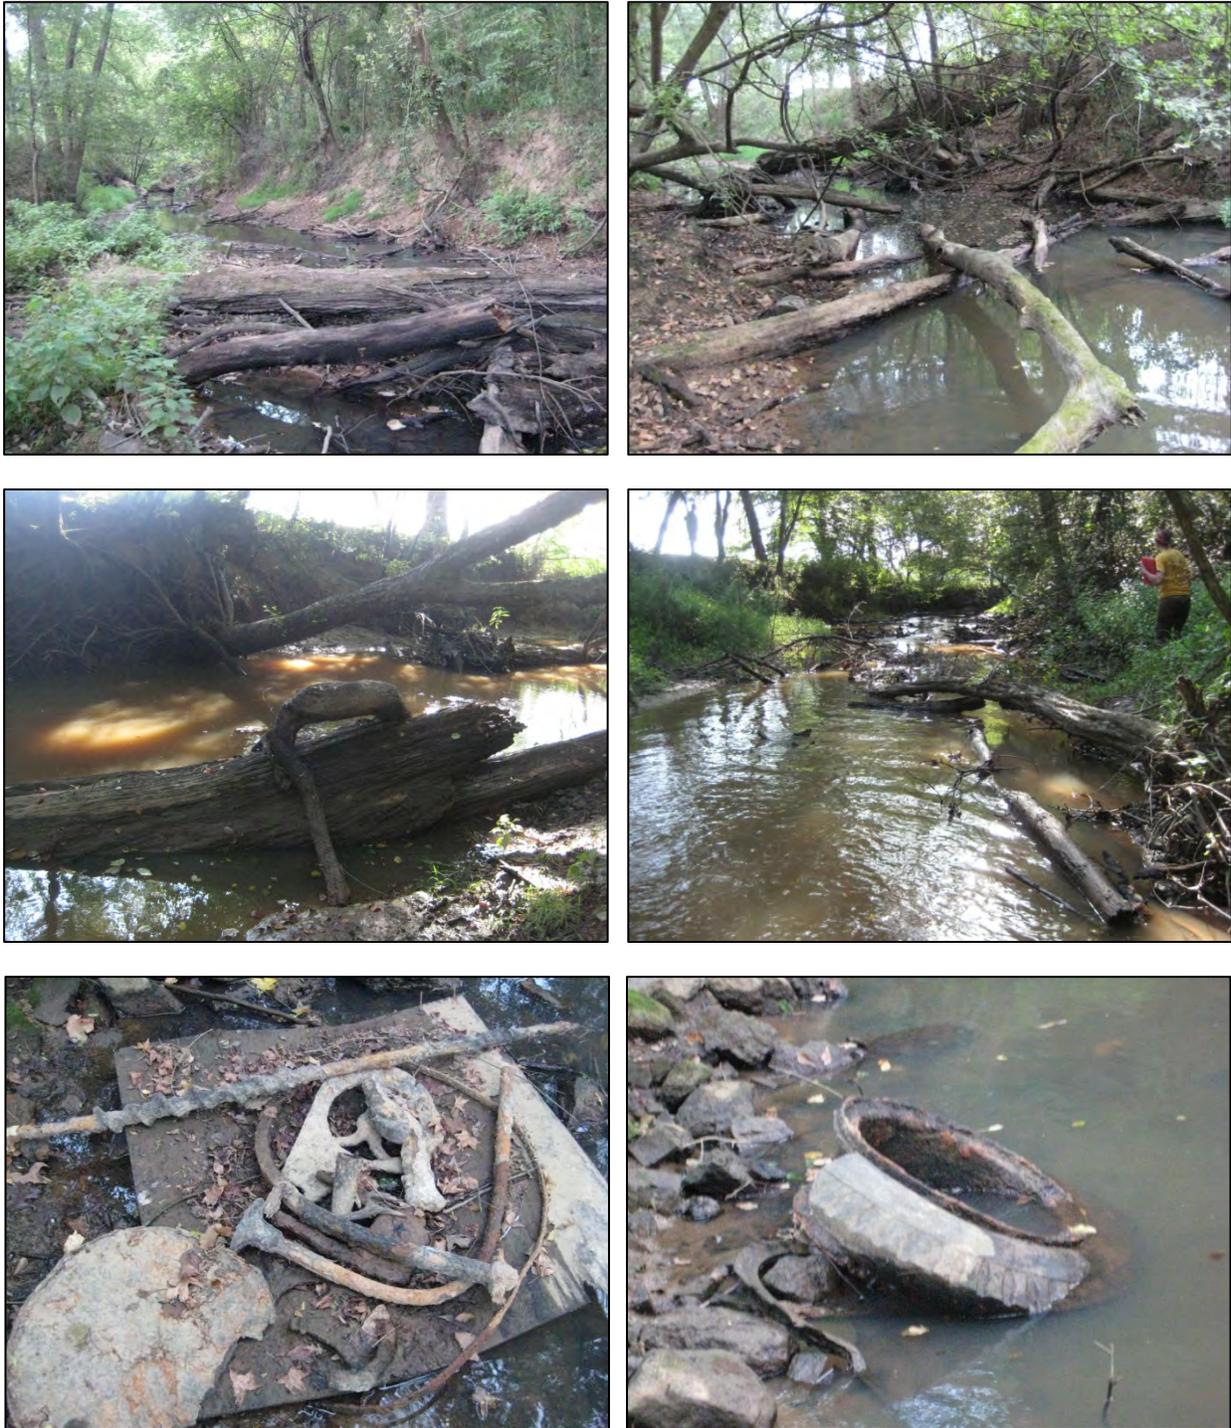
**Photogroup 4-30** Naconiche 11 depicting water surface characteristics. All individuals featured are SFASU and CES staff. Top left: 150-m transect, downstream, August 2012; Top right: Large woody debris across/within channel, August 2012; Middle left: Large woody debris, July 2012; Middle right: Large woody debris, July 2012; Bottom left: Large channel litter (various metal objects), August 2012; Bottom right: Large channel litter (tire with metal rim), August 2012.

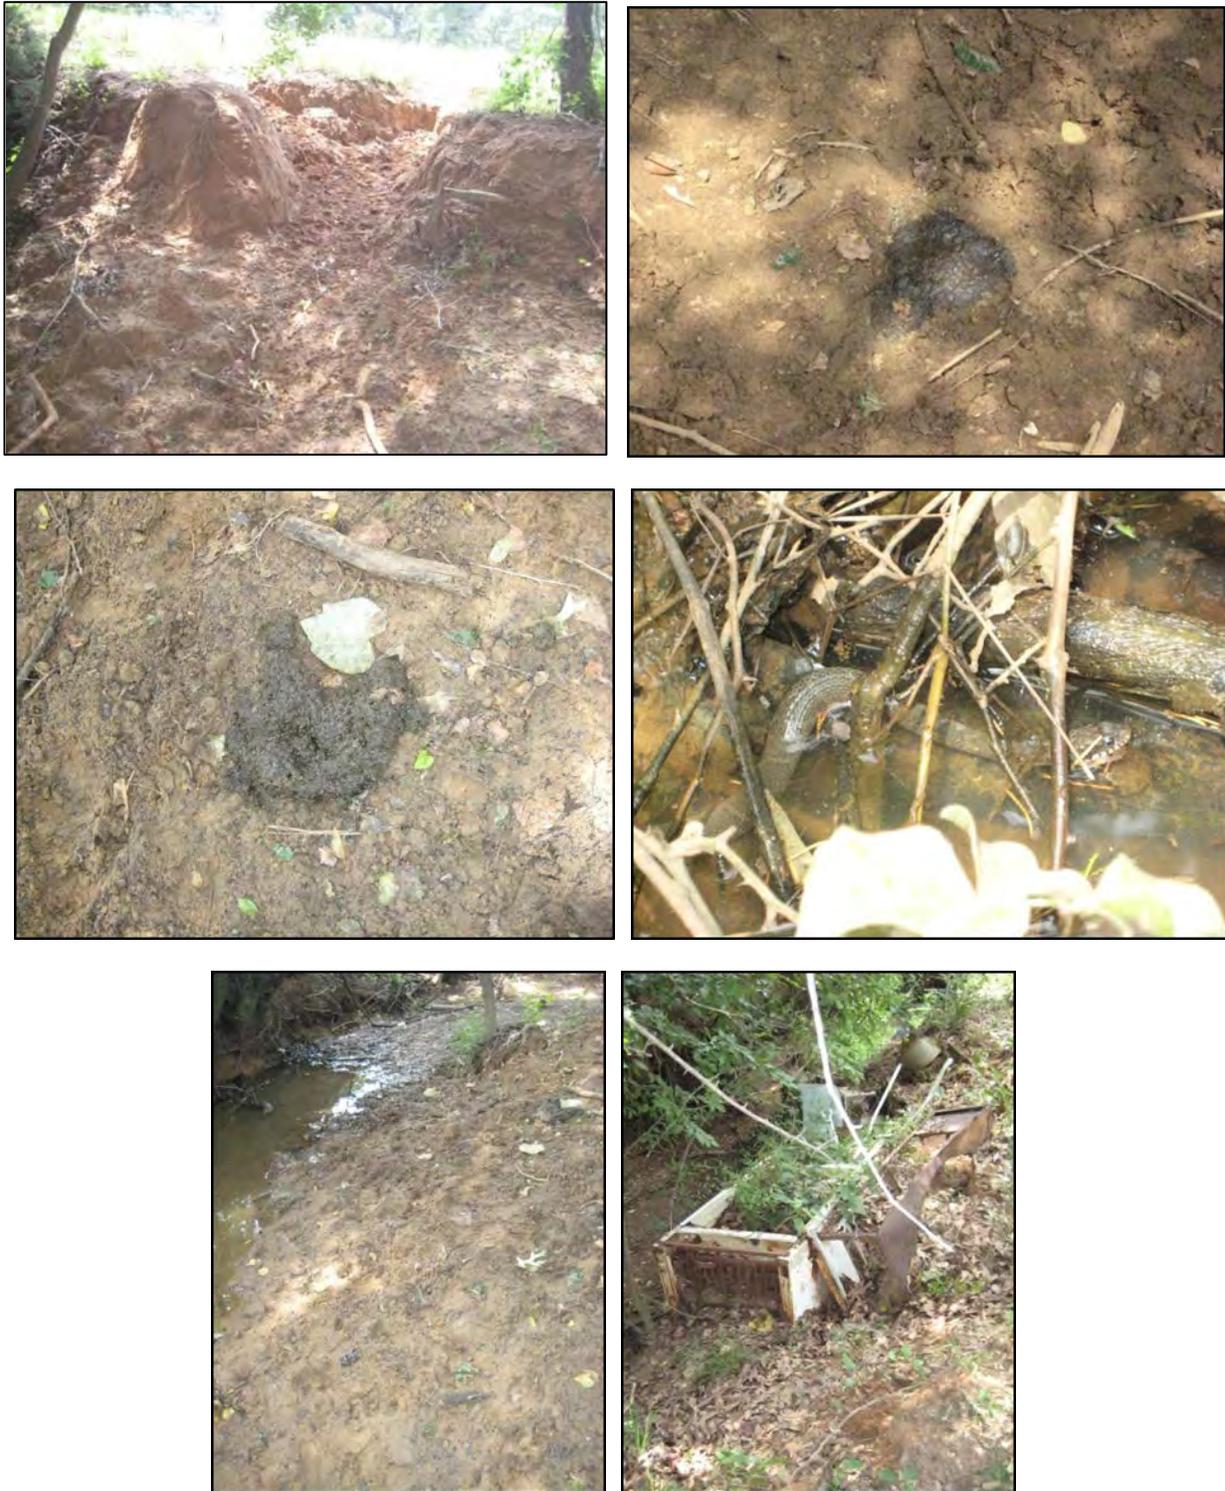
**Photogroup 4-35** Waffelou 1 depicting water surface characteristics and potential sources of contamination. Top left: Livestock access point, July 2012; Top right: Livestock fecal in portion of dry stream channel, July 2012; Middle left: Livestock fecal on bank, July 2012; Middle right: Water snake at CR 1878 access point, July 2012; Bottom left: Livestock bank use, July 2012; Bottom right: Large bank litter (refrigerator), July 2012.
