Recreational Use Attainability Analysis for Buffalo Creek (0214B), Paradise Creek (0230A), and Sweetwater Creek (0299A) in the Red River Basin

Prepared for:
Texas State Soil and Water Conservation Board
Project 12-52

Texas Institute for Applied Environmental Research
Tarleton State University
Stephenville, Texas

TR 1308

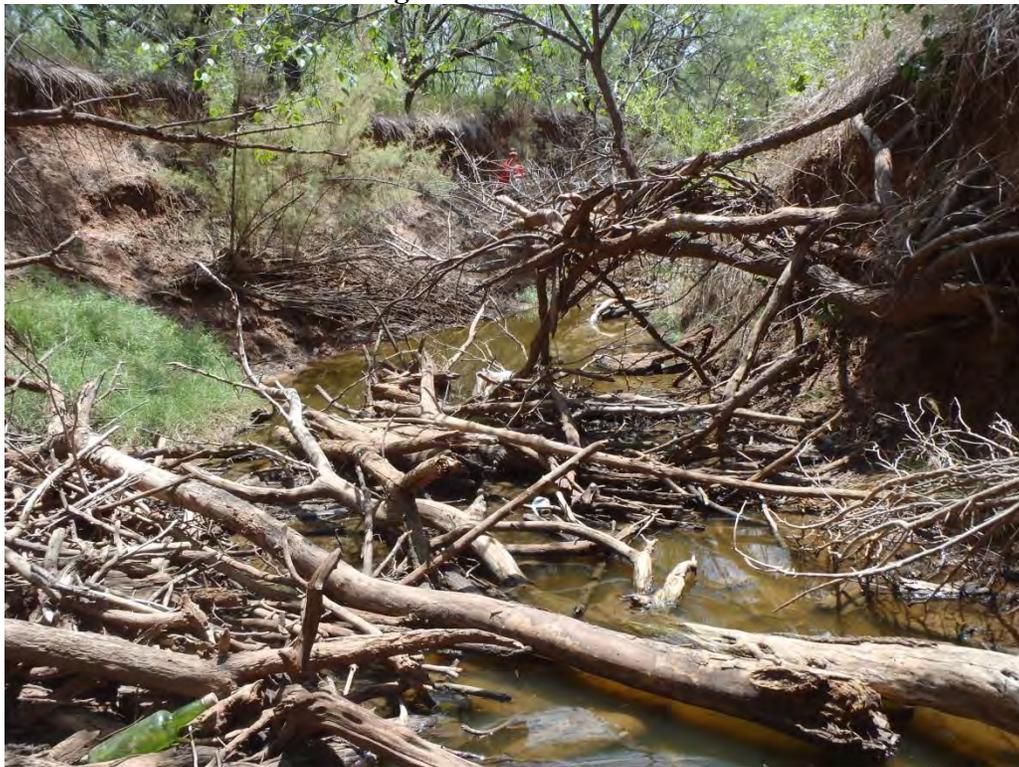
Figure 3.9 Photograph of BF003 taken on July 20, 2013, downstream view at 30-m transect. Note significant debris accumulation.

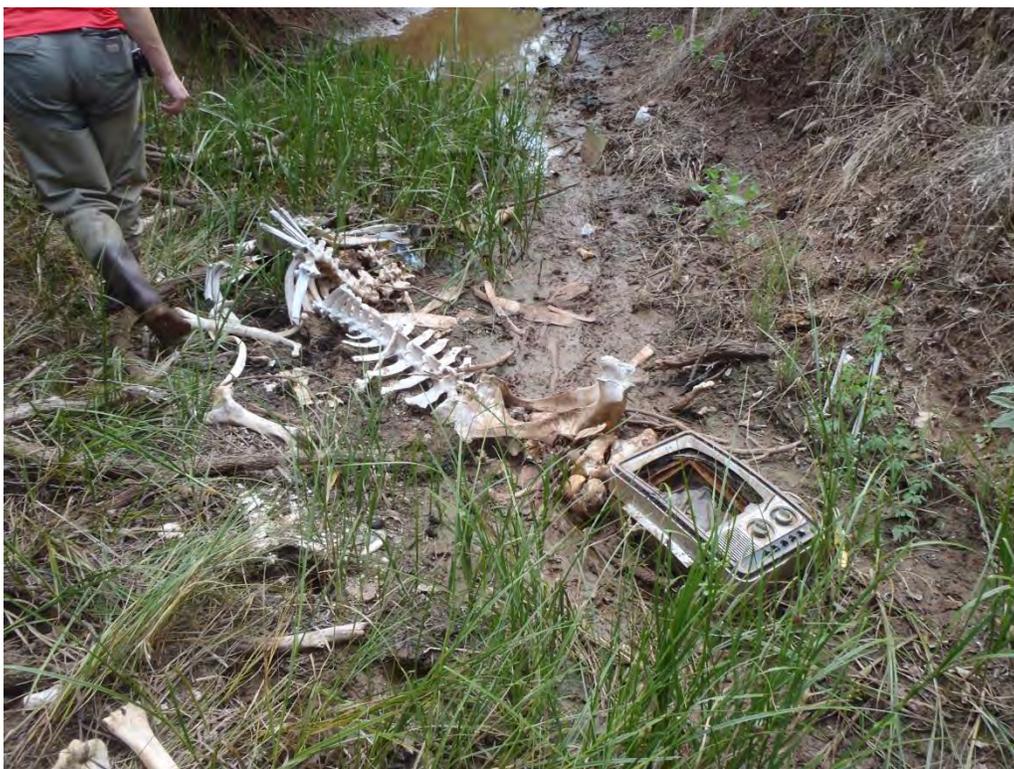
Figure 3.10 Photograph of Site BF003, downstream view at 30-m transect. Note animal carcass and television. TIAER personnel in photograph.

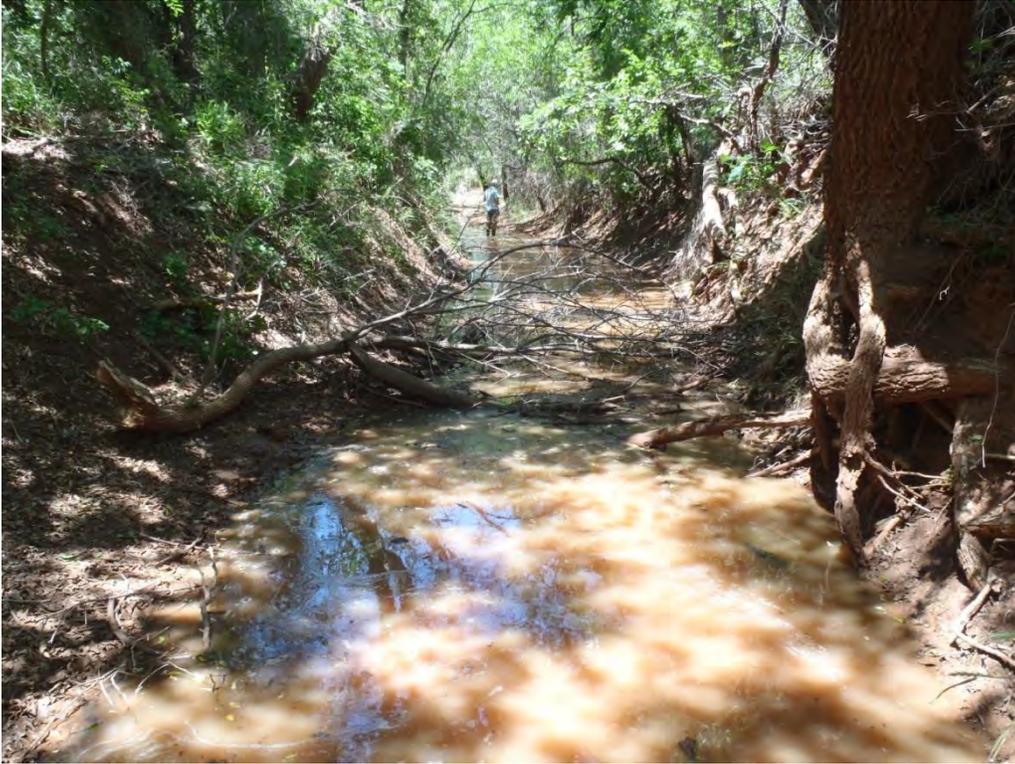
Figure 3.12 Photograph of BF004 taken on June 8, 2013 of log obstruction near the 30-m transect. TIAER personnel in photograph.

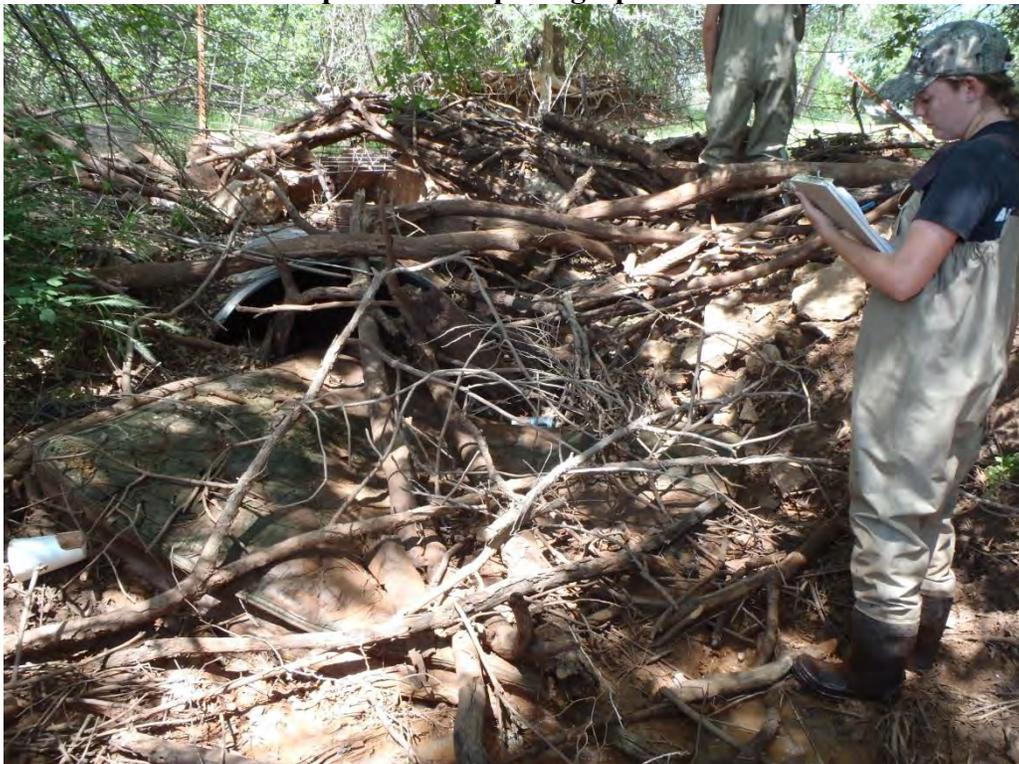
Figure 3.14 Photograph of BF005 taken on June 8, 2013 of mattress and logs jamming the culvert. TIAER personnel in photograph.

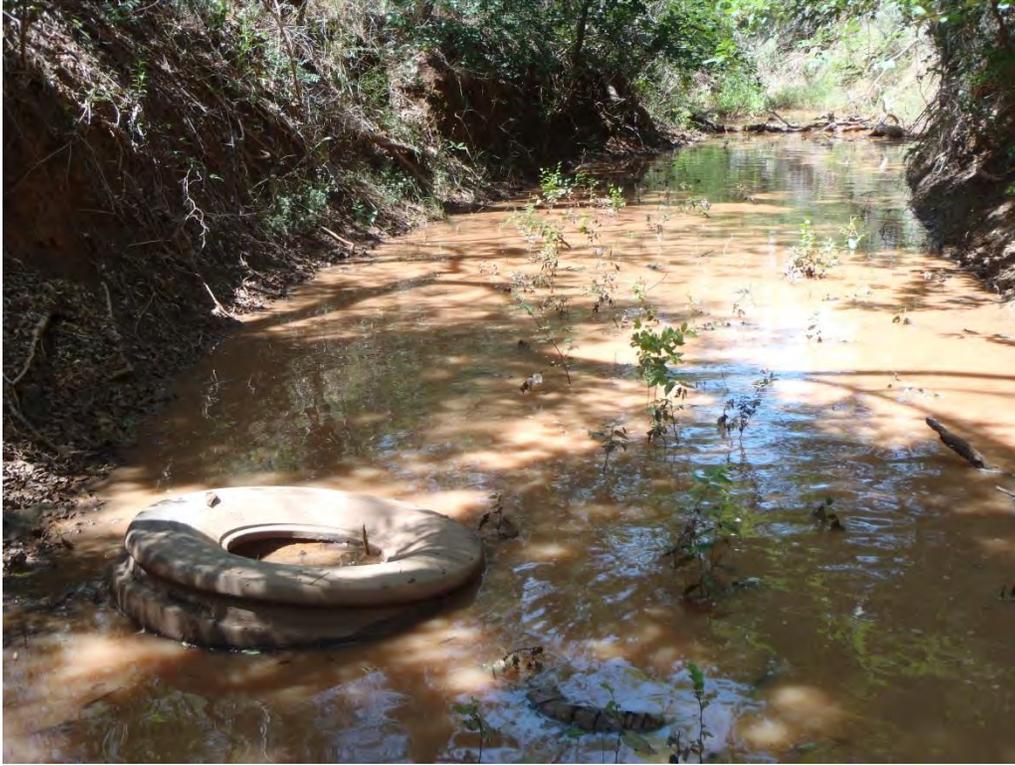
Figure 3.15 Photograph of Site BF005, upstream view at 150-m transect. Note tire and log jam.

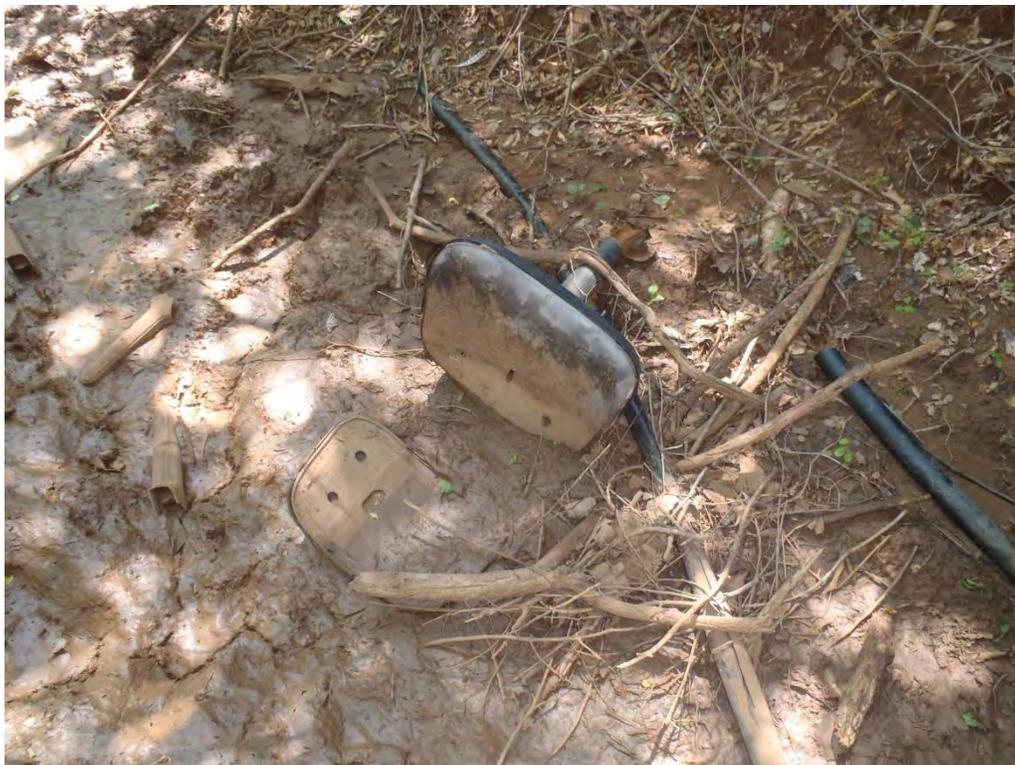
Figure 3.19 Photograph of Site BF006 taken July 20, 2013, broken office chair in stream.

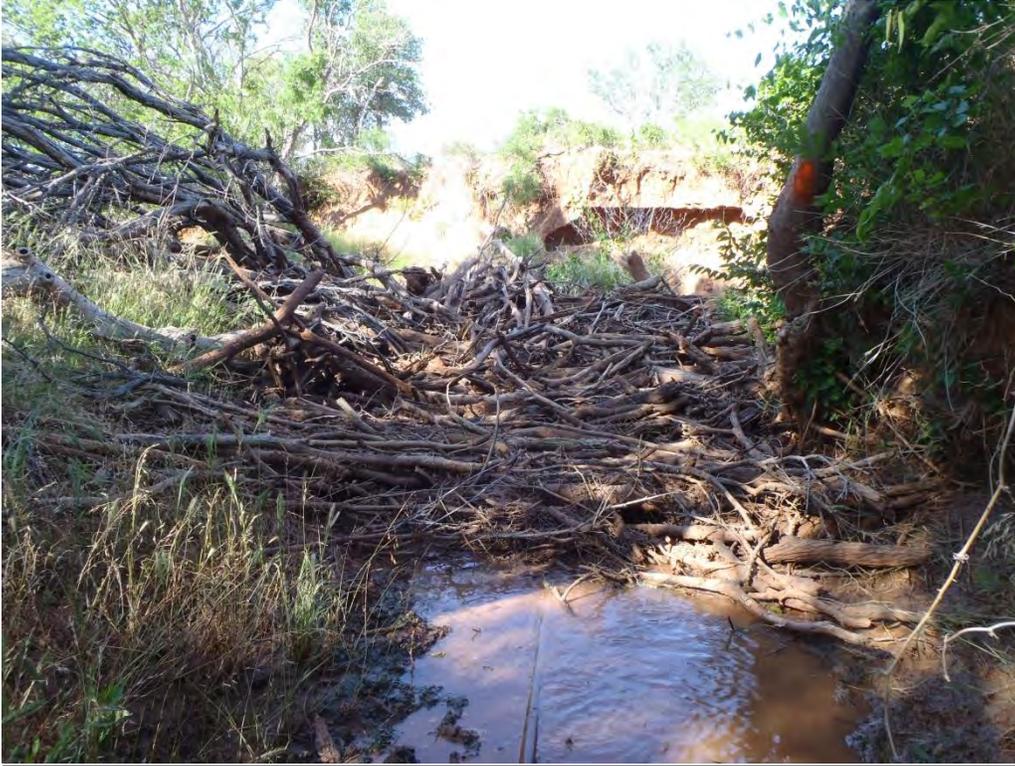
Figure 3.24 Photograph of Site BF008, taken on June 8, 2013 of a large log jam at 210-m. Note the steep bank beyond the jam.

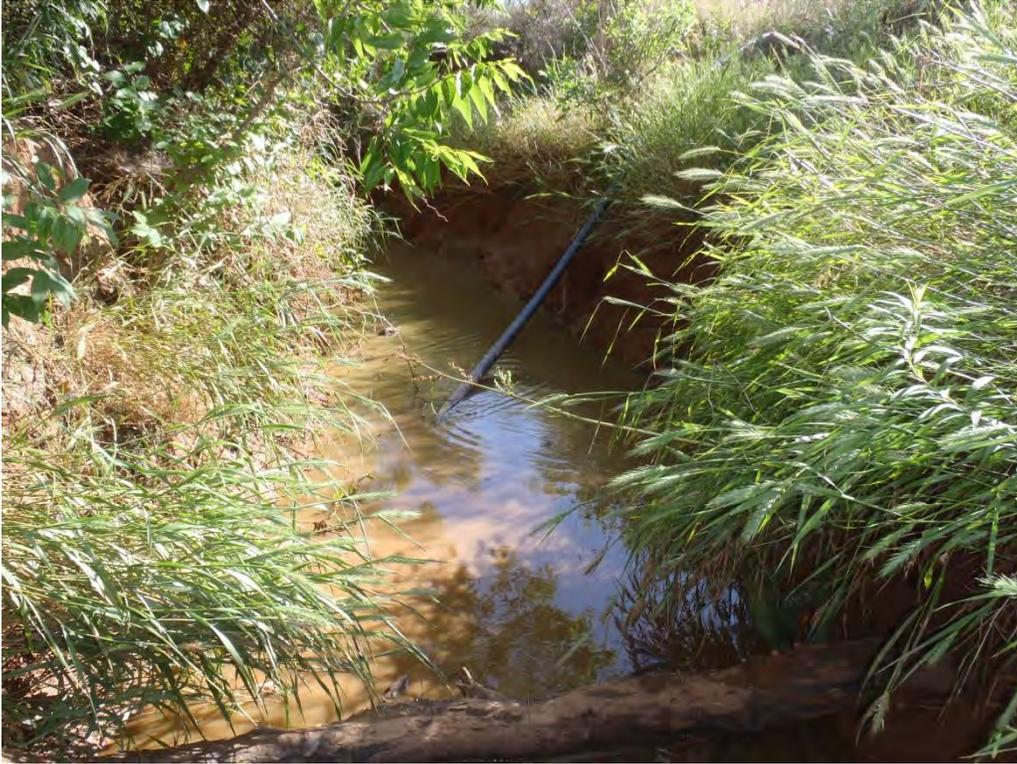
Figure 3.29 Photograph of BF010 taken on June 8, 2013, at 190-m transect. Note narrow channel, dense vegetation and pipe in stream.

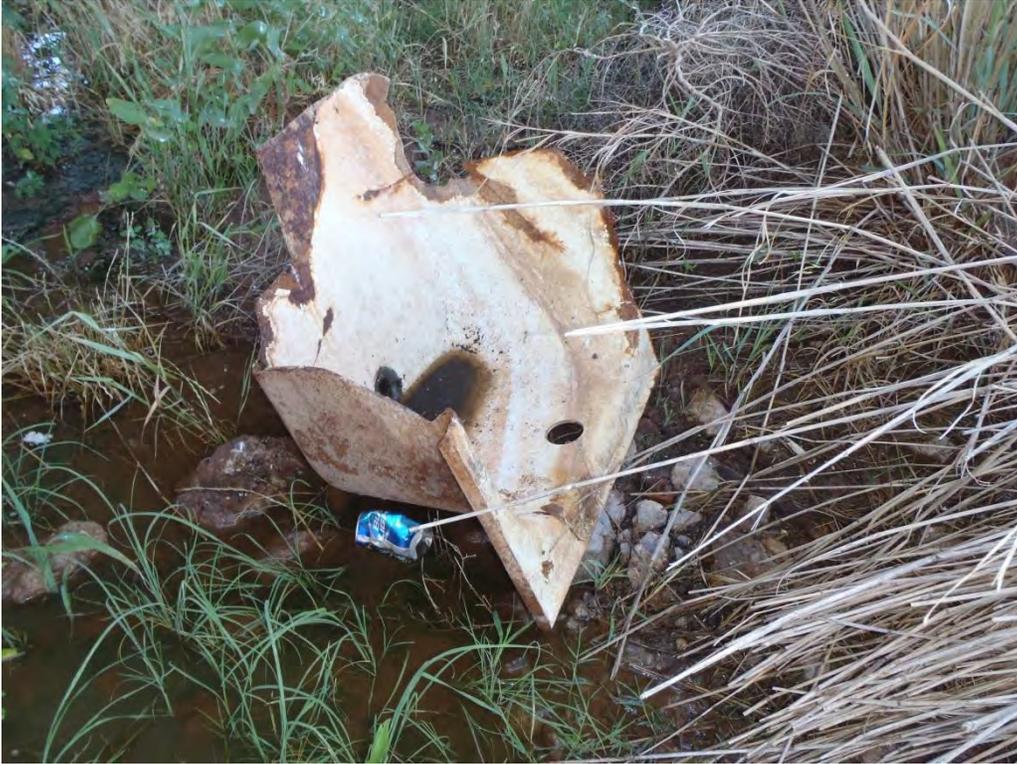
Figure 4.5 Photograph of site PD001 taken August 11, 2013 of bathtub and aluminum can garbage.

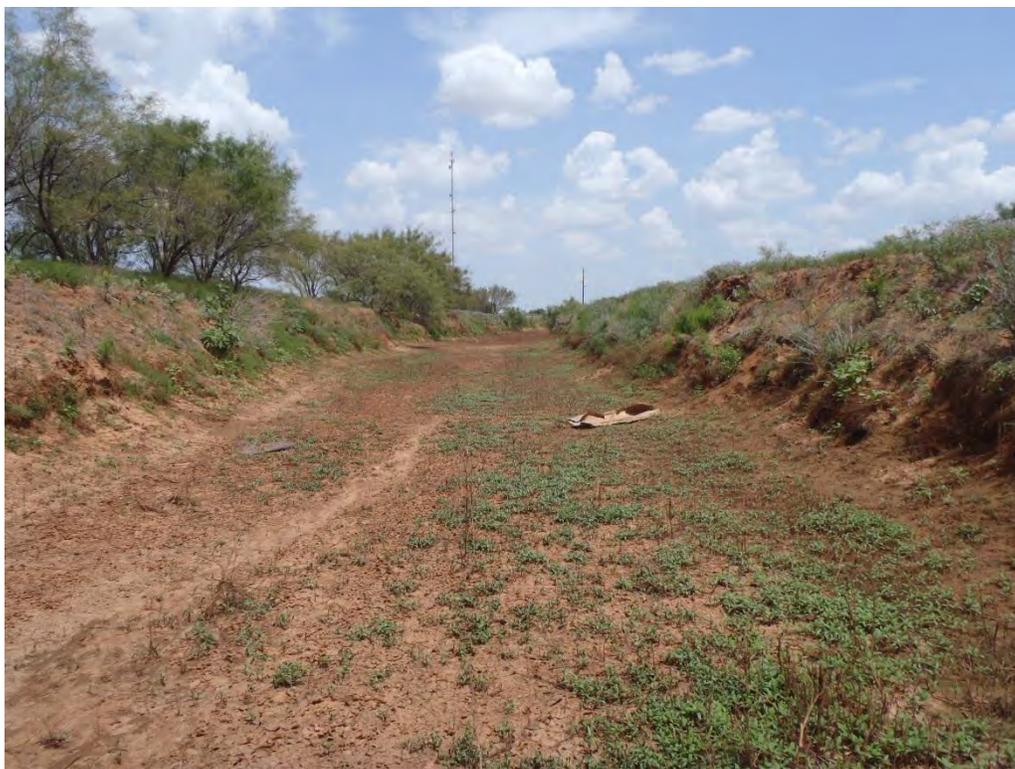
Figure 4.8 Photograph of PD002 taken on August 11, 2013. Downstream view at 300-m transect. Note the steep banks, lack of water, and cardboard garbage.

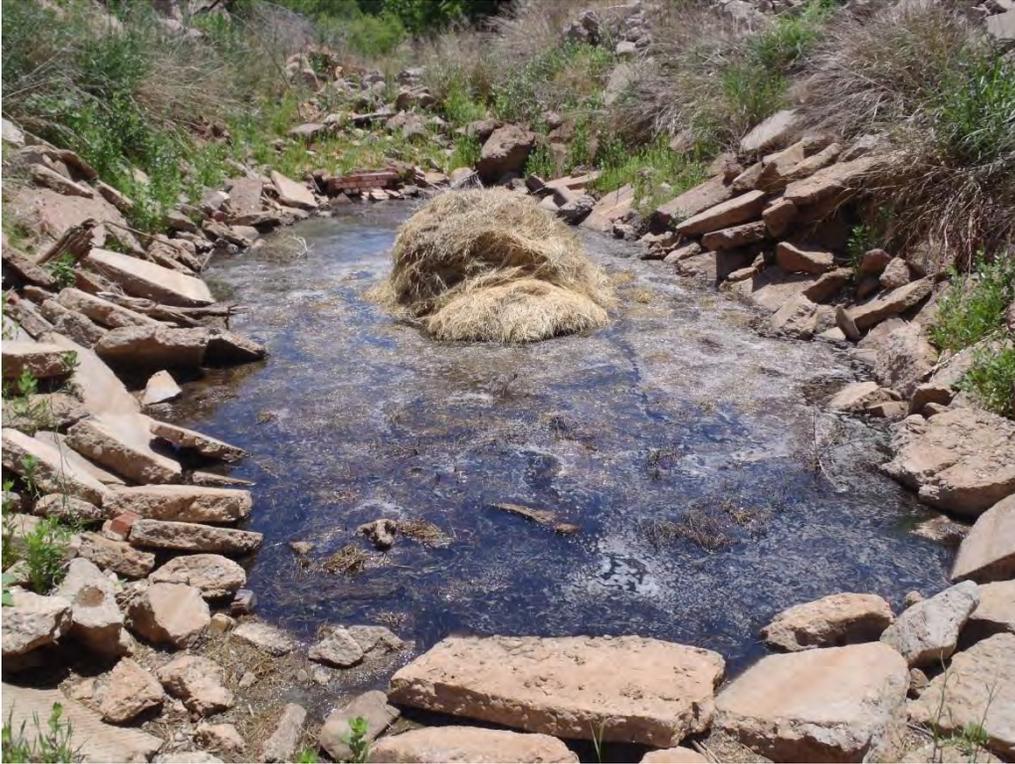
Figure 4.9 Photograph taken of PD003 on June 9, 2013. Photograph is of a pocket of water at about the 185-m transect. Note copious amounts of concrete debris, discarded hay bale and scum on water surface.

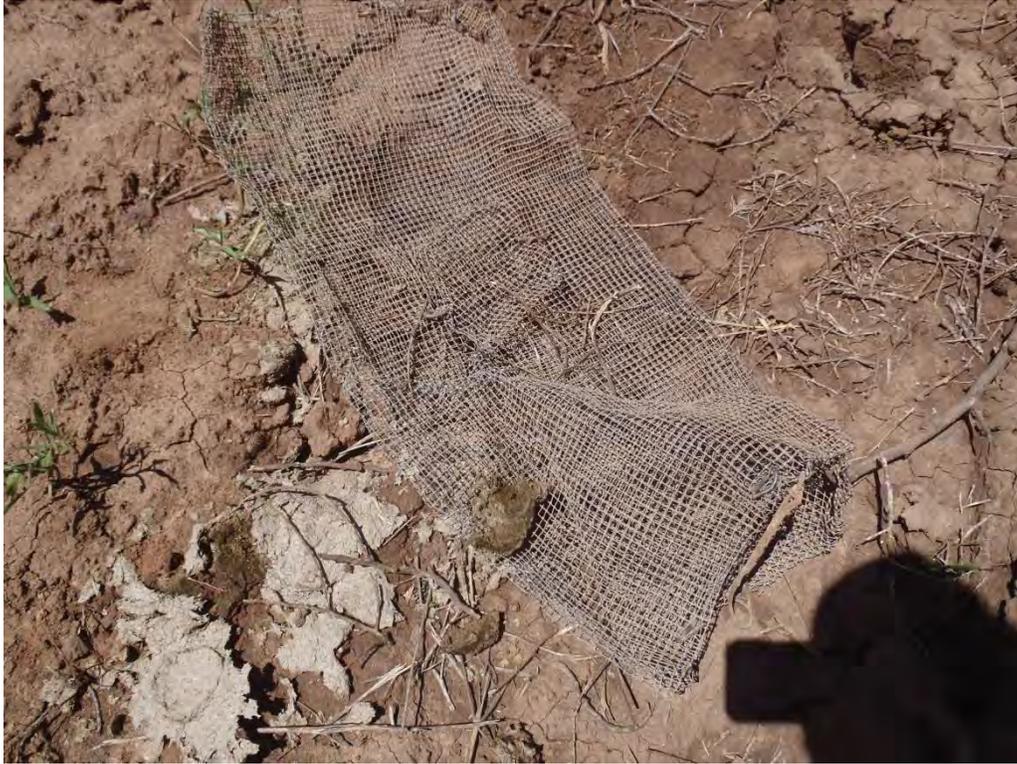
Figure 4.22 Photograph of PD006 taken on June 9, 2013 of a crushed minnow trap.

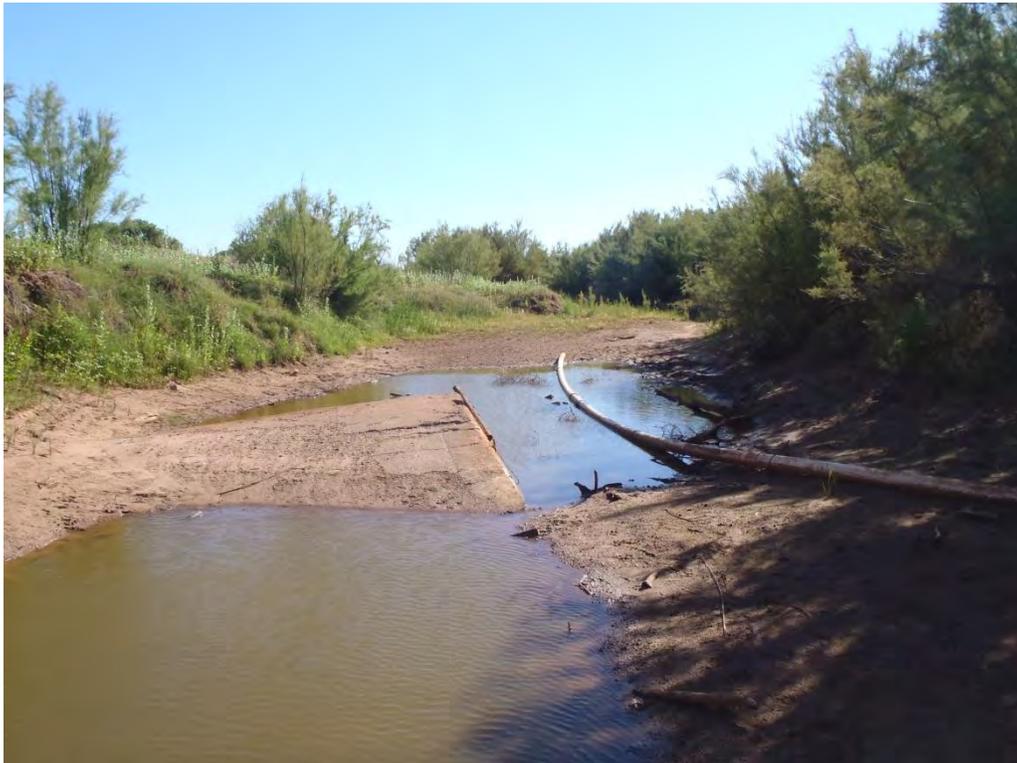
Figure 4.23 Photograph of PD007 taken on Jun10, 2013. Downstream view at the 30-m transect. Note the concrete debris and irrigation pipe.

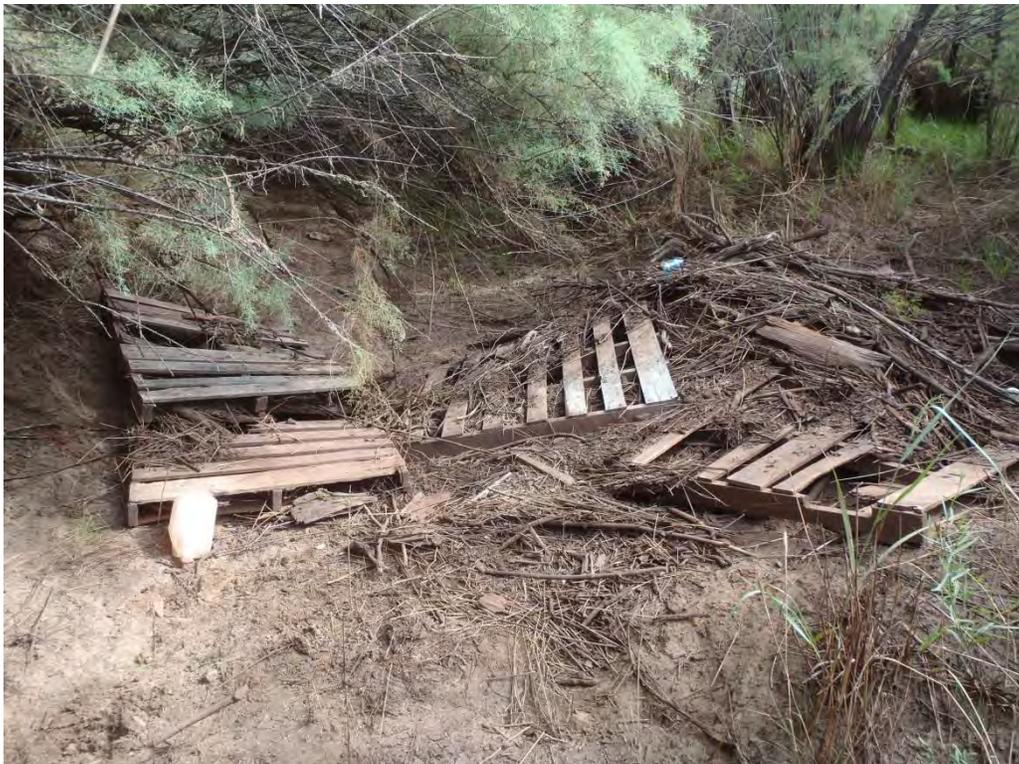
Figure 4.29 Photograph of PD008 taken on August 12, 2013 of garbage accumulation between the 150-m and 270-m transects. Note pallets and household garbage.

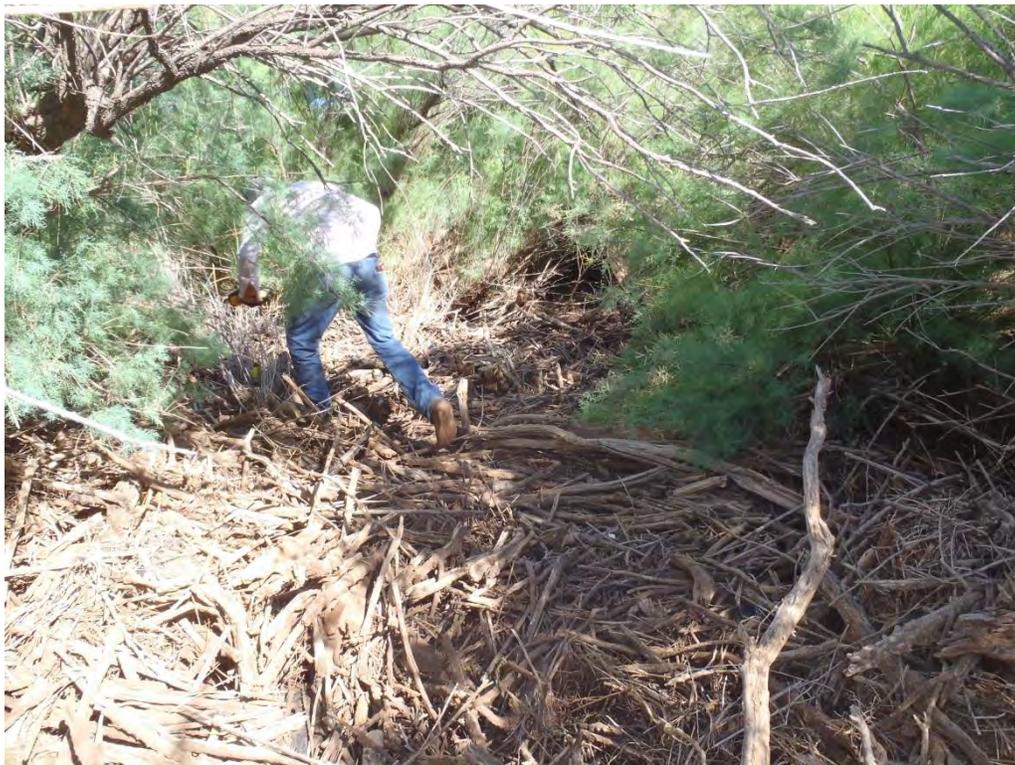
Figure 4.33 Photograph of PD010 taken June 9, 2013. Downstream view at the 300-m transect. Note log obstruction. TIAER personnel in photograph.

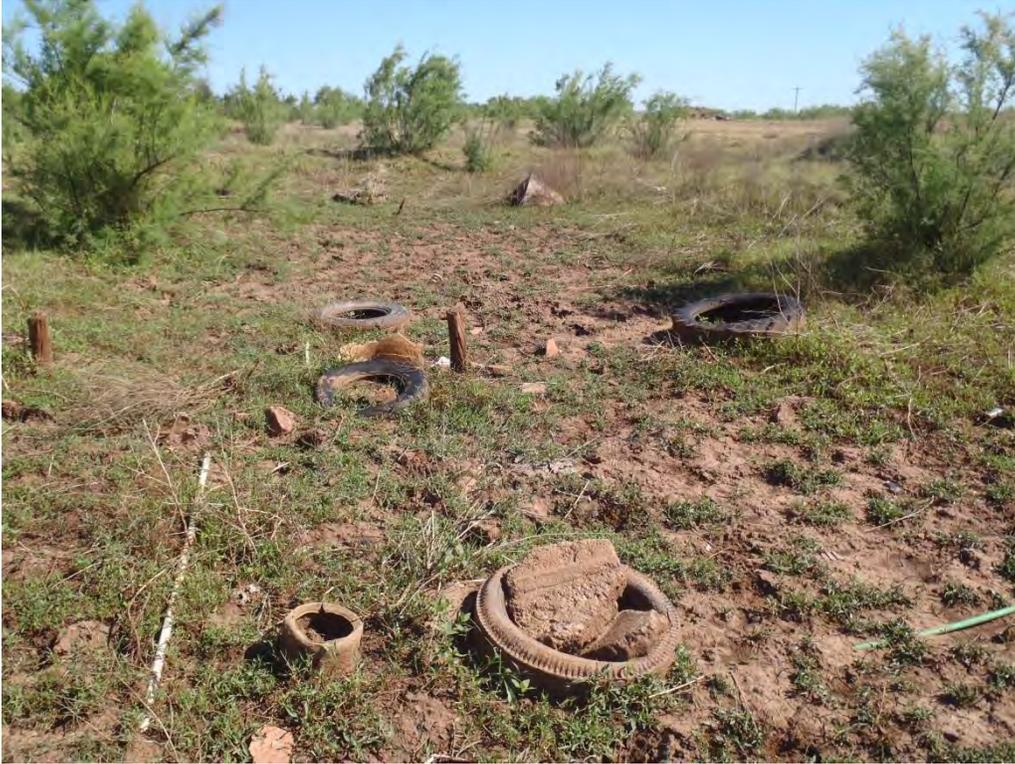
Figure 4.34 Photograph of PD010 taken June 9, 2013 of large debris in creek between the 0-m and 60m transects. Note shrubs on the banks and pasture beyond.

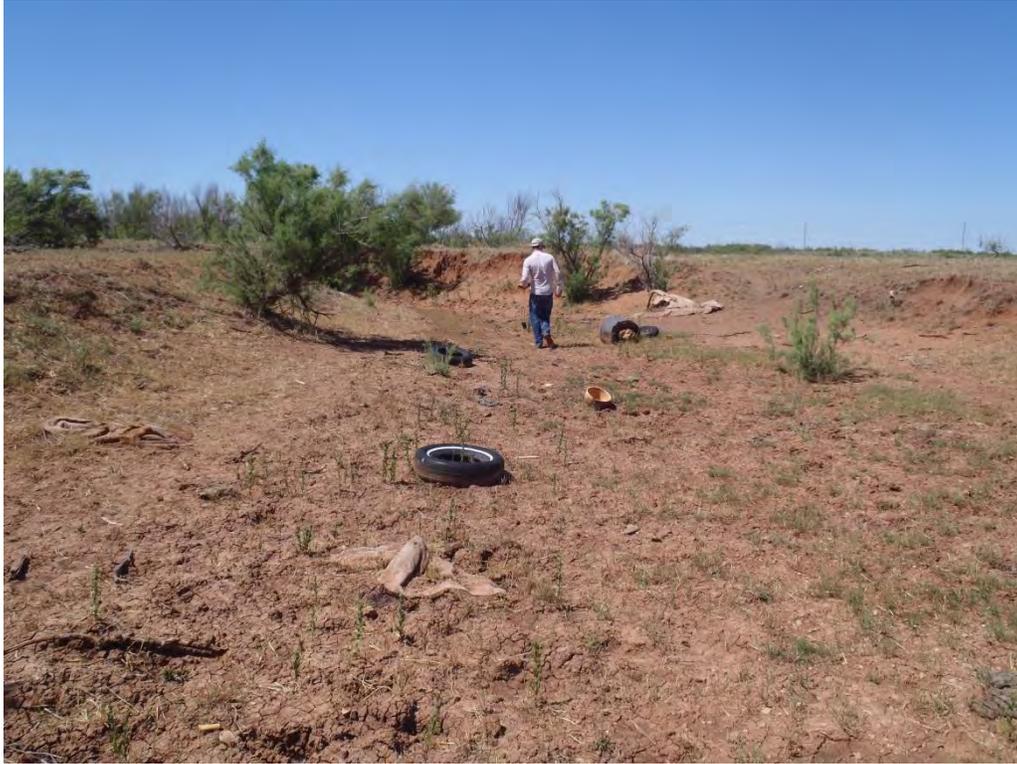
Figure 4.39 Photograph of PD013 taken June 10, 2013 of garbage in the stream bed. Note the open pastureland beyond the riparian area. TIAER personnel in photograph.

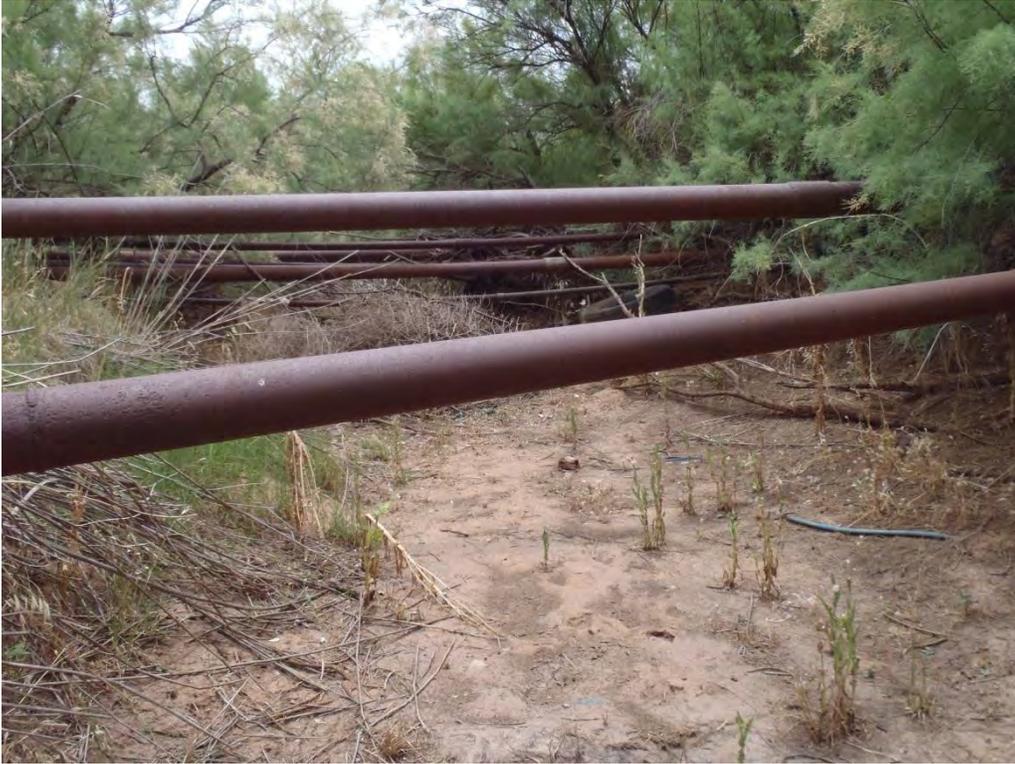
Figure 4.42 Photograph of PD015 taken June 14, 2013 of multiple steel pipes bisecting the creek. Note lack of water, dense bank vegetation and sandy substrate.

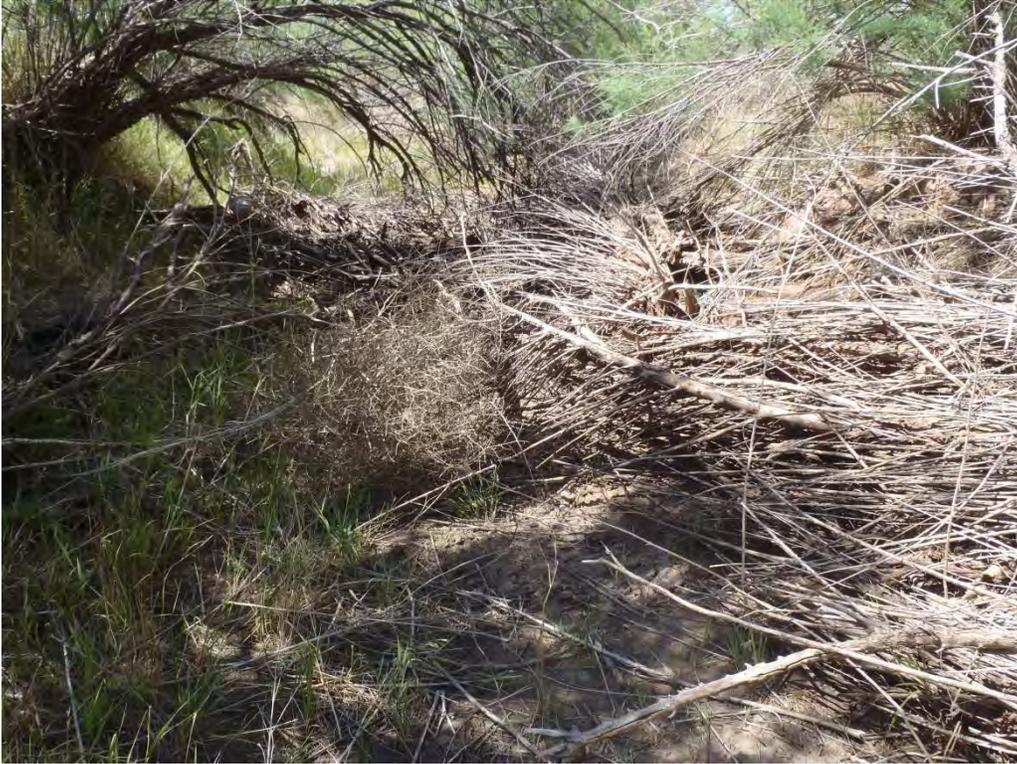
Figure 4.51 Photograph of PD018 taken June 9, 2013. Obstruction at 215-m transect.

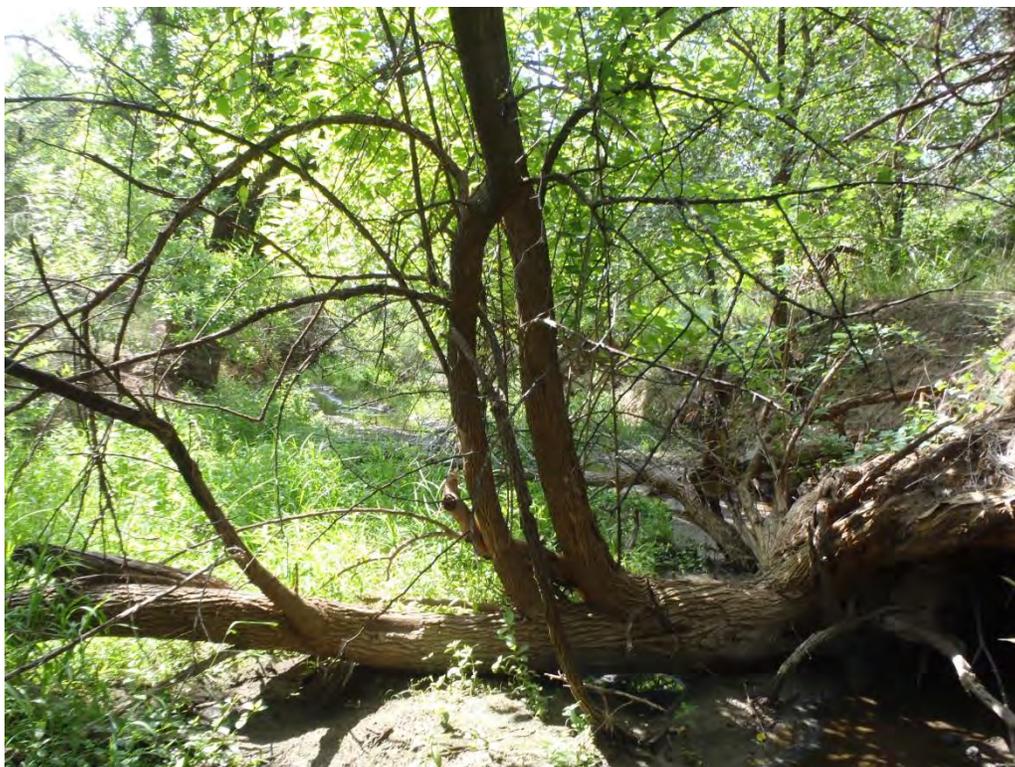
Figure 5.18 Photograph of typical obstructions at Sweetwater Creek Site SW007 taken on July 29, 2013.
