RE: Request for Contested Case Hearing – WQ 0002927000
TCEQ Commissioners Meeting – January 24, 2024

Purpose of this letter – Reaffirm My request for a contested case hearing on the proposed permit WQ 0002927000.

Applicant for the permit – Lyondell Chemical Corporation
2502 Sheldon Road, Channelview, Texas 77530

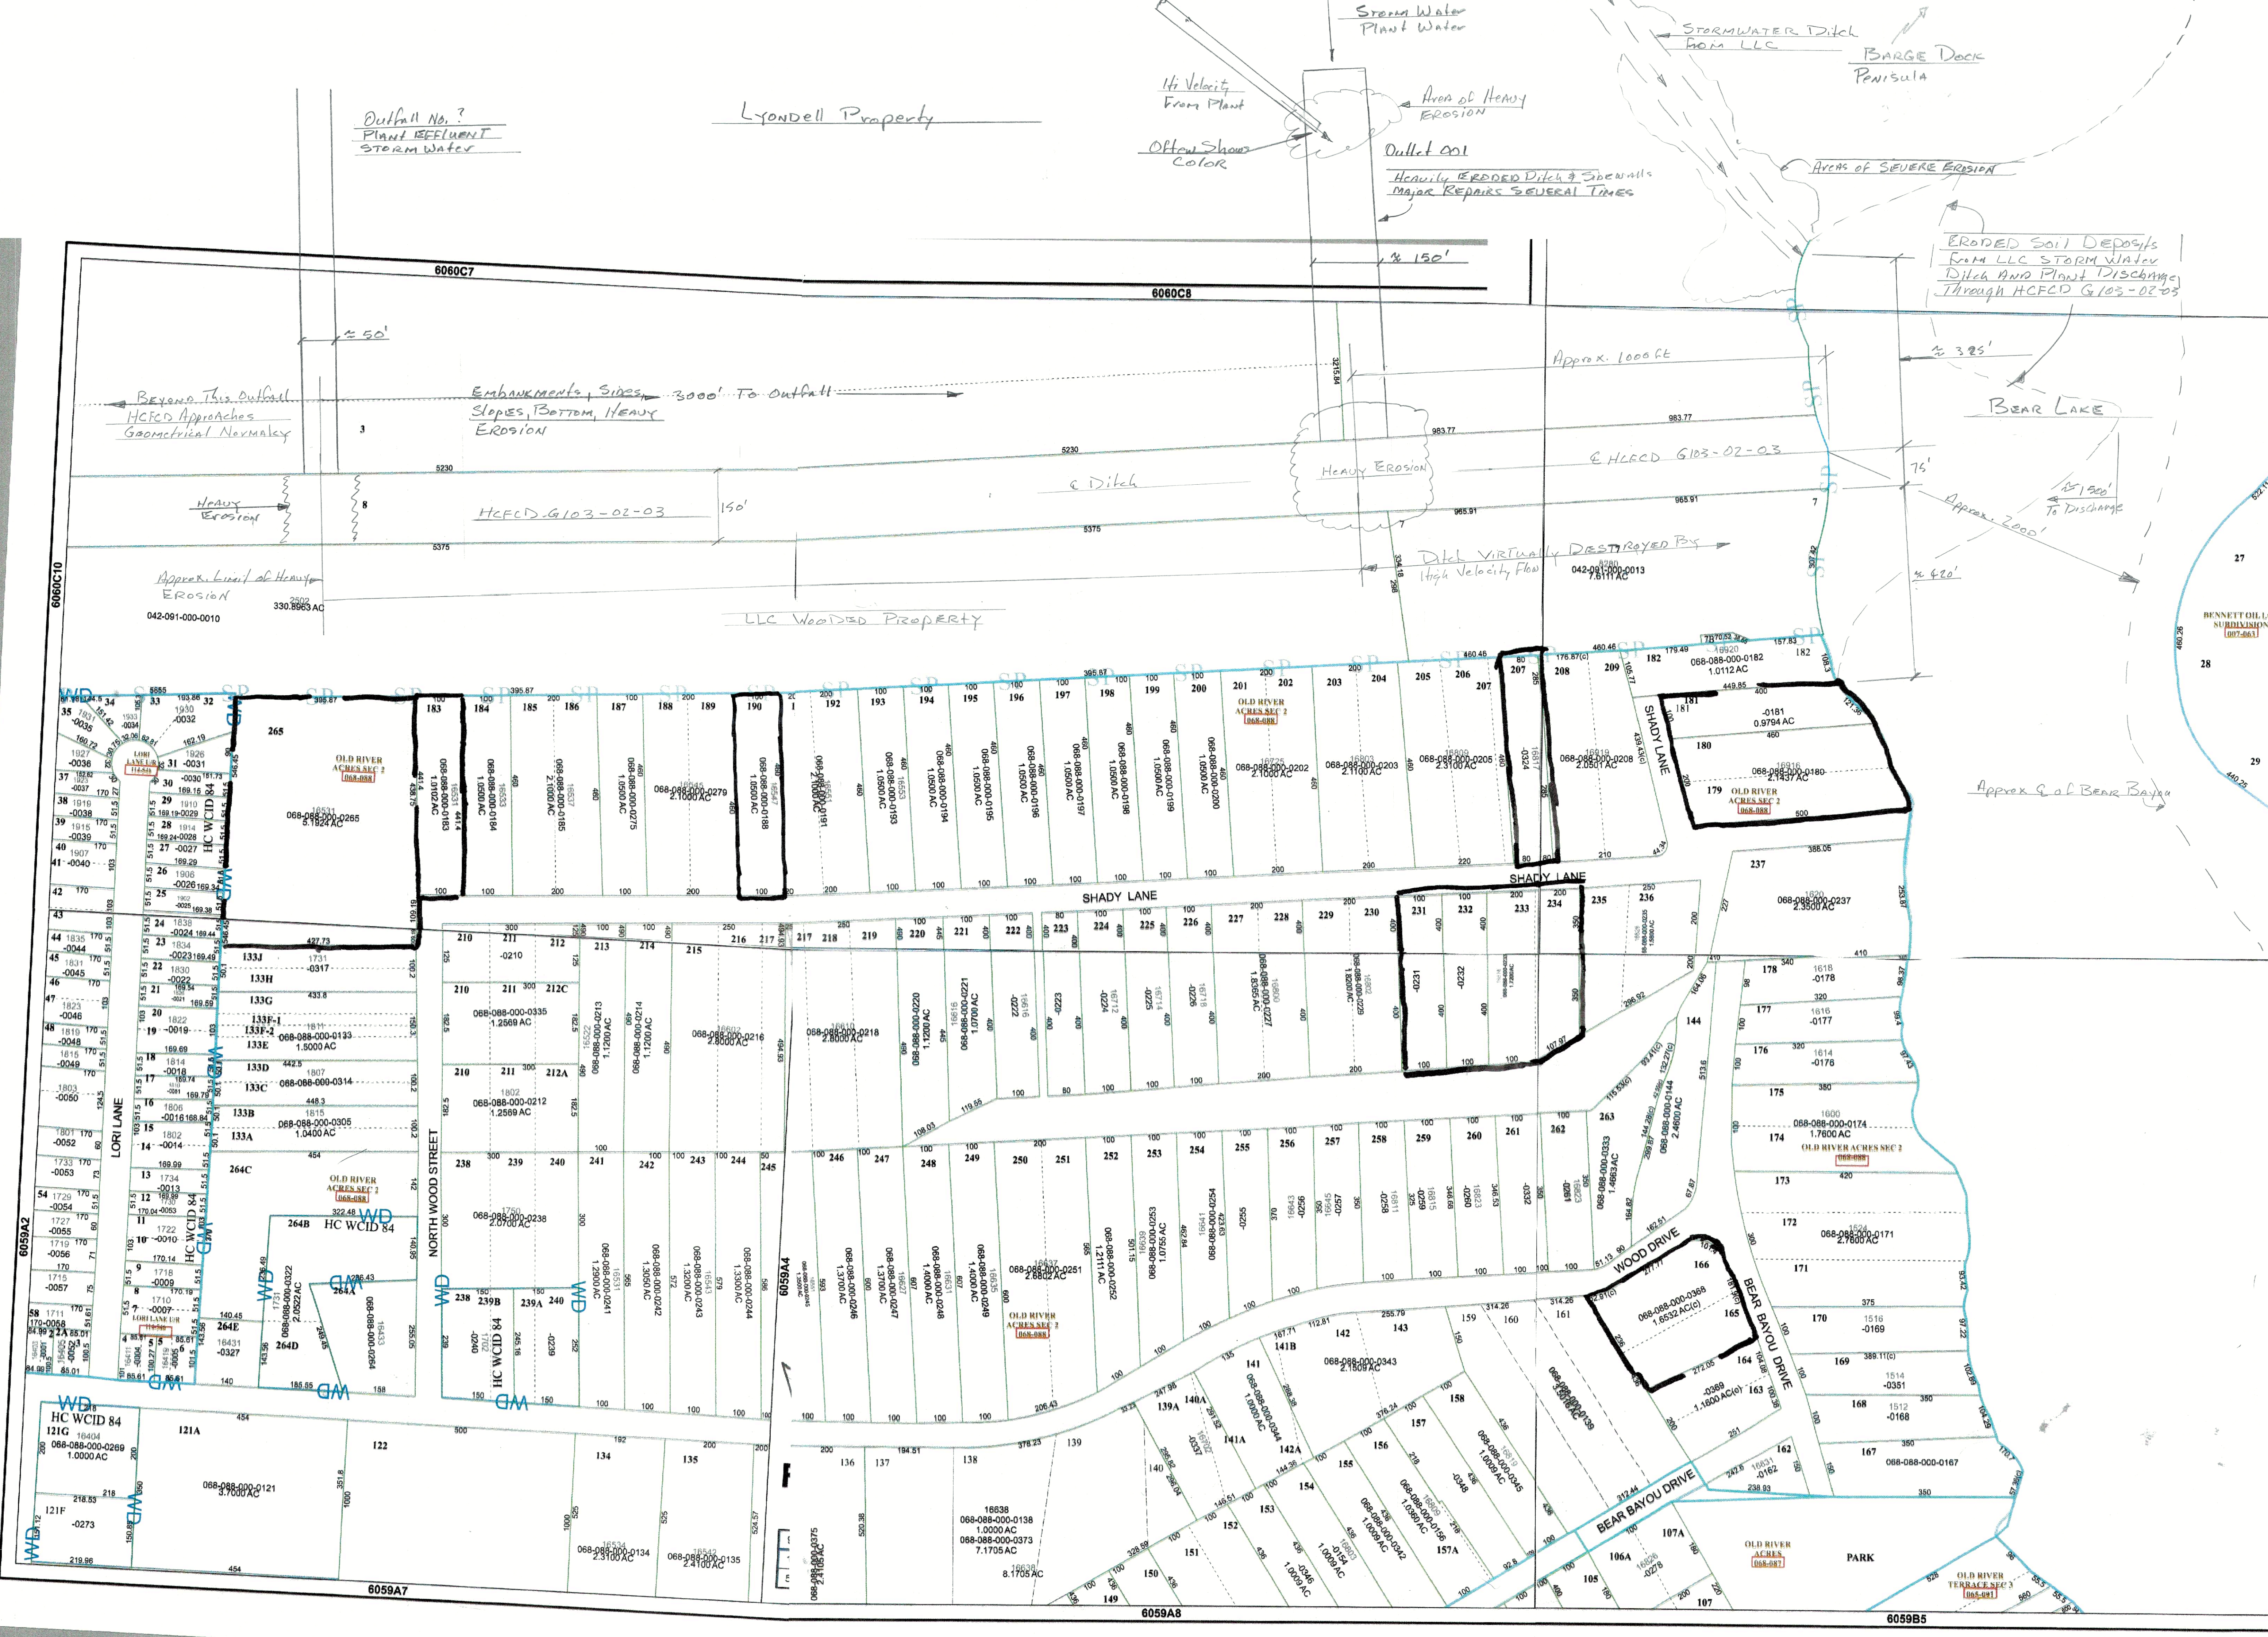
- The properties owned or mortgaged by myself and the distances of these properties from the Harris County Flood Control Ditch used as the main channel for plant effluent discharges. My homestead is located approximately 450' from the centerline of the discharge point for G103-02-03 into Bear Lake.

- The main discharge route for stormwater runoff from the plant facility. The discharge into Bear Lake is located approximately 350' from the main discharge from G103-02-03.

- The location of the main plant discharge of effluent is shown as outfall 001 on the map.
- The approximate location of the center line of Bear Bayou is shown.

- The approximate location of a high velocity discharge pipe that empties into outfall 001.
- The locations and areas of G103-02-03 which are heavily eroded.

- The location of the main stormwater discharge ditch that is heavily eroded.
- The length of G103-02-03 which is heavily eroded and the remaining part of G103-03-02 which appears to be operating as designed.

- The approximate length of eroded soil and plant effluent that have been deposited into Bear Bayou Lake by the discharges of G103-02-03 and the main stormwater discharge ditch.

- Outfall 001, G103-02-03, and the stormwater ditch are all heavily eroded due to high effluent flow. Increased discharge rates should not be allowed at present.

- The extent of the erosion is well confined to the areas starting at the discharge (G103-02-03) into Bear Lake and continuing to just beyond the outfall yet to be identified. This is approximately 50% of the entire length of the flood control ditch and it is significant that the erosion is limited generally to the area between the discharge point to outfall 001 (approx. 1000') and then to the unidentified outfall (approximately 3000') or for a total of approximately 4000'. Some meandering of G103-02-03 can be seen from outfall 001 to the unidentified outfall.

- The areas of erosion for the main stormwater discharge facility are also easily identified.
- The main reason for the erosion seems to be the velocity of discharged effluent in G103-02-03 and in the stormwater ditch (approximately 5-8 ft/sec) exceeds the soil strength.
