Riparian Evaluation of Oso Creek and Tributaries

Funding Entity: Texas Commission on Environmental Quality (TCEQ)

Contractor and Performing Party: Nueces River Authority (NRA)

Report Date: August 31, 2016

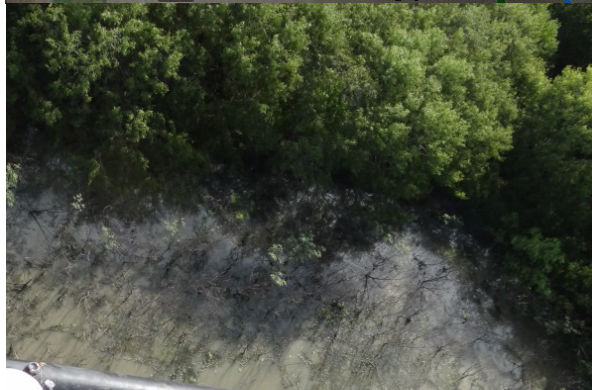
Saturated soils and standing water

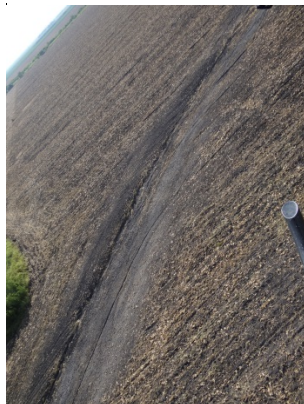
Non Functional

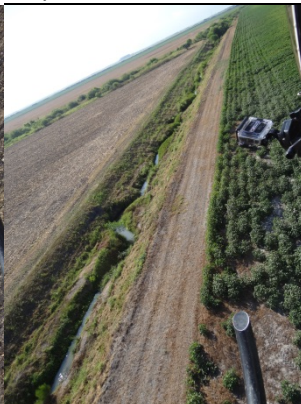
Improved Function

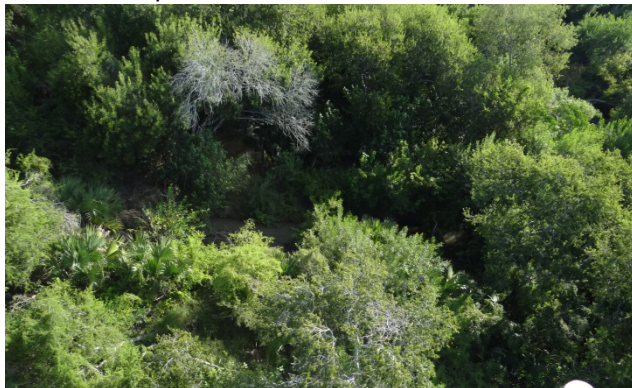
Bank clearing

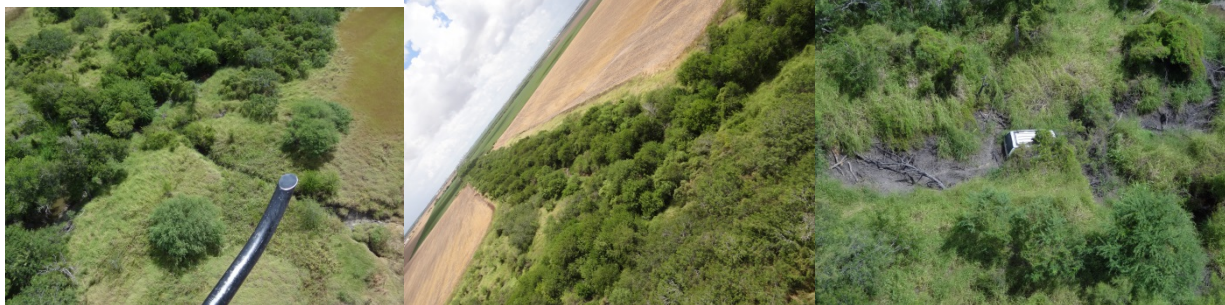
Numerous gullies enter the channel

Major drain enters from North

A vehicle is partially buried in a gully

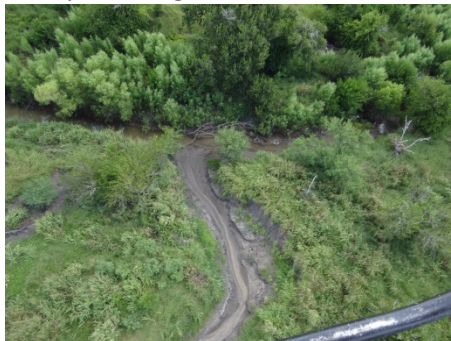
Gully entering the channel

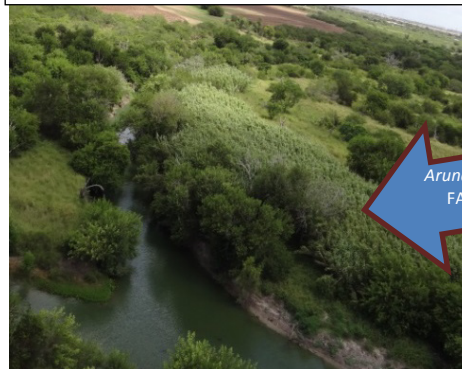
Arundo donax, an invasive plant

Arundo donax
FAC SR7

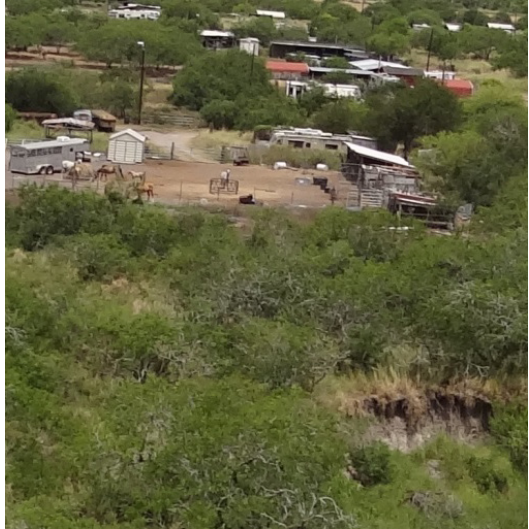
Animal rescue facility on bank of La Volla Creek

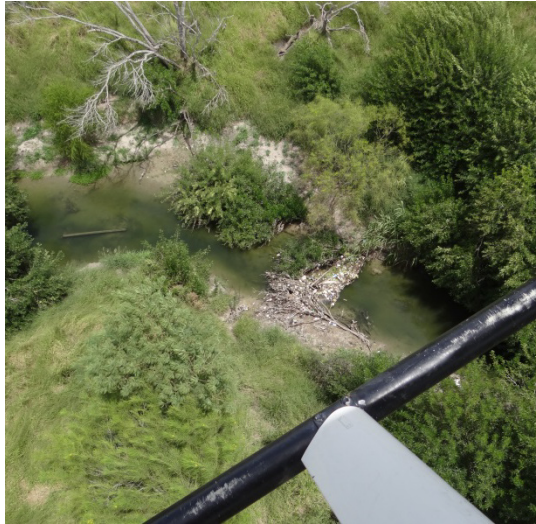
Clear water, large fish, and large volume of litter

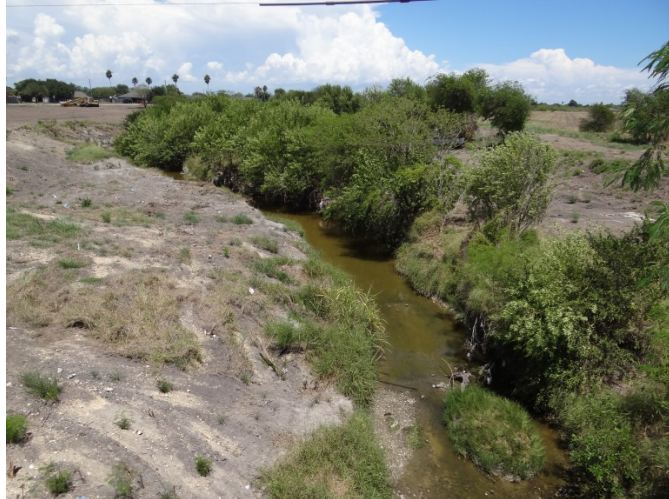
Bank clearing project on La Volla Creek

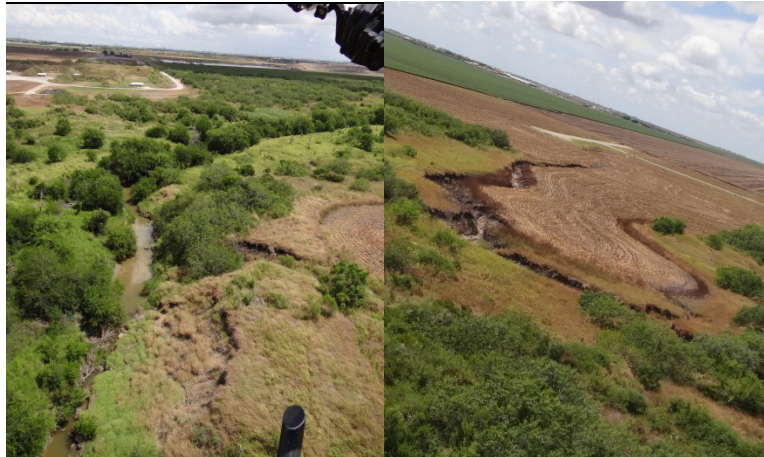
Deep gullies entering the creek from adjacent lands

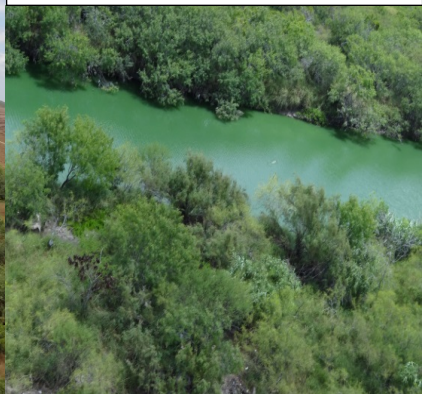
Possible algae bloom in Oso Creek

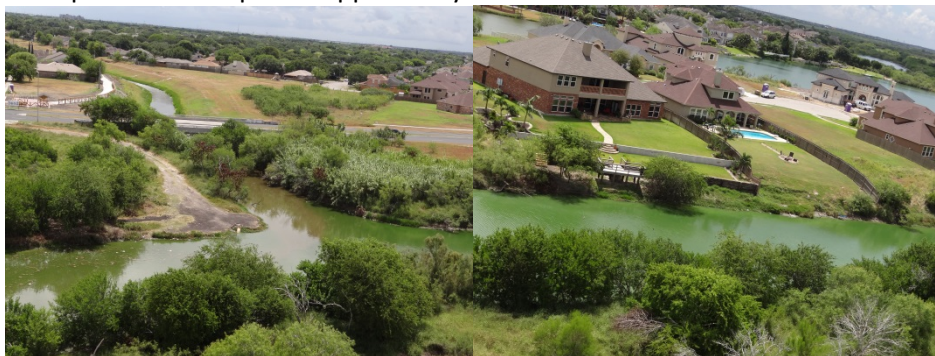
Example of urban riparian opportunity for enhanced function.

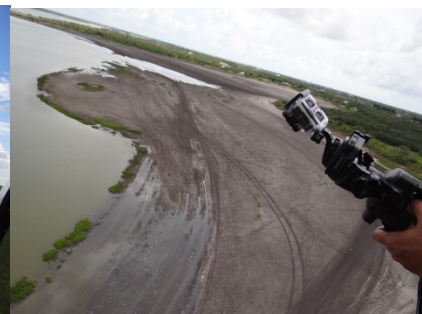
Off-road vehicle use

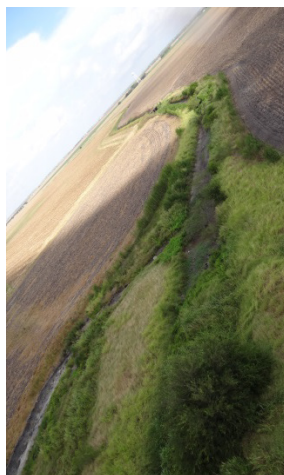
Thin band
of riparian vegetation

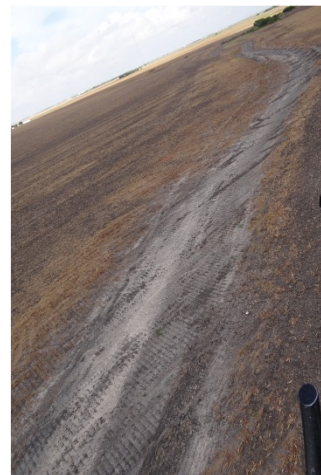
No riparian
vegetation

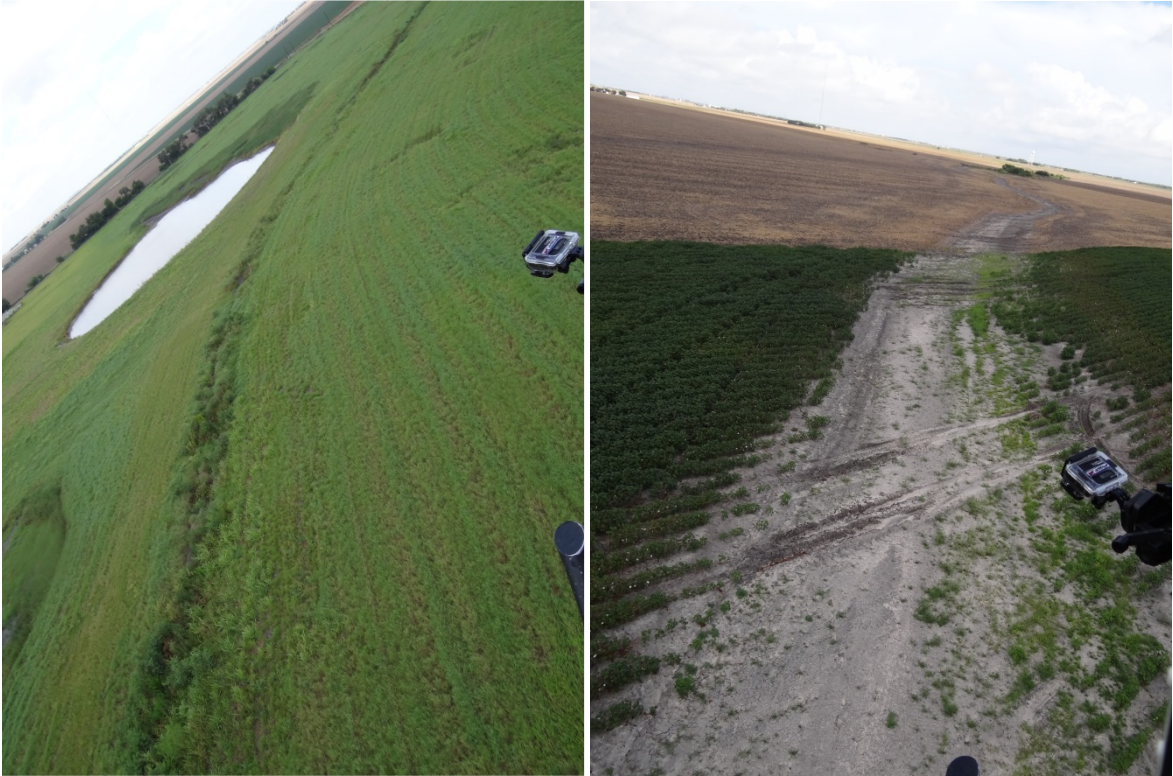
Example of non-functional riparian areas along West Oso Creek.

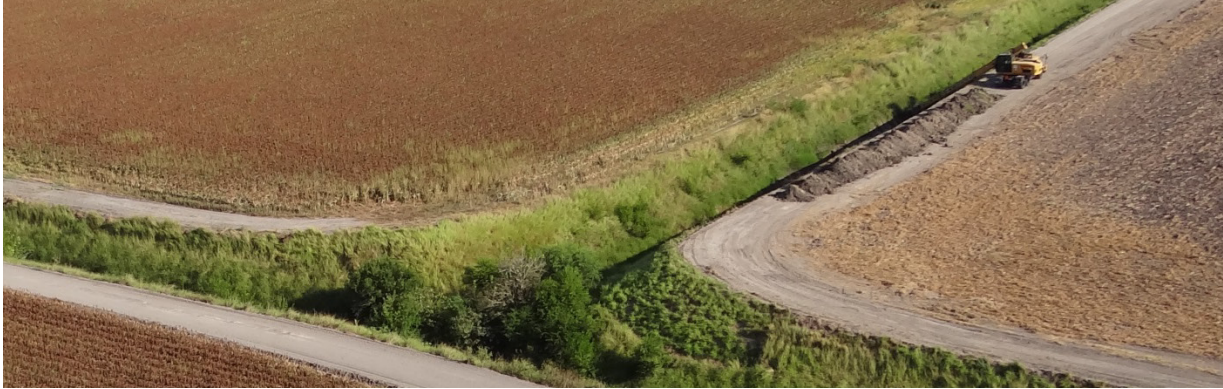
Ditch cleaning project on 2485C

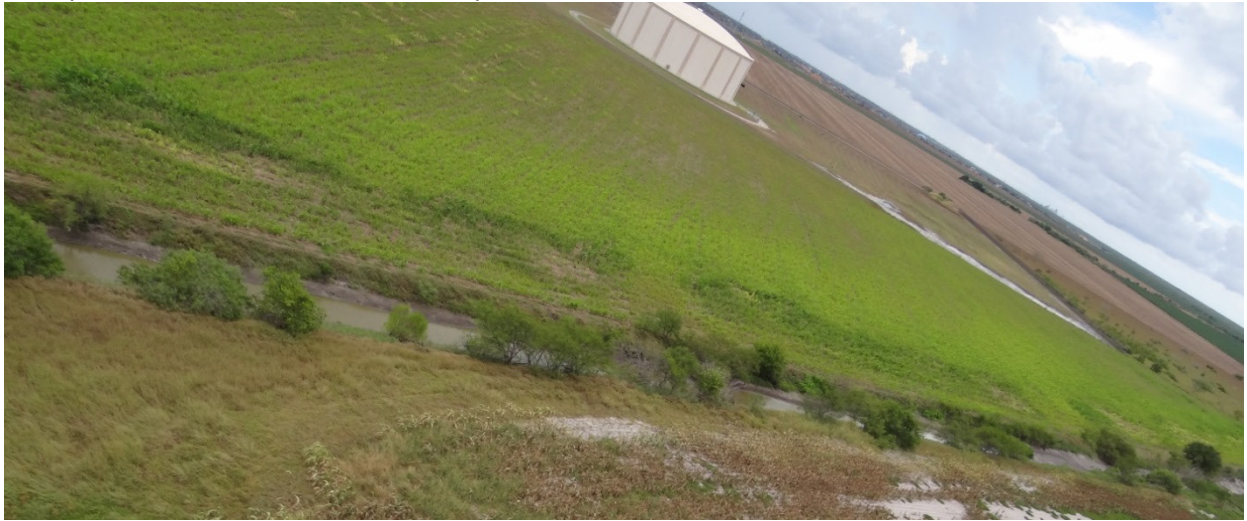
Example of non-functional, ditch-like, riparian area

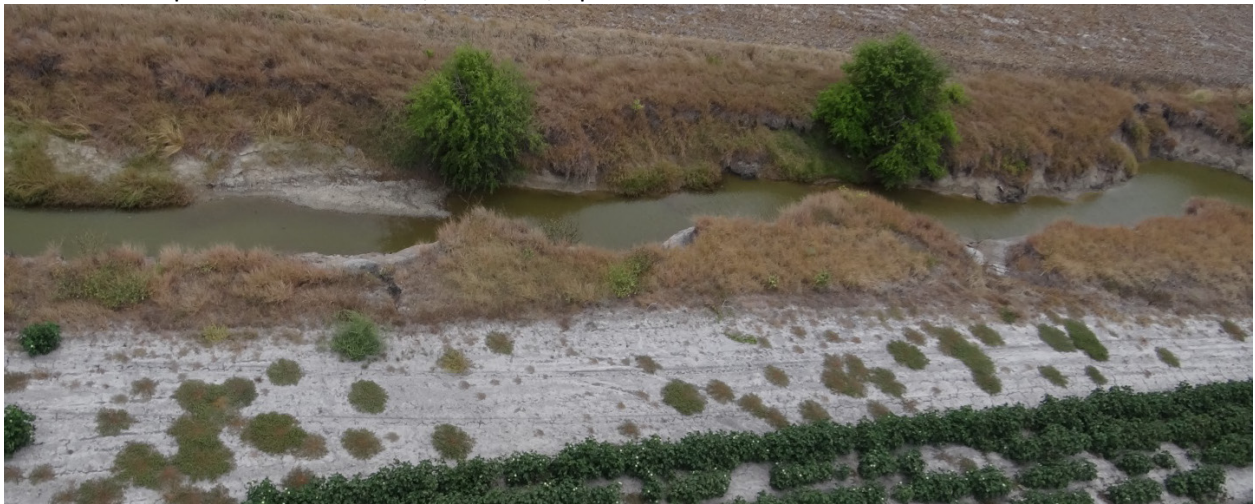
Another example of non-functional, ditch-like, riparian area

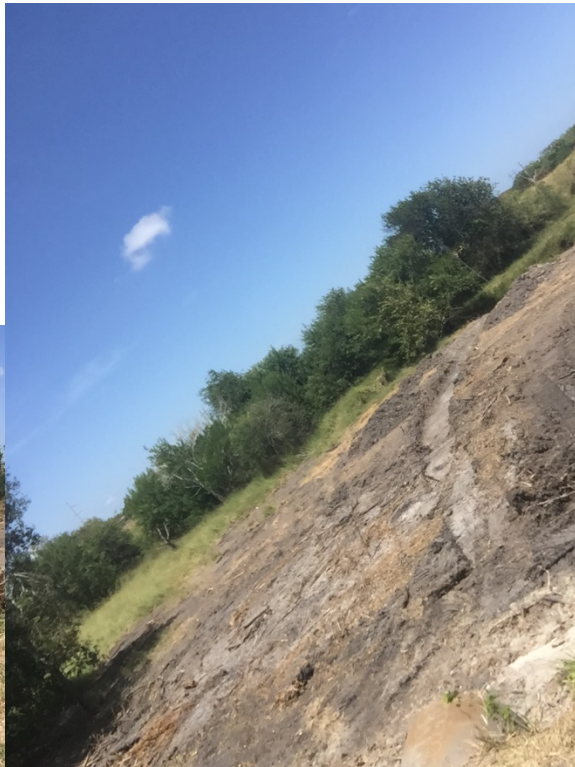
La Volla Creek channel clearing project at FM 357 (Saratoga Blvd.).

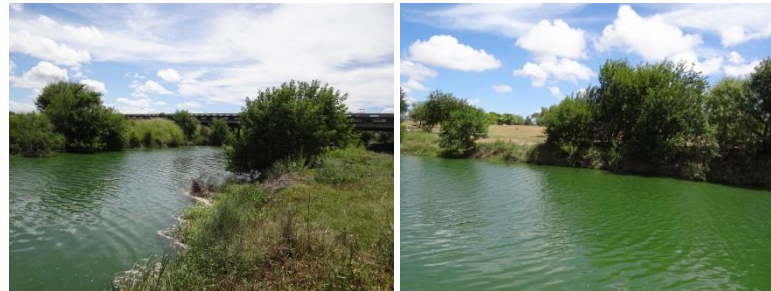
No active erosion from floodwaters is visible. Some erosion from construction site runoff was observed at this site.

Runoff from bridge construction area observed entering Oso Creek

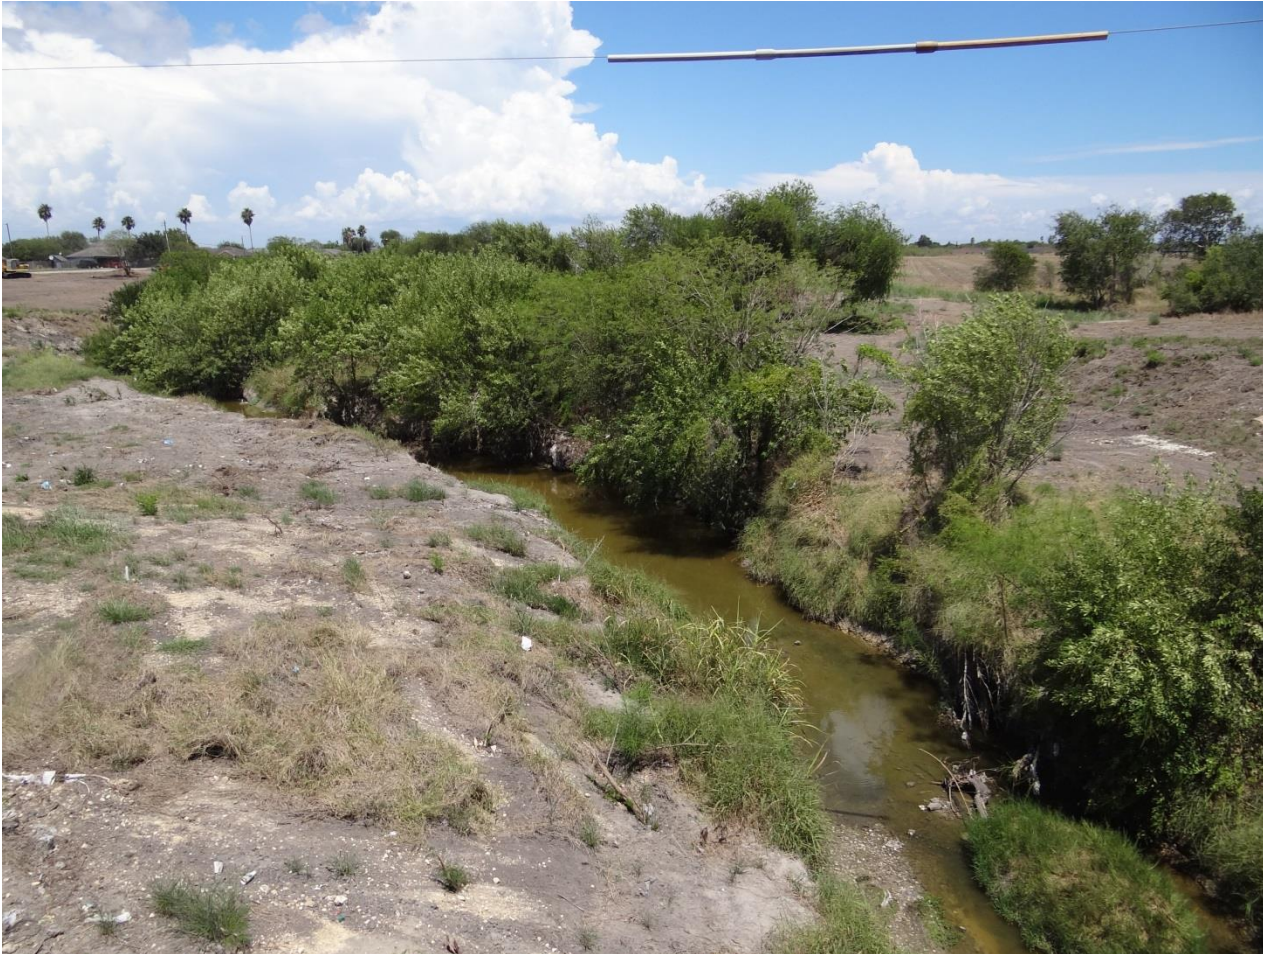
Site: La Volla Creek at Saratoga Blvd. (State Hwy 357)

A large scale stream bank and channel clearing project was observed upstream of evaluation site. Subsequent evaluations of this site may identify downstream riparian impacts. A photo point of the disturbed riparian site was established. Its recovery may be visually documented by taking subsequent photos over time.
