AIR CP_106597875_CP_20171016_Investigation_1415945_
Texas Commission on Environmental Quality
Investigation Report

Regulated Entity Name: LA QUINTA PLANT

Investigation # 1415945

Investigation Type: Compliance Investigation

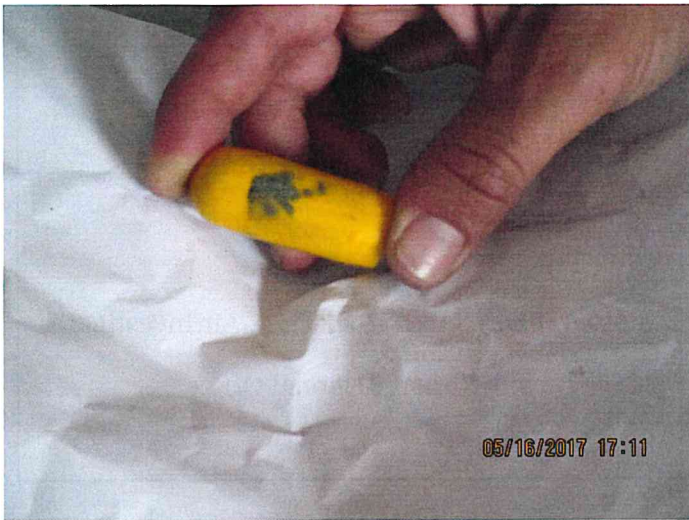
Subject: Demonstration of magnetic property
of the metallic particles on Citizen 1's
residence
Location: Citizen 1's Residence
TCEQ Incident No. 257967
City: Portland
County: San Patricio
Date: May 16, 2017
Photographer: Susan Hoelscher, Air Investigator
Digital File Location:
TCEQ Corpus Christi Regional Office
Photo No. 1

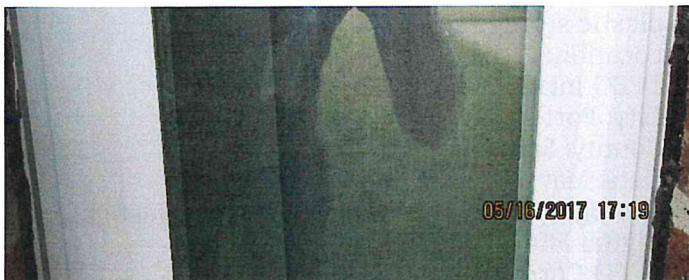
Subject: Location of Sample No. 1705011-001;
front siding of house
Location: Citizen 1's Residence
TCEQ Incident No. 257967
City: Portland
County: San Patricio
Date: May 16, 2017
Photographer: Susan Hoelscher, Air Investigator
Digital File Location:
TCEQ Corpus Christi Regional Office
Photo No. 2

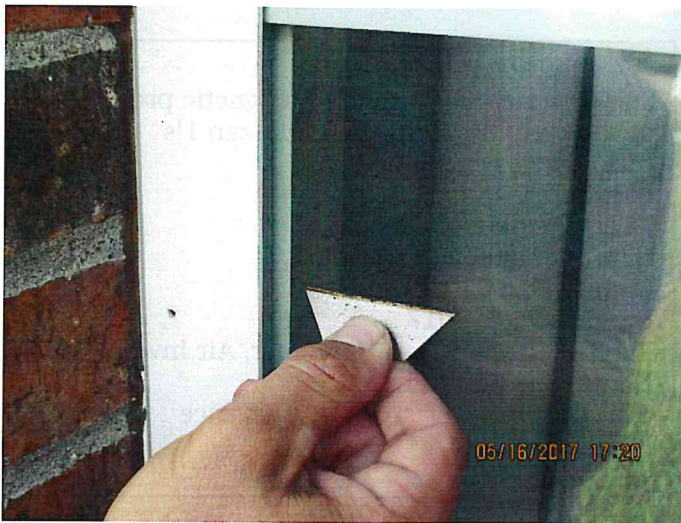
Subject: Location of Sample No. 1705011-002;
front window glass
Location: Citizen 1's Residence
TCEQ Incident No. 257967
City: Portland
County: San Patricio
Date: May 16, 2017
Photographer: Susan Hoelscher, Air Investigator
Digital File Location:
TCEQ Corpus Christi Regional Office
Photo No. 3

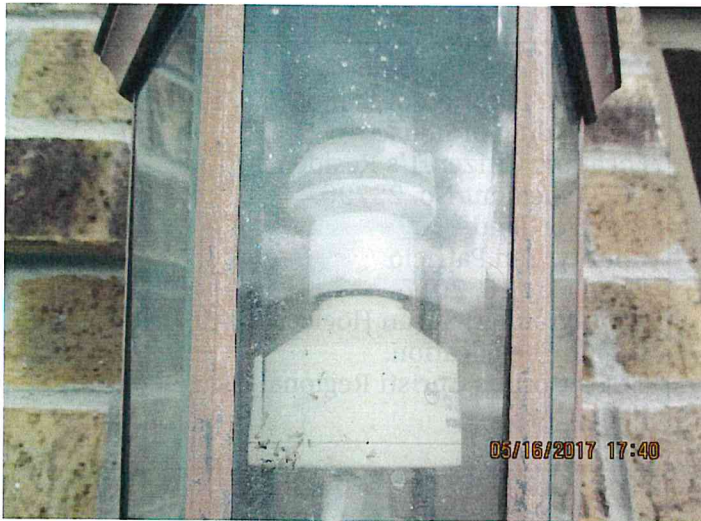
Subject: Location of Sample No. 1705011-003;
outdoor light glass cover
Location: Citizen 2's Residence
TCEQ Incident No. 258031
City: Portland
County: San Patricio
Date: May 16, 2017
Photographer: Susan Hoelscher, Air Investigator
Digital File Location:
TCEQ Corpus Christi Regional Office
Photo No. 5

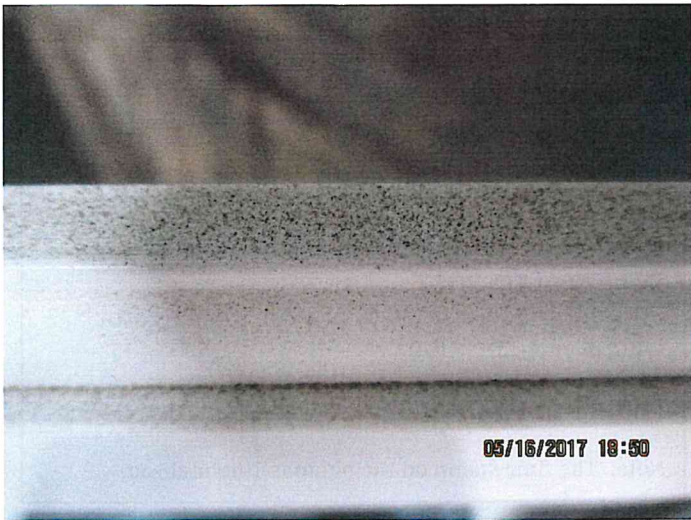
Subject: Location of Sample No. 1705011-005;
front door window sill
Location: Citizen 3's Residence
TCEQ Incident No. 258027
City: Portland
County: San Patricio
Date: May 16, 2017
Photographer: Ashley Scott, Air Investigator
Digital File Location:
TCEQ Corpus Christi Regional Office
Photo No. 7

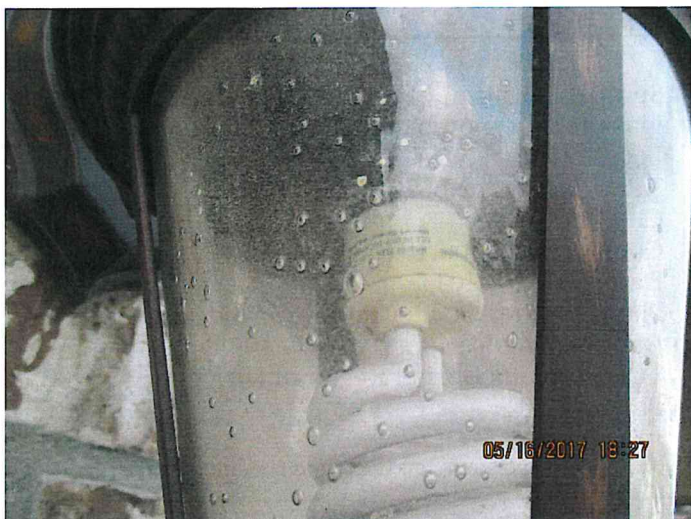
Subject: Location of Sample No. 1705011-007;
outdoor light glass cover
Location: Citizen 4's Residence
TCEQ Incident No. 258034
City: Portland
County: San Patricio
Date: May 16, 2017
Photographer: Susan Hoelscher, Air Investigator
Digital File Location:
TCEQ Corpus Christi Regional Office
Photo No. 9

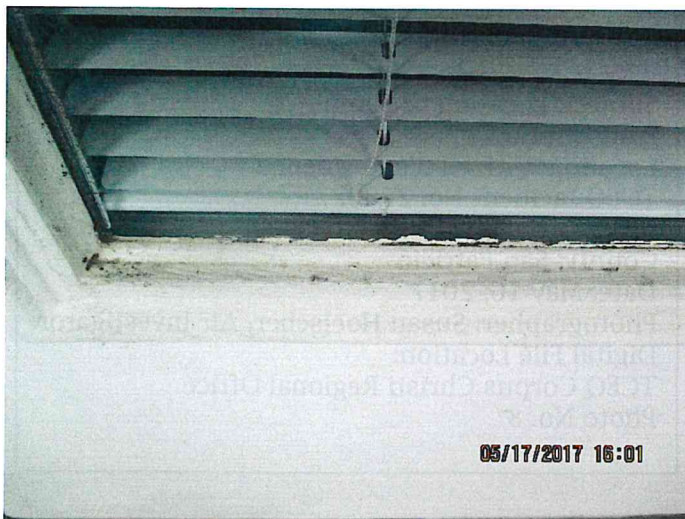
Subject: Location of Sample No. 1705011-008;
front window glass
Location: Citizen 4's Residence
TCEQ Incident No. 258034
City: Portland
County: San Patricio
Date: May 16, 2017
Photographer: Ashley Scott, Air Investigator
Digital File Location:
TCEQ Corpus Christi Regional Office
Photo No. 10

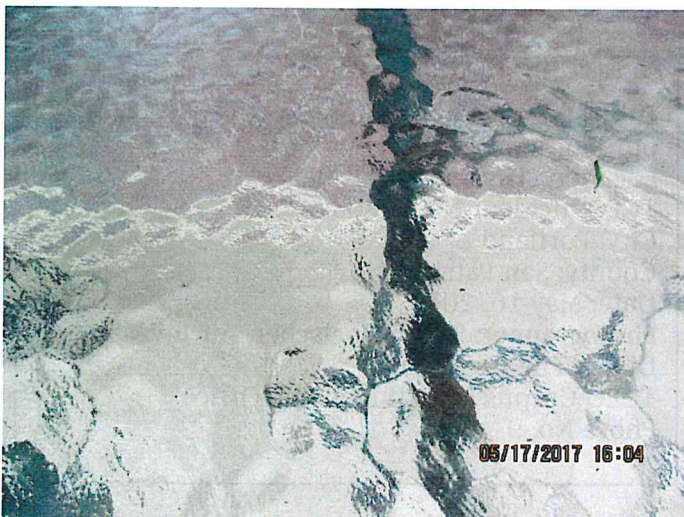
Subject: Location of Sample No. 1705012-001;
back door window glass
Location: Citizen 5's Residence
TCEQ Incident No. 258023
City: Portland
County: San Patricio
Date: May 17, 2017
Photographer: Ashley Scott, Air Investigator
Digital File Location:
TCEQ Corpus Christi Regional Office
Photo No. 11

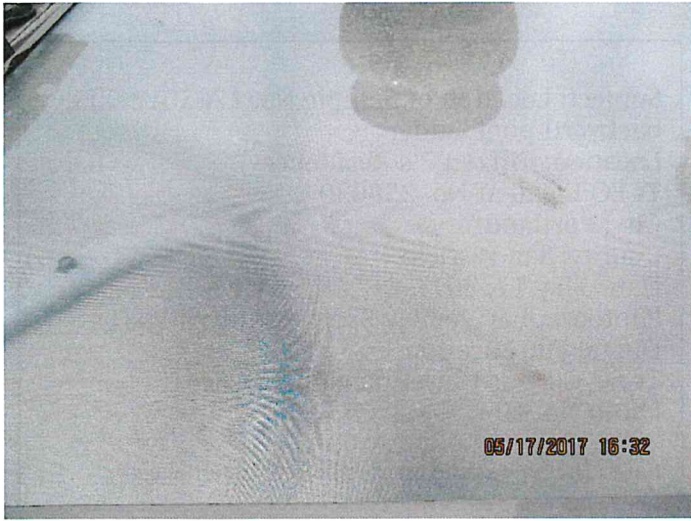
Subject: Location of Sample No. 1705012-003;
glass tabletop on back deck
Location: Citizen 6's Residence
TCEQ Incident No. 258012
City: Portland
County: San Patricio
Date: May 17, 2017
Photographer: Ashley Scott, Air Investigator
Digital File Location:
TCEQ Corpus Christi Regional Office
Photo No. 13

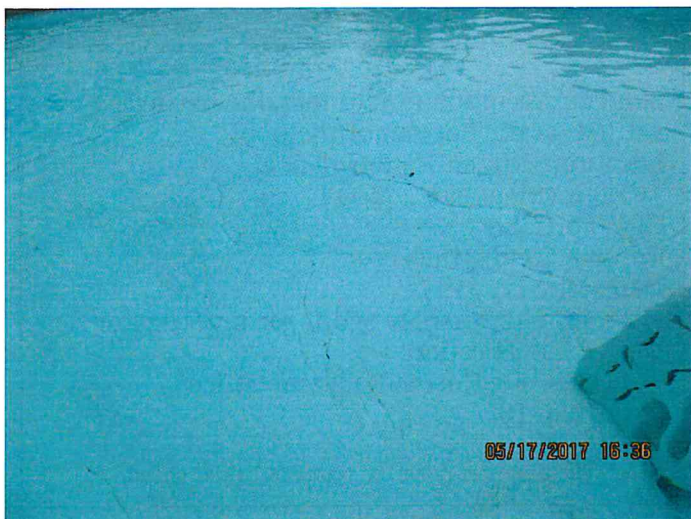
Subject: Metallic particles settled on the bottom
of Citizen 6's pool
Location: Citizen 6's Residence
TCEQ Incident No. 258012
City: Portland
County: San Patricio
Date: May 17, 2017
Photographer: Ashley Scott, Air Investigator
Digital File Location:
TCEQ Corpus Christi Regional Office
Photo No. 15

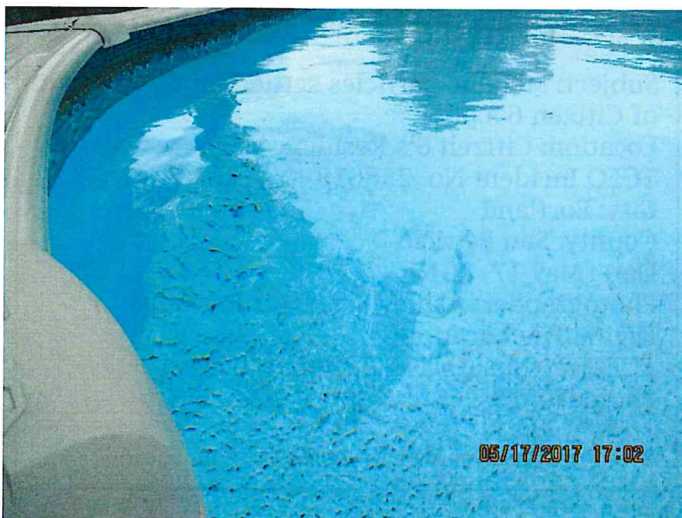
Subject: Metallic particles settled on the pool
ladder steps
Location: Citizen 7's Residence
TCEQ Incident No. 258039
City: Portland
County: San Patricio
Date: May 17, 2017
Photographer: Ashley Scott, Air Investigator
Digital File Location:
TCEQ Corpus Christi Regional Office
Photo No. 17

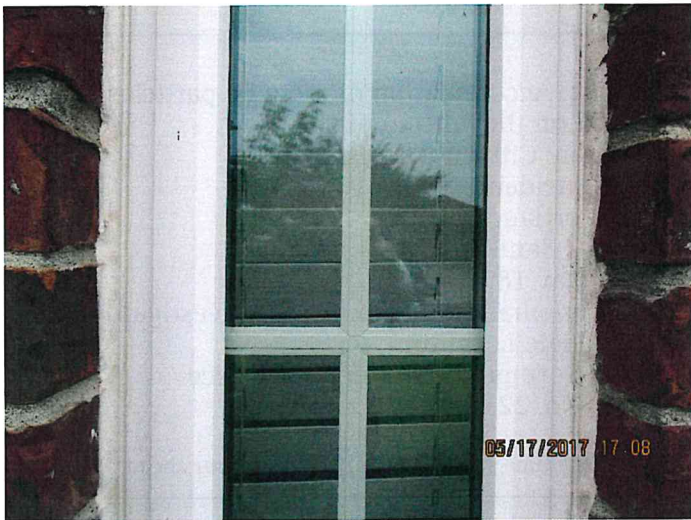
Subject: Location of Sample No. 1705012-006;
front window glass
Location: Citizen 7's Residence
TCEQ Incident No. 258039
City: Portland
County: San Patricio
Date: May 17, 2017
Photographer: Ashley Scott, Air Investigator
Digital File Location:
TCEQ Corpus Christi Regional Office
Photo No. 19

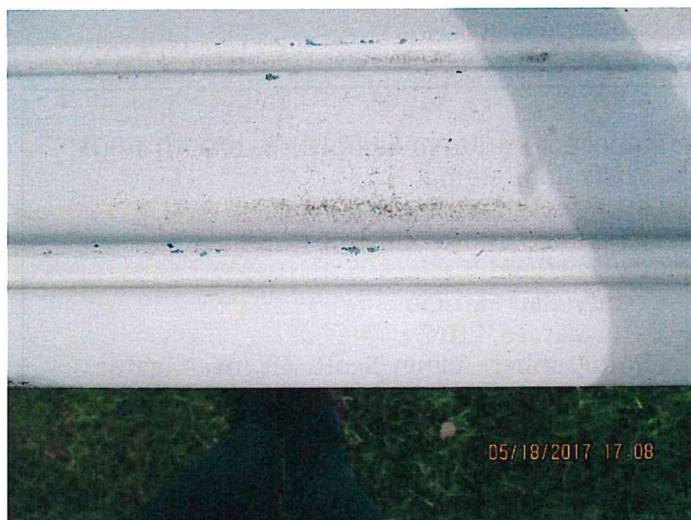
Subject: Location of Sample No. 1705014-007;
backyard pool ledge
Location: Citizen 8's Residence
TCEQ Incident No. 258158
City: Portland
County: San Patricio
Date: May 18, 2017
Photographer: Ashley Scott, Air Investigator
Digital File Location:
TCEQ Corpus Christi Regional Office
Photo No. 21

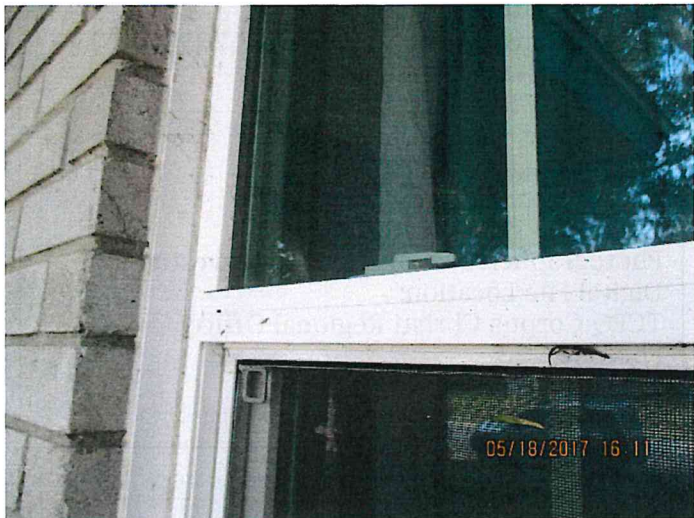
Subject: Location of Sample No. 1705014-002;
front window glass
Location: Citizen 10's Residence
TCEQ Incident No. 258147
City: Portland
County: San Patricio
Date: May 18, 2017
Photographer: Ashley Scott, Air Investigator
Digital File Location:
TCEQ Corpus Christi Regional Office
Photo No. 25

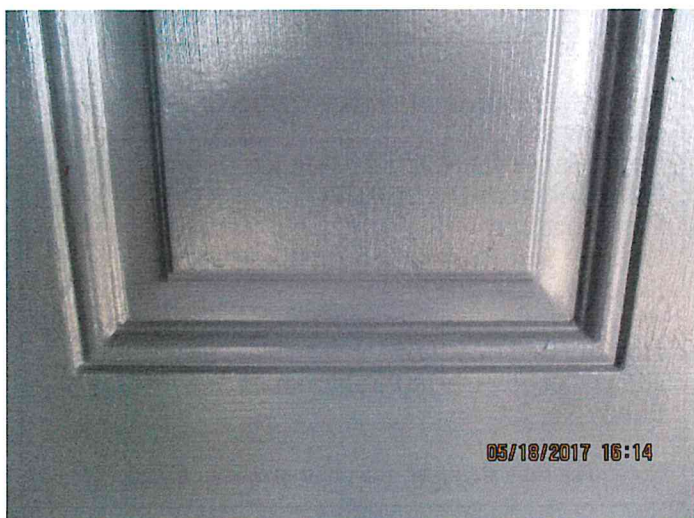
Subject: Location of Sample No. 1705014-003;
front door
Location: Citizen 10's Residence
TCEQ Incident No. 258147
City: Portland
County: San Patricio
Date: May 18, 2017
Photographer: Ashley Scott, Air Investigator
Digital File Location:
TCEQ Corpus Christi Regional Office
Photo No. 26

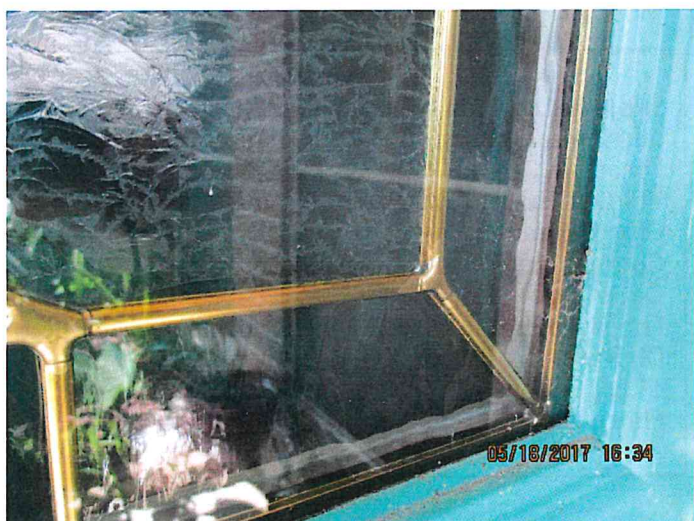
Subject: Location of Sample No. 1705014-004;
front door window glass
Location: Citizen 11's Residence
TCEQ Incident No. 258160
City: Portland
County: San Patricio
Date: May 18, 2017
Photographer: Ashley Scott, Air Investigator
Digital File Location:
TCEQ Corpus Christi Regional Office
Photo No. 27

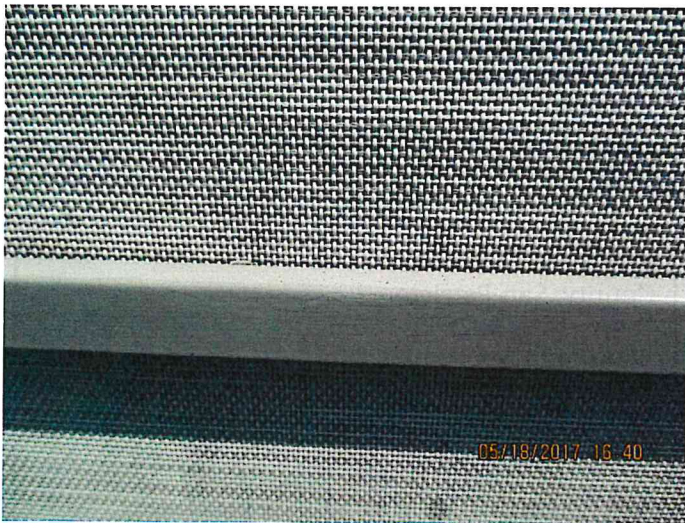
Subject: Location of Sample No. 1705014-005;
front window screen frame
Location: Citizen 11's Residence
TCEQ Incident No. 258160
City: Portland
County: San Patricio
Date: May 18, 2017
Photographer: Ashley Scott, Air Investigator
Digital File Location:
TCEQ Corpus Christi Regional Office
Photo No. 28

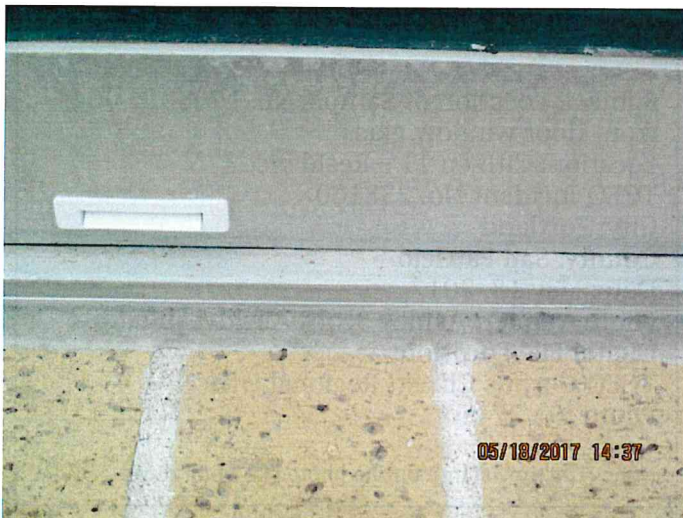
Subject: Location of sample collection-back
window sill
Location: Citizen 12's Residence
TCEQ Incident No. 258146
City: Portland
County: San Patricio
Date: May 18, 2017
Photographer: Ashley Scott, Air Investigator
Digital File Location:
TCEQ Corpus Christi Regional Office
Photo No. 29

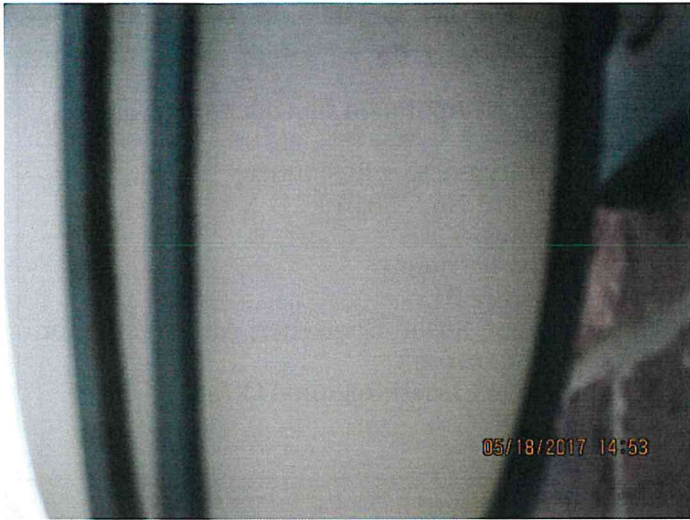
Subject: Location of Sample No. 1705013-002;
outdoor light glass cover
Location: Citizen 14's Residence
TCEQ Incident No. 258138
City: Portland
County: San Patricio
Date: May 18, 2017
Photographer: Susan Hoelscher, Air Investigator
Digital File Location:
TCEQ Corpus Christi Regional Office
Photo No. 31

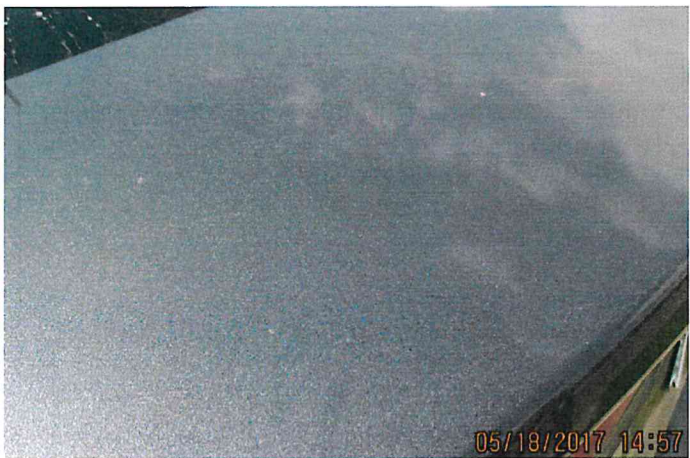
Subject: Location of Sample No. 1705013-003;
front window sill
Location: Citizen 14's Residence
TCEQ Incident No. 258138
City: Portland
County: San Patricio
Date: May 18, 2017
Photographer: Susan Hoelscher, Air Investigator
Digital File Location:
TCEQ Corpus Christi Regional Office
Photo No. 32

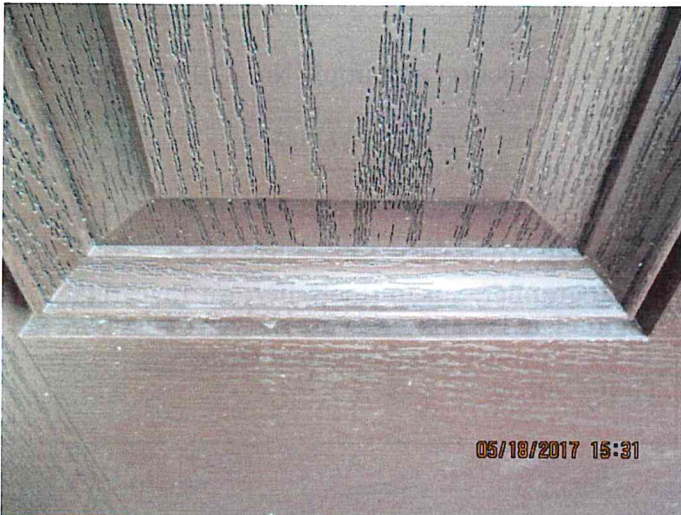
Subject: Location of Sample No. 1705013-005; front window sill
Location: Citizen 16's Residence
TCEQ Incident No. 258170
City: Portland
County: San Patricio
Date: May 18, 2017
Photographer: Susan Hoelscher, Air Investigator
Digital File Location:
TCEQ Corpus Christi Regional Office
Photo No. 35

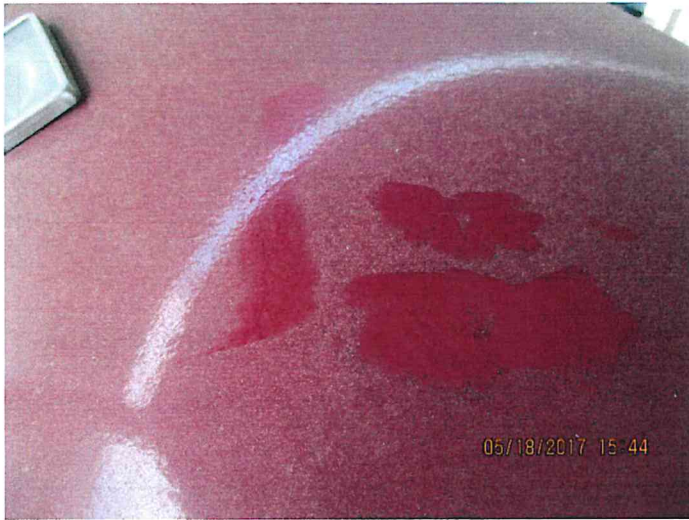
Subject: Location of Sample No. 1705013-006; front door
Location: Citizen 16's Residence
TCEQ Incident No. 258170
City: Portland
County: San Patricio
Date: May 18, 2017
Photographer: Susan Hoelscher, Air Investigator
Digital File Location:
TCEQ Corpus Christi Regional Office
Photo No. 36

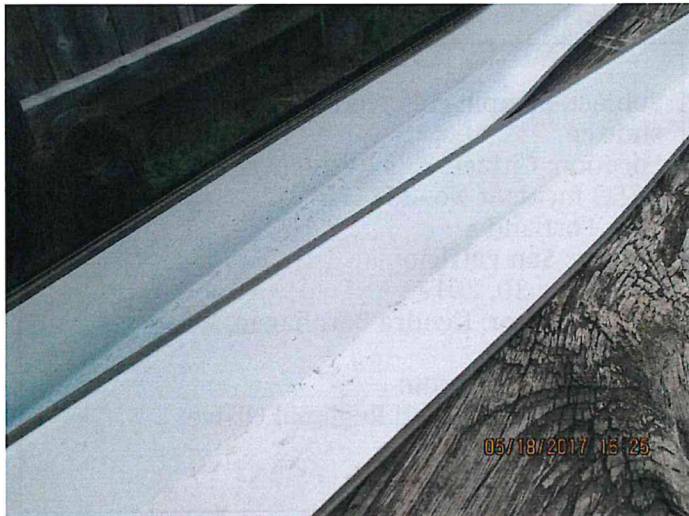
Subject: Location of sample collection-BBQ pit located in backyard
Location: Citizen 17's Residence
TCEQ Incident No. 258140
City: Portland
County: San Patricio
Date: May 18, 2017
Photographer: Susan Hoelscher, Air Investigator
Digital File Location:
TCEQ Corpus Christi Regional Office
Photo No. 37

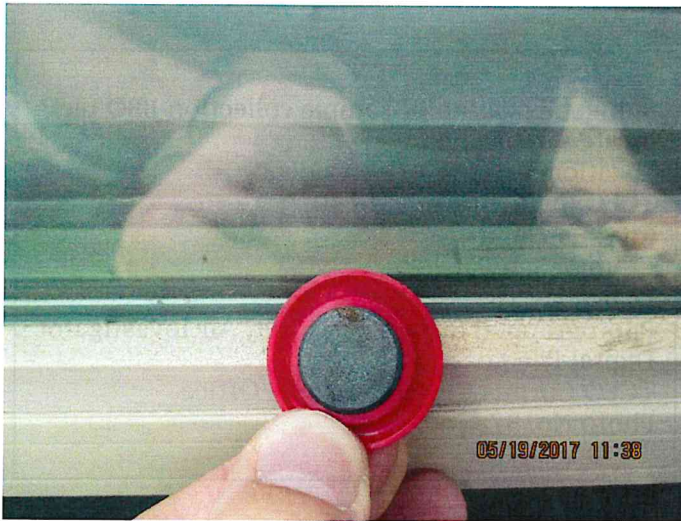
Subject: Location of sample collection-front window sill
Location: Citizen 21's Residence
TCEQ Incident No. 258162
City: Portland
County: San Patricio
Date: May 19, 2017
Photographer: Andrew Kiss, Air Investigator
Digital File Location:
TCEQ Corpus Christi Regional Office
Photo No. 39

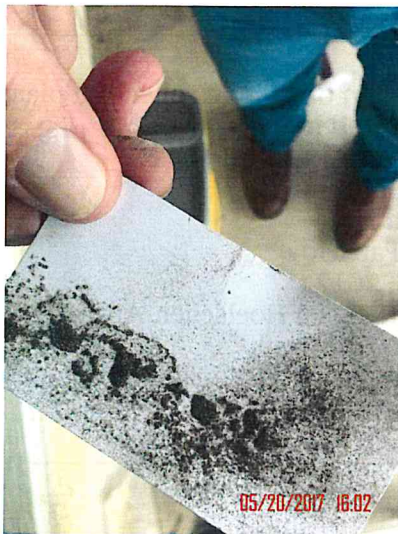
Subject: Location of sample collection-front window ledge
Location: Citizen 22's Residence
TCEQ Incident No. 258169
City: Portland
County: San Patricio
Date: May 19, 2017
Photographer: Susan Hoelscher, Air Investigator
Digital File Location:
TCEQ Corpus Christi Regional Office
Photo No. 40

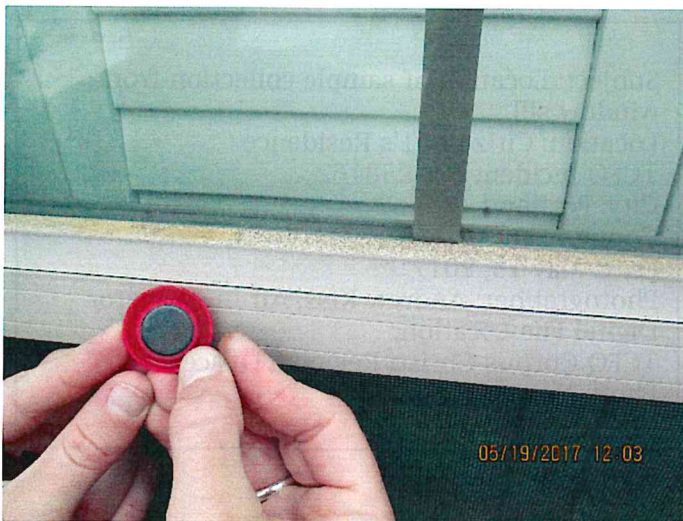
Subject: Sample collected from front window shutter
Location: Citizen 23's Residence
TCEQ Incident No. 258176
City: Portland
County: San Patricio
Date: May 20, 2017
Photographer: Kendra Bernhagen, Waste Investigator
Digital File Location:
TCEQ Corpus Christi Regional Office
Photo No. 41

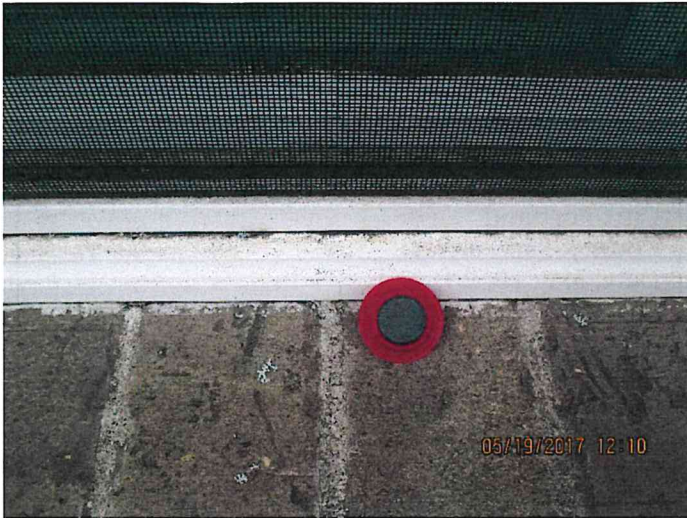
Subject: Location of sample collection-front window ledge
Location: Citizen 24's Residence
TCEQ Incident No. 258201
City: Portland
County: San Patricio
Date: May 19, 2017
Photographer: Andrew Kiss, Air Investigator
Digital File Location:
TCEQ Corpus Christi Regional Office
Photo No. 42

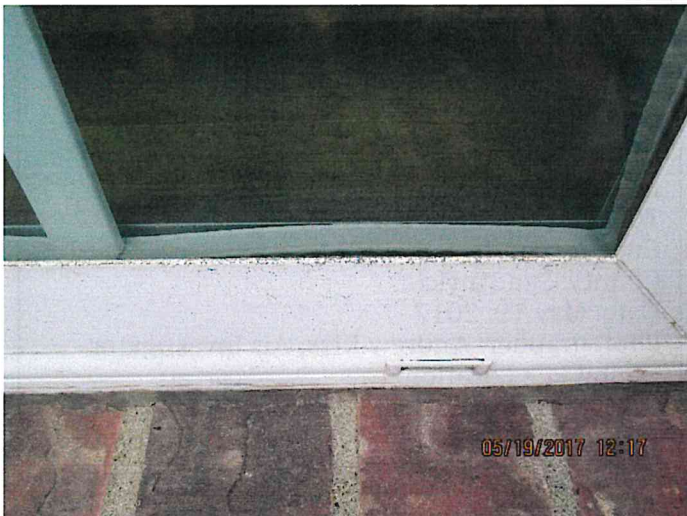
Subject: Location of sample collection-front window sill
Location: Citizen 25's Residence
TCEQ Incident No. 258243
City: Portland
County: San Patricio
Date: May 19, 2017
Photographer: Andrew Kiss, Air Investigator
Digital File Location:
TCEQ Corpus Christi Regional Office
Photo No. 43

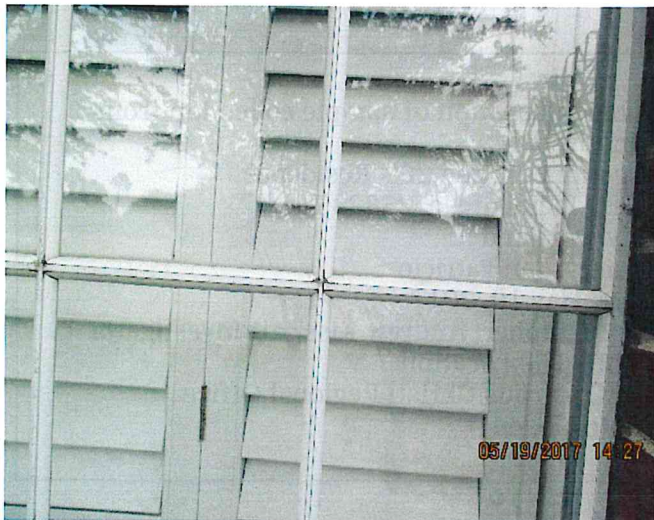
Subject: Location of sample collection-front window glass
Location: Citizen 27's Residence
TCEQ Incident No. 258251
City: Portland
County: San Patricio
Date: May 19, 2017
Photographer: Andrew Kiss, Air Investigator
Digital File Location:
TCEQ Corpus Christi Regional Office
Photo No. 46

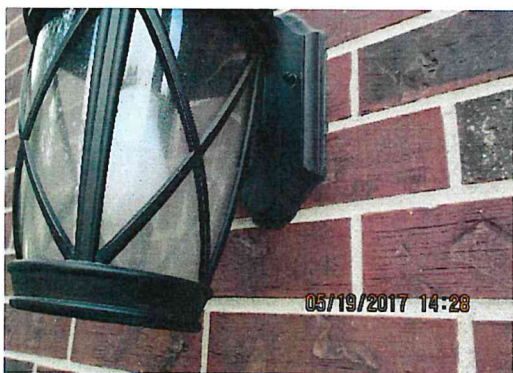
Subject: Location of Sample No. 1705016-004;
outdoor light glass cover
Location: Citizen 28's Residence
TCEQ Incident No. 258235
City: Portland
County: San Patricio
Date: May 19, 2017
Photographer: Andrew Kiss, Air Investigator
Digital File Location:
TCEQ Corpus Christi Regional Office
Photo No. 48

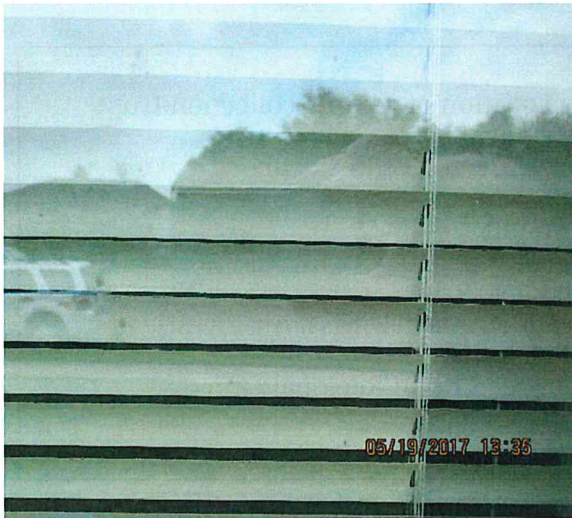
Subject: Location of Sample No. 1705016-001;
front window glass
Location: Citizen 29's Residence
TCEQ Incident No. 258250
City: Portland
County: San Patricio
Date: May 19, 2017
Photographer: Andrew Kiss, Air Investigator
Digital File Location:
TCEQ Corpus Christi Regional Office
Photo No. 49

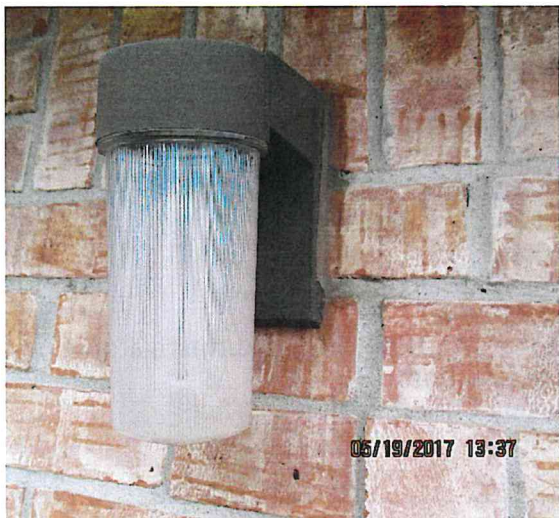
Subject: Location of Sample No. 1705016-002;
outdoor light plastic cover
Location: Citizen 29's Residence
TCEQ Incident No. 258250
City: Portland
County: San Patricio
Date: May 19, 2017
Photographer: Andrew Kiss, Air Investigator
Digital File Location:
TCEQ Corpus Christi Regional Office
Photo No. 50

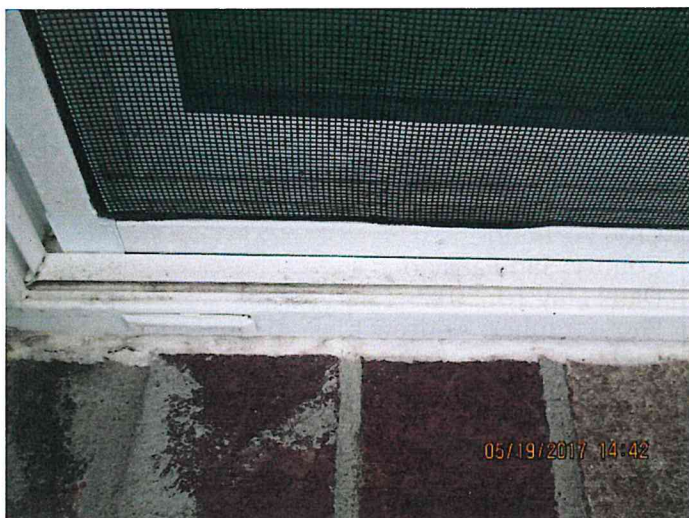
Subject: Location of sample collection-front
window sill
Location: Citizen 31's Residence
TCEQ Incident No. 258232
City: Portland
County: San Patricio
Date: May 19, 2017
Photographer: Andrew Kiss, Air Investigator
Digital File Location:
TCEQ Corpus Christi Regional Office
Photo No. 51

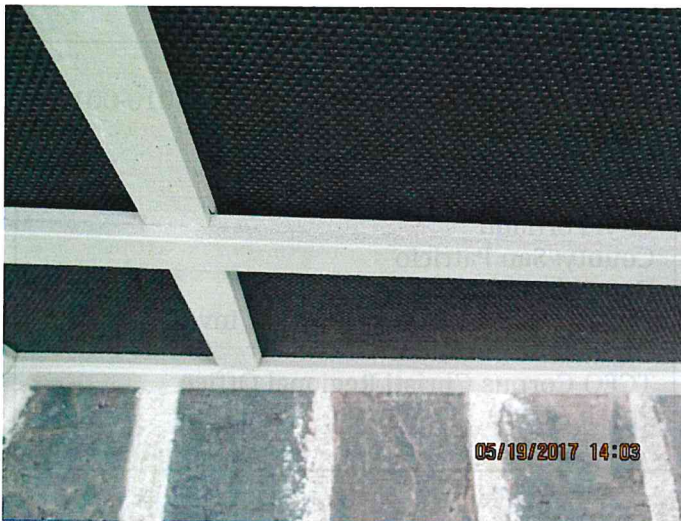
Subject: Location of sample collection-front window screen framework
Location: Citizen 32's Residence
TCEQ Incident No. 258248
City: Portland
County: San Patricio
Date: May 19, 2017
Photographer: Andrew Kiss, Air Investigator
Digital File Location:
TCEQ Corpus Christi Regional Office
Photo No. 52

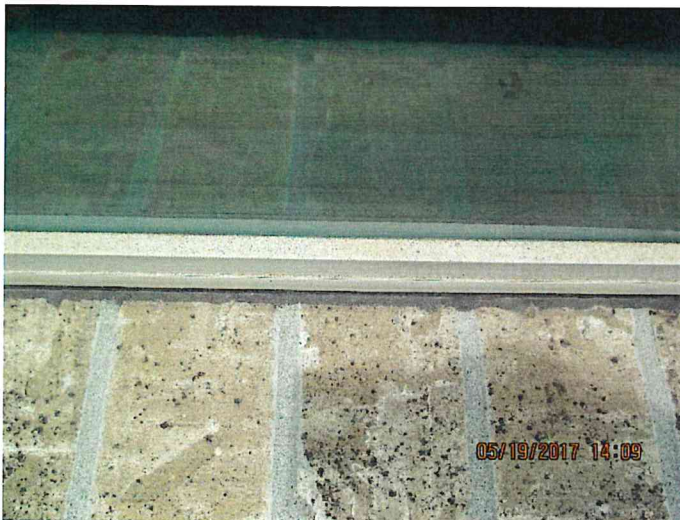
Subject: Location of sample collection-front window sill
Location: Citizen 33's Residence
TCEQ Incident No. 258242
City: Portland
County: San Patricio
Date: May 19, 2017
Photographer: Andrew Kiss, Air Investigator
Digital File Location:
TCEQ Corpus Christi Regional Office
Photo No.53

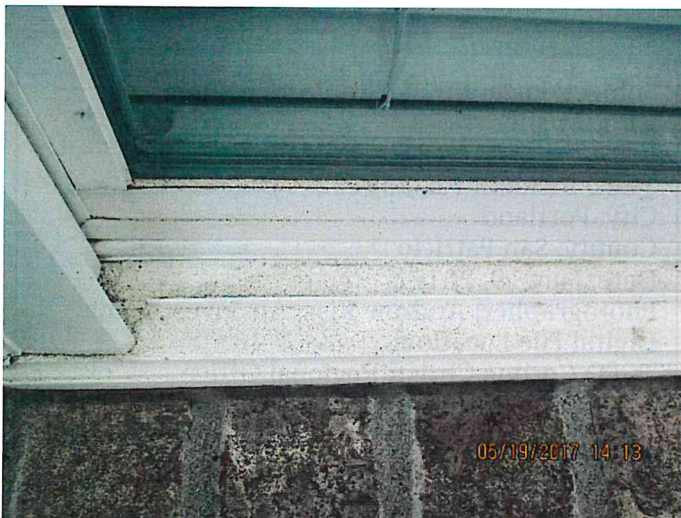
Subject: Location of sample collection-front window sill
Location: Citizen 34's Residence
TCEQ Incident No. 258244
City: Portland
County: San Patricio
Date: May 19, 2017
Photographer: Andrew Kiss, Air Investigator
Digital File Location:
TCEQ Corpus Christi Regional Office
Photo No. 54

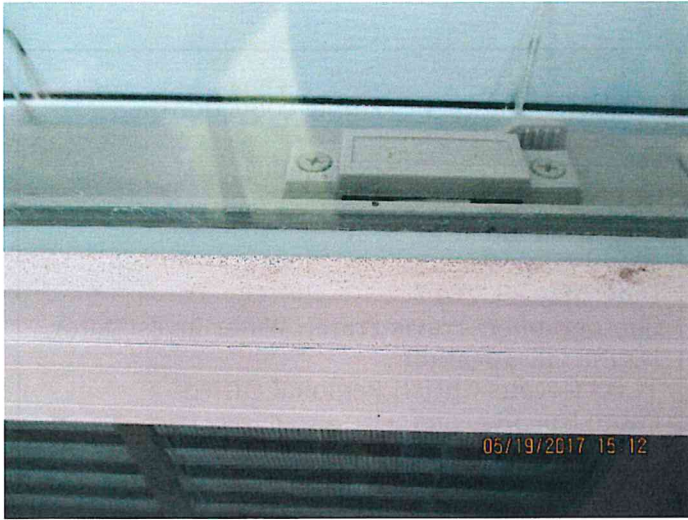
Subject: Location of sample collection-front window ledge
Location: Citizen 35's Residence
TCEQ Incident No. 258264
City: Portland
County: San Patricio
Date: May 19, 2017
Photographer: Andrew Kiss, Air Investigator
Digital File Location:
TCEQ Corpus Christi Regional Office
Photo No. 55

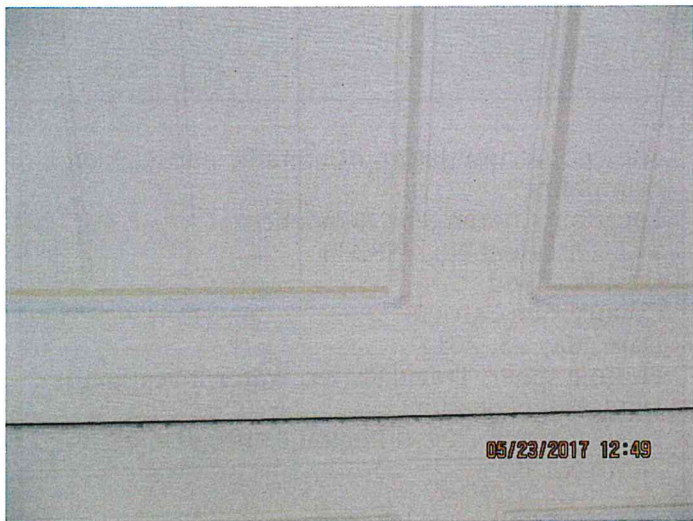
Subject: Location of sample collection-garage door
Location: Citizen 36's Residence
TCEQ Incident No. 258283
City: Portland
County: San Patricio
Date: May 23, 2017
Photographer: Travis Prater, Water Investigator
Digital File Location:
TCEQ Corpus Christi Regional Office
Photo No. 57

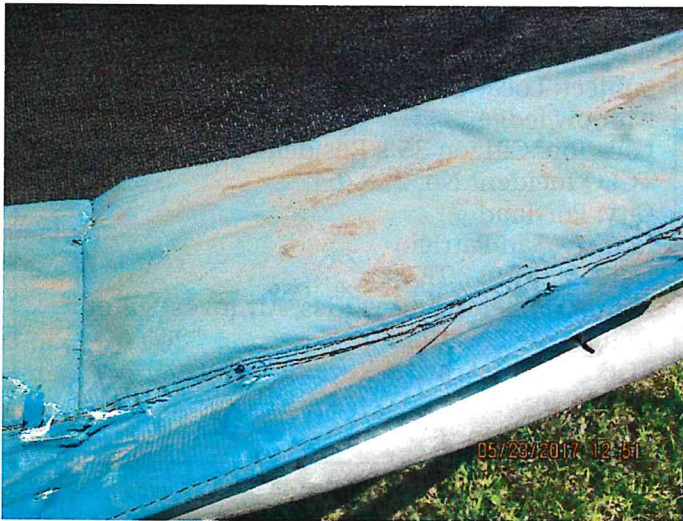
Subject: Location of sample collection-
trampoline
Location: Citizen 36's Residence
TCEQ Incident No. 258283
City: Portland
County: San Patricio
Date: May 23, 2017
Photographer: Travis Prater, Water Investigator
Digital File Location:
TCEQ Corpus Christi Regional Office
Photo No. 58

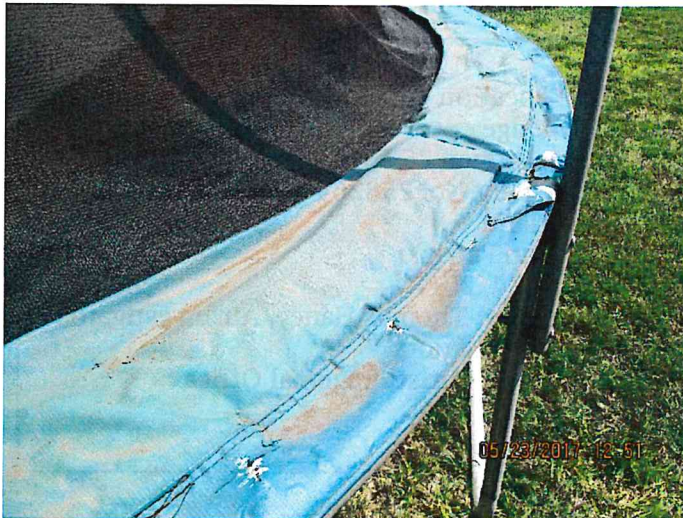
Subject: Accumulation of metallic particles on
trampoline
Location: Citizen 36's Residence
TCEQ Incident No. 258283
City: Portland
County: San Patricio
Date: May 23, 2017
Photographer: Travis Prater, Water Investigator
Digital File Location:
TCEQ Corpus Christi Regional Office
Photo No. 59

Failure to prevent nuisance dust conditions. Specifically, Voestalpine Texas LLC failed to prevent a discharge from any source whatsoever one or more air contaminants or combinations thereof, in such concentration and of such duration as are or may tend to be injurious to or to adversely affect human health or welfare, animal life, vegetation, or property, or as to interfere with the normal use and enjoyment of animal life, vegetation, or property. Based upon a response to 141 citizen complaints received on May 16, 2017, May 17, 2017, May 18, 2017, May 19, 2017, May 20, 2017, May 21, 2017, May 22, 2017, May 23, 2017, May 24, 2017, May 25, 2017, May 26, 2017, May 30, 2017, May 31, 2017, June 2, 2017, June 5, 2017, June 7, 2017, June 8, 2017, June 12, 2017, June 13, 2017, June 14, 2017, June 16, 2017, June 19, 2017, June 20, 2017, June 22, 2017, June 27, 2017, June 30, 2017, July 18, 2017, August 24, 2017, and October 13, 2017, by the TCEQ's onsite observations, analyses of samples collected, and review of citizen collected evidence, it was determined that deposits of particulate matter (iron ore dust) from the La Quinta Plant were found in sufficient concentration and of such duration to interfere with normal use and enjoyment of property. Nuisance dust conditions were documented on May 16, 2017, May 17, 2017, May 18, 2017, May 19, 2017, May 20, 2017, May 23, 2017, May 24, 2017, May 25, 2017, May 26, 2017, May 30, 2017, June 2, 2017, June 5, 2017, June 8, 2017, June 13, 2017, June 15, 2017, June 23, 2017, June 30, 2017, July 13, 2017, July 19, 2017, September 8, 2017, and October 16, 2017.

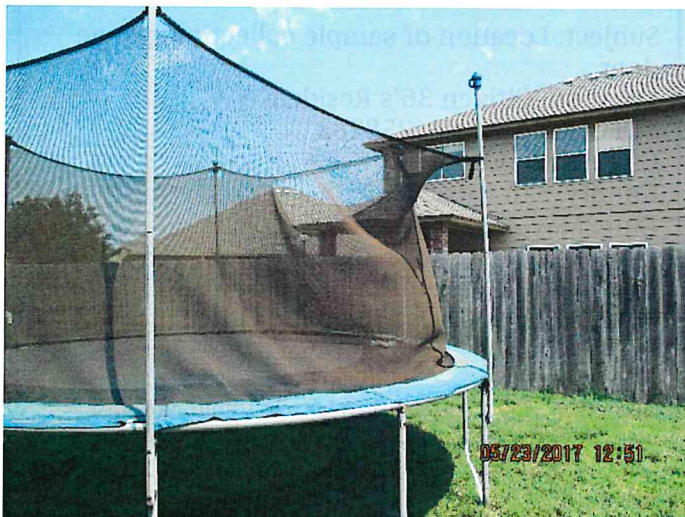
Subject: Accumulation of metallic particles on
trampoline
Location: Citizen 36's Residence
TCEQ Incident No. 258283
City: Portland
County: San Patricio
Date: May 23, 2017
Photographer: Travis Prater, Water Investigator
Digital File Location:
TCEQ Corpus Christi Regional Office
Photo No. 60

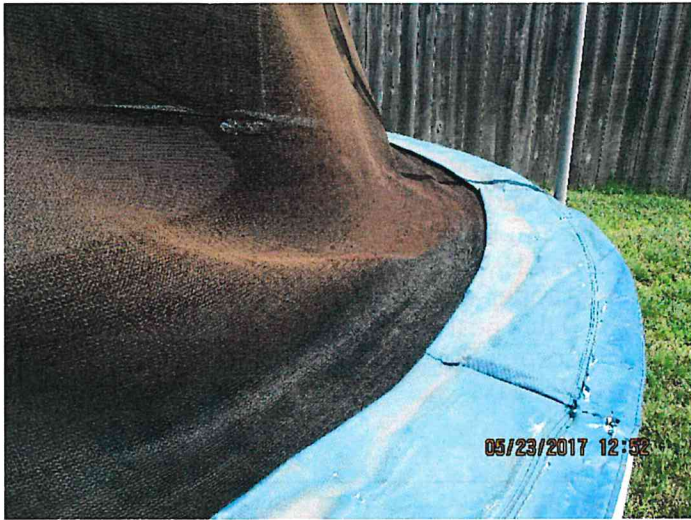
Subject: Accumulation of metallic particles on trampoline
Location: Citizen 36's Residence
TCEQ Incident No. 258283
City: Portland
County: San Patricio
Date: May 23, 2017
Photographer: Travis Prater, Water Investigator
Digital File Location:
TCEQ Corpus Christi Regional Office
Photo No. 61

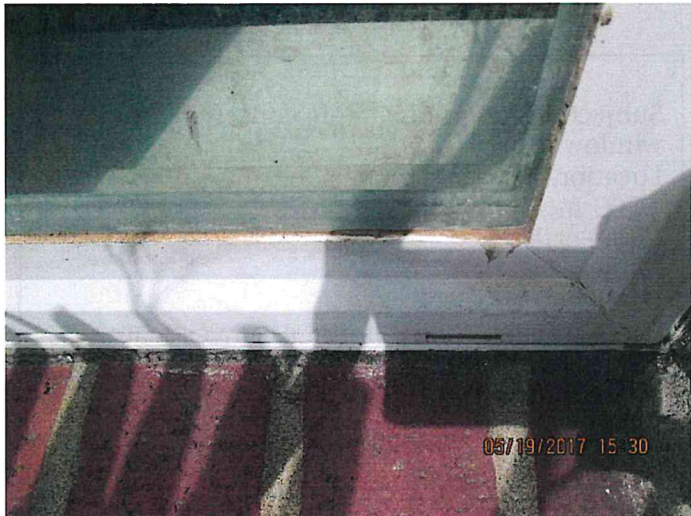
Subject: Location of sample collection-front window sill
Location: Citizen 37's Residence
TCEQ Incident No. 258285
City: Portland
County: San Patricio
Date: May 19, 2017
Photographer: Andrew Kiss, Air Investigator
Digital File Location:
TCEQ Corpus Christi Regional Office
Photo No. 62

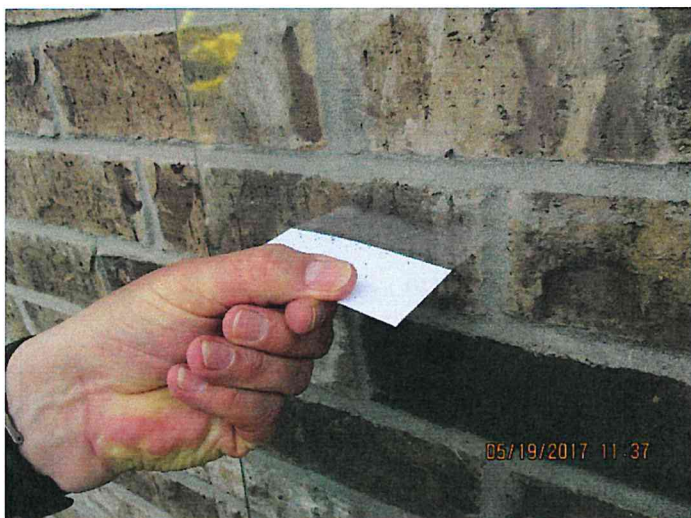
Subject: Location of sample collection-glass window pane on side of residence
Location: Citizen 38's Residence
TCEQ Incident No. 258166
City: Portland
County: San Patricio
Date: May 19, 2017
Photographer: Cindy Smith, Air Investigator
Digital File Location:
TCEQ Corpus Christi Regional Office
Photo No. 63

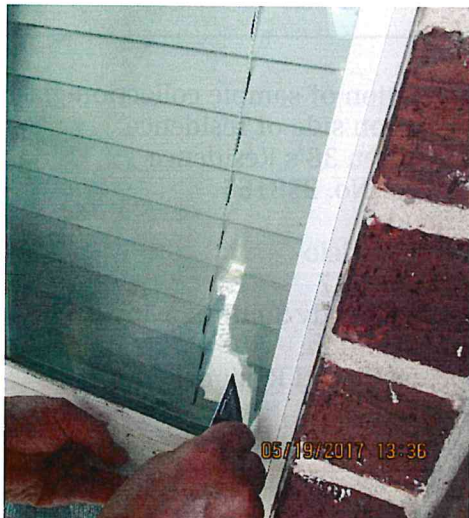
Subject: Location of sample collection-front
window ledge
Location: Citizen 42's Residence
TCEQ Incident No. 258177
City: Portland
County: San Patricio
Date: May 19, 2017
Photographer: Cindy Smith, Air Investigator
Digital File Location:
TCEQ Corpus Christi Regional Office
Photo No. 66

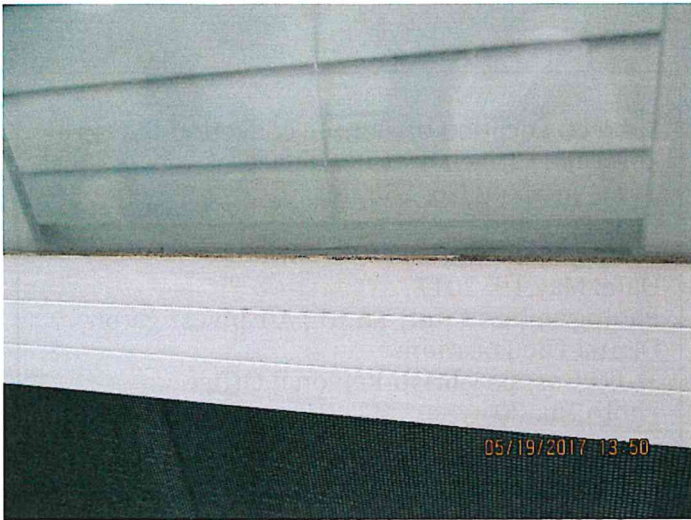
Subject: Location of sample collection-front window ledge
Location: Citizen 43's Residence
TCEQ Incident No. 258299
City: Portland
County: San Patricio
Date: May 19, 2017
Photographer: Cindy Smith, Air Investigator
Digital File Location:
TCEQ Corpus Christi Regional Office
Photo No. 67

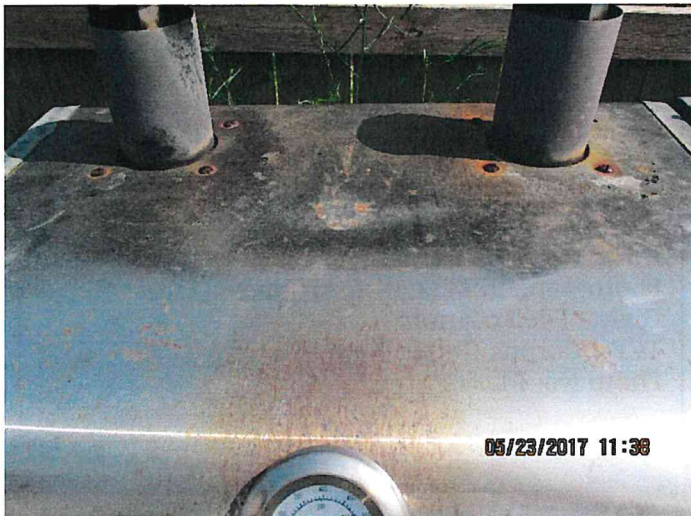
Subject: Location of sample collection-outdoor grill
Location: Citizen 44's Residence
TCEQ Incident No. 258226
City: Portland
County: San Patricio
Date: May 23, 2017
Photographer: Travis Prater, Water Investigator
Digital File Location:
TCEQ Corpus Christi Regional Office
Photo No. 68

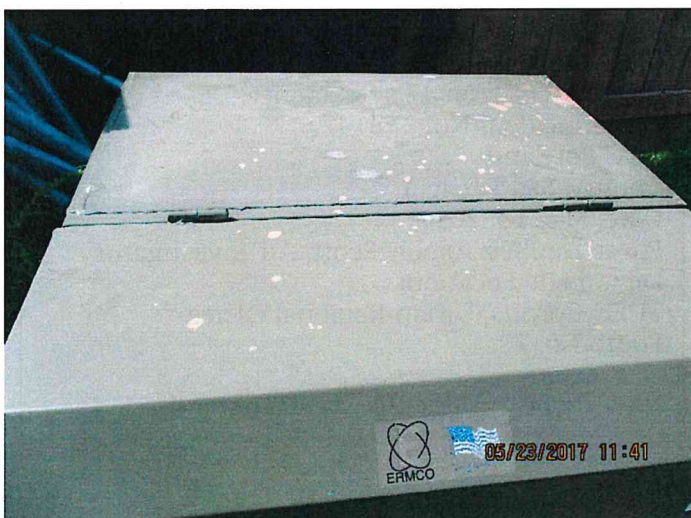
Subject: Location of sample collection-electric box
Location: Citizen 44's Residence
TCEQ Incident No. 258226
City: Portland
County: San Patricio
Date: May 23, 2017
Photographer: Travis Prater, Water Investigator
Digital File Location:
TCEQ Corpus Christi Regional Office
Photo No. 69

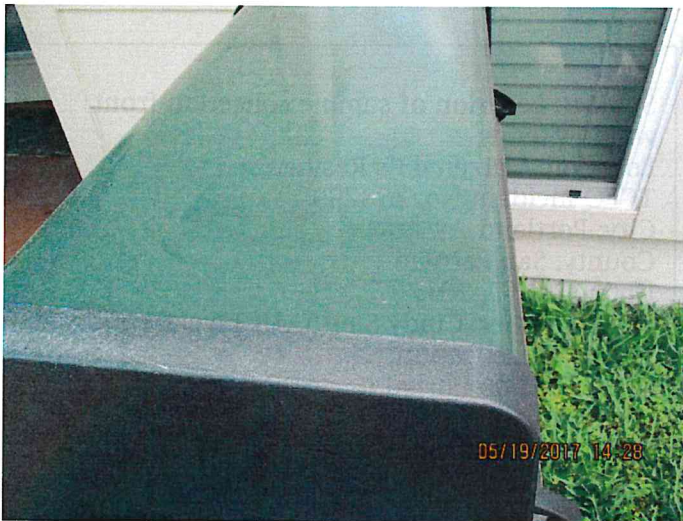
Subject: Location of sample collection-BBQ grill
Location: Citizen 45's Residence
TCEQ Incident No. 258230
City: Portland
County: San Patricio
Date: May 19, 2017
Photographer: Cindy Smith, Air Investigator
Digital File Location:
TCEQ Corpus Christi Regional Office
Photo No. 70

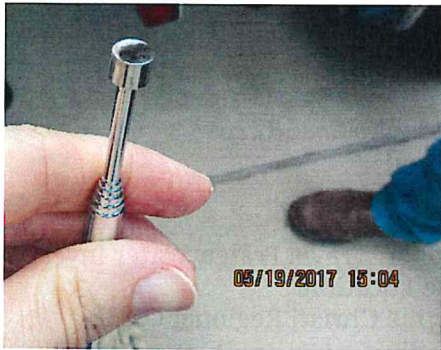
Subject: Magnetic property of metallic particles accumulation on vehicle
Location: Citizen 46's Residence
TCEQ Incident No. 258263
City: Portland
County: San Patricio
Date: May 19, 2017
Photographer: Mike Riff, Air Investigator
Digital File Location:
TCEQ Corpus Christi Regional Office
Photo No. 71

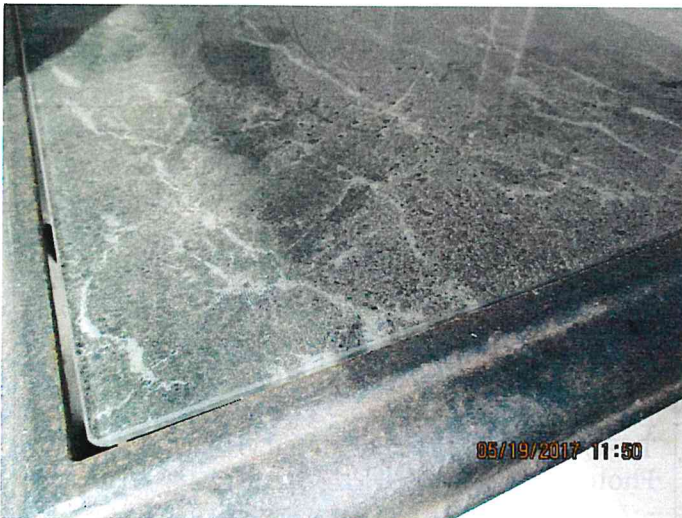
Subject: Location of sample collection-patio table
Location: Citizen 47's Residence
TCEQ Incident No. 258142
City: Portland
County: San Patricio
Date: May 19, 2017
Photographer: Ashley Scott, Air Investigator
Digital File Location:
TCEQ Corpus Christi Regional Office
Photo No. 72

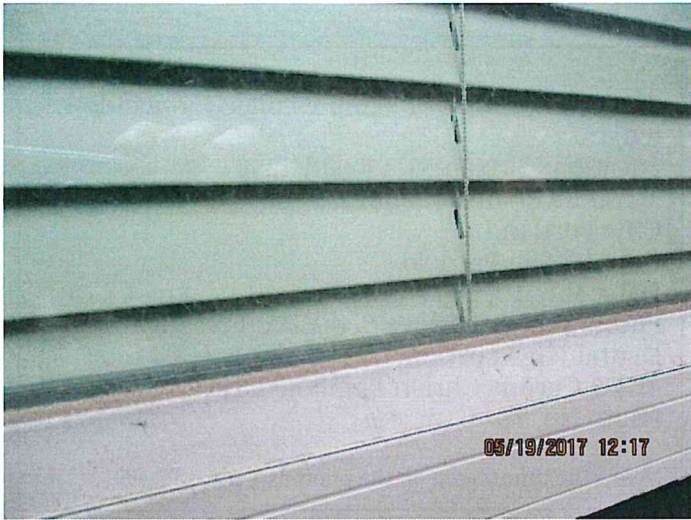
Subject: Location of sample collection-window ledge
Location: Citizen 49's Residence
TCEQ Incident No. 258150
City: Portland
County: San Patricio
Date: May 19, 2017
Photographer: Ashley Scott, Air Investigator
Digital File Location:
TCEQ Corpus Christi Regional Office
Photo No. 73

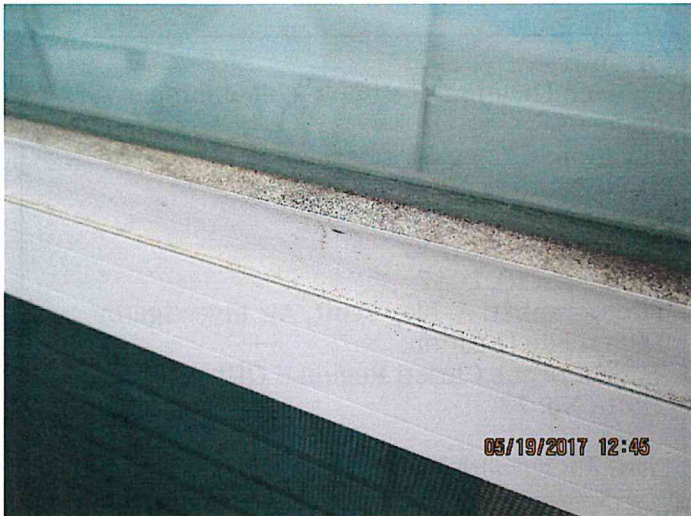
Subject: Location of sample collection-window ledge
Location: Citizen 50's Residence
TCEQ Incident No. 258171
City: Portland
County: San Patricio
Date: May 19, 2017
Photographer: Ashley Scott, Air Investigator
Digital File Location:
TCEQ Corpus Christi Regional Office
Photo No. 74
