AIR CP_106597875_CP_20171016_Investigation_1415945_
Texas Commission on Environmental Quality
Investigation Report

Regulated Entity Name: LA QUINTA PLANT

Investigation # 1415945

Investigation Type: Compliance Investigation

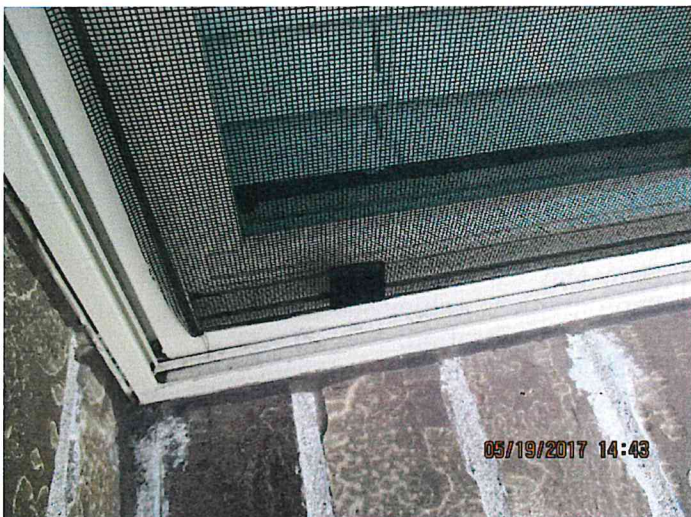
Subject: Location of sample collection-window sill
Location: Citizen 51's Residence
TCEQ Incident No. 258227
City: Portland
County: San Patricio
Date: May 19, 2017
Photographer: Ashley Scott, Air Investigator
Digital File Location:
TCEQ Corpus Christi Regional Office
Photo No. 75

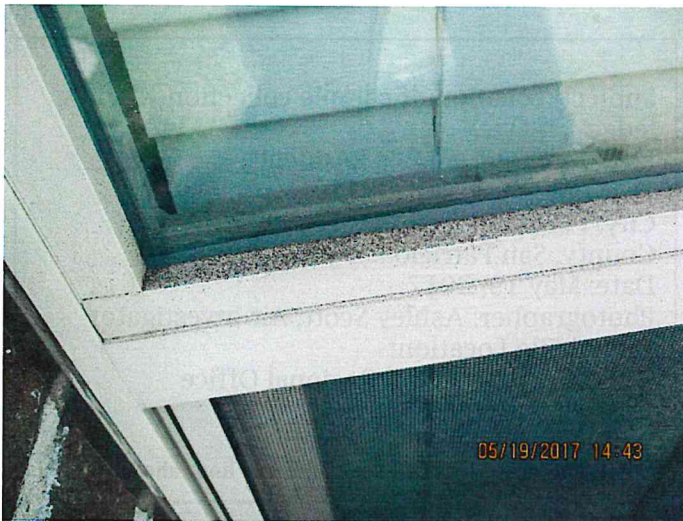
Subject: Location of sample collection-window ledge
Location: Citizen 51's Residence
TCEQ Incident No. 258227
City: Portland
County: San Patricio
Date: May 19, 2017
Photographer: Ashley Scott, Air Investigator
Digital File Location:
TCEQ Corpus Christi Regional Office
Photo No. 76

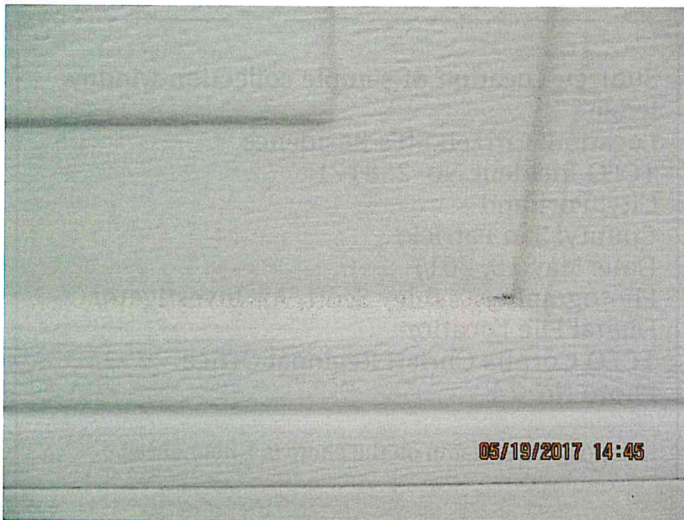
Subject: Location of sample collection-garage door
Location: Citizen 51's Residence
TCEQ Incident No. 258227
City: Portland
County: San Patricio
Date: May 19, 2017
Photographer: Ashley Scott, Air Investigator
Digital File Location:
TCEQ Corpus Christi Regional Office
Photo No. 77

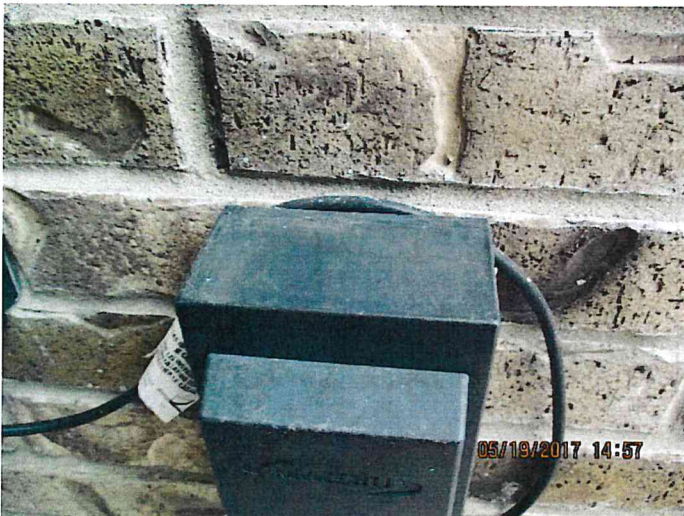
Subject: Location of sample collection-junction box
Location: Citizen 52's Residence
TCEQ Incident No. 258167
City: Portland
County: San Patricio
Date: May 19, 2017
Photographer: Ashley Scott, Air Investigator
Digital File Location:
TCEQ Corpus Christi Regional Office
Photo No. 78

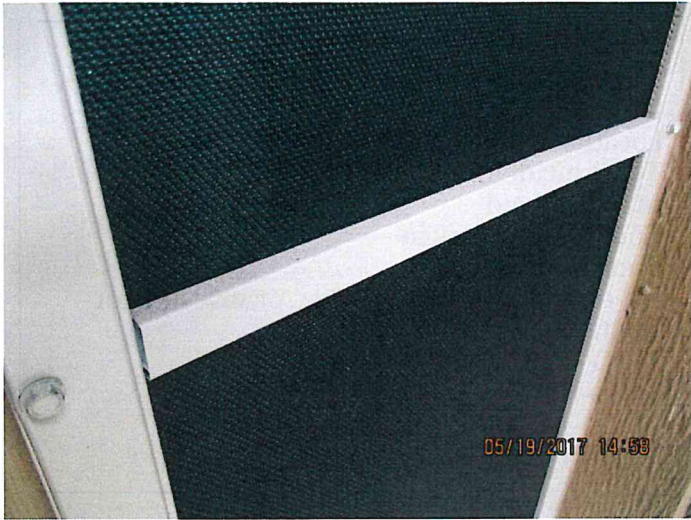
Subject: Location of sample collection-window
screen framework
Location: Citizen 52's Residence
TCEQ Incident No. 258167
City: Portland
County: San Patricio
Date: May 19, 2017
Photographer: Ashley Scott, Air Investigator
Digital File Location:
TCEQ Corpus Christi Regional Office
Photo No. 79

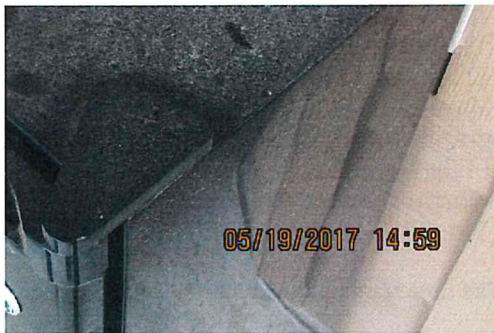
Subject: Location of sample collection-mini
refrigerator
Location: Citizen 52's Residence
TCEQ Incident No. 258167
City: Portland
County: San Patricio
Date: May 19, 2017
Photographer: Ashley Scott, Air Investigator
Digital File Location:
TCEQ Corpus Christi Regional Office
Photo No. 80

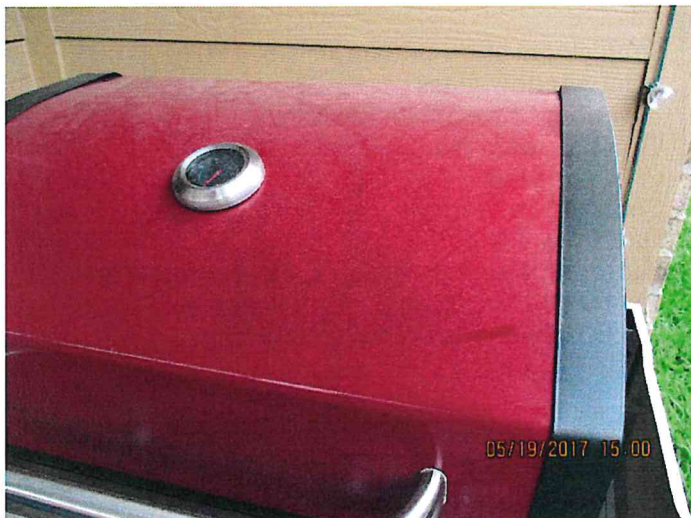
Subject: Location of sample collection-BBQ pit
Location: Citizen 52's Residence
TCEQ Incident No. 258167
City: Portland
County: San Patricio
Date: May 19, 2017
Photographer: Ashley Scott, Air Investigator
Digital File Location:
TCEQ Corpus Christi Regional Office
Photo No. 81

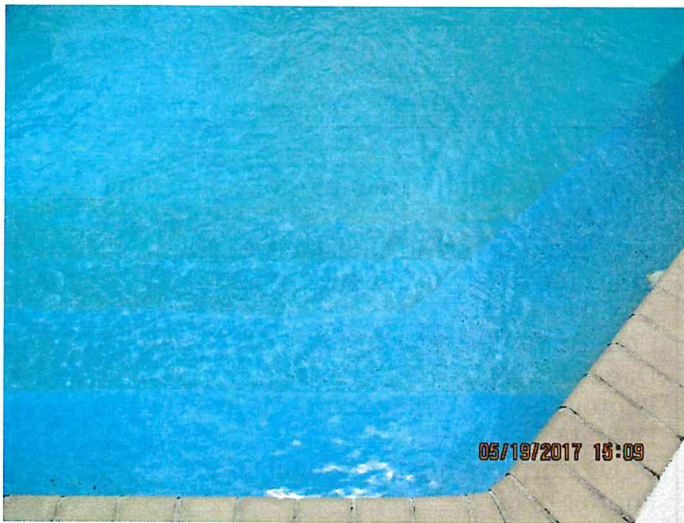
Subject: Accumulation of metallic particles settled on the bottom of the pool

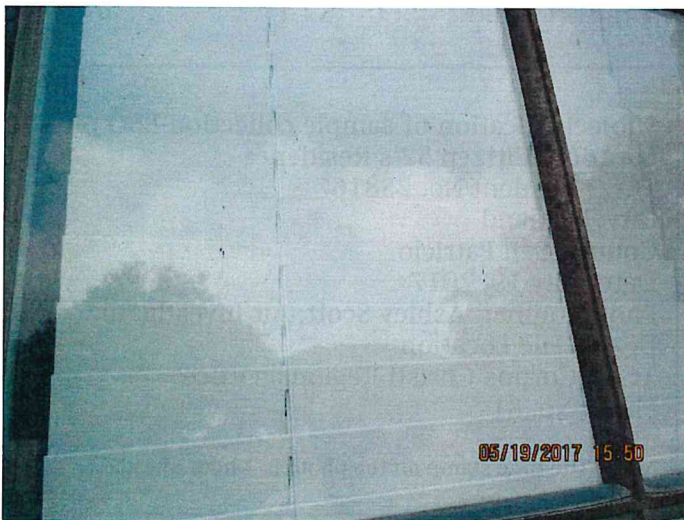
Subject: Location of Sample No. 1705016-005; front window glass

Location: Citizen 54's Residence

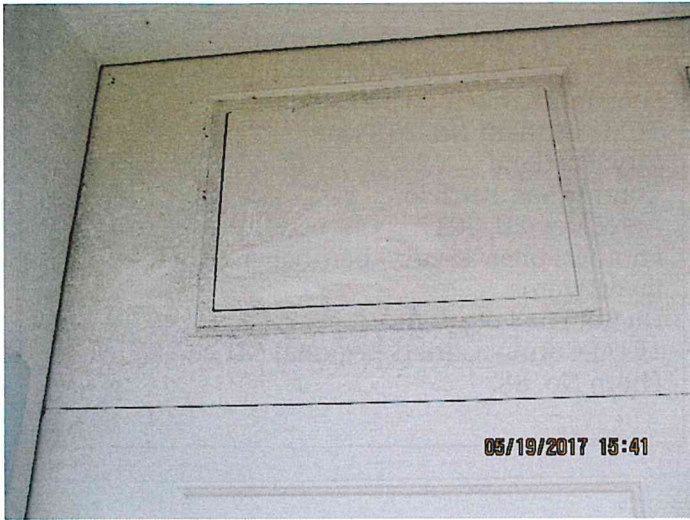
Subject: Location of Sample No. 1705016-006;
back garage door
Location: Citizen 54's Residence
TCEQ Incident No. 258203
City: Portland
County: San Patricio
Date: May 19, 2017
Photographer: Ashley Scott, Air Investigator
Digital File Location:
TCEQ Corpus Christi Regional Office
Photo No. 85

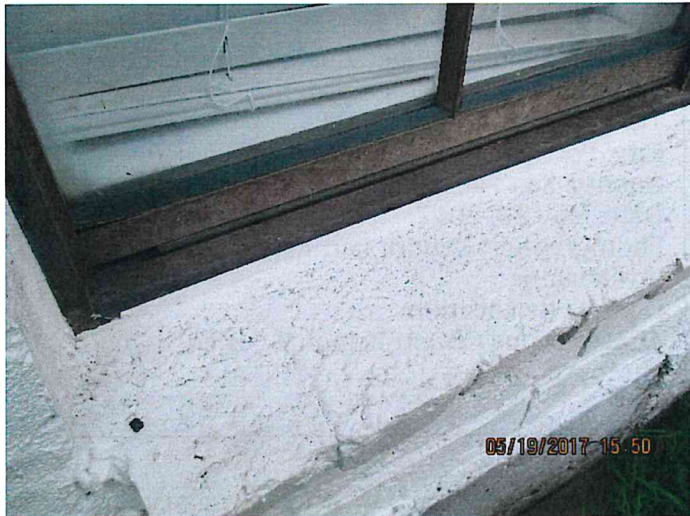
Subject: Location of sample collection-window
sill
Location: Citizen 55's Residence
TCEQ Incident No. 258223
City: Portland
County: San Patricio
Date: May 19, 2017
Photographer: Ashley Scott, Air Investigator
Digital File Location:
TCEQ Corpus Christi Regional Office
Photo No. 86

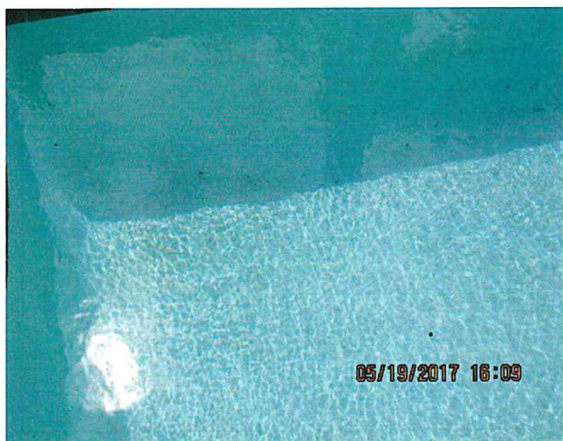
Subject: Accumulation of metallic particles
settled on the bottom of the pool
Location: Citizen 55's Residence
TCEQ Incident No. 258223
City: Portland
County: San Patricio
Date: May 19, 2017
Photographer: Ashley Scott, Air Investigator
Digital File Location:
TCEQ Corpus Christi Regional Office
Photo No. 87

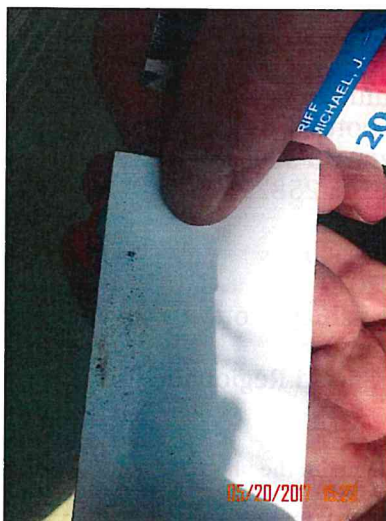
Subject: Sample collected from back window
Location: Citizen 58's Residence
TCEQ Incident No. 258309
City: Portland
County: San Patricio
Date: May 20, 2017
Photographer: Kendra Bernhagen, Waste Investigator
Digital File Location:
TCEQ Corpus Christi Regional Office
Photo No. 90

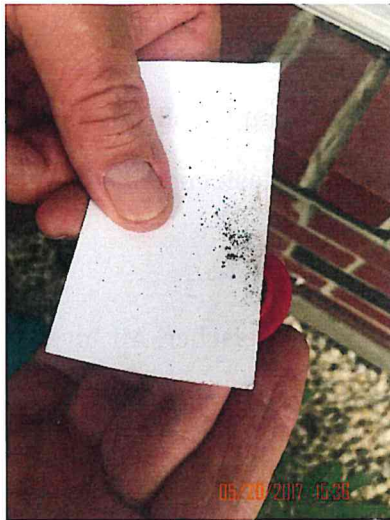
Subject: Sample collected from front window
Location: Citizen 59's Residence
TCEQ Incident No. 258287
City: Portland
County: San Patricio
Date: May 20, 2017
Photographer: Kendra Bernhagen, Waste Investigator
Digital File Location:
TCEQ Corpus Christi Regional Office
Photo No. 91

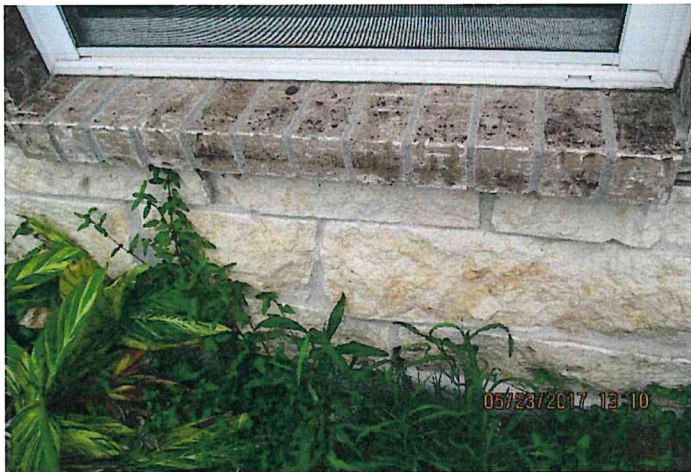
Subject: Location of sample collection-front window sill
Location: Citizen 60's Residence
TCEQ Incident No. 258415
City: Portland
County: San Patricio
Date: May 23, 2017
Photographer: Susan Hoelscher, Air Investigator
Digital File Location:
TCEQ Corpus Christi Regional Office
Photo No. 92

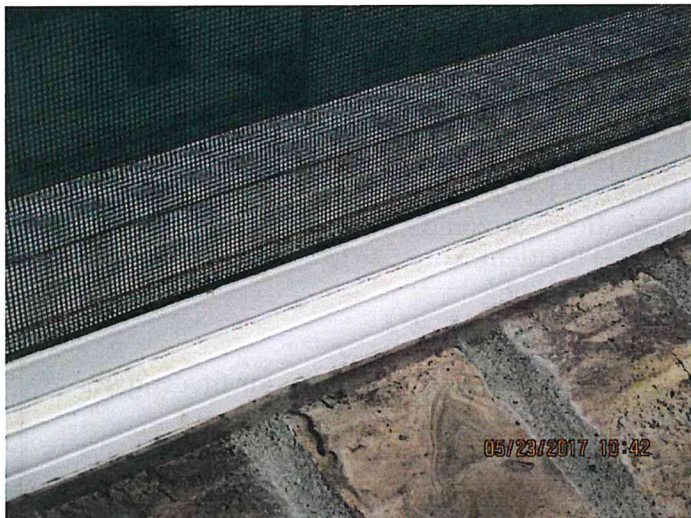
Subject: Location of sample collection-front window sill
Location: Citizen 61's Residence
TCEQ Incident No. 258282
City: Portland
County: San Patricio
Date: May 23, 2017
Photographer: Susan Hoelscher, Air Investigator
Digital File Location:
TCEQ Corpus Christi Regional Office
Photo No. 93

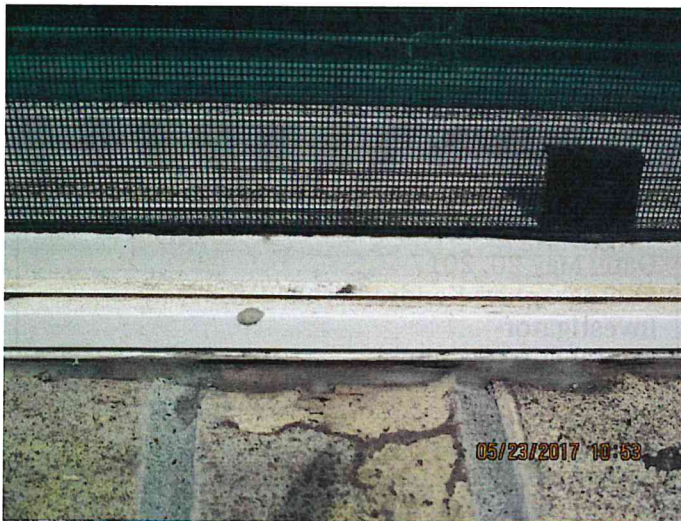
Subject: Location of sample collection-front window sill
Location: Citizen 62's Residence
TCEQ Incident No. 258199
City: Portland
County: San Patricio
Date: May 23, 2017
Photographer: Susan Hoelscher, Air Investigator
Digital File Location:
TCEQ Corpus Christi Regional Office
Photo No. 94

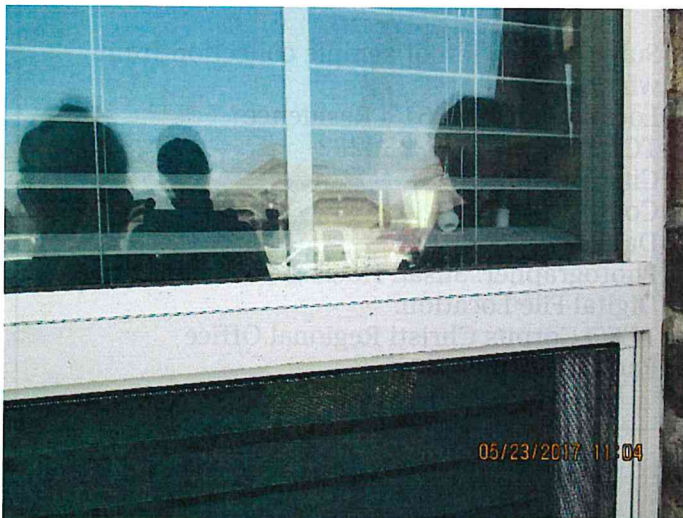
Subject: Location of sample collection-front window ledge
Location: Citizen 63's Residence
TCEQ Incident No. 258413
City: Portland
County: San Patricio
Date: May 23, 2017
Photographer: Karen Bridges, Air Investigator
Digital File Location:
TCEQ Corpus Christi Regional Office
Photo No. 96

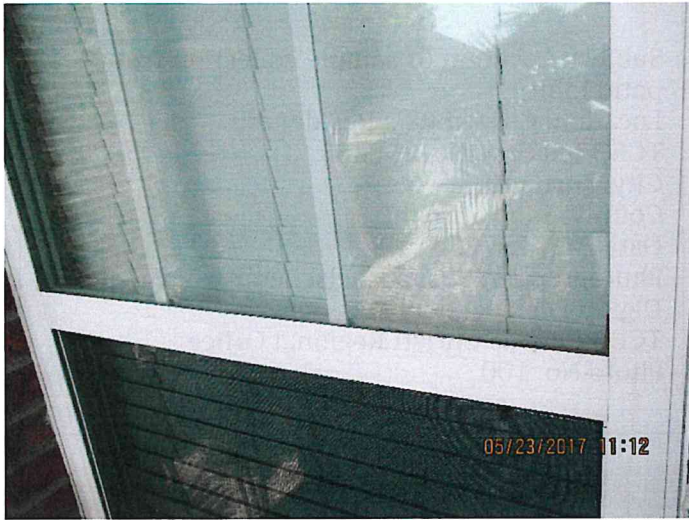
Subject: Location of sample collection-front window ledge
Location: Citizen 64's Residence
TCEQ Incident No. 258479
City: Portland
County: San Patricio
Date: May 23, 2017
Photographer: Susan Hoelscher, Air Investigator
Digital File Location:
TCEQ Corpus Christi Regional Office
Photo No. 97

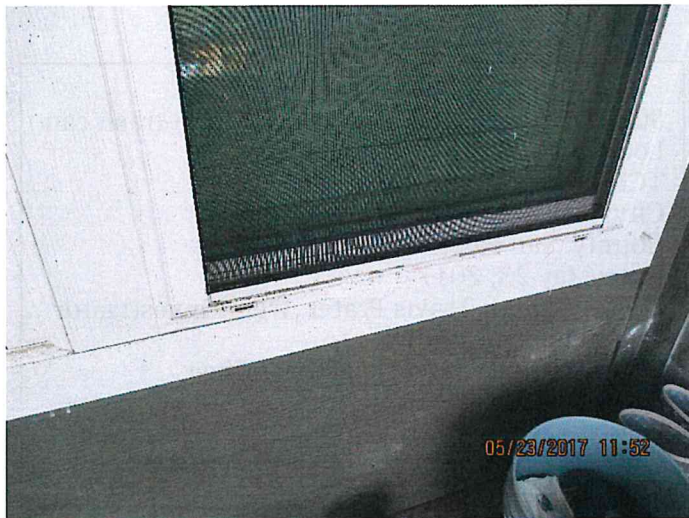
Subject: Location of sample collection-back porch window sill
Location: Citizen 67's Residence
TCEQ Incident No. 258408
City: Portland
County: San Patricio
Date: May 23, 2017
Photographer: Susan Hoelscher, Air Investigator
Digital File Location:
TCEQ Corpus Christi Regional Office
Photo No. 98

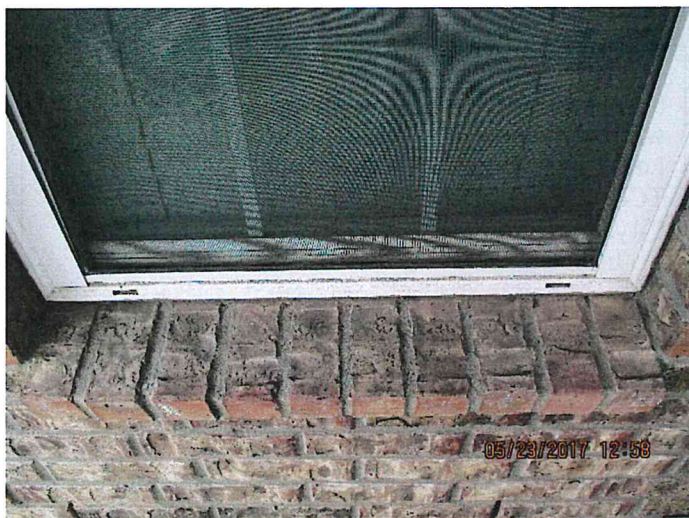
Subject: Location of sample collection-front window sill
Location: Citizen 68's Residence
TCEQ Incident No. 258485
City: Portland
County: San Patricio
Date: May 23, 2017
Photographer: Susan Hoelscher, Air Investigator
Digital File Location:
TCEQ Corpus Christi Regional Office
Photo No. 99

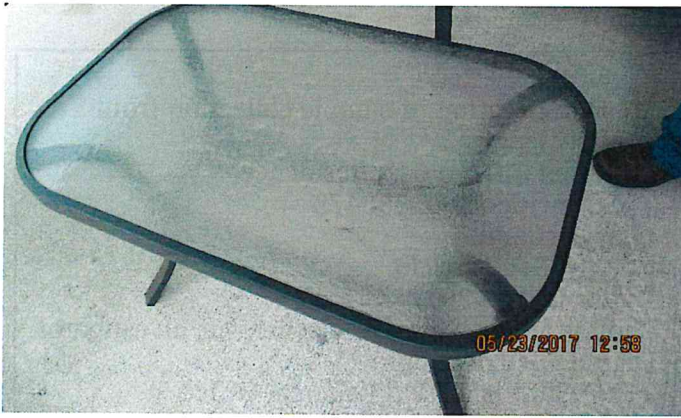
Subject: Location of sample collection-front patio table
Location: Citizen 68's Residence
TCEQ Incident No. 258485
City: Portland
County: San Patricio
Date: May 23, 2017
Photographer: Susan Hoelscher, Air Investigator
Digital File Location:
TCEQ Corpus Christi Regional Office
Photo No. 100

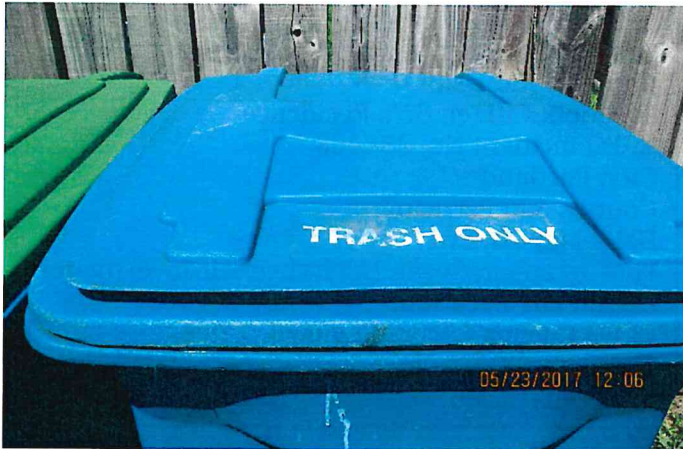
Subject: Location of sample collection-trash can
Location: Citizen 70's Residence
TCEQ Incident No. 258470
City: Portland
County: San Patricio
Date: May 23, 2017
Photographer: Travis Prater, Water Investigator
Digital File Location:
TCEQ Corpus Christi Regional Office
Photo No. 101

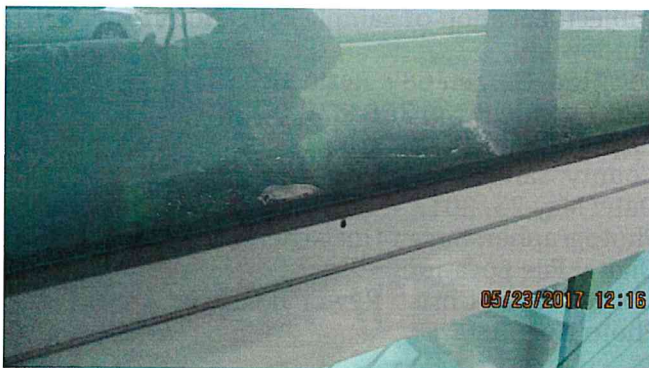
Subject: Location of sample collection-front window
Location: Citizen 71's Residence
TCEQ Incident No. 258472
City: Portland
County: San Patricio
Date: May 23, 2017
Photographer: Travis Prater, Water Investigator
Digital File Location:
TCEQ Corpus Christi Regional Office
Photo No. 102

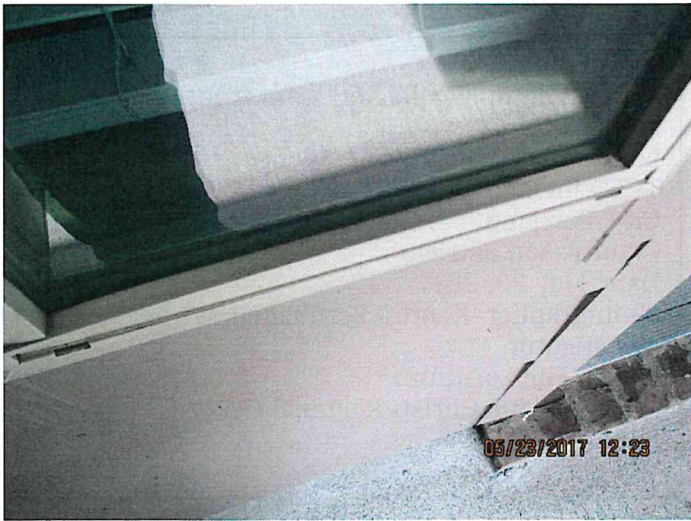
Subject: Location of sample collection-front window sill
Location: Citizen 72's Residence
TCEQ Incident No. 258471
City: Portland
County: San Patricio
Date: May 23, 2017
Photographer: Travis Prater, Water Investigator
Digital File Location:
TCEQ Corpus Christi Regional Office
Photo No. 103

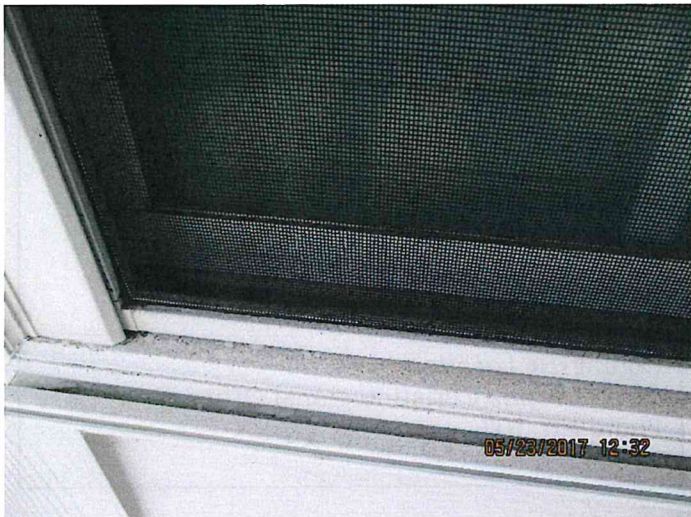
Subject: Location of sample collection-front window sill
Location: Citizen 73's Residence
TCEQ Incident No. 258473
City: Portland
County: San Patricio
Date: May 23, 2017
Photographer: Travis Prater, Water Investigator
Digital File Location:
TCEQ Corpus Christi Regional Office
Photo No. 104

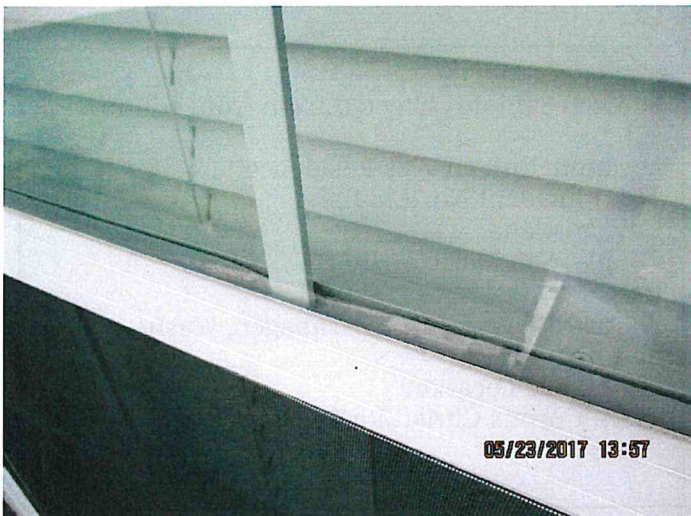
Subject: Location of sample collection-front window ledge
Location: Citizen 74's Residence
TCEQ Incident No. 258484
City: Portland
County: San Patricio
Date: May 23, 2017
Photographer: Travis Prater, Water Investigator
Digital File Location:
TCEQ Corpus Christi Regional Office
Photo No. 105

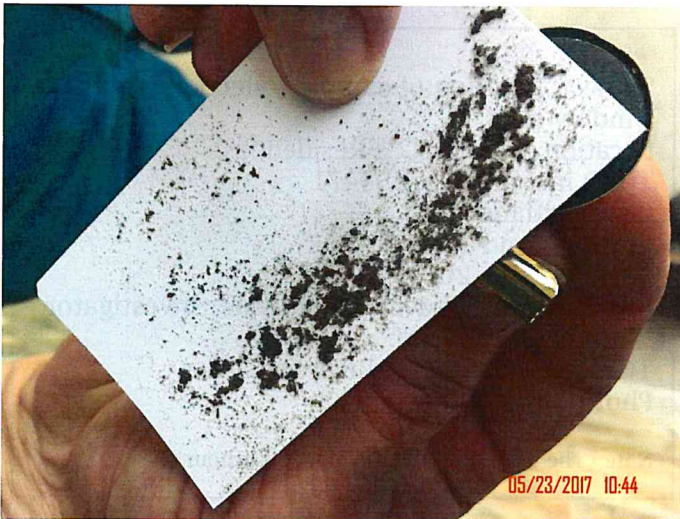
Subject: Sample collected from front window sill
Location: Citizen 75's Residence
TCEQ Incident No. 258418
City: Portland
County: San Patricio
Date: May 23, 2017
Photographer: Kendra Bernhagen, Waste Investigator
Digital File Location:
TCEQ Corpus Christi Regional Office
Photo No. 106

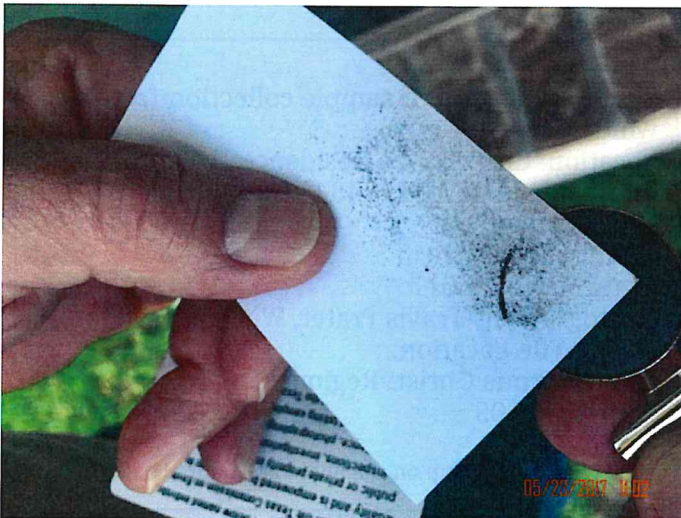
Subject: Sample collected from front window sill
Location: Citizen 77's Residence
TCEQ Incident No. 258424
City: Portland
County: San Patricio
Date: May 23, 2017
Photographer: Kendra Bernhagen, Waste Investigator
Digital File Location:
TCEQ Corpus Christi Regional Office
Photo No. 108

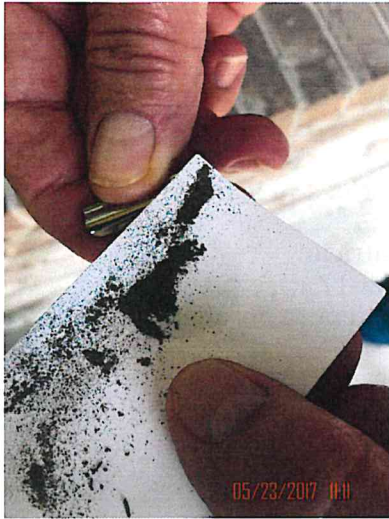
Subject: Sample collected from front window sill
Location: Citizen 78's Residence
TCEQ Incident No. 258475
City: Portland
County: San Patricio
Date: May 23, 2017
Photographer: Kendra Bernhagen, Waste Investigator
Digital File Location:
TCEQ Corpus Christi Regional Office
Photo No. 109

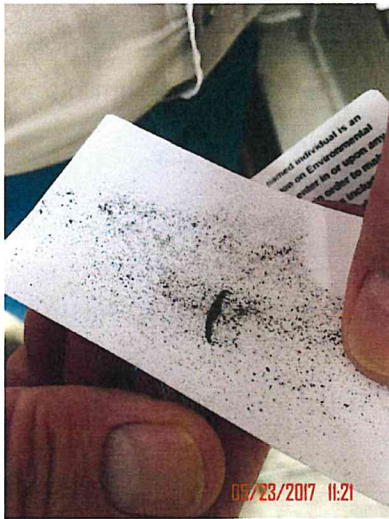
Subject: Sample collected from top of black box (attached) by front door
Location: Citizen 79's Residence
TCEQ Incident No. 258474
City: Portland
County: San Patricio
Date: May 23, 2017
Photographer: Kendra Bernhagen, Waste Investigator
Digital File Location:
TCEQ Corpus Christi Regional Office
Photo No. 110

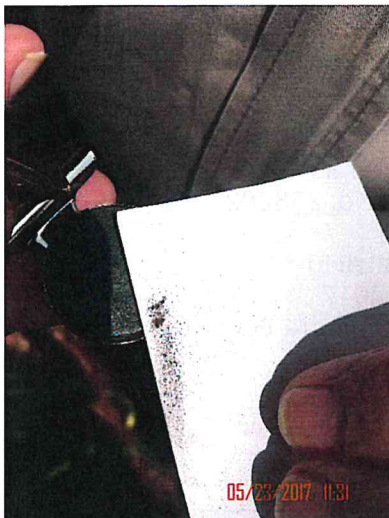
Subject: Sample collected from front window sill
Location: Citizen 80's Residence
TCEQ Incident No. 258476
City: Portland
County: San Patricio
Date: May 23, 2017
Photographer: Kendra Bernhagen, Waste Investigator
Digital File Location:
TCEQ Corpus Christi Regional Office
Photo No. 111

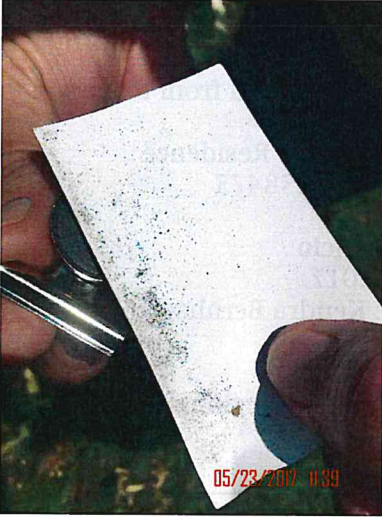
Subject: Sample collected from front window sill
Location: Citizen 81's Residence
TCEQ Incident No. 258477
City: Portland
County: San Patricio
Date: May 23, 2017
Photographer: Kendra Bernhagen, Waste Investigator
Digital File Location:
TCEQ Corpus Christi Regional Office
Photo No. 112

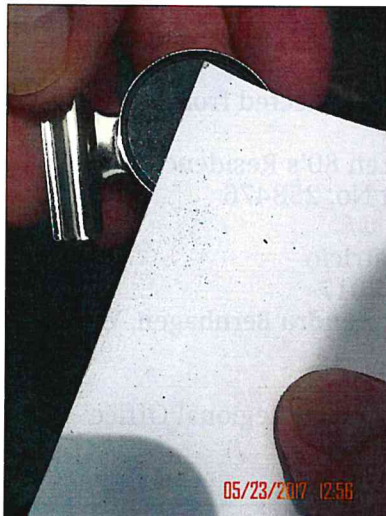
Subject: Sample collected from front window sill
Location: Citizen 83's Residence
TCEQ Incident No. 258482
City: Portland
County: San Patricio
Date: May 23, 2017
Photographer: Kendra Bernhagen, Waste Investigator
Digital File Location:
TCEQ Corpus Christi Regional Office
Photo No. 114

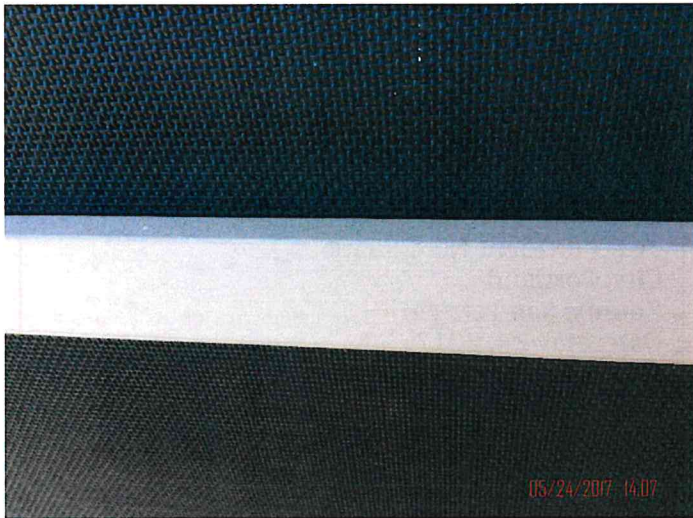
Subject: Location of sample collection-window screen framework
Location: Citizen 85's Residence
TCEQ Incident No. 258590
City: Portland
County: San Patricio
Date: May 24, 2017
Photographer: Thomas Haney, Air Investigator
Digital File Location:
TCEQ Corpus Christi Regional Office
Photo No. 116

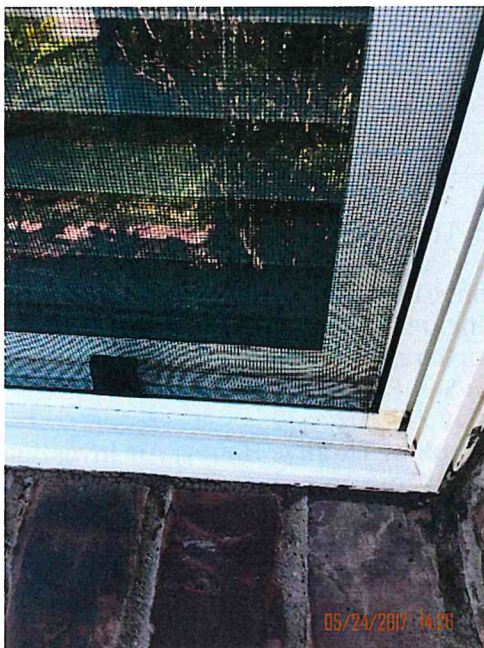
Subject: Location of sample collection-window sill
Location: Citizen 86's Residence
TCEQ Incident No. 258595
City: Portland
County: San Patricio
Date: May 24, 2017
Photographer: Thomas Haney, Air Investigator
Digital File Location:
TCEQ Corpus Christi Regional Office
Photo No. 117

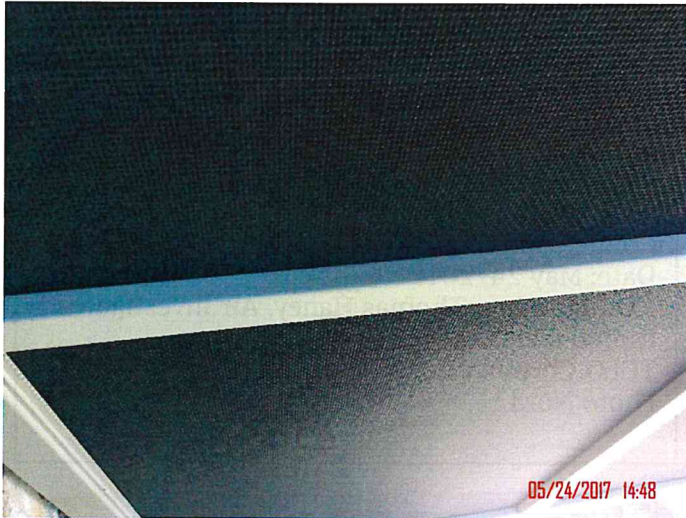
Subject: Location of sample collection-window
screen framework
Location: Citizen 87's Residence
TCEQ Incident No. 258589
City: Portland
County: San Patricio
Date: May 24, 2017
Photographer: Thomas Haney, Air Investigator
Digital File Location:
TCEQ Corpus Christi Regional Office
Photo No. 118

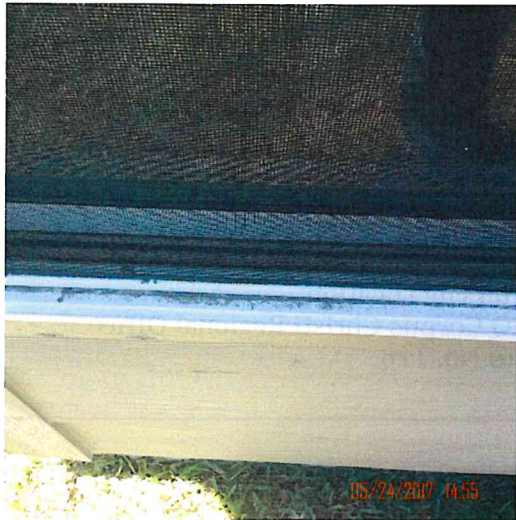
Subject: Location of sample collection-window
sill
Location: Citizen 88's Residence
TCEQ Incident No. 258596
City: Portland
County: San Patricio
Date: May 24, 2017
Photographer: Thomas Haney, Air Investigator
Digital File Location:
TCEQ Corpus Christi Regional Office
Photo No. 119

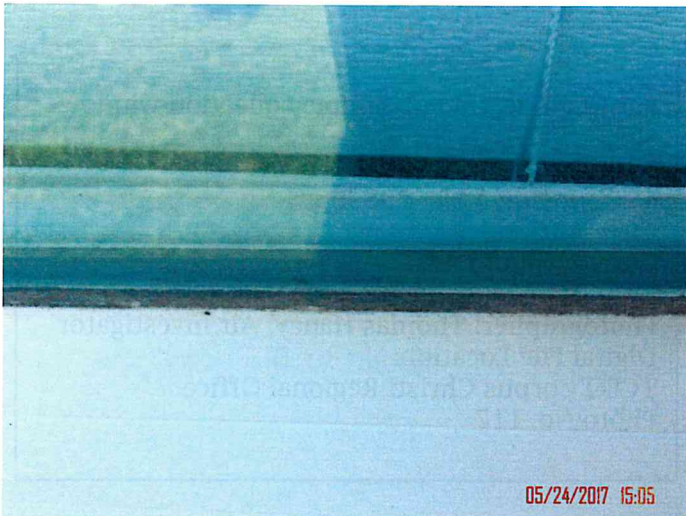
Subject: Location of sample collection-window
sill
Location: Citizen 89's Residence
TCEQ Incident No. 258591
City: Portland
County: San Patricio
Date: May 24, 2017
Photographer: Thomas Haney, Air Investigator
Digital File Location:
TCEQ Corpus Christi Regional Office
Photo No. 120

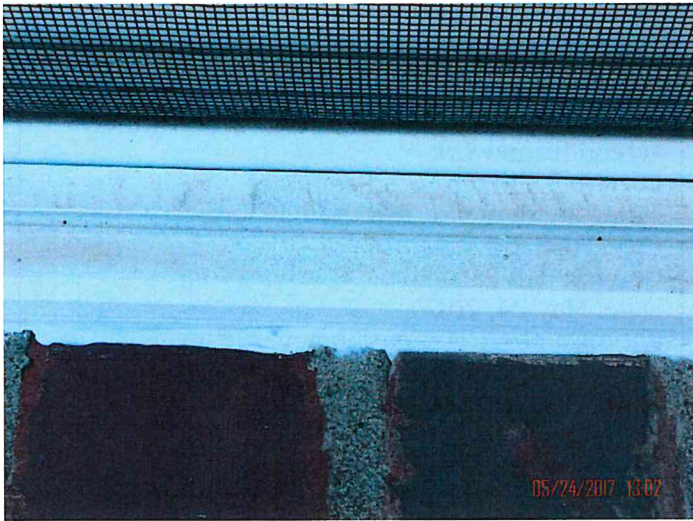
Subject: Location of sample collection-window sill
Location: Citizen 90's Residence
TCEQ Incident No. 258546
City: Portland
County: San Patricio
Date: May 24, 2017
Photographer: Thomas Haney, Air Investigator
Digital File Location:
TCEQ Corpus Christi Regional Office
Photo No. 121

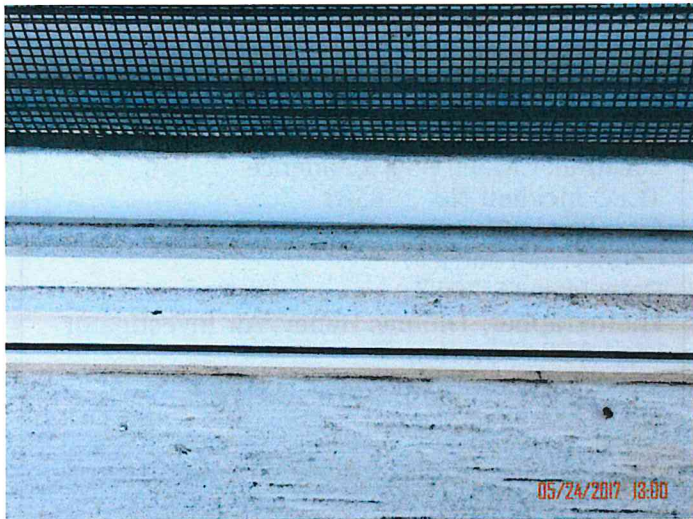
Subject: Location of sample collection-window sill
Location: Citizen 91's Residence
TCEQ Incident No. 258572
City: Portland
County: San Patricio
Date: May 24, 2017
Photographer: Thomas Haney, Air Investigator
Digital File Location:
TCEQ Corpus Christi Regional Office
Photo No. 122

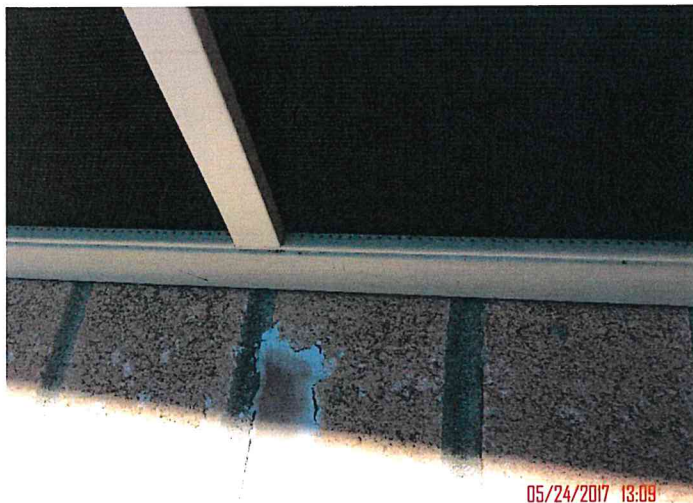
Subject: Location of sample collection-window screen framework
Location: Citizen 92's Residence
TCEQ Incident No. 258599
City: Portland
County: San Patricio
Date: May 24, 2017
Photographer: Thomas Haney, Air Investigator
Digital File Location:
TCEQ Corpus Christi Regional Office
Photo No. 123

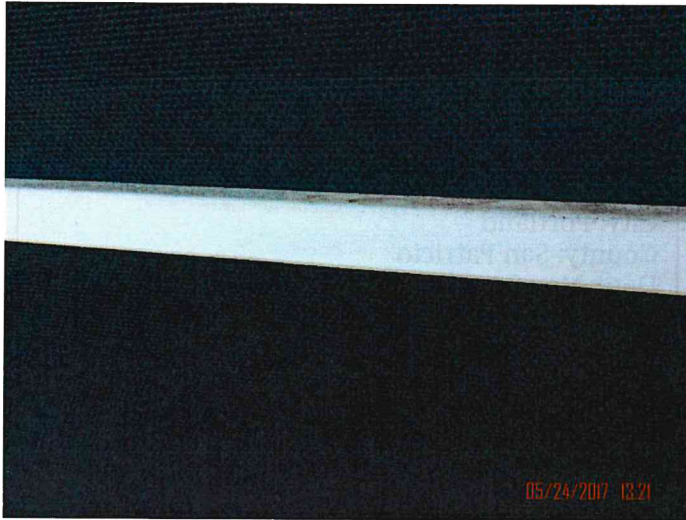
Subject: Location of sample collection-window
screen framework
Location: Citizen 93's Residence
TCEQ Incident No. 258554
City: Portland
County: San Patricio
Date: May 24, 2017
Photographer: Thomas Haney, Air Investigator
Digital File Location:
TCEQ Corpus Christi Regional Office
Photo No. 124

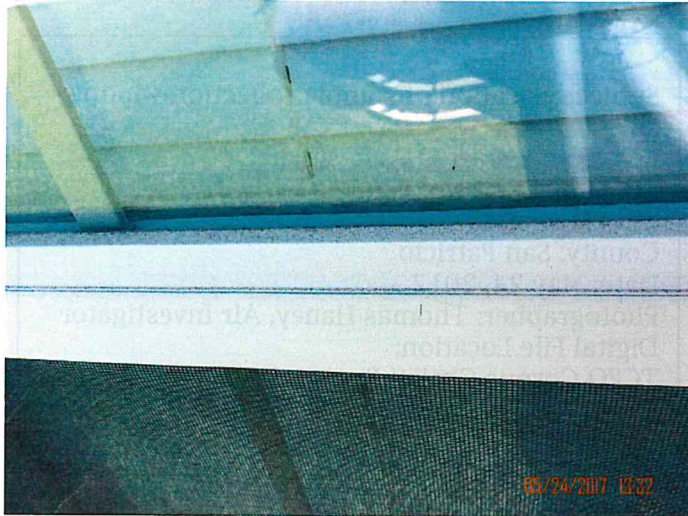
Subject: Location of sample collection-window
ledge
Location: Citizen 94's Residence
TCEQ Incident No. 258581
City: Portland
County: San Patricio
Date: May 24, 2017
Photographer: Thomas Haney, Air Investigator
Digital File Location:
TCEQ Corpus Christi Regional Office
Photo No. 125

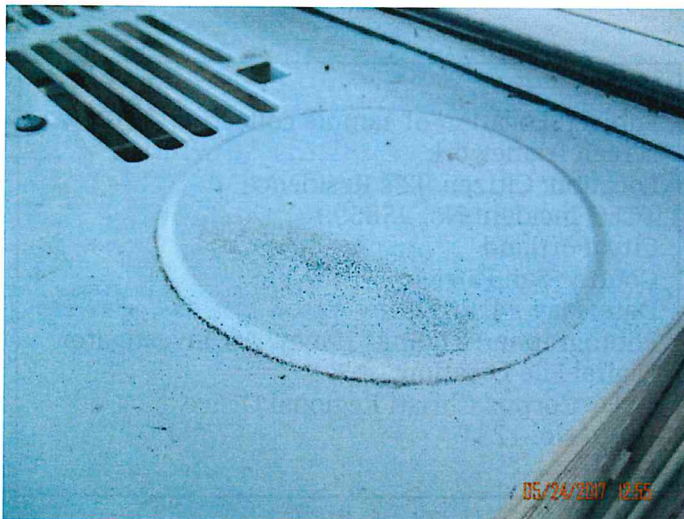
Samples of metallic particles collected on a backyard window air condition unit of Citizen 97's residence were confirmed to have magnetic properties consistent with the metallic particles identified on the other citizens' residences.

Subject: Location of sample collection-outdoor
window air condition unit
Location: Citizen 97's Residence
TCEQ Incident No. 258646
City: Portland
County: San Patricio
Date: May 24, 2017
Photographer: Corey Burke, Waste Investigator
Digital File Location:
TCEQ Corpus Christi Regional Office
Photo No. 126

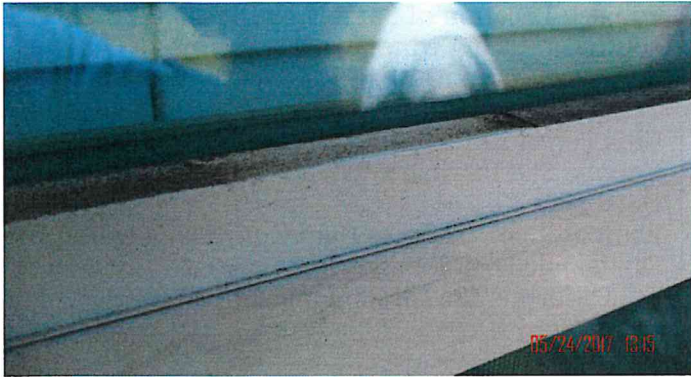
Subject: Location of sample collection-window ledge
Location: Citizen 98's Residence
TCEQ Incident No. 258570
City: Portland
County: San Patricio
Date: May 24, 2017
Photographer: Corey Burke, Waste Investigator
Digital File Location:
TCEQ Corpus Christi Regional Office
Photo No. 127

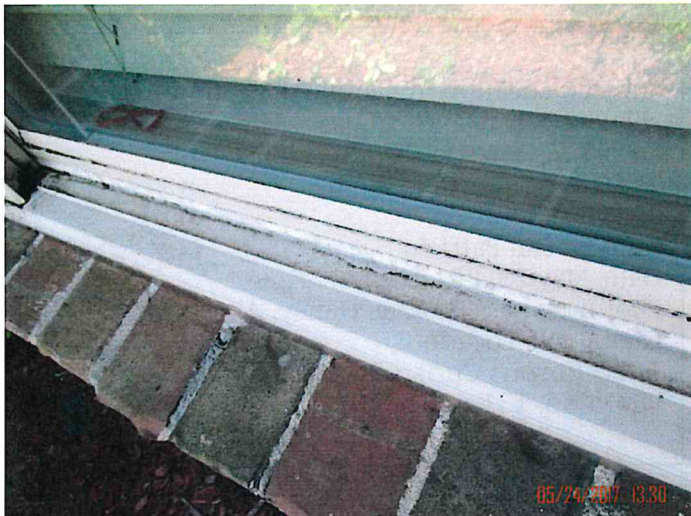
Subject: Location of sample collection-window sill
Location: Citizen 99's Residence
TCEQ Incident No. 258575
City: Portland
County: San Patricio
Date: May 24, 2017
Photographer: Corey Burke, Waste Investigator
Digital File Location:
TCEQ Corpus Christi Regional Office
Photo No. 128

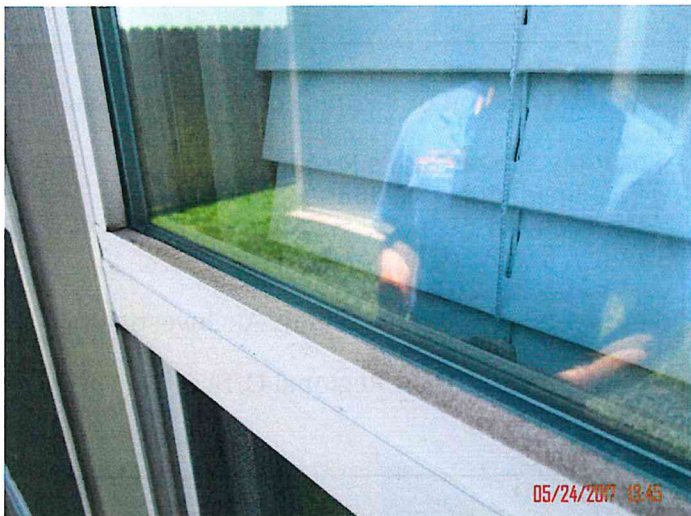
Subject: Location of sample collection-window ledge
Location: Citizen 100's Residence
TCEQ Incident No. 258580
City: Portland
County: San Patricio
Date: May 24, 2017
Photographer: Corey Burke, Waste Investigator
Digital File Location:
TCEQ Corpus Christi Regional Office
Photo No. 129

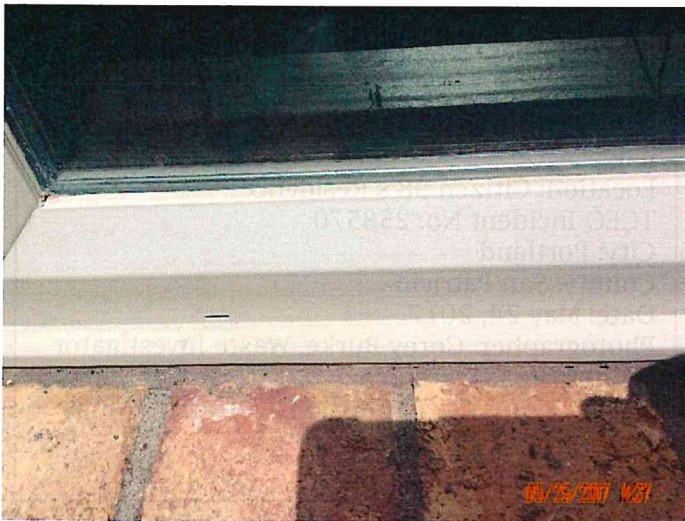
Subject: Location of Sample No. 1706003-002;
southeast facing window sill
Location: Citizen 101's Residence
TCEQ Incident No. 258626
City: Portland
County: San Patricio
Date: May 25, 2017
Photographer: Thomas Haney, Air Investigator
Digital File Location:
TCEQ Corpus Christi Regional Office
Photo No. 130

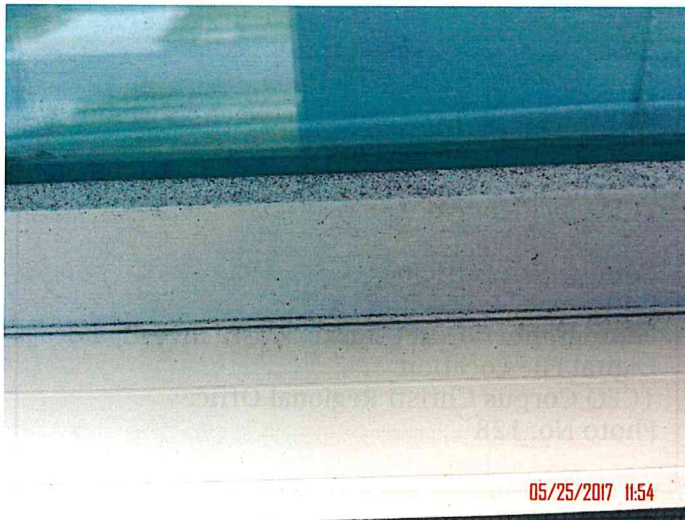
Subject: Location of sample collection-window
sill
Location: Citizen 102's Residence
TCEQ Incident No. 258648
City: Portland
County: San Patricio
Date: May 25, 2017
Photographer: Thomas Haney, Air Investigator
Digital File Location:
TCEQ Corpus Christi Regional Office
Photo No. 131

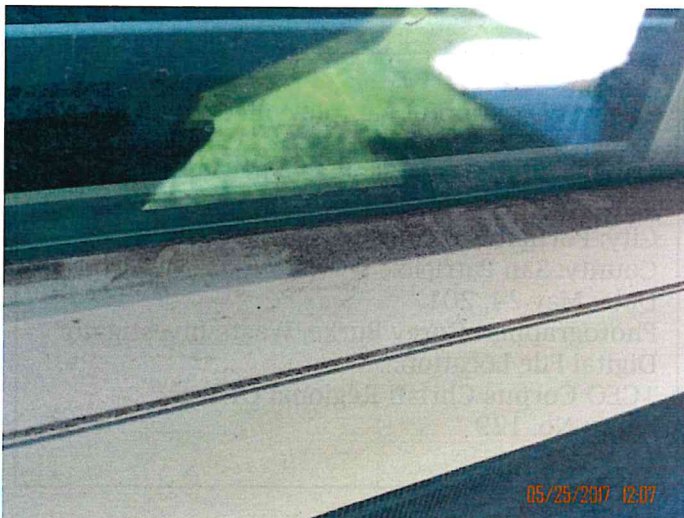
Subject: Location of sample collection-window
ledge
Location: Citizen 103's Residence
TCEQ Incident No. 258660
City: Portland
County: San Patricio
Date: May 25, 2017
Photographer: Thomas Haney, Air Investigator
Digital File Location:
TCEQ Corpus Christi Regional Office
Photo No. 132

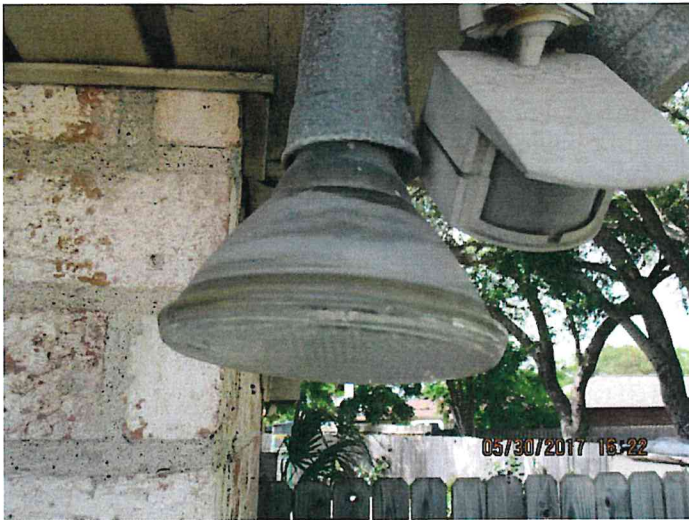
Subject: Location of Sample No. 1706004-002;
outdoor garage light bulb
Location: Citizen 115's Residence
TCEQ Incident No. 259029
City: Portland
County: San Patricio
Date: May 30, 2017
Photographer: Susan Hoelscher, Air Investigator
Digital File Location:
TCEQ Corpus Christi Regional Office
Photo No. 145

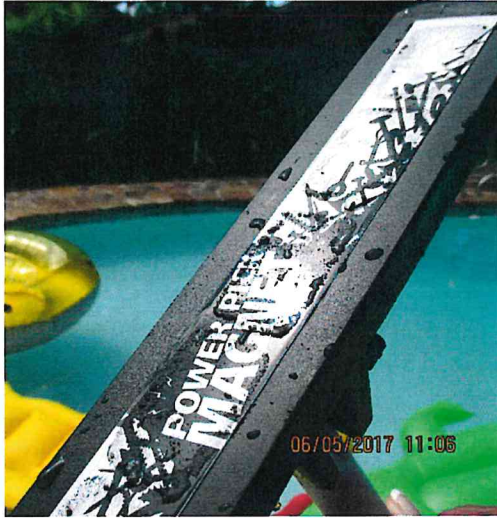
Subject: Accumulation of metallic particles settled in the pool
Location: Citizen 120's Residence
TCEQ Incident No. 259694
City: Portland
County: San Patricio
Date: June 5, 2017
Photographer: Susan Hoelscher, Air Investigator
Digital File Location:
TCEQ Corpus Christi Regional Office
Photo No. 150

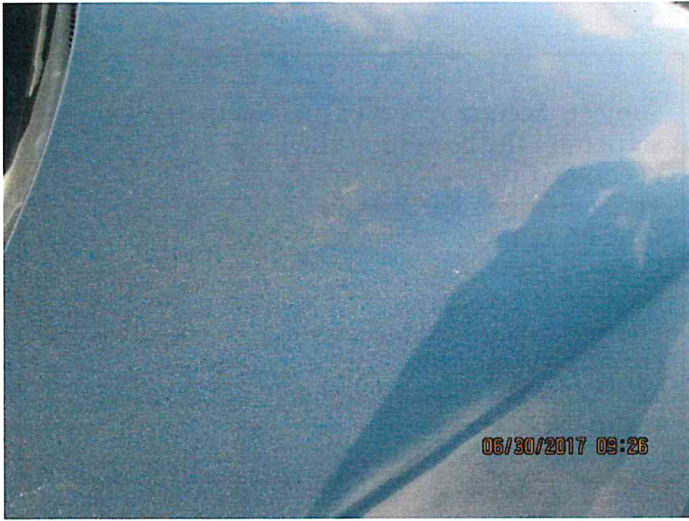
Subject: Accumulation of metallic particles on vehicle hood
Location: Citizen 136's Residence
TCEQ Incident No. 261418
City: Portland
County: San Patricio
Date: June 30, 2017
Photographer: Susan Hoelscher, Air Investigator
Digital File Location:
TCEQ Corpus Christi Regional Office
Photo No. 163

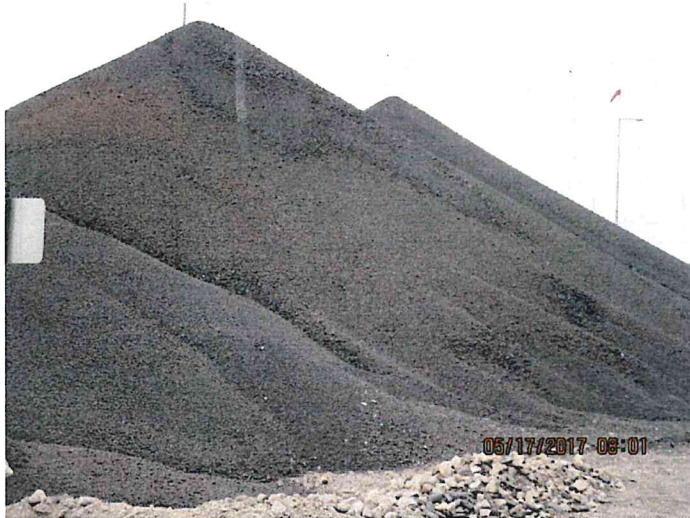
Subject: Location of Reference Sample No. 1705011-009RS; remelt pellets
Location: North side of Voestalpine's property
Direction: Facing northeast
City: Portland
County: San Patricio
Date: May 17, 2017
Photographer: Susan Hoelscher, Air Investigator
Digital File Location:
TCEQ Corpus Christi Regional Office
Photo No. 1

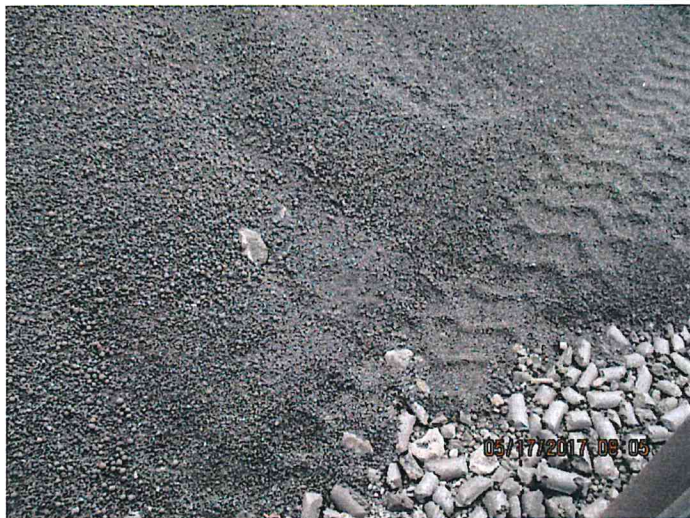
Subject: Location of Reference Sample No. 1705011-010RS; remelt fines
Location: North side of Voestalpine's property
Direction: Facing east
City: Portland
County: San Patricio
Date: May 17, 2017
Photographer: Susan Hoelscher, Air Investigator
Digital File Location:
TCEQ Corpus Christi Regional Office
Photo No. 2
