AIR CP_106597875_CP_20171016_Investigation_1415945_
Texas Commission on Environmental Quality
Investigation Report

Regulated Entity Name: LA QUINTA PLANT

Investigation # 1415945

Investigation Type: Compliance Investigation

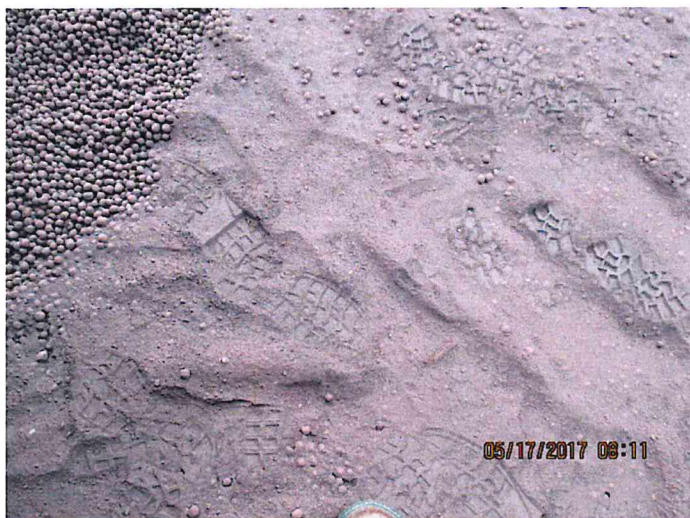
Subject: Location of Reference Sample No. 1705011-011RS; fines unprocessed pellets
Location: South side of Voestalpine's property
Direction: Facing northeast
City: Portland
County: San Patricio
Date: May 17, 2017
Photographer: Susan Hoelscher, Air Investigator
Digital File Location:
TCEQ Corpus Christi Regional Office
Photo No. 3

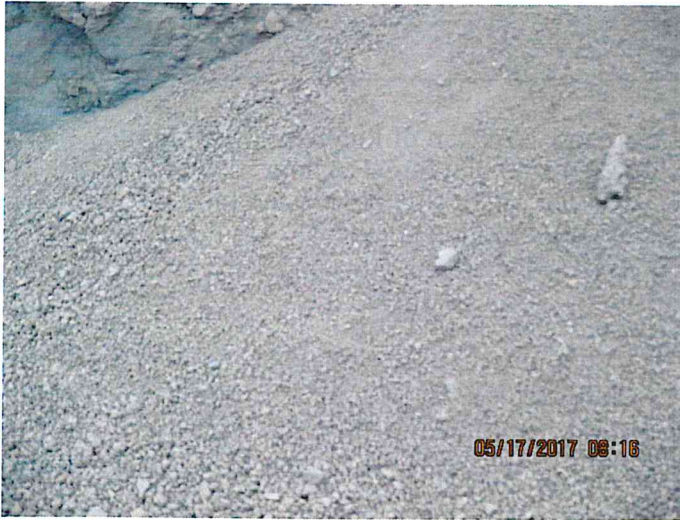
Subject: Location of Reference Sample No. 1705011-012RS; HBI fines
Location: South side of Voestalpine's property
Direction: Facing west
City: Portland
County: San Patricio
Date: May 17, 2017
Photographer: Susan Hoelscher, Air Investigator
Digital File Location:
TCEQ Corpus Christi Regional Office
Photo No. 4

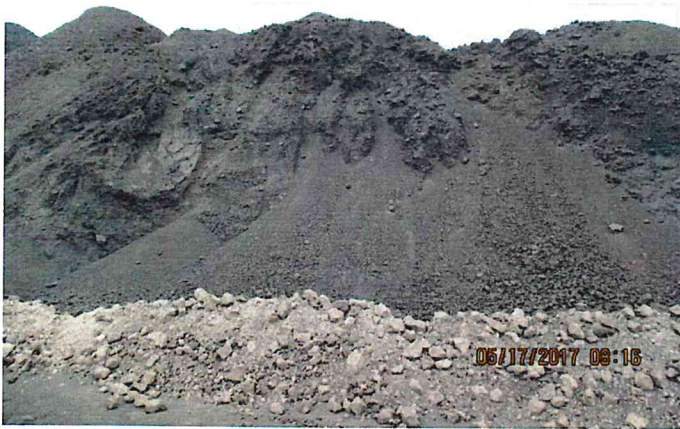
Subject: Bulk pile of HBI fines (Reference Sample No. 1705011-012RS)
Location: South side of Voestalpine's property
Direction: Facing west
City: Portland
County: San Patricio
Date: May 17, 2017
Photographer: Susan Hoelscher, Air Investigator
Digital File Location:
TCEQ Corpus Christi Regional Office
Photo No. 5

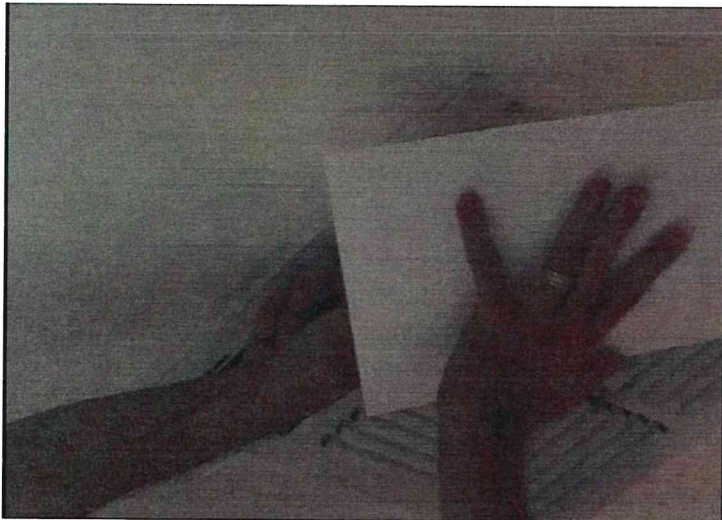
On May 23, 2017, Citizen 43 submitted citizen collected evidence (CCE) (video) indicating that the metallic particles were inside their residence in the kitchen air conditioner (AC) vent.

Subject: Collection of metallic particles in
Citizen 43's AC vent inside the kitchen
Location: Citizen 43's Residence
TCEQ Incident No. 258299
City: Portland
County: San Patricio
Date: May 19, 2017
Photographer: Citizen 43
Digital File Location:
TCEQ Corpus Christi Regional Office
Confidential Files (IMG_7646 2.MOV)
Photo No. 1

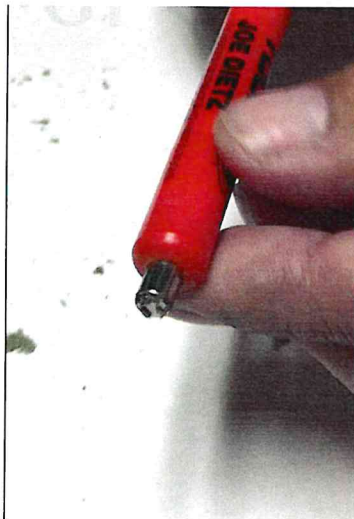
Subject: Collection of metallic particles from
Citizen 43's AC vent inside the kitchen
Location: Citizen 43's Residence
TCEQ Incident No. 258299
City: Portland
County: San Patricio
Date: May 19, 2017
Photographer: Citizen 43
Digital File Location:
TCEQ Corpus Christi Regional Office
Confidential Files (IMG_7646 2.MOV)
Photo No. 2

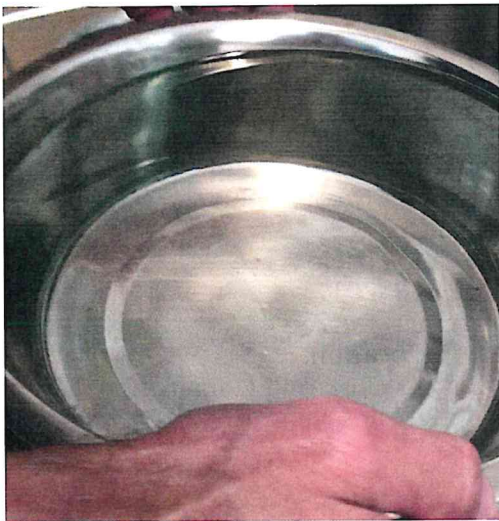
-June 7, 2017: Stainless steel dog bowl was cleaned/scrubbed, filled with fresh water, and left in the middle of the backyard from 6 am until 6 pm. After 12 hours, Citizen 43 confirmed the magnetic property of the metallic particles accumulated in the dog bowl.

Subject: Dog bowl (stainless steel) that was cleaned/scrubbed, filled with fresh water, and left in the middle of the Citizen 43's backyard (at ~6 am)
Location: Citizen 43's Residence
TCEQ Incident No. 258299
City: Portland
County: San Patricio
Date: June 7, 2017
Photographer: Citizen 43
Digital File Location:
TCEQ Corpus Christi Regional Office
Confidential Files (IMG_7686 2.mov)
Photo No. 4

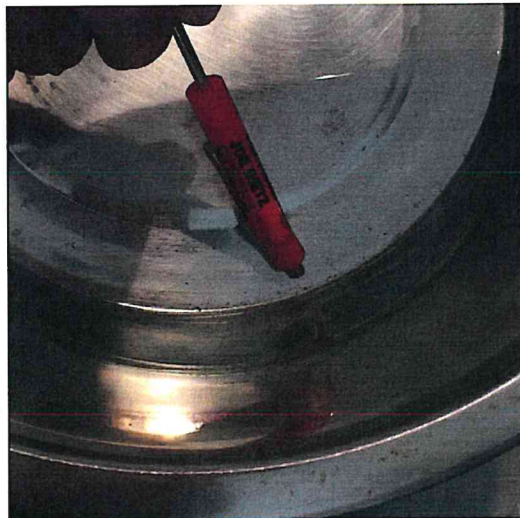
Subject: Demonstration of magnetic property of the metallic particles accumulated in the dog bowl (stainless steel) within ~12 hours (6 am-6 pm) from Citizen 43's backyard
Location: Citizen 43's Residence
TCEQ Incident No. 258299
City: Portland
County: San Patricio
Date: June 7, 2017
Photographer: Citizen 43
Digital File Location:
TCEQ Corpus Christi Regional Office
Confidential Files (IMG_7686 2.mov)
Photo No. 4

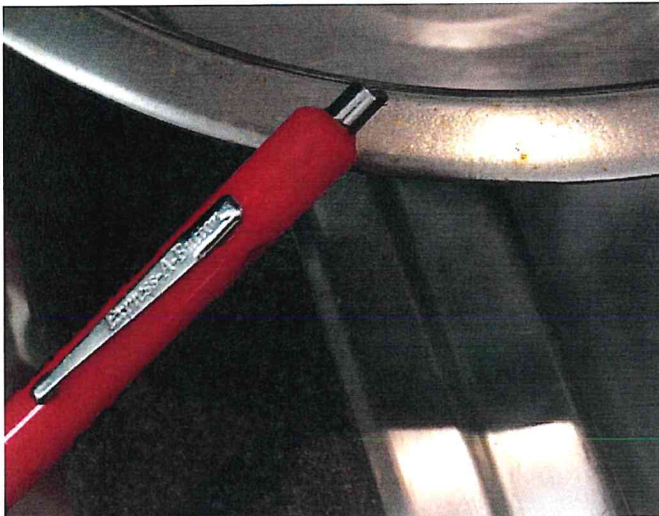
Subject: Demonstration of magnetic property of the metallic particles accumulated in the dog bowl (stainless steel) within ~12 hours (6 am-6 pm) from Citizen 43's backyard
Location: Citizen 43's Residence
TCEQ Incident No. 258299
City: Portland
County: San Patricio
Date: June 7, 2017
Photographer: Citizen 43
Digital File Location:
TCEQ Corpus Christi Regional Office
Confidential Files (IMG_7686 2.mov)
Photo No. 5

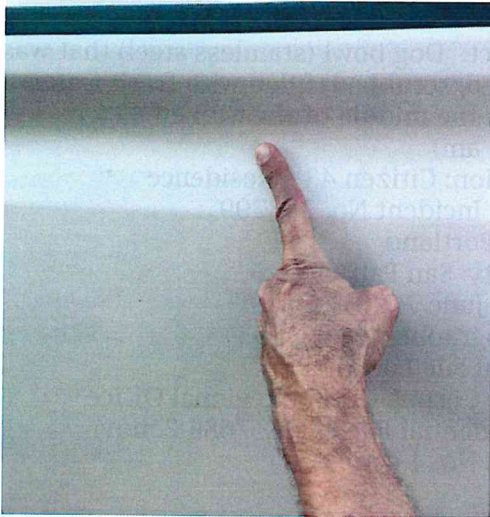
Subject: Collection of metallic particles from Citizen 43's vehicle which had been detailed a week before (Thursday, June 8, 2017)
Location: Citizen 43's Residence
TCEQ Incident No. 258299
City: Portland
County: San Patricio
Date: June 15, 2017
Photographer: Citizen 43
Digital File Location:
TCEQ Corpus Christi Regional Office
Confidential Files (June 15, 2017 Truck Black Dust.mov)
Photo No. 6

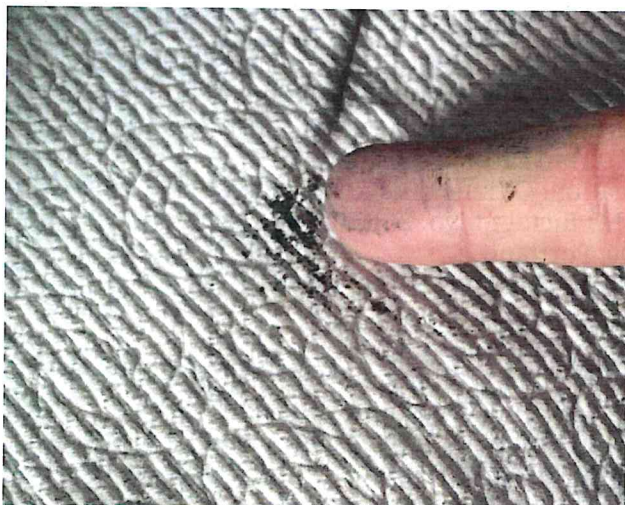
Subject: Collection of metallic particles from Citizen 43's vehicle which had been detailed a week before (Thursday, June 8, 2017)
Location: Citizen 43's Residence
TCEQ Incident No. 258299
City: Portland
County: San Patricio
Date: June 15, 2017
Photographer: Citizen 43
Digital File Location:
TCEQ Corpus Christi Regional Office
Confidential Files (June 15, 2017 Truck Black Dust.mov)
Photo No. 7

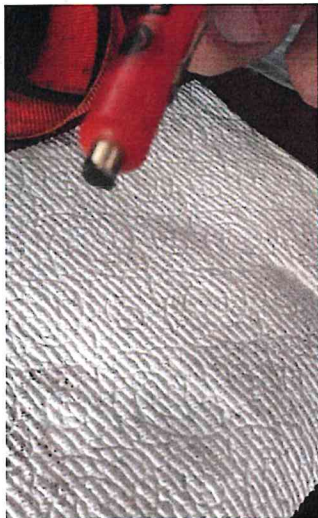
Subject: Demonstration of magnetic property of the metallic particles from Citizen 43's vehicle which had been detailed a week before (Thursday, June 8, 2017)
Location: Citizen 43's Residence
TCEQ Incident No. 258299
City: Portland
County: San Patricio
Date: June 15, 2017
Photographer: Citizen 43
Digital File Location:
TCEQ Corpus Christi Regional Office
Confidential Files (June 15, 2017 Truck Black Dust.mov)
Photo No. 9

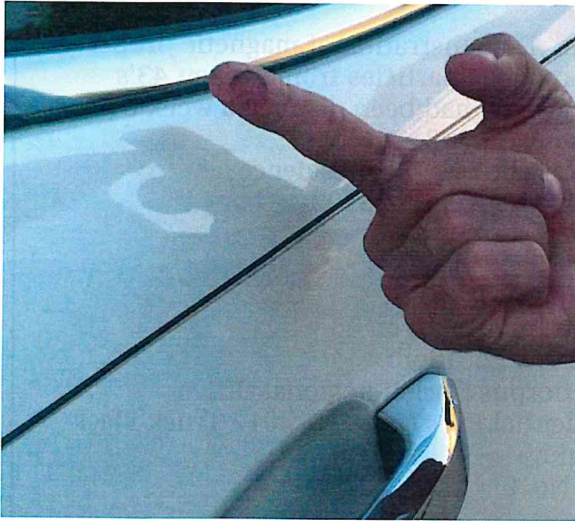
Subject: Collection of metallic particles from Citizen 43's vehicle which had been detailed the previous Friday, June 16, 2017
Location: Citizen 43's Residence
TCEQ Incident No. 258299
City: Portland
County: San Patricio
Date: June 22, 2017
Photographer: Citizen 43
Digital File Location:
TCEQ Corpus Christi Regional Office
Confidential Files (June 22, 2017 Metallic Dust Video.mov)
Photo No. 11

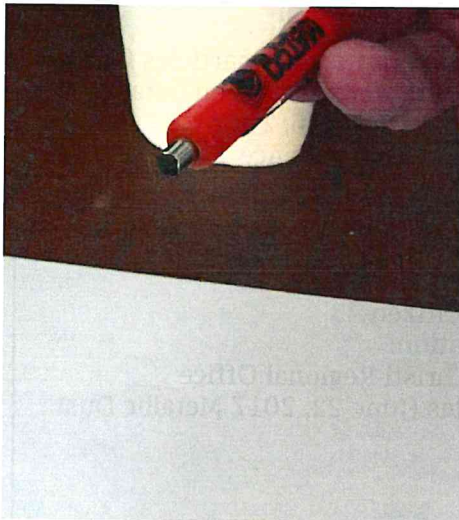
Subject: Demonstration of magnetic property of the metallic particles from Citizen 43's vehicle which had been detailed the previous Friday, June 16, 2017
Location: Citizen 43's Residence
TCEQ Incident No. 258299
City: Portland
County: San Patricio
Date: June 22, 2017
Photographer: Citizen 43
Digital File Location:
TCEQ Corpus Christi Regional Office
Confidential Files (June 22, 2017 Metallic Dust Video.mov)
Photo No. 18

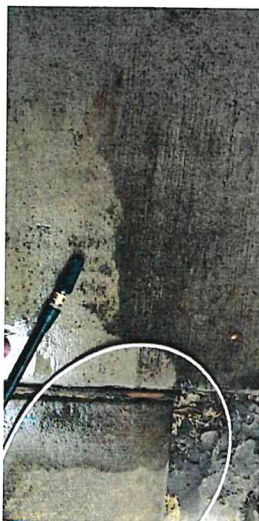
Subject: Demonstration of magnetic property of the metallic particles from Citizen 43's vehicle which had been detailed the previous Friday, June 16, 2017
Location: Citizen 43's Residence
TCEQ Incident No. 258299
City: Portland
County: San Patricio
Date: June 22, 2017
Photographer: Citizen 43
Digital File Location:
TCEQ Corpus Christi Regional Office
Confidential Files (June 22, 2017 Metallic Dust Video.mov)
Photo No. 19

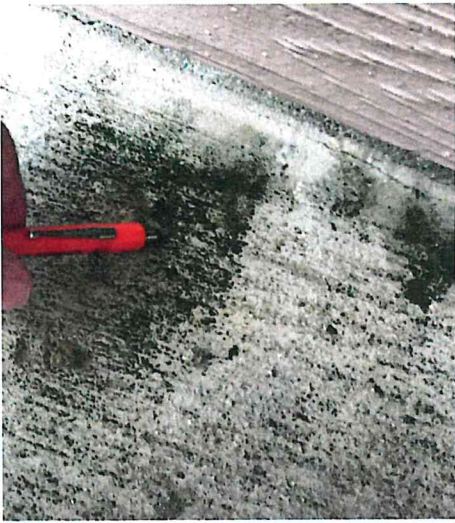
Subject: Line indicating the accumulation of metallic particles (left light side power washed; right dark side metallic particles) on Citizen 43's exterior front alcove (prior to the current power wash, the exterior front alcove had been cleaned in January 2017)
Location: Citizen 43's Residence
TCEQ Incident No. 258299
City: Portland
County: San Patricio
Date: June 24, 2017
Photographer: Citizen 43
Digital File Location:
TCEQ Corpus Christi Regional Office
Confidential Files (IMG_1415.mov)
Photo No. 20

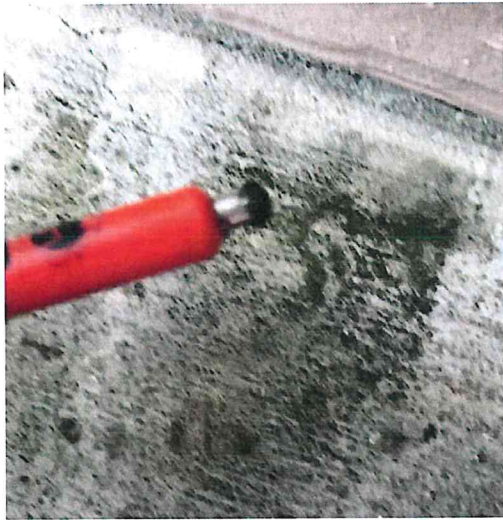
Subject: Demonstration of magnetic property of the accumulated metallic particles power washed from Citizen 43's exterior front alcove
Location: Citizen 43's Residence
TCEQ Incident No. 258299
City: Portland
County: San Patricio
Date: June 24, 2017
Photographer: Citizen 43
Digital File Location:
TCEQ Corpus Christi Regional Office
Confidential Files (IMG_1415.mov)
Photo No. 21

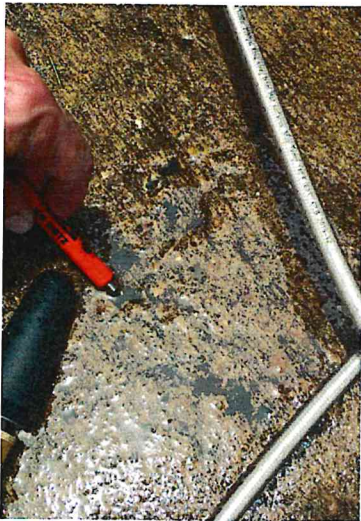
Subject: Accumulation of metallic particles on Citizen 43's front sidewalk (top light area power washed, bottom dark area metallic particles)
Location: Citizen 43's Residence
TCEQ Incident No. 258299
City: Portland
County: San Patricio
Date: June 24, 2017
Photographer: Citizen 43
Digital File Location:
TCEQ Corpus Christi Regional Office
Confidential Files (IMG_1416.mov)
Photo No. 23

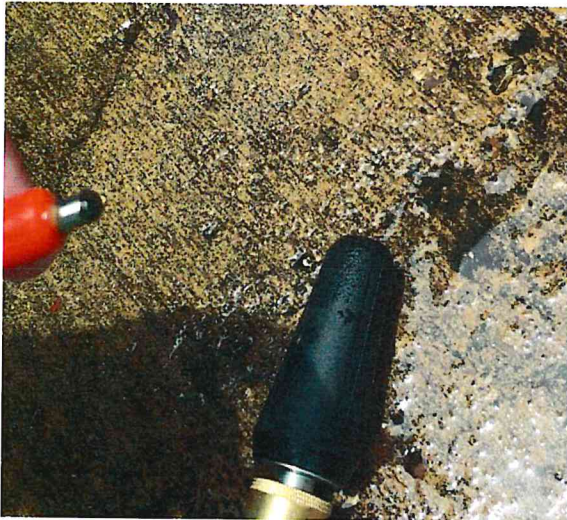
Subject: Demonstration of magnetic property of the accumulated metallic particles power washed from Citizen 43's front sidewalk
Location: Citizen 43's Residence
TCEQ Incident No. 258299
City: Portland
County: San Patricio
Date: June 24, 2017
Photographer: Citizen 43
Digital File Location:
TCEQ Corpus Christi Regional Office
Confidential Files (IMG_1416.mov)
Photo No. 24

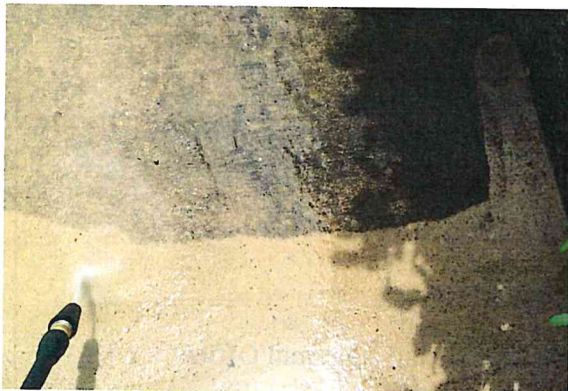
Subject: Demonstration of magnetic property of the accumulated metallic particles power washed from Citizen 43's front sidewalk
Location: Citizen 43's Residence
TCEQ Incident No. 258299
City: Portland
County: San Patricio
Date: June 24, 2017
Photographer: Citizen 43
Digital File Location:
TCEQ Corpus Christi Regional Office
Confidential Files (IMG_1416.mov)
Photo No. 25

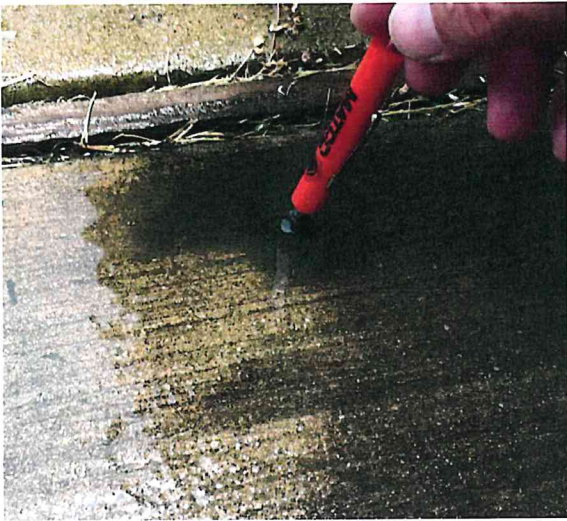
Subject: Line indicating the accumulation of metallic particles on Citizen 43's front sidewalk (top dark area metallic particles, bottom light area power washed)
Location: Citizen 43's Residence
TCEQ Incident No. 258299
City: Portland
County: San Patricio
Date: June 24, 2017
Photographer: Citizen 43
Digital File Location:
TCEQ Corpus Christi Regional Office
Confidential Files (IMG_1417.mov)
Photo No. 26

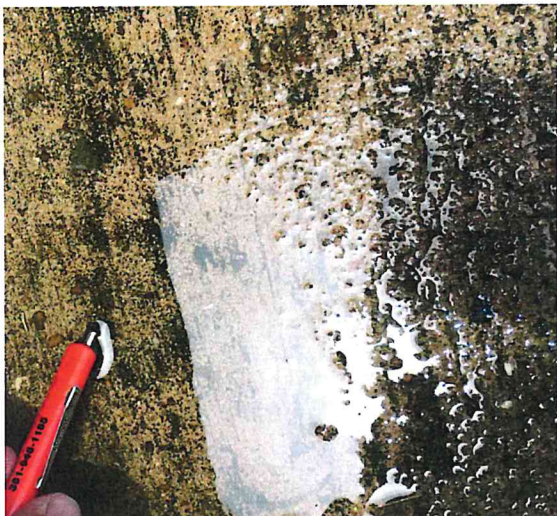
Subject: Demonstration of magnetic property of the accumulated metallic particles power washed from Citizen 43's front sidewalk
Location: Citizen 43's Residence
TCEQ Incident No. 258299
City: Portland
County: San Patricio
Date: June 24, 2017
Photographer: Citizen 43
Digital File Location:
TCEQ Corpus Christi Regional Office
Confidential Files (IMG_1417.mov)
Photo No. 28

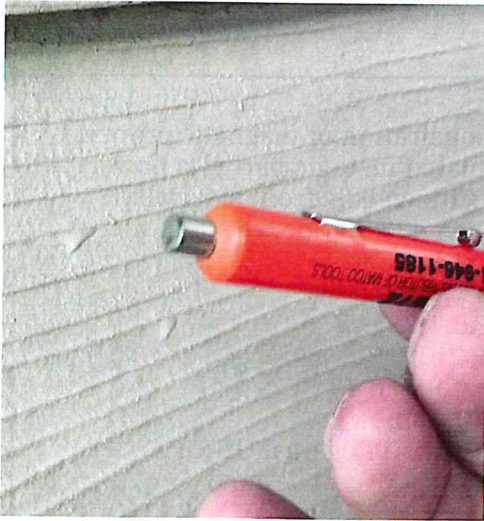
Subject: Demonstration of magnetic property of the embedded metallic particles on Citizen 43's front siding after power washing twice (prior to the current power washing, the siding was cleaned and painted in January 2017)
 Location: Citizen 43's Residence
 TCEQ Incident No. 258299
 City: Portland
 County: San Patricio
 Date: June 24, 2017
 Photographer: Citizen 43
 Digital File Location:
 TCEQ Corpus Christi Regional Office
 Confidential Files (IMG_1424.mov)
 Photo No. 30

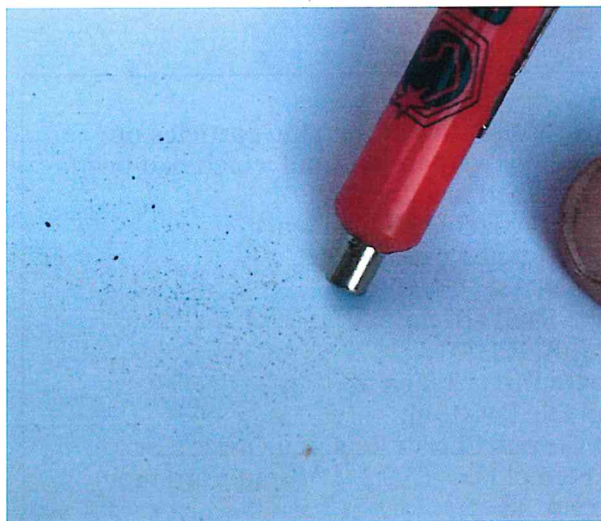
Subject: Collection of metallic particles on Citizen 43's back patio window sill which had been power washed on June 24, 2017
Location: Citizen 43's Residence
TCEQ Incident No. 258299
City: Portland
County: San Patricio
Date: July 12, 2017
Photographer: Citizen 43
Digital File Location:
TCEQ Corpus Christi Regional Office
Confidential Files (7/12/17 Back Patio.mov)
Photo No. 34

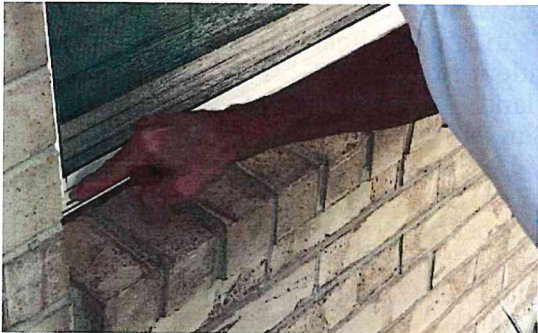
Subject: Demonstration of magnetic property of the accumulated metallic particles on Citizen 43's back patio window sill and electrical box which had been power washed on June 24, 2017
Location: Citizen 43's Residence
TCEQ Incident No. 258299
City: Portland
County: San Patricio
Date: July 12, 2017
Photographer: Citizen 43
Digital File Location:
TCEQ Corpus Christi Regional Office
Confidential Files (7/12/17 Back Patio.mov)
Photo No. 36

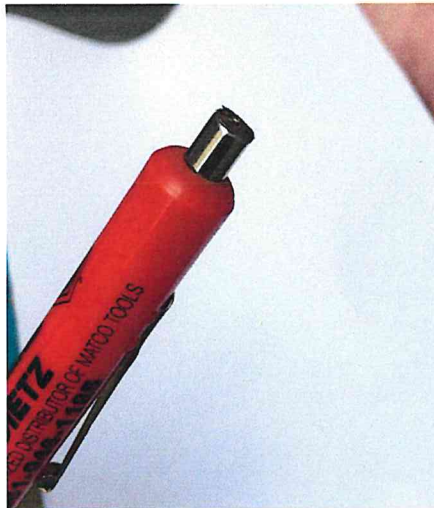
Subject: Demonstration of magnetic property of the accumulated metallic particles on Citizen 43's front window sill which had been power washed on June 24, 2017
Location: Citizen 43's Residence
TCEQ Incident No. 258299
City: Portland
County: San Patricio
Date: July 12, 2017
Photographer: Citizen 43
Digital File Location:
TCEQ Corpus Christi Regional Office
Confidential Files (7/12/17 Front Yard.mov)
Photo No. 39

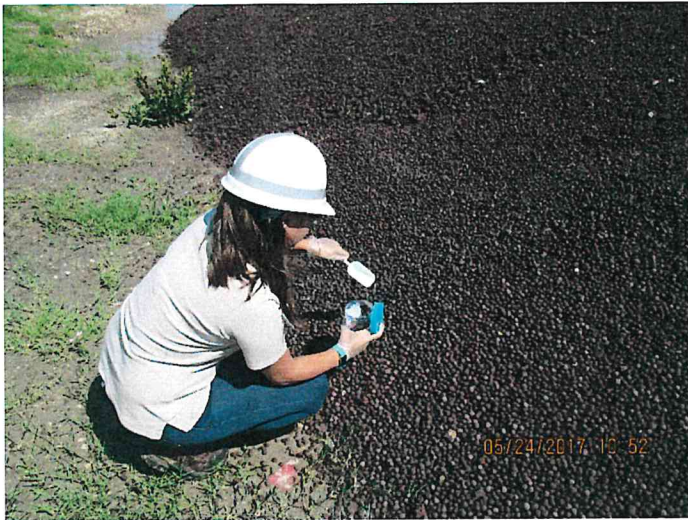
Subject: Collection of Lab Sample ID
HS17051351-01 (01-Remet Pile)
Location: North side of Voestalpine's property;
northwest side of pile
Direction: Facing northeast
City: Portland
County: San Patricio
Date: May 24, 2017
Photographer: Susan Hoelscher, Air Investigator
Digital File Location:
TCEQ Corpus Christi Regional Office
Photo No. 1

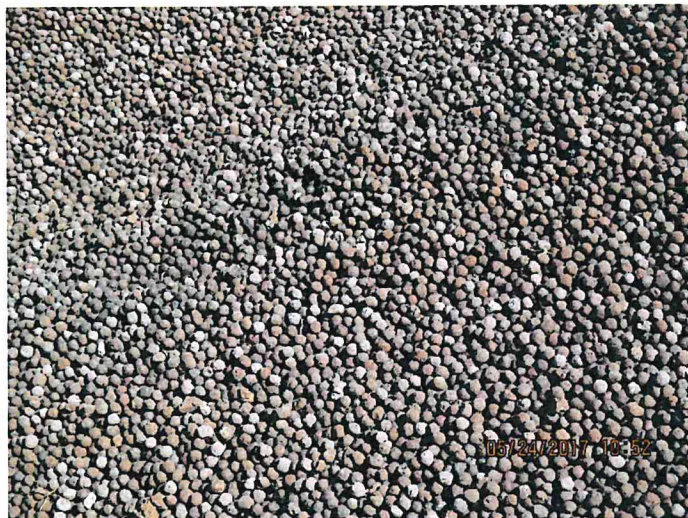
Subject: Location of Lab Sample ID
HS17051351-01 (01-Remet Pile)
Location: North side of Voestalpine's property;
northwest side of pile
Direction: Facing northeast
City: Portland
County: San Patricio
Date: May 24, 2017
Photographer: Susan Hoelscher, Air Investigator
Digital File Location:
TCEQ Corpus Christi Regional Office
Photo No. 2

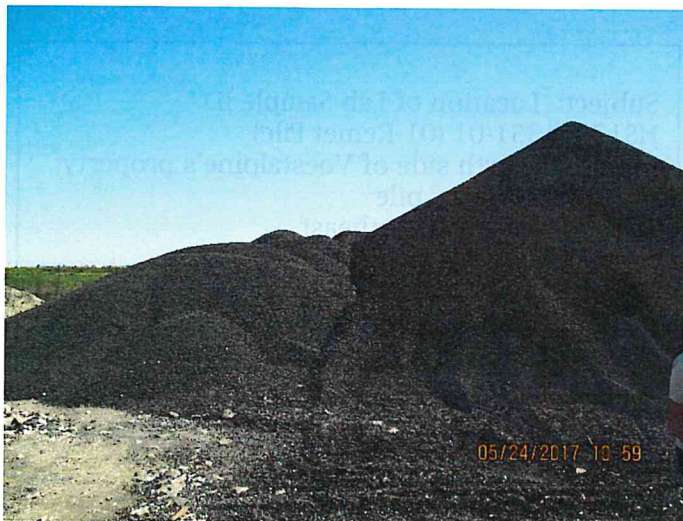
Subject: 02-HBI Chips & Fines
Location: North side of Voestalpine's property
Direction: Facing northeast
City: Portland
County: San Patricio
Date: May 24, 2017
Photographer: Susan Hoelscher, Air Investigator
Digital File Location:
TCEQ Corpus Christi Regional Office
Photo No. 5

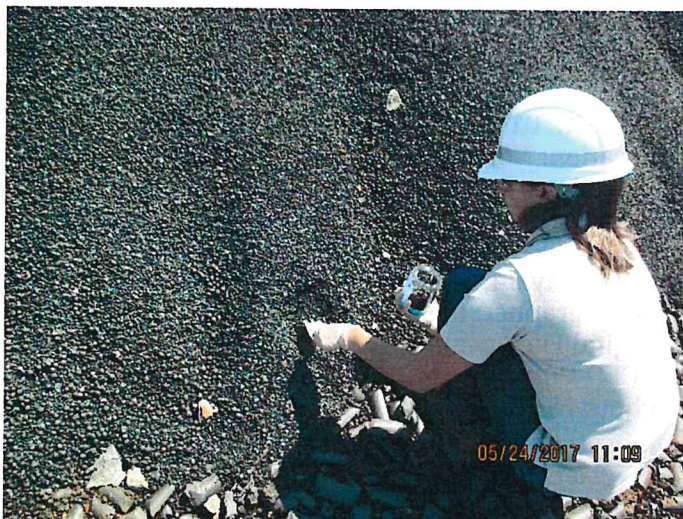
Subject: Collection of Lab Sample ID
HS17051351-03 (03-Remet/Fines/Iron Oxide
Pellets)
Location: North side of Voestalpine's property;
south side of pile
Direction: Facing northeast
City: Portland
County: San Patricio
Date: May 24, 2017
Photographer: Susan Hoelscher, Air Investigator
Digital File Location:
TCEQ Corpus Christi Regional Office
Photo No. 6

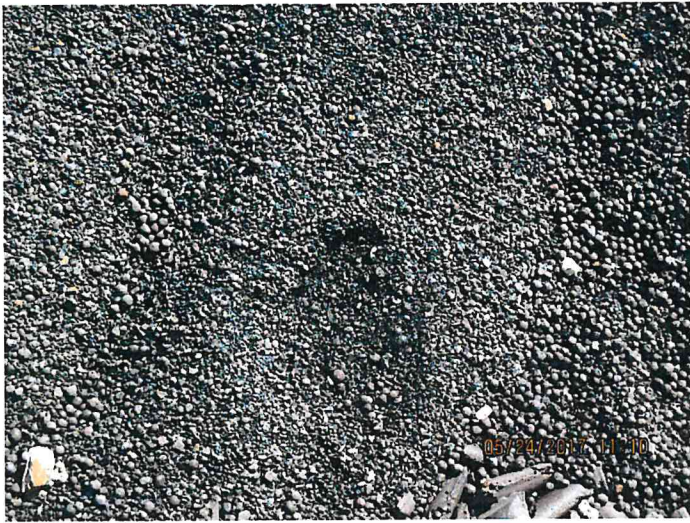
Subject: Location of Lab Sample ID
HS17051351-03 (03-Remet/Fines/Iron Oxide
Pellets)
Location: North side of Voestalpine's property;
south side of pile
Direction: Facing northeast
City: Portland
County: San Patricio
Date: May 24, 2017
Photographer: Susan Hoelscher, Air Investigator
Digital File Location:
TCEQ Corpus Christi Regional Office
Photo No. 7

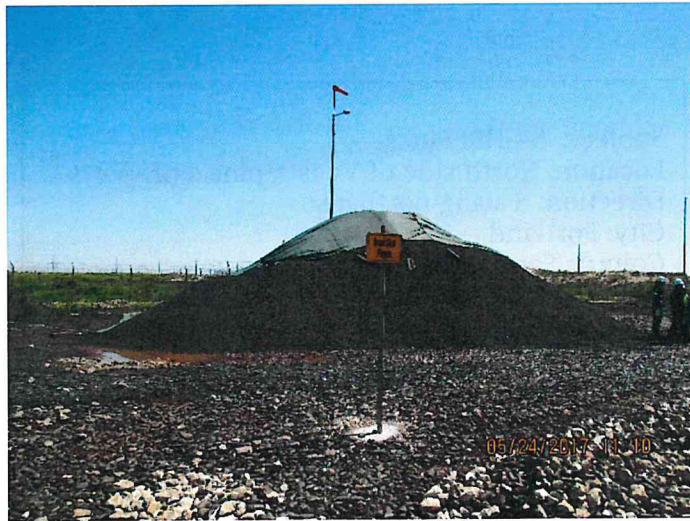
Subject: 03-Remet/Fines/Iron Oxide Pellets
Location: North side of Voestalpine's property
Direction: Facing northeast
City: Portland
County: San Patricio
Date: May 24, 2017
Photographer: Susan Hoelscher, Air Investigator
Digital File Location:
TCEQ Corpus Christi Regional Office
Photo No. 8

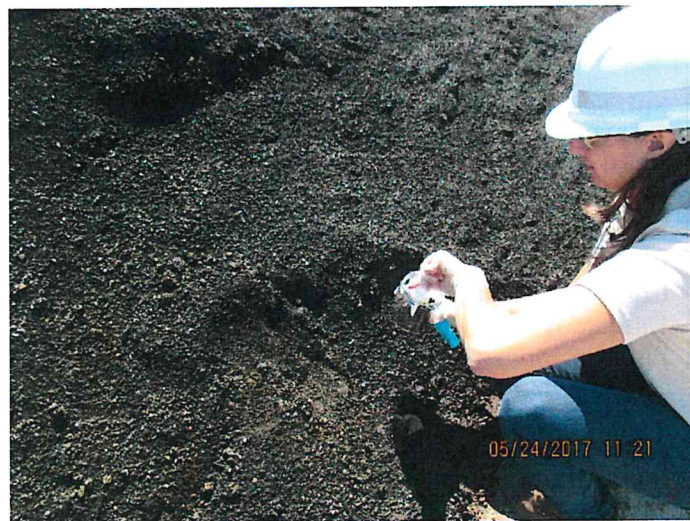
Subject: Collection of Lab Sample ID
HS17051351-04 (04-HBI Fines)
Location: North side of Voestalpine's property;
south side of pile
Direction: Facing northeast
City: Portland
County: San Patricio
Date: May 24, 2017
Photographer: Susan Hoelscher, Air Investigator
Digital File Location:
TCEQ Corpus Christi Regional Office
Photo No. 9

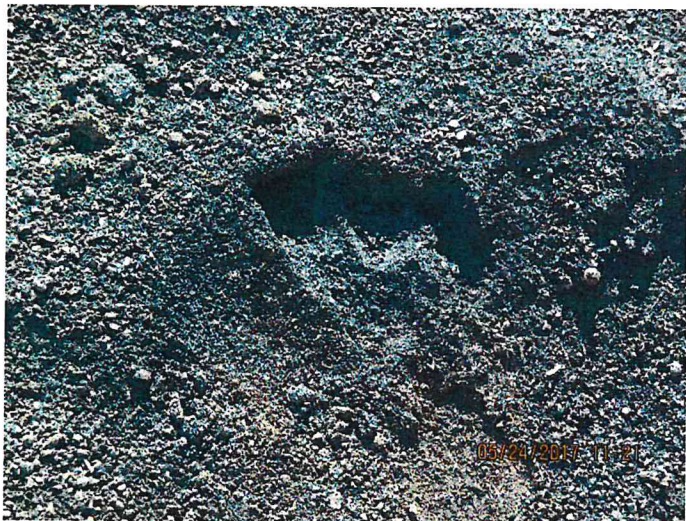
Subject: Location of Lab Sample ID
HS17051351-04 (04-HBI Fines)
Location: North side of Voestalpine's property;
south side of pile
Direction: Facing northeast
City: Portland
County: San Patricio
Date: May 24, 2017
Photographer: Susan Hoelscher, Air Investigator
Digital File Location:
TCEQ Corpus Christi Regional Office
Photo No. 10

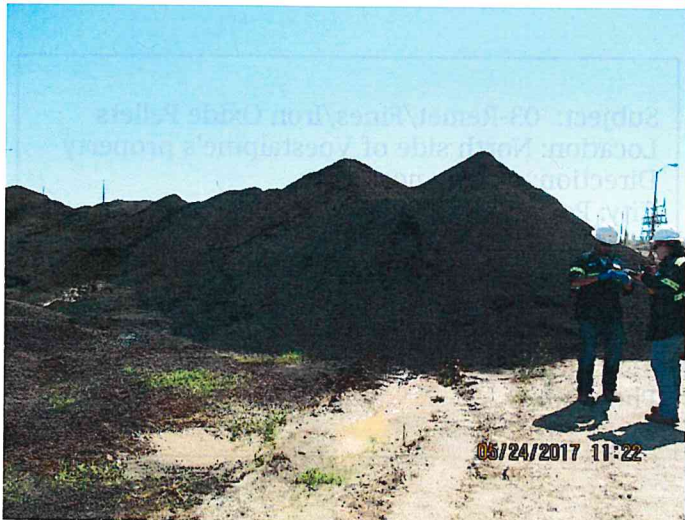
Subject: 04-HBI Fines
Location: North side of Voestalpine's property
Direction: Facing northeast
City: Portland
County: San Patricio
Date: May 24, 2017
Photographer: Susan Hoelscher, Air Investigator
Digital File Location:
TCEQ Corpus Christi Regional Office
Photo No. 11

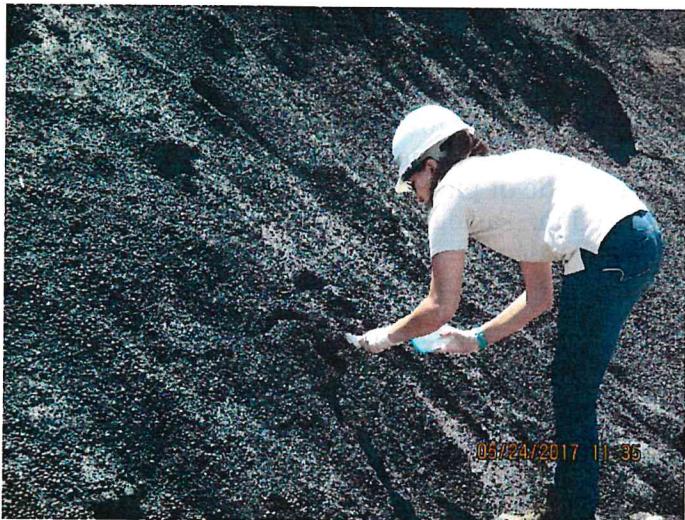
Subject: Collection of Lab Sample ID
HS17051351-05 (05-Remet & HBI Fines)
Location: South side of Voestalpine's property;
north side of pile
Direction: Facing southeast
City: Portland
County: San Patricio
Date: May 24, 2017
Photographer: Susan Hoelscher, Air Investigator
Digital File Location:
TCEQ Corpus Christi Regional Office
Photo No. 12

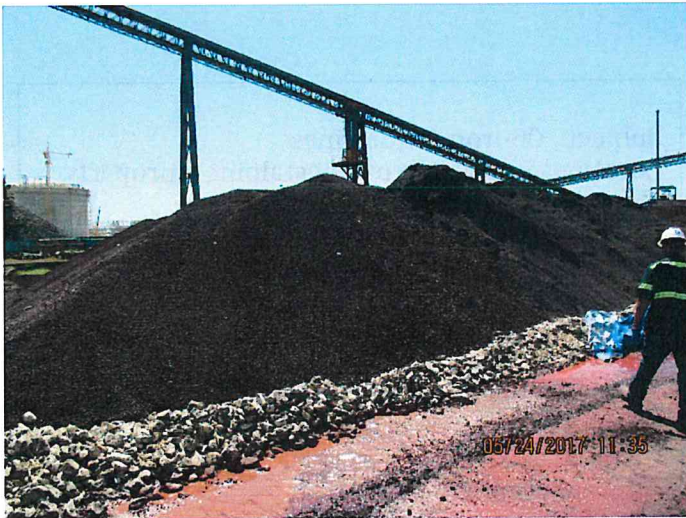
Subject: 05-Remet & HBI Fines
Location: North side of Voestalpine's property
Direction: Facing southeast
City: Portland
County: San Patricio
Date: May 24, 2017
Photographer: Susan Hoelscher, Air Investigator
Digital File Location:
TCEQ Corpus Christi Regional Office
Photo No. 14

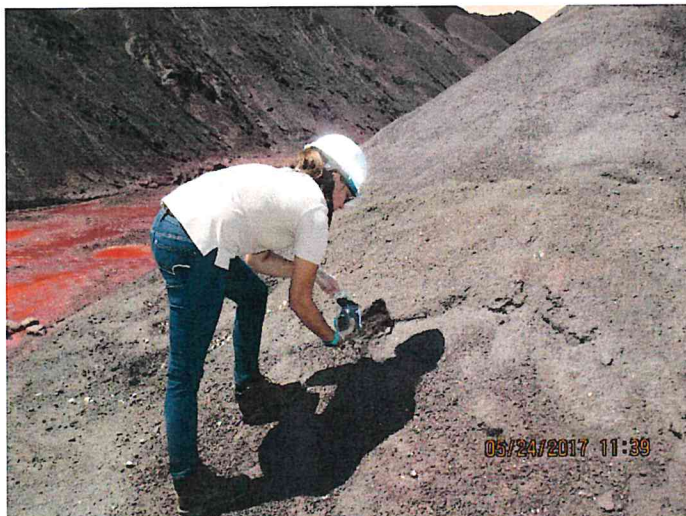
Subject: Collection of Lab Sample ID
HS17051351-06 (06-Iron Oxide Fines)
Location: South side of Voestalpine's property;
northeast side of pile
Direction: Facing southwest
City: Portland
County: San Patricio
Date: May 24, 2017
Photographer: Susan Hoelscher, Air Investigator
Digital File Location:
TCEQ Corpus Christi Regional Office
Photo No. 15

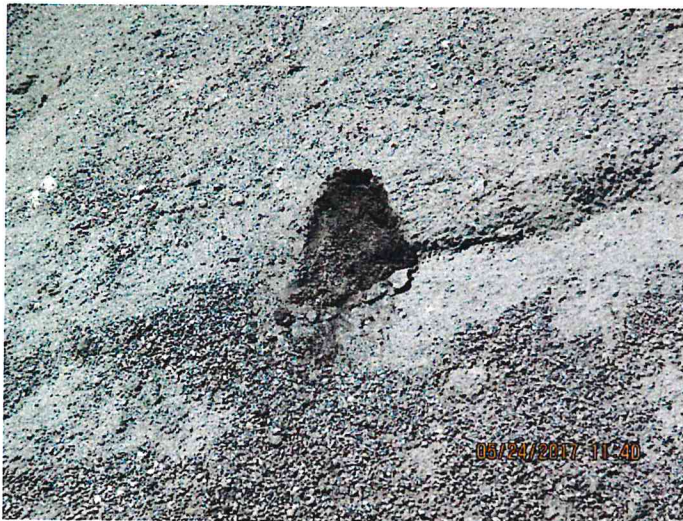
Subject: Location of Lab Sample ID
HS17051351-06 (06-Iron Oxide Fines)
Location: South side of Voestalpine's property;
northeast side of pile
Direction: Facing southwest
City: Portland
County: San Patricio
Date: May 24, 2017
Photographer: Susan Hoelscher, Air Investigator
Digital File Location:
TCEQ Corpus Christi Regional Office
Photo No. 16

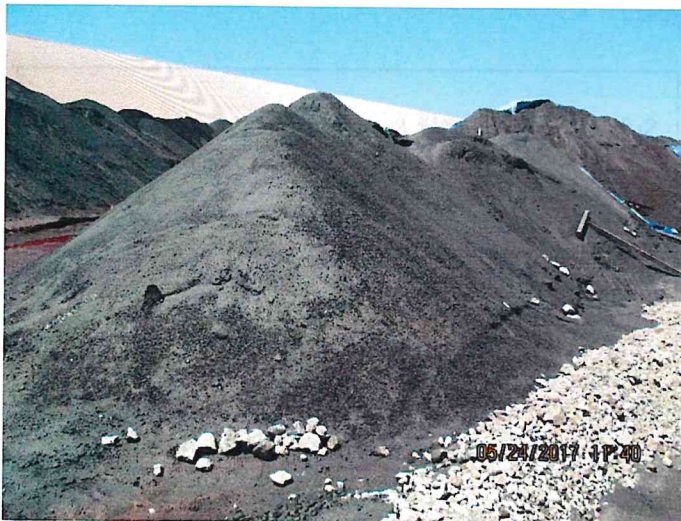
Subject: 06-Iron Oxide Fines
Location: South side of Voestalpine's property
Direction: Facing southwest
City: Portland
County: San Patricio
Date: May 24, 2017
Photographer: Susan Hoelscher, Air Investigator
Digital File Location:
TCEQ Corpus Christi Regional Office
Photo No. 17

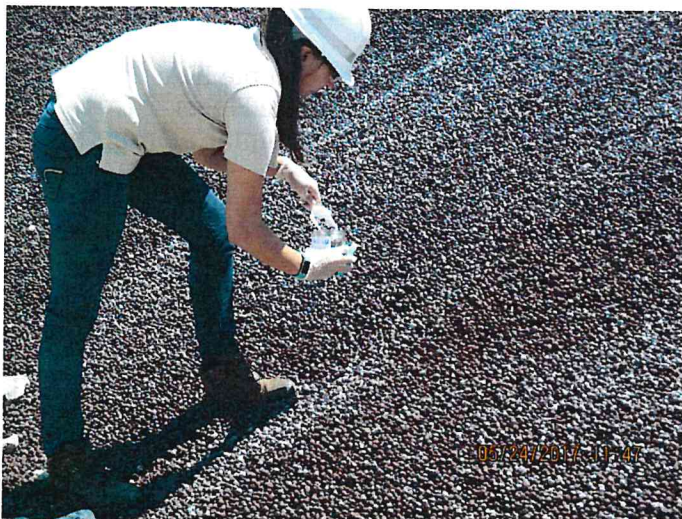
Subject: Collection of Lab Sample ID
HS17051351-07 (07-Coated Iron Oxide Pellets)
Location: South side of Voestalpine's property;
northwest side of pile
Direction: Facing northeast
City: Portland
County: San Patricio
Date: May 24, 2017
Photographer: Susan Hoelscher, Air Investigator
Digital File Location:
TCEQ Corpus Christi Regional Office
Photo No. 18

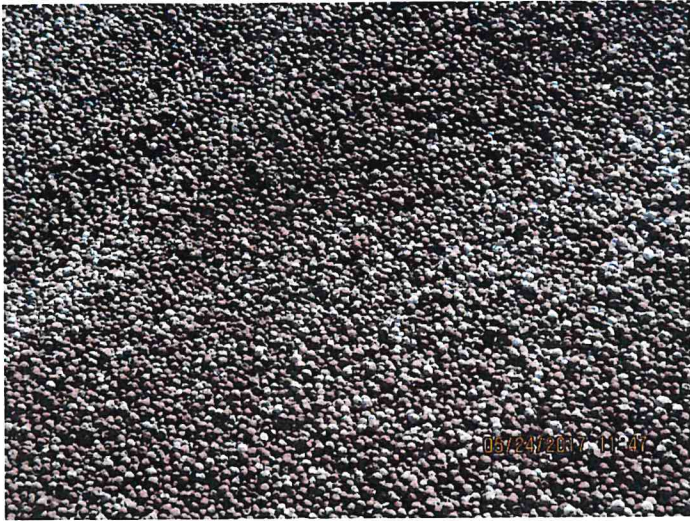
Subject: Location of Lab Sample ID
HS17051351-07 (07-Coated Iron Oxide Pellets)
Location: South side of Voestalpine's property;
northwest side of pile
Direction: Facing northeast
City: Portland
County: San Patricio
Date: May 24, 2017
Photographer: Susan Hoelscher, Air Investigator
Digital File Location:
TCEQ Corpus Christi Regional Office
Photo No. 19

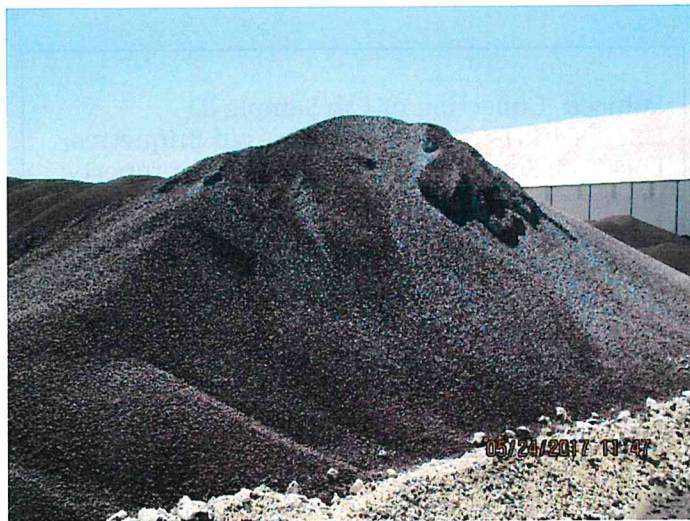
Subject: 07-Coated Iron Oxide Pellets
Location: South side of Voestalpine's property
Direction: Facing southeast
City: Portland
County: San Patricio
Date: May 24, 2017
Photographer: Susan Hoelscher, Air Investigator
Digital File Location:
TCEQ Corpus Christi Regional Office
Photo No. 20

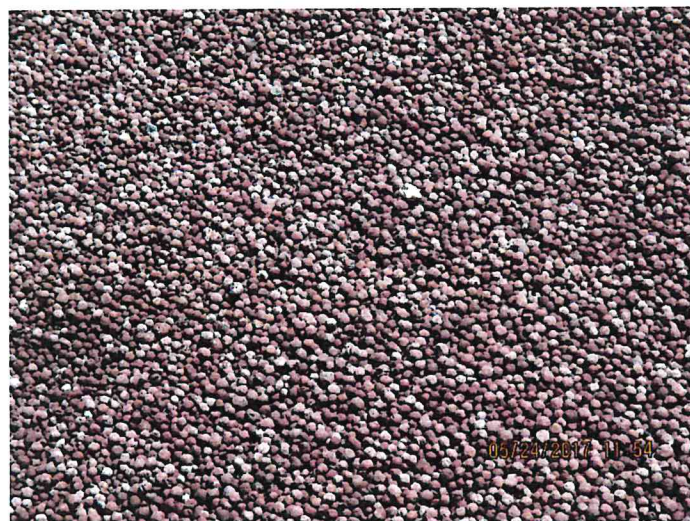
Subject: Location of Lab Sample ID
HS17051351-08 (08-Iron Oxide Pellets)
Location: South side of Voestalpine's property;
northwest side of pile
Direction: Facing northeast
City: Portland
County: San Patricio
Date: May 24, 2017
Photographer: Susan Hoelscher, Air Investigator
Digital File Location:
TCEQ Corpus Christi Regional Office
Photo No. 21

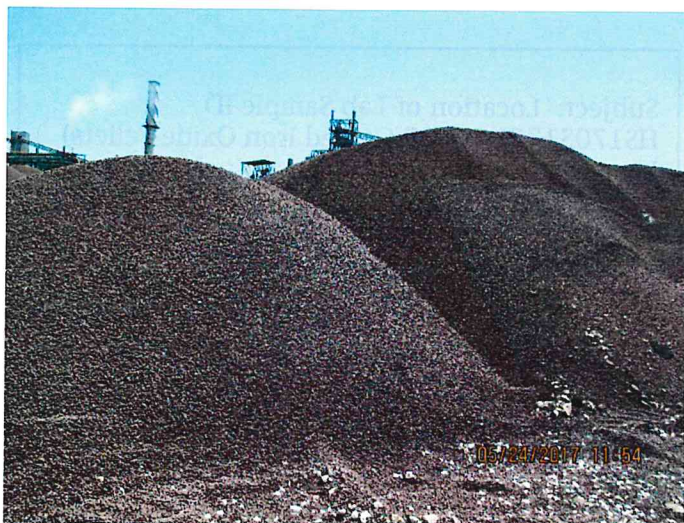
Subject: 08-Iron Oxide Pellets
Location: South side of Voestalpine's property
Direction: Facing northeast
City: Portland
County: San Patricio
Date: May 24, 2017
Photographer: Susan Hoelscher, Air Investigator
Digital File Location:
TCEQ Corpus Christi Regional Office
Photo No. 22

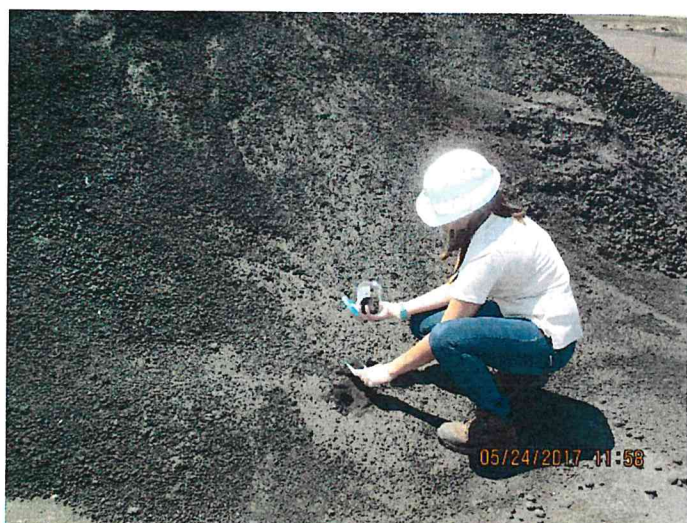
Subject: Collection of Lab Sample ID
HS17051351-09 (09-HBI Fines Cold Briquettes)
Location: South side of Voestalpine's property;
northwest side of pile
Direction: Facing southeast
City: Portland
County: San Patricio
Date: May 24, 2017
Photographer: Susan Hoelscher, Air Investigator
Digital File Location:
TCEQ Corpus Christi Regional Office
Photo No. 23

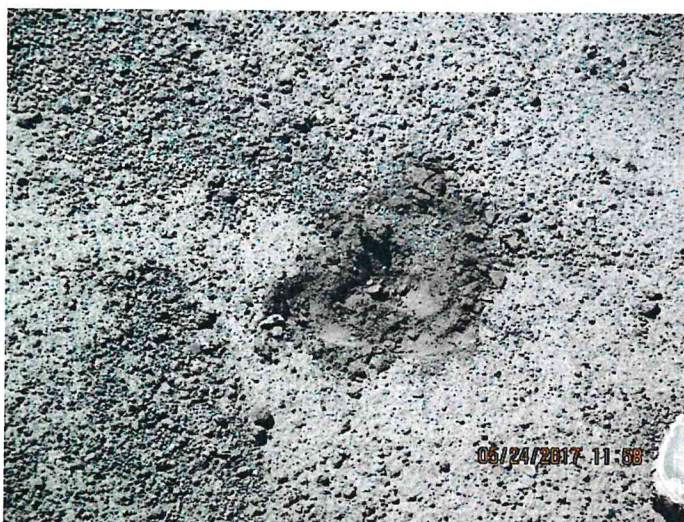
Subject: Location of Lab Sample ID
HS17051351-09 (09-HBI Fines Cold Briquettes)
Location: South side of Voestalpine's property;
northwest side of pile
Direction: Facing southeast
City: Portland
County: San Patricio
Date: May 24, 2017
Photographer: Susan Hoelscher, Air Investigator
Digital File Location:
TCEQ Corpus Christi Regional Office
Photo No. 24

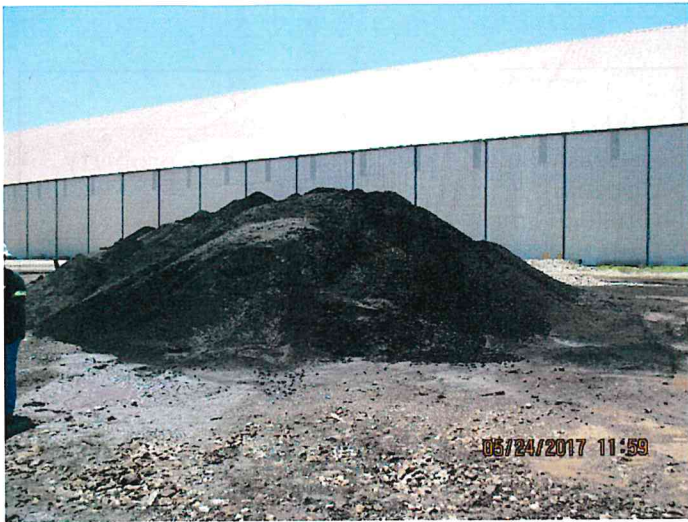
Subject: 09-HBI Fines Cold Briquettes
Location: South side of Voestalpine's property
Direction: Facing southeast
City: Portland
County: San Patricio
Date: May 24, 2017
Photographer: Susan Hoelscher, Air Investigator
Digital File Location:
TCEQ Corpus Christi Regional Office
Photo No. 25

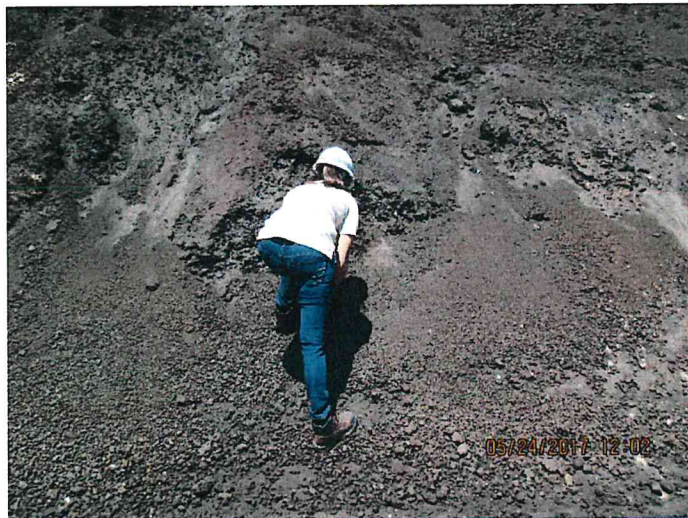
Subject: Collection of Lab Sample ID
HS17051351-10 (10-HBI Fines)
Location: South side of Voestalpine's property;
southeast side of pile
Direction: Facing southwest
City: Portland
County: San Patricio
Date: May 24, 2017
Photographer: Susan Hoelscher, Air Investigator
Digital File Location:
TCEQ Corpus Christi Regional Office
Photo No. 26

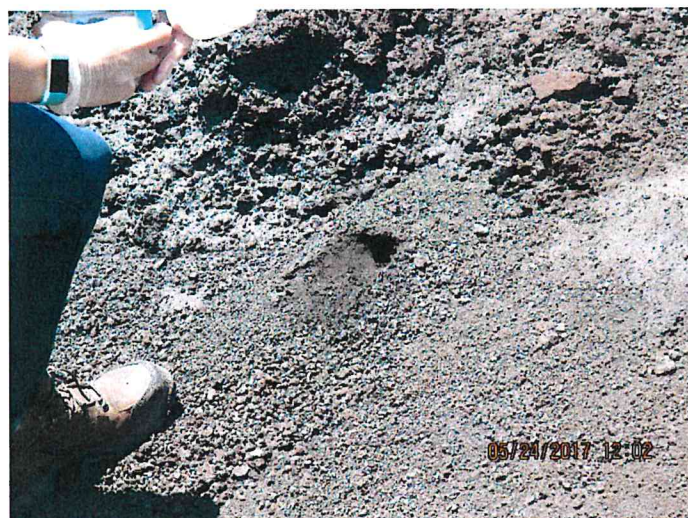
Subject: Location of Lab Sample ID
HS17051351-10 (10-HBI Fines)
Location: South side of Voestalpine's property;
southeast side of pile
Direction: Facing southwest
City: Portland
County: San Patricio
Date: May 24, 2017
Photographer: Susan Hoelscher, Air Investigator
Digital File Location:
TCEQ Corpus Christi Regional Office
Photo No. 27

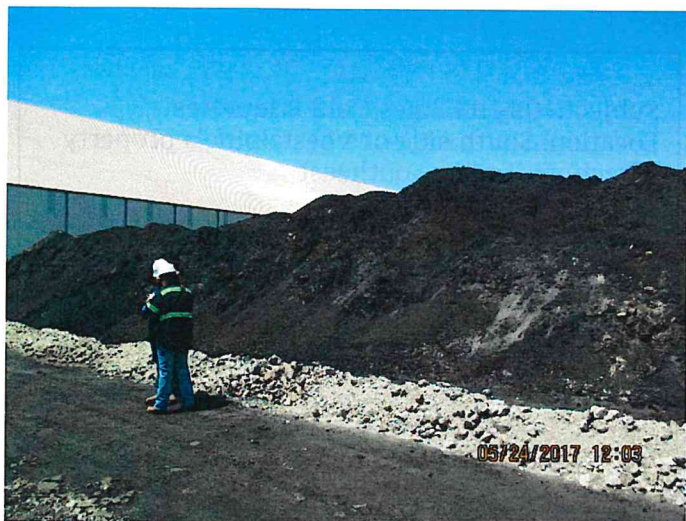
Subject: 10-HBI Fines
Location: South side of Voestalpine's property
Direction: Facing southwest
City: Portland
County: San Patricio
Date: May 24, 2017
Photographer: Susan Hoelscher, Air Investigator
Digital File Location:
TCEQ Corpus Christi Regional Office
Photo No. 28

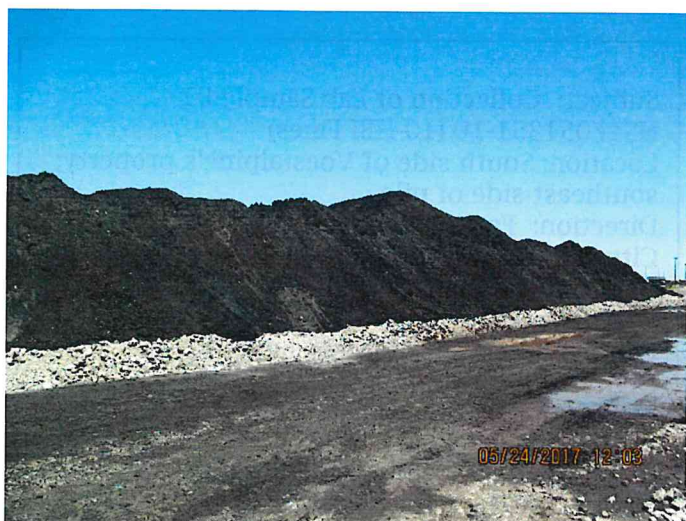
Subject: 10-HBI Fines
Location: South side of Voestalpine's property
Direction: Facing northwest
City: Portland
County: San Patricio
Date: May 24, 2017
Photographer: Susan Hoelscher, Air Investigator
Digital File Location:
TCEQ Corpus Christi Regional Office
Photo No. 29

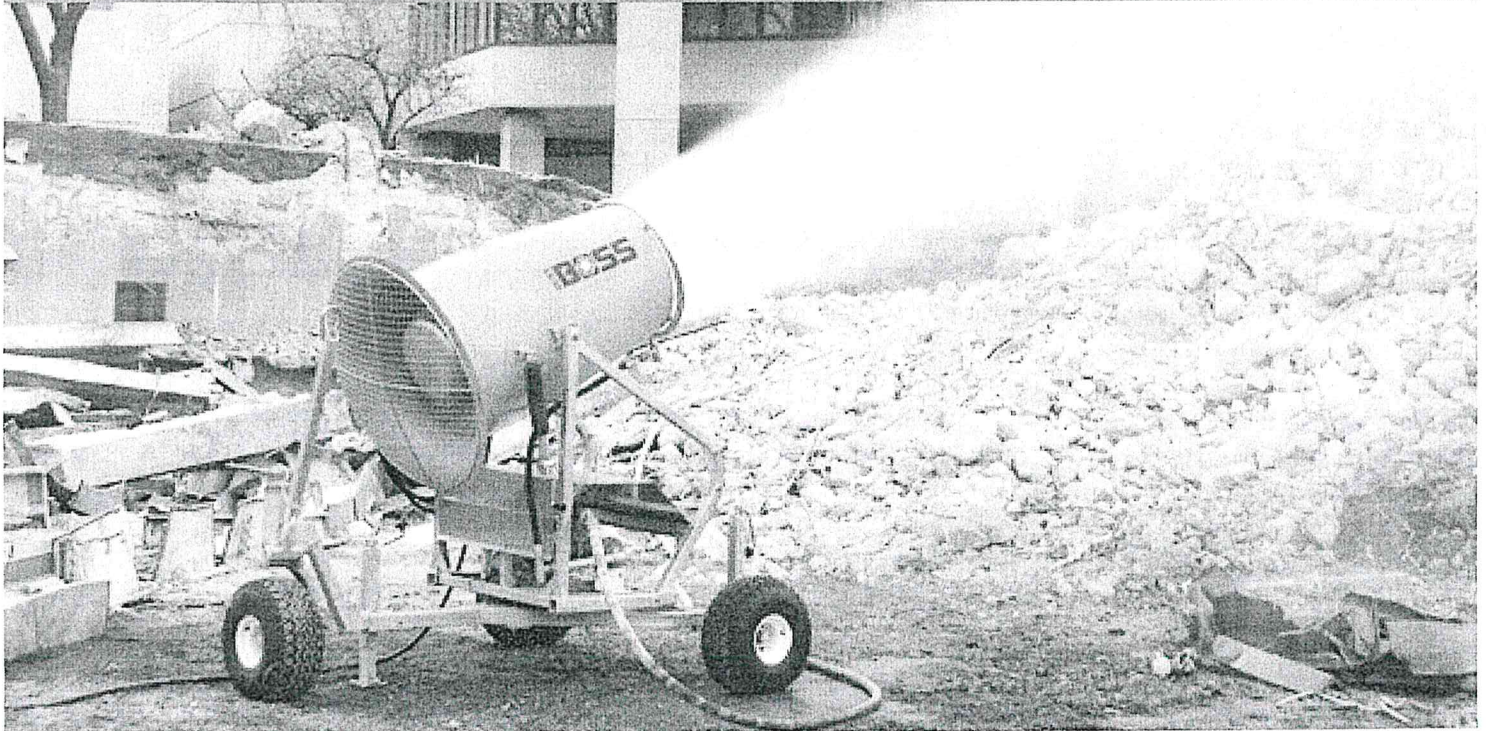
DUSTBOSS® 60

The DB-60 is capable of covering more than 125,000 square feet (11,613 square meters) with its powerful dust-trapping mist when equipped with optional user-definable oscillation (up to 359°).
