AIR CP_106597875_CP_20171016_Investigation_1415945_
Texas Commission on Environmental Quality
Investigation Report

Regulated Entity Name: LA QUINTA PLANT

Investigation # 1415945

Investigation Type: Compliance Investigation

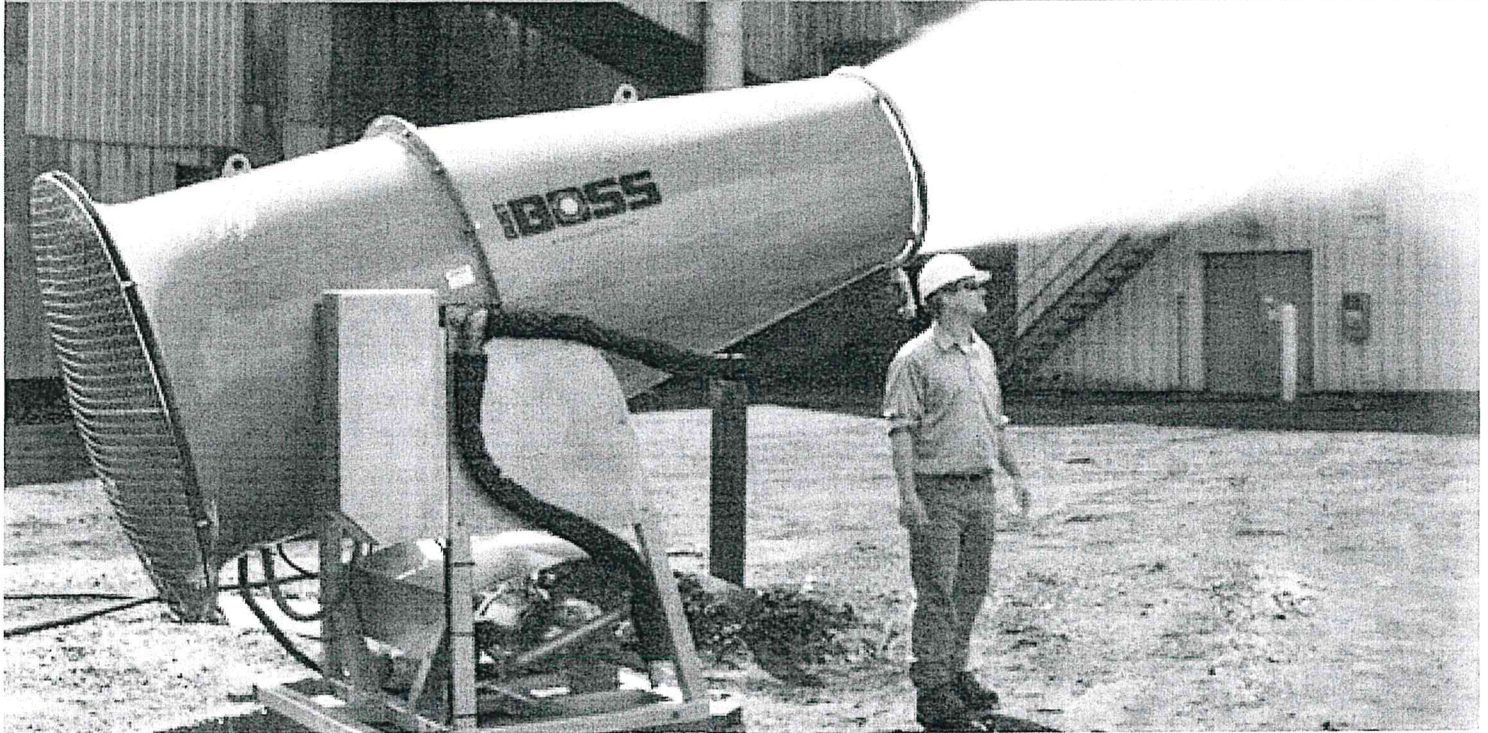
DUSTBOSS® 100

Engineered to fight dust on the largest and toughest of work sites, the DB-100 is the biggest DustBoss ever designed.

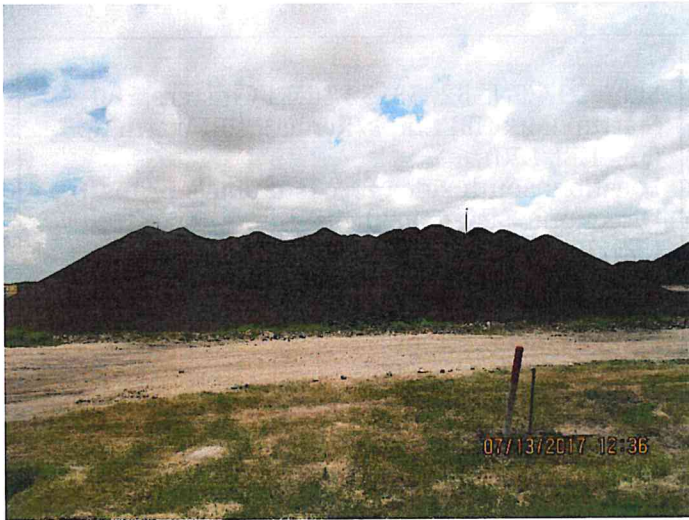
Subject: EPN 41-Remet
Location: North side of Voestalpine's property
Direction: Facing northeast
City: Portland
County: San Patricio
Date: July 13, 2017
Photographer: Susan Hoelscher, Air Investigator
Digital File Location:
TCEQ Corpus Christi Regional Office
Photo No. 1

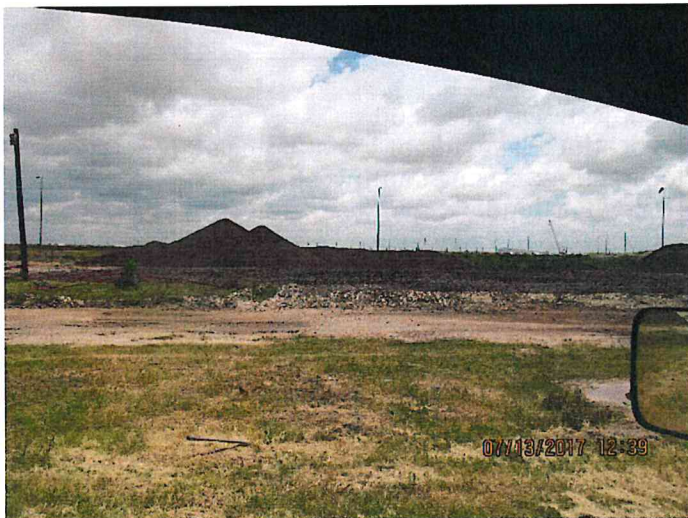
Subject: EPN 42-HBI Chips/Fines
Location: North side of Voestalpine's property
Direction: Facing east
City: Portland
County: San Patricio
Date: July 13, 2017
Photographer: Susan Hoelscher, Air Investigator
Digital File Location:
TCEQ Corpus Christi Regional Office
Photo No. 2

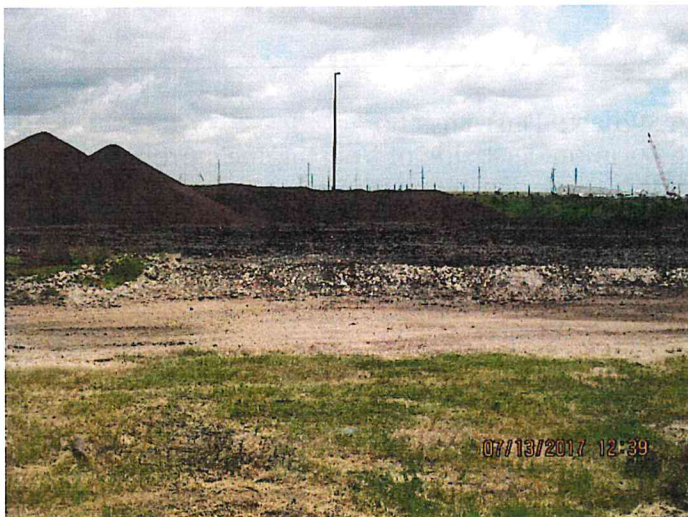
Subject: EPN 51 (Sold)-HBI
Location: South side of Voestalpine's property
Direction: Facing east
City: Portland
County: San Patricio
Date: July 13, 2017
Photographer: Susan Hoelscher, Air Investigator
Digital File Location:
TCEQ Corpus Christi Regional Office
Photo No. 3

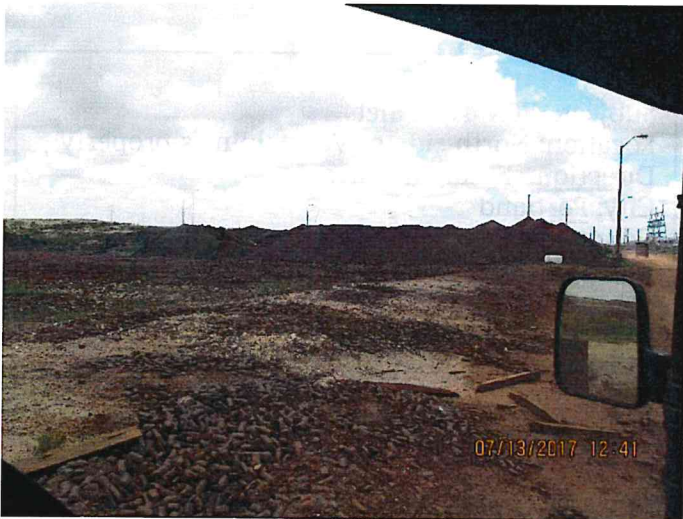
Subject: EPNs 52, 53, 54-HDRI Clusters, HBI Startup (Mix HBI Chips/Remet), HBI Warm up (Mix HBI/DRI)
Location: South side of Voestalpine's property
Direction: Facing northeast
City: Portland
County: San Patricio
Date: July 13, 2017
Photographer: Susan Hoelscher, Air Investigator
Digital File Location: TCEQ Corpus Christi Regional Office
Photo No. 4

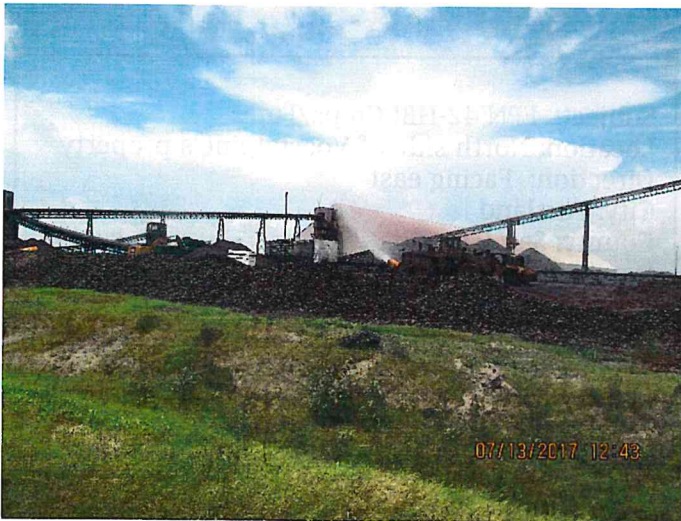
Subject: Dust Boss 60
Location: East side of Voestalpine's property
Direction: Facing southwest
City: Portland
County: San Patricio
Date: July 23, 2017
Photographer: Susan Hoelscher, Air Investigator
Digital File Location: TCEQ Corpus Christi Regional Office
Photo No. 5

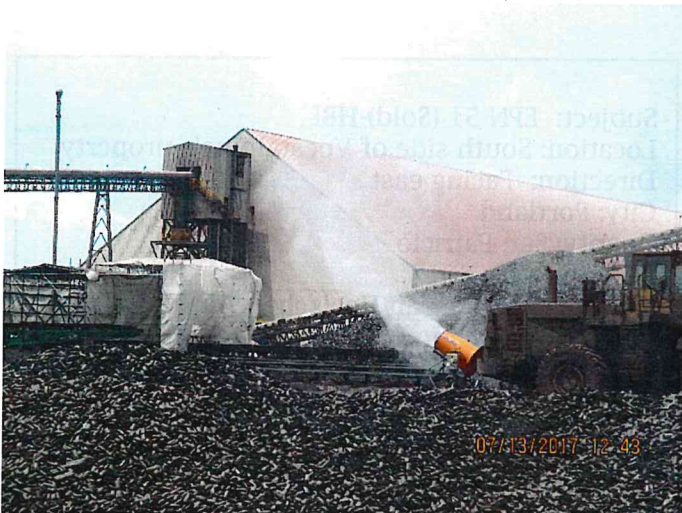
Subject: Dust Boss 60
Location: East side of Voestalpine's property
Direction: Facing southwest
City: Portland
County: San Patricio
Date: July 23, 2017
Photographer: Susan Hoelscher, Air Investigator
Digital File Location: TCEQ Corpus Christi Regional Office
Photo No. 6

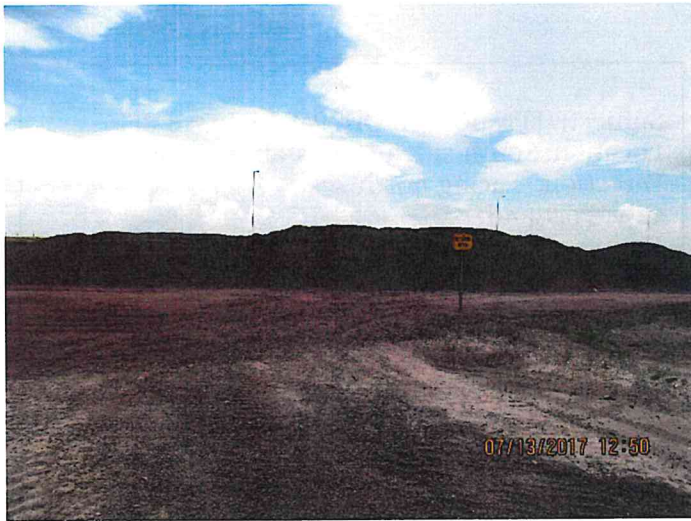
Subject: EPN 45-Iron Ore Pellets RH20
Location: South side of Voestalpine's property
Direction: Facing northwest
City: Portland
County: San Patricio
Date: July 23, 2017
Photographer: Susan Hoelscher, Air Investigator
Digital File Location:
TCEQ Corpus Christi Regional Office
Photo No. 7

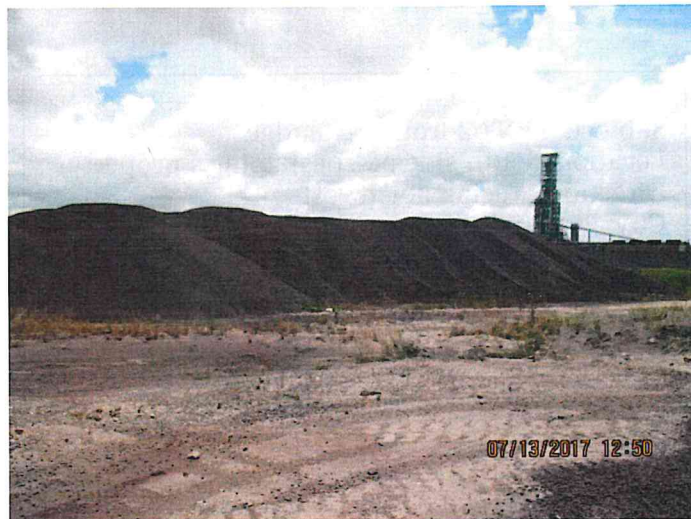
Subject: EPN 46-Iron Ore Pellets LKAB BFP
Location: South side of Voestalpine's property
Direction: Facing northeast
City: Portland
County: San Patricio
Date: July 23, 2017
Photographer: Susan Hoelscher, Air Investigator
Digital File Location:
TCEQ Corpus Christi Regional Office
Photo No. 8

- (4) *According to NSR Permit No. 108113 Special Condition 17, iron ore pellets shall be stored in enclosed storage. During sampling conducted at Voestalpine on May 24, 2017, it was documented that some iron ore pellets are stored outside. Please provide documentation indicating when outside storage of iron ore pellets began.*

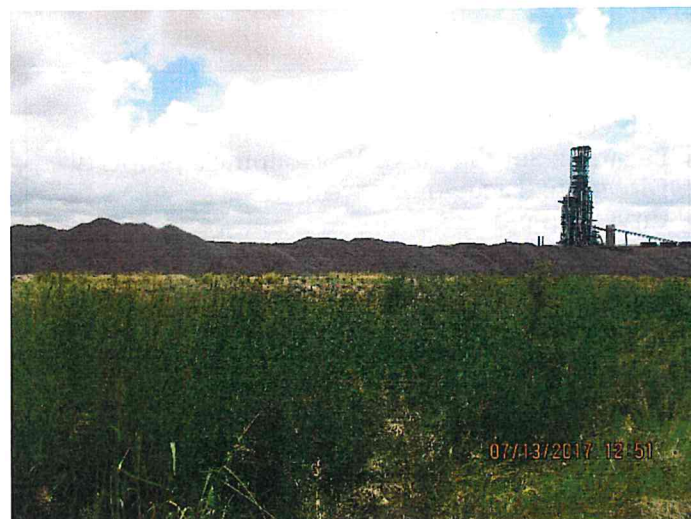
Subject: EPN 46-Iron Ore Pellets LKAB BFP
Location: South side of Voestalpine's property
Direction: Facing northeast
City: Portland
County: San Patricio
Date: July 23, 2017
Photographer: Susan Hoelscher, Air Investigator
Digital File Location:
TCEQ Corpus Christi Regional Office
Photo No. 9

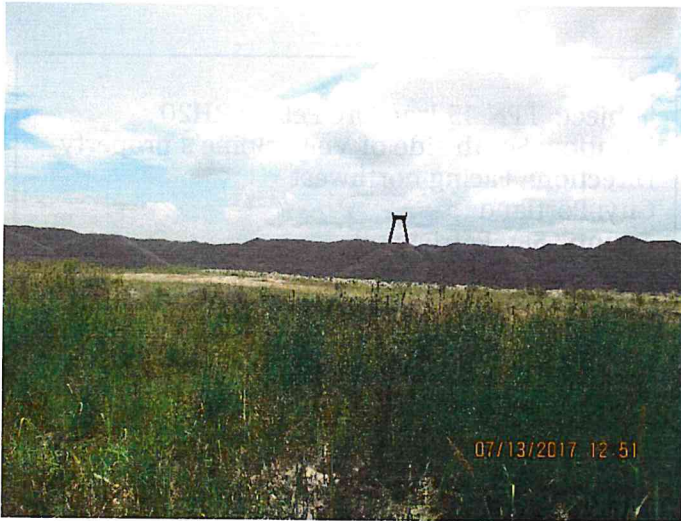
Subject: EPN 46-Iron Ore Pellets LKAB BFP
Location: South side of Voestalpine's property
Direction: Facing northwest
City: Portland
County: San Patricio
Date: July 23, 2017
Photographer: Susan Hoelscher, Air Investigator
Digital File Location:
TCEQ Corpus Christi Regional Office
Photo No. 10

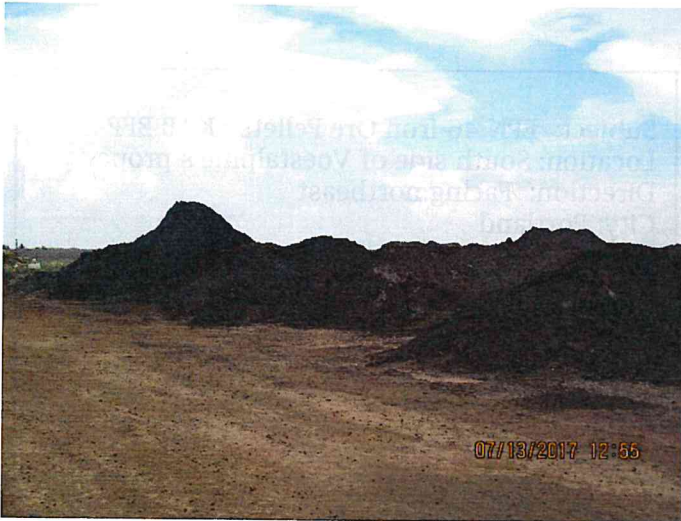
Subject: EPN 62-Iron Ore Sludge
Location: South side of Voestalpine's property
Direction: Facing northwest
City: Portland
County: San Patricio
Date: July 23, 2017
Photographer: Susan Hoelscher, Air Investigator
Digital File Location:
TCEQ Corpus Christi Regional Office
Photo No. 11

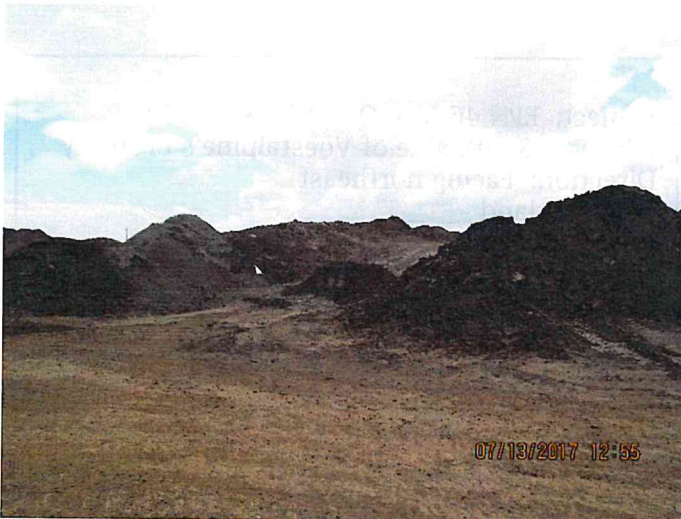
Subject: EPN 61-HBI Sludge
Location: South side of Voestalpine's property
Direction: Facing northwest
City: Portland
County: San Patricio
Date: July 23, 2017
Photographer: Susan Hoelscher, Air Investigator
Digital File Location:
TCEQ Corpus Christi Regional Office
Photo No. 12

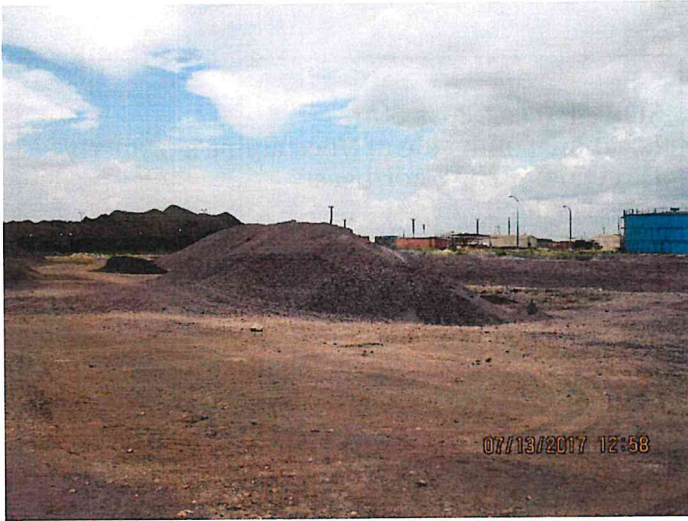
Subject: EPN 59-RH20 Iron Ore Coated Pellets
Location: South side of Voestalpine's property
Direction: Facing northwest
City: Portland
County: San Patricio
Date: July 23, 2017
Photographer: Susan Hoelscher, Air Investigator
Digital File Location:
TCEQ Corpus Christi Regional Office
Photo No. 13

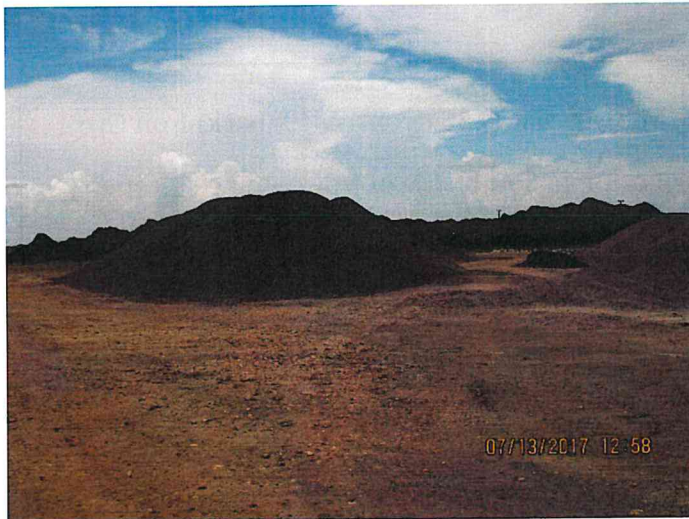
Subject: EPN 60-RH20 Iron Ore Coated Pellets
Location: South side of Voestalpine's property
Direction: Facing northwest
City: Portland
County: San Patricio
Date: July 23, 2017
Photographer: Susan Hoelscher, Air Investigator
Digital File Location:
TCEQ Corpus Christi Regional Office
Photo No. 14

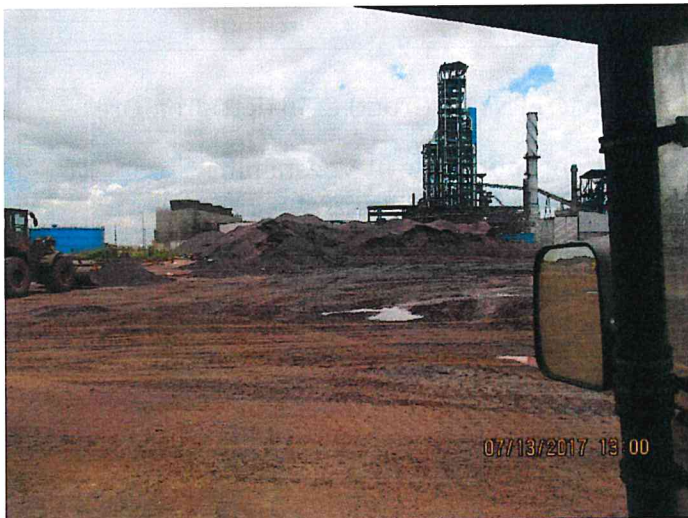
Subject: EPNs 47 & 48-Iron Ore Fines
Location: South side of Voestalpine's property
Direction: Facing north
City: Portland
County: San Patricio
Date: July 23, 2017
Photographer: Susan Hoelscher, Air Investigator
Digital File Location:
TCEQ Corpus Christi Regional Office
Photo No. 15

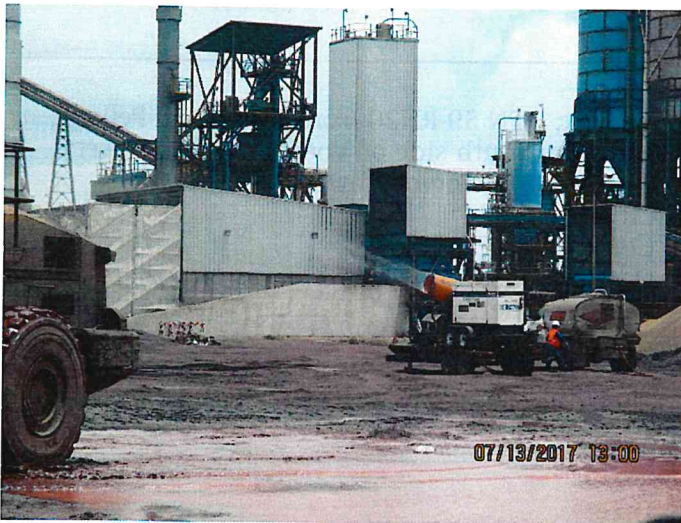
Subject: Dust Boss 60
Location: South side of Voestalpine's property
Direction: Facing northeast
City: Portland
County: San Patricio
Date: July 23, 2017
Photographer: Susan Hoelscher, Air Investigator
Digital File Location:
TCEQ Corpus Christi Regional Office
Photo No. 16

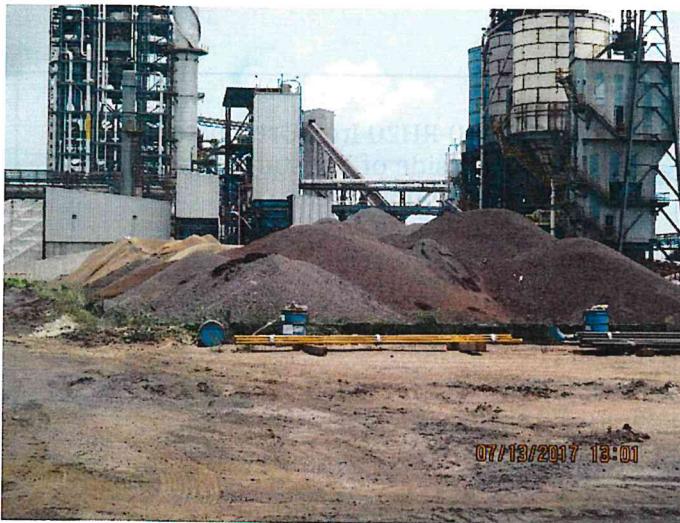
Subject: EPNs 56 (front) & 49 (back)-Iron Ore Fines
Location: South side of Voestalpine's property
Direction: Facing northeast
City: Portland
County: San Patricio
Date: July 23, 2017
Photographer: Susan Hoelscher, Air Investigator
Digital File Location:
TCEQ Corpus Christi Regional Office
Photo No. 17

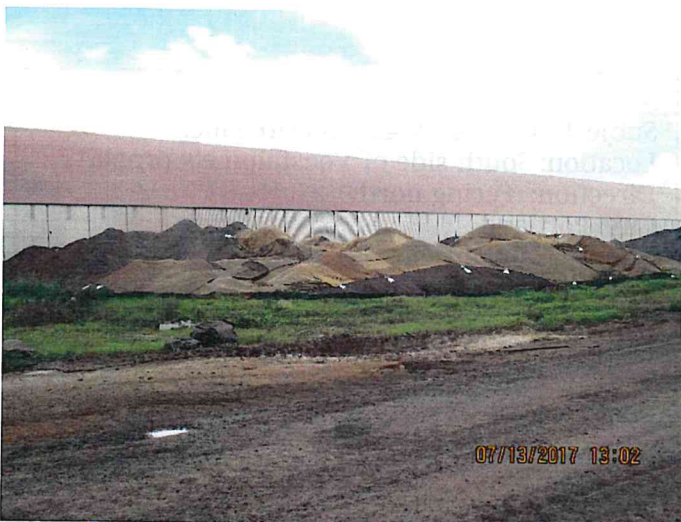
Subject: EPNs 49 (front) & 56 (left)-Iron Ore Fines
Location: South side of Voestalpine's property
Direction: Facing southwest
City: Portland
County: San Patricio
Date: July 23, 2017
Photographer: Susan Hoelscher, Air Investigator
Digital File Location:
TCEQ Corpus Christi Regional Office
Photo No. 18
