UNITED STATES ENVIRONMENTAL PROTECTION AGENCY

Inspection Date: March 15 - 16, 2010 EPA ID Number: not applicable

Facility Name: Frisco Neighborhood Soil Survey

Physical Location: Public areas within 1 mile of Exide Technologies
Frisco, Texas

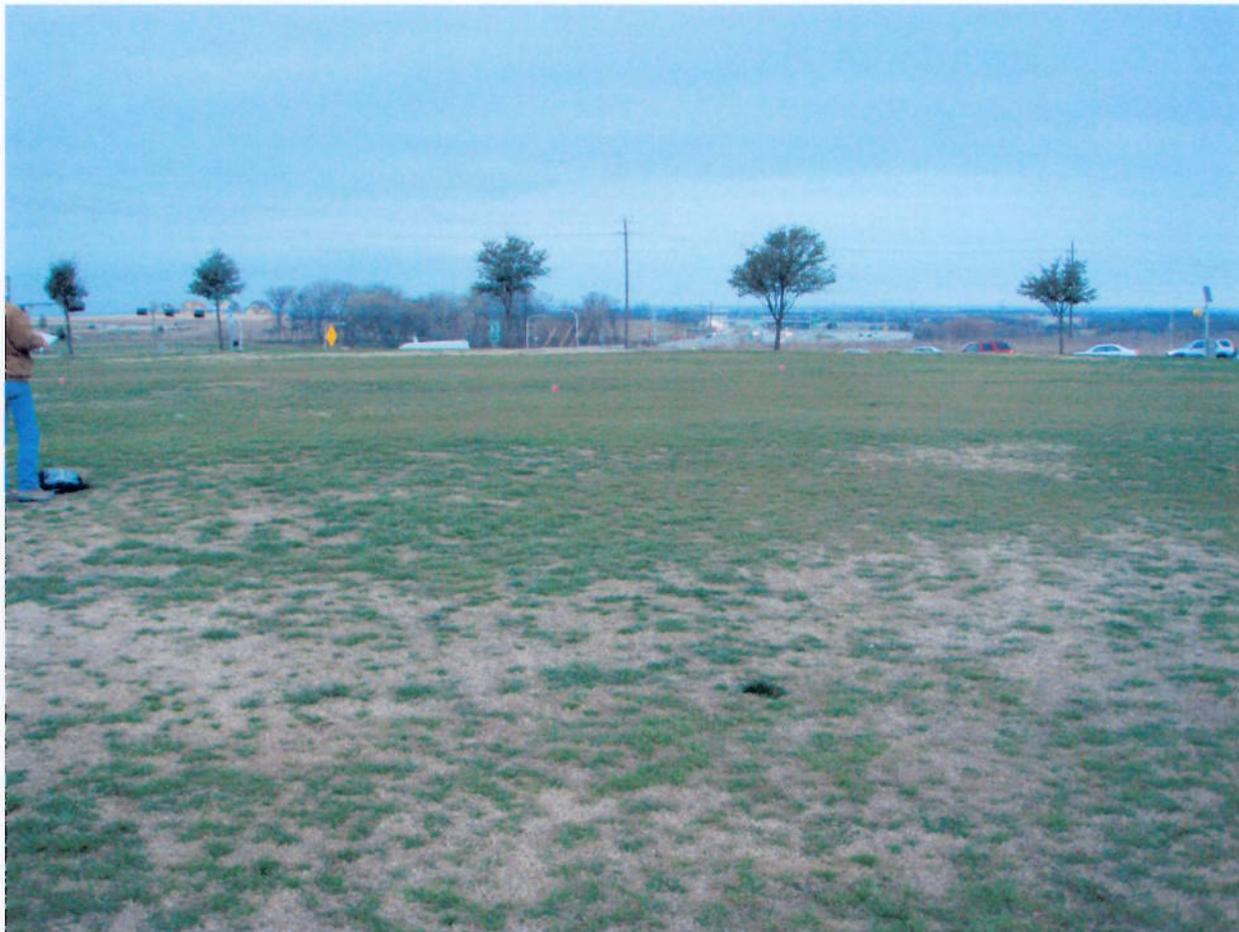
Photo # 1

Photographer: Melissa Smith	Date: 03/15/10	Time: 8:01 AM
City/County: Frisco / Collin County		State: TX
Location: Frisco High School		
Subject: Band practice area on NW side of school. Pink flags denote the grid and composite sample locations.

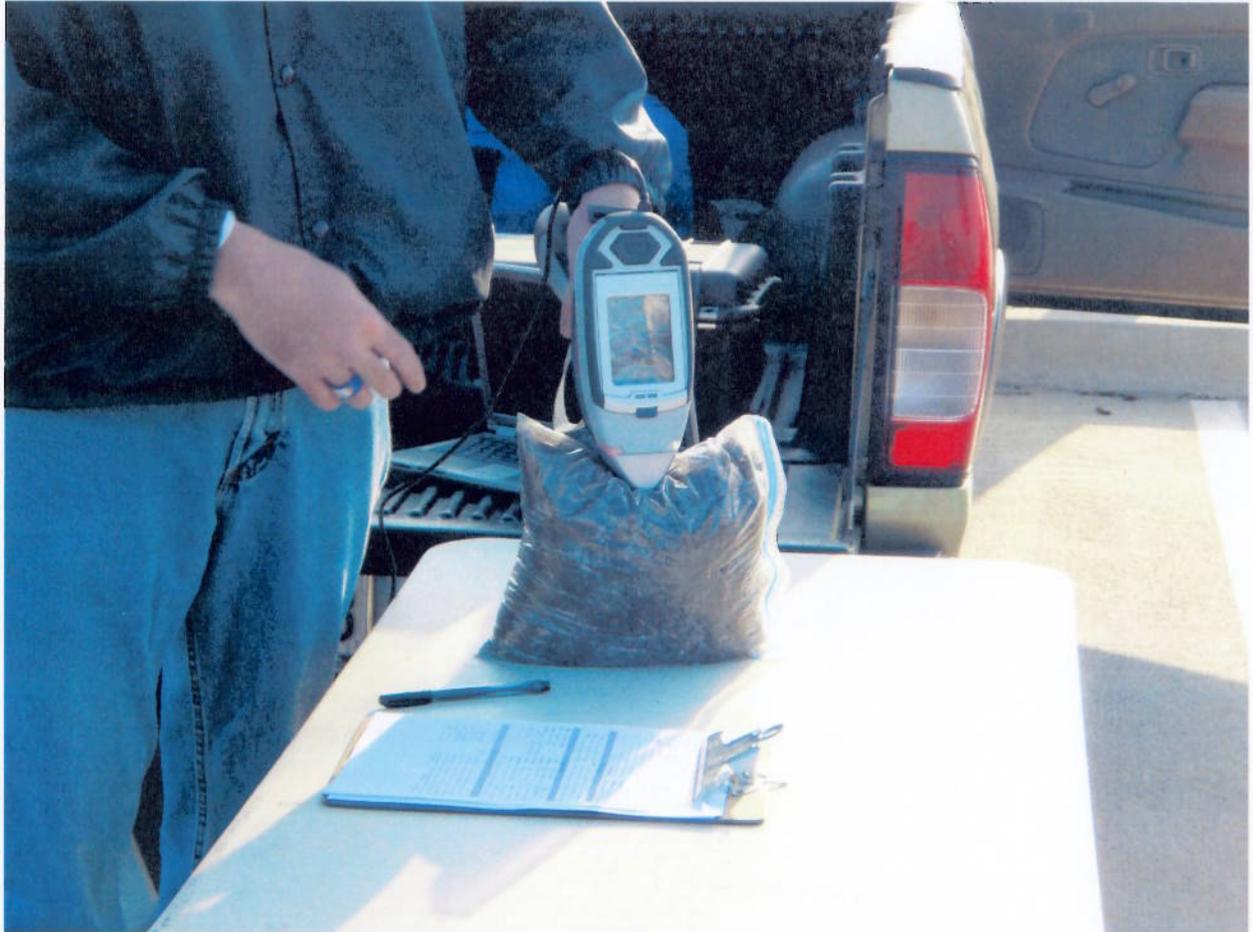
Photo # 2

Photographer: Melissa Smith	Date: 03/15/10	Time: 8:53 AM
City/County: Frisco / Collin County		State: TX
Location: Frisco High School		
Subject: XRF screening of band practice area sample.

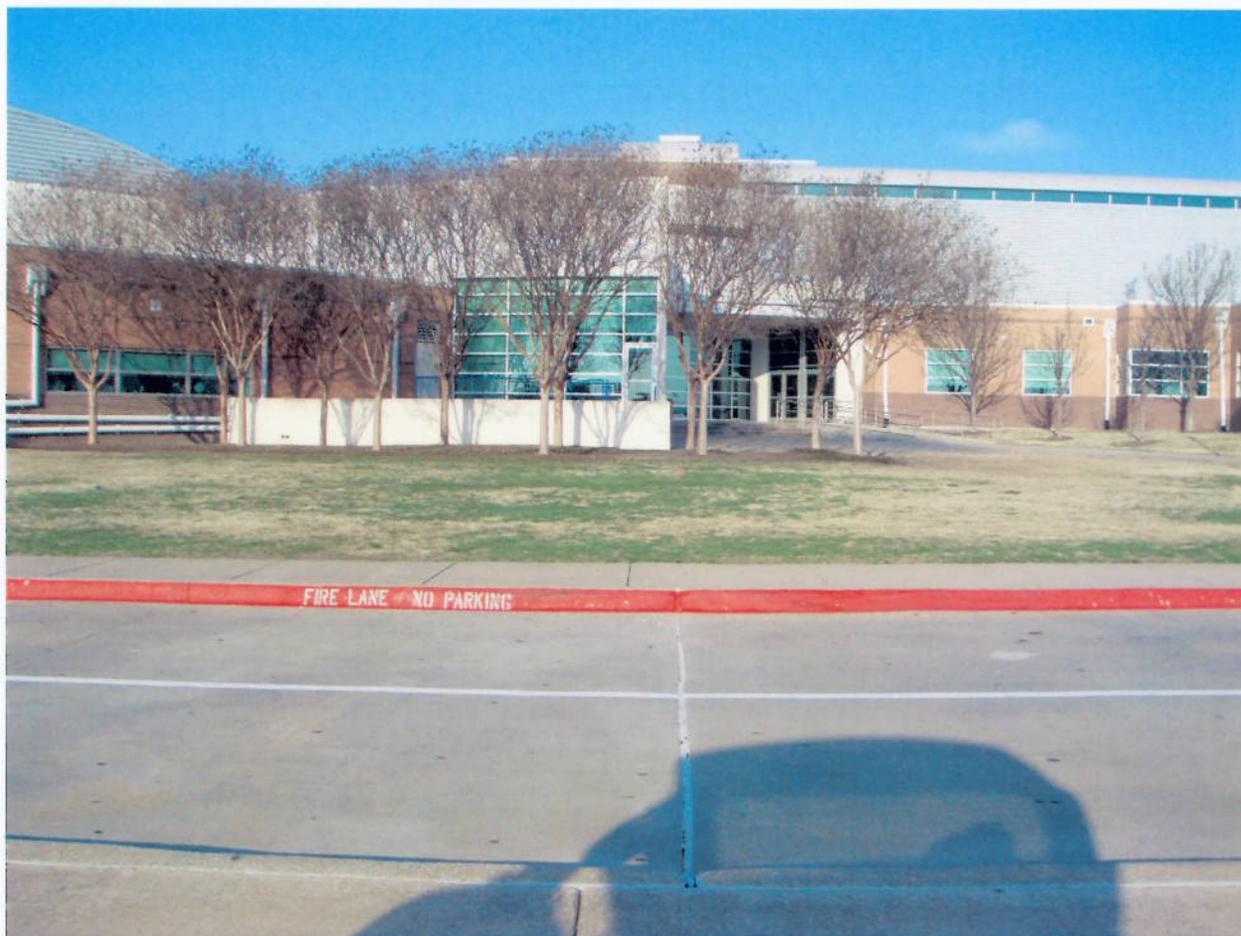
Photo # 3

Photographer: Melissa Smith	Date: 03/15/10	Time: 8:59 AM
City/County: Frisco / Collin County		State: TX
Location: Frisco High School		
Subject: Front of school. Pink flags denote grid and composite sample locations.

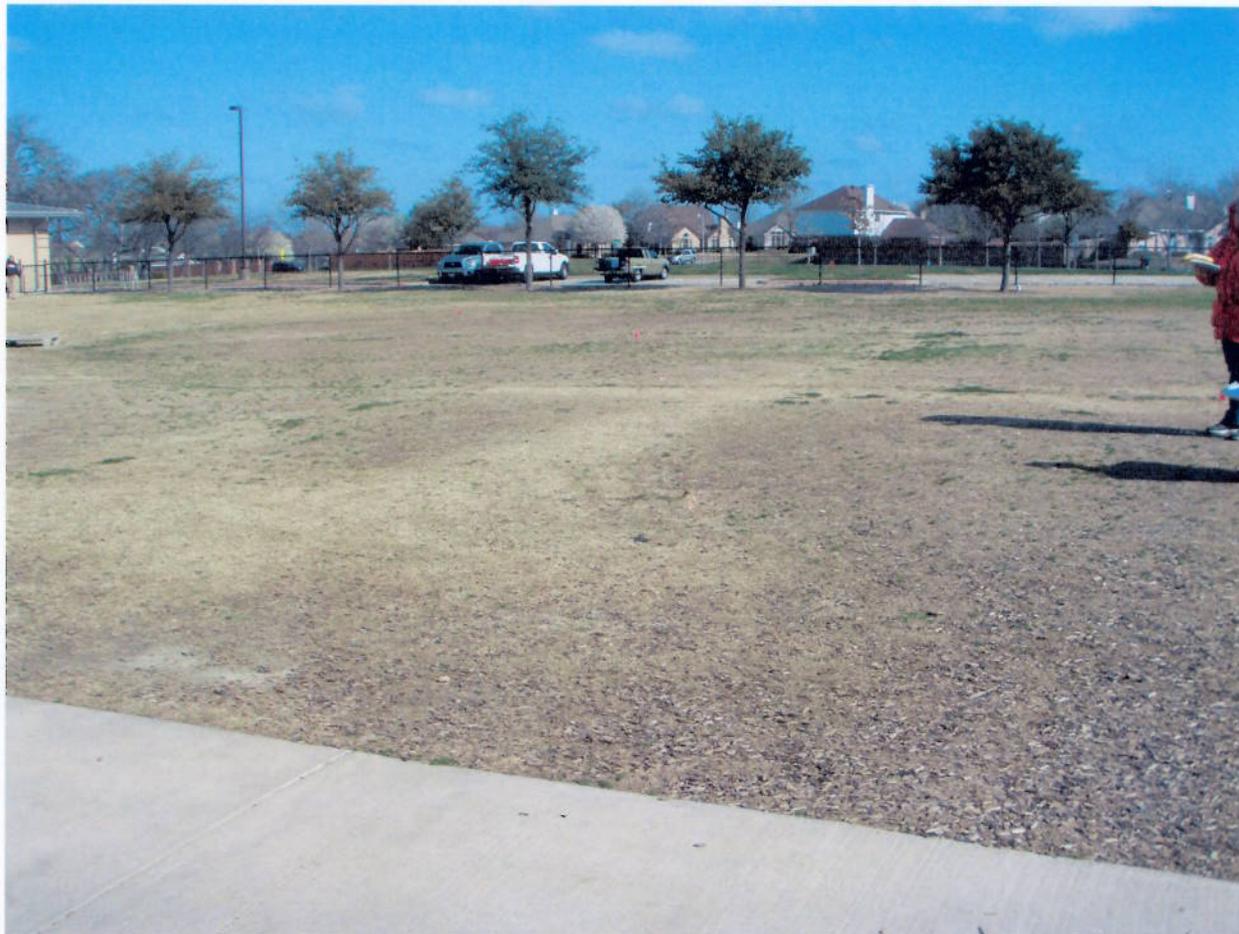
Photo # 4

Photographer: Melissa Smith	Date: 03/15/10	Time: 10:45 AM
City/County: Frisco / Collin County		State: TX
Location: Ida Lee Bright Elementary		
Subject: Playground area east of school.

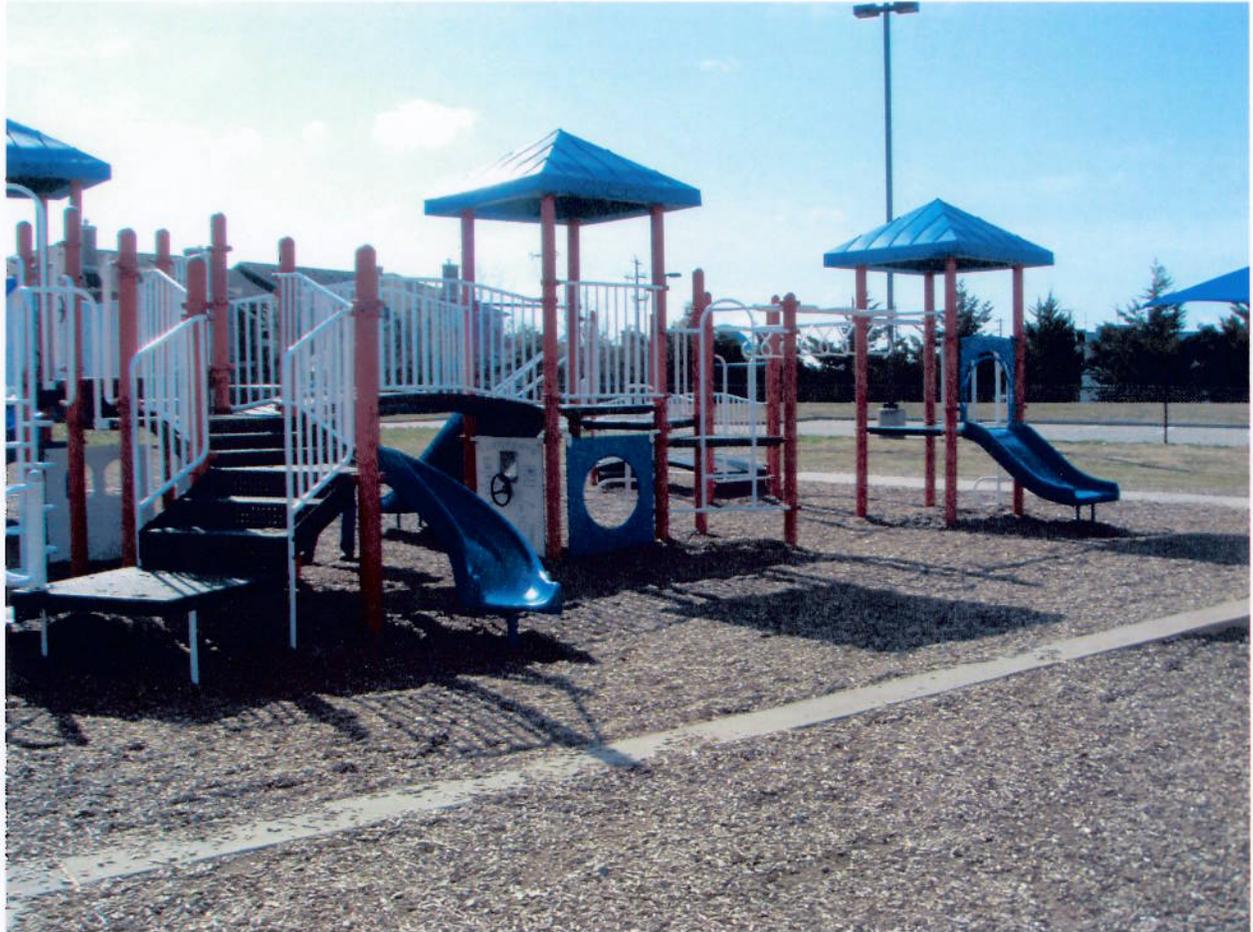
Photo # 5

Photographer: Melissa Smith	Date: 03/15/10	Time: 10:45 AM
City/County: Frisco / Collin County		State: TX
Location: Ida Lee Bright Elementary		
Subject: Playground east of school.

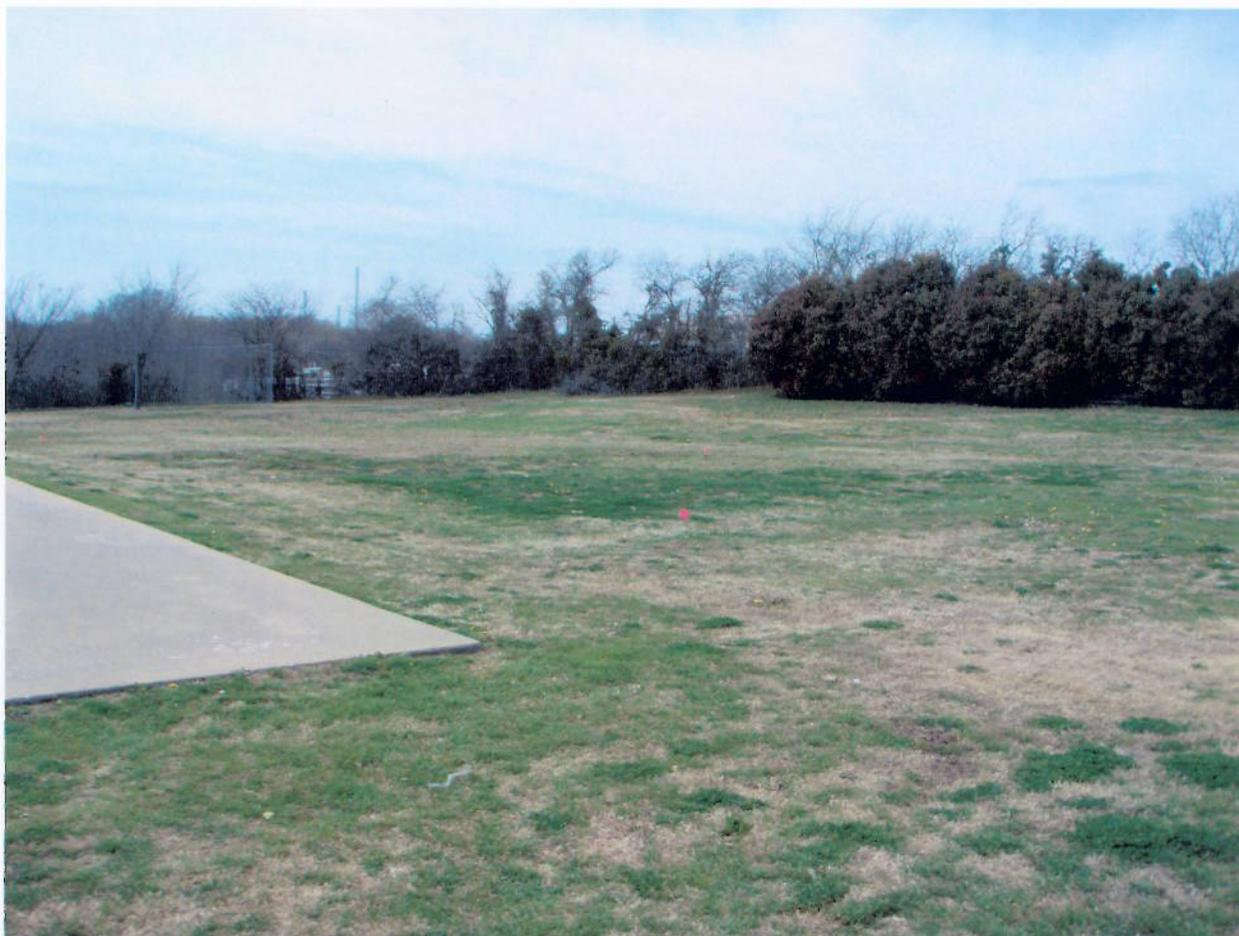
Photo # 6

Photographer: Melissa Smith	Date: 03/15/10	Time: 12:23 PM
City/County: Frisco / Collin County		State: TX
Location: ZT Acker Special Program Center		
Subject: Play field south of building.

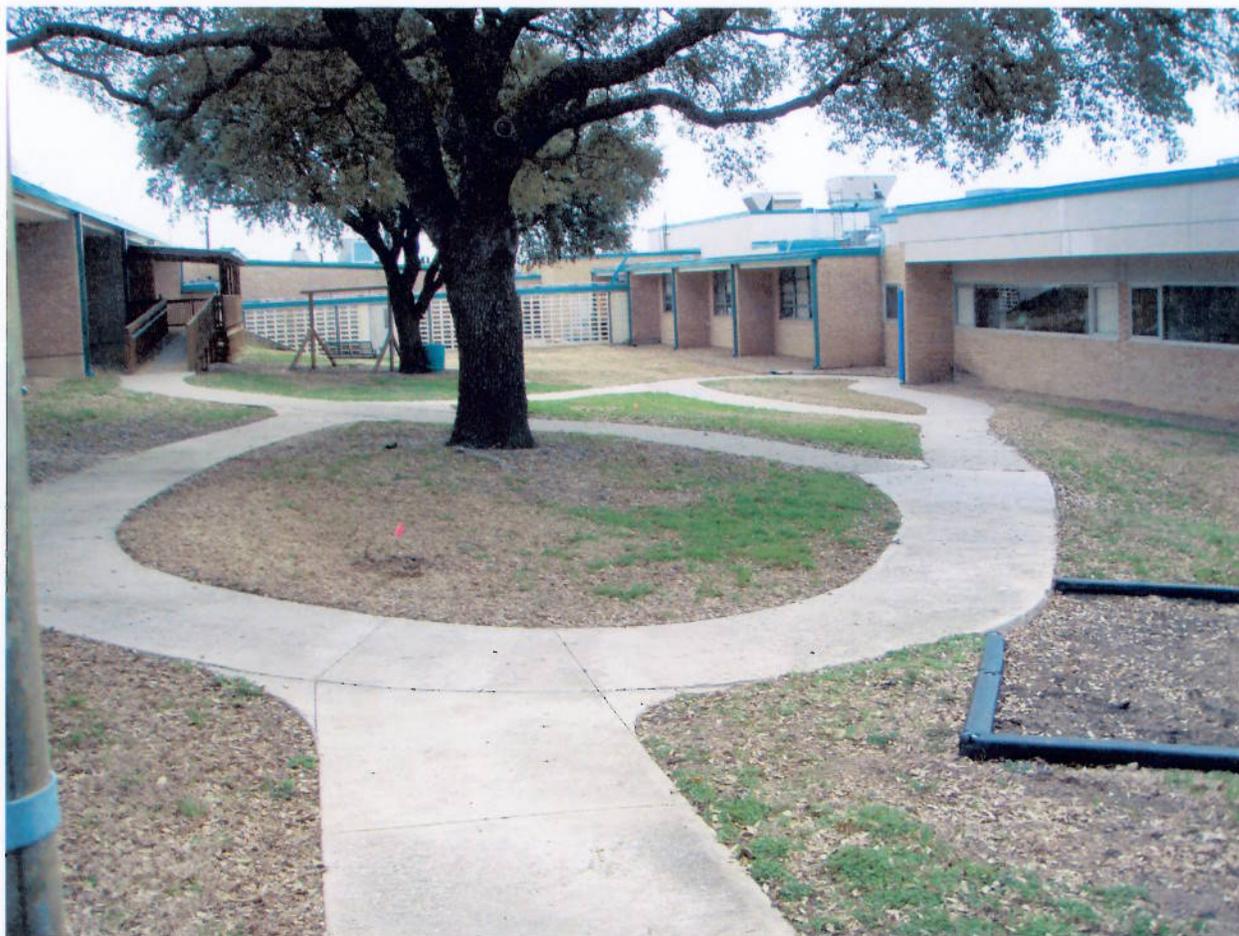
Photo # 7

Photographer: Melissa Smith	Date: 03/15/10	Time: 12:40 PM
City/County: Frisco / Collin County		State: TX
Location: ZT Acker Special Program Center		
Subject: Courtyard in center of building.

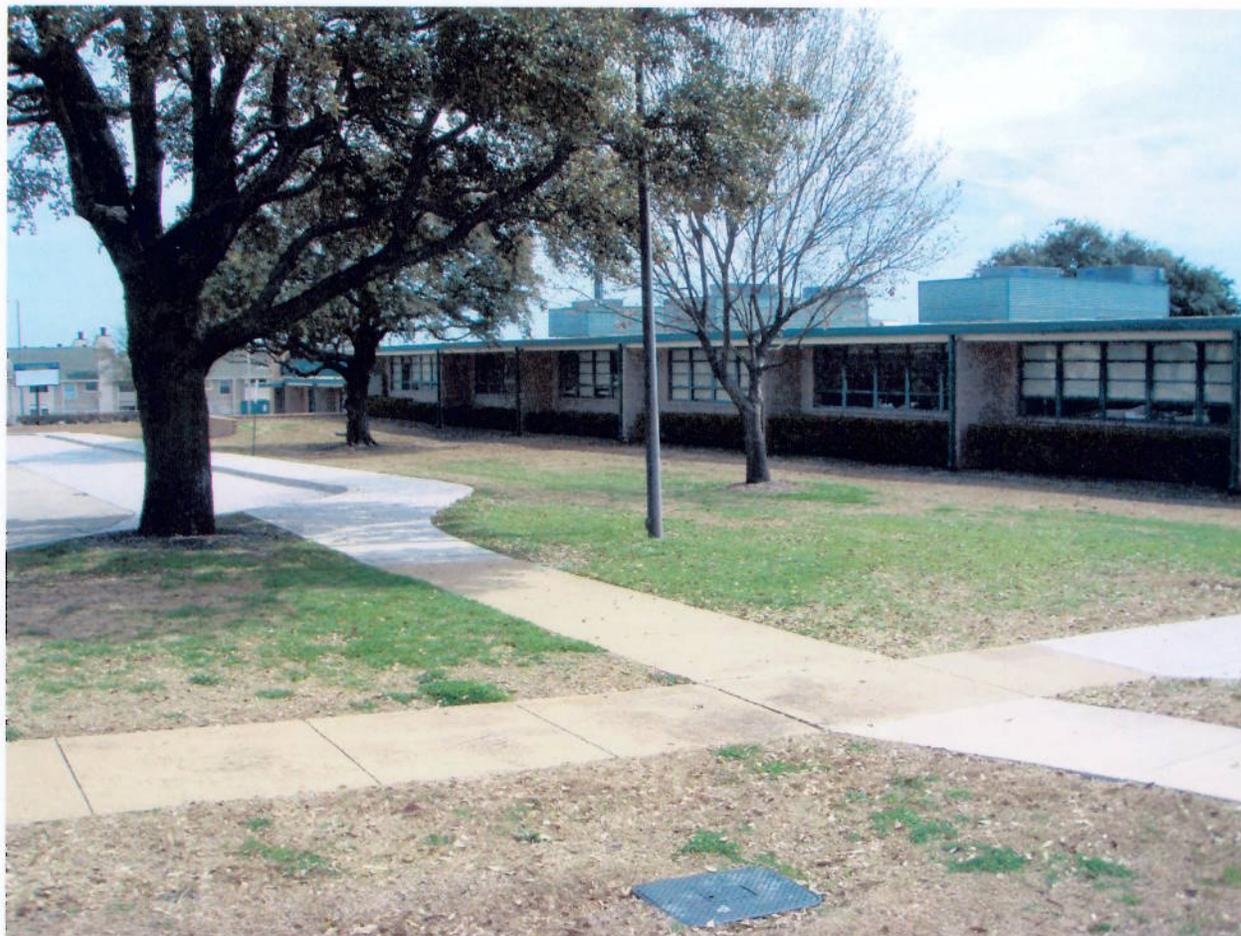
Photo # 8

Photographer: Melissa Smith	Date: 03/15/10	Time: 2:08 PM
City/County: Frisco / Collin County		State: TX
Location: ZT Acker Special Program Center		
Subject: Front of building.

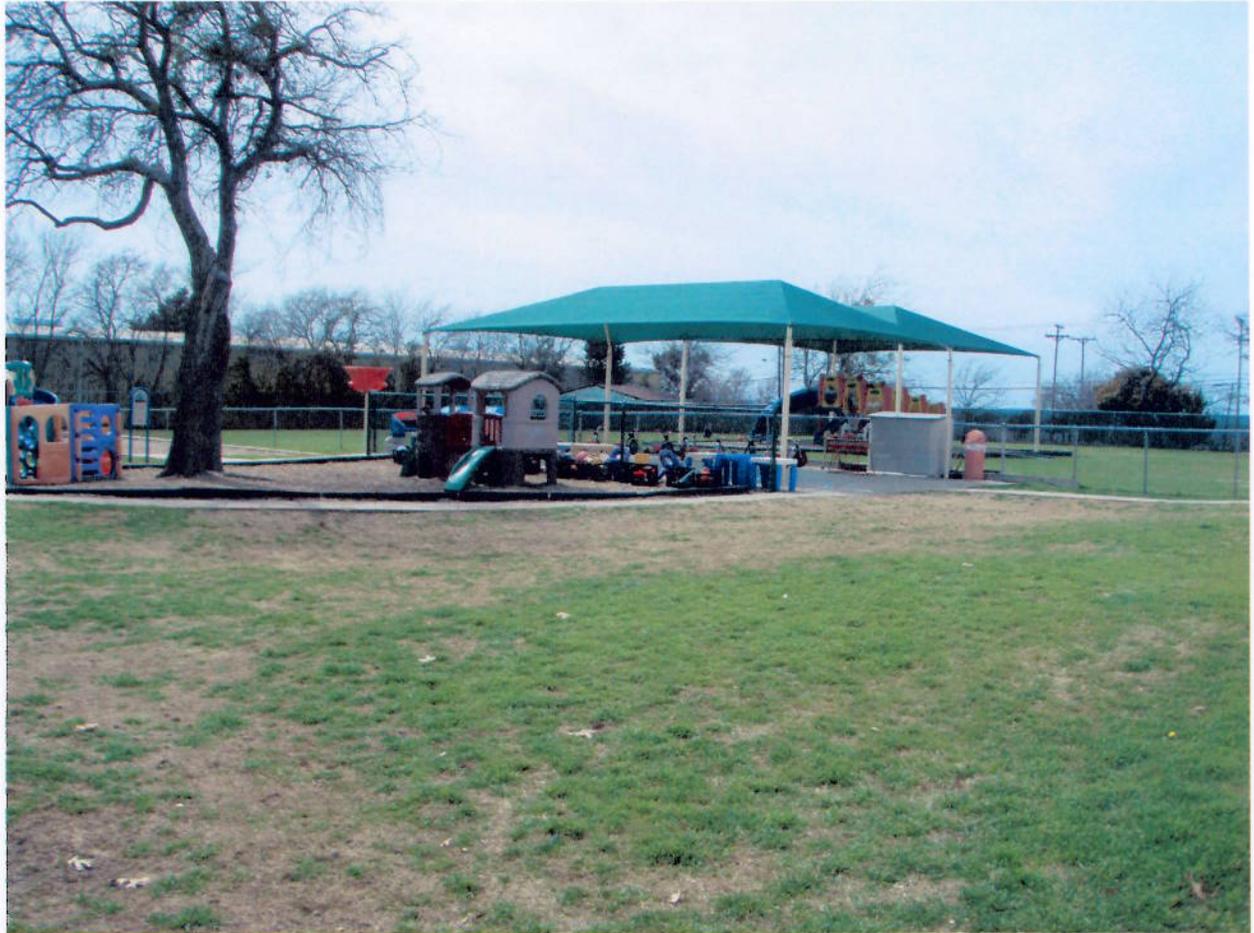
Photo # 9

Photographer: Melissa Smith	Date: 03/15/10	Time: 2:09 PM
City/County: Frisco / Collin County		State: TX
Location: FISS Child Development Center		
Subject: Playground south of building.

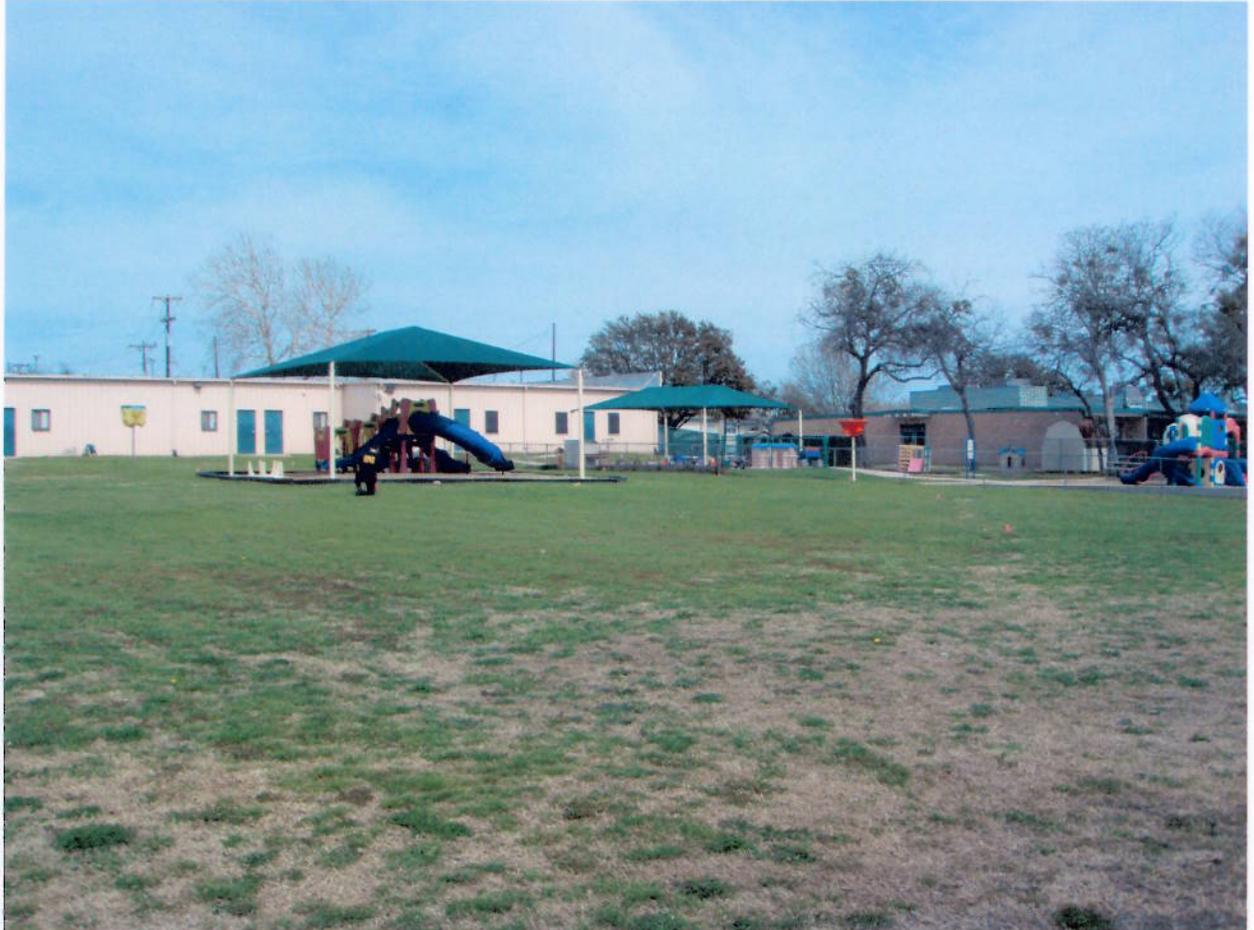
Photo # 10

Photographer: Melissa Smith	Date: 03/15/10	Time: 2:10 PM
City/County: Frisco / Collin County		State: TX
Location: FISSD Child Development Center		
Subject: Sample location south of playground.

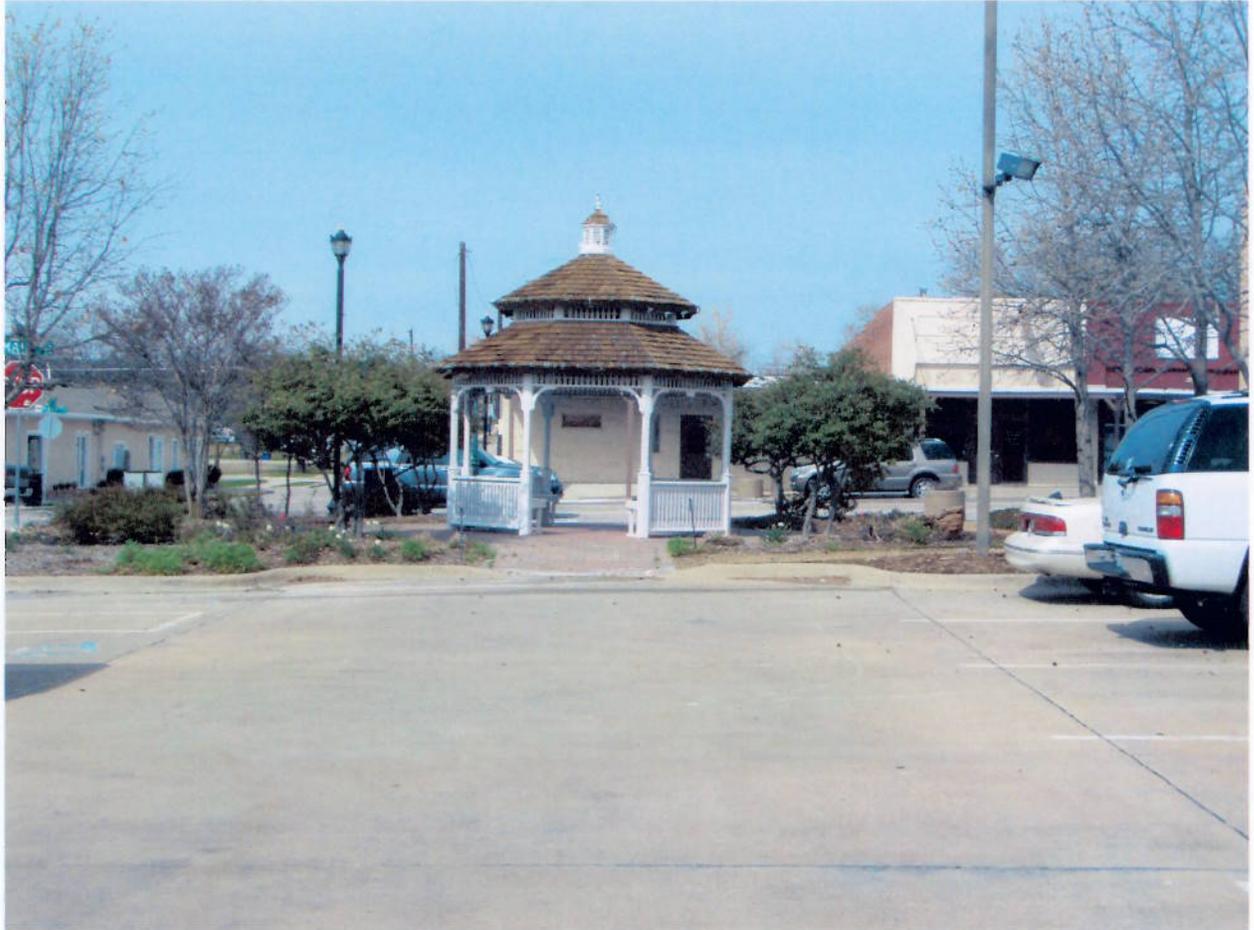
Photo # 11

Photographer: Melissa Smith	Date: 03/15/10	Time: 3:30 PM
City/County: Frisco / Collin County		State: TX
Location: Downtown Gazebo		
Subject: Downtown Gazebo sampling location.

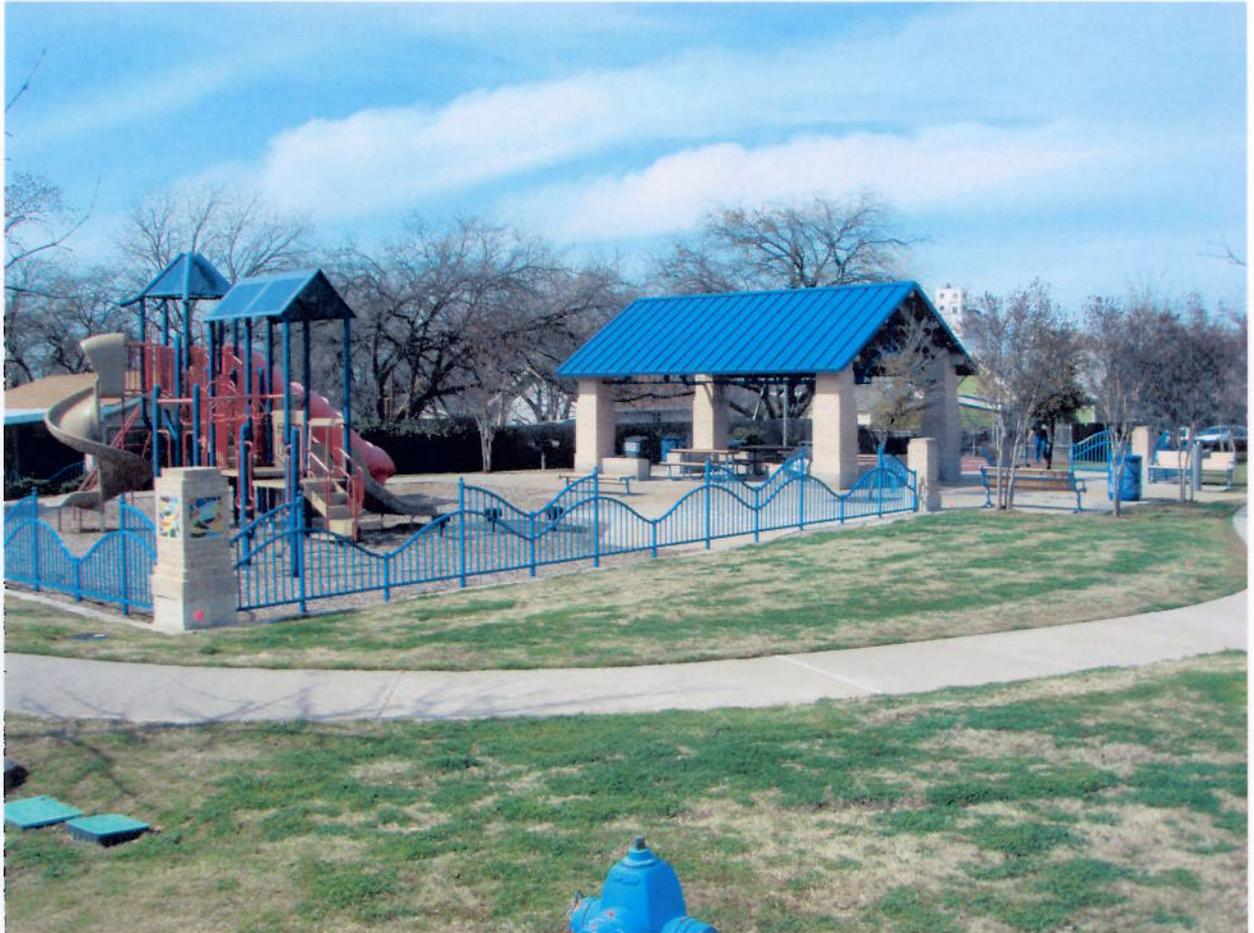
Photo # 12

Photographer: Melissa Smith	Date: 03/15/10	Time: 2:10 PM
City/County: Frisco / Collin County		State: TX
Location: Gallegos Park		
Subject: Sampling grid at the southeast corner of park.

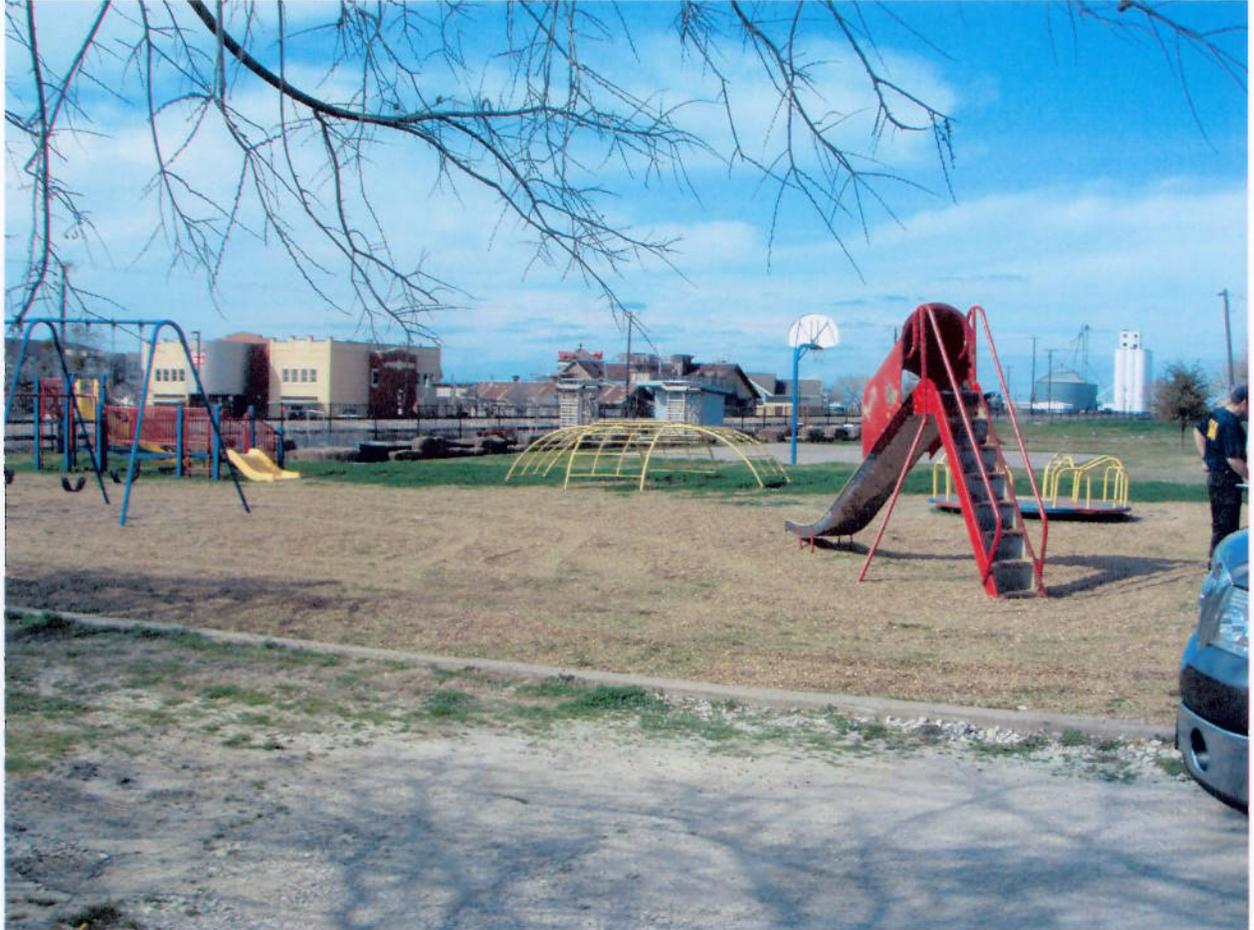
Photo # 13

Photographer: Melissa Smith	Date: 03/15/10	Time: 4:26 PM
City/County: Frisco / Collin County		State: TX
Location: First Street Park		
Subject: Playground at First Street Park.

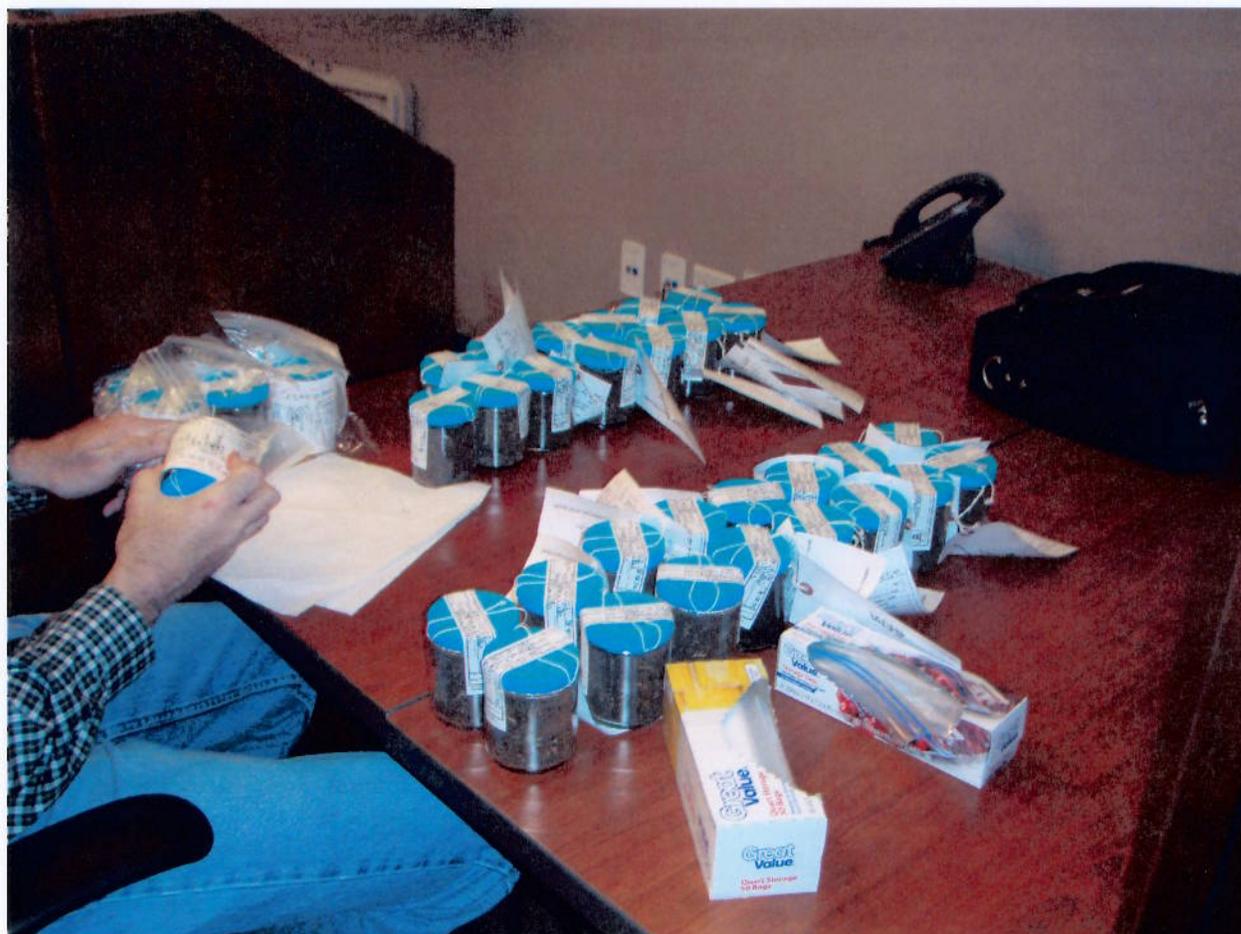
Photo # 14

Photographer: Melissa Smith	Date: 03/16/10	Time: 8:51 AM
City/County: Frisco / Collin County		State: TX
Location: Frisco Police Department		
Subject: Labeling sample containers.

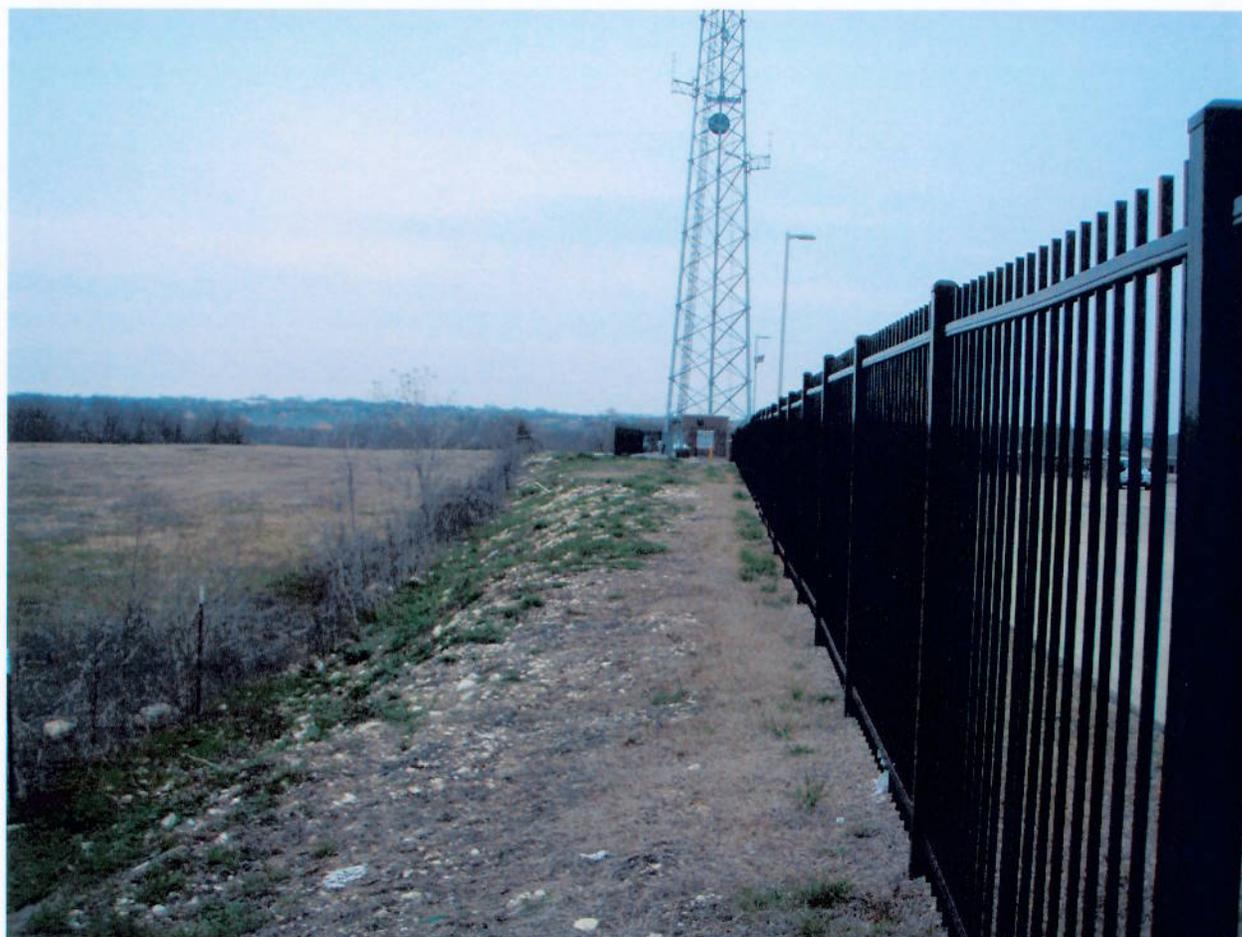
Photo # 15

Photographer: Melissa Smith	Date: 03/16/10	Time: 10:08 AM
City/County: Frisco / Collin County		State: TX
Location: Frisco Police Department		
Subject: Sample area north of police dept. parking lot.

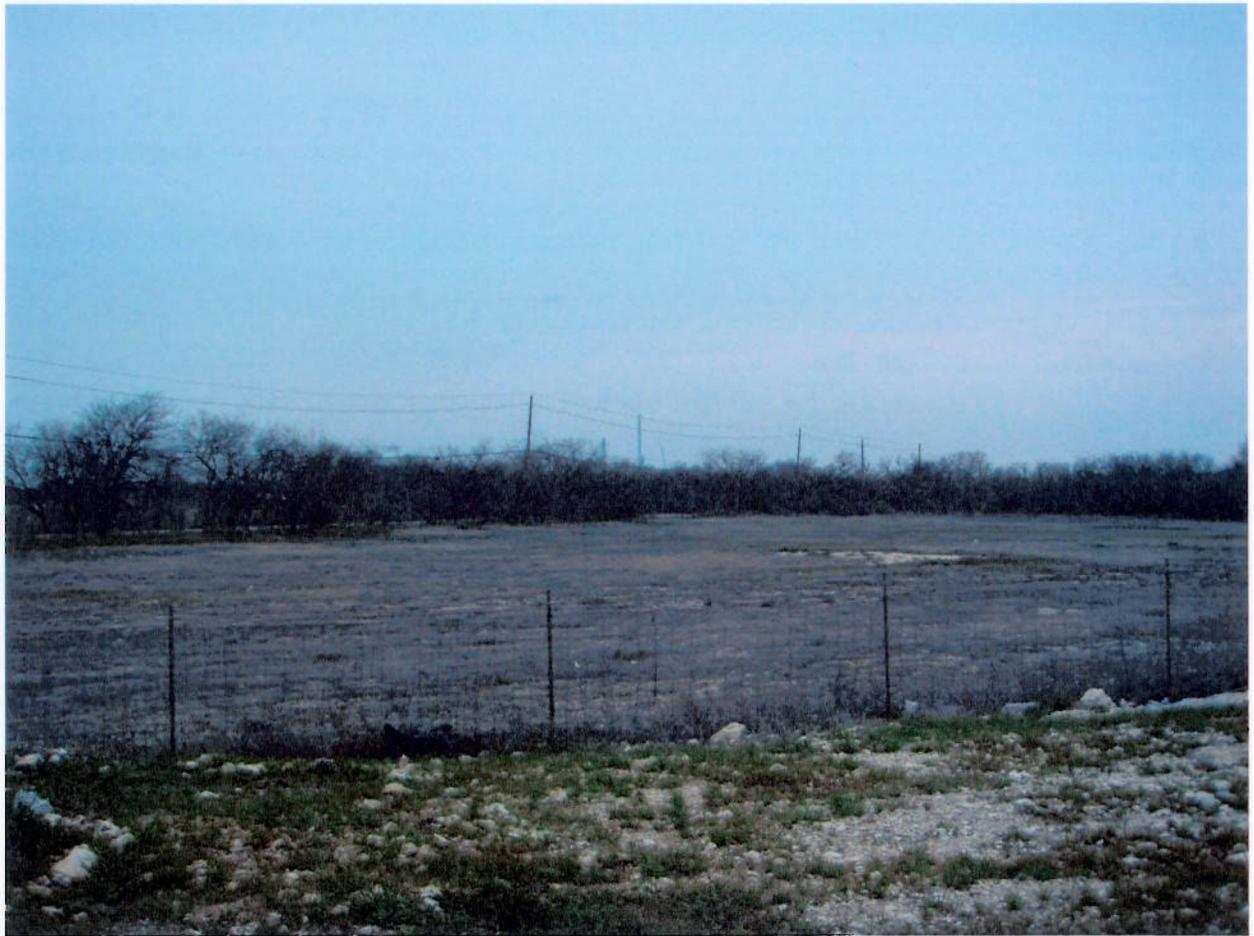
Photo # 16

Photographer: Melissa Smith	Date: 03/16/10	Time: 10:09 AM
City/County: Frisco / Collin County		State: TX
Location: Frisco Police Department		
Subject: Exide property looking north from police department.

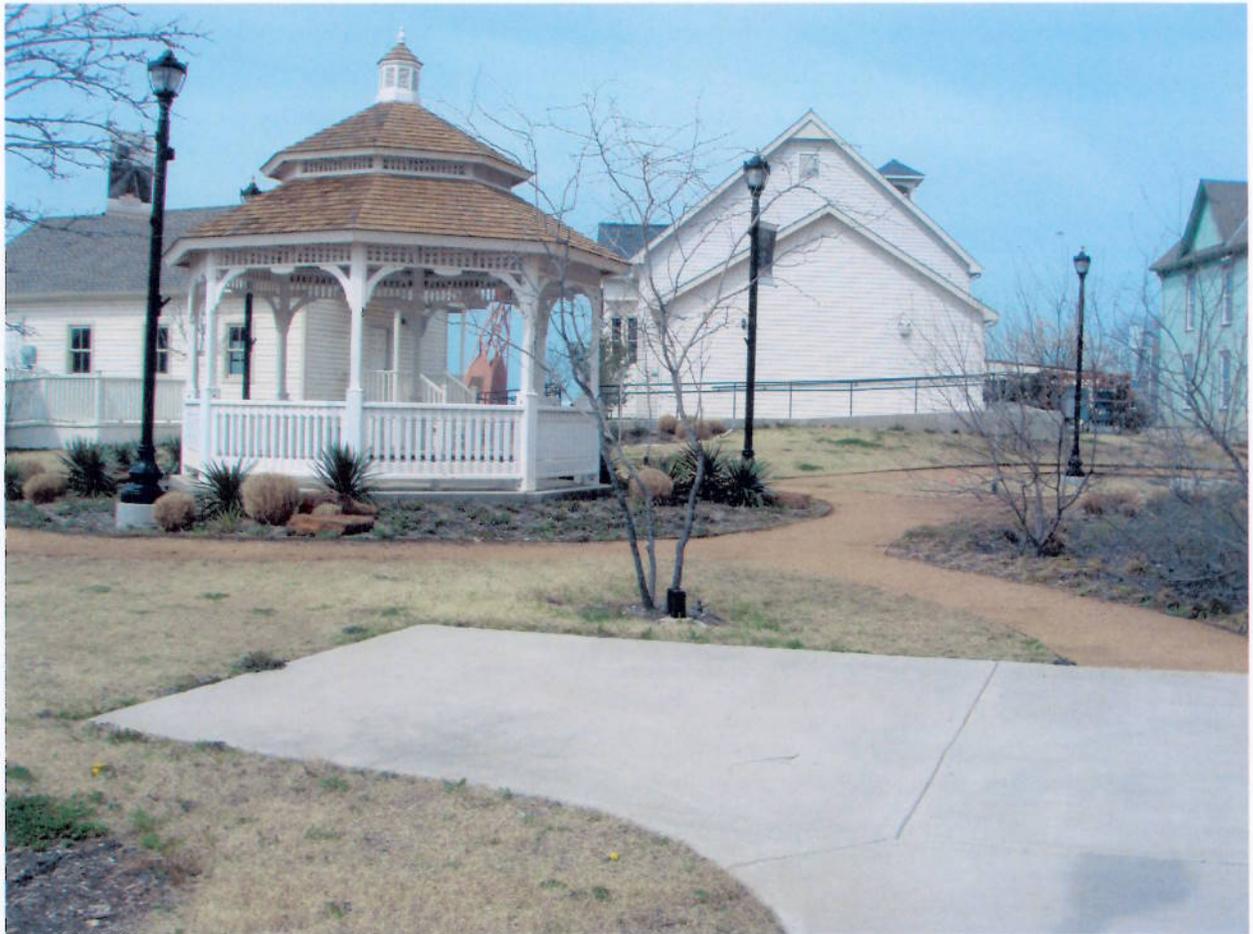
Photo # 17

Photographer: Melissa Smith	Date: 03/16/10	Time: 2:49 PM
City/County: Frisco / Collin County		State: TX
Location: Heritage Center		
Subject: Sample area near gazebo at Heritage Center.

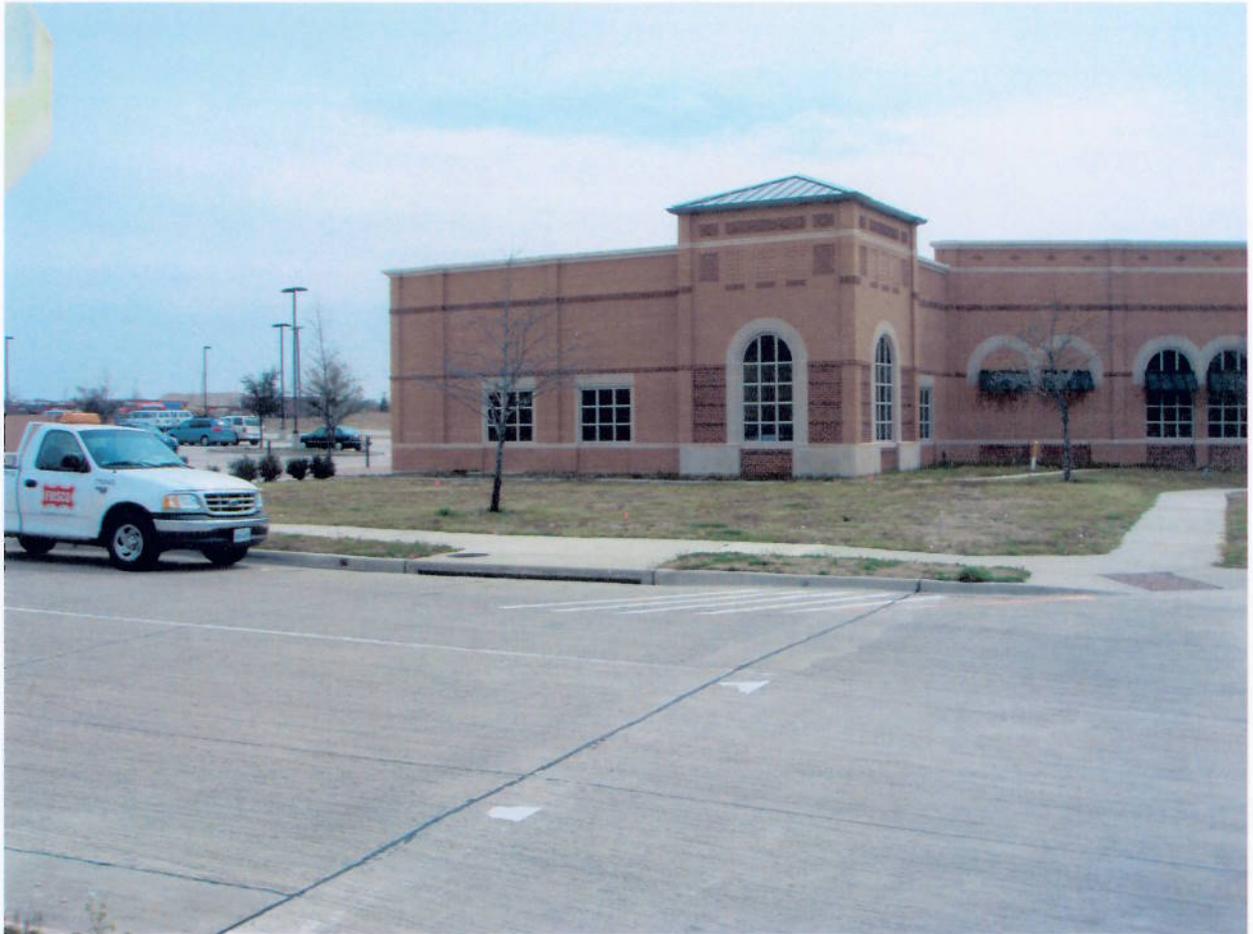
Photo # 18

Photographer: Melissa Smith	Date: 03/16/10	Time: 2:49 PM
City/County: Frisco / Collin County		State: TX
Location: Senior Center		
Subject: Sample area in front of Senior Center.

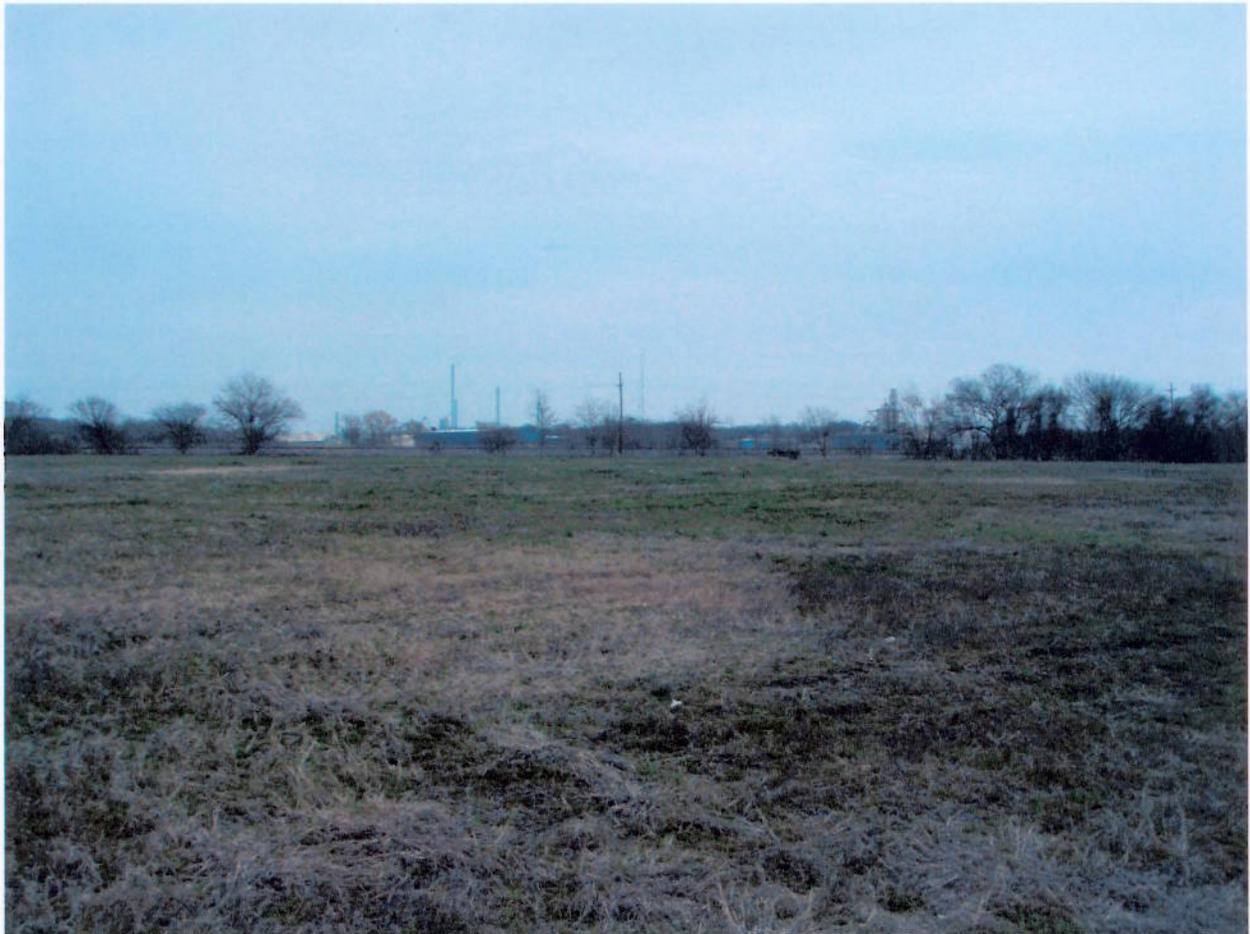
Photo # 19

Photographer: Melissa Smith	Date: 03/16/10	Time: 3:32 PM
City/County: Frisco / Collin County		State: TX
Location: Grand Park		
Subject: Sampling areas on southeast side of park; Exide facility in background.
