UNITED STATES ENVIRONMENTAL PROTECTION AGENCY

Inspection Date: March 15 - 16, 2010 EPA ID Number: not applicable

Facility Name: Frisco Neighborhood Soil Survey

Physical Location: Public areas within 1 mile of Exide Technologies
Frisco, Texas

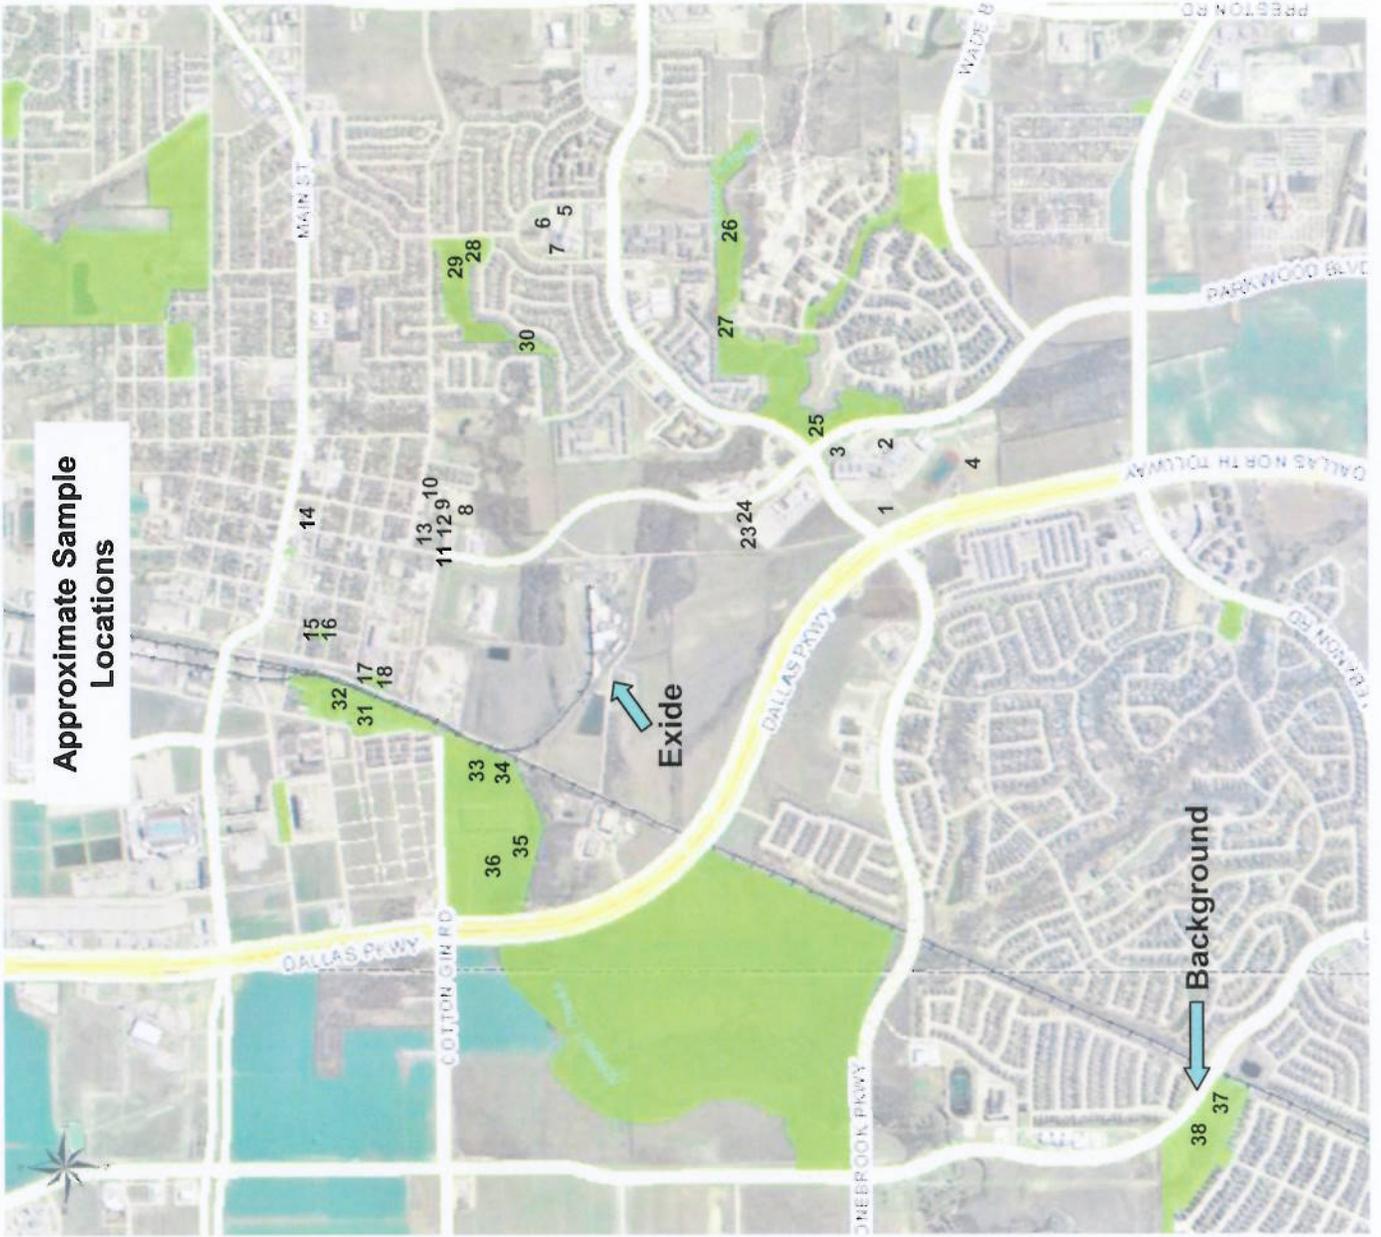
Approximate Sample Locations

EPA collected a total of thirty-eight (38) soil samples from the following fourteen (14) locations within in the City of Frisco (See Attachment 2 for a map of approximate sample locations):
