**New Technology Research & Development Program  
Grant Contract 582-5-65591-0010**

**Task 3 Deliverable Report**

**Report on the Installation and Optimization of  
Eaton Corporation's  
Hydraulic Launch Assist™ (HLA®) System**

Doug Gilbert  
Eaton Corporation  
June 20, 2006

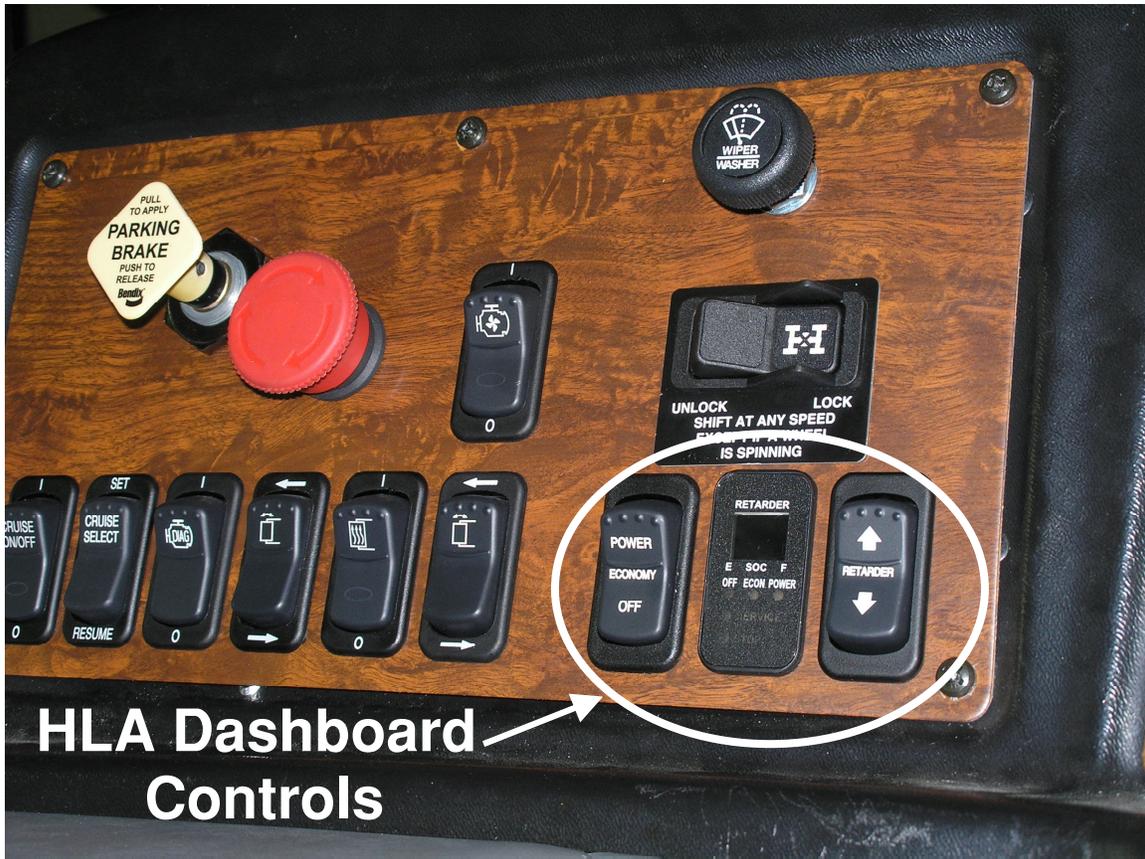
Another part of the HLA system is the Electronic Control Unit (ECU) and wire harness. These parts were installed in the vehicle and connected to the existing vehicle electrical supply and data bus. The HLA system has a user interface that consists of switches and a display. These parts were mounted in the dashboard for easy access to the operator. The user interface allows the vehicle operator the ability to select HLA operating modes and make some adjustments. The display communicates operating states and conditions. Figure 3 shows the truck dashboard.

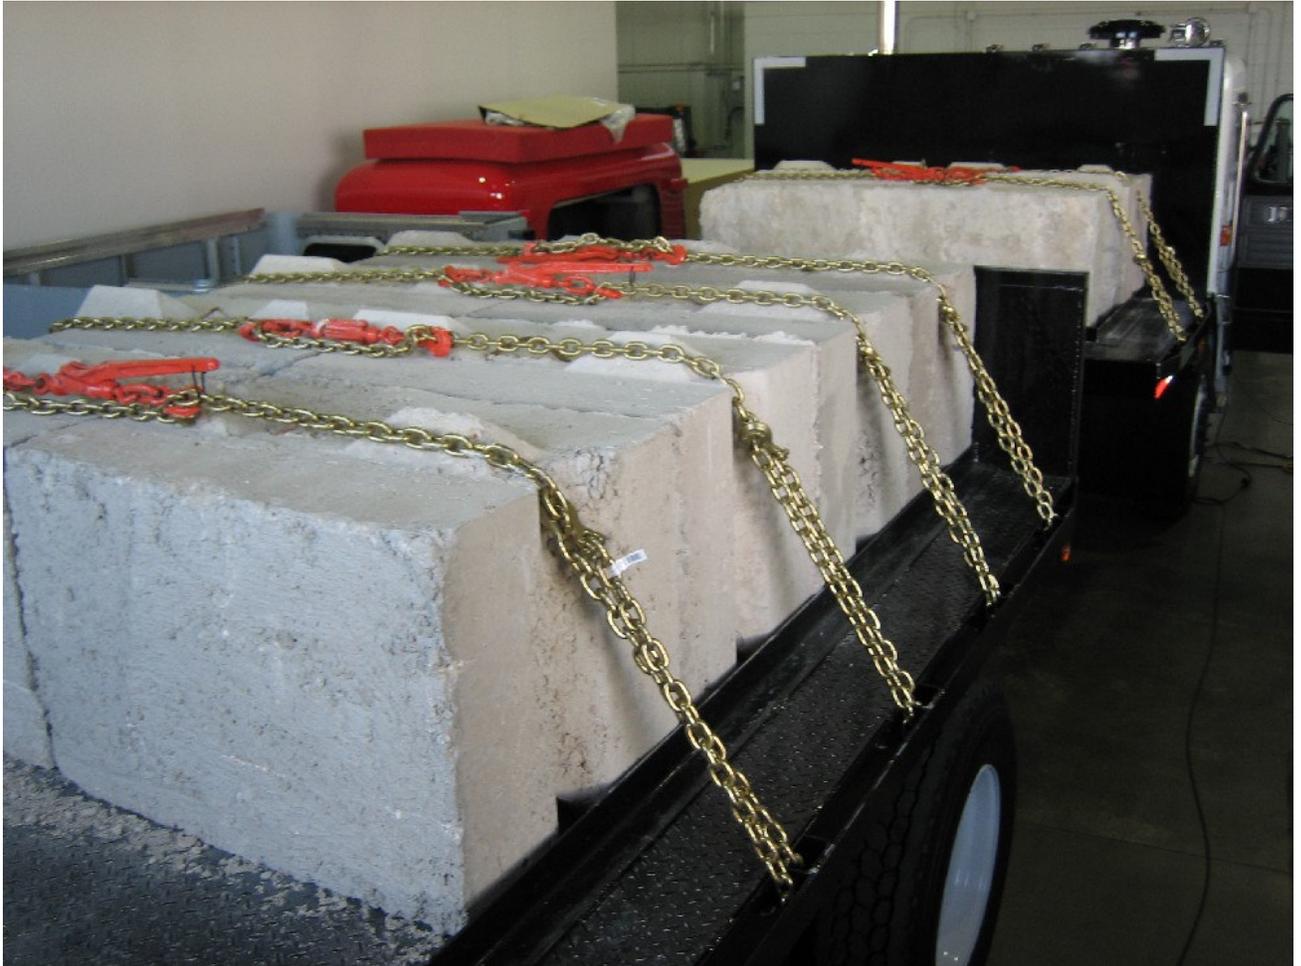
**Figure 4**

After the HLA system was installed, a bed was put on the truck to carry weights. 22,000 lbs of concrete weights were added to enable the truck to be tested in a loaded condition. This amount of weight simulates a garbage truck that is half full. Figure 4 shows the truck with the bed and weights in place.
