## Arkema Facility - Harvey Response

Crosby, TX

Arkema Inc.

Project #109489 Summary

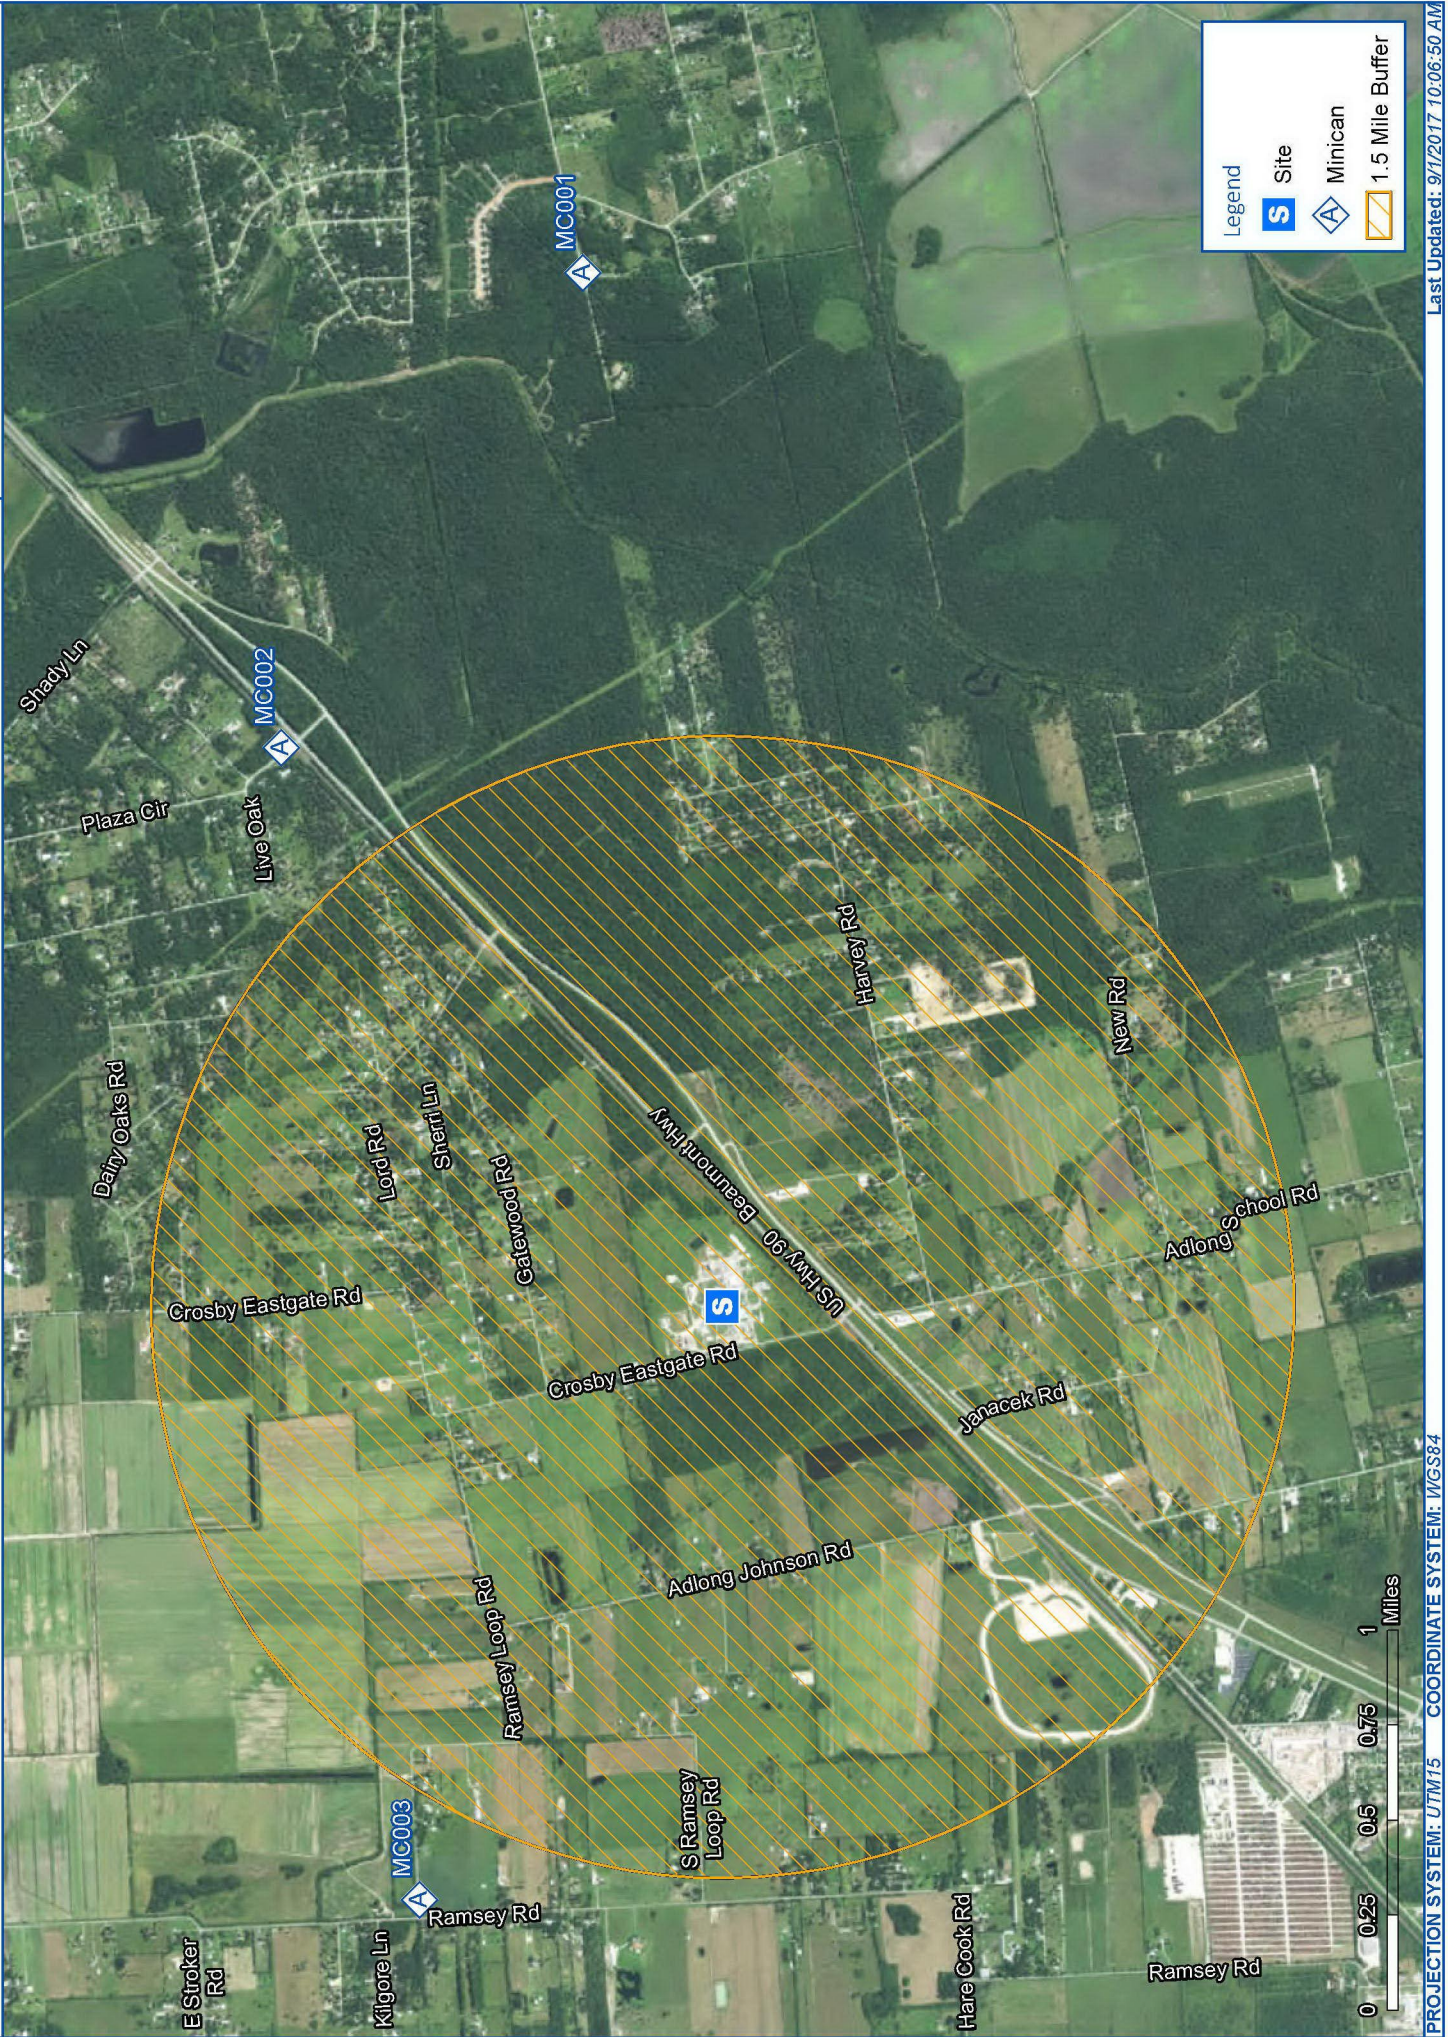
## Map of Analytical Air Sampling Locations

To supplement real-time air monitoring, CTEH® deployed areas along the perimeter of the evacuated area within the community. Evacuated canister (Minican™) samplers were regulated to collect air evenly over a 24-hr period. Analytical air samples will be submitted to SGS Galson Laboratories, an AIHA-accredited laboratory, for analysis using EPA Method TO-15. A map highlighting the analytical air sampling locations is provided as **Attachment C. Analytical Air Sampling Results** will be reported upon receipt from the laboratory.

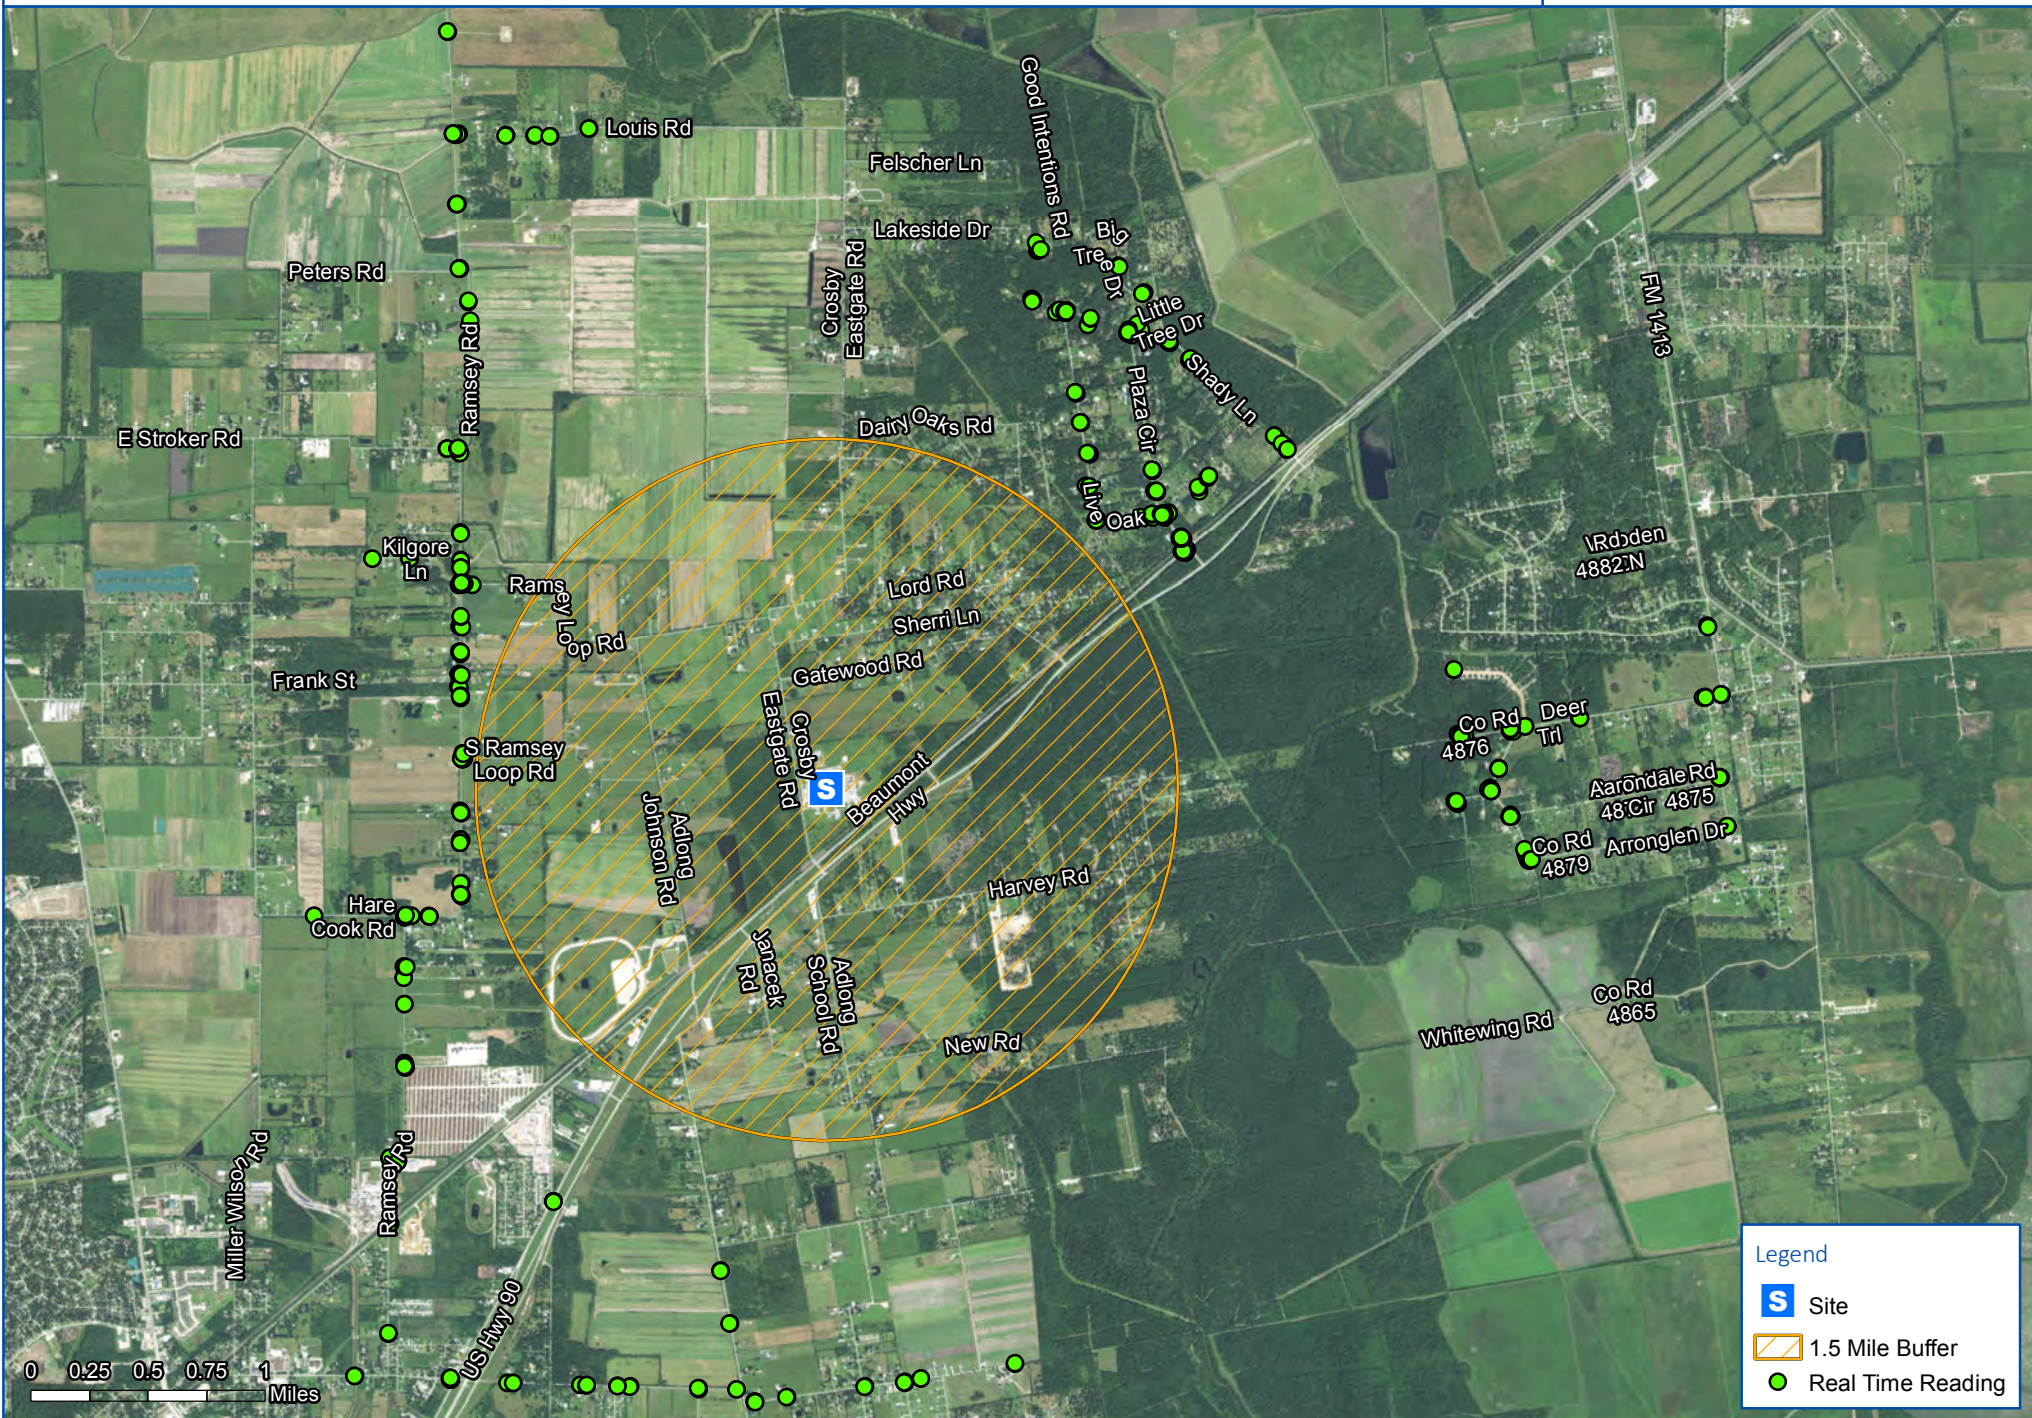
## **Handheld Real-time Air Monitoring Locations**

All real-time air monitoring instrumentation was calibrated per the manufacturer's recommendations prior to air monitoring. Handheld, real-time air monitoring was conducted for benzene, cumene, atmosphere flammability (lower explosive limit - LEL), and volatile organic compounds (VOCs) using RAE Systems and Gastec instruments. Additionally, combustion byproducts potentially associated with fire smoke, such as particulate matter (PM<sub>2.5</sub>), nitrogen dioxide (NO<sub>2</sub>) and sulfur dioxide (SO<sub>2</sub>) were assessed. **Table 1** summarizes the data for all real-time air monitoring readings recorded in Crosby, TX from 06:00 on September 1, 2017 through 06:00 on September 2, 2017. Maps of real-time air monitoring locations are provided as **Attachment B**.

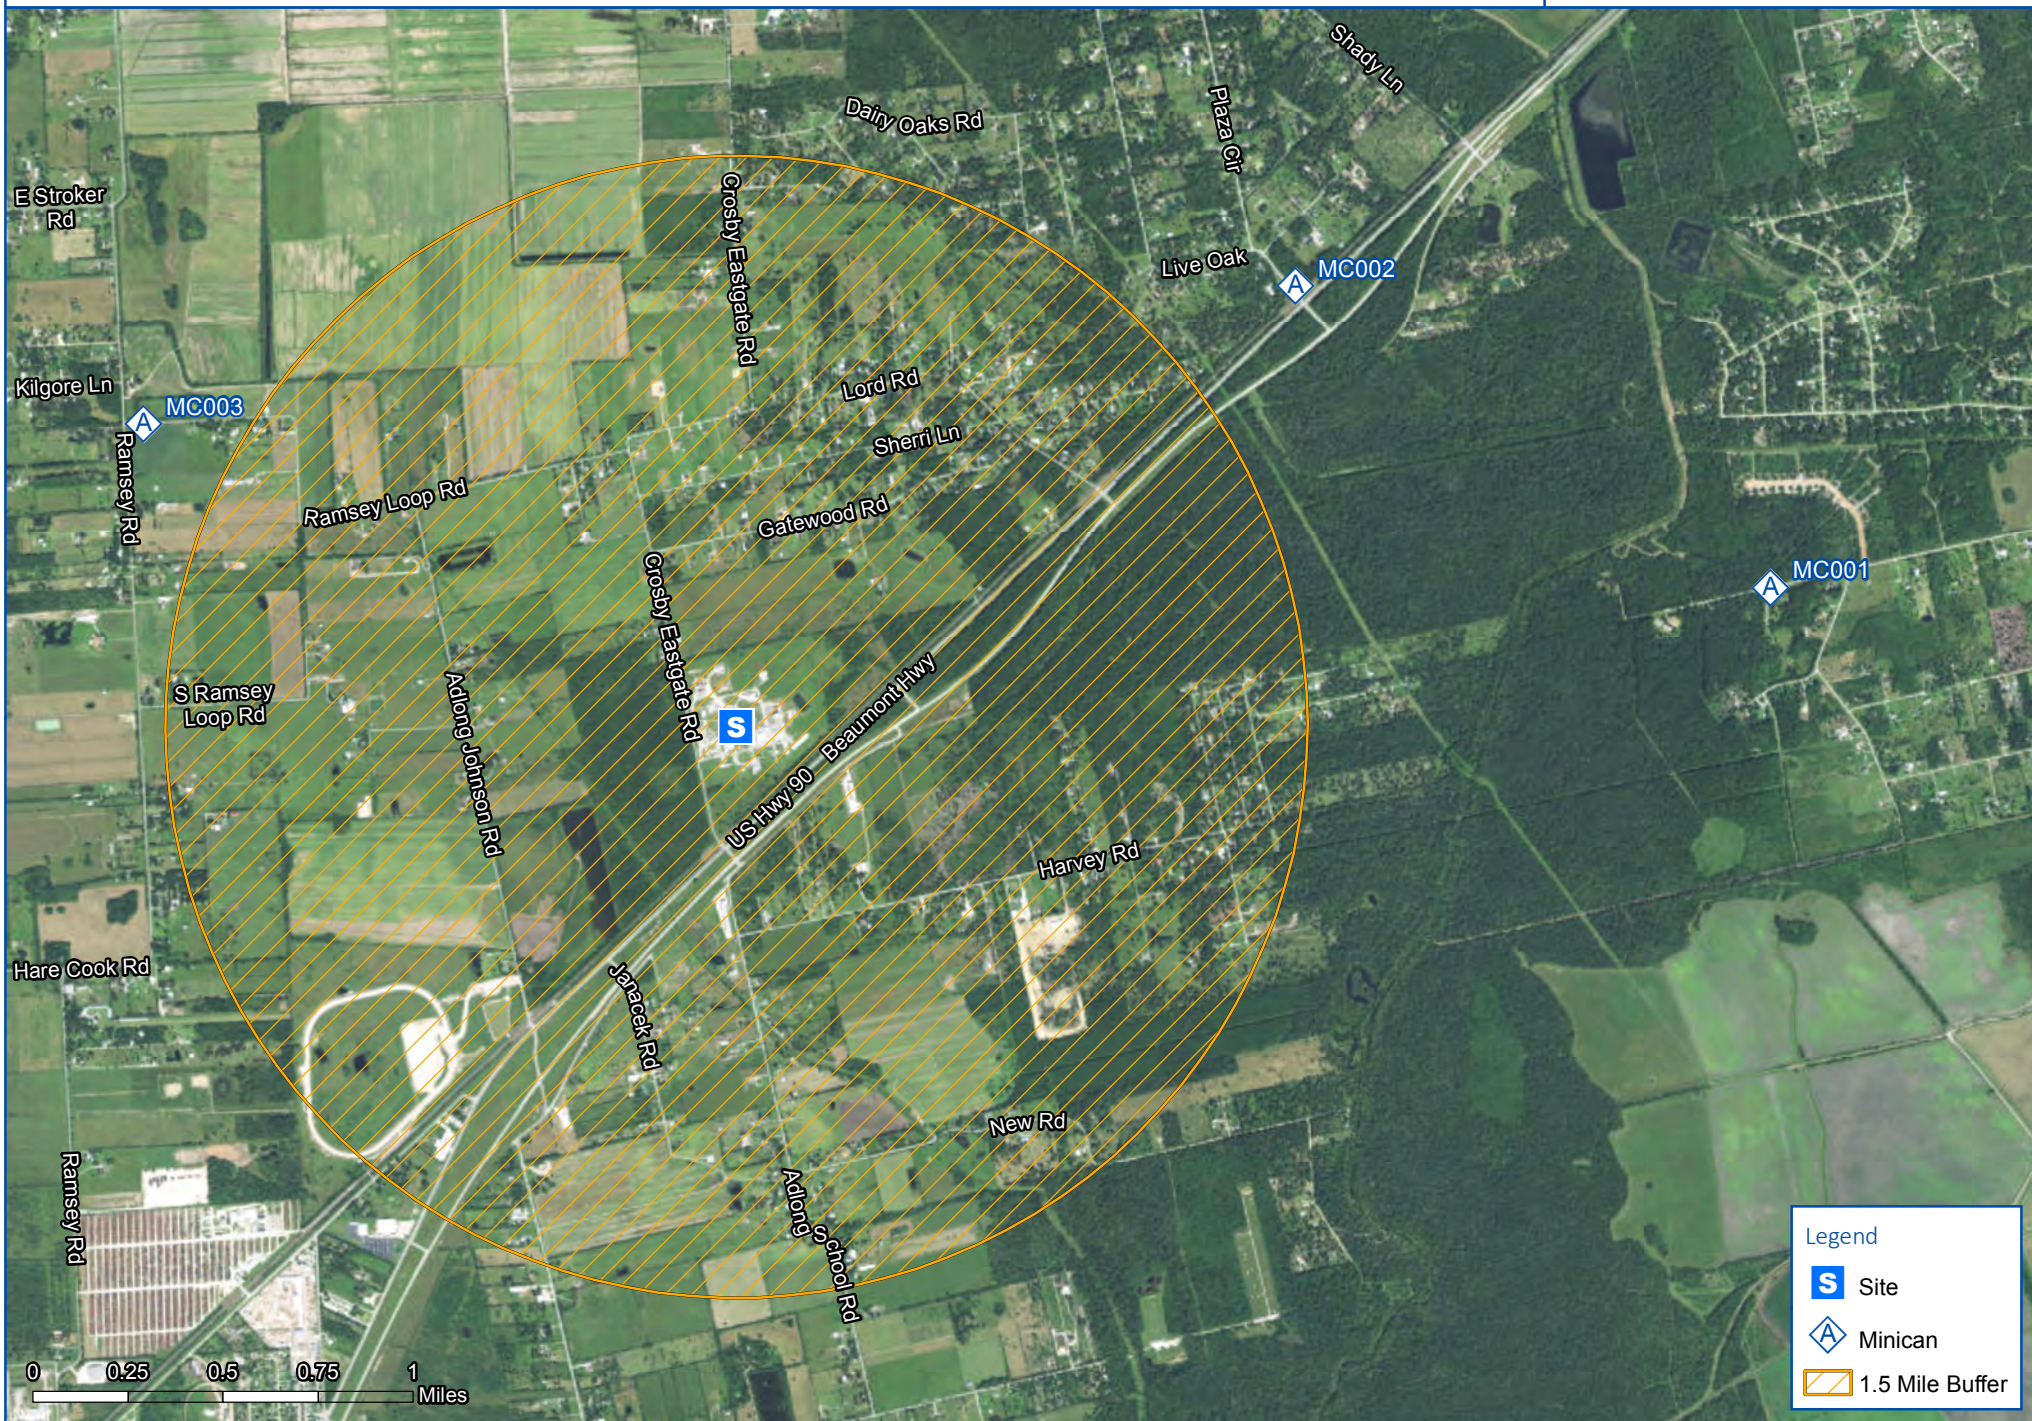
## Map of Analytical Air Sampling Locations

To supplement real-time air monitoring, CTEH® deployed areas along the perimeter of the evacuated area within the community. Evacuated canister (Minican™) samplers were regulated to collect air evenly over a 24-hr period. Analytical air samples will be submitted to SGS Galson Laboratories, an AIHA-accredited laboratory, for analysis using EPA Method TO-15. A map highlighting the analytical air sampling locations is provided as **Attachment C**. Analytical Air Sampling Results will be reported upon receipt from the laboratory.

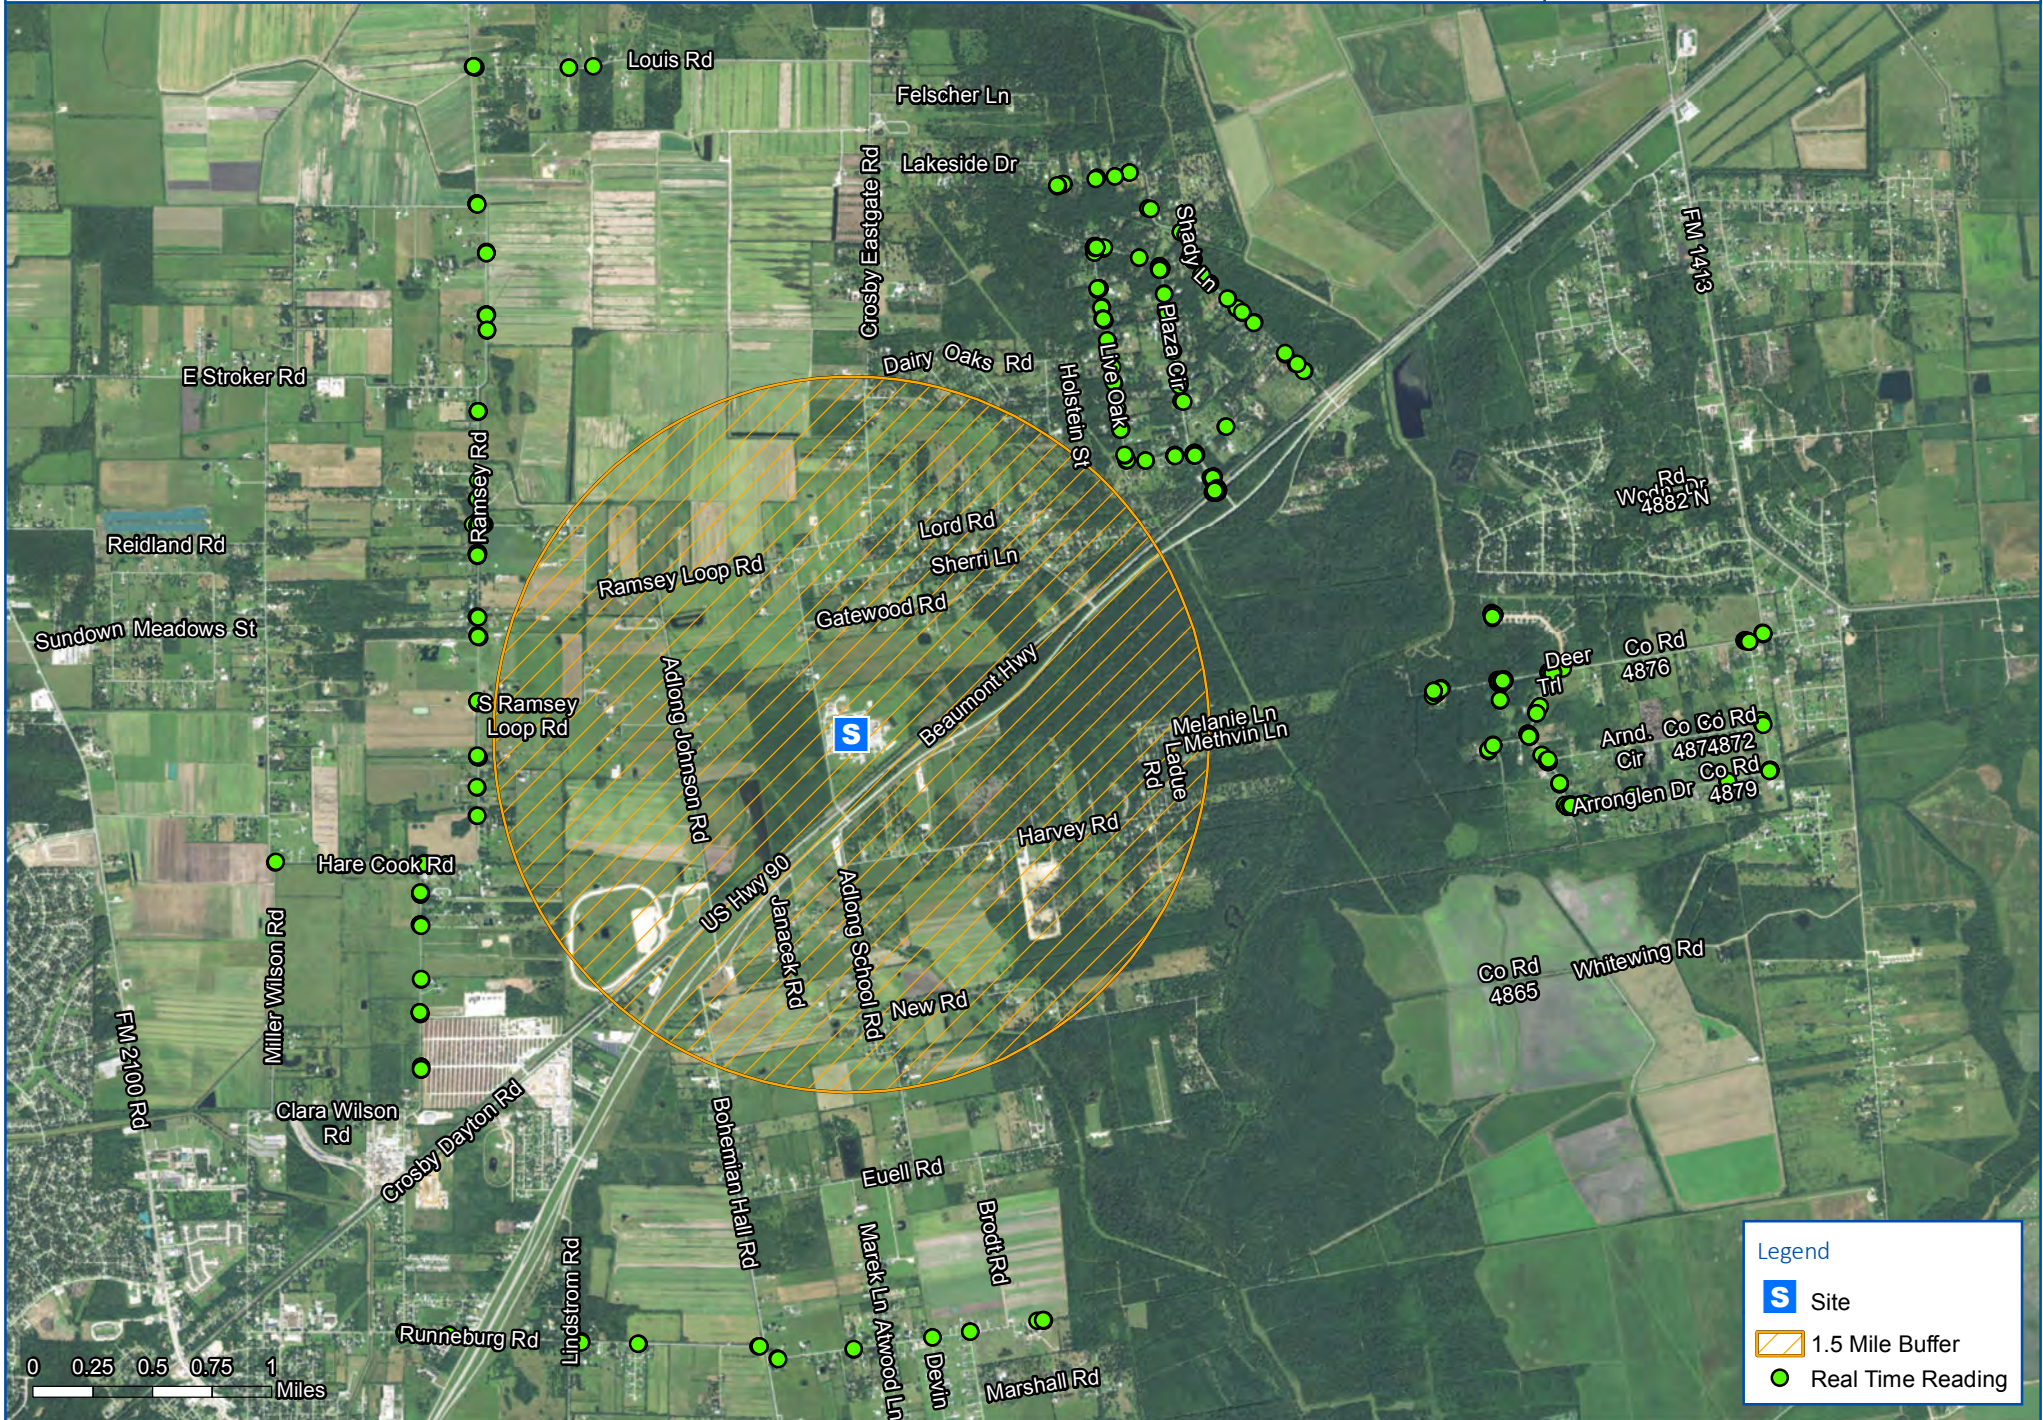
## **Handheld Real-time Air Monitoring Locations**

All real-time air monitoring instrumentation was calibrated per the manufacturer's recommendations prior to air monitoring. Handheld, real-time air monitoring was conducted for benzene, cumene, and volatile organic compounds (VOCs) using RAE Systems and Gastec instruments. Additionally, combustion byproducts potentially associated with fire smoke, such as particulate matter (PM<sub>2.5</sub>), nitrogen dioxide (NO<sub>2</sub>), and sulfur dioxide (SO<sub>2</sub>) were assessed. **Table 1** summarizes the data for all real-time air monitoring readings recorded in Crosby, TX from 06:00 on September 2, 2017 through 06:00 on September 3, 2017. Maps of real-time air monitoring locations are provided as **Attachment B**.

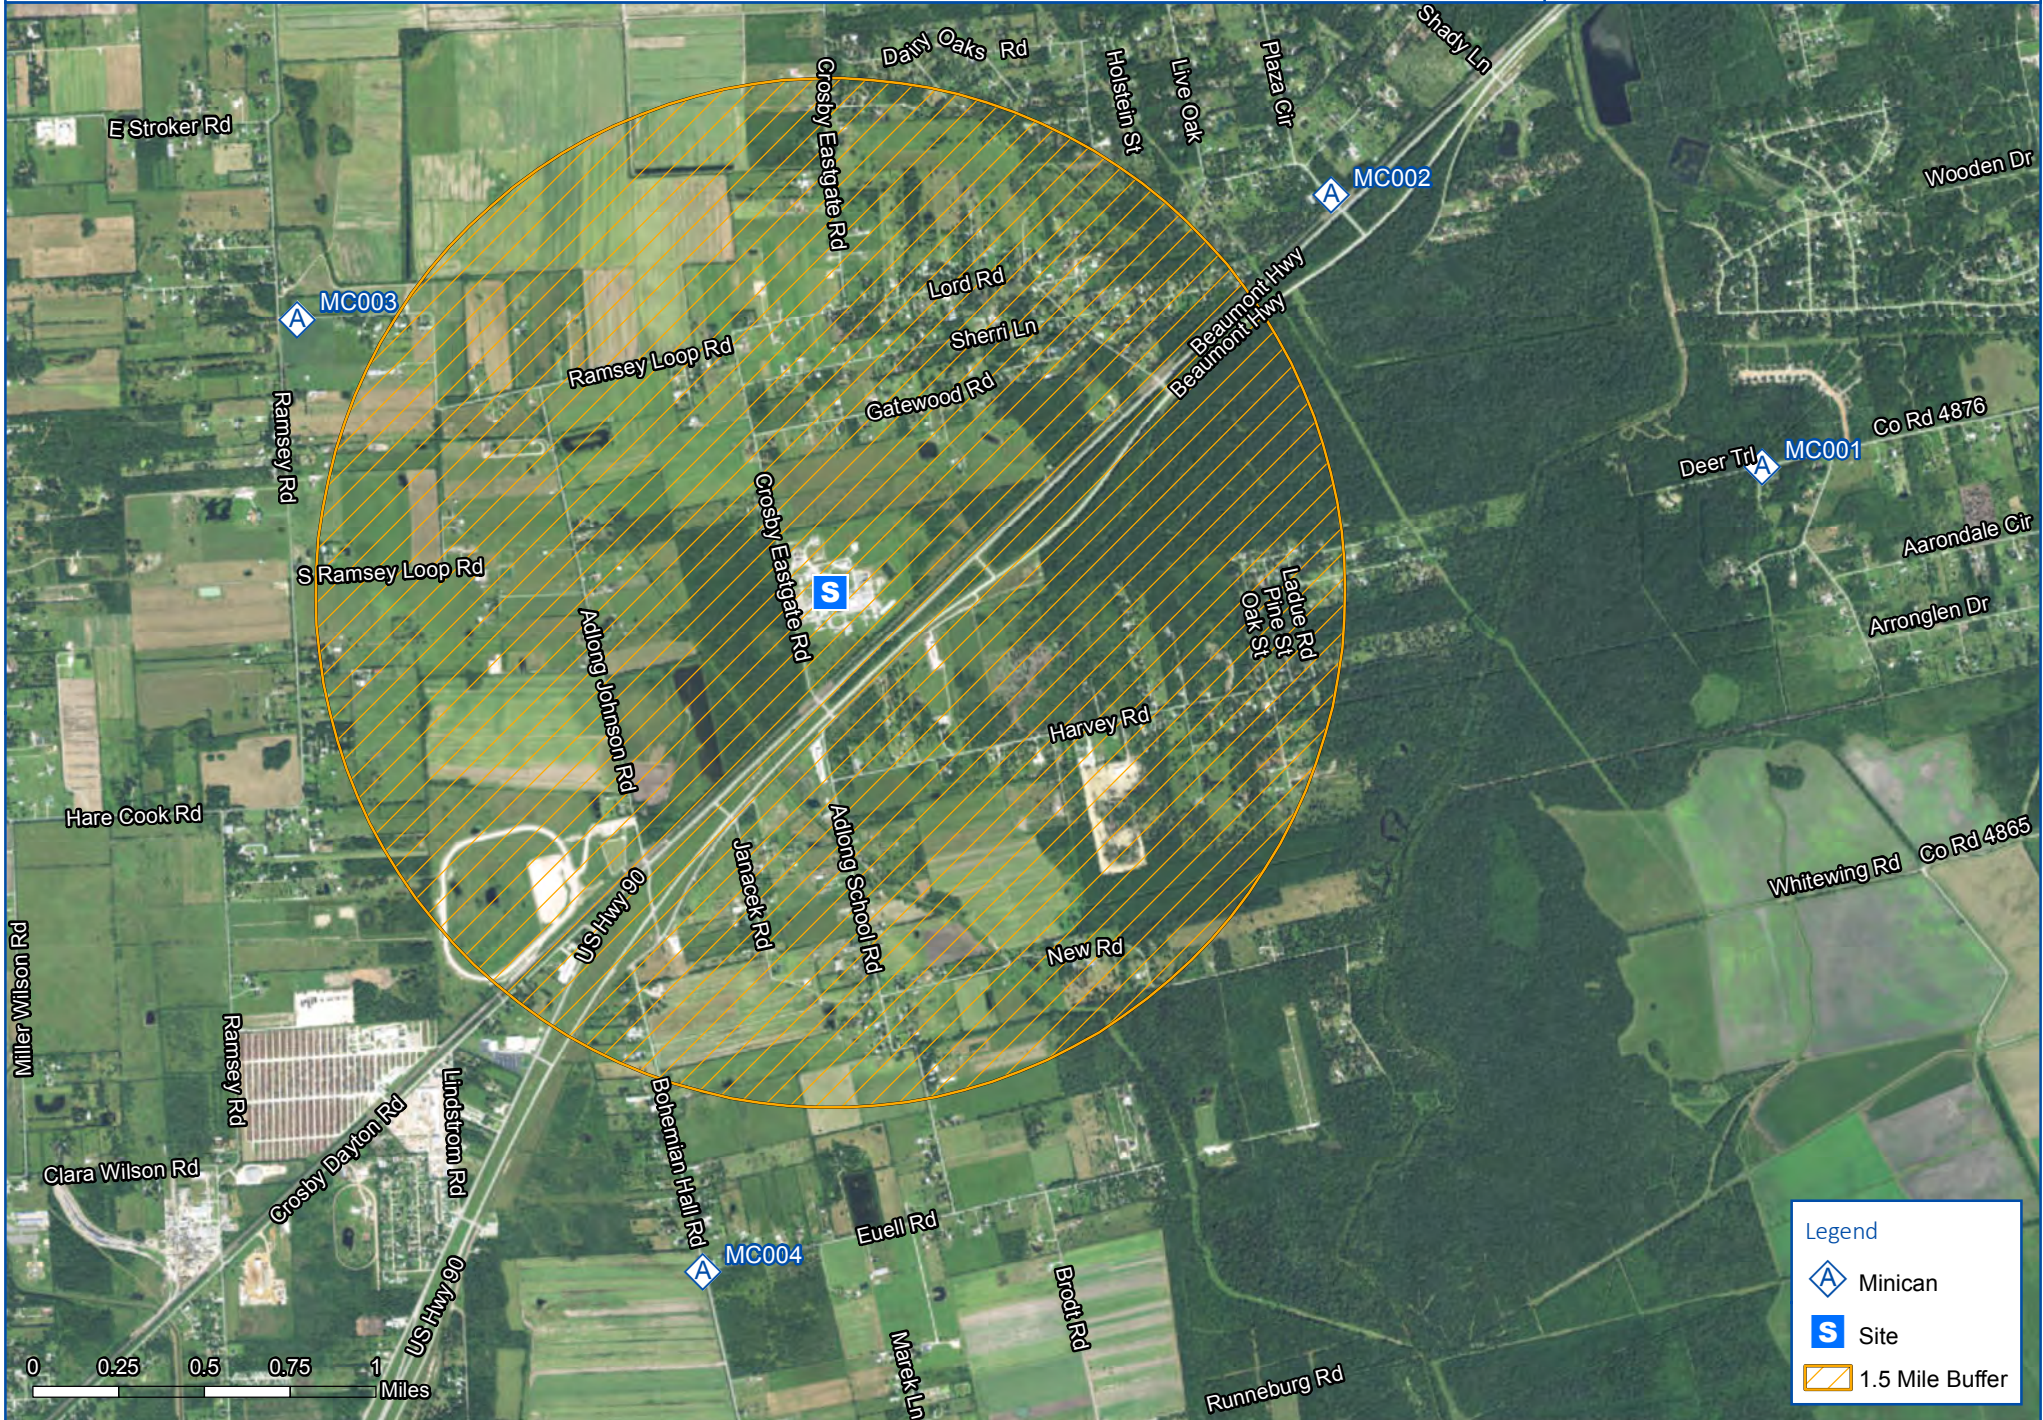
## Map of Analytical Air Sampling Locations

To supplement real-time air monitoring, CTEH® deployed areas along the perimeter of the evacuated area within the community. Evacuated canister (Minican™) samplers were regulated to collect air evenly over a 24-hr period. Analytical air samples will be submitted to SGS Galson Laboratories, an AIHA-accredited laboratory, for analysis using EPA Method TO-15. A map highlighting the analytical air sampling locations is provided as **Attachment C**. Analytical Air Sampling Results will be reported upon receipt from the laboratory.

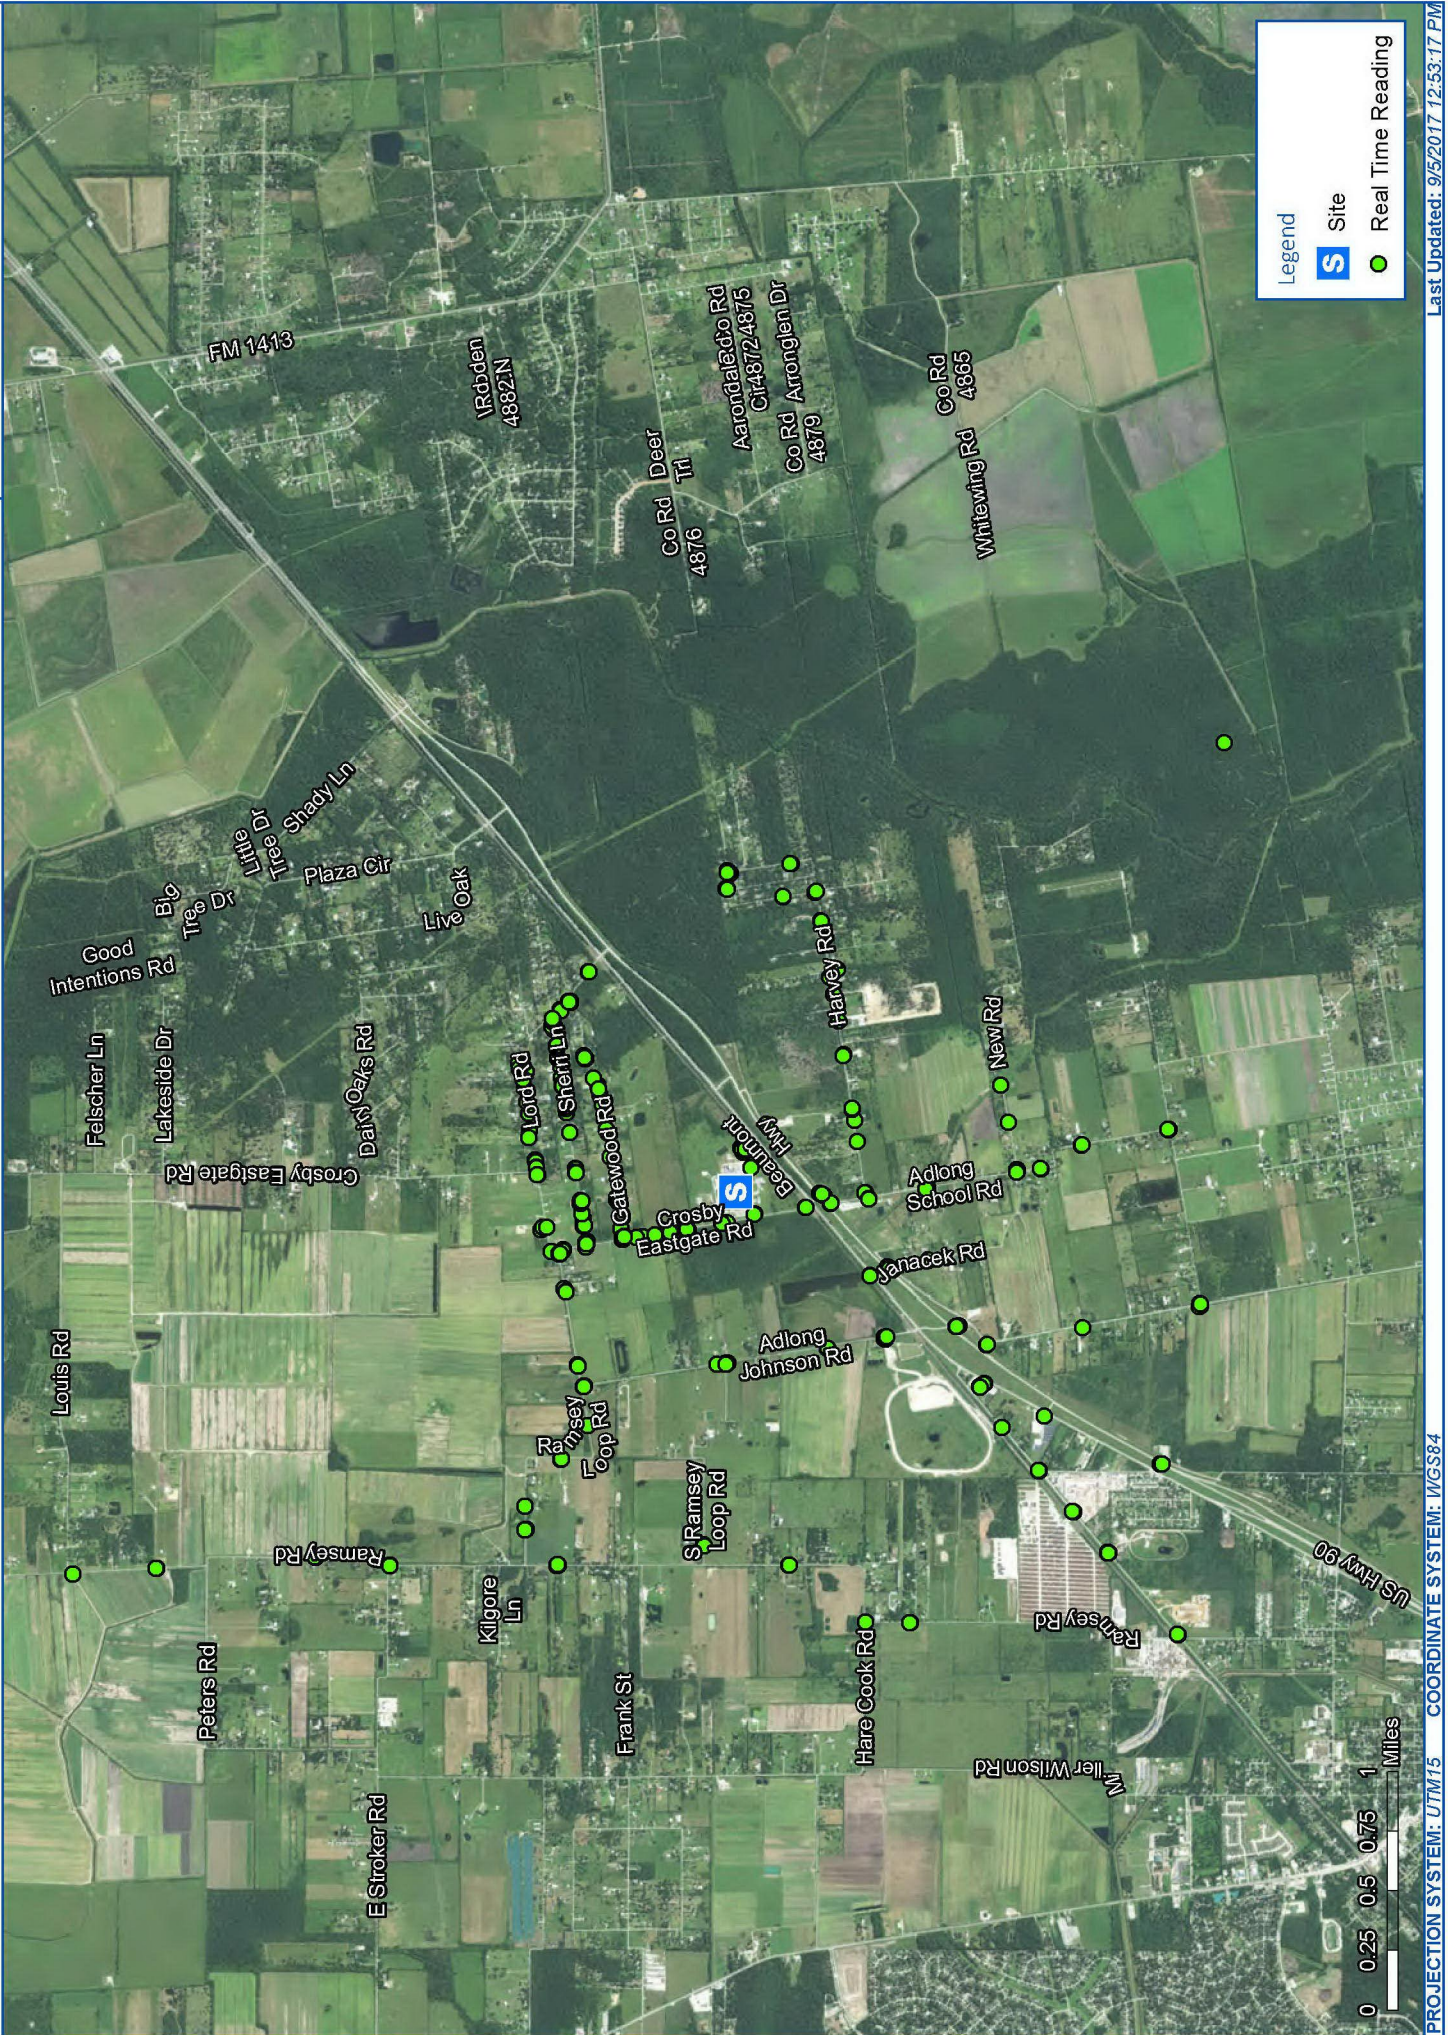
# Hand-held Real-time Reading Locations

Harvey Response - 06:00 September 4, 2017 to 06:00 September 5, 2017

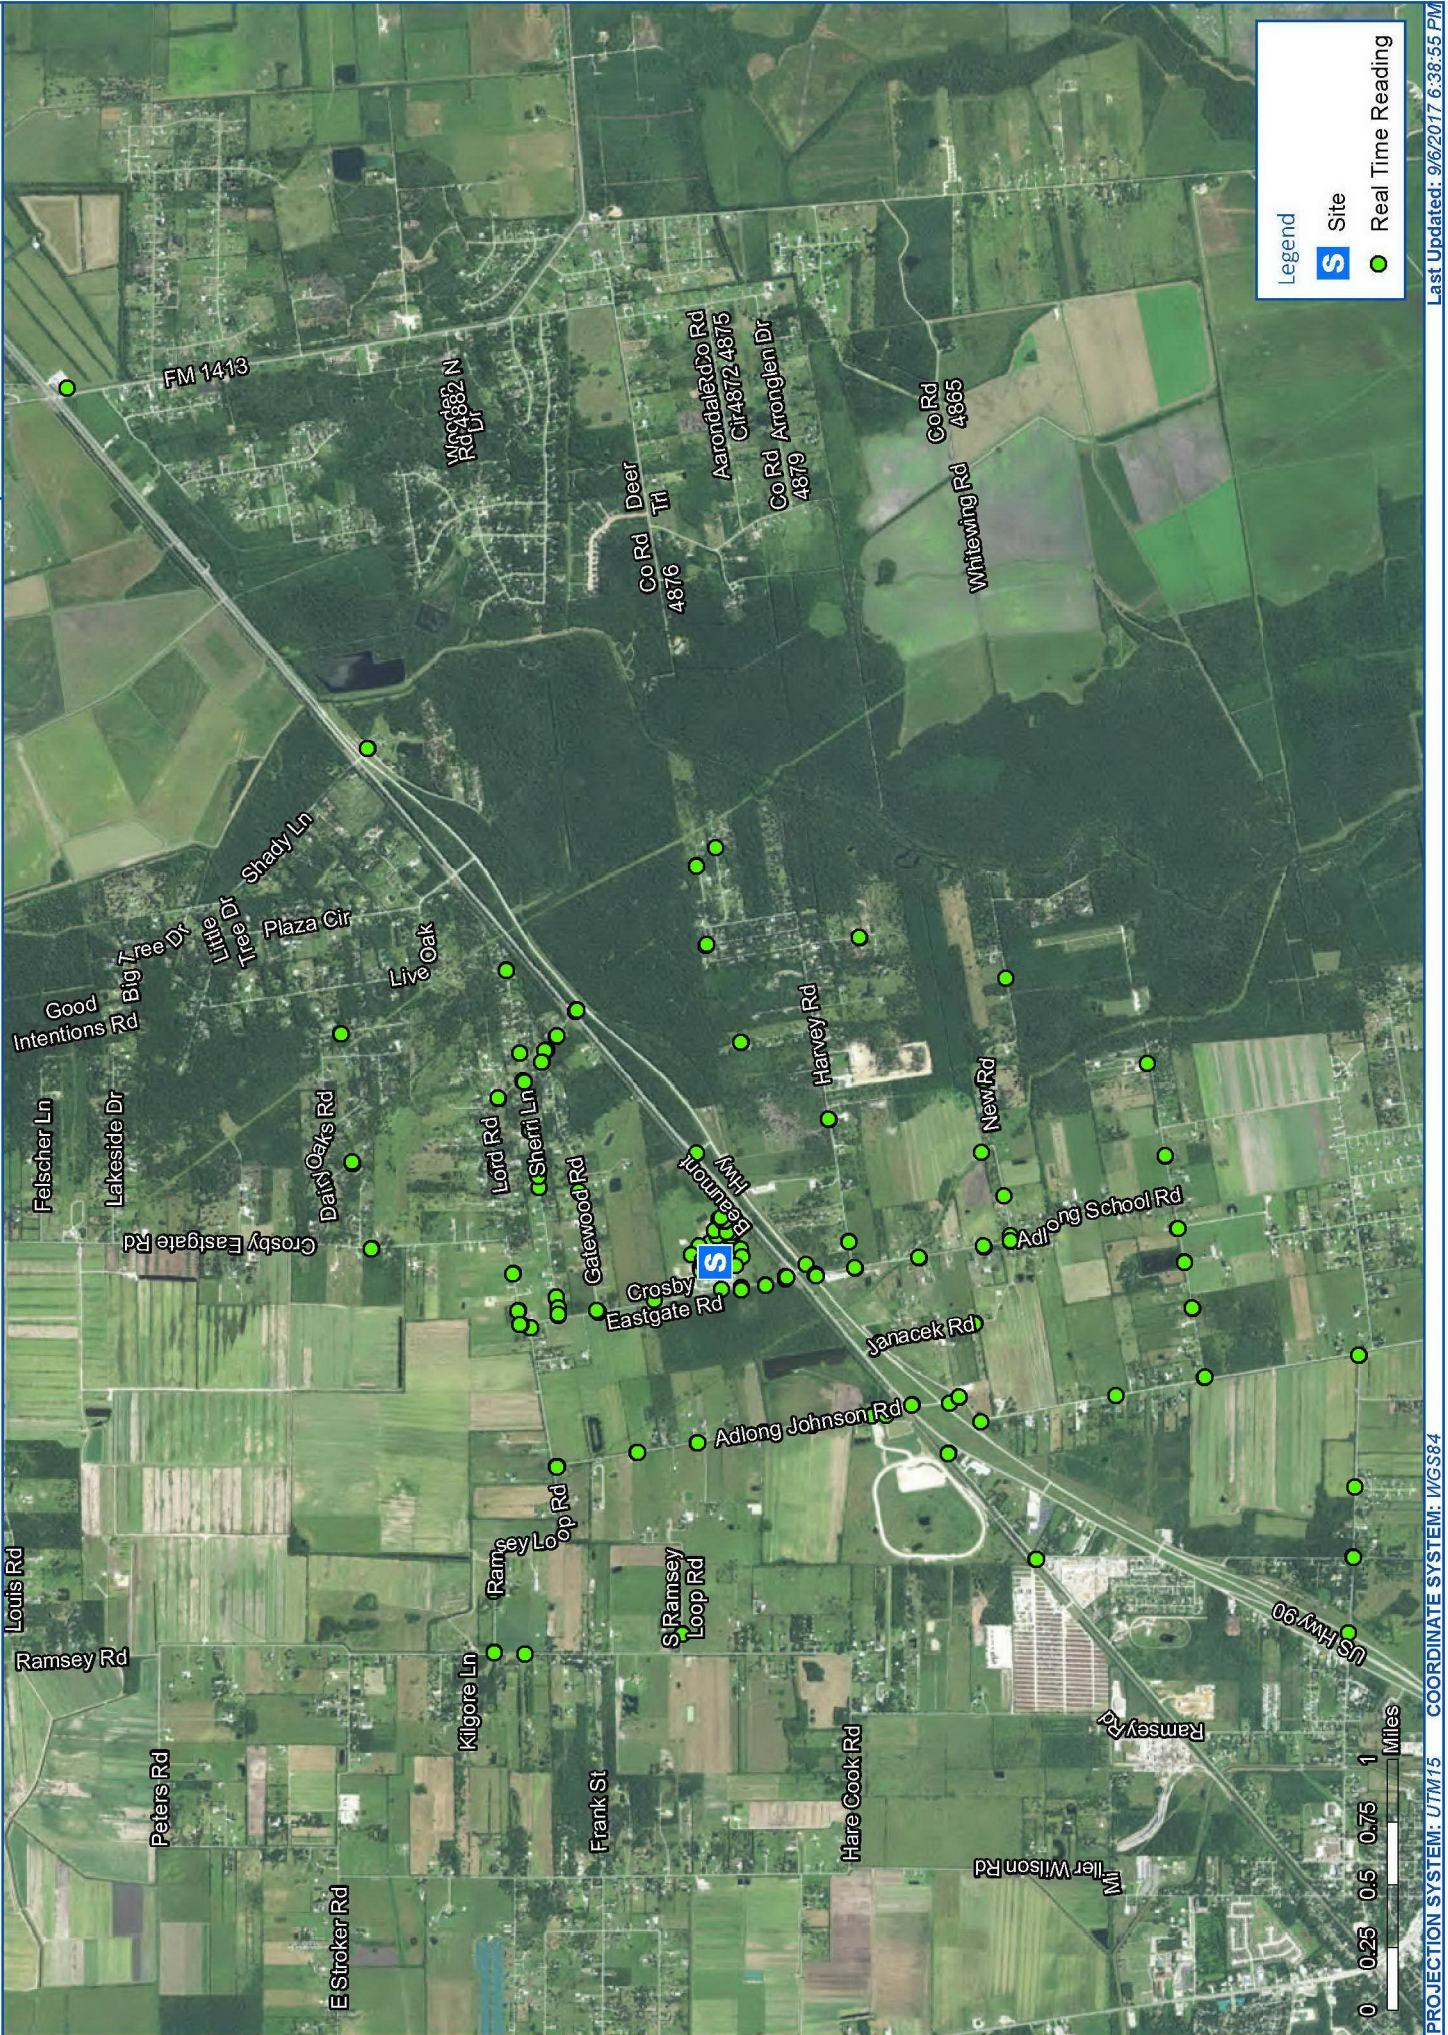
# Hand-held Real-time Reading Locations

Harvey Response - 06:00 September 5, 2017 to 06:00 September 6, 2017
