## Arkema Facility - Harvey Response

Crosby, TX

Arkema Inc.

Project #109489 Summary

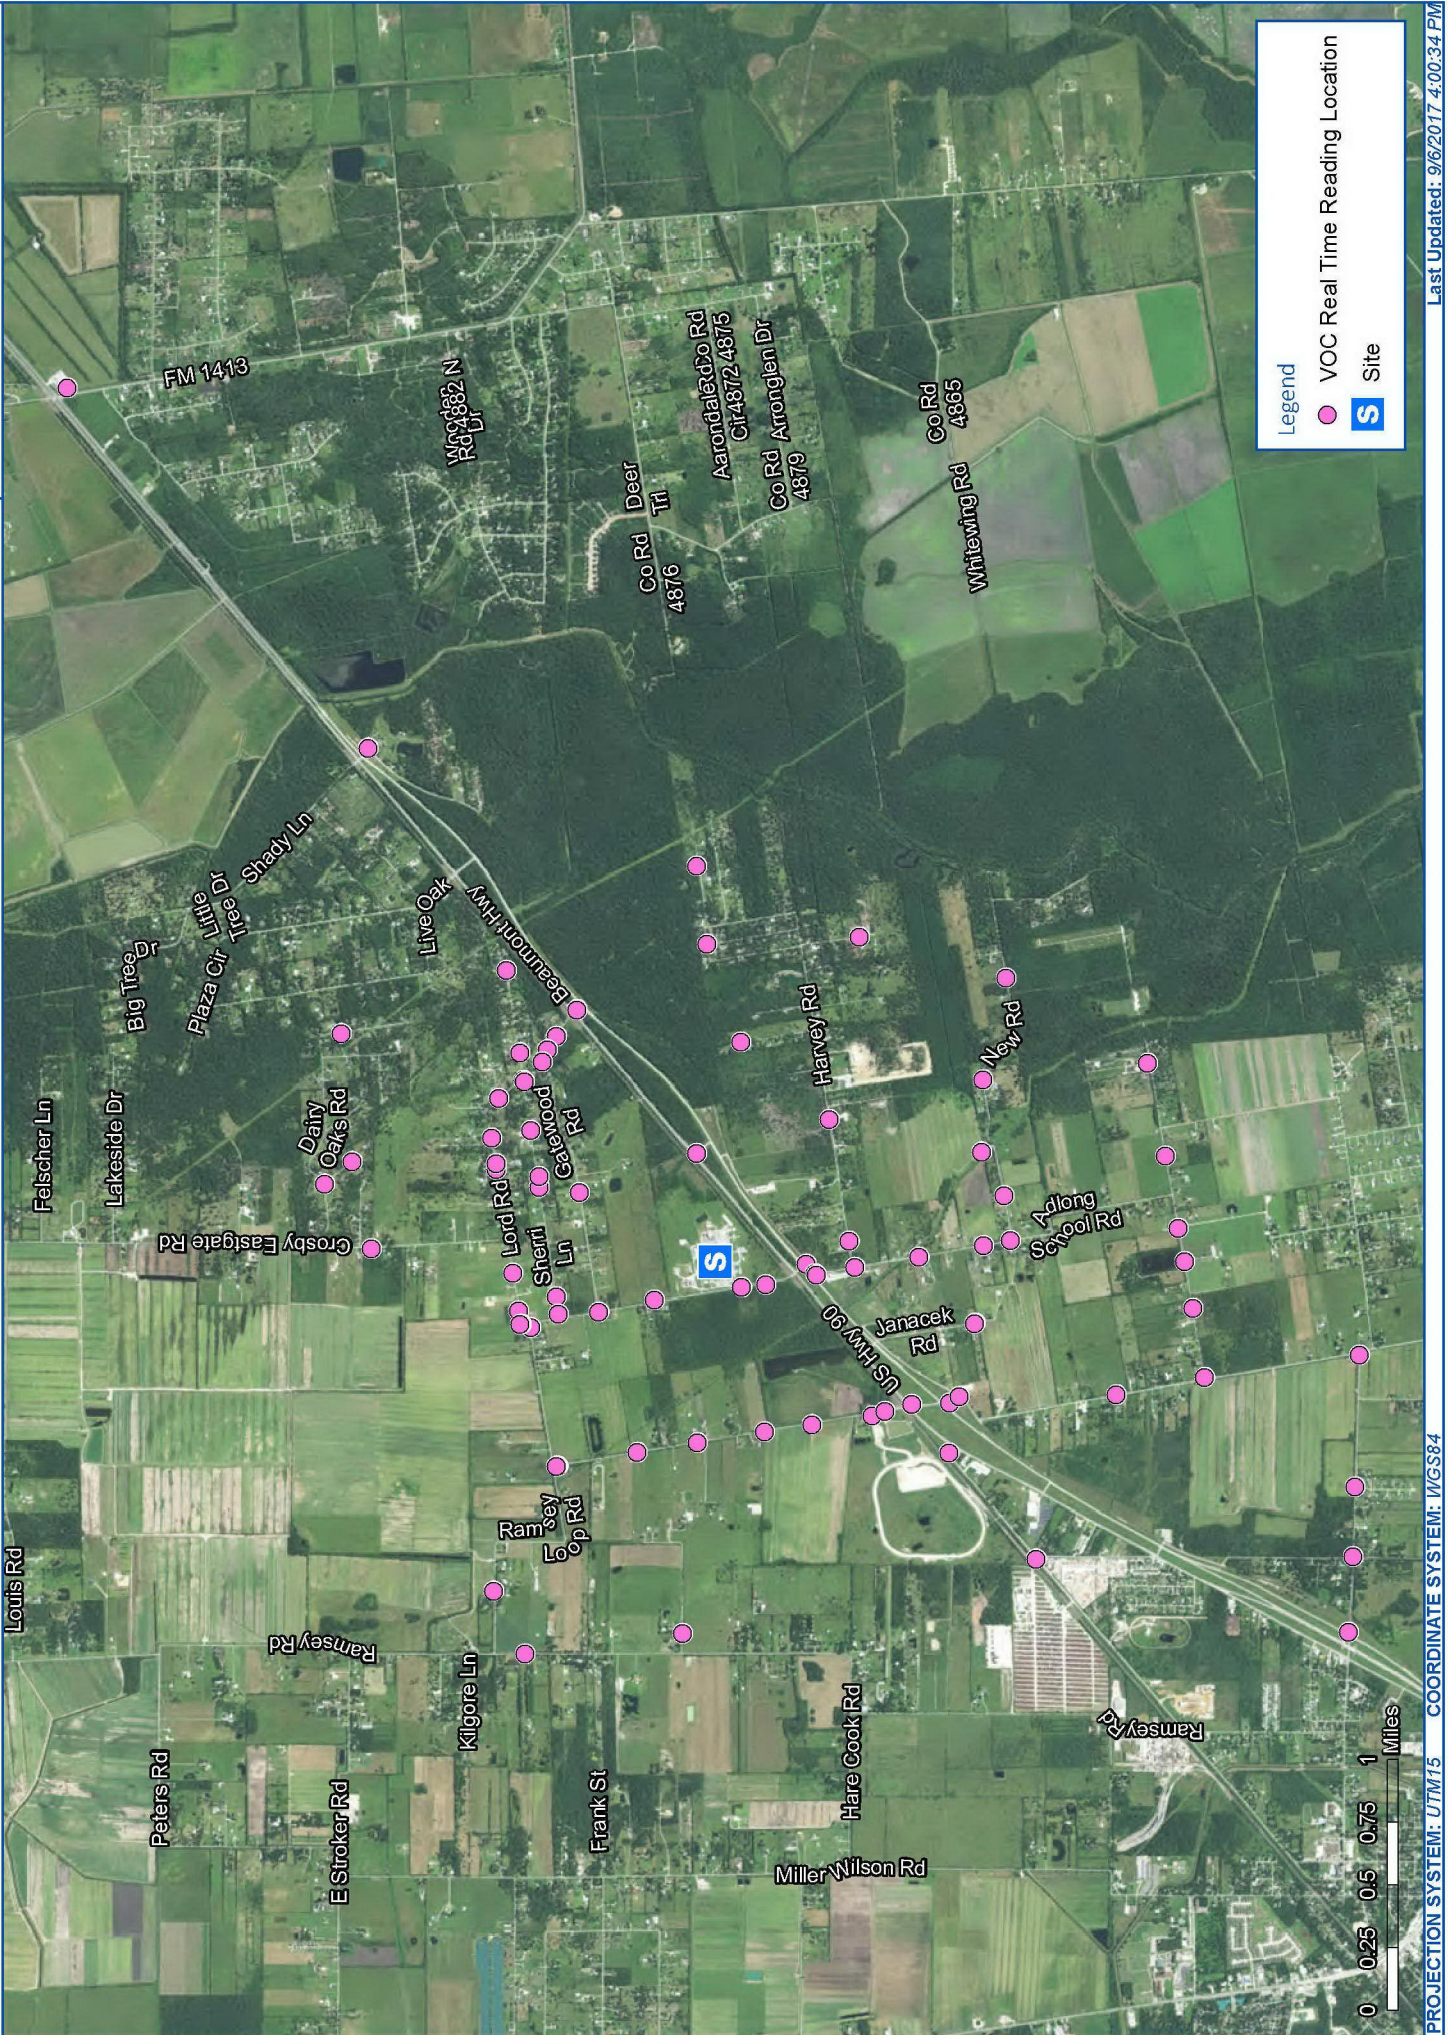
# Community VOC Hand-held Real-time Reading Locations

Harvey Response - 06:00 September 5, 2017 to 06:00 September 6, 2017

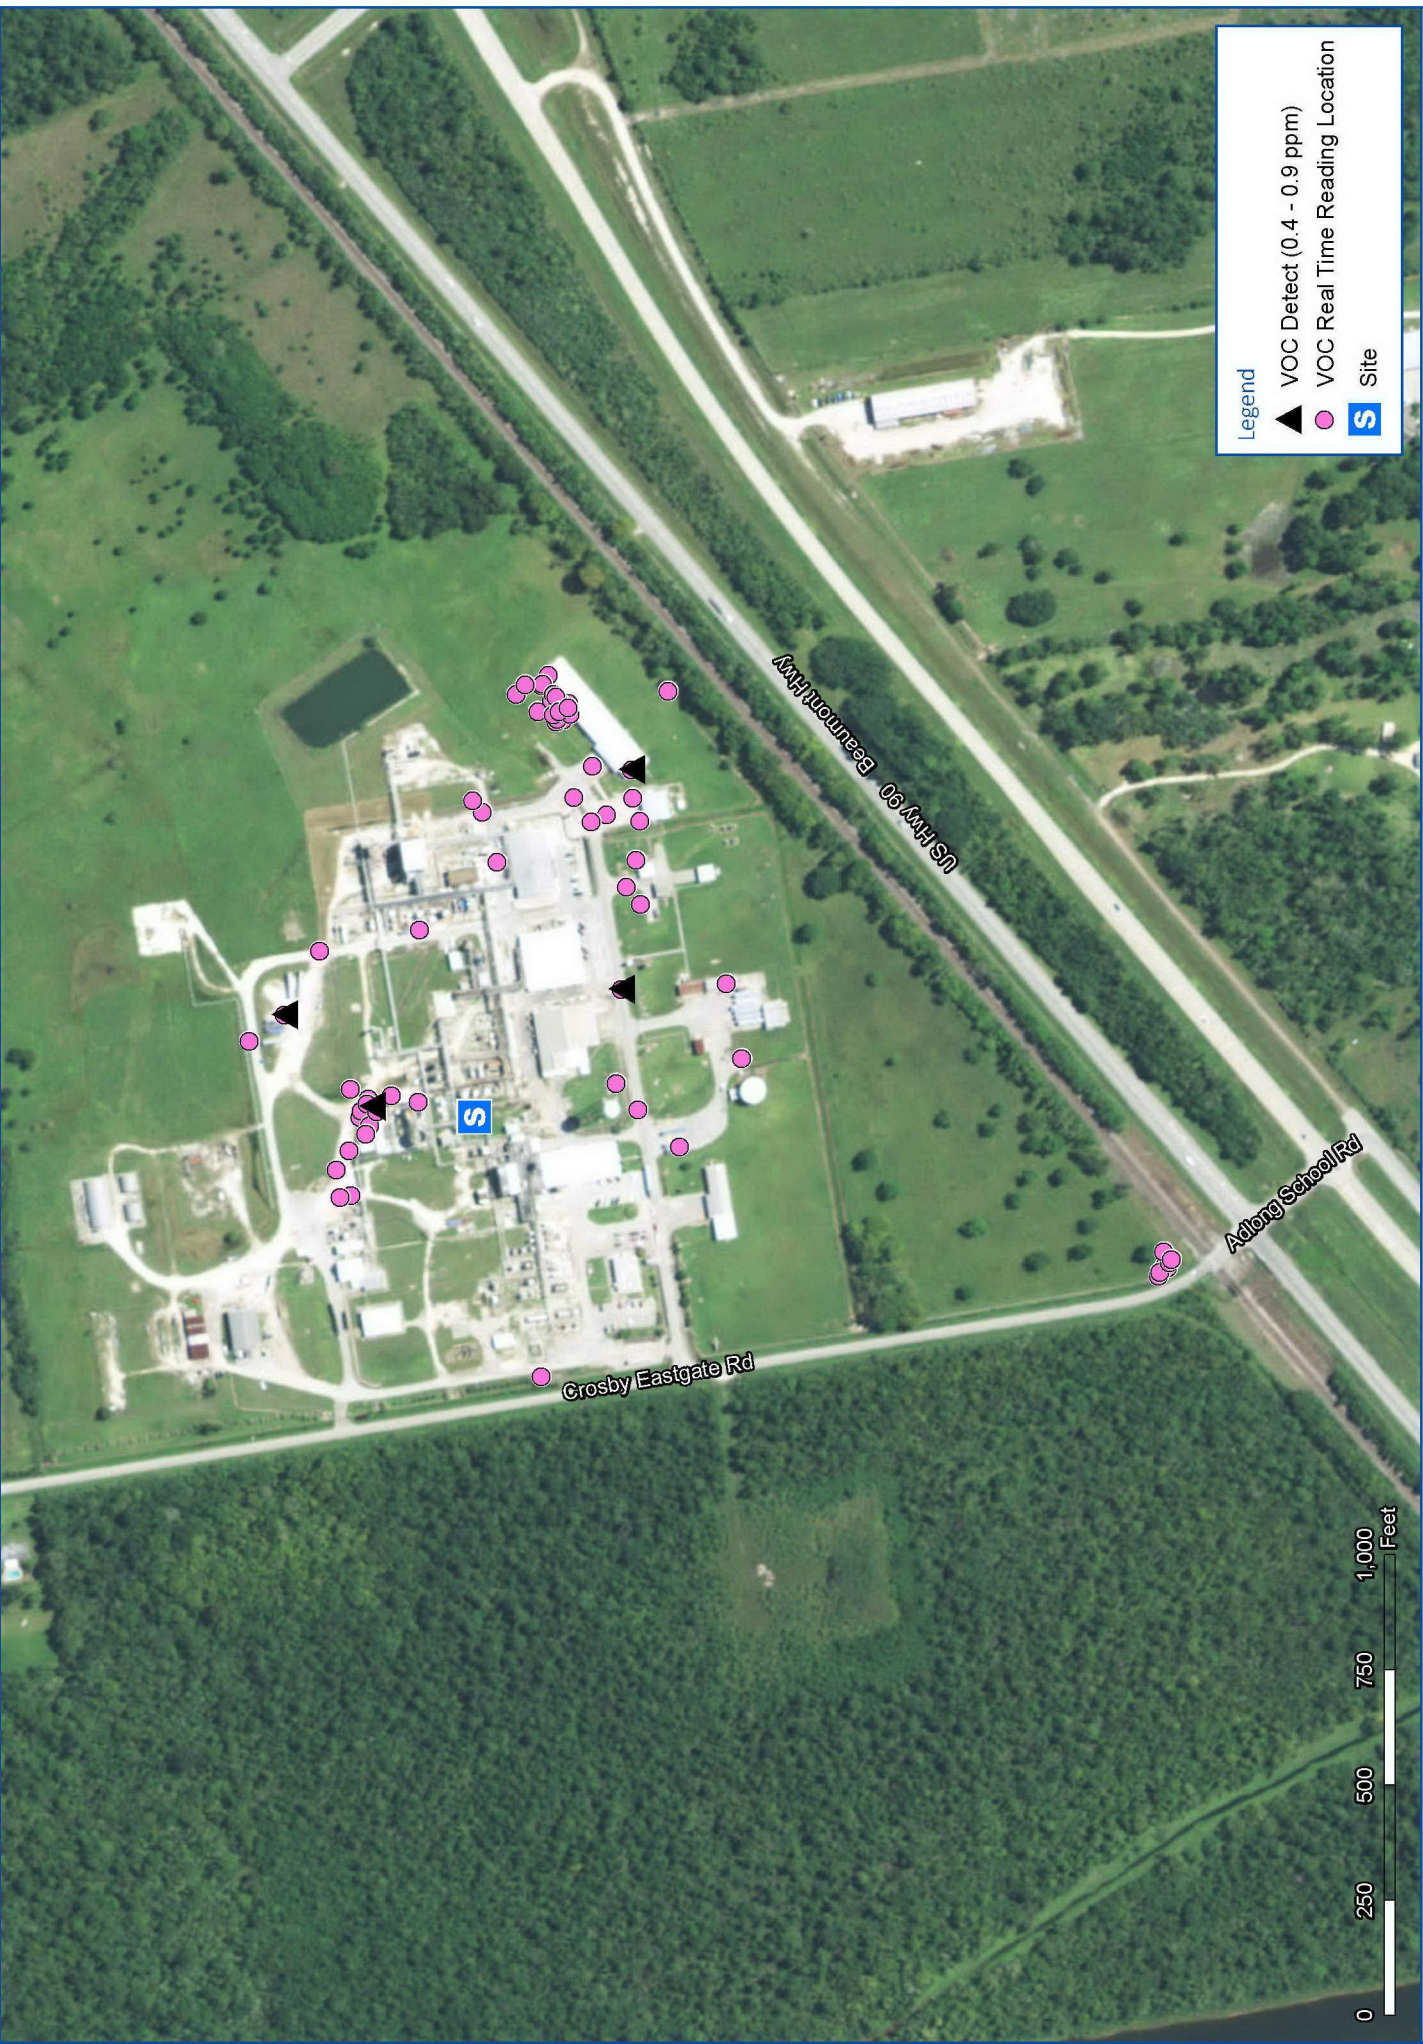
# VOC Hand-held Real-time Reading Locations - Worker Activity

Harvey Response - 06:00 September 5, 2017 to 06:00 September 6, 2017

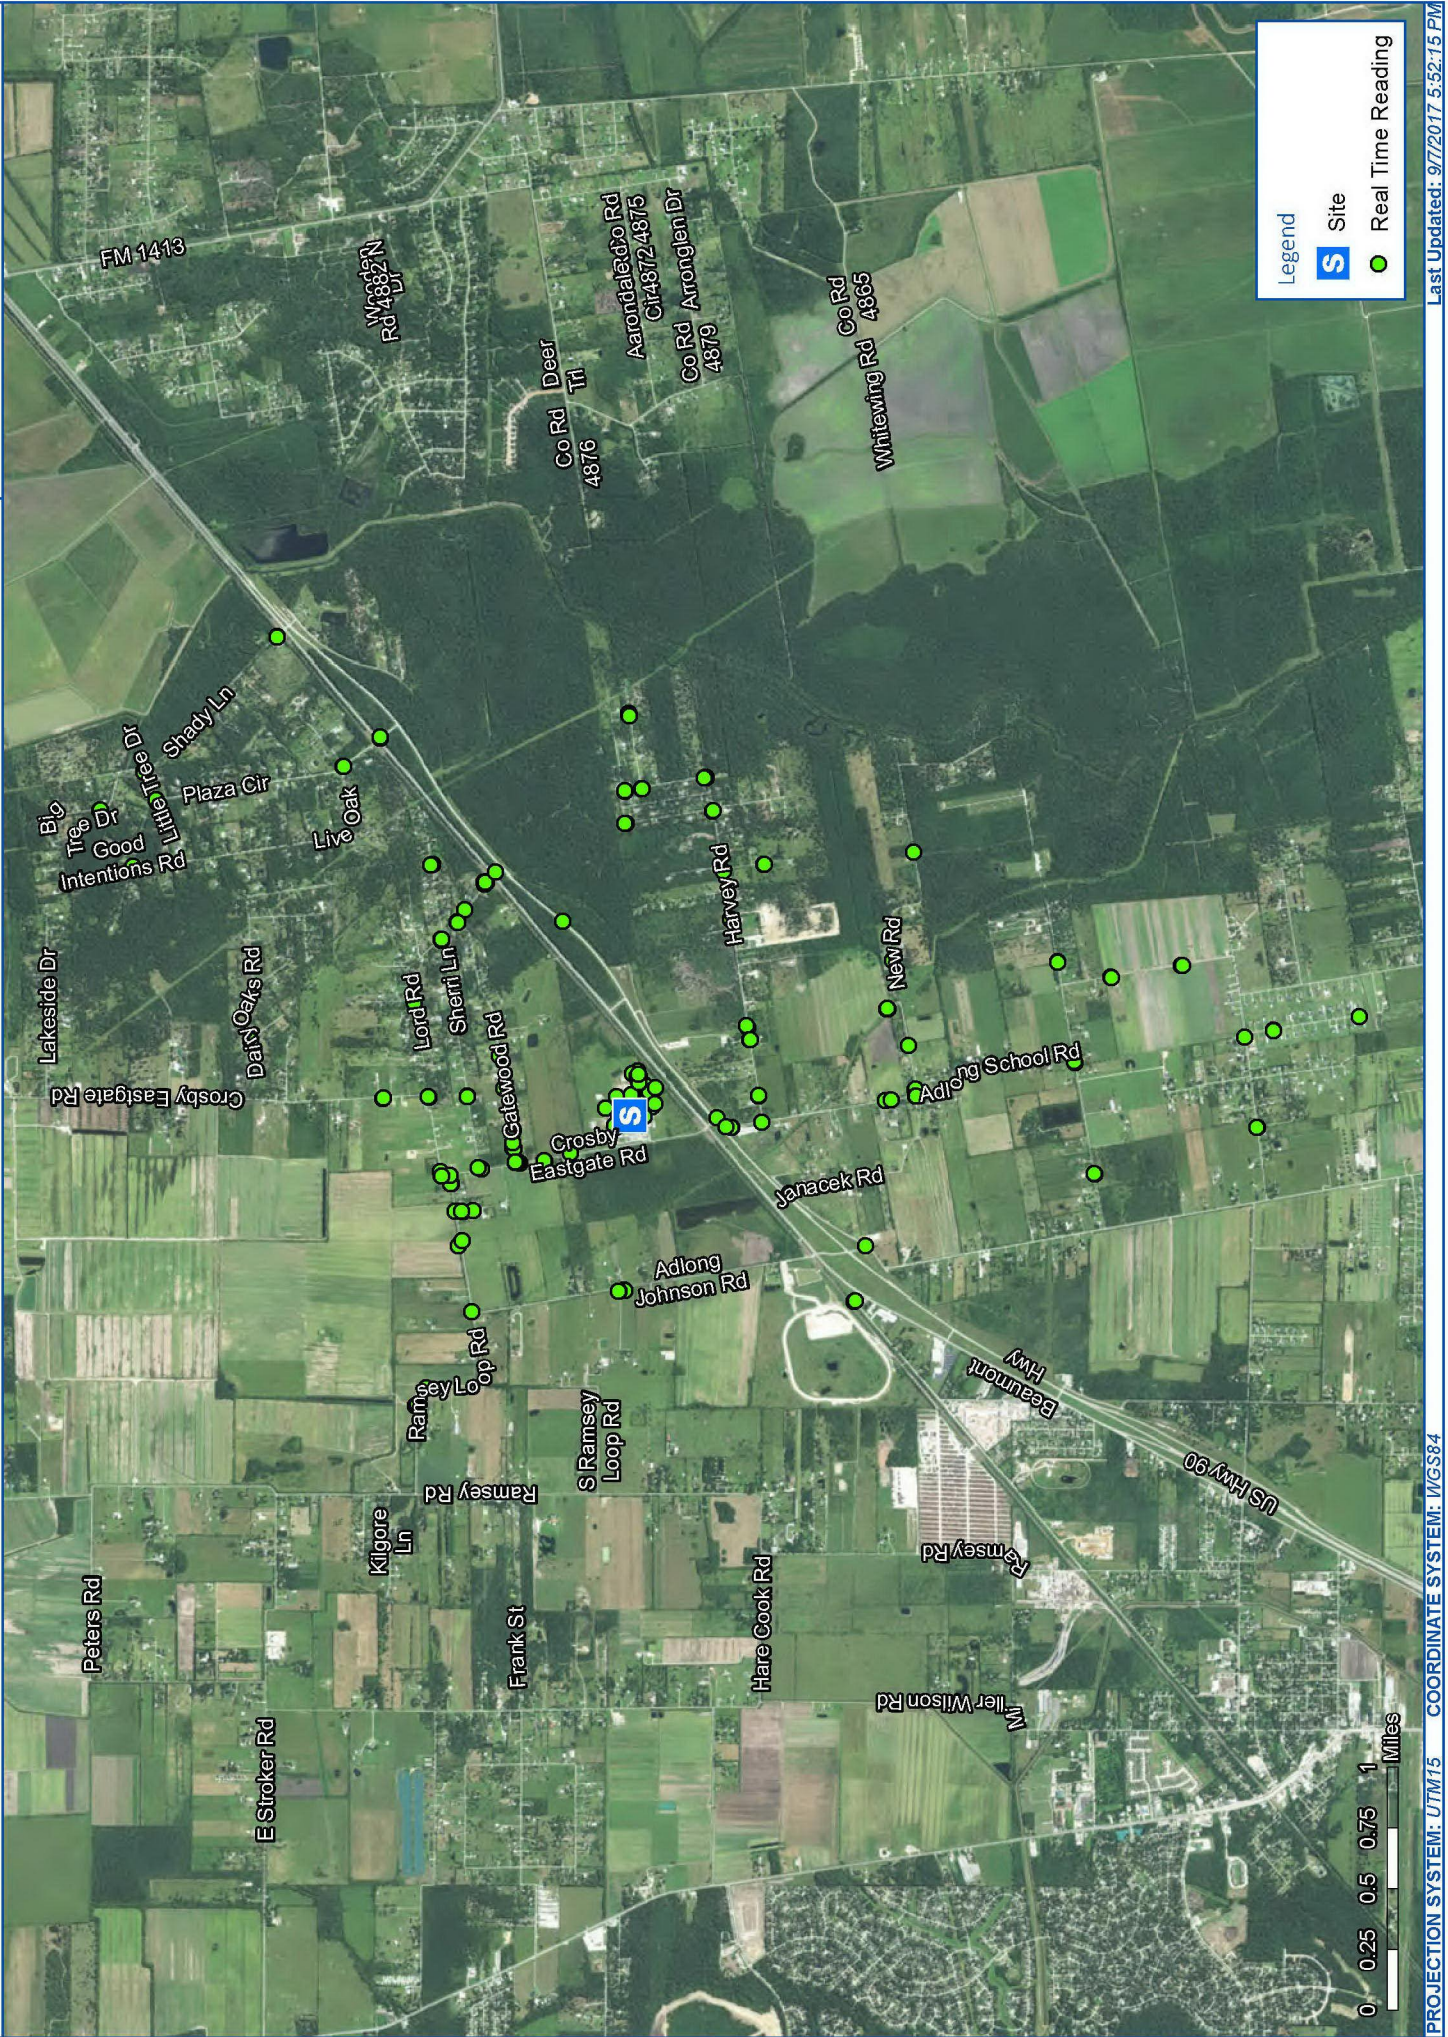
# Hand-held Real-time Reading Locations

Harvey Response - 06:00 September 6, 2017 to 06:00 September 7, 2017

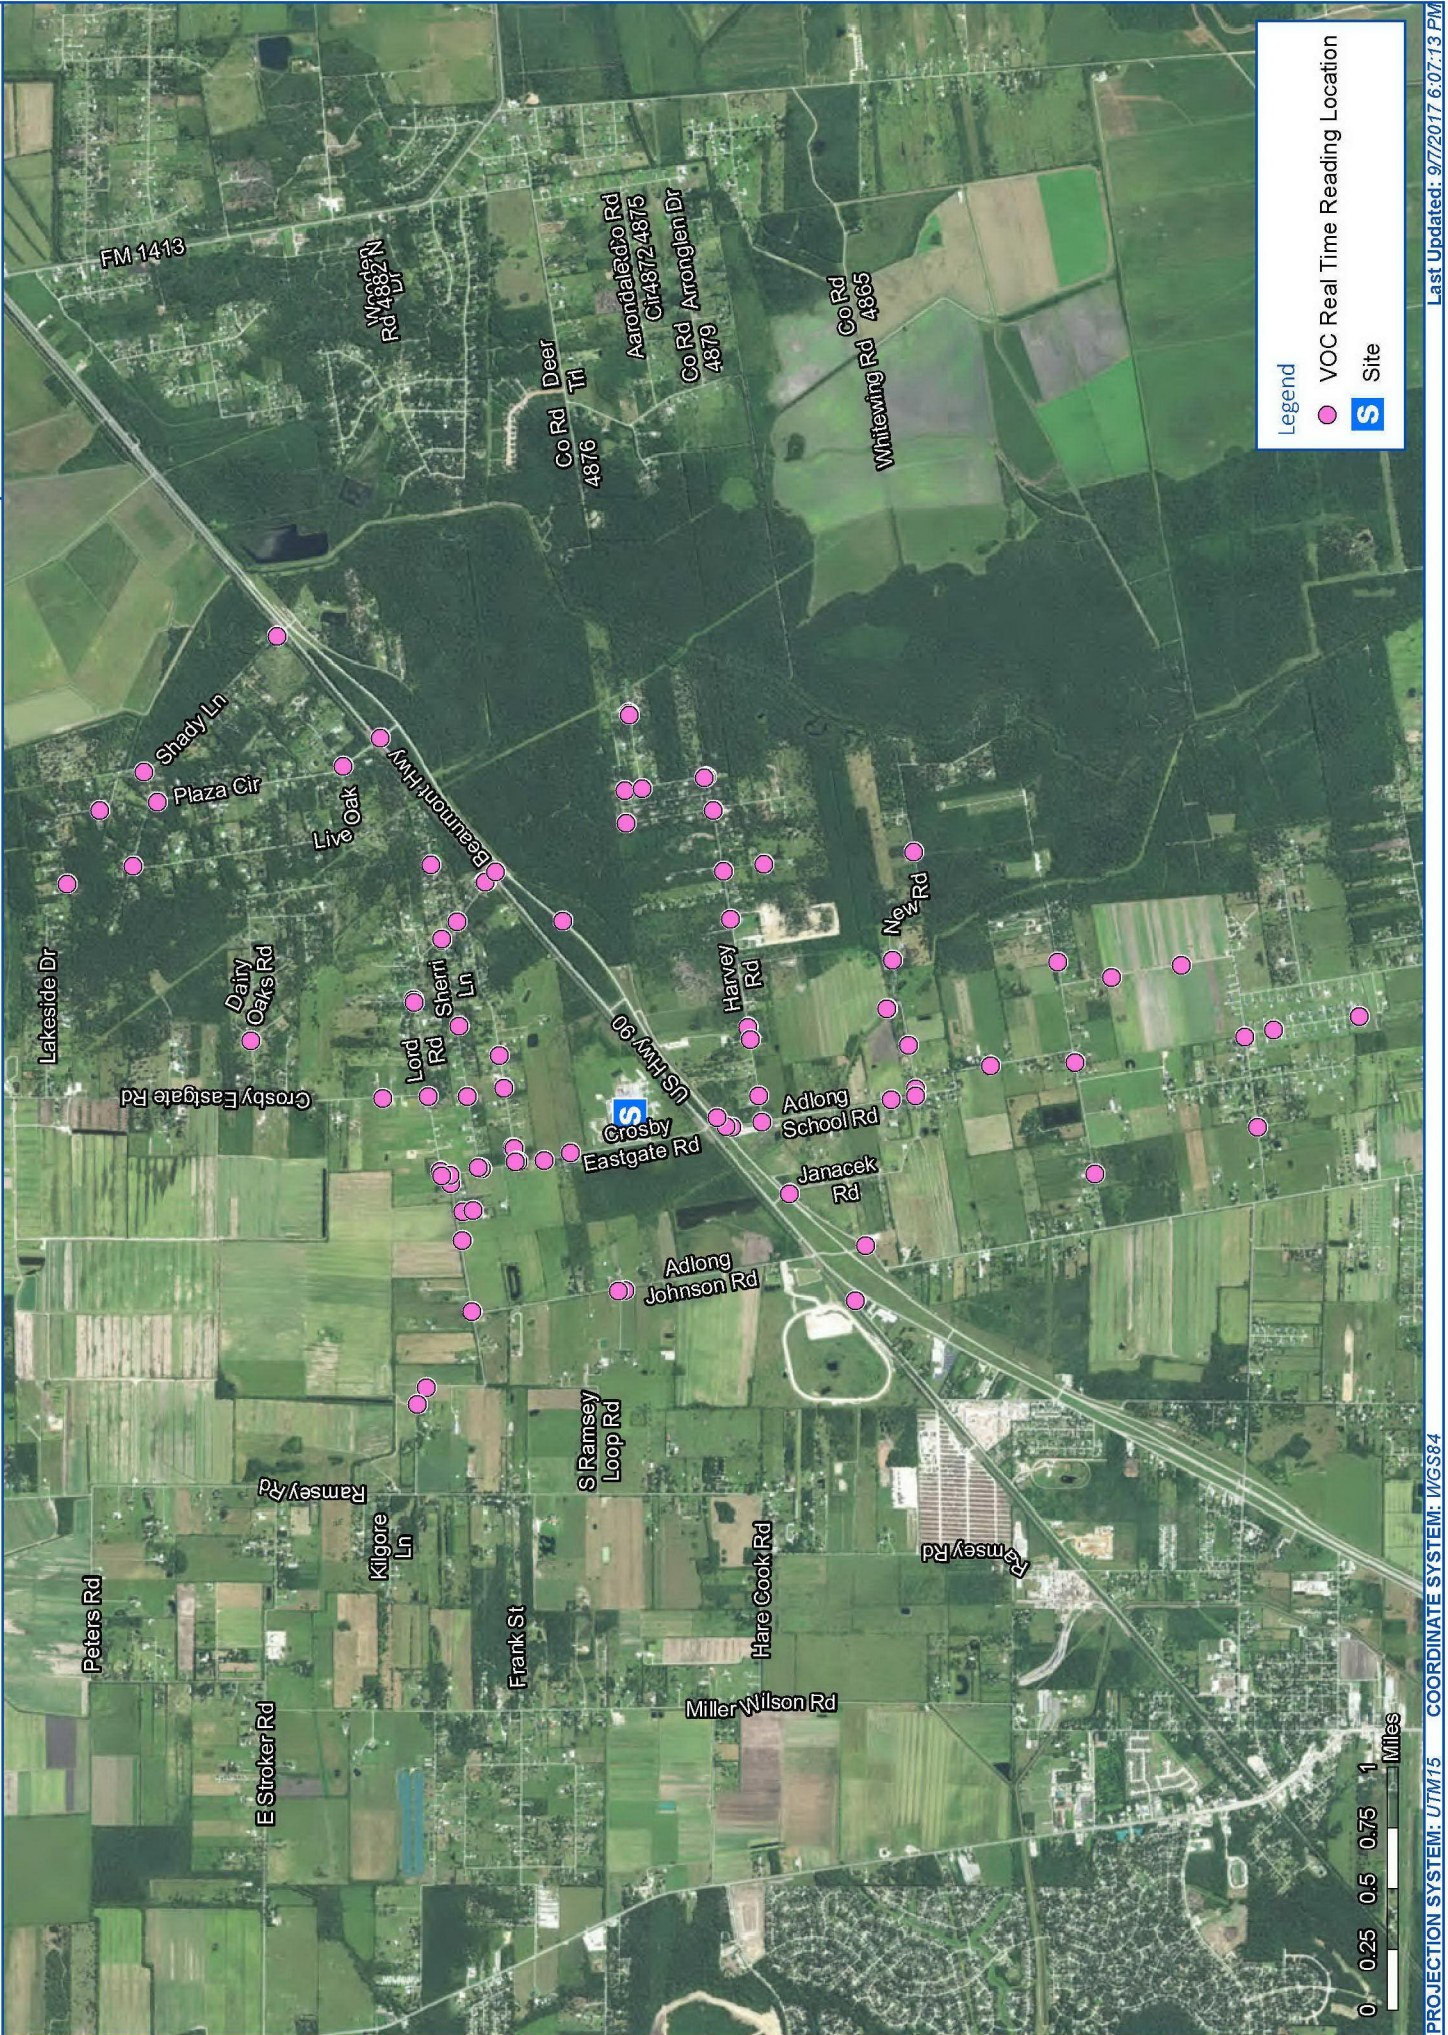
# Community PM2.5 Hand-held Real-time Reading Locations

Harvey Response - 06:00 September 6, 2017 to 06:00 September 7, 2017

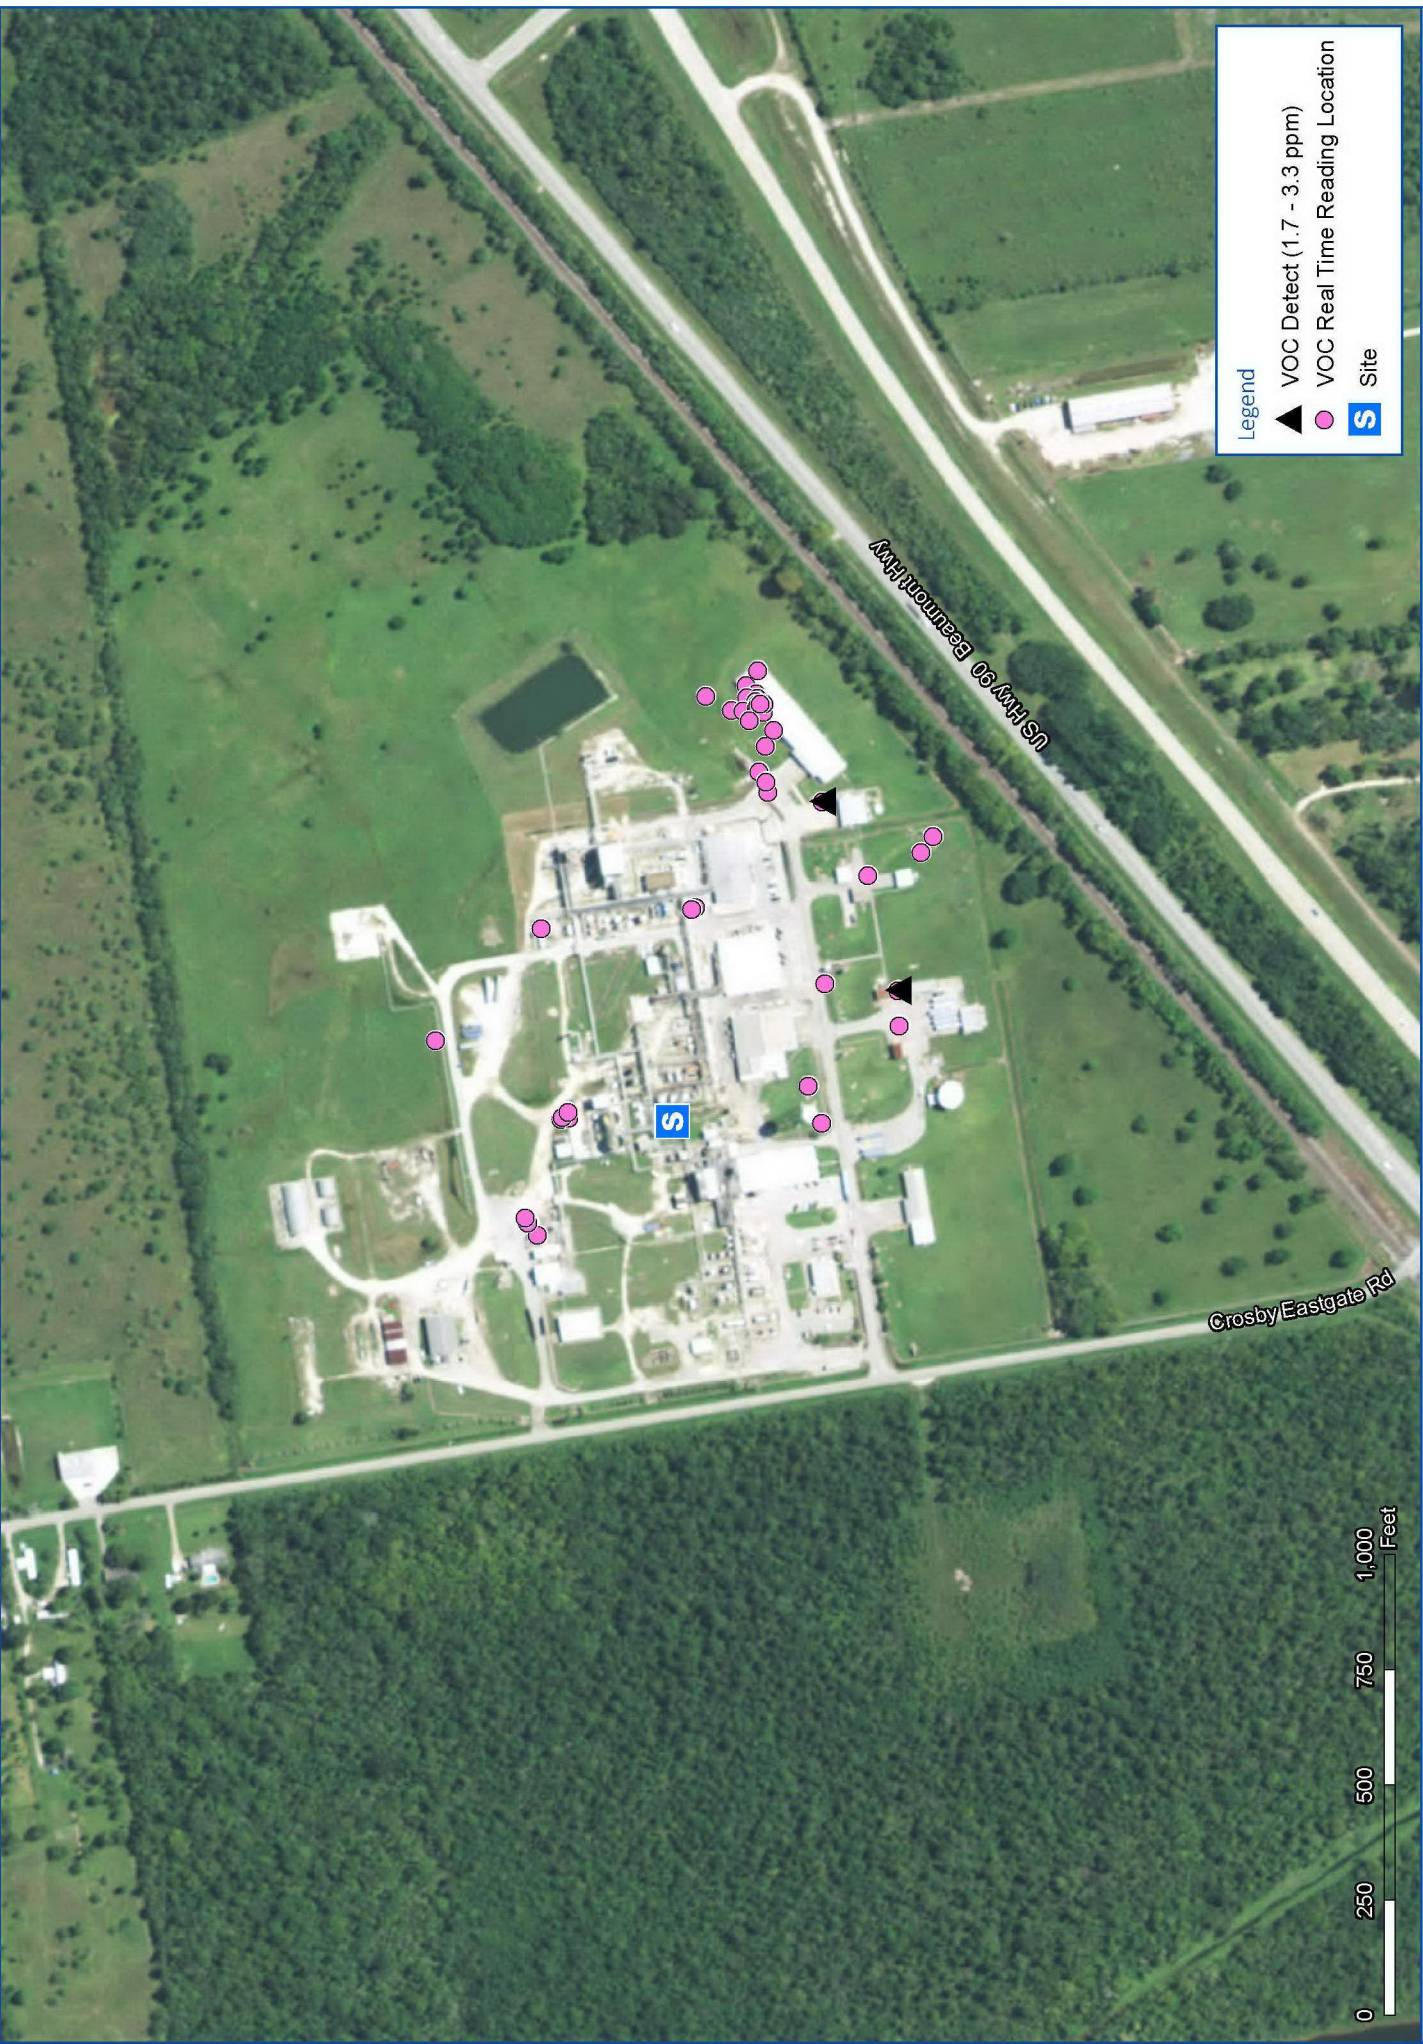
# VOC Hand-held Real-time Reading Locations - Worker Activity

Harvey Response - 06:00 September 6, 2017 to 06:00 September 7, 2017

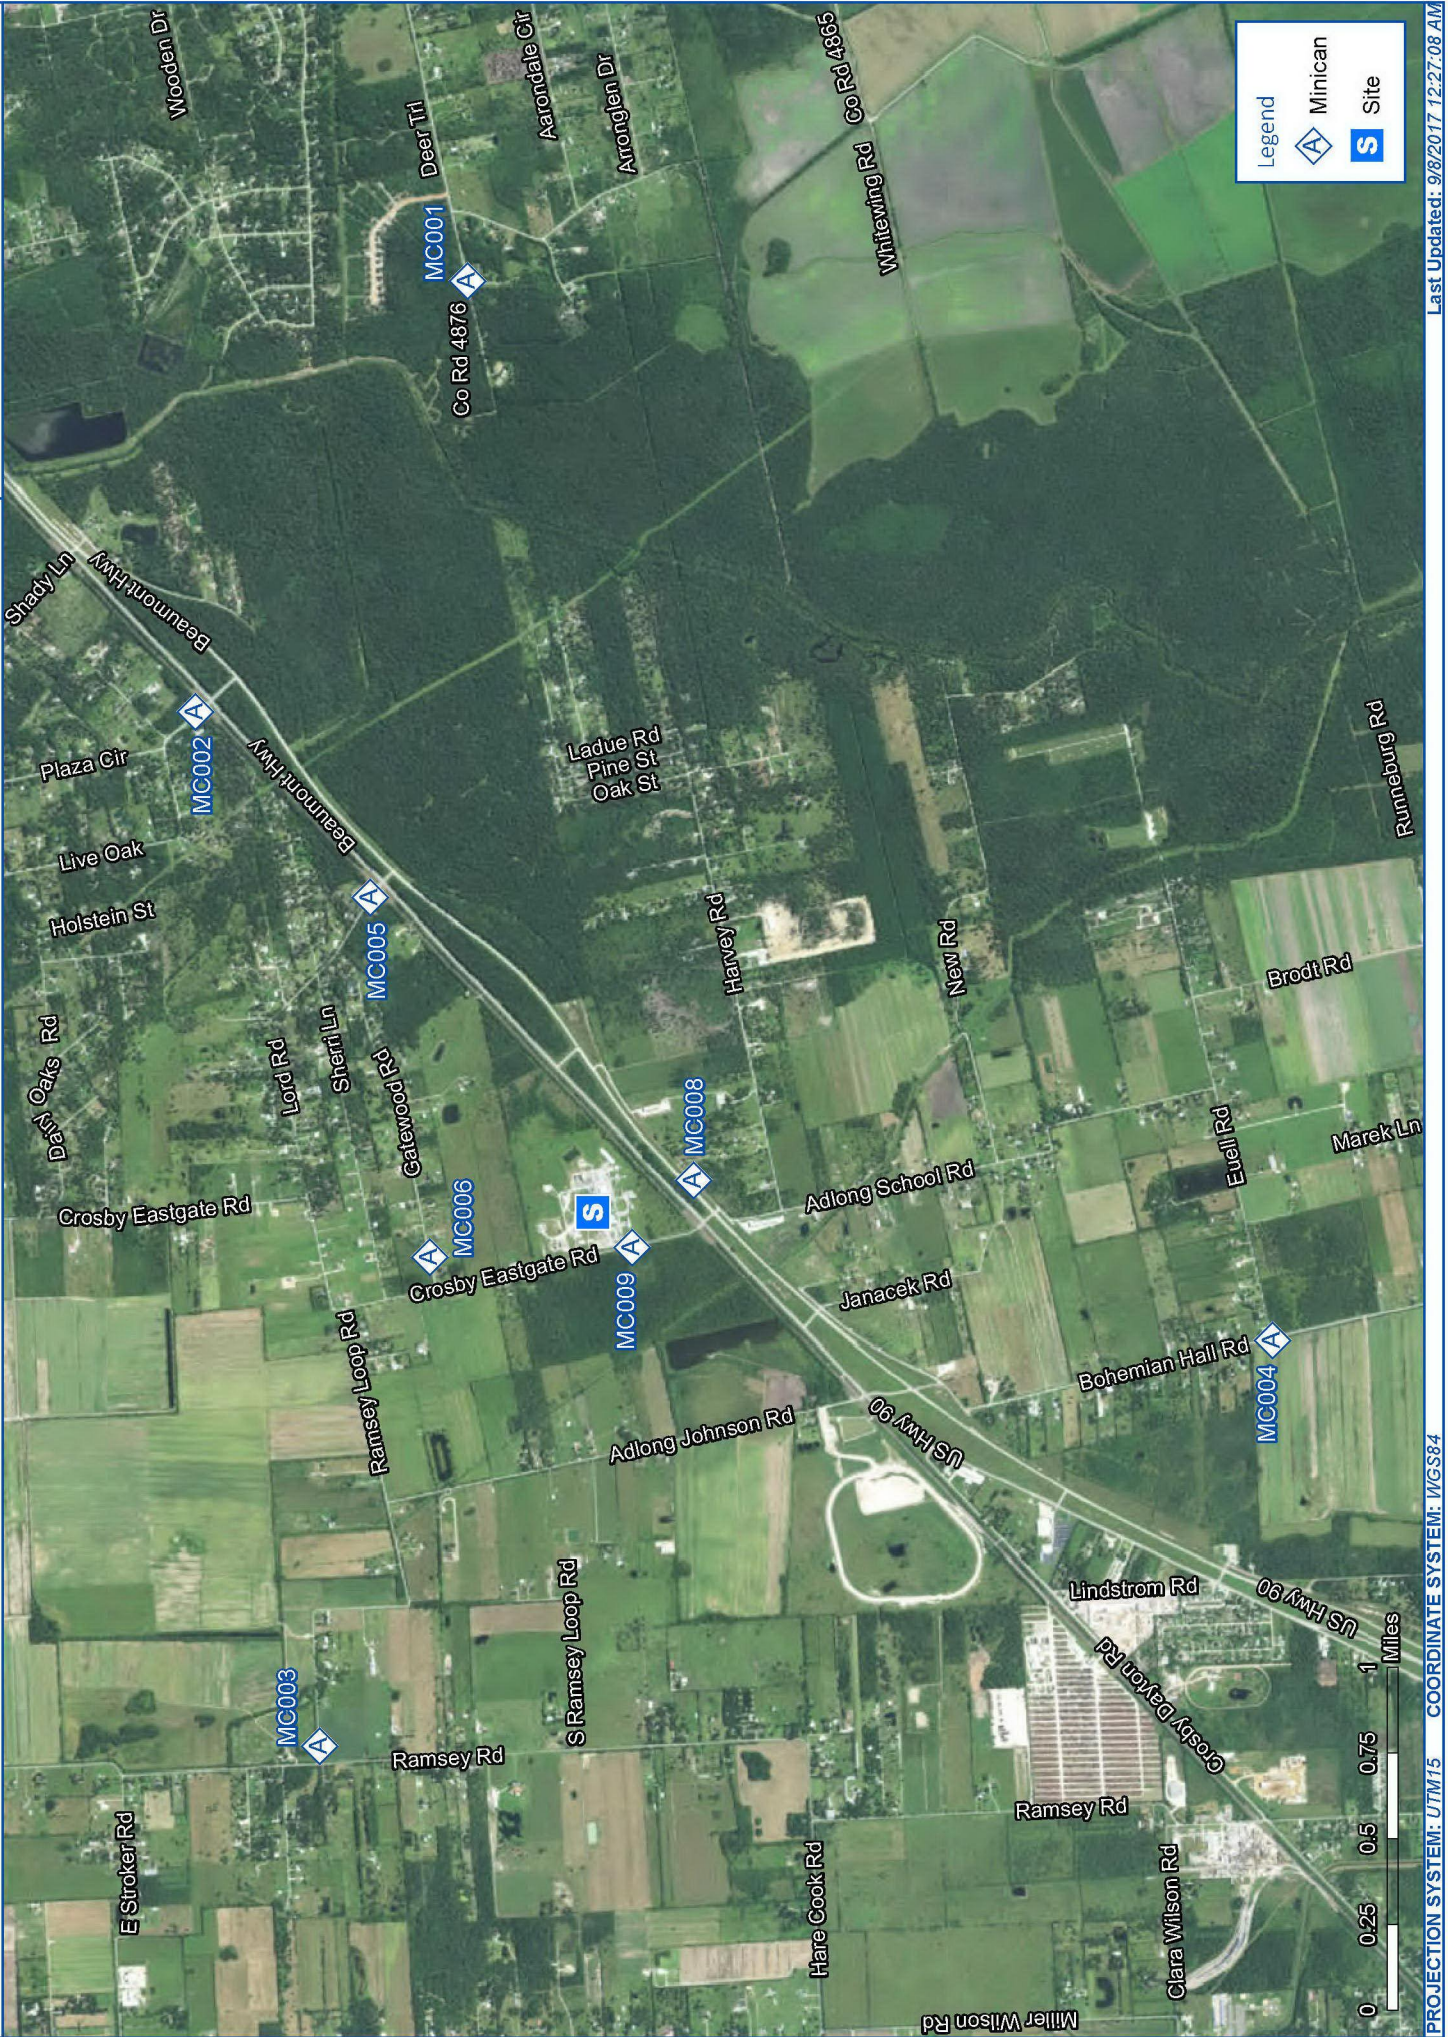
# Analytical Air Monitoring Station Locations as of September 7, 2017

Harvey Response

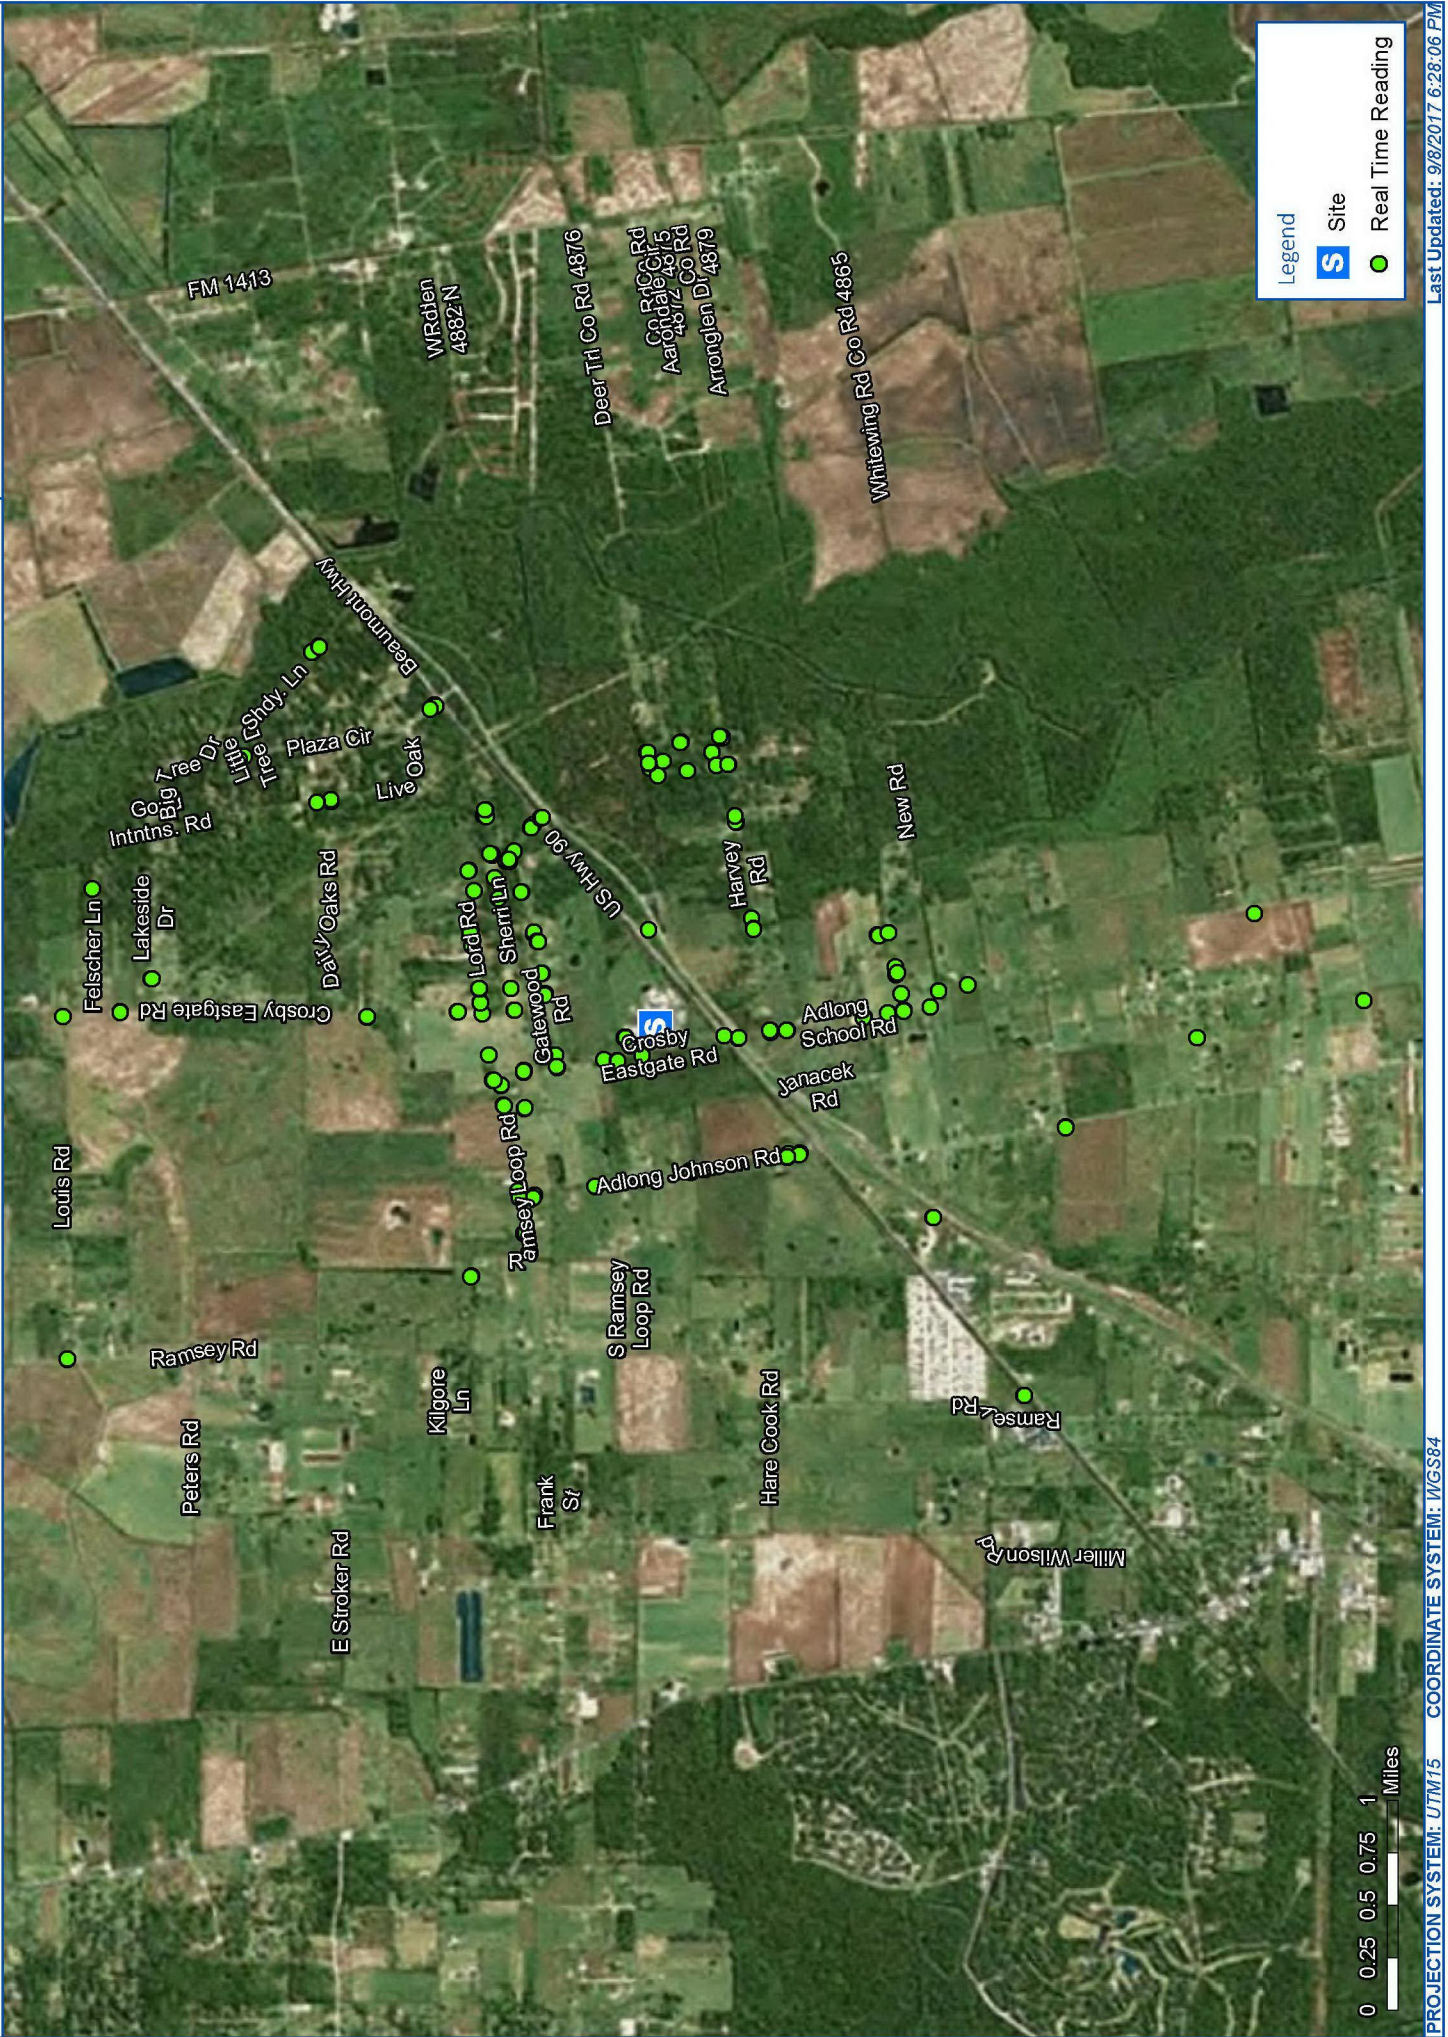
# Hand-held Real-time Reading Locations

Harvey Response - 06:00 September 7, 2017 to 06:00 September 8, 2017
