## Arkema Facility - Harvey Response

Crosby, TX

Arkema Inc.

Project #109489 Summary

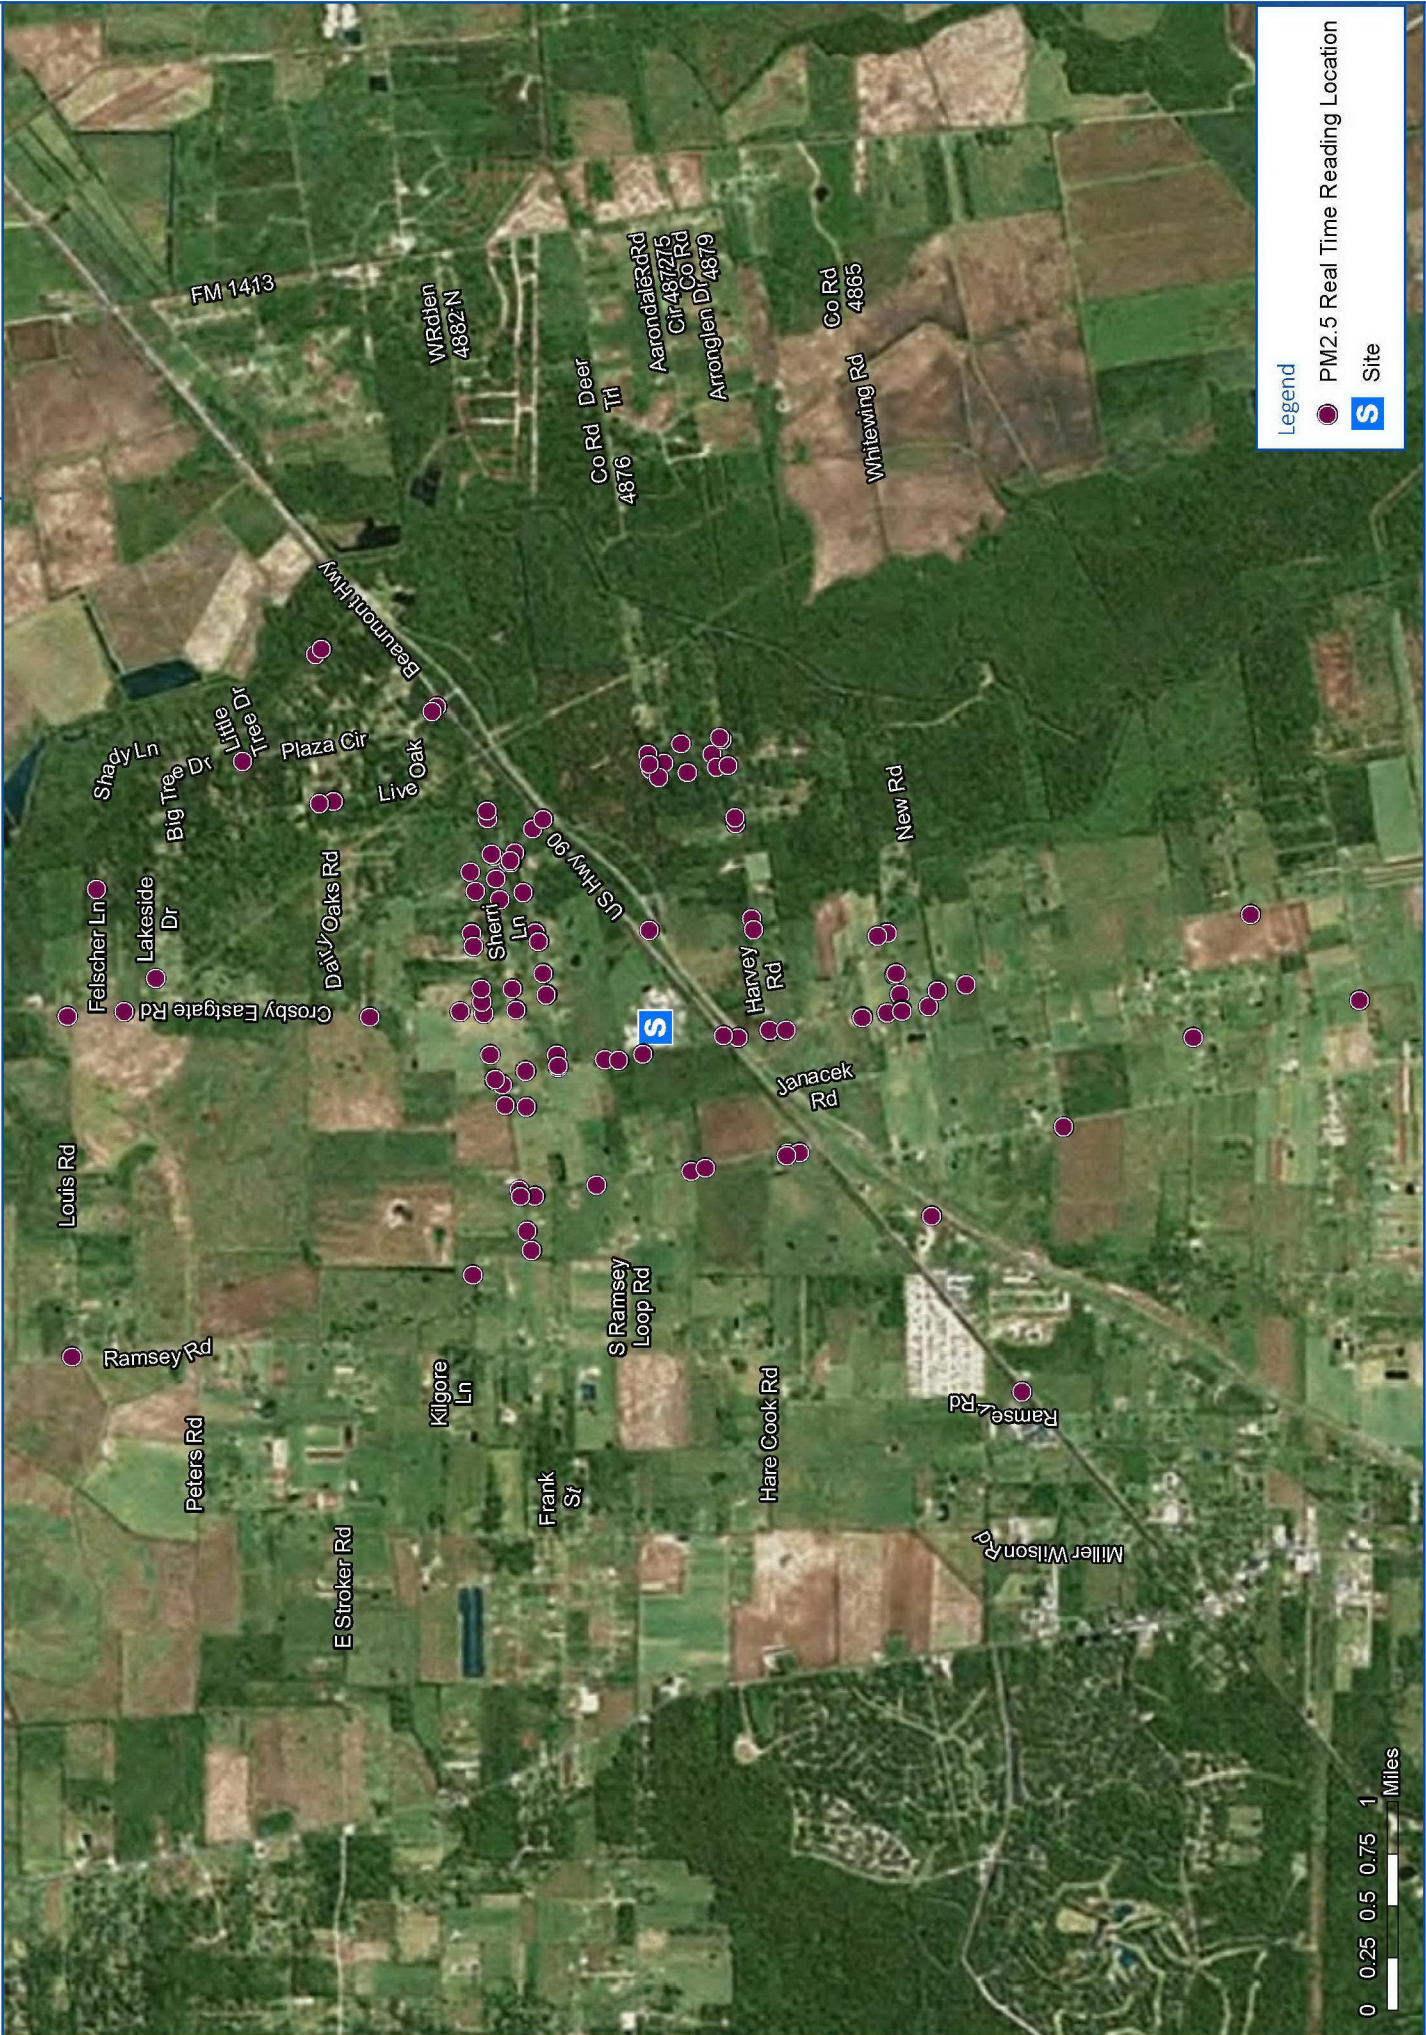
# Community PM2.5 Hand-held Real-time Reading Locations

Harvey Response - 06:00 September 7, 2017 to 06:00 September 8, 2017

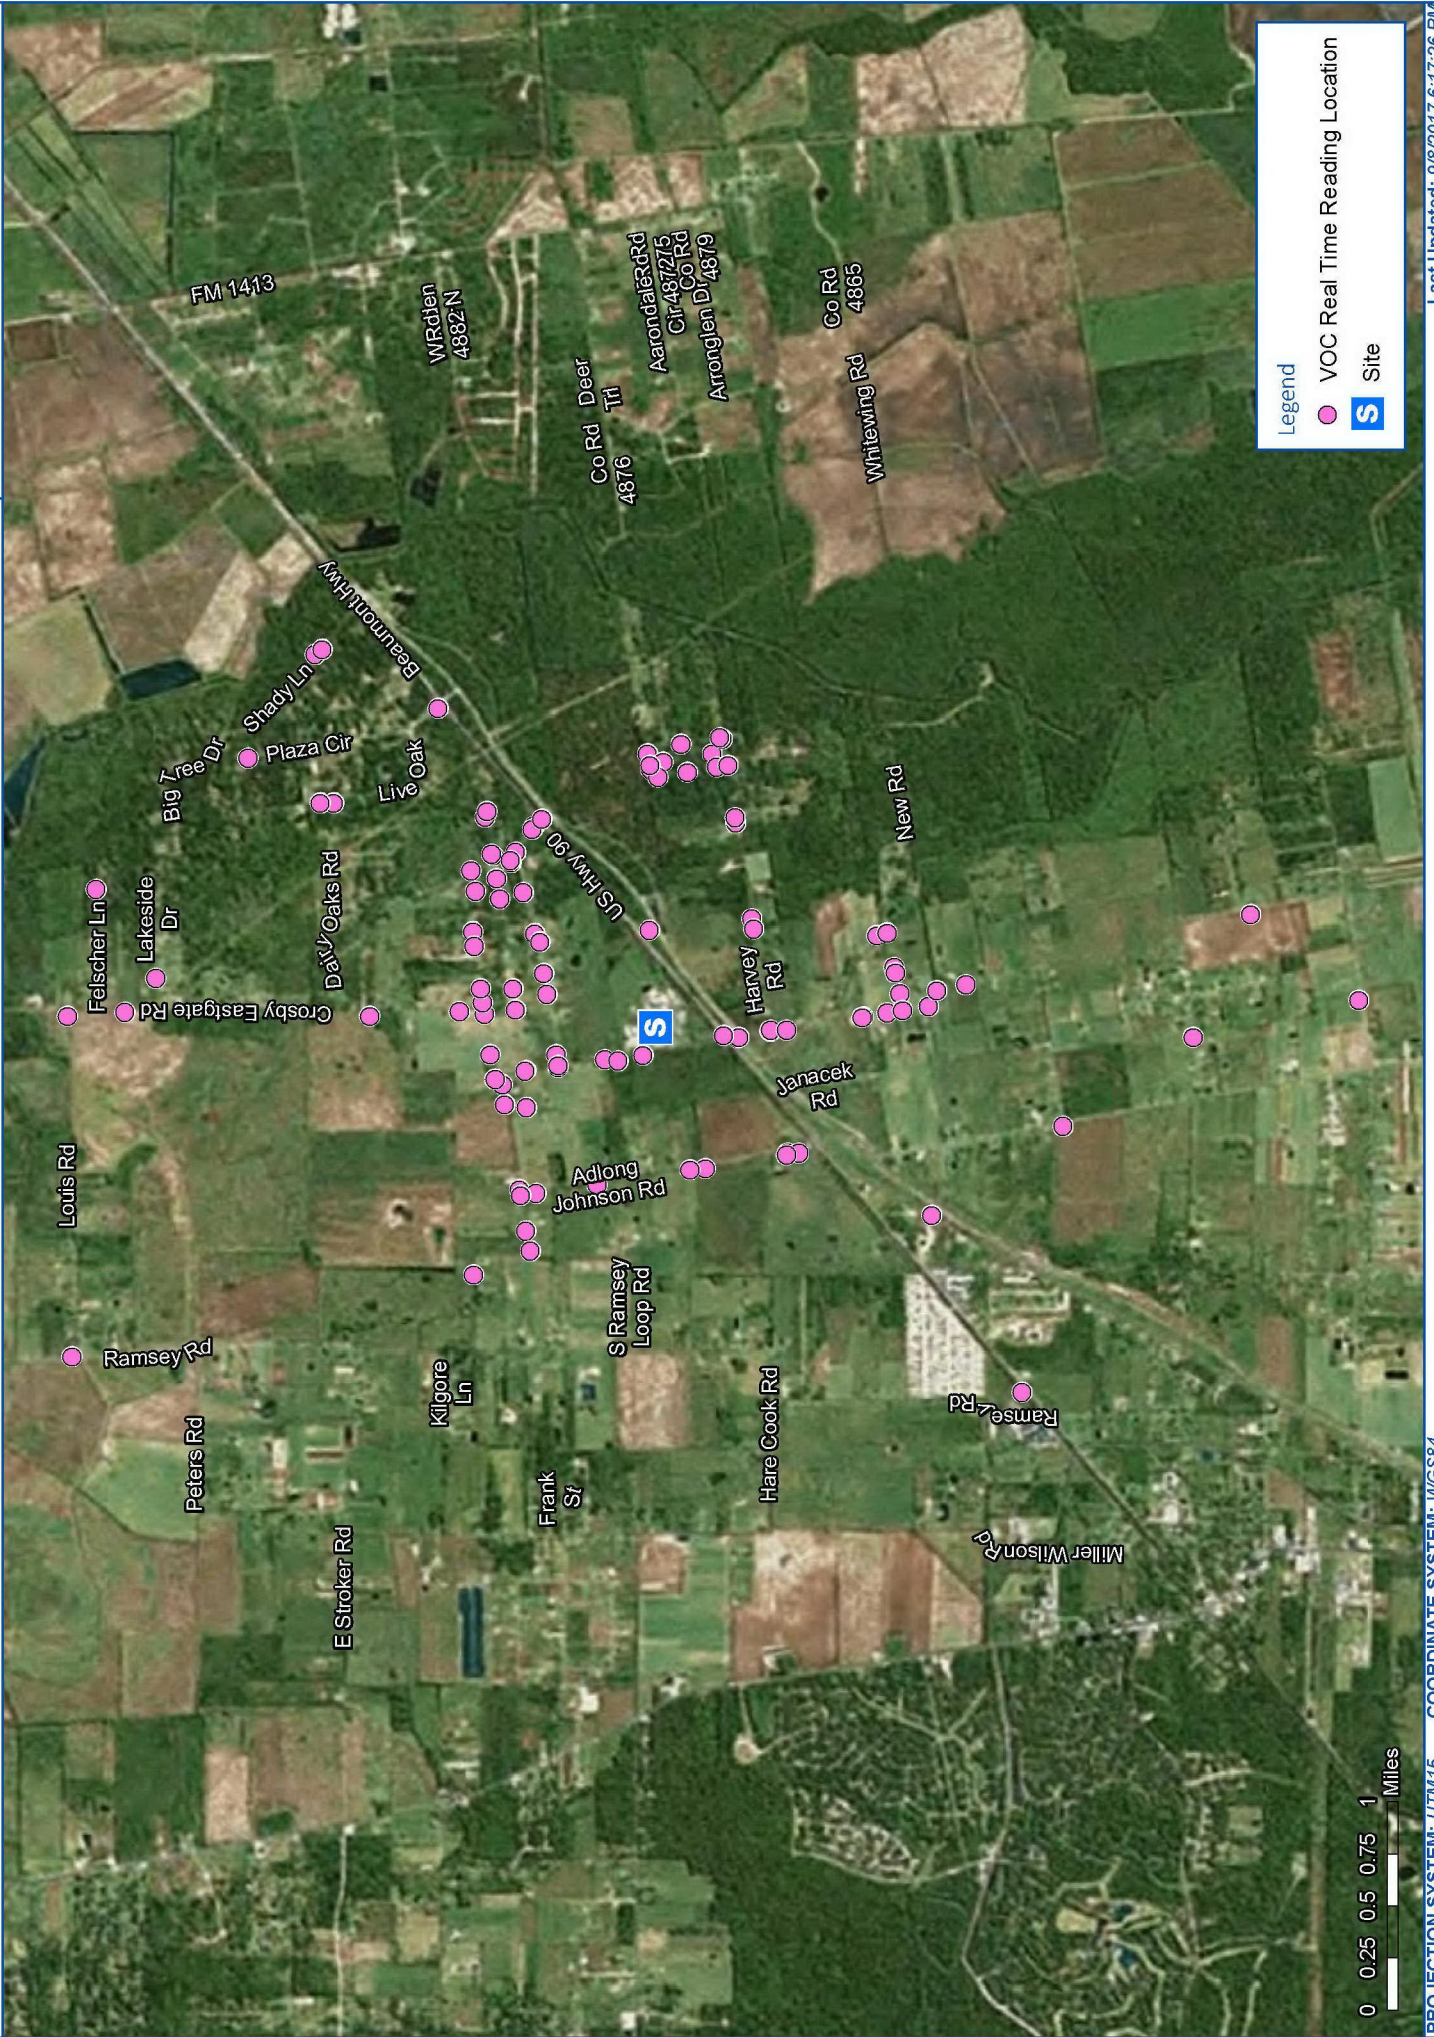
# Community VOC Hand-held Real-time Reading Locations

Harvey Response - 06:00 September 7, 2017 to 06:00 September 8, 2017

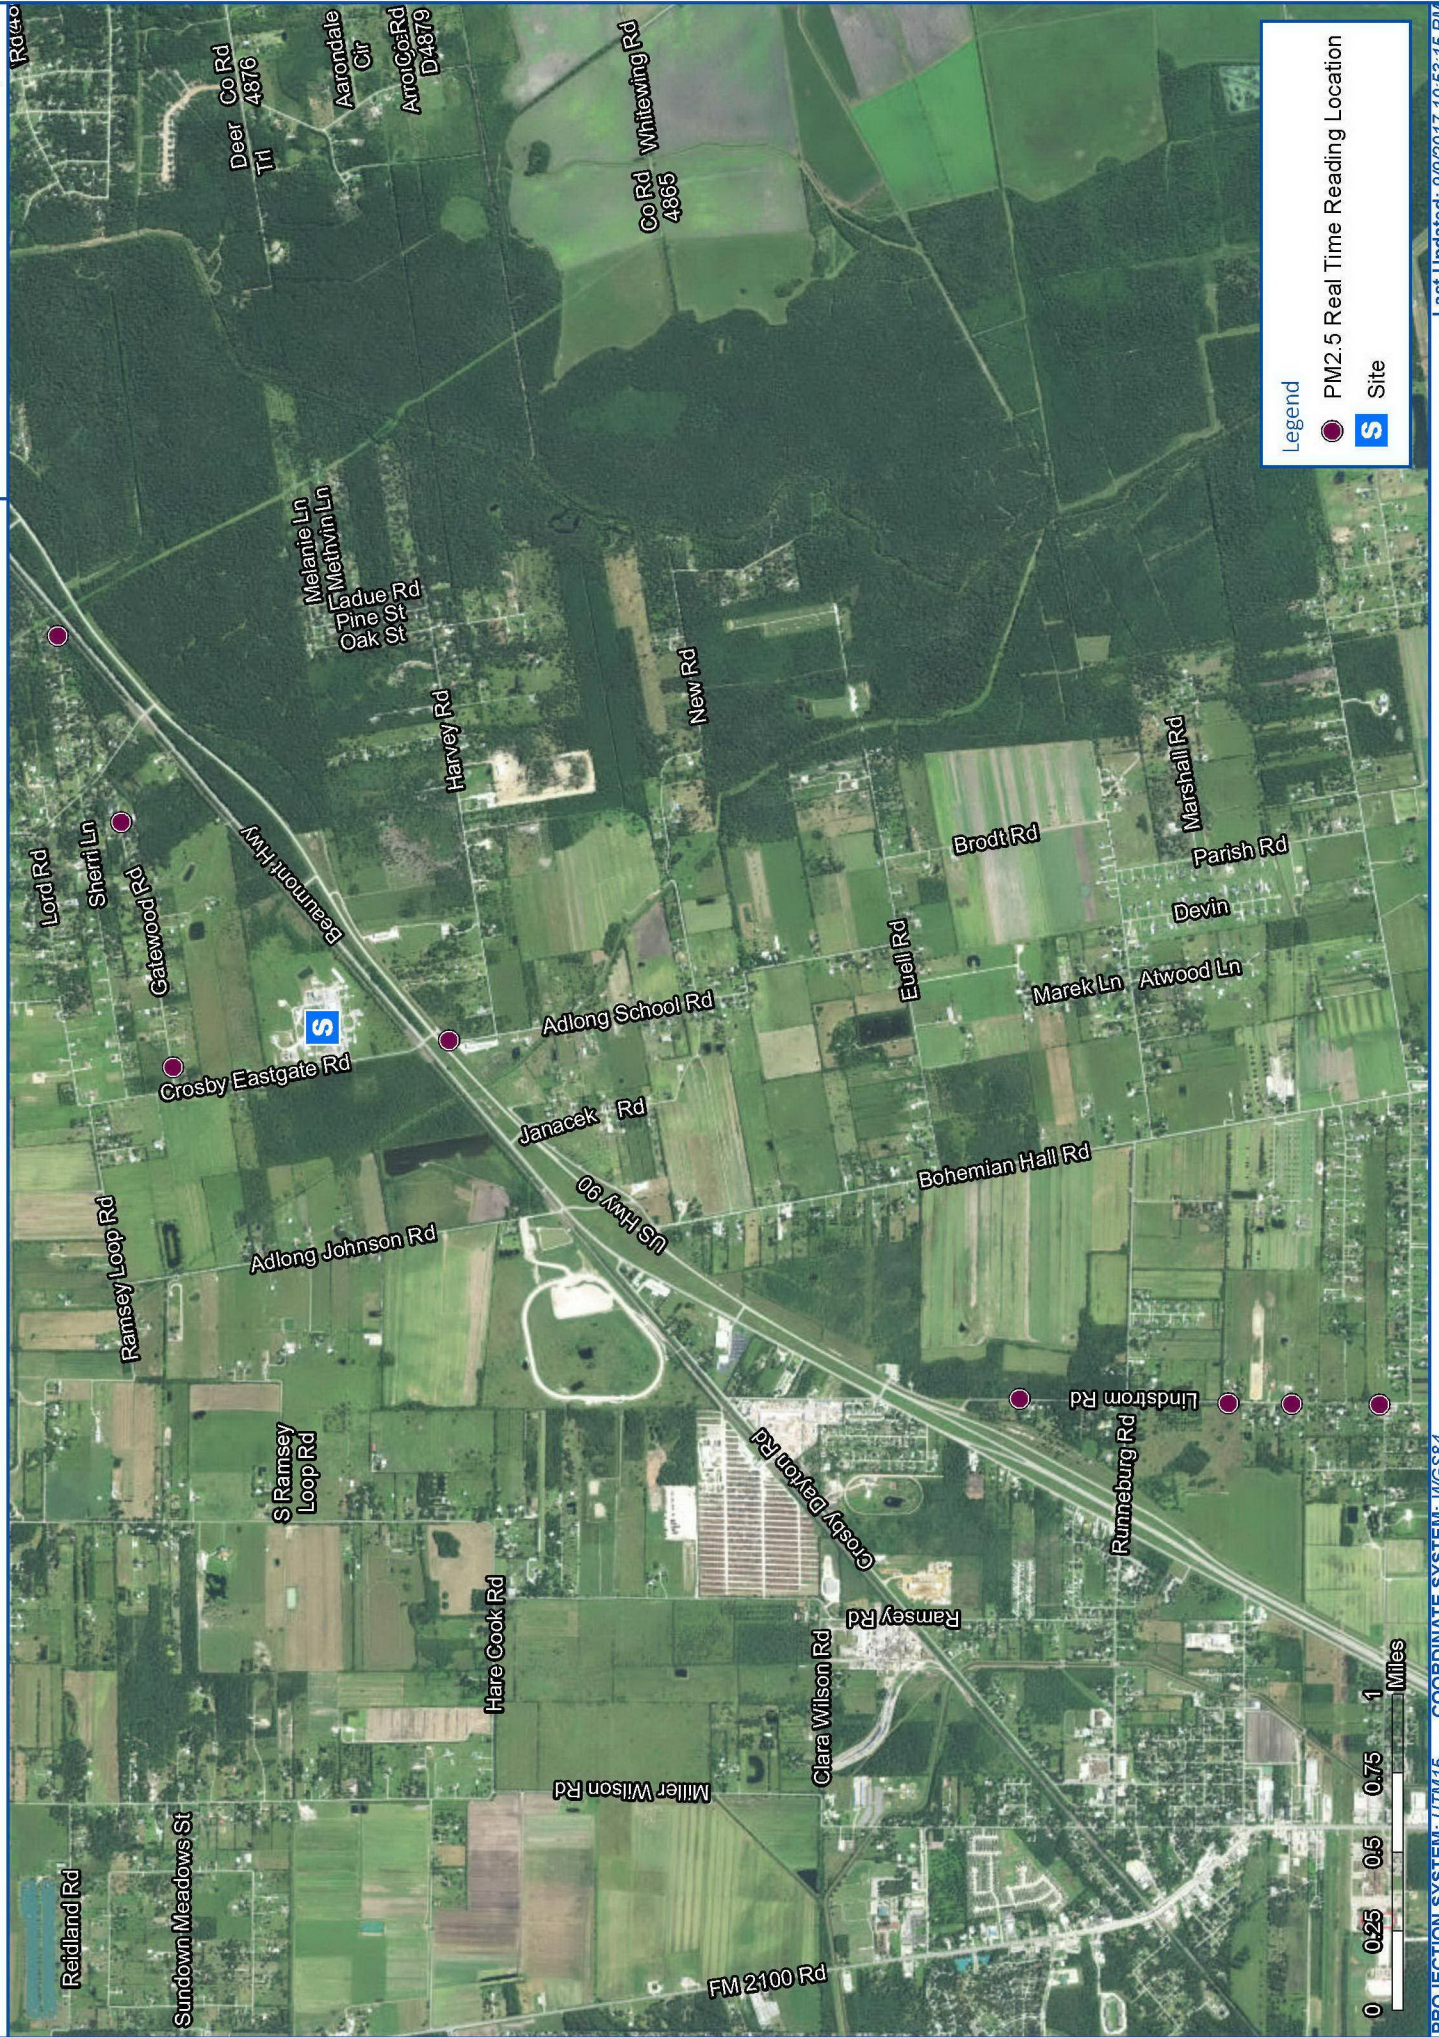
# Community PM2.5 Hand-held Real-time Reading Locations

Harvey Response - 06:00 September 8, 2017 to 06:00 September 9, 2017

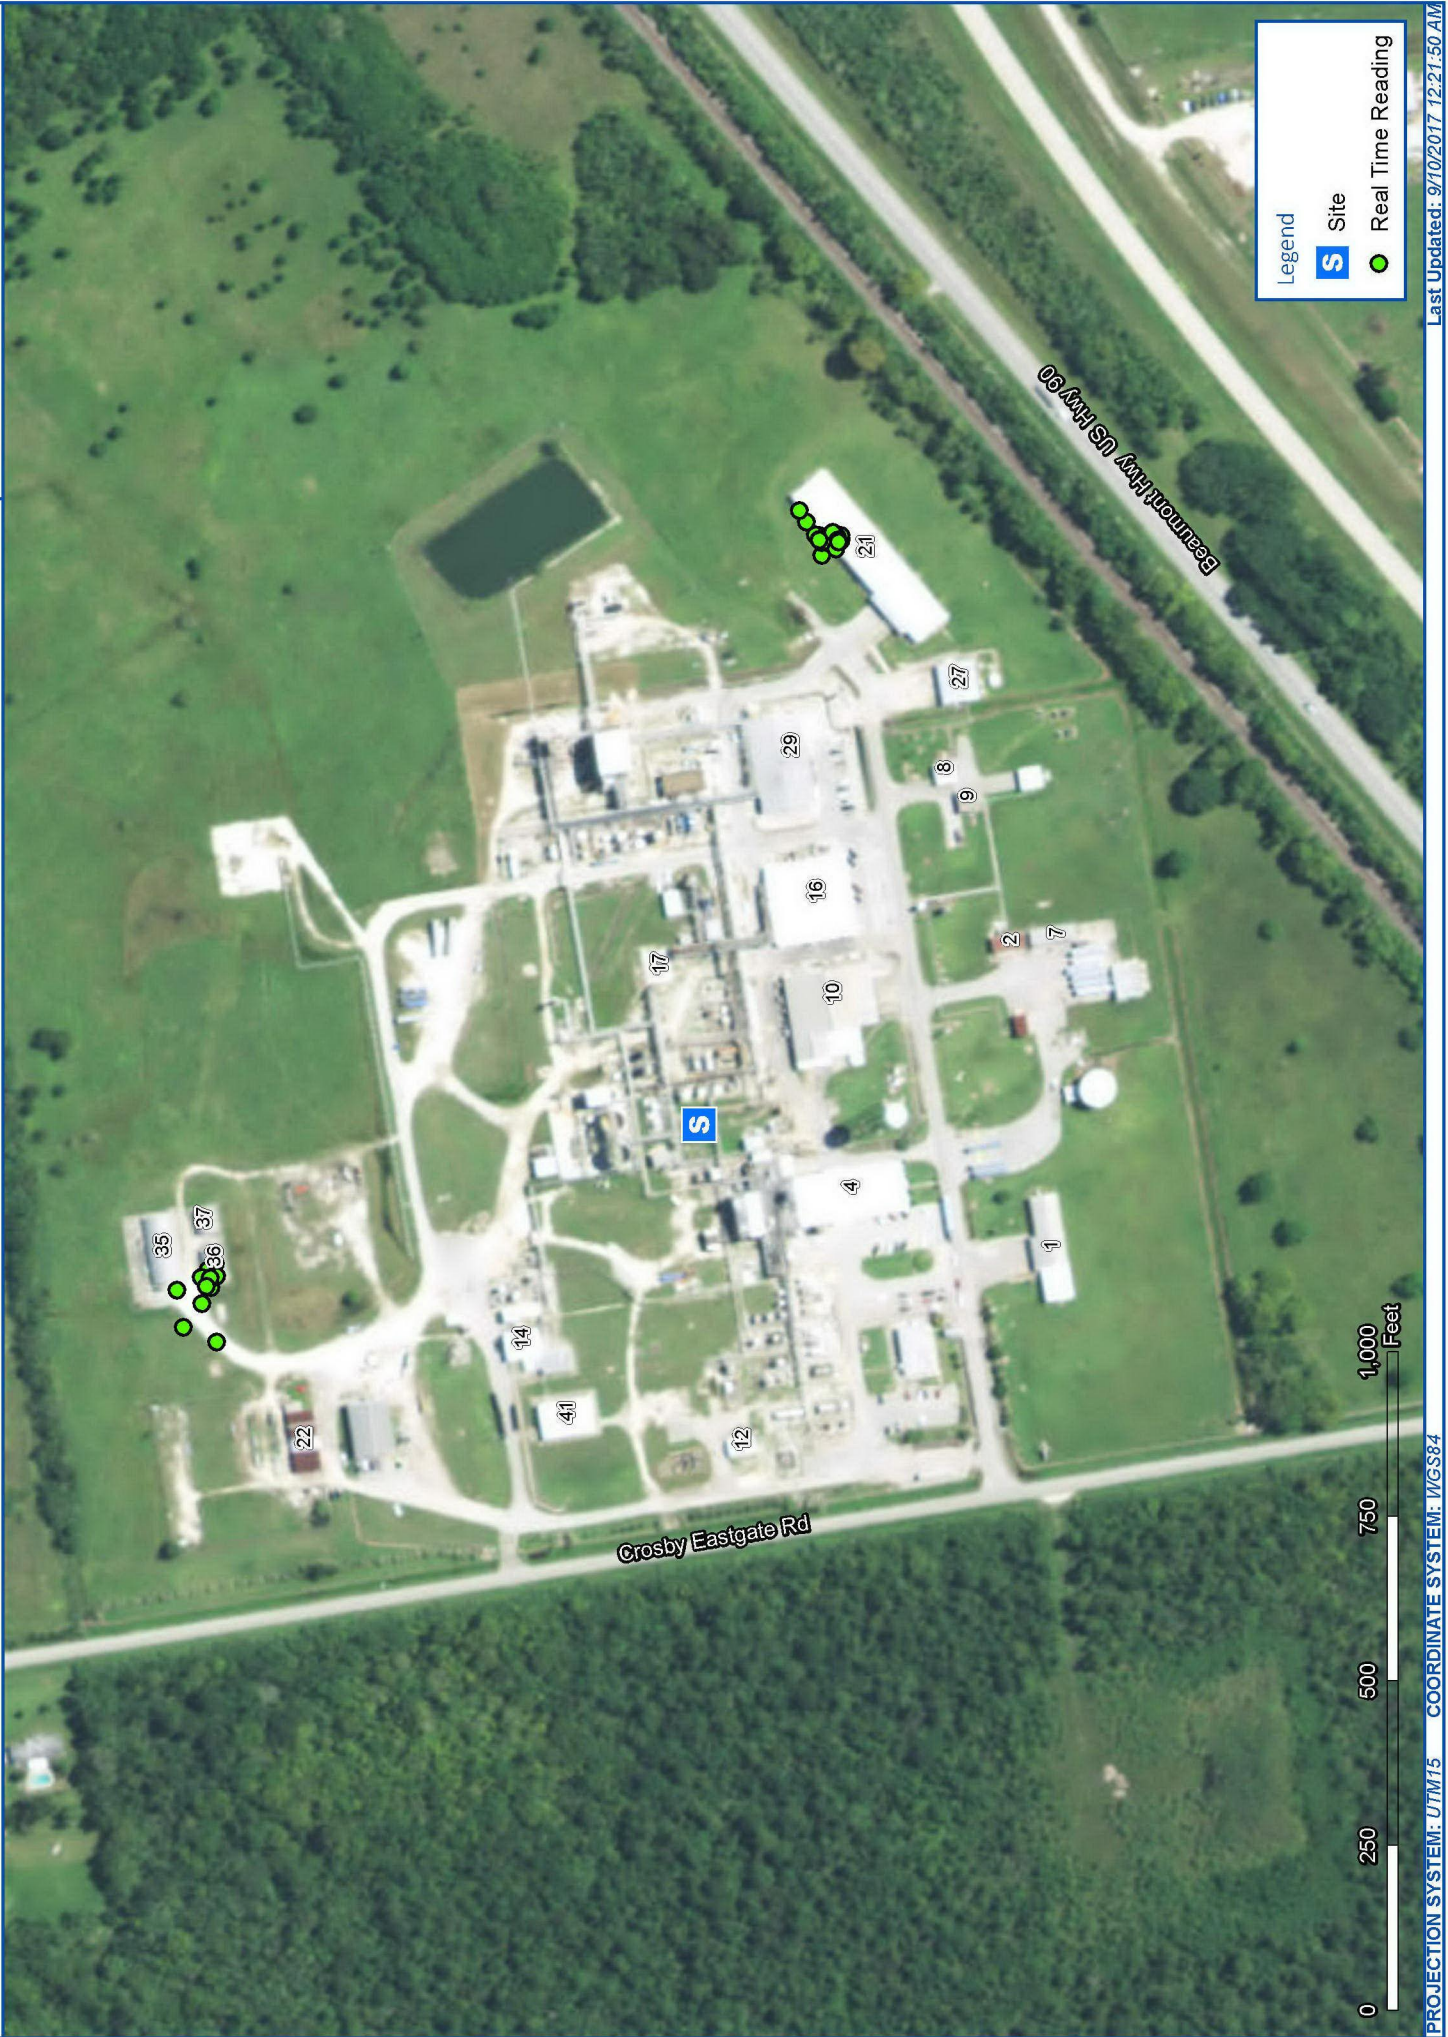
# Worker Activity Hand-held Real-time Reading Locations

Harvey Response - 06:00 September 8, 2017 to 06:00 September 9, 2017

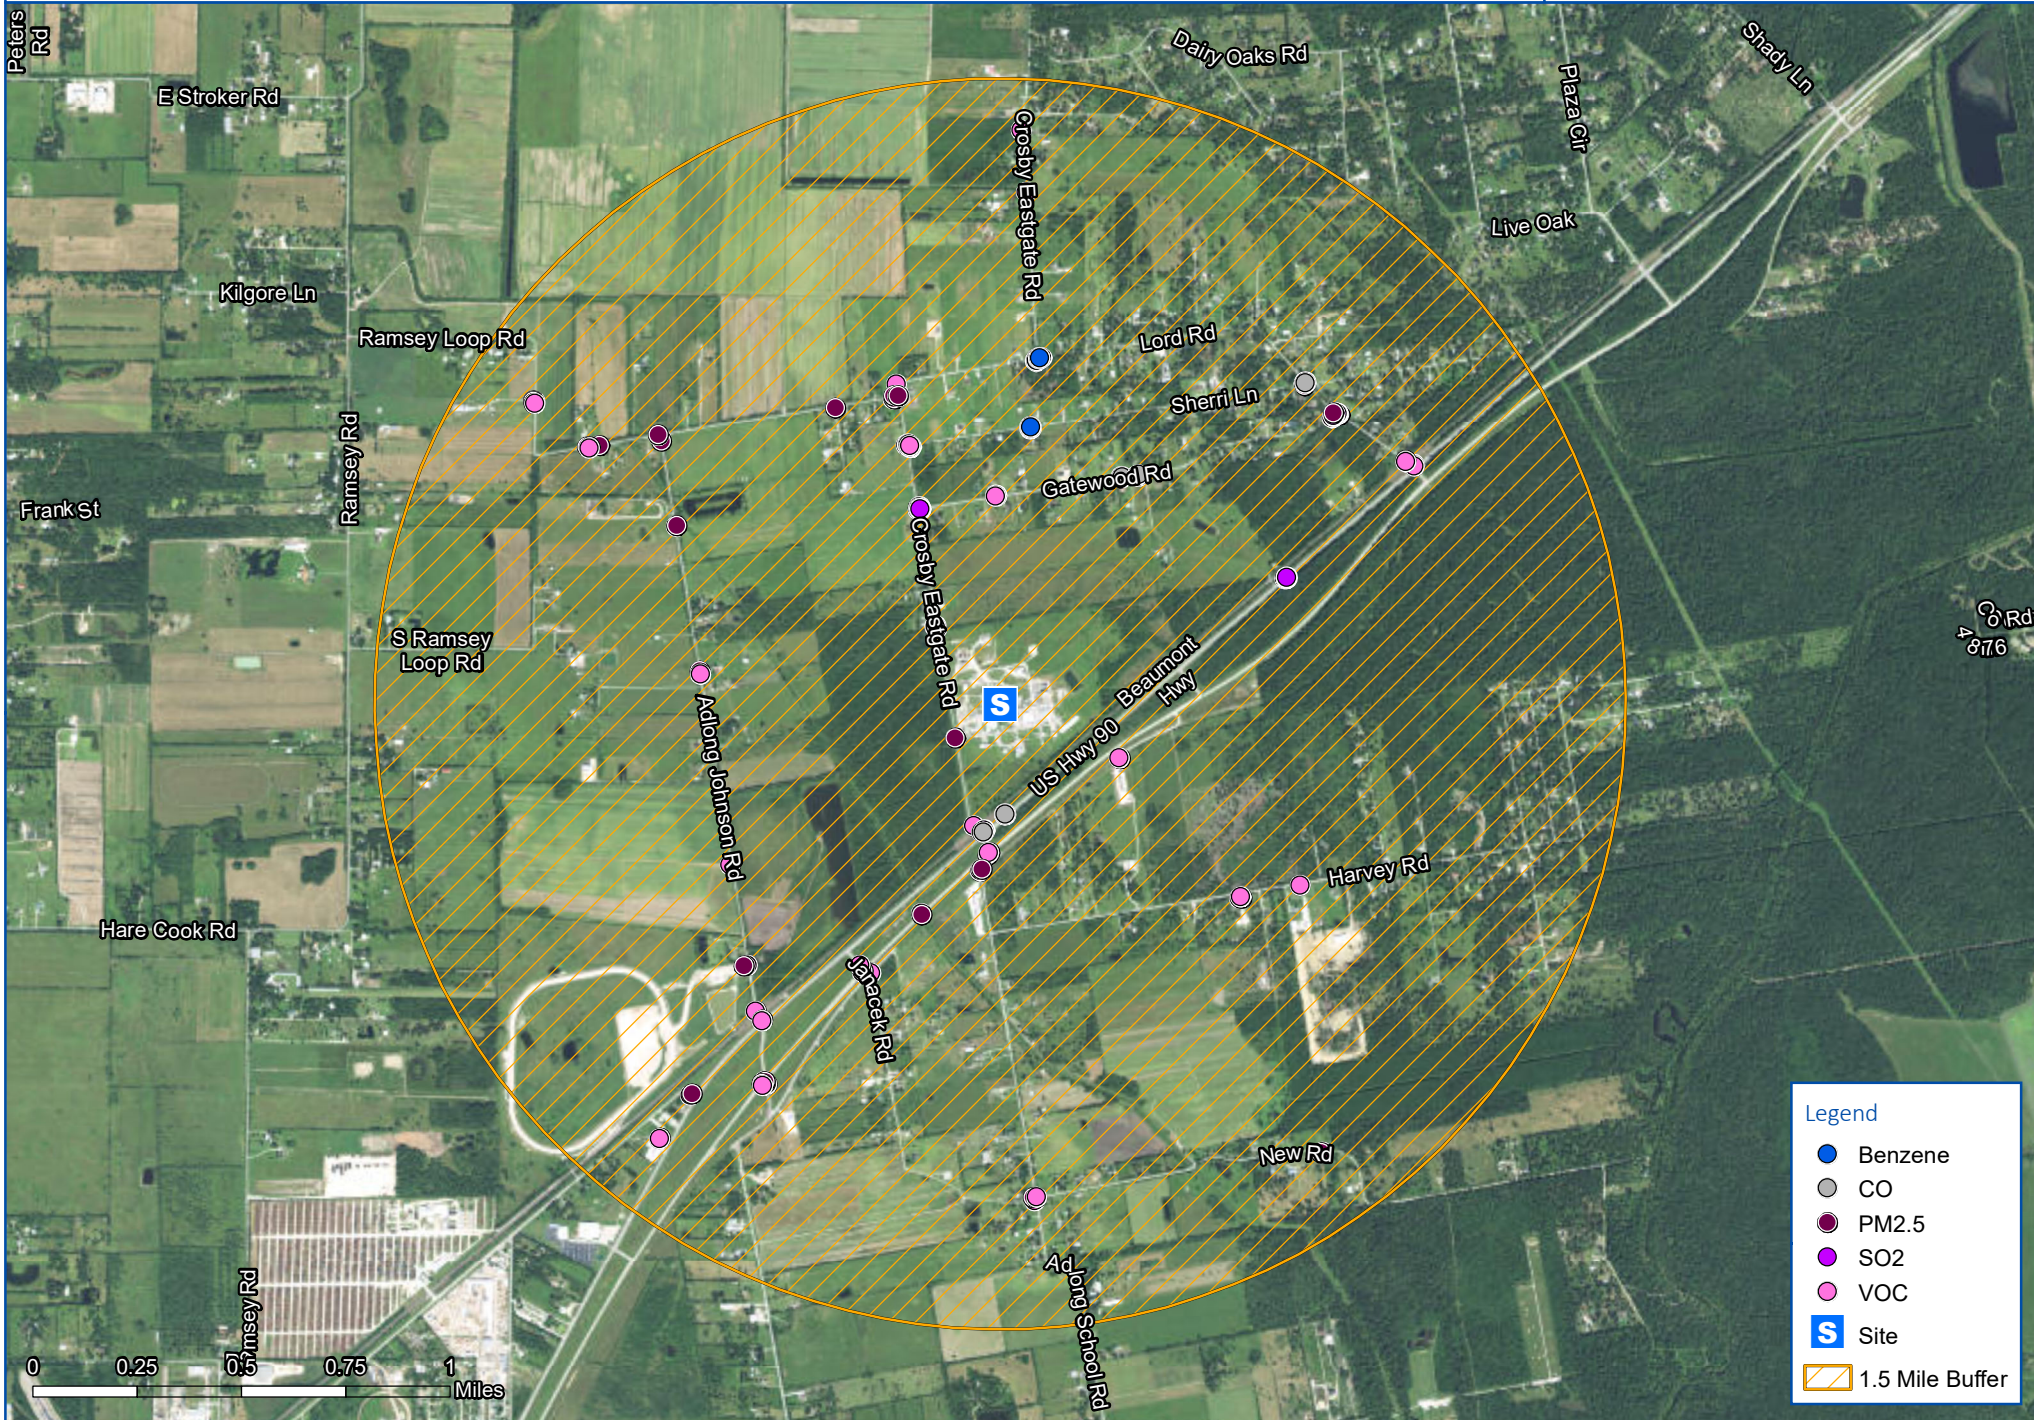
## **Handheld Real-time Air Monitoring Locations**

All real-time air monitoring instrumentation was calibrated per the manufacturer's recommendations prior to air monitoring. Handheld, real-time air monitoring was conducted for benzene, and volatile organic compounds (VOCs) using the RAE Systems MultiRAE and UltraRAE. Additionally, combustion byproducts potentially associated with fire smoke, such as particulate matter (PM<sub>2.5</sub>), and sulfur dioxide (SO<sub>2</sub>), were assessed. **Table 1** summarizes the data for all real-time air monitoring readings recorded within a 1.5-mile radius of the Arkema facility in Crosby, TX from 21:04 on September 3, 2017 to 05:50 on September 4, 2017.
