WEST FORK TRINITY RIVER BELOW BRIDGEPORT RESERVOIR RECREATIONAL USE ATTAINABILITY ANALYSES PROJECT

(West Fork Trinity River below Bridgeport Reservoir - Segment 0810)

Contract No. 582-9-90439-05

AUGUST 30, 2010

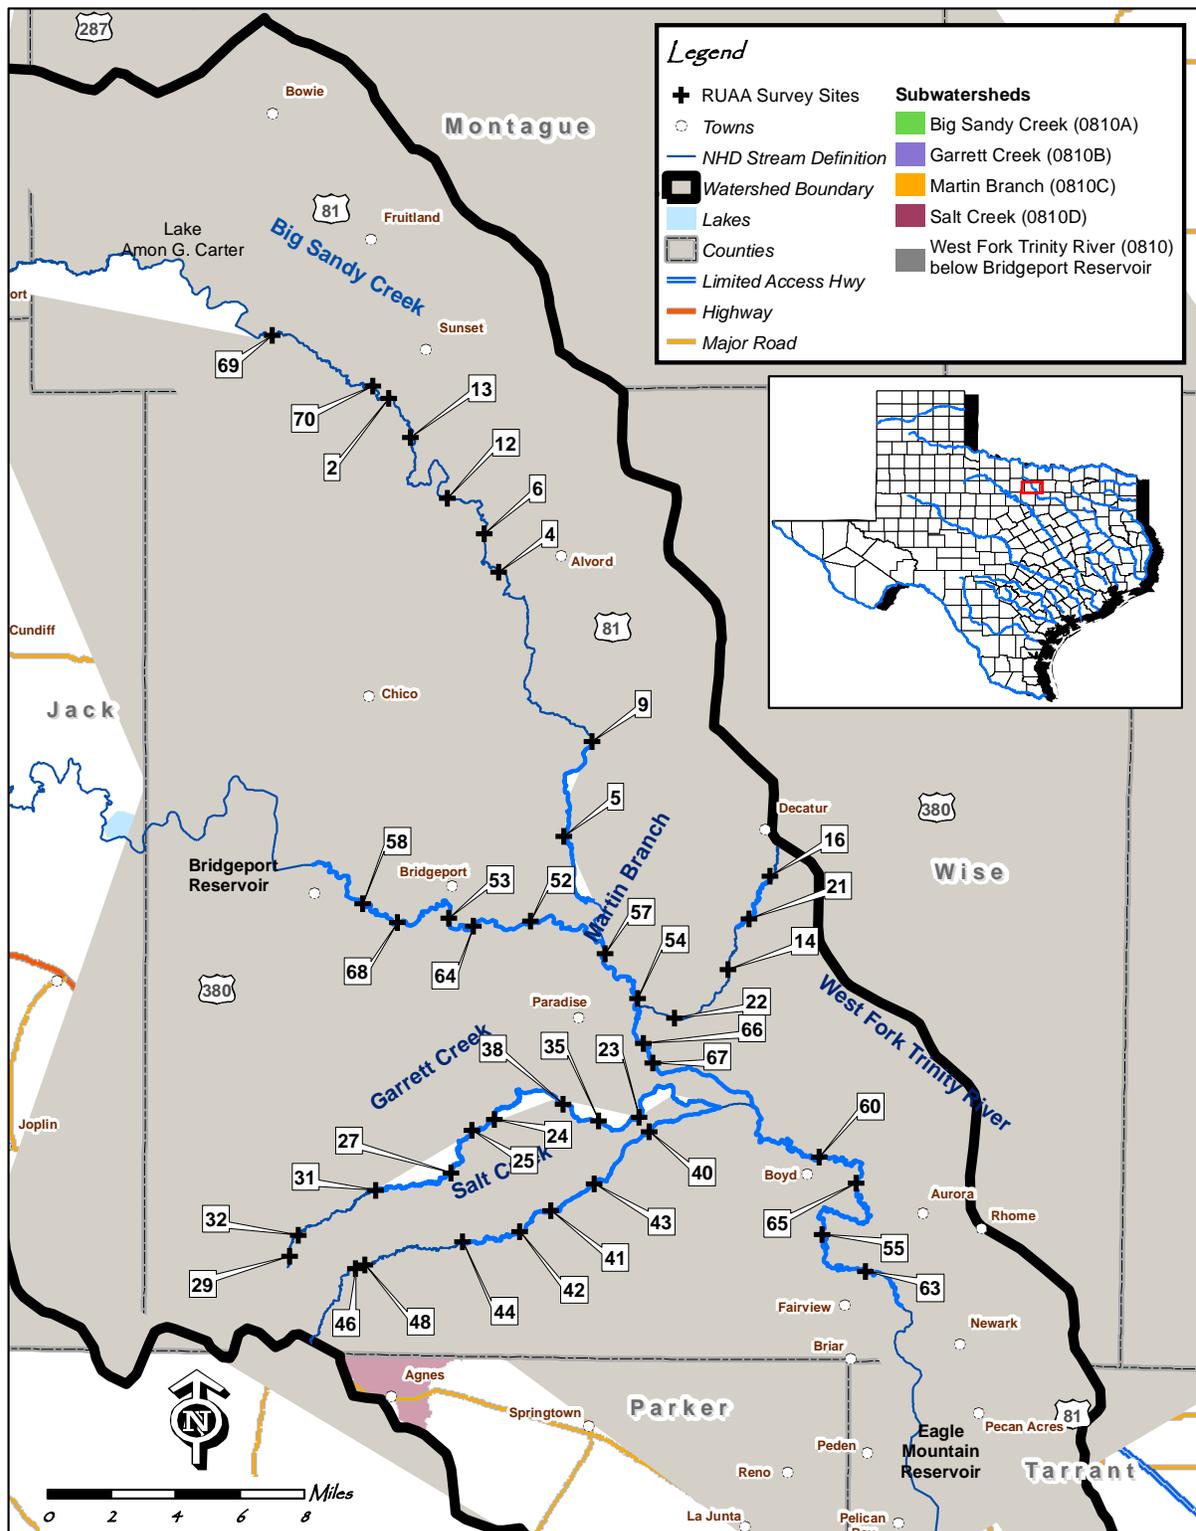
Figure 2.1 RUAA Survey Sites for the West Fork Trinity River below Bridgeport Reservoir

attempted to reach each of the 62 potential sites to obtain and record details about the condition and accessibility of each survey site. Locating potential sites at points where public road access was possible using GIS mapping was an important, time-efficient step taken prior to conducting the reconnaissance survey. Not all sites were accessible to the public; however, attempts to contact property owners through local organizations such as the Wise County Extension agent Mr. Gary Clayton and the Wise County Appraisal District office resulted in access to only a few additional survey sites. Efforts were made to evaluate the accessibility along 300 meters of the creek bed at each of the sites. TCEQ and Texas AgriLife Research agreed that the field team would not enter fenced or signed private property without landowner or tenant permission for safety and property rights reasons. This decreased the total number of sites that could actually be surveyed. Only those sites that the survey team could access from public roads or through prior approval from property owner were surveyed. The site reconnaissance proved to be a valuable and necessary step to prepare the field crews for conducting the actual surveys to support the RUAA. The site reconnaissance resulted in the determination that of the original 62 potential sites only 42 survey sites could be accessed and these would serve as the basis for the RUAA for the five different streams targeted in this study. The 42 survey sites are displayed in Figure 2.1 and are listed in Table 2.2. Thirteen of the 42 sites were surveyed twice in accordance with the TCEQ RUAA guidance for Comprehensive RUAs. These 13 sites are identified in Table 2.2.

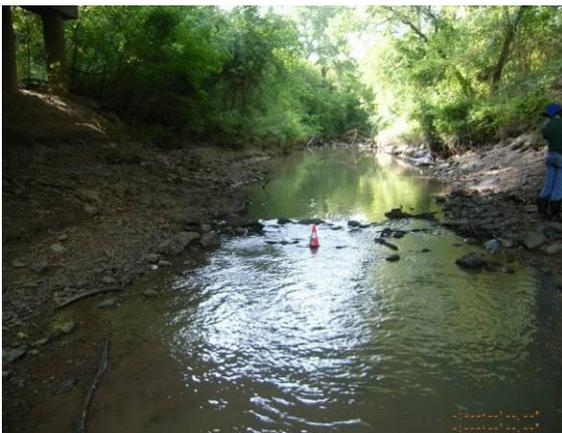
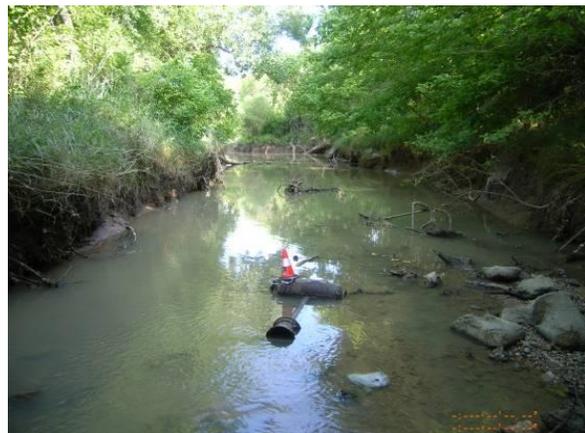
Figure 4.1 West Fork Trinity River below Bridgeport Reservoir, Survey Site #58

The most upstream survey site that was accessible was #58 located at U.S. Hwy 380. When no release occurs from Bridgeport Reservoir, the river typically flows slowly under a thick, closed canopy of hardwood trees which is portrayed by photographs in Figure 4.1 which were taken at Site 58 from the 30 meter transect. The photographs depict the shrub dominated riparian corridor, a shallow thalweg (average thalweg depth = 0.49 meters), no public access and no evidence of recreation use. Flow was measured at 1.73 cubic feet per second (cfs).

Site #58 @ U.S. Hwy 380 Upstream View

Site #58 @ U.S. Hwy 380 Downstream View

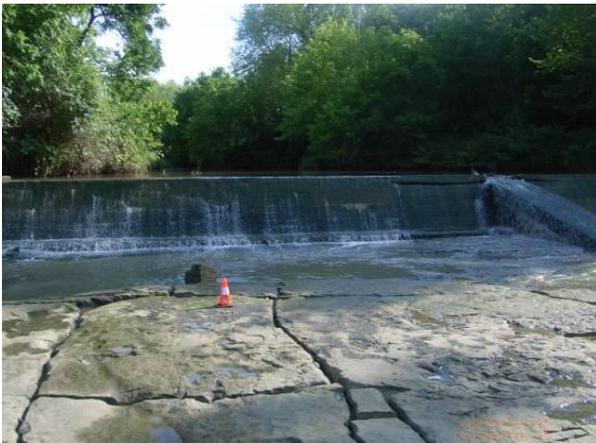
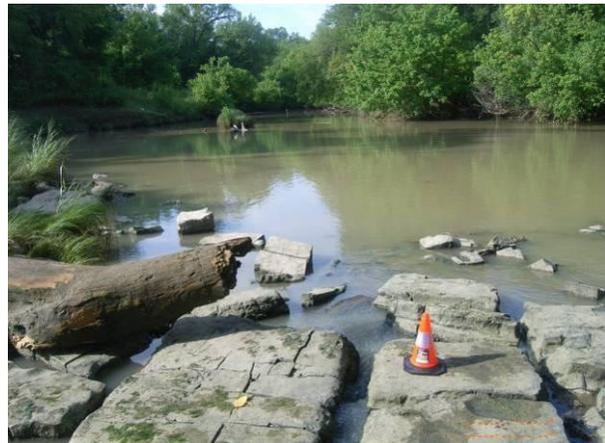
Figure 4.2 West Fork Trinity River below Bridgeport Reservoir, Survey Site #53

Site #53, located 300 meters downstream from the bridge at County Road 2123, is adjacent to the Bridgeport Country Club golf course. There is a parking lot nearby and a trail that leads to the river. Figure 4.2 provides photographs which were taken under normal flow conditions from the 30 meter transect. The photographs depict the shrub dominated riparian corridor, a low water dam, and a public access point to the edge of the river from the trail. The average thalweg depth at Site #53 is > 0.94 meters deep (downstream transects were too deep to wade) and evidence of primary and secondary contact recreation use was documented during both the basic and comprehensive surveys (July 2009 and July 2010). Flow was measured at 6.5 cfs.

Site #53 @ Bridgeport CC Upstream View

Site #53 @ Bridgeport CC Downstream View

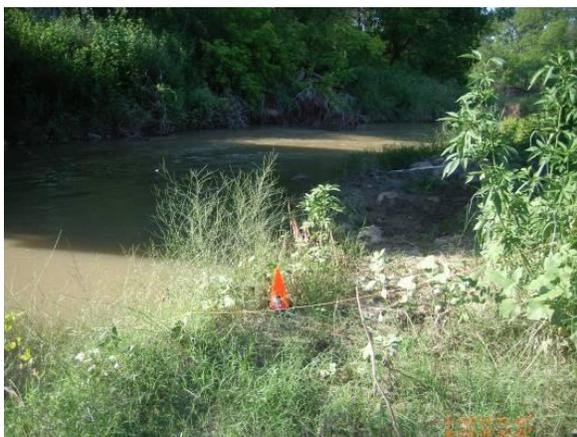
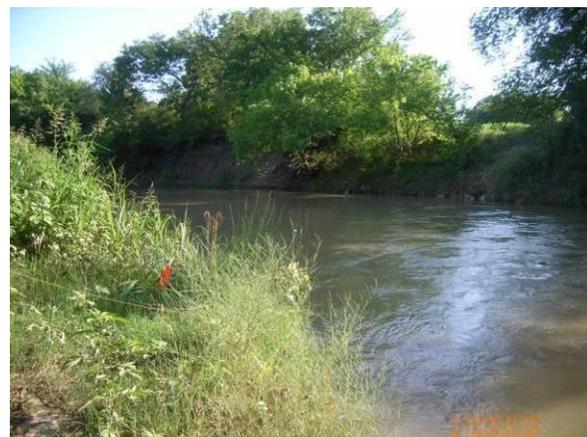
Figure 4.3 West Fork Trinity River below Bridgeport Reservoir, Survey Site #66

Site #66, located east of Paradise, TX at County Road 3390 is typical of much of the West Fork Trinity River below Bridgeport Reservoir. Figure 4.3 provides photographs which were taken from the 30 meter transect depicting the shrub dominated riparian corridor. The estimated thalweg depth at Site #53 is 1.52 meters. Public access is possible at the site; however there was no evidence recreational use documented.

Site #66 @ County Road 3390 Upstream View

Site #66 @ County Road 3390 Downstream View

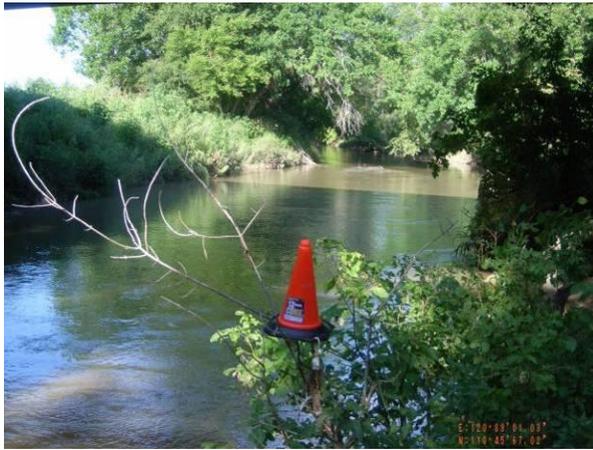
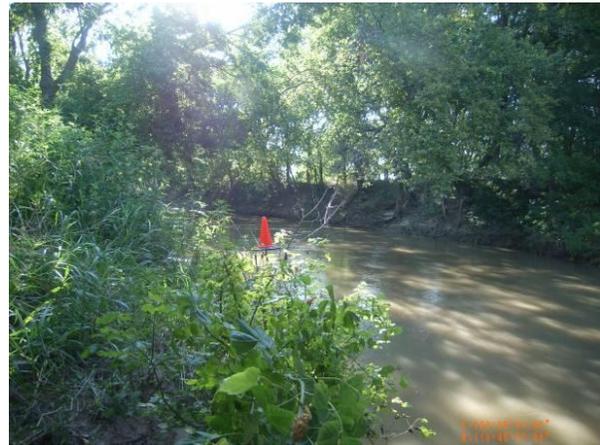
Figure 4.4 West Fork Trinity River below Bridgeport Reservoir, Survey Site #60

Farther downstream at Site #60 the West Fork Trinity River below Bridgeport Reservoir flows near the small town of Boyd, TX (population 1,099) (Wikipedia 2010). Site #60, located at FM 730, continues to flow through private rural land at this point and there appears to be little or no recreational influence in the river corridor at this site despite its close proximity to a town. Conditions at this site are typical of much of the West Fork Trinity River below Bridgeport Reservoir. Figure 4.4 provides photographs which were taken from the 30 meter transect depicting the shrub dominated riparian corridor. For safety reasons, measurements for thalweg depth at Site #60 were not recorded. There is public access at Site #60 and secondary contact recreation activity was identified.

Site #60 @ FM 730 Upstream View

Site #60 @ FM 730 Downstream View

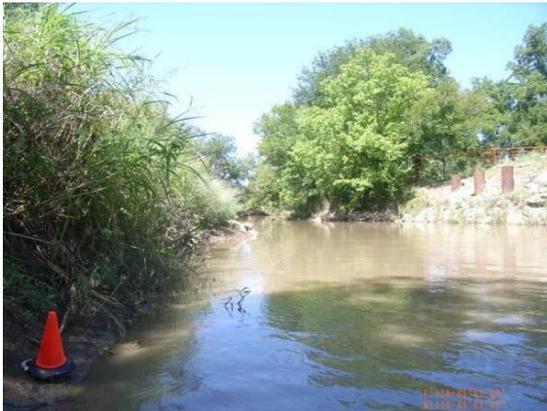
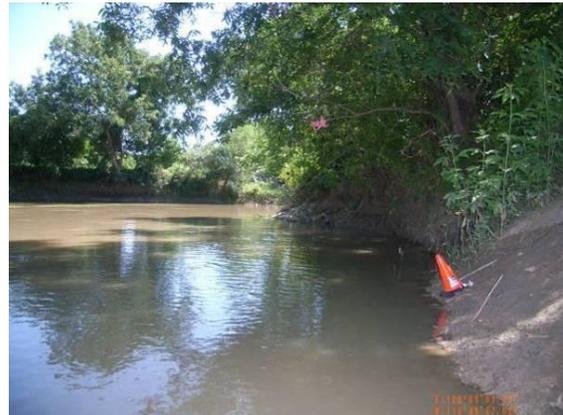
Figure 4.5 West Fork Trinity River below Bridgeport Reservoir, Survey Site #63

The most downstream site that was surveyed was Site #63 located at County Road 4757. Conditions at this site are typical of much of the West Fork Trinity River below Bridgeport Reservoir. Figure 4.5 provides photographs which were taken from the 30 meter transect depicting the shrub dominated riparian corridor. For safety reasons, measurements for thalweg depth and water flow at Site #63 were not recorded. Public access is possible at Site #60 and no primary or secondary contact recreation activity was evident.

Site #63 @ County Road 4757 Upstream View

Site #63 @ County Road 4757 Downstream View

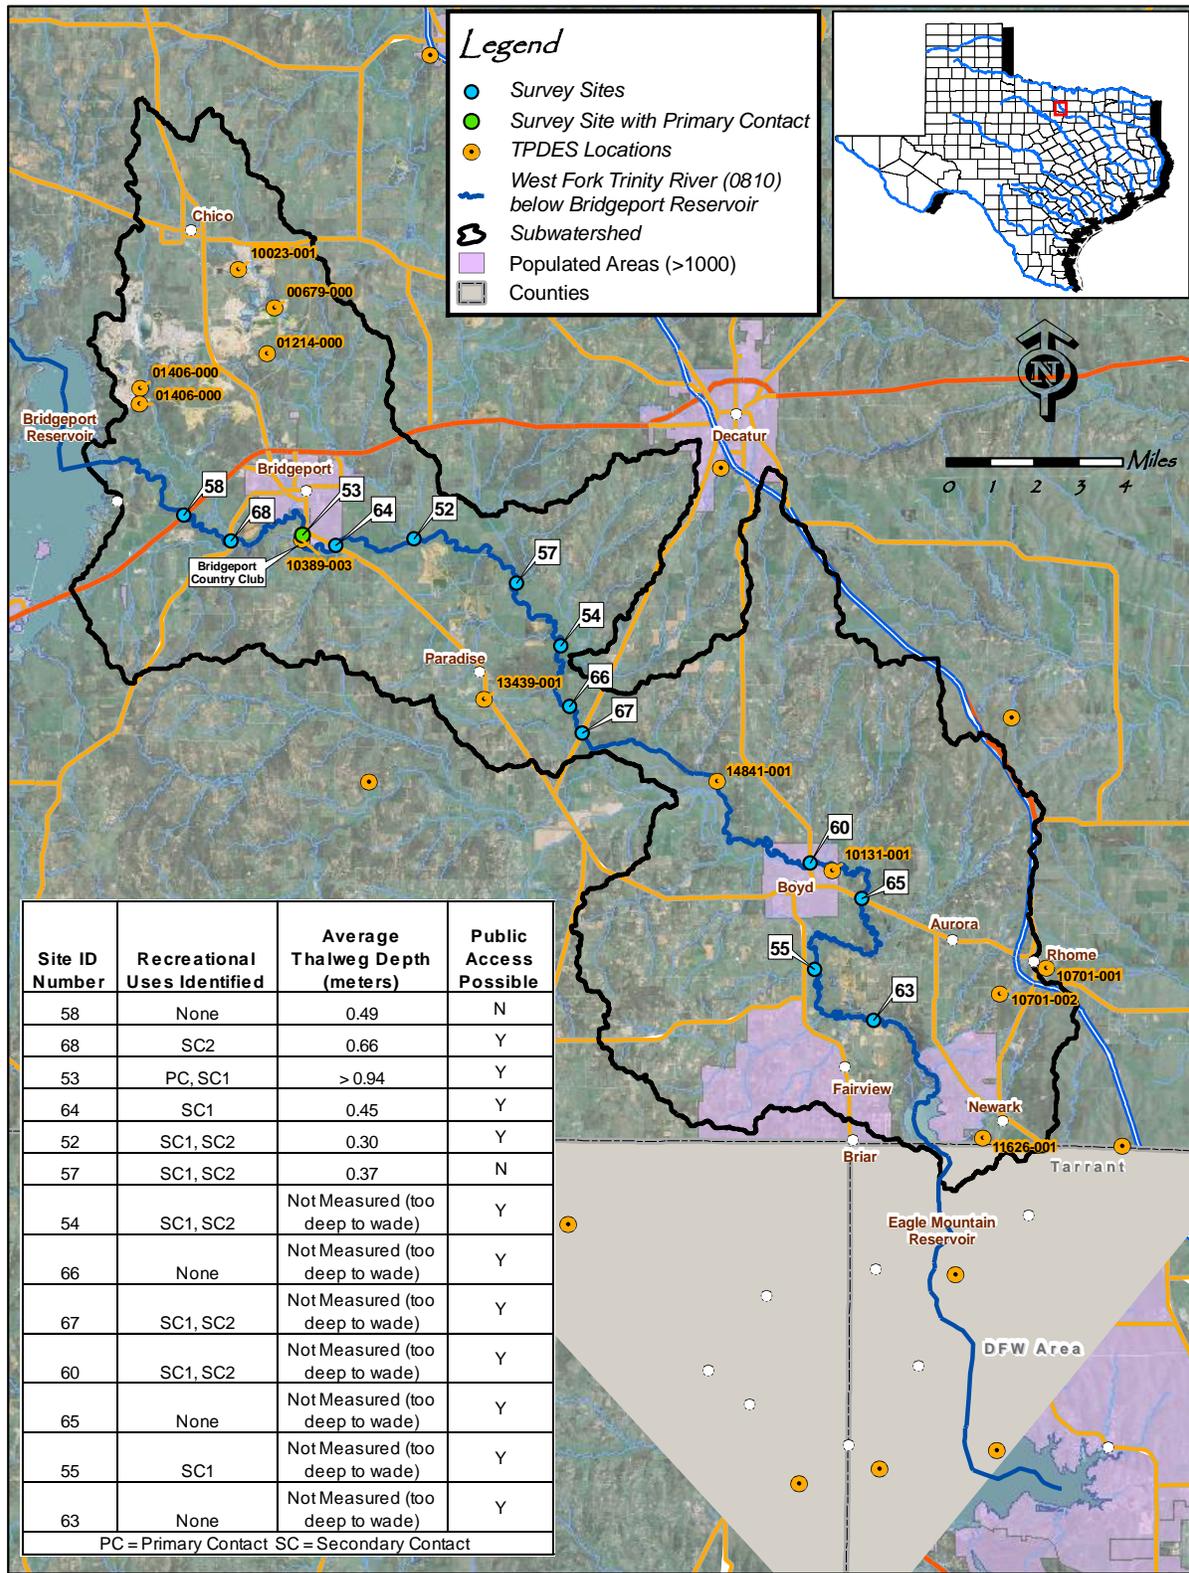
Figure 4.6 West Fork Trinity River below Bridgeport Reservoir

Figure 4.6 provides a map that summarizes the average thalweg depth (where measurement was possible), observed uses, and availability of public access documented at the sites surveyed along West Fork Trinity River below Bridgeport Reservoir. The map also displays other relevant information that may influence the potential for recreation activities along the river corridor including parks, bridge crossings, cities, and wastewater treatment plant outfalls. Additional information providing evidence or lack of evidence that recreation activities have occurred are provided in the field data summary sheets completed for each site surveyed.

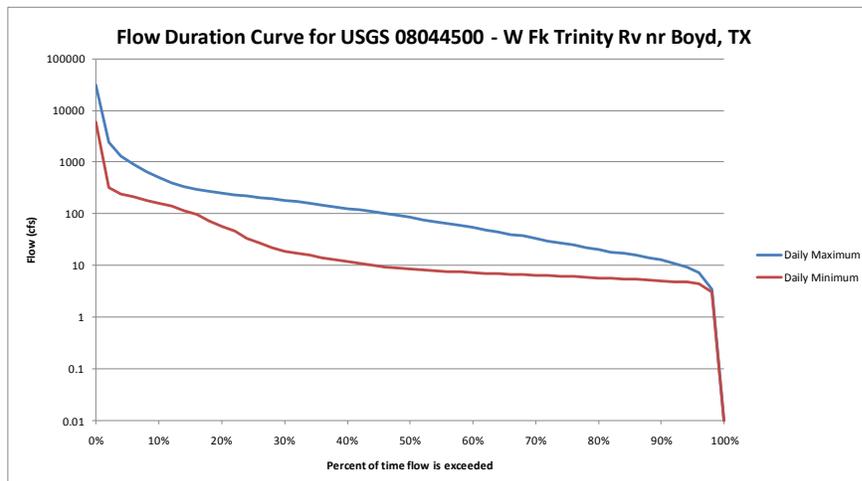
Figure 4.7 Flow Duration Curve for USGS Gage 08044500

Under normal flow conditions the West Fork Trinity River below Bridgeport Reservoir is murky and has unpredictable depths that changed 1 to 2 meters without warning. Table 4.2 provides a summary of the means of monthly flow data between 1990 and 2009 at the USGS gage station 08044500 located on the West Fork Trinity River at Boyd, TX (USGS 2010). Figure 4.7 provides a flow duration curve derived from the flow data collected at USGS gage station 08044500 between 1990 and 2009.

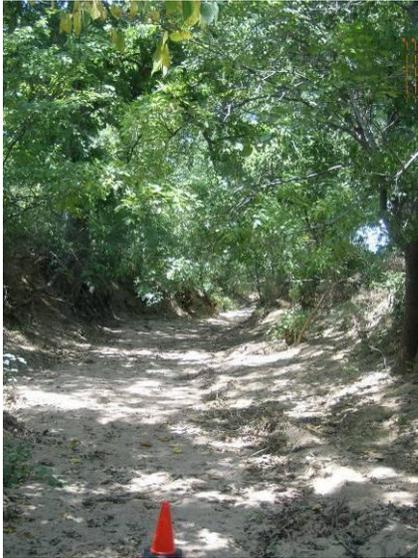
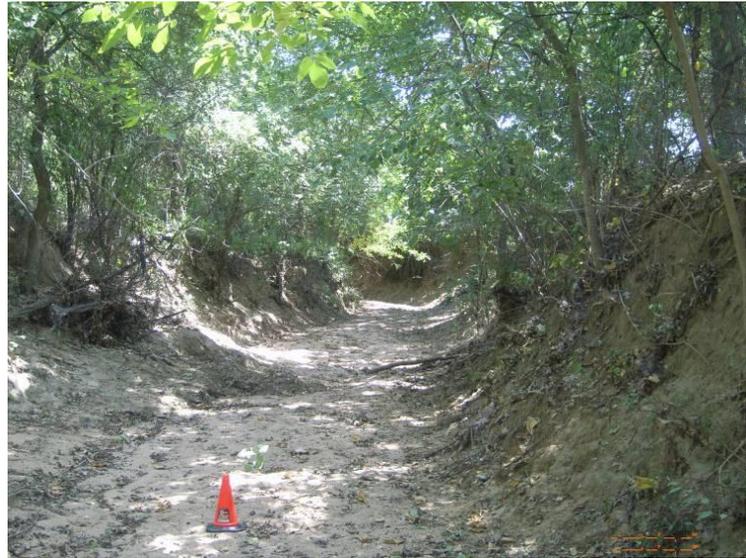
Figure 4.8 Big Sandy Creek, Survey Site #69

The most upstream survey site accessible was #69 located at Turkey Creek Road downstream of the Amon Carter Lake dam. When no release occurs from Amon Carter Lake, there is no flow in Big Sandy Creek. The creek had no flow when the site was visited and the stream corridor has steep incised banks with deciduous trees and shrubs dominating both banks which are portrayed by photographs in Figure 4.8 taken at the 30 meter transect. Public access is possible at this site; however no evidence of recreation use was identified. Flow and thalweg depth could not be measured because the stream was dry.

**Site #69 @ Turkey Creek Road
Upstream View**

Site #69 @ Turkey Creek Road Downstream View

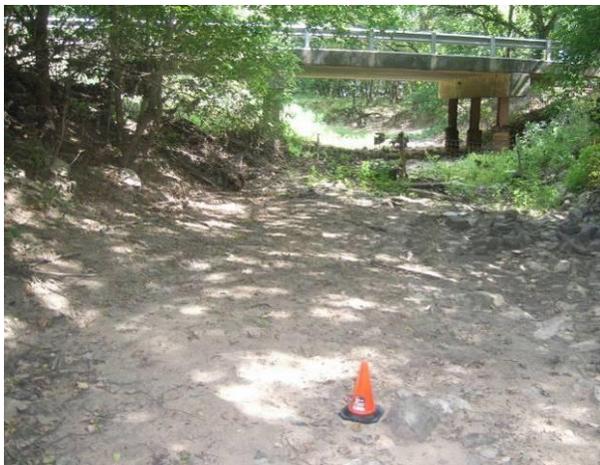
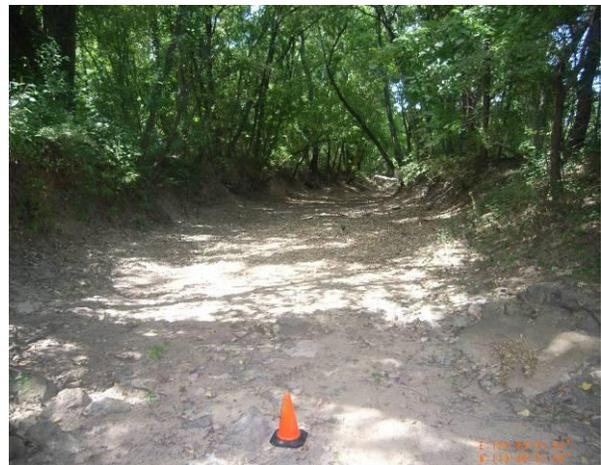
Figure 4.9 Big Sandy Creek, Survey Site #4

Site #4, west of the town of Alvord, is located on the north side of FM 1655. Figure 4.9 provides photographs from the 30 meter transect which depict the typical dry condition of the stream and the dense deciduous trees and shrubs along both banks. The average thalweg depth and flow could not be measured given the dry condition. No evidence of contact recreation use was identified. The site is at a remote, rural location surrounded by pastureland and there is public access.

Site #4 @ FM 1655 Upstream View

Site #4 @ FM 1655 Downstream View

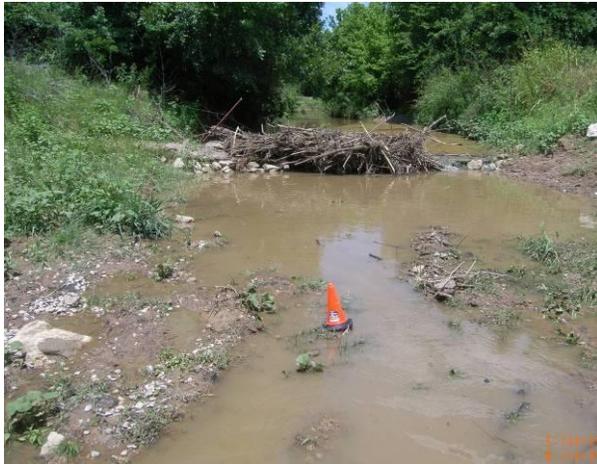
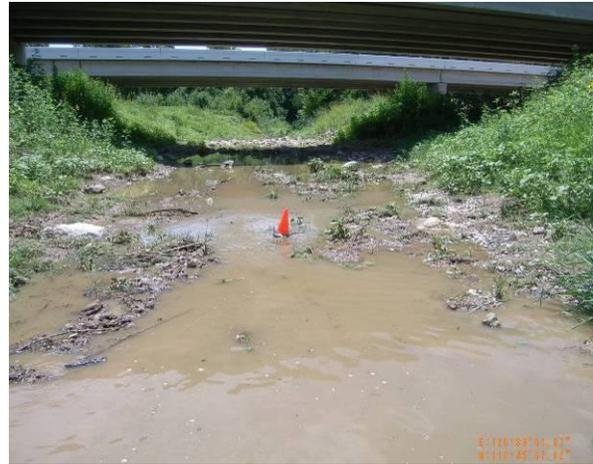
Figure 4.10 Big Sandy Creek, Survey Site #5

The most downstream site that was surveyed on Big Sandy Creek was Site #5 located at U.S. Hwy 380. Figure 4.10 provides photographs which were taken from the 30 meter transect depicting shallow pooling water and negligible flow. The average thalweg depth measured was 0.5 meters and a flow of 0.49 cfs was measured. There is public access at Site #5 from a steep dirt road that has been made from U.S. Hwy 380 down to the creek. There was no evidence of primary contact, however, evidence of secondary contact recreation activity (fishing tackle) was observed.

Site #5 @ U.S. Hwy 380 Upstream View

Site #5 @ U.S. Hwy 380 Downstream View

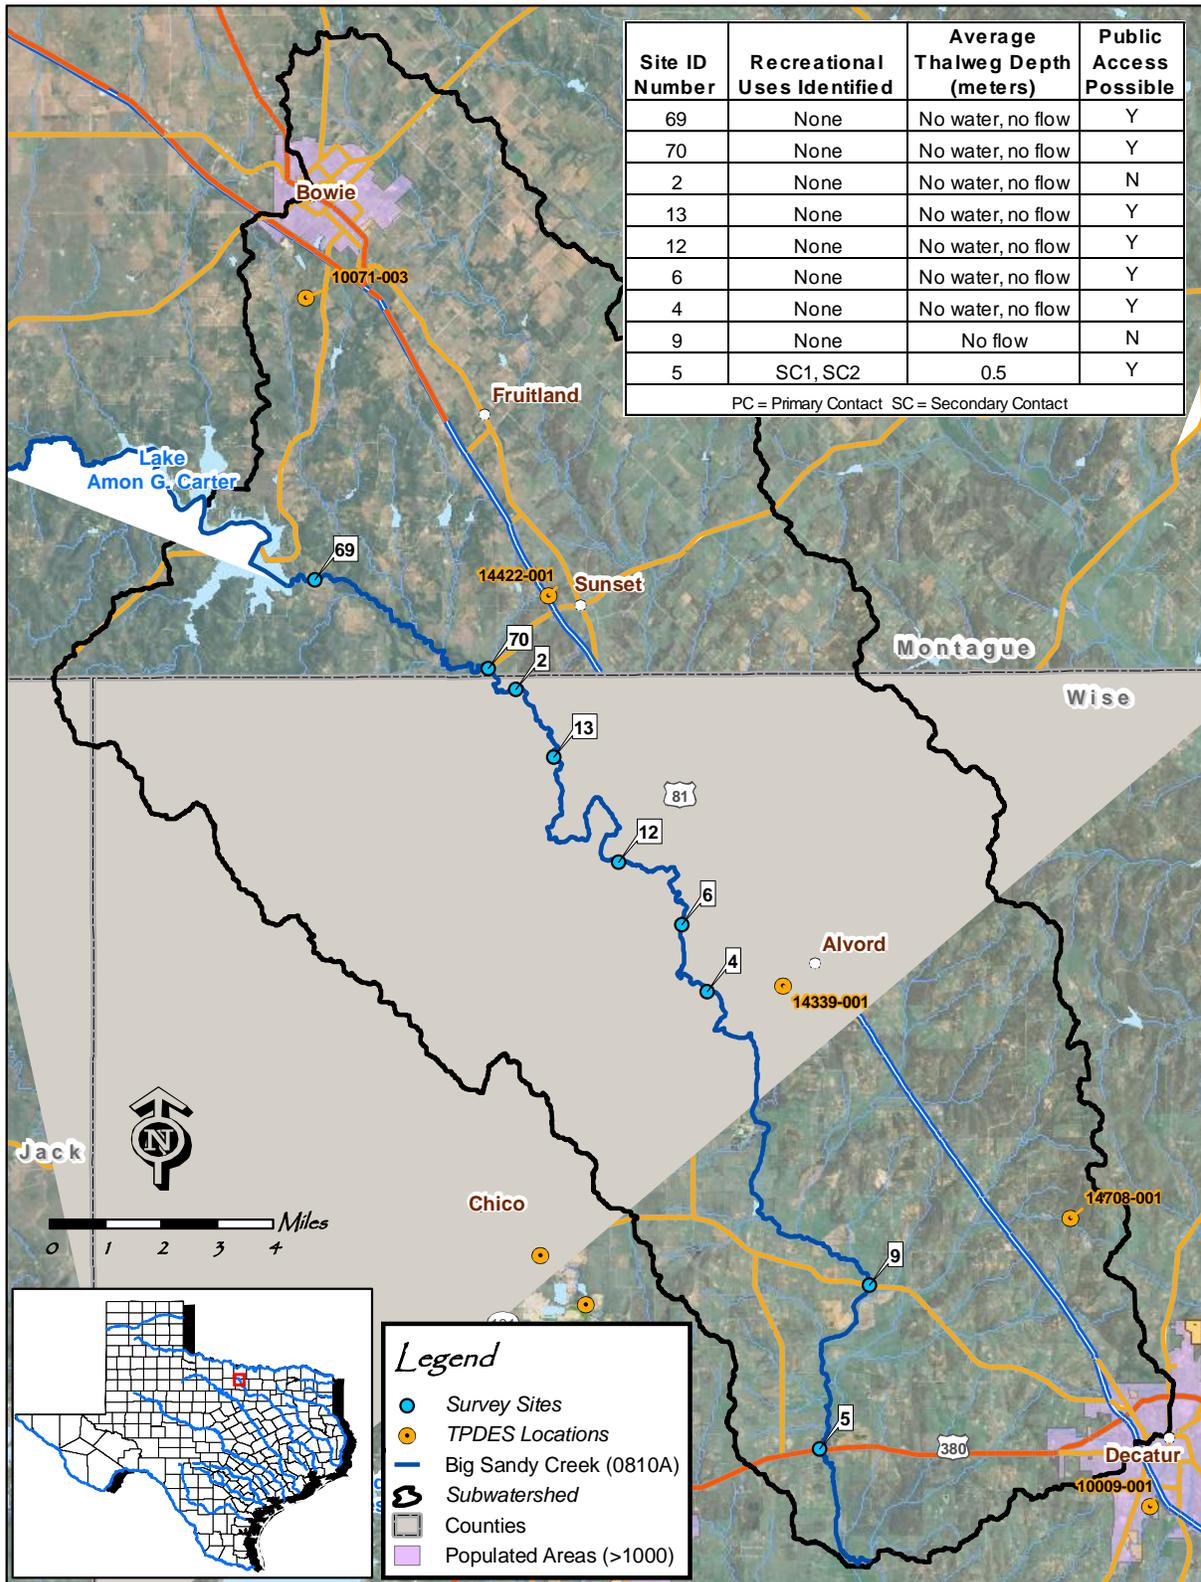
Figure 4.11 Big Sandy Creek

Figure 4.11 provides a map that summarizes the average thalweg depth (where measurement was possible), observed uses, and availability of public access documented at the sites surveyed along Big Sandy Creek. The map also displays other relevant information that may influence the potential for recreation activities along the river corridor including parks, bridge crossings, cities, and wastewater treatment plant outfalls. Additional information providing evidence or lack of evidence that recreation activities have occurred are provided in the field data summary sheets completed for each site surveyed.

Public access from bridges is possible at seven of the nine sites surveyed. Evidence of recreation including four-wheeling tracks and hunting stands was identified. The creek bed was 4 to 12 meters wide, shaded by native hardwoods, and consisted of deep sand, with almost no clay or silt. Wildlife and cattle spoor was common.

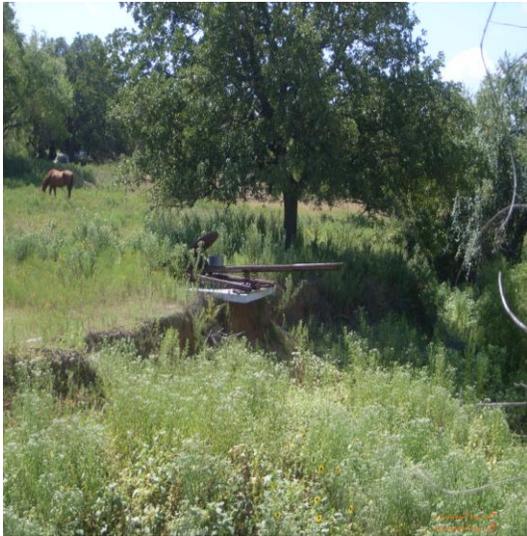
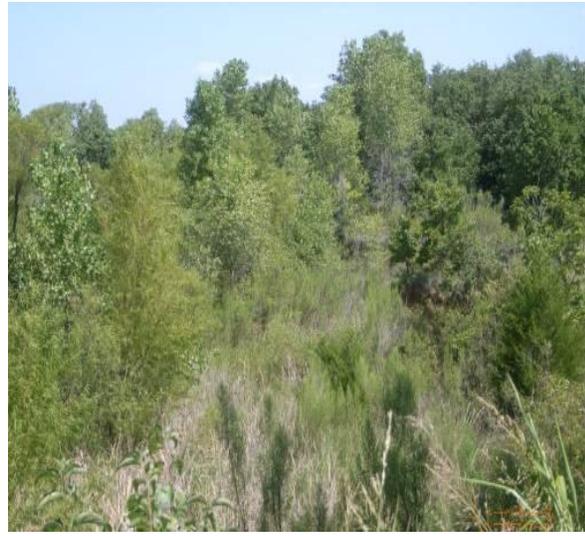
Figure 4.12 Garrett Creek, Survey Site #29

The most upstream survey site that was accessible was #29 located at County Road 3855. The site is at a remote, rural location surrounded by shrub land and deciduous woods with no public access. The creek bed at this site, portrayed by photographs in Figure 4.12 taken at the 30 meter transect, is overgrown with vegetation and had no flow when the site was visited. Evidence of recreation use identified at the site included a diving board and a flat bottom boat. Flow and thalweg depth could not be measured because the stream was dry.

Site #29 @ County Road 3855 Upstream View

Site #29 @ County Road 3855 Downstream View

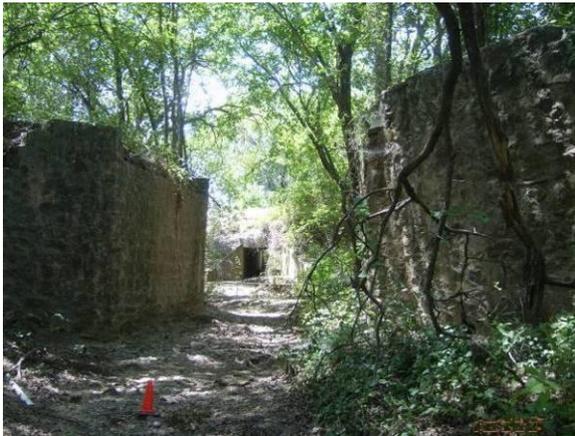
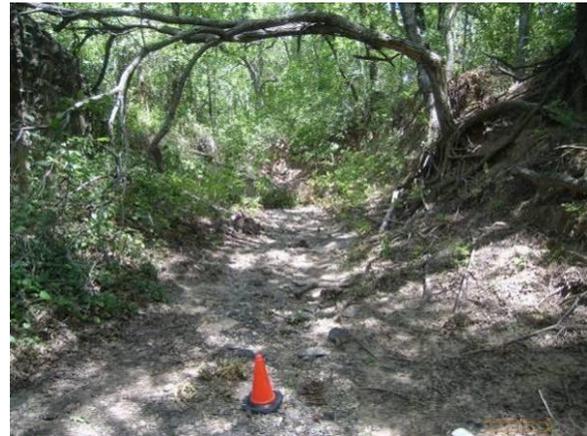
Figure 4.13 Garrett Creek, Survey Site #27

Further downstream, at approximately the midpoint of the creek, is survey Site #27 which was accessed from a private driveway. The site is at a remote, rural location surrounded by shrub land and deciduous woods. The creek bed at this site, portrayed by photographs in Figure 4.13 taken at the 30 meter transect, has steep, eroded banks and no flow. Public access is possible at the site however; no evidence of recreation use was identified. Flow and thalweg depth could not be measured because the stream was dry.

Site #27 @ Private Driveway Upstream View

Site #27 @ Private Driveway Downstream View

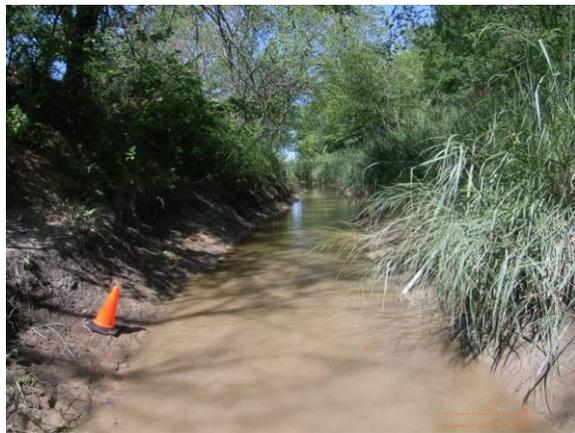
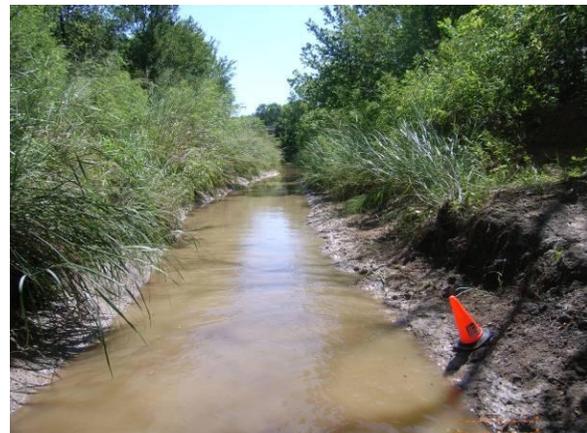
Figure 4.14 Garrett Creek, Survey Site #23

Site #23, located at State Hwy 114, is the most downstream site that was surveyed. The creek bed at this site, portrayed by photographs in Figure 4.14 taken at the 150 meter transect, is wadeable with shrub dominated banks that impede access. The average thalweg depth measured at this site was 0.45 meters. Public access is possible at the site however; no evidence of recreation use was identified. The site is at a remote, rural location surrounded by pastureland and some deciduous woods.

Site #23 @ State Hwy 114 Upstream View

Site #23 @ State Hwy 114 Downstream View

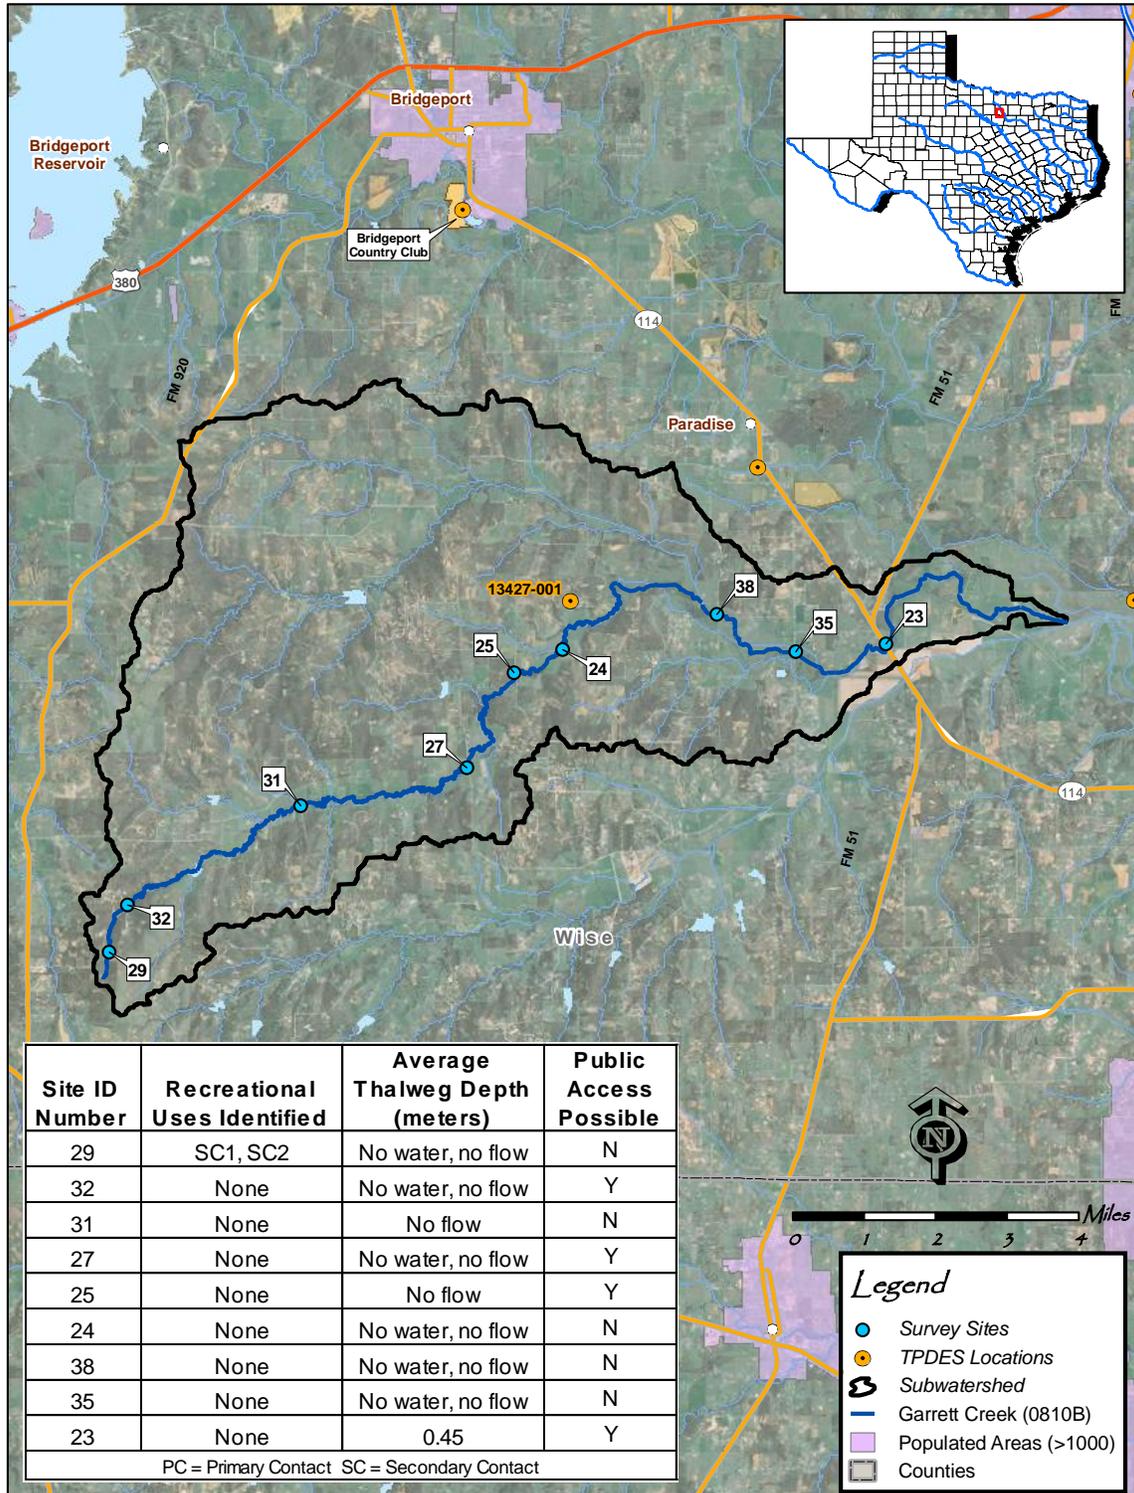
Figure 4.15 Garrett Creek

Figure 4.15 provides a map that summarizes the average thalweg depth (where measurement was possible), identified uses, and availability of public access documented at the sites surveyed along Garrett Creek. The map also displays other relevant information that may influence the potential for recreation activities along the river corridor including parks, bridge crossings, cities, and wastewater treatment plant outfalls. There was some farming along Garrett Creek. There were more permanent water pools with no accessibility for measurements as Garrett Creek approached the confluence with Salt Creek and before it flowed into the West

Fork Trinity River, but no evidence of fish that would lead to an interest in secondary recreation. Evidence of water recreation was only identified at site #29.

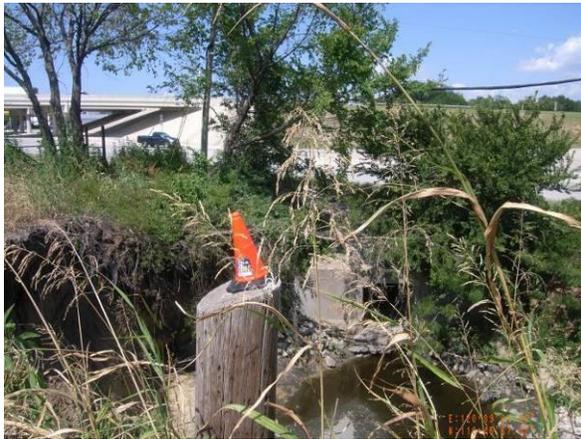
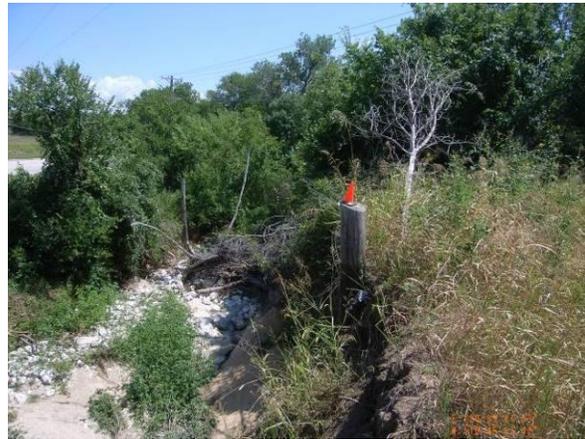
Figure 4.16 Martin Branch, Survey Site #16

The most upstream survey site accessible was #16 located at U.S. Hwy 287 on the south side of Decatur. Martin Branch at this site is an eroded channel with steep banks. The creek bed at this site, portrayed by photographs in Figure 4.16 taken at the 30 meter transect, is overgrown with vegetation and had no flow when the site was visited. Public access from the roadside is possible and there was no evidence of recreation use at the site. Flow and thalweg depth could not be measured because the stream was dry.

Site #16 @ U.S Hwy 287 Upstream View

Site #16 @ U.S Hwy 287 Downstream View

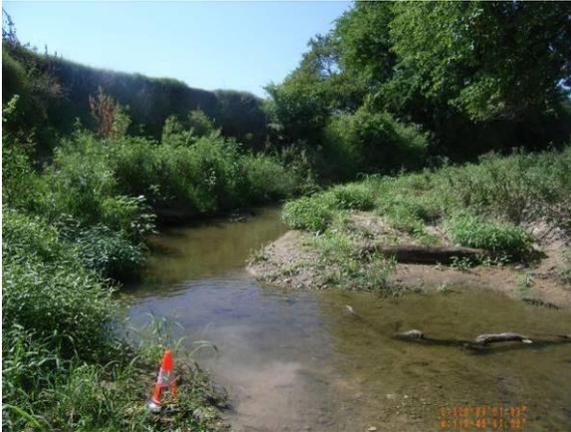
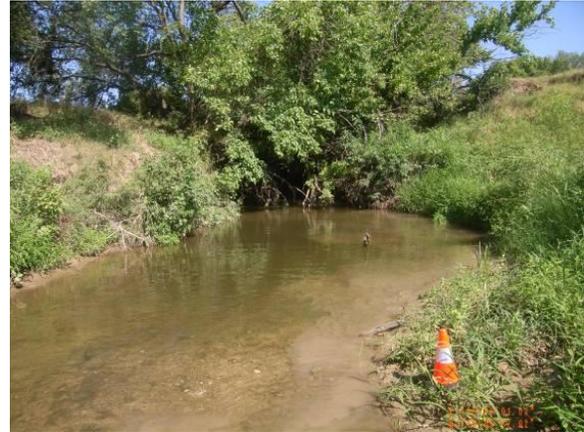
Figure 4.17 Martin Branch, Survey Site #14

Further downstream, at approximately the midpoint of the Martin Branch, is survey Site #14 which was accessed from an unnamed street. The site is at a remote, rural location and is publicly accessible. The creek bed at this site, portrayed by photographs in Figure 4.17 taken at the 150 meter transect, has shrub and tree dominated banks. There was no evidence of recreation use identified at the site. The average thalweg depth was 2 meters and flow was measured at 7.48 cfs.

Site #14 @ Unnamed Street Upstream View

Site #14 @ Unnamed Street Downstream View

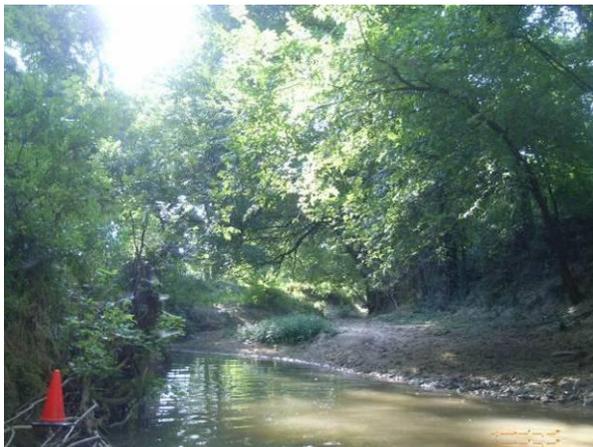
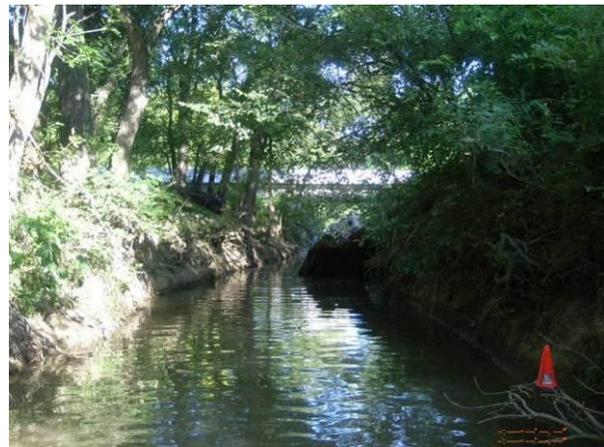
Figure 4.18 Martin Branch, Survey Site #22

Site #22, located at FM 51, is the downstream most site that was surveyed on Martin Branch. The creek bed at this site, portrayed by photographs in Figure 4.18 taken at the 150 meter transect, is wadeable with stream banks that are dominated by large trees and dense shrubs. The average thalweg depth measured at this site was 0.31 meters and a flow of 1.7 cfs was measured. There is public access at the site however; no evidence of recreation use was identified. The average width of the creek at the 300 meter transect was 2 meters. The site is at a remote, rural location surrounded by pastureland and some deciduous woods.

Site #22 @ FM 51 Upstream View

Site #22 @ FM 51 Downstream View

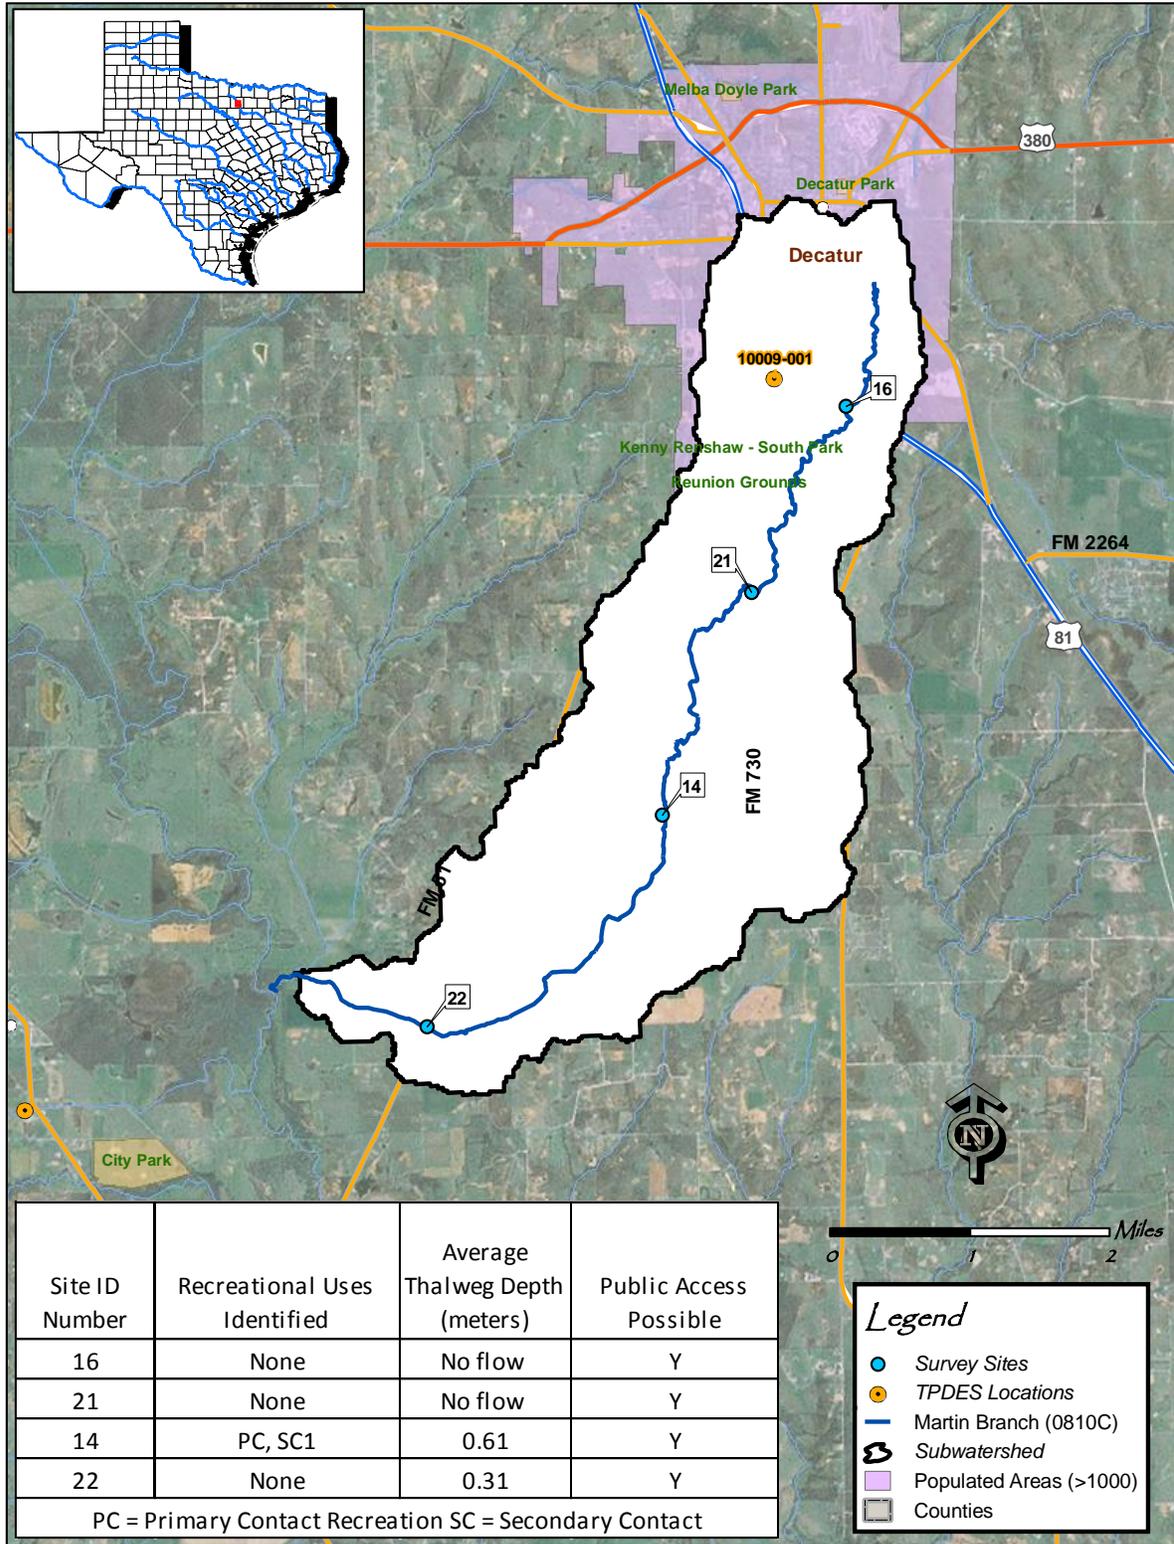
Figure 4.19 Martin Branch

Figure 4.19 provides a map that summarizes the average thalweg depth (where measurement was possible), identified uses, and availability of public access documented at the sites surveyed along Martin Branch. The map also displays other relevant information that may influence the potential for recreation activities along the river corridor including parks, bridge crossings, cities, and wastewater treatment plant outfalls.

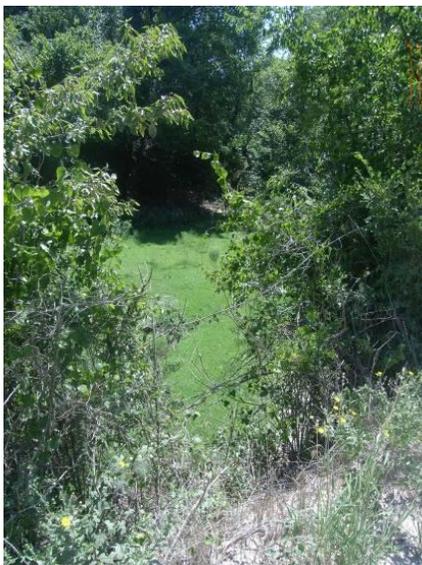
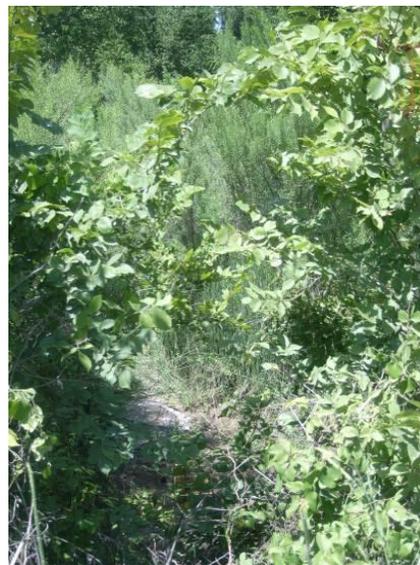
Figure 4.20 Salt Creek, Survey Site #46

The majority of Salt Creek, like its adjacent neighbor Garrett Creek, was dry or had no flowing water. It was a completely dry sandy, brushy creek bed surrounded by cattle pastureland. There are no WWTPs within the Salt Creek subwatershed. The most upstream survey site accessible was #46 located at an unnamed street. Salt Creek at this site is an eroded channel with steep banks. The creek bed at this site, portrayed by photographs in Figure 4.20 taken at the 30 meter transect, is overgrown with vegetation and had no flow and no standing water. Public access from the roadside is possible but very difficult and there is no evidence of recreation use at the site. Flow and thalweg depth could not be measured because there was no water.

Site #46 @ Unnamed Street Upstream View

Site #46 @ Unnamed Street Downstream View

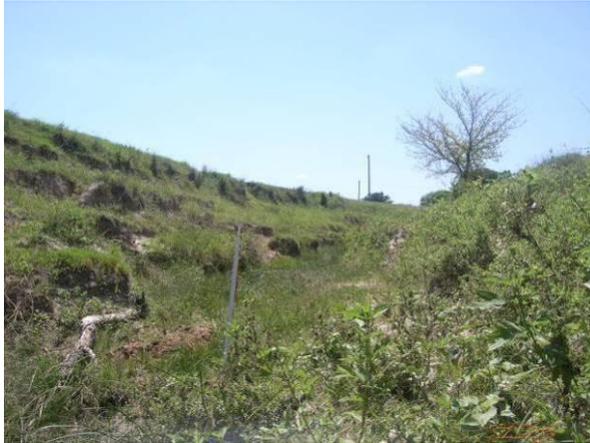
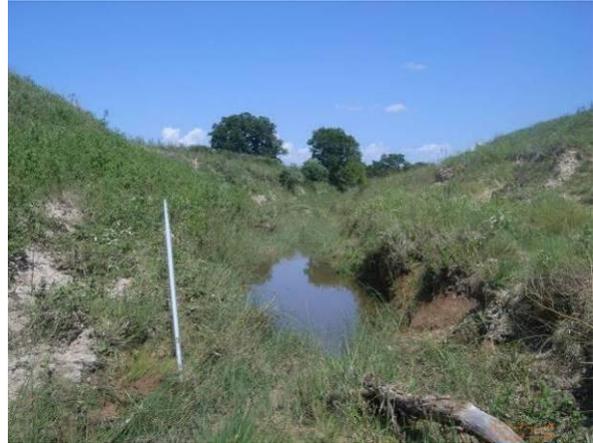
Figure 4.21 Salt Creek, Survey Site #41

Further downstream, at approximately the midpoint of the Salt Creek, is survey Site #41 which located at County Road 3585. The site is on private property in a remote, rural location. The creek bed at this site, portrayed by photographs in Figure 4.21 taken at the 150 meter transect, is an open channel with steep sloping grass banks bordered by pastureland. There was no evidence of recreational use identified at the site.

Site #41 @ County Road 3585 Upstream View

Site #41 @ County Road 3585 Downstream View
