WEST FORK TRINITY RIVER BELOW BRIDGEPORT RESERVOIR RECREATIONAL USE ATTAINABILITY ANALYSES PROJECT

(West Fork Trinity River below Bridgeport Reservoir - Segment 0810)

Contract No. 582-9-90439-05

AUGUST 30, 2010

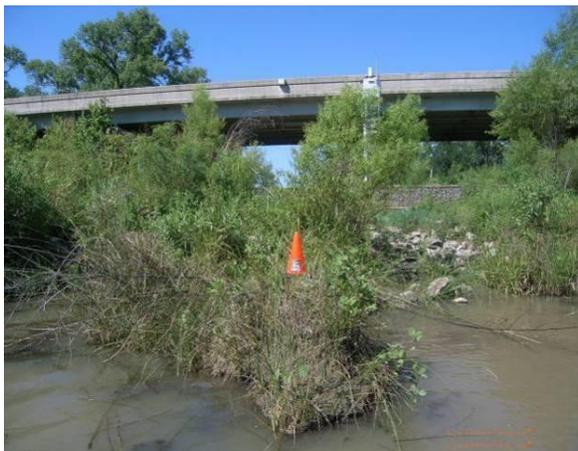
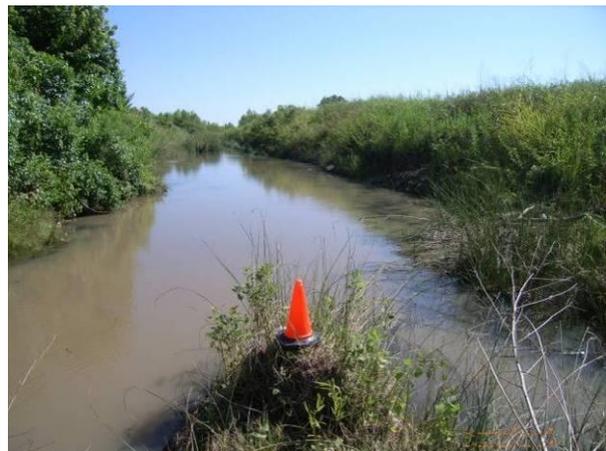
Figure 4.22 Salt Creek, Survey Site #40

Site #40, located at State Hwy 114 is the downstream most site that was surveyed on Salt Creek. The creek bed at this site, portrayed by photographs in Figure 4.22 taken at the 30 meter transect, is wadeable with stream banks that are dominated by some trees and dense shrubs. The average thalweg depth measured at this site was 0.54 meters and the average width of the creek at the 300 meter transect was 20 meters. A flow of 2.3 cfs was measured at the site. There was no public access and no evidence of recreation use at the site. The site is at a remote, rural location surrounded by pastureland and some deciduous forest.

Site #40 @ State Hwy 114 Upstream View

Site #40 @ State Hwy 114 Downstream View

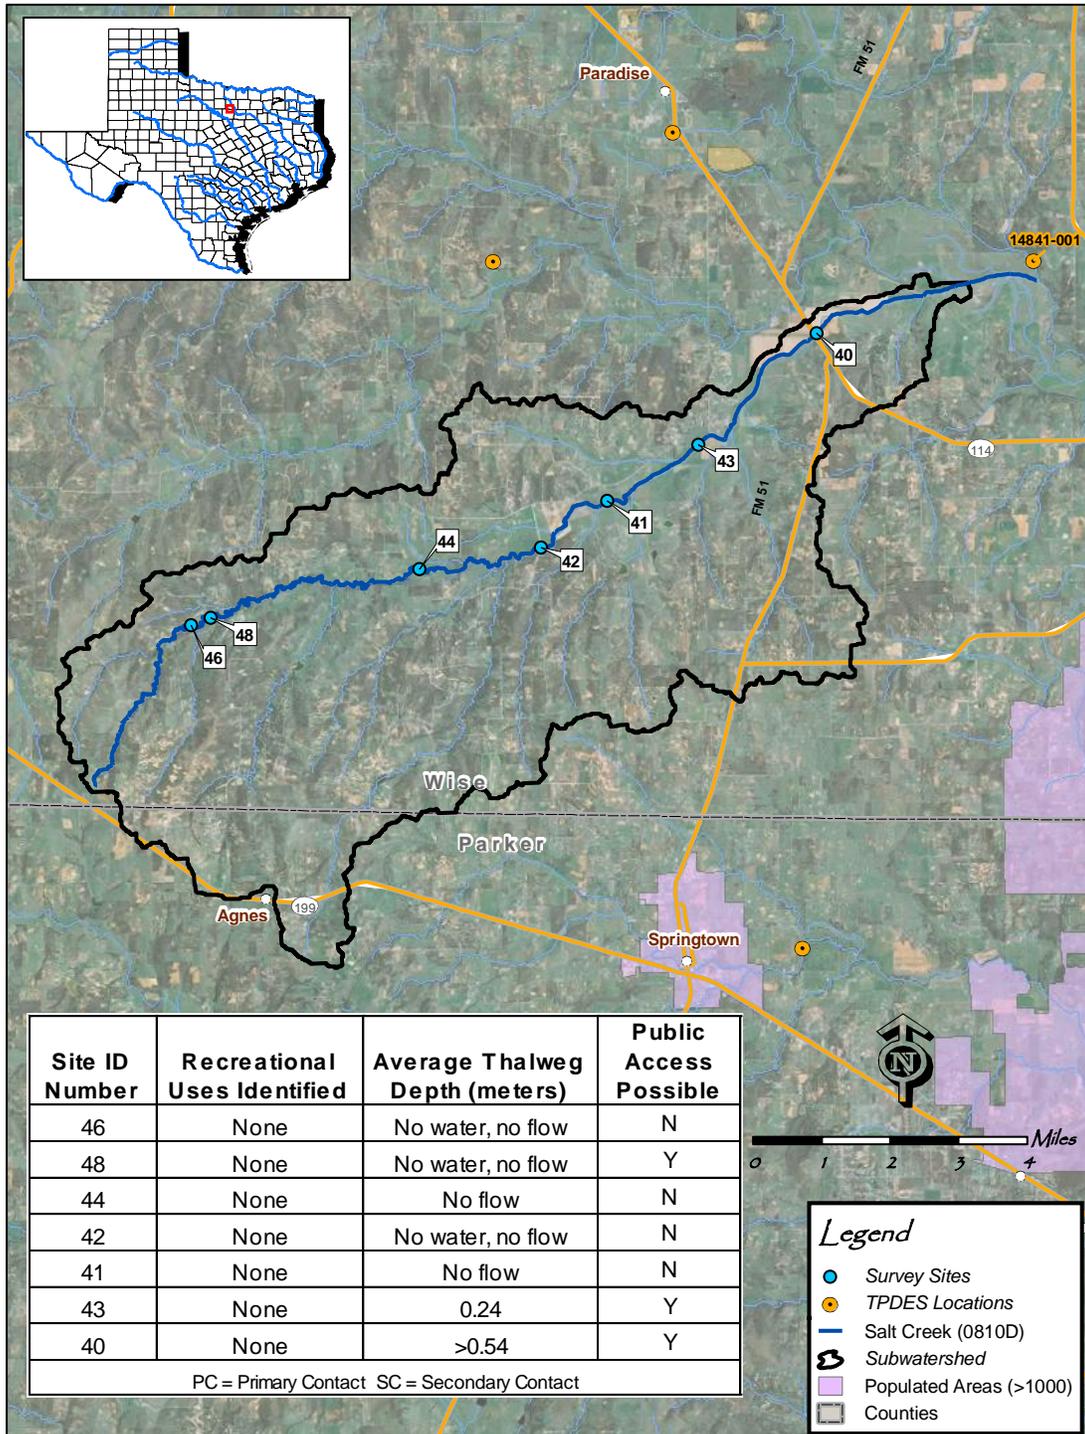
Figure 4.23 Salt Creek

Figure 4.23 provides a map that summarizes the average thalweg depth (where measurement was possible), identified uses, and availability of public access documented at the sites surveyed along Salt Creek.
