Examples of Unacceptable Stack Designs

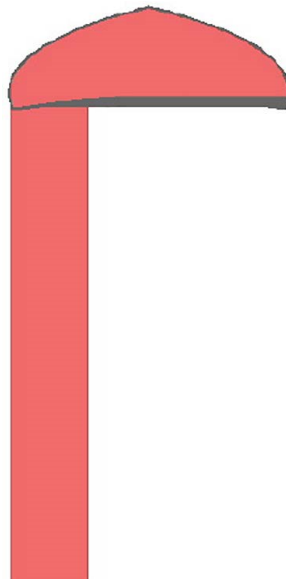
The examples on this page do not meet the requirements of Permit By Rule 106.436. The cap on Stack A obstructs vertical discharge of air contaminants. Stack B, a goose neck, also prevents vertical discharge. Stack C, which comes out of the building horizontally, simply does not provide for vertical discharge.
