Texas Dam Failures

- ▶ Since 1900, 171 dams have been reported to have either failed or have been damaged due to overtopping or structural issues.
- ▶ Some of these dam failures were significant due to size, use, or loss of life, which we will discuss.

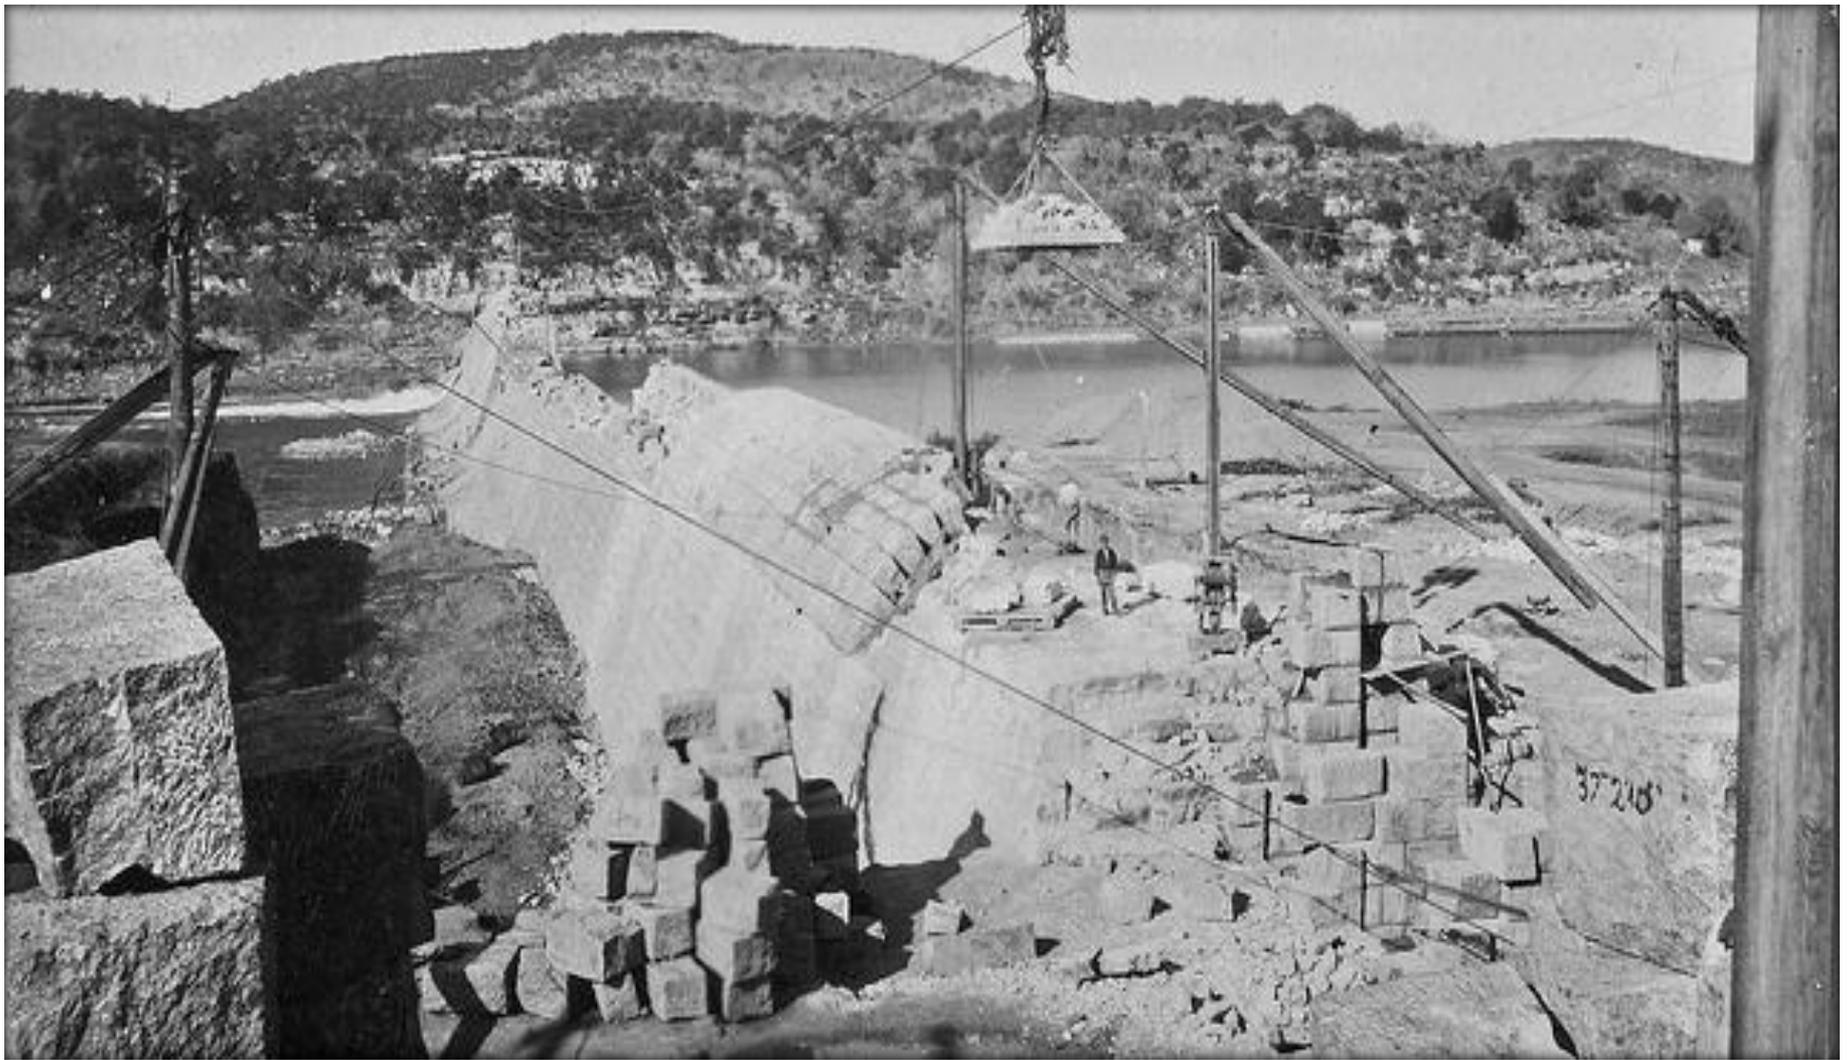
Lake Austin Dam under construction

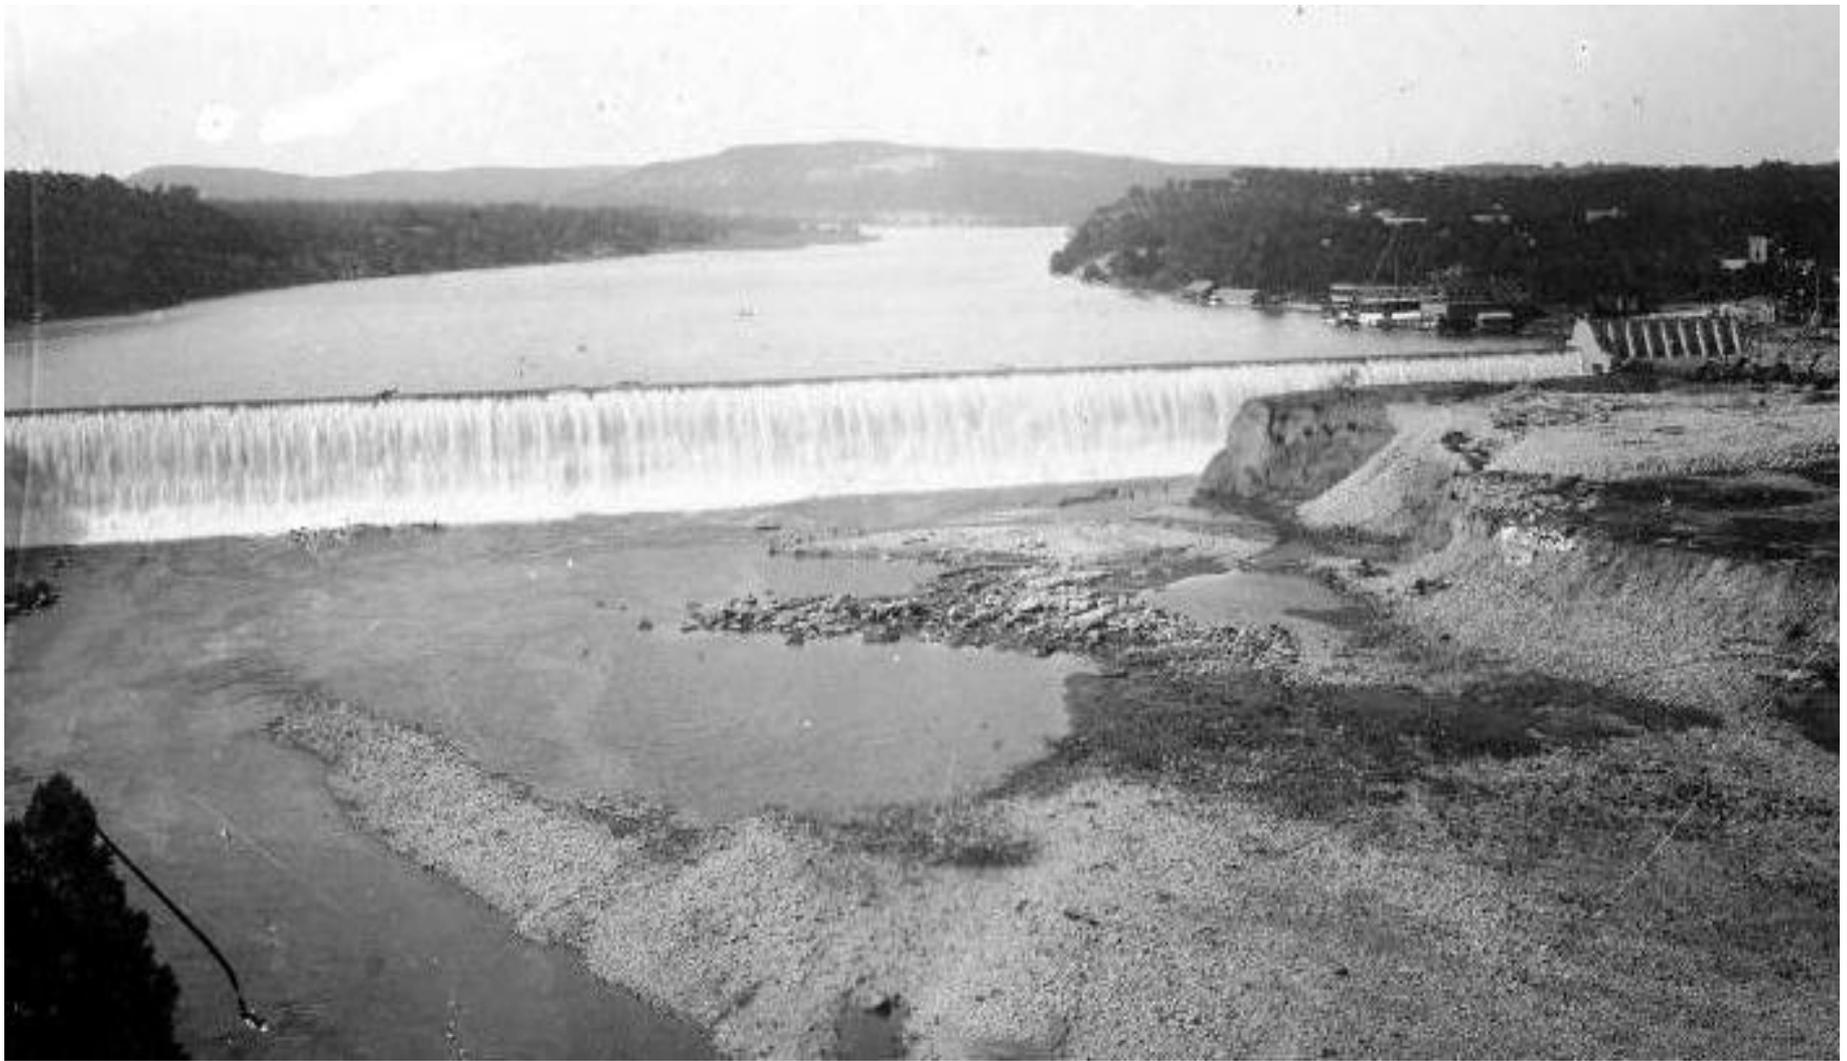
Dam following construction circa 1900

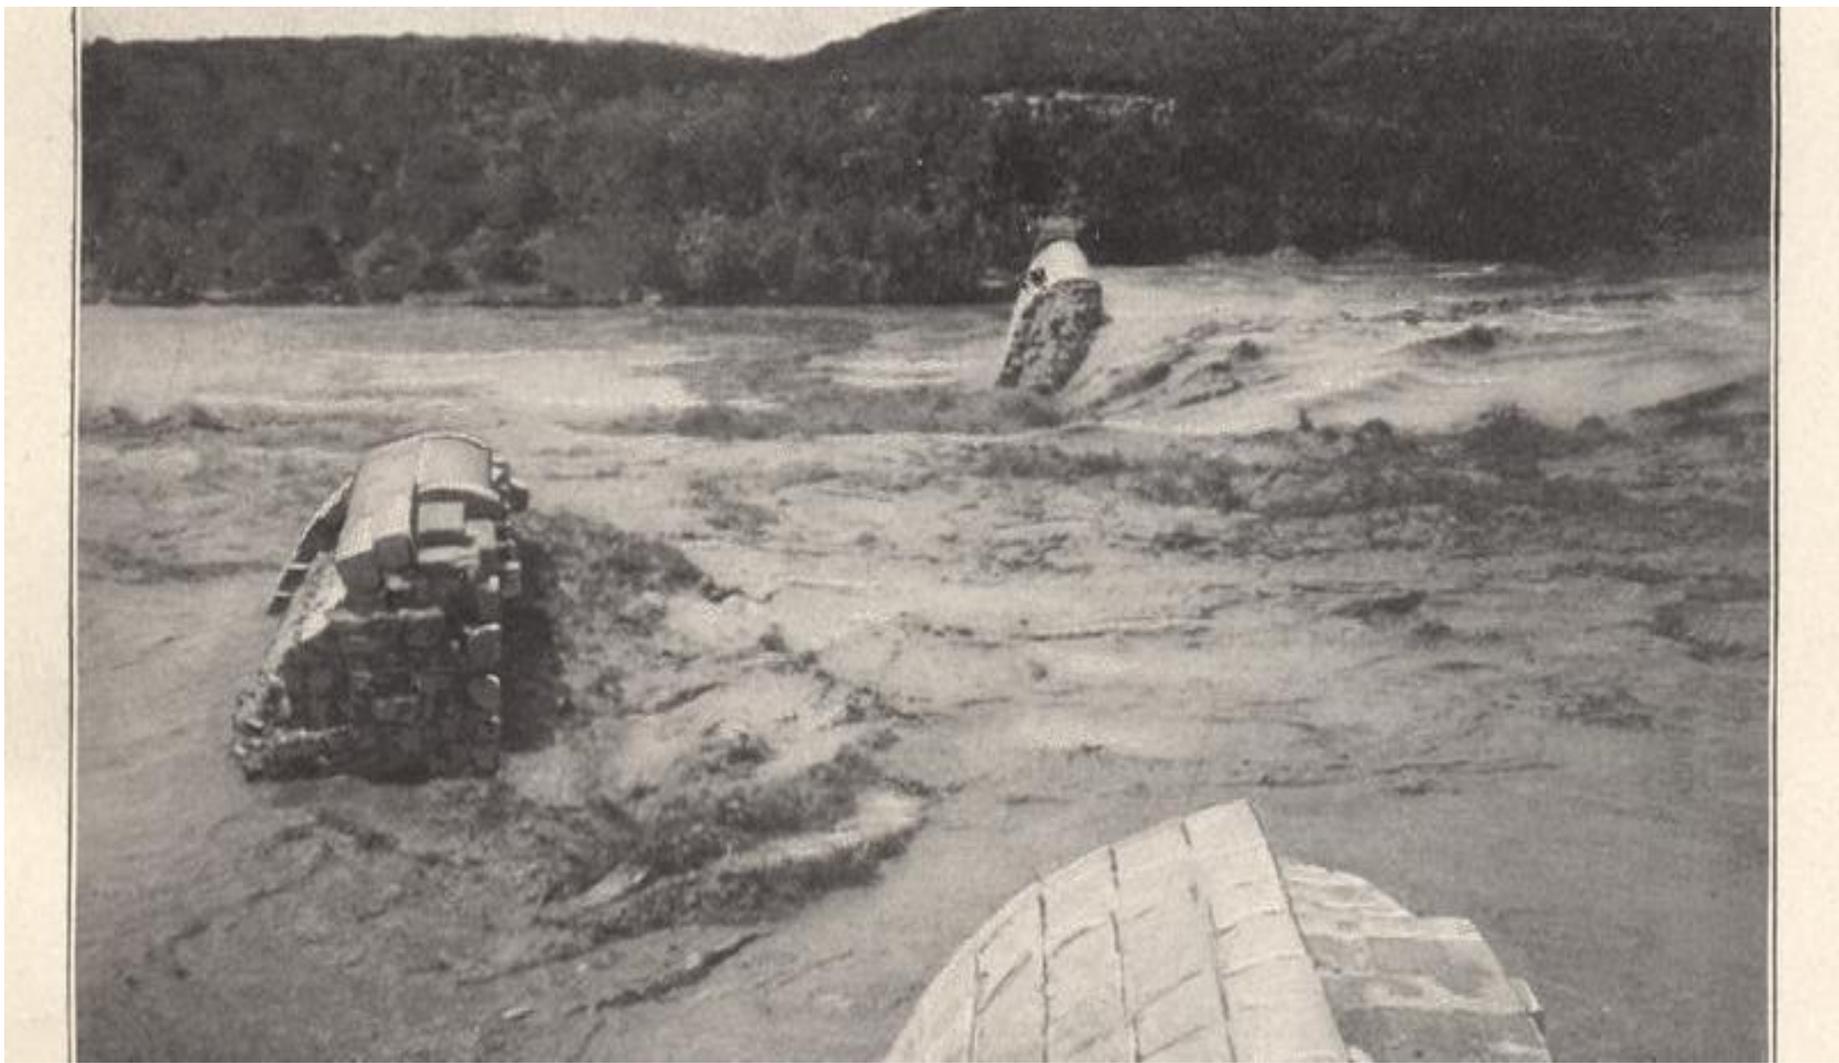
One hour after failure, April 7, 1900

- ▶ 40 foot high wave pounded the powerhouse on the east shore. 8 people died, including 3 children, in the powerhouse.
- ▶ Two sections of dam, each about 200 feet long, were pushed downstream about 60 feet, but did not overturn.
- ▶ 23 people died, over 200 were injured, \$1.4 million in damages (1900 dollars).

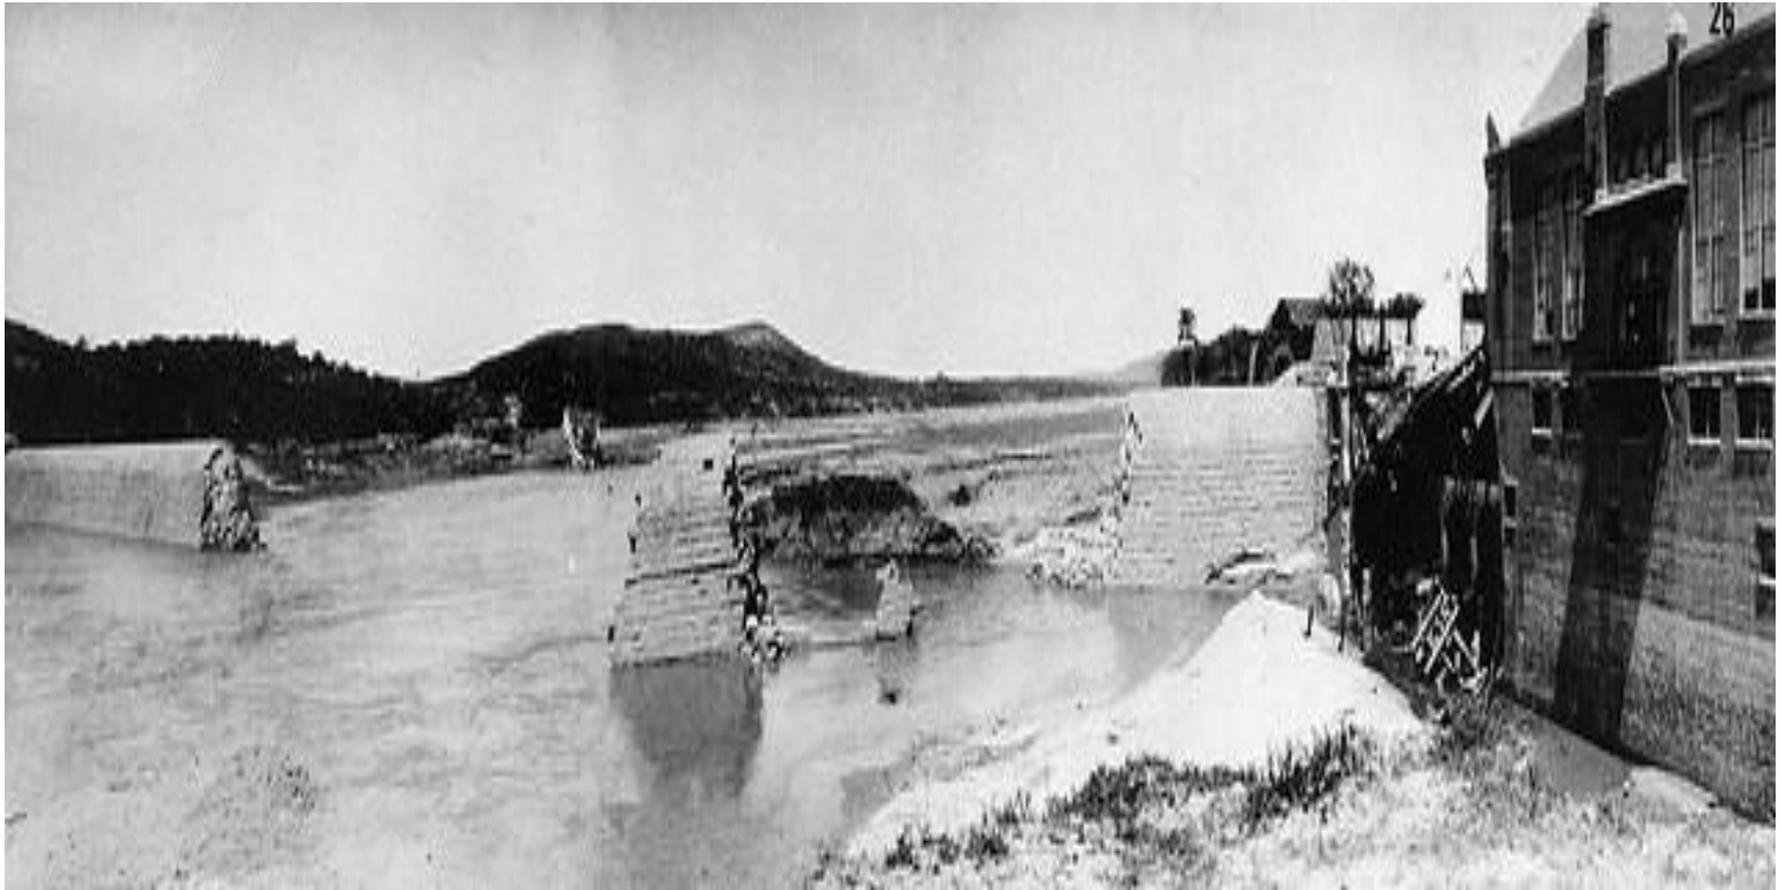
Dam after failure, April 1900

- ▶ Not built of solid granite. The interior was made up of fill and rubble, not granite blocks.
- ▶ Springs and leakage.
- ▶ Poor foundation.
- ▶ Uplift.
- ▶ Faults.
- ▶ Dam not built as designed.

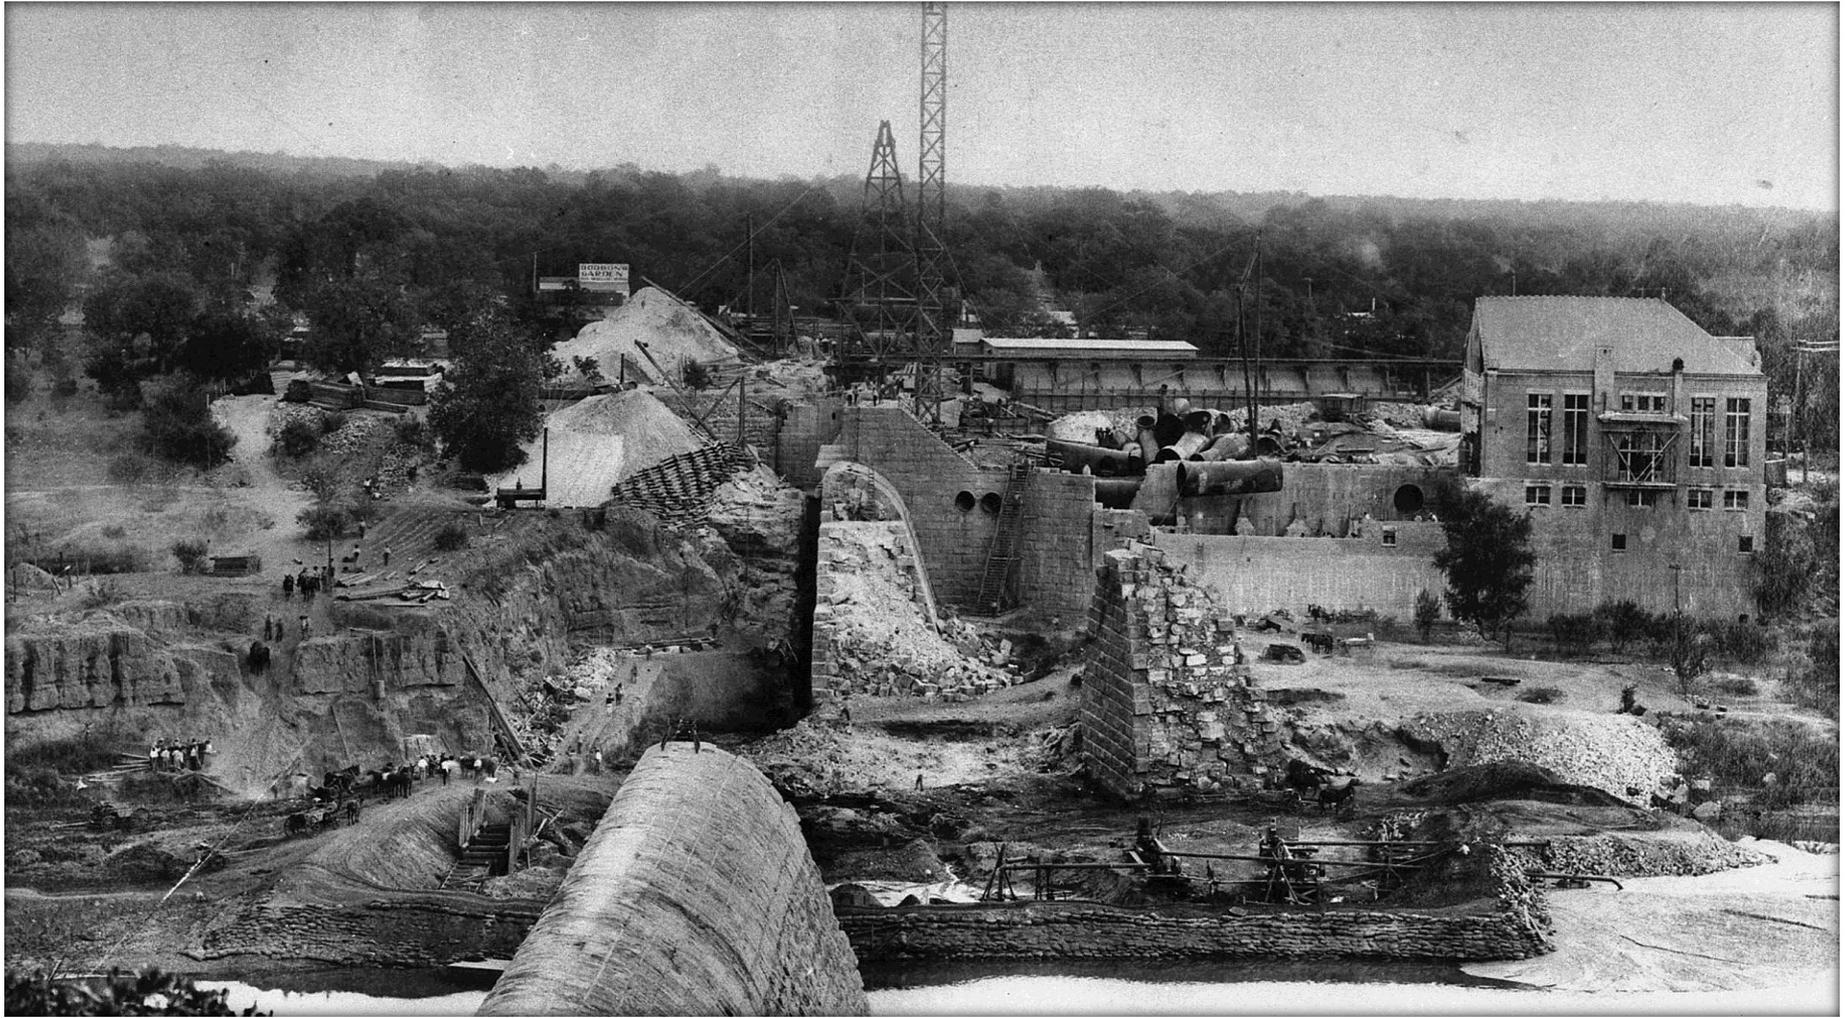
Lake Austin Dam during reconstruction circa 1913

- ▶ Reconstruction started in 1911.
- ▶ Regarded as complete in 1915.
- ▶ Constructed with 54 automated gates on top, 28 large gates and 26 small gates.

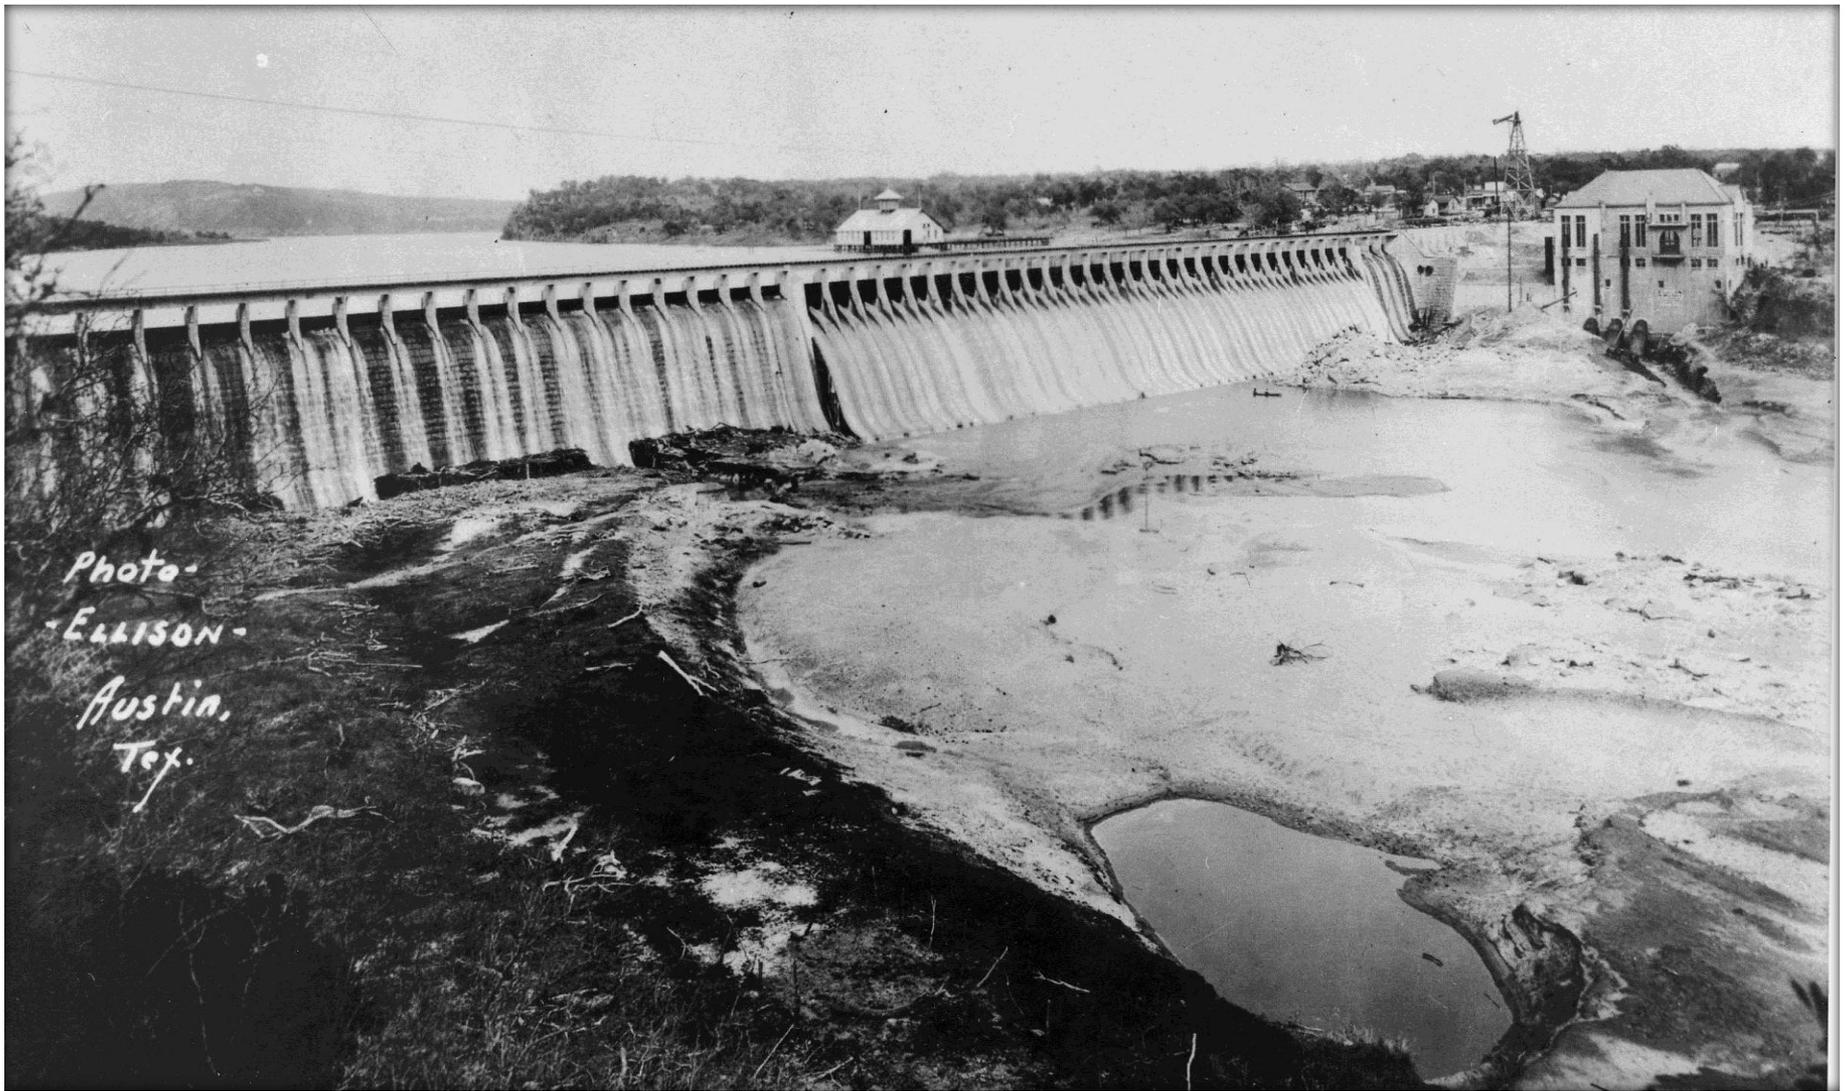
Completed dam in 1915

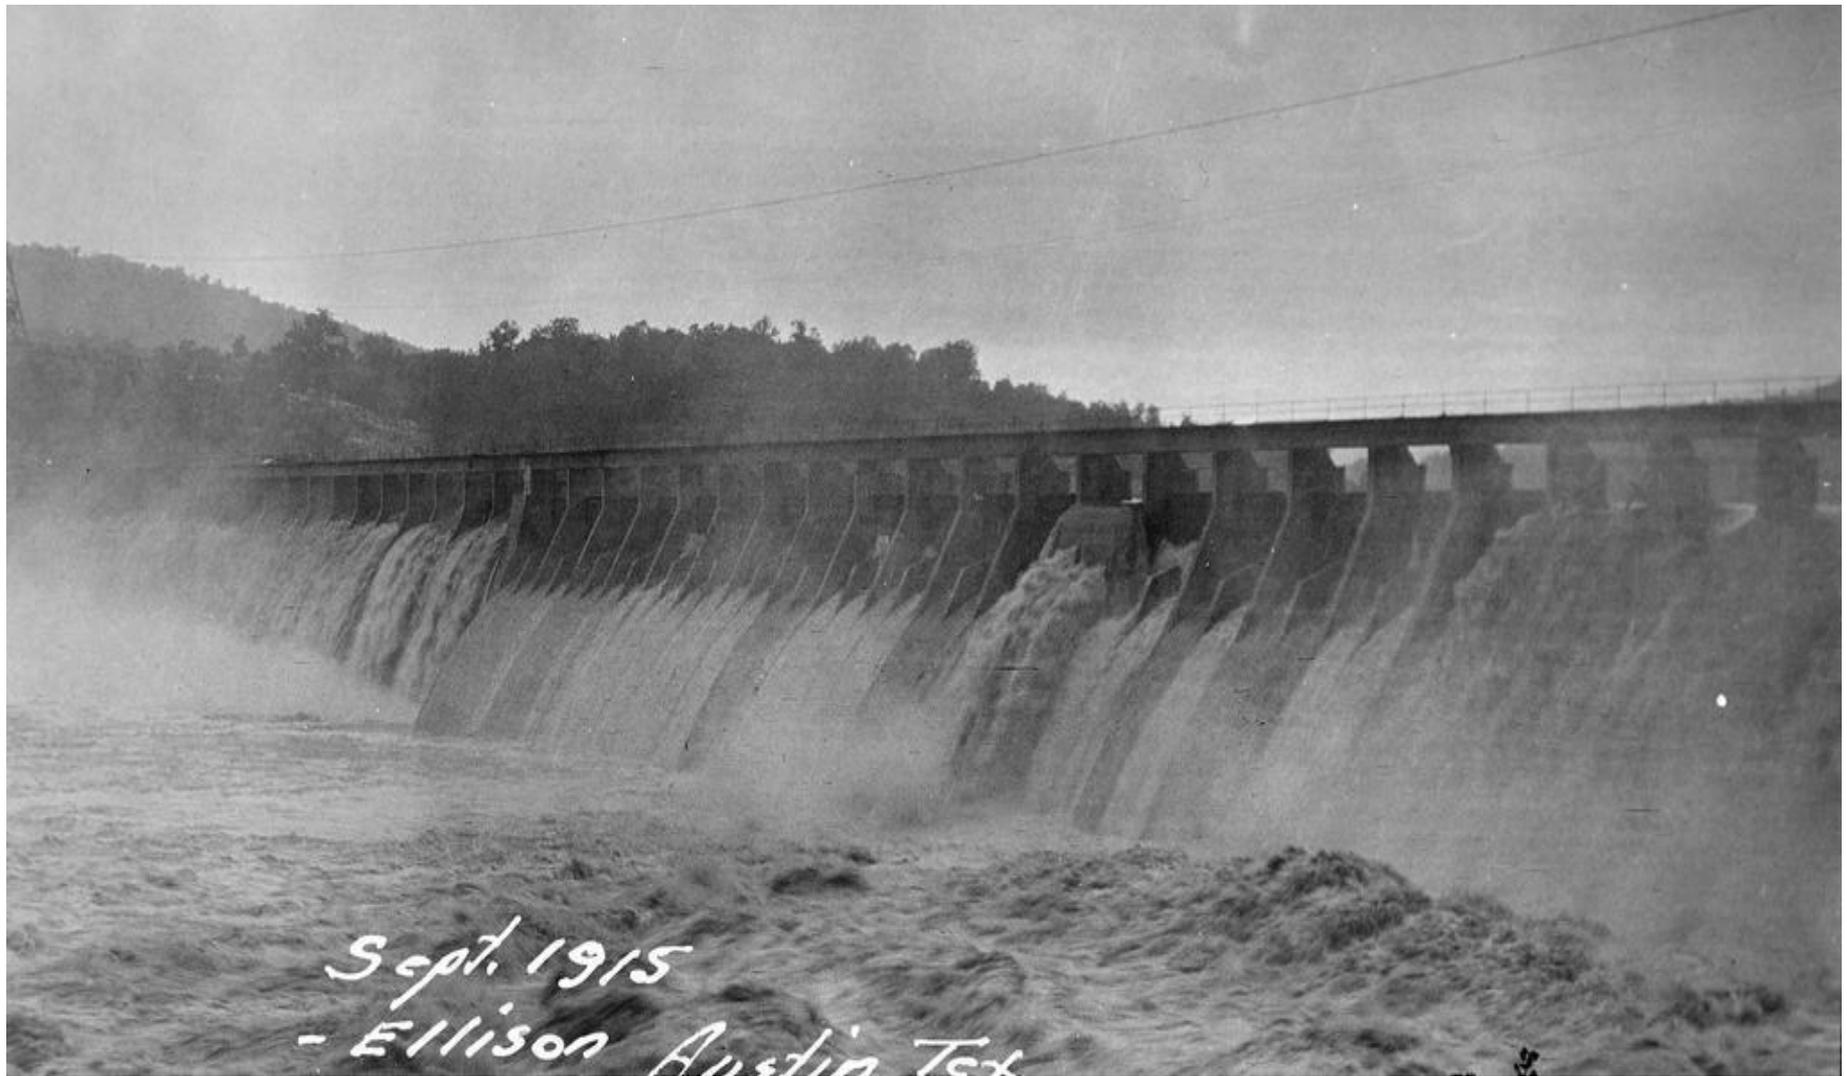
September 1915 Flood

- ▶ Another large flood.
- ▶ “raft of drift” (estimated to be 20 feet thick) destroyed 20 of the 28 large gates and all 26 small gates.

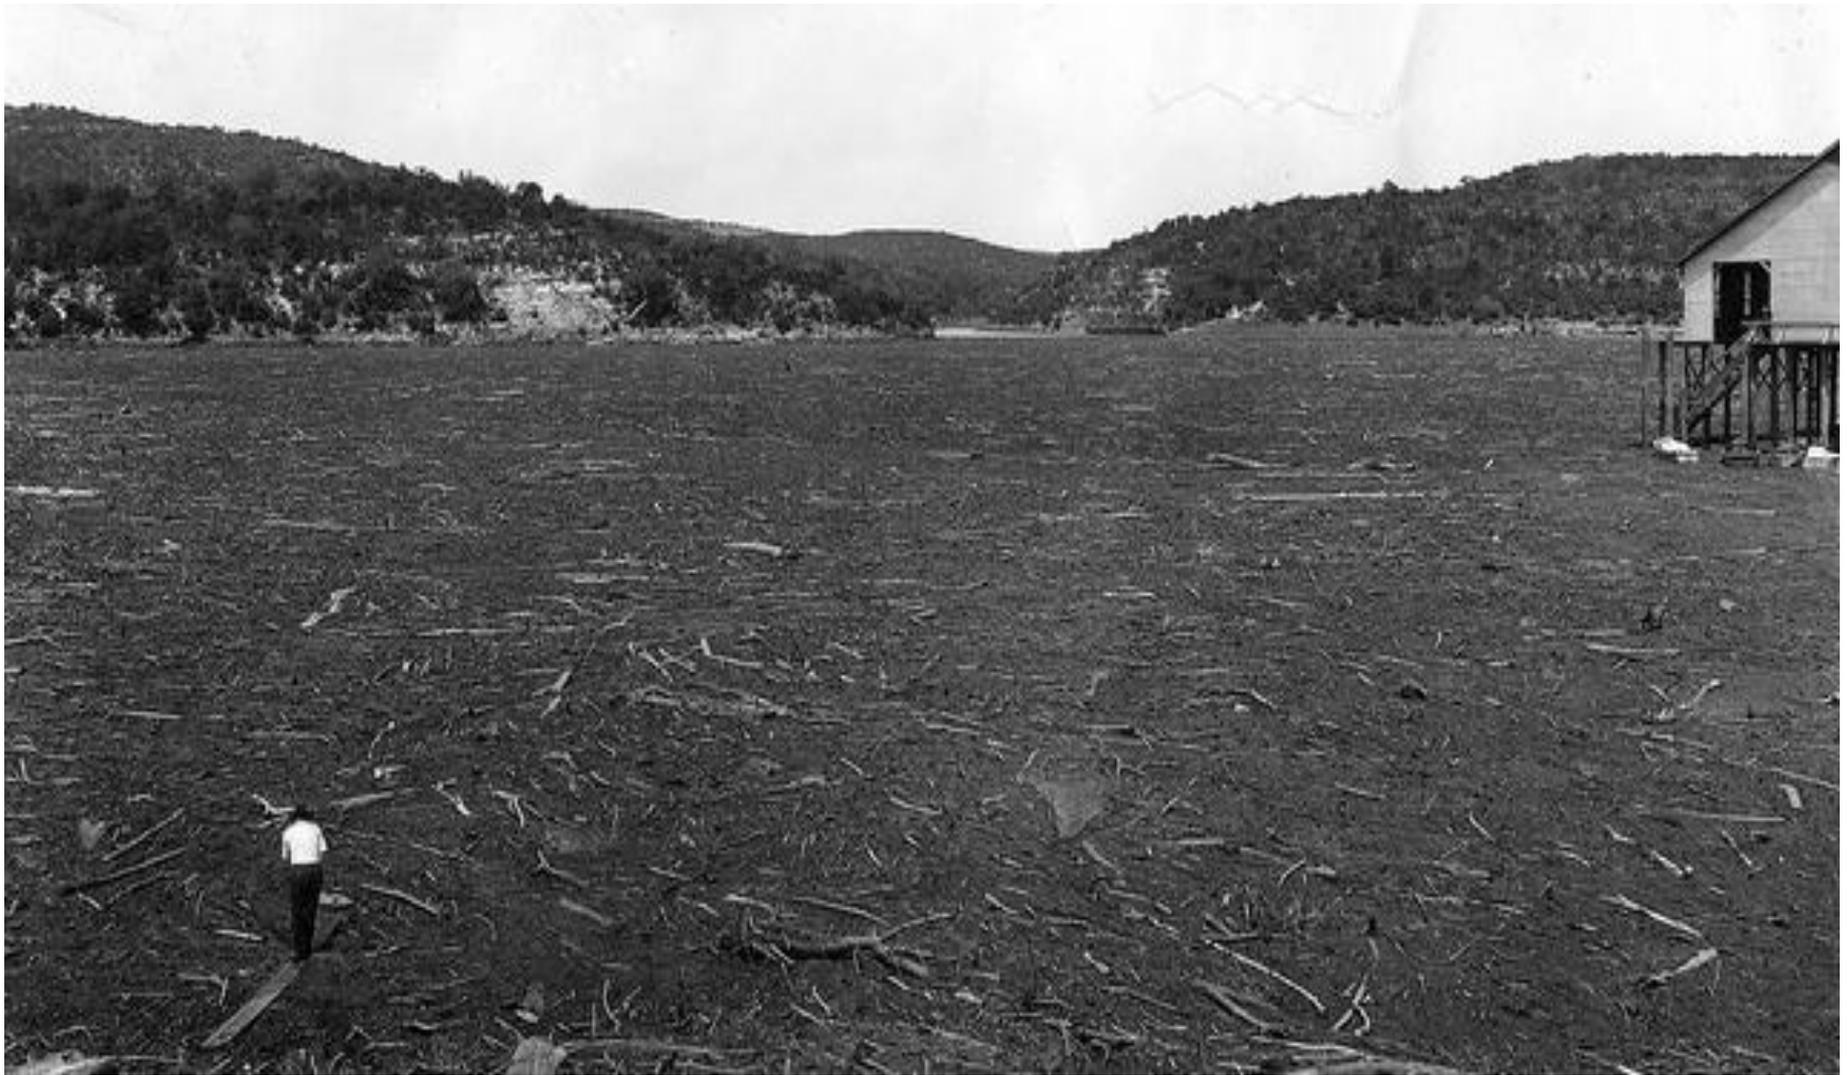
Raft of drift circa September 1915

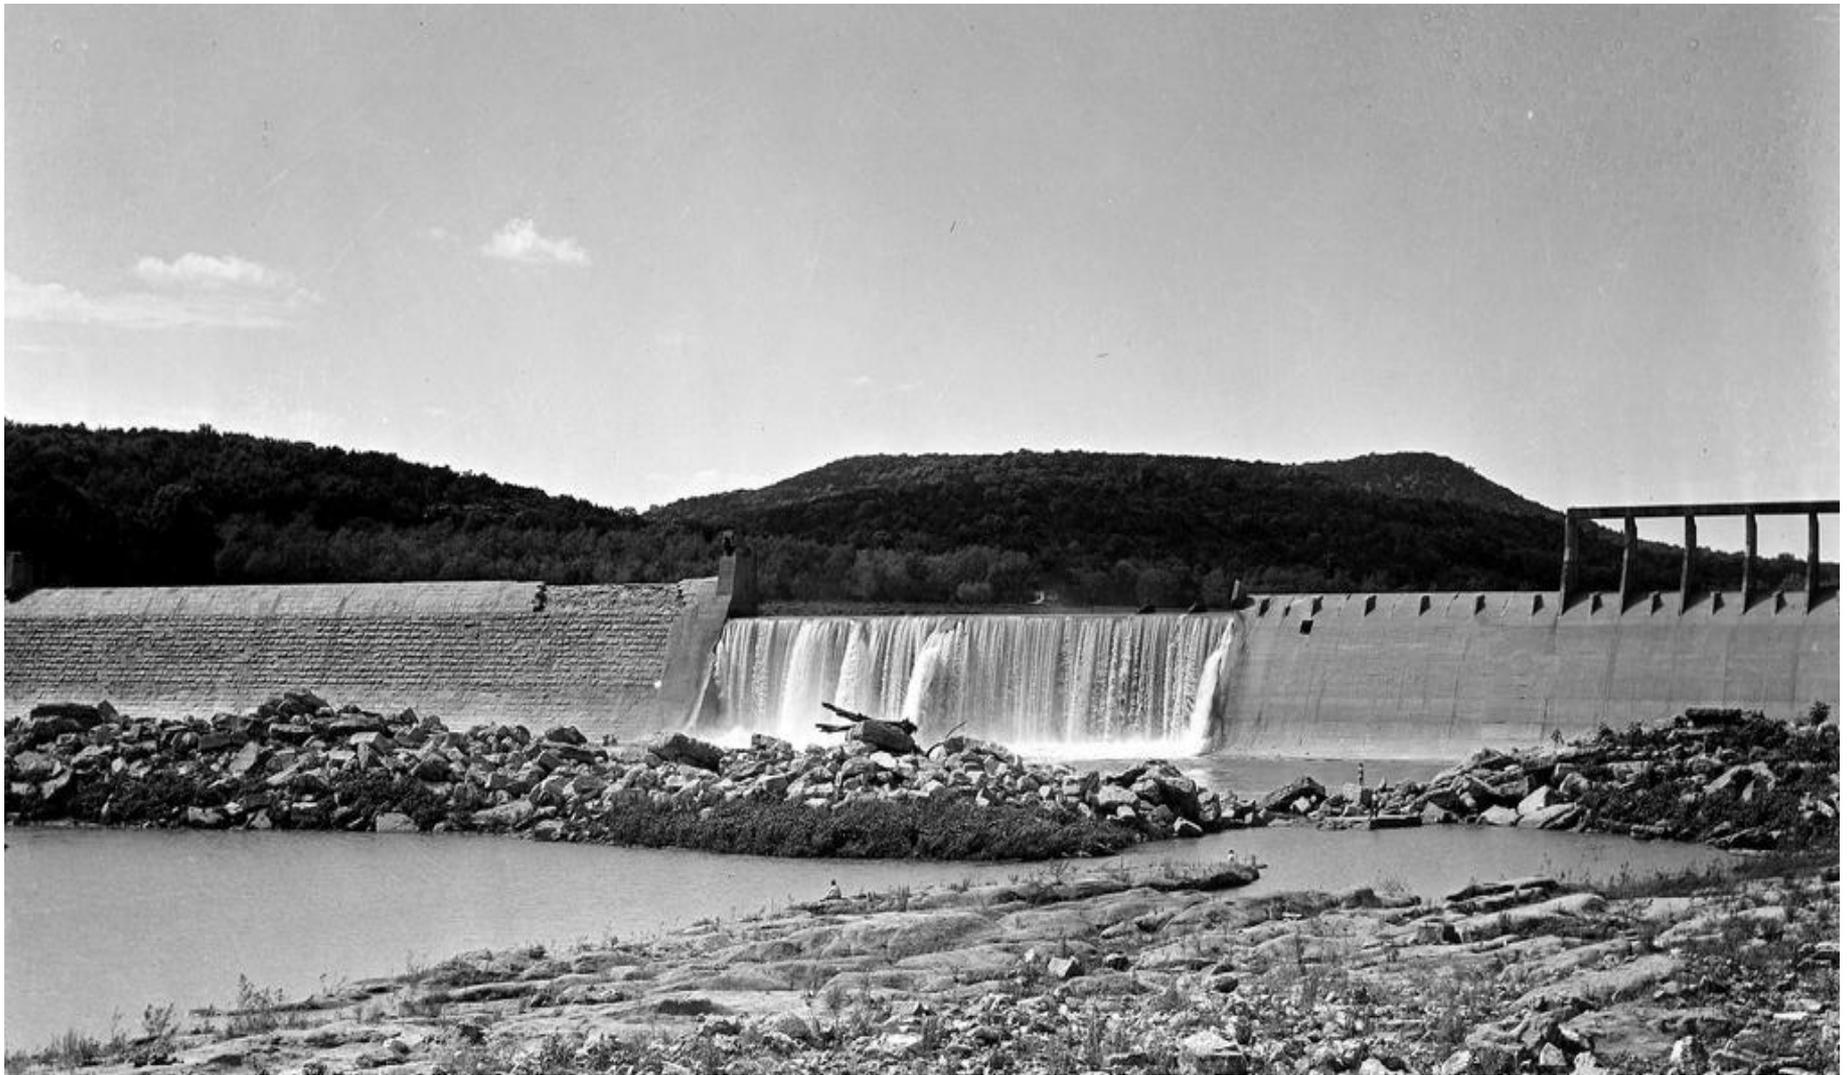
Dam following 1915 failure

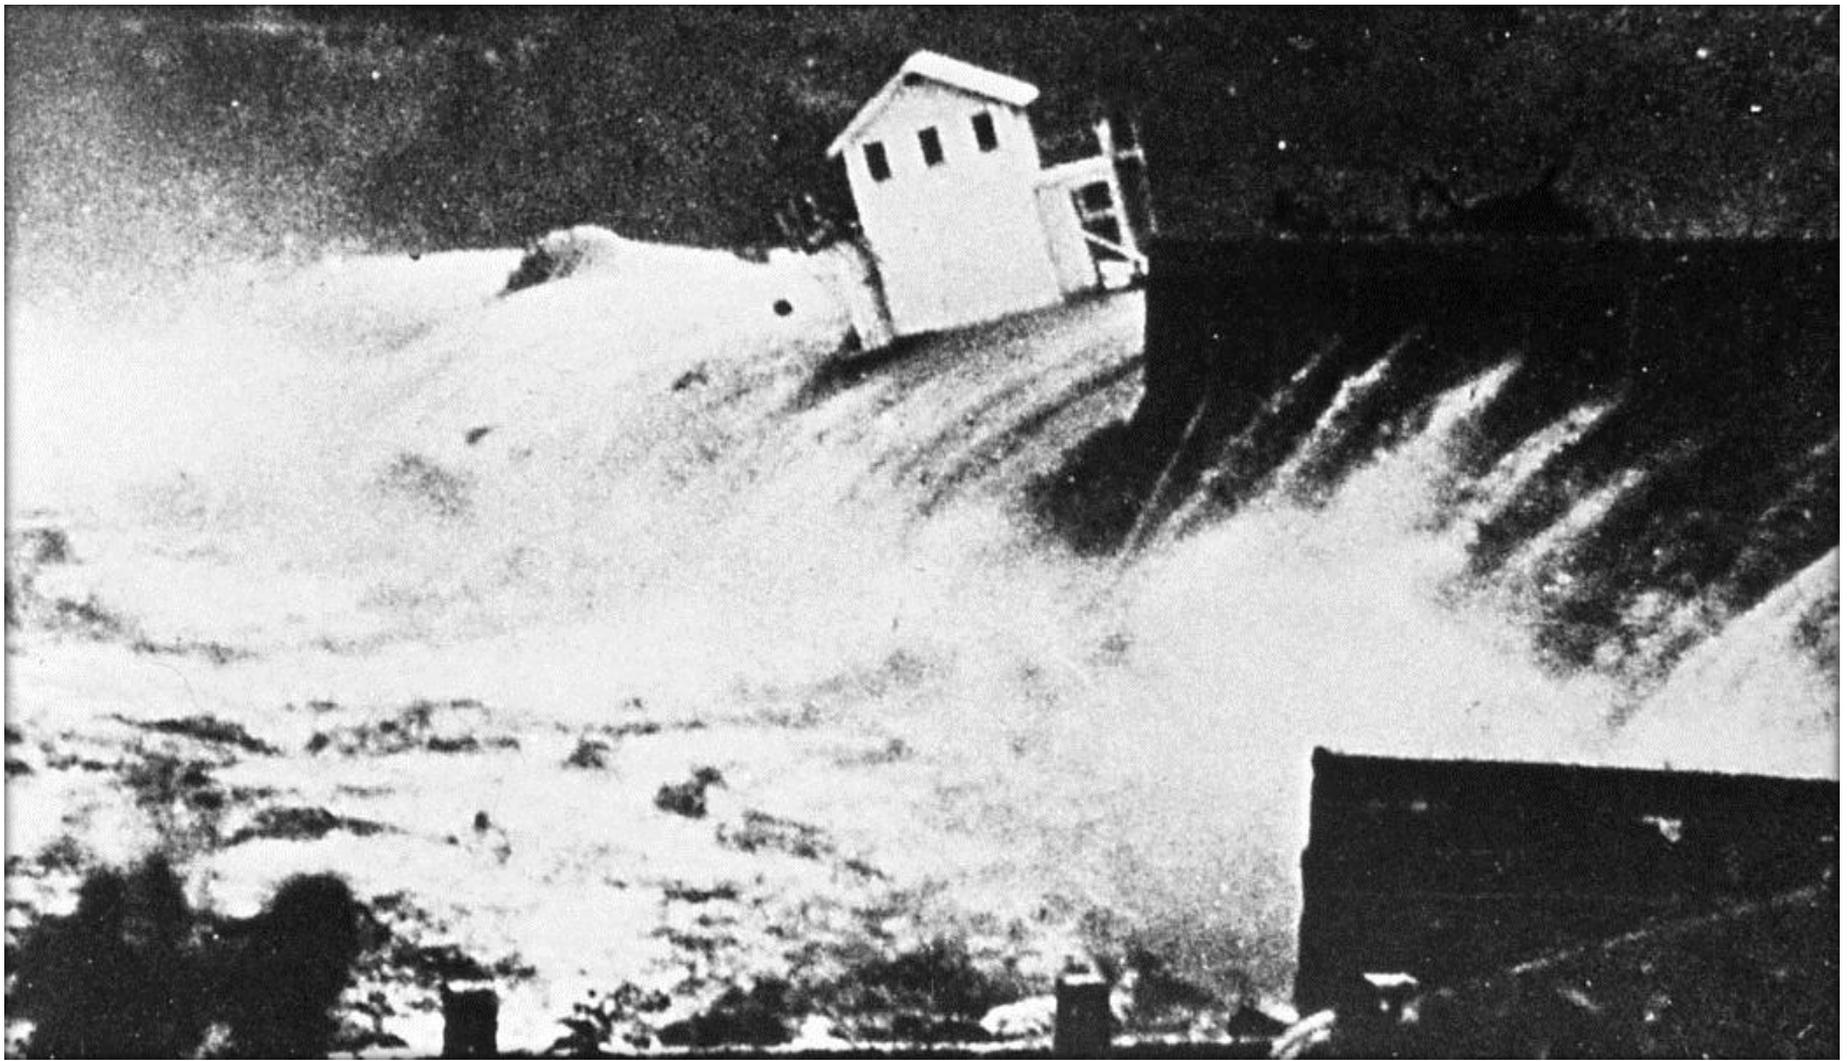
Houseboat over the dam circa 1932

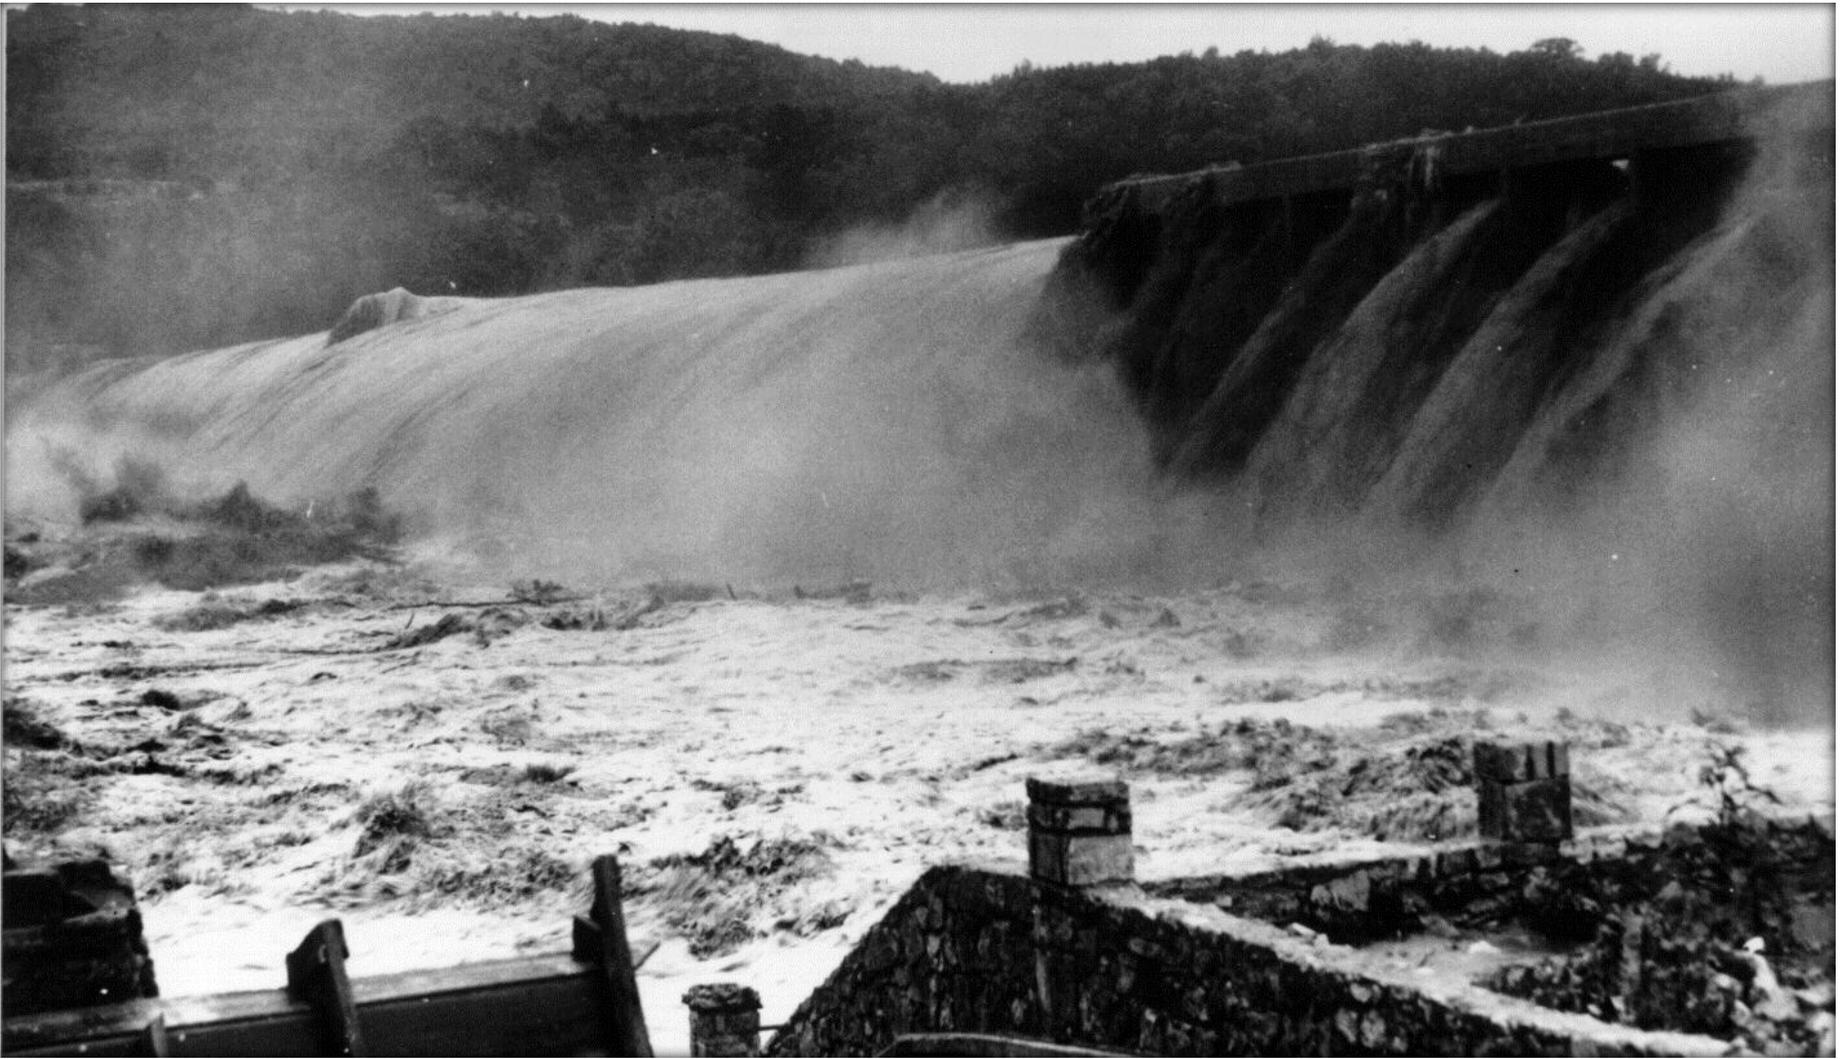
1935 Flood

- ▶ No reconstruction work for a number of years.
- ▶ Several floods occurred, damaging the dam even more; however, there was no failure.
- ▶ The 1935 flood caused considerable damage to the City, resulting in a move to construct other dams upstream of Austin.
- ▶ Mansfield Dam, Buchanan Dam, Tom Miller Dam, Inks Dam, Alvin Wirtz Dam, and Max Starcke Dam were built.
