Texas Dam Failures

- ▶ Since 1900, 171 dams have been reported to have either failed or have been damaged due to overtopping or structural issues.
- ▶ Some of these dam failures were significant due to size, use, or loss of life, which we will discuss.

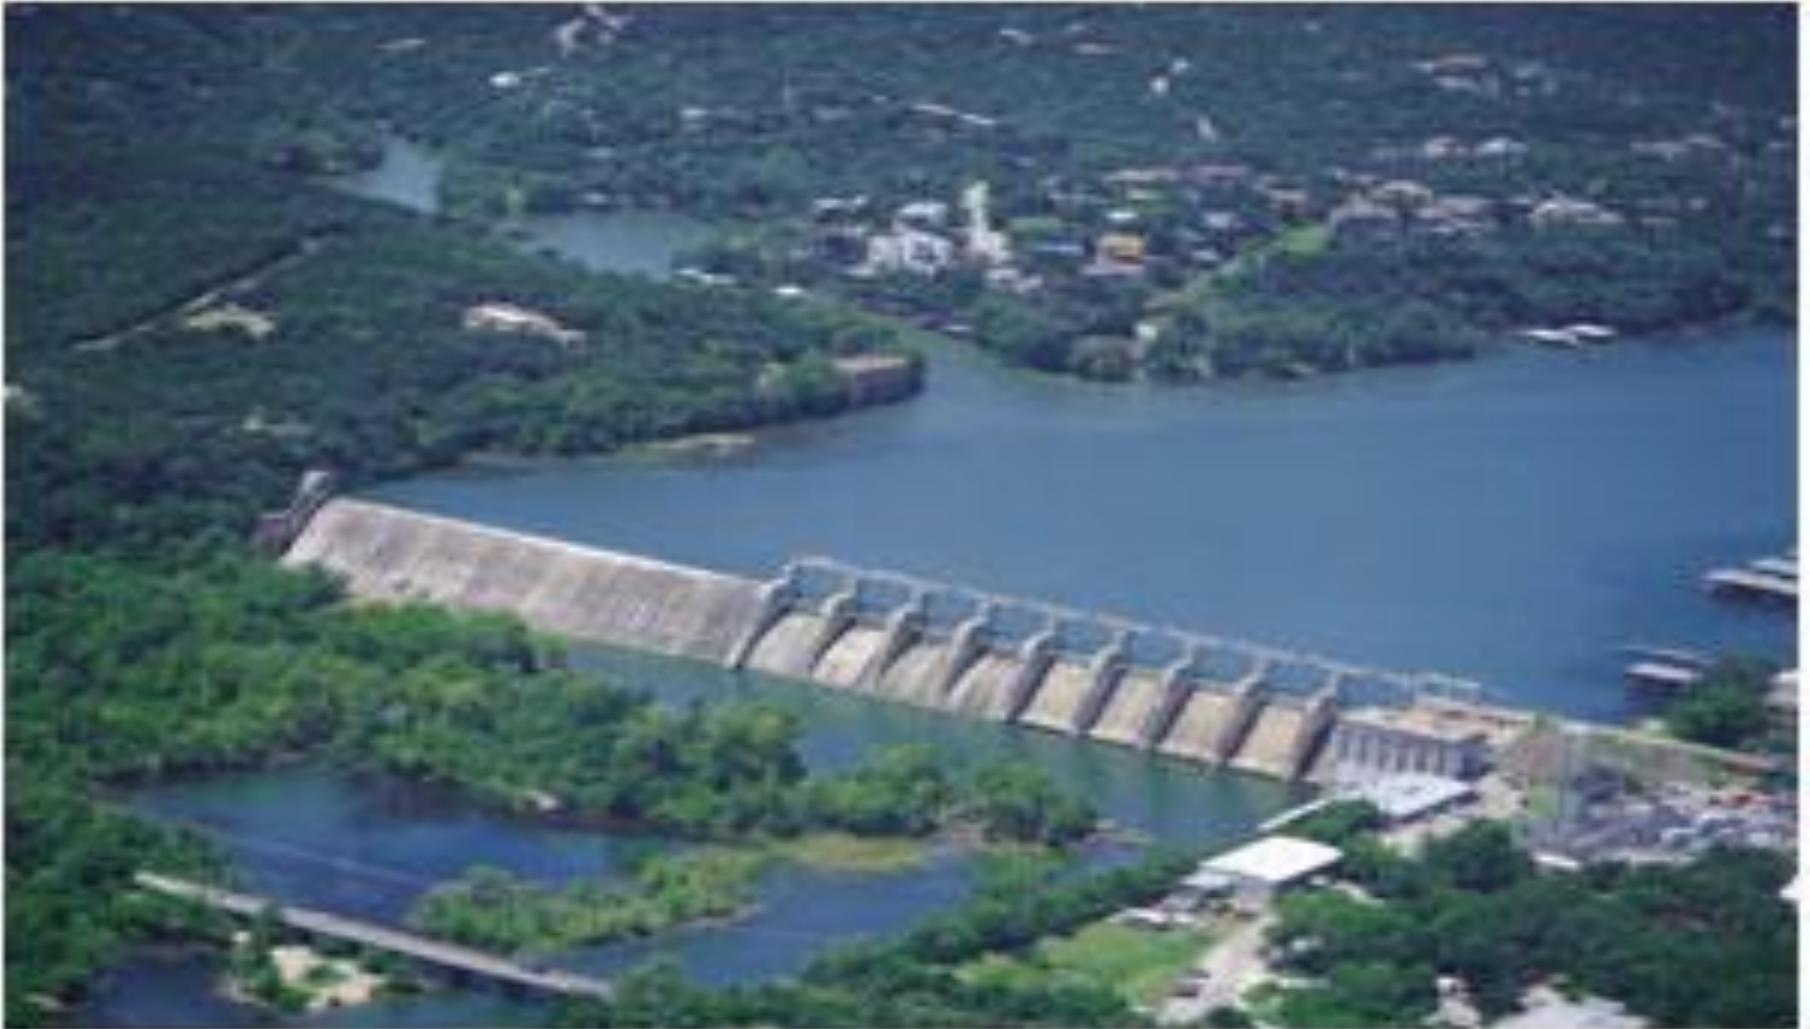
Tom Miller Dam

- ▶ Tom Miller Dam was built in 1940.
- ▶ Portions of the original 1900 dam were left in place.
- ▶ In 2004 – 2005 the dam was anchored to prevent overturning or sliding during the probable maximum flood.

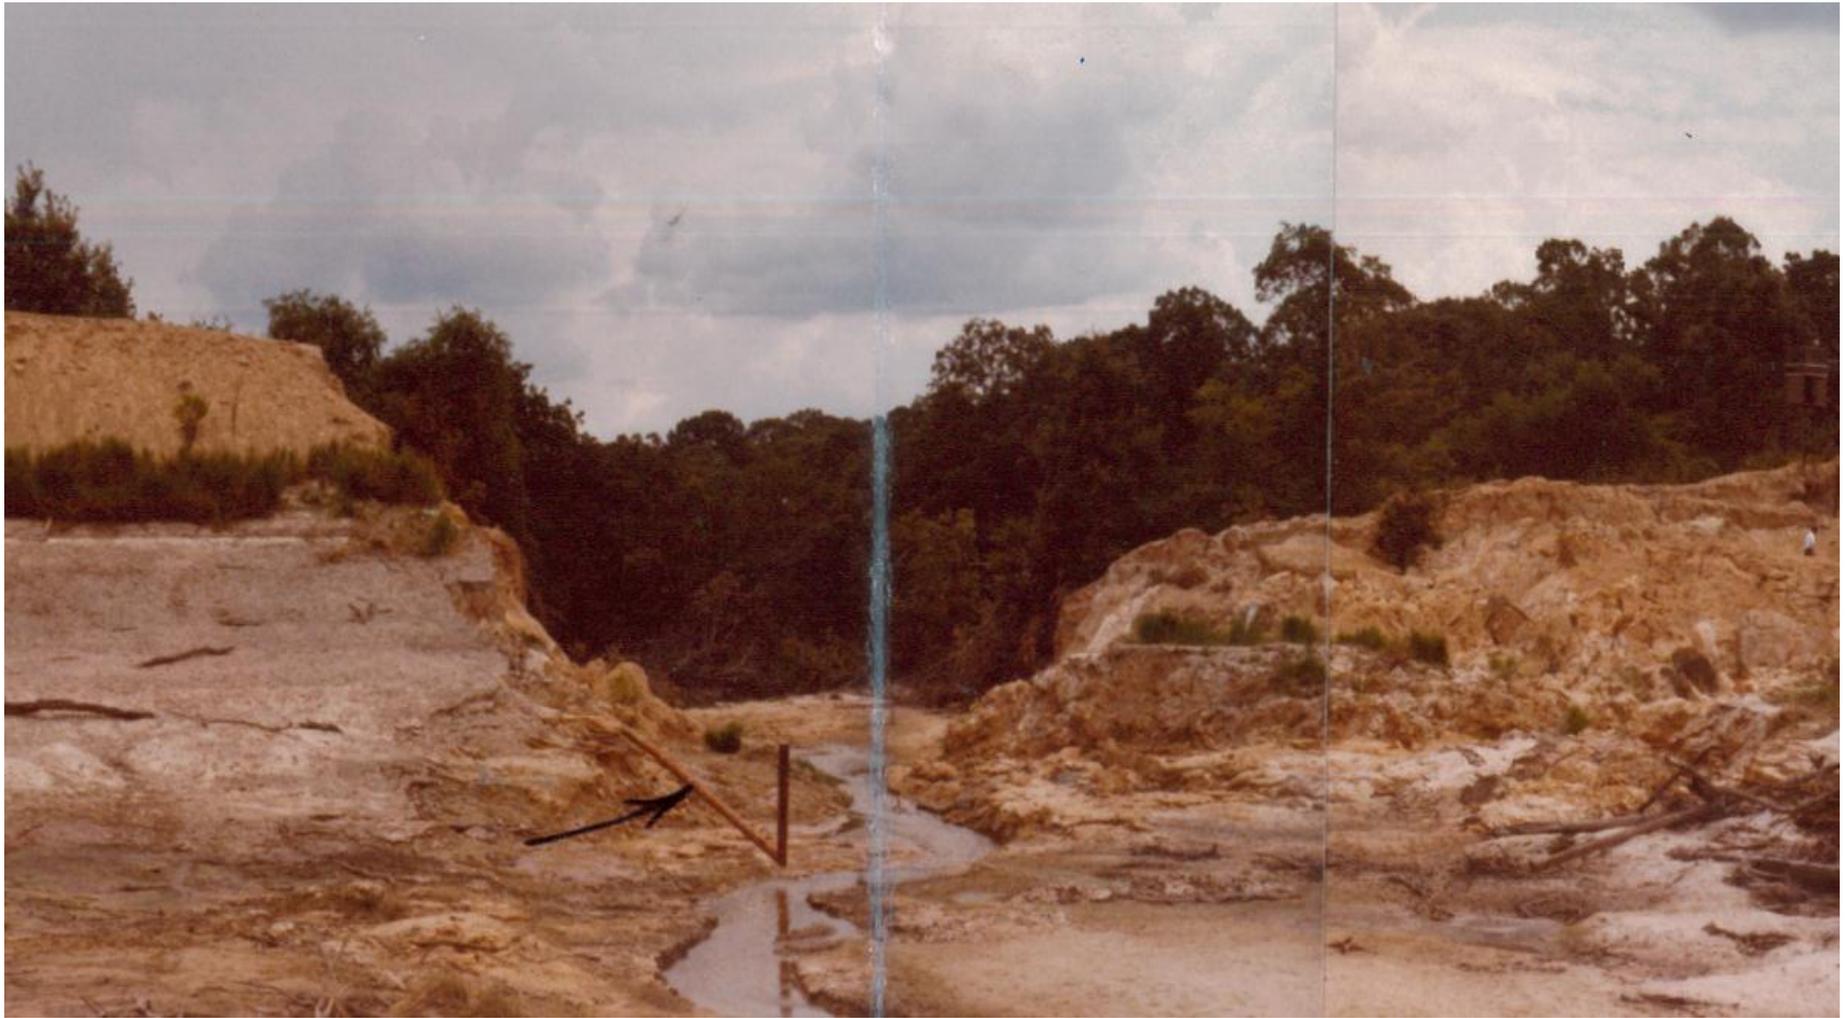
After failure from upstream

- ▶ Dam was cut and water allowed to flow through cut on August 17, 1984.
- ▶ Dam eroded quicker than planned due to sandy material in dam.
- ▶ Slightly over an hour after draining started, soil in the lake bottom started to move.
- ▶ Then the entire upstream slope and the crest at the right end moved toward the lake due to the rapid drawdown.

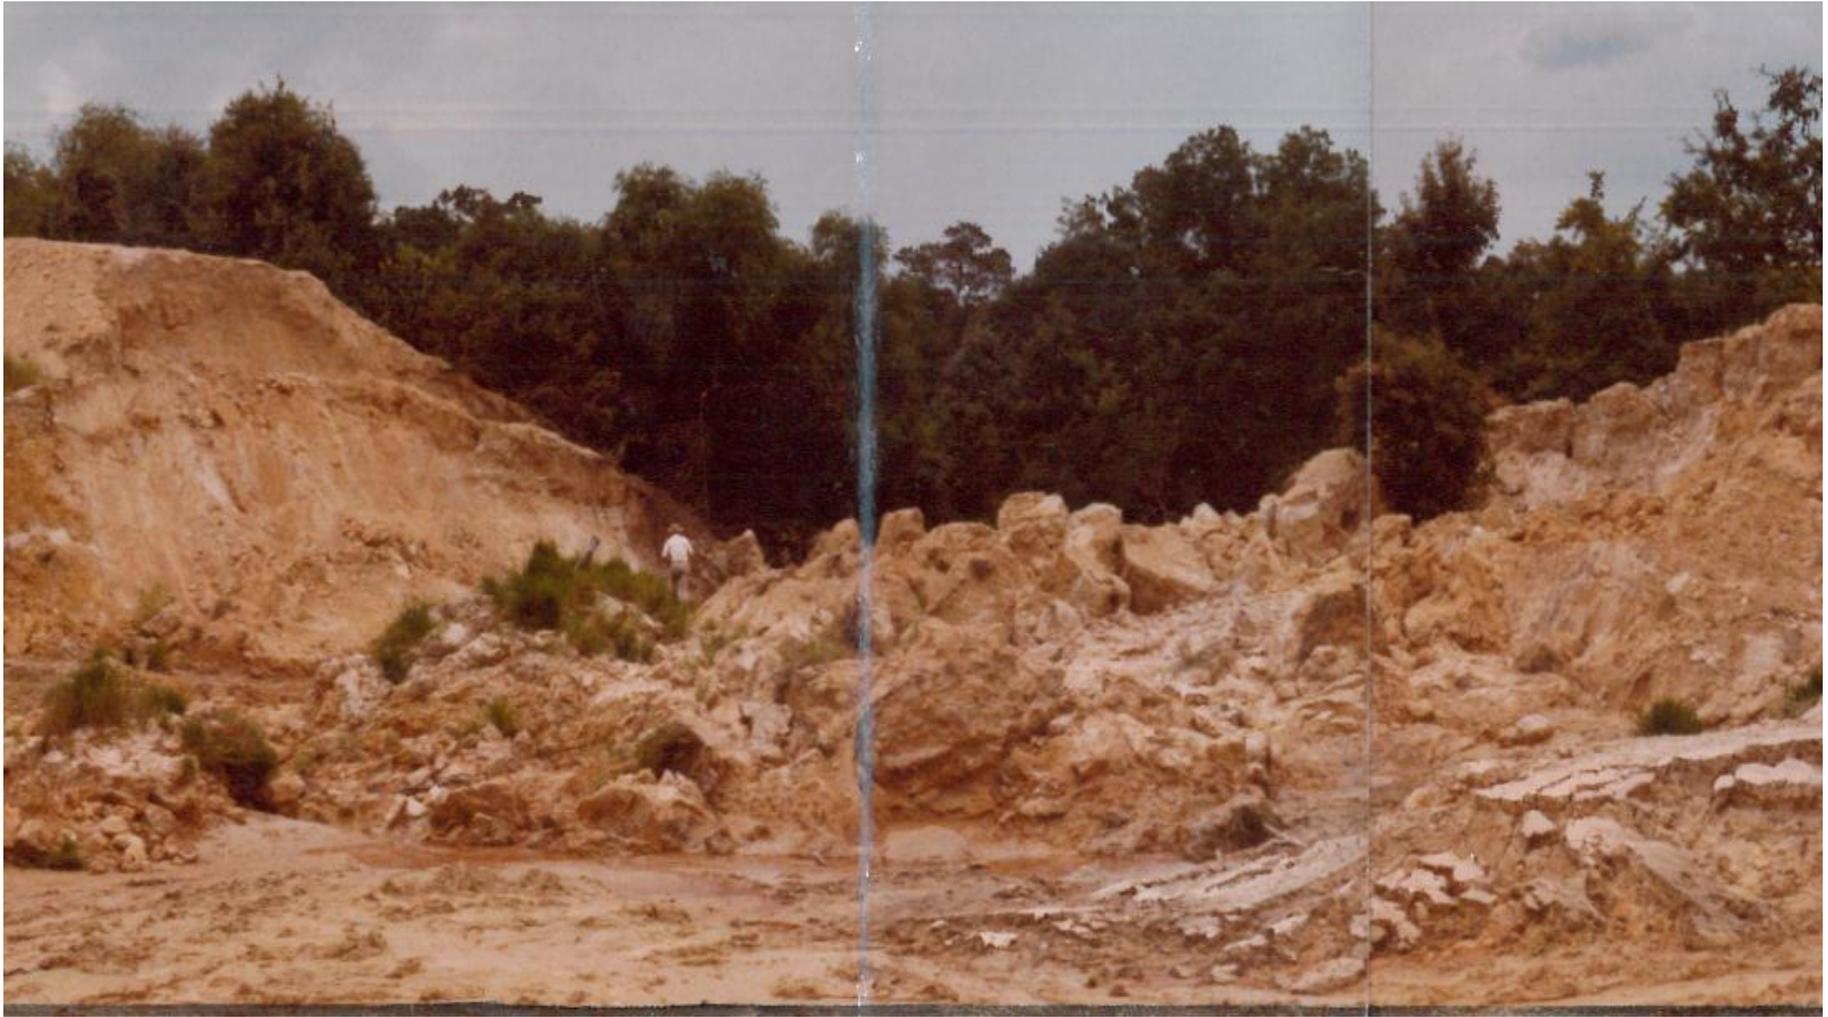
Failure from right side

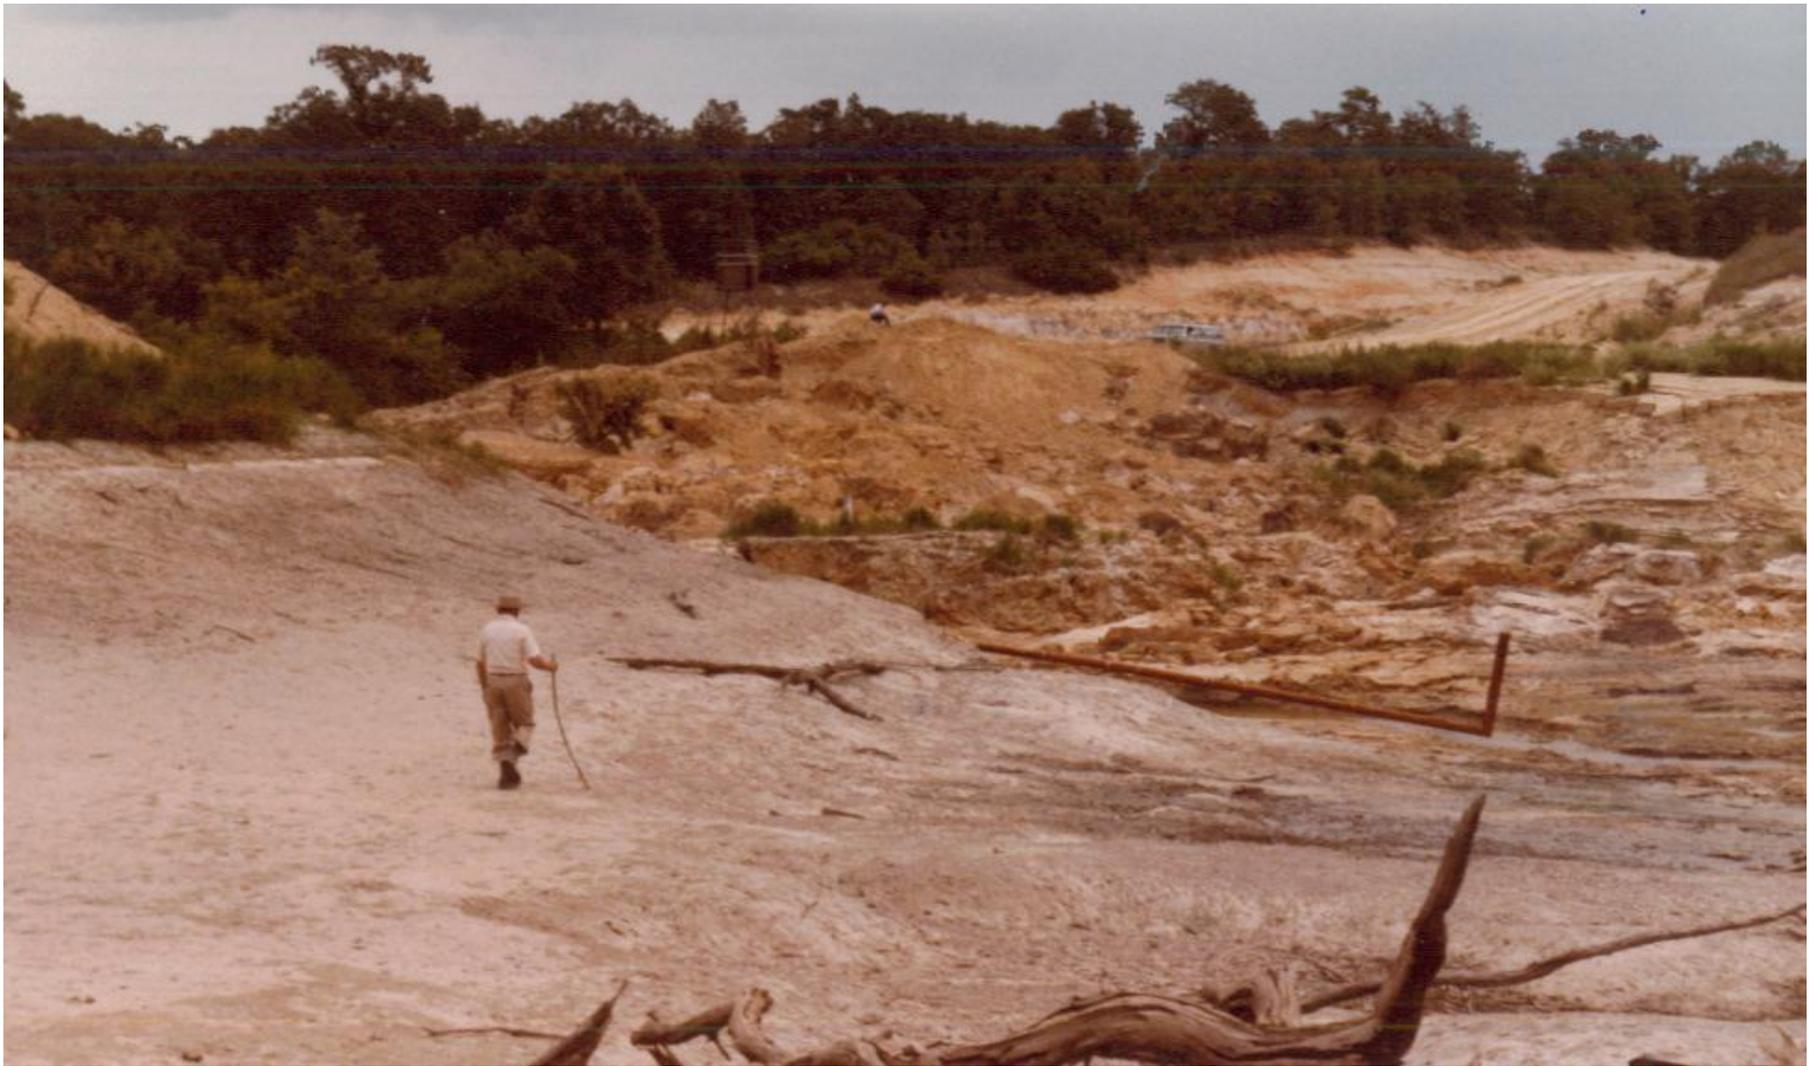
View of failure from left end of dam

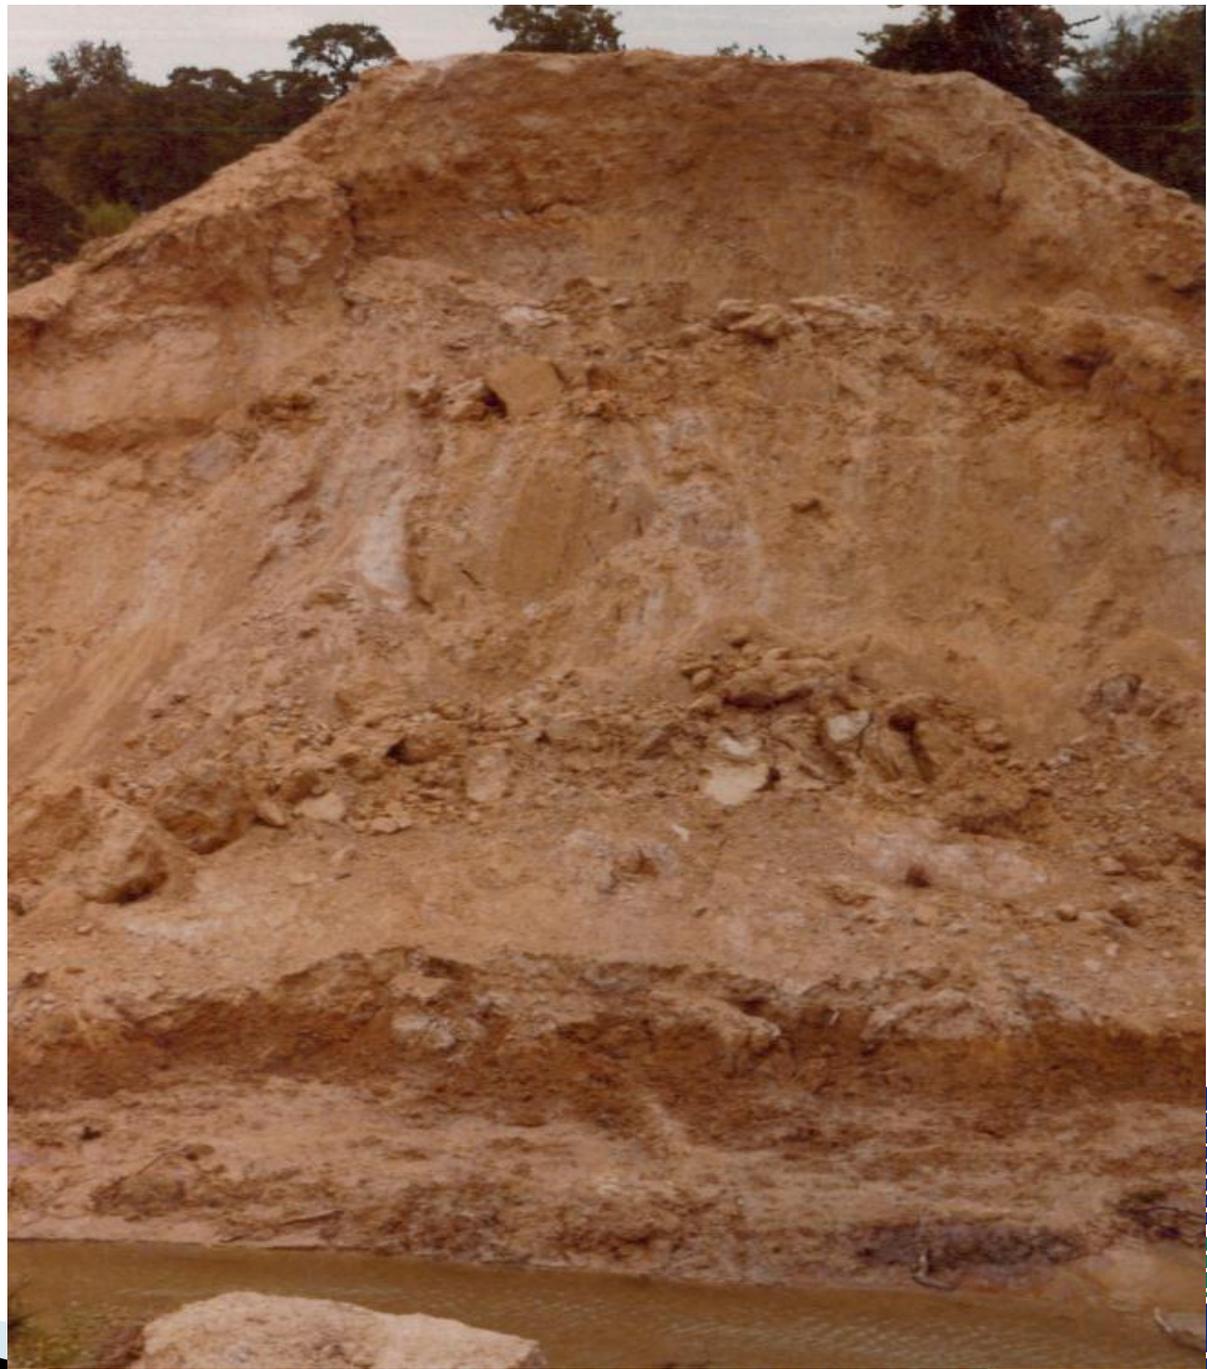
Side slope of failure

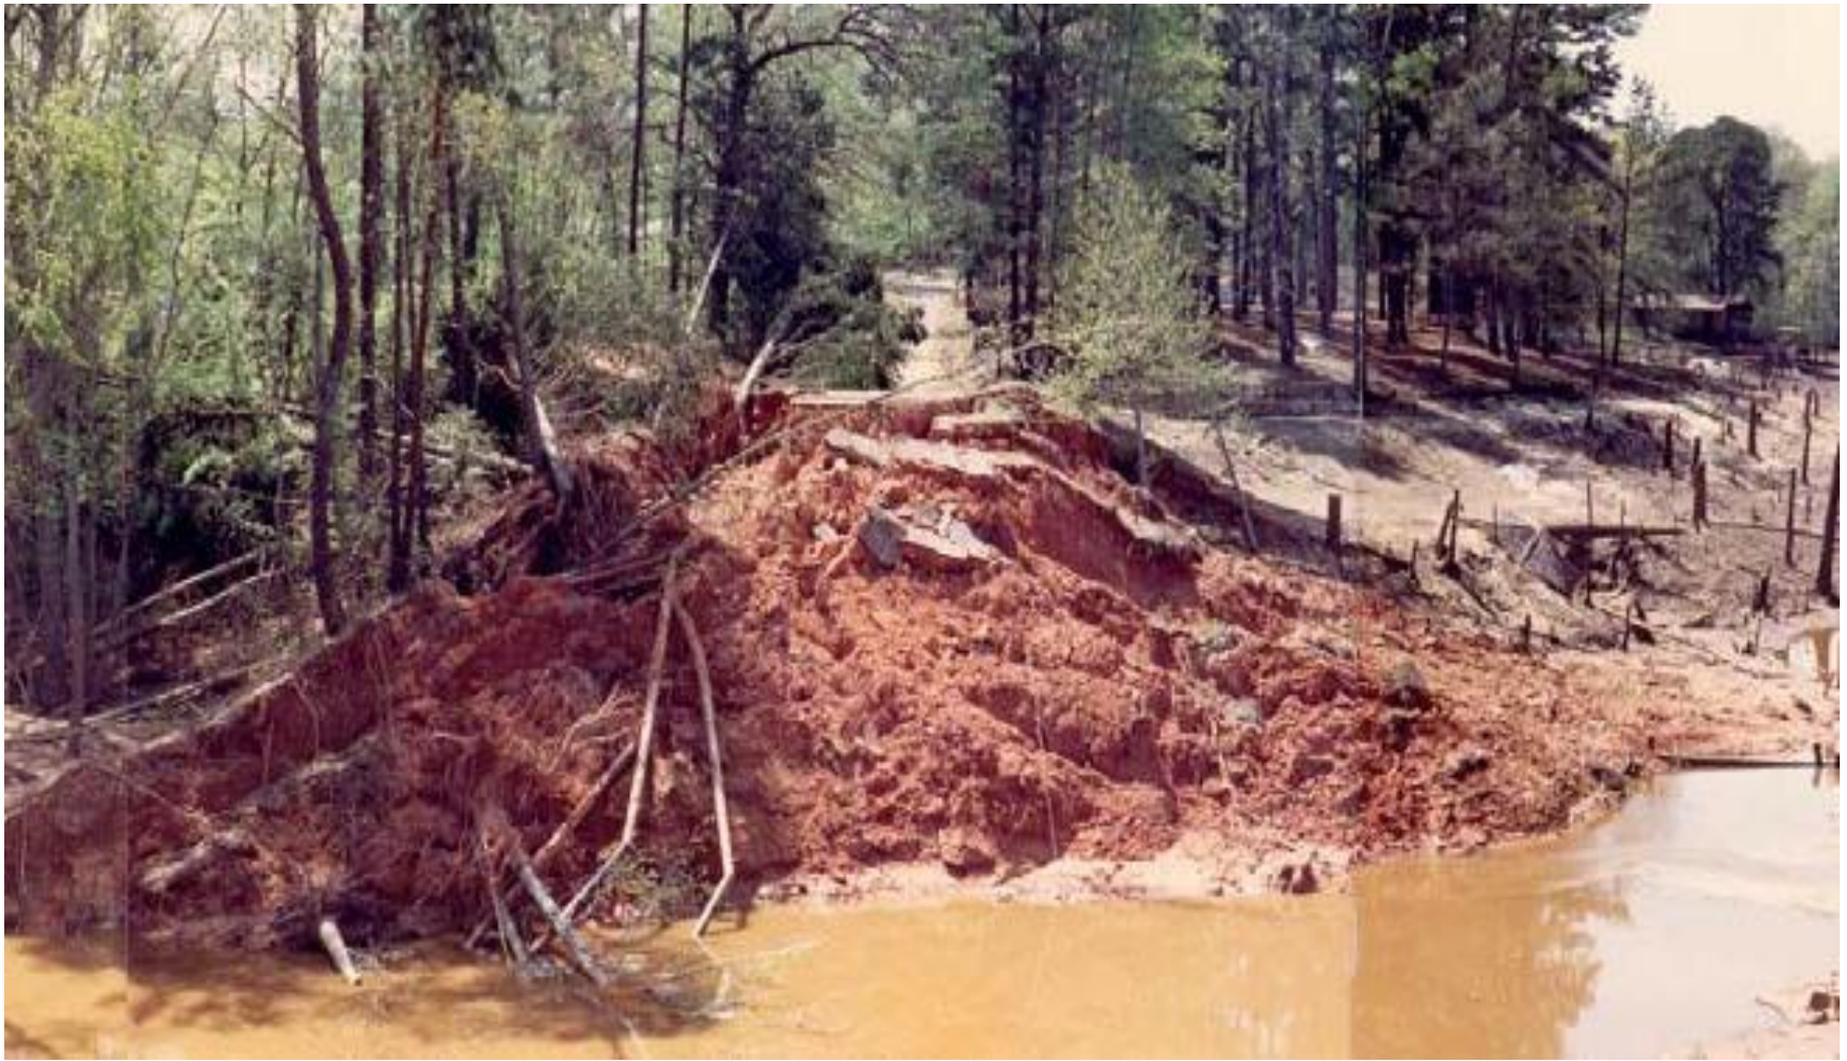
Failure March 1989

- ▶ Under-designed spillway with blocked fish screen across entrance.
- ▶ Questionable construction materials (mostly sands).
- ▶ Possible toppling of trees due to high winds with the root balls creating low areas on the crest.
- ▶ Sandy soils easily erodible.
- ▶ Overtopping of the dam.

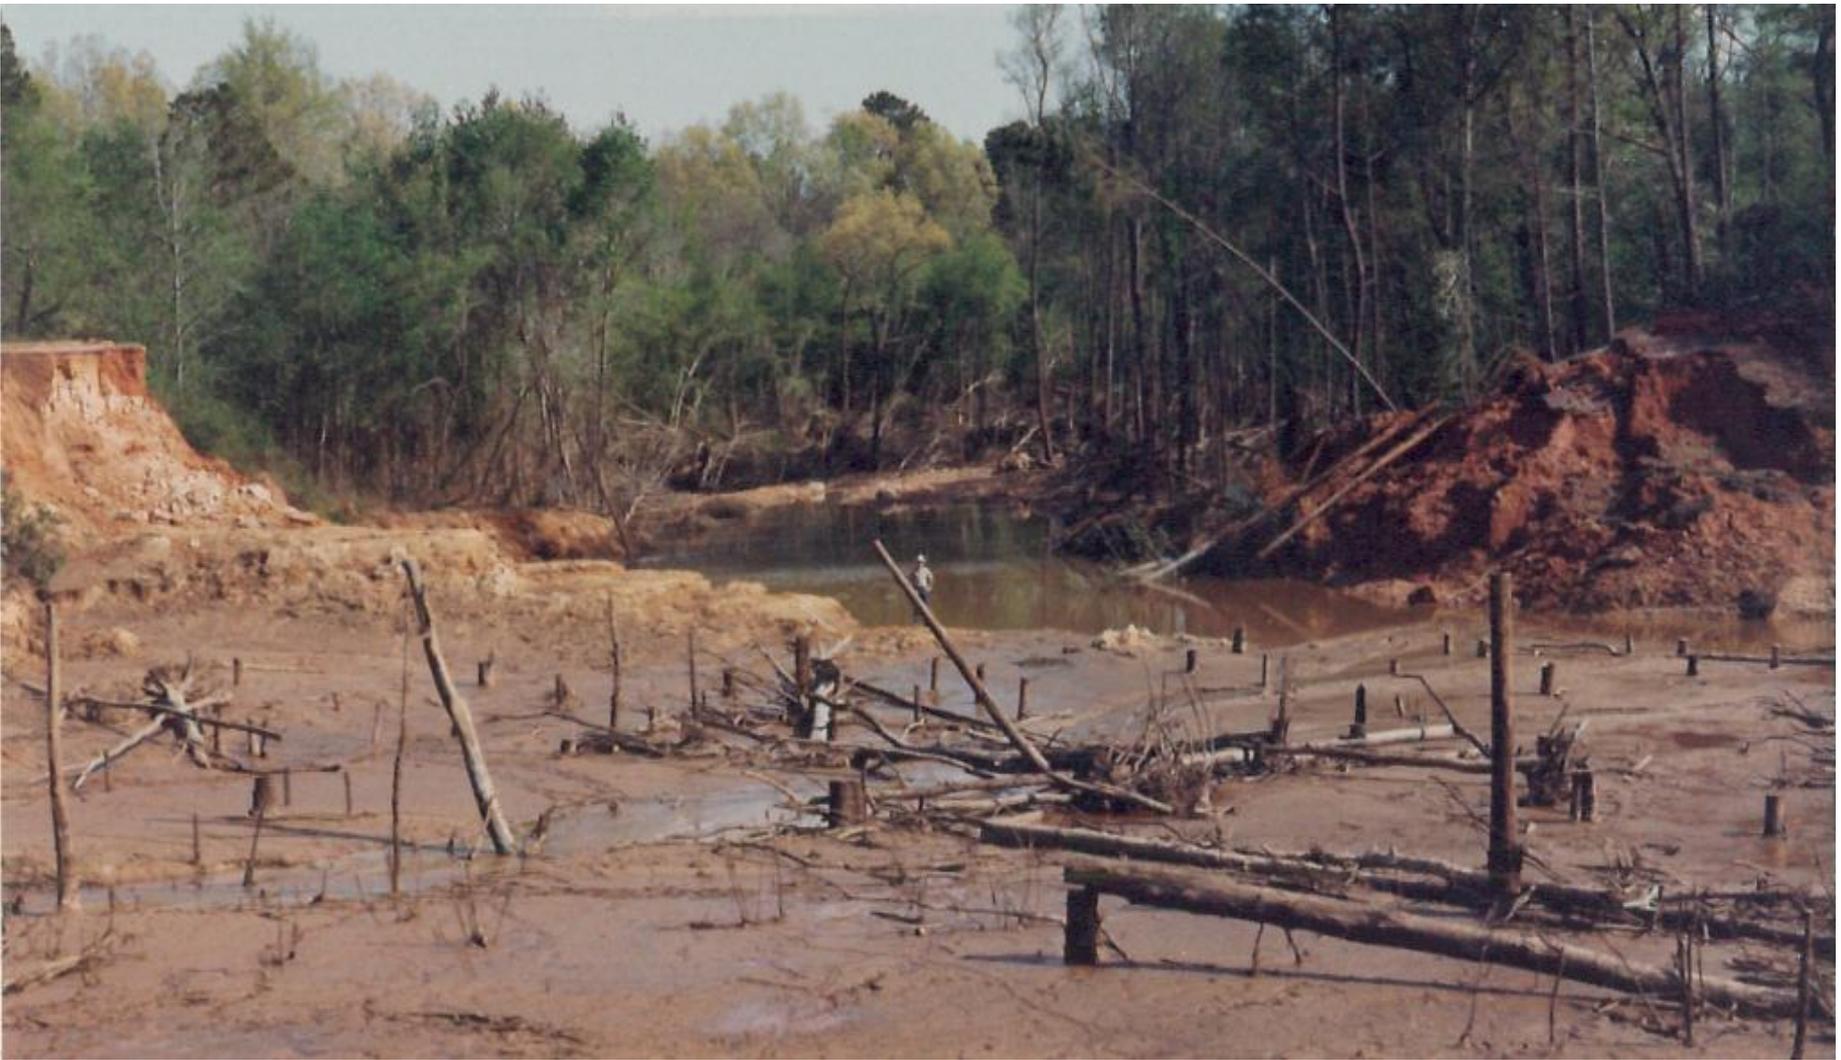
Failure width

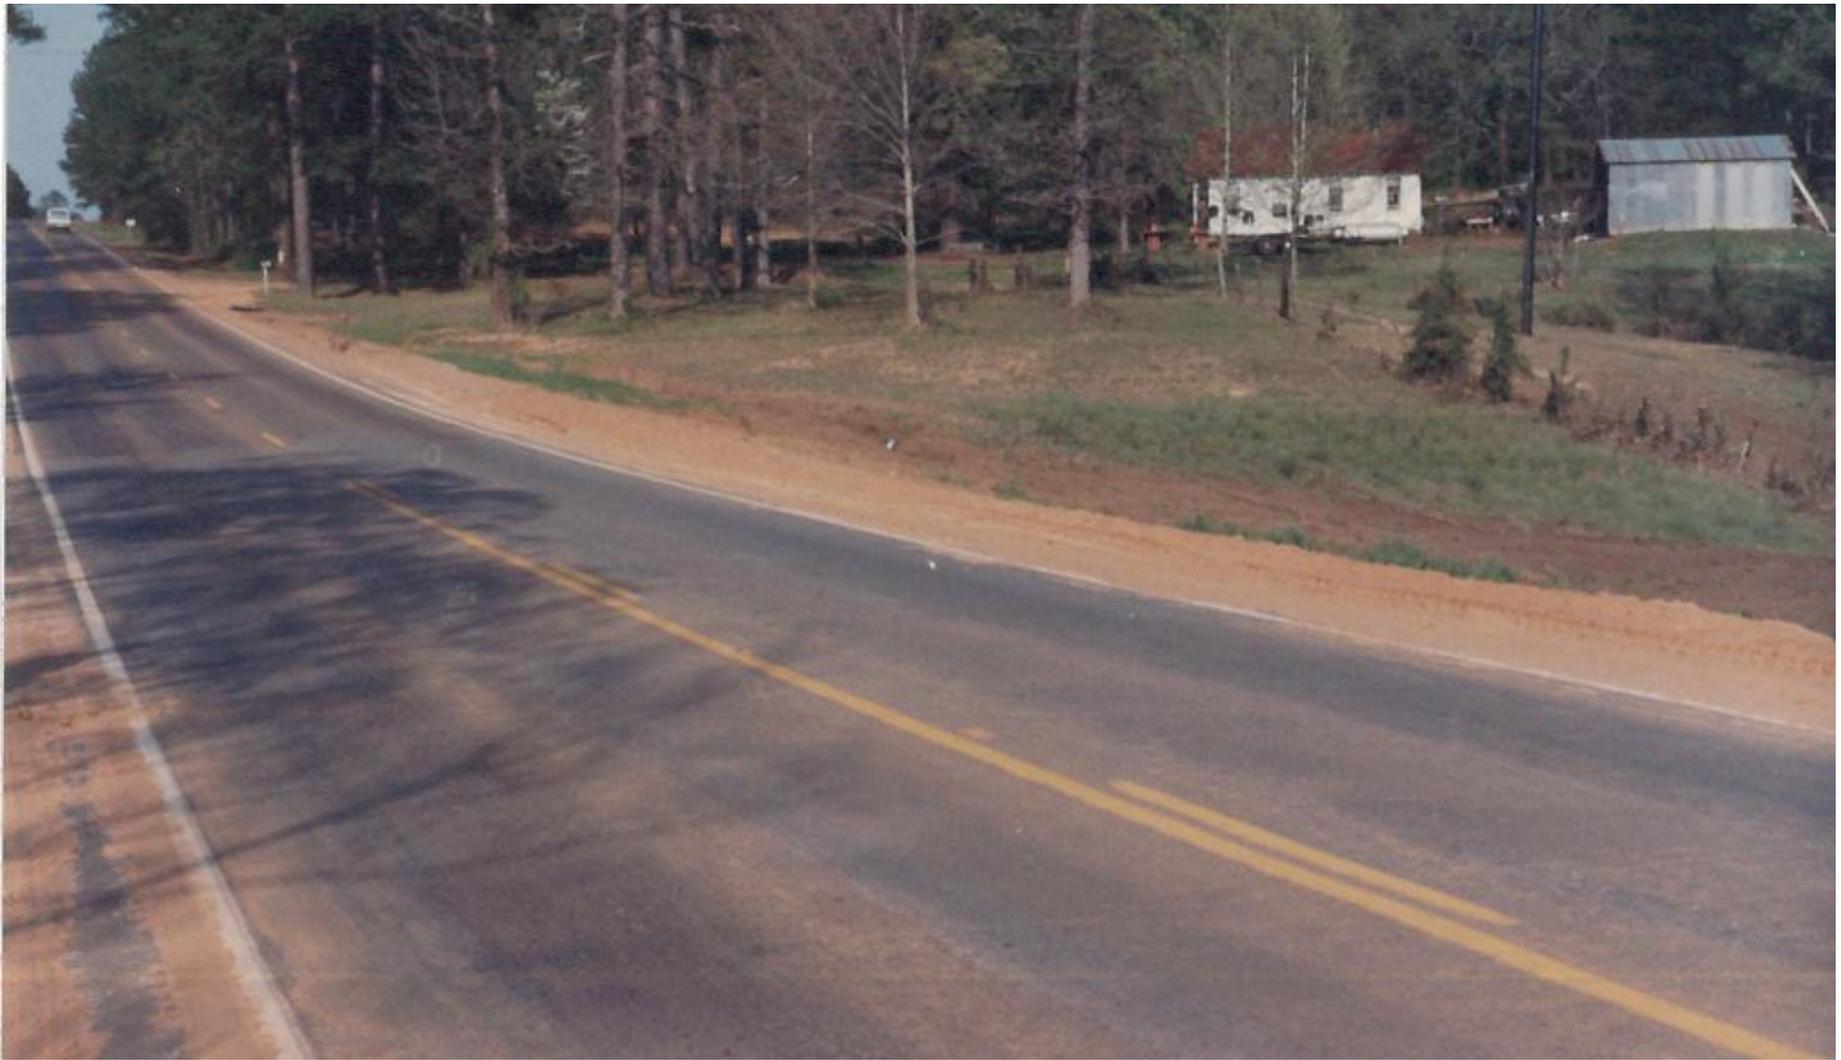
- ▶ Flooded State Highway downstream.
- ▶ Came within ½ foot of a house downstream of the highway.
- ▶ 51 foot railroad embankment downstream of highway detained the water and backed it up over the highway, reportedly 29.5 feet deep.
- ▶ One man died after driving into the water over the highway.

Downstream highway and house

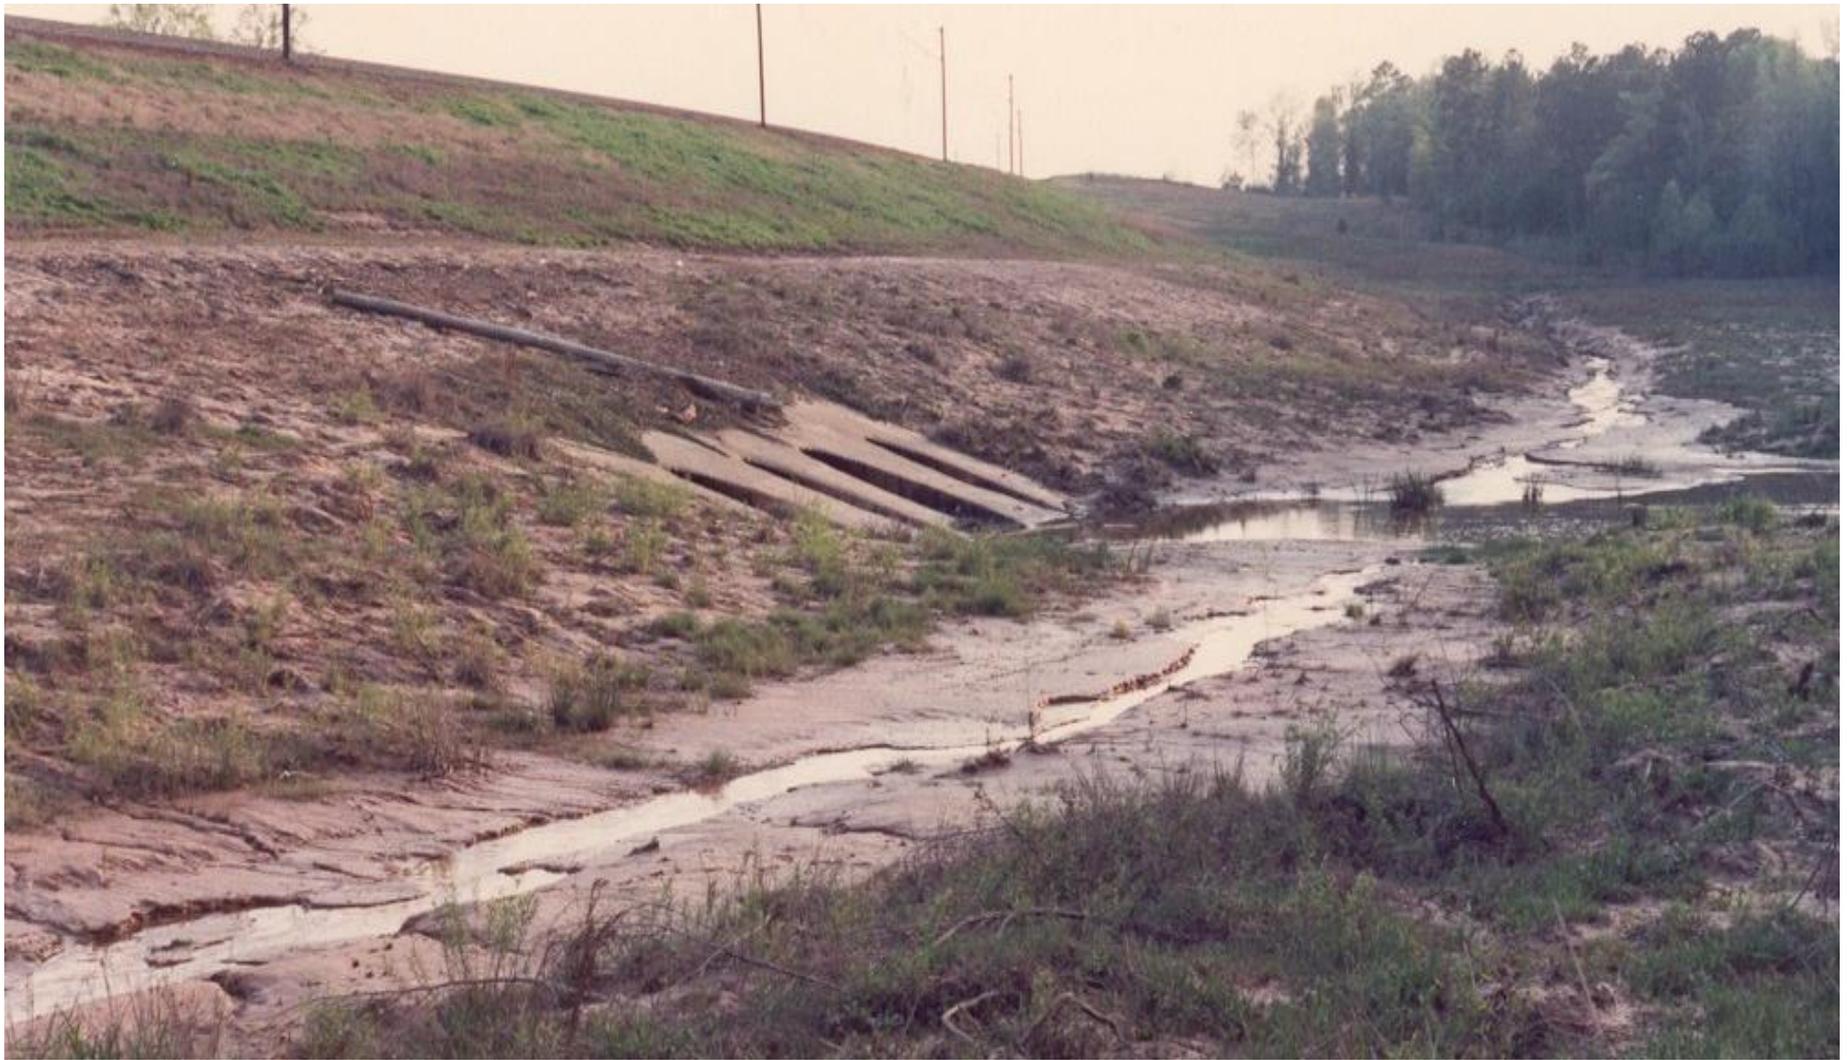
Downstream railroad embankment

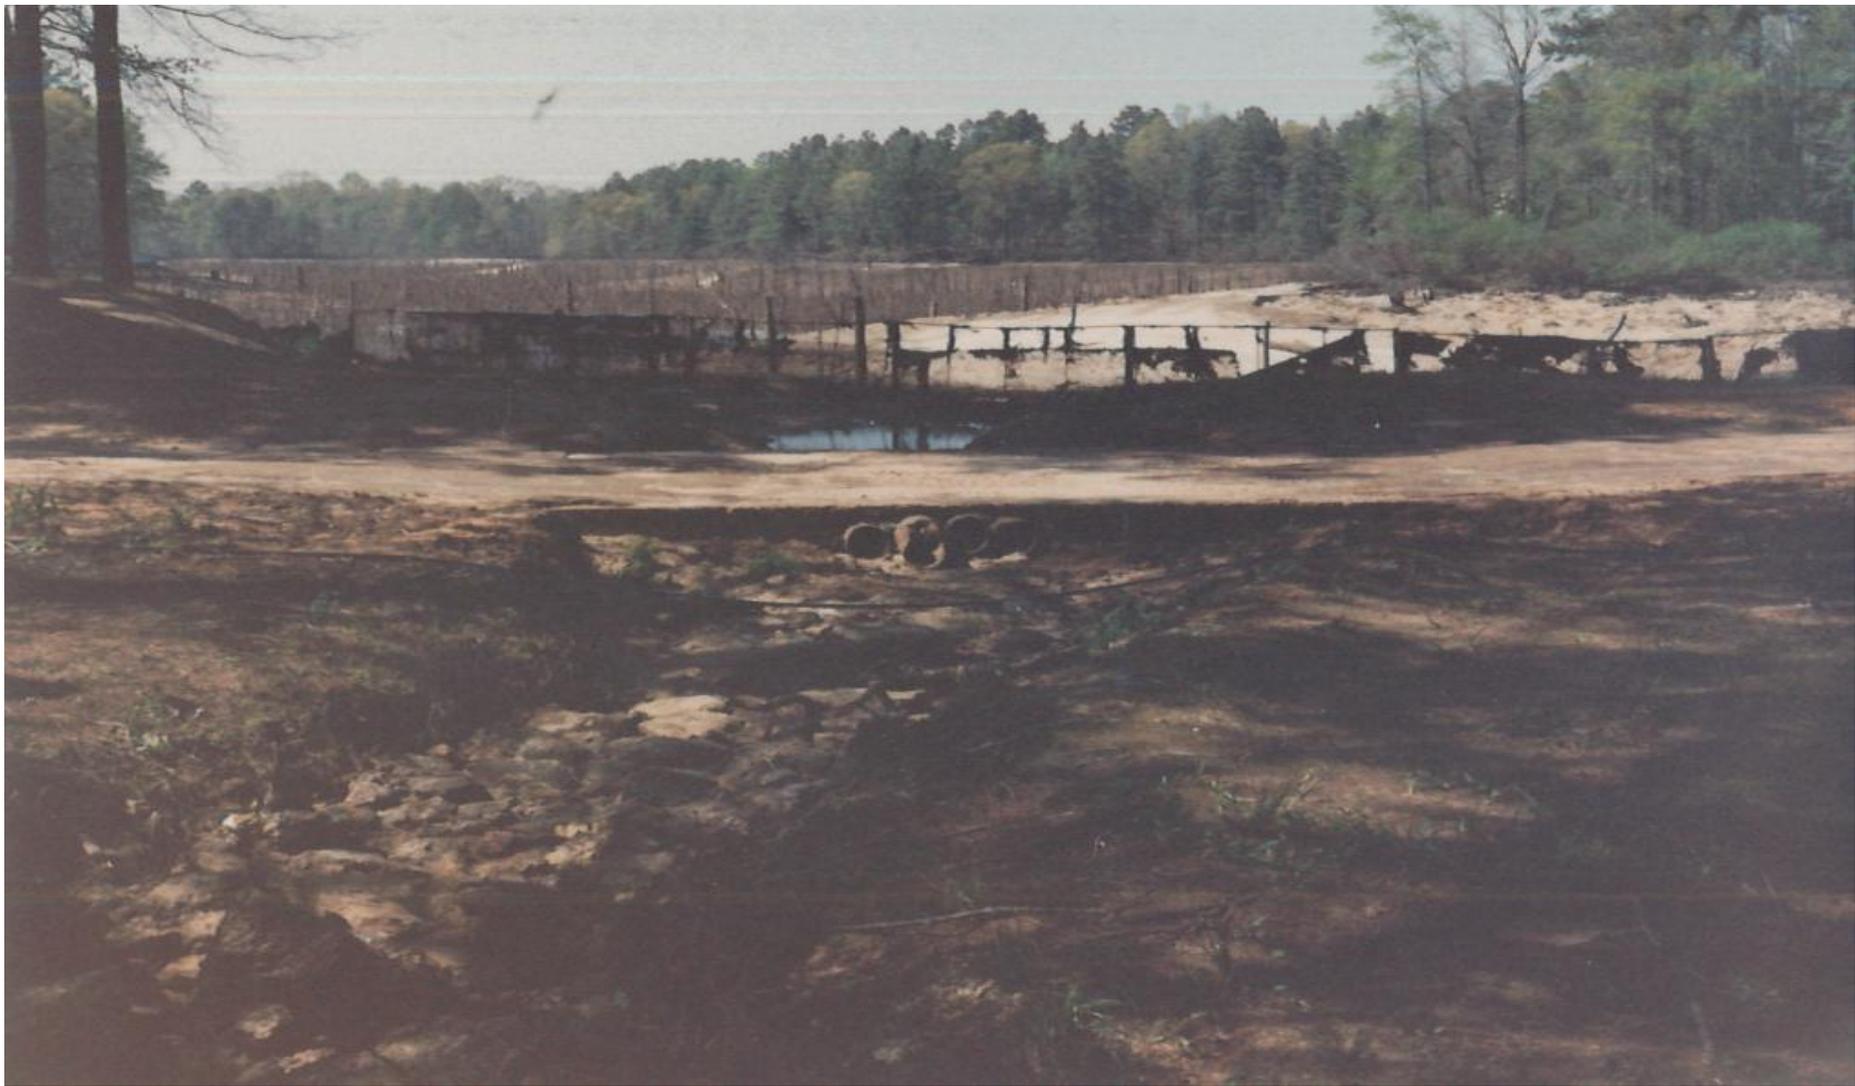
Partially blocked fish screen

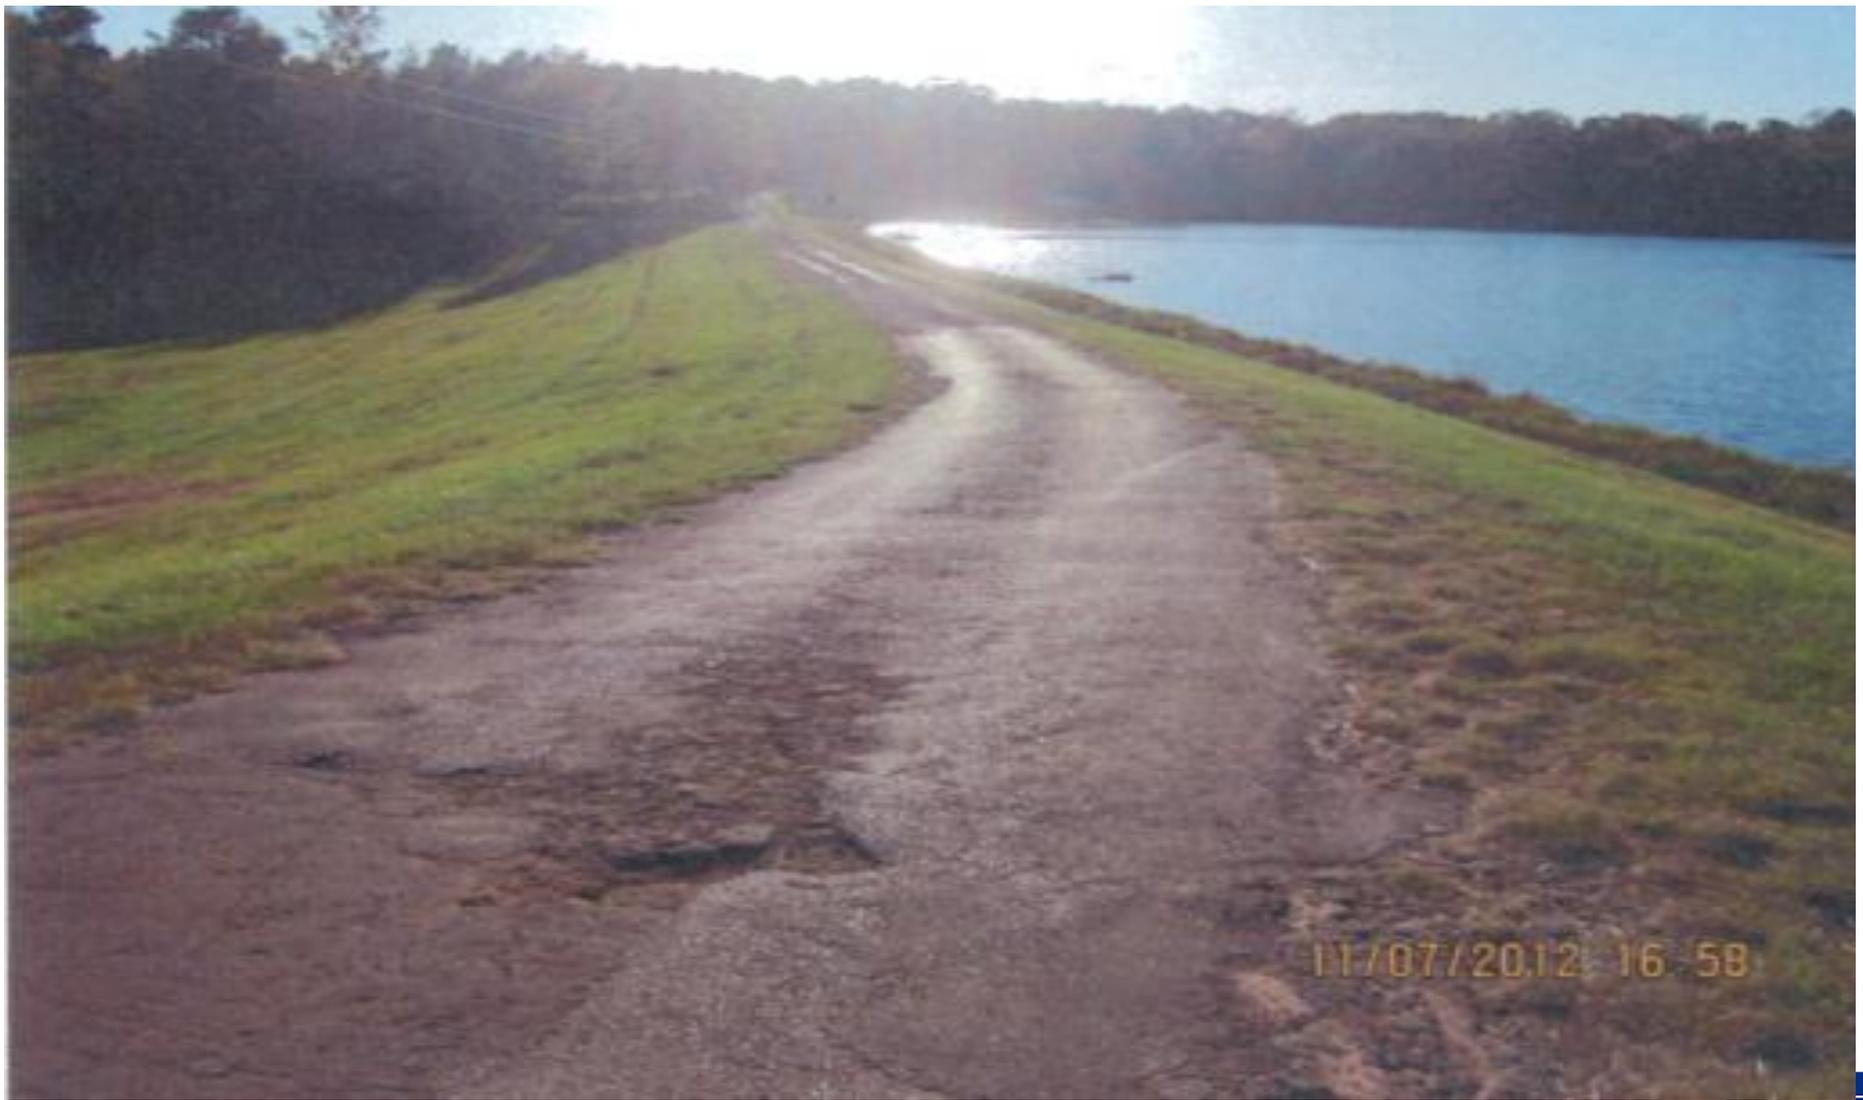
Nix Lake Dam 2012

- ▶ Media coverage on site.
- ▶ Law suits.
 - Dam Safety Program staff provided depositions and copies of material.
 - Law suit reportedly settled outside the courts.
- ▶ Dam eventually rebuilt without knowledge of Dam Safety Program.
