Texas Dam Failures

- ▶ Since 1900, 171 dams have been reported to have either failed or have been damaged due to overtopping or structural issues.
- ▶ Some of these dam failures were significant due to size, use, or loss of life, which we will discuss.

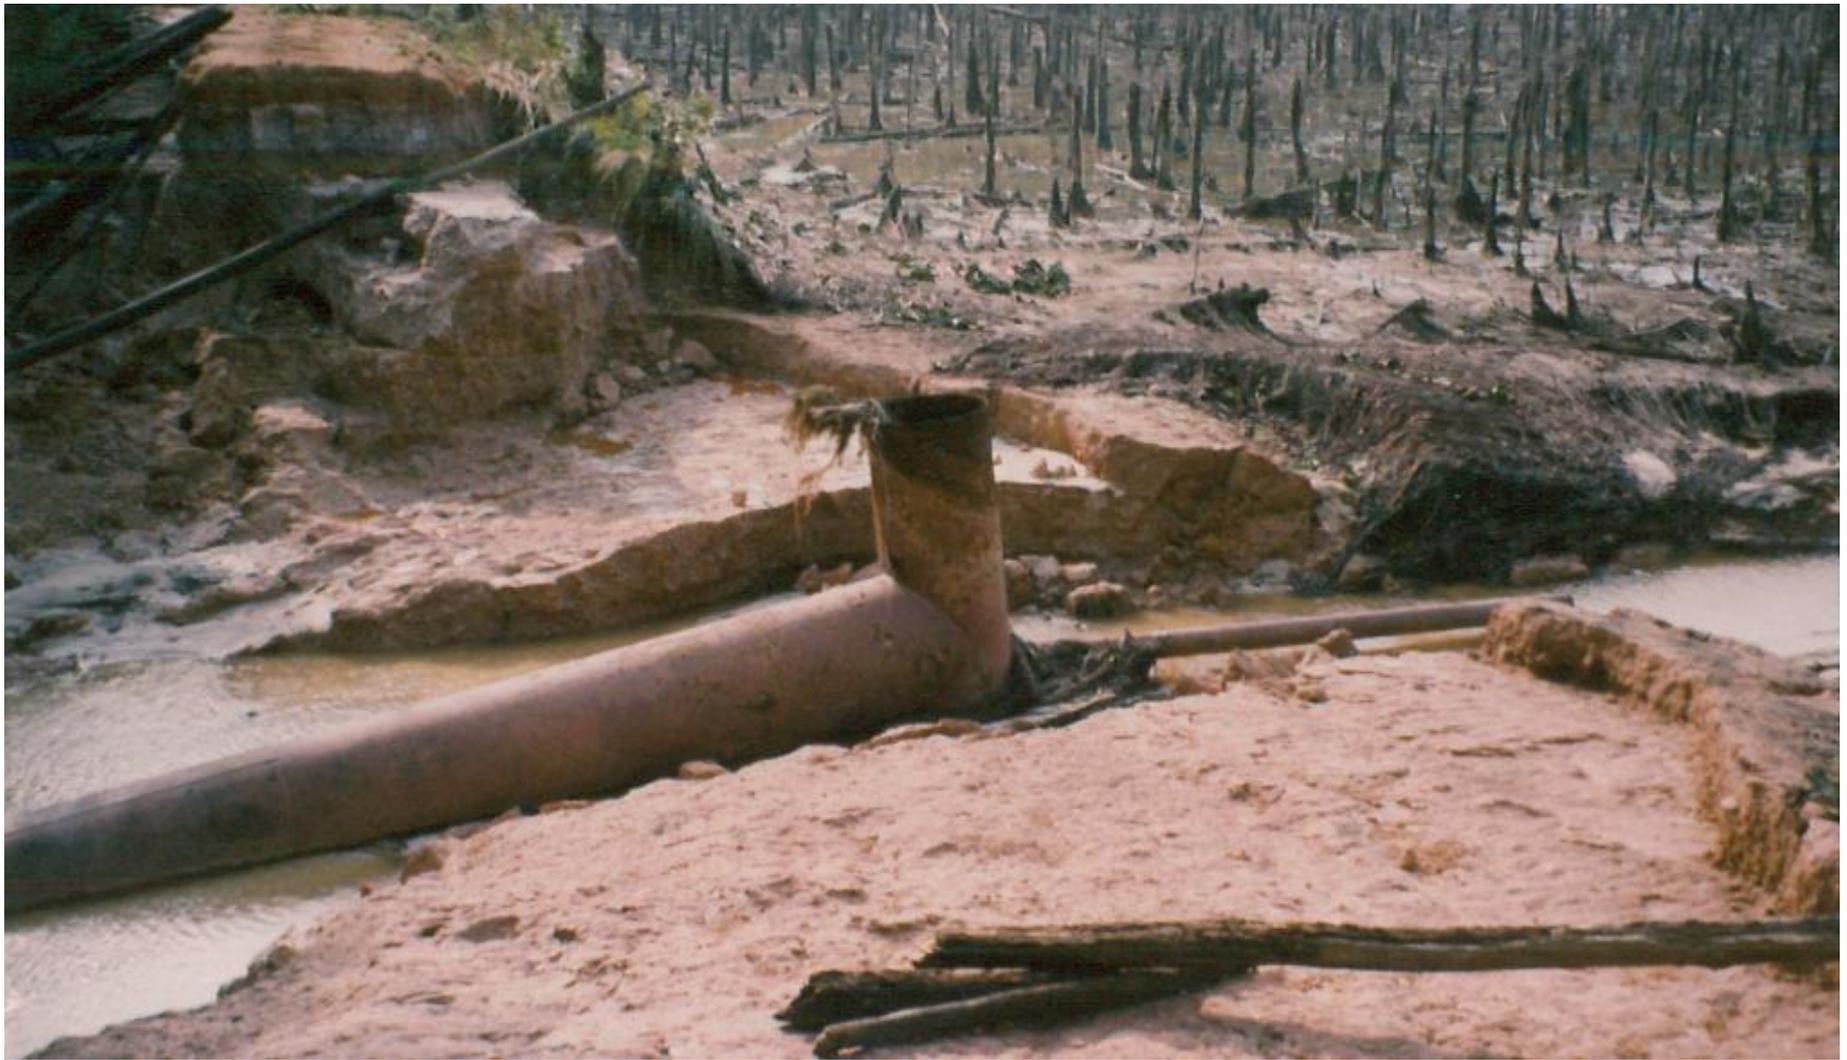
Boykin Lake Dam failure September 1996

- ▶ Statistics:
 - 12 feet high.
 - 23 acre-feet normal capacity.
 - 57 acre-feet maximum capacity.
 - Significant hazard.
- ▶ Breached in two places from overtopping by 2 feet.
 - First breach: top width 130 feet; bottom width 100 feet.
 - Second breach: top width 60 feet; bottom width 40 feet.
- ▶ Sandy soils in embankment.
- ▶ Now exempt

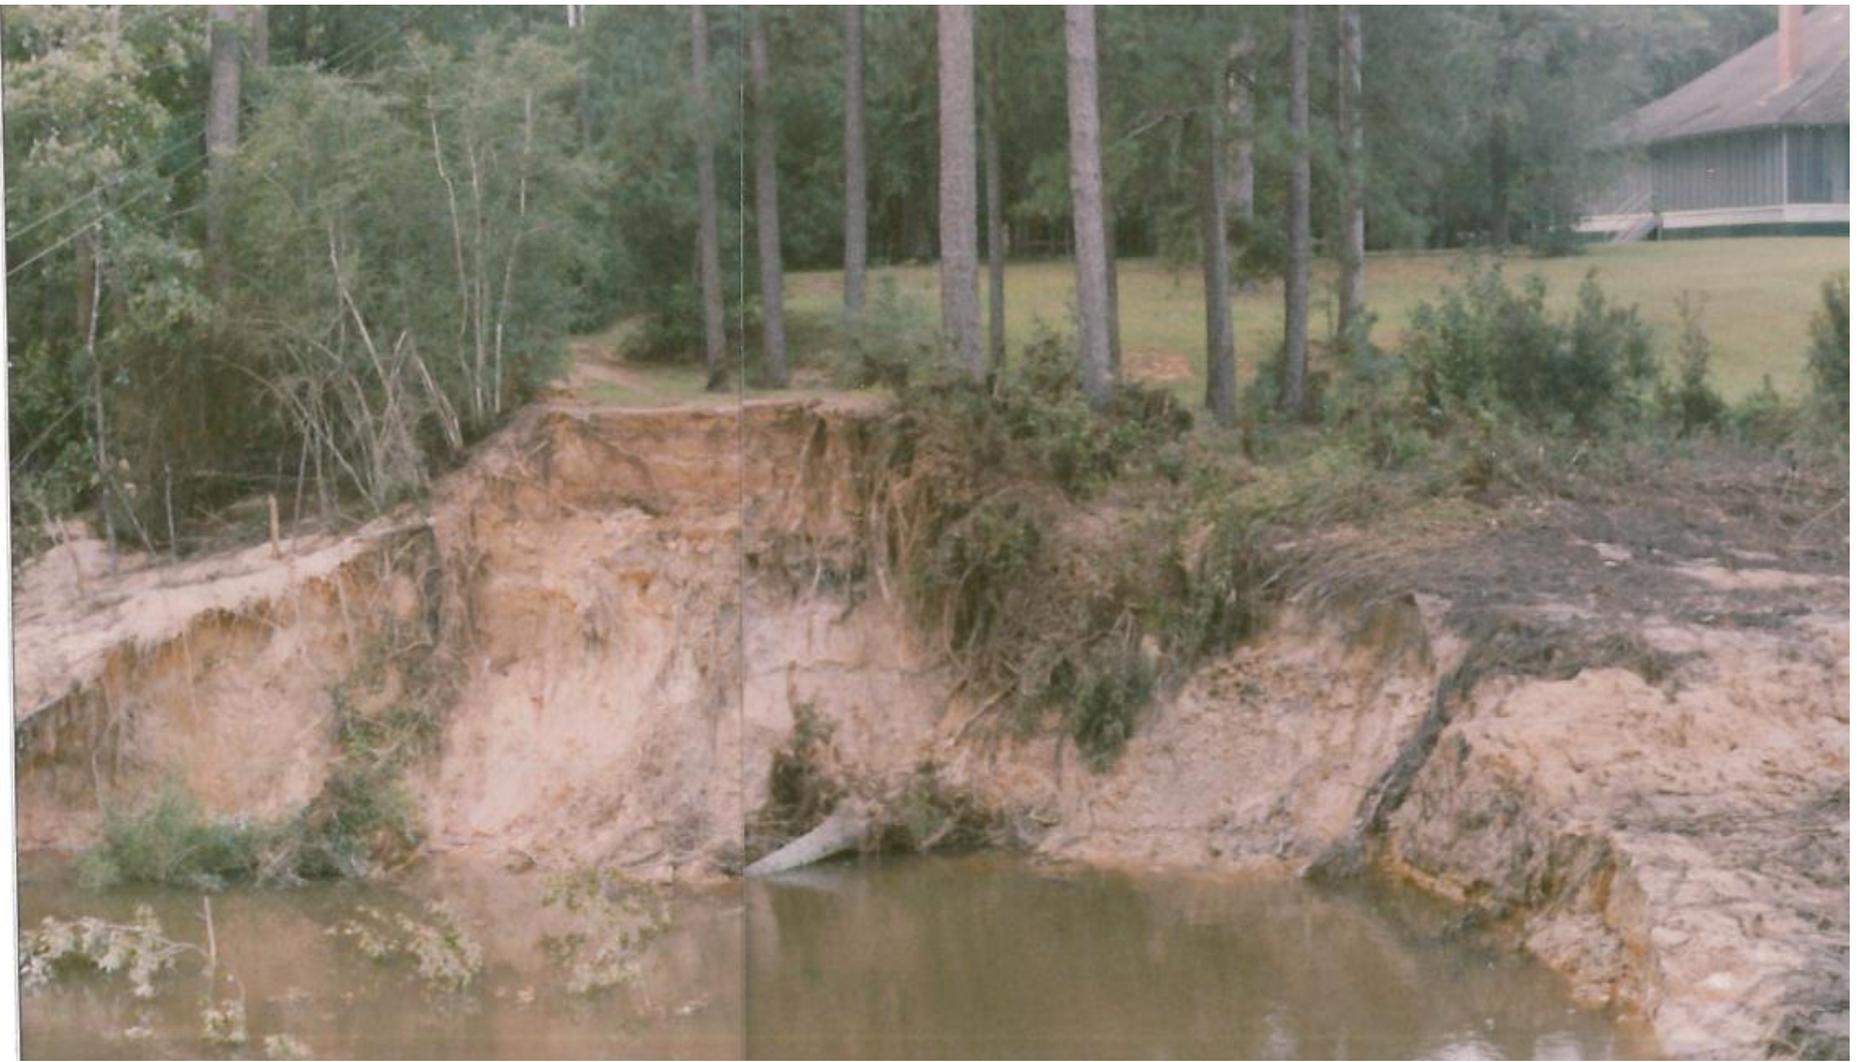
Sutton Lake Dam failure September 1996

- ▶ Statistics:
 - 13 feet high.
 - 164 acre-feet normal capacity.
 - 210 acre-feet maximum capacity.
 - Significant hazard.
- ▶ Breached from overtopping by 2 to 3 feet.
- ▶ Top width of breach: 125 feet.
- ▶ Bottom width of breach: 75 feet.
- ▶ Sandy soils in embankment.
- ▶ Now exempt

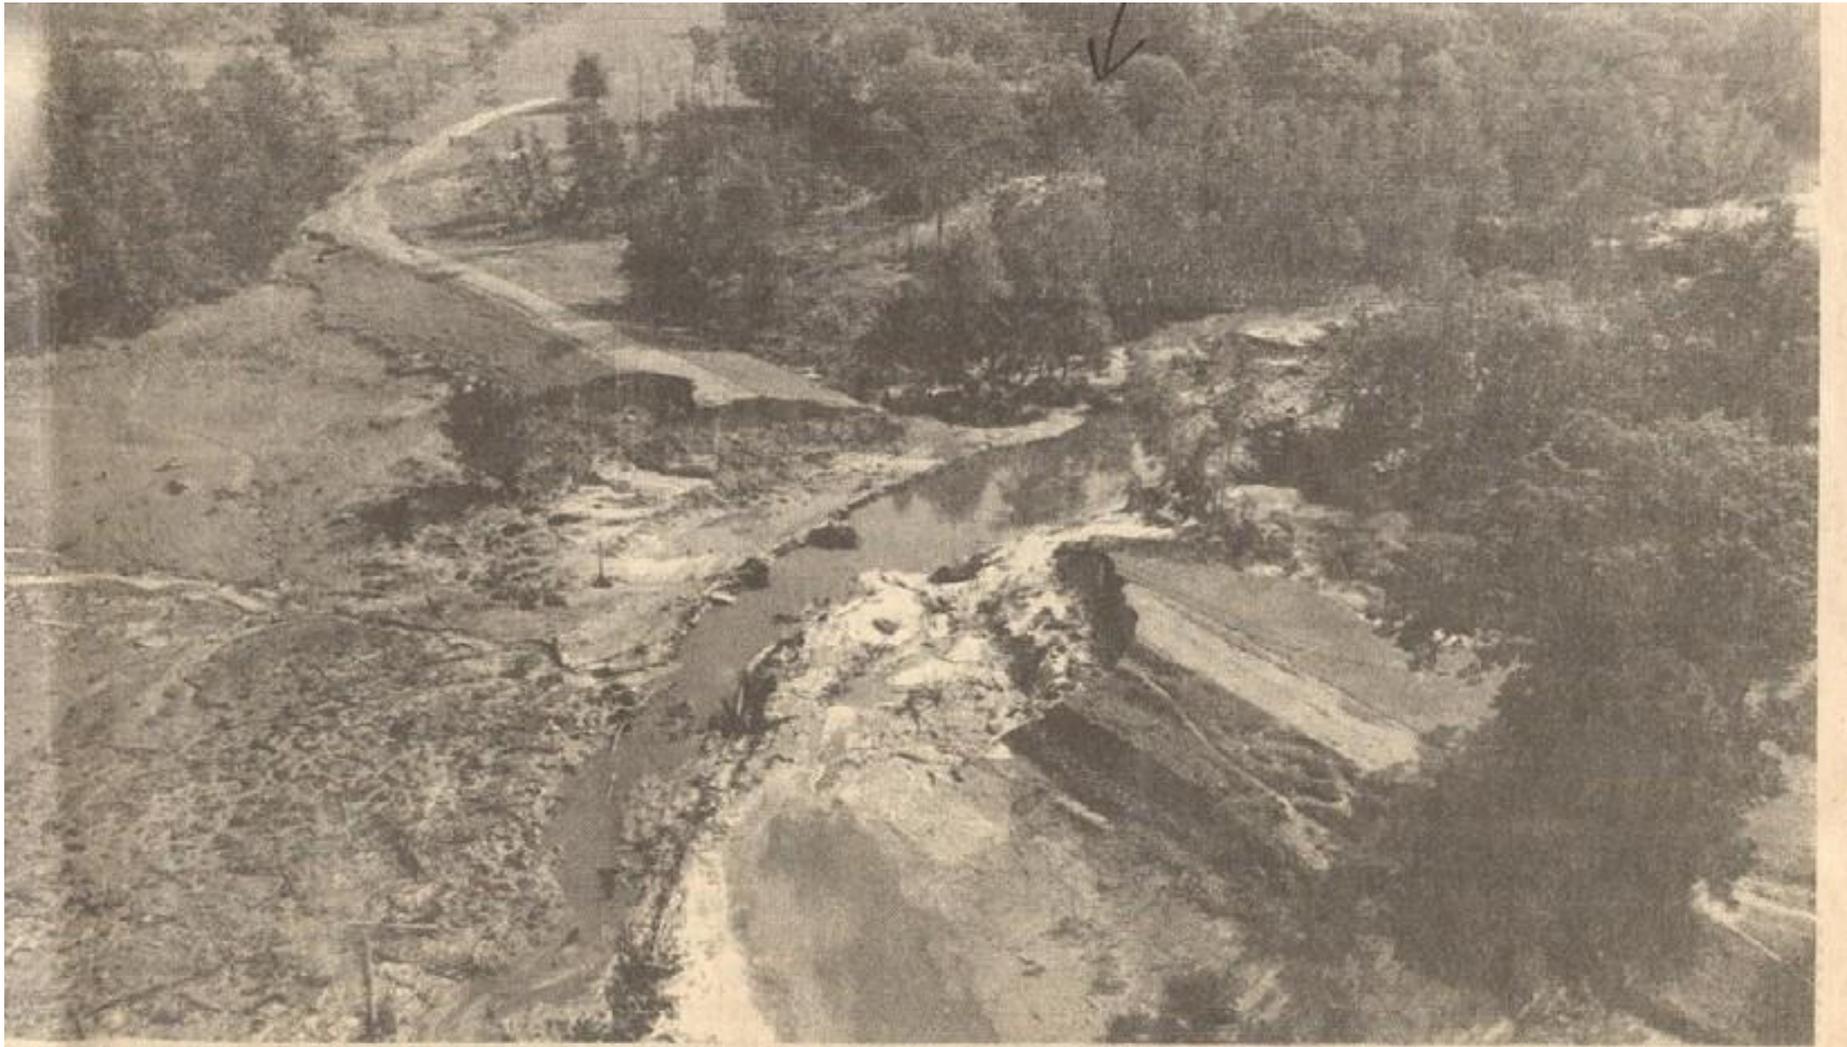
Aerial of West Lake Dam failure September 1996

- ▶ Statistics:
 - 18 feet high.
 - 140 acre-feet normal capacity.
 - 257 acre-feet maximum capacity.
 - Significant hazard.
- ▶ Breached from overtopping by 1.5 to 2 feet.
- ▶ Top width of breach 150 feet.
- ▶ Bottom width of breach 75 feet.
- ▶ Sandy soils in embankment.
- ▶ Now exempt

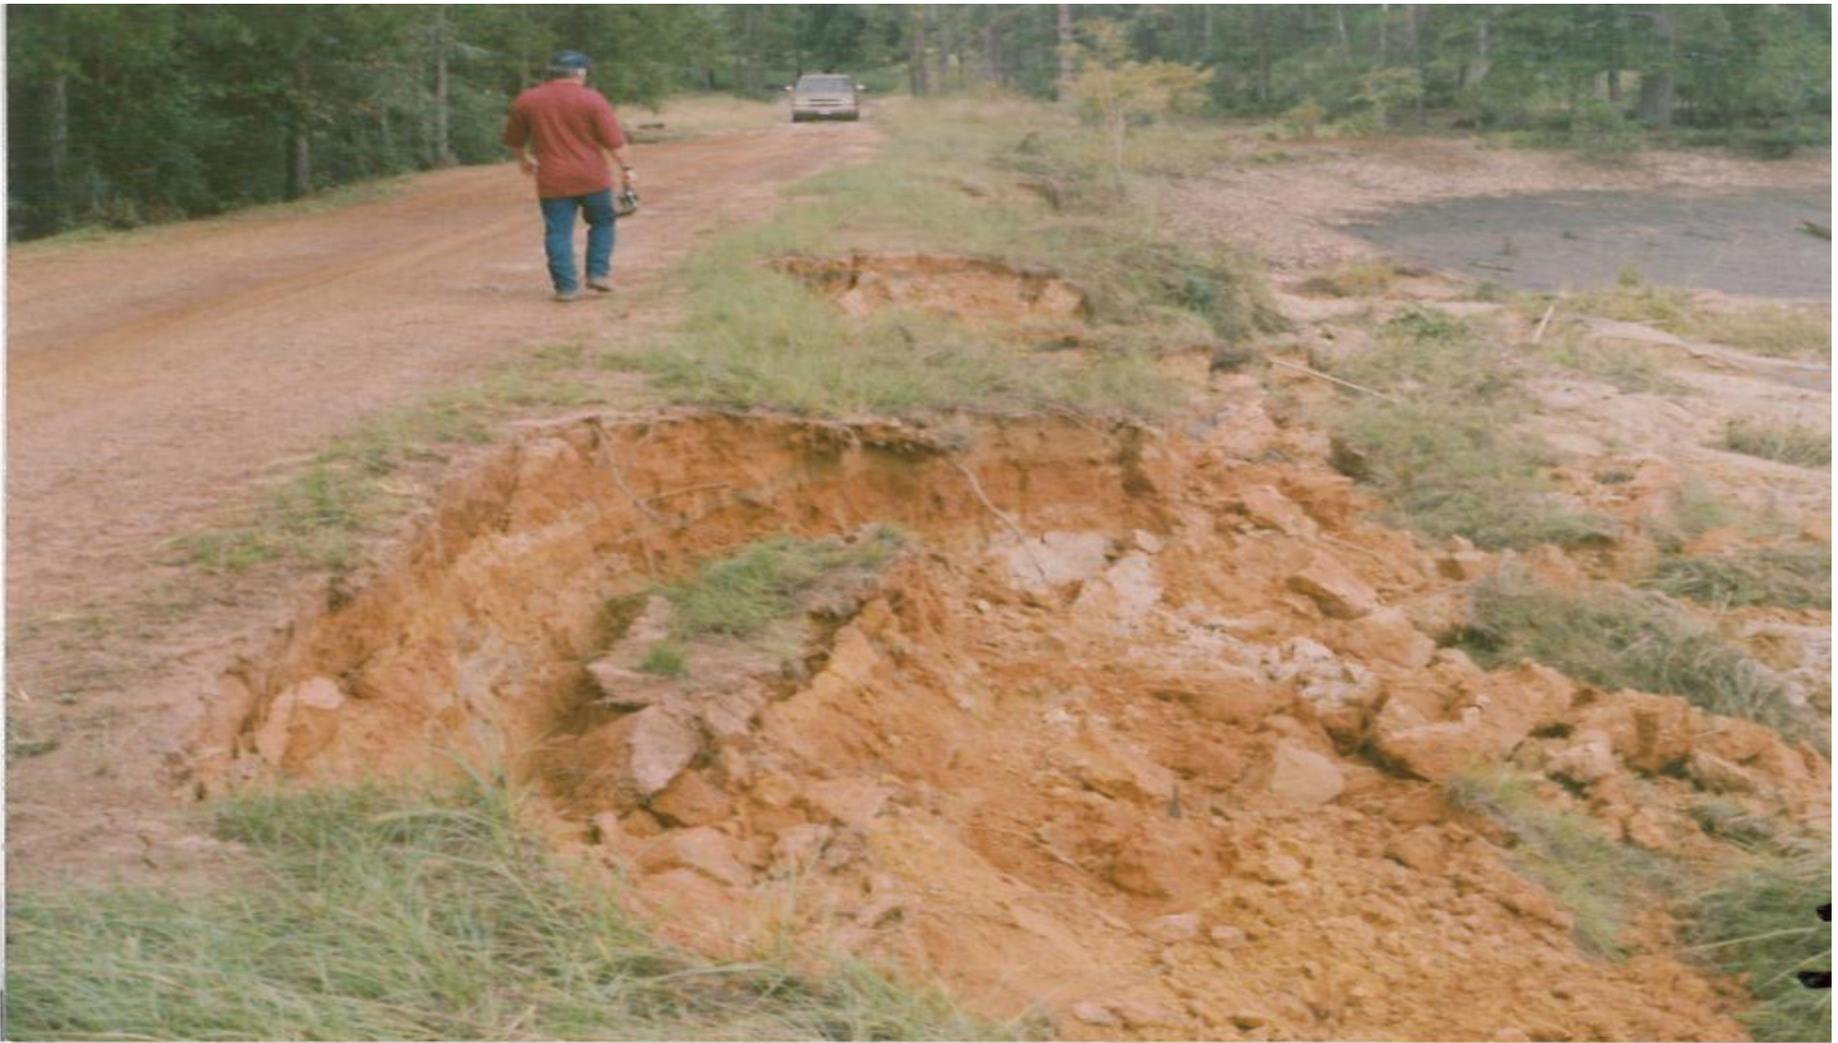
East Lake Dam failure September 1996

- ▶ Statistics:
 - 18 feet high.
 - 129 acre-feet normal capacity.
 - 327 acre-feet maximum capacity.
 - Significant hazard.
- ▶ Breached from overtopping by 1.5 to 2 feet.
- ▶ Top width of breach 100 feet.
- ▶ Bottom width of breach 40 feet.
- ▶ Sandy soils in embankment.
- ▶ Now exempt

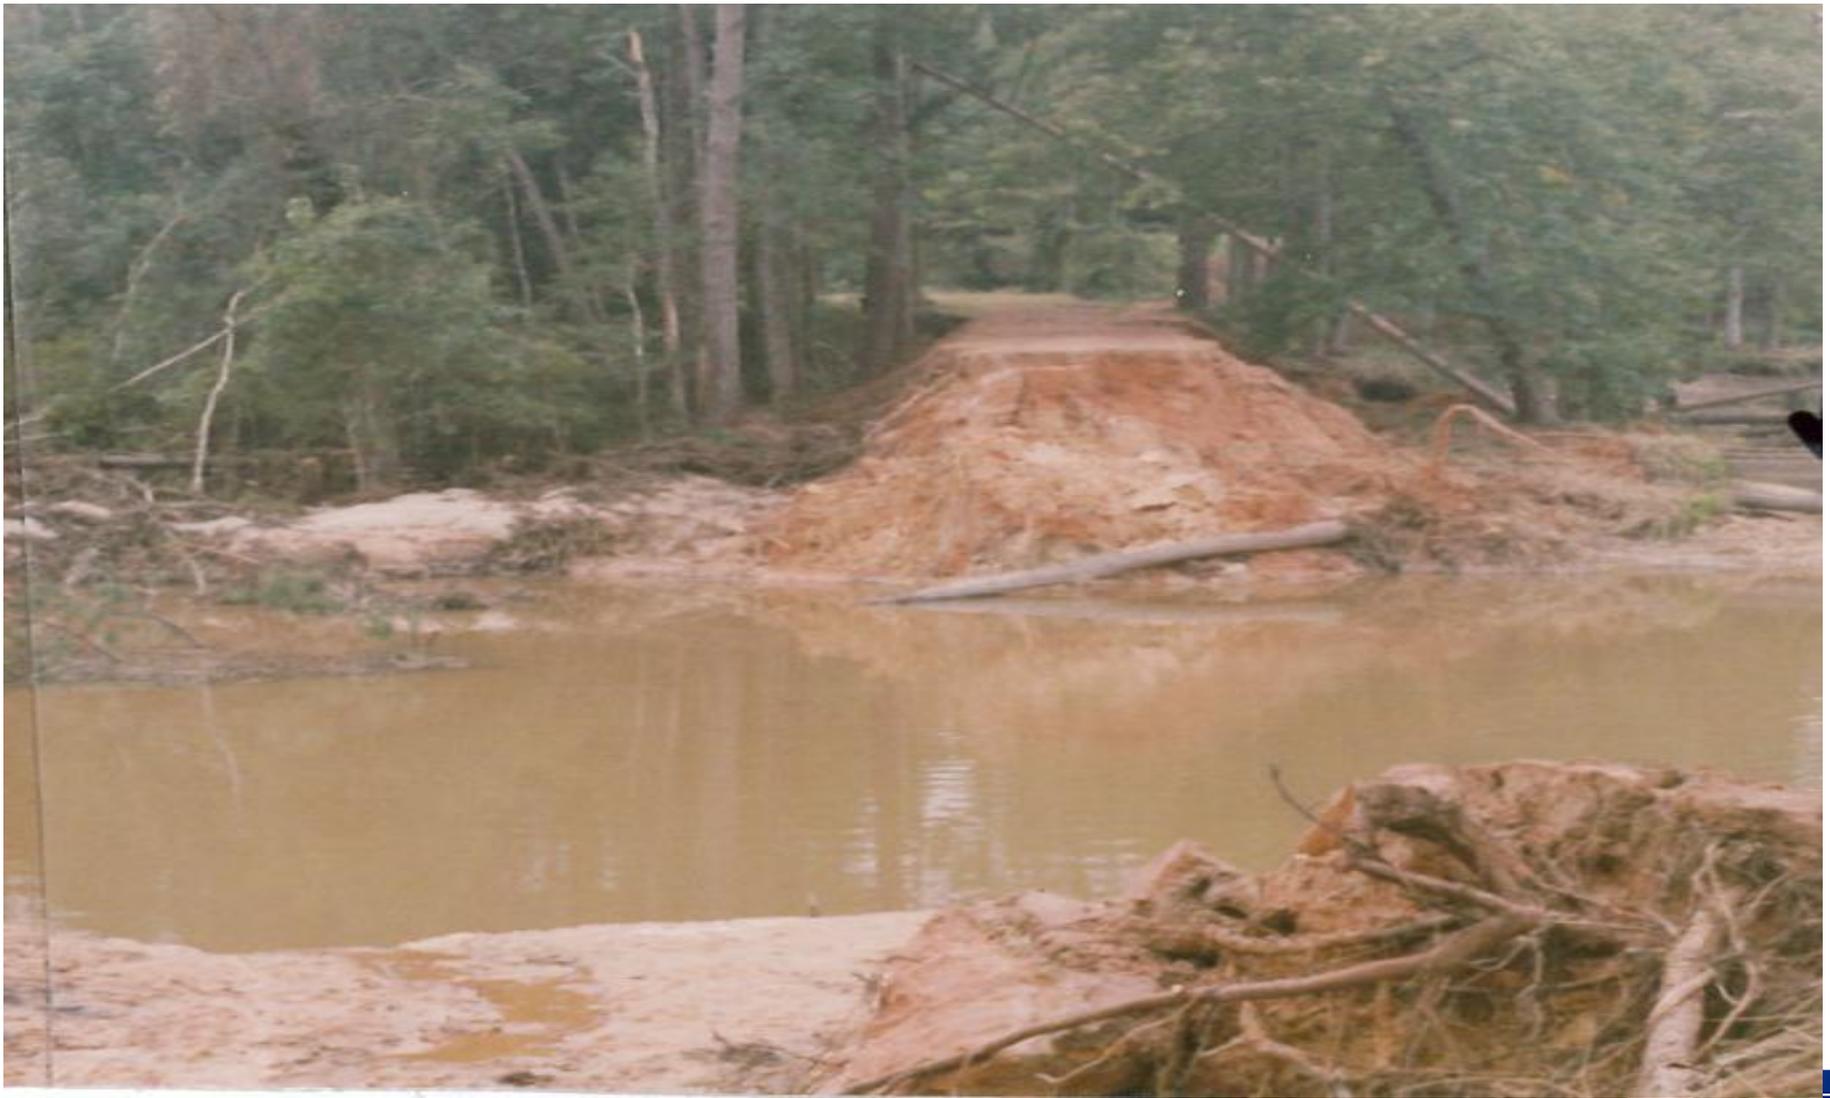
Big Lake Dam failure September 1996

- ▶ Statistics:
 - 21 feet high.
 - 161 acre-feet normal capacity.
 - 357 acre-feet maximum capacity.
 - Significant hazard.
- ▶ Breached from overtopping by 1.5 to 2 feet.
- ▶ Top width of breach 225 feet.
- ▶ Bottom width of breach 125 feet.
- ▶ Sandy soils in embankment.
- ▶ Now exempt

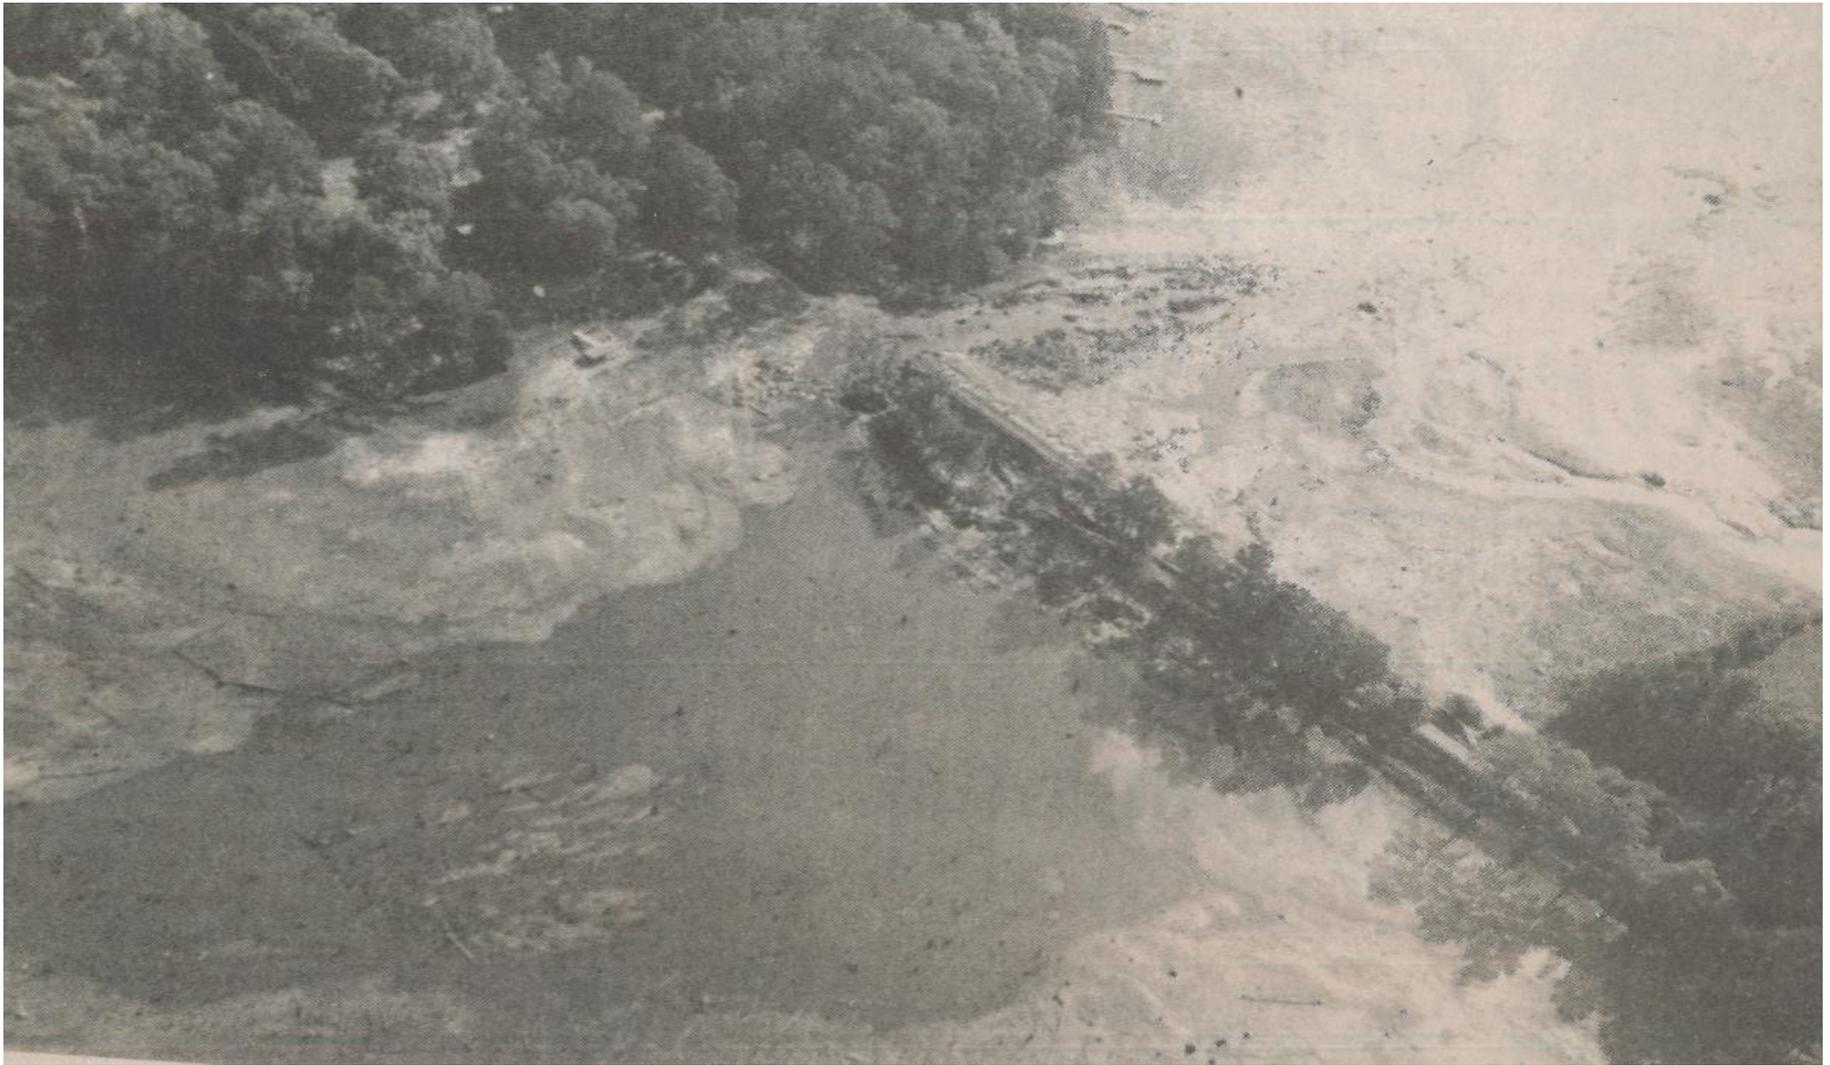
Aerial of Lake Galahad Dam failure 1996

- ▶ Statistics:
 - 18 feet high.
 - 129 acre-feet normal capacity.
 - 327 acre-feet maximum capacity.
 - Significant hazard.
- ▶ Breached from overtopping by 1.5 to 2 feet.
- ▶ Top width of breach 100 feet.
- ▶ Bottom width of breach 40 feet.
- ▶ Sandy soils in embankment.

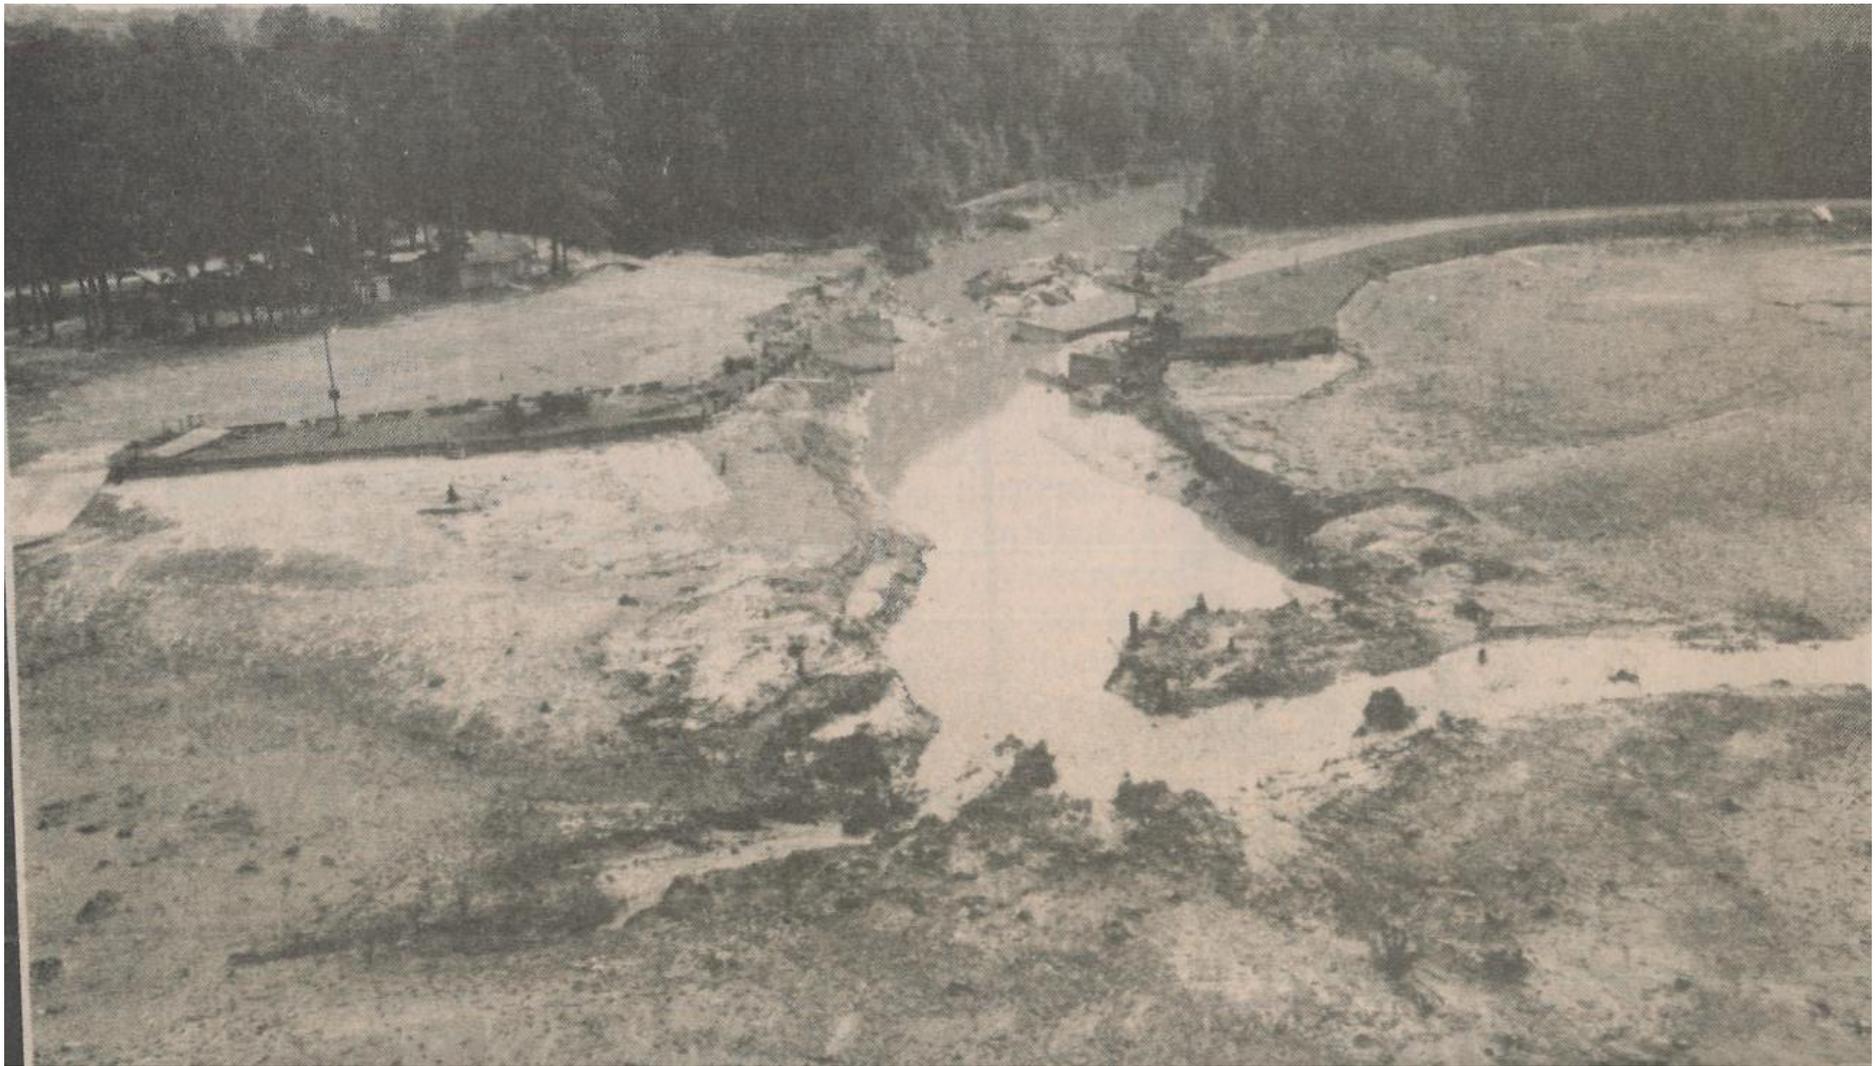
Aerial of Lake Charmaine Dam failure 1996

- ▶ Statistics:
 - 18 feet high.
 - 129 acre-feet normal capacity.
 - 327 acre-feet maximum capacity.
 - Significant hazard.
- ▶ Breached in spillway due to erosion undercutting.
- ▶ Sandy soils under the spillway.

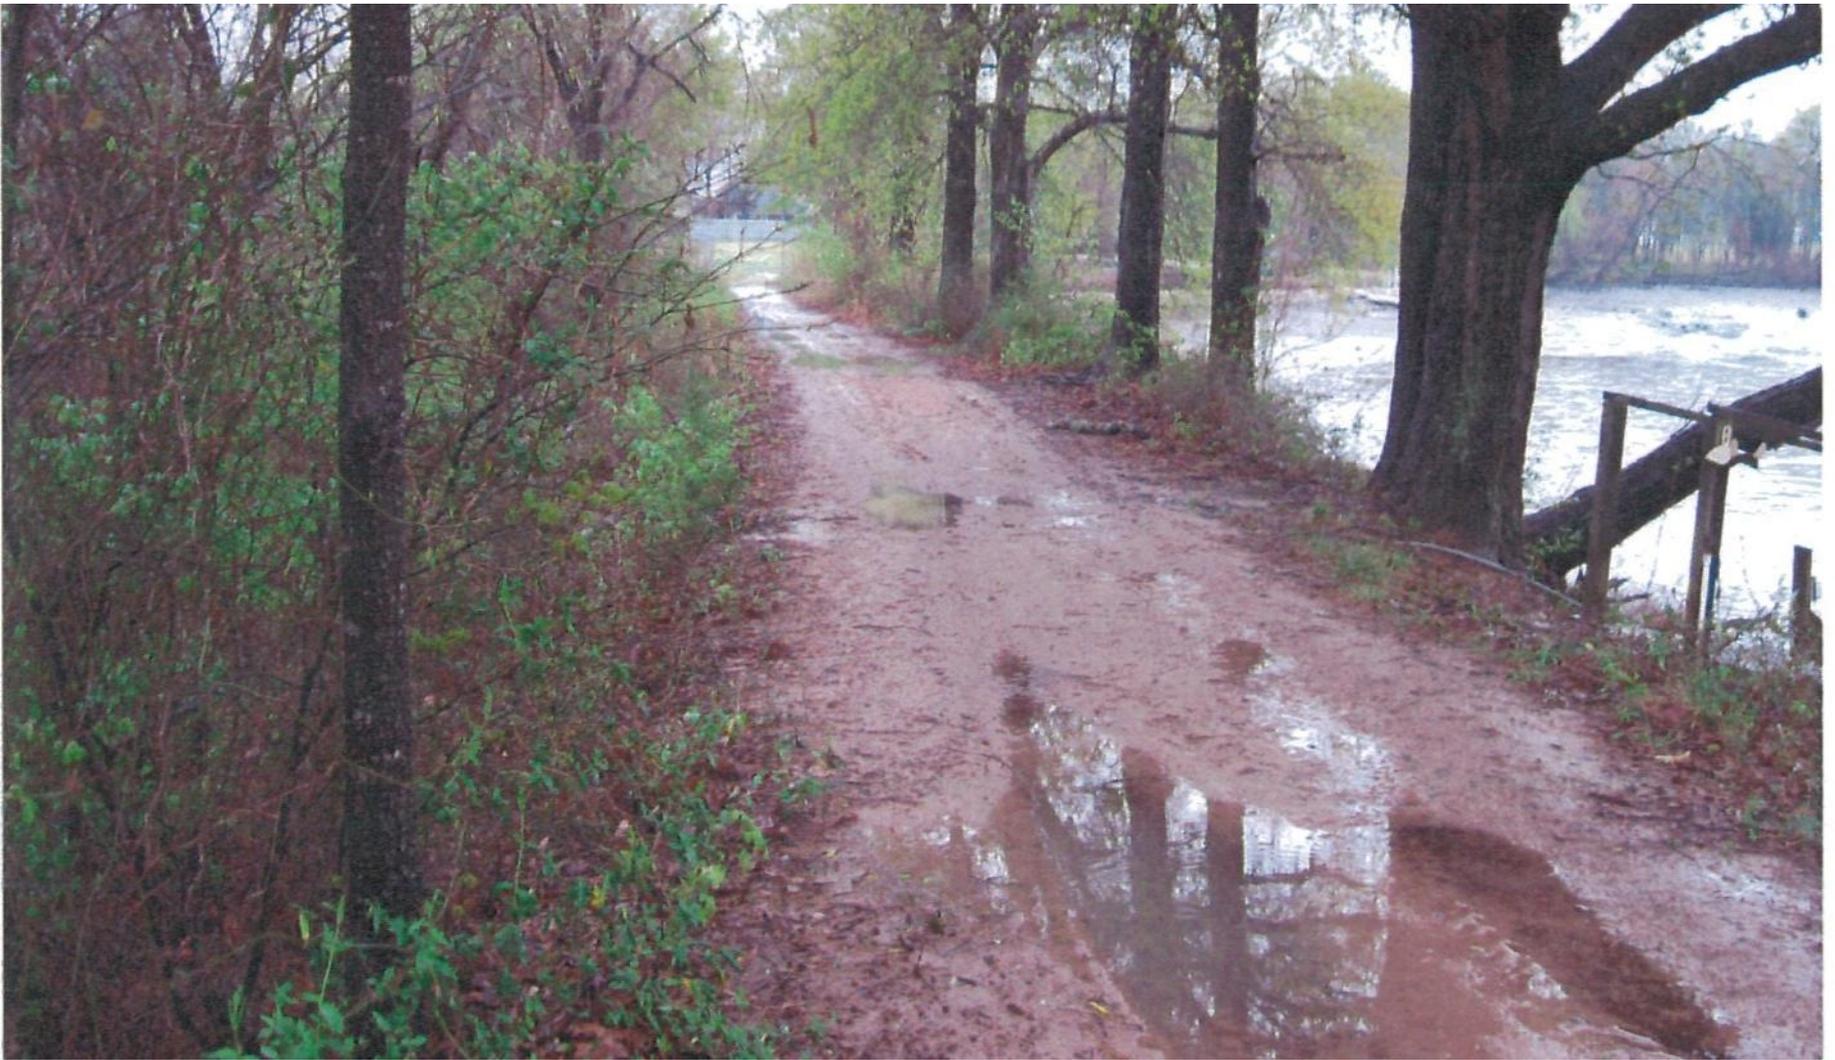
Crest of Edgewood Old City Lake Dam 2009

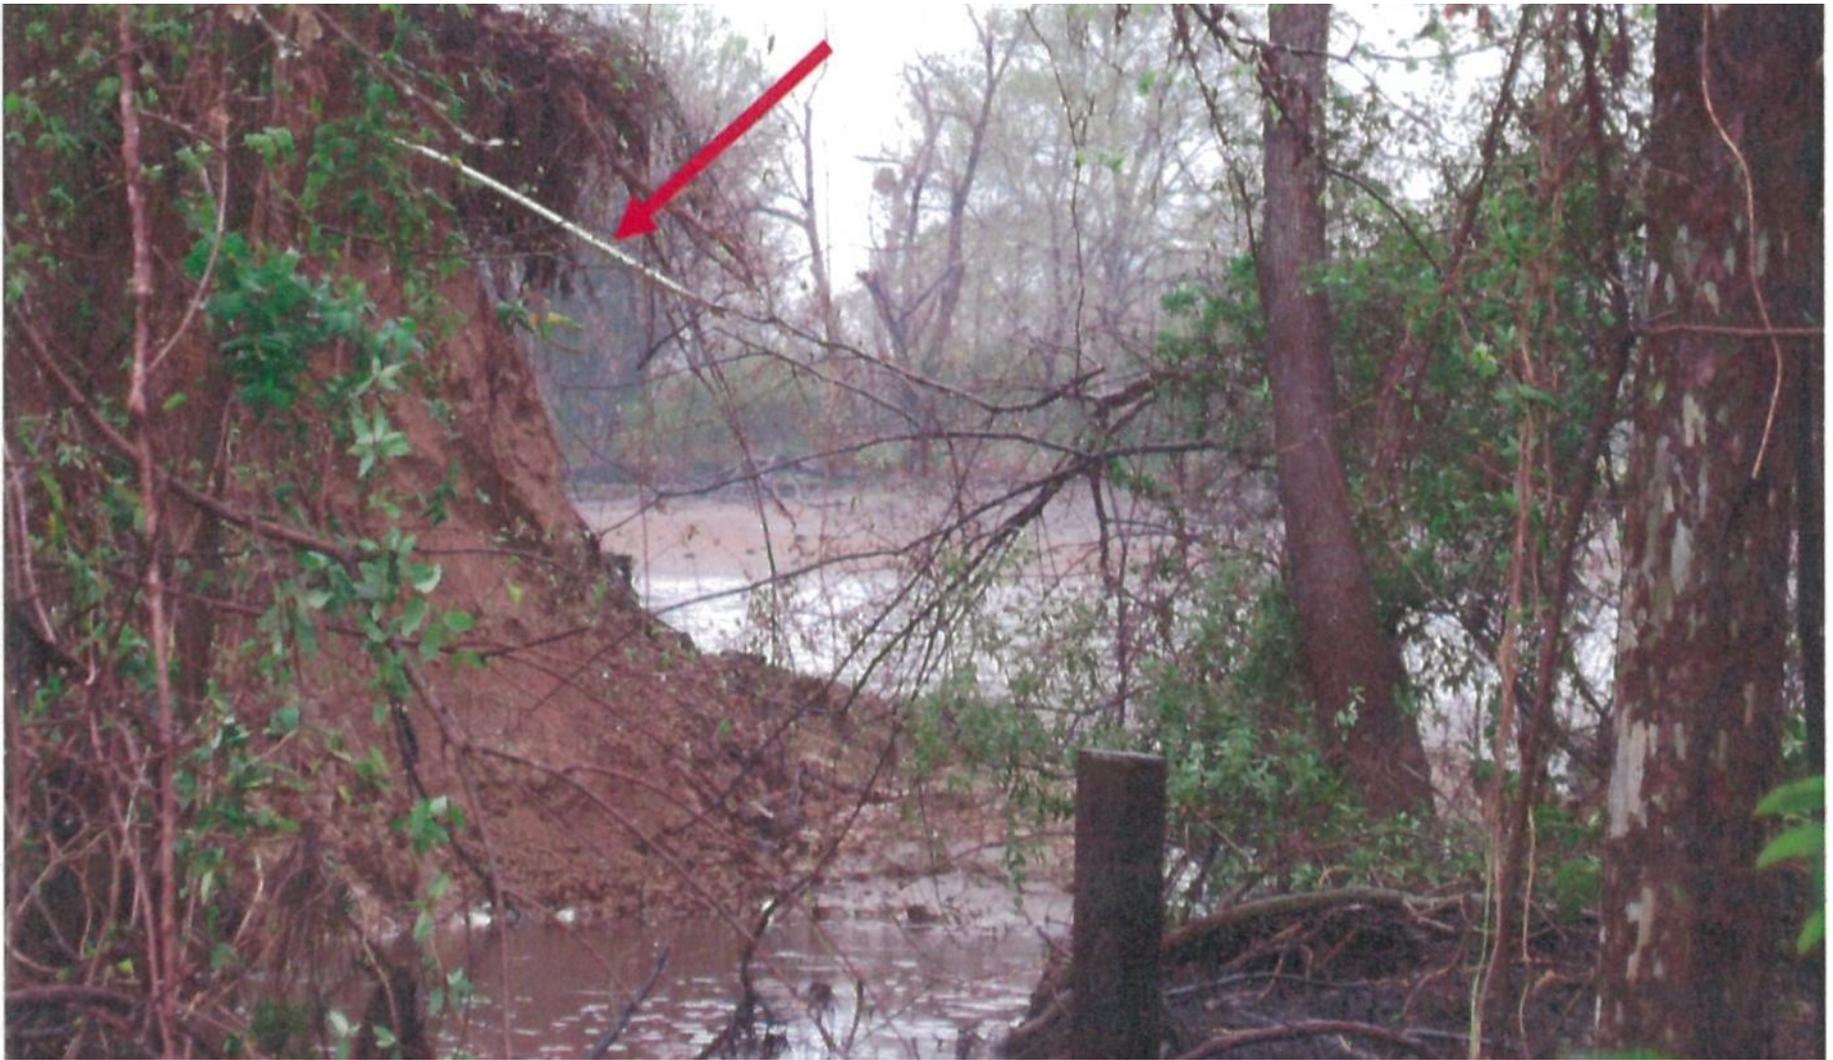
Failure of Edgewood Old City Lake Dam 2009

- Local resident reported water flow from downstream side of dam around 11:00 AM, March 12, 2009.
- Failure occurred around 1:00 PM, March 12, 2009.
- Rainfall event – 3 day event with over 3-inches reported in that time frame.
- Breach at maximum section, 20 feet wide at base and 30 feet wide at crest.

- Failure was attributed to piping, possibly along beaver tunnels through the dam.
- Breach zone was also area of old City water supply line.
- Numerous trees on the dam.
- Traffic ruts with standing water on crest.
- Sinkholes in crest reported by owner.

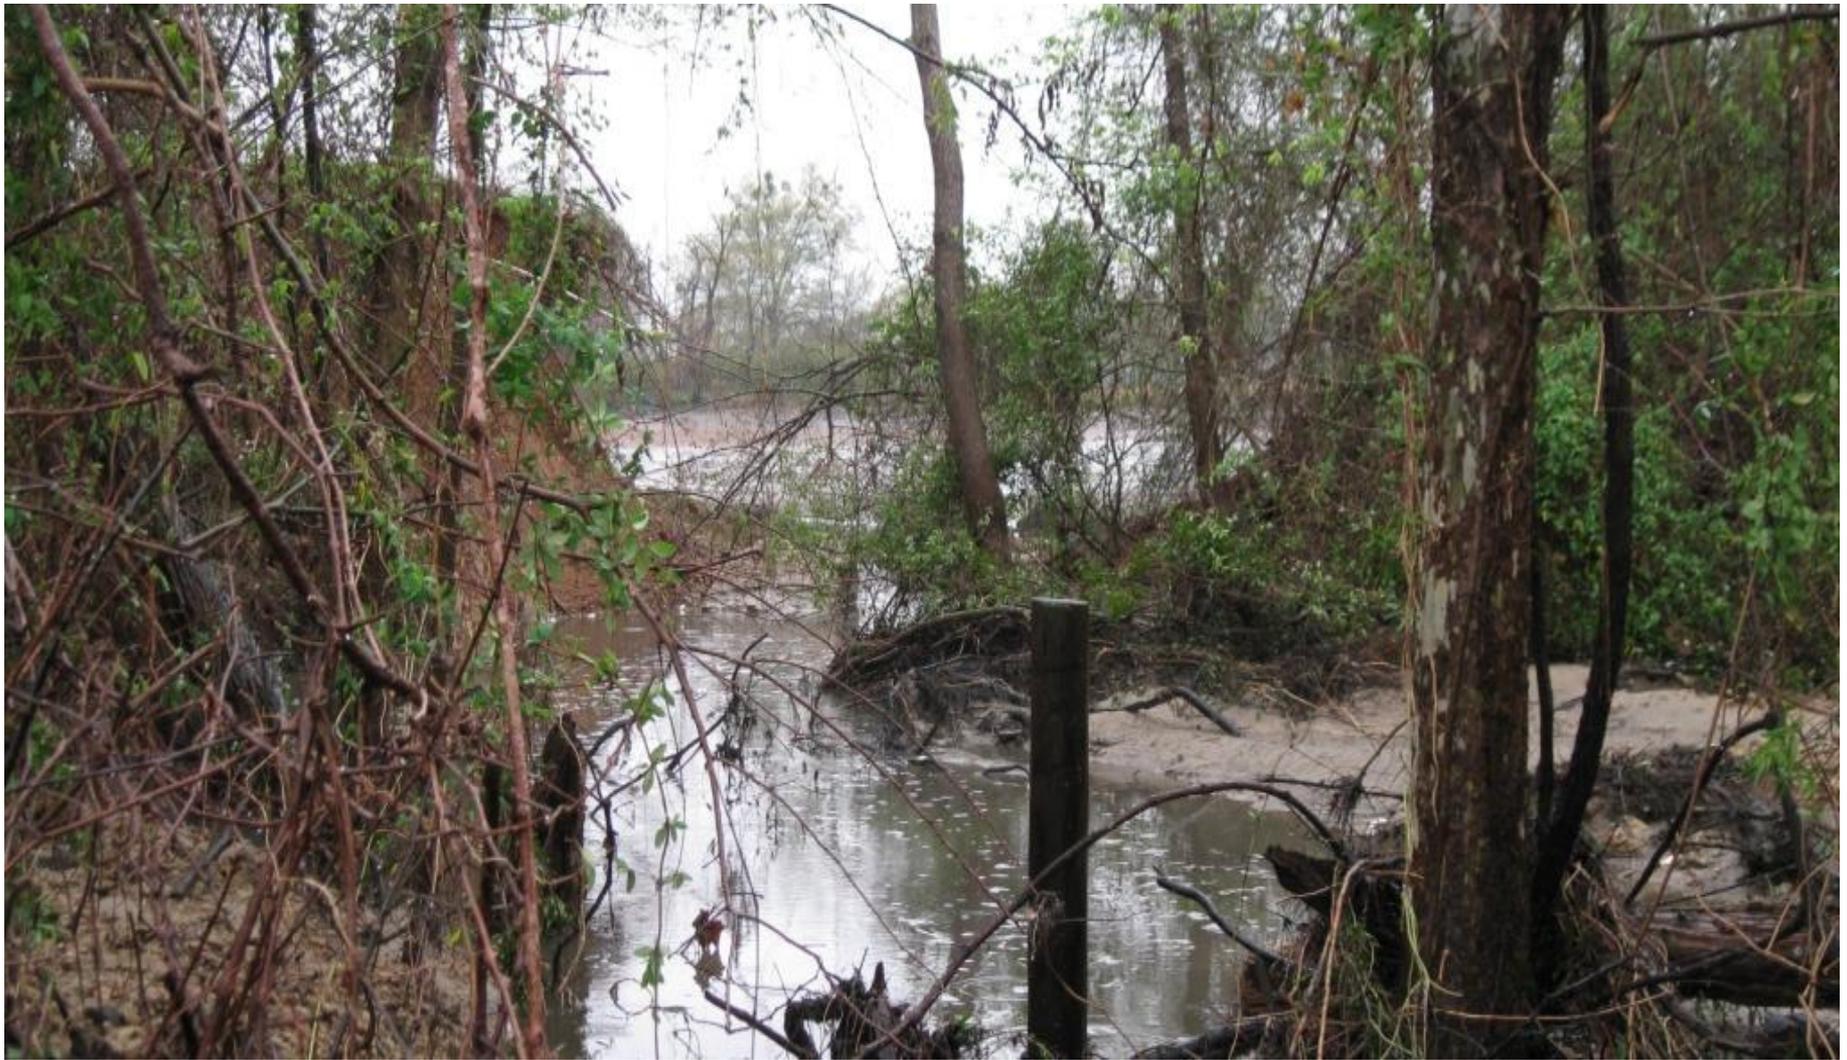
Edgewood Old City Lake Dam failure

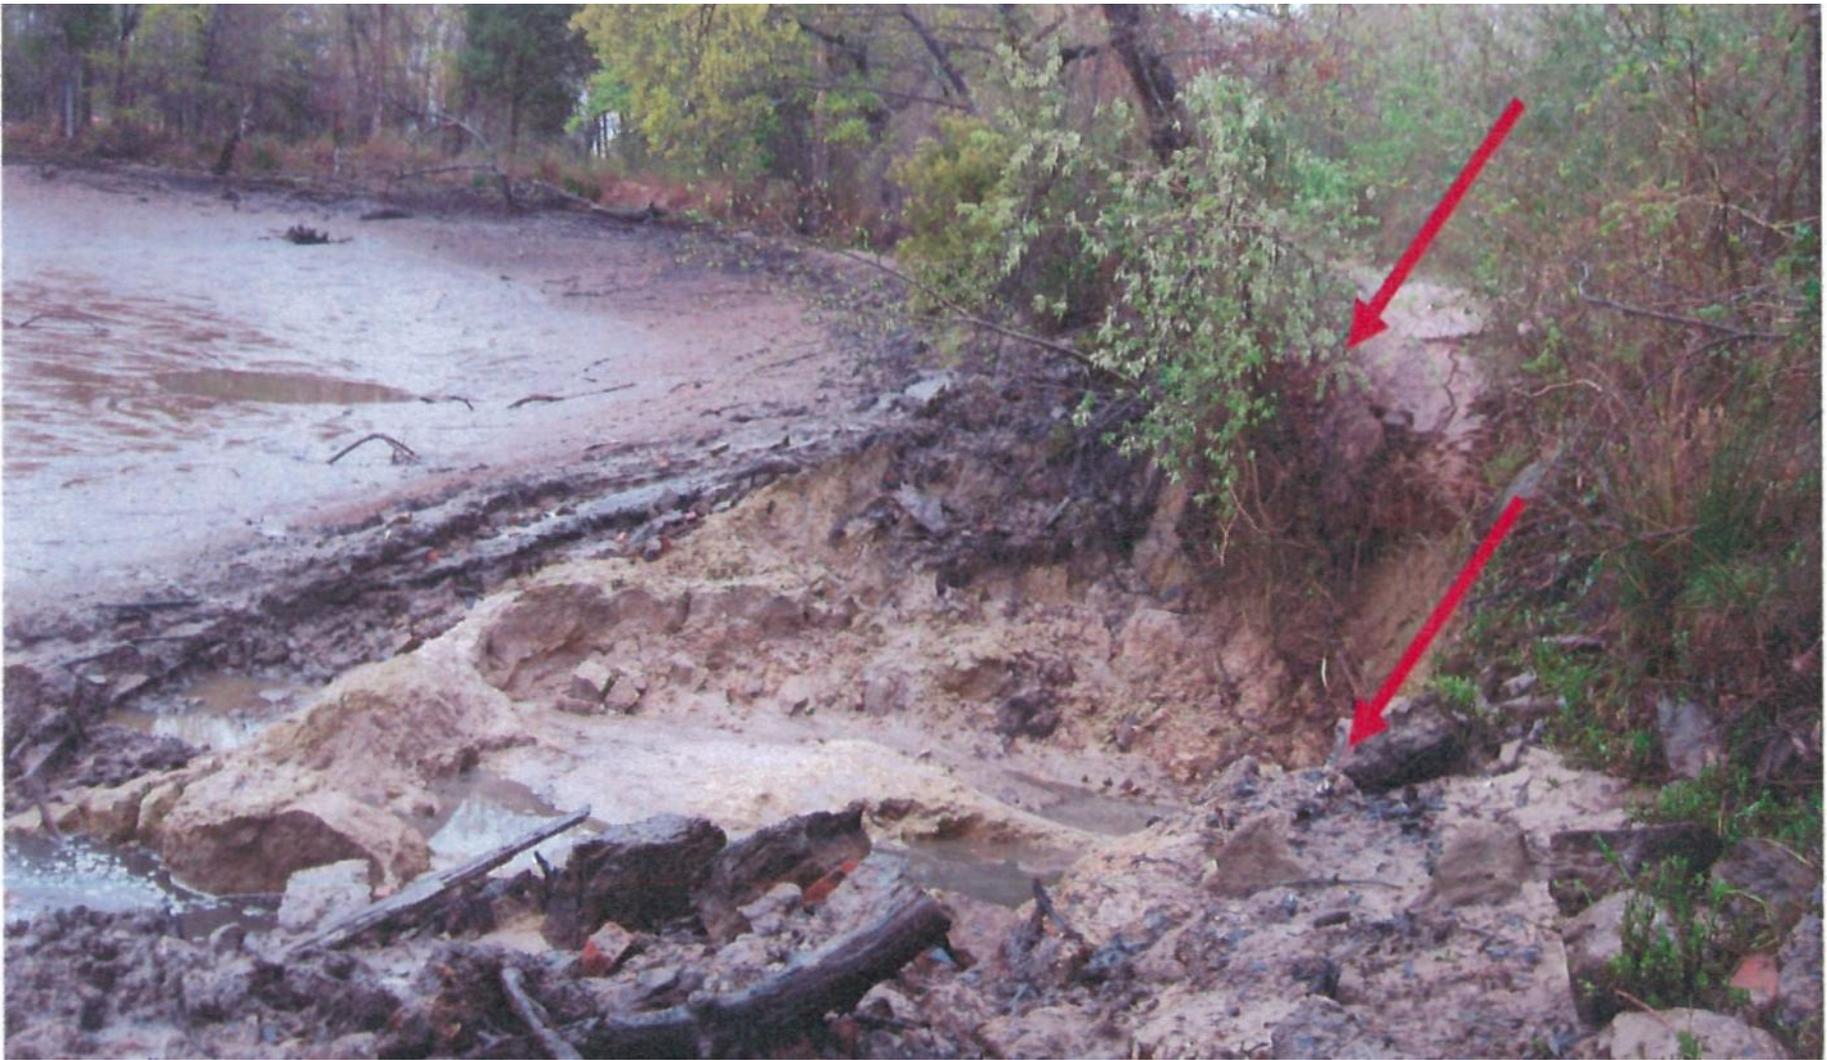
Upstream view of failure
