Texas Dam Failures

- ▶ Since 1900, 171 dams have been reported to have either failed or have been damaged due to overtopping or structural issues.
- ▶ Some of these dam failures were significant due to size, use, or loss of life, which we will discuss.

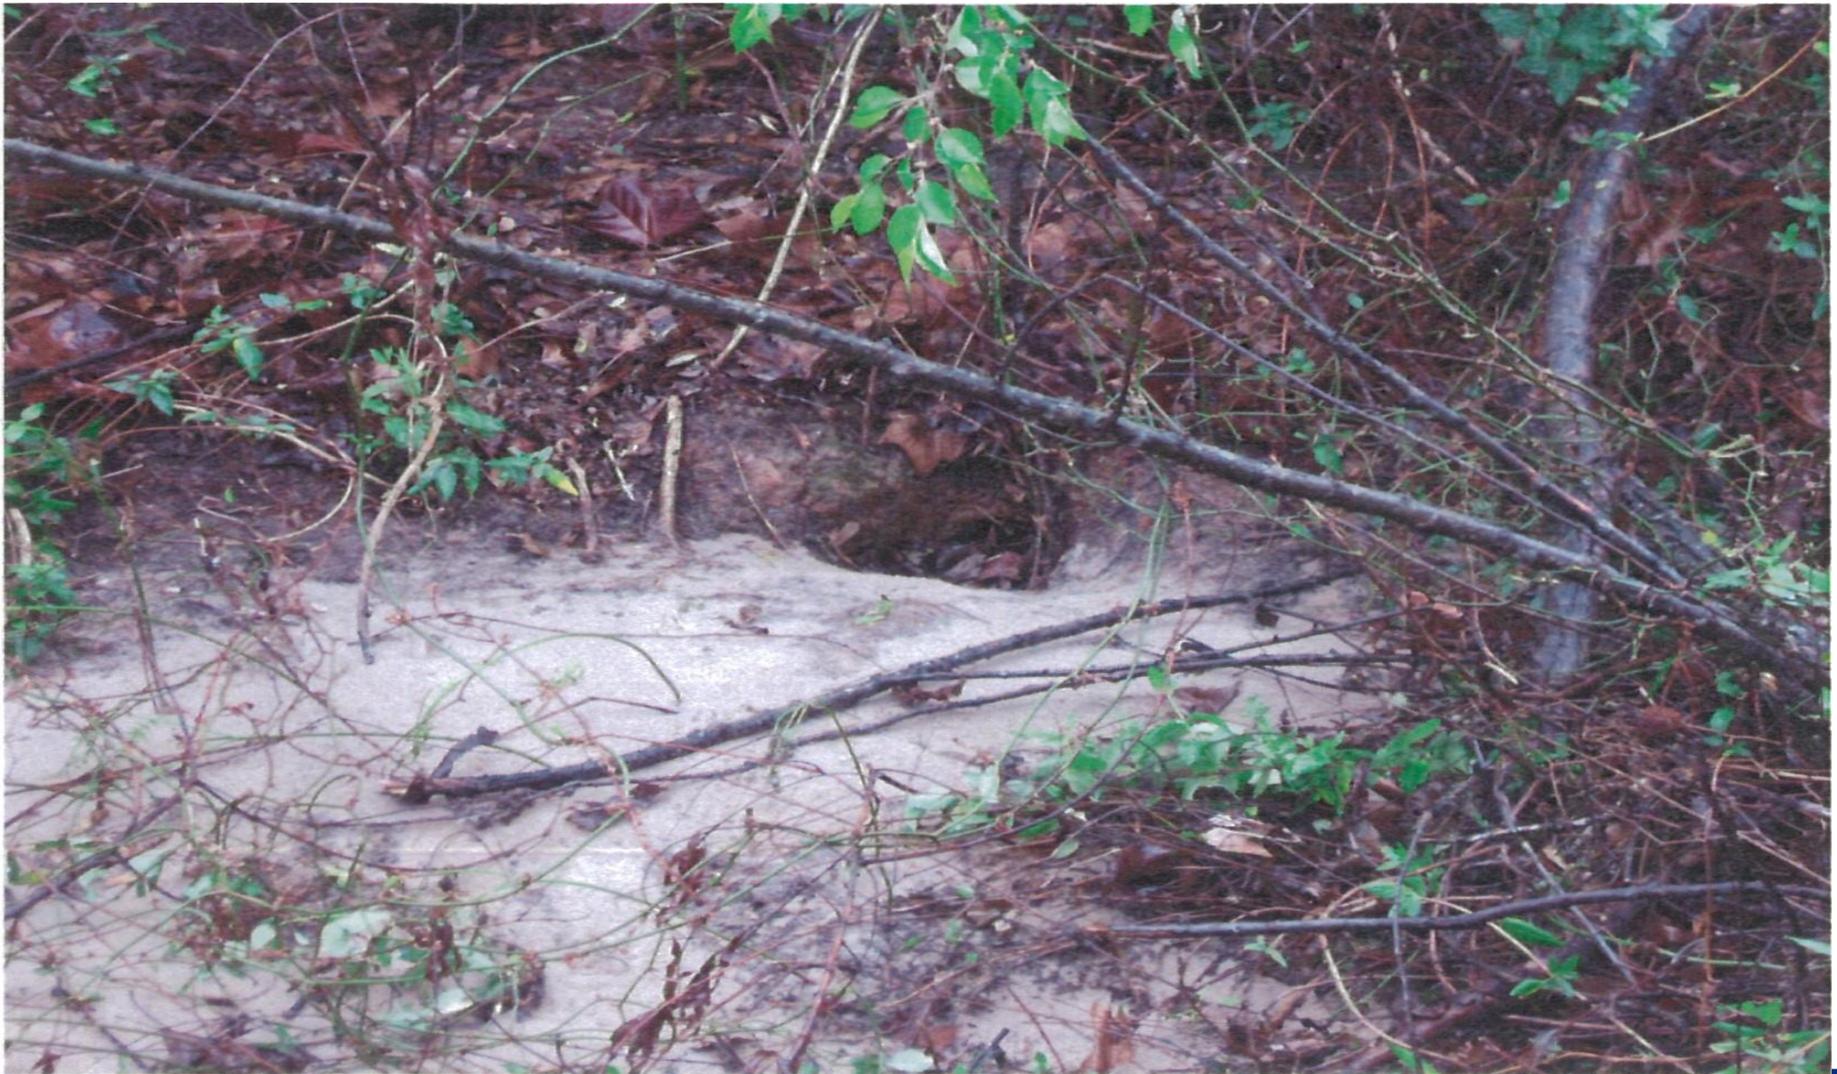
Animal burrow

- Failure was attributed to piping, possibly along beaver tunnels through the dam.
- Breach zone was also area of old City water supply line.
- Numerous trees on the dam.
- Traffic ruts with standing water on crest.
- Sinkholes in crest reported by owner.

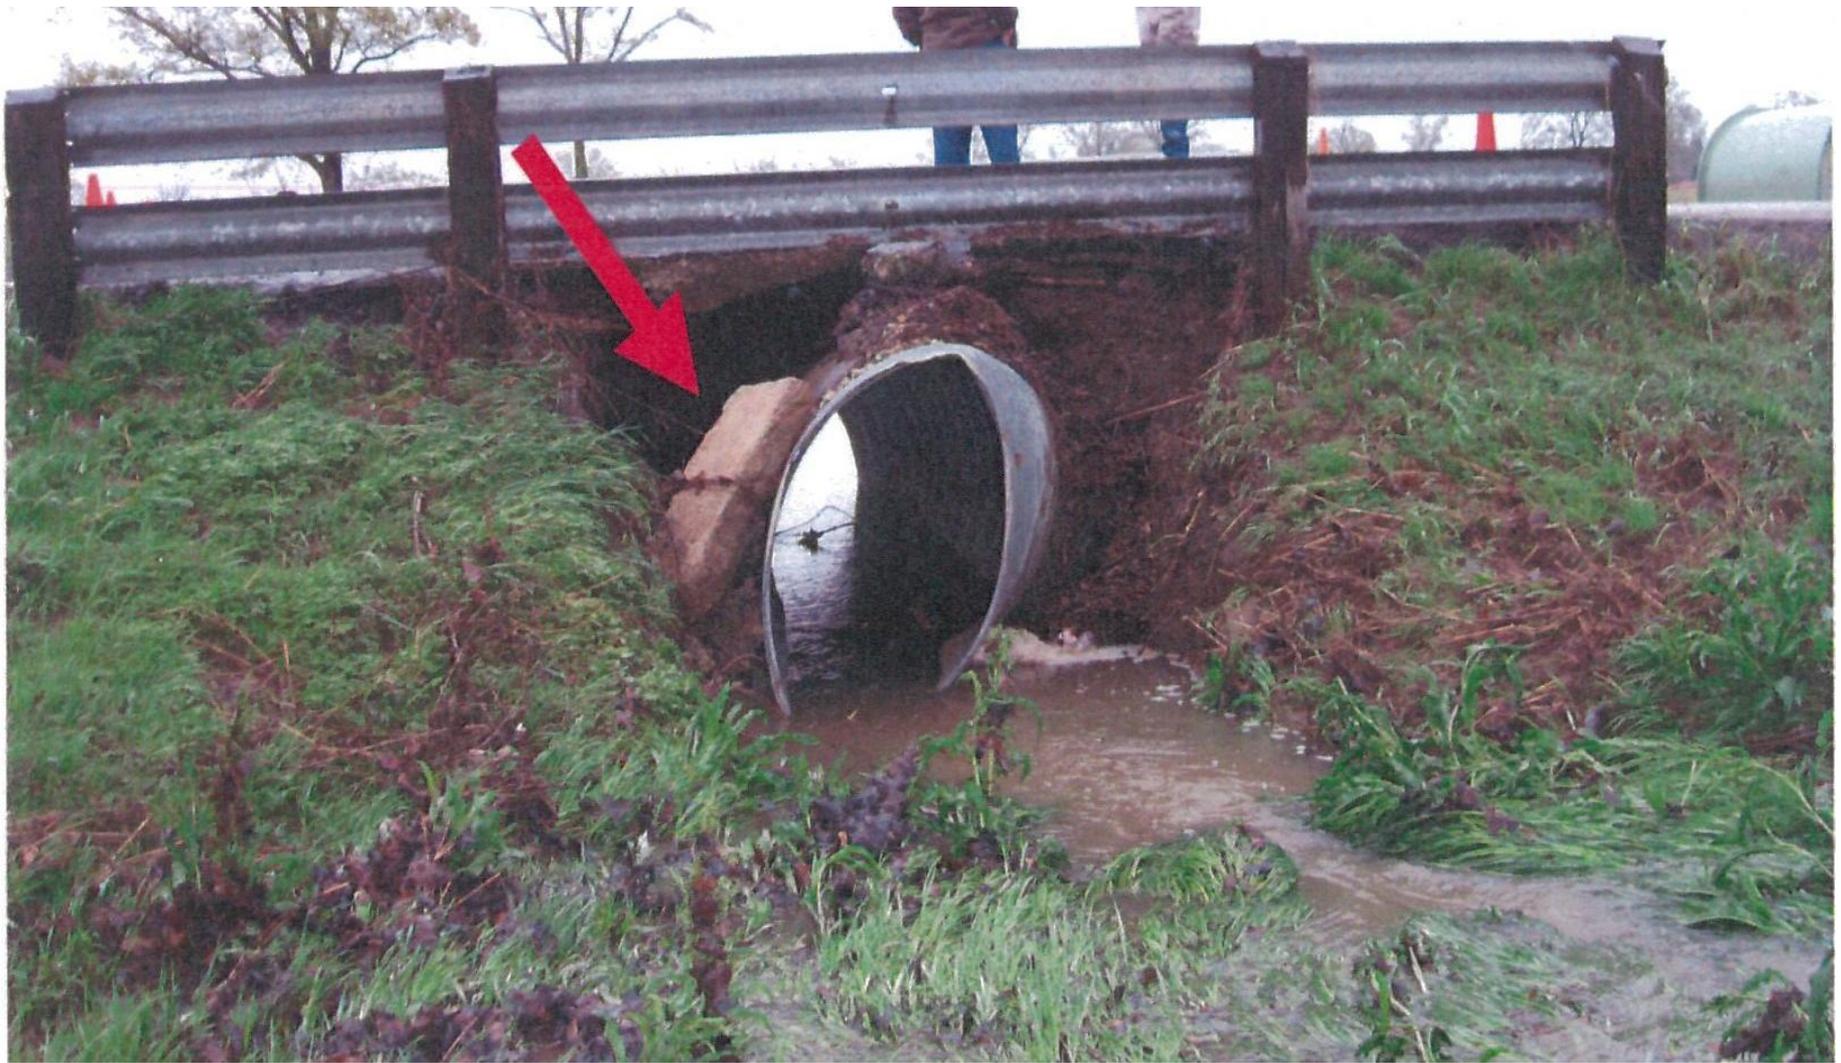
Downstream damage

- 2/3 of county road undermined.
- Farm-to-Market road overtopped by at least 18 inches. School bus route.
- Several wastewater manholes submerged for a short period of time.
- Wastewater lift station just above water.
- Water within 1 foot of two houses. Fences and septic systems affected. Dead fish everywhere.

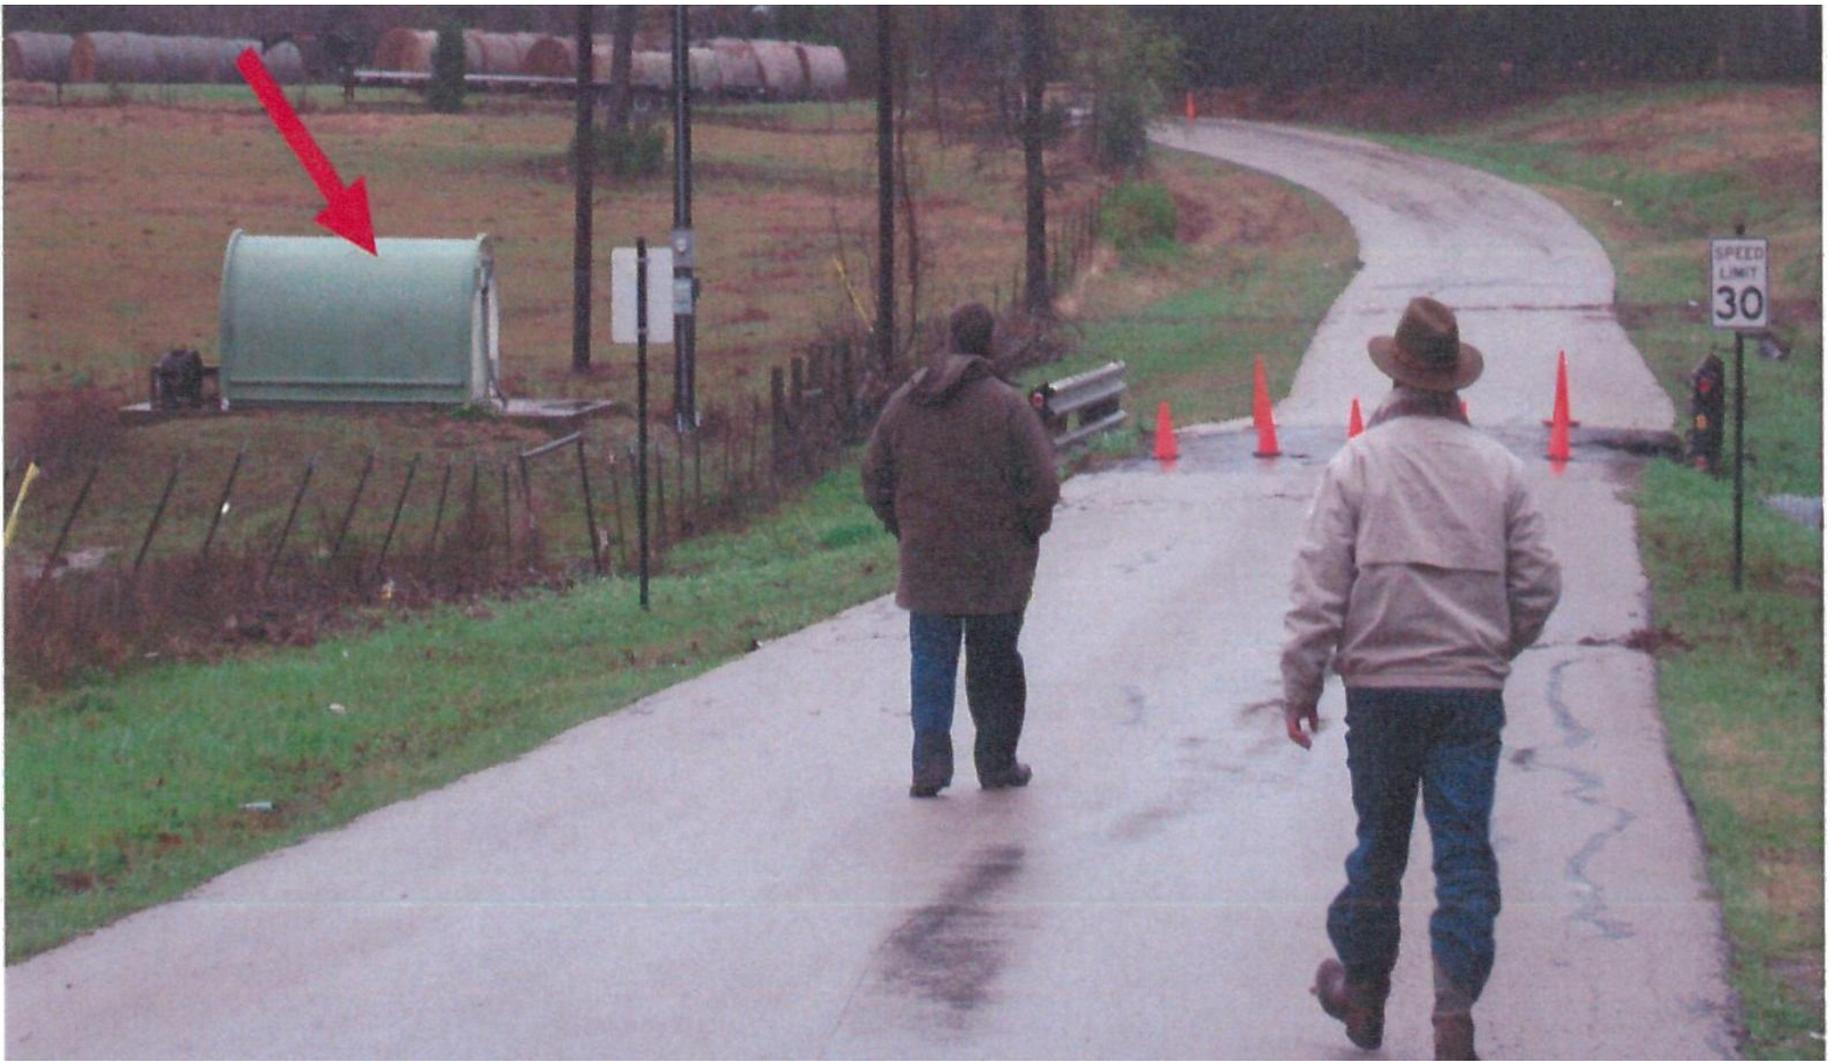
Downstream hazards

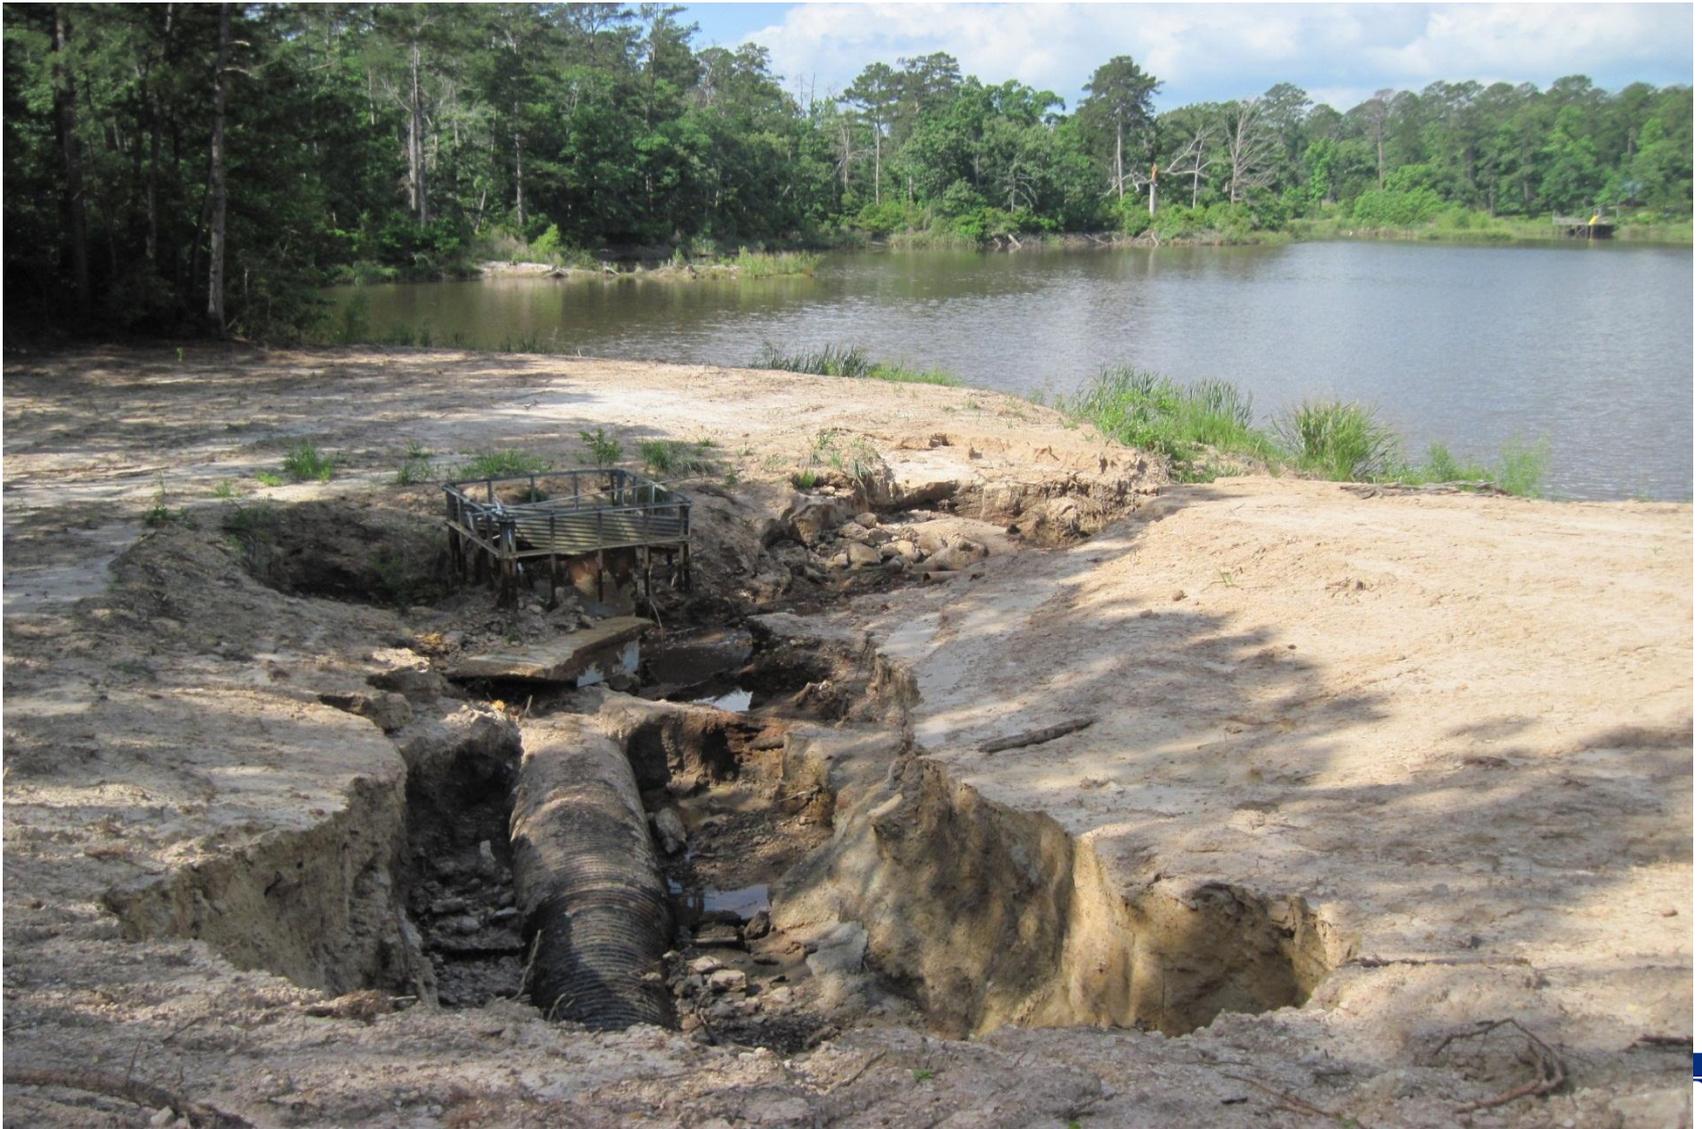
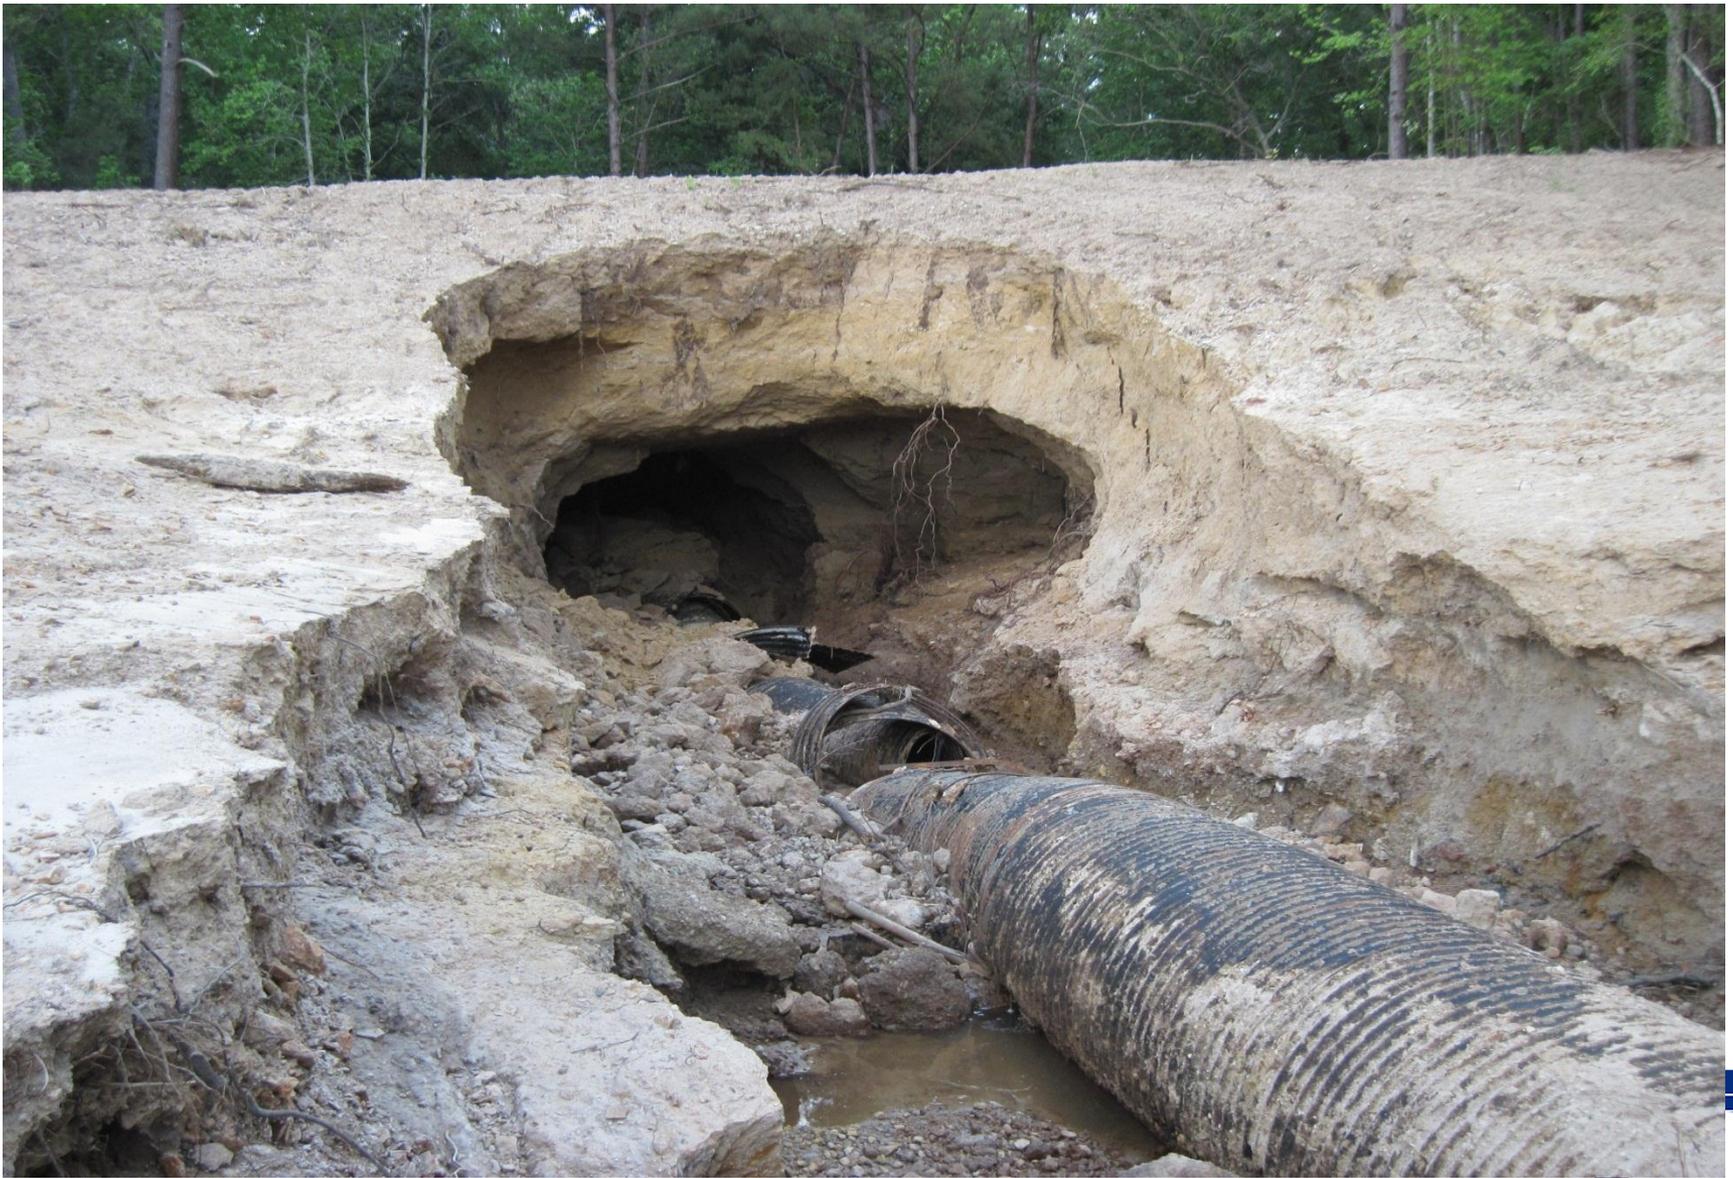
- Now rebuilt by owner.
- One of the dams exempted by the Legislature.
