**Texas Commission on Environmental Quality
New Technology Research & Development (NTRD) Program
Monthly Project Status Report**

Contract Number: 582-11-13472-2019

Grantee: Transportation Power, Inc. (TransPower)

Report for the Monthly period: August 11, 2012 to September 7, 2012 **Date Submitted:** 09/10/2012

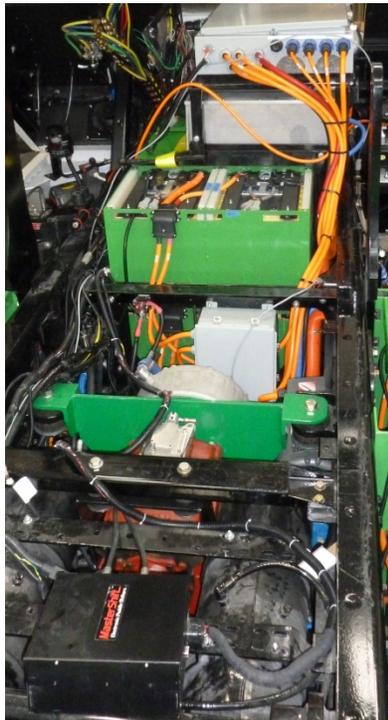
Figure 1: ICU, main drive motor, and automated manual transmission installed in Tractor #1

- The motive drive subsystem was fully installed into Tractor #1. This includes TransPower’s proprietary automated manual transmission, the main traction motor, and TransPower’s proprietary inverter charger unit (ICU). Several sub-assembly and sub-system level tests were completed on the motive drive subsystem during the most recent reporting period in preparation for vehicle-level testing. The automated shifting functionality was validated to confirm that the subsystem was correctly moved over from the dynamometer into the tractor. Additionally, the tractor’s rear axles were lifted up on jacks and the rear wheels were spun to confirm that the motive drive subsystem was performing as intended prior to drive-testing the tractor. Figure 1 shows the interior of Yard Tractor #1, with the ICU at the top of the picture and the main drive motor and automated manual transmission at the bottom of the shot.

- The power control and distribution subsystem was fully installed in Tractor #1 and can be seen at the top of Figure 1. The orange cables coming out of the central control module are high voltage cabling, both for the energy storage system and to provide power to the electric accessories. Low and high

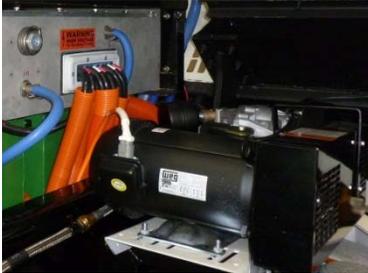
Figure 2: Air compressor in Tractor #1

- The electric accessory subsystem was fully installed into Yard Tractor #1 (Figure 2 and Figure 3). This includes physical mounting and all connections including electrical wiring, hydraulic hoses, and air hoses. Before vehicle-level testing could commence, each accessory was tested to ensure that it was functioning as expected.

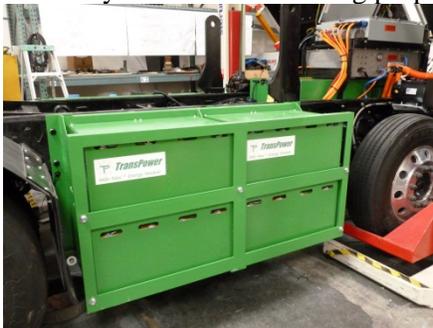
Figure 4: Mile Max™ modules on Tractor #1

- The energy storage system is fully installed in Tractor #1. There are four Mile Max™ modules mounted on each side of the tractor (Figure 4), and six Mile Max™ modules underneath the cab. These 14 modules represent two full-voltage battery strings. All of the green structures in Figure 6 below are Mile Max™ modules. The sub-system level tests mentioned above were all conducted using the energy storage subsystem as an energy source, confirming that the energy storage subsystem was functioning properly.

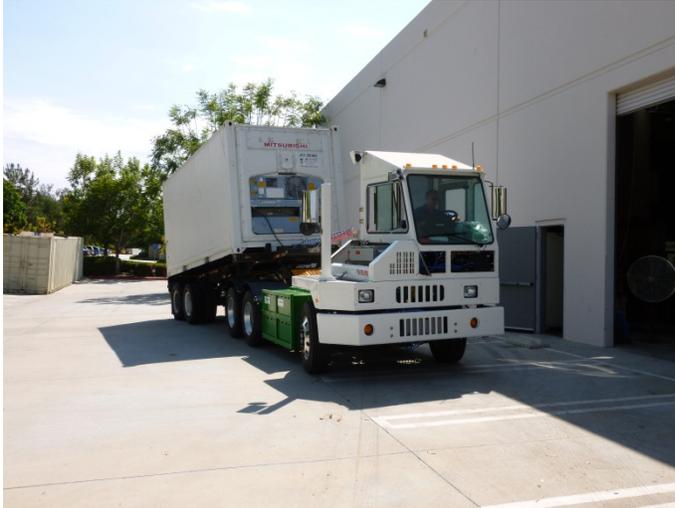
Figure 5: Tractor #1 lifting and pulling a trailer

- TransPower has begun vehicle-level testing of Tractor #1. In addition to spinning the wheels with Tractor #1 on jacks, TransPower has completed basic drive testing of Tractor #1 on level pavement and demonstrated that Tractor #1 can attach to and pull a trailer (Figure 5). TransPower also unveiled Tractor #1 at the PortTech Expo, a public forum on September 5, 2012, through September 6, 2012. The tractor was driven at this event.
