**Texas Commission on Environmental Quality
New Technology Research & Development (NTRD) Program
Monthly Project Status Report**

Contract Number: 582-11-13472-2019

Grantee: Transportation Power, Inc. (TransPower)

Report for the Monthly period: 04/12/12 – 05/13/12 **Date Submitted:** 5/10/12

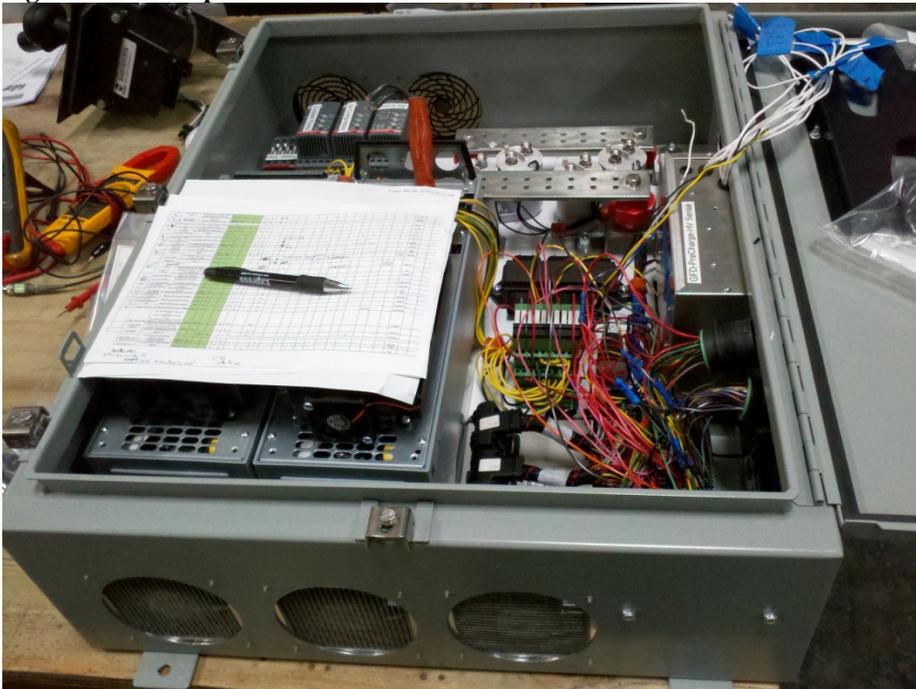
- Control system development continues to make significant progress towards a complete running powertrain on the bench and then in the vehicle. Next week the input/output (I/O) will be verified and logic checked for start-up and simple state functions.
 - The Vehicle Powertrain Control Center (VPCC) is 90% complete. This is the primary assembly of the electrical distribution subsystem. All components and controllers are in place with only a small amount of control wiring and the high power cabling to finish.

Figure 1: Vehicle powertrain control center 90% assembled

- The pre-charge and voltage sensing circuits are complete and installed in the VPCC. This assembly also contains a bender ground fault detection device.

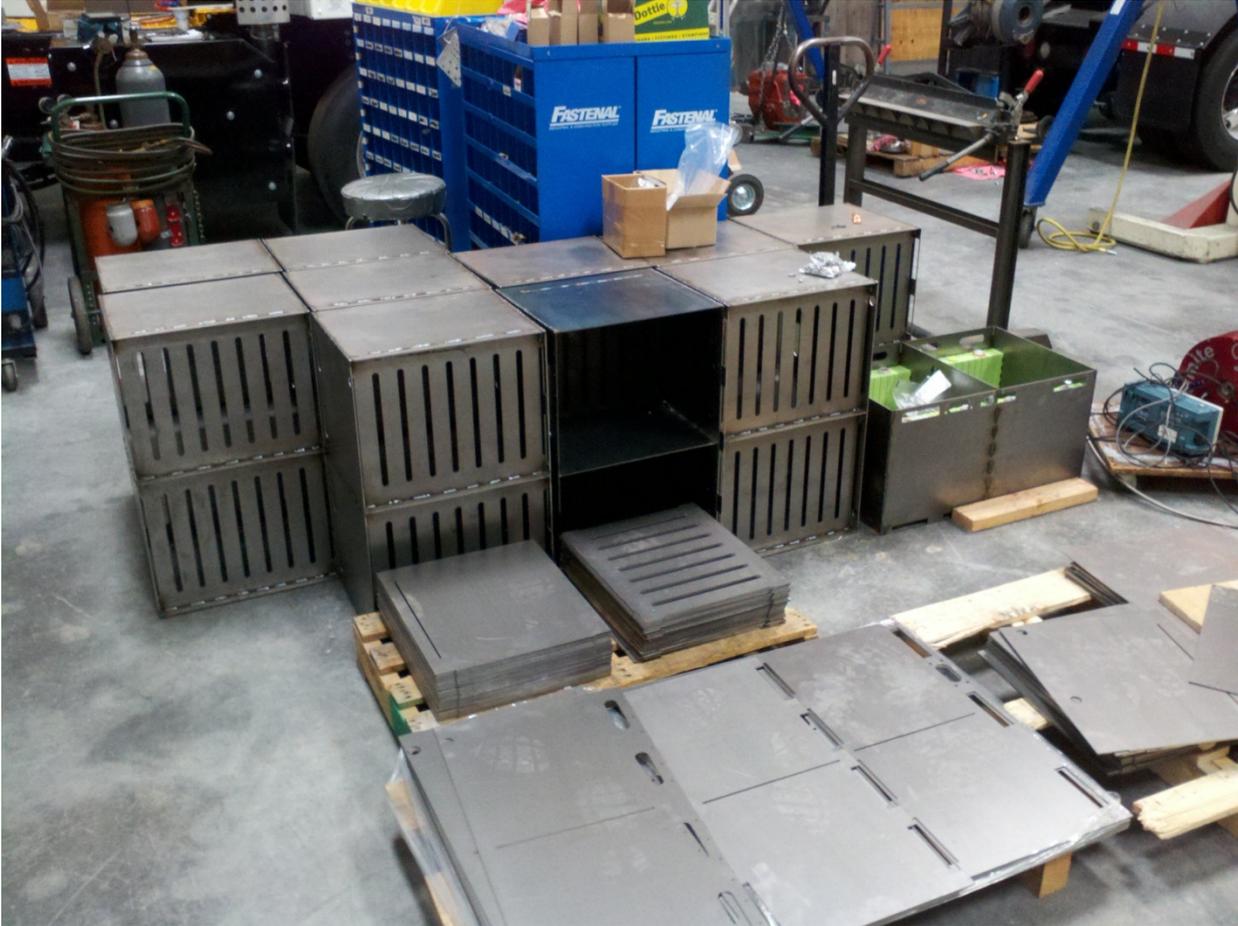
- The ESS suitcase parts are in house and being fabricated.

Figure 3: Completed suitcases stacked up in the shop

During the next period TransPower expects to fabricate the remaining battery suitcases and install the cells, BMS wiring, and HV cabling. The vehicle ESS mounting structure will be installed on Tractor 1. The suitcases themselves will be used to power the motors on the dynamometer then moved into the vehicle after the next report. Electrical accessory installation will be completed on the first tractor and then begun on the second vehicle. Vehicle 2 control system assembly will then begin. The VPCC external harnessing will be complete and connected to key components on the bench for dynamometer powertrain testing. The longer lead items will be acquired in the coming period, allowing dynamometer development and testing to proceed.
