**Texas Commission on Environmental Quality
New Technology Research & Development (NTRD) Program
Monthly Project Status Report**

Contract Number: 582-11-13472-2019

Grantee: Transportation Power, Inc. (Transpower)

Report for the Monthly period: 12/08/12 – 01/04/13 **Date Submitted:** 01/09/13

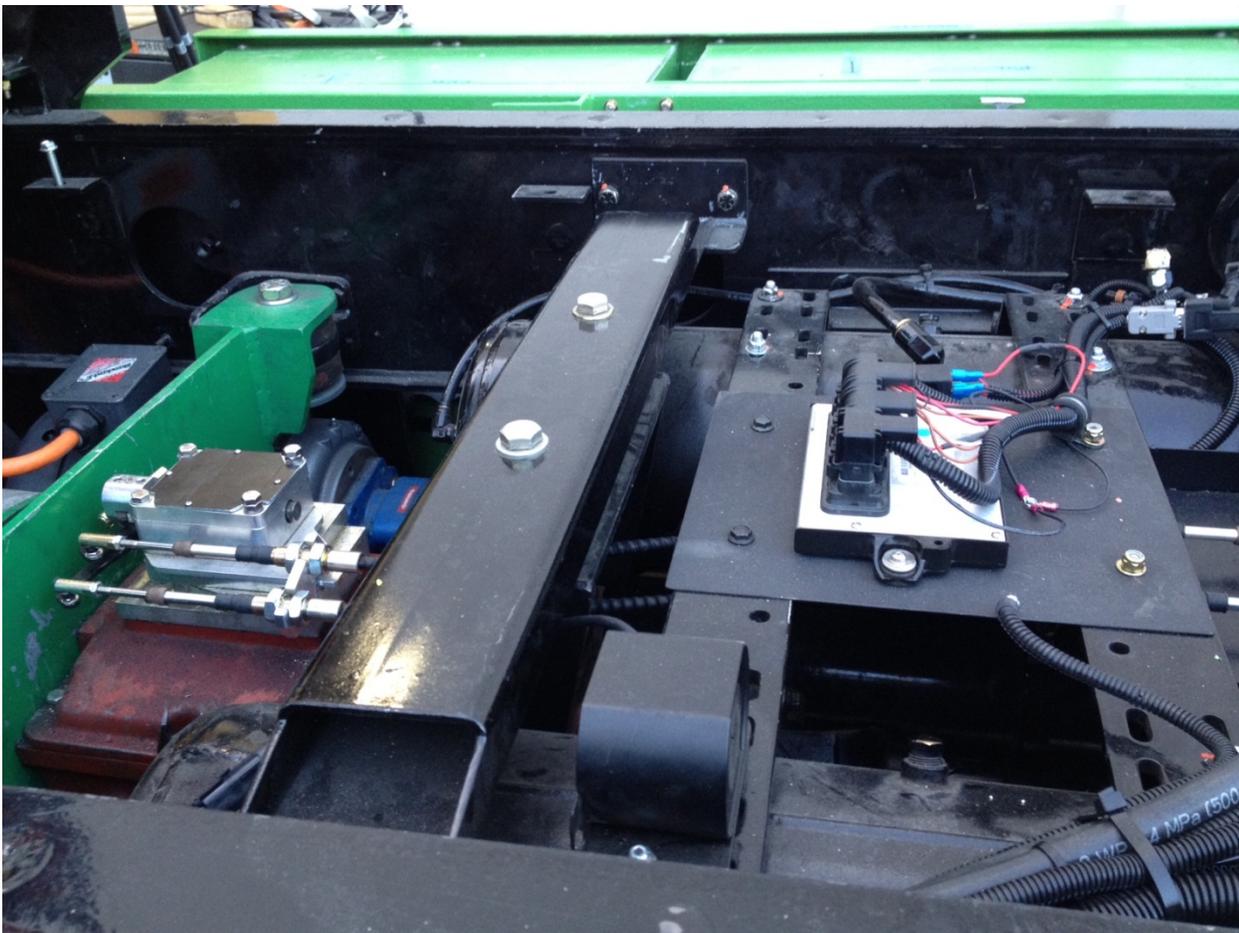
- Durability testing of Tractor #1 continued. After months of effort, it finally appears our engineering team has overcome the difficulties experienced in perfecting our automated manual transmission (AMT). Several hours of successful drive testing has been performed with the latest generation design of the AMT. During this testing, smooth automatic shifting between two gears has been achieved for the first time. Figure 1 shows the AMT assembly mounted into the tractor.

Figure 1: Latest generation AMT installed into Tractor #1.

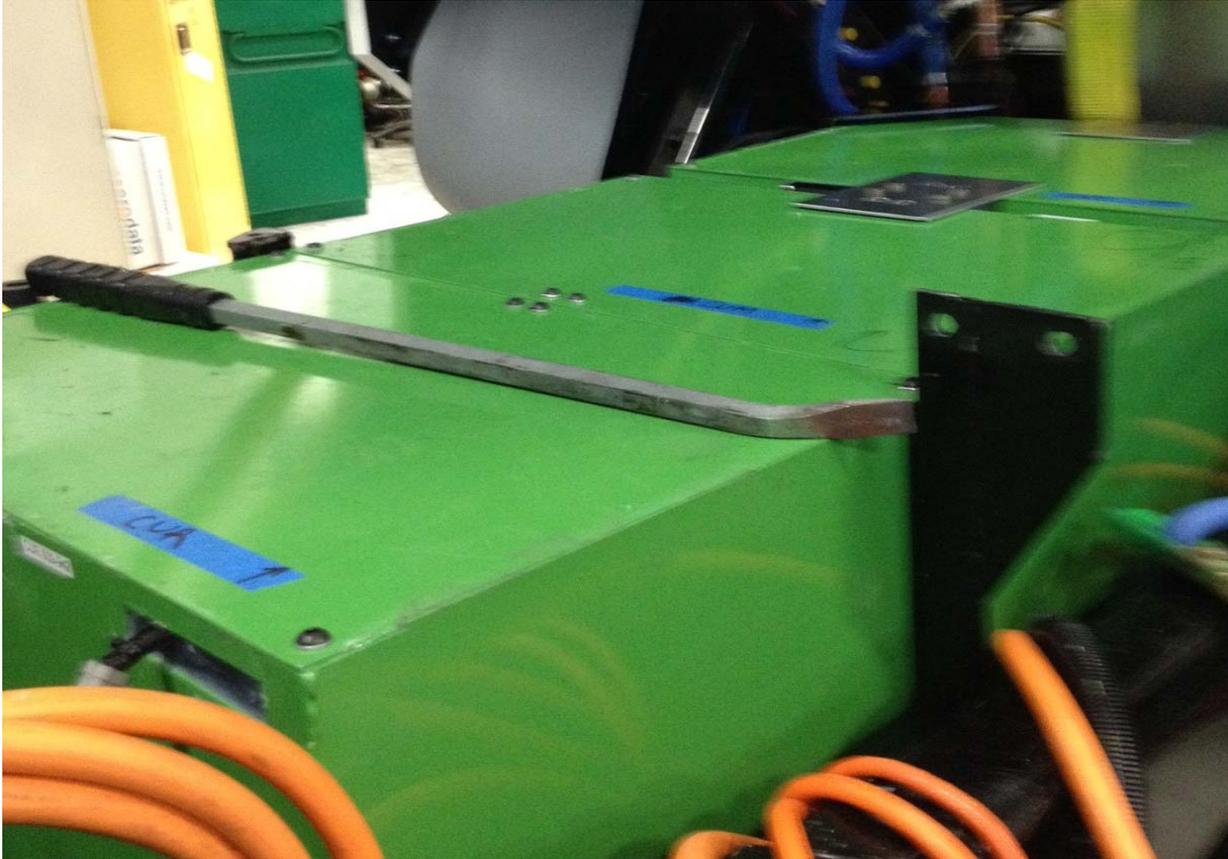
Figure 3: Battery modules reinstalled into Tractor #2 following cleaning and sealing.

- In addition to sealing the large oval air holes in the battery modules, it was decided to use silicone sealant to seal the module lids to the modules. This will present minor complications when lids need to be removed to inspect or replace cells (e.g., scraping off of old silicone and reapplying a new coat to reseal the module), but was determined to be preferable to allowing dust or water to creep into the modules through small gaps under each lid (also visible upon close inspection of Figure 2). Figure 3 shows the interior battery modules of Tractor #2 reinstalled into the tractor after being removed for cleaning of the cells and sealing of the air holes and gaps in the modules. Close inspection of the lids shows signs of the silicone sealant. This disassembly, cleaning, sealing, and reassembly of the 14 battery modules on each tractor delayed completion of commissioning of Tractor #2.

- a) As discussed previously, all battery modules were removed from both tractors and thoroughly cleaned, and then all holes and gaps in the modules were sealed. This was determined to be a much better solution than doing nothing, and much less costly and time-consuming than redesigning and rebuilding the battery modules. We believe the sealed modules will perform adequately for the two tractors built under this project for the duration of the project and probably for a significant amount of time thereafter. Battery modules for future vehicles will be designed with fewer openings that can allow entry of dust or water.
