**Texas Commission on Environmental Quality  
New Technology Research & Development (NTRD) Program  
Monthly Project Status Report**

**Contract Number:** 582-11-13472-2019

**Grantee:** Transportation Power, Inc.

**Report for the Monthly period:** 03/10/12 – 04/06/12      **Date Submitted:** 4/09/12

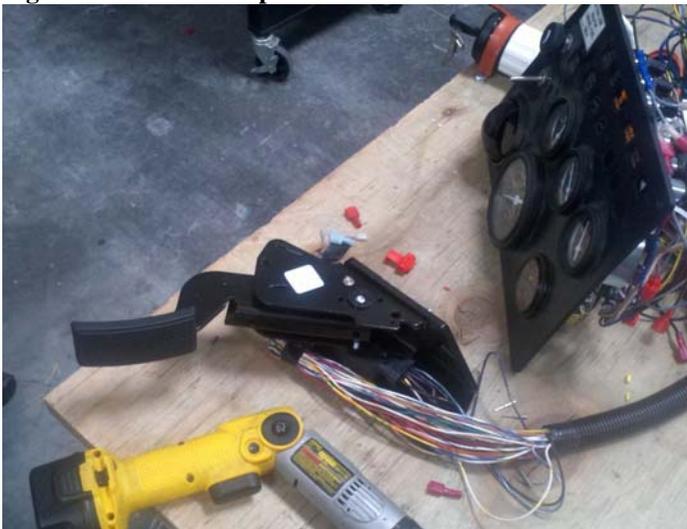
- Control system development has progressed significantly. A complete code set exists and is being vetted and calibrated on the bench. This is a significant milestone in the control development process enabling fine calibration of sensors and actuators with logic.
- The accelerator pedal has been calibrated and a pedal smoothing algorithm is in place to smooth out Pilot Induced Oscillations (PIO) common to responsive powertrains in vehicles that tend to ride roughly. This phenomenon occurs when the vehicle encounters a bump and the driver's foot jerks the pedal, causing the vehicle to lurch and inducing more driver pedal input. Figure 1 shows the accelerator pedal mounted to the bench.

**Figure 1: Accelerator pedal on the bench**

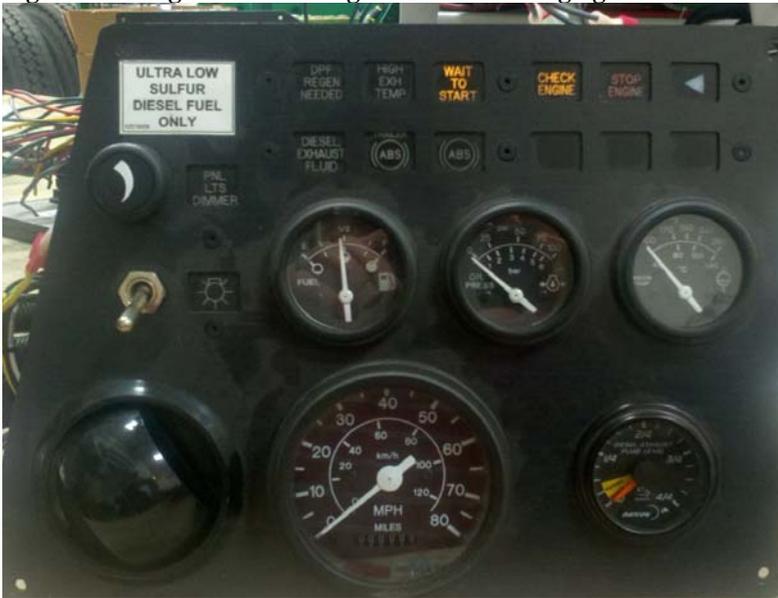
- The fuel gauge has been repurposed to report State of Charge (SOC). The Check Engine, Stop Engine, and Wait To Start lights are now under control of the supervisory controller and repurposed to report accordingly. New temperature gauges (with more appropriate temperature ranges) have been ordered and will report inverter and battery temperatures. Figure 2 shows the yard yuck gauge cluster on the bench during testing.

**Figure 2: Gauge cluster during SOC and warning light tests**

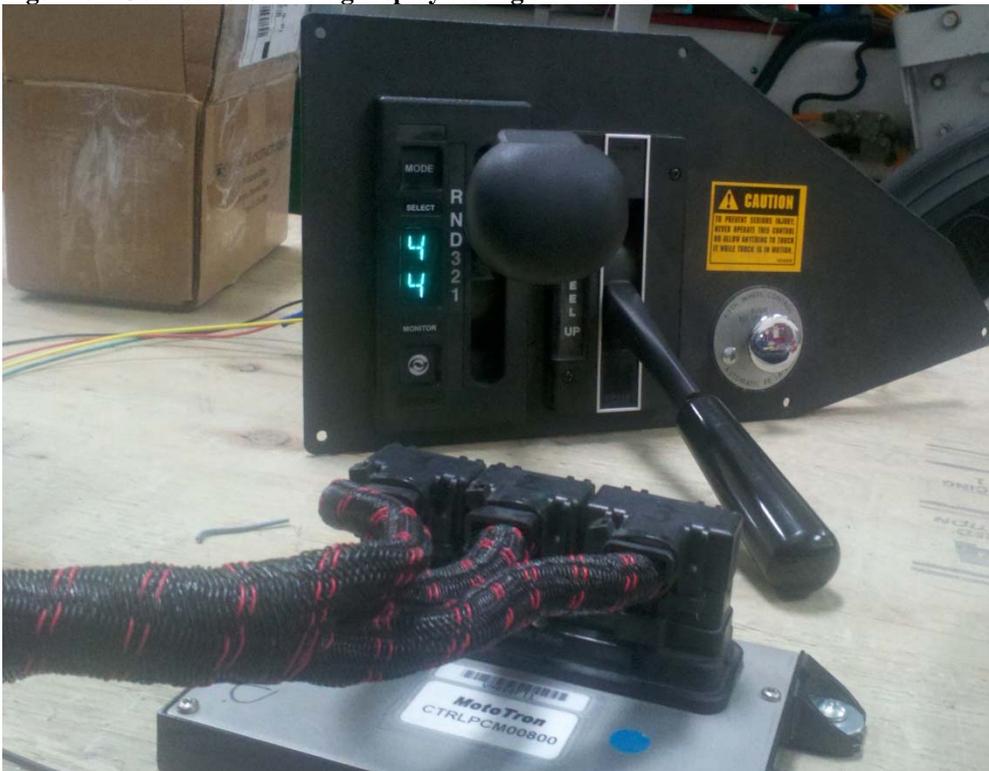
- The gear selector is now under control of the supervisory controller reporting the selected gear and displaying the actual current gear just as it did with the original powertrain. The integrated transmission warning lamp can be used to signal a transmission issue. Figure 3 shows the gear selector on the bench during testing.

**Figure 3: Gear selector during display testing and verification**

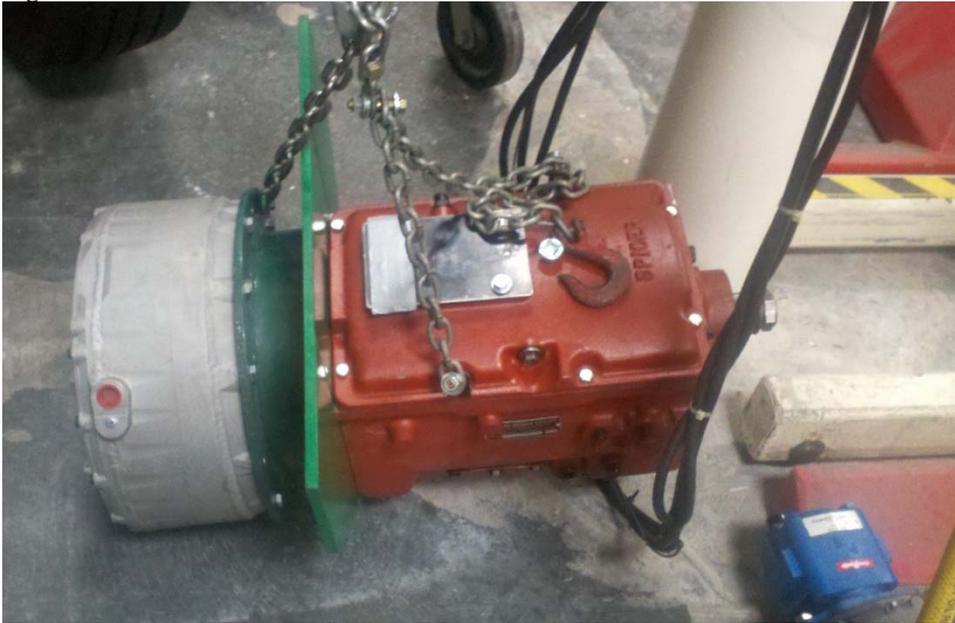
- The pre-charge and voltage sensing circuits are nearly complete undergoing some refinement on the part of the contracted engineer. I/O and logic are in the vehicle control code. This is important to establish the state of the vehicle before beginning the start up sequence as well as knowing when to fully enable high voltage.
- TransPower is in the process of fabricating parts for powertrain integration. The new input shaft has arrived and the powertrain unit, comprised of the motor and transmission, has been assembled. It has been placed in the vehicle to verify mount locations and is now slated to be installed on the dynamometer. Figure 4 shows the complete and painted motor-to-transmission adapter in between the motor and transmission.

**Figure 4: Assembled Powertrain Unit**

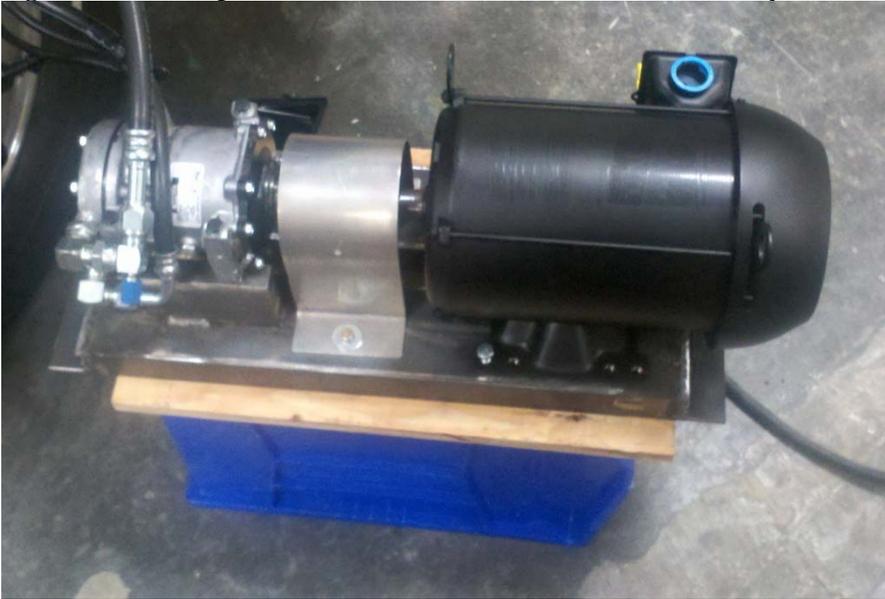
- Dynamometer assembly continues. Custom shafts have been identified and are being sourced at local manufacturers. Off-the-shelf parts are arriving and the physical structure is being designed.
- Electric accessories have arrived and most are installed or in testing.
  - The air conditioning assembly is ready for installation once the Love-Joy coupler has passed durability testing that is currently underway. The approach has made for a more favorable space claim and is more efficient than a standard V-belt coupling. This assembly is shown in Figure 5.

**Figure 5: AC Compressor and motor mounted to the base and ready for durability testing**
