**Texas Commission on Environmental Quality
New Technology Research & Development (NTRD) Program
Monthly Project Status Report**

Contract Number: 582-11-13472-2019

Grantee: Transportation Power, Inc. (TransPower)

Report for the Monthly period: 10/06/12 – 11/09/12 **Date Submitted:** 11/11/12

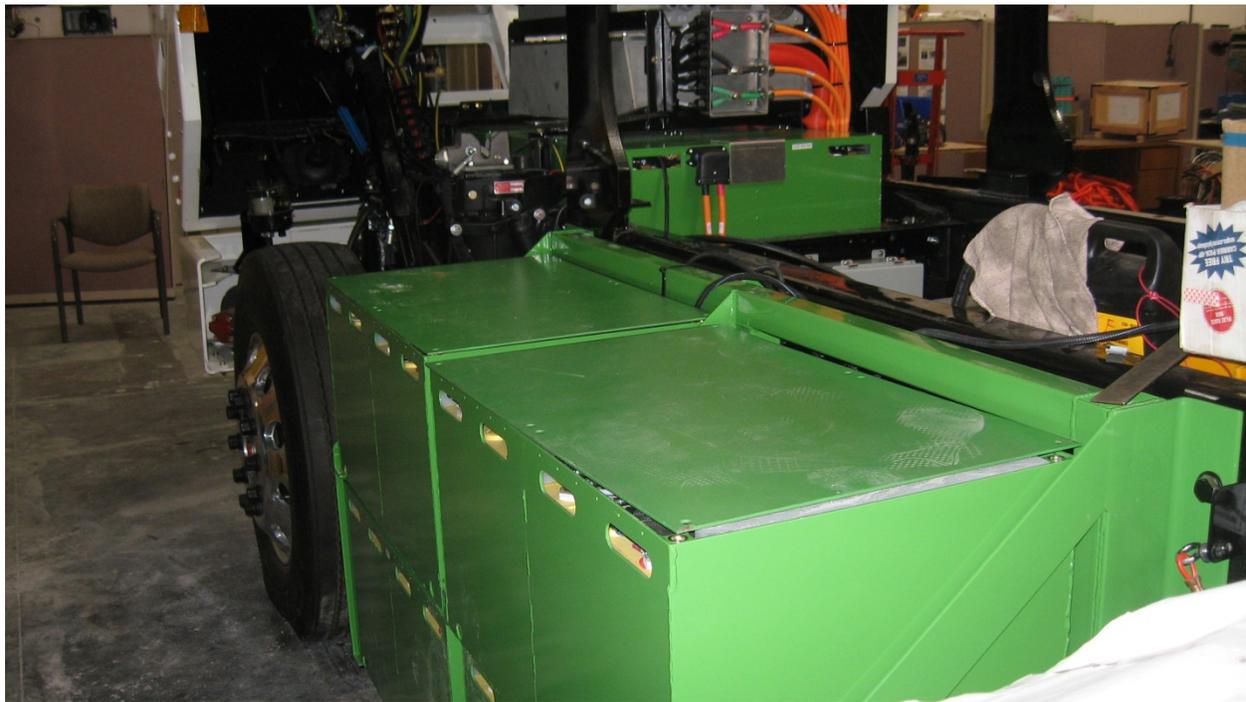
Figure 1: Tractor #2 showing installation of driver-side and interior battery modules, ICU, and CCM.

- Integration of Tractor #2 was completed. This is important to the project because it closes out Task 2, which took several months longer to complete than expected, for reasons discussed below and in our Task 2 report, submitted concurrently with this monthly report. This also allows us to focus project resources on Tasks 3 and 4, which involve durability testing followed by in-service testing of both tractors. Figure 1 is a photo of Tractor #2 shortly after integration was completed, with driver-side battery modules visible in the foreground and the under-cab components – interior battery modules, inverter-charger unit (ICU), and central control module (CCM) visible near the top center of the photo.

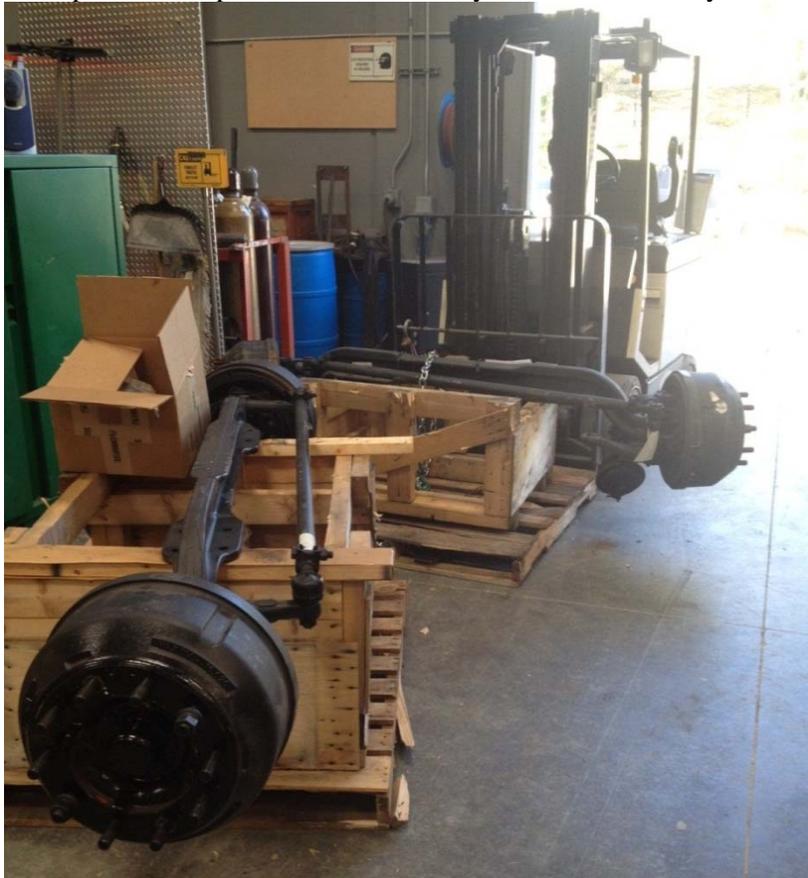
Figure 22: Axle removed from Tractor #2 (left) and heavier duty axle prior to installation into Tractor #1 (background).

- Numerous upgrades were made to Tractor #1 and Tractor #2 as a result of experience gained during two months of intermittent testing and refinement of Tractor #1. Among the key changes made to both tractors, the front axle on Tractor #2 was replaced with a heavier duty axle following determination that the weight placed on the front end of the tractors exceeded the weight limitations of the original front axles. Figure 2 shows the original axle removed from Tractor #2 (left foreground) and the heavier axle purchased for Tractor #1 (background). Another key achievement is that we completed development and bench testing of the communications hardware and software to enable automated shifting of the three-speed transmissions in both tractors. While shifting from first to second gear had previously been demonstrated on a dynamometer, it was discovered after initial drive testing of Tractor #1 that shifting to third gear couldn't be achieved quickly and reliably enough for seamless shifting to higher speed tractor operation. Steps taken to resolve this issue are discussed below. In addition to these achievements, we made numerous smaller improvements in the design of the drive system installed into Tractor #2, based on experience gained in building and testing Tractor #1. These included rewiring of the CCM and general improvements in vehicle wiring that are expected to improve tractor reliability and maintainability.

- b) Also as discussed in last month's report, initial drive testing revealed that excessive weight is being placed on the front axle of Tractor #1 and the vehicle's front tires. This is caused by the fact that space constraints required us to install several heavy components toward the front of the tractor, including six battery modules, the ICU, the CCM, and most of the electrically-driven accessories.

- b) The potential solutions to the weight problem were to redesign the installation to move components further back in the tractor, reduce the size or number of batteries on the tractor, or strengthen the front end of the tractor to handle the higher weight. As reported in last month's report, the last of these solutions was selected as it was viewed as the least costly and will have the least impact on vehicle performance.

- b) Two heavier duty axles were purchased from Cargotec. One was installed into Tractor #2. The other will be installed into Tractor #1 once it completes durability testing, prior to its delivery to H-E-B. After further discussions with Cargotec, it was determined that the front tires will not need to be replaced, which at one point was another solution that was contemplated. The effect of this change was an increase of approximately \$10,000 in project costs.
- c) As discussed above, TransPower will inquire with the TCEQ as to whether there are any unspent New Technology Research and Development (NTRD) program funds that can be allocated to this project to help offset some of the cost increases that have been experienced, but is prepared to increase its cost sharing to meet these expenses if such additional funding cannot be obtained.
