### Reading Date

8/9/2019 7:00:00 AM to 8/9/2019 8:00:00 AM

### Recent Benzene Detections

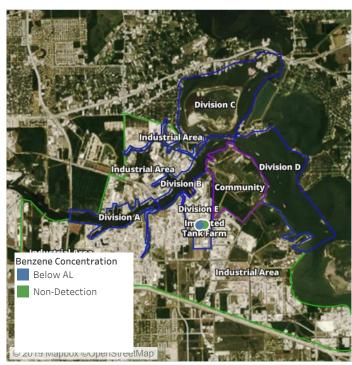
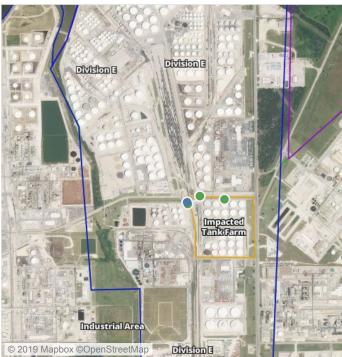
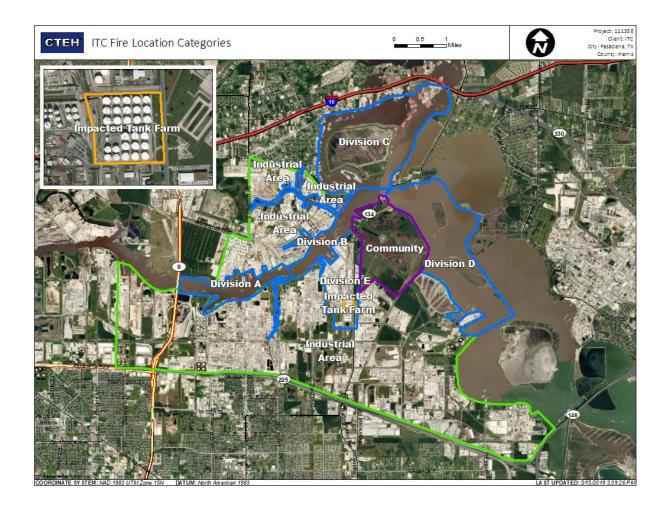
Location Category	Reading Date	Range of Detections
Division E	8/9/2019 07:49:10	0.1100 ppm

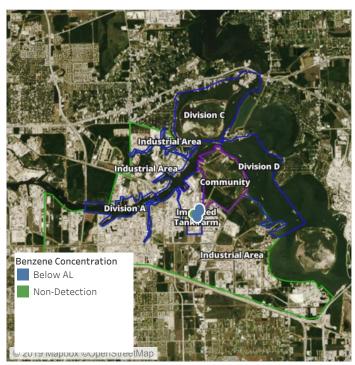
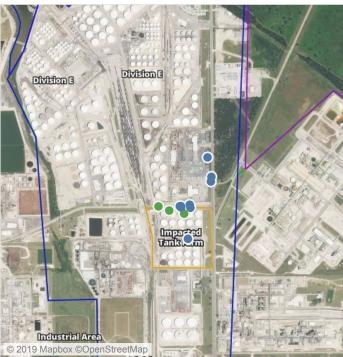
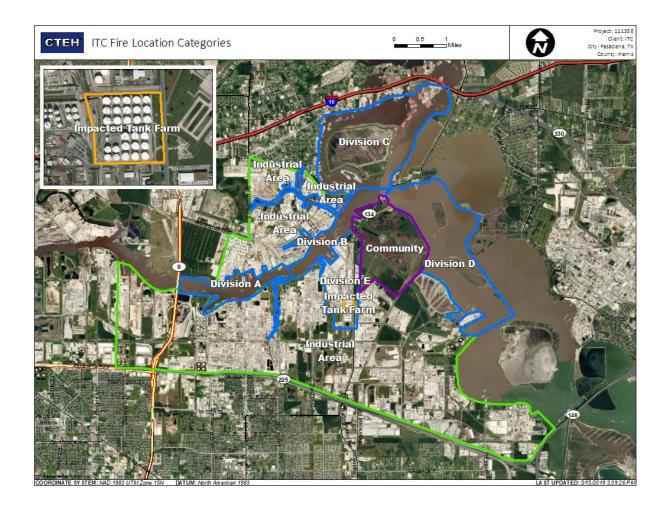
8/8/2019 8:00:00 AM to 8/8/2019 9:00:00 AM

Location Category	Reading Date	Range of Detections
Division E	8/8/2019 08:01:09	0.0300 ppm
	8/8/2019 08:03:00	0.0700 ppm
	8/8/2019 08:18:58	0.0700 ppm
	8/8/2019 08:38:01	0.0800 ppm
	8/8/2019 08:49:53	0.0900 ppm
	8/8/2019 08:47:50	0.2300 ppm
Impacted Tank Farm	8/8/2019 08:13:15	0.2500 ppm
	8/8/2019 08:25:20	0.3300 ppm
	8/8/2019 08:21:49	0.1500 ppm
	8/8/2019 08:26:56	0.0900 ppm

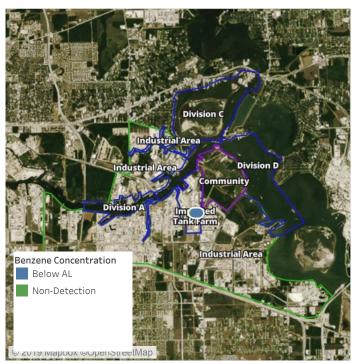
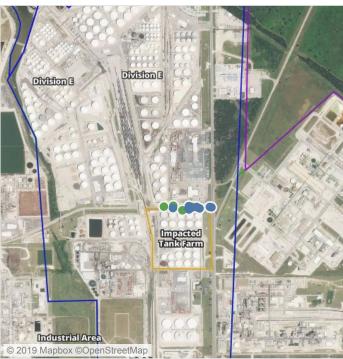
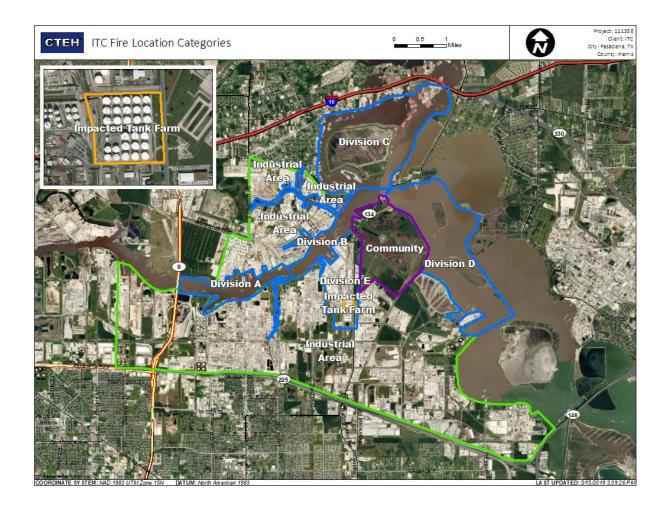
8/8/2019 9:00:00 AM to 8/8/2019 10:00:00 AM

L. E. C.	B. P. B.L.	D (D.). (1)
Location Category	Reading Date	Range of Detections
Division E	8/8/2019 09:08:53	0.0400 ppm
	8/8/2019 09:22:49	0.1000 ppm
	8/8/2019 09:41:16	0.1000 ppm
	8/8/2019 09:25:55	0.2200 ppm
	8/8/2019 09:29:31	0.3500 ppm
	8/8/2019 09:38:52	0.1000 ppm
	8/8/2019 09:44:40	0.0600 ppm
	8/8/2019 09:58:29	0.2000 ppm
	8/8/2019 09:50:22	0.1900 ppm
	8/8/2019 09:55:09	0.0500 ppm

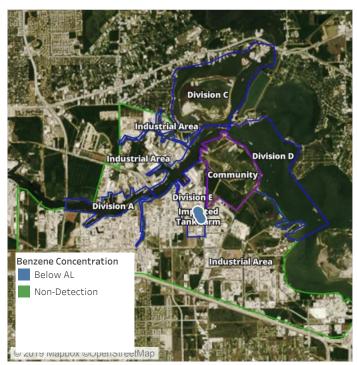
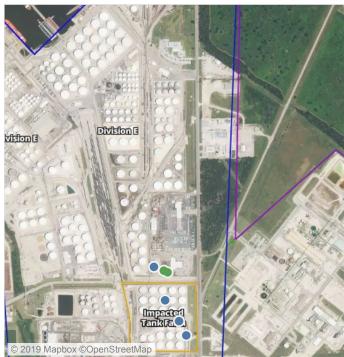
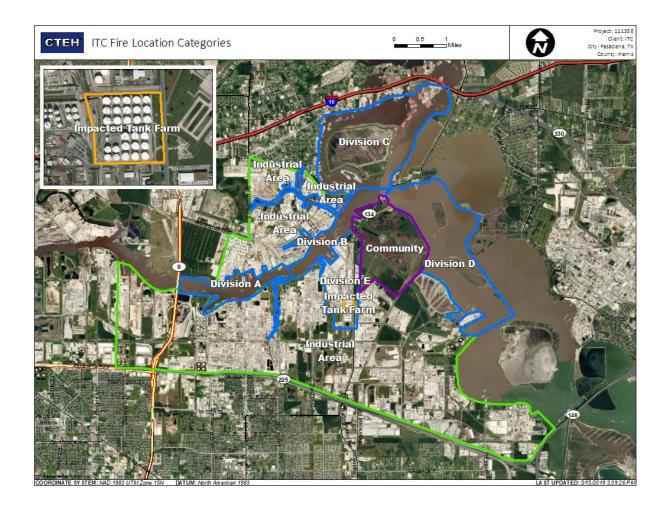
8/9/2019 10:00:00 AM to 8/9/2019 11:00:00 AM

Location Category	Reading Date	Range of Detections
Division E	8/9/2019 10:21:25	0.0600 ppm
	8/9/2019 10:48:12	0.1200 ppm
	8/9/2019 10:50:22	0.0200 ppm
Impacted Tank Farm	8/9/2019 10:09:37	0.1400 ppm

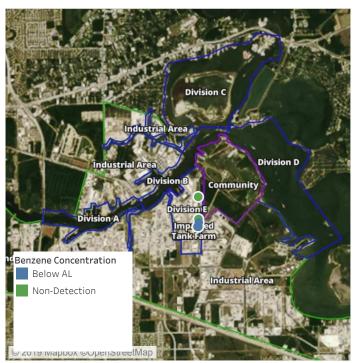
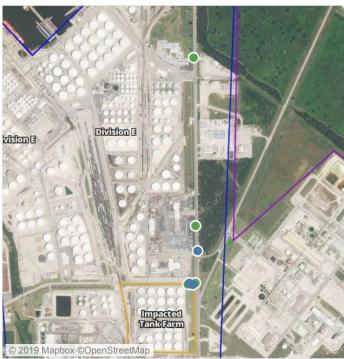
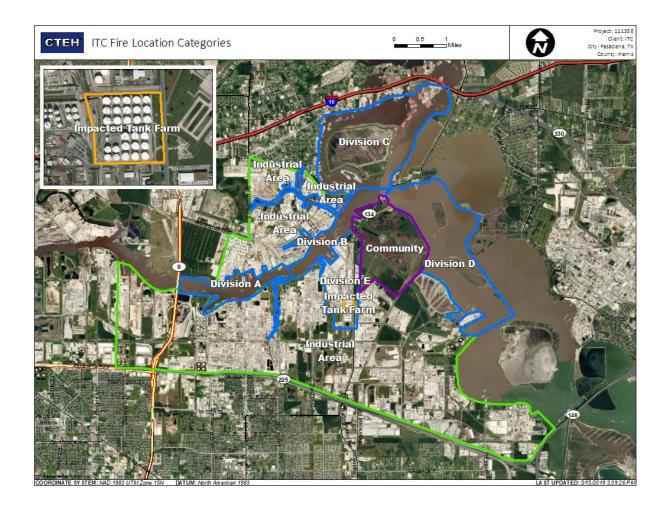
8/9/2019 11:00:00 AM to 8/9/2019 12:00:00 PM

Location Category	Reading Date	Range of Detections
Division E	8/9/2019 11:20:26	0.08000 ppm
	8/9/2019 11:39:30	0.02000 ppm
	8/9/2019 11:46:29	0.08000 ppm
	8/9/2019 11:52:27	0.02000 ppm

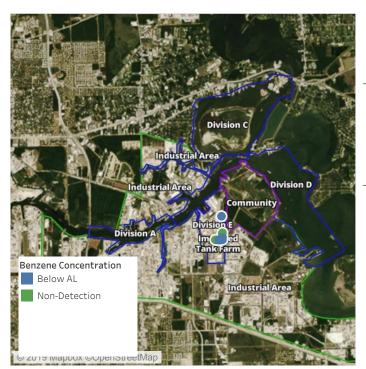
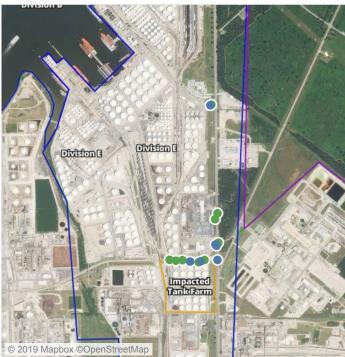
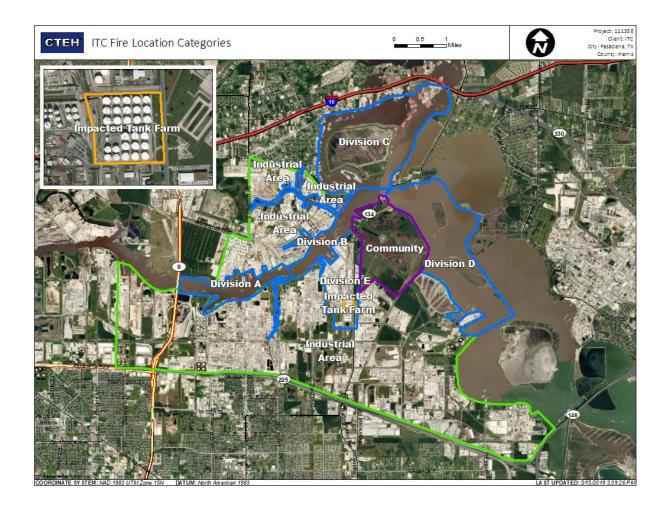
8/9/2019 12:00:00 PM to 8/9/2019 1:00:00 PM

Location Category	Reading Date	Range of Detections
Division E	8/9/2019 12:04:04	0.07000 ppm
	8/9/2019 12:23:18	0.03000 ppm
	8/9/2019 12:17:47	0.03000 ppm
	8/9/2019 12:22:43	0.03000 ppm
	8/9/2019 12:46:31	0.05000 ppm
	8/9/2019 12:54:41	0.03000 ppm

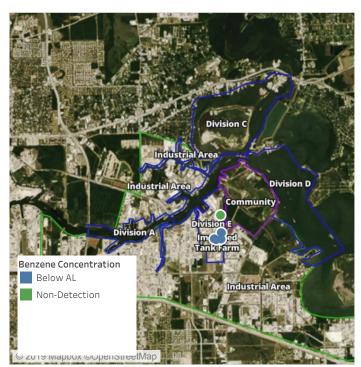
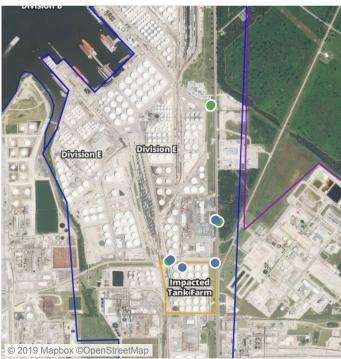
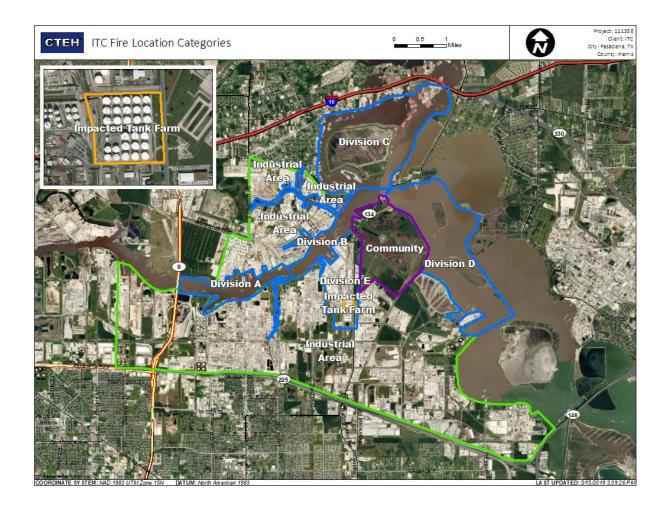
8/9/2019 1:00:00 PM to 8/9/2019 2:00:00 PM

Location Category	Reading Date	Range of Detections
Division E	8/9/2019 13:51:36	0.0300 ppm
	8/9/2019 13:22:18	0.0700 ppm
	8/9/2019 13:50:26	0.0500 ppm
	8/9/2019 13:42:21	0.1500 ppm

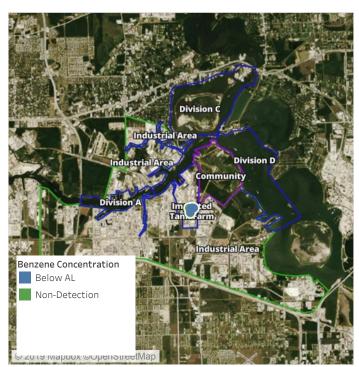
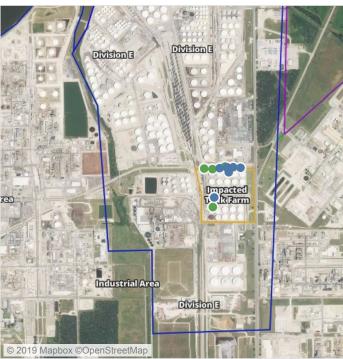
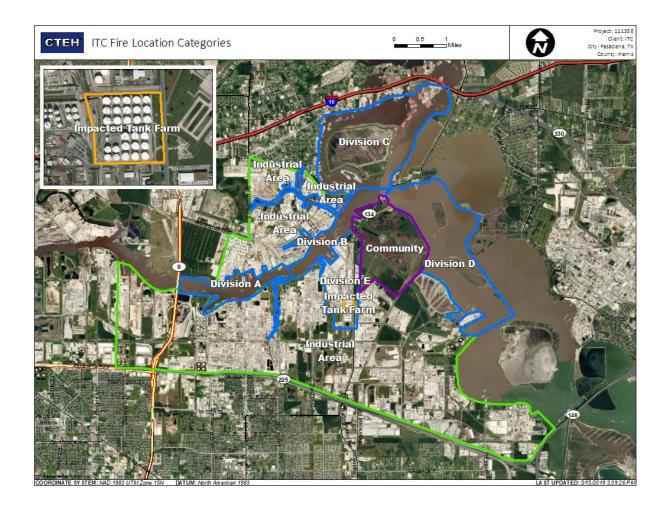
8/9/2019 4:00:00 PM to 8/9/2019 5:00:00 PM

Location Category	Reading Date	Range of Detections
Division E	8/9/2019 16:17:13	0.03000 ppm
	8/9/2019 16:26:12	0.04000 ppm
	8/9/2019 16:34:14	0.09000 ppm
	8/9/2019 16:29:27	0.03000 ppm
	8/9/2019 16:36:47	0.07000 ppm
	8/9/2019 16:31:31	0.03000 ppm
Impacted Tank Farm	8/9/2019 16:59:30	0.09000 ppm

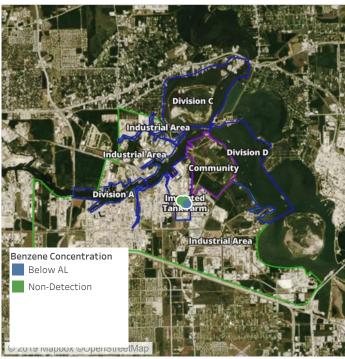
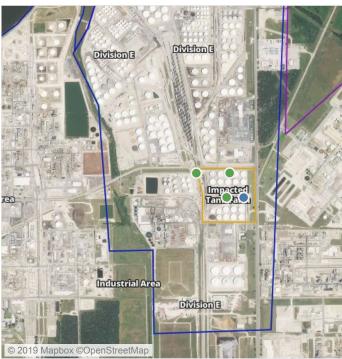
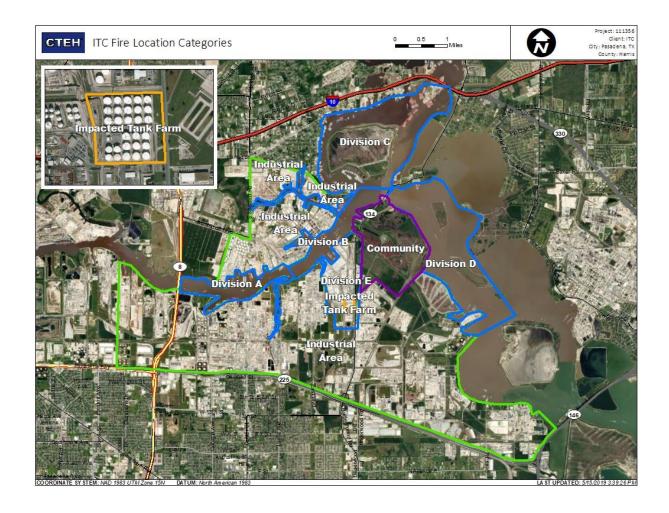
8/9/2019 5:00:00 PM to 8/9/2019 6:00:00 PM

Location Category	Reading Date	Range of Detections
Impacted Tank Farm	8/9/2019 17:14:08	0.1500 ppm
