Task 5: Data Analysis and Reporting

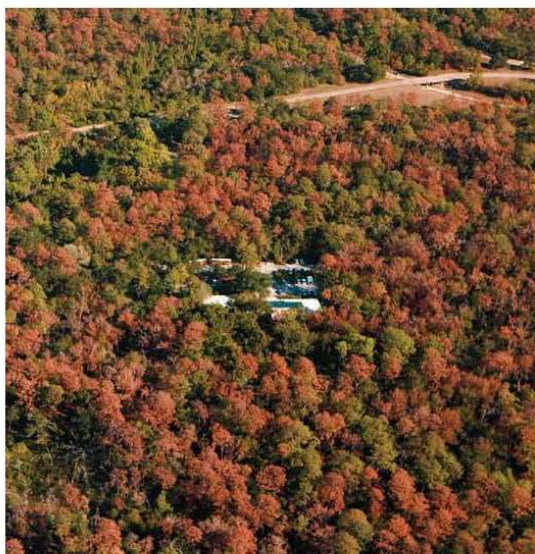
Approximately 90% of Houston's Memorial Park's canopy cover has died as a result of the drought. (photo by Jim Olive)

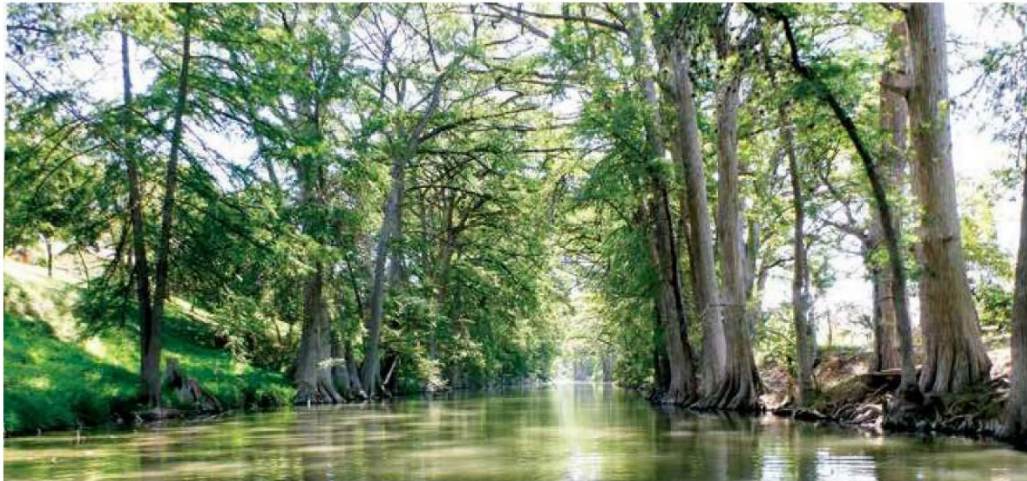
GUADALUPE RIVER BELOW FLAT ROCK DAM

GBRA. There are two USGS gages located in this AU, two miles downstream of Flat Rock Dam and downstream of the City of Comfort. The UGRA performs routine sampling at four stations within the AU. The most upstream monitoring station located on this AU is 15113, which is located off Split Rock Road near SH 27, -1.5 miles downstream of Flat Rock Dam and Kerrville Lake. A regression analysis of the data from June of 2003 to December of 2016 revealed several water quality trends at this station. This station has experienced an increase in specific conductance (TDS is calculated from this measurement), an increase in pH, and a decrease in Total Suspended Solids (Figures 1 & 2 & 3). Although no significant correlations with stream flow

were noted for these parameters, stream flow was significantly decreasing overtime and the changes in these parameters were most likely due to prolonged drought conditions. This station also has the lowest E. coli geometric mean in the AU, with a concentration of 22 MPN/100 ml. The excellent water quality (Table 1) at this station, including the diminishing suspended sediments and exceptional bacteria values may be due to the proximity of this station to active best management practices associated with the TMDL implementation plan that have been put into place immediately upstream. The only concern in this segment is for biological habitat. Two aquatic life monitoring events were performed in 2012 and 2014, which scored the biological habitat below the "excellent" designation for this water body. These scores were partially depressed due to low flow conditions during aquatic life monitoring, likely as a result of several years of drought. The next downstream station in this AU is 12608, which is located at Center Point Lake, -5.1 miles downstream of Split Rock Road. The only statistically significant observation that could be made at this station was that stream flow was diminishing over time, just as in the other stations in this AU (Figure 4). The 62 MPN/100 ml geometric mean of E. coli at this station was slightly higher than any other station in this AU. This value was most likely slightly elevated due to depositions from water fowl on Center Point Lake. The next downstream
