# East Texas Basic Recreational Use Attainability Analyses Project Report

Sabine River Basin - Nichols Creek (Segment 0502A) and Grace Creek (Segment 0505B)  
Contract No. 582-9-90439-11

**East Texas Basic Recreational Use Attainability Analyses  
Project Report**

**Sabine River Basin – Nichols Creek (Segment 0502A) and Grace Creek (Segment 0505B)**

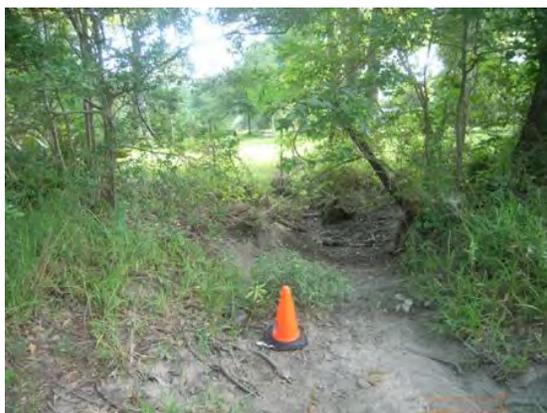
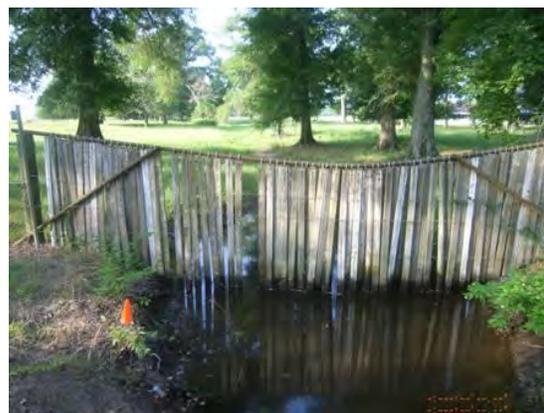
**Figure 4.1 Nichols Creek, Survey Site 81**

Site 81 sits just downstream of Site 82, on FM 1013. The stream characteristics of this site also provided no indications of recreational evidence. This site is in a rural area, surrounded by low sloped, fenced, forested banks with no public access. The creek bed at this site, shown by photographs in Figure 4.1 taken from FM 1013, had no flow when this site was visited. The water present was a shallow pool with no flow.

**Site 81 at FM 1013 Upstream View**

**Site 81 at FM 1013 Downstream View**

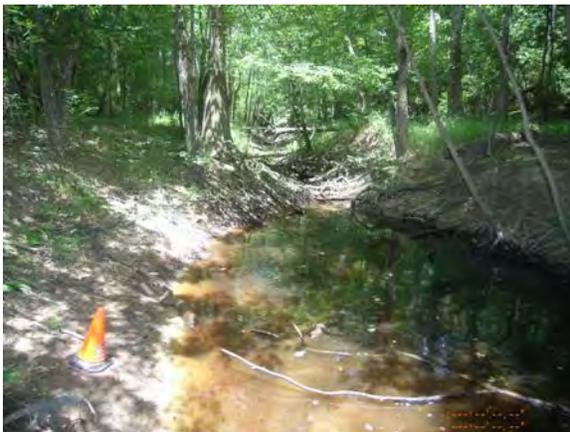
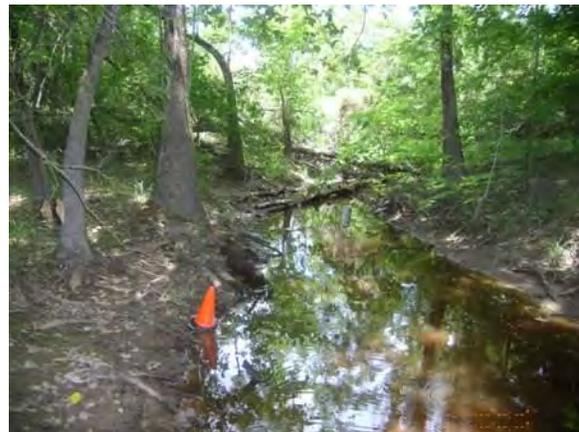
**Figure 4.3 Nichols Creek Survey Site 76**

Site 76, located on Texas Highway 96 in a rural area approximately 4.75 miles south of Kirbyville, was the only site surveyed along subsegment 0502A\_06. Dominated by a forested riparian corridor, this stream was easily accessible from below the Highway 96 bridge. No flow was observed. The average thalweg measured was 0.38m. Within the 300m reach surveyed, the Field Data Sheet for the site indicates an absence of water at 120, 180, and 240 through 300m. In the presence of water, the typical average stream width was 2.50m, as shown in Figure 4.3 below. Evidence of human presence included garbage (cans, cups, and candy wrappers) and all-terrain vehicle (ATV) tracks.

**Site 76 at Highway 96 Upstream View**

**Site 76 at Highway 96 Downstream View**

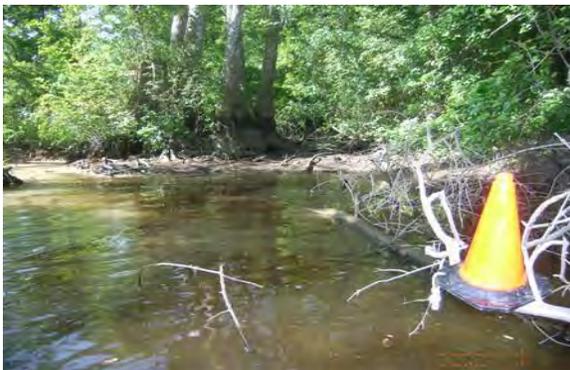
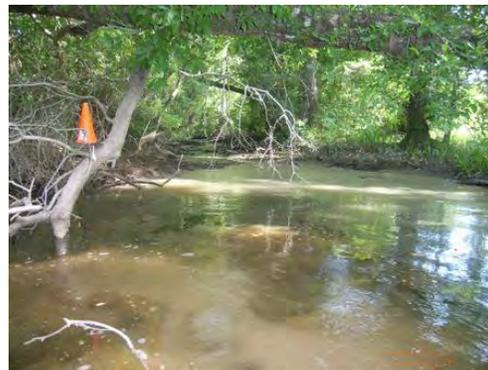
**Figure 4.4 Nichols Creek, Survey Site #66**

The most downstream site surveyed by the field team was Site 66, located at FM 253. Figure 4.4 provides photographs taken from the 30m transect depicting the forest-like riparian corridor and a substantial isolated pool. Access to the site was easily attainable as field team was able to drive down to river's edge. Typical average width where water was present was 4.00m. During the survey, no flowing water was observed between the 150m and 300m transect. The average thalweg measured for that stretch was 0.41m. Channel obstructions observed were log jams, rip rap, and old house appliances. Indicators of human use were footpaths/prints and a fish net.

Site 66 at FM 253 Upstream View

Site 66 at FM 253 Downstream View

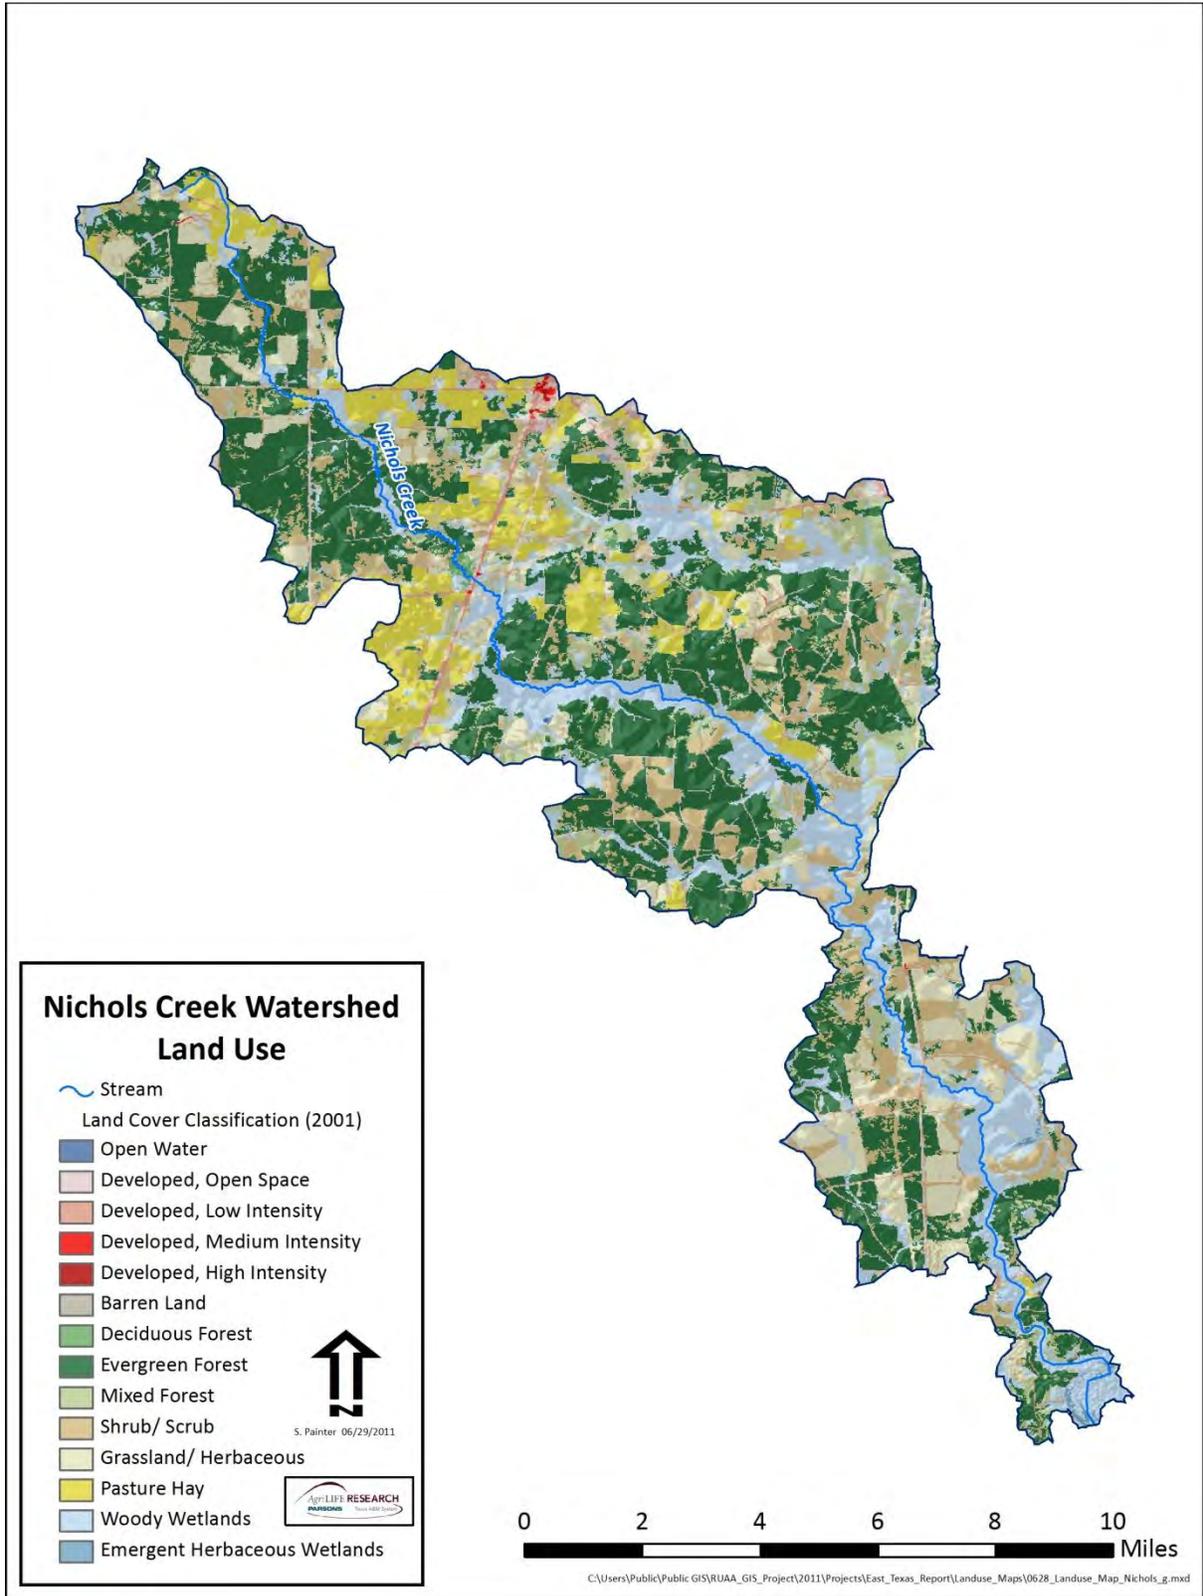
Figure 4.5 Nichols Creek Watershed Land Use Map

**Table 4.2 Nichols Creek Watershed: Land Use Summary by Category**

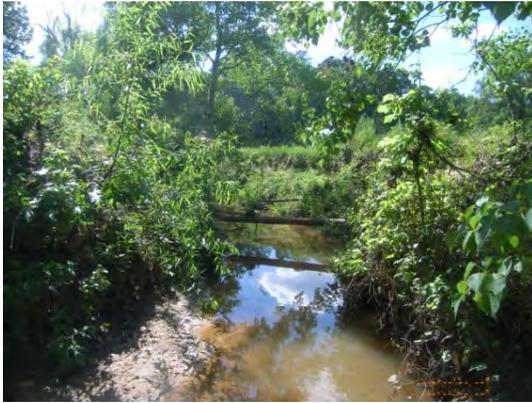
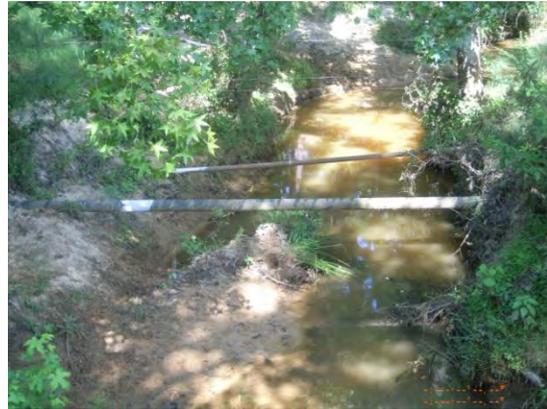
**Figure 4.6 Grace Creek, Survey Site 13**

just below the culvert road crossing was taken and photographs were only taken up to the 150m transect to detail stream characteristics. No specific evidence of recreational activity was recorded at this site. Evidence of livestock feces and the pasture-dominated corridor was photographed and is documented in Appendix D.

**Site 13 at McCann Creek Rd. Upstream View**

**Site 13 McCann Creek Rd. Downstream View**

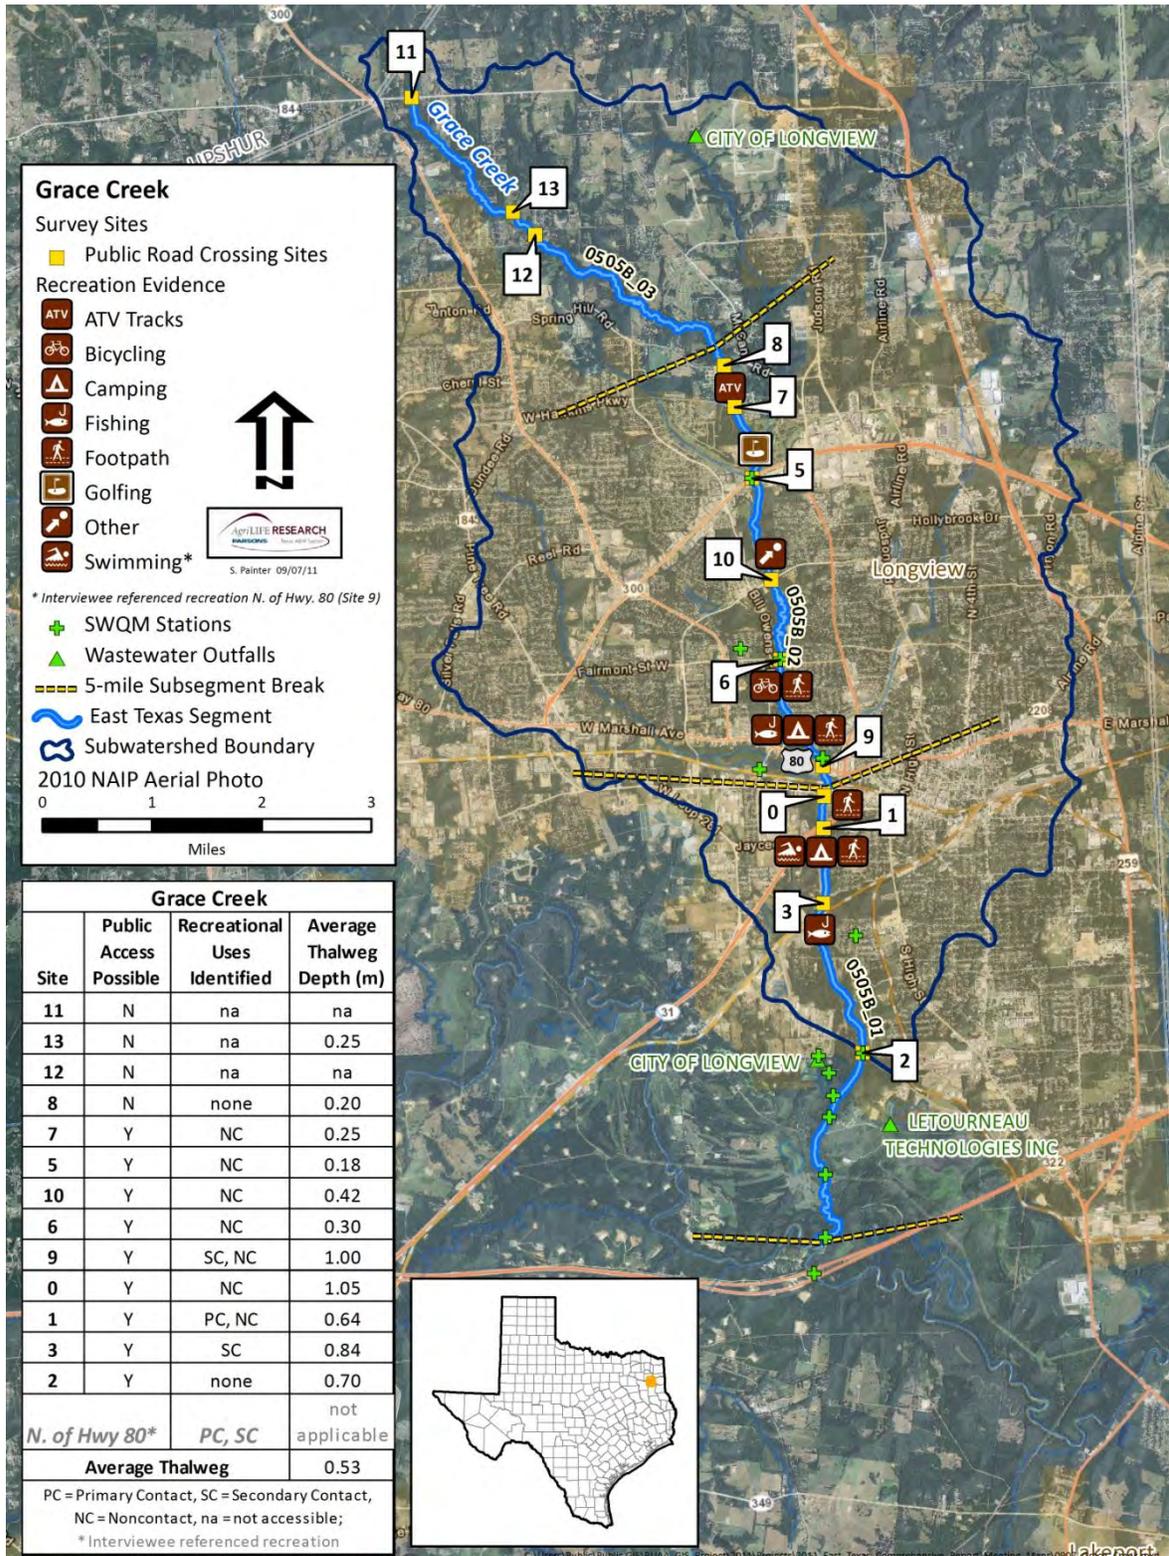
Figure 4.7 Map of Grace Creek

Note: The single foot path symbol on Figure 4.7 above between Sites 6 and 9 represents foot paths observed at both sites (See Table 4.8).

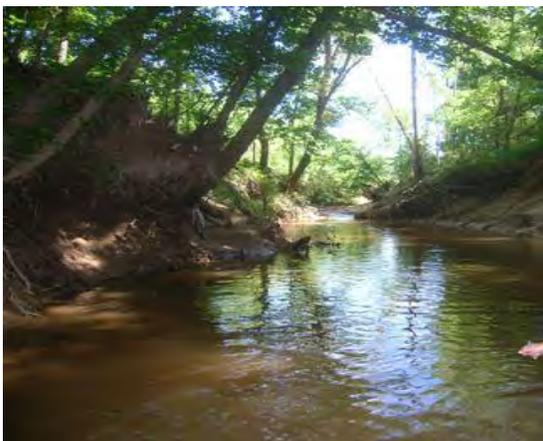
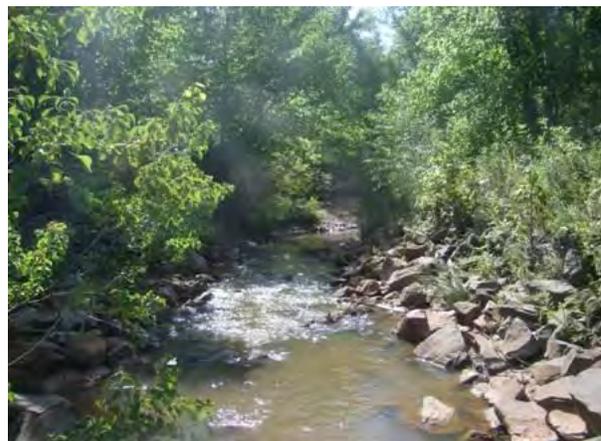
**Figure 4.8 Grace Creek, Survey Site #10**

Site 10 is located farther downstream on H.G. Mosley Parkway between two residential areas of Longview. This site is situated at the approximate mid-point of both Grace Creek and subsegment 0505B\_02. Evidence of noncontact recreation included graffiti on the bridge trusses, bicycle tracks, and city employees working in the riparian corridor. Channel obstructions included a large utility pipeline that crosses the creek immediately downstream of the bridge and large cobble stone, which can be seen in Figure 4.8. The large cobble meandered into the creek bed creating a riffle/pool condition. At the 60m transect, the channel transitioned from cobble to a mud/clay bottom, providing for smoother wading. Characteristics of the water at this site indicated an average depth measuring 0.42m, a channel width of 6.50m, and a flow of 0.78 cfs. Other characteristics of the clear, brown water include occasional algae cover and odor.

**Site 10 at H.G. Mosley Pkwy Upstream View**

**Site 10 at H.G. Mosley Pkwy Downstream View**

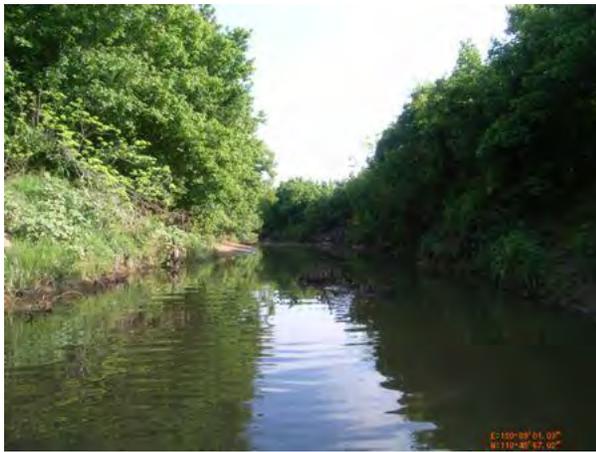
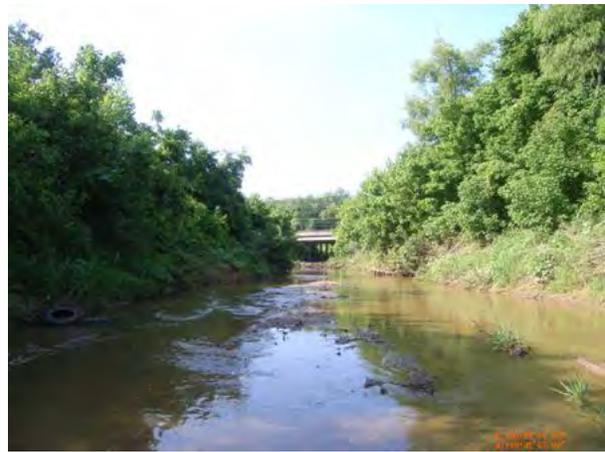
**Figure 4.9 Grace Creek, Survey Site 02**

The most downstream site that was surveyed on subsegment 0505B\_01 of Grace Creek was Site 02, located on State Loop 281. Figure 4.9 provides photographs taken from the 150m transect depicting a wide channel flanked by forest riparian zones and normal flowing water. The average thalweg measured was 0.70m. Water flow at the location was calculated at 8.78 cfs. There is public access at Site 02 from a steep vegetated bank below the bridge. There was no evidence of primary, secondary, or noncontact recreation at this site. The streambed of the channel was sediment-rich, making the stream very difficult to wade. There were no access points to Grace Creek downstream of this site.

**Site 02 at State Loop 281 Upstream View**

**Site 02 at State Loop 281 Downstream View**

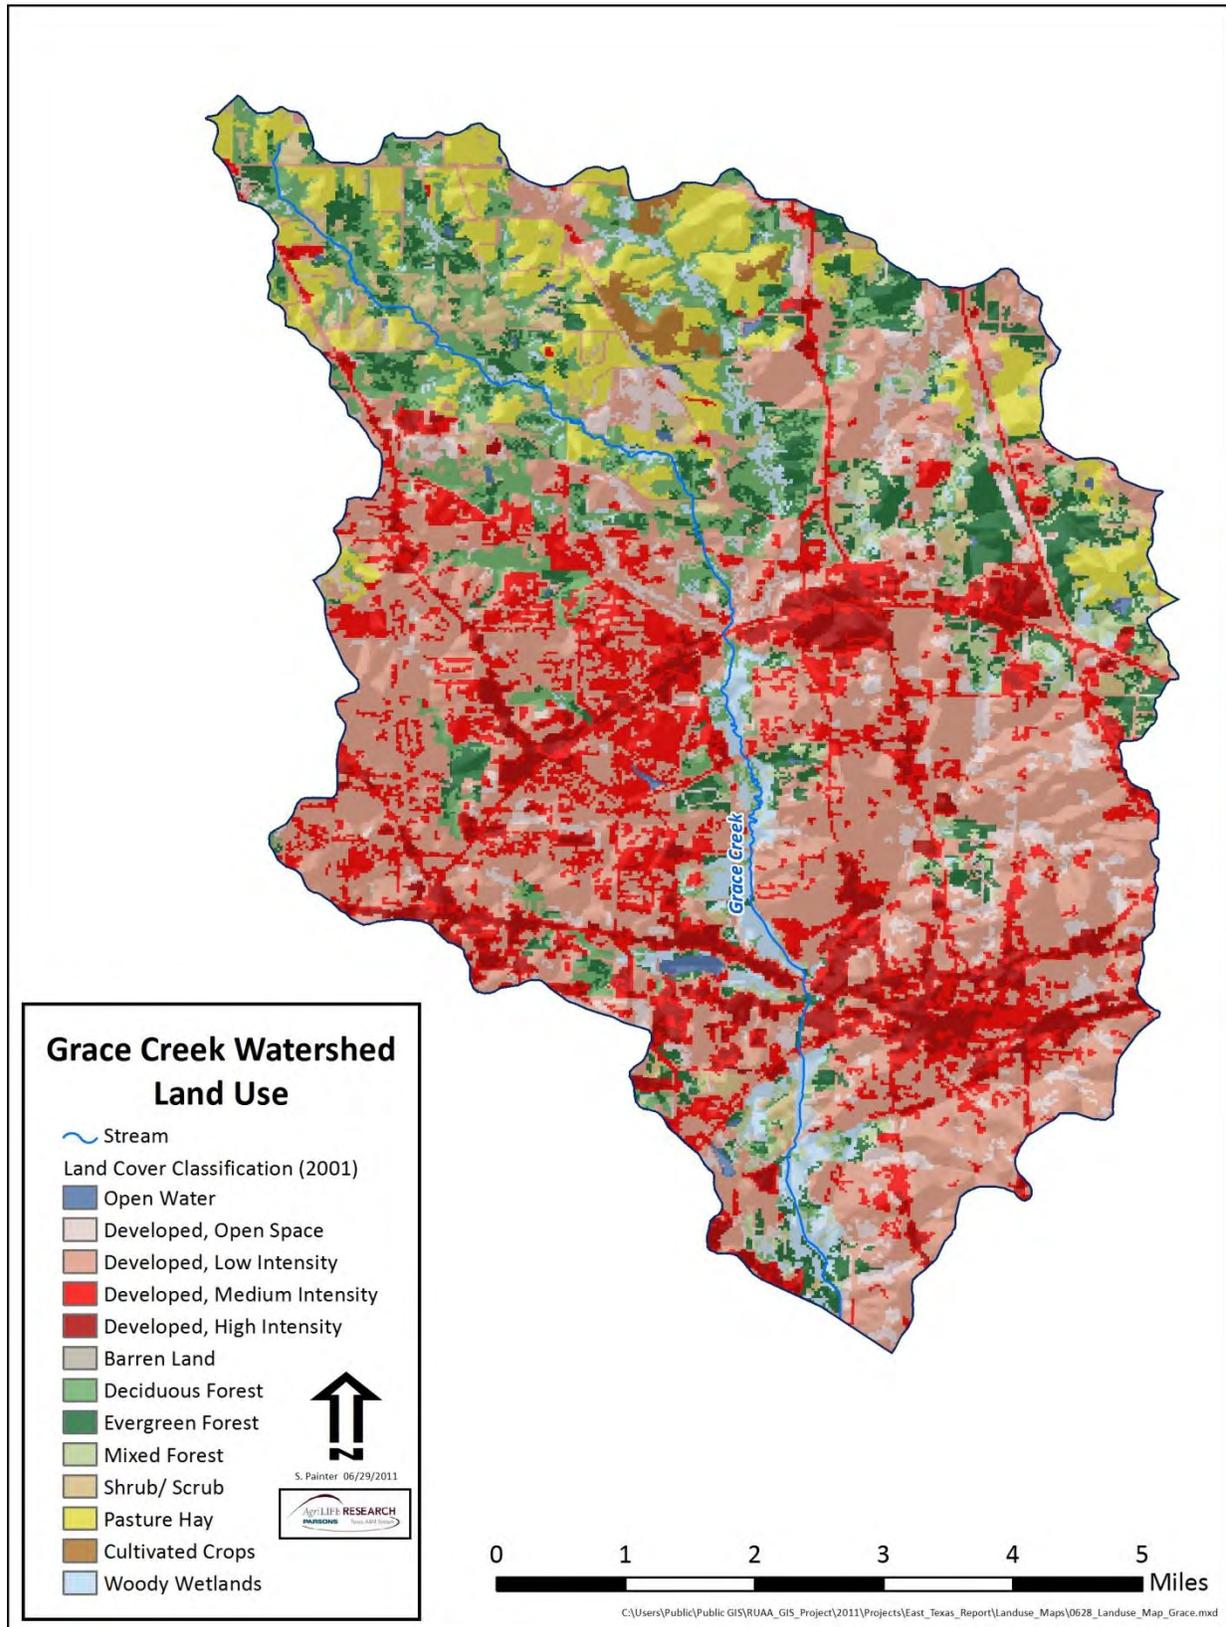
Figure 4.10 Grace Creek Watershed Land Use Map

**Table 4.4 Grace Creek Watershed: Land Use Summary by Category**
