**Pecos Bend Gas Processing Plant**

**Electric Motor Installation**

**Final Implementation Report for:**

**New Technology Implementation Grant (NTIG) Program**

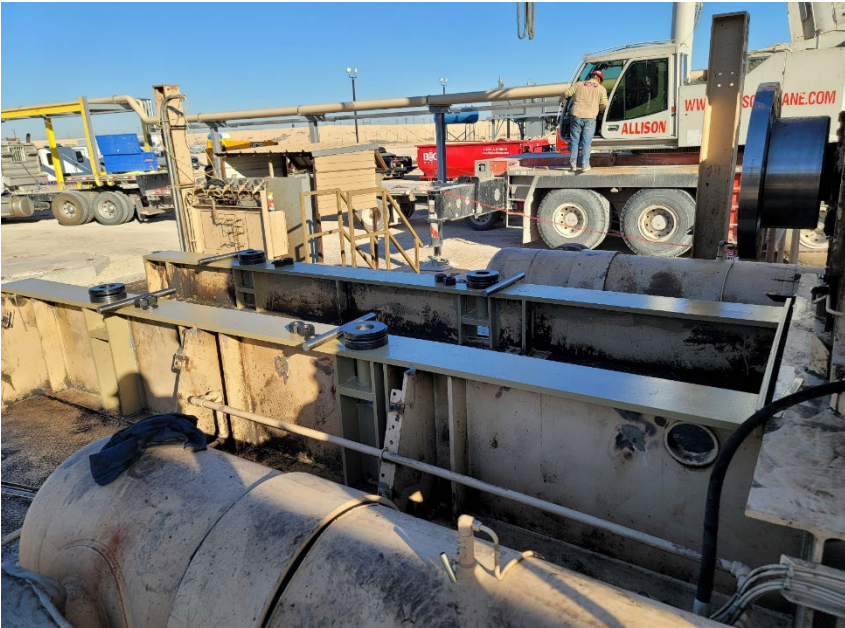
*Figure 1 Skid Modifications: Cat 3616 engine removed from skid*

No significant earthwork was needed to prepare the site for construction since this project mostly involved modifying and replacing existing equipment. Preparatory project work involved planning for the operational outage, removing the engine from the skid, and modifying the skid for the motor installation.

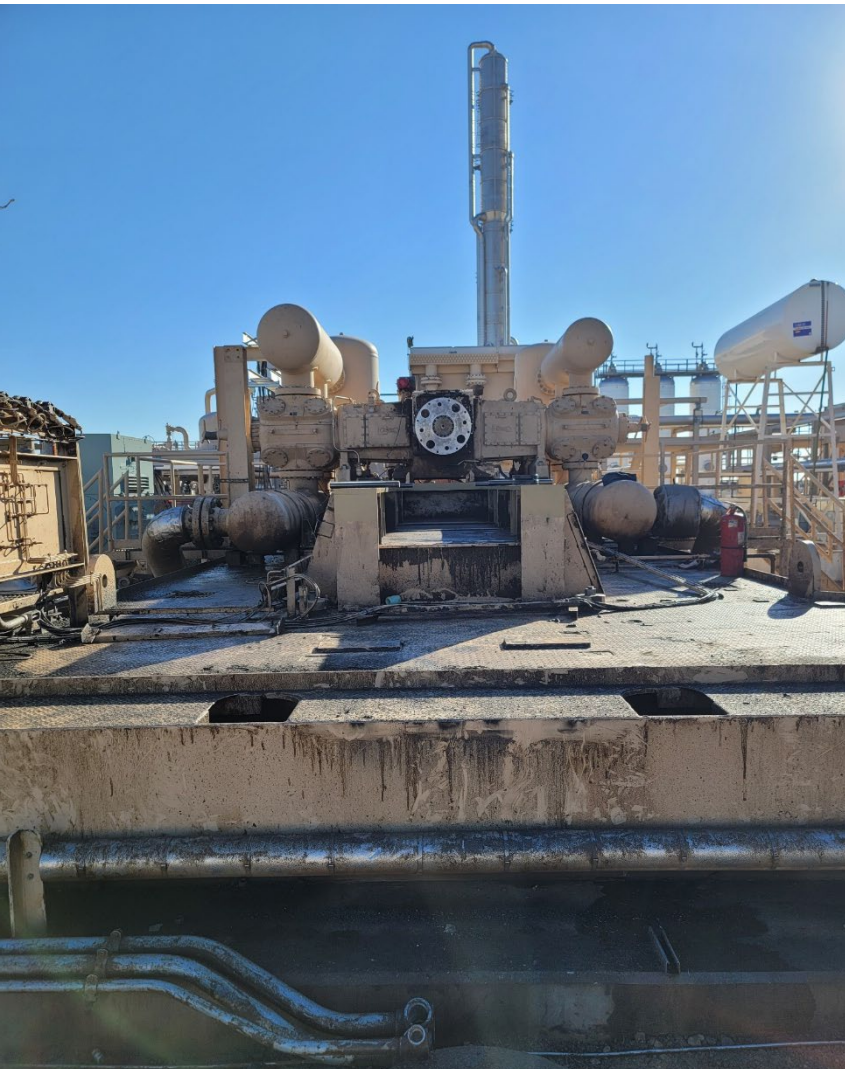
*Figure 2 Skid Modifications: CAT 3616 engine removed from skid*

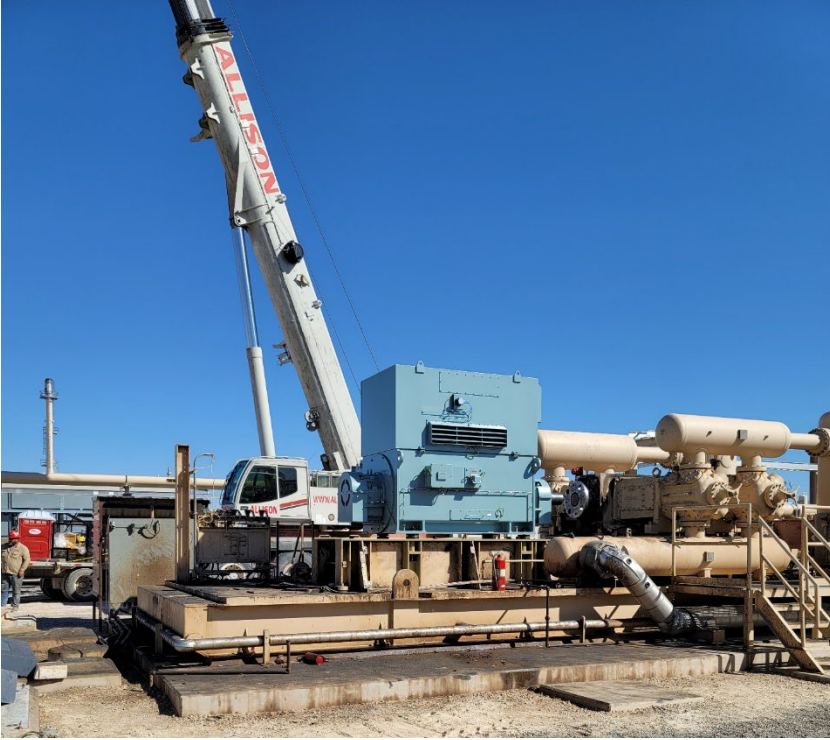
Figure 3 Electric motor set on skid

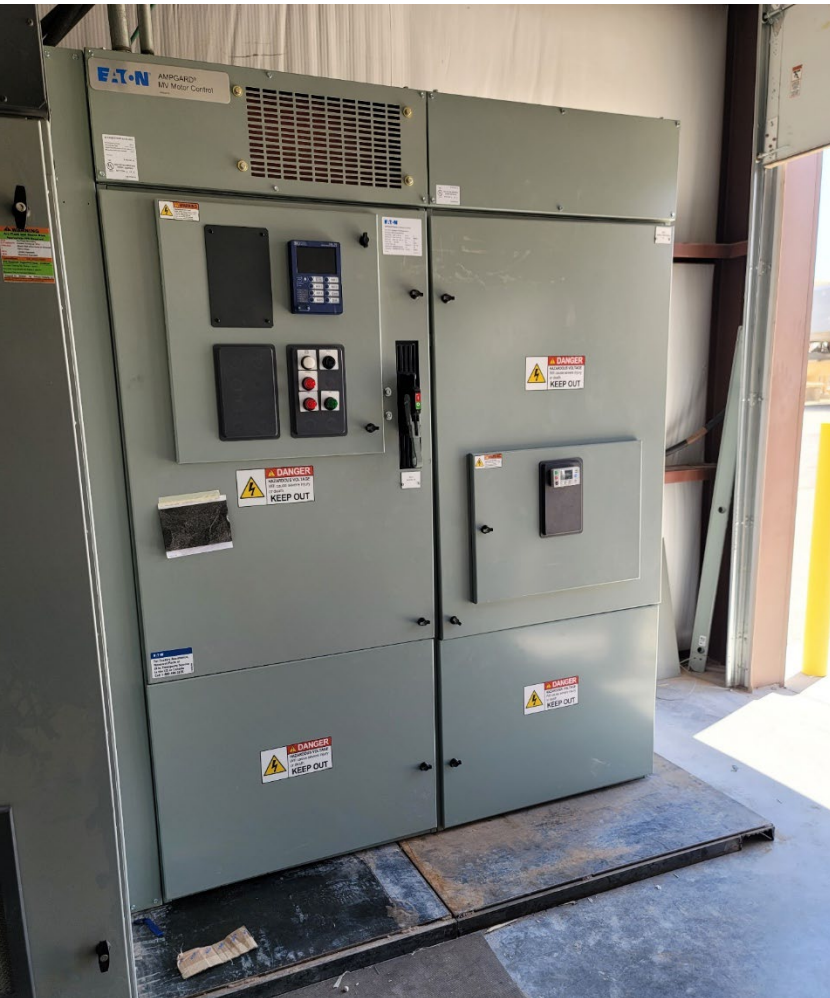
Figure 4 Completed RVSS Installation

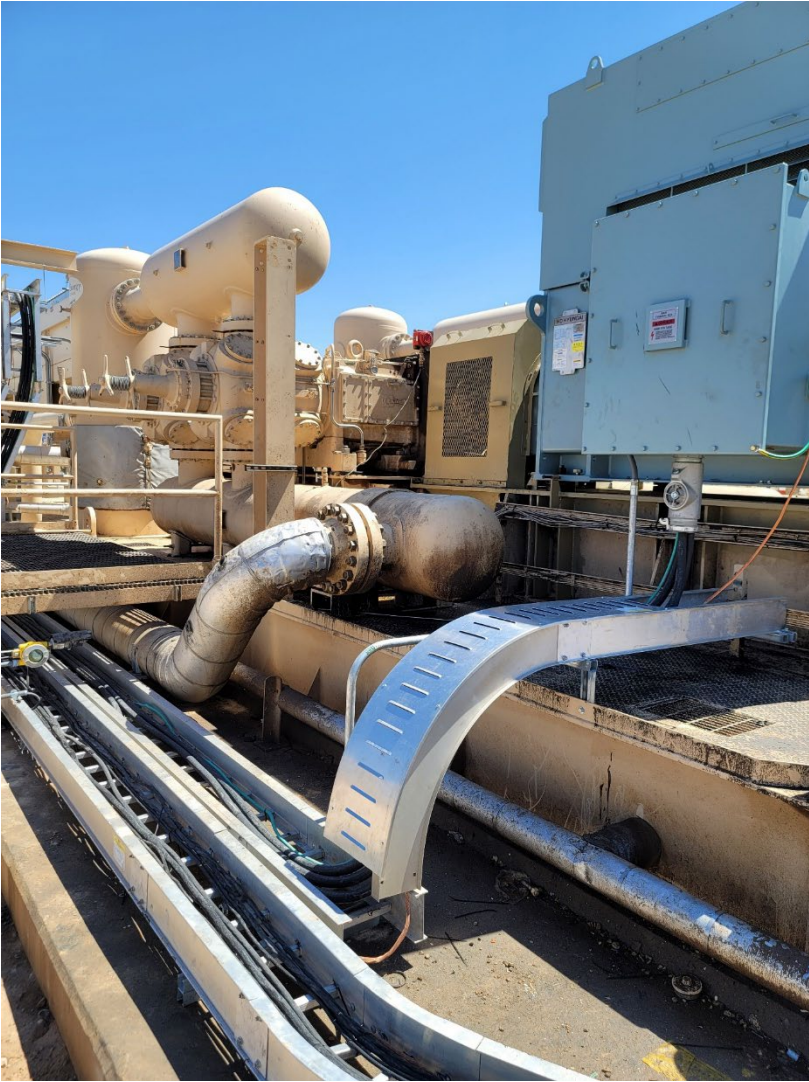
*Figure 5 Completed Motor Installation*
