Mobile Monitoring Team Monitoring Data Summary Goldsmith, Texas & West Odessa, Texas – October 10 – 13, 2022

The Texas Commission on Environmental Quality (TCEQ) Mobile Monitoring Team (MMT) conducted ambient air monitoring in Goldsmith, Texas and West Odessa, Texas to support a Region 7 investigation of potential hydrogen sulfide (H_2S) emission sources. Elevated H_2S concentrations above the regulatory limit of 80 parts per billion by volume (ppbv) based on 30-minute net averages (30 Texas Administrative Code, Part 1, Chapter 112, Subchapter B, Rule §112.31) have been measured at the Goldsmith Street Continuous Air Monitoring Station (CAMS) 1093. Additionally, elevated H_2S concentrations above 1 part per million by volume (ppmv) were measured with personal monitors and Jerome H_2S analyzers and multiple complaints were received in the West Odessa neighborhood just north of West 42nd Street and east of Farm to Market (FM) Road 1882.

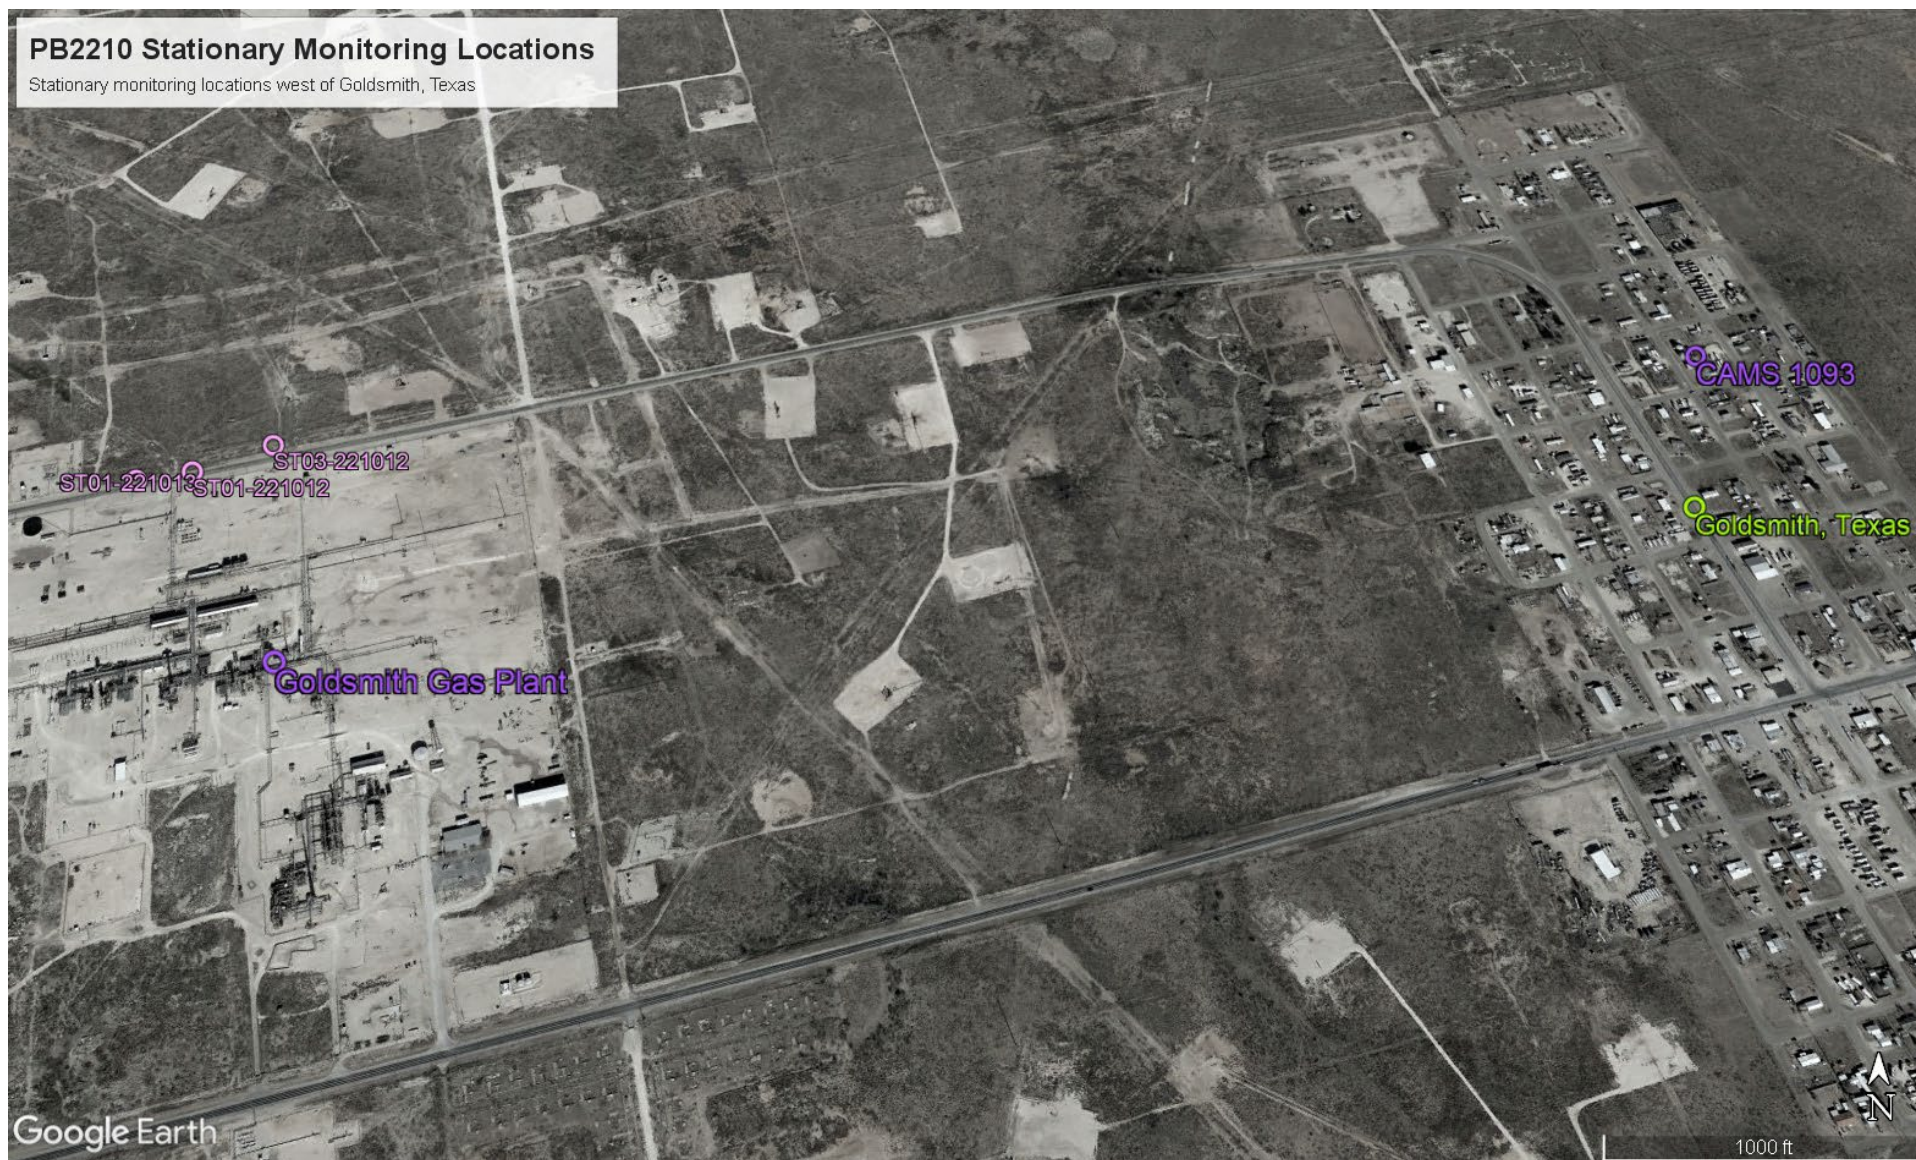
Figure 1: Stationary monitoring locations west of Goldsmith, Texas.

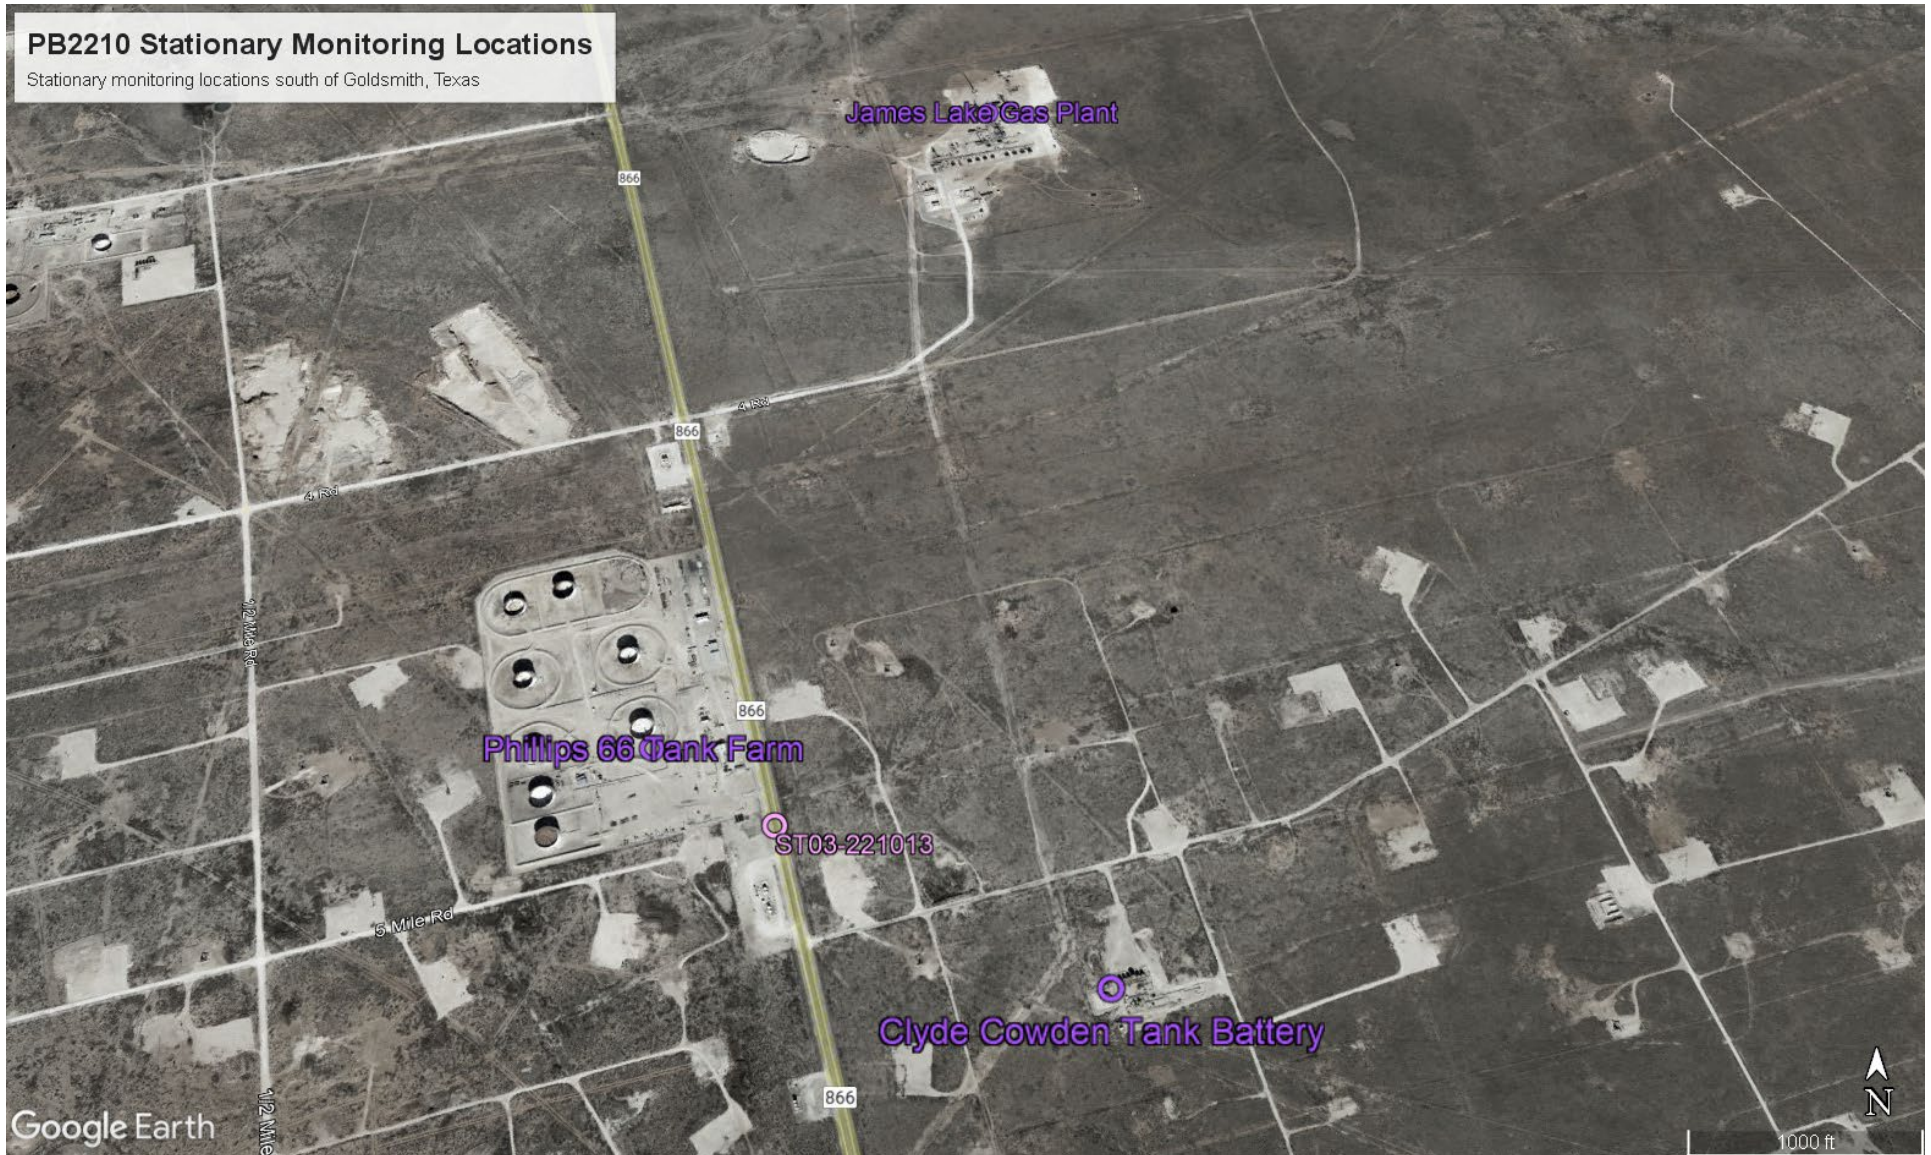
Figure 2: Stationary monitoring location south of Goldsmith, Texas.

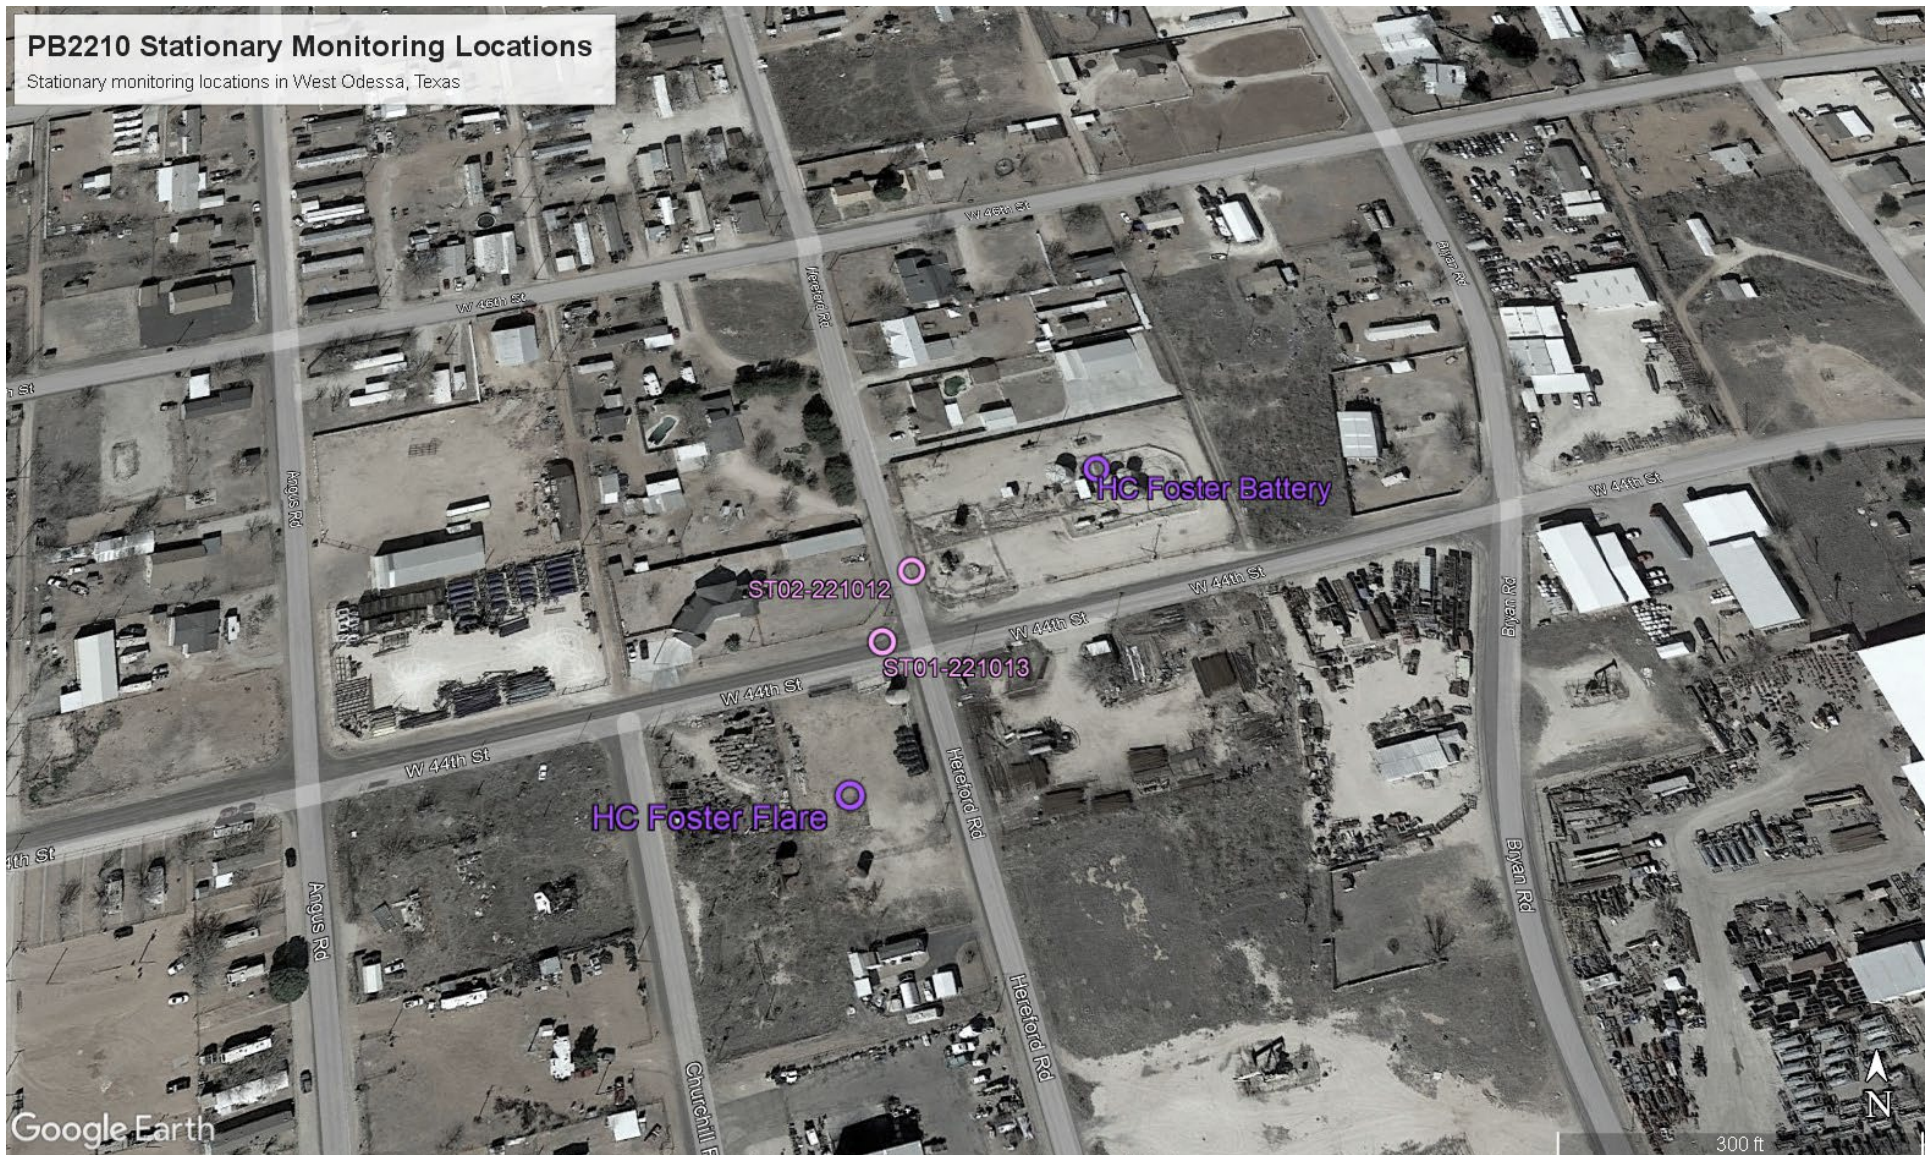
Figure 3: Stationary monitoring locations in West Odessa, Texas.

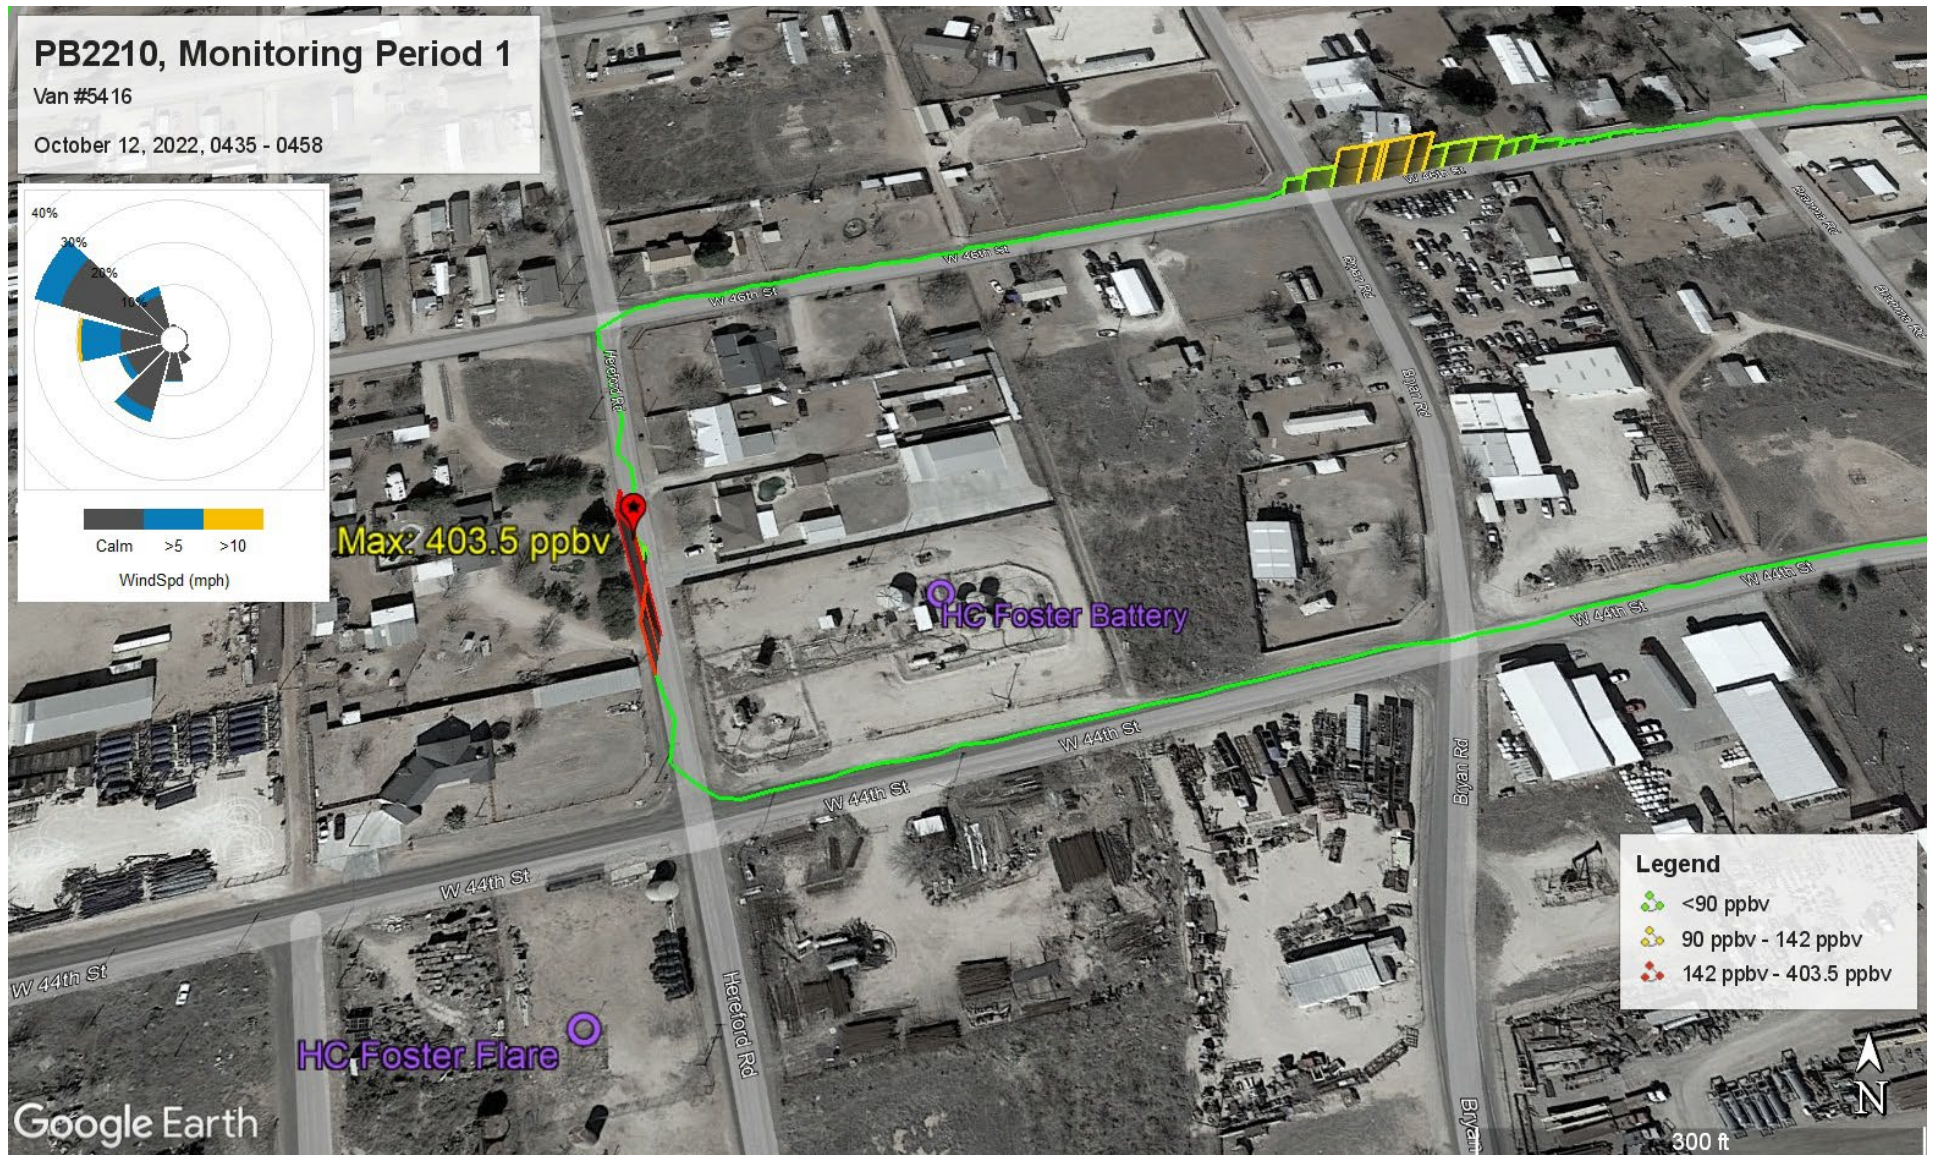
Figure 5: Van #5416 MA06-221012 survey with maximum instantaneous H₂S concentration of 403.5 ppbv on Hereford Road between West 46th Street and West 44th Street in West Odessa, Texas.

Van #5416 MA06-221012 Survey - West Odessa, TX								
Route Time	0435 - 0458							
Route Start	Angus Road and West 43rd Street (31.876842, -102.415056)							
Route Stop	Rasco Avenue and West 46th Street (31.881998, -102.408688)							
Parameters	WindSpeed (mph)	Average WindDir (degrees)	Hydrogen sulfide (ppbv)	1,3 - butadiene (ppbv)	Benzene (ppbv)	Toluene (ppbv)	Ethylbenzene + Xylenes (ppbv)	Styrene (ppbv)
Min Values	0.2	266	-1.3	0.0	0.0	0.0	0.0	0.0
Max Values	13.7		403.5	0.6	2.0	7.7	3.8	1.0

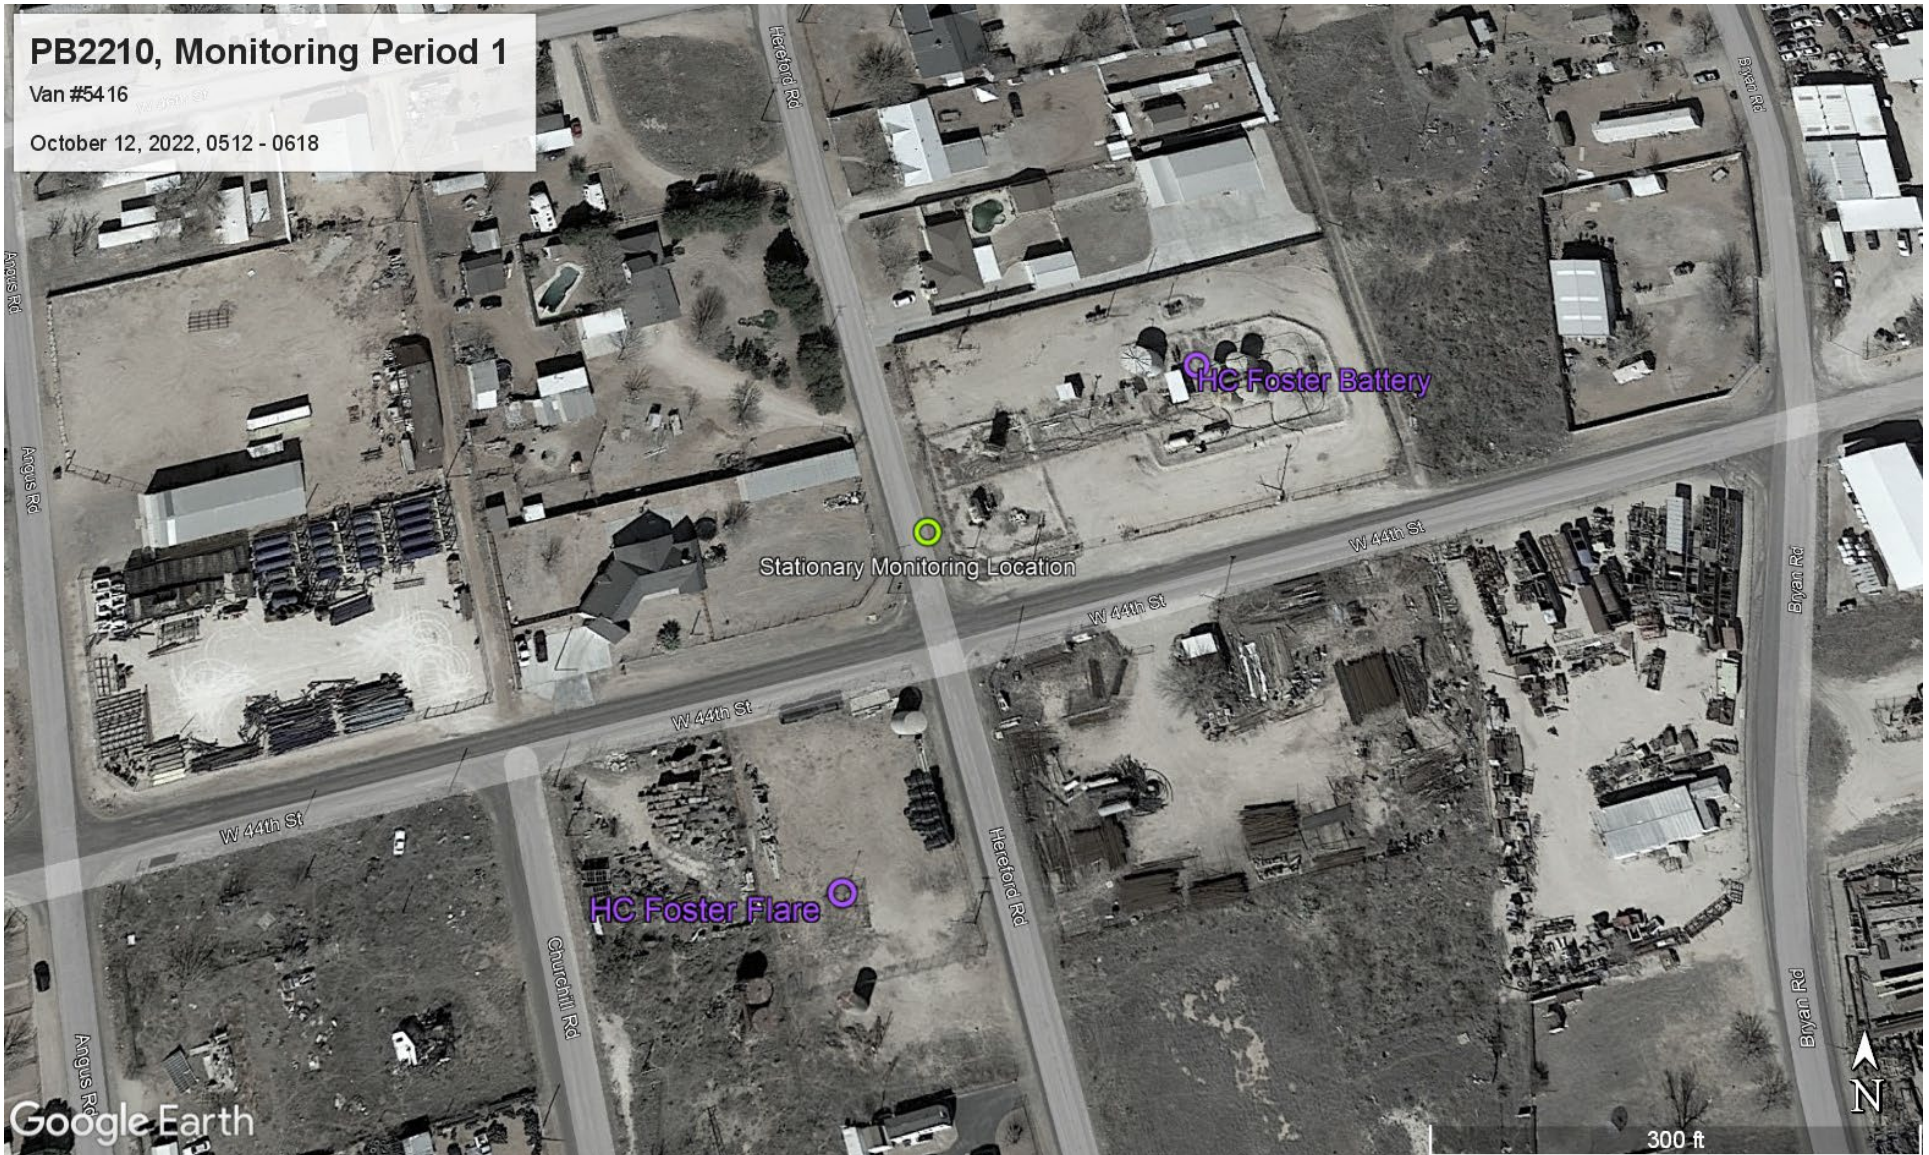
Stationary monitoring was performed in West Odessa where maximum concentrations were observed during survey routes. The maximum instantaneous H₂S concentration observed during this stationary monitoring event was 21.42 ppmv with a maximum 30-minute average H₂S concentration of 373.5 ppbv between 0512 – 0618 (Attachment A, Figure 6). Due to sampler error, this stationary monitoring period was not recorded in the data logger. H₂S and BTEX+ data were obtained directly from the instruments, but wind data could not be obtained; therefore, a pollution rose could not be generated for Figure 6. The predominant wind direction was southwesterly during this stationary sampling event. Regional staff were immediately notified when these H₂S concentrations were observed. Data for this stationary monitoring period can be found in Attachment C.

Figure 6: Van #5416 ST02-221012 stationary monitoring location with maximum instantaneous H_2S concentration of 21.42 ppmv and maximum 30-minute average H_2S concentration of 373.5 ppbv on Hereford Road between West 46th Street and West 44th Street in West Odessa, Texas. A pollution rose could not be generated due to missing wind data.

Van #5416 ST02-221012 Stationary Monitoring Location - West Odessa, TX								
Route Time	0512 - 0618							
Monitoring Location	44th and Hereford (31.87961, -102.413976)							
Parameters	WindSpeed (mph)	Average WindDir (degrees)	Hydrogen sulfide (ppbv)	1,3 - butadiene (ppbv)	Benzene (ppbv)	Toluene (ppbv)	Ethylbenzene + Xylenes (ppbv)	Styrene (ppbv)
Min Values	NA	NA	0.3	0.0	0.0	0.0	0.0	0.0
Max Values	NA		21417.2	1.2	20.1	70.8	95.0	1.4
Max Avg*			373.5	0.1	1.6	2.5	1.7	0.3

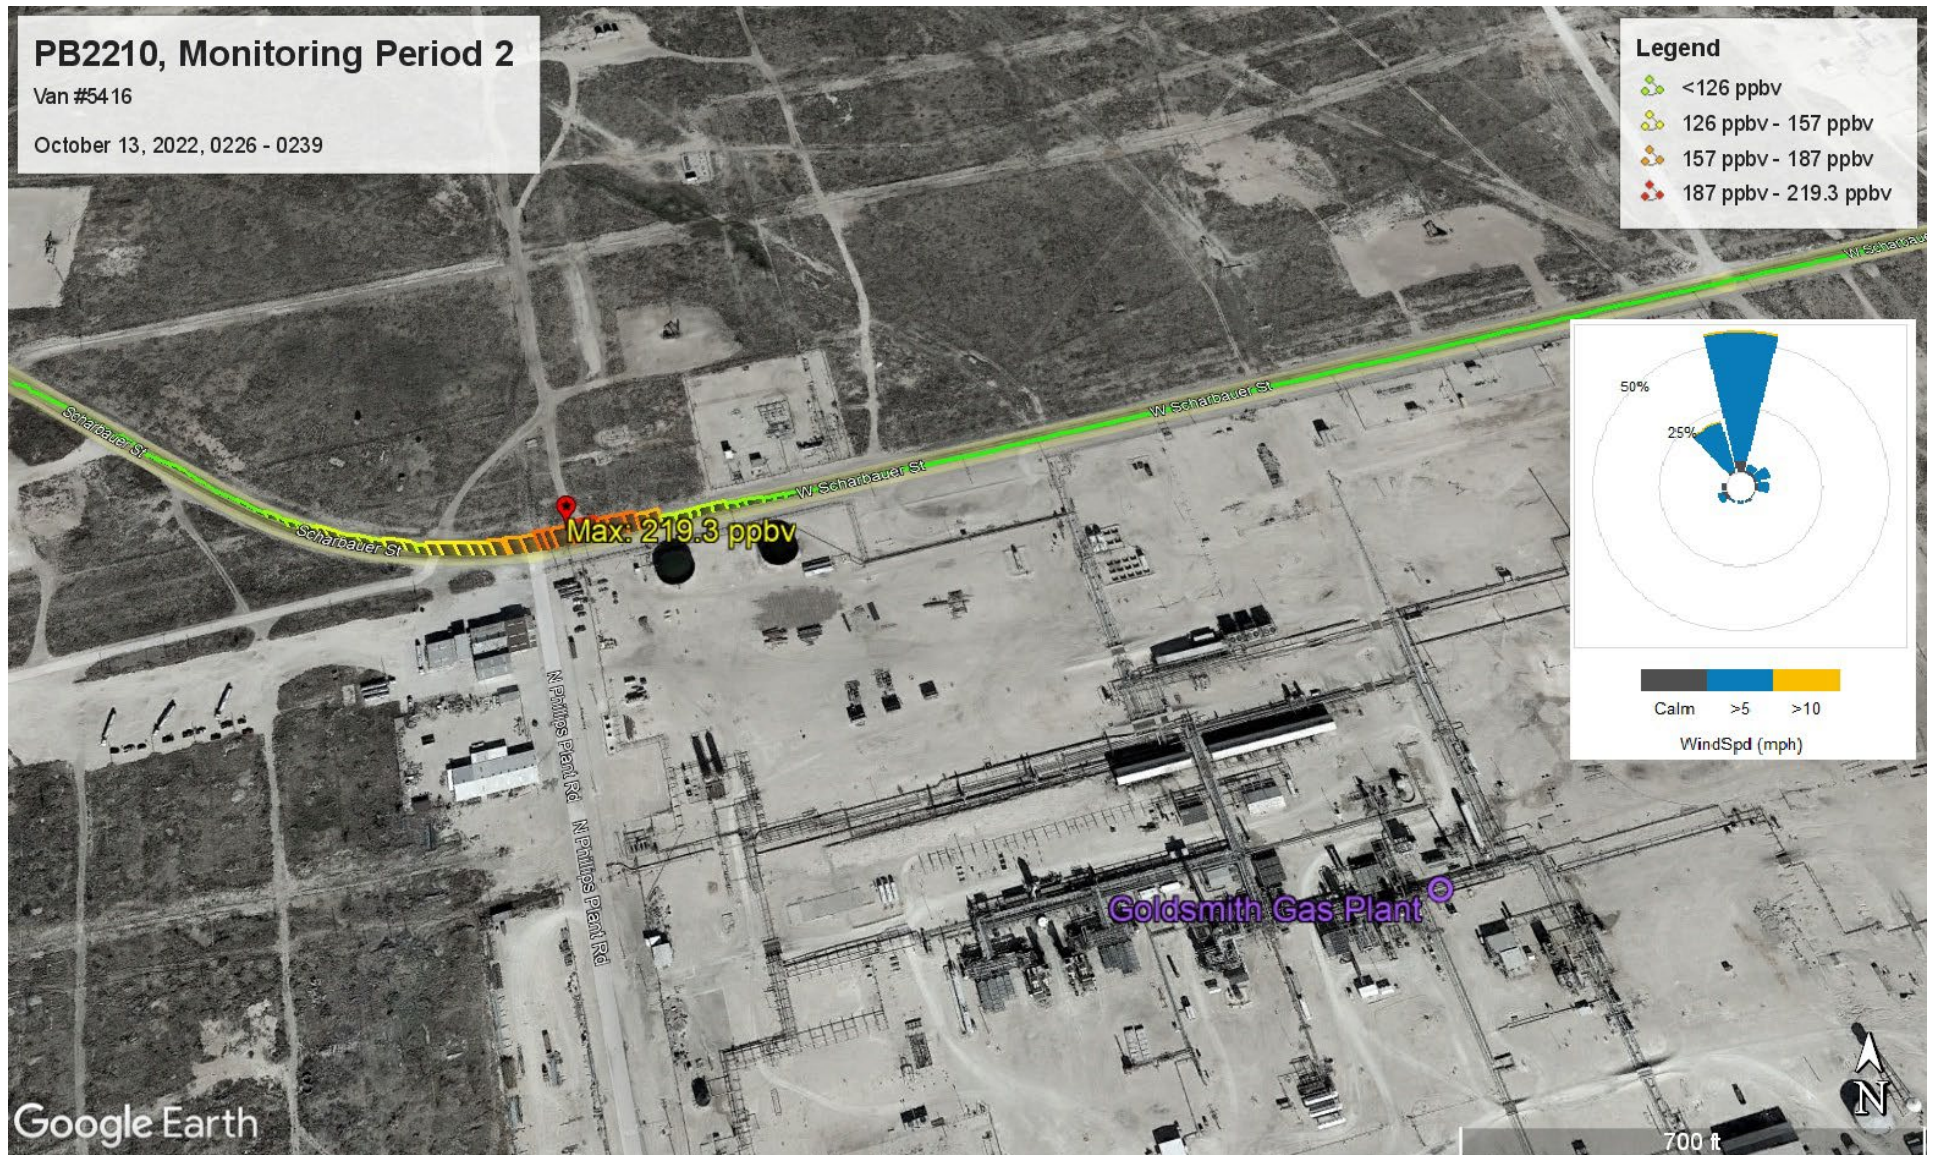
Figure 8: Van #5416 MA01-221013 survey with maximum instantaneous H₂S concentration of 219.3 ppbv on West Scharbauer Street just north of Goldsmith Gas Plant in Goldsmith, Texas.

Van #5416 MA01-221013 Survey - Goldsmith, TX								
Route Time	0226 - 0239							
Route Start	Sharbauer Street ~1.5 miles West of Odessa Street (31.984004, -102.64248)							
Route Stop	Sharbauer Street and Avenue E (31.985294, -102.616896)							
Parameters	WindSpeed (mph)	Average WindDir (degrees)	Hydrogen sulfide (ppbv)	1,3 - butadiene (ppbv)	Benzene (ppbv)	Toluene (ppbv)	Ethylbenzene + Xylenes (ppbv)	Styrene (ppbv)
Min Values	1.3	359	5.1	0.0	0.0	0.1	0.0	0.0
Max Values	11.2		219.3	0.5	33.2	8.5	2.5	0.7

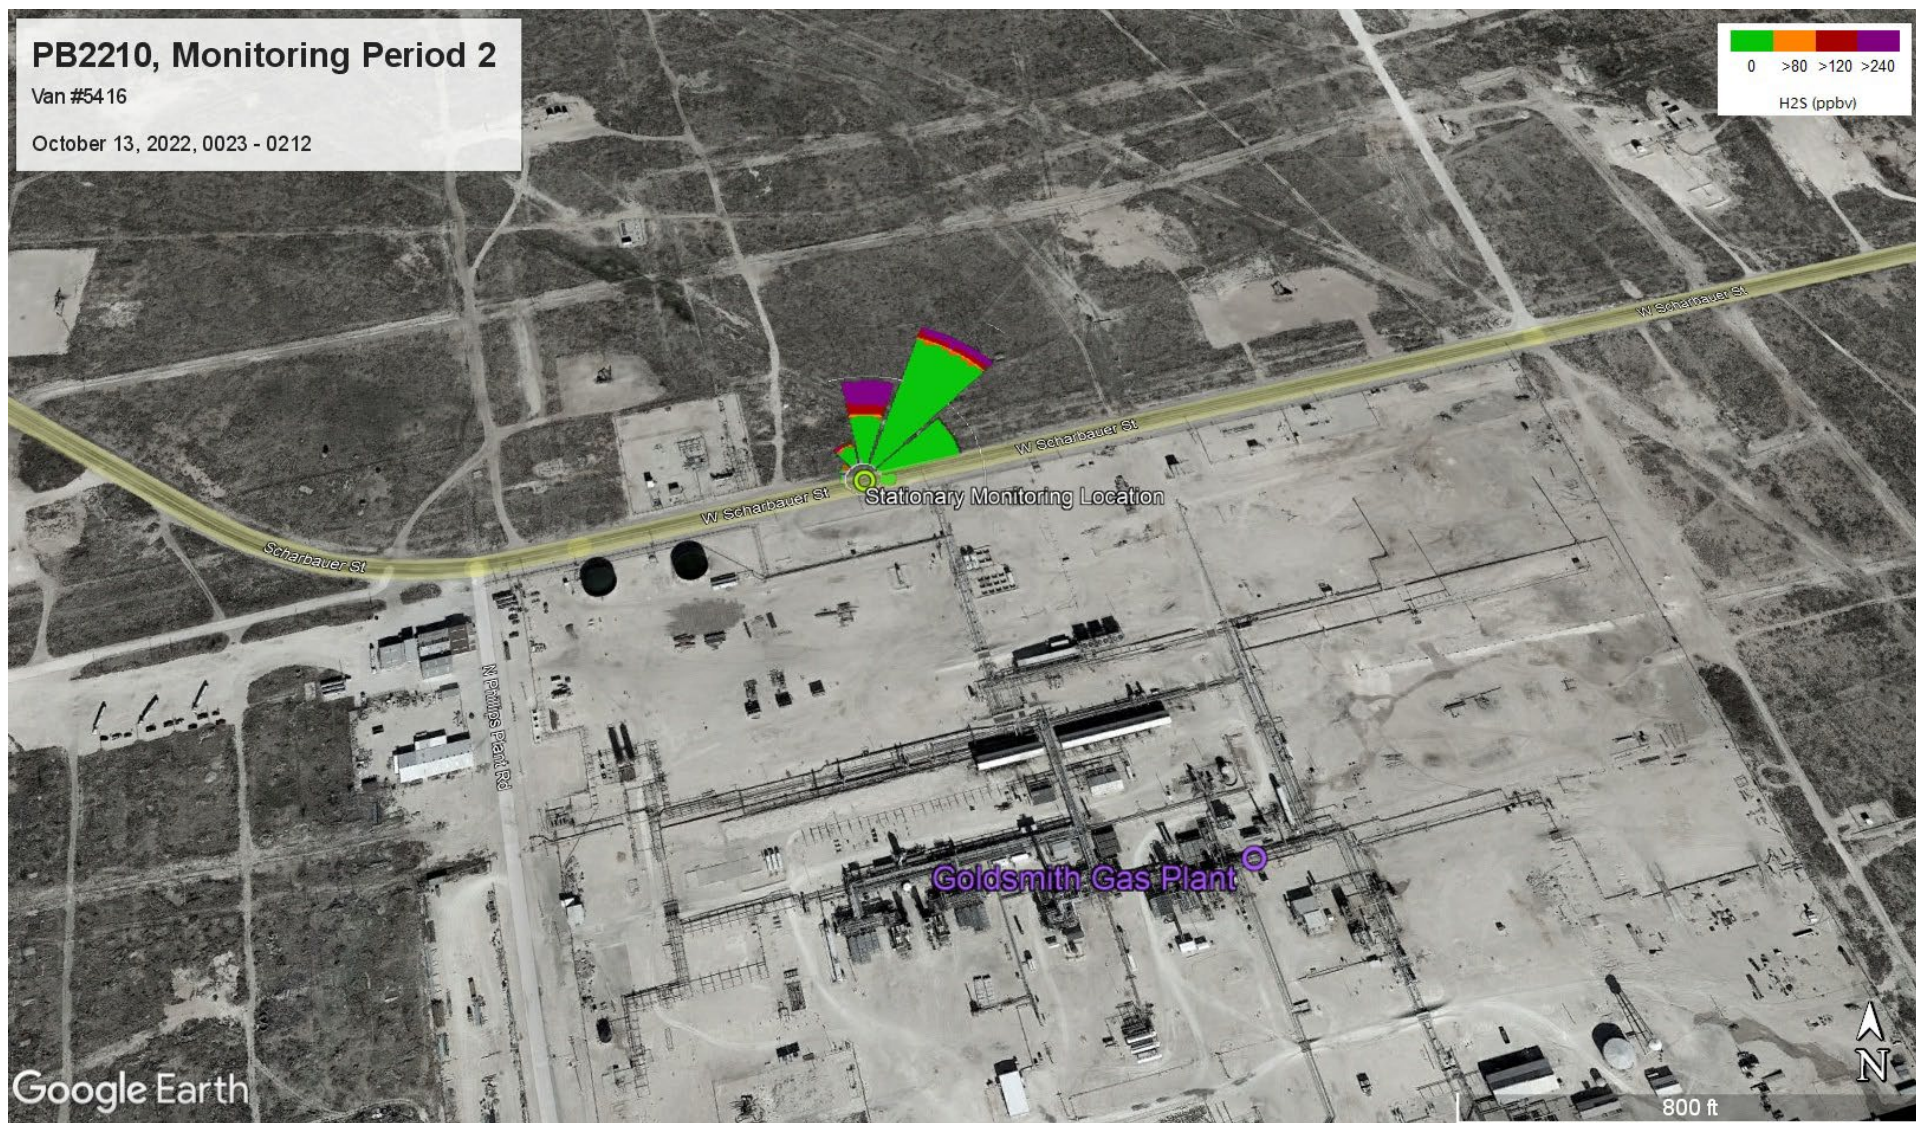
Stationary monitoring was performed in Goldsmith where maximum concentrations were observed during survey routes. The maximum instantaneous H₂S concentrations and maximum 30-minute average H₂S concentrations observed during these stationary monitoring periods were 929.6 ppbv and 145.0 ppbv, respectively, between 0023 – 0212 (Attachment A, Figure 10) and 206.6 ppbv and 83.3 ppbv, respectively, between 0350 – 0457 (Attachment A, Figure 11). Data for these stationary monitoring periods can be found in Attachment C. Based on surveys MA02-221012 and MA01-221013 and stationary monitoring location ST01-221013 (Figures 7, 8, and 10), the average wind directions appear to indicate a source north of W Scharbauer St.

Figure 10: Van #5416 ST01-221013 stationary monitoring location with maximum instantaneous H₂S concentration of 929.6 ppbv and maximum 30-minute average H₂S concentration of 145.0 ppbv on West Scharbauer Street just north of Goldsmith Gas Plant in Goldsmith, Texas.

Van #5416 ST01-221013 Stationary Monitoring Location - Goldsmith, TX								
Route Time	0023 - 0212							
Monitoring Location	Sharbauer Street ~1 mile West of Odessa Street (31.983386, -102.636184)							
Parameters	WindSpeed (mph)	Average WindDir (degrees)	Hydrogen sulfide (ppbv)	1,3 - butadiene (ppbv)	Benzene (ppbv)	Toluene (ppbv)	Ethylbenzene + Xylenes (ppbv)	Styrene (ppbv)
Min Values	0.1	26	2.5	0.0	0.0	0.0	0.0	0.0
Max Values	8.5		929.6	0.9	29.9	23.0	6.9	1.1
Max Avg*			145.0	0.1	3.5	2.3	1.2	0.2

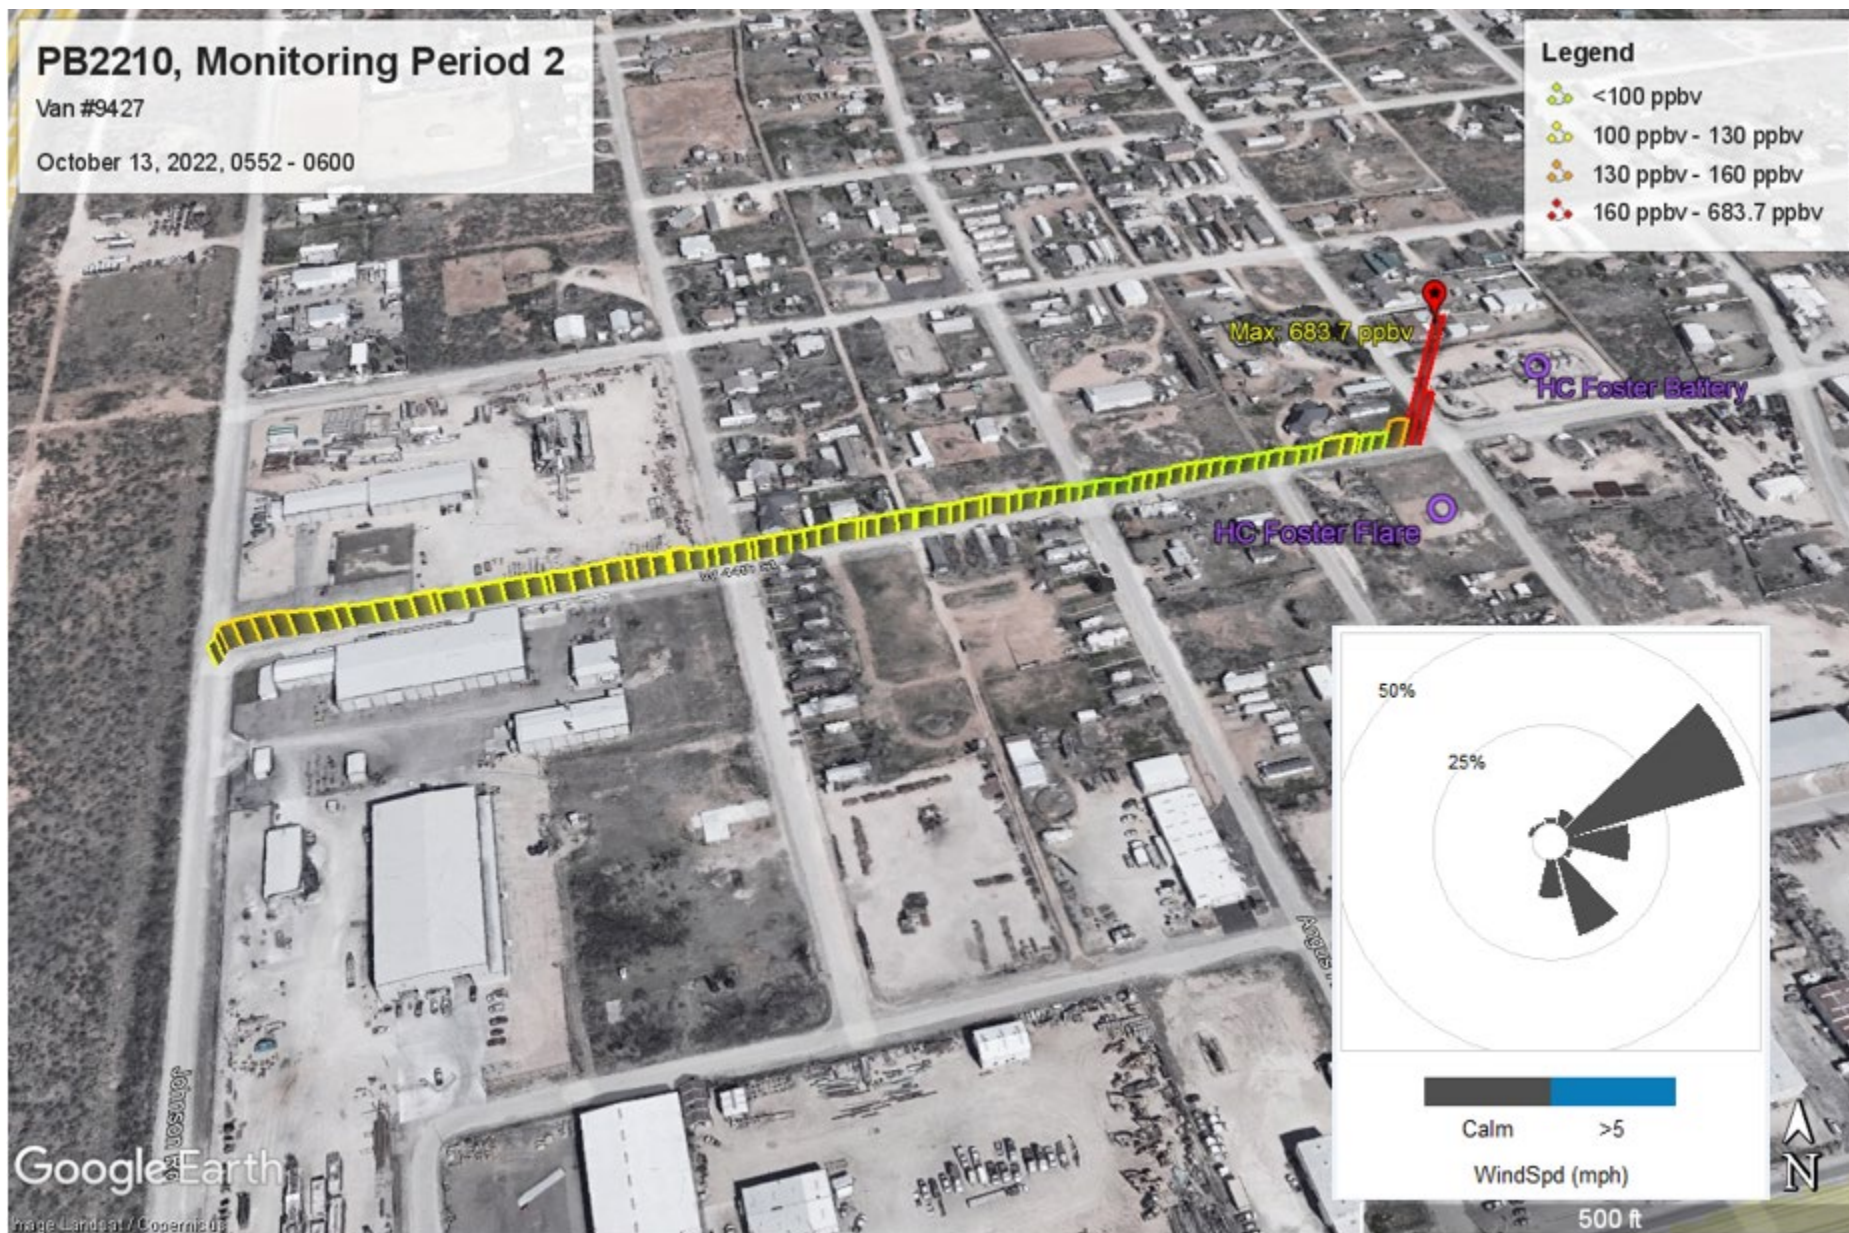
Figure 14: Van #9427 MA08-221013 survey with maximum instantaneous H₂S concentration of 683.7 ppbv on West 44th Street between Churchill Road and Hereford Road in West Odessa, Texas.

Van #9427 MA08-221013 Survey - West Odessa, TX								
Route Time	0552 - 0600							
Route Start	Johnson Road and West 44th Street (31.878116, -102.419576)							
Route Stop	West 44th Street and Hereford Road (31.879386, -102.414064)							
Parameters	WindSpeed (mph)	Average WindDir (degrees)	Hydrogen sulfide ^B (ppbv)	1,3 - butadiene (ppbv)	Benzene (ppbv)	Toluene (ppbv)	Ethylbenzene + Xylenes (ppbv)	Styrene (ppbv)
Min Values	0.2	90	86.0	NA	NA	NA	NA	NA
Max Values	4.7		683.7	NA	NA	NA	NA	NA

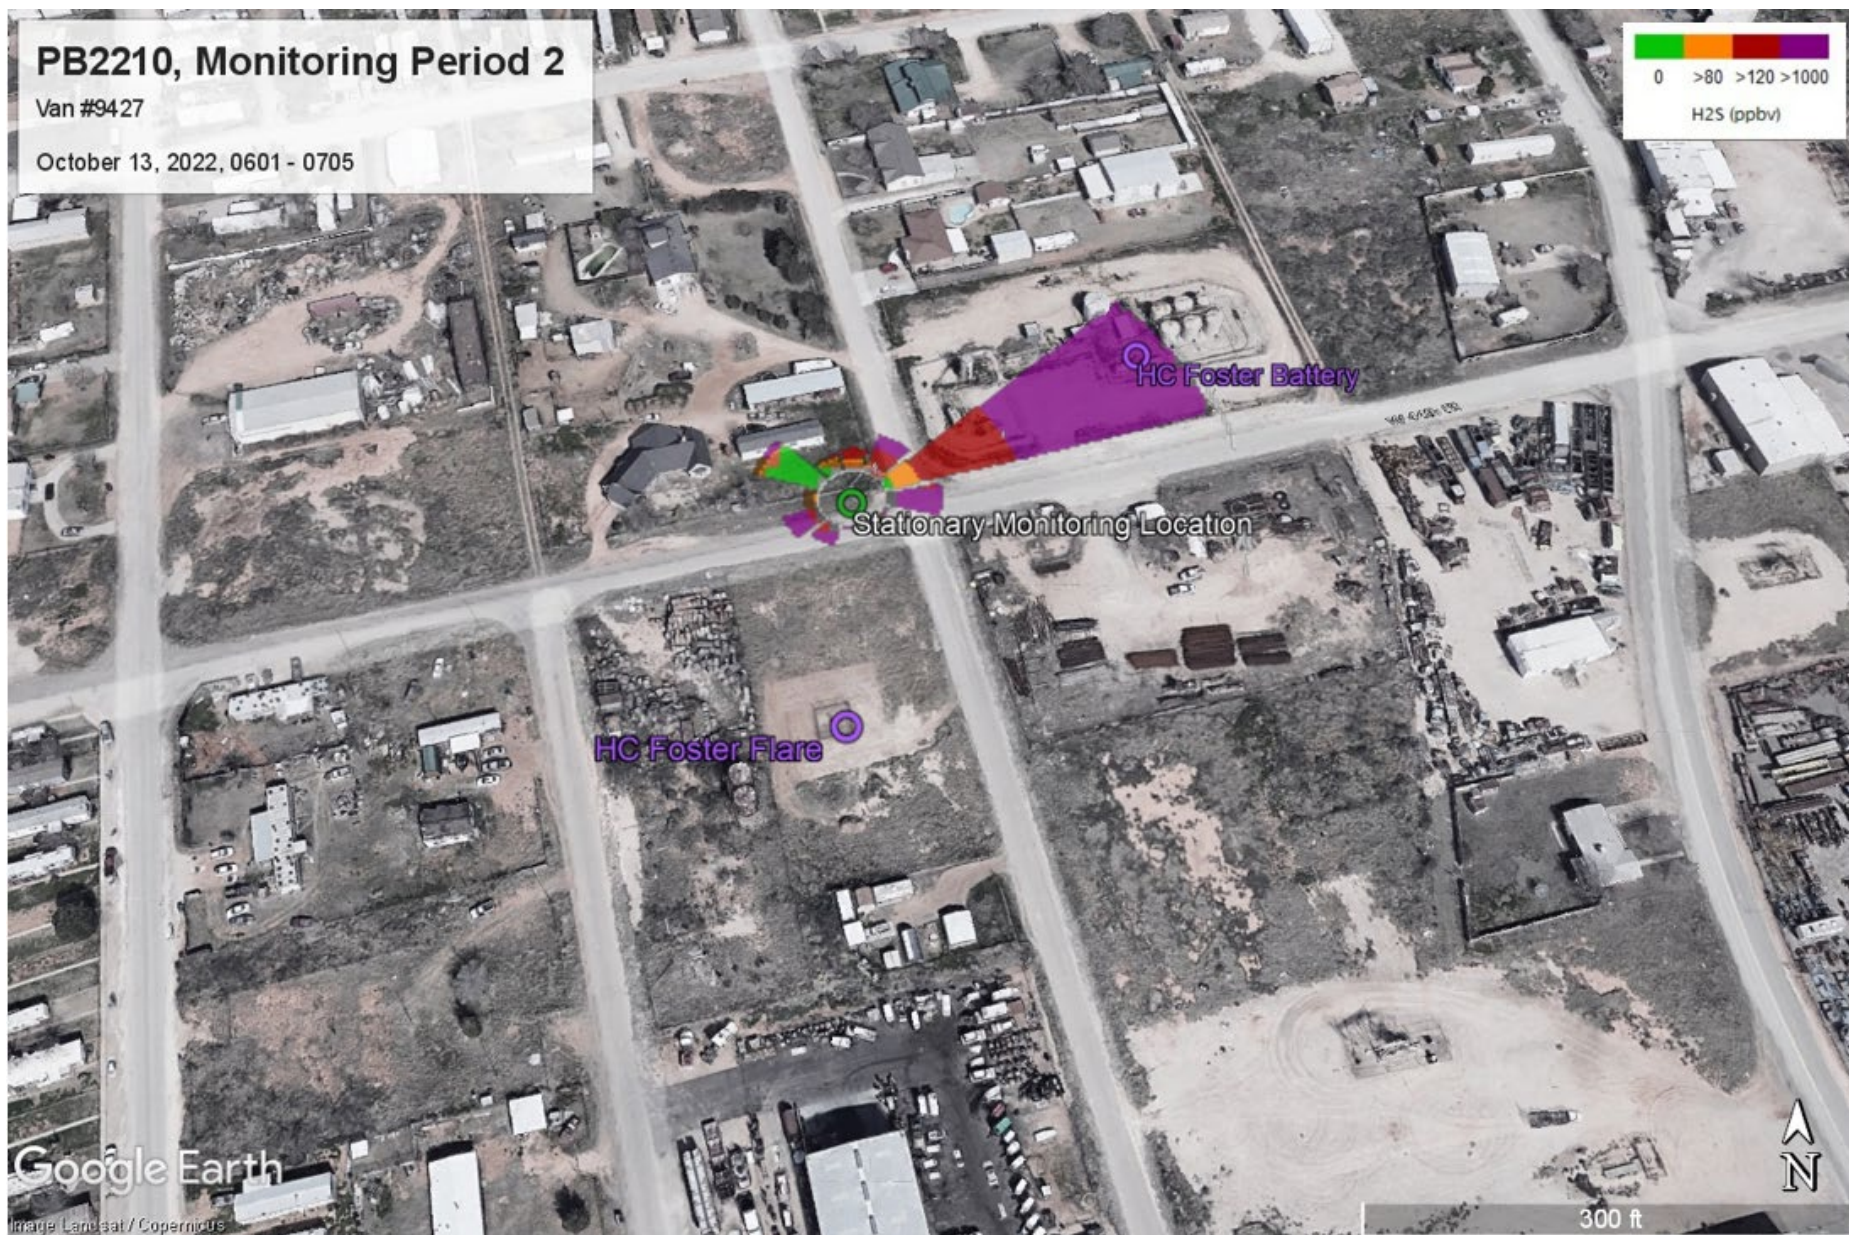
Stationary monitoring was performed in West Odessa at the intersection of W 44th St and Hereford Rd, adjacent to HC Foster Battery and flares. The maximum instantaneous H₂S concentration observed during this stationary monitoring period was 61.91 ppmv and the maximum 30-minute average H₂S concentration was 6.61 ppmv between 0601 – 0705 (Attachment A, Figure 15). Winds were light and variable during this stationary monitoring event and the pollution rose generated may not fully represent meteorological conditions. Regional staff were immediately notified when these H₂S concentrations were observed. Data for this stationary monitoring period can be found in Attachment C.

Figure 15: Van #9427 ST01-221013 stationary monitoring location with maximum instantaneous H₂S concentration of 61.91 ppmv and maximum 30-minute average H₂S concentration of 6.61 ppmv on West 44th Street between Churchill Road and Hereford Road in West Odessa, Texas.
