Re: Water Pollution Abatement Plan Modification Submittal

Loop 1604 Segment 4 Project

Loop 1604 from Stone Oak Parkway to 1.09 mile East of Redland Road

CSJ: 2452-02-130, 2452-03-113

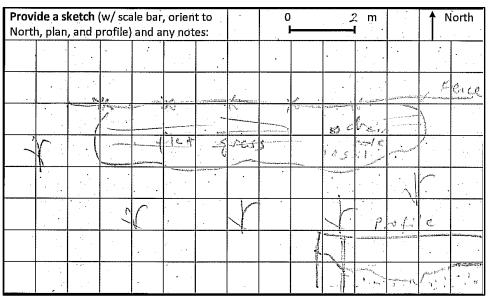
Figure 7. Field sketch of feature 1604-002.

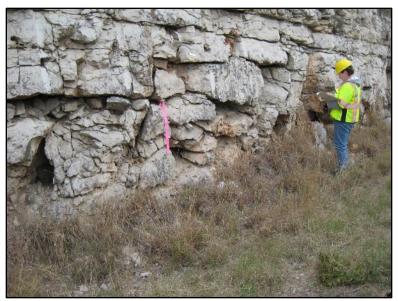
Figure 8. Overview of feature 1604-801.

This feature was located in a roadcut north of the westbound mainlanes of Loop 1604 and east of Huebner Road (Figure 8 - Figure 10; Attachment D page 83). The feature was a zone of three solution-enlarged fractures within an area 20 ft wide by 6 ft long by 2.5 ft high. The largest opening was 1.5 ft wide by 2 ft high and extended 6 ft into the roadcut. The fractures had a trend of 55 degrees (55°), which is consistent with trends along the Balcones Fault Zone. The feature contained exposed bedrock and breakdown. It had a catchment area of less than 1.6 ac. There was a low potential for this feature to rapidly transmit water to the subsurface as it was exposed above the base of the roadcut; however, due to it being a zone of features developed along fractures that align with the dominant trend of faults and fractures in the region, this feature was determined to be sensitive according to the Edwards Aquifer Rules (30 TAC §213.5(b)(3)).

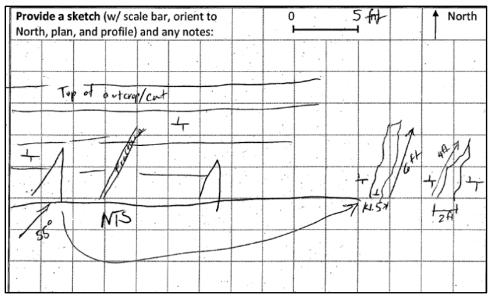
Figure 10. Field sketch of feature 1604-801.

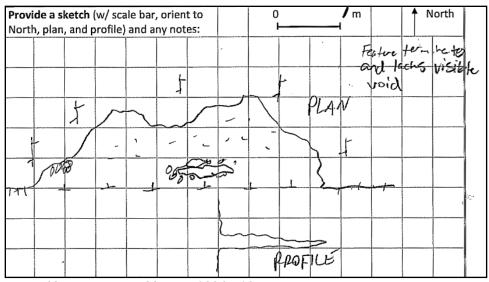
Figure 43. Field sketch of feature 1604-D13.

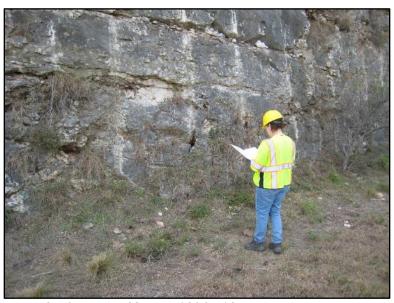
Figure 47. Overview of feature 1604-D16.

This feature was located in a roadcut south of the eastbound mainlanes of Loop 1604 and west of Huebner Road (Figure 47 - Figure 49; Attachment D page 81-82). The feature was a solution cavity that was 0.8 ft wide by 3.1 ft long by 1 ft high. It was guided by a fracture with a trend of 5°. This feature contained brown clayey soils and exposed bedrock. It had a catchment area of less than 1.6 ac. It was determined that there was a low potential for this feature to rapidly transmit water to the subsurface as it was approximately 3 ft above the base of the roadcut. This feature was not determined to be sensitive according to the Edwards Aquifer Rules (30 TAC §213.5(b)(3)).

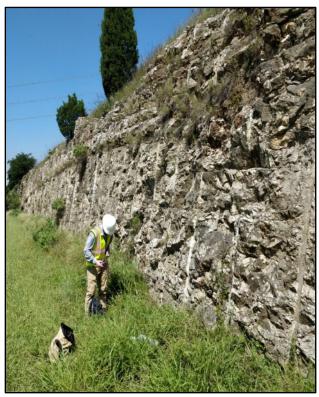
Figure 50. Overview of feature 1604-D17.

This feature was located in a roadcut north of the westbound mainlanes of Loop 1604 and west of Huebner Road (Figure 50 - Figure 52; Attachment D page 80). The feature was a solution cavity that measured 2.4 ft long by 2.4 ft wide and 0.8 ft deep. This feature contained loose organic soil and leaf-litter. It had a catchment area of greater than 1.6 ac. It was determined that there was a moderate potential for this feature to rapidly transmit water to the subsurface due to presence of downward trending voids and relatively large catchment area. This feature was determined to be sensitive according to the Edwards Aquifer Rules (30 TAC §213.5(b)(3)).

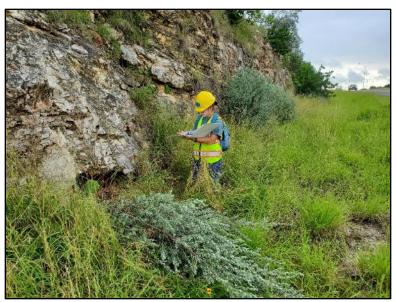
Figure 58. Overview of feature 1604-E04.

This feature was located in a roadcut north of the westbound mainlanes of Loop 1604 and east of Bitters Road (Figure 58 - Figure 62; Attachment D page 84). The feature was excavated on July 10-11, 2019 using a total 7 man-hours to remove 2 cubic feet (ft³) of material. No continuing mesocaverns or downward trending voids were found during excavation. The excavated feature was a solution cavity that measured 2.6 ft wide by 1.3 ft high and extended 4.6 ft into bedrock. This feature contained loose rocks and compact sediment. It had a catchment area of less than 1.6 ac. It was determined that there is a low potential for this feature to rapidly transmit water to the subsurface as it was slightly above the base of the roadcut and lacked downward trending voids. This feature was not determined to be sensitive according to the Edwards Aquifer Rules (30 TAC §213.5(b)(3)).

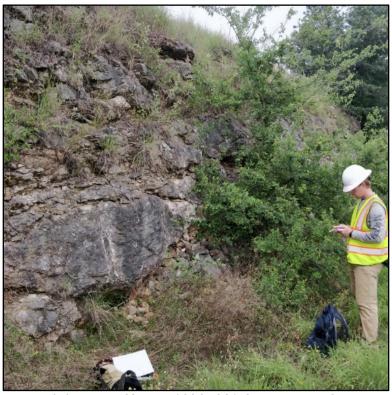
Figure 74. Overview of feature 1604-F061, Scottish Beard Cave, prior to excavation.

This feature was located south of the eastbound mainlanes of Loop 1604 and east of W. Bitters Road (Figure 74 - Figure 79; Attachment D page 80). The feature was a cave that measured 13.1 ft wide by 3.3 ft high at the entrance and extended 9.8 ft into bedrock. On June 20, 2019, rocks covering the entrance were removed. It was identified in the TSS database as Scottish Beard Cave. This feature contained loose rocks and red clay with a loose depth of 1 cm. The cave terminated in a mesocavern with a compact clay floor. It had a catchment area of greater than 1.6 ac. It was determined that there was a high potential for this feature to rapidly transmit water to the subsurface as it was situated along the base of the roadcut. This feature was determined to be sensitive according to the Edwards Aquifer Rules (30 TAC §213.5(b)(3)).

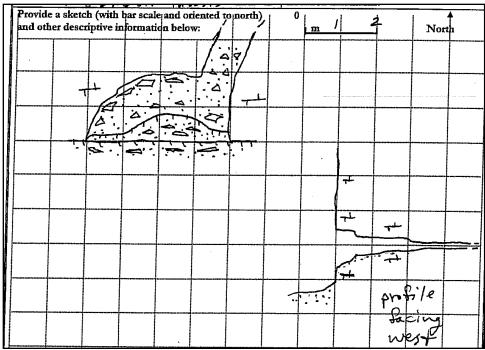
Figure 90. Field sketch of feature 1604-F069.

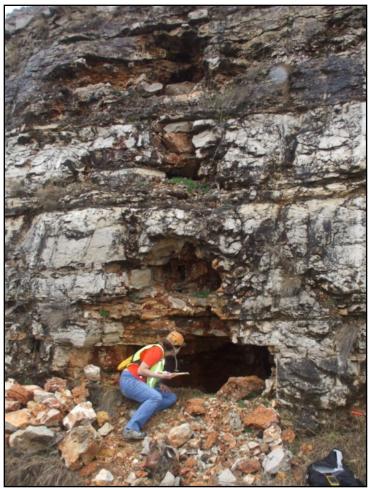
Figure 139. Overview of feature 1604-F101 (Tally Ho Cave) in 2009, after excavation.

This feature was located in a roadcut south of the eastbound mainlanes of Loop 1604 and west of Gold Canyon Road (Figure 139 - Figure 142; Attachment D page 97). The feature was a cave identified in the TSS database as Tally Ho Cave. This cave was found on 15 July 2009 and evaluated in October 2009 (TxDOT 2015). The cave was sealed by the Alamo Regional Mobility Authority, who identified the feature as S-7-B-South, pursuant to EAPP ID 13-10090211 approved by the TCEQ on December 22, 2011 (Bryant 2020). This feature was comprised of four vertically aligned holes developed in an enlarged fracture with a trend of 45°. The lowest entrance, near ground level, was initially 7.2 ft wide and extended 5.2 ft into the face of the roadcut. The total vertical extent of this feature was 16.4 ft. The lower part of the feature was excavated using 15.8 person hours of effort, with 80.7 ft<sup>3</sup> of material removed from the feature making it 16.4 ft long and 6.6 ft deep. After an initial drop-off at the entrance, there was a step-up at a narrow spot that opened to a room measuring 4.9 ft by 2 m 6.6 ft with some small holes that extended up into the ceiling. The grouted entrance observed in 2019 was 39.4 ft wide by 2 ft high. The feature had a catchment area of less than 1.6 ac. It was determined that there was a low potential for this feature to rapidly transmit water to the subsurface as the entrance was grouted shut. However, it was determined that there could be potential for rapid recharge to the subsurface if the feature is reopened by construction activities. This feature was determined to be sensitive according to the Edwards Aguifer Rules (30 TAC §213.5(b)(3)).

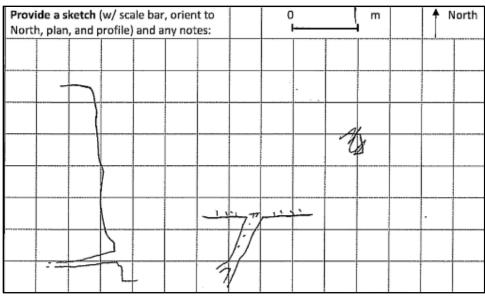
Figure 150. Field sketch of feature 1604-FZ4.

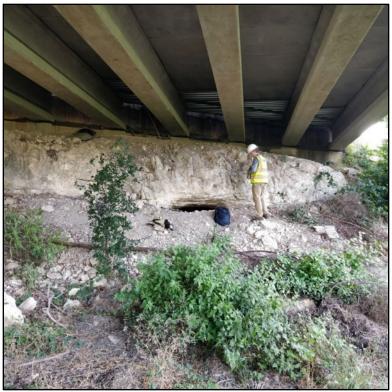
Figure 186. Overview of feature 1604-M21 (Hans Grotto).

This feature was located in Salado Creek under the west bound access road of Loop 1604 and west of Bitters Road (Figure 186 - Figure 189; Attachment D page 77-78). The feature was a cave that measured 6.5 ft wide by 0.98 ft high at the entrance and extended 9.8 ft into bedrock. This feature was filled with loose rocks, concrete, and compact silt. It had a catchment area of greater than 1.6 ac. It was determined that there was a moderate potential for this feature to rapidly transmit water to the subsurface due its location adjacent to a creek channel. This feature was determined to be sensitive according to the Edwards Aquifer Rules (30 TAC §213.5(b)(3)).

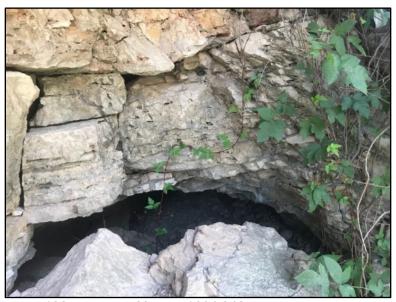
Figure 193. Entrance of feature 1604-Q48.

This feature was located high in the western sloping bank of Leon Creek under the westbound mainlanes of Loop 1604 and west of I-10 (Figure 193 - Figure 195; Attachment D page 61). The feature was a solution cavity developed along a bedding plane. It measured 4.9 ft wide by 2.5 ft high and extended 6.6 ft into bedrock. This feature contained bedrock, loose rocks, and fine, compact soil. It had a catchment area of less than 1.6 ac. It is possible that this feature has received recharge during high floods as it was situated in the side slope of Leon Creek. It was determined that there was a low potential for this feature to rapidly transmit water to the subsurface due to the absence of downward trending voids and a compact soil floor. This feature was not determined to be sensitive according to the Edwards Aquifer Rules (30 TAC §213.5(b)(3)).

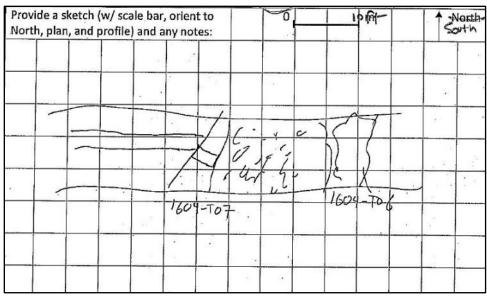
Figure 221. Field sketch of feature 1604-T07.

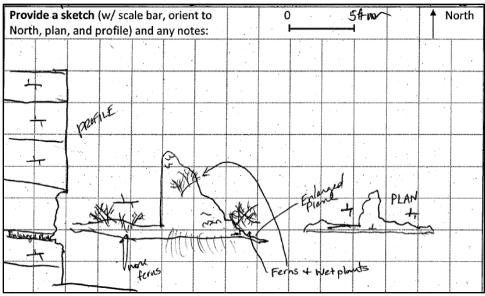
Figure 231. Field sketch of feature 1604-W05.

This feature was located in a roadcut north of the westbound mainlanes of Loop 1604 immediately west of Huebner Road (Figure 230 - Figure 231; Attachment D page 82). The feature was a zone containing a solution cavity that was bisected in the roadcut, extending upward from a solution-enlarged bedding plane. The solution cavity was 5 ft wide by 3 ft long by 5 ft high. The solution-enlarged bedding plane continued an additional 7 ft west of the edge of the solution cavity and is 1 ft wide by 1 ft high. This feature contained loose rocks, vegetation, and bedrock. It had a catchment area of less than 1.6 ac. The feature was located 3.5 ft above the base of the roadcut and appeared to function as a discharge point (seep) based on the presence of ferns and other similar vegetation, there was a low potential for this feature to rapidly transmit water to the subsurface. This feature was not determined to be sensitive according to the Edwards Aquifer Rules (30 TAC §213.5(b)(3)).

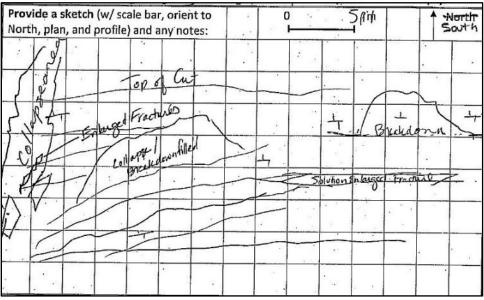
Figure 233. Field sketch of feature 1604-W08.

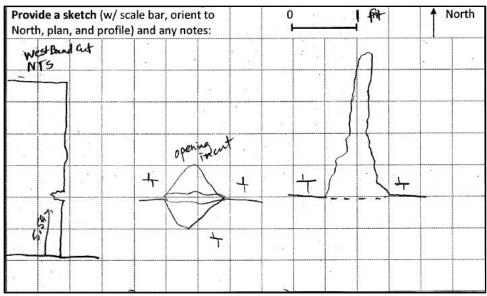
Figure 312. Field sketch of feature HB-038.

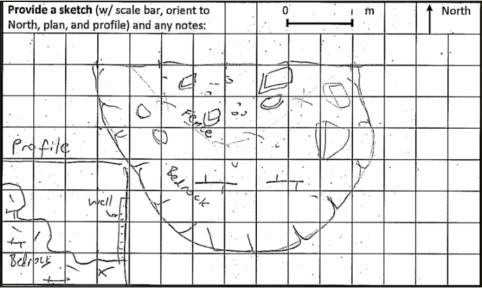
Figure 316. Field sketch of feature LOOP—001.

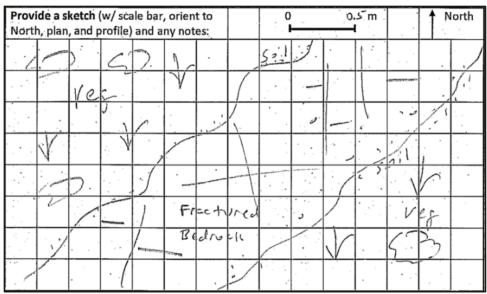
Figure 320. Field sketch of feature LOOP-002.

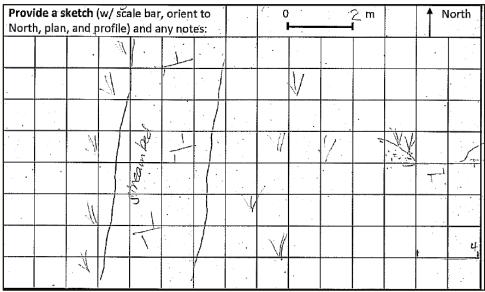
Figure 327. Field sketch of feature LOOP-006.

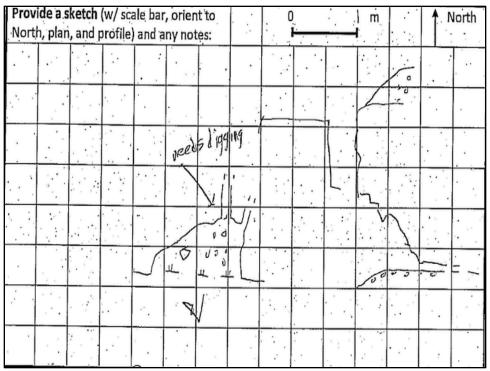
Figure 340. Pre-excavation field sketch of feature LOOP-010.

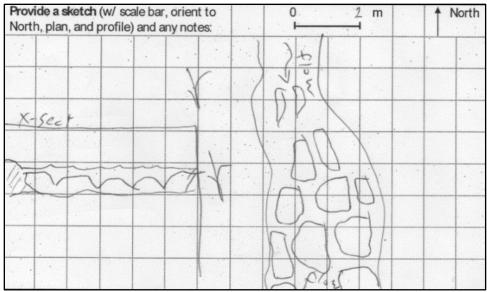
Figure 345. Field sketch of feature LOOP-012 upstream portion.

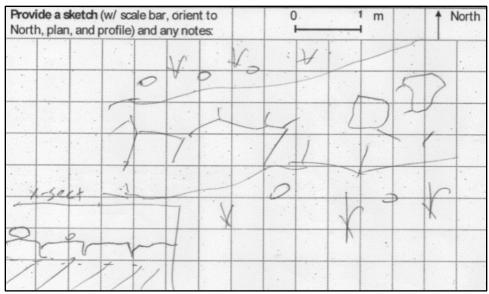
Figure 348. Field sketch of feature LOOP-013.

This feature was located in the median between the westbound access road and mainlanes of Loop 1604 and west of highway 281 (Figure 346 - Figure 348; Attachment D page 91). This feature measured 3.2 ft wide by 19.6 ft long. Two sets of fractures were present in the bedrock with apertures of <0.01 ft and trends of 50° and 120°. This feature consisted only of exposed bedrock. It had a catchment area less than 1.6 ac. There was a low potential for this feature to rapidly transmit water to the subsurface as the fractures had a small aperture and the feature was situated on a hillside. This feature was not determined to be sensitive according to the Edwards Aquifer Rules (30 TAC §213.5(b)(3)).

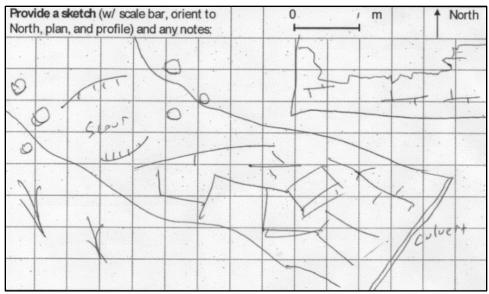
Figure 351. Field sketch of feature LOOP-014.

This feature was located in an easement north of the westbound mainlanes of Loop 1604 and east of Huebner Road (Figure 349 - Figure 351; Attachment D page 83). The feature was an area of fractured bedrock that measured 6.6 ft wide and 19.7 ft long. Two sets of fractures were present with apertures of 0.03 ft and trends of 70° and 135°. This feature consisted of exposed bedrock that was partially covered by gravel and organic soil. It was situated in a streambed that had a catchment area greater than 1.6 ac. There was a low potential for this feature to rapidly transmit water to the subsurface as the fractures were thin and filled with compact soil. This feature was not determined to be sensitive according to the Edwards Aquifer Rules (30 TAC §213.5(b)(3)).

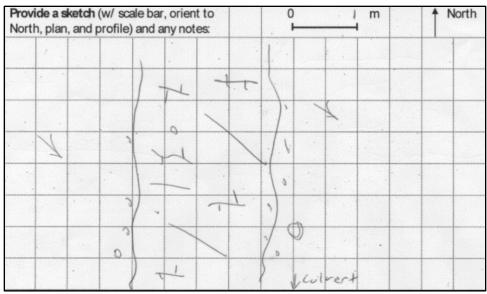
Figure 354. Field sketch of feature LOOP-015.

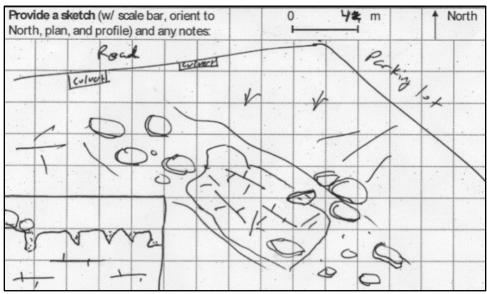
Figure 357. Field sketch of feature LOOP-016.

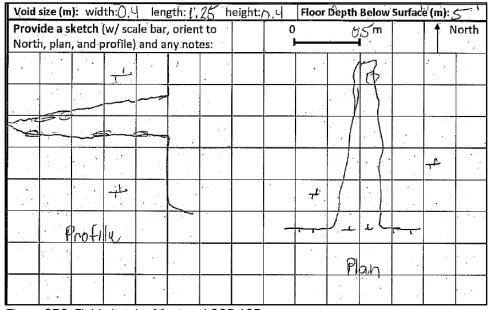
Figure 376. Field sketch of feature LOOP-105.

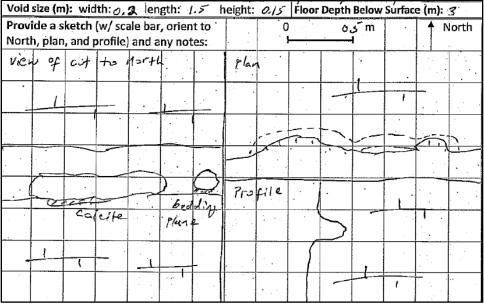
Figure 382. Field sketch of feature LOOP-107.

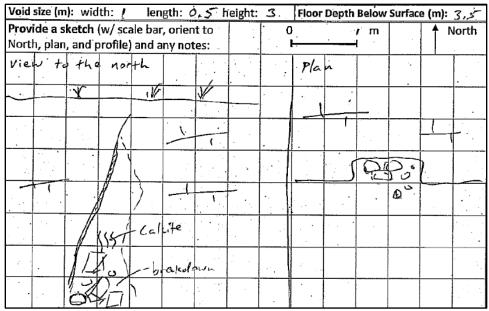
Figure 385. Field sketch of feature LOOP-108.

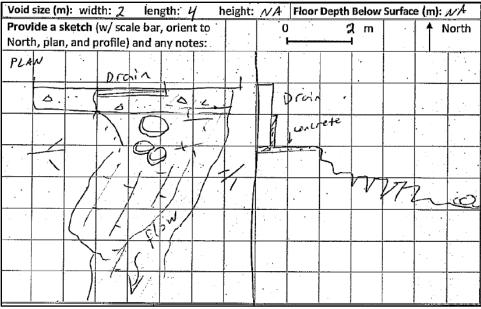
Figure 400. Field sketch of feature LOOP-113.

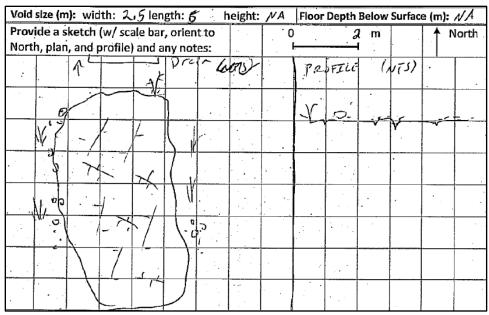
Figure 403. Field sketch of feature LOOP-114.

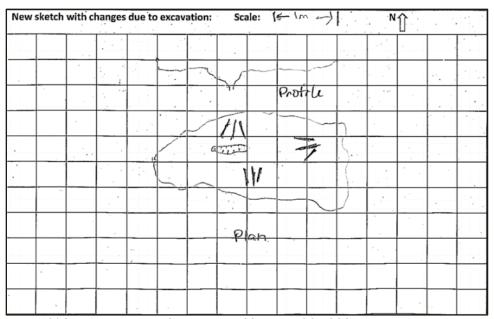
Figure 414. Post-excavation field sketch of feature LOOP-202.

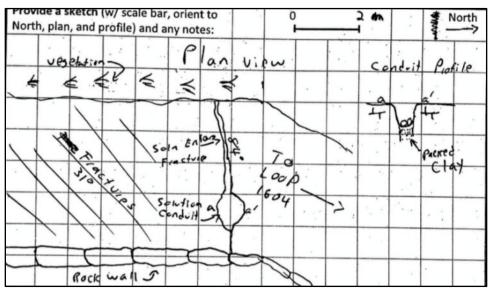
Figure 417. Field sketch of feature LOOP-204.

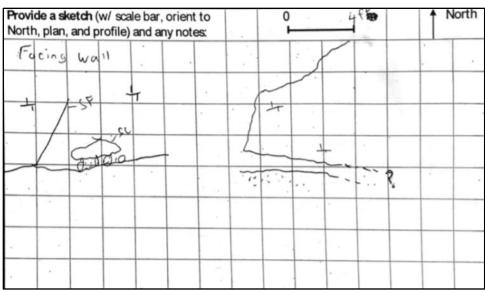
Figure 424. Field sketch of feature LOOP-207.

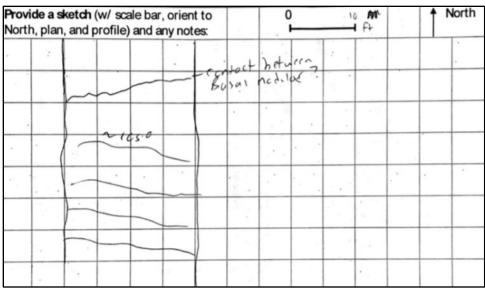
Figure 427. Field sketch of feature LOOP-208.

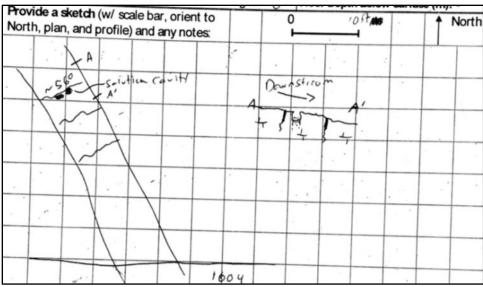
Figure 430. Field sketch of feature LOOP-209.

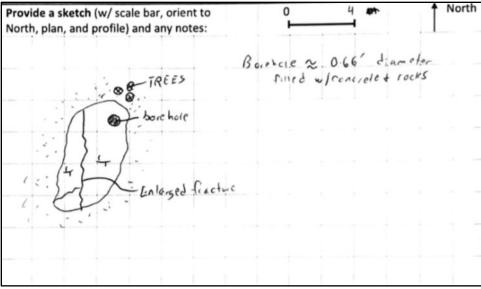
Figure 435. Field sketch of feature LOOP-211.

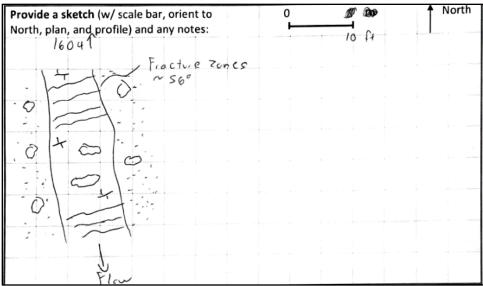
Figure 438. Field sketch of feature LOOP-212.

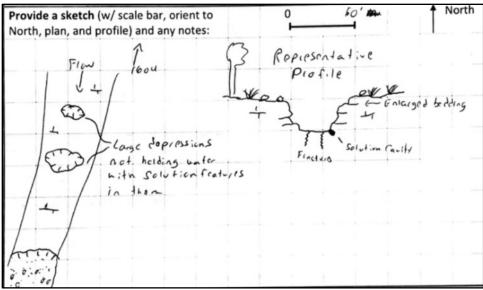
Figure 446. Field sketch of feature LOOP-214.
