Re: UTSA Habitat Conservation Plan
Recharge Zone Exception Application

UTSA HABITAT CONSERVATION PLAN

Recharge Zone Exception Request

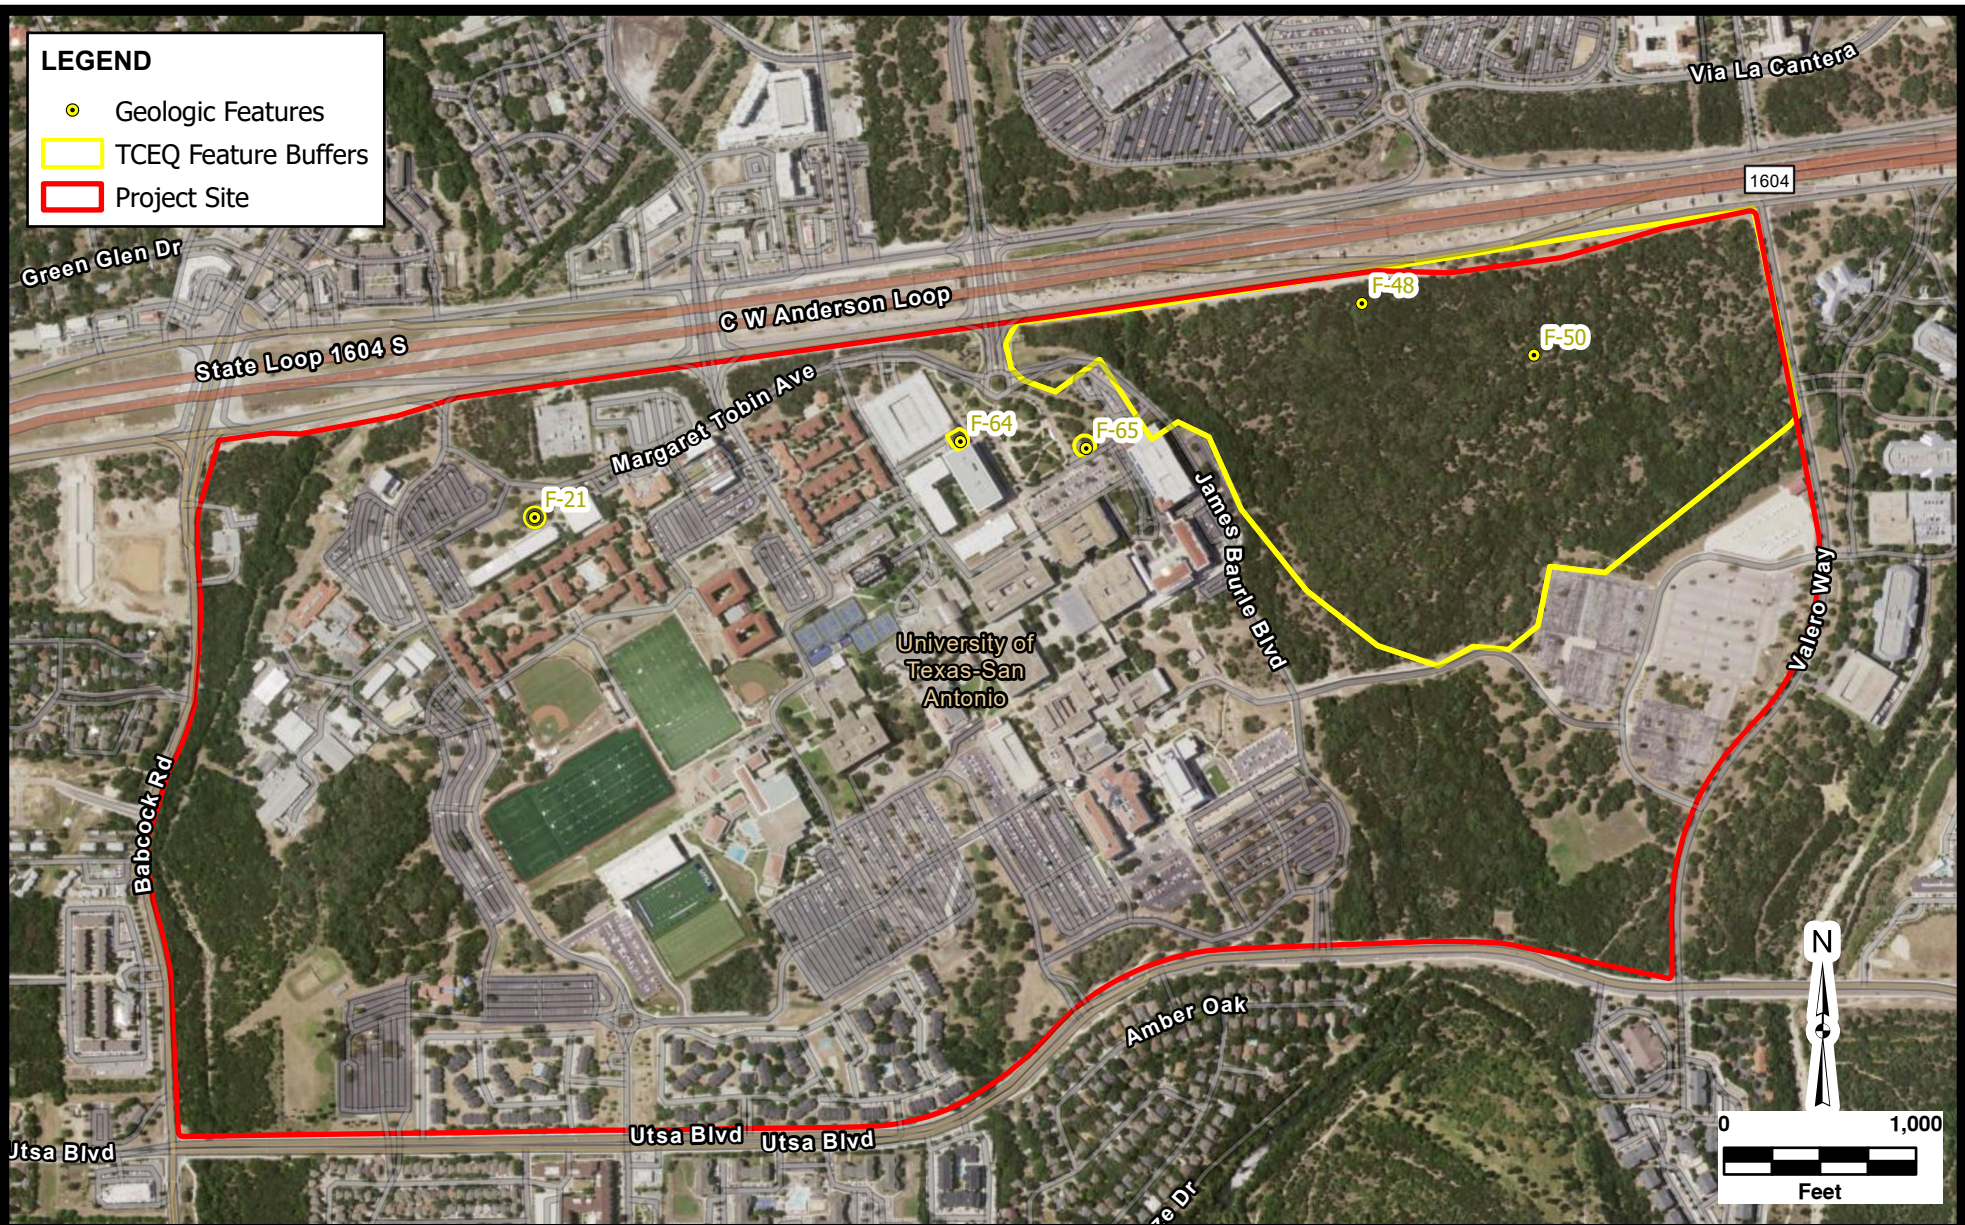
JOB NO.	12932-00
DATE	Sep 2024
DESIGNER	FF
CHECKED	VC
DRAWN	FF
SHEET	EXHIBIT 6

UTSA EXCAVATION FEATURES
KARST FEATURE EVALUATION
EXCAVATED FEATURES MAP

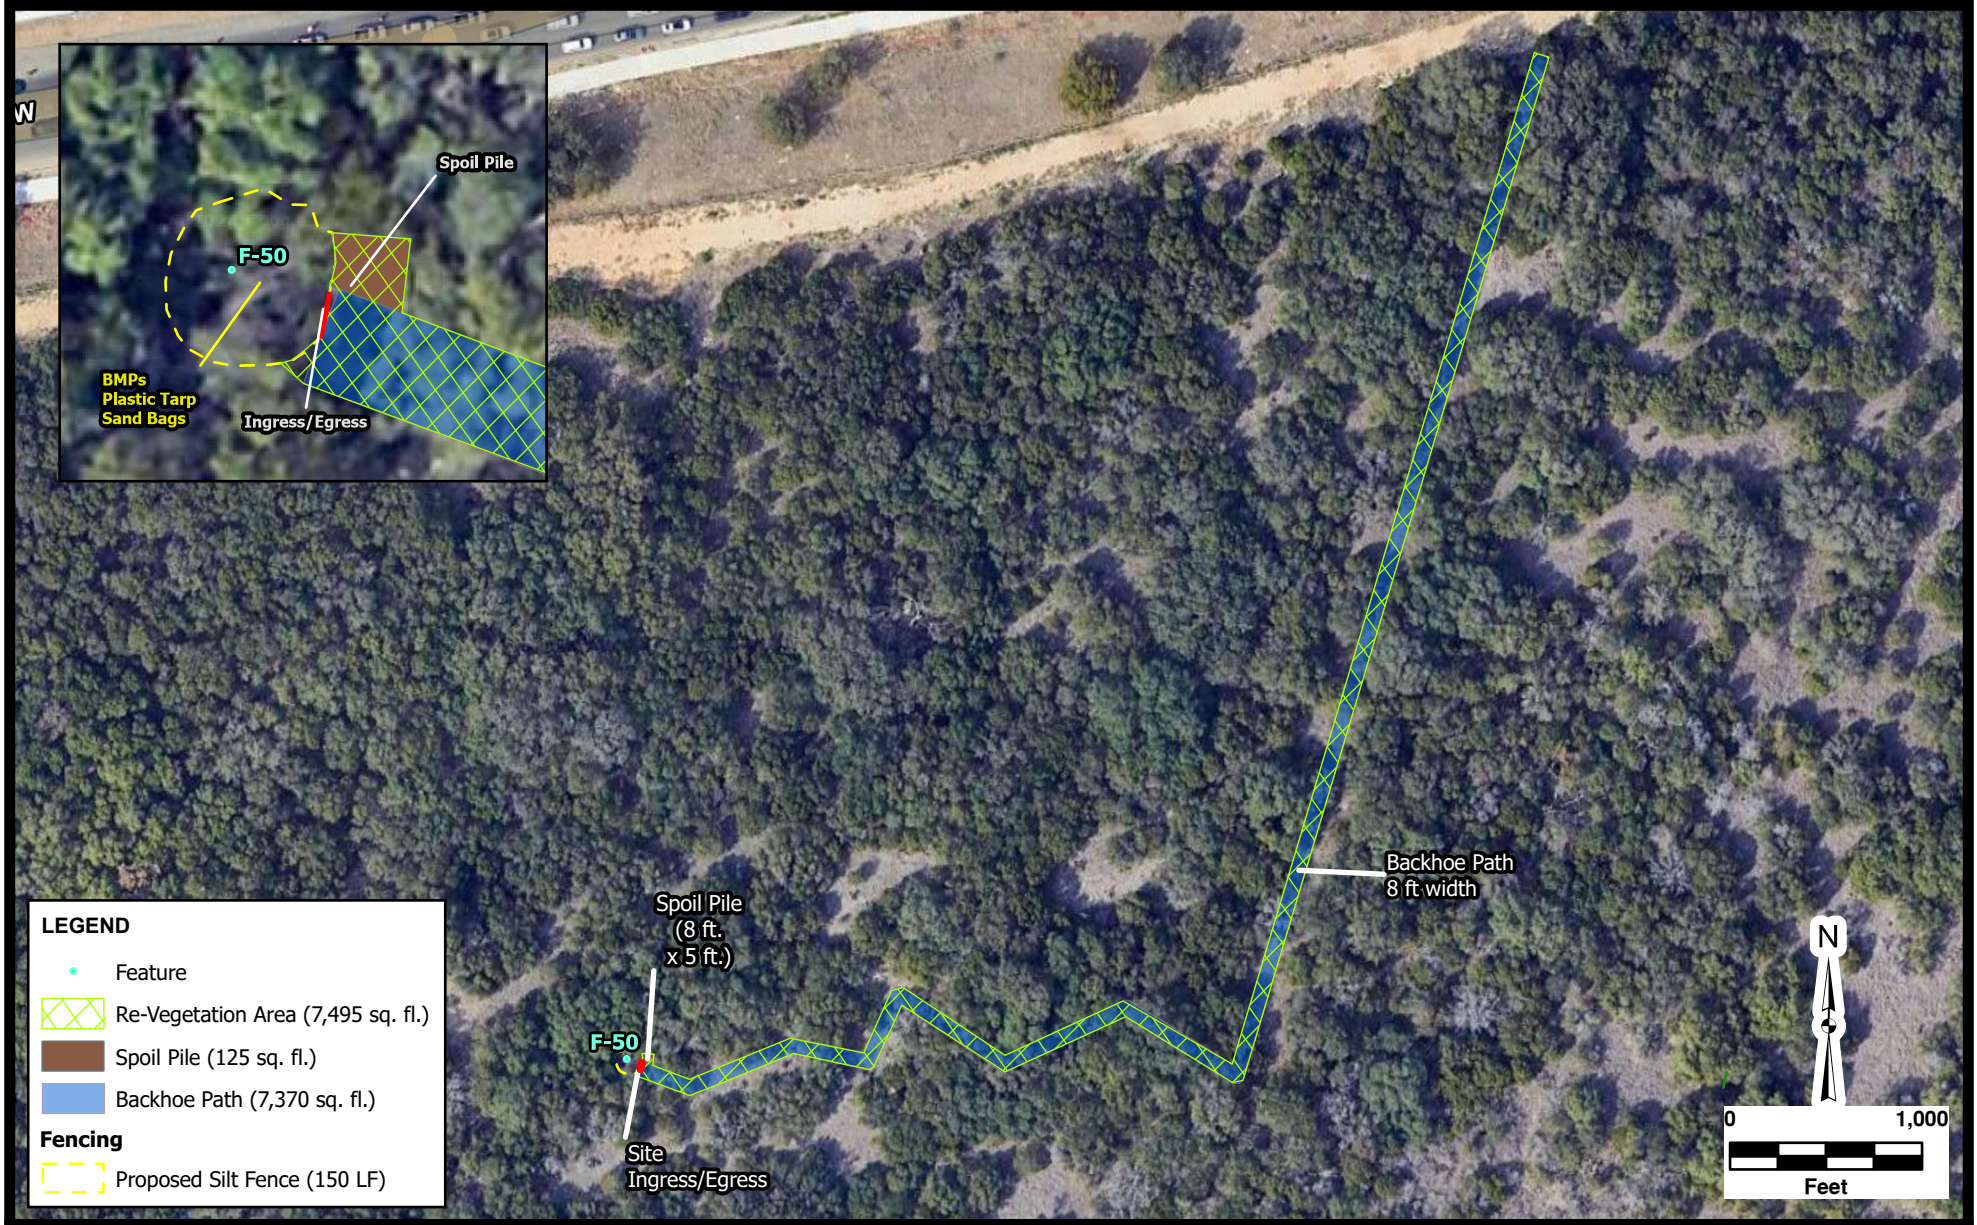
- Feature
- Re-Vegetation Area (7,495 sq. fl.)
- Spoil Pile (125 sq. fl.)
- Backhoe Path (7,370 sq. fl.)

**UTSA FEATURE F-50
KARST FEATURE EVALUATION
EXCAVATION/SITE PLAN MAP**
