EXPERT REPORT

ESTIMATION OF COSTS TO PERFORM CLEANUP AT THE  
ASARCO EL PASO SMELTER  
ON BEHALF OF  
THE TEXAS COMMISSION ON ENVIRONMENTAL QUALITY

James Shih-Hong Sher, P.E.  
Texas Commission on Environmental Quality

April 2009

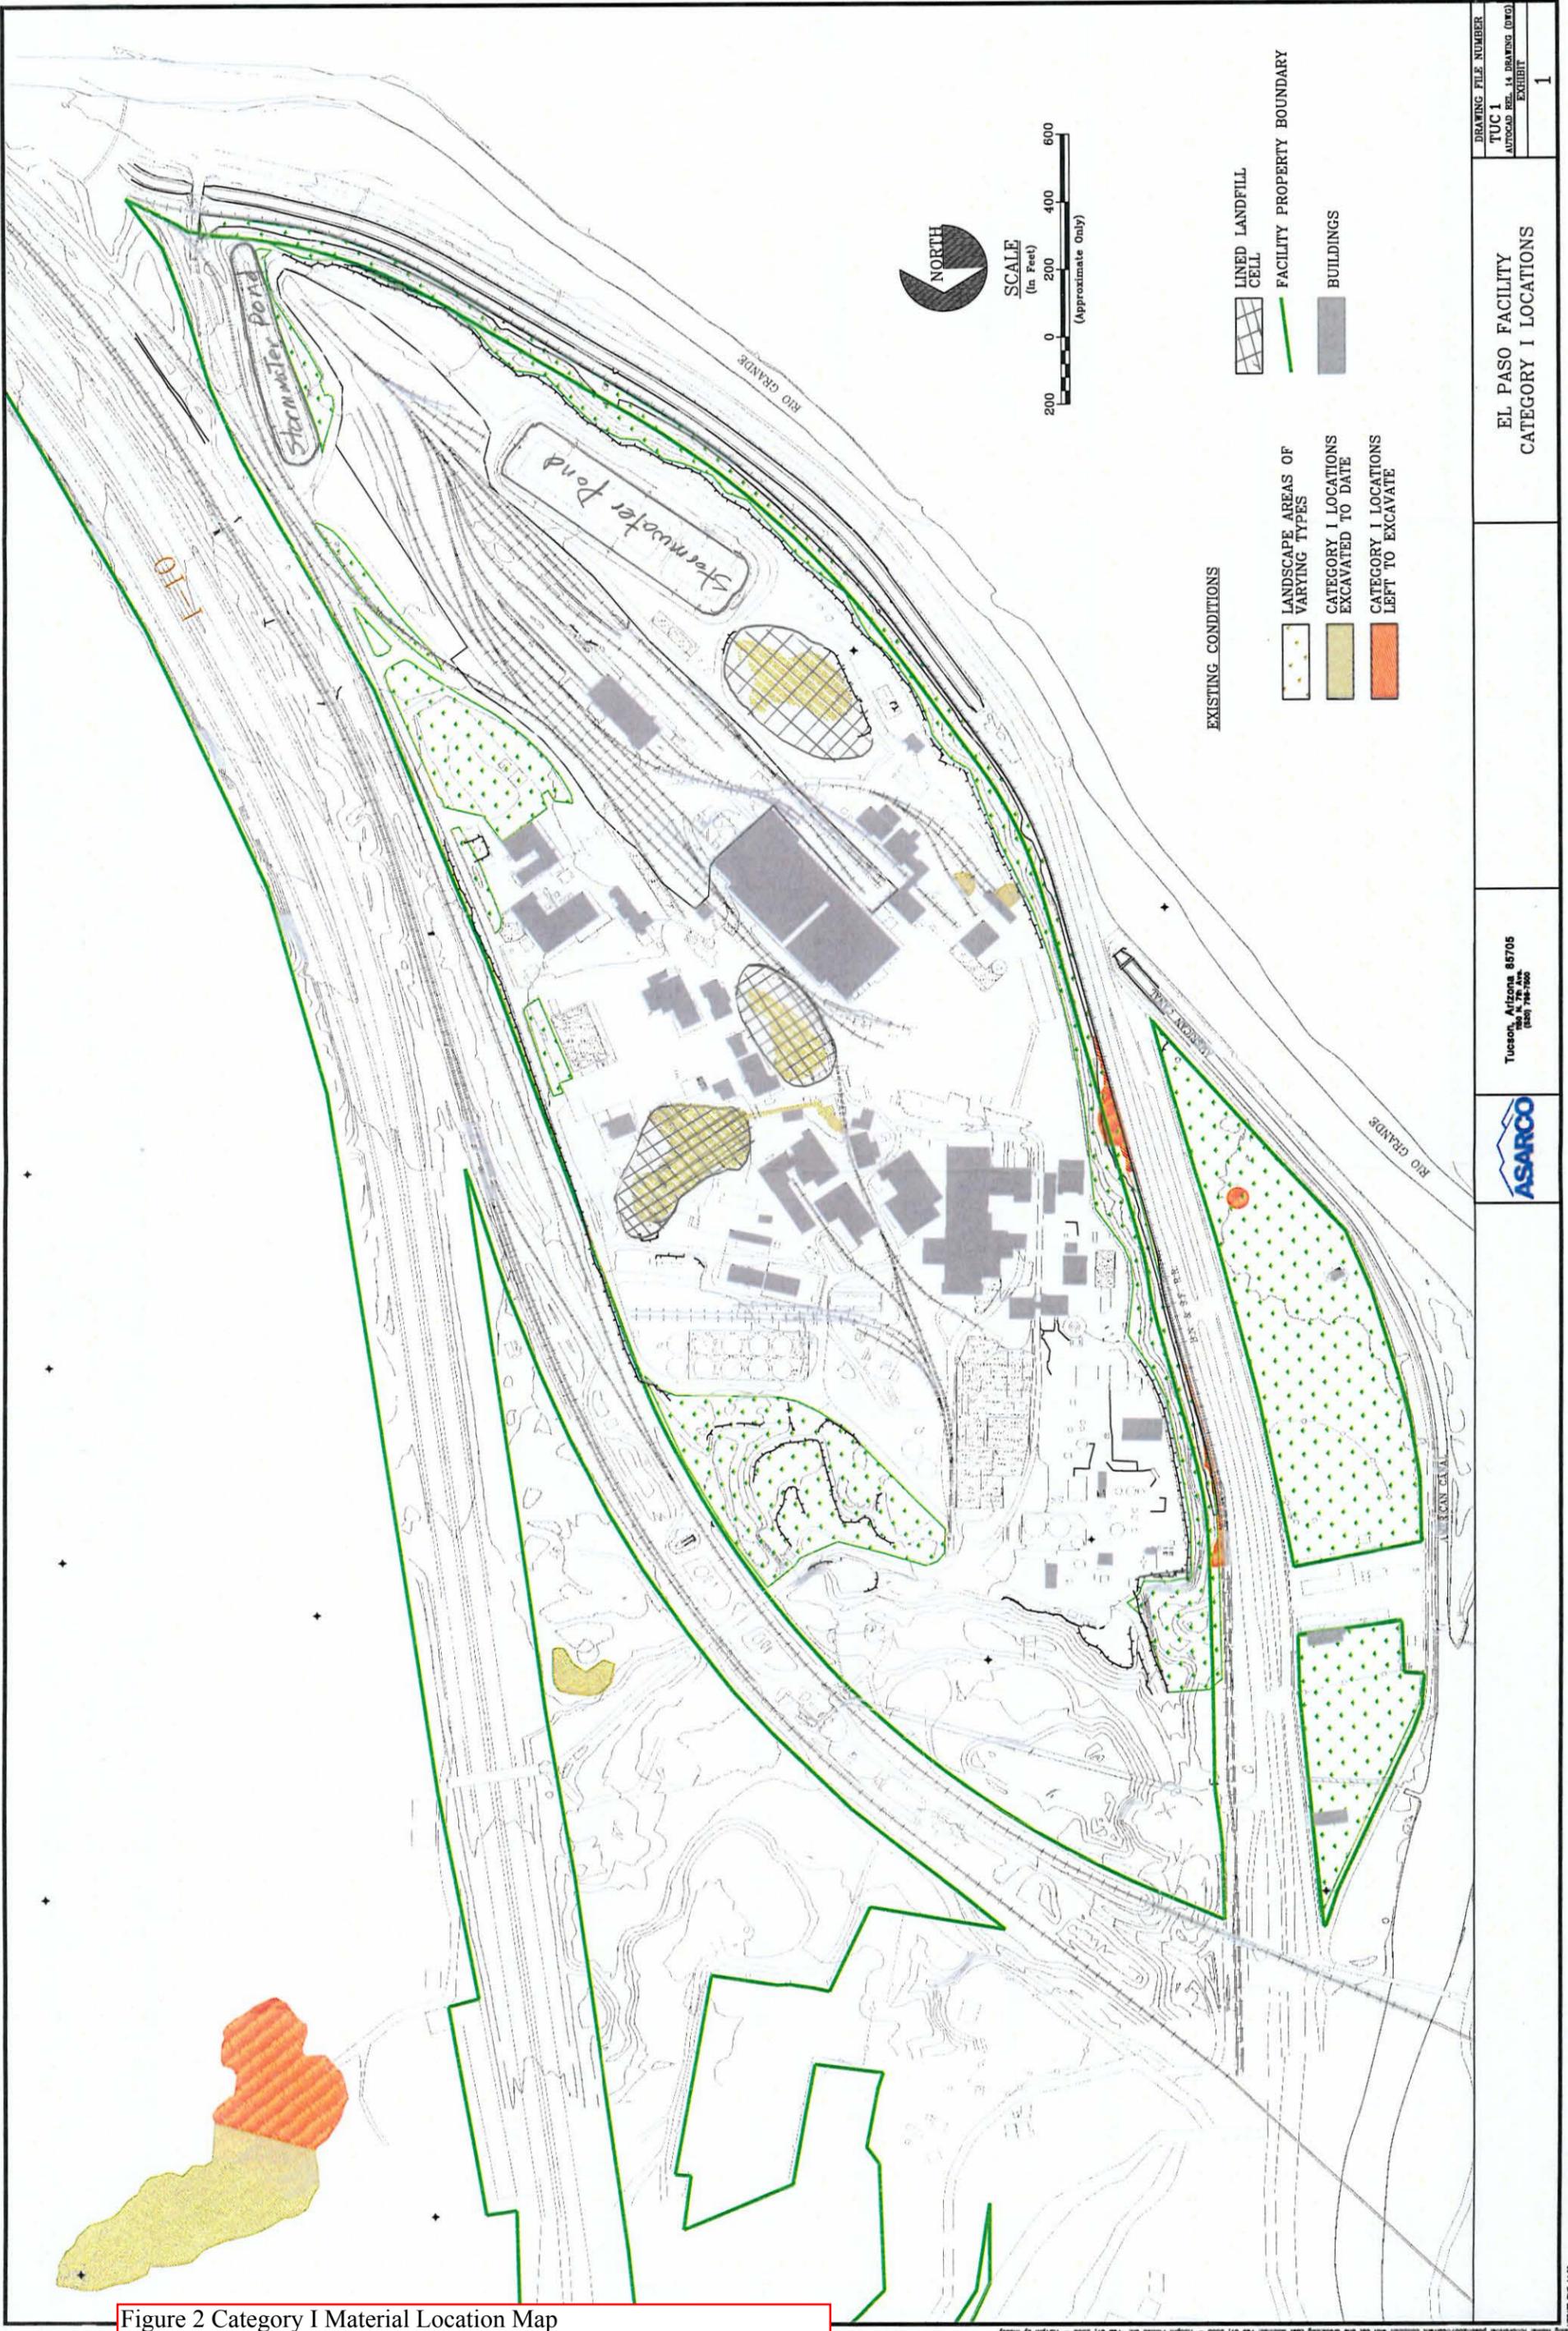
Figure 2 Category I Material Location Map

As part of the waste management strategy, an additional waste repository cell will need to be constructed because the third waste cell currently exceeds capacity (See ASARCO Photograph # 4). There is approximately 15,000 cubic yards of excess material from the third cell and about 25,000 cubic yards of Category I material located on the east side of I-10 that are required to be managed and contained in the proposed repository cell 4. The waste to be contained in proposed repository cell 4 is Category I waste which has elevated concentrations of metals with a high potential to leach to groundwater. Figure 2 displays

Category I material which has been excavated and identifies the remaining area that needs to be excavated. Figures 12 & 12-1 show typical cross sections of a repository cell drawing. The cell floor is comprised of a geosynthetic clay liner (GCL), a High Density Polyethylene (HDPE) geomembrane and a geocomposite drainage layer. GCL is a high performance environmental liner comprised of a layer of low-permeability sodium bentonite combined with geosynthetic carriers such as woven and/or nonwoven geotextiles and in some cases polymer geomembrane. In general, GCLs have been proven to provide better engineered performance and durability than several feet of compacted clay with a total composite thickness of less than one quarter of an inch.

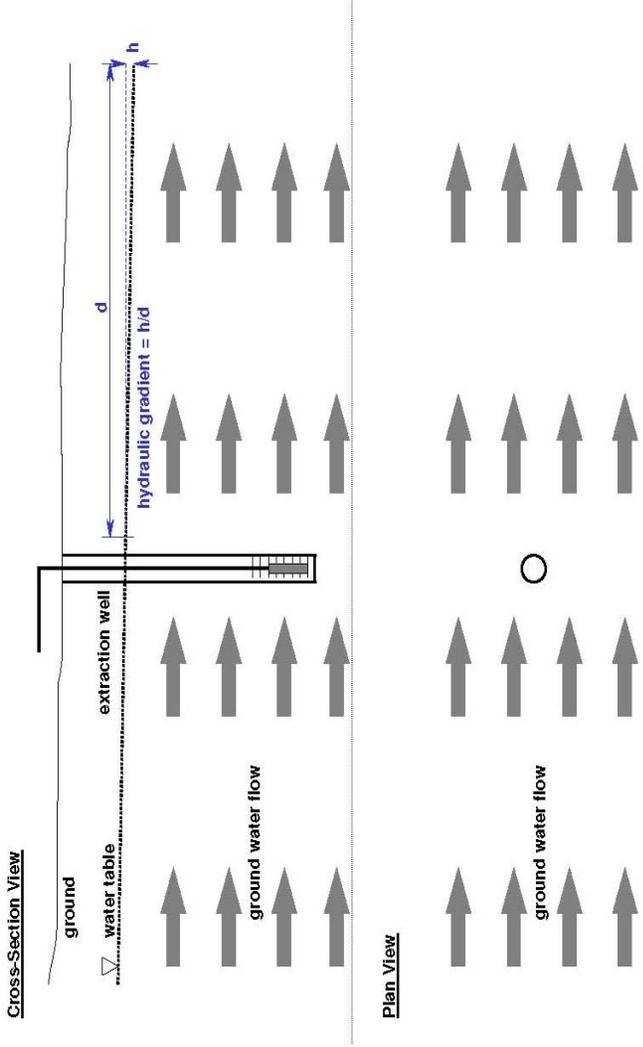
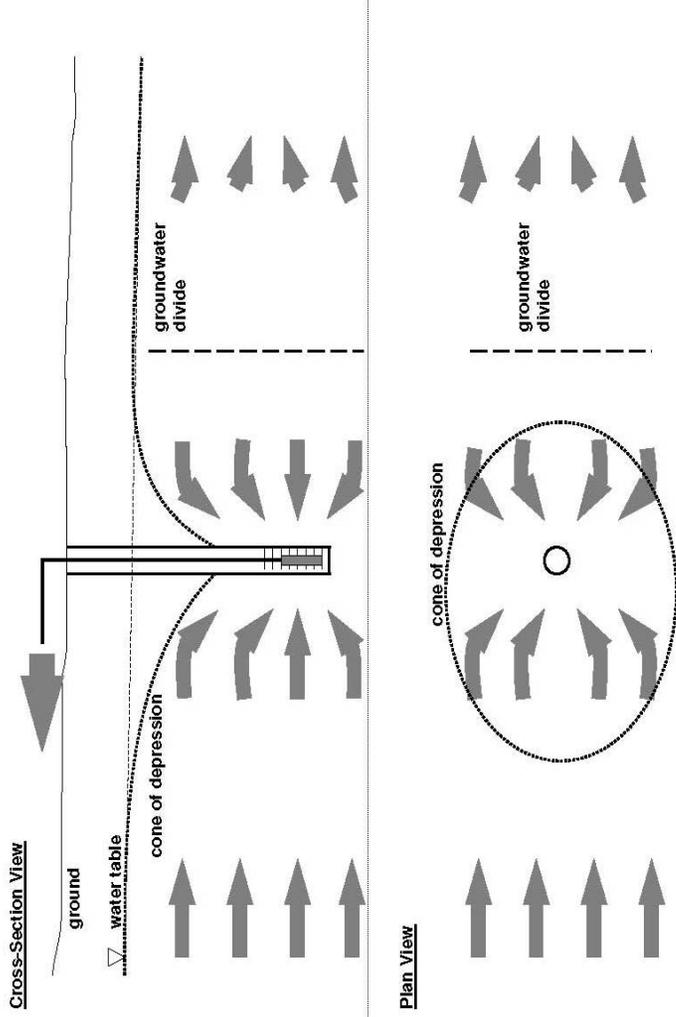
FIGURE 6

# SHAPE OF SINGLE WELL DRAWDOWN

## NO PUMPING

## PUMPING WITH CONE OF DEPRESSION

A groundwater extraction system involves the design and installation of a system of extraction wells capable of hydraulically influencing a volume of the aquifer (i.e., water bearing zone) that is contaminated. An inward gradient or cone of depression occurs in an aquifer when groundwater is pumped from a well. As groundwater flows into the well, the water levels in the aquifer decrease around the well. The groundwater level decline decreases with an increased distance from the well thus resulting in a conical-shaped depression radiating away from the pumping well. The pumping effect from a single well is shown on Figure 7.

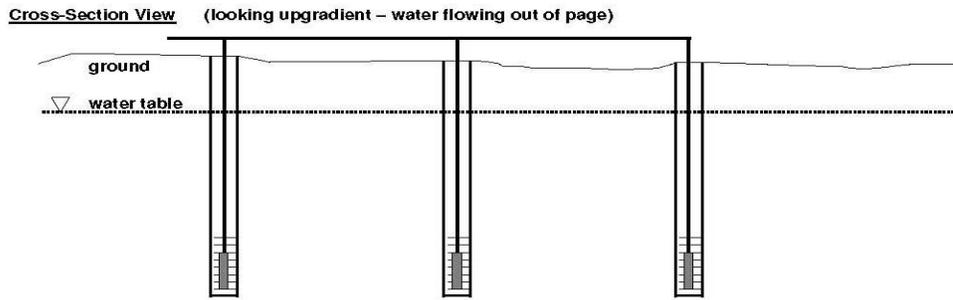
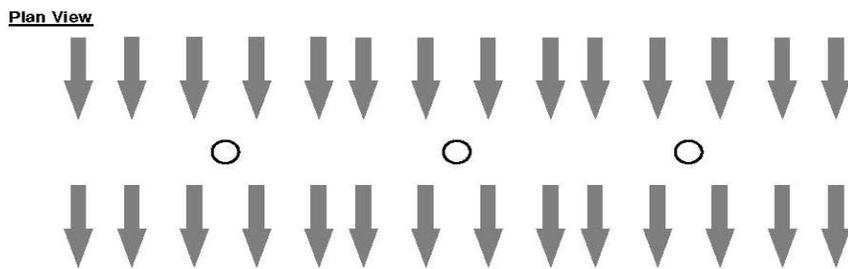
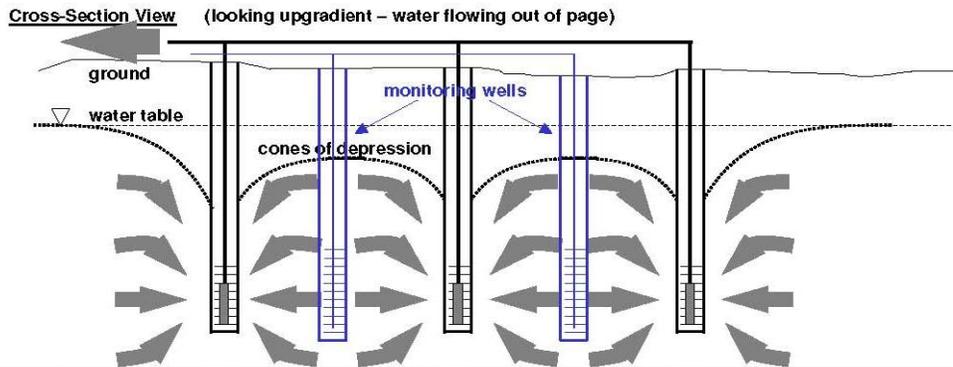
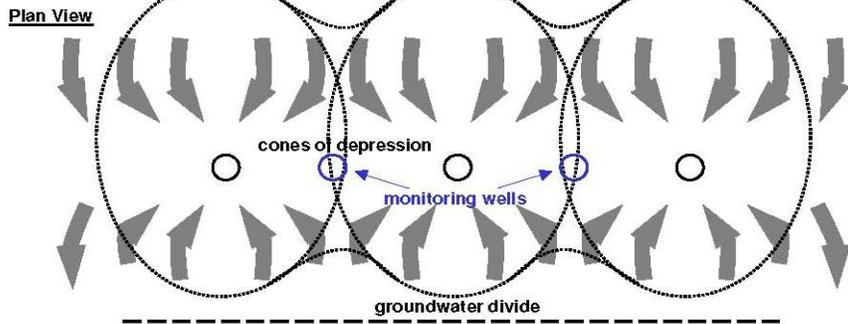
Figure 7

# SHAPE OF MULTIPLE WELLS DRAWDOWN

## NO PUMPING

## PUMPING WITH CONE OF DEPRESSION

When multiple cones of depression coalesce, they tend to have a combined affect on drawdown (i.e., groundwater level decline) and change the groundwater flow direction as shown on Figure 8. The groundwater levels between the extraction wells are lowered, and minimal contaminated groundwater flows past extraction wells, thus forming the hydraulic barrier. The use of extraction wells to contain the groundwater flow is a common groundwater remediation technology.

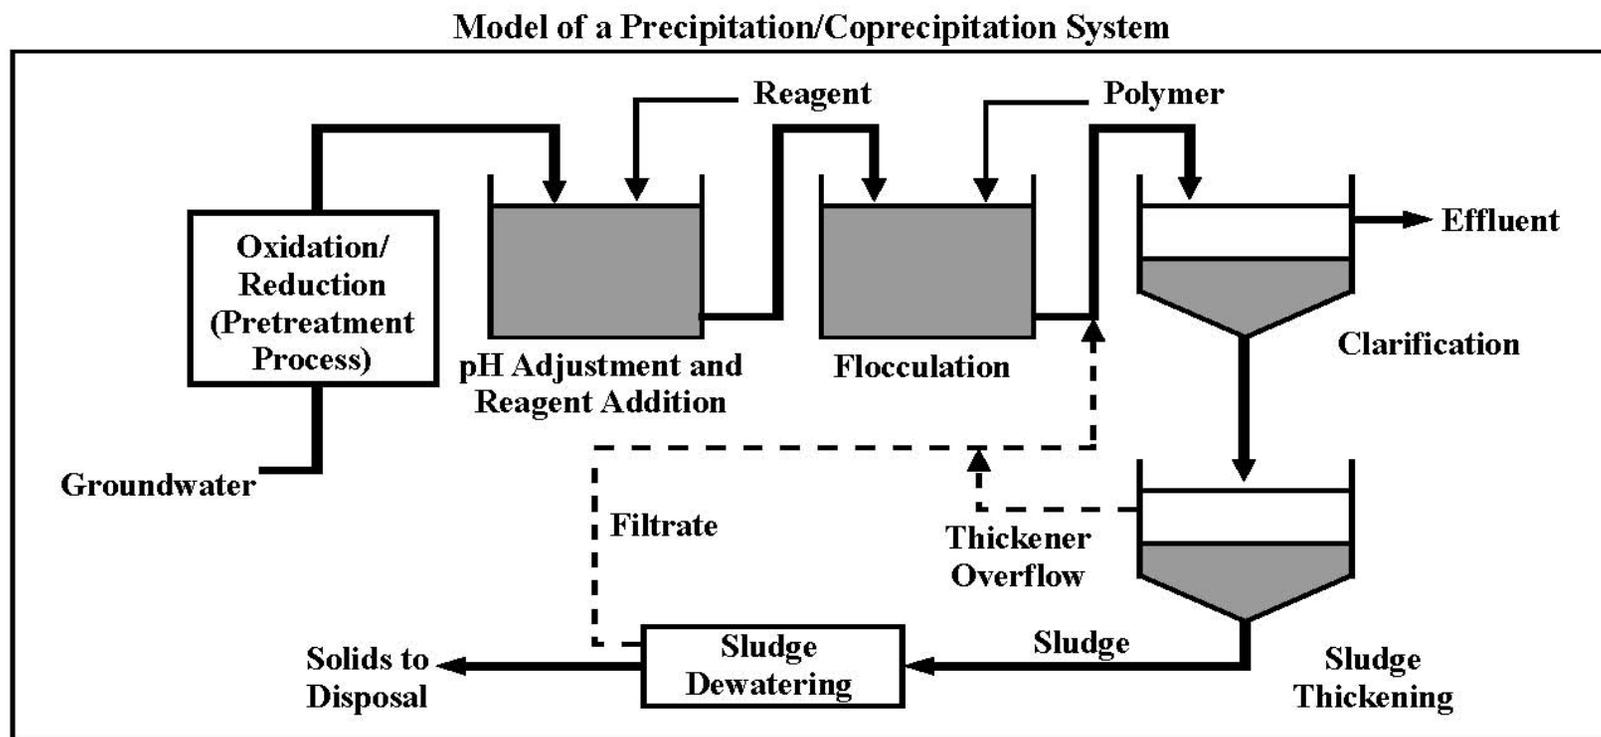
Figure 9

# MODEL OF A PRECIPITATION/COPRECIPITATION WATER TREATMENT SYSTEM PROCEE FLOW CHART

This drawing is obtained from EPA Publication 542-R-02-004 "Arsenic Treatment Technologies for Soil Waste and Water" 2002.

- Precipitation/Coprecipitation. Precipitation uses chemicals to transform dissolved contaminants into an insoluble solid. In coprecipitation, the target contaminant may be dissolved or in colloidal or suspended forms. Dissolved contaminants do not precipitate, but are adsorbed onto another species that are precipitated. Colloidal or suspended contaminants are removed through processes such as coagulation and flocculation then removed from the liquid phase by clarification or filtration. This technology is less sensitive to the COC concentrations in the groundwater and water chemistry than other water treatment technologies. Therefore, this procedure is the most frequently used technology to treat metals in the groundwater. It is also capable of treating water characteristics or contaminants other than arsenic, such as hardness or heavy metals. For the above reasons, the TCEQ proposes to use this technology to treat the contaminated groundwater. The general process flow chart of this technology is shown on Figure 9.

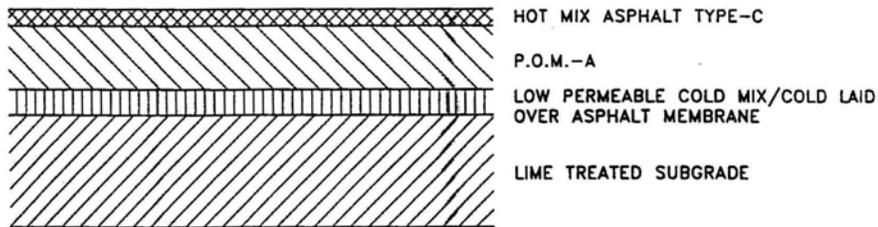
Figure 10

ASPHALT PAVING CROSS SECTION  
(Provided by ASARCO EL Paso Plant)

LAYERED THICKNESS (INCHES)	$S_{cf}$	$SN$
HOT MIX ASPHALTIC CONCRETE TYPE-C	1.5	0.44	0.66
P.O.M.-A COLD MIX/COLD LAID	4.0	(ASSUMED) 0.30	1.20
LOW PERMEABLE COLD MIX/COLD LAID OVER ASPHALT MEMBRANE	2.0	(ASSUMED) 0.28	0.56
LIME TREATED SUBGRADE (VERSABIND)	6.0	(ASSUMED) 0.14	0.84
			WSN = 3.26

NOTE: GEOGRID TENSAR CAPITOL BX-1100 MAY BE USED IN PLACE OF LIME TREATED SUBGRADE.

LIGHT TRAFFIC RECOMMENDED PAVEMENT  
CROSS-SECTION

Figure 3 displays the current asphalt paved areas and the planned asphalt paved areas that ASARCO was directed to construct for an operating smelter. If the future use of the facility is not for an operating smelter, then additional asphalt paving is needed. The additional asphalt paving is needed to cover waste and/or the soil with elevated metals to prevent direct contact and mitigate waste dust particles from blowing offsite as well as prevent contaminated storm water runoff. The paving area was estimated from ASARCO plats. Since the facility has been in operation for over 100 years, there is a high probability that contaminants may be discovered outside the investigation area. Therefore, the TCEQ intends to pave the majority of the plant area to prevent any potential exposure. Figure 4 displays the 59.5 paved area. The cross section for current light traffic asphalt pavement with 1.5" Type C asphalt and 6" cold mix and cold laid asphalt material on top of 6" crushed slag as road base material is shown on Figure 10. ASARCO estimated a \$2 million cost to complete the paving of the additional 16 acres, which was required in the TCEQ's May 20, 2005 letter. Based on the 2005 ASARCO cost estimate, the unit cost is \$125,000 per acre. The TECQ cost estimate is \$130,000 an acre with a 4% inflation adjustment.

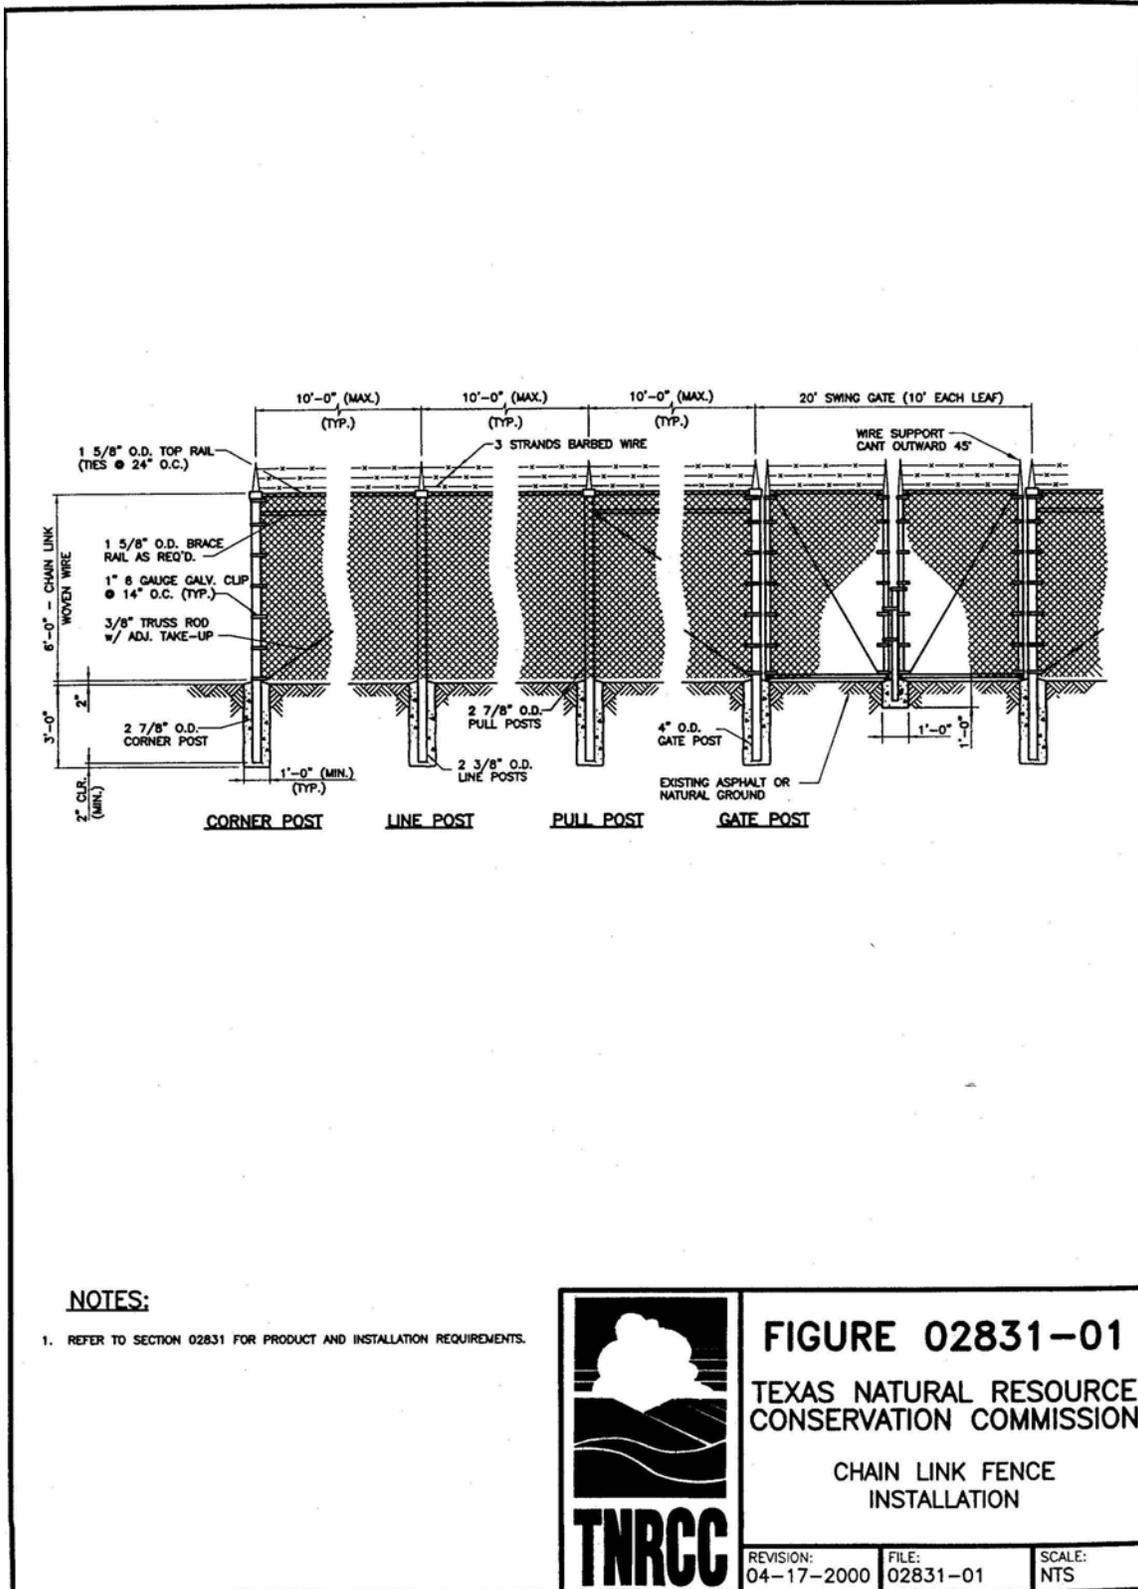
# CHAIN LINK FENCE CROSS SECTION

The installation of a fence as shown on Figure 11 is needed to enclose the northern section of the site to limit public access to the abandoned site. The length of the fence was estimated by measuring distances based on the ASARCO plat. The cost estimate for the fence is based on the measured distance multiplied by the state contracted unit cost of \$25 a foot for a standard 6 foot chain link fence (See References - Documents for Cost Estimation #12).

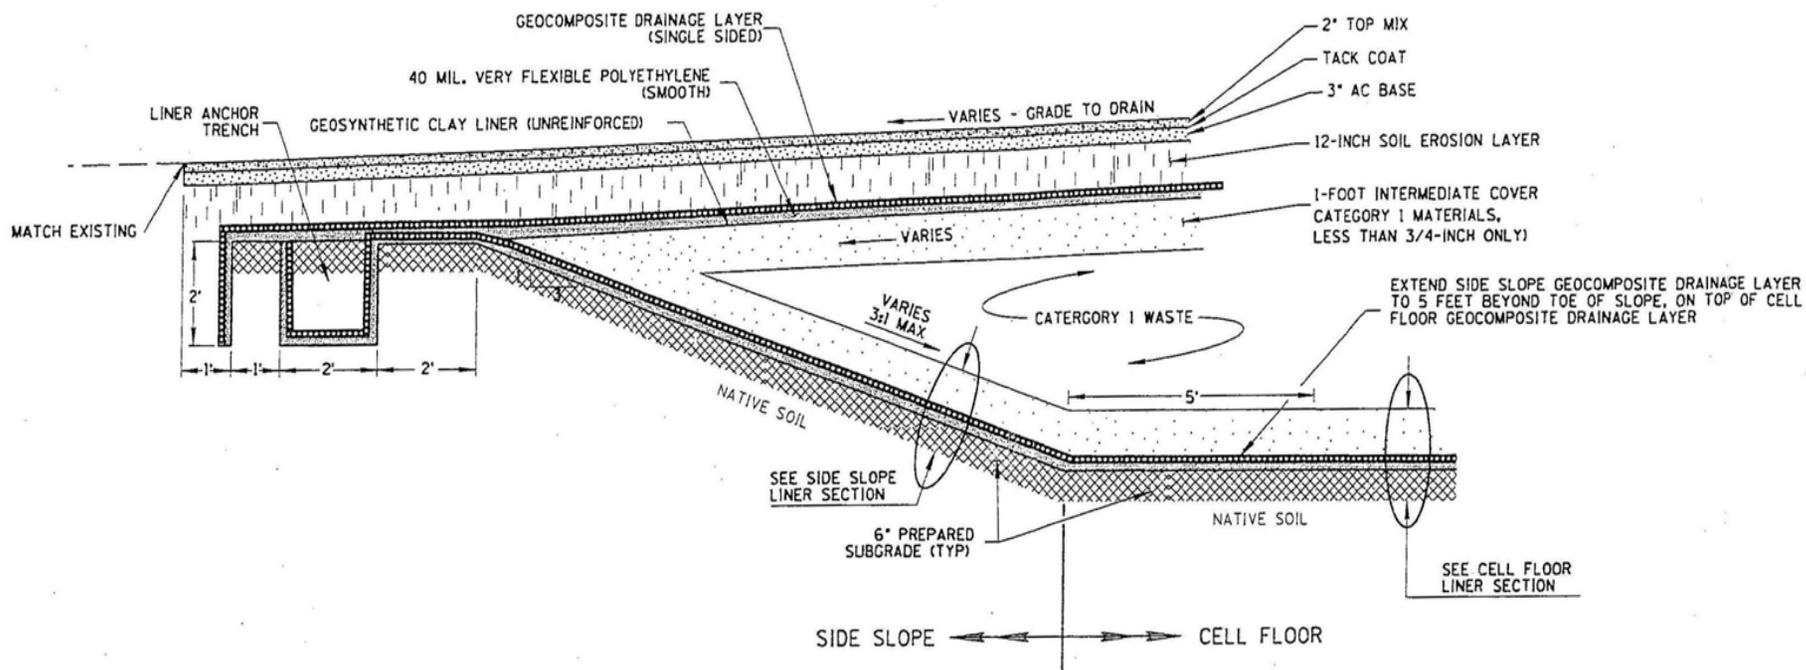
Figure 12

## TYPICAL REPOSITORY CELL LINER DESIGN

### TYPICAL FINAL COVER AND LINER DETAIL

The HDPE geomembrane liner is placed on top of the GCL. The combination of the GCL and HDPE liner will create a nearly impermeable barrier that surrounds the buried material. The GCL and HDPE liners prevent the material and liquid generated from the waste (if any) from leaching out of the cell. The HDPE liner has chemical and physical characteristics that are not adversely affected by the placement of waste.

A geocomposite drainage layer is then placed on top of the HDPE liner. The geocomposite layer consists of a drainage net that is bonded to one layer or sandwiched between two layers of geotextiles to create a single-sided or double-sided geocomposite. The drainage net provides a layer for the transmission of liquids and/or gases. The geotextile also serves as a filter and separator.

After the waste material is placed into the repository cell, a cell cover is constructed. The cover is comprised of asphalt, with soil, GCL, flexible polyethylene material, and a geocomposite drainage layer underneath the asphalt. The GCL and a flexible polyethylene material will create a nearly impermeable barrier to prevent surface water from coming in contact with the buried material. A geocomposite drainage layer is then placed on top of the polyethylene layer to ensure that any water seeping through the asphalt will drain away from the repository cell. This procedure is commonly used in landfill construction.

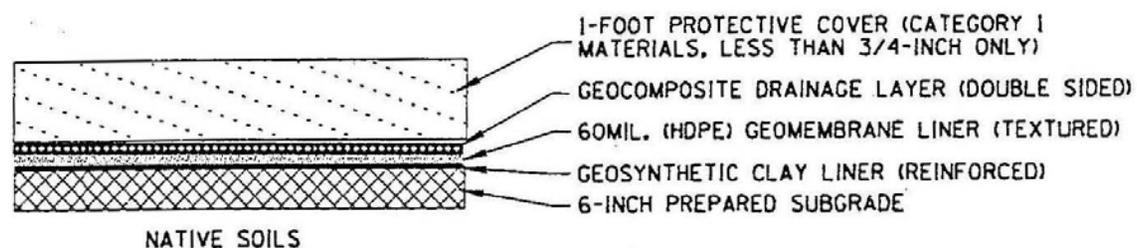
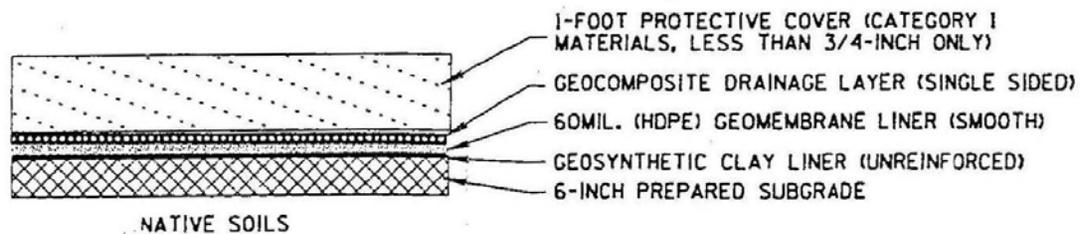
## TYPICAL REPOSITORY CELL LINER CROSS SECTION

### TYPICAL LINER SECTION (SIDE SLOPE)

### TYPICAL LINER SECTION (CELL FLOOR)

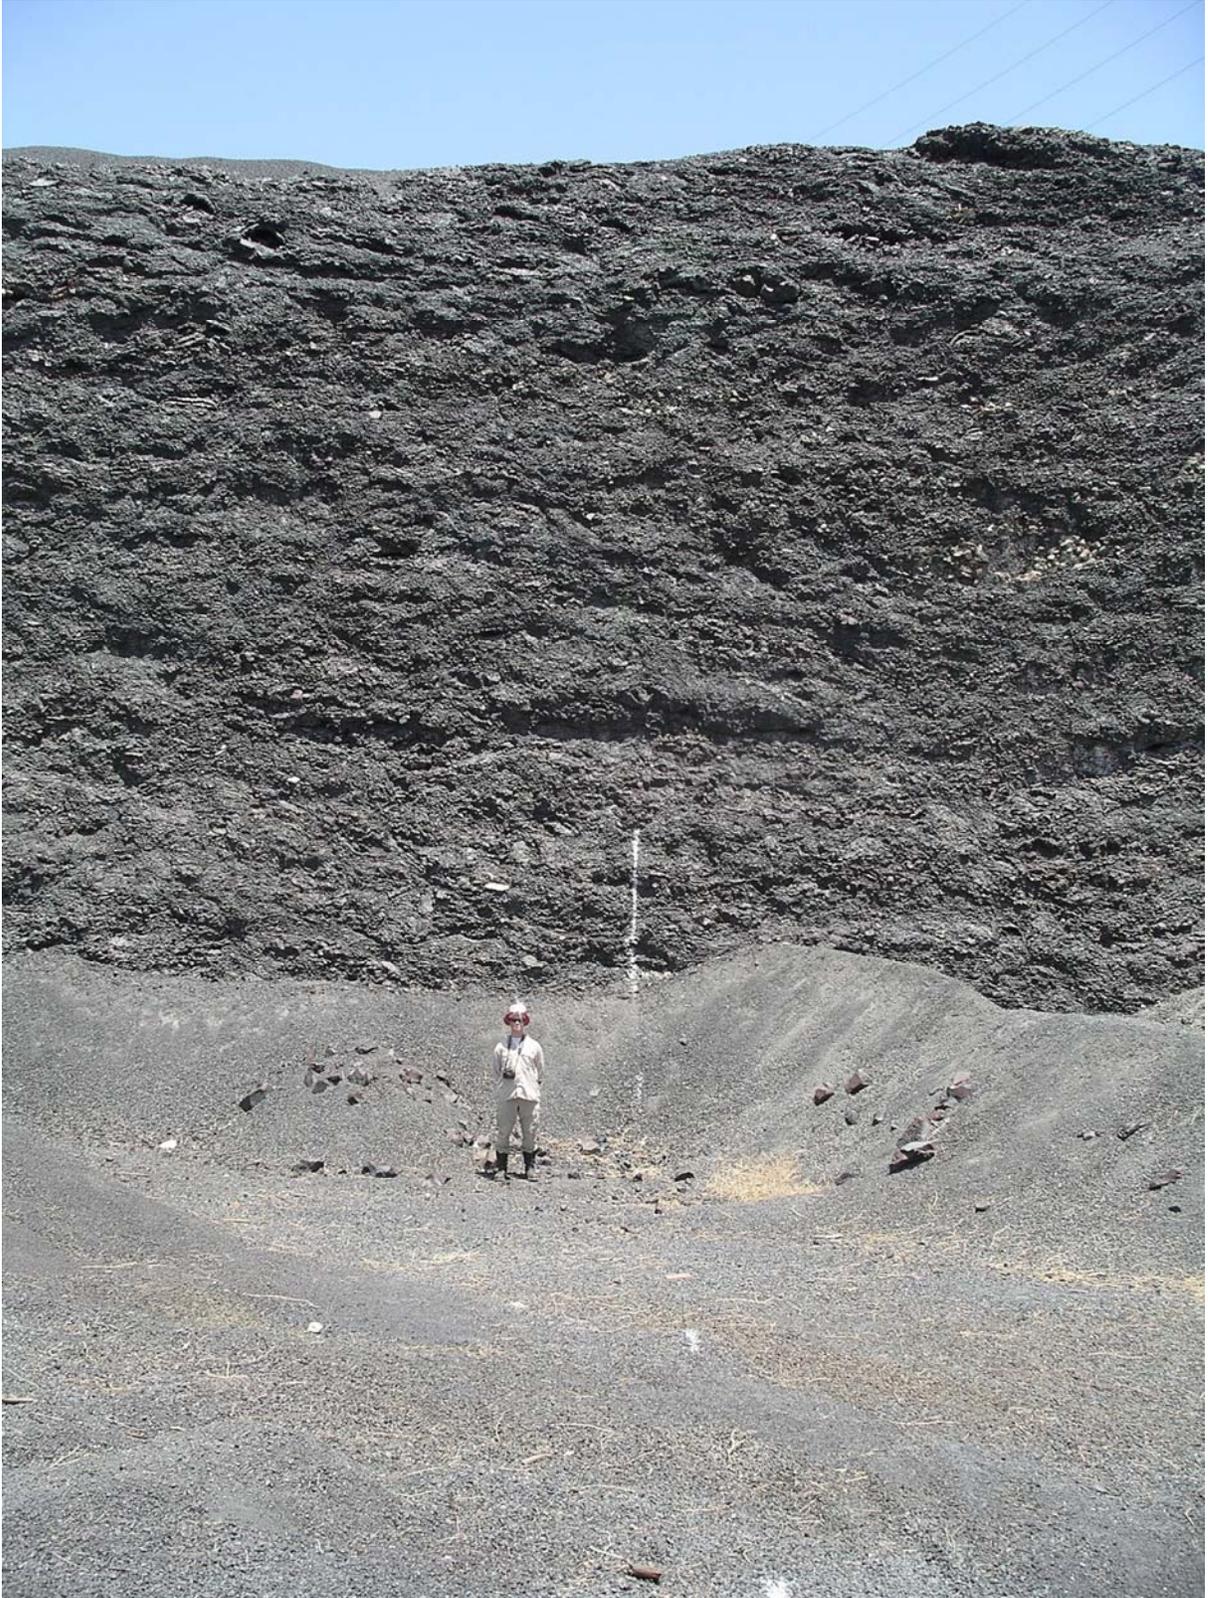
2. Looking east at exposed slag in northern section of the ASARCO smelter.

The facility is located in El Paso County on the Rio Grande floodplain at an elevation approximately 3,600 feet above mean sea level. The surface geology consists of a mix of colluvial sediments from the surrounding mountains and fluvial sediments from the Rio Grande River (Rio Grande). Typical fluvial sediments can be classified into fine to coarse grain gravel and sand with a mixture of silt and clay all of which are present at the ASARCO El Paso smelter site. The site is built over a series of arroyos which have been filled with either native soils or slag. Slag is a by-product of the smelting process and is considered a solid waste. The thickness of the slag varies across the facility to a maximum of sixty feet (see ASARCO Photograph # 2).

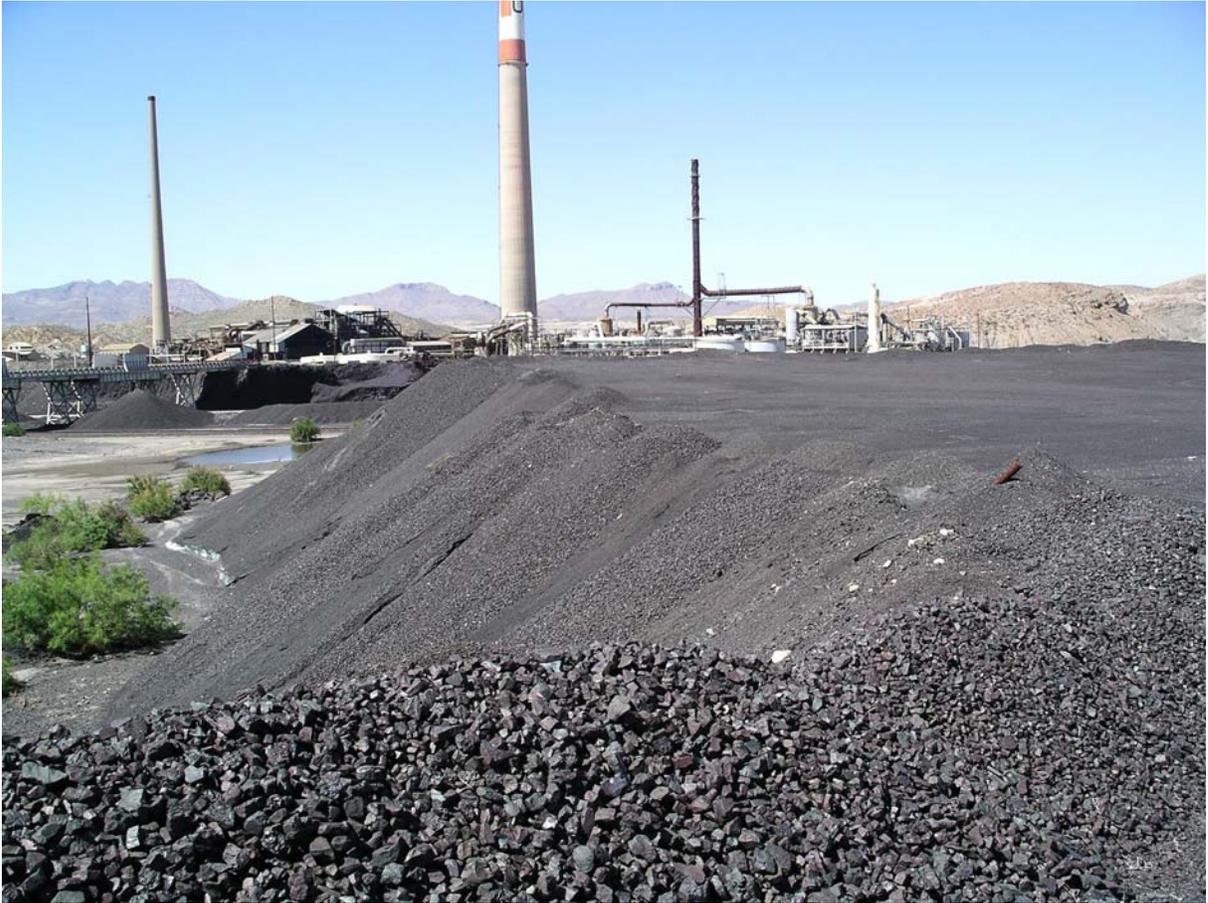
3. Looking southwest at minus 50 slag/dust and fines pile in foreground and the ASARCO smelter in background.

The term “minus 50” means that the particles just like a powder and are small enough to pass through a sieve size 50 (a 0.0117 inch opening), which could be

subject to wind dispersion. The material from the minus 50 waste pile is subject to leaching metals to the groundwater and to wash out to the Rio Grande. The TCEQ believes the best long term remedial solution for the minus 50 waste pile is to dispose of the fines in a repository cell.

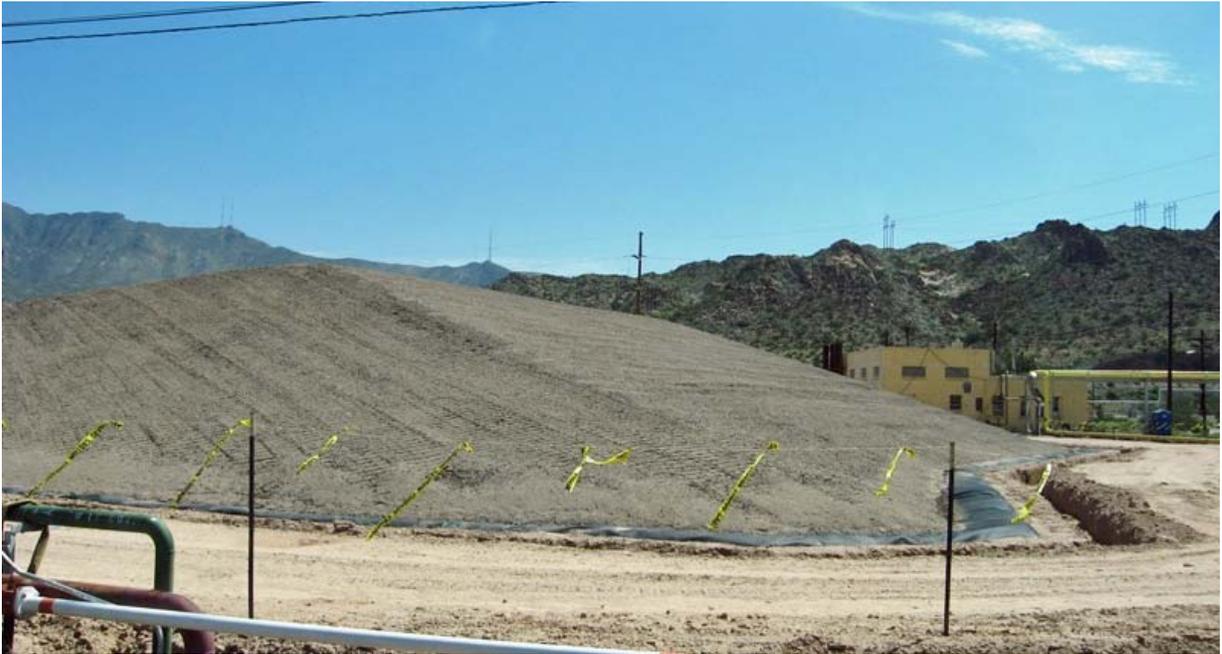
4. Looking at the third cell. The top of the waste material is approximately 14 feet above the ground which is over the design capacity.
