Exide Technologies  
 Frisco Smelter  
 P.O. Box 250  
 Frisco, TX 75034  
 Tel (972) 335-2121

Subject: Exide Technologies Frisco Recycling Center, Frisco, Texas  
 TCEQ Agreed Order Docket No. 2011-1712-IHW-E; IHW Permit No. 50206; TCEQ SWR  
 No. 30516  
 EPA Administrative Order on Consent RCRA 06-2012-0966  
 Certification of Compliance with Ordering Provision Deadlines to Date  
 Submission of Affected Property Assessment Report

RE: South Disposal Area Cap Repair Report  
Exide Frisco Recycling Center  
7471 South 5<sup>th</sup> Street - Frisco, Texas  
TCEQ SWR No. 30516, TCEQ Hazardous Waste Permit No. HW-50206; TCEQ  
Agreed Order Docket No. 2011-1712-IHW-E; EPA ID No. TXD006451090;  
W&M Project No. 112.072

**Attachment A**  
**Photographic Log**  
South Disposal Area Capping  
Frisco, Texas

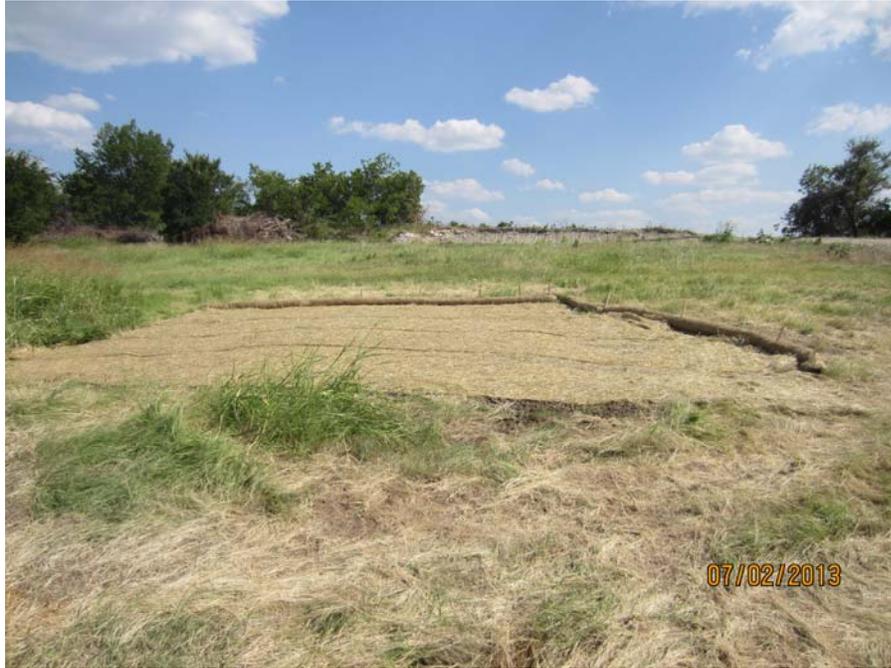
**Photo 11: View of repaired area after placement of seed and erosion mats.**

Areas of disturbance in the soil cap in the SDA were identified and systematically repaired to reinstate cap integrity. All identified areas were repaired by filling open holes with fine bentonite pellets and/or capped using clean imported soil, and stabilized using seed, straw mats and erosion control wattles.

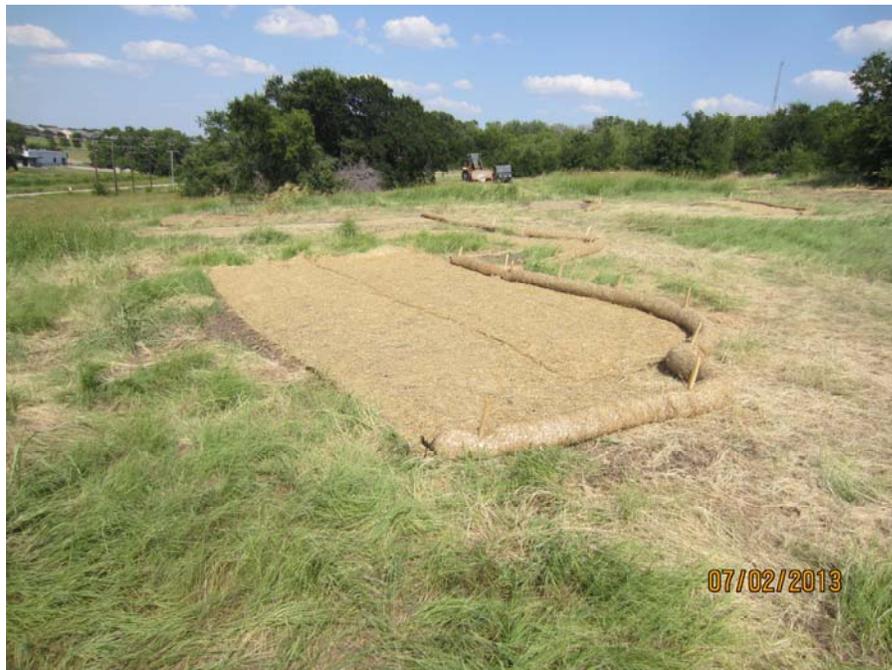
**Photo 12: Completed area with erosion mat and wattle.**

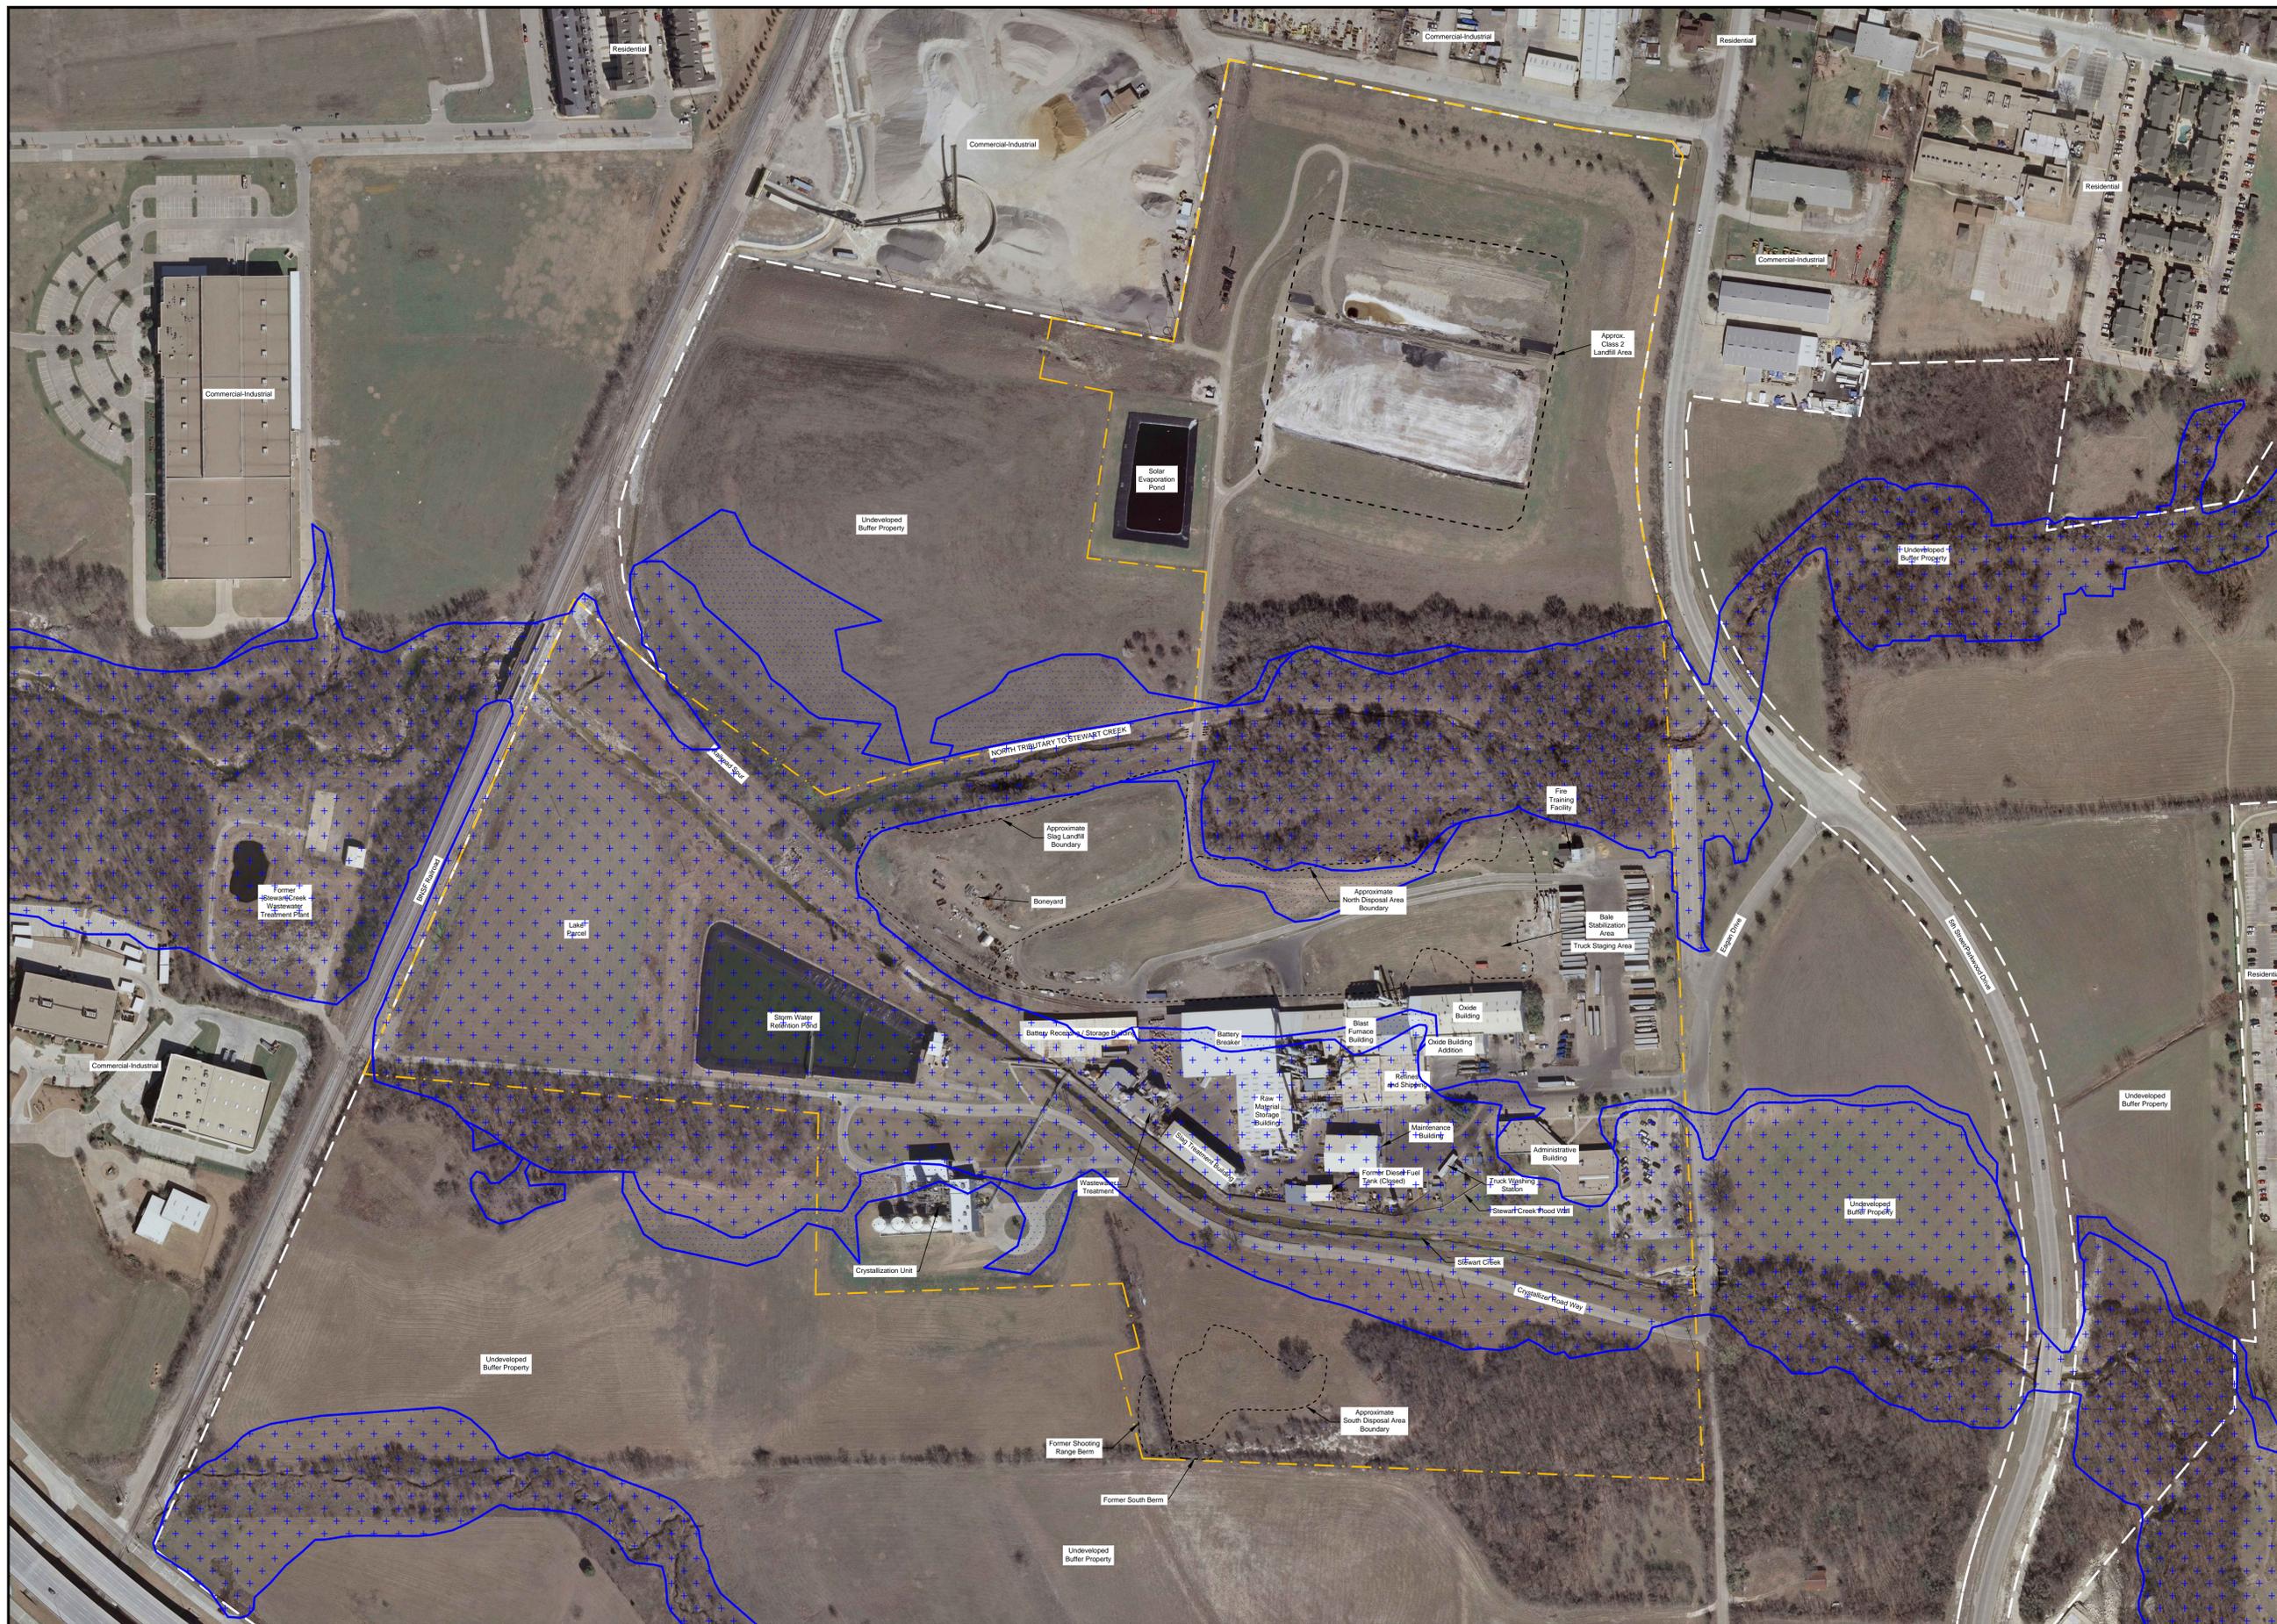
<b>FORMER OPERATING PLANT FRISCO RECYCLING CENTER FRISCO, TEXAS</b>		
Figure 1A.2 <b>ON-SITE PROPERTY MAP WITH FLOOD ZONES</b>		
PROJECT: 1785	BY: AJD	REVISIONS
DATE: MAY, 2013	CHECKED: WFW	
<b>PASTOR, BEHLING &amp; WHEELER, LLC</b> CONSULTING ENGINEERS AND SCIENTISTS

- EXPLANATION**
- On-Site Property Boundary
  - FRC Property Boundary
  - Special Flood Hazard Areas Subject to Inundation by the 1% Annual Chance Flood (100-year Flood) (FEMA, 2009)
  - Areas of 0.2% Annual Chance Flood, Areas of 1% Chance Flood with Average Depths of Less than 1 foot or with Drainage Areas Less than 1 Square Mile, or Areas Protected by Levees from 1% Annual Chance Flood (FEMA, 2009)

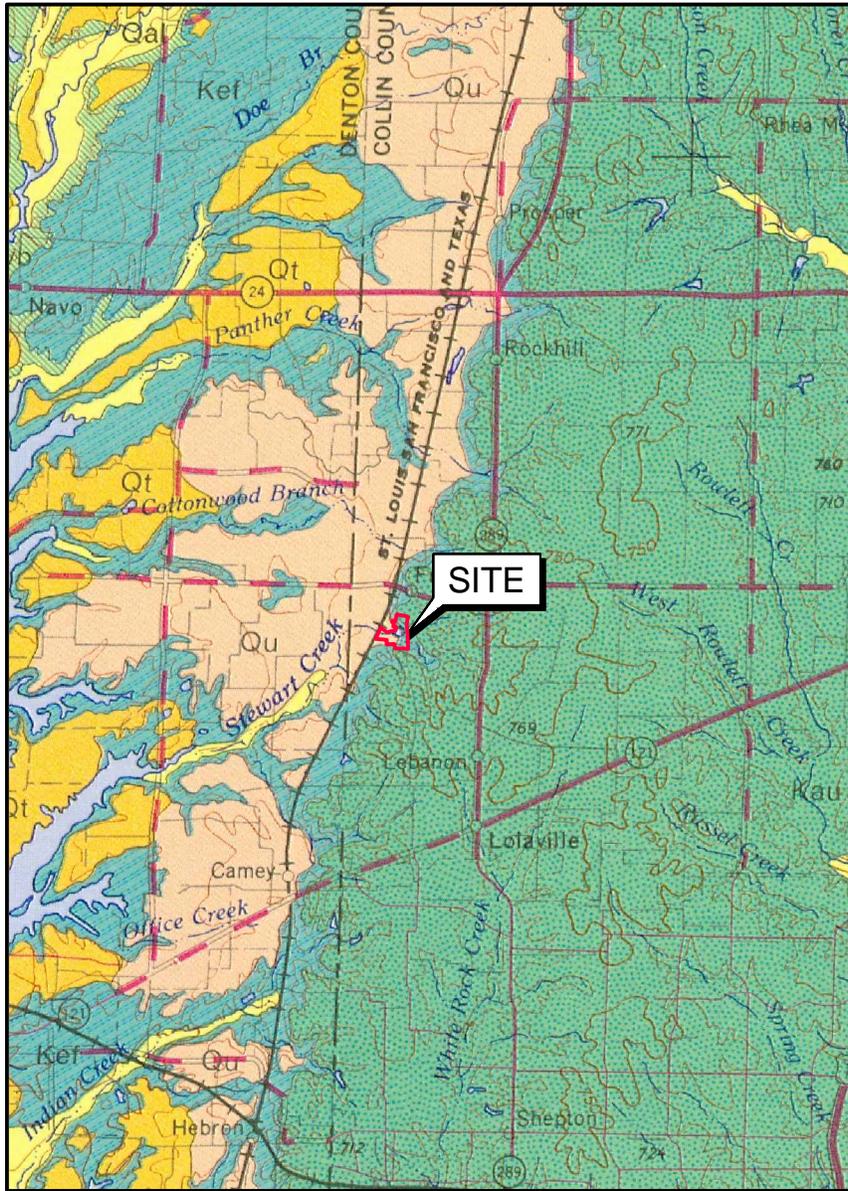
<b>FRISCO RECYCLING CENTER</b> FRISCO, TEXAS		
Figure 1C		
<b>REGIONAL GEOLOGIC MAP</b>		
PROJECT: 1755	BY: AJD	REVISIONS
DATE: APR., 2013	CHECKED: WFW	
<b>PASTOR, BEHLING &amp; WHEELER, LLC</b> CONSULTING ENGINEERS AND SCIENTISTS

**EXPLANATION**

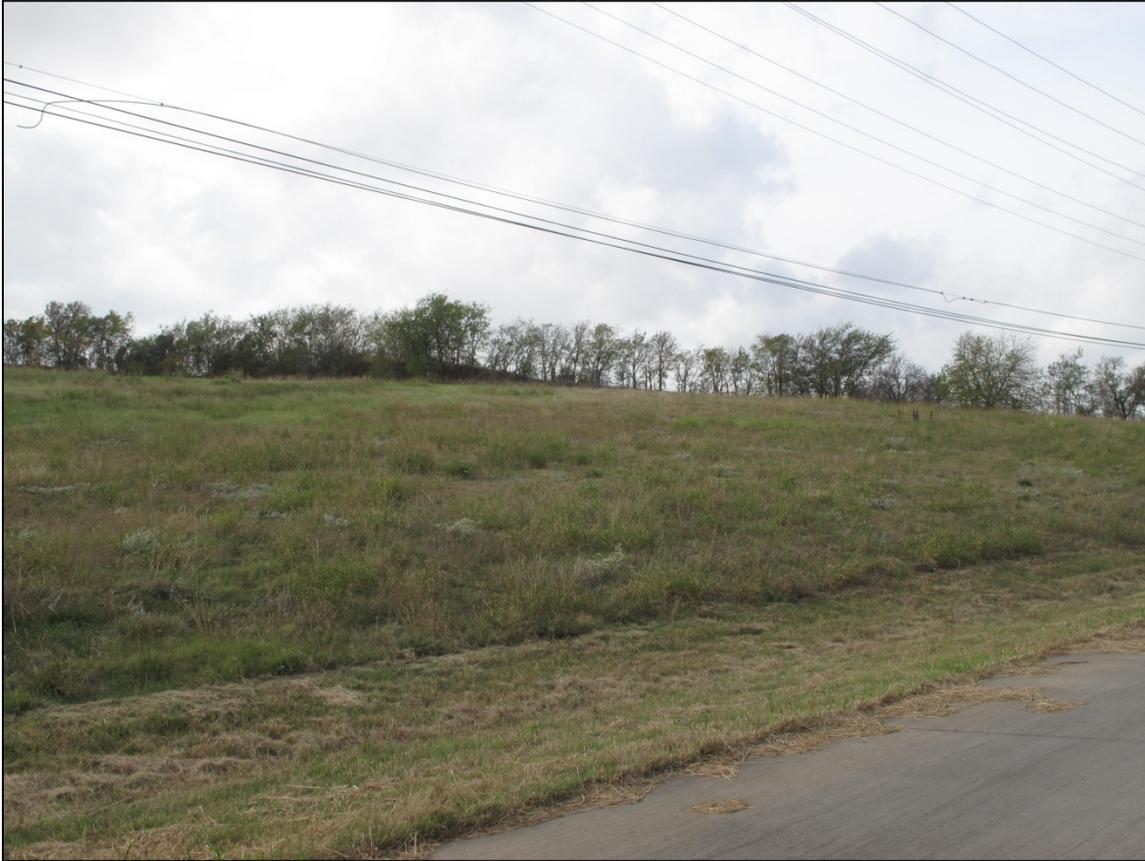
**Photo 13** Standing on Crystallizer Rd. Way looking southwest. The former Shooting Range Berm is visible in the background.

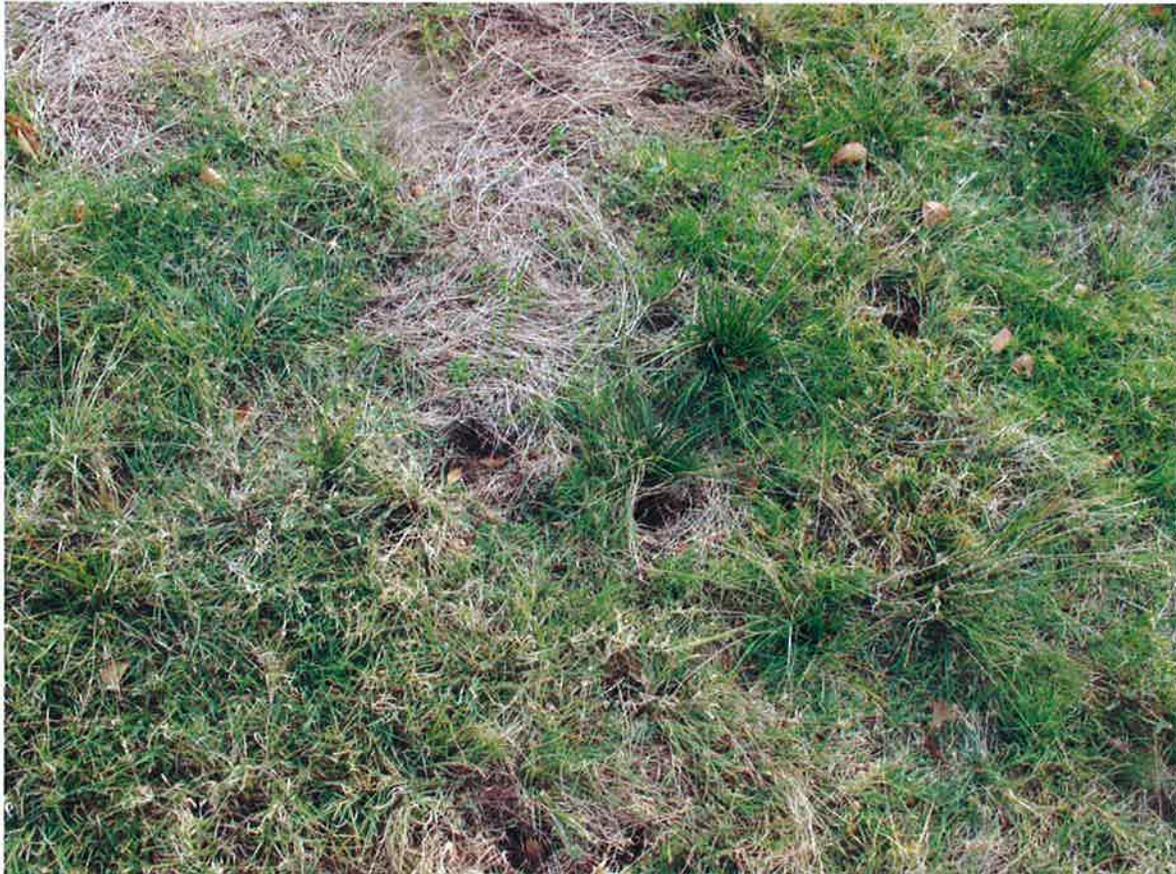
**Picture 5d.** Standing in the South Disposal Area and showing evidence of burrows or feeding by mammals in the area. These holes were approximately 3 inches in diameter, mostly appears surficial and in the grass bed, and if they extended to the soil, they generally did not extend very far into the soil.

The most common type of disturbance in the cap consisted of animal burrows which occasionally resulted in small pieces of plastic or battery case fragments being brought to ground surface. Only a few areas of the SDA had experienced erosion, depressions, or areas of exposed slag. All 21 disturbances identified were targeted for repairs based upon the cap inspection.

On June 5, 2013 W&M and RSI Remediation Services, Inc. (RSI) initiated SDA cap repair activities by filling each open hole or apparent cap penetration with fine gravel sized bentonite clay. Pin flags marking each disturbance were left in place for later capping with clay soil.

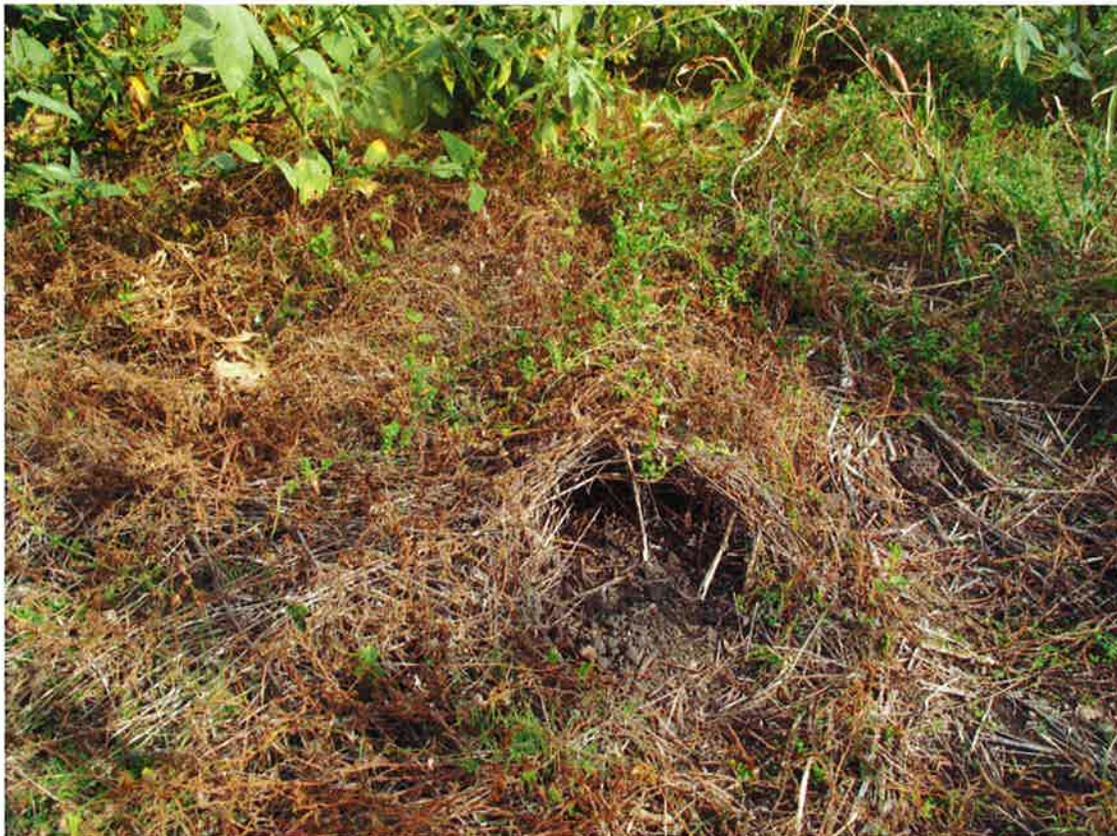
**Picture 7b.** Evidence of larger burrowing mammal in the hayfield in the "Lake Parcel". This hole was approximately 6 to 8 inches across but did not extend very far into the soil.

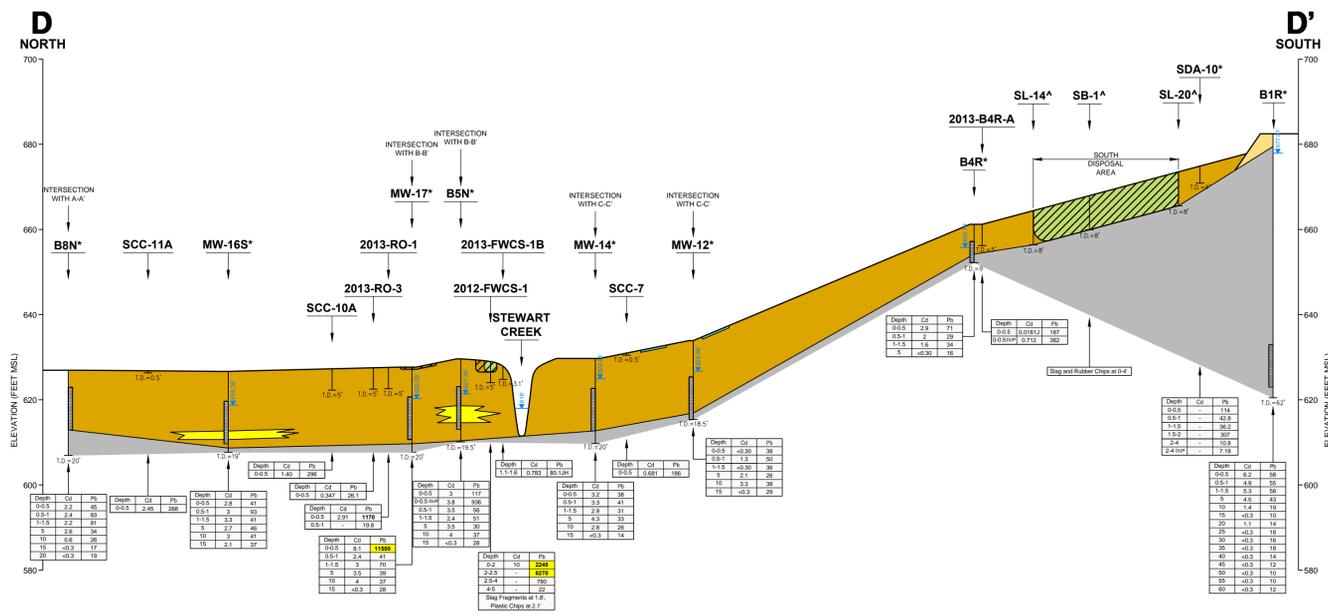
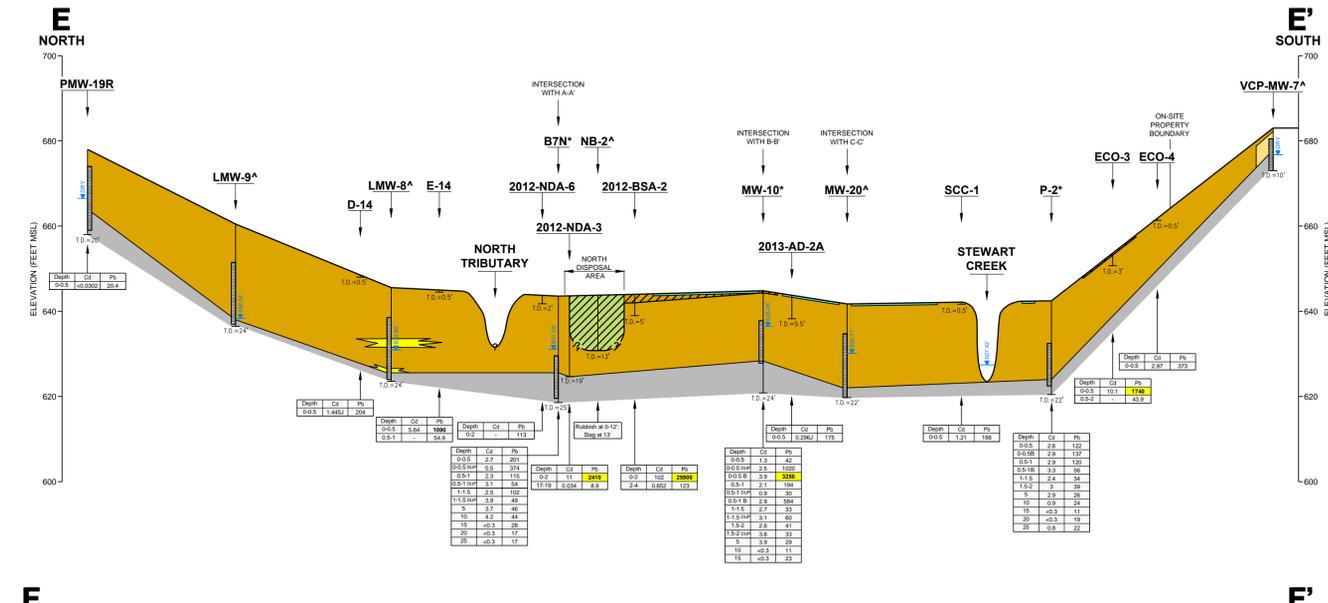
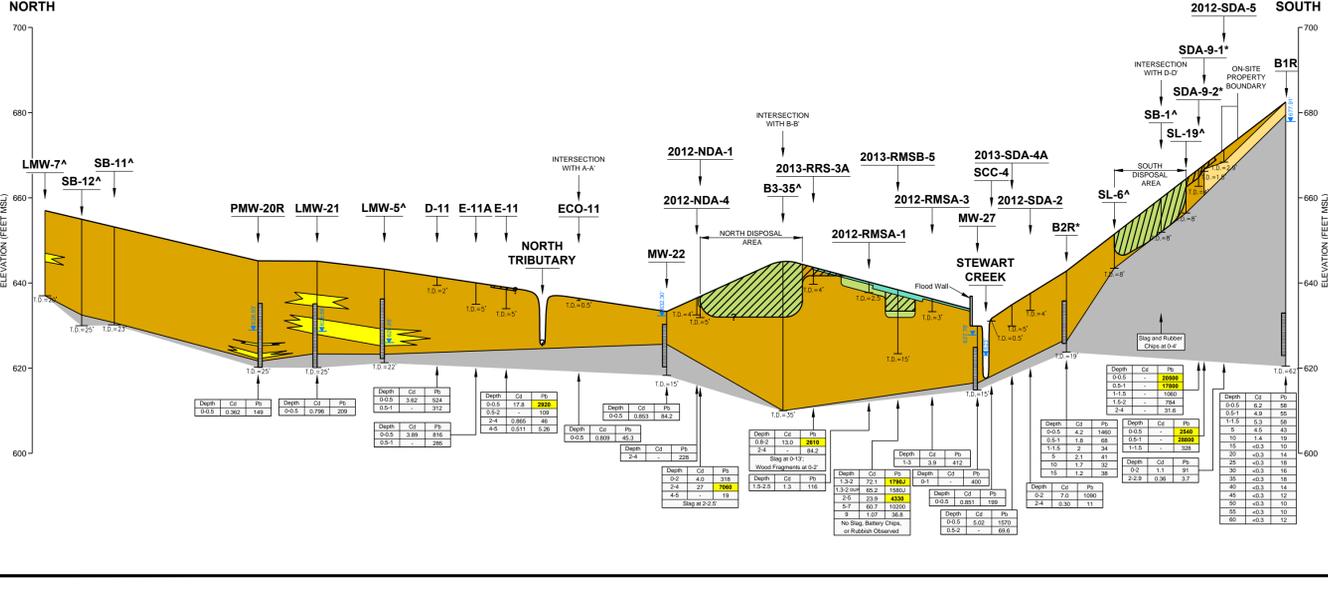
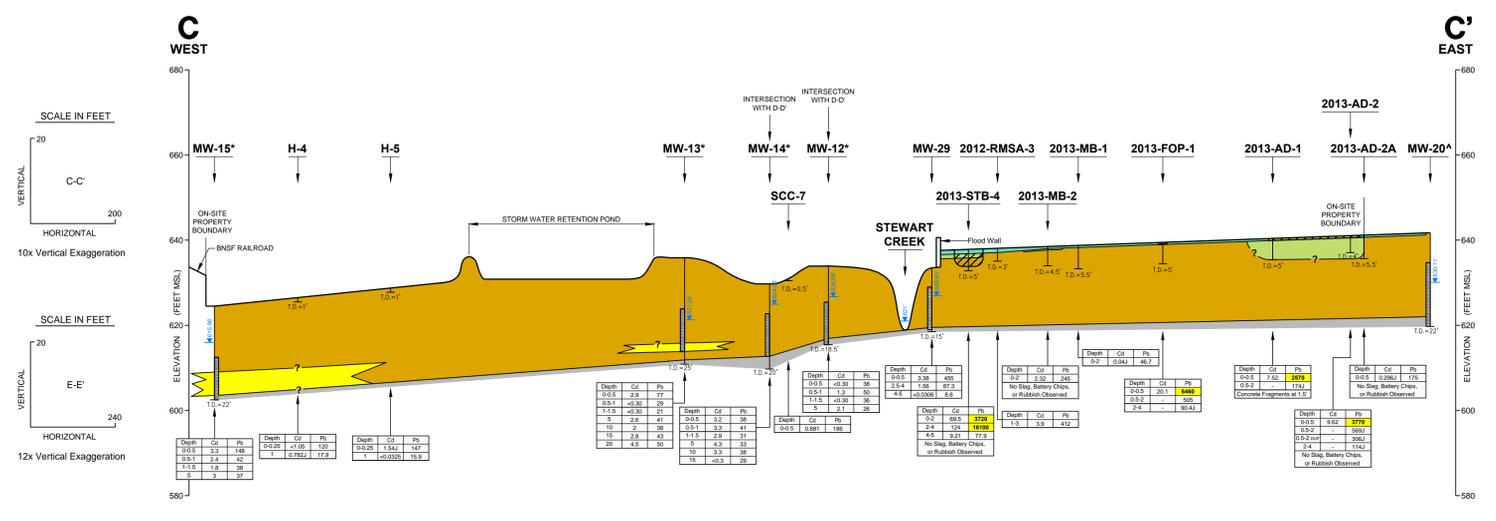
- NOTES:**
- See Figure 4C.1 for cross section locations.
  - Ground surface elevations and creek bed topography are estimated.
  - Monitoring well elevations were surveyed by a professional surveyor.
