# Draft Recreational Use Attainability Analysis for Black Cypress Creek (0410A) in the Cypress Creek River Basin

By Leah Taylor  
Texas Institute for Applied Environmental Research  
Submitted to TCEQ April 2023

Prepared for  
Texas Commission on Environmental Quality  
P.O. Box 13087  
Austin, Texas 78711-3087

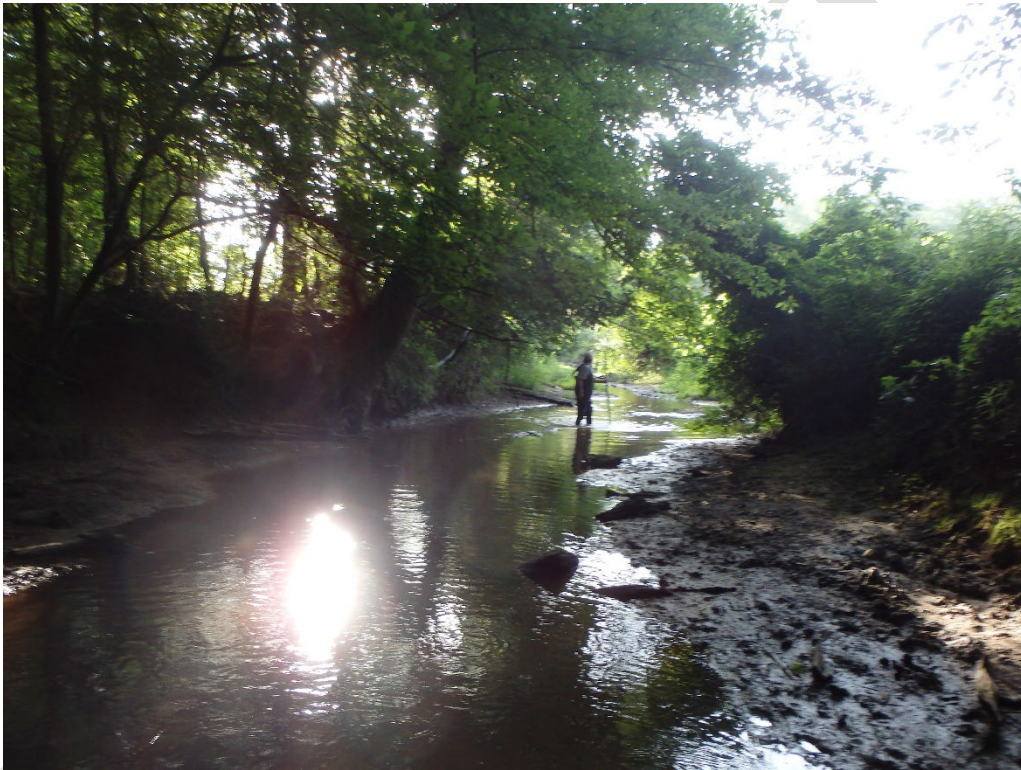
The creek at this site passes through a forest riparian zone that led directly up to the creek. Banks were steep and slippery and with thick vegetation. The general appearance of the creek at this location is shown in Figures 4.2 and 4.3.

**Figure 4.2** Photograph of Black Cypress Creek Site BC01 taken on June 15, 2022. The upstream view of the 150-m transect. TIAER personnel in the photo.

Site BC01 was wadeable with average thalweg ranging from 0.37 m to 0.30 m between surveys. Figure 4.2 illustrates the typical observed width of the creek at this site, approximately 3.5 m. Widths ranged from 1.0 m to 6.0 m during the two surveys (Tables 4.6 and 4.7).

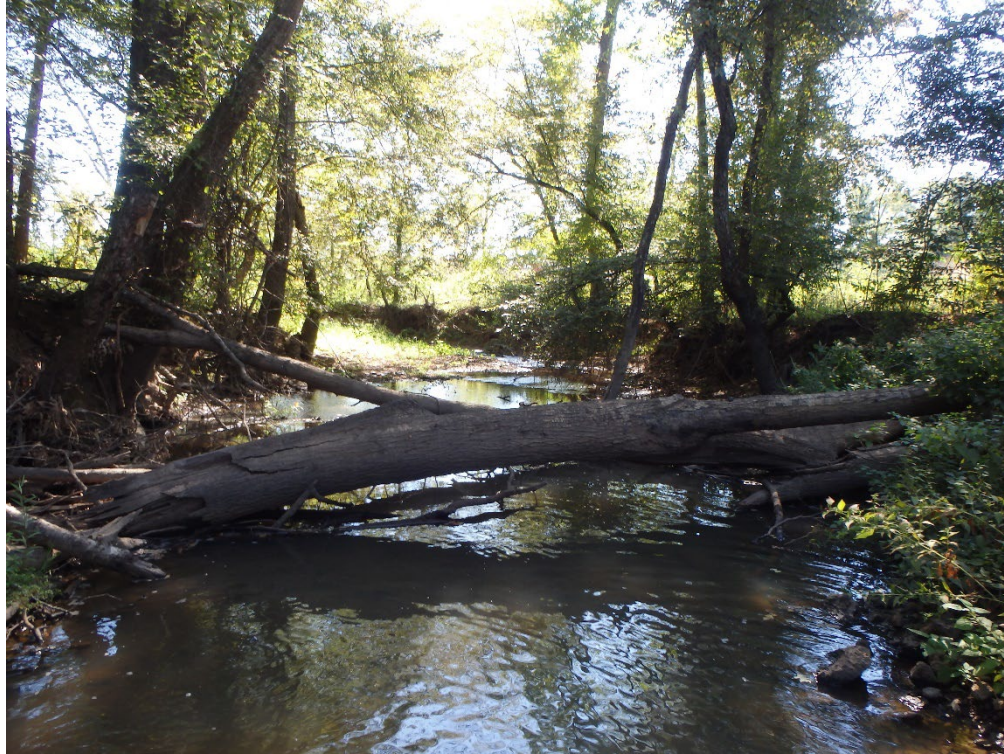
**Figure 4.3** Photograph of Black Cypress Creek Site BC01 taken on September 20, 2022. The downstream view of the 300-m transect

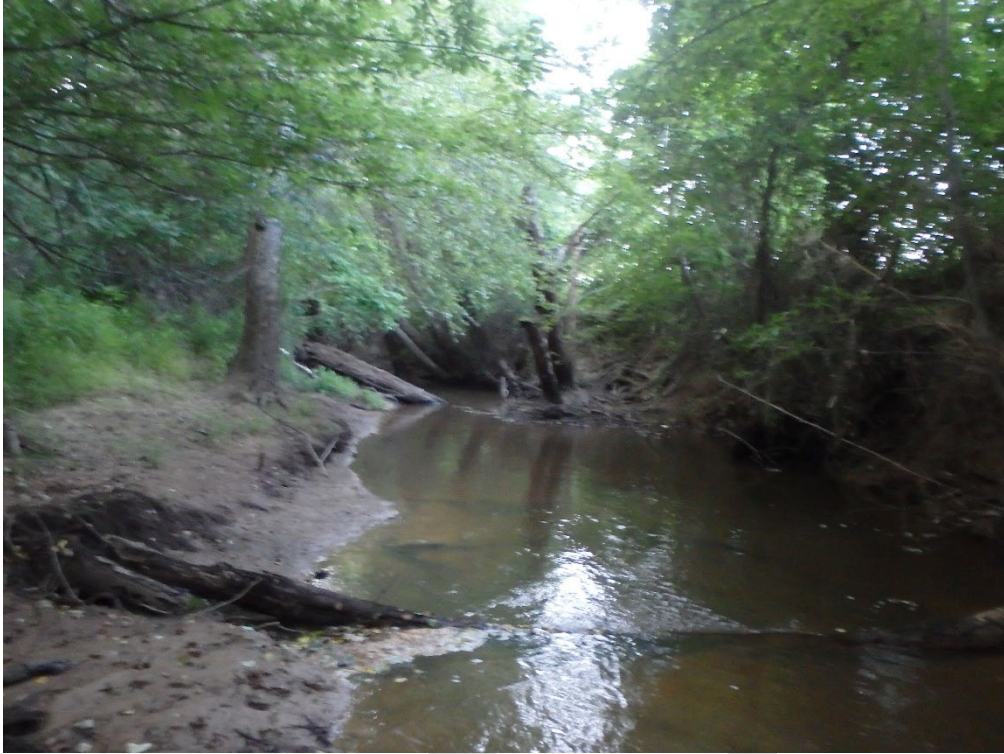
**Figure 4.4** Photograph of Black Cypress Creek Site BC02 taken on June 15, 2022. Photograph shows the downstream view of the 0-m transect.

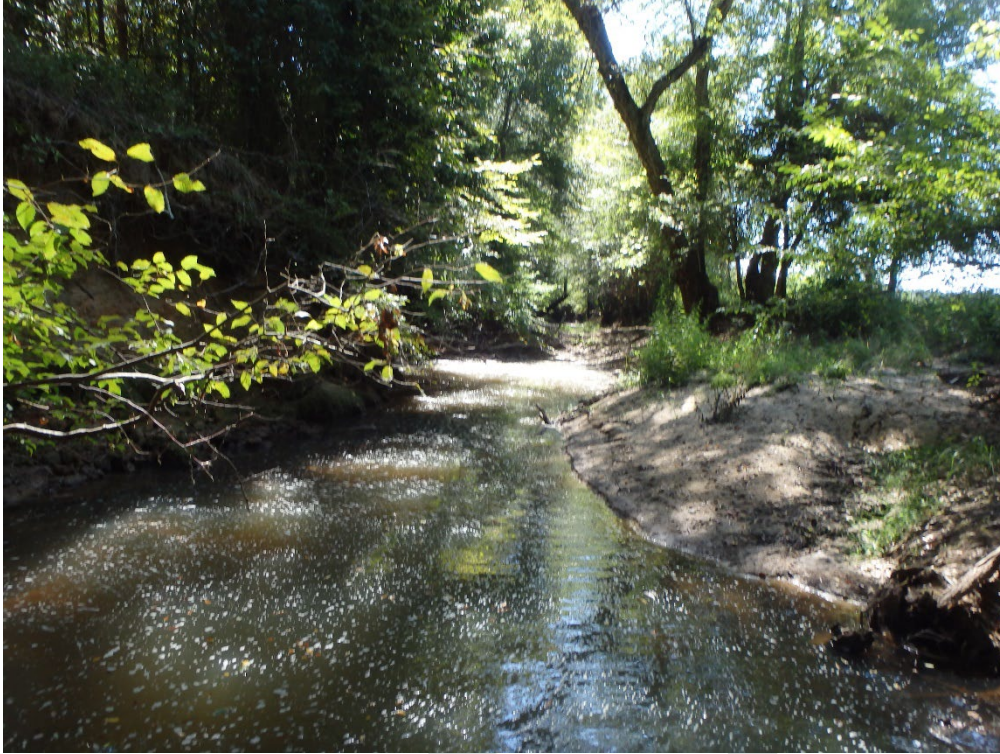
**Figure 4.5** Photograph of Black Cypress Creek at Site BC02 taken on September 20, 2022. Photograph at the 300-m transect facing upstream.

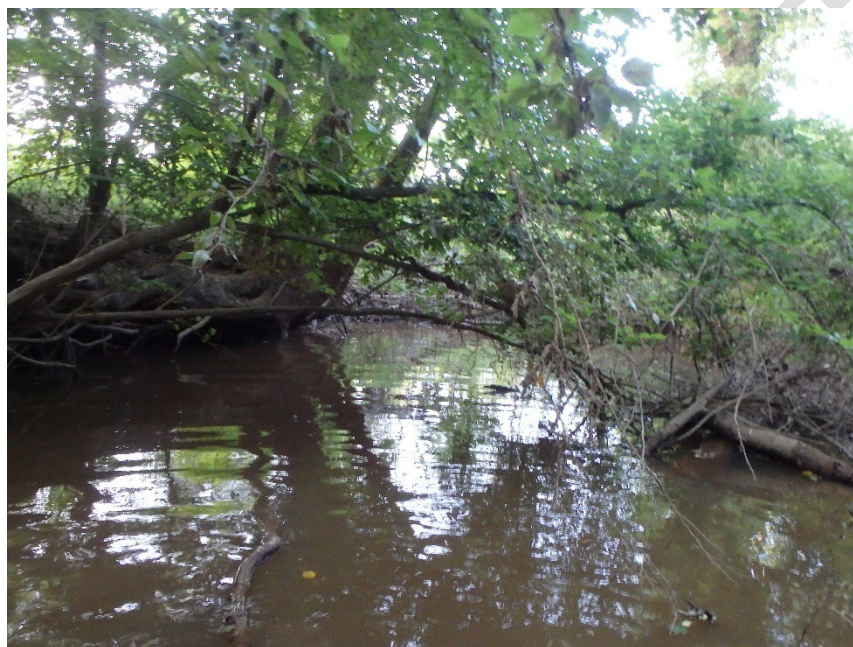
The stream banks were densely vegetated at BC03. Channel obstructions at this site included log jams and tree branches (as seen in Figure 4.6). Aquatic vegetation was absent during the first survey and rare during the second with algae cover absent during both surveys. The water was brown in color with surface scum observed during the second survey.

**Figure 4.6** Photograph of Black Cypress Creek Site BC03 taken on June 15, 2022, the downstream view of the 150-m transect.
