# Draft Recreational Use Attainability Analysis for Lilly Creek (0409A) in the Cypress Creek River Basin

By Leah Taylor  
Texas Institute for Applied Environmental Research  
Submitted to TCEQ January 2022

TIAER Publication TR2021

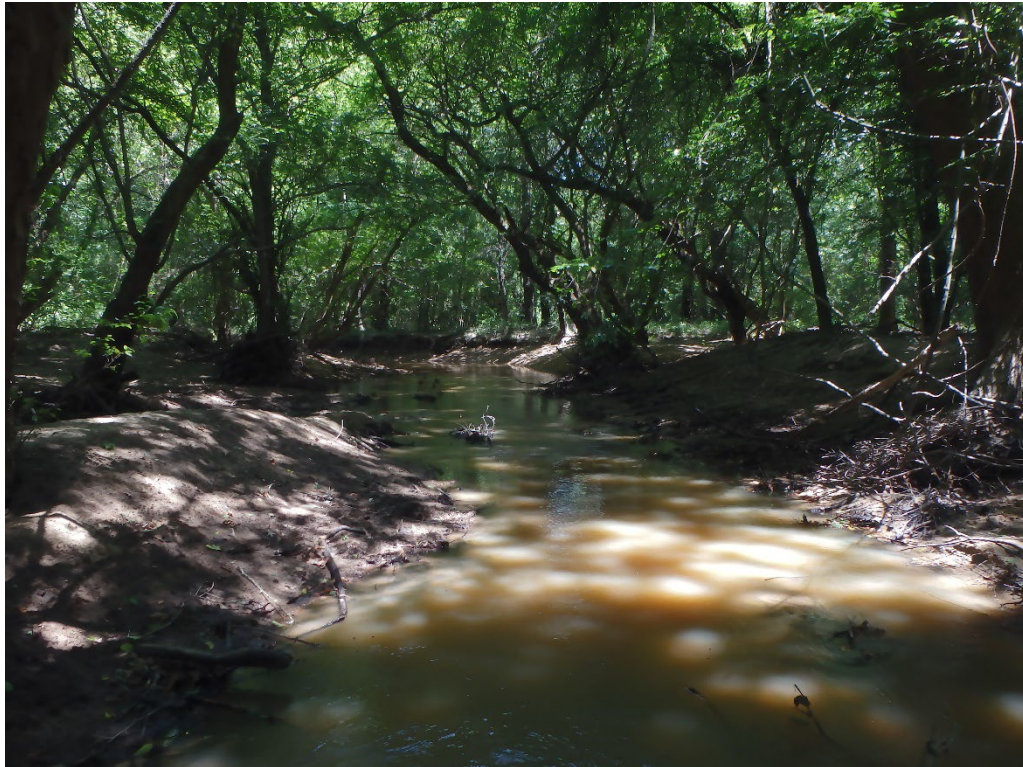
**Figure 4.2 Photograph of Lilly Creek Site LC01 taken on June 22, 2021**

The downstream view of the 150-m transect

Site LC01 was wadeable with average thalweg of 0.33 m during the first survey. Site LC01 was dry at the time of the second survey. Figure 4.2 illustrates the typical observed width of the creek at this site, approximately 3.5 m. Widths ranged from 0 m to 7.3 m during the two surveys (Tables 4.6 and 4.7).

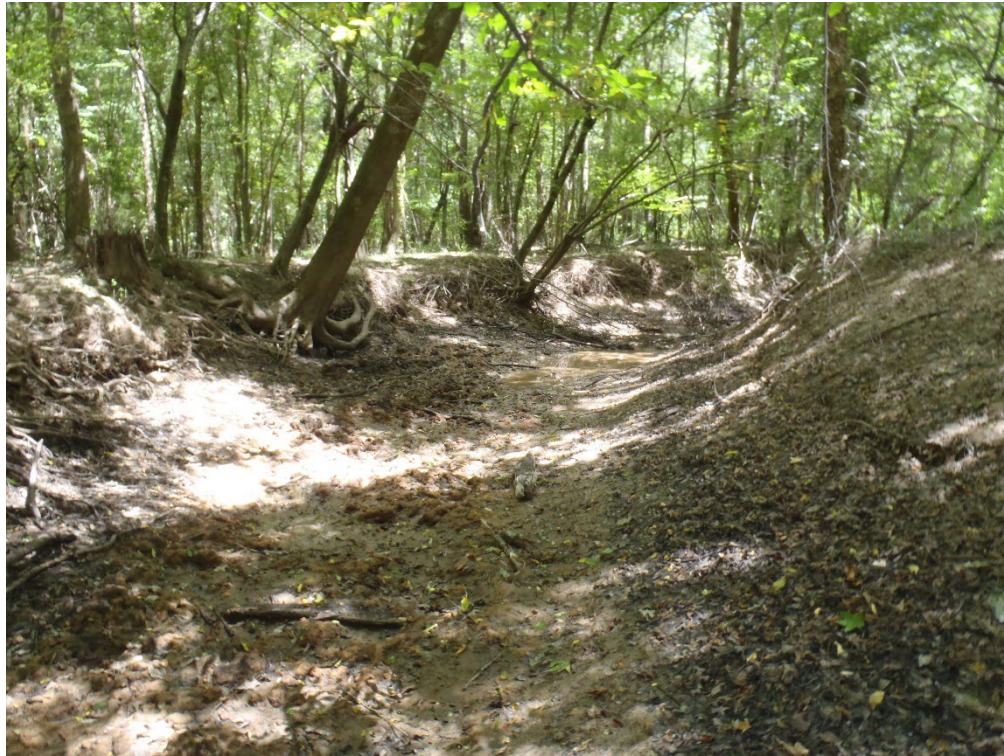
**Figure 4.3** Photograph of Lilly Creek Site LC01 taken on August 24, 2021

The upstream view of the 300-m transect

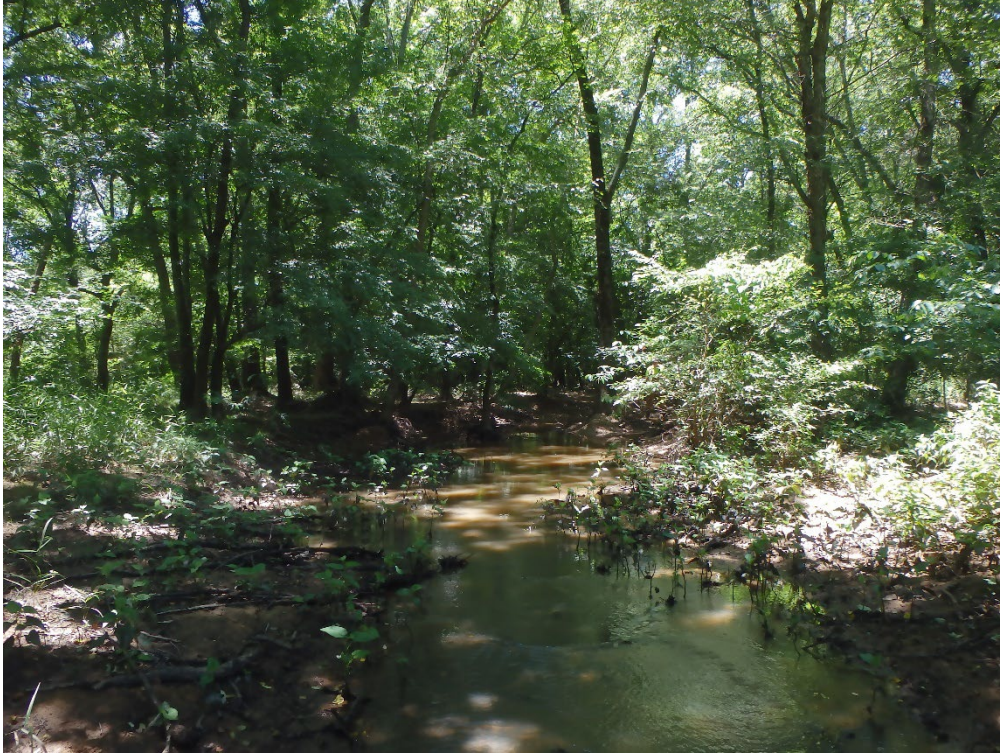
**Figure 4.4** Photograph of Lilly Creek Site LC02 taken on June 22, 2021  
Photograph shows the upstream view of the 0-m transect.

The riparian zone at Site LC02 was forest with thick vegetation and shrub dominated corridor on both the right and left banks (Table 4.4). Banks were vegetated with larger trees and a larger shaded understory (Figures 4.4 and 4.5) throughout this site. The stream was wadeable during both surveys with average thalweg depths ranging from 0.0 m to 0.50 m. The stream at this site had no flow from the 0-m transect to the 180-m transect. The stream was designated as intermittent with perennial pools during both surveys (Table 4.5). Channel widths ranged from 16.3 m to 0 m throughout the reach during both surveys with a typical observed width of 5 m (Tables 4.6 and 4.7).

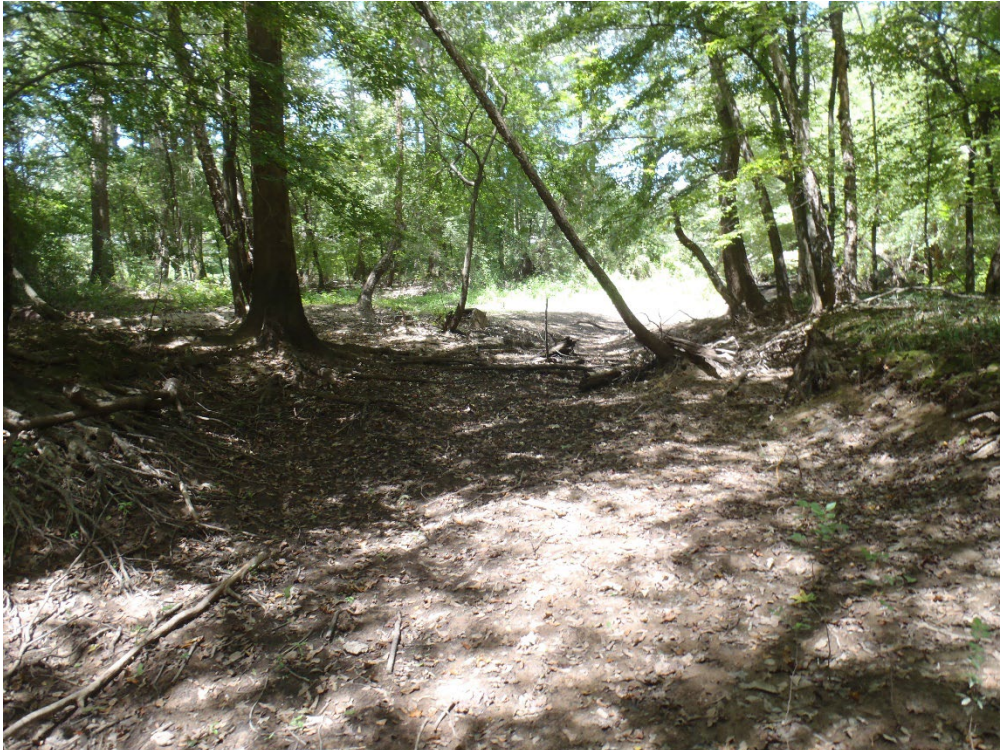
**Figure 4.5** Photograph of Lilly Creek at Site LC02 taken on August 24, 2021  
Photograph at the 150-m transect facing downstream.

No water dependent birds were observed at this site during either survey (Tables 4.8 and 4.9). Bird droppings were observed in addition to raccoon, hog, and deer tracks. No evidence of wildlife was observed in either survey. Aquatic vegetation was rare and algae was absent during both surveys. No odor was detected, water color was brown, and the surface clear during each survey. Tires were observed in the channel during the second survey, but no other garbage was observed during either survey.

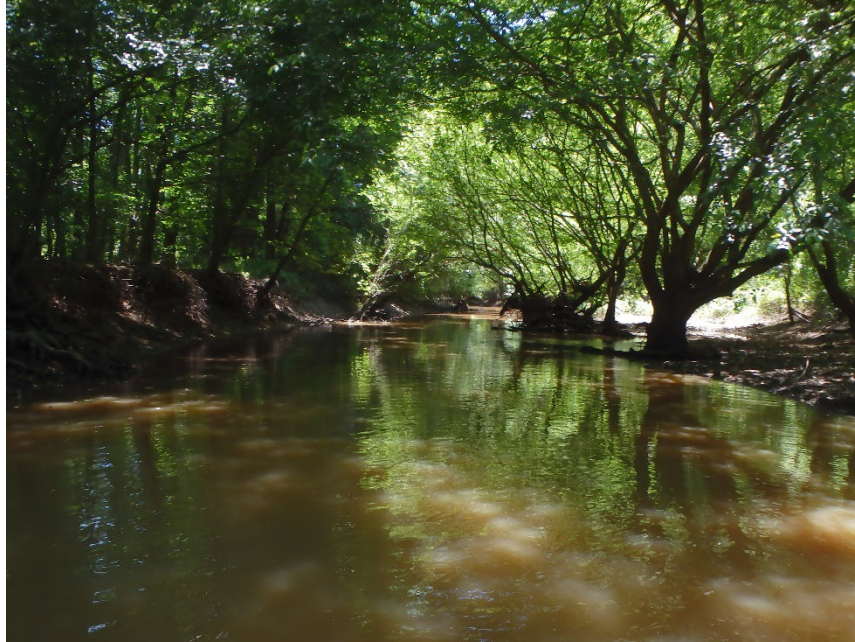
**Figure 4.6** Photograph of Black Fork Creek Site BF03 taken on August 3, 2021, the upstream view of the 150-m transect

The stream banks were densely vegetated (as seen in Figure 4.6) at LC03. Channel obstructions at this site included submerged log jams and tree branches. Additionally, there was a strong odor at this site during the first survey. Aquatic vegetation and algae cover were absent during each survey. The water was brown or tan in color with scum observed during the second survey only.

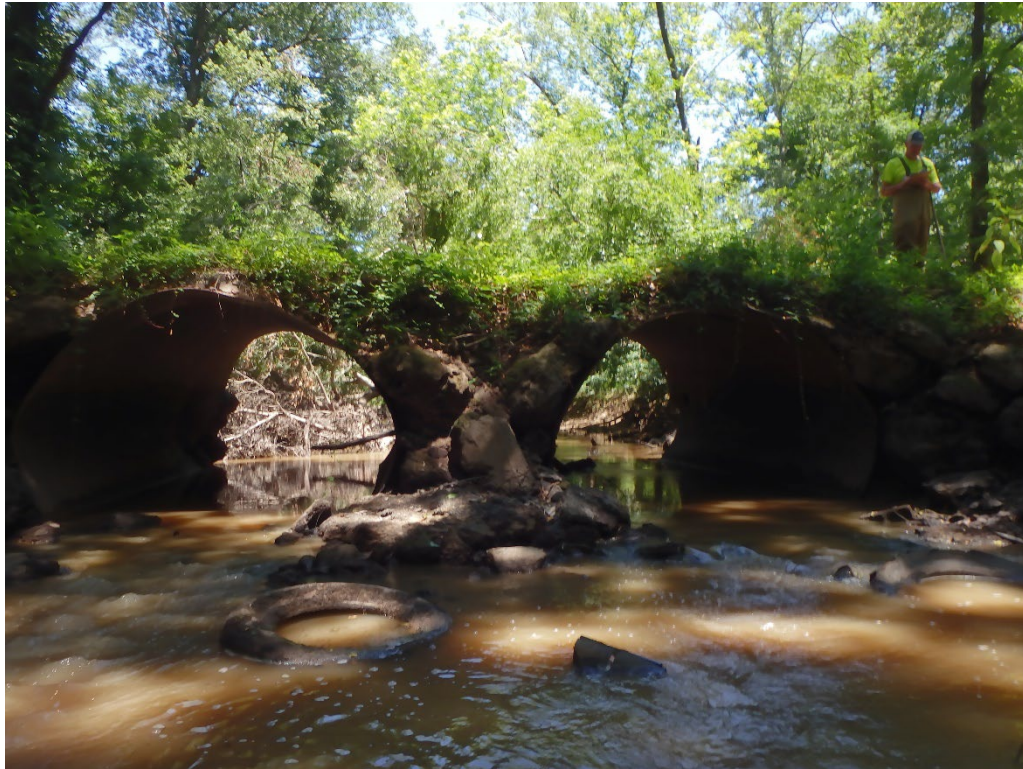
**Figure 4.7 Photograph of Lilly Creek Site LC04 taken on June 22, 2021**

Access to the stream at this site was moderately easy at the road crossing, but because moderately difficult past the road crossing access. The riparian area was forest with thick vegetation and slippery slopes on both the right and left banks (Table 4.4). Banks were steep, slippery, and overgrown with vegetation (Figures 4.7 and 4.8).

The upstream view of the 150-m transect.

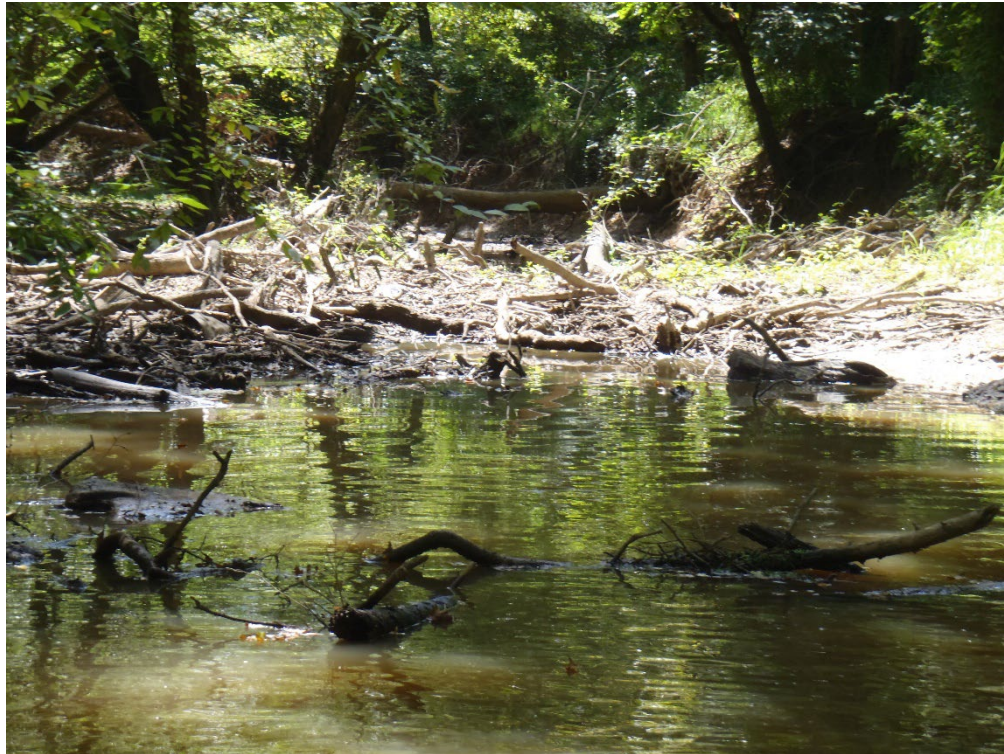
**Figure 4.8 Photograph of Lilly Creek Site LC04 taken on August 24, 2021**

The downstream view of the 0-m transect.

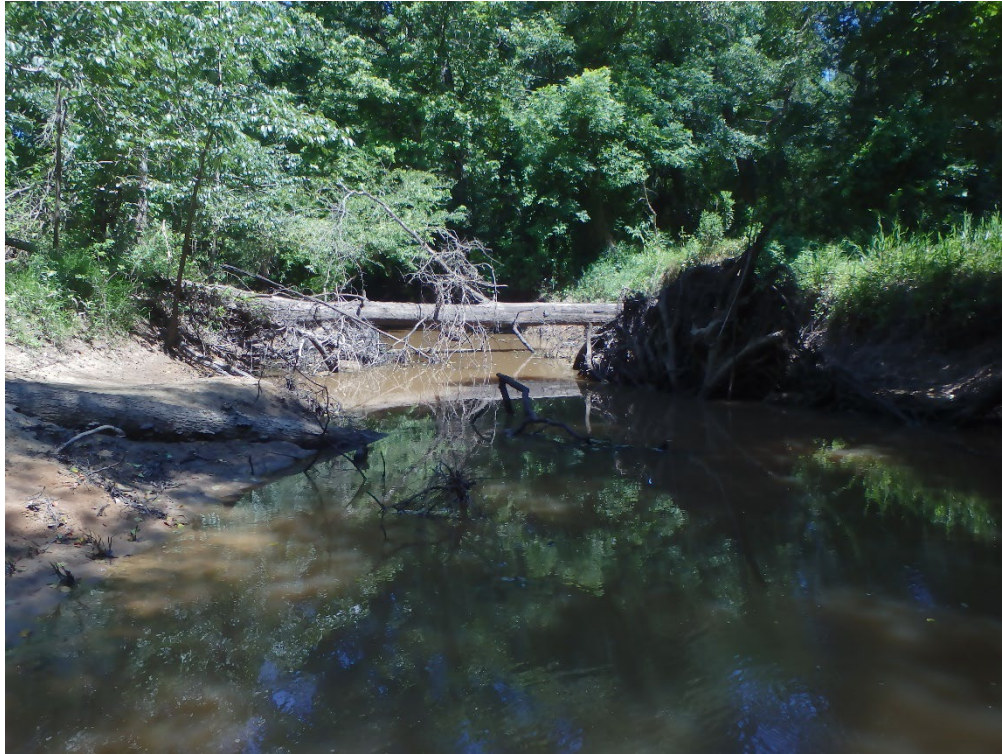
**Figure 4.9** Photograph of pool at Lilly Creek Site LC05 taken on June 22, 2021  
Photograph shows the upstream view of the 300-m transect.

The riparian zone at Site LC05 was forest with thick vegetation along both banks (Table 4.4). The stream was wadeable during both surveys with an average thalweg depths of 0.78 m to 0.63 m between the first and second surveys respectively. The stream is observed as intermittent with perennial pools (Table 4.5). Channel widths ranged from 1.8 m to 8 m throughout the reach during both surveys with a typical observed width of 5 m during the first survey and 6 m during the second survey (Tables 4.6 and 4.7). Figure 4.9 depicts the typical channel width during each survey.

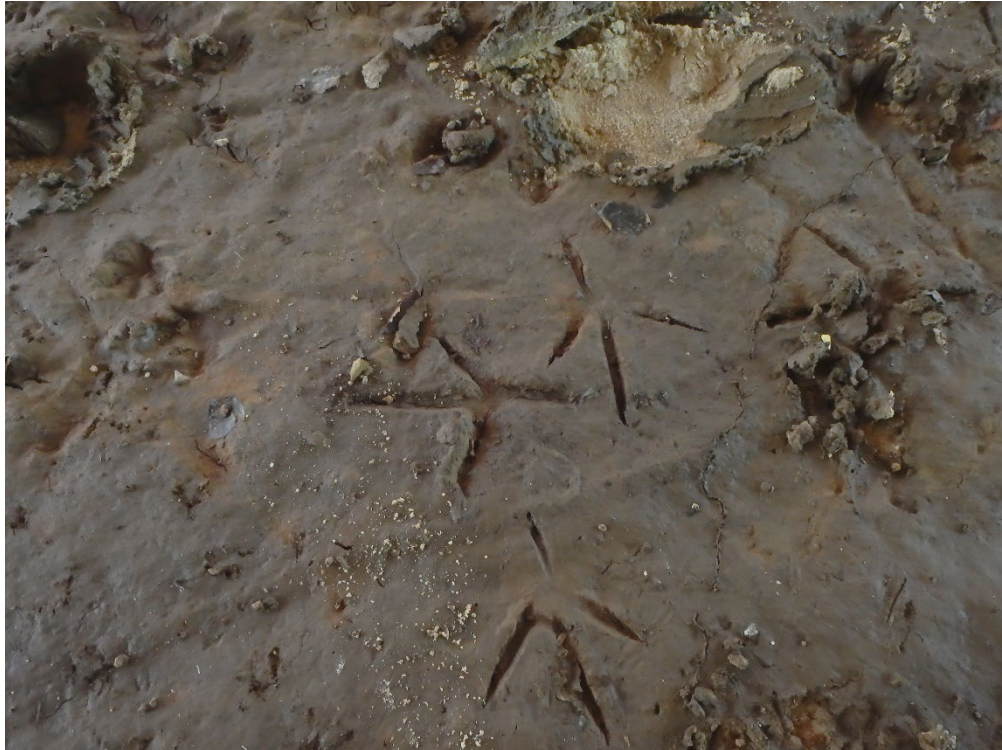
**Figure 4.10** Photograph of Heron Tracks spotted on the banks of Lilly Creek on June 22, 2021

Heron tracks were observed at this site during the first survey (Figure 4.10 and Tables 4.8 and 4.9). Bird droppings were observed in addition to raccoon and hog tracks. Aquatic vegetation was rare during the first survey and absent during the second. Algae cover was absent during both surveys. No odor was detected, water color was brown, and the surface was clear during each survey.

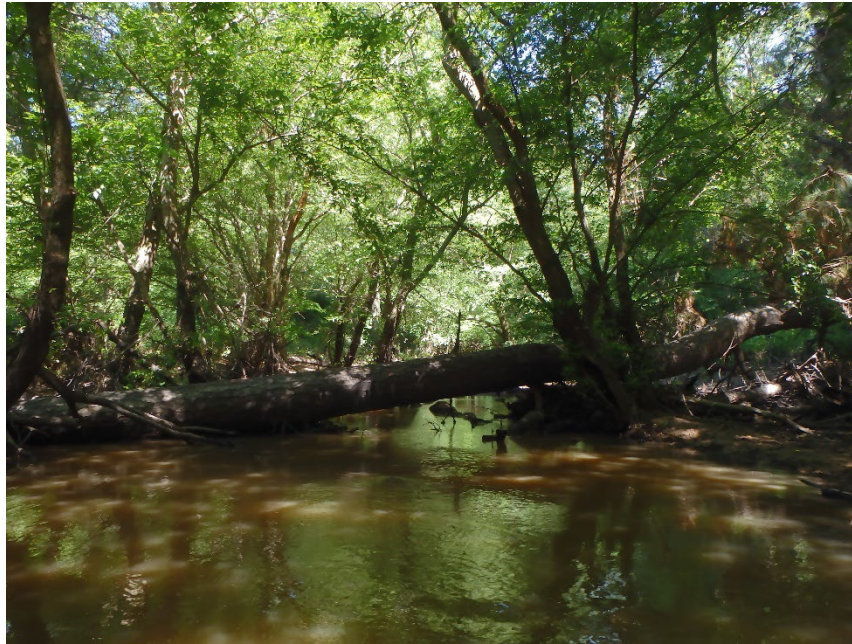
**Figure 4.11** Photograph of Lilly Creek at Site LC06 taken on June 22, 2021, the upstream view of the 0-m transect

The stream banks were densely vegetated (as seen in Figure 4.11) at BF06. The stream channel was populated with downed logs and twig debris during both surveys (Figure 4.12). Aquatic vegetation and algae cover was absent during both surveys. The water was brown in color with a clear surface during both surveys.
