Recreational Use Attainability Analysis for Big Cypress Creek (0405A) in the Cypress Creek River Basin

By Leah Taylor
Texas Institute for Applied Environmental Research
Submitted to TCEQ February 2022

TIAER Publication TR2022

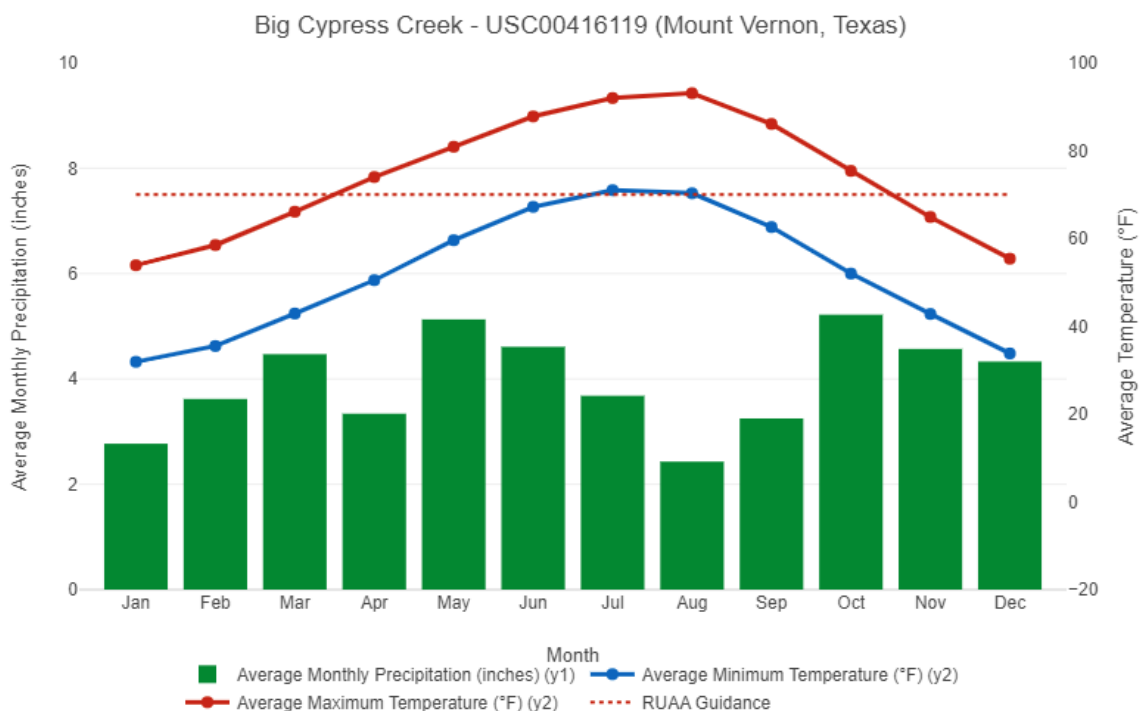
Figure 3.1 Monthly average precipitation for Mount Vernon, Texas

Annual precipitation for the Big Cypress Creek watershed was based on data obtained from the National Oceanic and Atmospheric Administration's website (NOAA, 2015) for Mount Vernon, Texas (Station USC00416119). It is important to note that this station is not within the Big Cypress Creek watershed boundaries. However, it is the nearest station with climate data available for both precipitation and temperature. Normal precipitation (1981-2010) for Station USC00416119 averages 47.42 inches per year with a peak rainfall typically occurring in the months of October and May (Figure 3.1).

Average maximum temperatures for Station USC00416119 rise above 70°F beginning in April and ending in October (Figure 3.1). March through October are the months known as generally suitable for assessing recreational use, but only if temperatures reach above 70°F (TCEQ, 2014b).

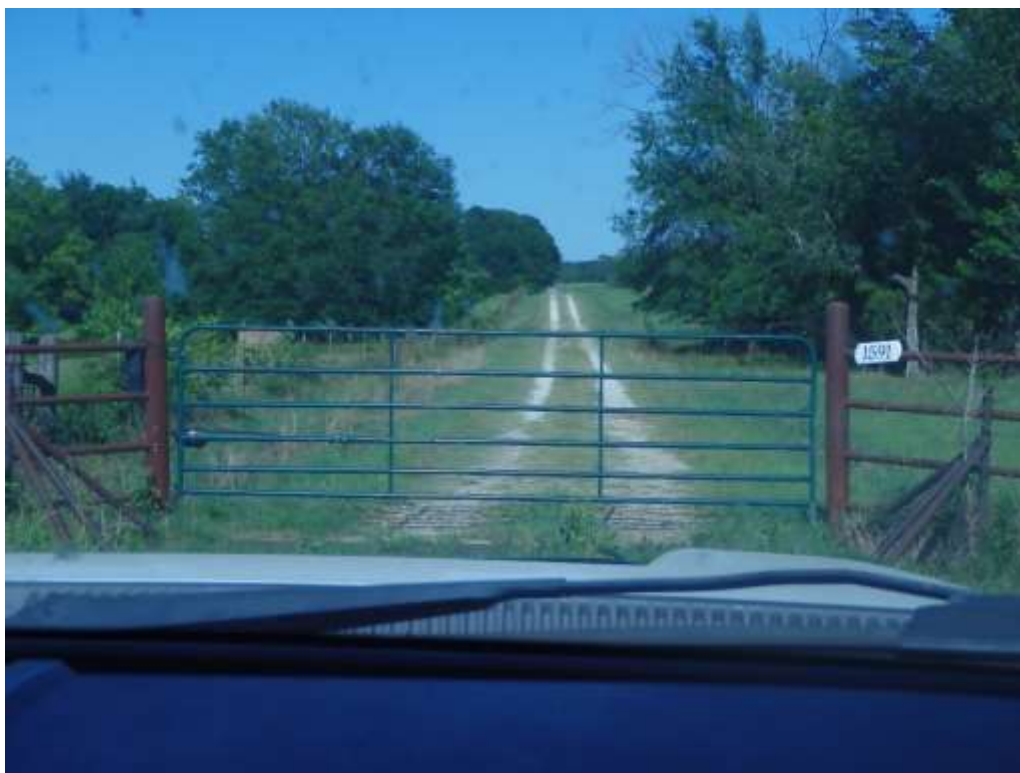
Figure 4.2 Photograph of Big Cypress Creek near Site BC01 taken on June 22, 2021

Big Cypress Creek site BC01 was visited on June 22 and August 24, 2021. This site was located at the crossing on CR 2386 in Franklin County. The site was initially thought to be publicly accessible via the crossing. Upon arrival during the first survey, a gate had been installed at the assumed county road entry and attempts to contact a landowner were unsuccessful. Figure 4.2 shows the gate installed across the road. Figure 4.3 shows the solar panel to power the gate.

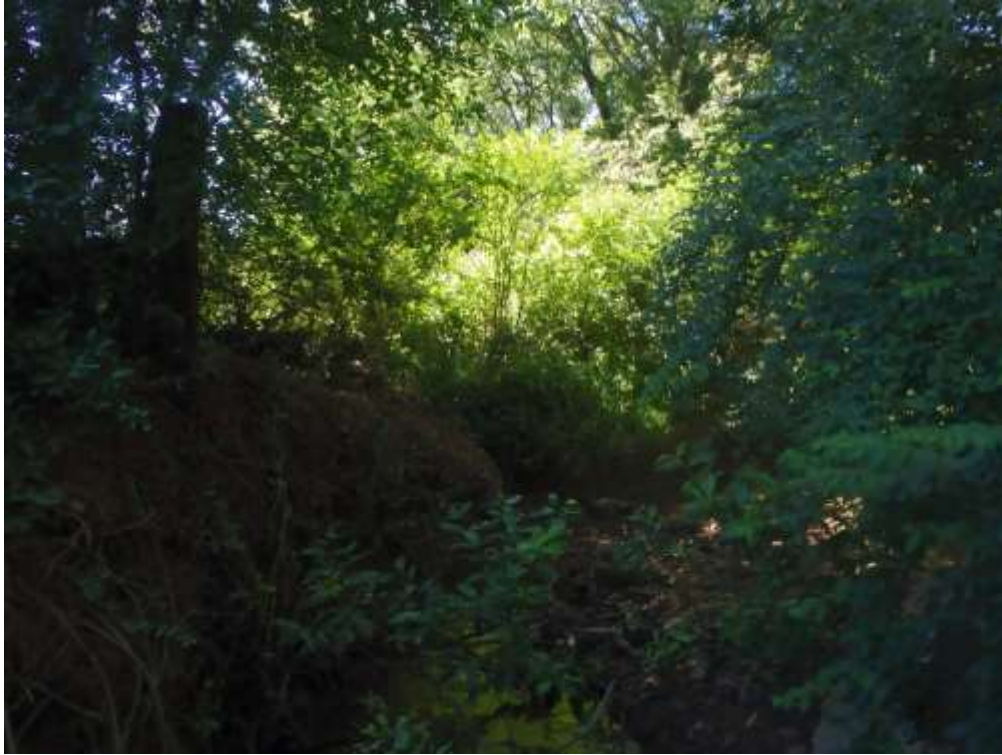
Figure 4.4 Photograph of Big Cypress Creek Site BC02 taken on June 22, 2021

The riparian zone at Site BC02 was forest dominated upstream of the road crossing and pasture dominated downstream of the crossing along both the right and left banks (Table 4.4). The stream was wadeable during each survey with average thalweg depths ranging from 0.21 m to 0.12 m. The stream, designated as intermittent with perennial pools during each survey, was only flowing during the first survey (Table 4.5). Channel widths ranged from a maximum of 2.3 m during the first survey to 0.75 m during the second survey, when the stream was not flowing. Typical observed widths were 1.5 and 0.8 m during each survey (Tables 4.6 and 4.7).

Photograph shows the upstream view of the 150-m transect.

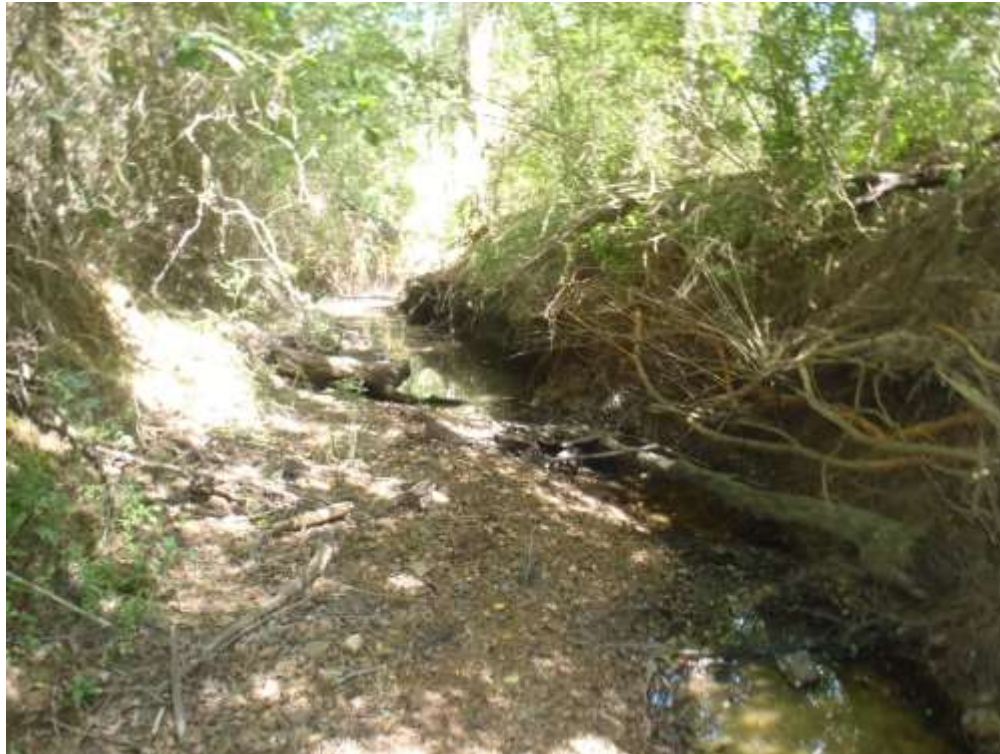
Figure 4.5 Photograph of Big Cypress Creek at Site BC02 taken on August 24, 2021
Photograph at the 300-m transect facing downstream.

No water dependent birds were observed at this site during either survey (Tables 4.8 and 4.9). Bird and canine droppings were observed in addition to raccoon, bovine and canine tracks. No evidence of wildlife was observed in either survey, but two dogs and a few cows were encountered during the first survey. Aquatic vegetation and algae were absent during both surveys. No odor was detected, water color and surface were both clear during each survey. A bucket and some tires were rarely observed during the first survey with no evidence of human recreation observed during either survey.

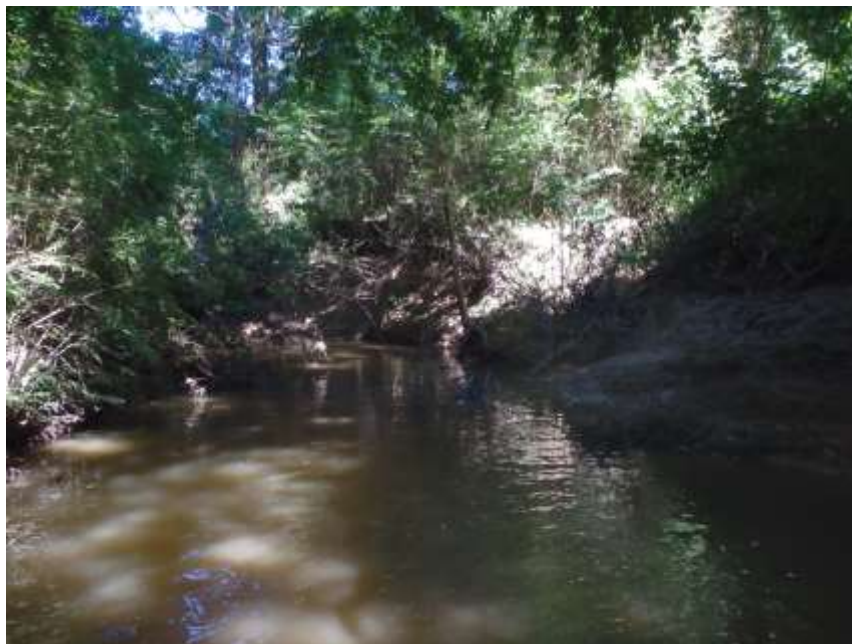
Figure 4.6 Photograph of Big Cypress Creek Site BC03 taken on June 22, 2021

The stream banks were steep and densely vegetated (as seen in Figure 4.6) at BC03. Channel obstructions at this site included log jams and overhanging tree branches. Aquatic vegetation and algae cover were absent during each survey. The water was clear with a bottom deposit of fine sediments and an occasional observance of surface scum.

The downstream view of the 150-m transect.

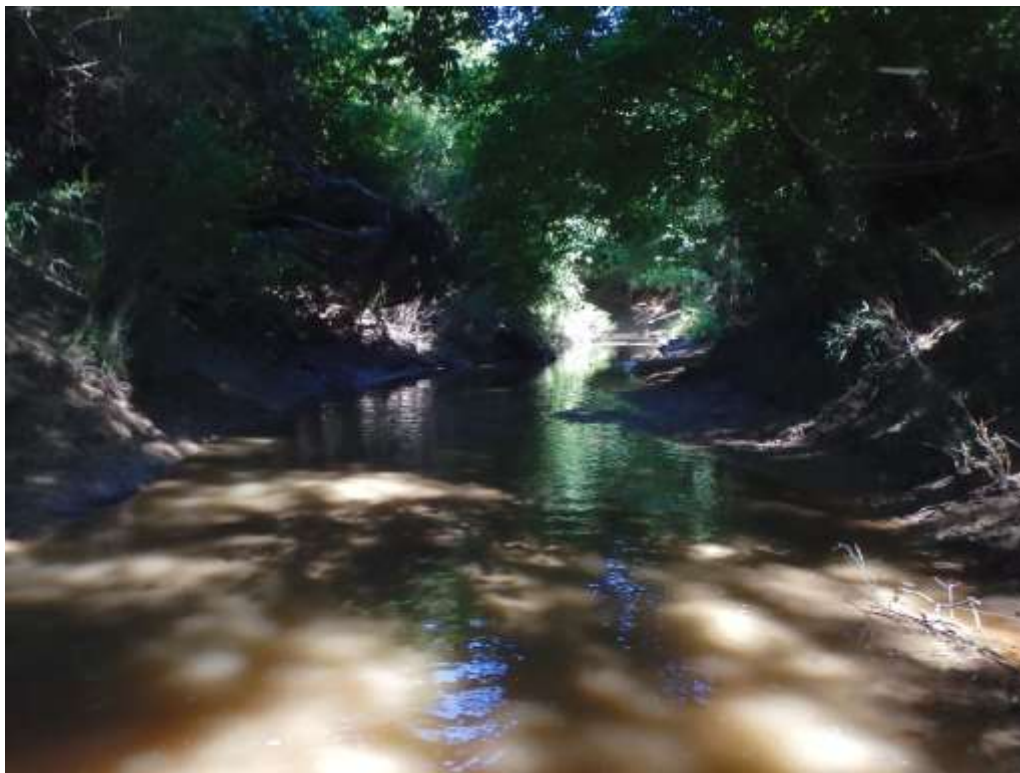
Figure 4.7 Photograph of Big Cypress Creek Site BC04 taken on June 22, 2021

The riparian area was forest and shrub dominated with steep banks and dense vegetation on both banks (Table 4.4 and Figure 4.7). The dominant substrate was a combination of sand, mud and clay depending on the location within the survey reach.

The downstream view of the 150-m transect.

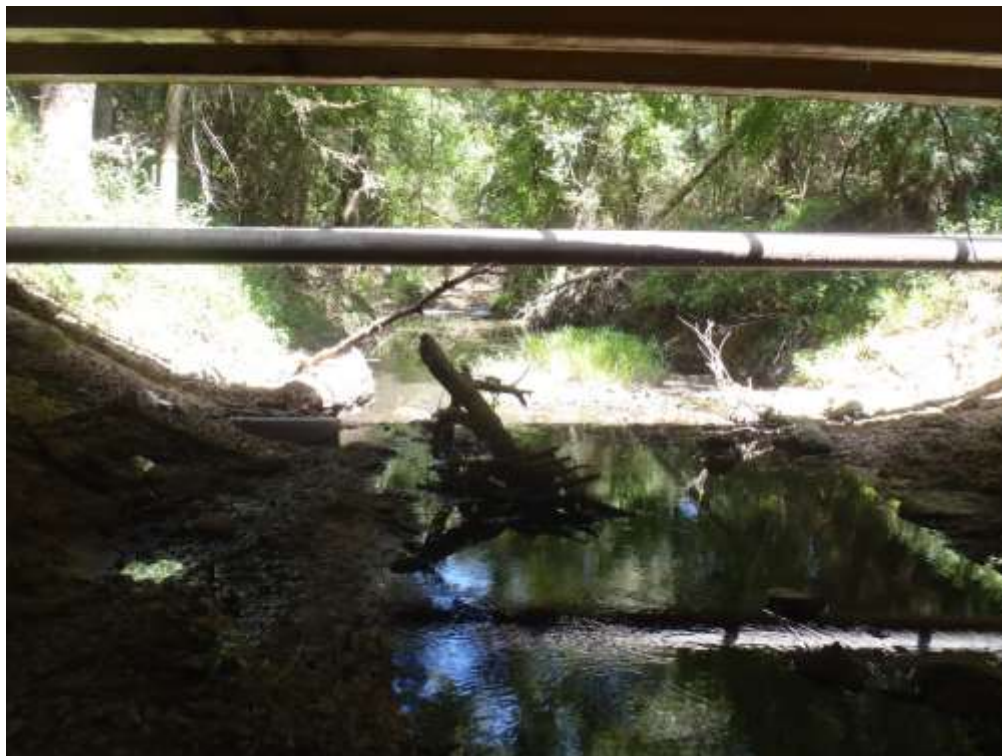
Figure 4.8 Photograph of Big Cypress Creek Site BC04 taken on August 24, 2021

No water dependent birds, mammals or reptiles were observed during either survey (Tables 4.8 and 4.9). Tracks and fecal droppings from birds and raccoons were noted throughout the survey reach. A small pipeline ran underneath the bridge across the stream at the road crossing as depicted in Figure 4.8. Human footprints were also observed during the first survey, but only underneath the bridge. No other evidence of recreation was encountered. Typical household garbage (plastics, glass, cans) was rarely observed in the stream and on the bank during each survey. A television and a few tires were also observed in the stream just downstream of the bridge crossing.

The downstream view of the 150-m transect.

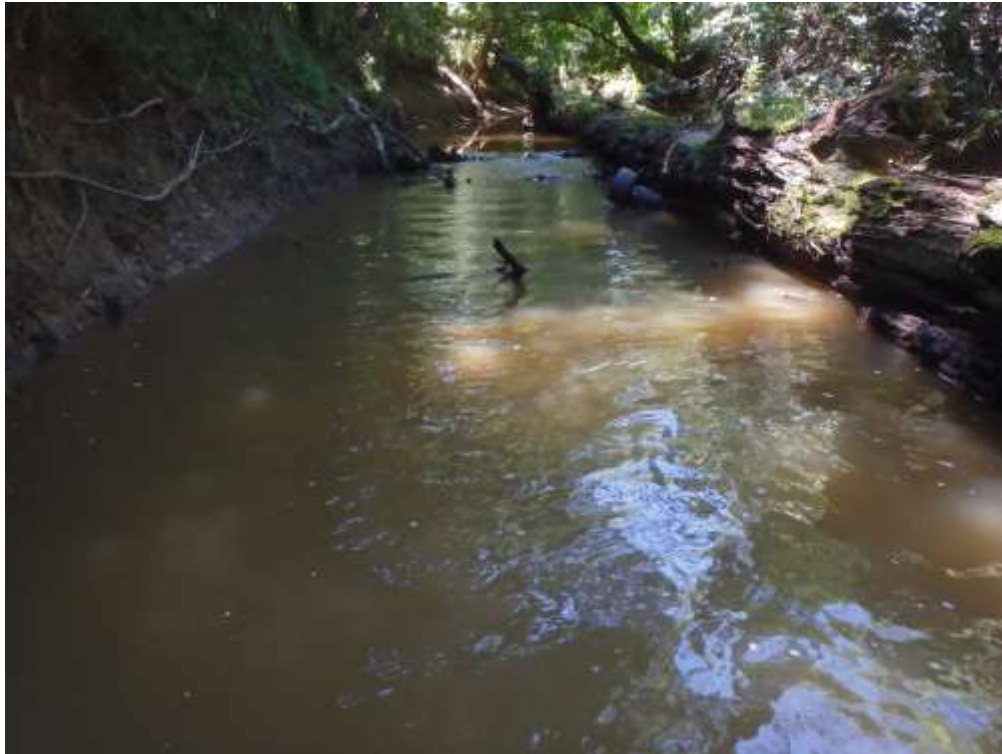
Figure 4.9 Photograph of Big Cypress Creek Site BC05 taken on June 22, 2021

The riparian zone at Site BC05 was forest and shrub dominated with thick vegetation along both banks (Table 4.4). The stream was wadeable during both surveys and observed to be intermittent with perennial pools (Table 4.5). One pool was encountered during each survey with dimensions of approximately 18.0 m long, 8.0 m wide and a maximum depth of 0.90 m. Average thalweg depths were 0.65 m to 0.47 m between the first and second surveys respectively. Channel widths ranged from 1.8 m to 8.5 m throughout the reach during both surveys with a typical observed width of 5.5 m (Tables 4.6 and 4.7). Figure 4.9 depicts the typical channel width during each survey.

Photograph shows the upstream view of the 150-m transect.

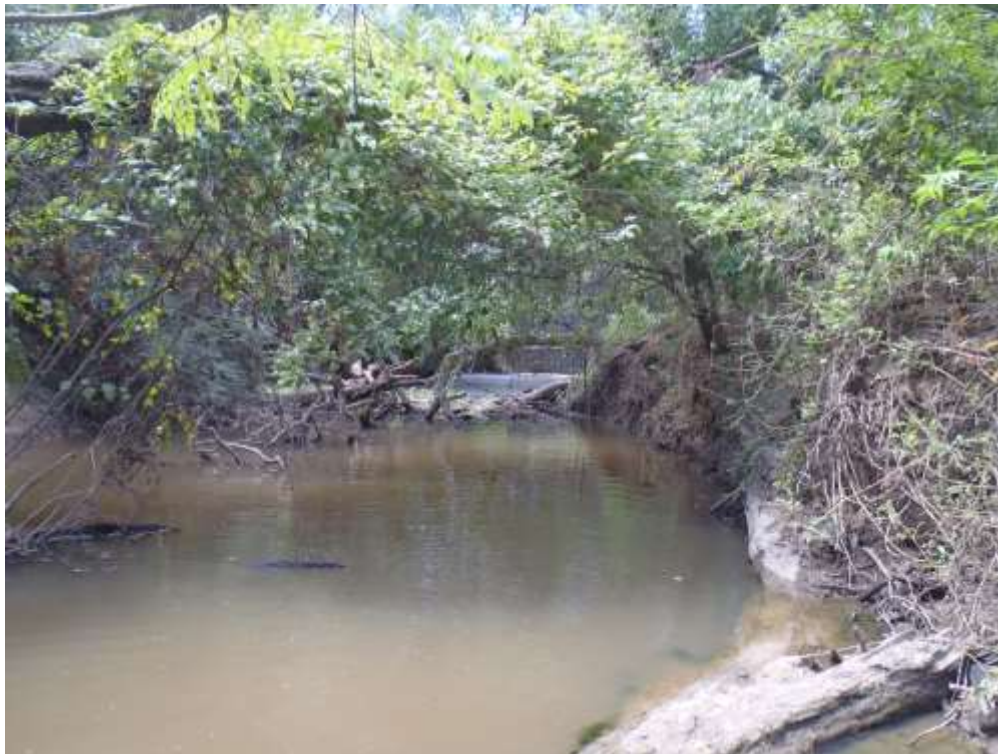
Figure 4.10 Photograph of Big Cypress Creek at Site BC05 taken on August 24, 2021

No water dependent birds, mammals or reptiles were observed at this site during either survey (Tables 4.8 and 4.9). Bird droppings were observed in addition to heron, raccoon and deer tracks. Aquatic vegetation and algae cover was absent during both surveys. No odor was detected, water color was brown, and the surface was primarily with some occasional scum observed near debris piles or log jams. Trash was rarely observed throughout the survey reach and consisted of a motorized toy car and typical plastic cups, bags and bottles, primarily near the road crossing.

Photograph at the 300-m transect facing upstream.
